Preservation Department – Item 7, LPC-20-08722

44-54 9th Avenue/351-355 West 14th Street,

44-54 NINTH AVENUE & 351-355 WEST 14TH STREET

LPC PUBLIC HEARING 06/02/2020

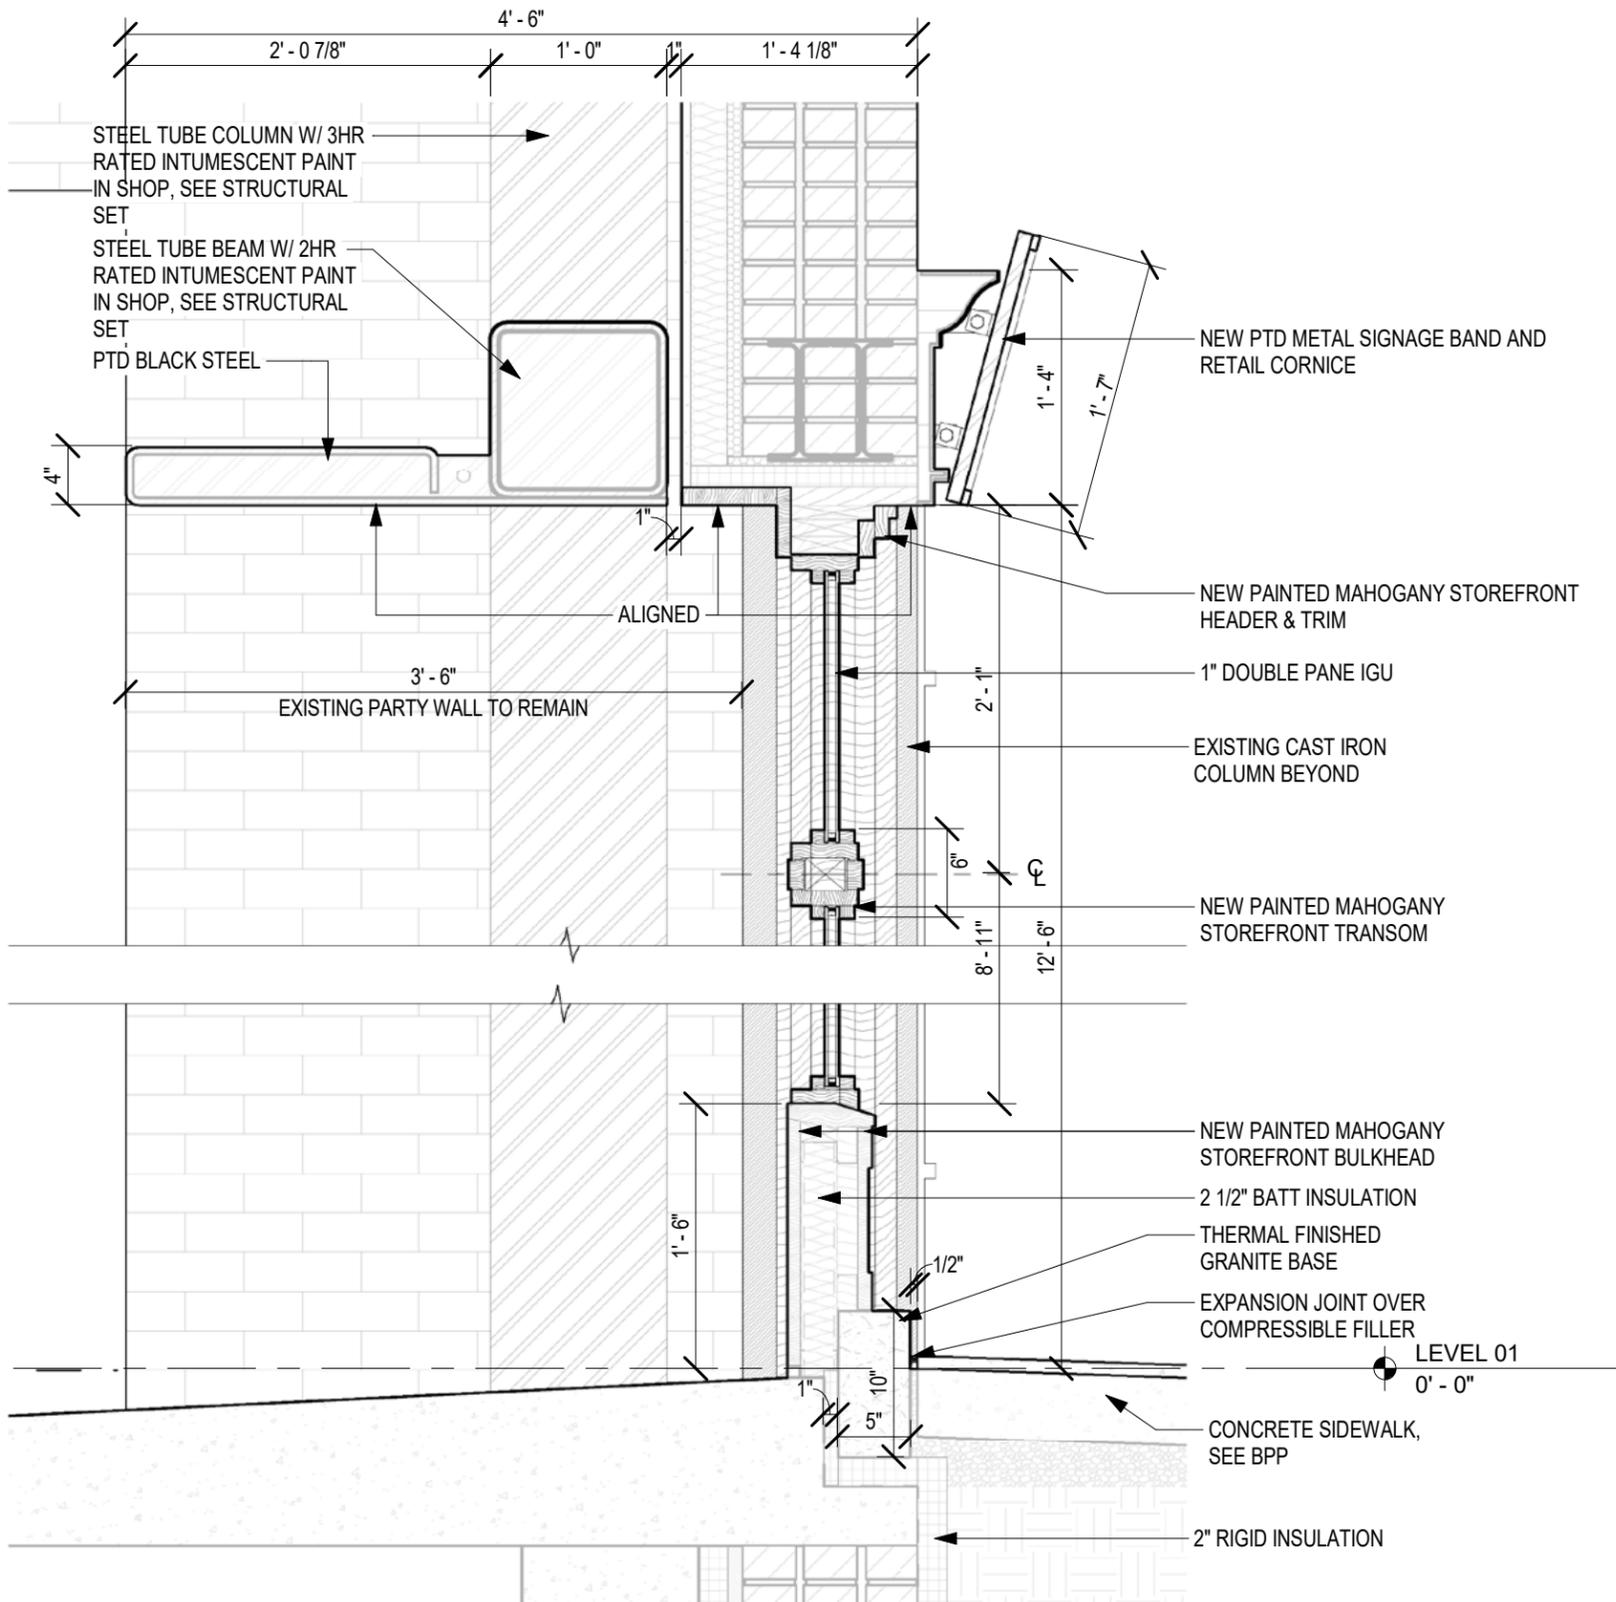
① 14TH ST STOREFRONT DETAIL SECTION
1" = 1'-0"

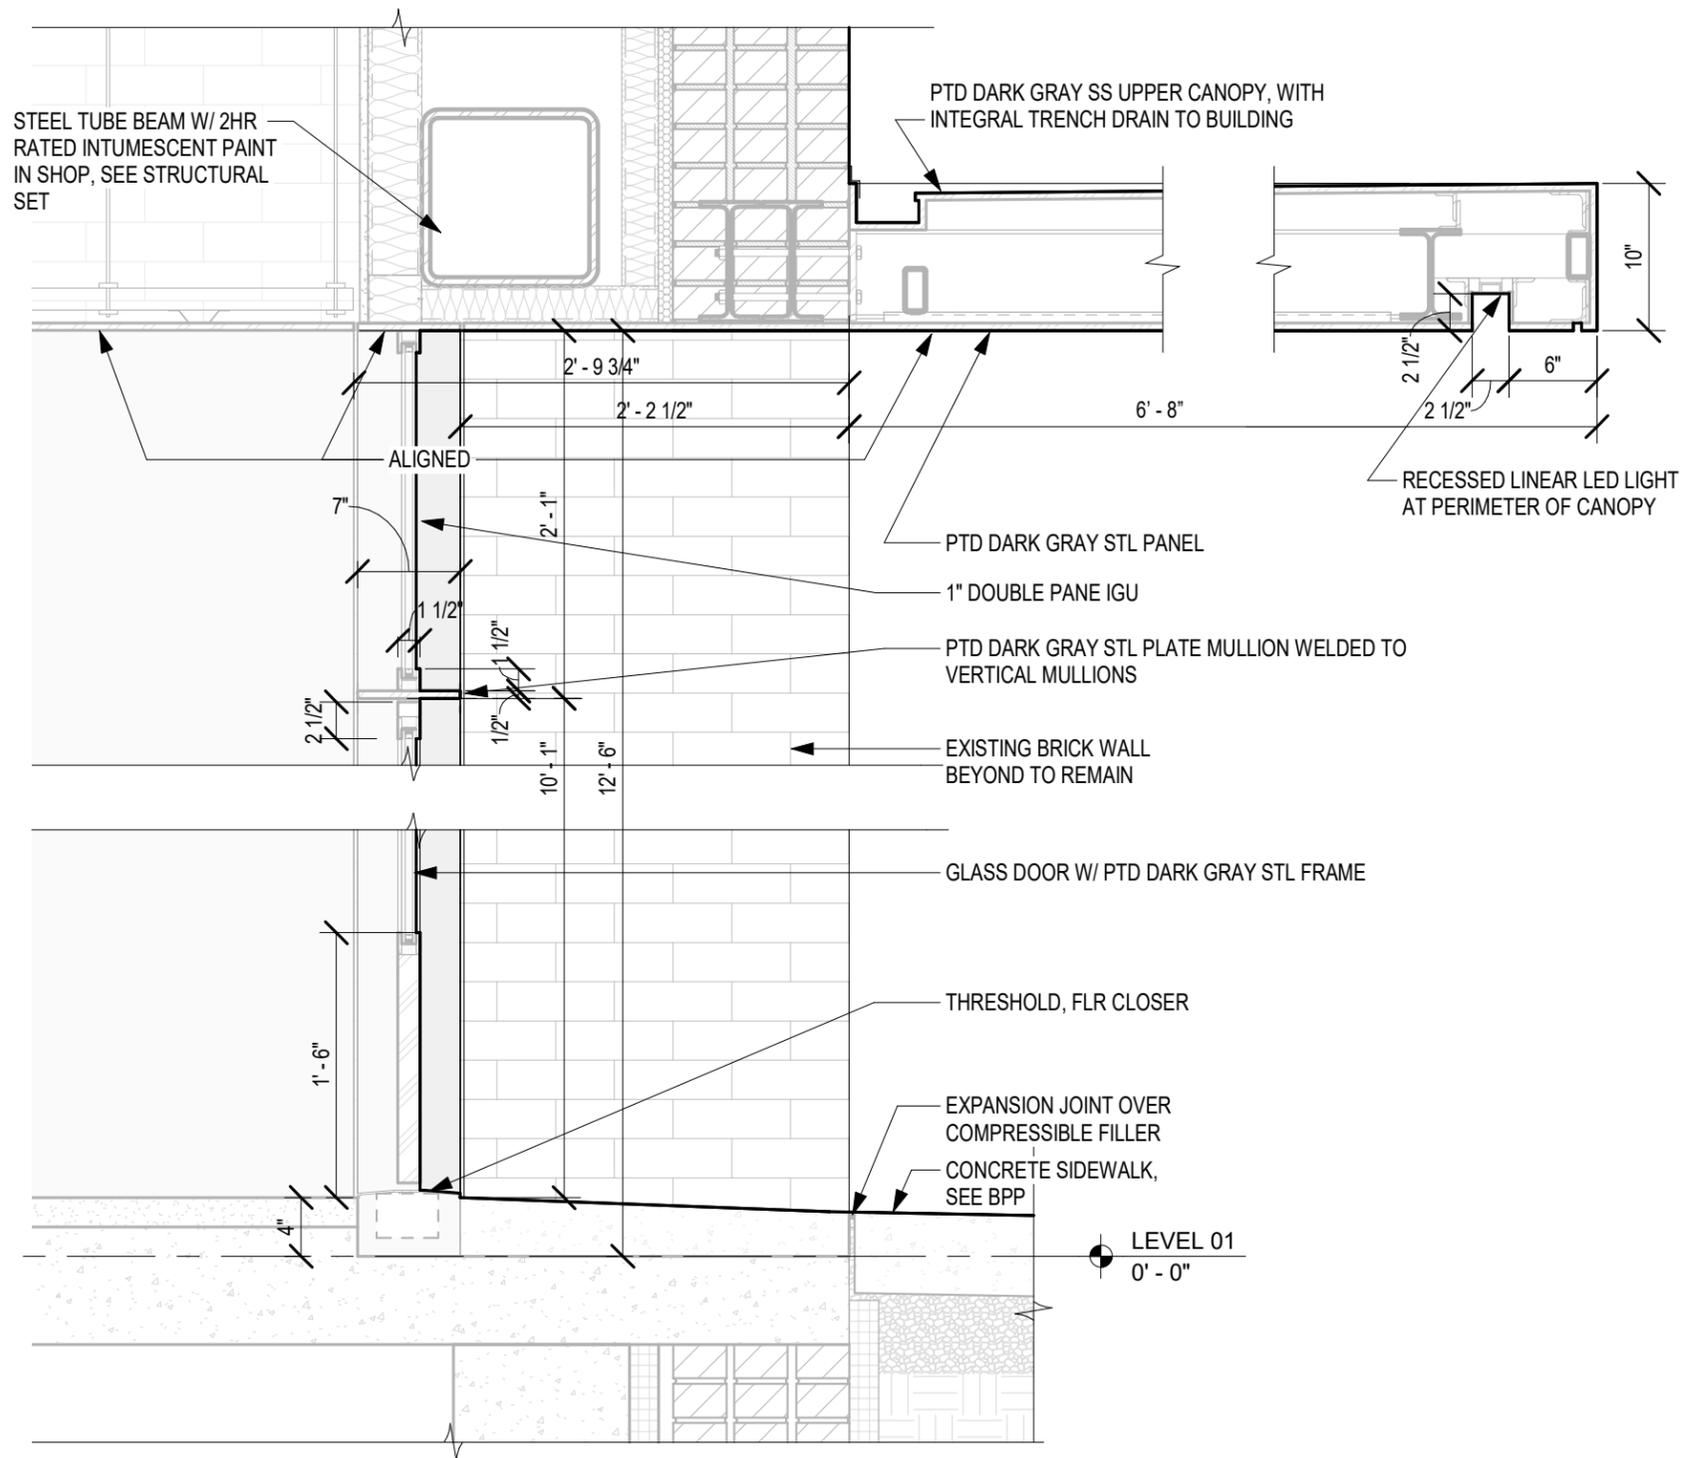
① 14TH ST OFFICE ENTRANCE DETAIL SECTION
1" = 1'-0"

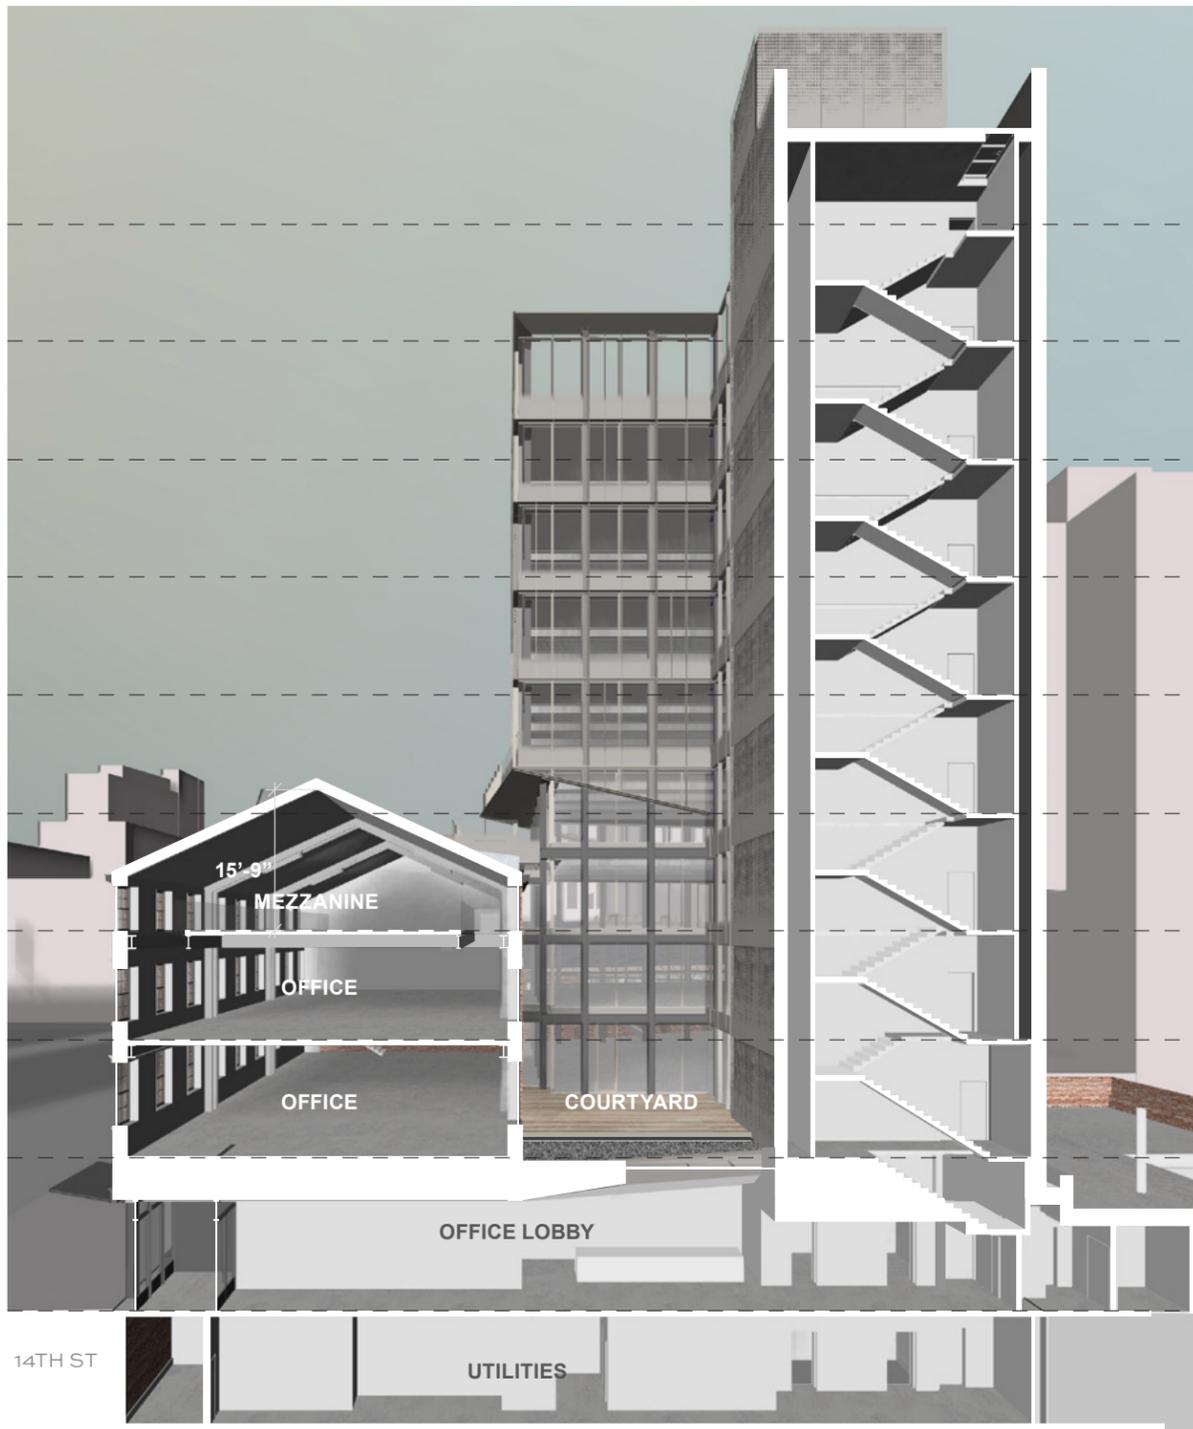
SECTION A
(N-S SECTION LOOKING WEST)

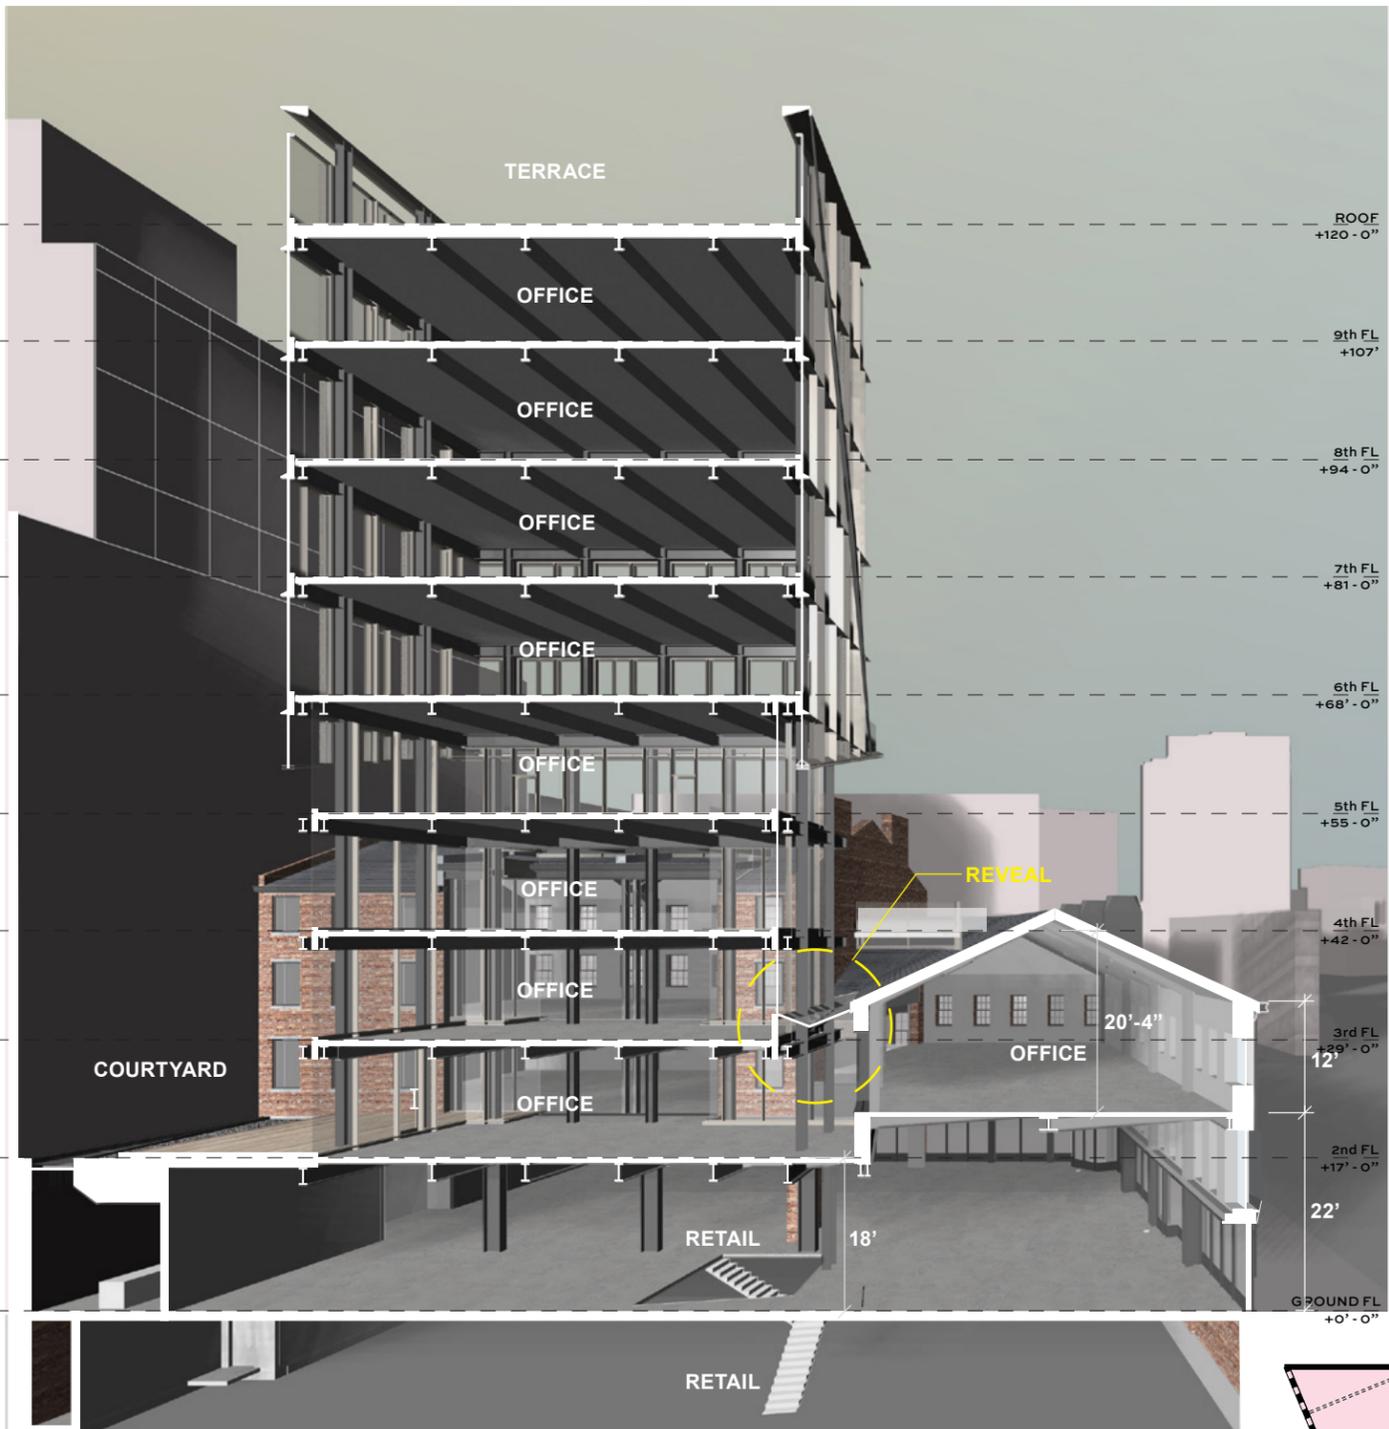
SECTION B
(E-W SECTION LOOKING SOUTH)

ADDITION SET BACK FROM HISTORIC BUILDING TO REVEAL COMPLETE HISTORIC ROOF FORMS

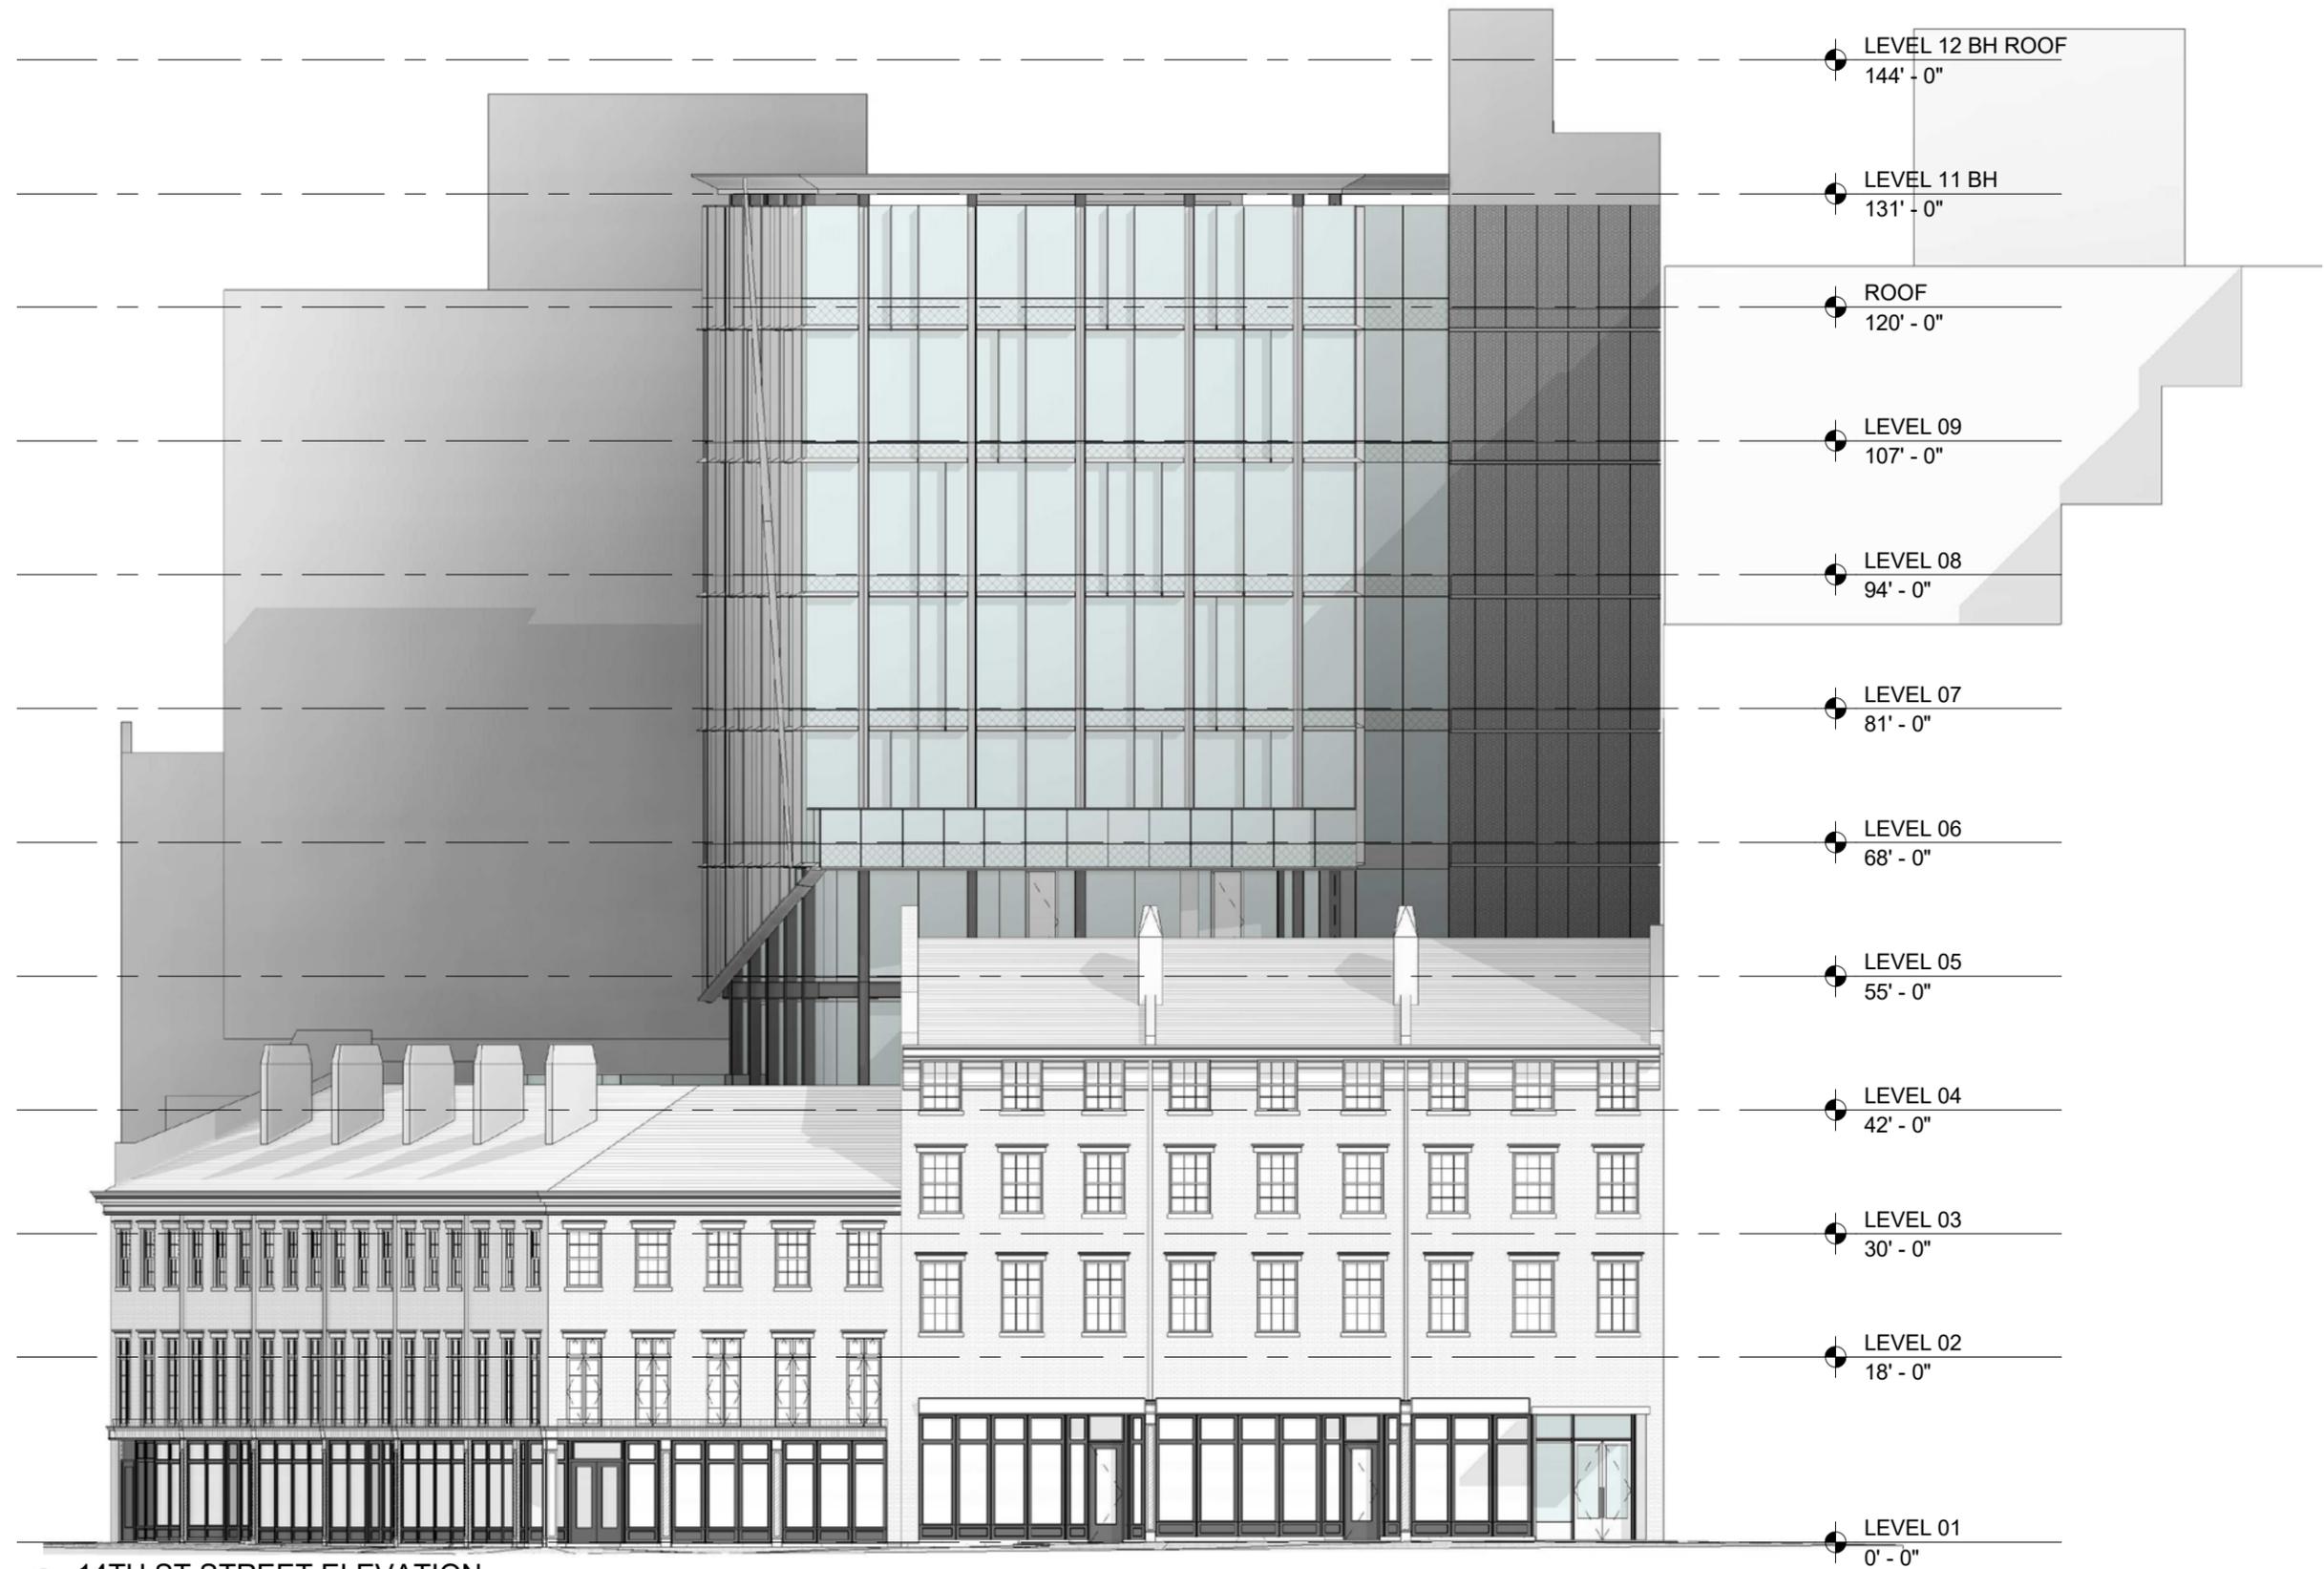
① 14TH ST STREET ELEVATION
1/16" = 1'-0"

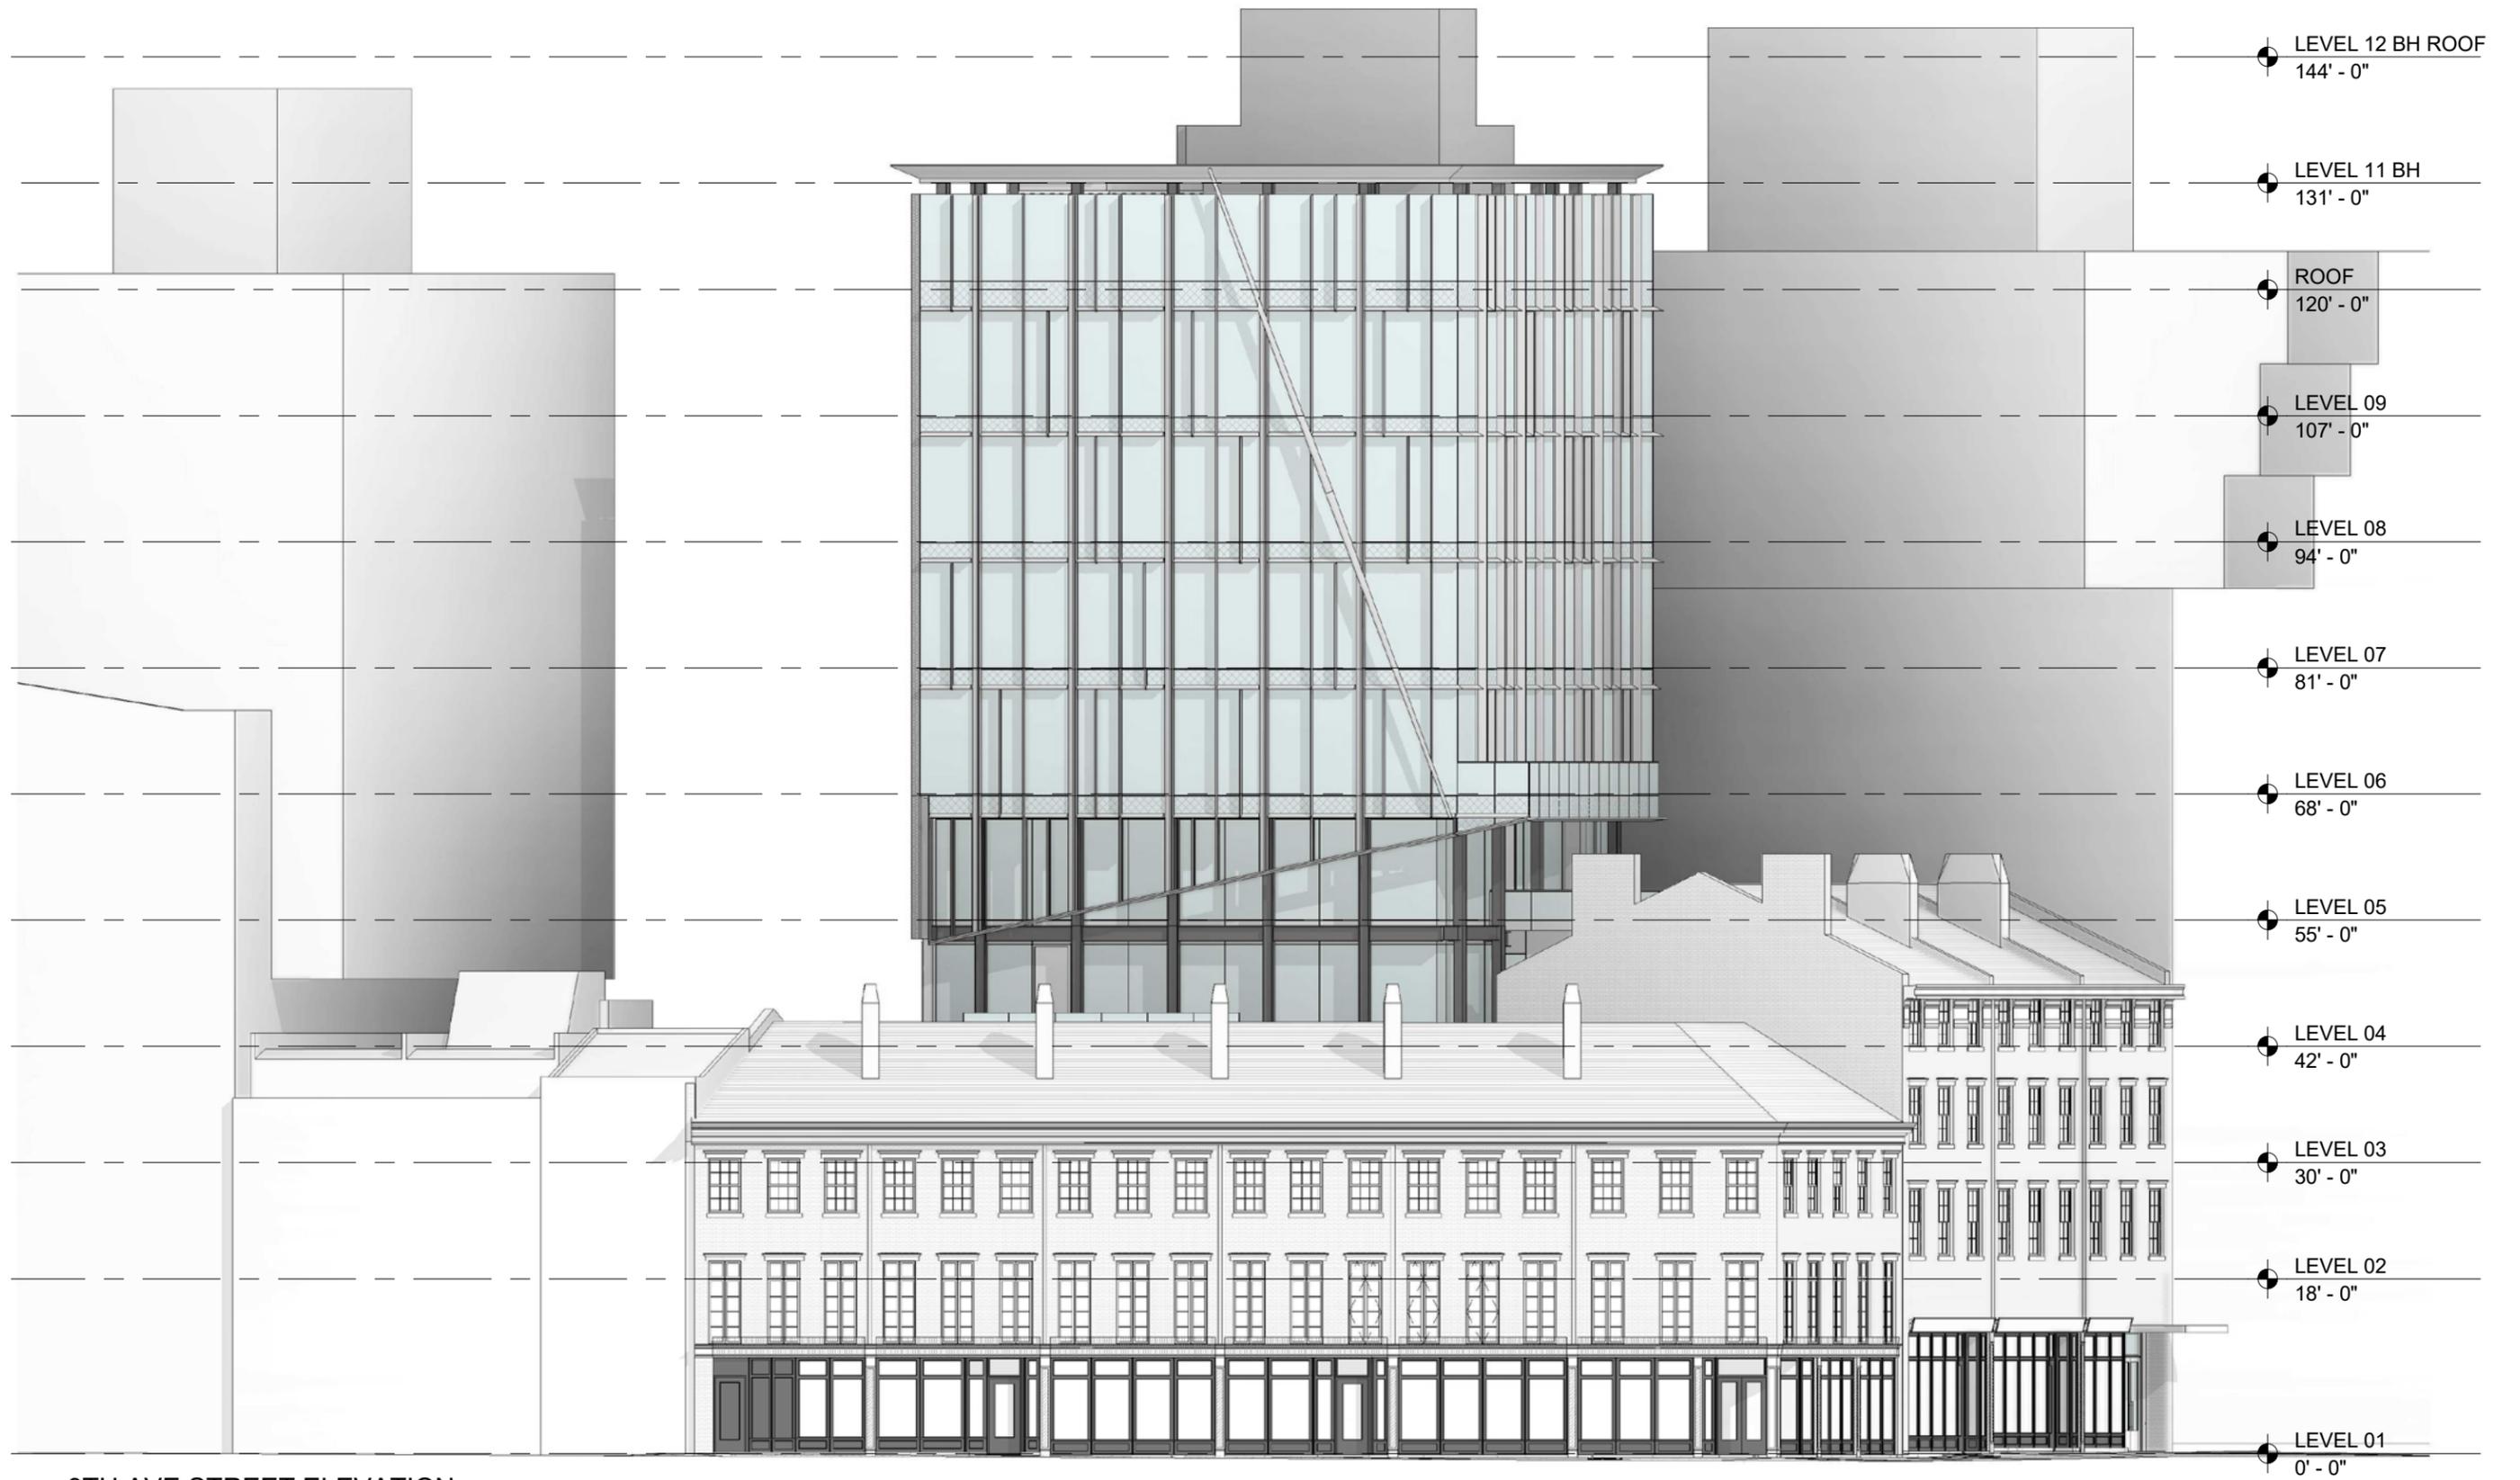
① 9TH AVE STREET ELEVATION
1/16" = 1'-0"
