**170 Central Park West – New York Historical Society,
Borough of Manhattan**

Window Master Plan

New-York Historical Society

PBDW ARCHITECTS

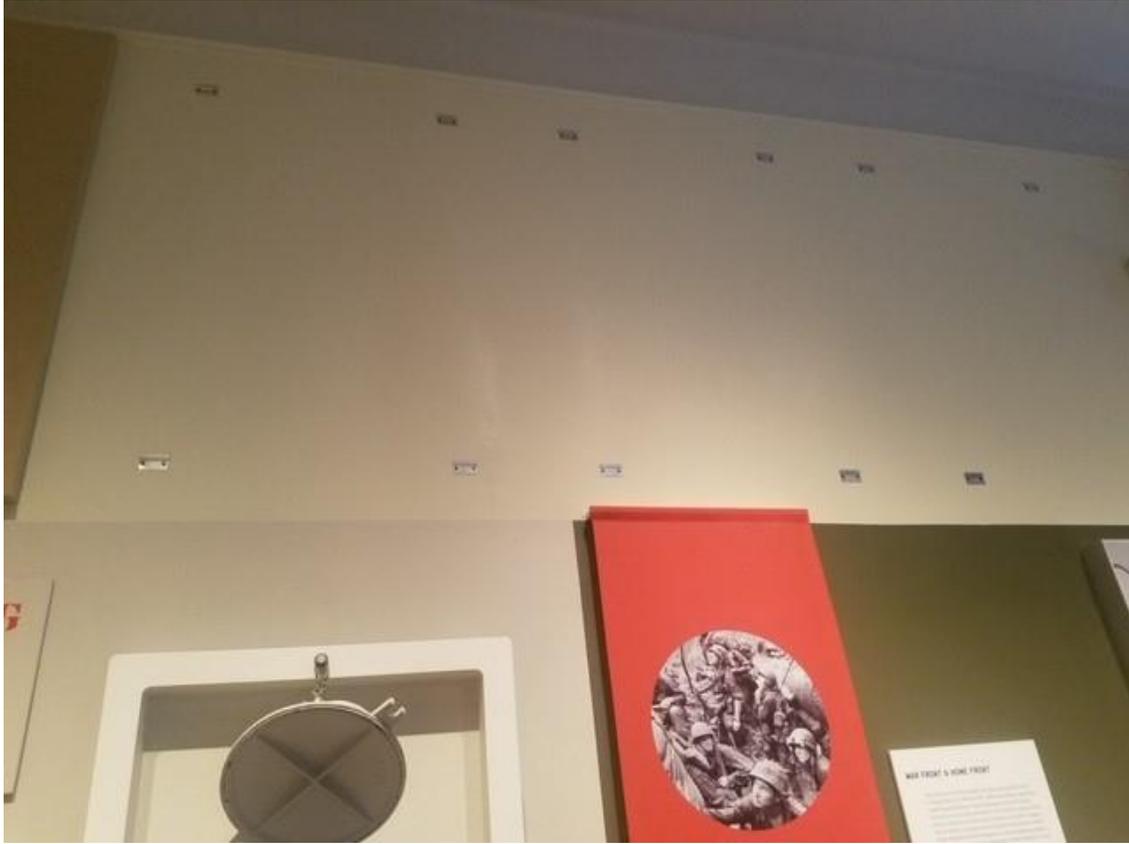
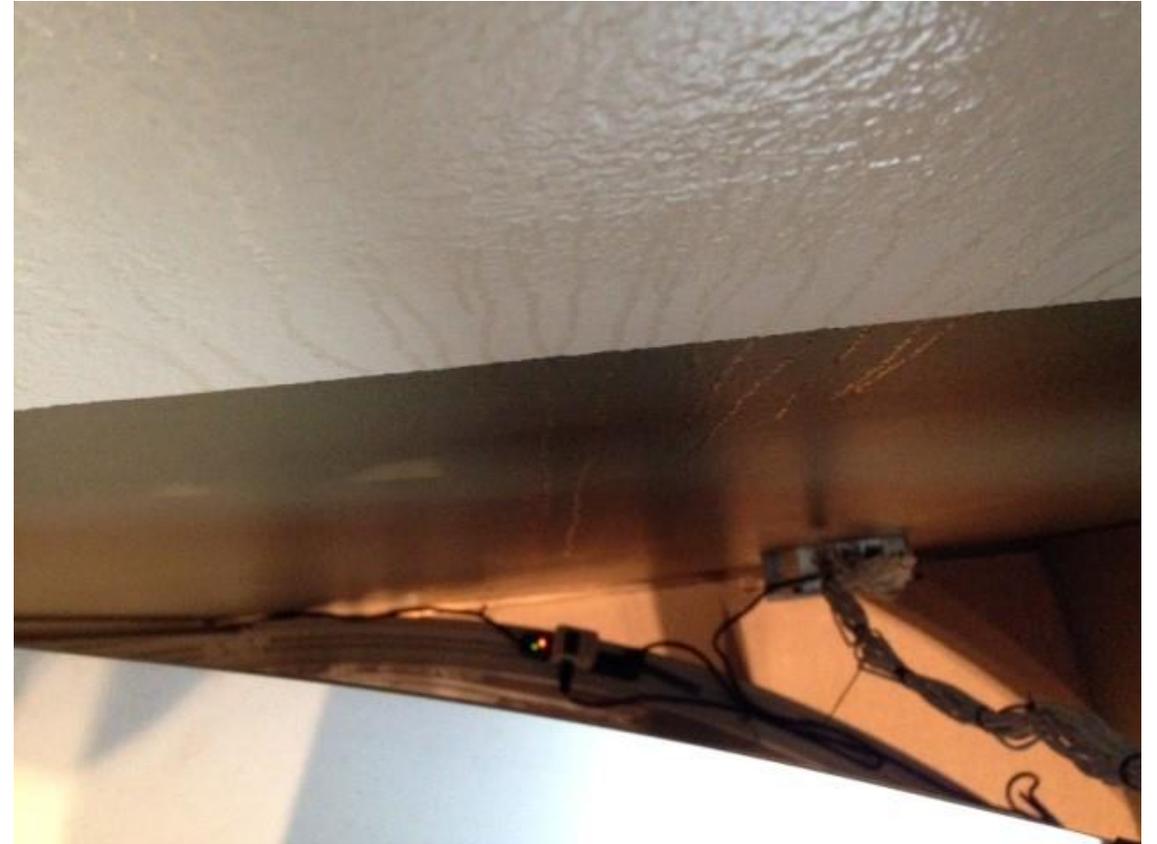
2018 GALLERY WALL CONDENSATION
NEW-YORK HISTORICAL SOCIETY

Condensation on gallery wall

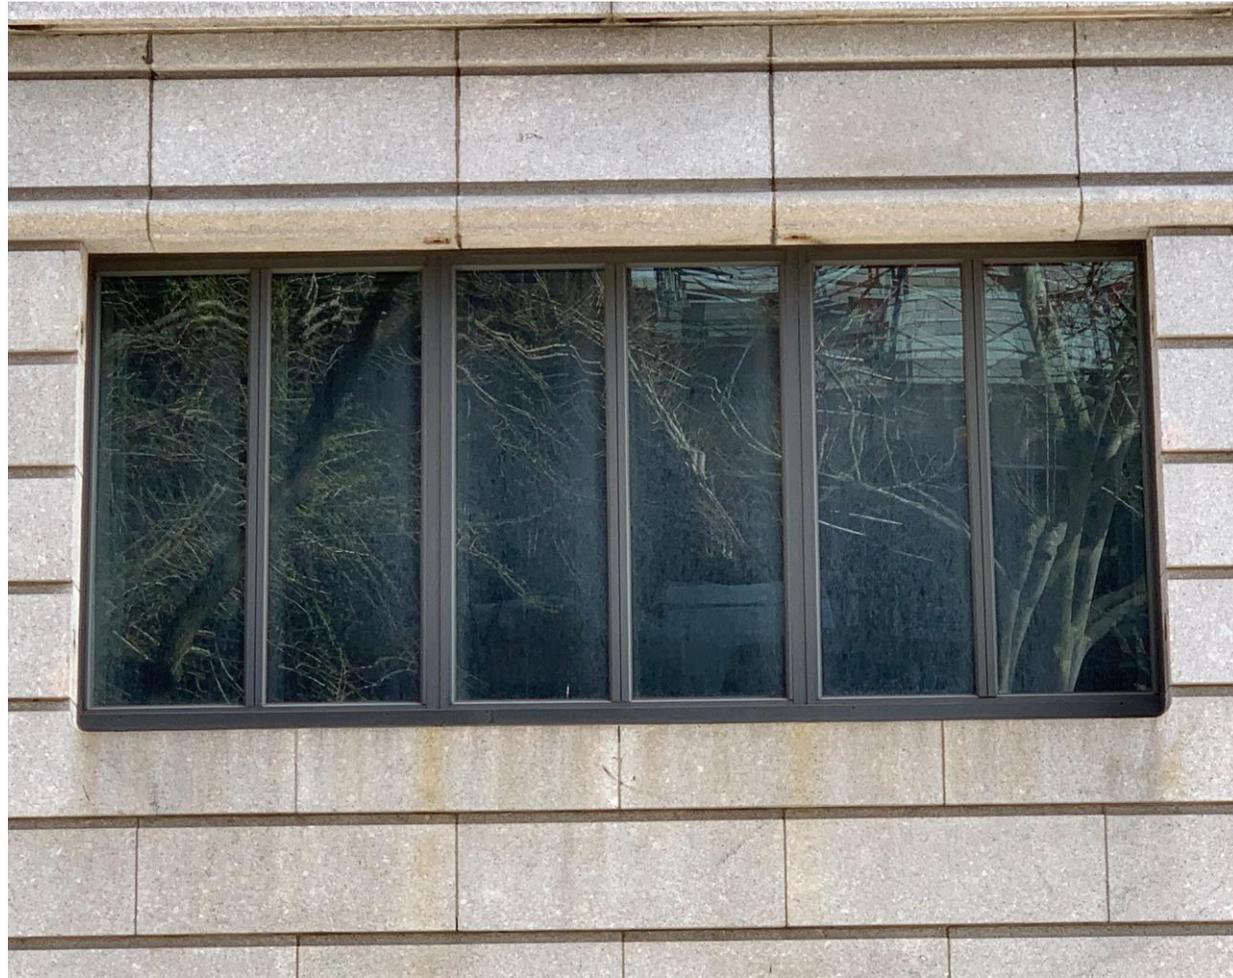
TEMPORARY EXTERIOR STORM WINDOW – WINDOW TYPE D

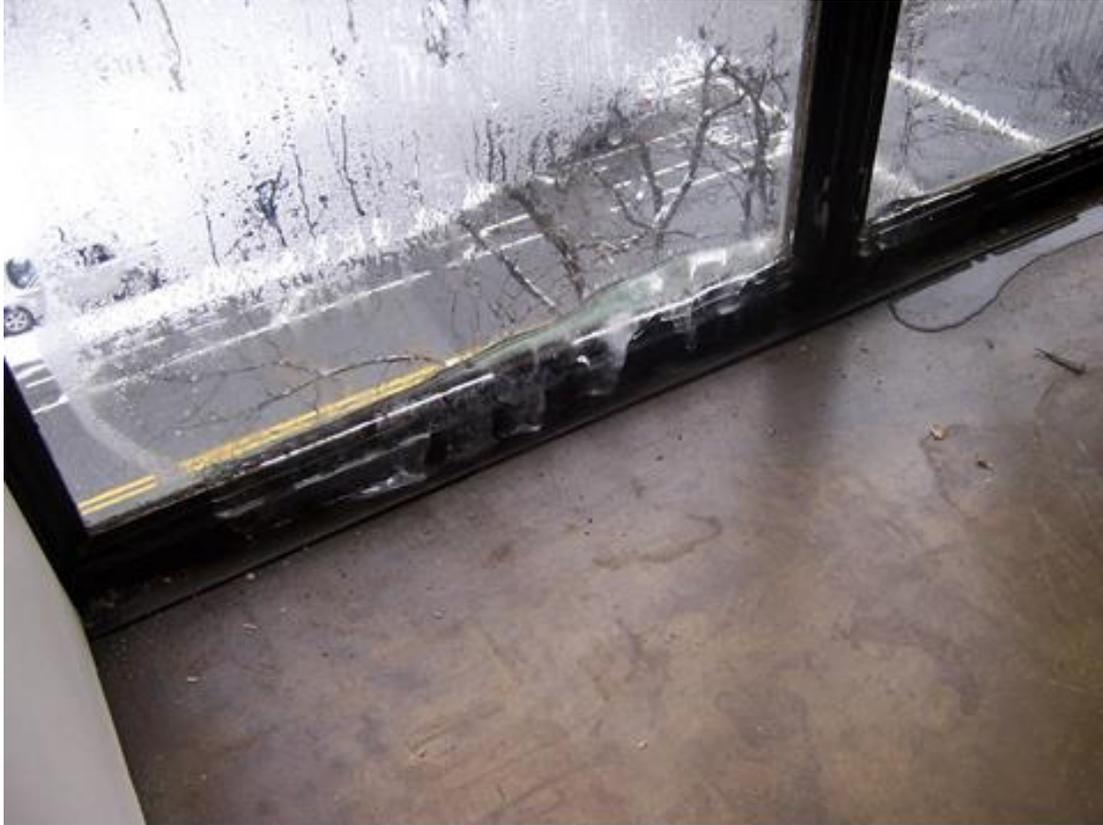
Condensation, ice and water pooling.

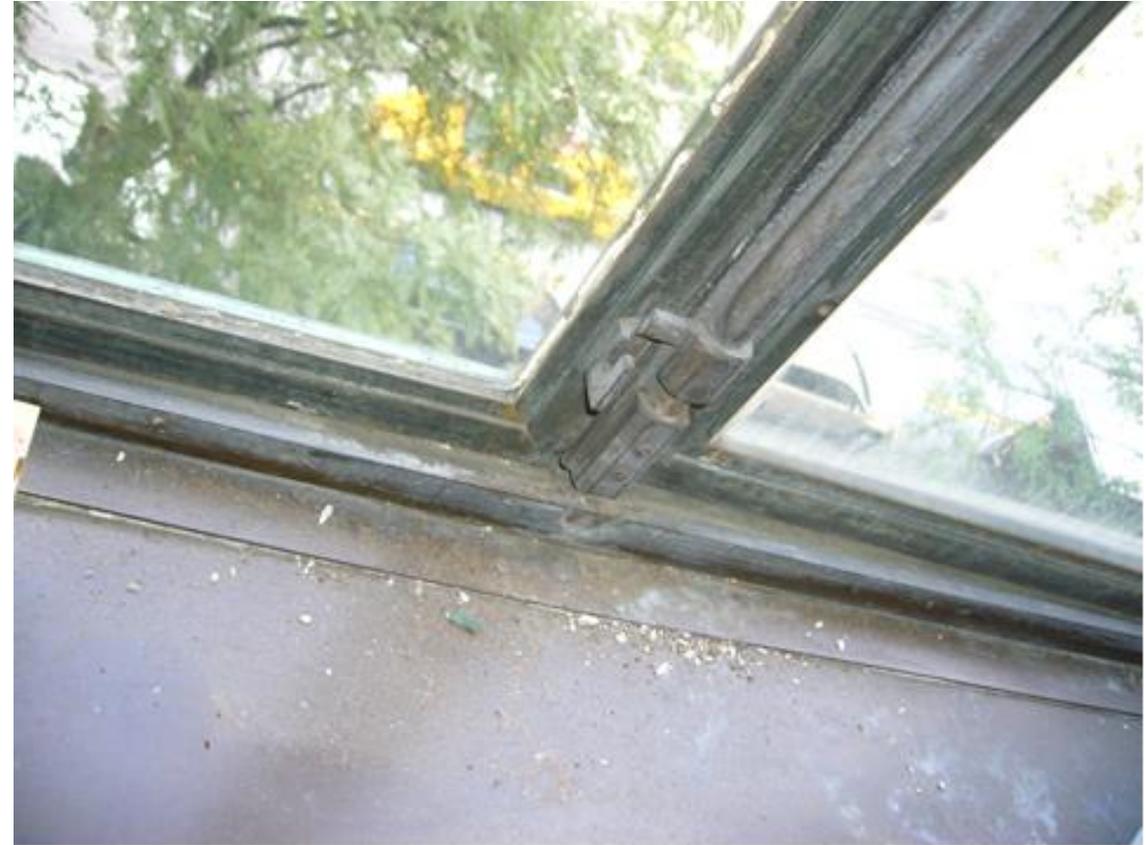
Deteriorated putty. Oxidation not allowing proper closing and locking.

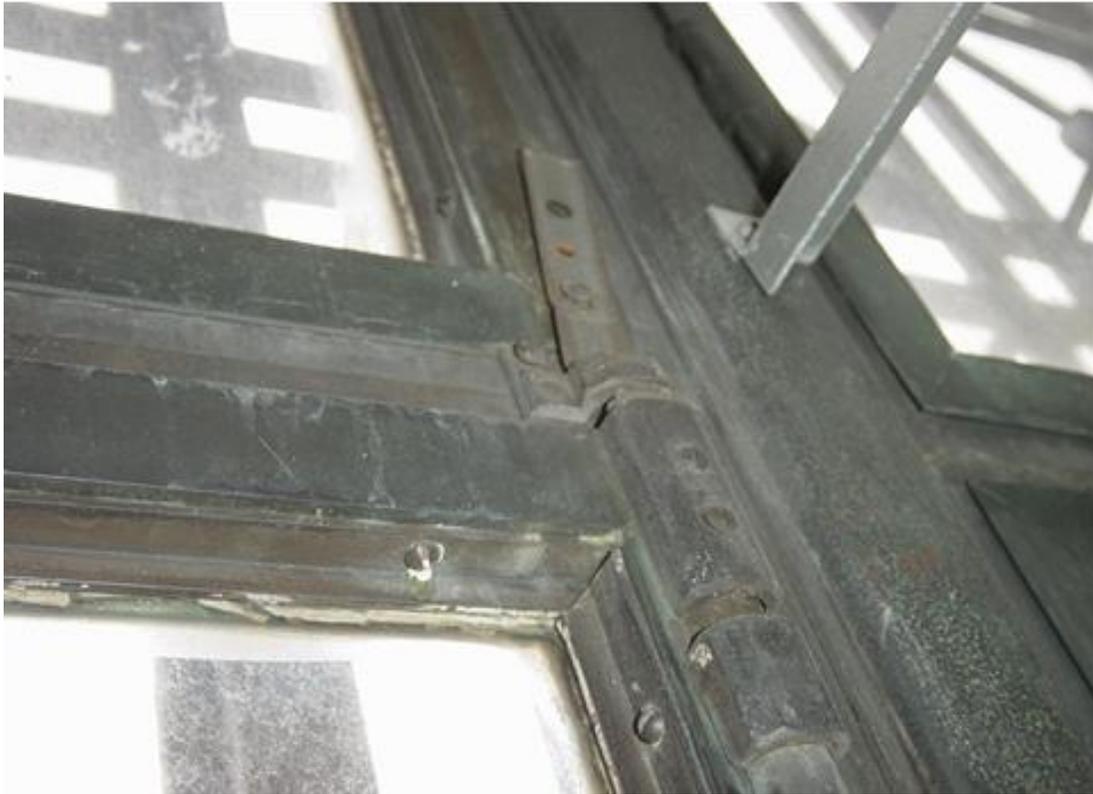
Damaged hardware, signs of water run-off, deteriorated putty and pitting.

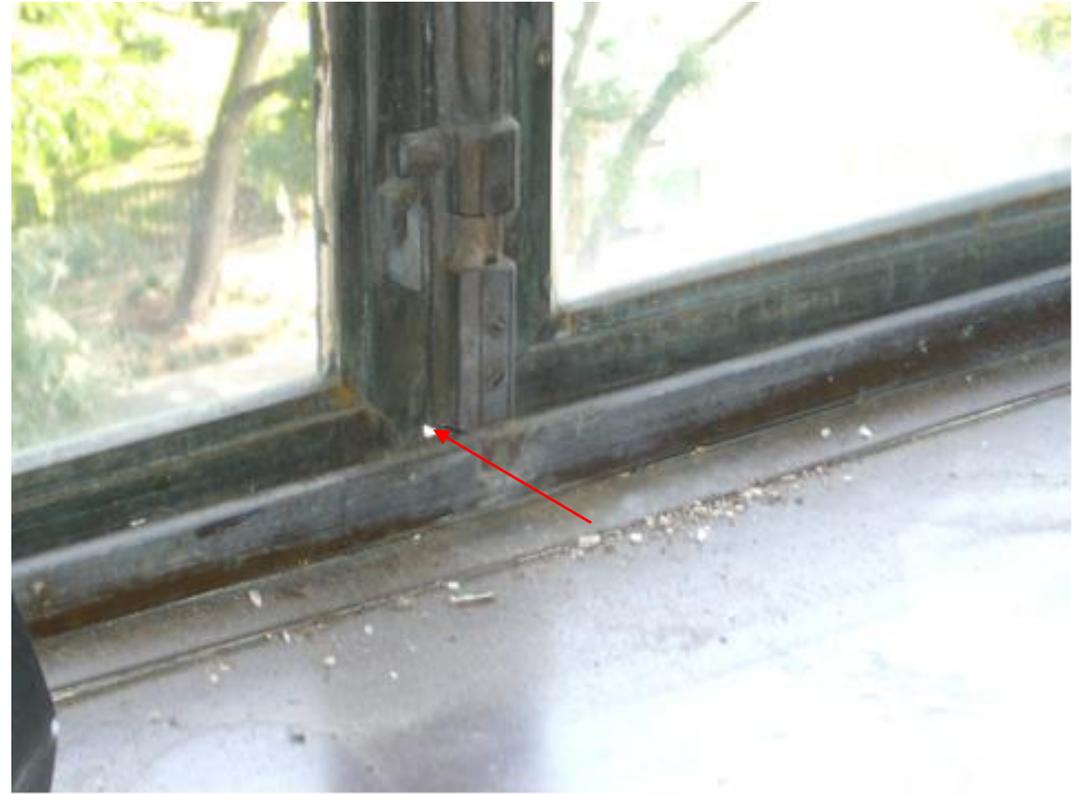
Typical gap between casement and frame.

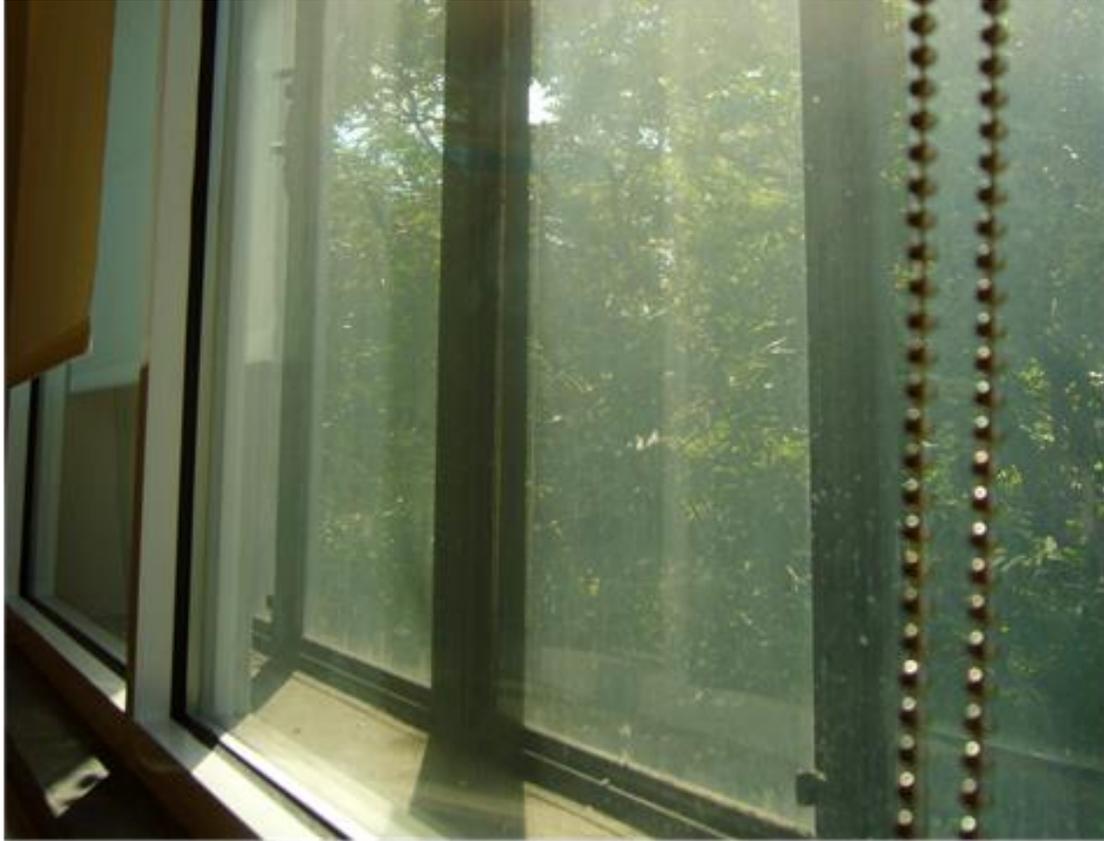
One type of existing interior storm window.

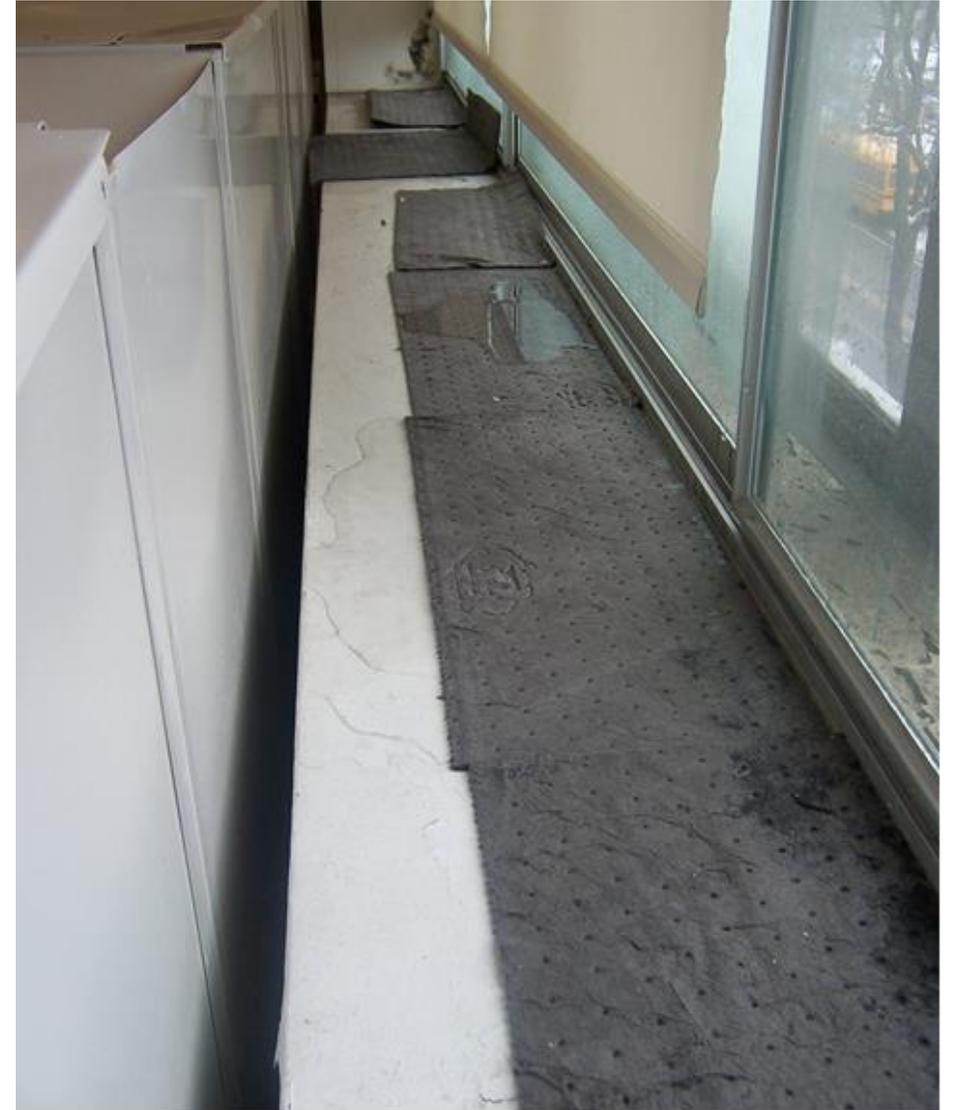
Water pooling and mold at existing interior storm window.

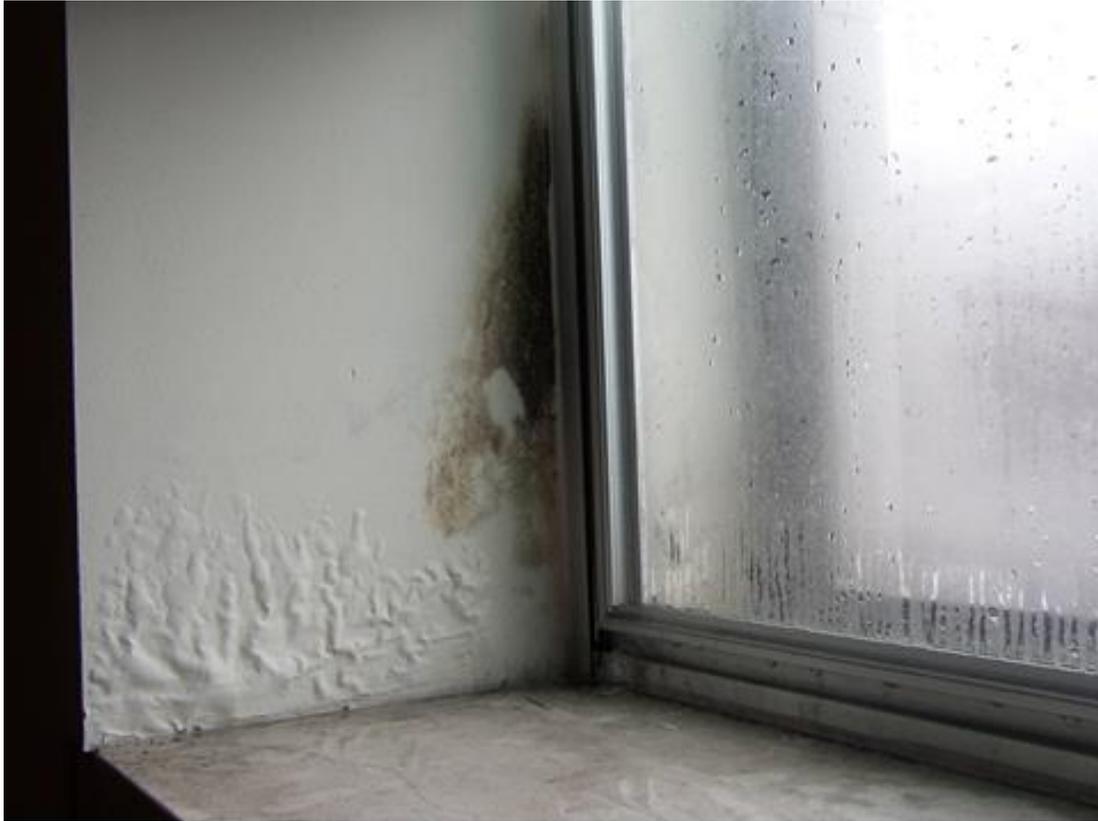
Finish damage and mold at interior storm window.

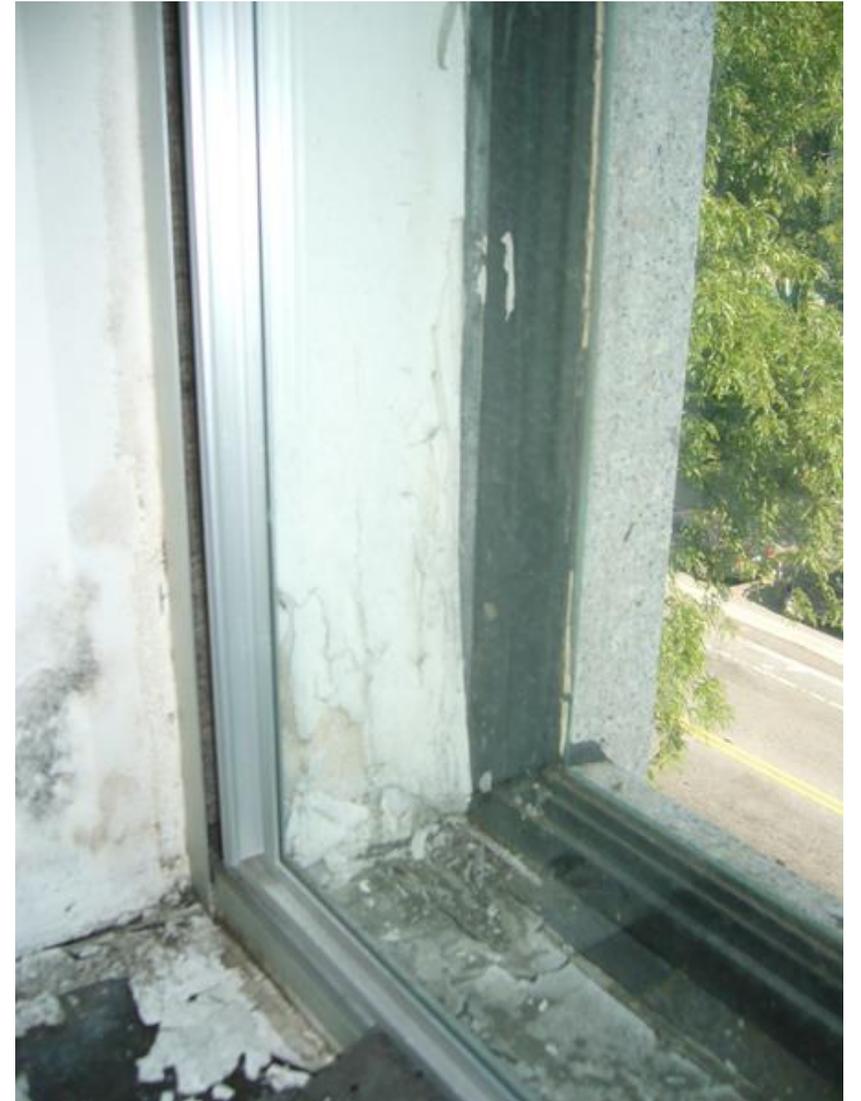
Finish damage and mold at interior storm window.

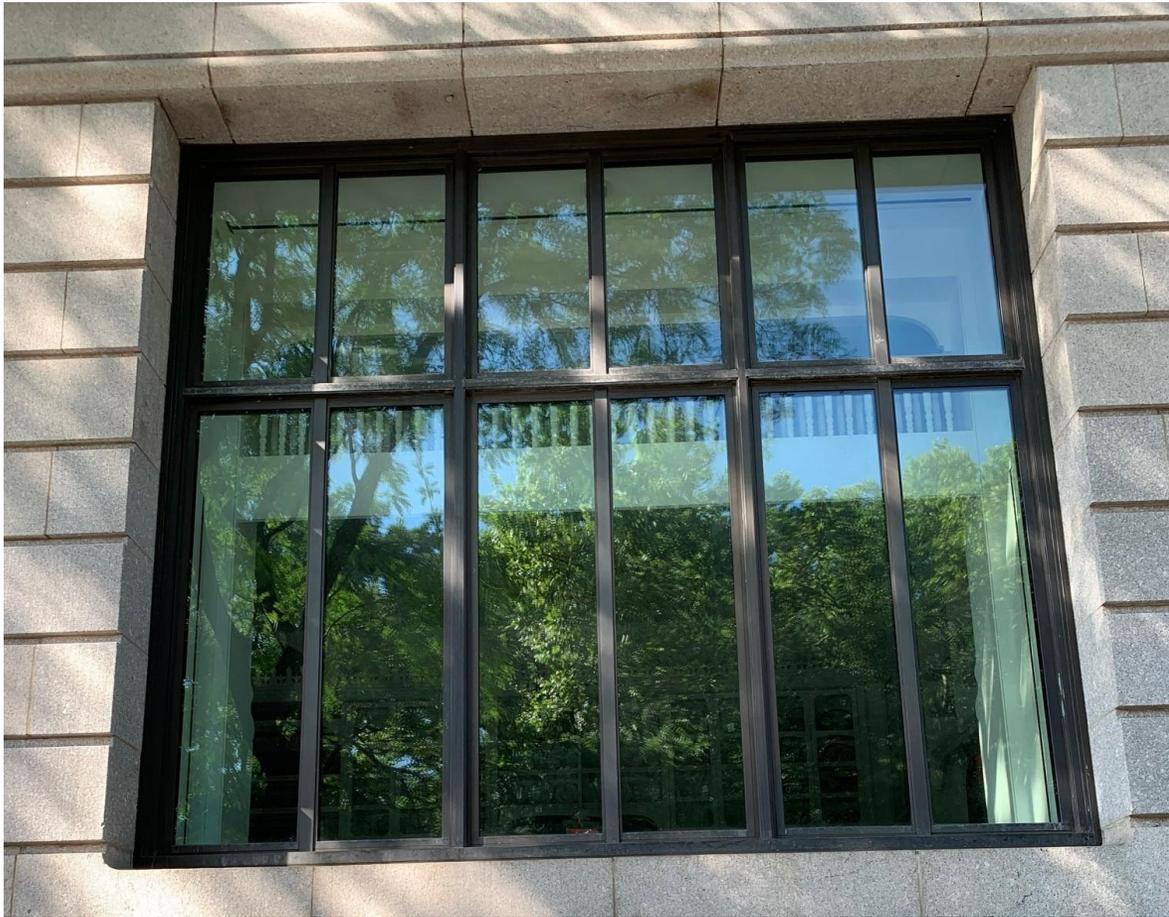
EXISTING FIRST FLOOR 77TH STREET BRONZE WINDOWS

- Aluminum Replacement Windows
- Double-Glazing
- Thermally Broken Construction
- Surround and Mullion Extrusions to Match Existing
- Kynar 2605 Finish
- Finish to Match First Floor North Bronze Windows

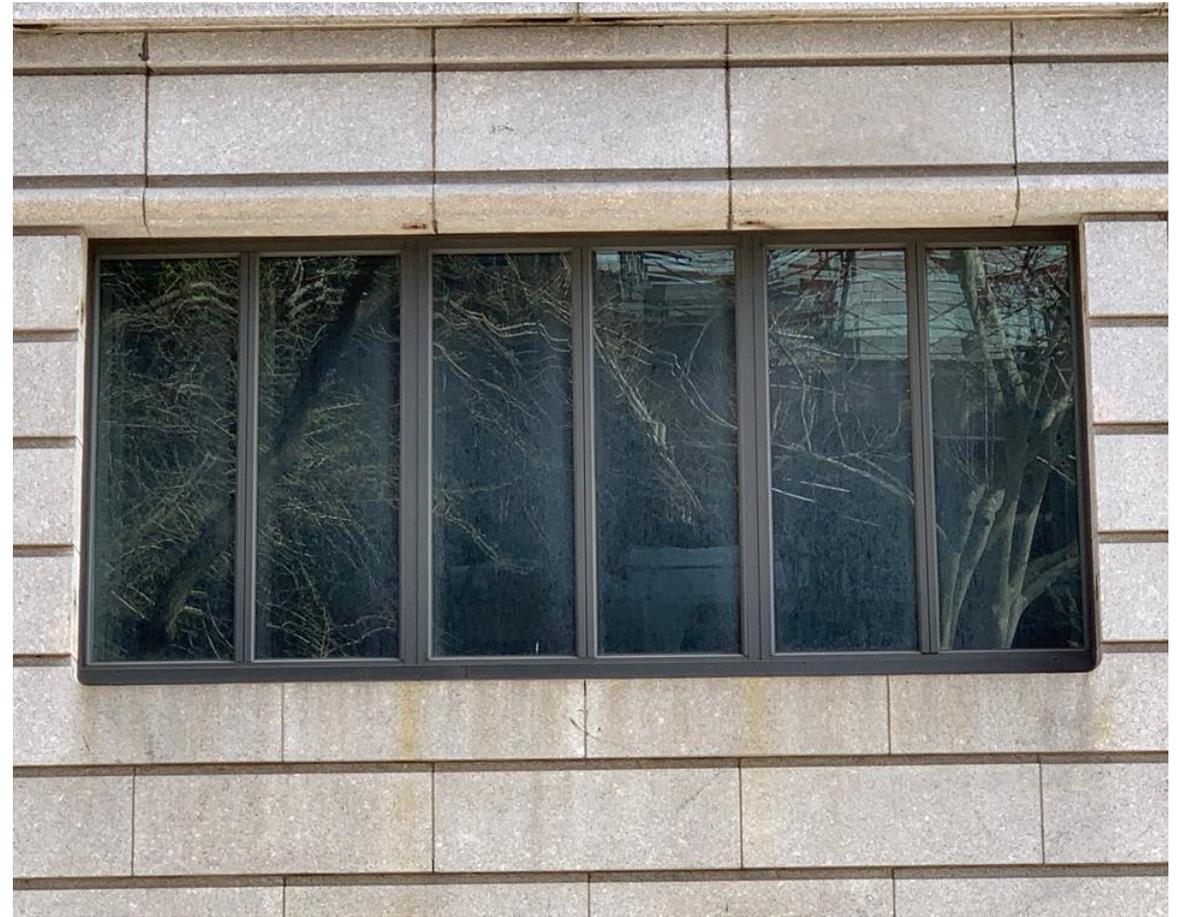
TEMPORARY STORM WINDOW FINISH - UMBRA GREY

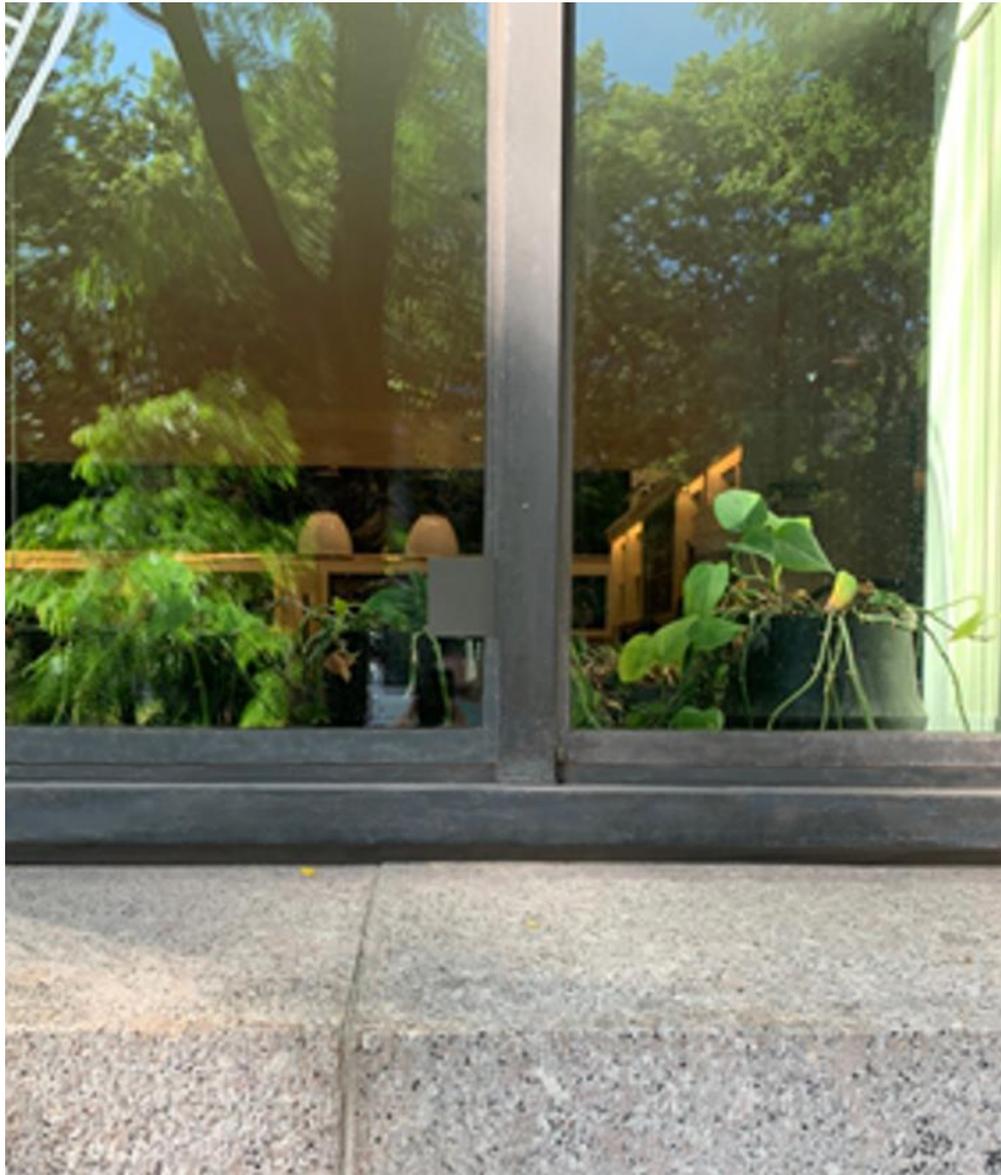
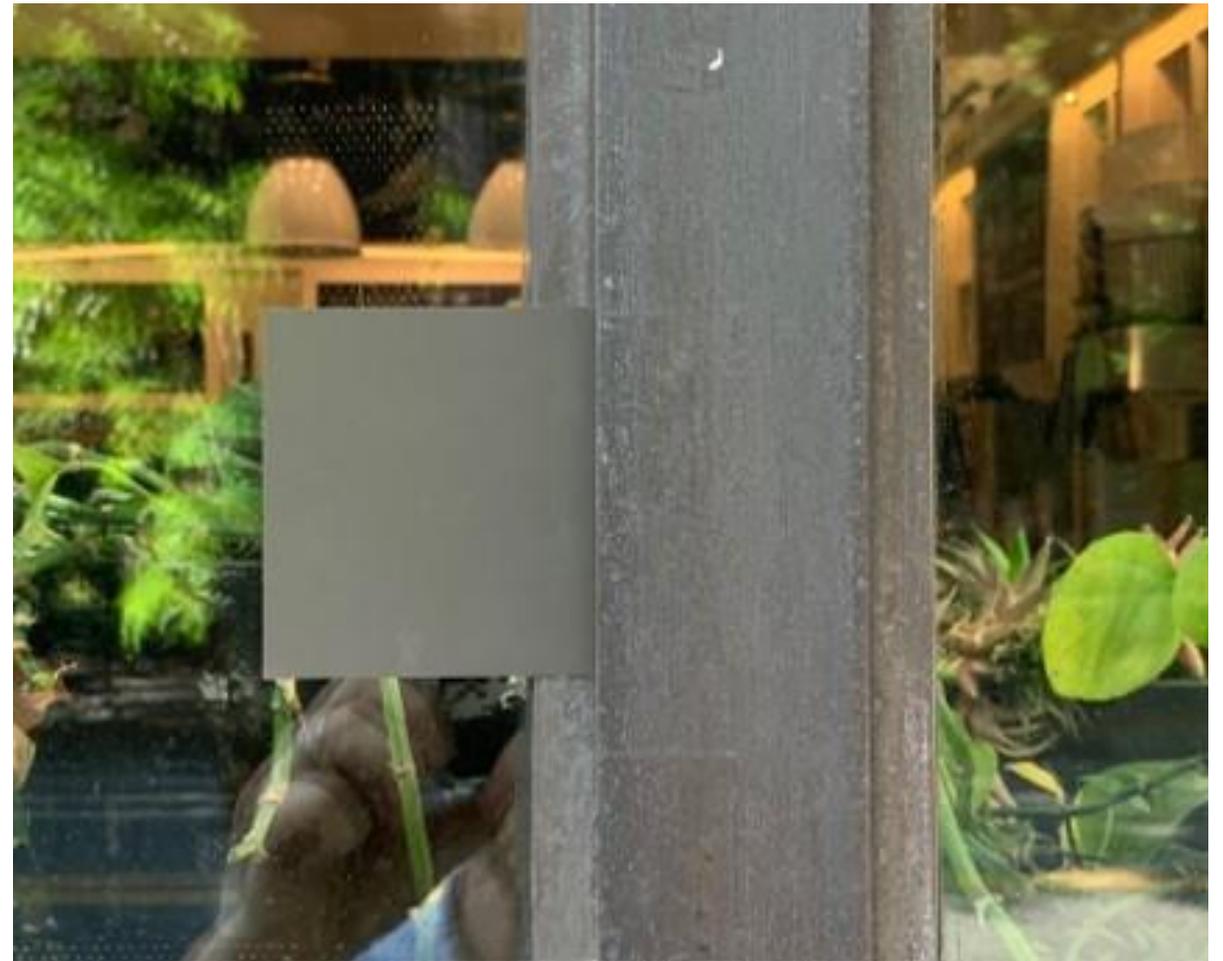
PROPOSED FINISH - UMBRA GREY

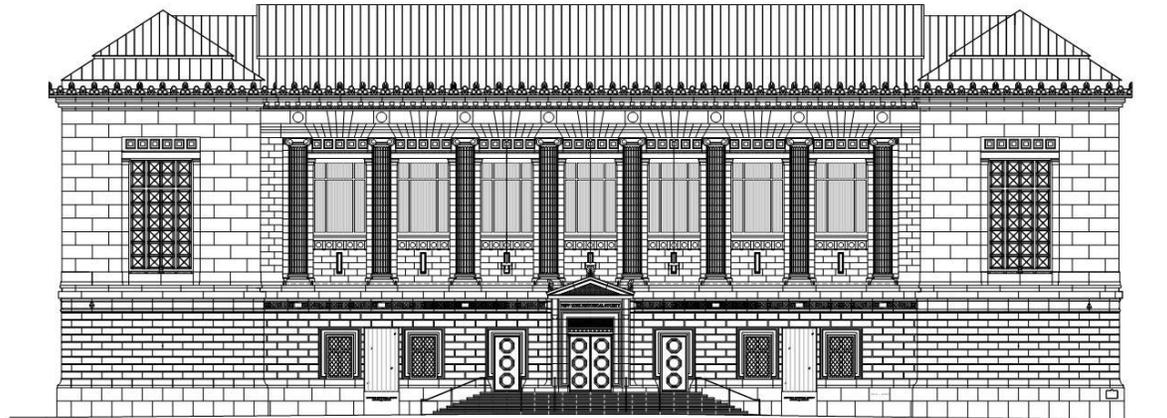
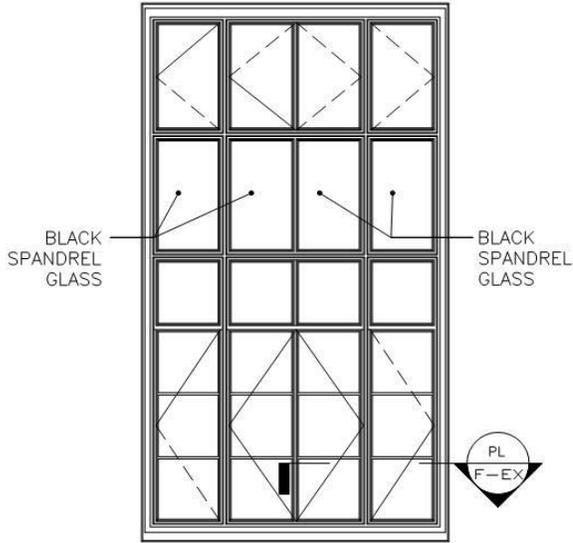
EXTERIOR ELEVATION
DAYLIGHT AREA: 136.40 SF

2nd & 3rd Floors, Central Park West

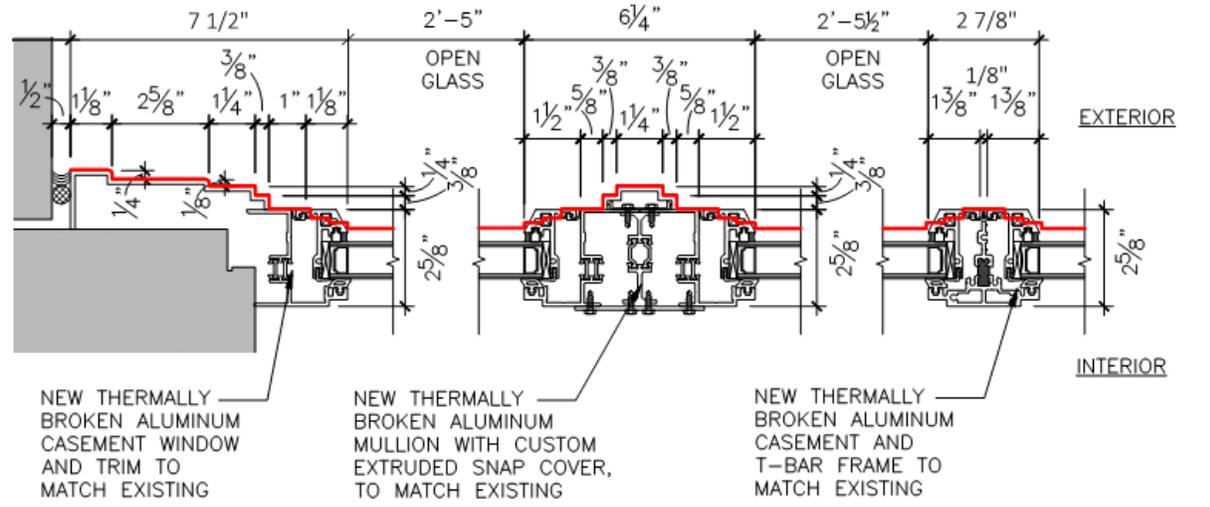
PL PLAN DETAILS THRU CASEMENT WINDOWS
SCALE: 3" = 1'-0"

DAYLIGHT AREA: 135.77 SF
(-0.46% CHANGE FROM EXISTING)

Proposed - Aluminum

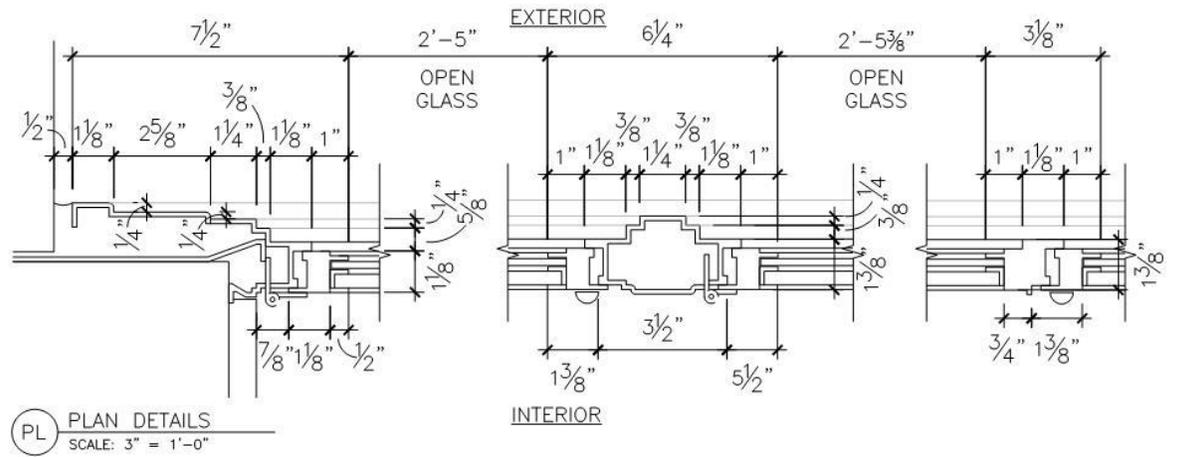
PL PLAN DETAILS
SCALE: 3" = 1'-0"

Existing - Bronze

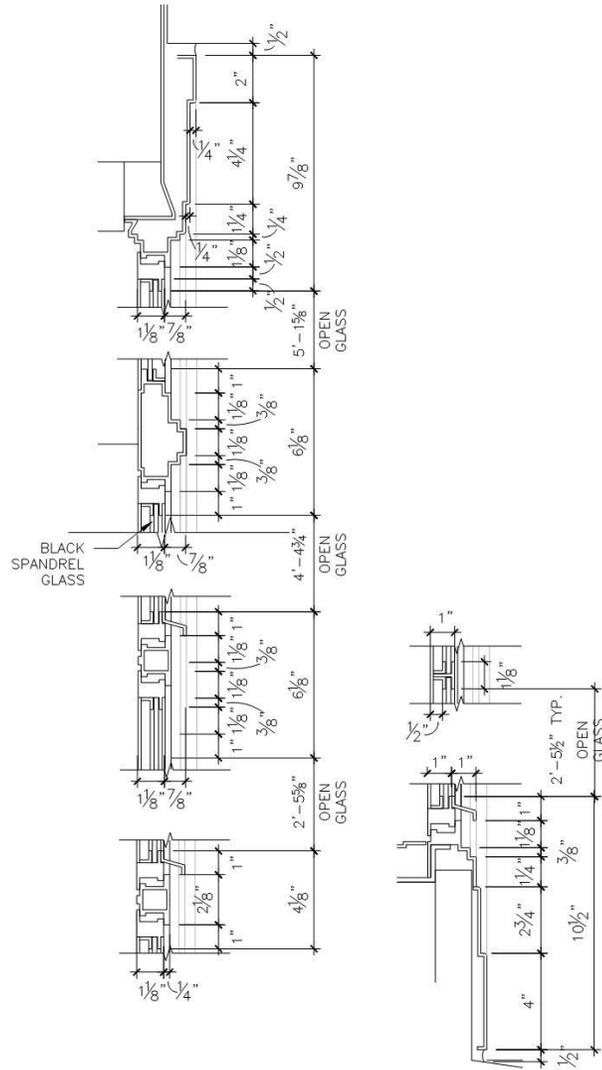
SC SECTION DETAILS
SCALE: 3" = 1'-0"

Existing - Bronze

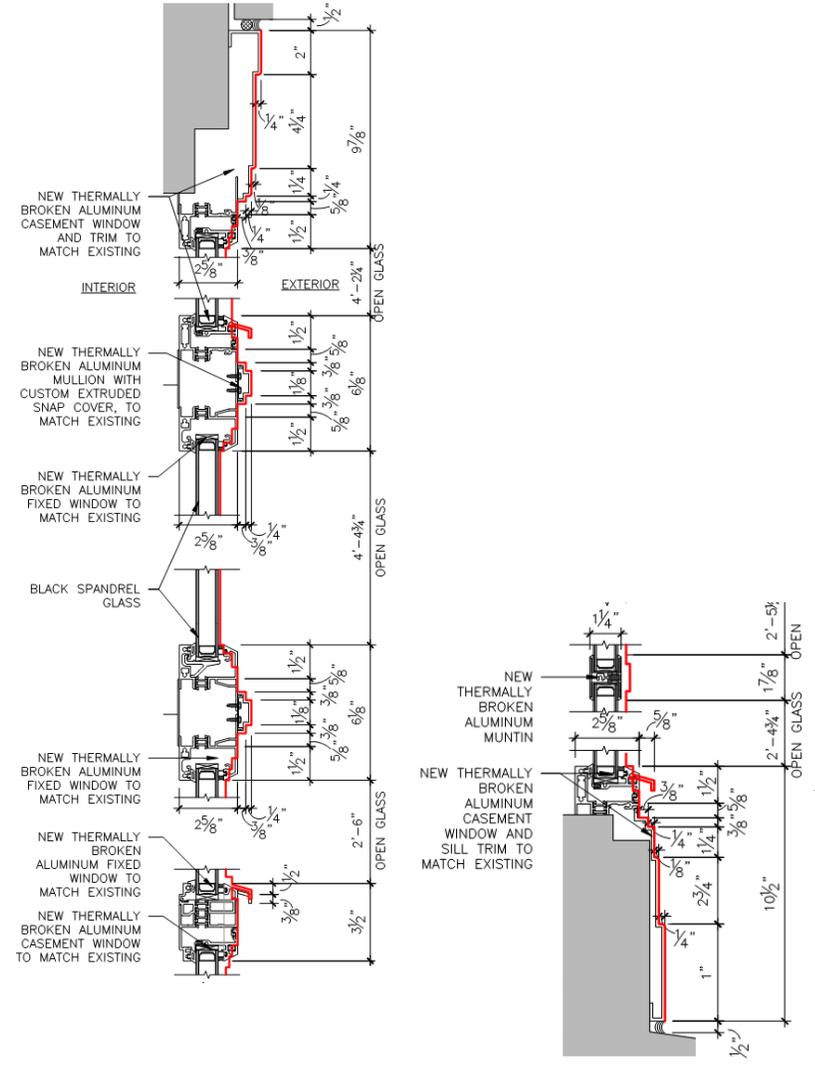
SC SECTION DETAILS
SCALE: 3" = 1'-0"

Proposed - Aluminum

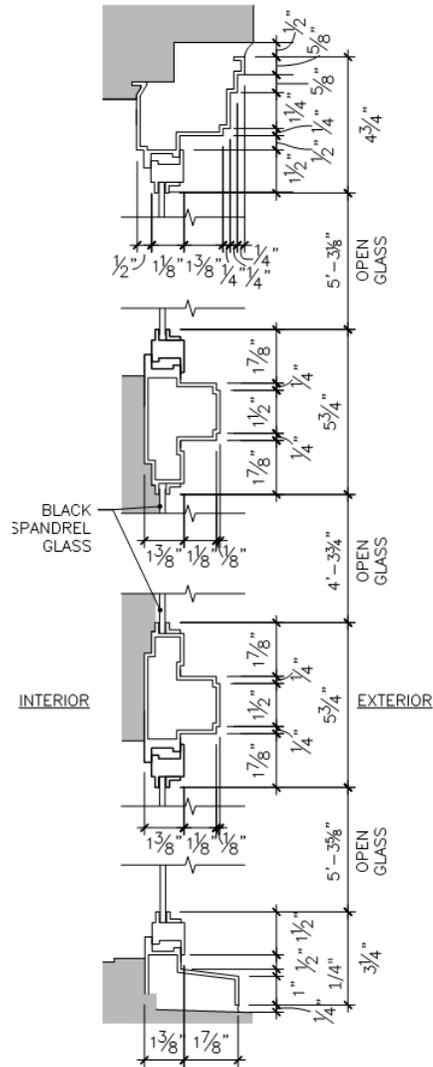
SC SECTION DETAILS
SCALE: 3" = 1'-0"

Existing - Bronze

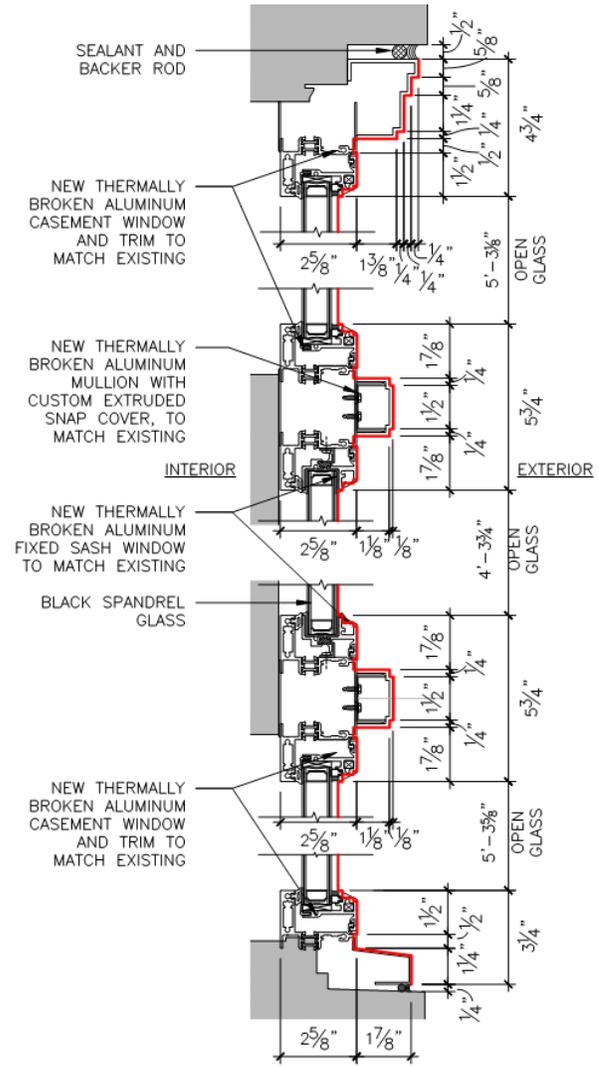
SC SECTION DETAILS
SCALE: 3" = 1'-0"

Proposed - Aluminum

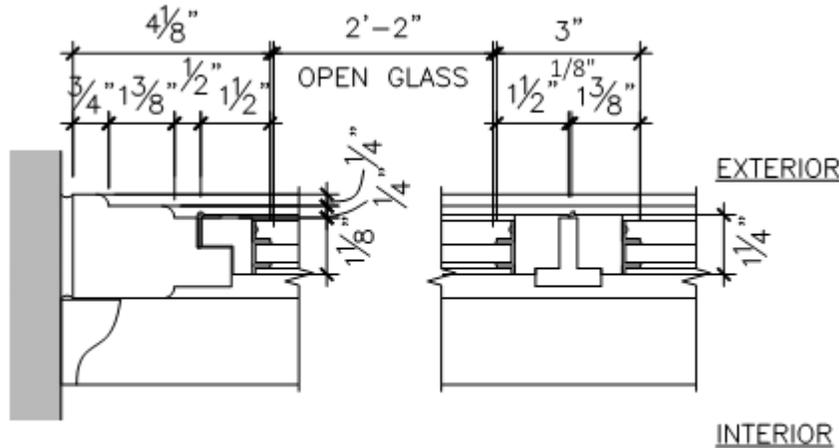
PL PLAN DETAILS
SCALE: 3" = 1'-0"

Existing - Bronze

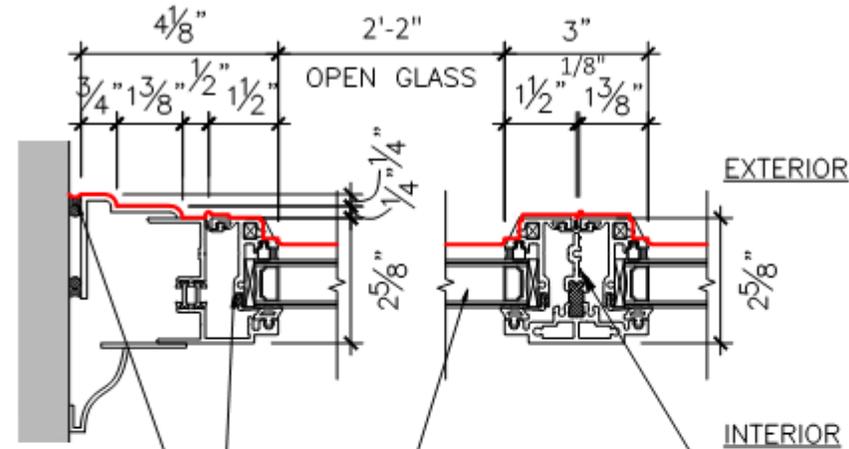
PROVIDE BACKER ROD AND SEALANT AT EXTERIOR JOINTS BETWEEN FRAMES AND MASONRY

THERMALLY BROKEN ALUMINUM JAMB TO MATCH EXISTING

PL PLAN DETAILS
SCALE: 3" = 1'-0"

Proposed - Aluminum

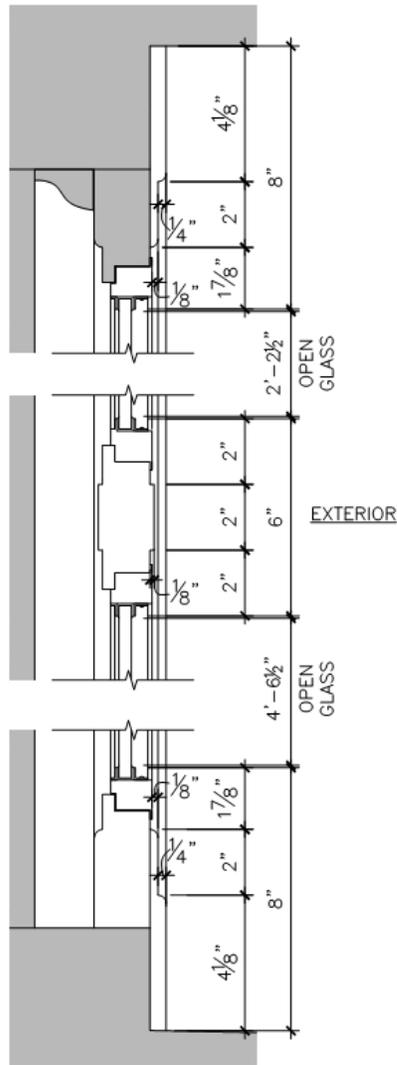
SC SECTION DETAILS
SCALE: 3" = 1'-0"

Existing - Bronze

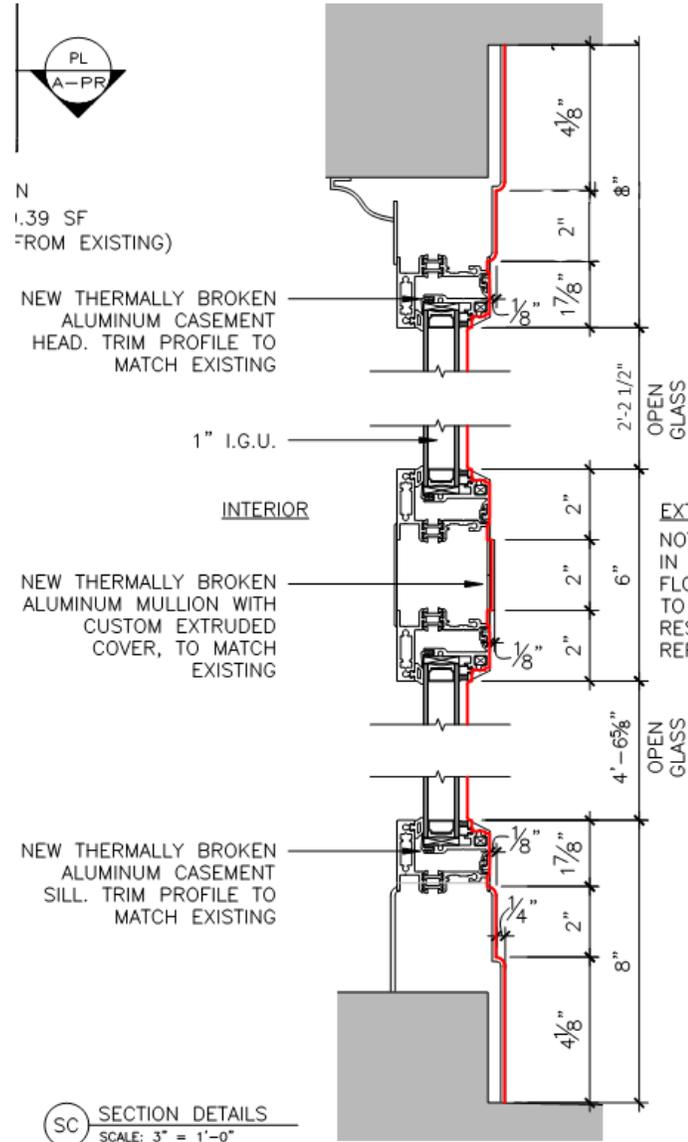
SC SECTION DETAILS
SCALE: 3" = 1'-0"

Proposed - Aluminum

NEW THERMALLY BROKEN
ALUMINUM CASEMENT
HEAD. TRIM PROFILE TO
MATCH EXISTING

NEW THERMALLY BROKEN
ALUMINUM MULLION WITH
CUSTOM EXTRUDED
COVER, TO MATCH
EXISTING

NEW THERMALLY BROKEN
ALUMINUM CASEMENT
SILL. TRIM PROFILE TO
MATCH EXISTING

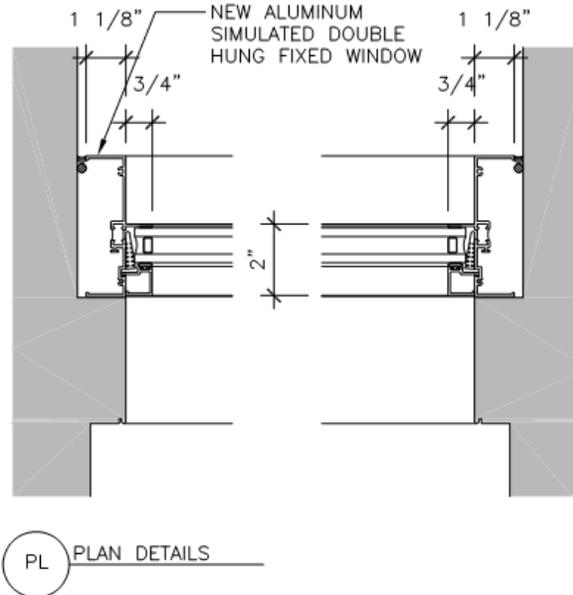
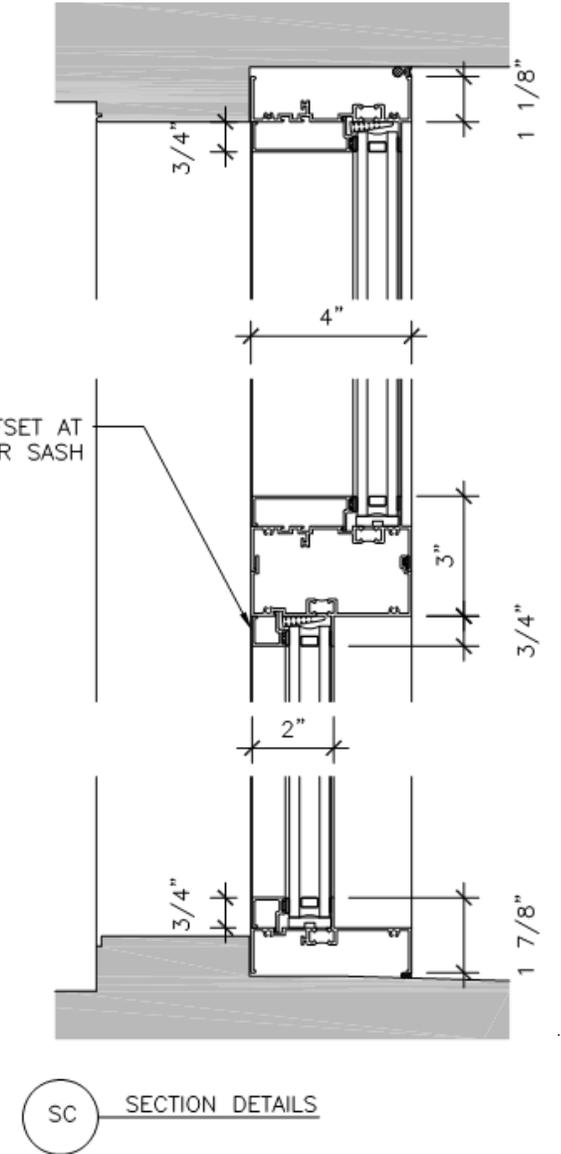
WINDOW TYPE C1 (C2, C3, C4, M1 & M2 SIMILAR)

OPTIONAL OFFSET AT LOWER SASH

Proposed - Aluminum
