**170 Central Park West – New York Historical Society,
Borough of Manhattan**

Window Master Plan

New-York Historical Society

PBDW ARCHITECTS

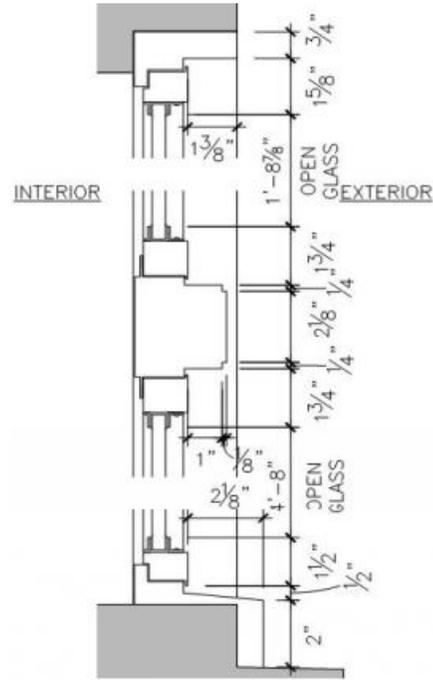
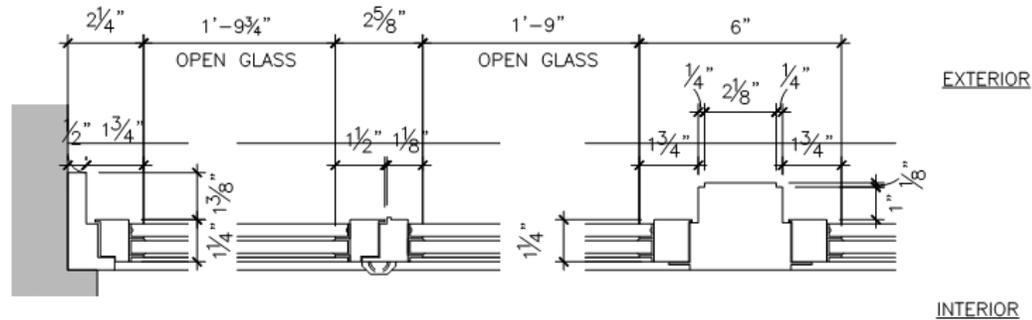
SECTION DETAILS
SCALE: 3" = 1'-0"

PLAN DETAILS
SCALE: 3" = 1'-0"

Existing - Bronze

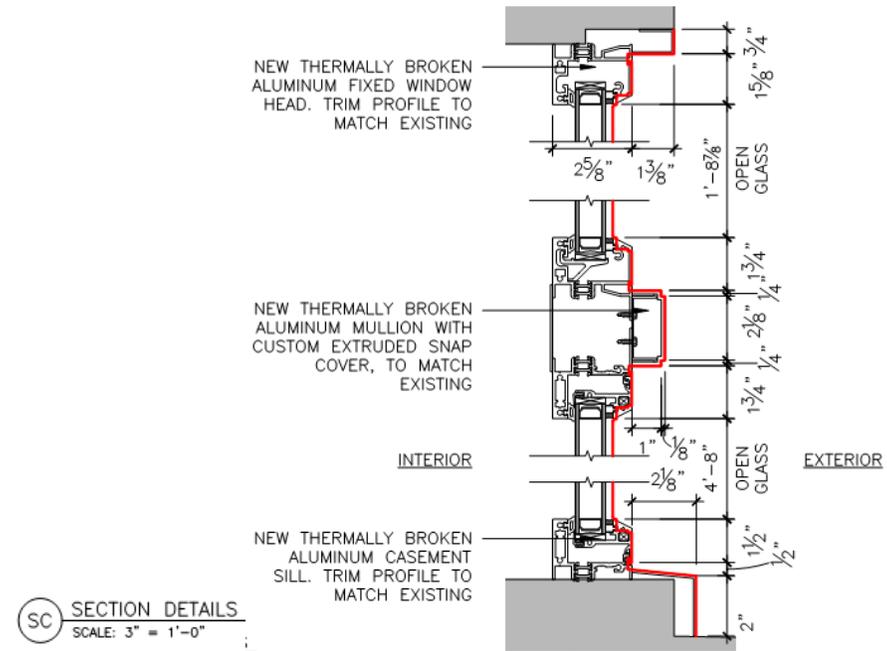
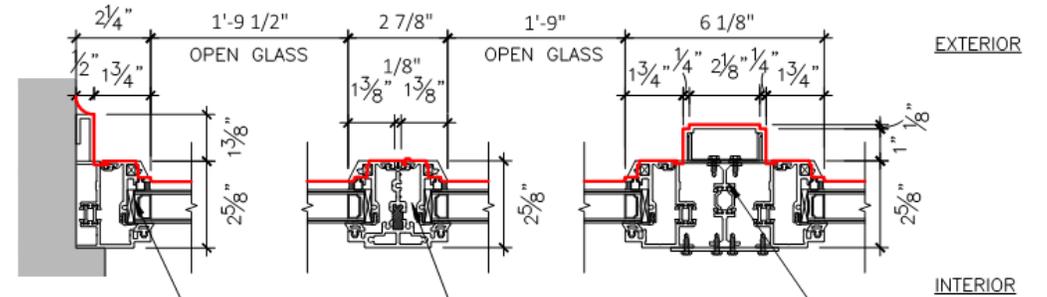
SECTION DETAILS
SCALE: 3" = 1'-0"

PLAN DETAILS THRU CASEMENT WINDOWS
SCALE: 3" = 1'-0"

Proposed - Aluminum

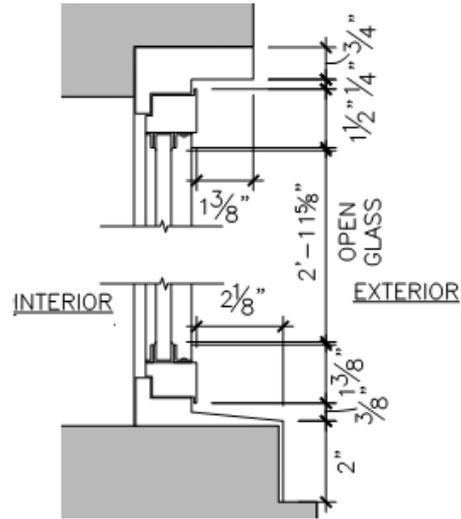
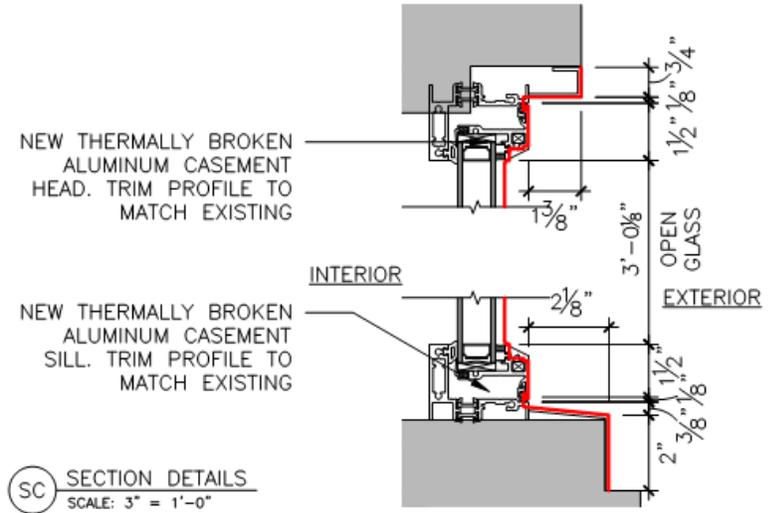
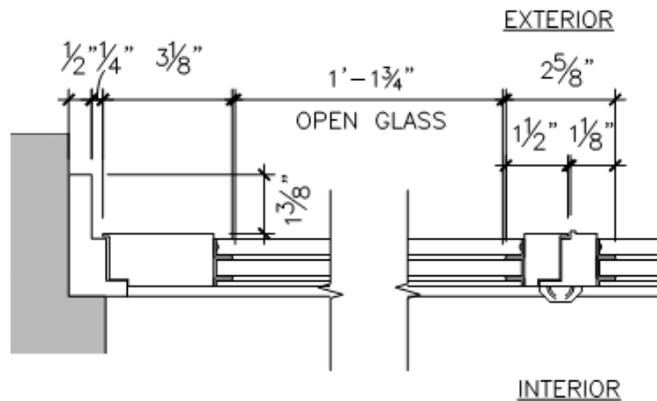
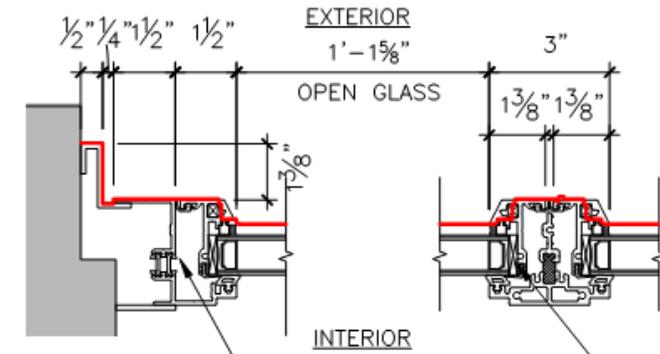
WINDOW TYPE J

SC SECTION DETAILS
SCALE: 3" = 1'-0"

PL PLAN DETAILS
SCALE: 3" = 1'-0"

Existing - Bronze

Proposed - Aluminum

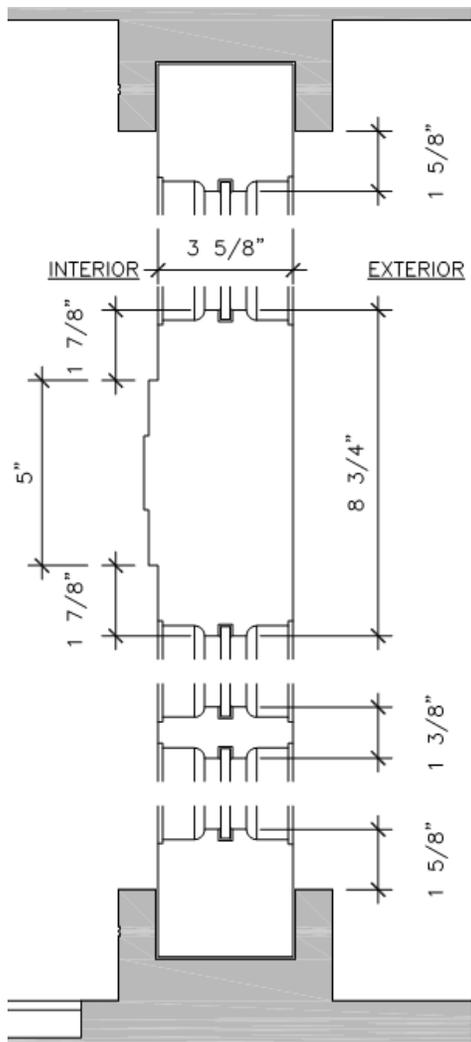
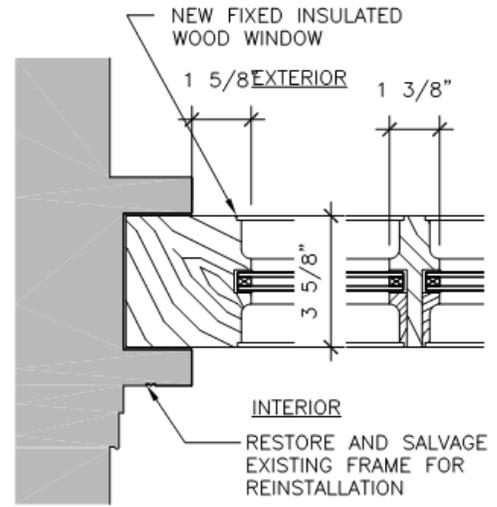
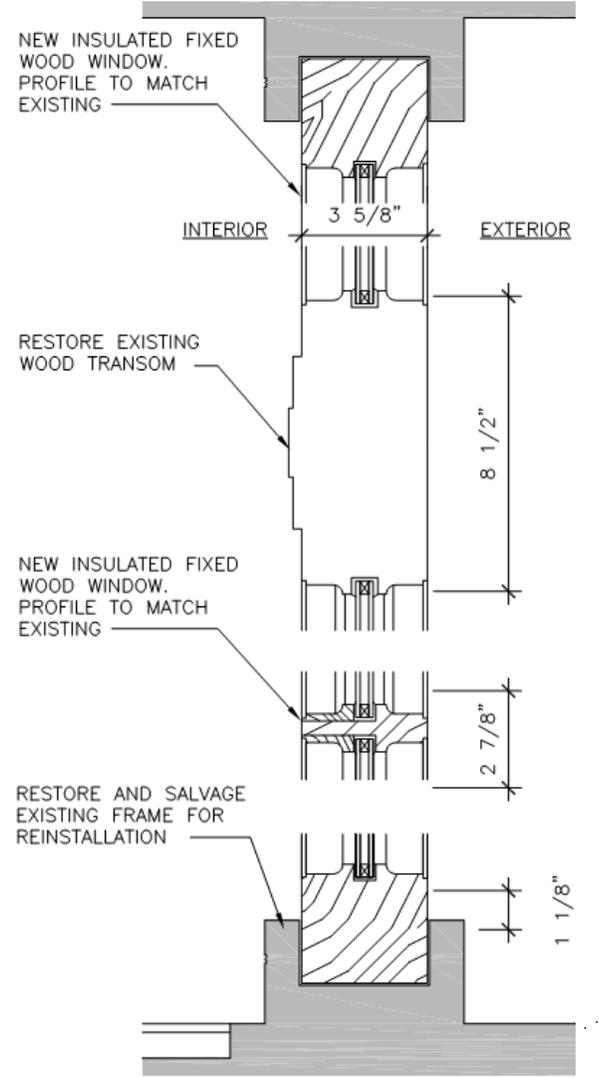
WINDOW TYPE K

SC SECTION DETAILS

Existing - Wood

PL PLAN DETAILS

Proposed - Wood

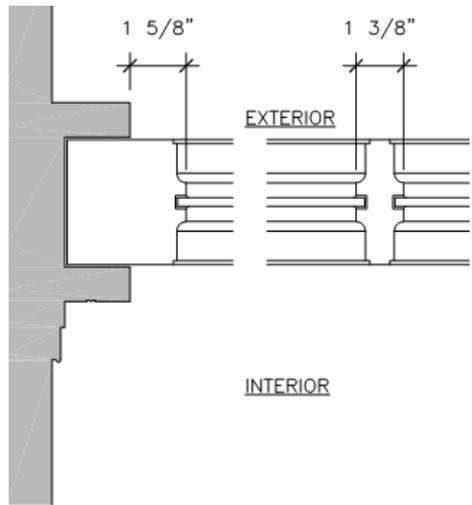
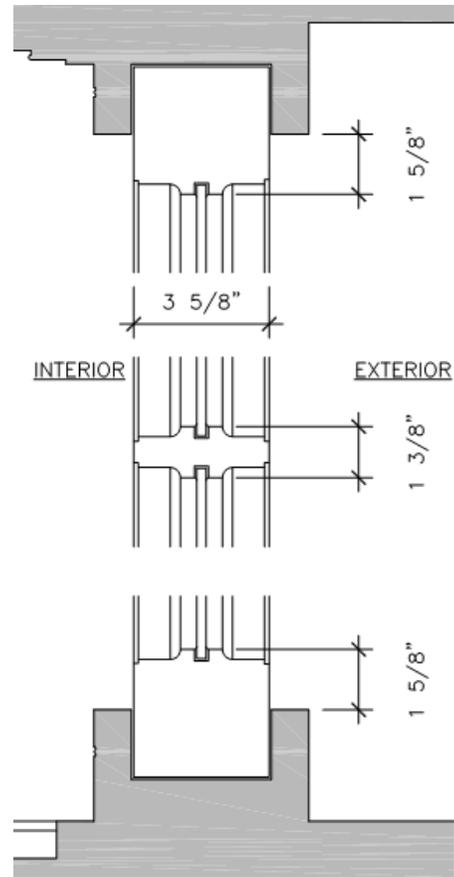
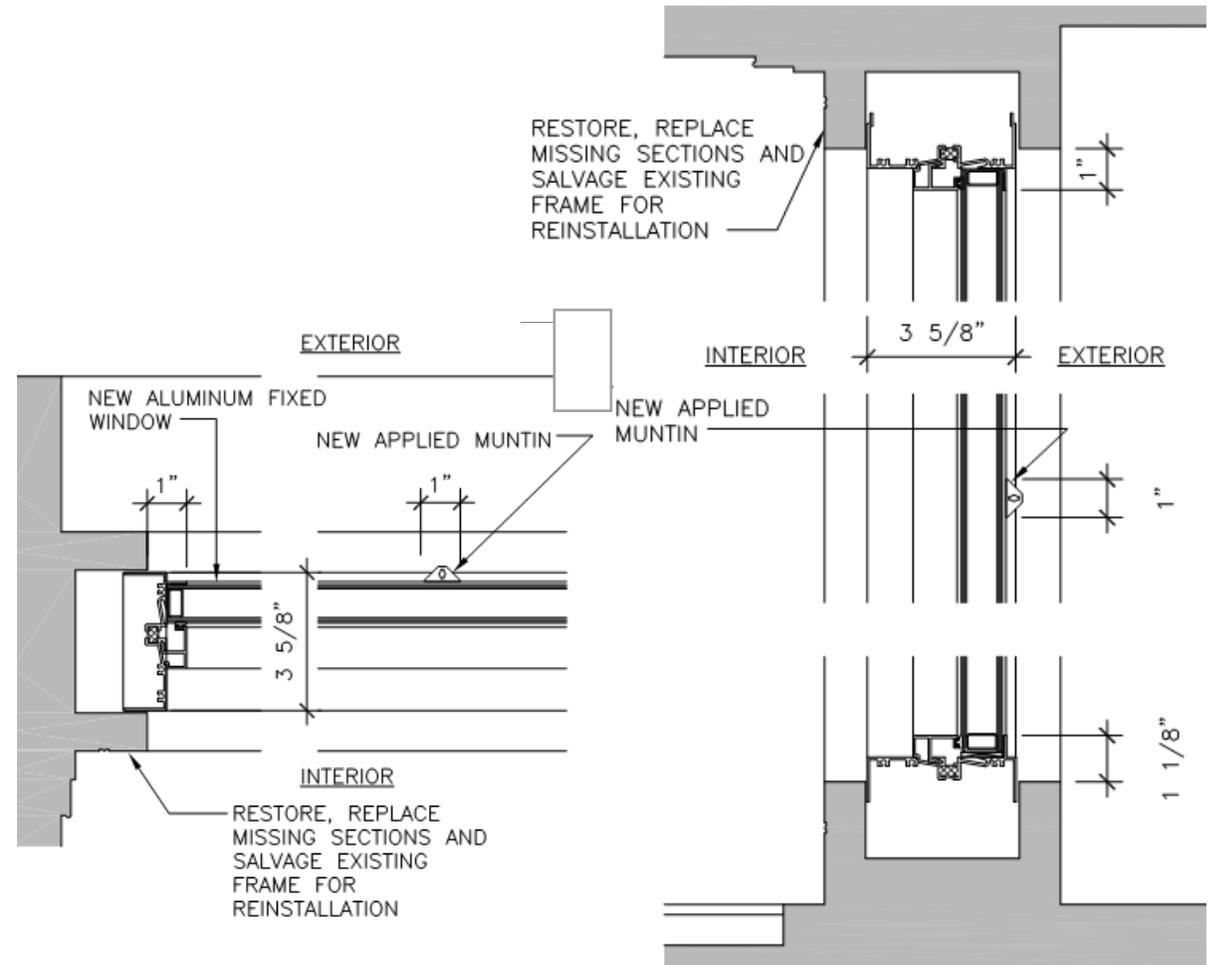
WINDOW TYPE L

PL PLAN DETAILS

SC SECTION DETAILS

Existing - Wood

Proposed - Aluminum

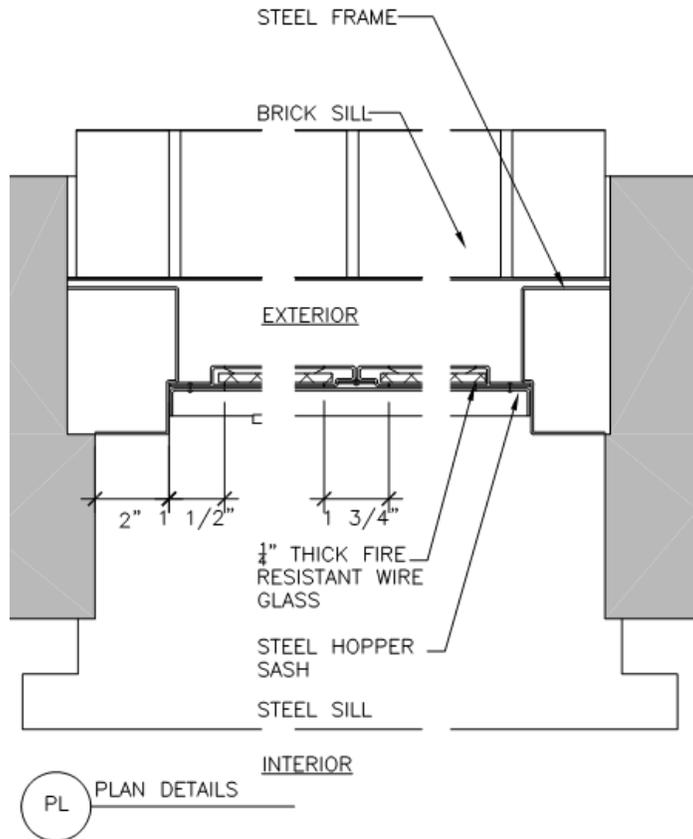
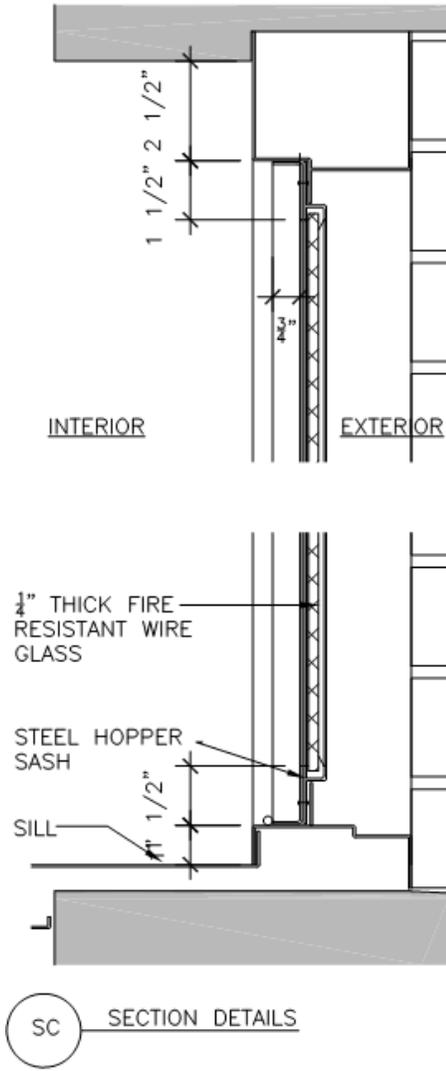
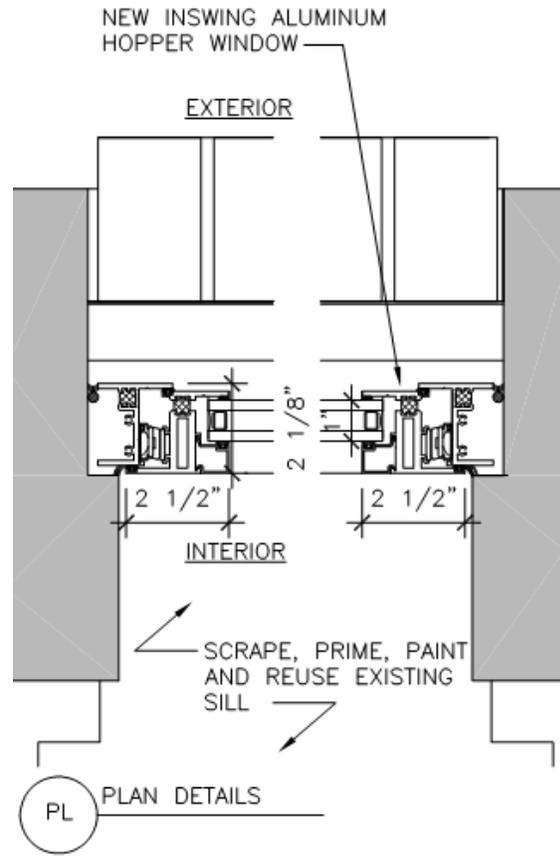
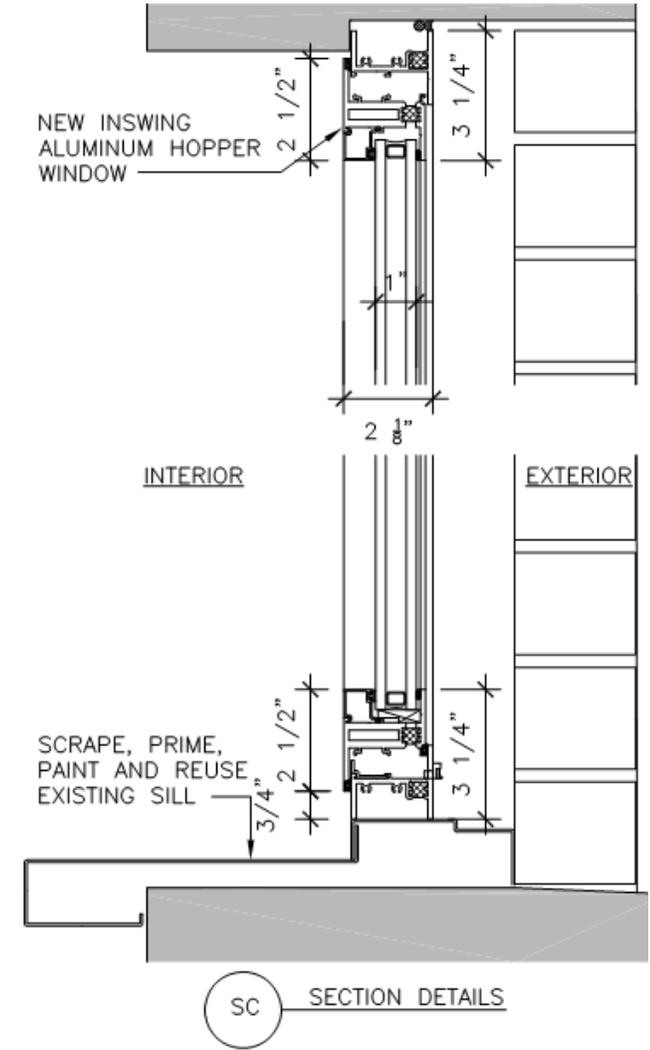
WINDOW TYPE N

Existing - Steel

Proposed - Aluminum

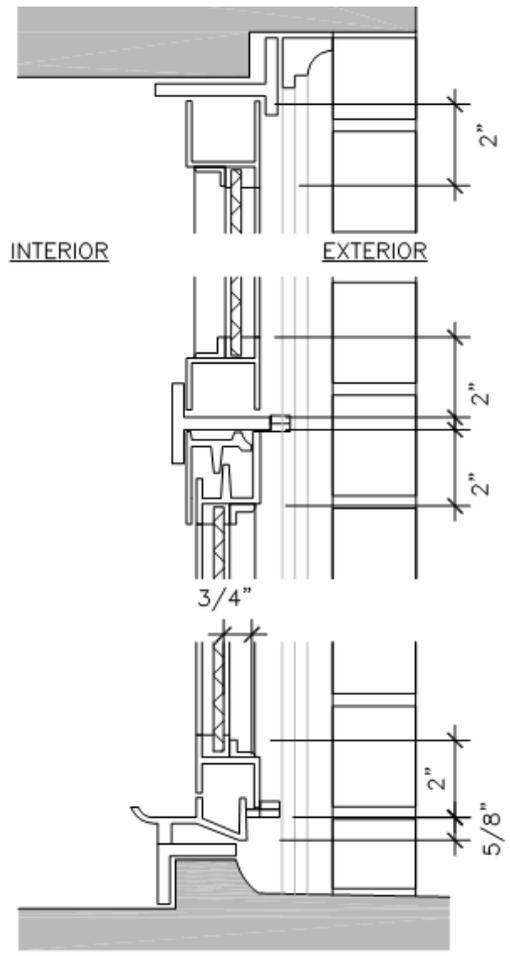
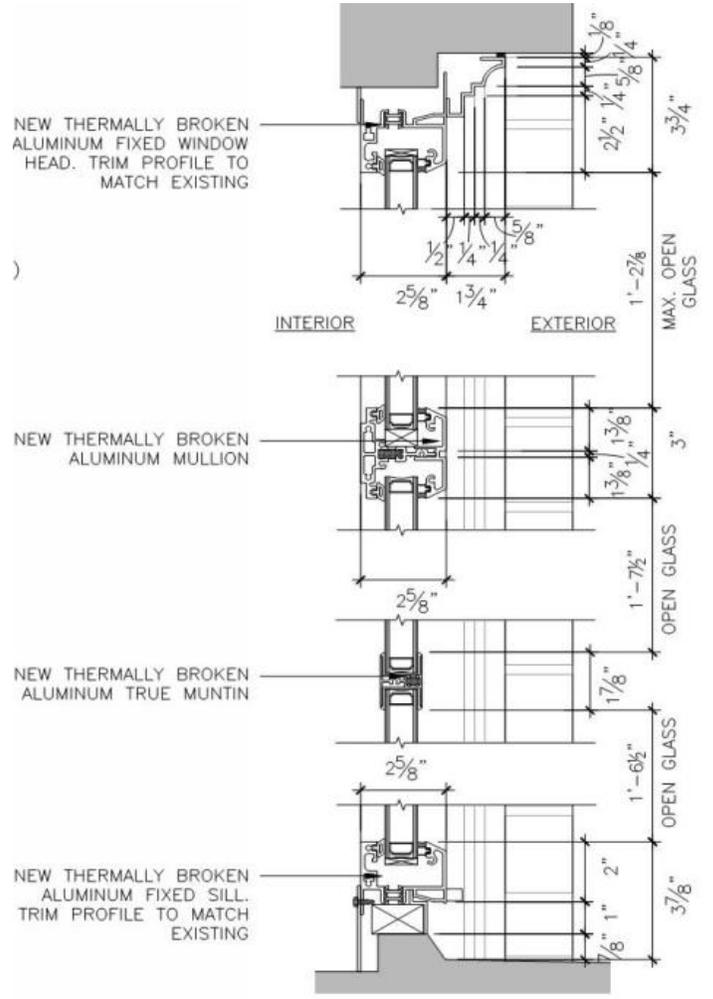
WINDOW TYPE R

SC SECTION DETAILS

Existing - Steel

SC SECTION DETAILS
SCALE: 3" = 1'-0"

Proposed - Aluminum

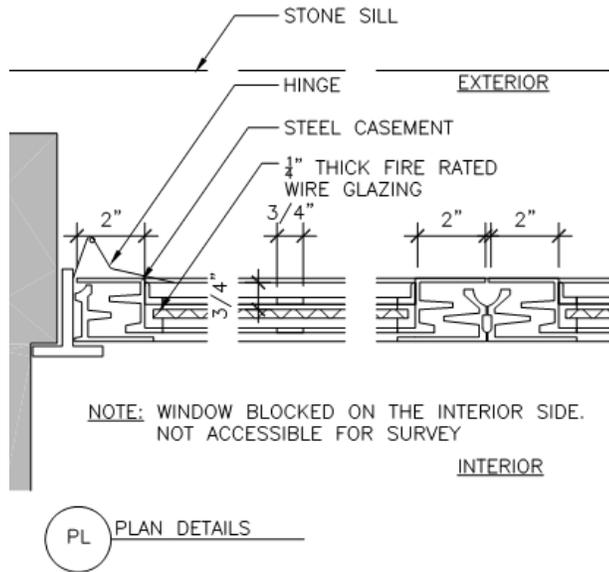
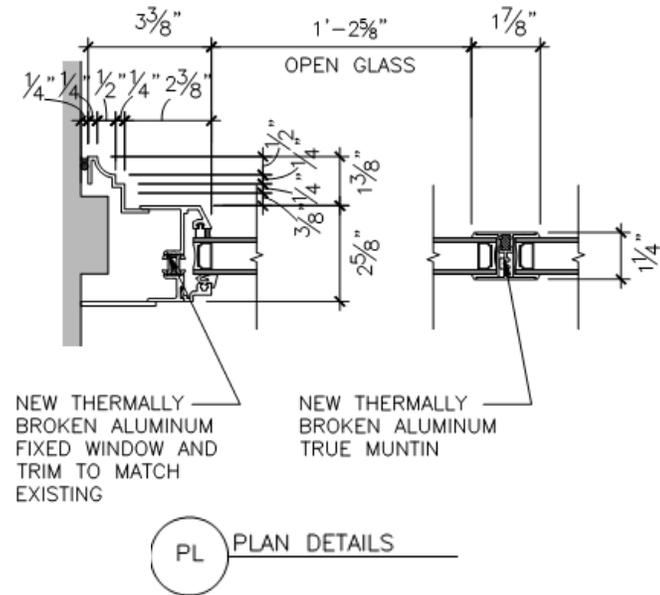
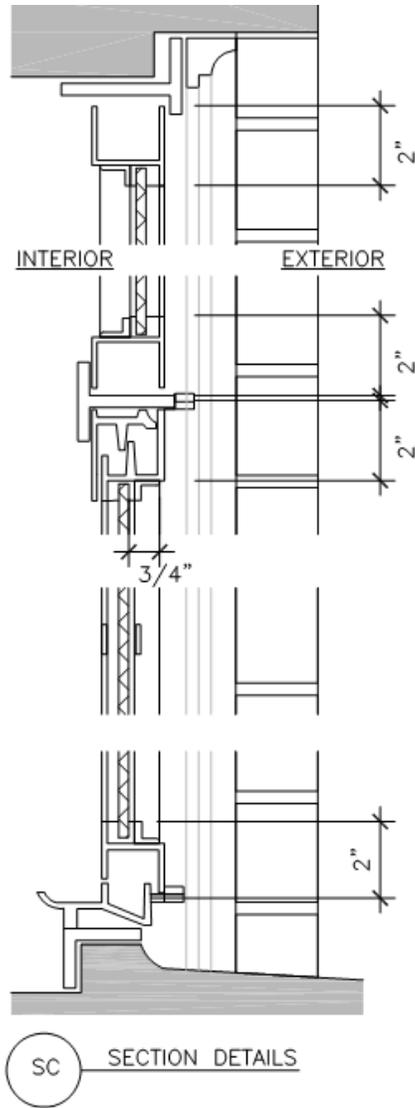
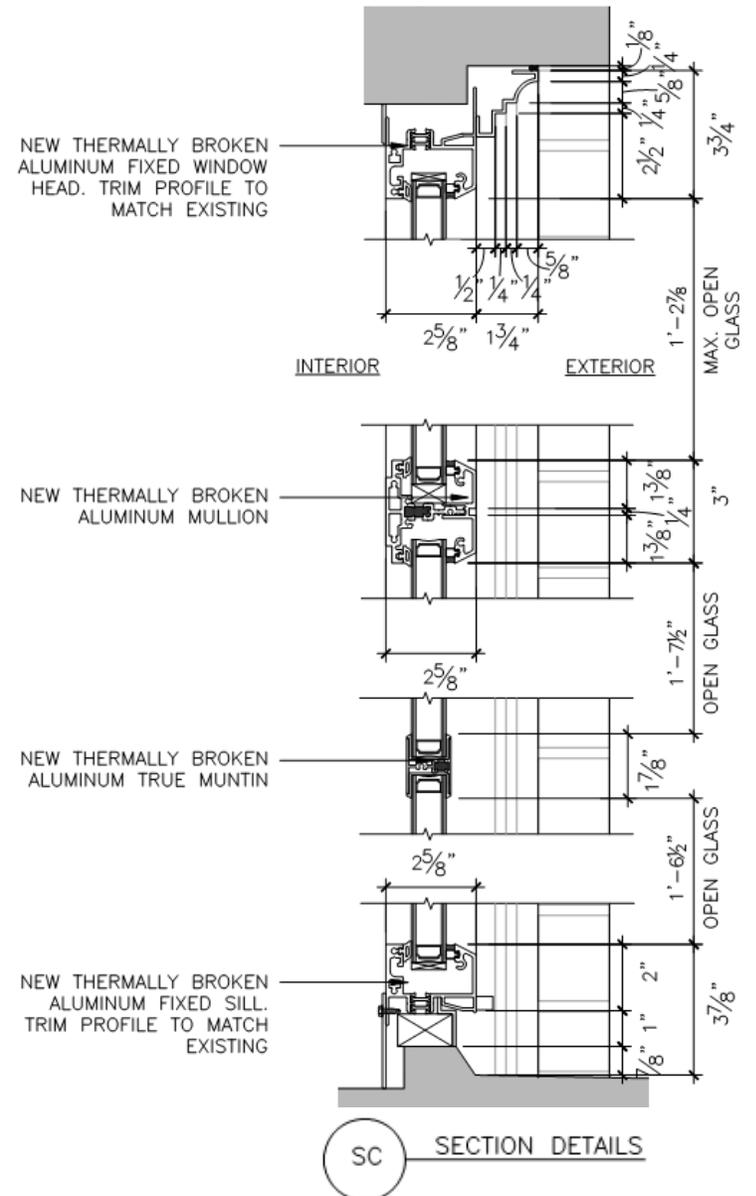
WINDOW TYPE S

Existing - Steel

Proposed - Aluminum
