Preservation Department – Item 11. LPC-21-00050

**130 West 42nd Street – Bush Tower – Individual Landmark,
Borough of Manhattan**

BUSH TOWER

ROOF REPLACEMENT

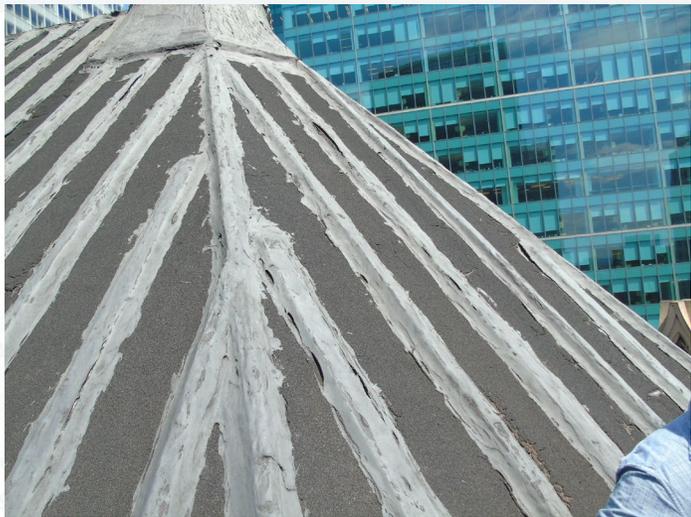
Ex. copper roof covered with modified bitumen membrane.

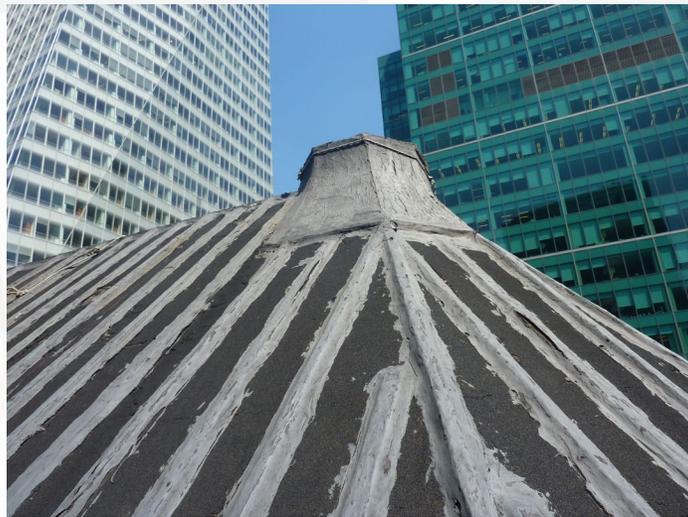
South end of the roof. Ex. fleur-de-lis base covered with bitumen flashing.

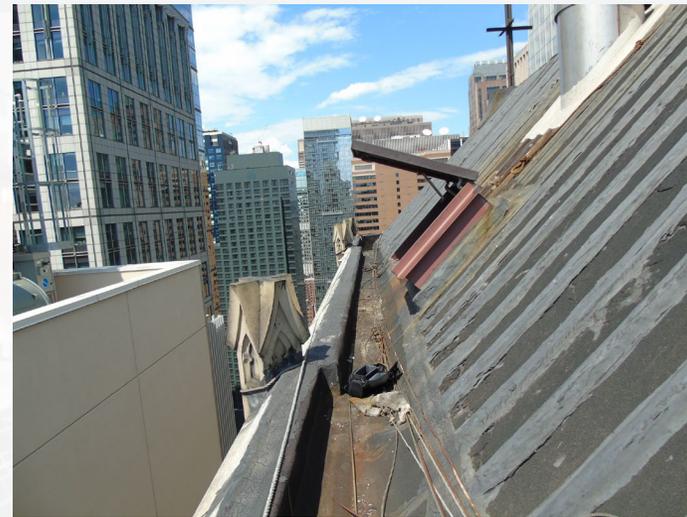
Roof East elevation and access hatch.

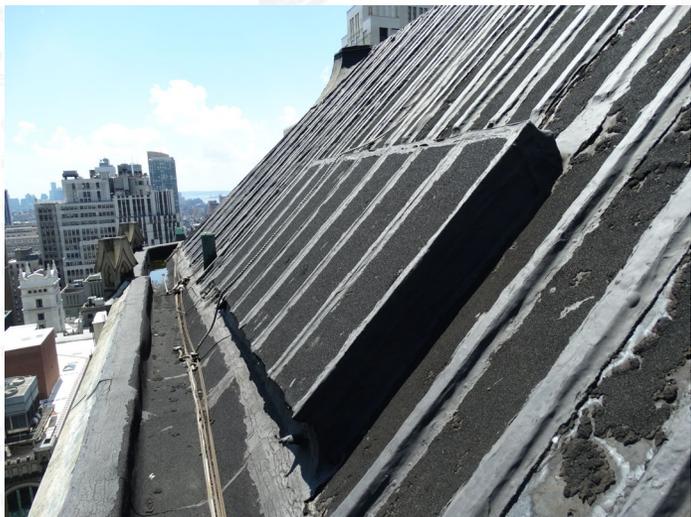
Roof West elevation and covered skylight.

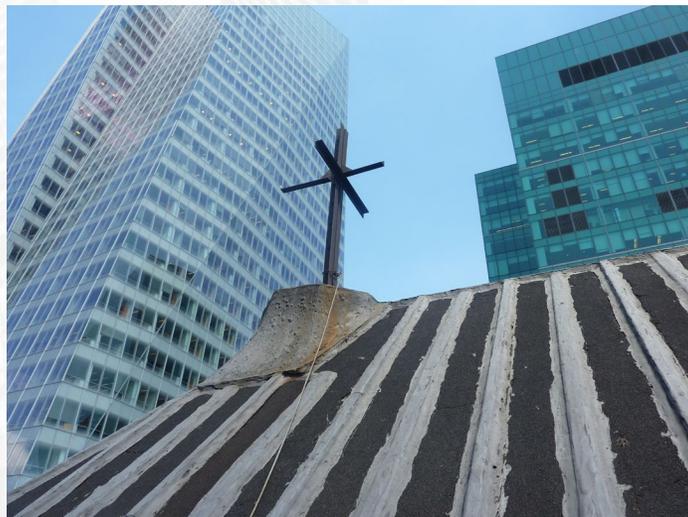
Roof North End. Remnants of the steel fleur-de-lis armature.

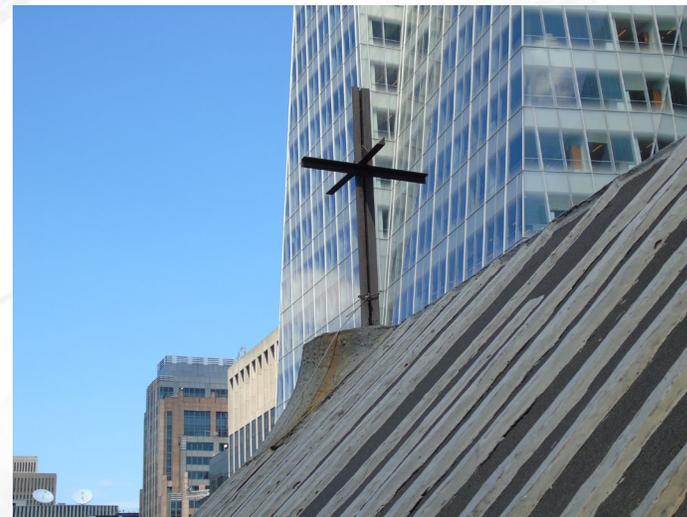
Roof North End. Remnants of the steel fleur-de-lis armature.

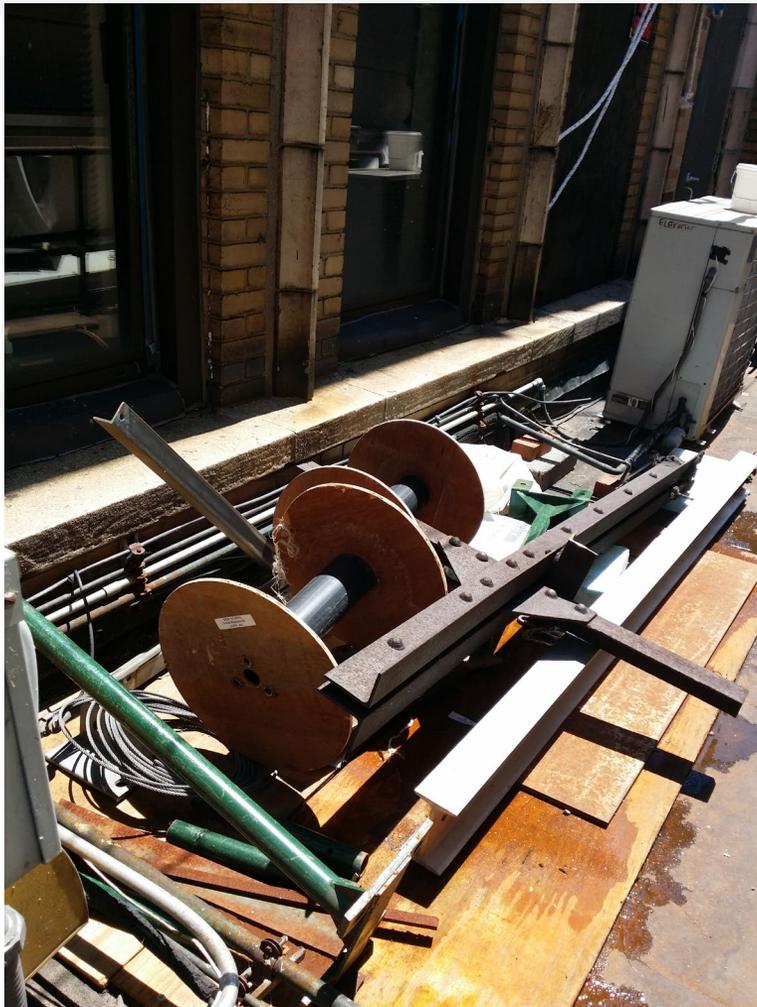
CORRODED FLEUR-DE-LIS ARMATURE

Remnants of fleur-de-lis steel armature lowered to 28th fl. setback roof after armature collapse from South end of the main roof.

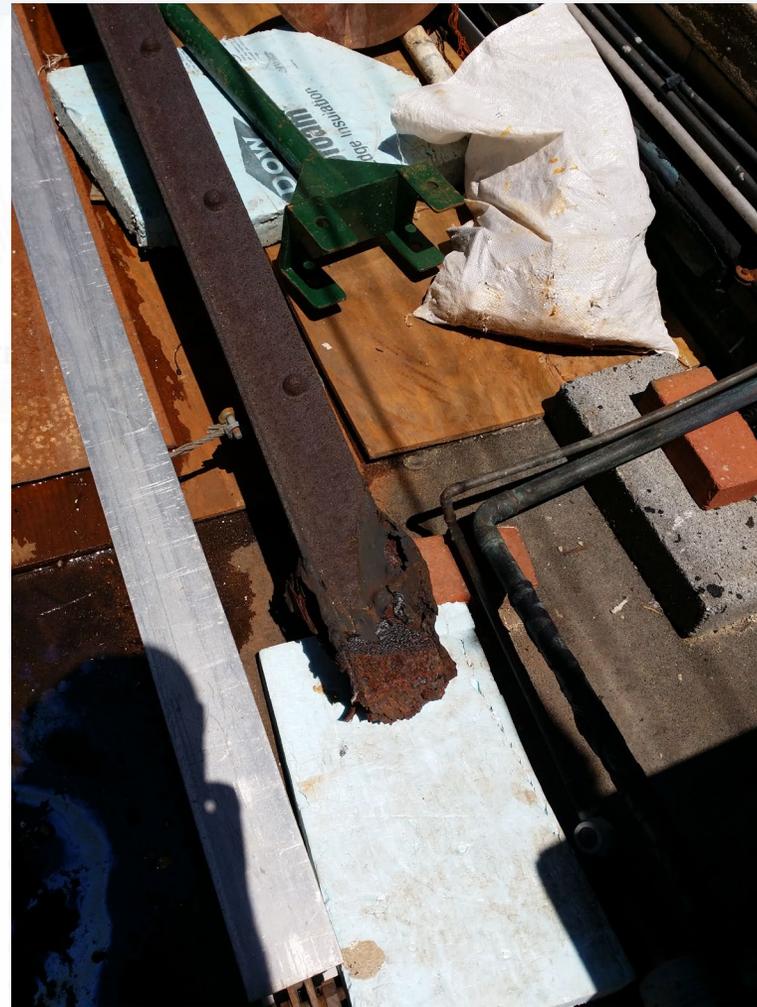
Corroded bottom end of the steel armature, close-up.

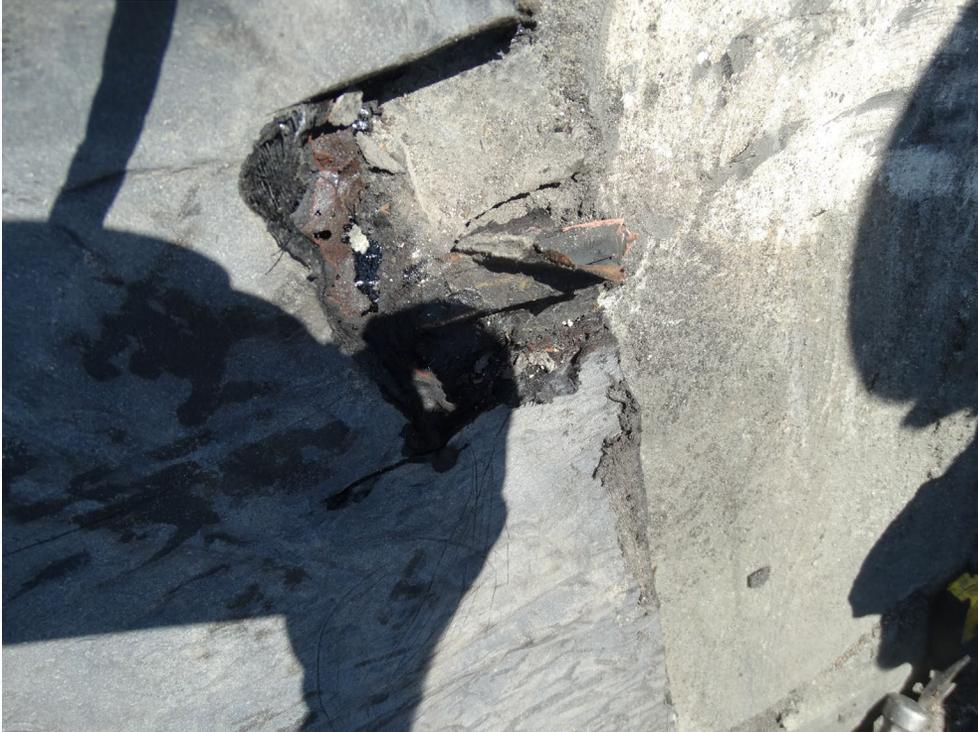
Probe at roof membrane: Existing concrete deck exposed on the right, ex. copper roof covered with modified bitumen membrane on the left.

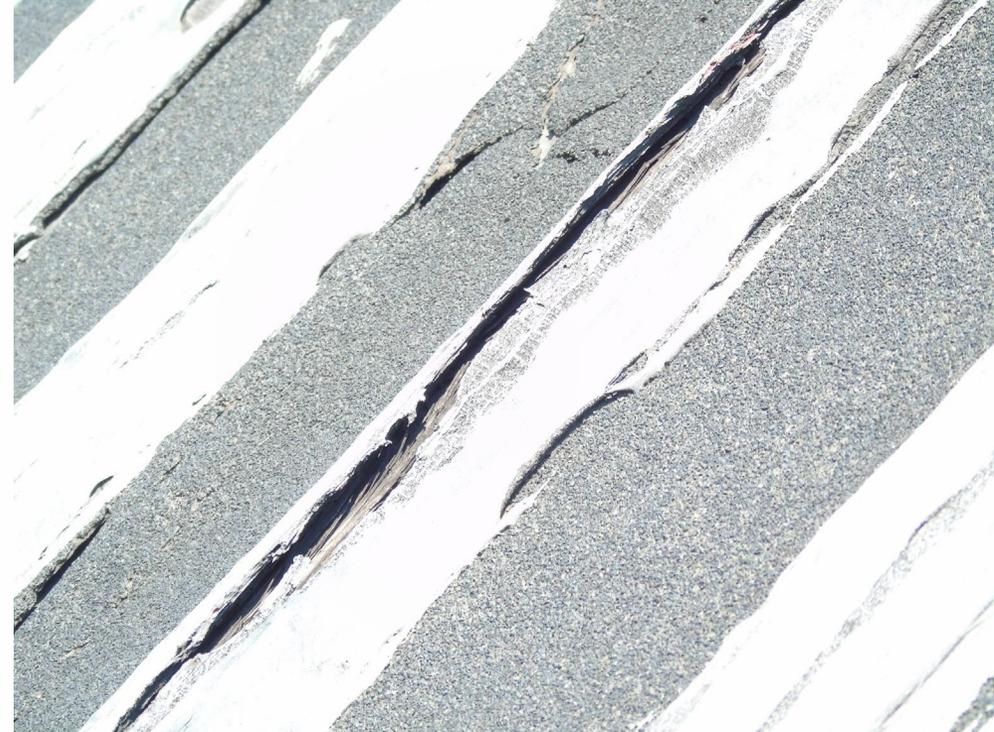
Deteriorated wood batten, copper roofing disintegrated, gap in bitumen membrane & flashing.

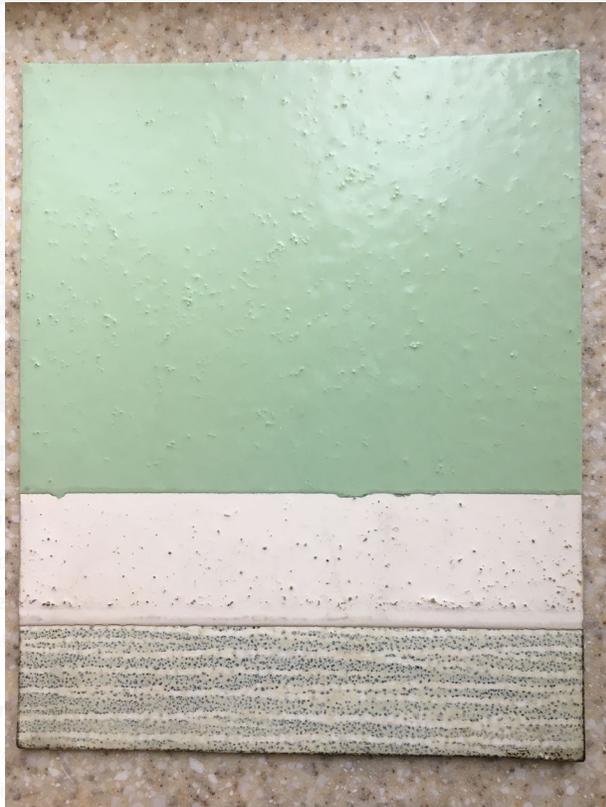
Modified bitumen base ply, torch applied.

- Roof is located approx. 400 ft above sidewalk
- Roof is only minimally visible from any public vantage points. These being distant sidewalk locations East and West.
- High wind uplift ratings superior to conventional copper roof.
- Reinforced liquid application is safe to install at this height, working in steeply sloped confined space.
- Eliminates wait for patina to naturally occur over the years. Will look like patinaed copper roof once installed.
- 20 year manufacturer's warranty available.
- Has been previously successfully installed at historic building(s) in NYC (w/o battens).

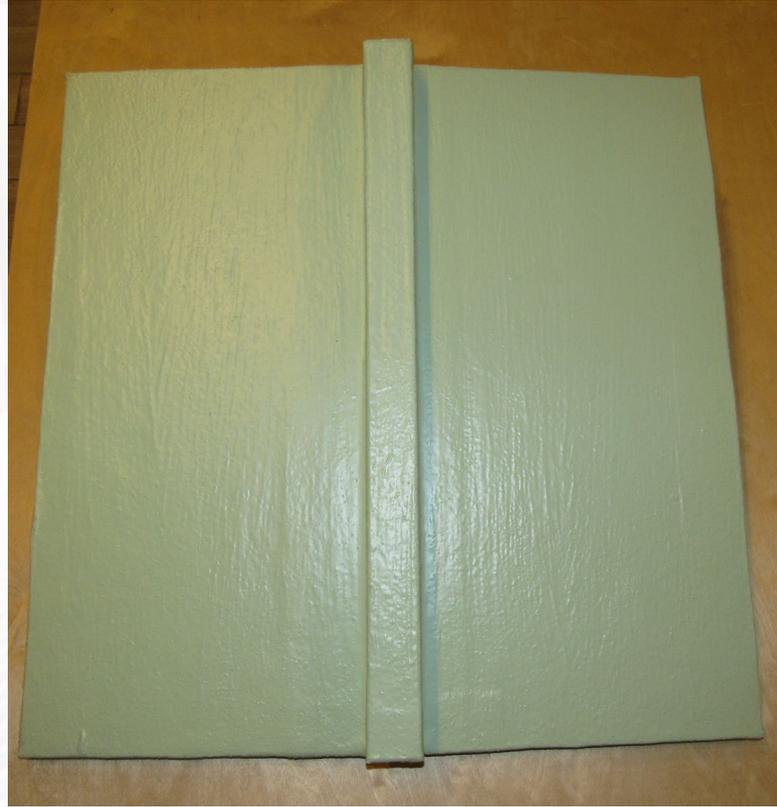
PMMA Resin, liquid applied, fleece reinforced - second ply.

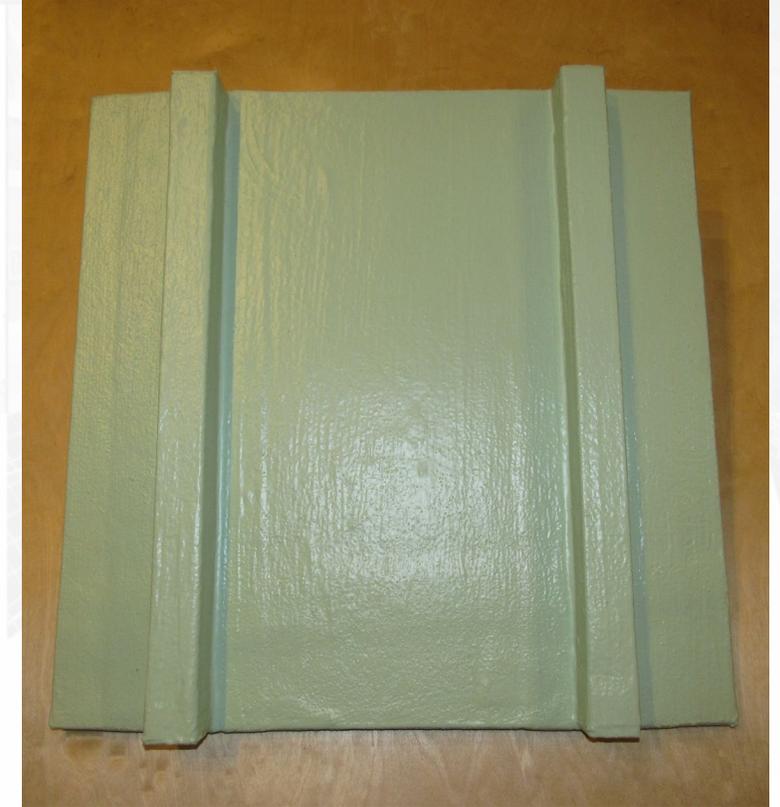
Patina Green color resin coating – final coat.

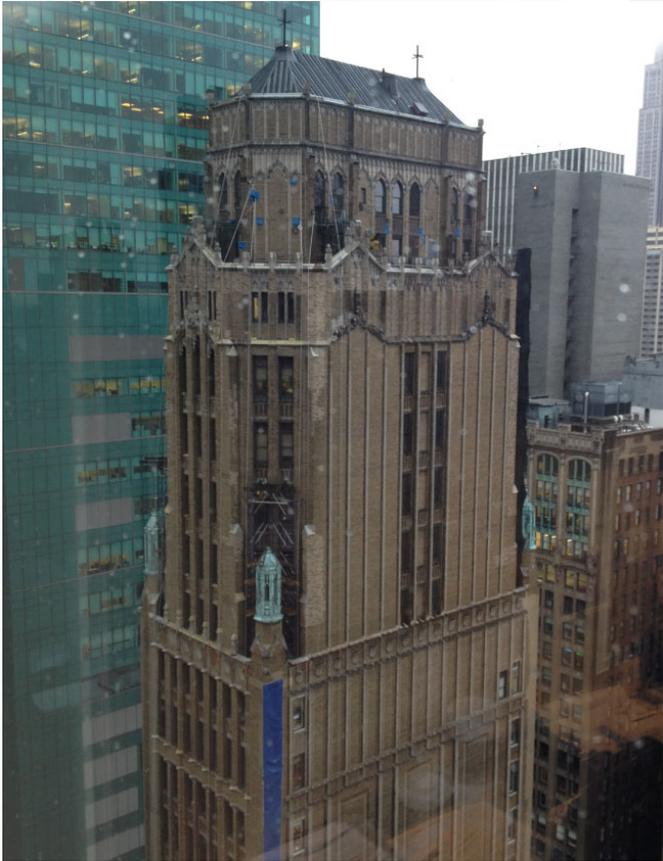
Photo c. (2006-2007) provided by LPC.

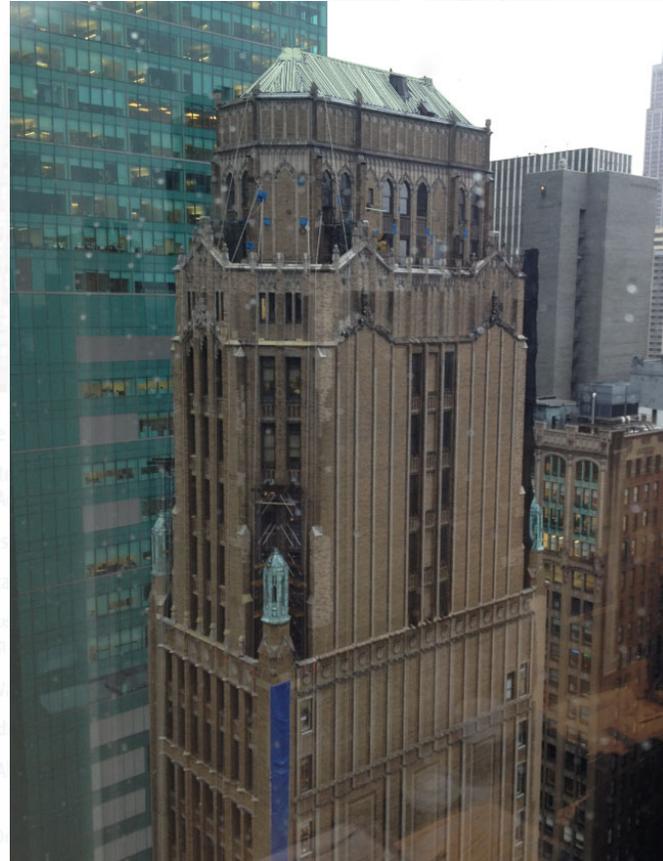
Proposed roof with PMMA patina green membrane.

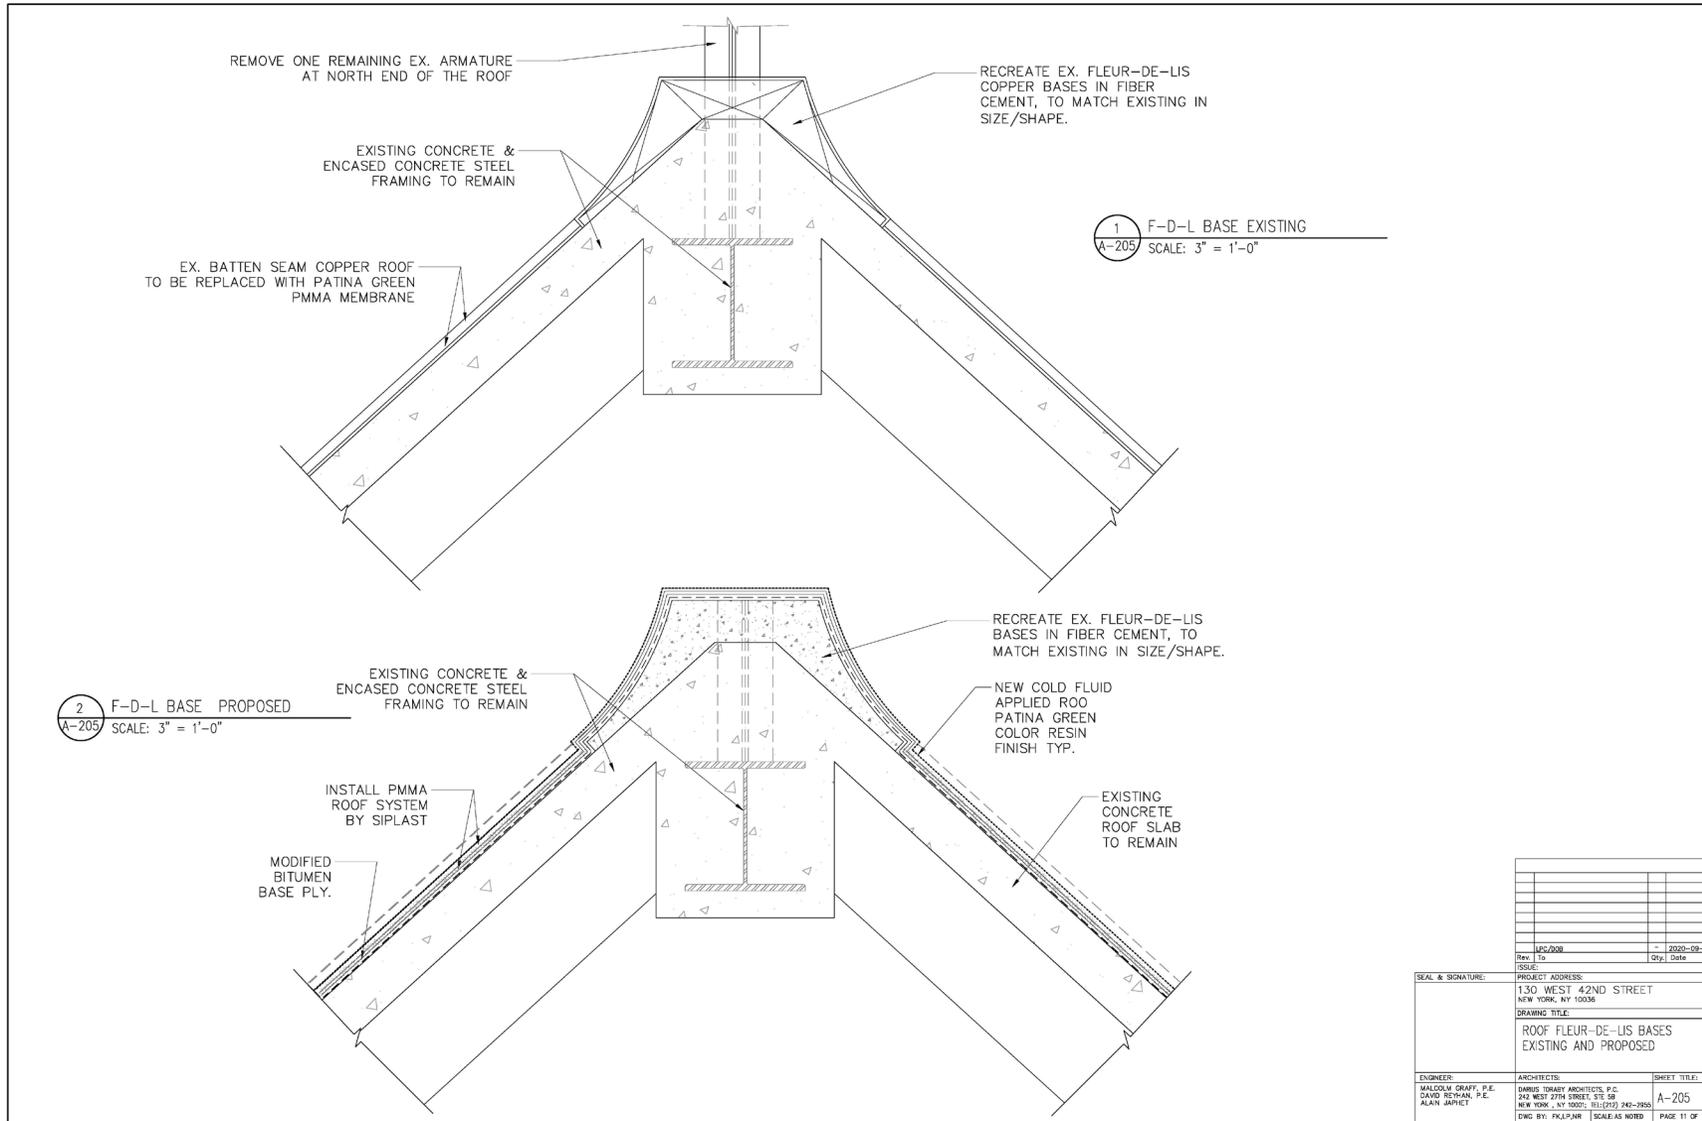
PROPOSED DETAILS

PROJECT ADDRESS:	130 WEST 42ND STREET NEW YORK, NY 10036
DRAWING TITLE:	ROOF FLEUR-DE-LIS BASES EXISTING AND PROPOSED
ENGINEER:	MALCOLM GRAFF, P.E. DAVID ROSEMAN, P.E. ALAN JAPHET
ARCHITECTS:	DARIUS TORABY ARCHITECTS, P.C. 245 WEST 27TH STREET, 5TH FL NEW YORK, NY 10001; TEL: (212) 242-2855
SHEET TITLE:	A-205
DWG BY:	FK/AP/HR
SCALE:	AS NOTED
PAGE:	11 OF 11
