Chinatown Pedestrian Circulation Study

Prepared for Manhattan Community Board 3
By Dylan Dekay-Bemis
2016 Community Planning Fellow

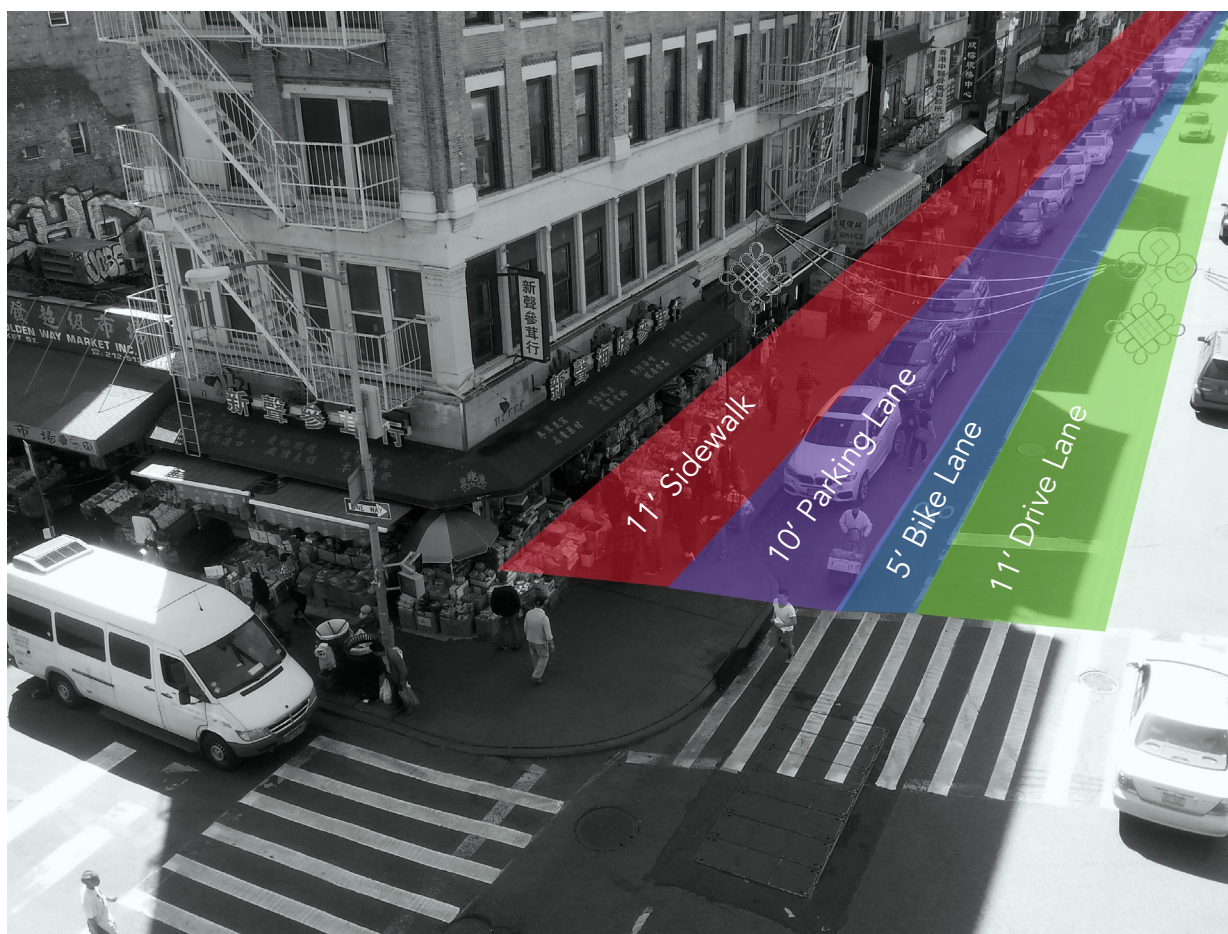
Existing Conditions, East Broadway

Buildings within the study area are mostly low-rise in character, ranging from one to twelve stories in height. Given the neighborhood's long and storied history, many buildings in the area are walk-ups and contain no elevator, creating accessibility issues for the mobility impaired. The sidewalk environment on East Broadway creates mobility issues as well. Although the standard sidewalk width is 11 feet, numerous objects within the study area obstruct navigable sidewalk space and impede pedestrian circulation. While the constriction of effective sidewalk space is certainly a problem for seniors and the mobility impaired, poor circulation is an issue that adversely affects all pedestrians.

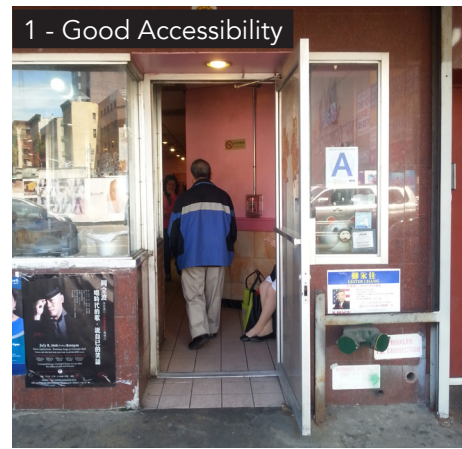
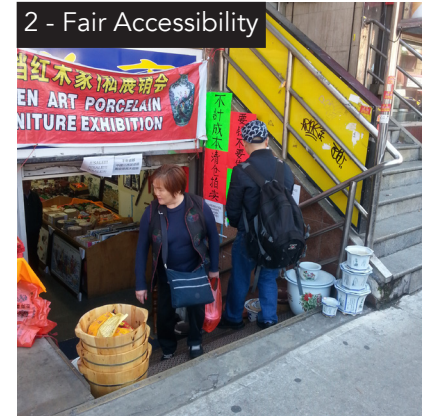
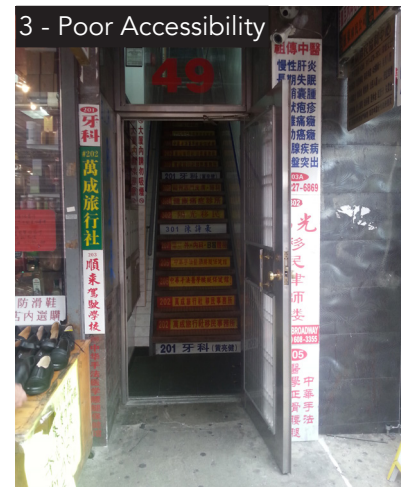
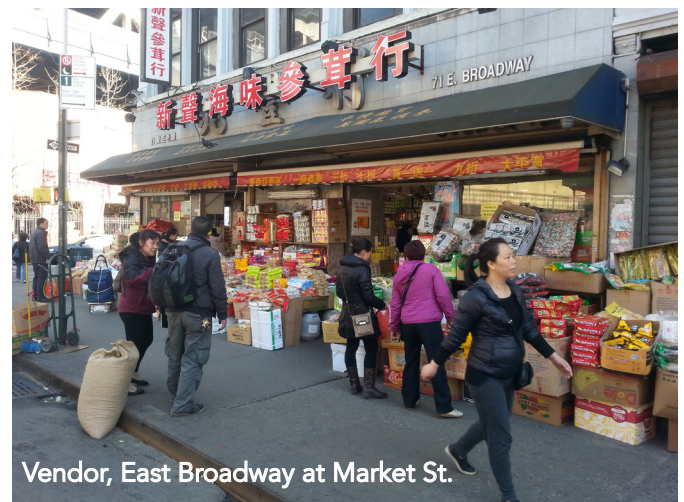
Vendor, East Broadway at Market St.

Many shops within the study area display goods on the sidewalk, protruding and constricting effective sidewalk width. Many of these sidewalk displays qualify as stoop line vendor stands, as they sell fruits, vegetables, confectionery, or flowers from a stand outside or directly adjacent to an existing retail establishment. Additionally, a number of stand-alone street vendor stands are also located within the study area. Both the vendor stands and sidewalk displays inhibit pedestrian circulation by attracting a congregation of customers within a concentrated area. Vendor and sidewalk displays are particularly problematic in areas where adjacent sidewalk furniture creates chokepoints that seriously impede pedestrian circulation. Many (but not all) of the street vendor stands and sidewalk displays were ranked as heavy obstructions to pedestrian circulation (obstruction rating = 3). While vendor stands and sidewalk displays are dispersed around the study area, sidewalk vending activity is heavily concentrated between Market and Catherine Streets.

The section of East Broadway between Market St. and Catherine St. contains nine stoop line vendor stands, six stairwells that protrude onto the sidewalk, a multitude of street furniture, and heavy delivery volumes. Additionally, the section of East Broadway between Forsyth and Market contains a problematic chokepoint involving a set of payphones and one of the two stoop line vendors located on the block. In order to better facilitate pedestrian movement, it is recommended that Community Board 3 file a request with NYC DOT to study the feasibility of installing painted curb extensions on the south side of East Broadway between Market St. and Catherine St., and between Market St. and Forsyth St.

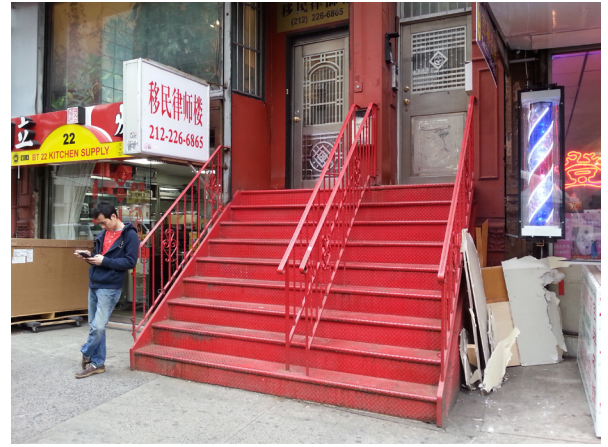
Many above- and below-ground entrances within the study area contain stairwells that protrude into the sidewalk and impede pedestrian circulation. When combined with other sidewalk furniture, the stairwells create chokepoints that greatly inhibit navigable sidewalk space. Similar to vendor stands and sidewalk displays, many stairwells within the study area received an obstruction rating of 3, indicating a significant impediment to pedestrian movement.

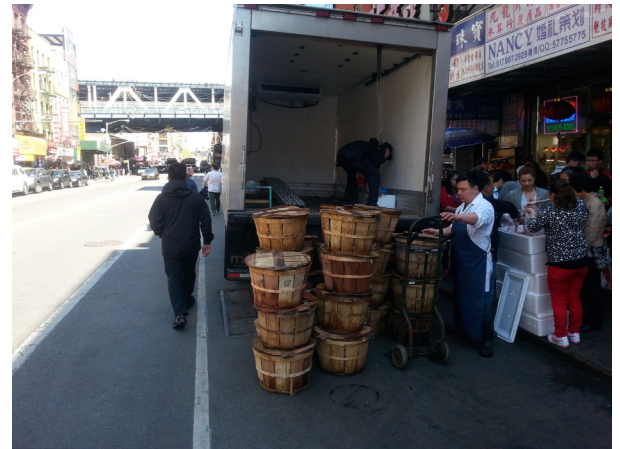
The standard 11-foot sidewalk in the study area is often too narrow to accommodate the many competing uses on East Broadway. Consequently, frustrated pedestrians often leave the sidewalk and walk in the parking or bicycle lanes, where travel is both faster and more direct, creating potentially hazardous situations for pedestrians, cyclists, and drivers alike. Pedestrian traffic can also become excessively bad on one side of the street. When this situation occurs pedestrians will often cross to the other, less congested side of the street midblock where no crosswalk is present, jaywalking and creating unsafe traffic situations.

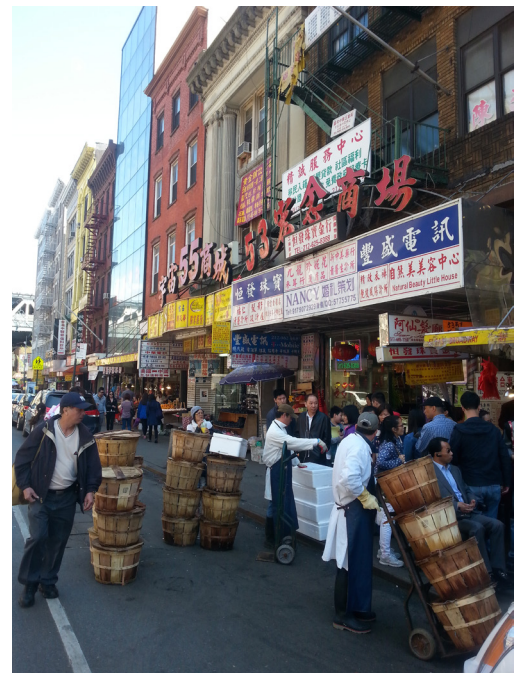
Delivery trucks bring products to the many businesses and vendors of East Broadway on a daily basis. Loading and unloading of goods on the sidewalk restricts navigable sidewalk space, making it very difficult for pedestrians to navigate East Broadway. Deliveries to outdoor vendors are particularly problematic, as boxed goods and vendor tables and shelves combine to make pedestrian space practically non-existent. Delivery vehicles are present at multiple times throughout the day and greatly exacerbate the already chaotic pedestrian environment on East Broadway.

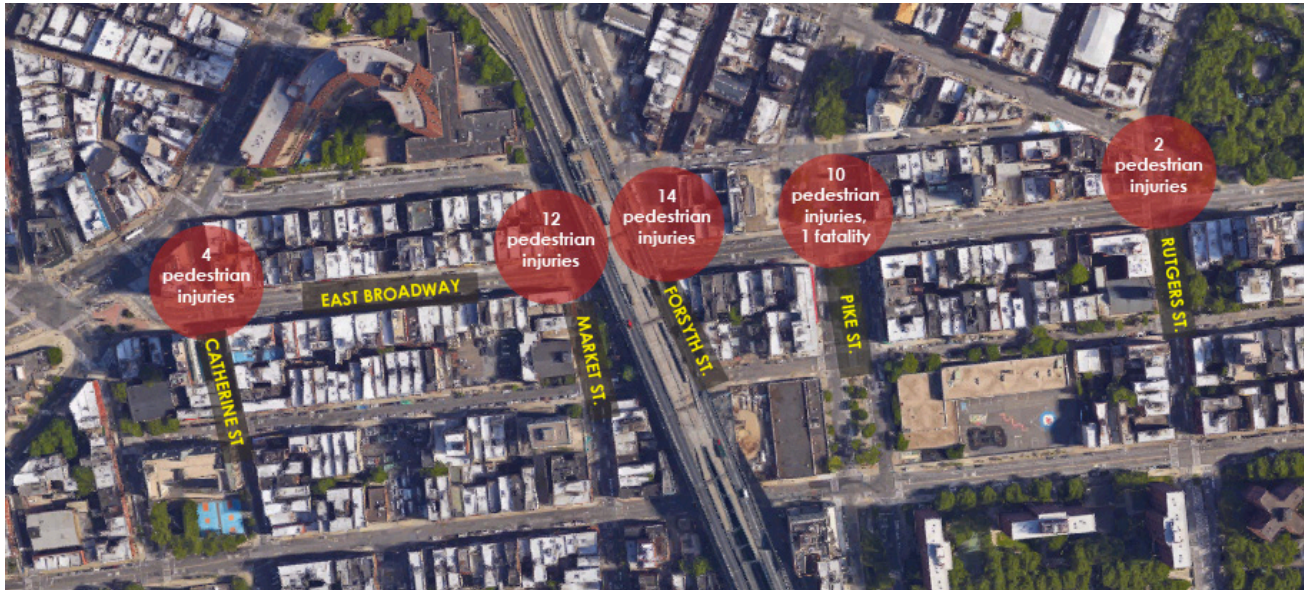
Pedestrian injuries and fatalities, 2010-2015
Source: NYC Vision Zero

Between 2010 and 2015 there were a total of 42 motor vehicle-related pedestrian injuries and 1 fatality within the study area. All of these incidents occurred at intersections, with the vast majority occurring at the intersection of East Broadway and Market St. (12 pedestrian injuries), East Broadway and Forsyth St. (14 pedestrian injuries), and East Broadway and Pike St. (10 pedestrian injuries, 1 fatality). Traffic safety is clearly an issue within the study area, especially given the particularly vulnerable senior and mobility-impaired populations living in the surrounding neighborhoods.

As stated earlier in this report, a significant amount of motor vehicle-related pedestrian injuries have occurred within the study area. Between 2010 and 2015 there were a total of 42 motor vehicle-related pedestrian injuries and 1 fatality. All of these incidents occurred at intersections, with the vast majority occurring at the intersection of East Broadway and Market St. (12 pedestrian injuries), East Broadway and Forsyth St. (14 pedestrian injuries), and East Broadway and Pike St. (10 pedestrian injuries, 1 fatality). Painted corner bulb outs installed at East Broadway and Pike St. have significantly reduced the crossing distance and enhanced pedestrian safety. These improvements should be replicated at other problematic intersections along East Broadway. It is recommended that Community Board 3 file a request with DOT to have painted curb extensions and “Look” pavement markings installed at the corner crossings at East Broadway and Market St. and East Broadway and Forsyth St. The southwest corner of East Broadway and Forsyth should be left unchanged, as this corner serves as a stop location for the M9 bus route and any alterations to the sidewalk could create conflicts between the bus stop and existing bicycle lane. Additionally, CB3 should request that the crosswalks be restriped in order to enhance the visibility of the pedestrian crossing space. Curb extensions would reduce crossing distances, calm traffic by tightening the vehicle turning radius, and allow pedestrians to both see and be seen by oncoming traffic, while the “Look” pavement markings would remind pedestrians to remain alert. Combined, these improvements would serve to greatly enhance pedestrian safety at dangerous intersections.

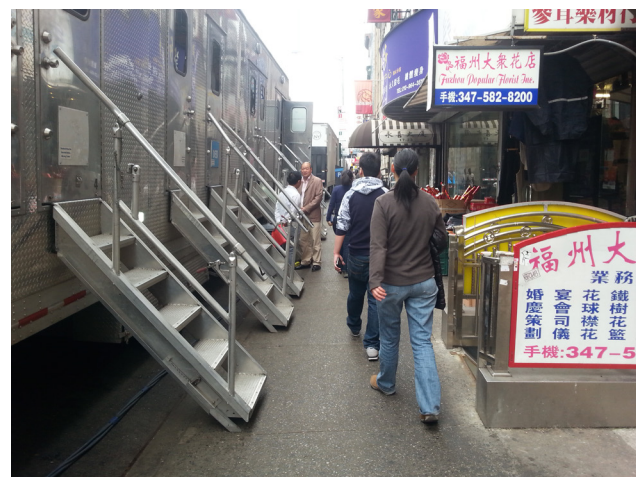
The Lower East Side and Chinatown have served as the backdrop for many major motion pictures, network television shows and commercial advertisements. Although data on film permits is no longer publicly available, observational evidence suggests that filming activity is a regular occurrence within and surrounding the study area. While revenue from film permits is great for New York City, the amount of space occupied by filming crews is often problematic at the neighborhood level. Within the study area, trailers parked along East Broadway during a film shoot greatly constrict effective sidewalk space and impede pedestrian circulation.

Film production trailers,
East Broadway at Catherine St.

While entertainment production is a vital part of the New York City economy and should definitely be encouraged in Community Board 3, filming activity should not adversely impact local residents and visitors. Allowing bulky film trailers to park along heavily congested areas of East Broadway greatly inhibits pedestrian circulation and should be discouraged. With this in mind, it is recommended that film production trailers be prohibited from parking on the south side of East Broadway between Market St. and Catherine St. Redirecting film trailers to park on less congested sections of East Broadway will help to improve pedestrian circulation. Although film trailer parking may no longer be an issue if the Market-Catherine curb extensions are installed, interim restrictions on film trailer parking will provide relief for pedestrians while the feasibility of curb extensions is being studied by DOT.

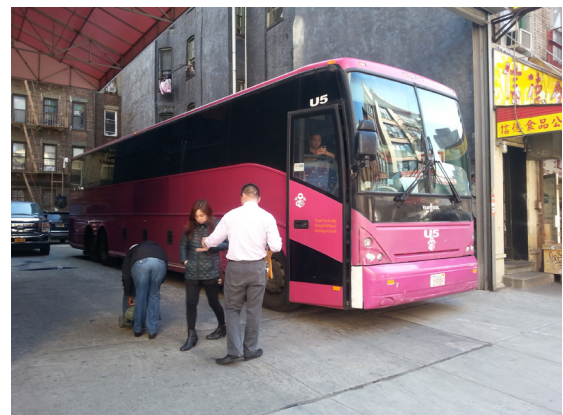
Intercity Bus Stop, 133 E. Broadway

Although the addresses mentioned above represent the permitted stop sites, GD Tour Inc. lists its stop location as 127 East Broadway and Rockledge Bus Tour Inc. lists its stop location as 133 East Broadway. While it is unclear if GD Tour and Rockledge are violating the terms of their permits on a daily basis, multiple unmarked buses were seen departing from the parking lot adjacent to 133 East Broadway during one field visit. All of the stop locations – those permitted and unpermitted – are located on a section of East Broadway that is relatively untraveled by pedestrians throughout most of the day. Nonetheless, intercity bus loading and unloading in the study area can pose a problem to pedestrian circulation during peak commute times.

As mentioned earlier in this report, the intercity bus stop listed for Rockledge Tour Bus Inc. (133 East Broadway) does not match the address of the stop as designated by the New York City Department of Transportation (150 East Broadway). It is recommended that CB 3 investigate this potential violation of the intercity bus stop terms as designated by NYC DOT in order to ensure that Rockledge Tour Bus Inc. is in compliance. Investigation of potential violations could consist of a survey performed at Rockledge's officially designated bus stop at 150 East Broadway and the observed and listed bus stop location at 133 East Broadway to determine if Rockledge is using its designated stop or is instead using an alternate, undesignated location.

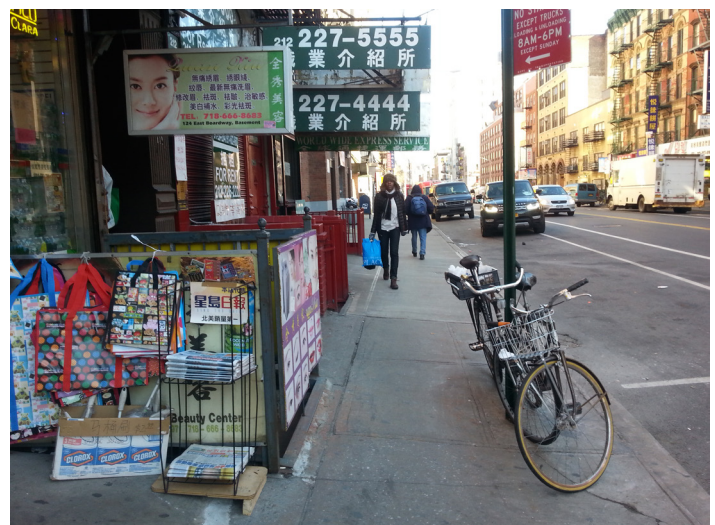
Lack of Bicycle Parking

With only two CityRacks located within the study area (in front of 133 and 162 East Broadway), there is a noticeable lack of sidewalk bicycle parking. Without adequate bike parking facilities, bicycles are instead locked to street signposts or railings, further constricting useable sidewalk space along East Broadway.

Although bicycle lanes are located on either side of East Broadway, there is currently very few bicycle parking facilities located within the study area. As noted earlier in this report, bicycles chained to signposts, railings and other street furniture often take away from useable sidewalk space, and contribute to pedestrian bottlenecks. Lack of bicycle parking is of particular consequence near restaurants with bicycle delivery service, as delivery drivers are forced to secure their bicycles to whatever street furniture is available, which can adversely impact the sidewalk environment. In order to make better use of available sidewalk space, it is recommended that Community Board 3 petition DOT to request that CityRacks be installed at the following locations:

- 17 East Broadway
- 28 East Broadway
- 33 East Broadway
- 39 East Broadway
- 42-44 East Broadway
- 47 East Broadway
- 54 East Broadway
- 91 East Broadway
- 94 East Broadway
- 120 East Broadway
- 148 East Broadway
- 160 East Broadway

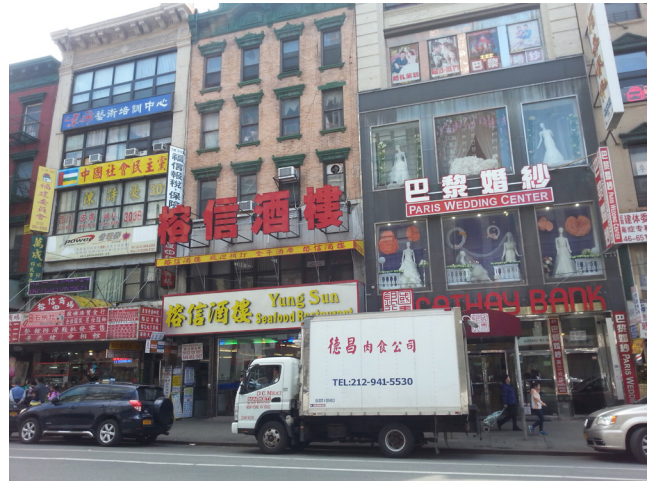
The study area contains many above- and below-ground businesses and cultural facilities. Many of these businesses and cultural facilities are located in buildings that lack elevator access and are thus inaccessible to seniors and mobility-impaired individuals. Fortunately some of the services provided in locations with poor accessibility are offered elsewhere within the study area, but unfortunately others are not.

Inaccessible above-ground businesses

There are many services within the study area that are either unavailable or difficult to access for people with mobility impairments, due to the inaccessible nature of the building in which the service is located. With this in mind, it is recommended that CB 3 perform outreach to inform senior centers about services within the study area that are inaccessible. Difficult to access or inaccessible services and facilities with no alternative options in the study area include: driving schools, employment agencies, mailbox rental services, notary publics, supermarkets and sign makers. It is recommended that CB 3 inform senior centers near the study area about these missing services, so that the centers can find alternative locations for seniors and disabled residents of CB 3.

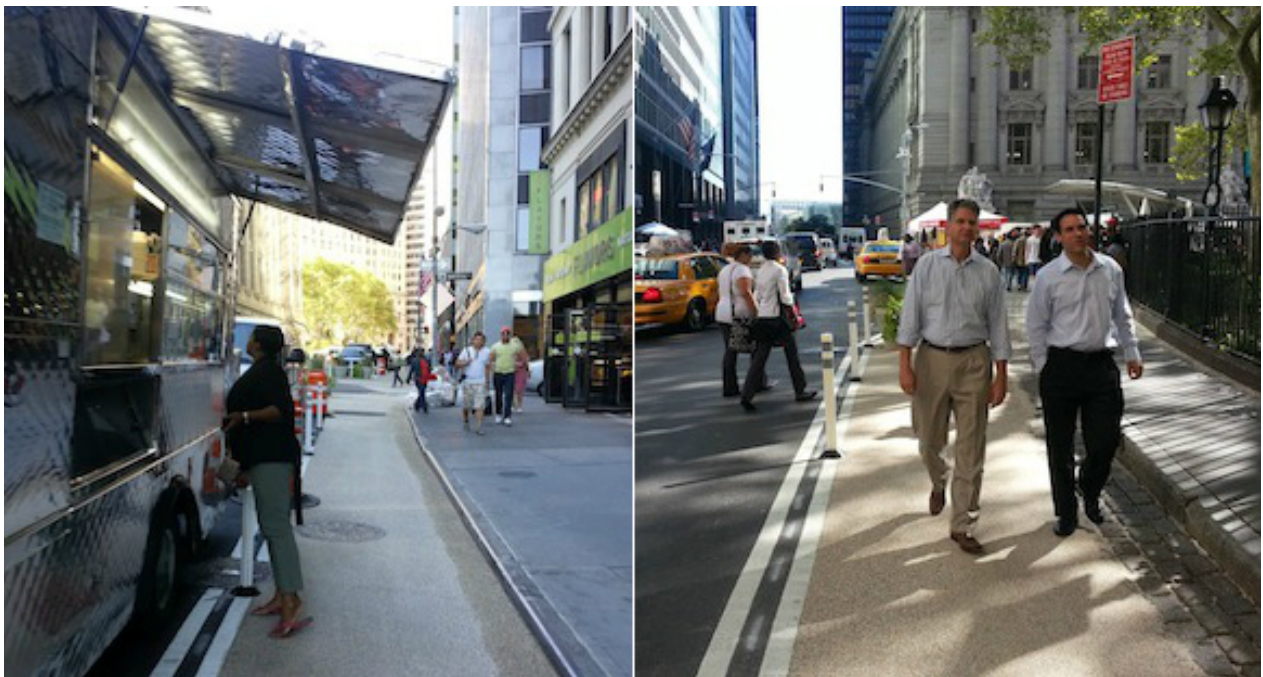
Painted sidewalk extensions, Manhattan
Source: Streetsblog

In areas with high pedestrian volumes, widening the existing sidewalk may help relieve congestion. If appropriate, excess space in the parking, moving or bike lanes can be reallocated to widen the sidewalk. Although a permanent sidewalk widening using concrete or other comparable materials may be desirable, the sidewalk can also be widened in advance of or in place of permanent reconstruction using interim materials such as epoxied gravel, planters or flexible delineators. The use of interim materials provides a low-cost way to assess the impacts of the intended project in real time and realize immediate benefits. Temporary projects can also be reconfigured based on their performance, allowing for improved design if the project is made permanent.

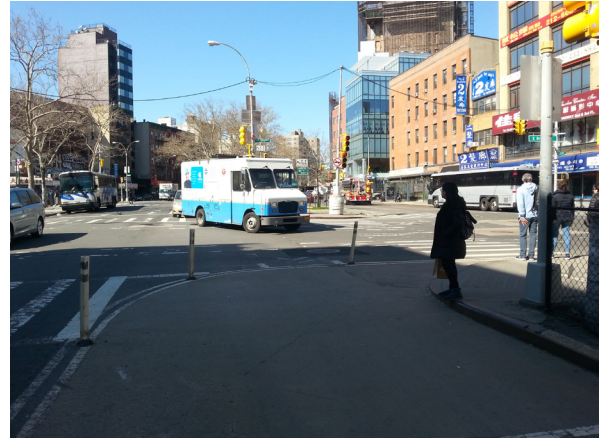
Painted curb extension, East Broadway at Pike St.

A curb extension (a.k.a. neckdown or bulb-out) is “an expansion of the curb line into the lane of the roadway adjacent to the curb (typically a parking lane) for a portion of a block either at a corner or mid-block.”⁴ Curb extensions physically and visually extend the curb and can greatly improve pedestrian safety by calming traffic, shortening crossing distances, improving driver visibility of pedestrians, and preventing drivers from passing each other in the parking lane. Two curb extensions can also be placed on opposite sides of the street to create a midblock narrowing. In addition to enhancing safety, curb extensions create additional sidewalk space that can be used to alleviate crowding and reducing sidewalk obstructions, or for making streetscape enhancements by adding seating, planting or other street furniture. Moreover, strategically placed curb extensions can help reduce illegal activity by keeping the fire hydrant zone clear when placed in front of fire hydrants and preventing illegal parking in the crosswalk when located at corner crossings. Intermittent curb extensions can be used in areas where some loading, drop-off, or parking access must be maintained. Drawbacks of curb extensions include the loss of curbside parking and potentially complicating delivery access and garbage removal.

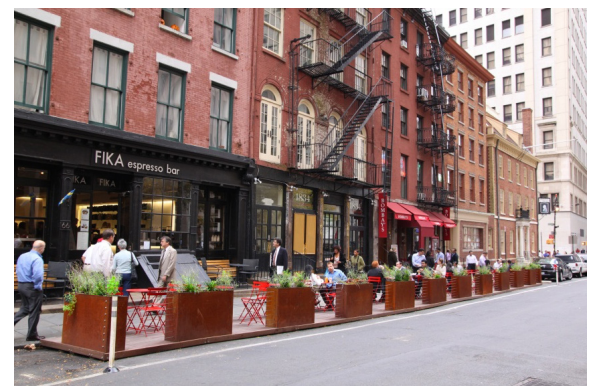
Street seats (a.k.a. parklets) are public seating platforms that replace several on-street parking spaces. Street seats are typically installed where narrow or congested sidewalks prevent the installation of sidewalk cafes or where additional seating and public space is needed. In New York City, street seats are administered through DOT at the request of local businesses, business improvement districts, and non-profits, and temporarily replace on-street parking spaces to provide additional public seating during warm-weather months.

Street Seats - Pearl St., Manhattan
Source: NYC DOT

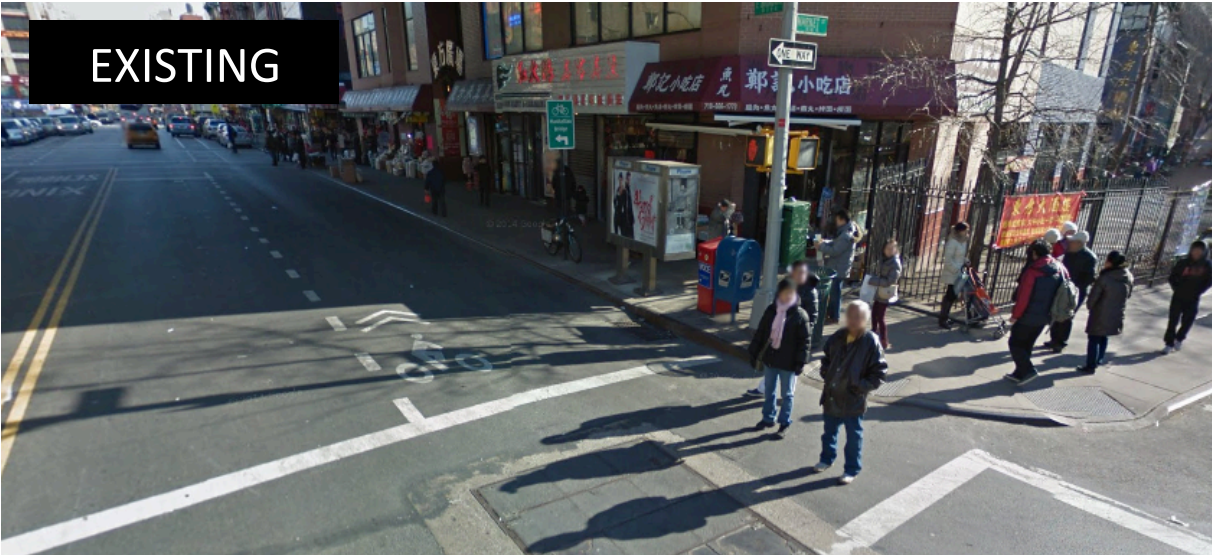
Market St. - Forsyth St. Sidewalk Extension

The Market – Forsyth St. curb extension should extend toward Forsyth St. from the southeast corner of Market and East Broadway for approximately half the distance to Forsyth St., long enough to better accommodate pedestrian circulation while still allowing space for the M9 bus to stop at the corner of East Broadway and Forsyth St. without blocking the bicycle lane. The Market – Catherine St. curb extension should be placed in areas with concentrated vendor activity (from the corner of East Broadway and Market to 69 East Broadway and in front of 57 to 49 East Broadway). Curb extensions would not only provide additional space for pedestrian circulation, but would also provide space for seating, planting and other streetscape improvements that are currently lacking along East Broadway. It is recommended that CB3 enlist the assistance of the Chinatown Partnership to help maintain any planting and/or seating that is added along the curb extensions. Combined, the recommended sidewalk extensions would require the loss of only approximately five on-street parking spaces - two spaces for the curb extension spanning from the corner of East Broadway and Market to 69 East Broadway, and three spaces for the curb extension spanning from 57 to 49 East Broadway. In addition to the sidewalk extensions, it is recommended that a mid-block narrowing be installed at the existing mid-block crosswalk located between Market St. and Catherine St. in order to shorten the crossing distance.

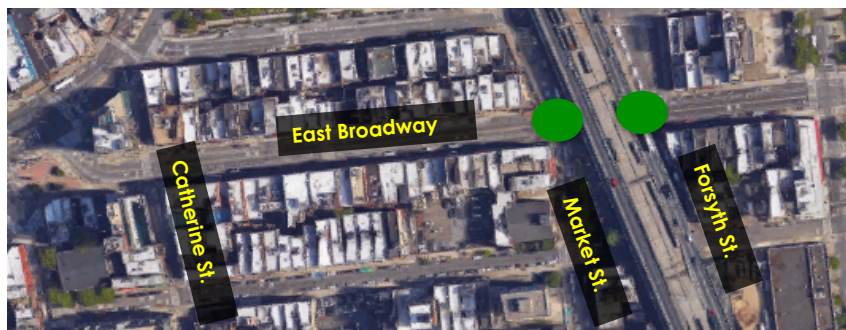
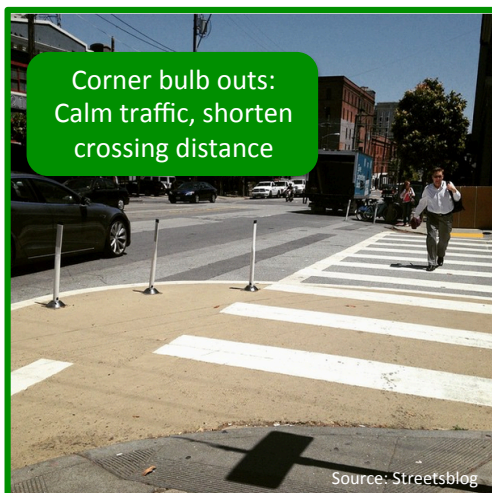
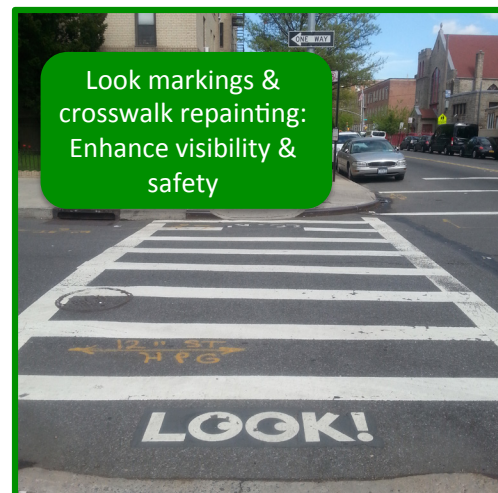
Install painted bulb outs, “Look” pavement markings, and repaint crosswalks at the following intersections:

1. East Broadway & Market St. (all corners)
2. East Broadway & Forsyth St. (all corners, except southwest)

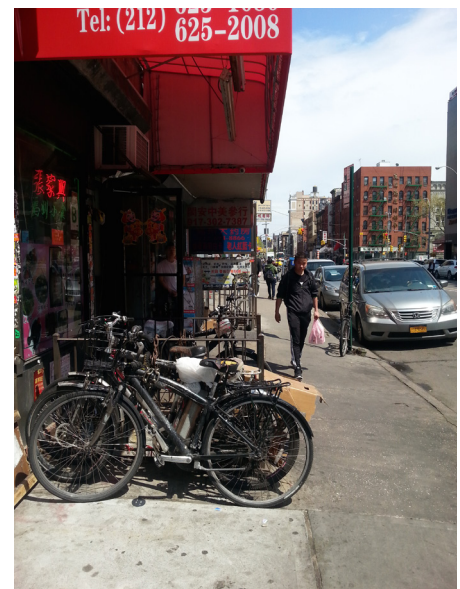
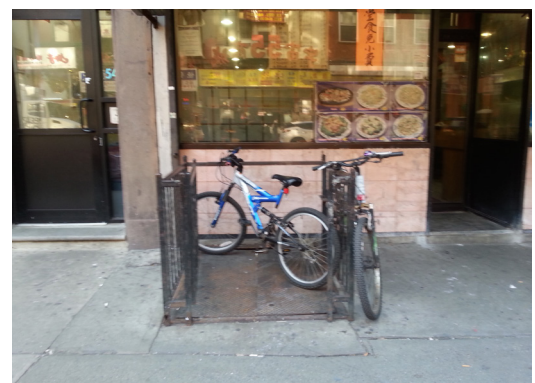
Existing demand for bicycle parking:
94 East Broadway (Top)
54 East Broadway (Bottom)

These locations were identified as having unmet demand for bicycle parking during field visits. Installing CityRacks in the recommended locations will encourage cyclists to store their bicycles at locations better suited for bicycle parking, thus making more efficient use of available sidewalk space.
