# New York City Bicycle Lane and Trail Inventory

New York City Department of City Planning, Transportation Division  
Member of New York Metropolitan Transportation Council

**FINAL REPORT**

**October 2007**

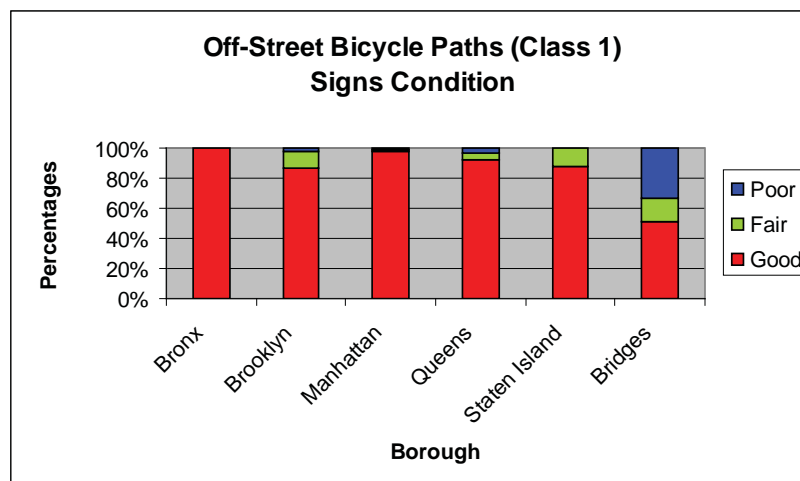
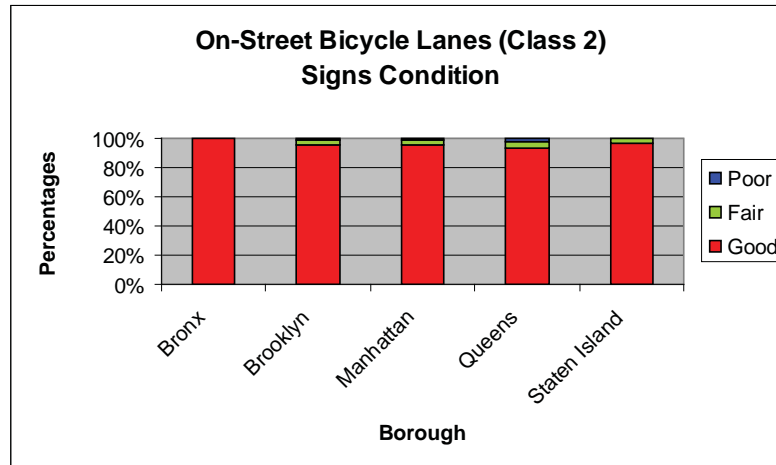
The data revealed that more than 85% of the signs were in good condition within each borough for both off-street and on-street bicycle facilities. The borough with the highest percentage of signs in poor condition was Queens with 3% of off-street, and 2% of on-street signs in poor condition. While the vast majority (more than 90%) of signs on lanes and trails within the boroughs were in good condition, 33% of the signs on the bridges surveyed were in poor condition. See Charts 9 and 10.

- Replace the signs in poor condition on the bridges with priority given to the Williamsburg and the Triborough Bridge where there is a concentration of signs that were vandalized (33 % of all signs on the bridges were in poor condition).

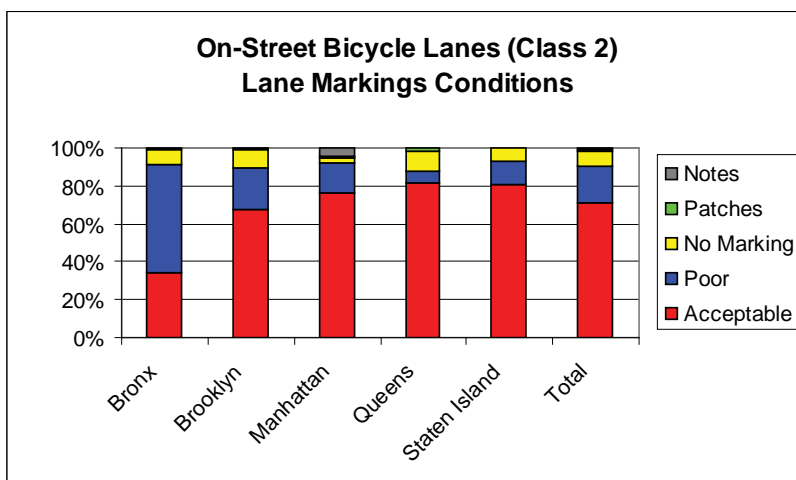
For the off-street bicycle paths, the results show that Staten Island was the only borough with all markings in acceptable condition (0% in poor condition). Brooklyn had the highest percentage (15%) of markings along the bicycle paths in poor condition. However, over half of the bicycle paths surveyed citywide had no markings with only Queens and the Bronx having more than 50% of their lanes marked. The bridges with bicycle paths had 13% of their markings in poor condition, which was significantly higher than the percentage of paths in poor condition for individual boroughs.

The lane markings data for the on-street bicycle lanes shows that Queens had the highest percentage of its markings in good condition compared to the other boroughs, with 82% of the lanes in acceptable condition and only 6% in poor condition. The Bronx had the worst conditions, with 57% in poor condition, representing more than half of its lanes. See Charts 13 and 14.

- Further analyze Class 1 and Class 2 bicycle facilities where there are no markings and install these markings as appropriate. In doing so, Class 1 bicycle routes should be a priority since 57% of the paths have been identified with no markings citywide. It appears as though many times the markings are missing not because they were not implemented but because of the wear and tear of the markings over the years.
