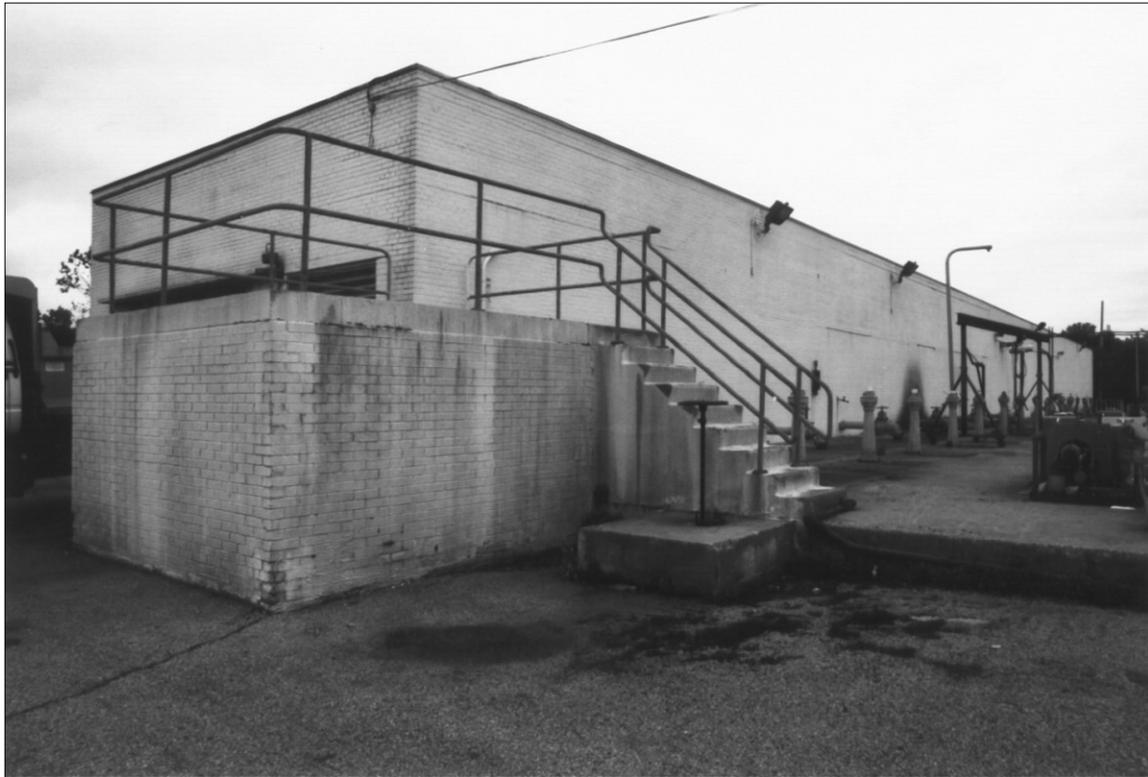
Photo 24: Looking south toward Storage Building (1961) which was clad in white brick in 1970, obscuring original facade arrangement.

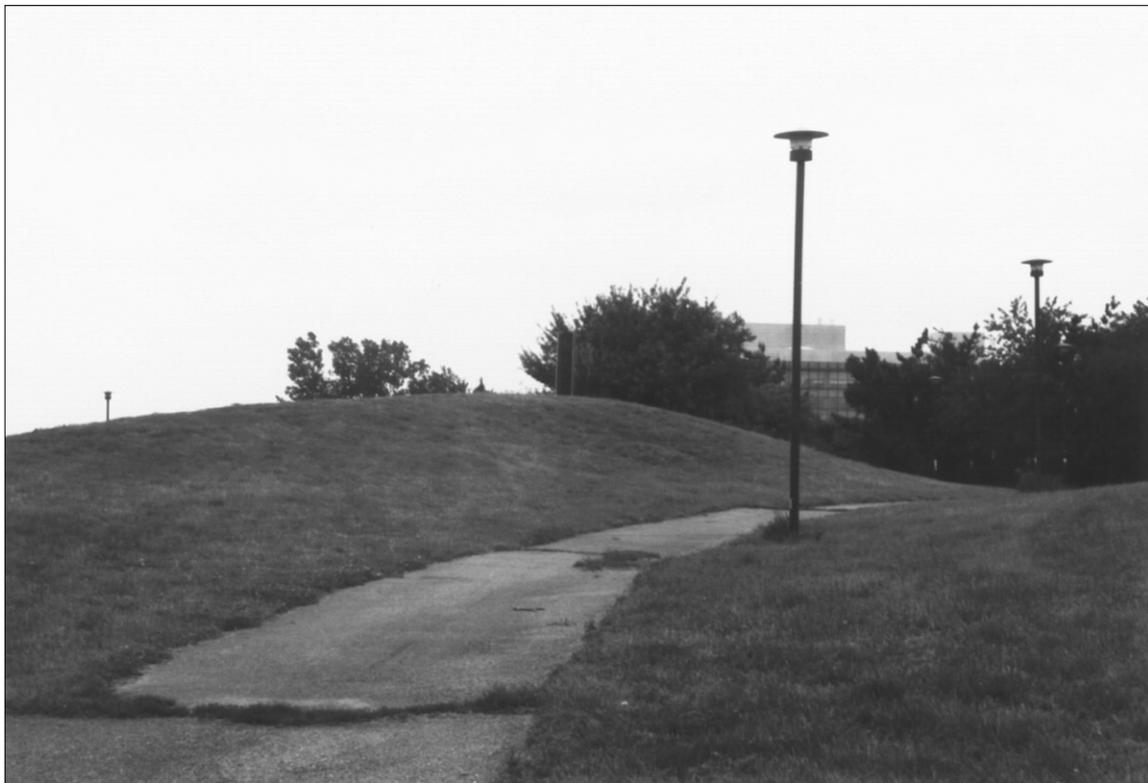
Photo 25: View north along path toward relocated black granite columns in park area, southwest of West Battery.

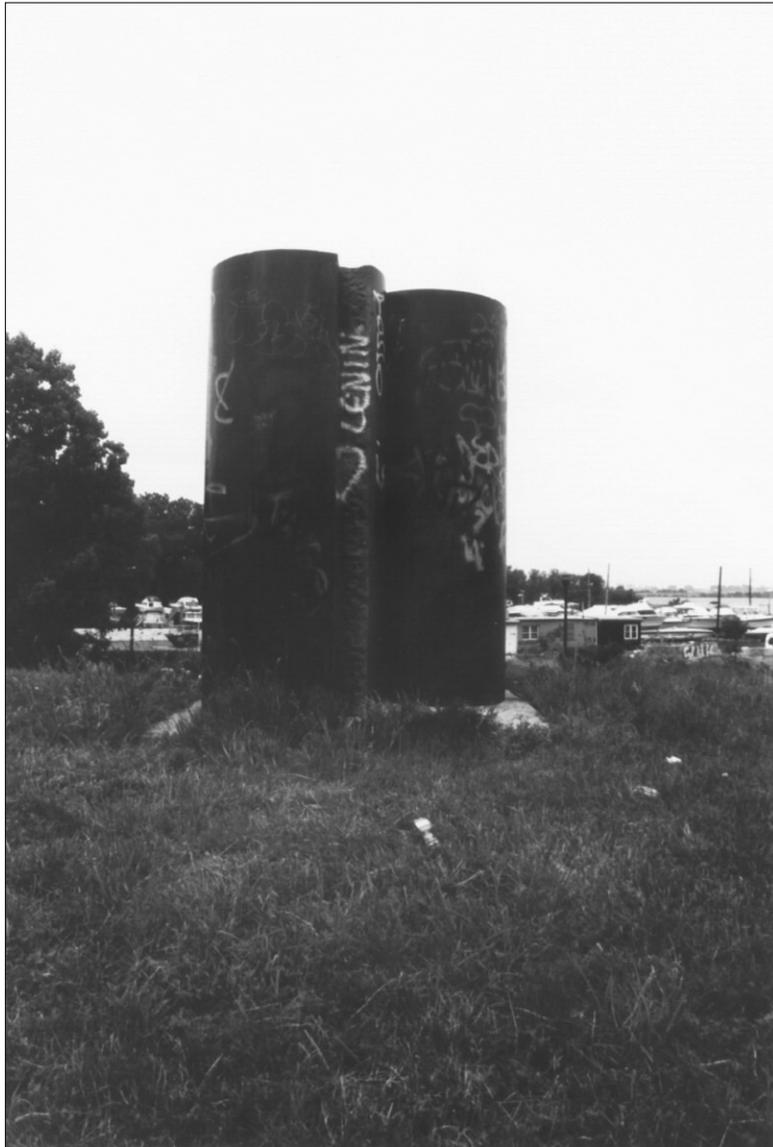
Photo 26: Close-up of black granite columns which originally flanked main entry to Pump and Blower Building (1938). Columns were relocated to park following renovation of Pump and Blower Building in the 1970s.

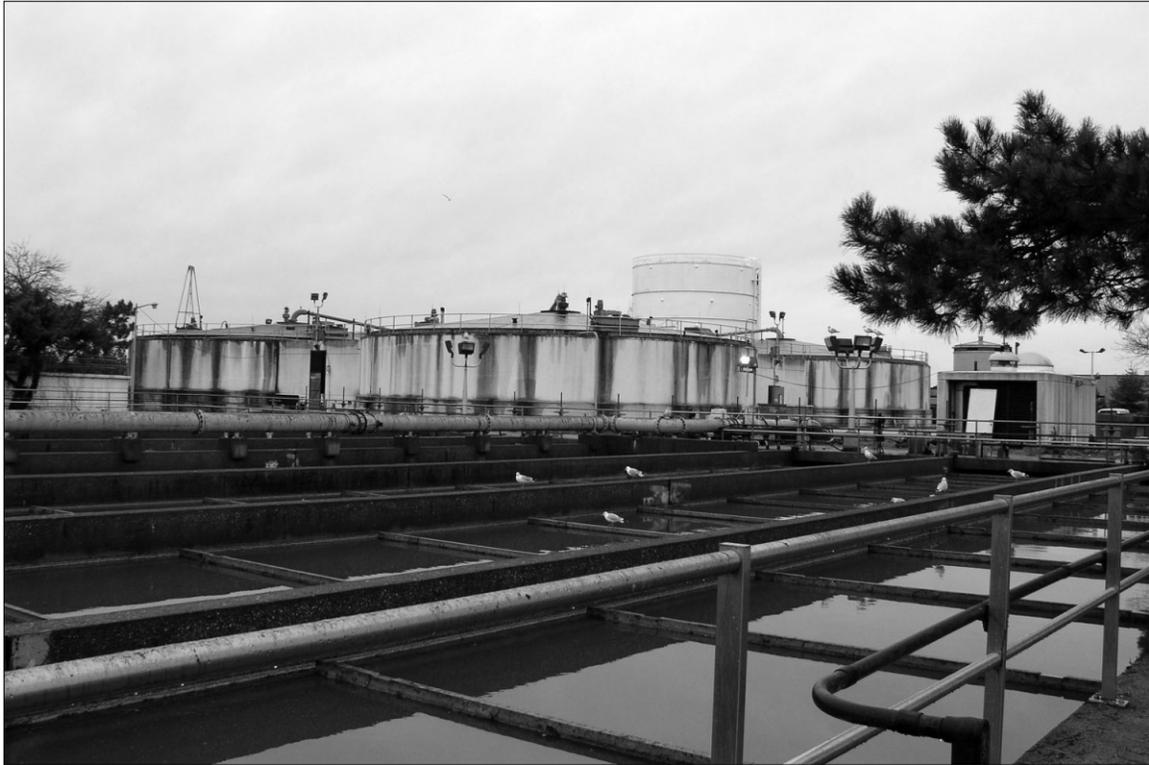
Photo 27: Looking east toward Digesters from Preliminary Settling Tanks in East Battery. Note dome-shaped roofs pierced by multiple pipes.

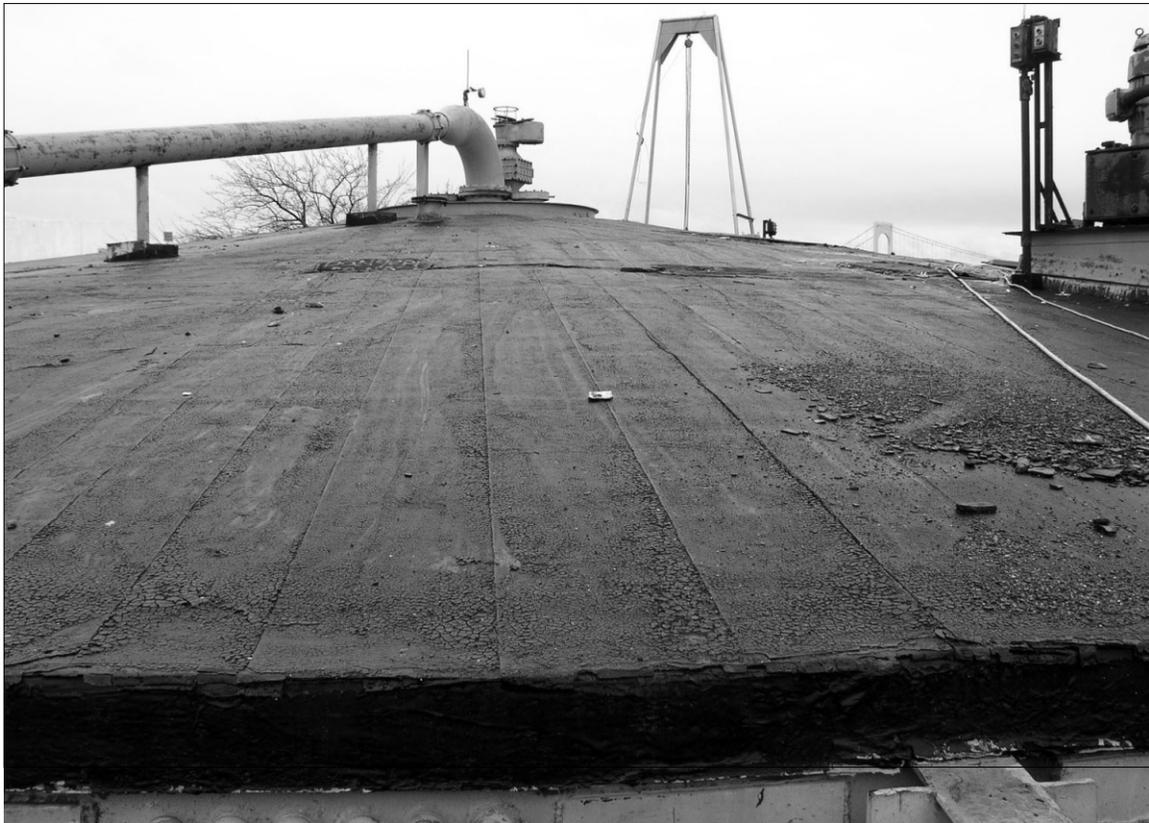
Photo 28: Looking north toward Digester Tank No. 4. Asphalt-clad roof is in poor condition.

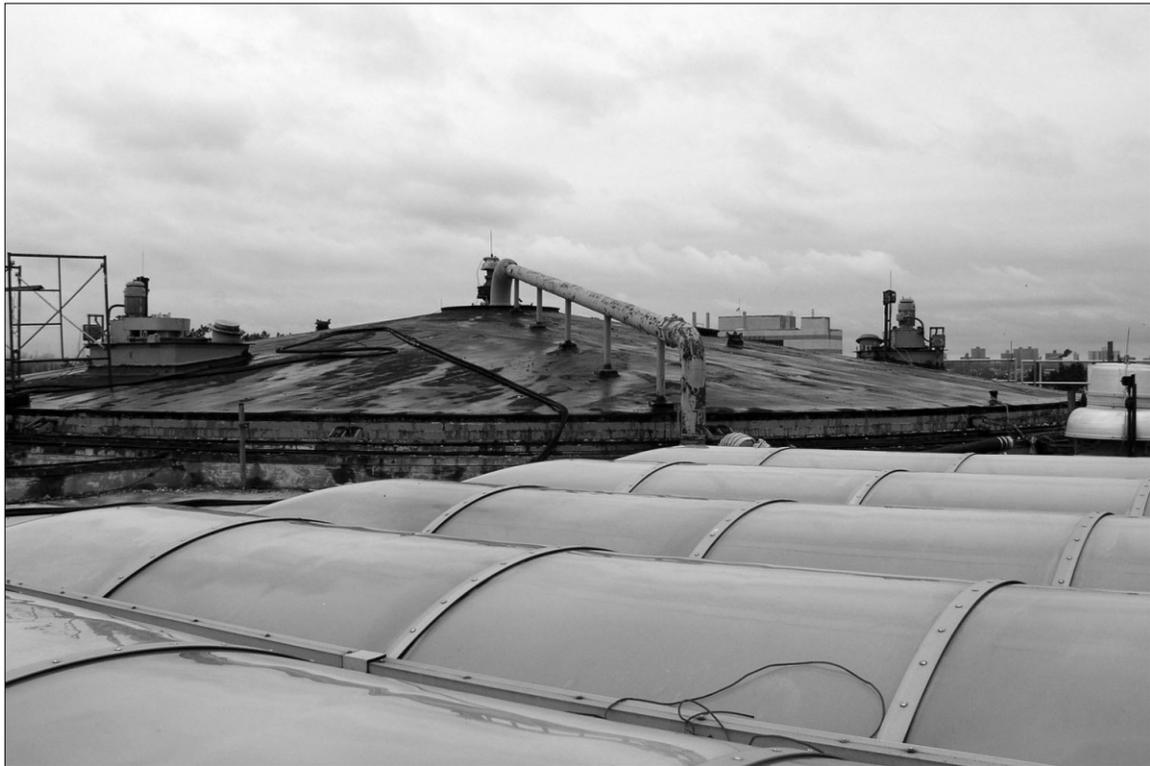
Photo 29: Looking west toward Digester Tank No. 2. Note Plexiglas roof light situated between four tanks.
