BROOKLYN

GRAND ARMY PLAZA

IMPROVEMENTS IN THE VICINITY OF EASTERN PARKWAY, UTICA AVENUE & KINGS HIGHWAY, LINDEN BOULEVARD AND REMSEN AVENUE

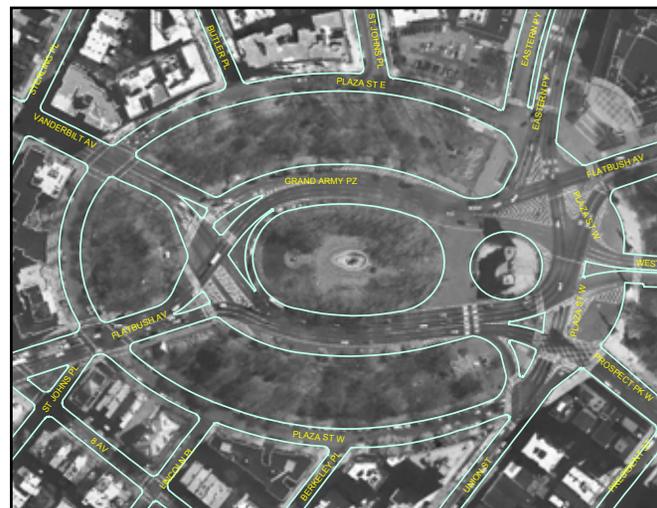
Aerial view of reconfigured intersection

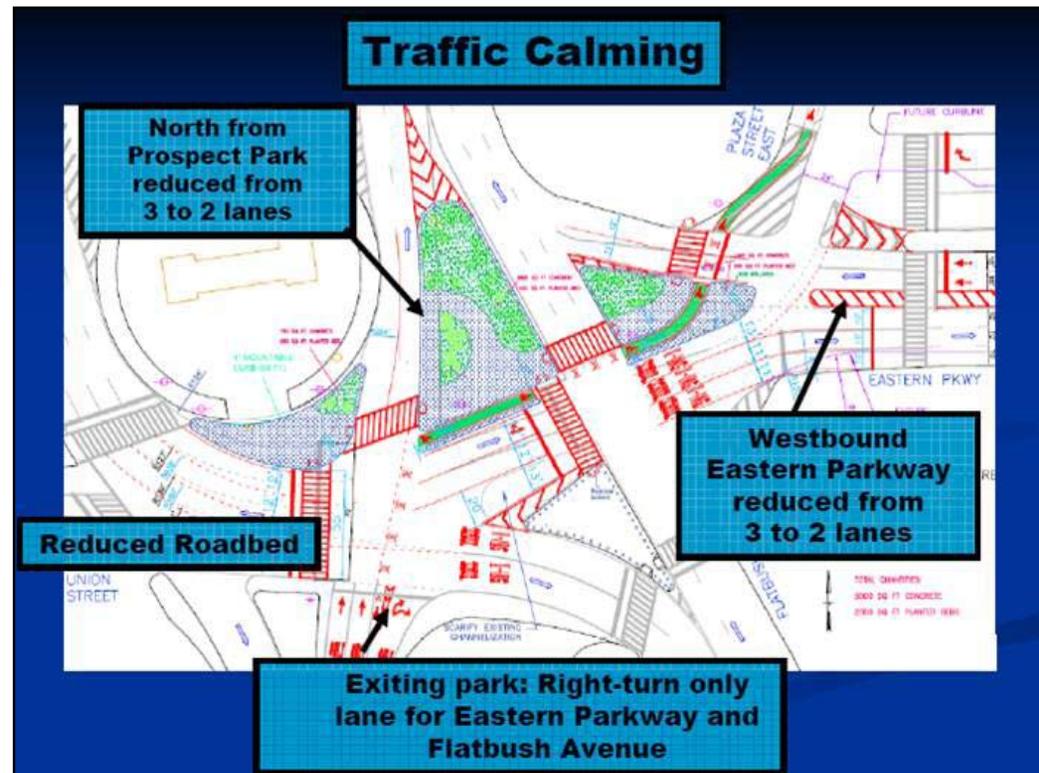
Plan of Traffic Calming measures implemented at Grand Army Plaza, Brooklyn in 2007

Starting in October 2007 NYCDOT introduced additional safety improvements by adding three new landscaped pedestrian islands, five new crosswalks, ten new pedestrian signals, and a separated bike path to create a safer environment for all those who use Grand Army Plaza. Working with the Parks Department, landscaping was added to the newly completed islands in June of 2008. In all, the project converted approximately 11,000 square feet of asphalt and street markings into space that is usable for pedestrians and cyclists.

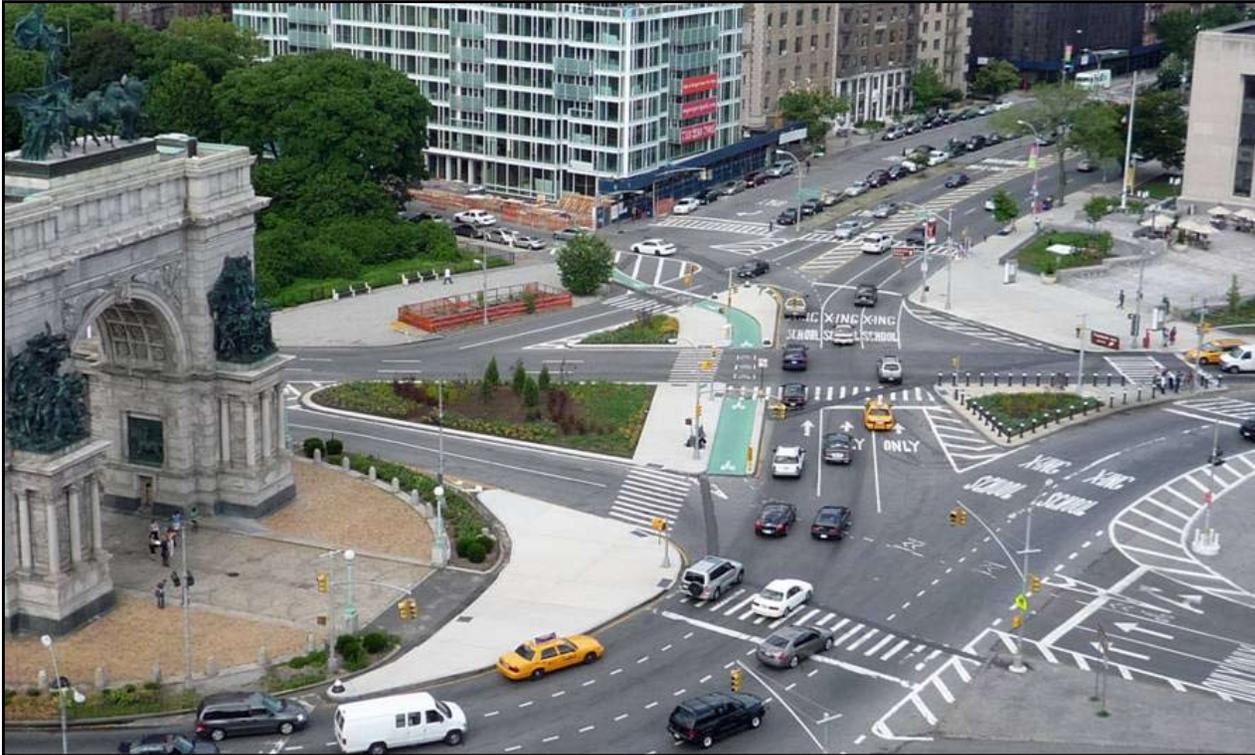
Aerial view of new pedestrian islands, plantings, and Class 1 "green" bike path

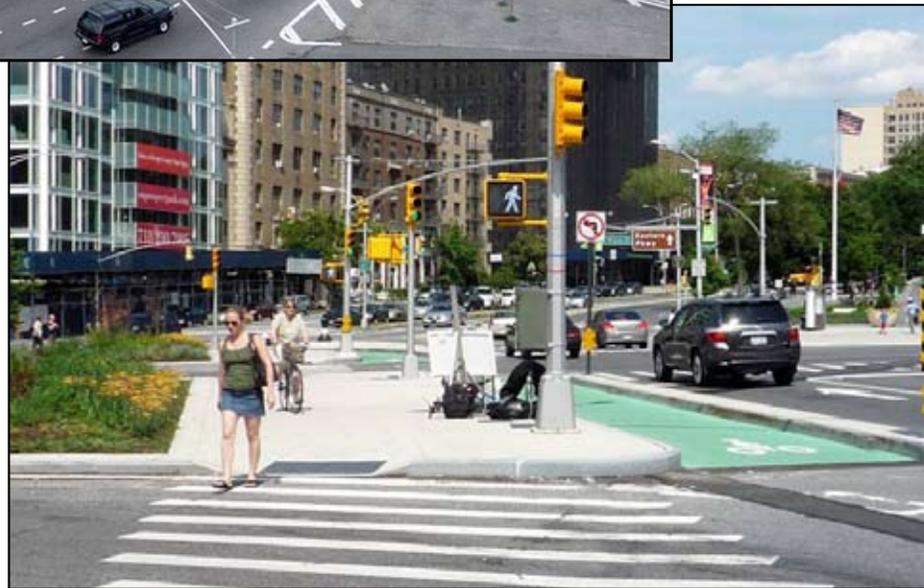
View of newly constructed Pedestrian Island with plantings, and Class 1 "green" bike path

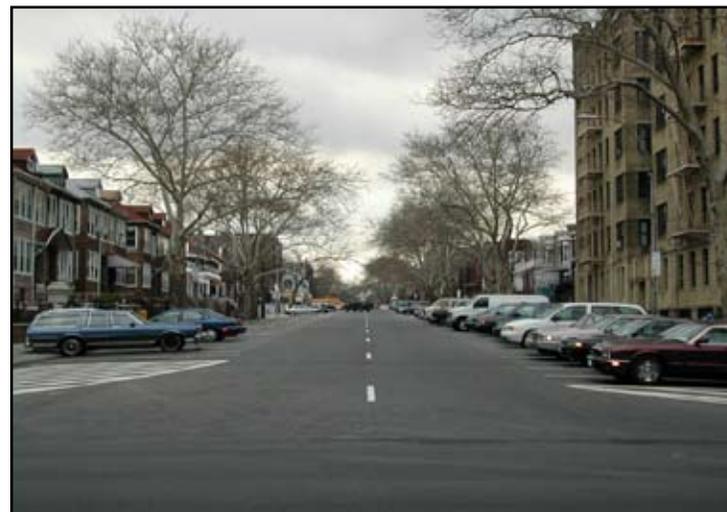
Angle Parking on President Street

- Angle parking was installed on both the north and south curbs of President Street between Utica Avenue and Rochester Avenue to provide 52 additional parking spaces (from 56 to 108). This work was completed in July 2001.

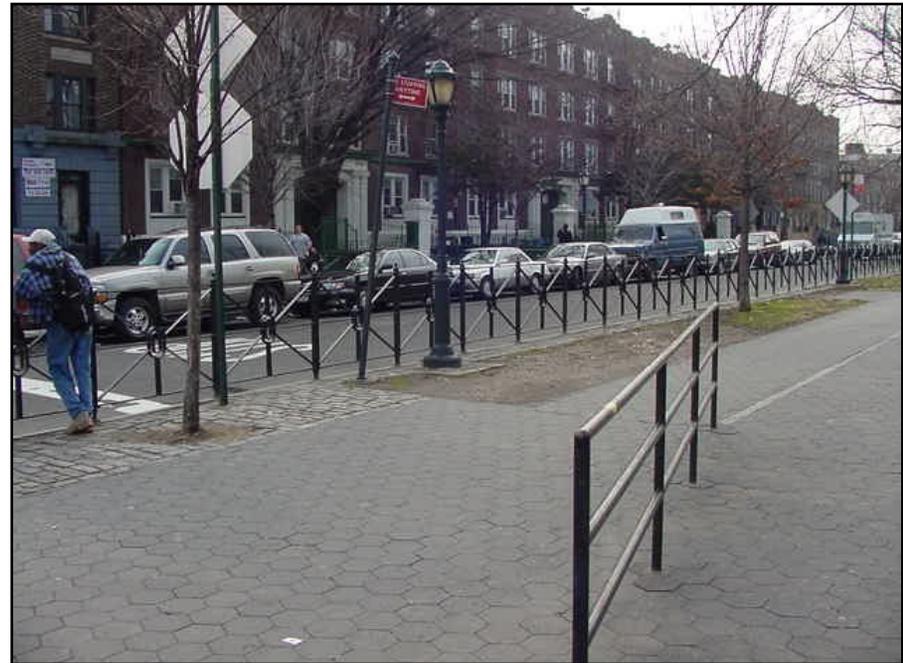
Pedestrian barriers along the service road island prevent individuals from crossing the service road midblock

- In coordination with the Department of Parks & Recreation, installed pedestrian barriers on the Eastern Parkway north and south medians for 320 feet west of Utica Avenue to discourage pedestrians from crossing midblock and to direct them to the intersection. This work was completed in April 2002.

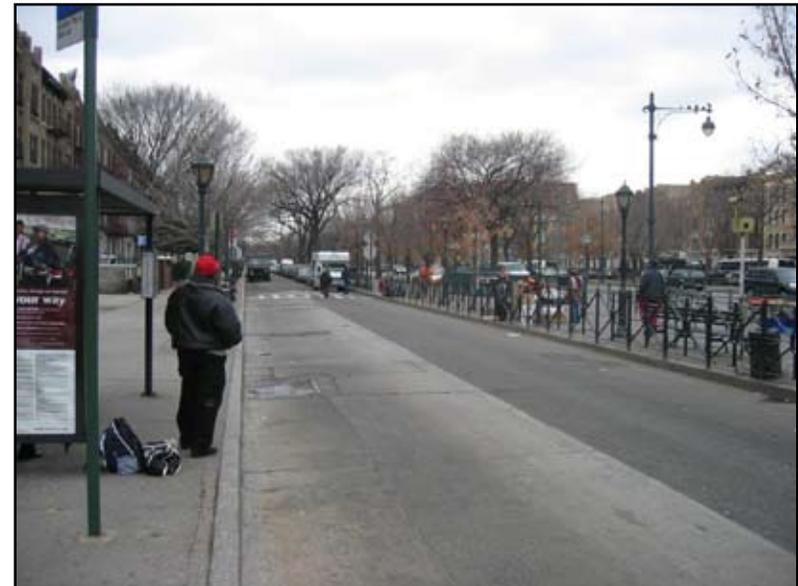
View of extended bus stop along Eastern Parkway Service Road, pedestrian barriers and additional travel lane created by removal of parking along barrier

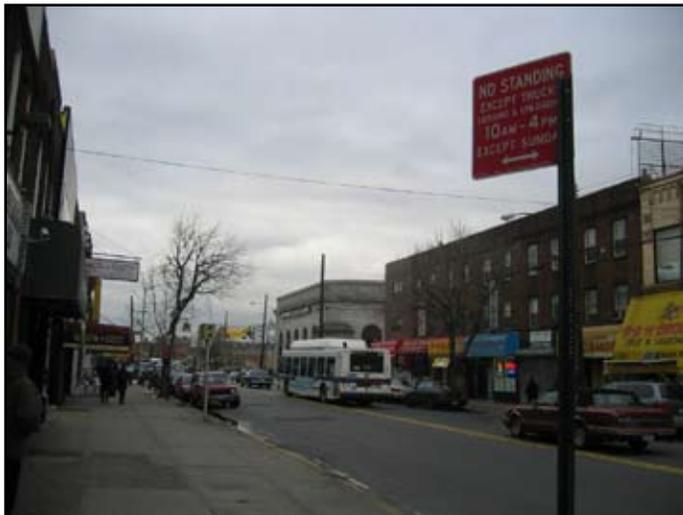
Example of new loading zone along Church Avenue

- Created a truck loading/unloading zone on Church Avenue in the westbound direction (for approximately 100 feet) between Utica Avenue and East 52nd Street. This was accomplished through the installation of “No Standing Except Truck Loading/Unloading 10AM - 4 PM” regulations.
- Installed a Leading Pedestrian Interval (LPI) to reduce conflicts between pedestrians and motorists.
- Relocated the near side bus stops to far side and eliminated four curbside meter parking spaces to accommodate relocated bus stop, as well as assist in facilitating through traffic in the eastbound and westbound directions on Church Avenue

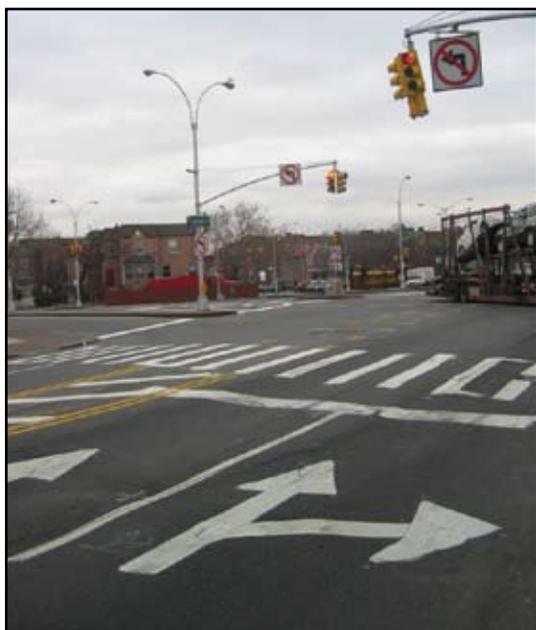
New markings and signage were installed to improve safety and operation of the intersection

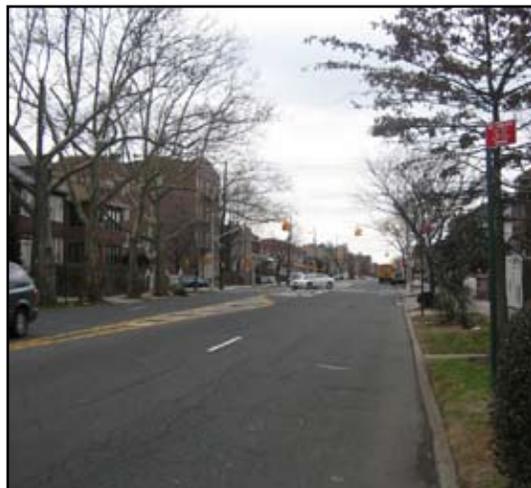
No Standing regulations during the peak periods provide for additional lane capacity

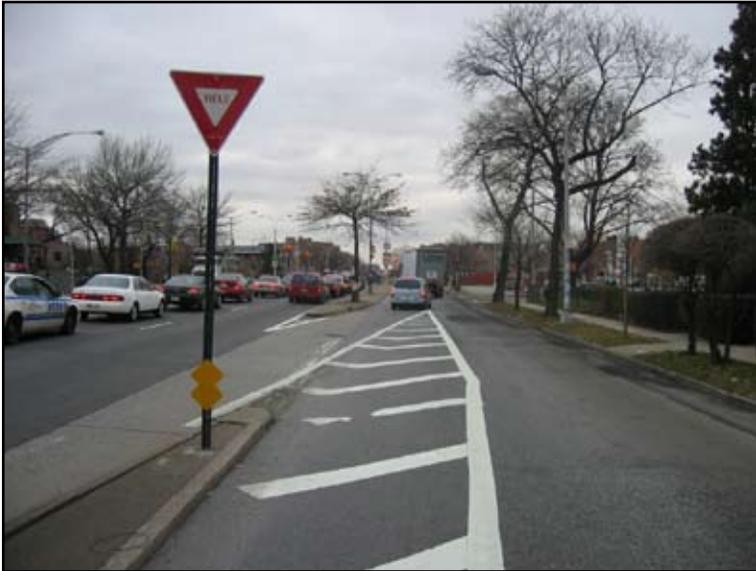
New markings to prevent illegal maneuvers between main line and service road

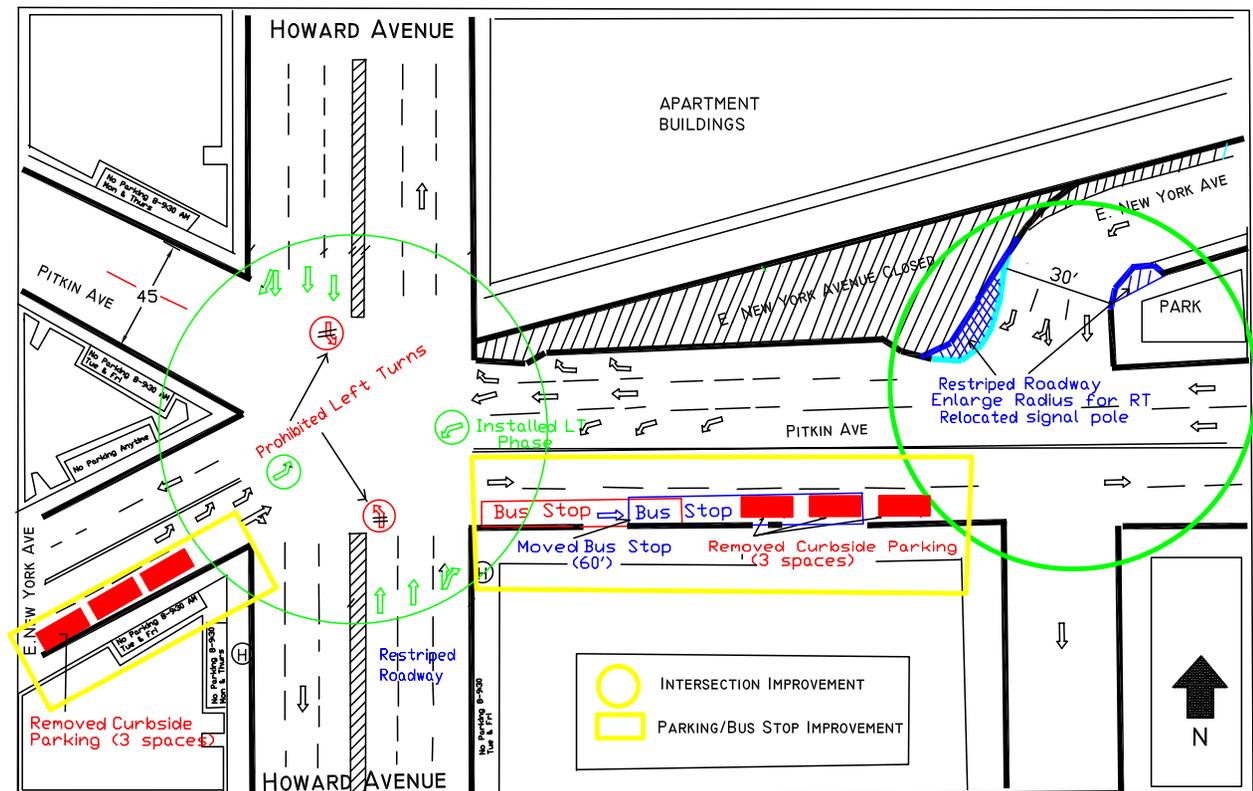
Detailed improvements at the intersection of Pitkin Avenue, East New York Avenue and Howard Avenue

The improvements are depicted in the figure to the right.

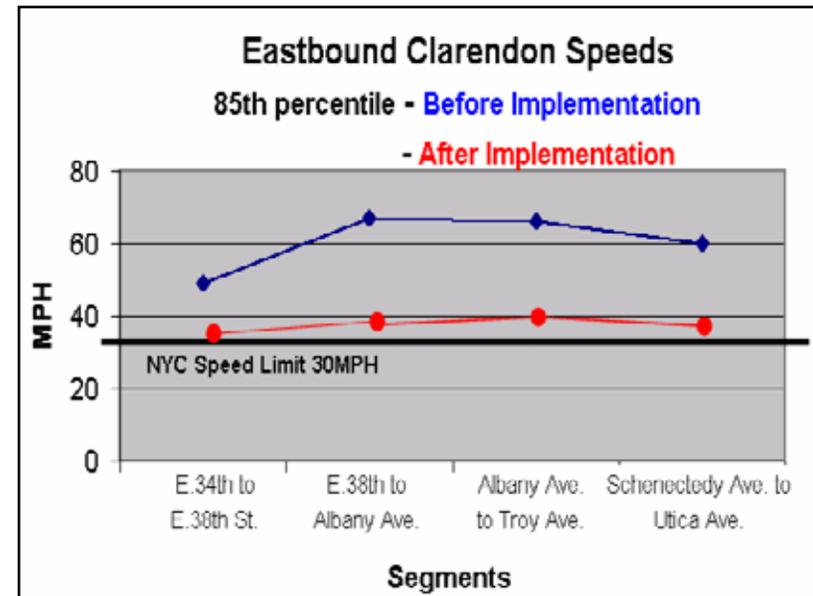
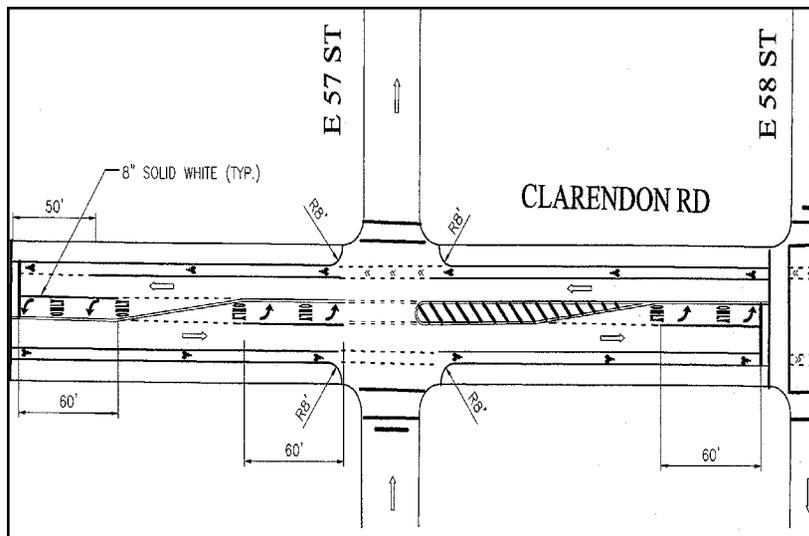
Eastern half of Clarendon Road corridor - narrowing with bike lanes, painted median and left turn bays

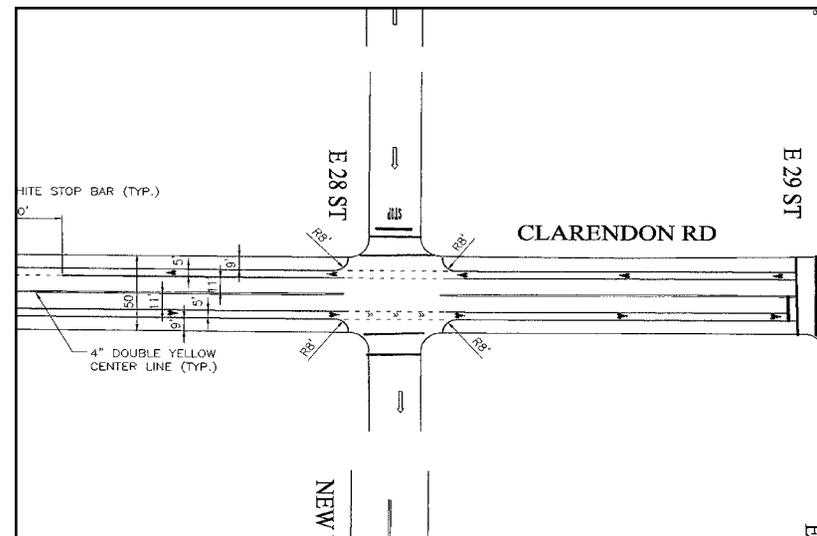
Western half of Clarendon Road corridor - narrowing with bike lanes

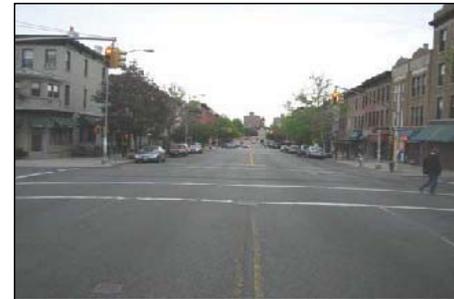
Vanderbilt Avenue BEFORE implementation

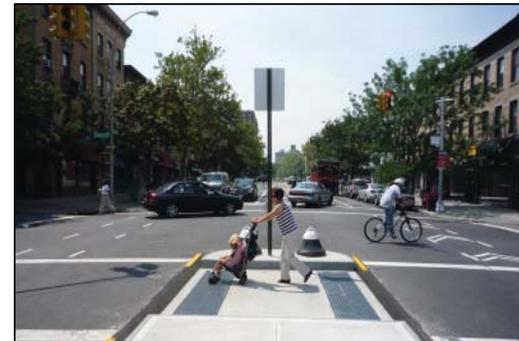
Left and Below: Vanderbilt Avenue AFTER implementation with pedestrian island and built median

- Bike lanes were installed between Dean Street and Plaza Street East
- Three green pedestrian refuge island were installed
- A 200 foot planted median was installed between Prospect Place and St. Marks Avenue

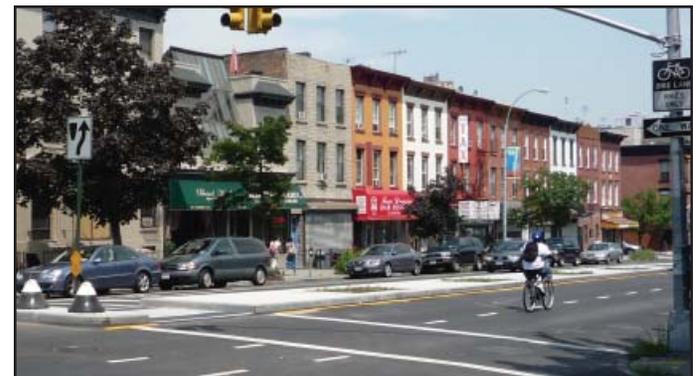
Speed Survey Summary: Before & After Median and Left-turn Lane Implementation (Road Diet)

Before Road Diet										
Time	Direction	Percentiles (mph)			% Above Speed Limit	Max (mph)	Avg. (mph)	Date	Cross	Source
		85th	50th	15th						
745a-810a	N	41	34	26	71%	49	34	11/14/2005	St. Mark's PI	NYCDOT - Planning
1030a-1140a	N	38	34	30	82%	48	35	11/14/2005	St. Mark's PI	NYCDOT - Planning
100p-220p	N	40	33	29	74%	47	34	11/14/2005	St. Mark's PI	NYCDOT - Planning
Average		40	34	28	76%	48	34			
After Road Diet										
Time	Direction	Percentiles (mph)			% Above Speed Limit	Max (mph)	Avg. (mph)	Date	Cross	Unit
		85th	50th	15th						
700-900a	N	34	27	22	24%	42	27	10/12/2006	St Marks/Prospect PI	NYCDOT - Planning
1000a-1200n	N	32	27	21	21%	44	26	10/11/2006	St Marks/Prospect PI	NYCDOT - Planning
1000a-1200n	N	36	29	24	42%	45	30	10/12/2006	St Marks/Prospect PI	NYCDOT - Planning
100-230p	N	34	28	22	30%	59	28	10/11/2006	St Marks/Prospect PI	NYCDOT - Planning
100-230p	N	31	27	22	17%	48	27	10/12/2006	St Marks/Prospect PI	NYCDOT - Planning

Average NB		33	28	22	27%	48	28

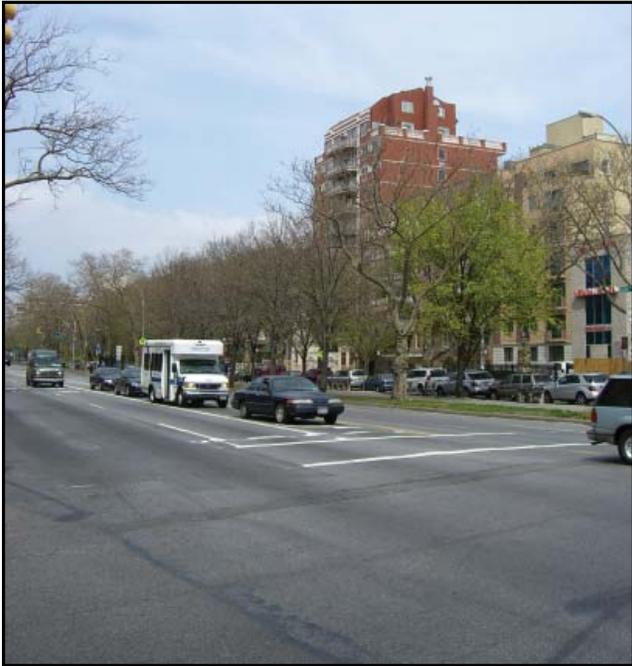
BEFORE: North crosswalk on Ocean Parkway at Neptune Avenue

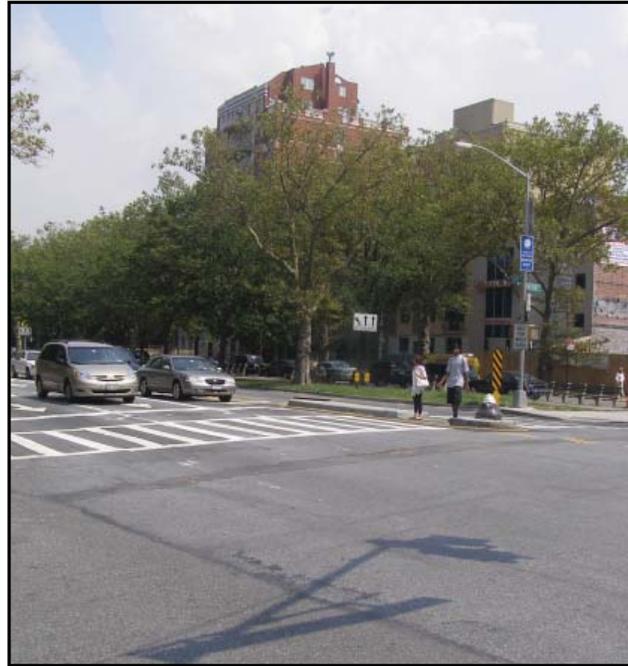
AFTER: North crosswalk on Ocean Parkway at Neptune Avenue with pedestrian refuge island

- Installed pedestrian refuge islands in north and south crosswalks
 - Shortens crossing distance
 - Allows 2-stage crossing
- Upgraded existing sidewalks at intersection
- Refurbished intersection with upgraded markings and signage
- Banned right turn from northbound Ocean Parkway to eastbound Neptune Avenue
 - Eliminates vehicle/pedestrian conflicts in crosswalks
 - Eliminates conflict with Ocean Parkway service road
- Removed lane on westbound Neptune Avenue west of intersection
 - Channellization creates predictable vehicle movements for pedestrians
 - Expands pedestrian refuge space
 - Shortens crossing distance

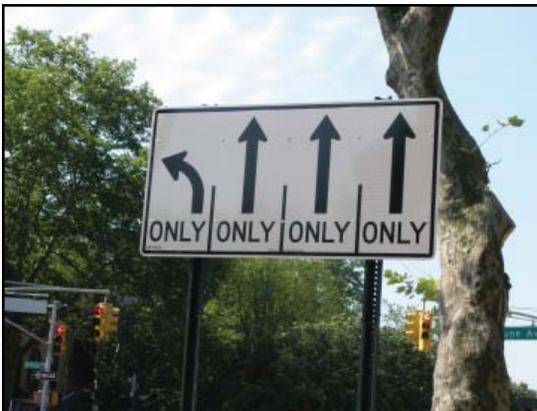
Installed new lane designation signs to more effectively direct traffic

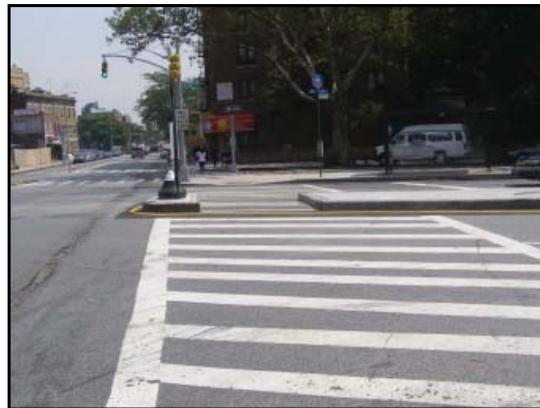
New pedestrian refuge island in south crosswalk on Ocean Parkway at Neptune Ave protects pedestrians who are unable to make it to the other side of this long crossing

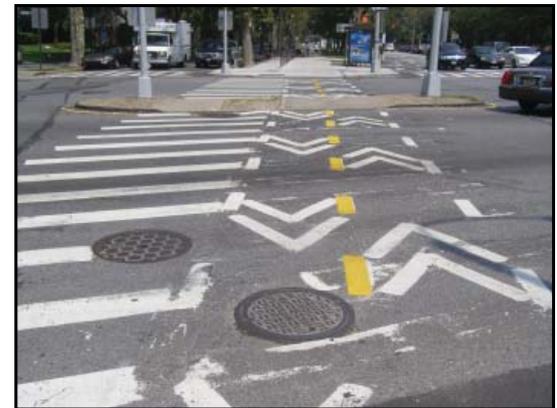
New markings between the service and main roads of Ocean Parkway direct bicycles and pedestrians and alert motorists to their presence.

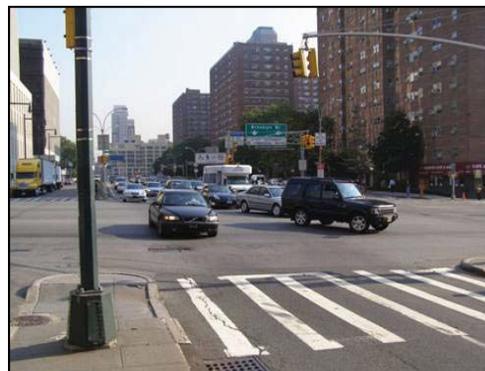
BEFORE: left turn permitted

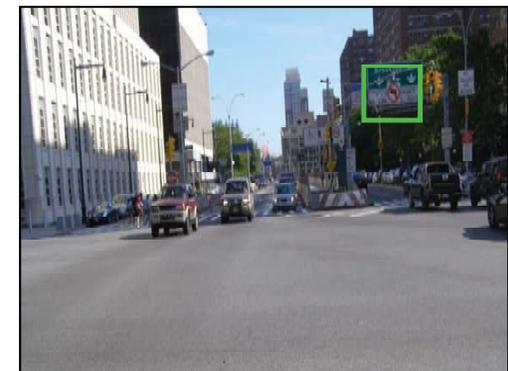
AFTER: left turn banned

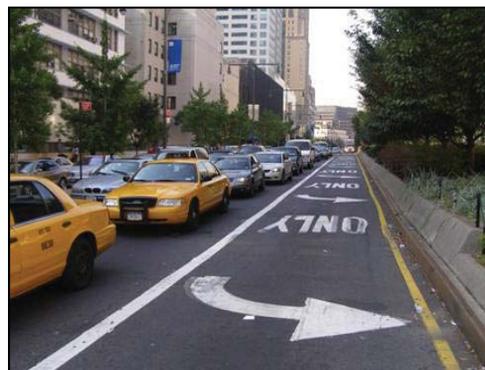
BEFORE: left turn permitted

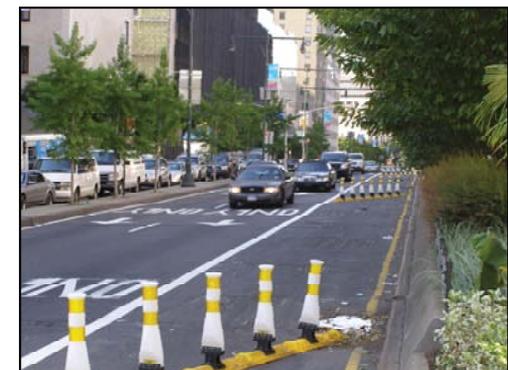
AFTER: left turn banned

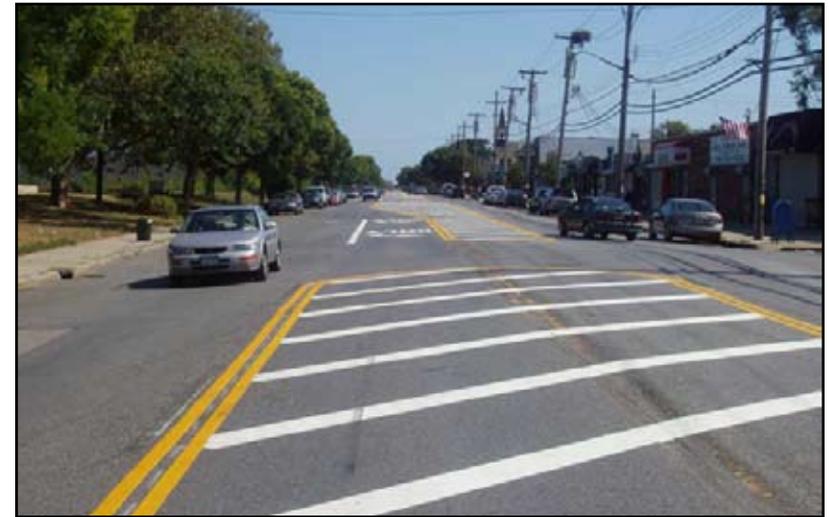
New painted center median and turning bays

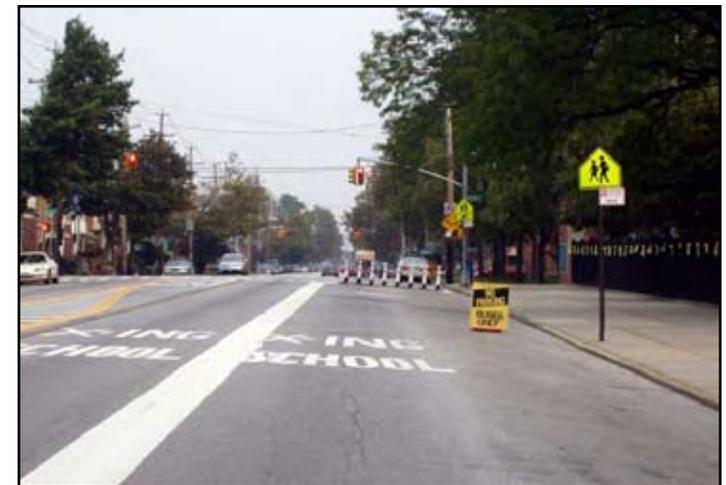
Supplemental signs and markings around P.S. 277 to improve safety

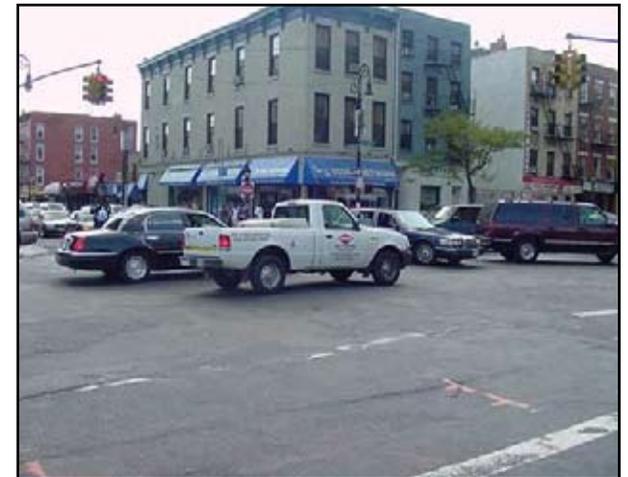
Vehicular conflicts at the intersection of Smith Street and Atlantic Avenue prior to improvements

- Angle parking was removed and converted to parallel parking on Smith Street between Atlantic Avenue and Schermerhorn Street (2 blocks)
- A northbound bike lane was installed on Smith Street between Bergen and Fulton Streets, continuing onto Jay Street between Fulton and Tillary Streets
- A southbound bike lane was installed on Jay Street between Tillary and Fulton Streets, continuing onto Smith Street between Fulton and Schermerhorn Streets. This route continues east on Schermerhorn Street to Hoyt Street and south on Hoyt Street to Bergen Street
- Northbound left turn bays were added on Smith Street at Atlantic Avenue and Schermerhorn Street
- Southbound left turn bays added on Smith Street at both Livingston and Schermerhorn Streets

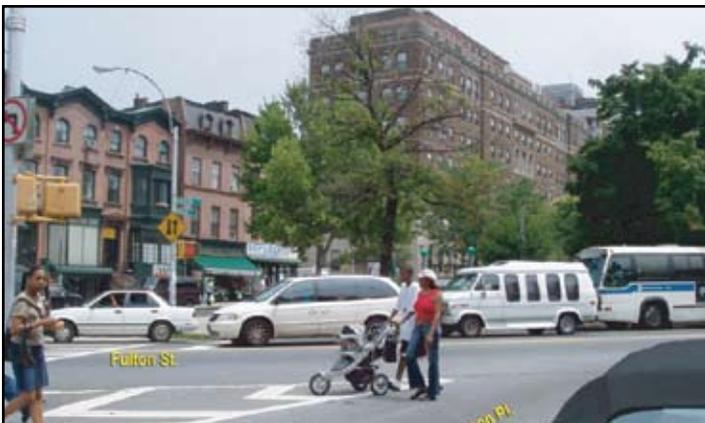
On eastbound Hanson Place approaching Fulton Street, the right-turn slip created difficult, unprotected crossing for pedestrians

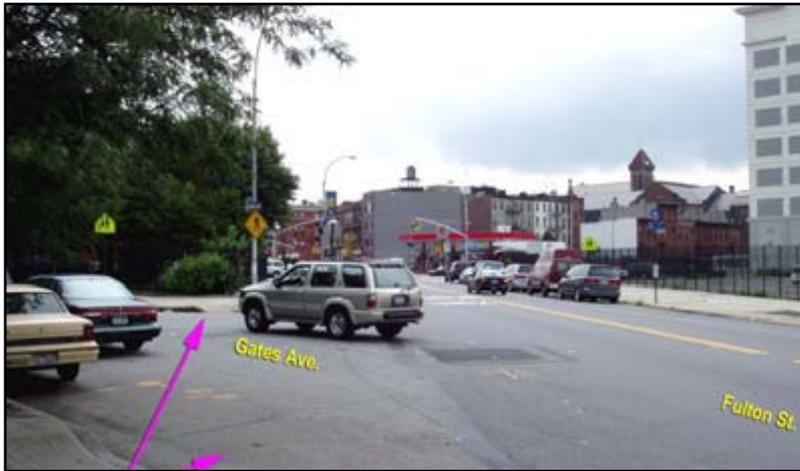
At Gates Avenue and Fulton Street, the offset geometry contributed to speeding, as well as a long crossing for pedestrians

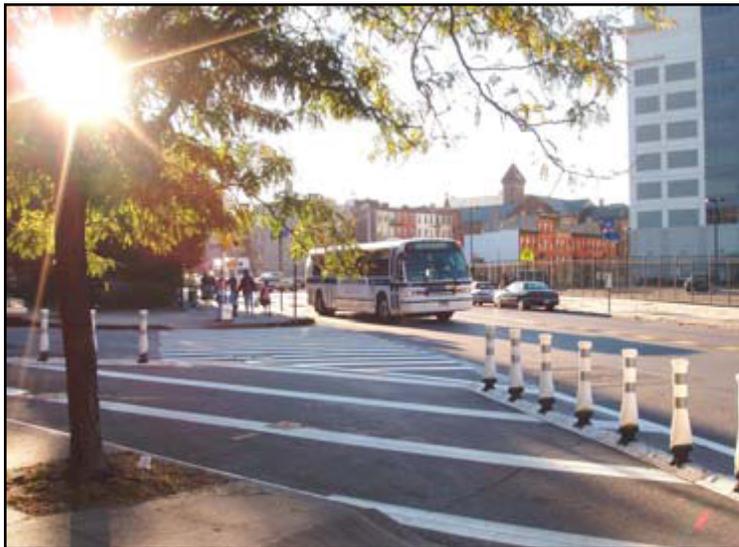
Through the use of flexible bollards and markings, the Department normalized the intersection and significantly shortened the crossing distance across Gates Avenue

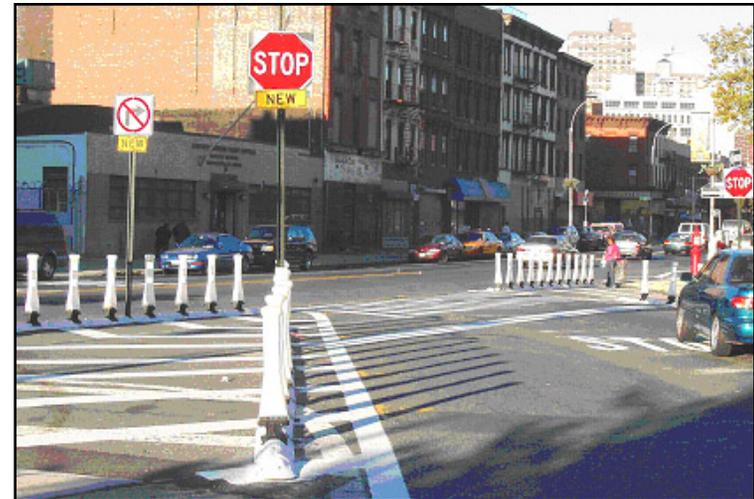
Temporary Treatments: Gateway treatment and street-direction conversion at Putnam Avenue and Fulton Street

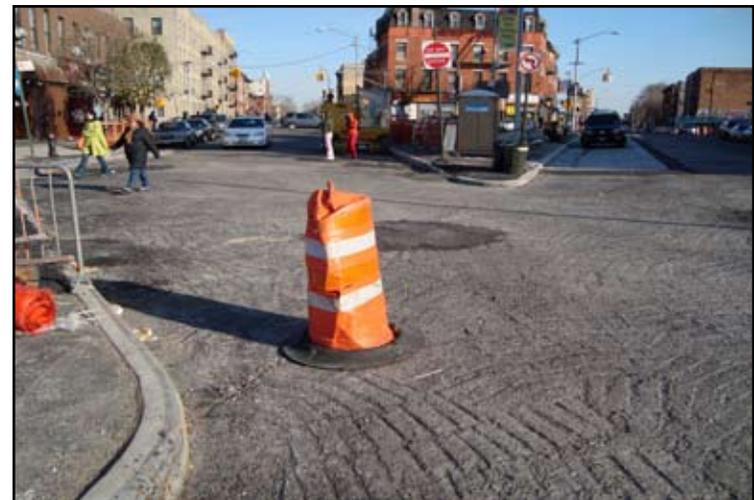
Permanent Treatments: Temporary treatments made permanent - currently under construction.

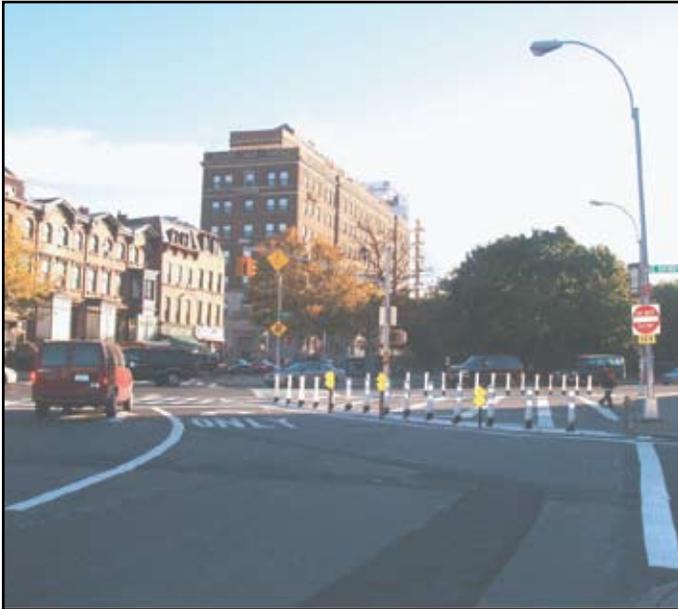
At Hanson Place, the Department eliminated the “free right turn” through the use of markings and flexible bollards, as well as shortening the crossing distance by half

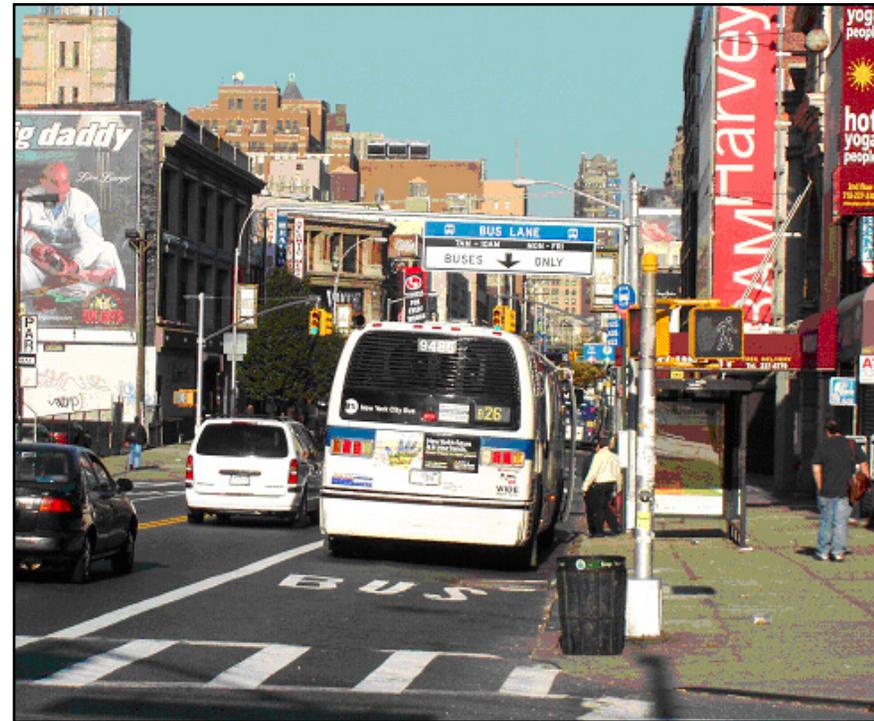
Dedicated bus lanes and newly designed overhead signs were installed to make the bus lanes more prominent.

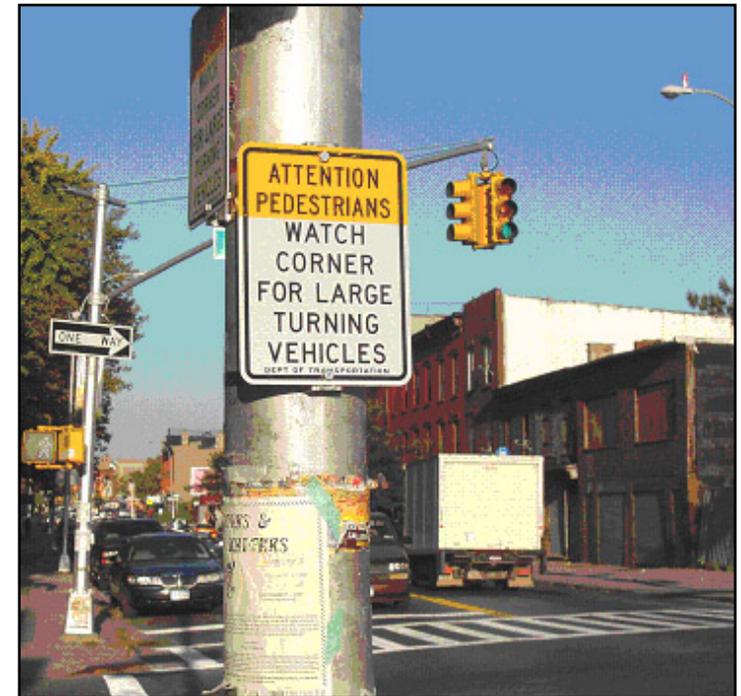
Unique signage advises pedestrians of turning vehicles at Wide Turn Zones

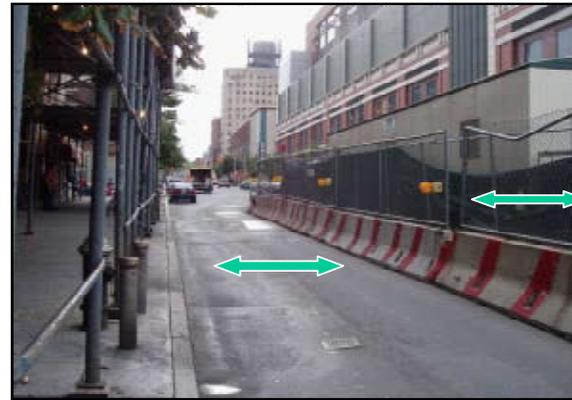
BEFORE: Ashland Place as a one-way street

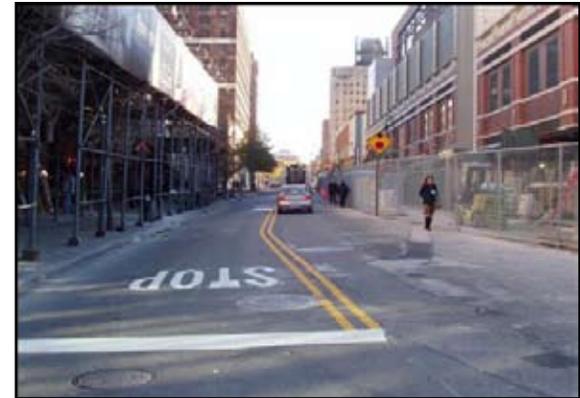
AFTER: Ashland Place as a two-way street

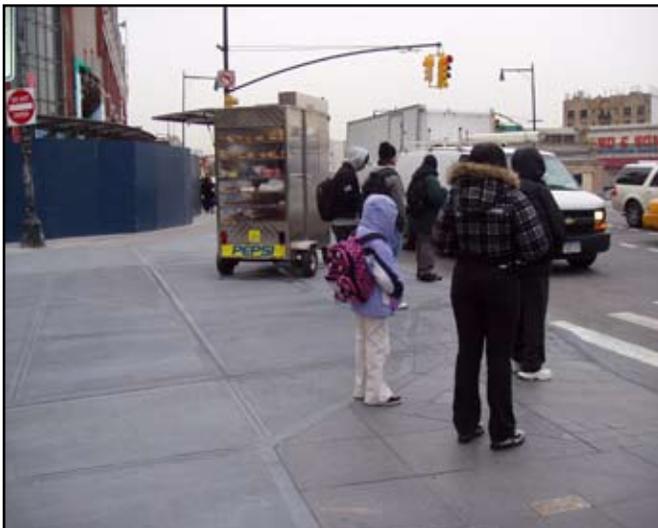
New Pedestrian space created with a sidewalk that closes the slip at Hanson Place and Ashland Place

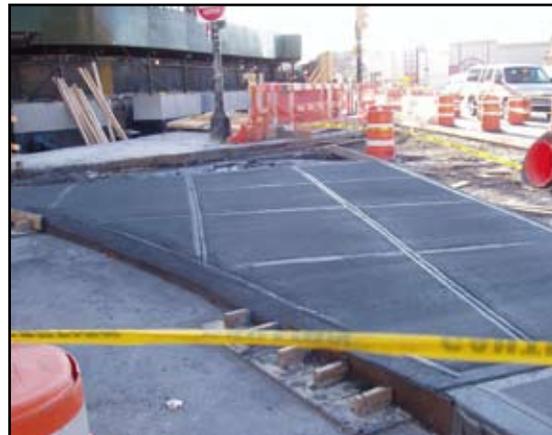
Construction phase of new pedestrian space installation
