New York City Department of Transportation

School Safety Engineering Project

FINAL REPORT: Oholei Torah Elementary School, Brooklyn

**Prepared by
The RBA Group/Urbitran Associates**

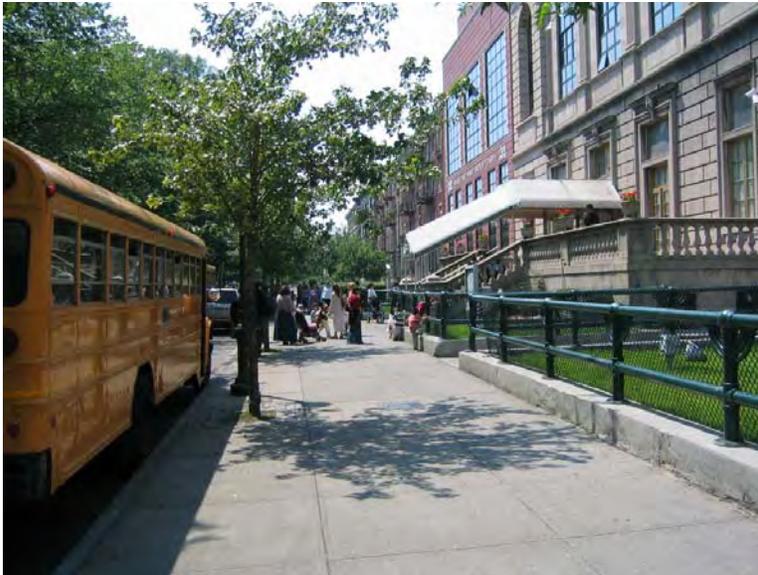
Figure 1: Front of Oholei Torah Elementary school (looking west)

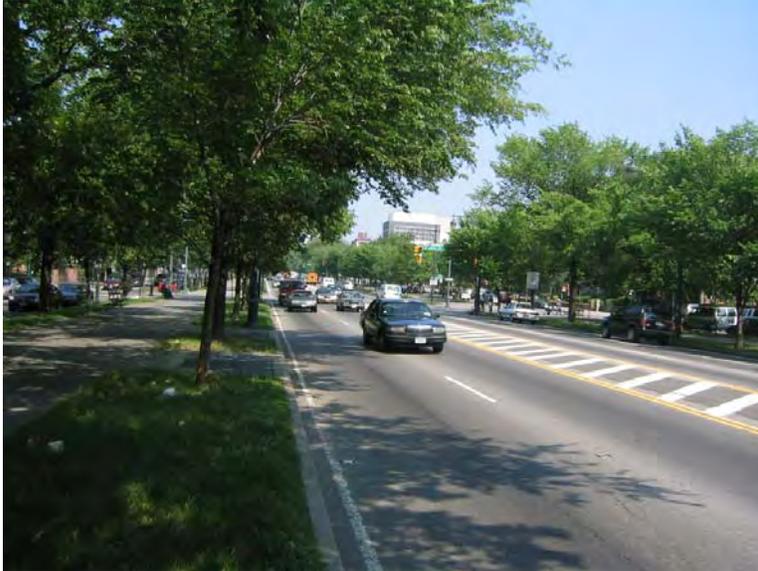
Figure 2: Eastern Parkway – main roadway (looking east)

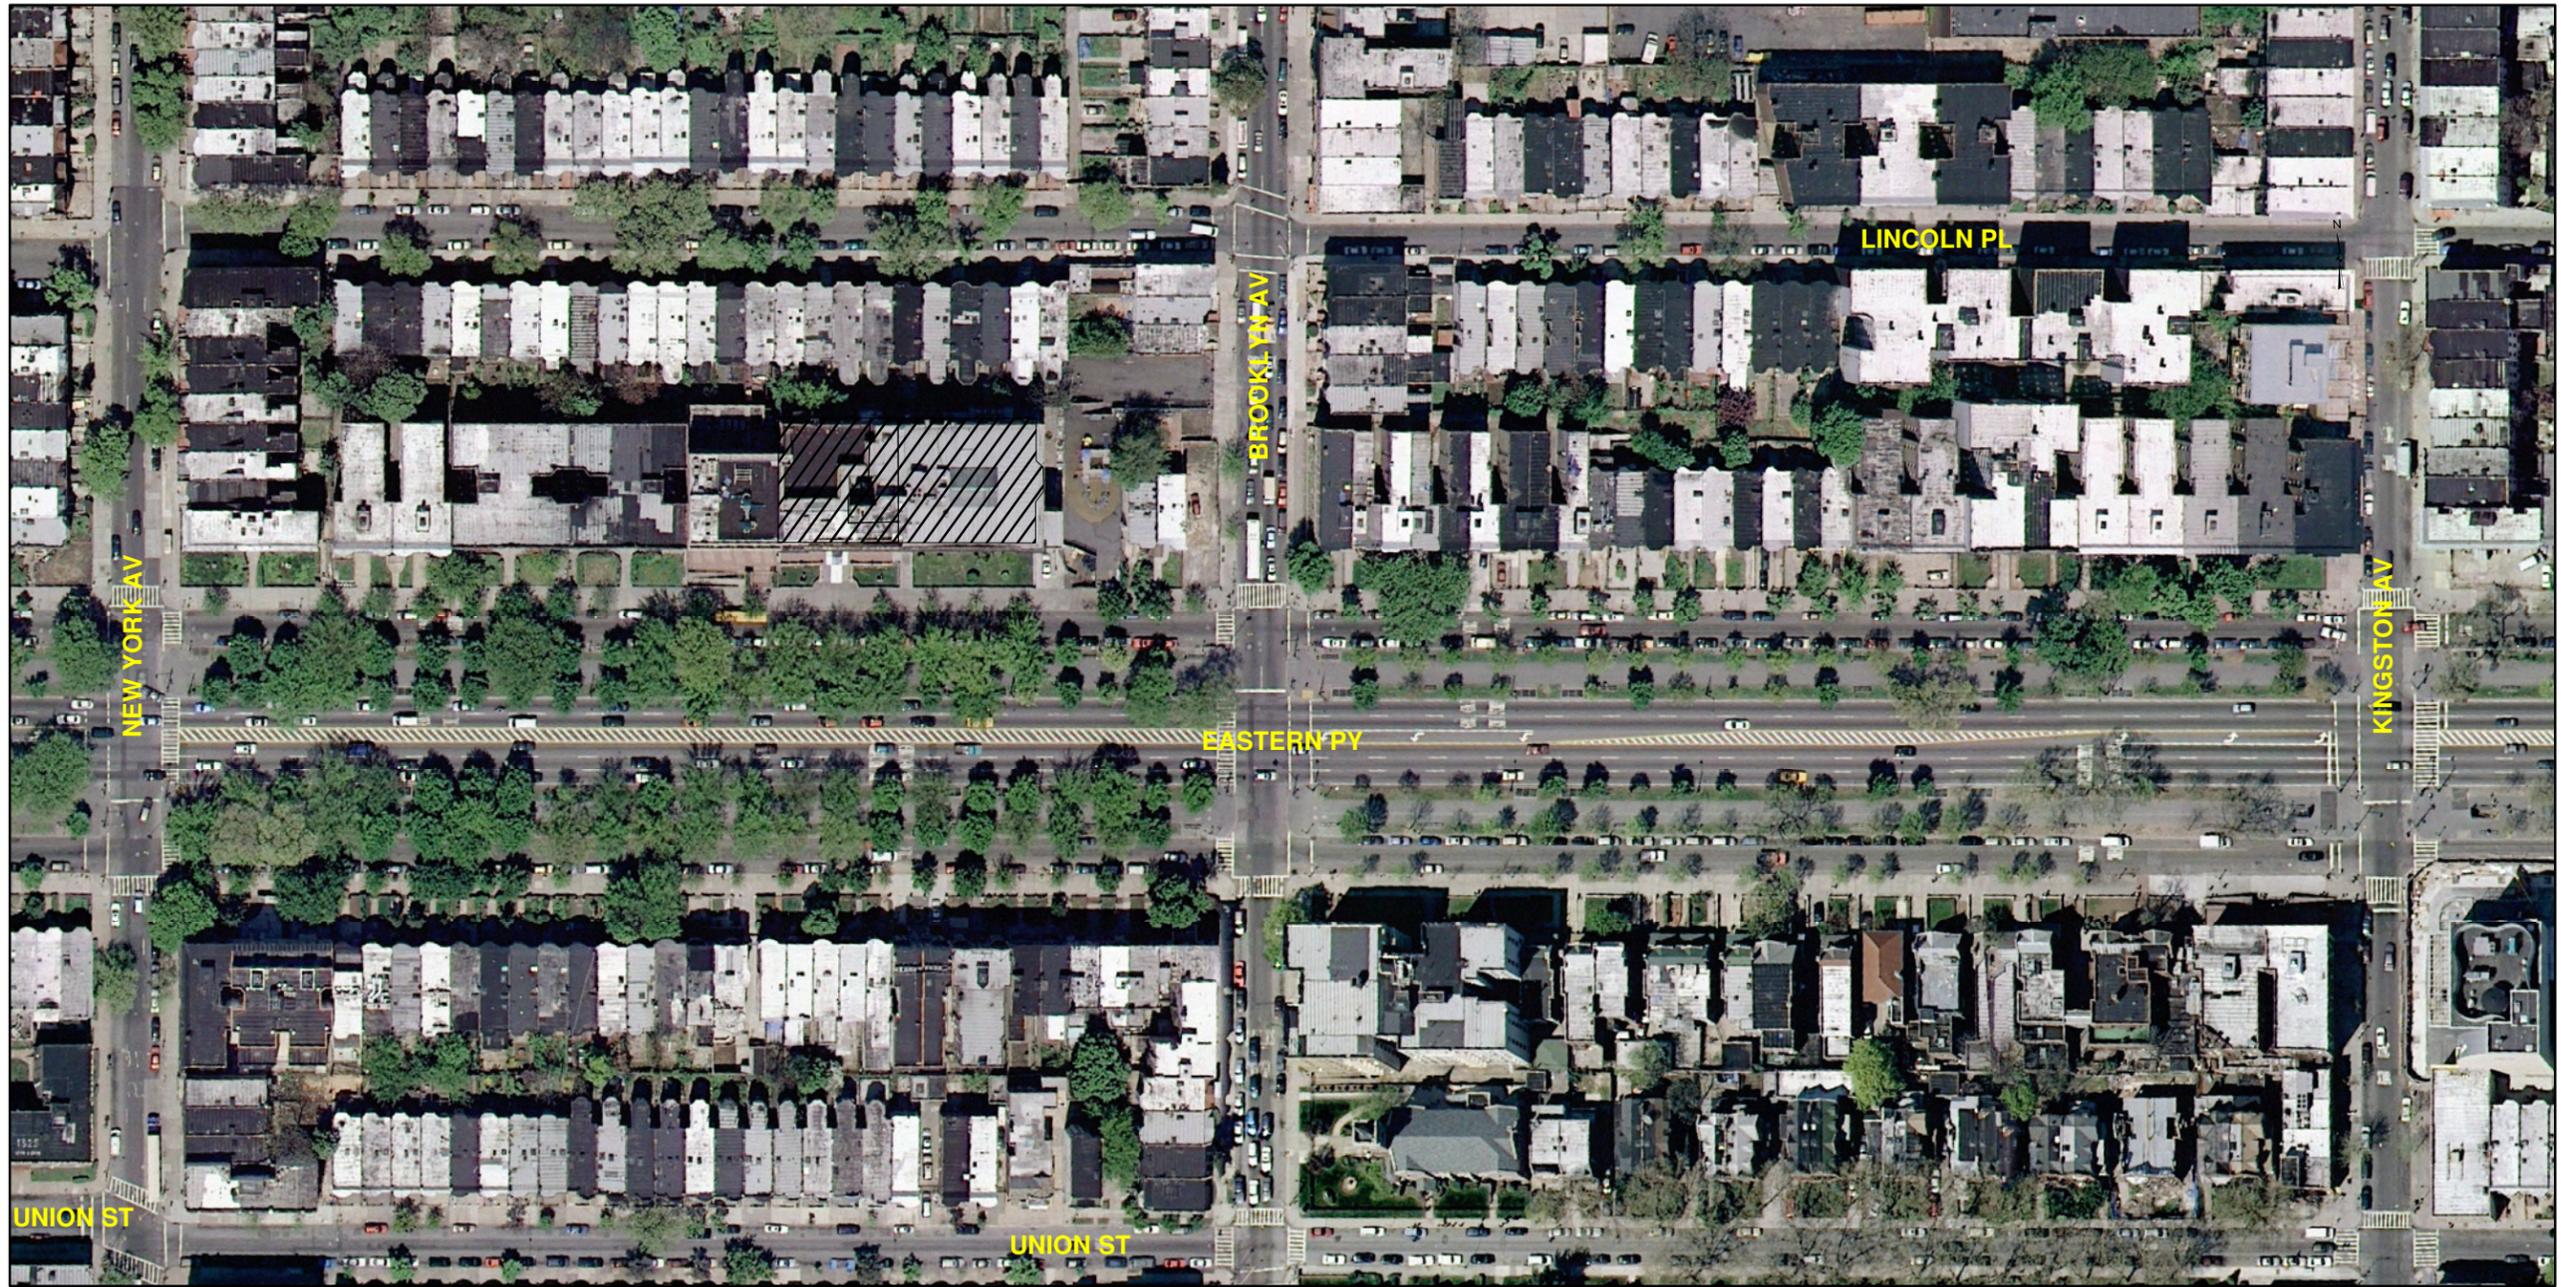
**EXHIBIT 1
OHOLEI TORAH ELEMENTARY
BROOKLYN**

AERIAL PHOTOGRAPH

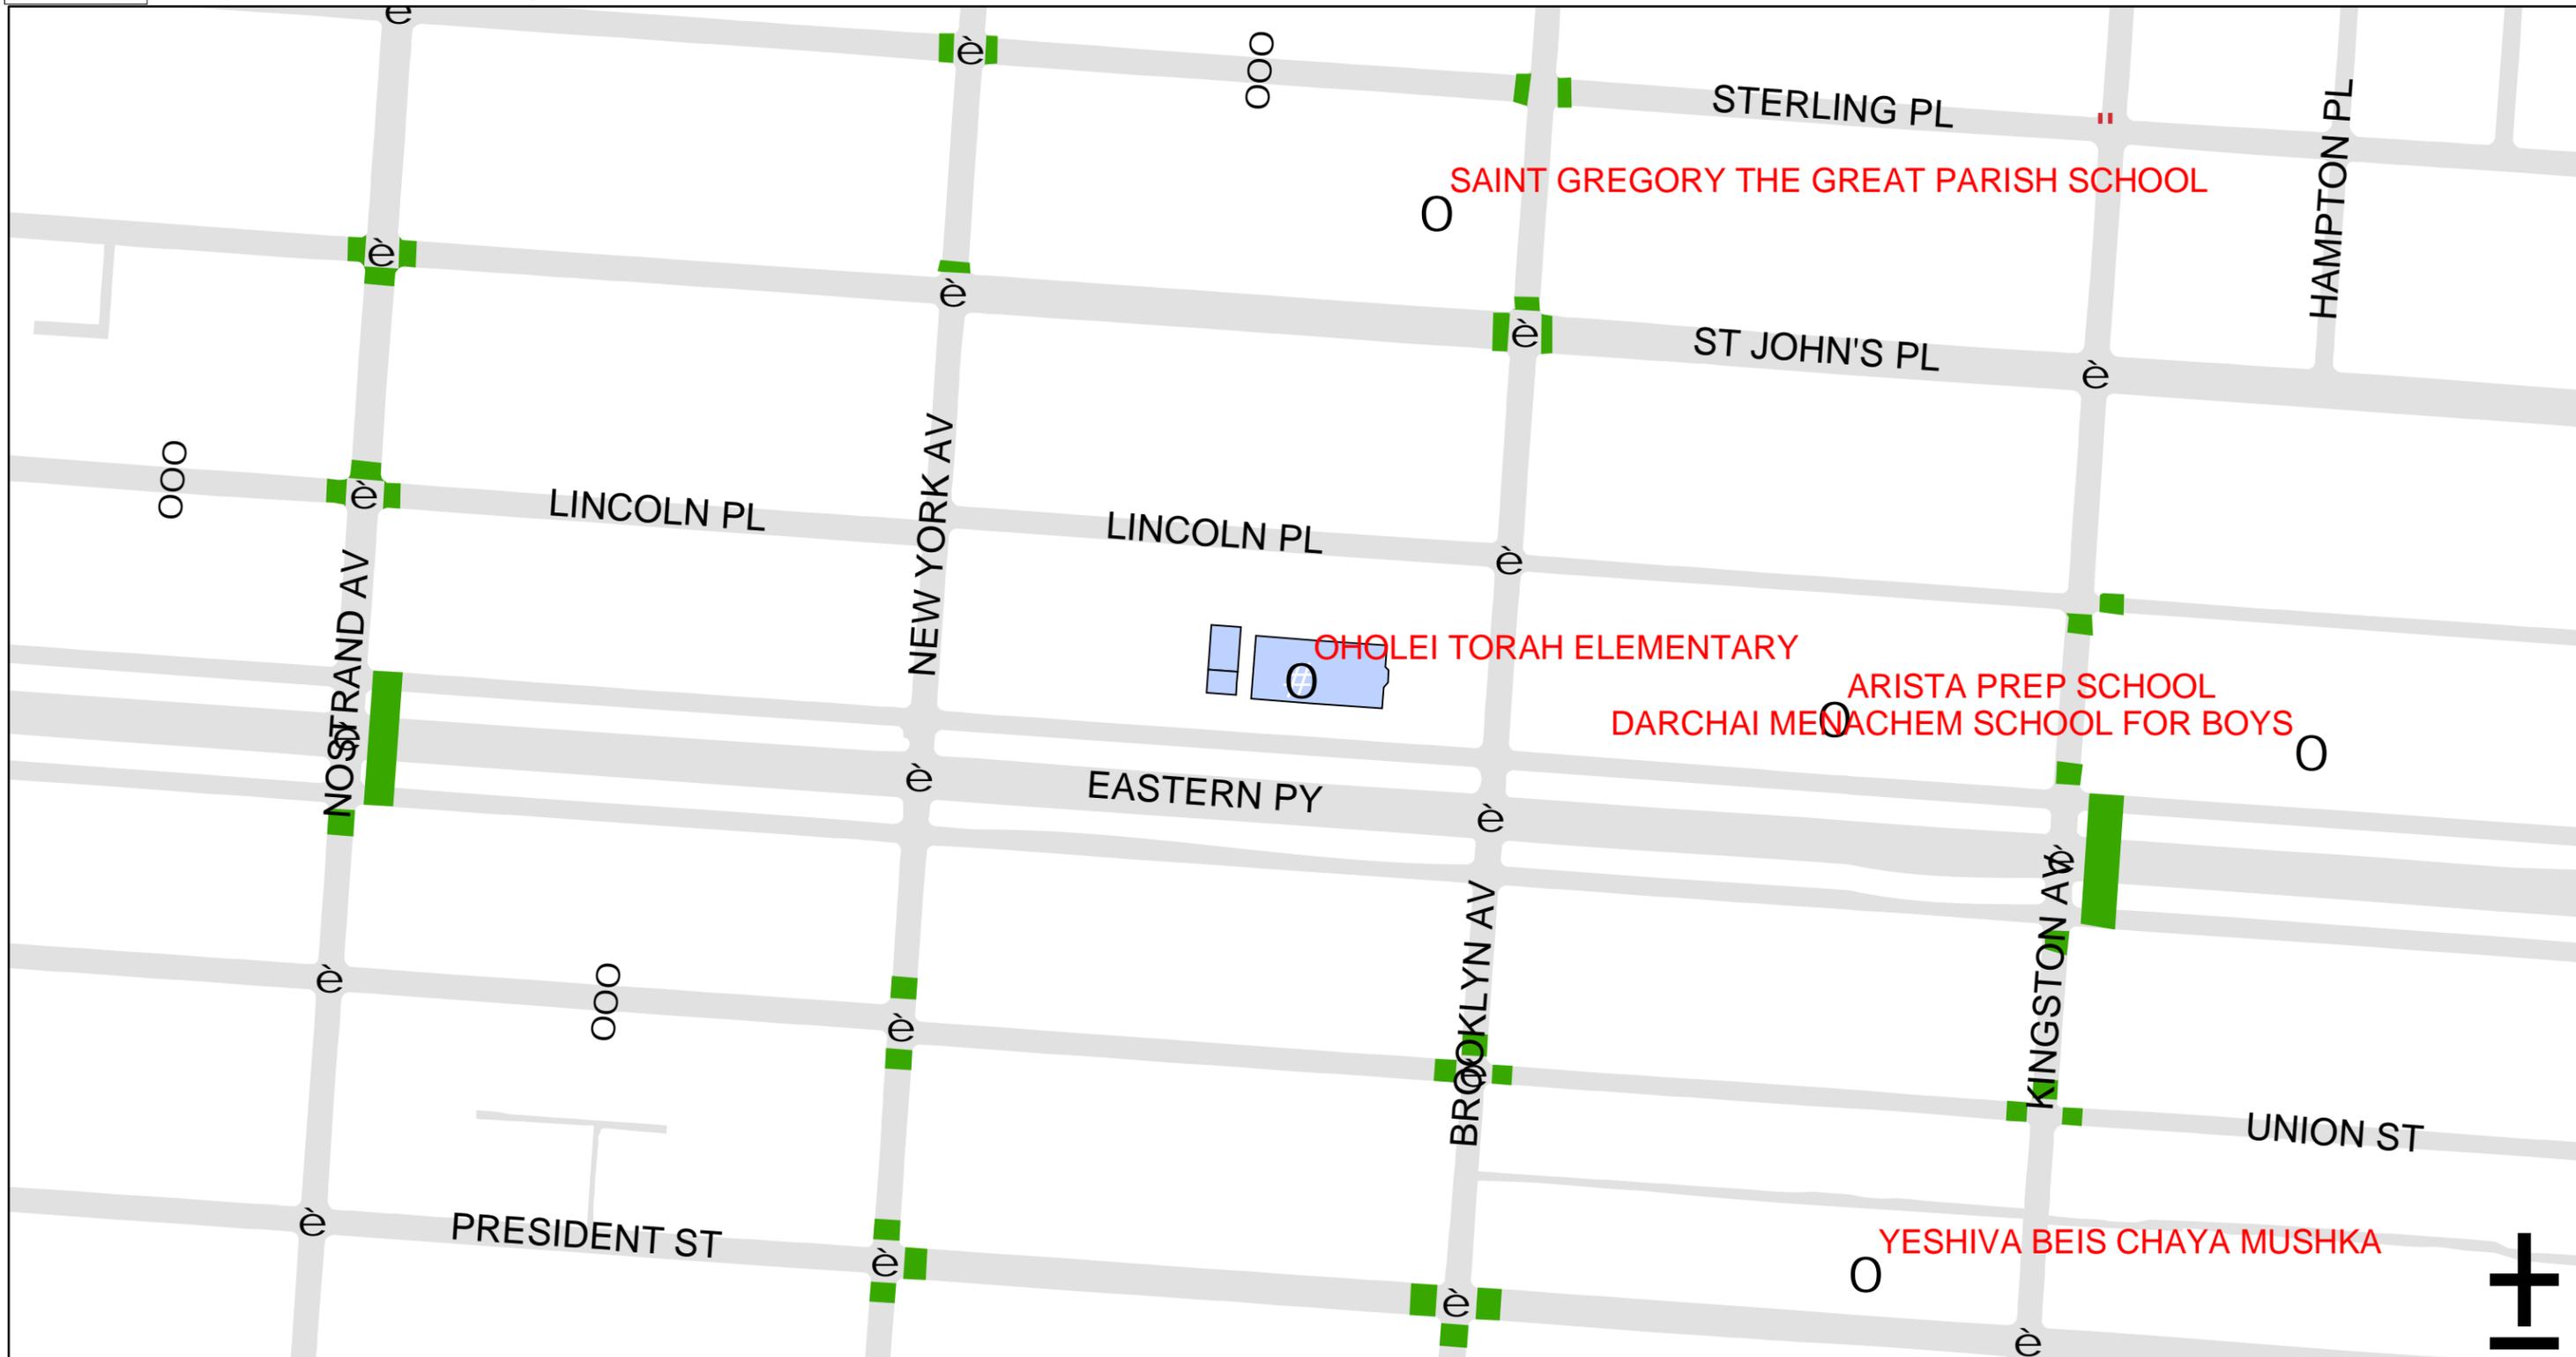
EXHIBIT 2

The School Traffic Safety Map was established to help provide the maximum degree of safety for children going to and from school - by indicating the location of advance warning signs, speed reducers, school crosswalks and some traffic control devices. (While virtually all intersections in NYC benefit from traffic control devices - such as stop signs, traffic signals, yield signs, and all way stop signs - this map only shows traffic signals and all way stop signs.) The school crosswalks that are shown are ladder striped and make the crosswalk more visible to drivers and help make the intersection safer. These crosswalks are where school children are recommended to cross.

The Traffic Safety Map, Exhibit 2, shows existing crosswalk pavement markings. It is noted that a citywide signage program is currently underway to upgrade school signage to current Federal Manual of Uniform Traffic Control Devices (MUTCD) standards of fluorescent yellow-green signs accompanied by downward pointing arrows. Signs scheduled to be installed under this program are shown as “existing” on Exhibit 7.

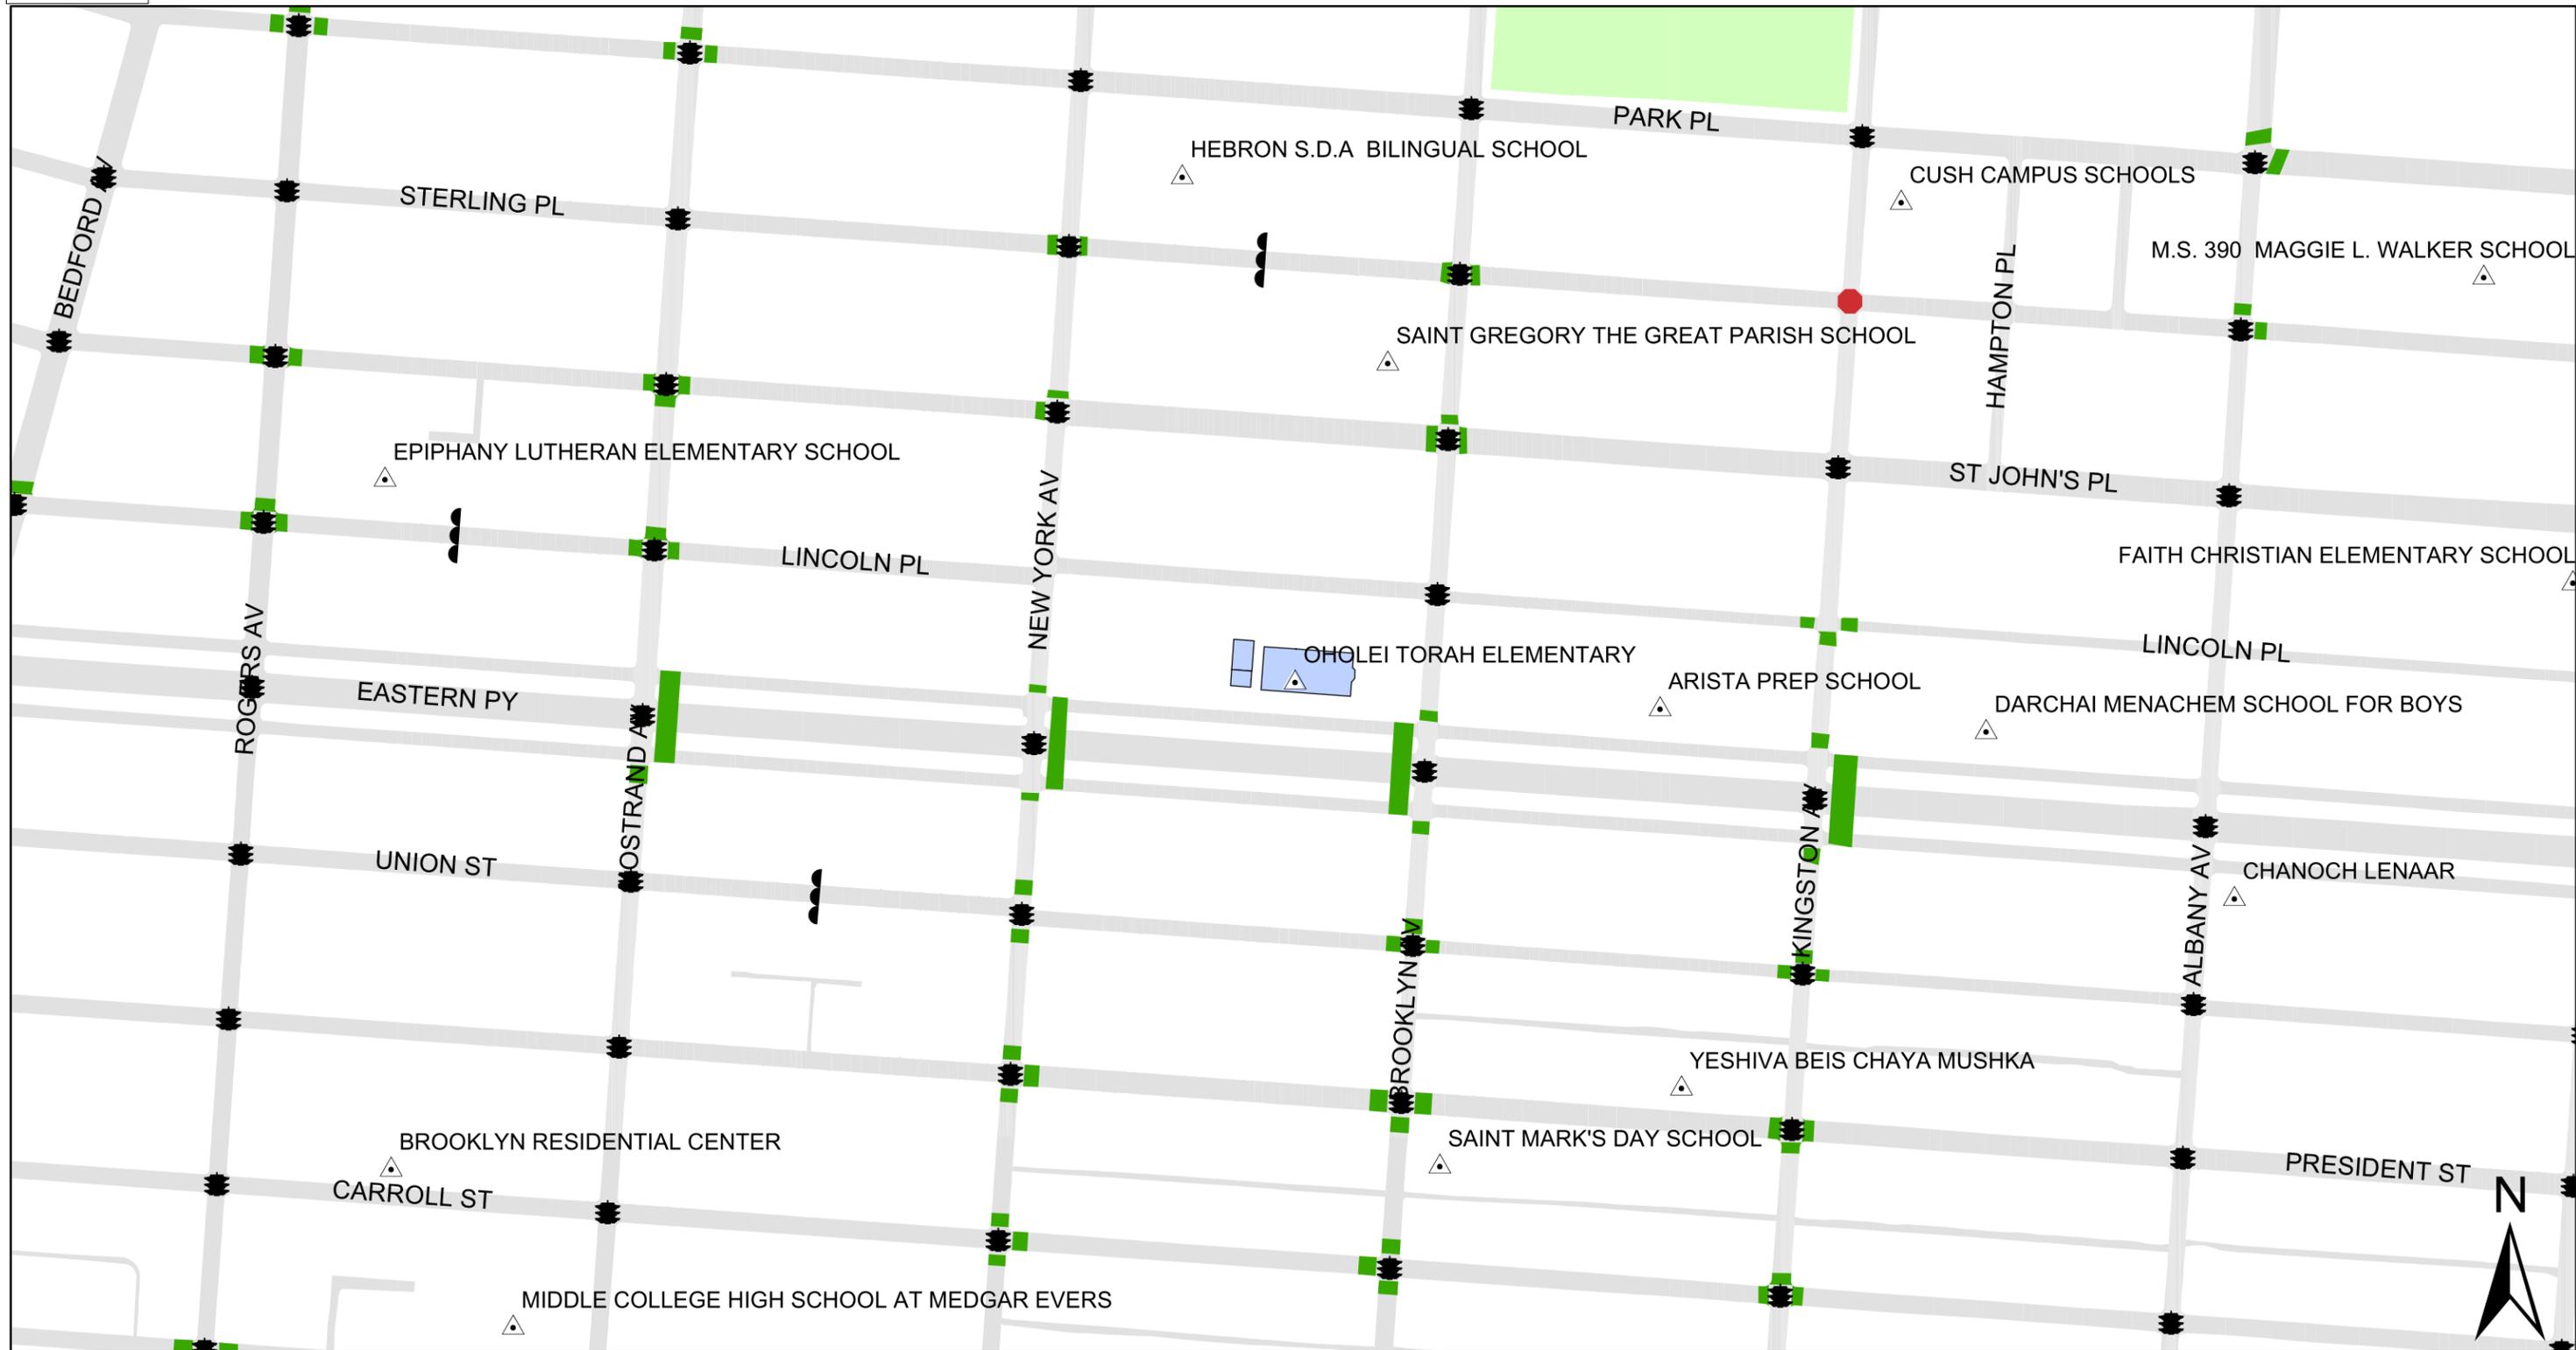
EXHIBIT 3

There are two crossing guards assigned to this school. One crossing guard is stationed at the intersection of Eastern Parkway North Service Road and Brooklyn Avenue, and the second crossing guard is stationed at the intersection of Eastern Parkway South Service Road and Brooklyn Avenue. It was noted that during dismissal times the crossing guard stationed on the north side of Eastern Parkway accompanied students across the North Service Road to the north median, waited for the mainline walk signal and then directed students across the four lane roadway while the second crossing guard awaits them on the other side (on the south median). The school officials expressed concern regarding this operation, and repeatedly asked for another crossing guard to accompany students across the mainline of Eastern Parkway. See Exhibit 3 for a map of crossing guard locations.

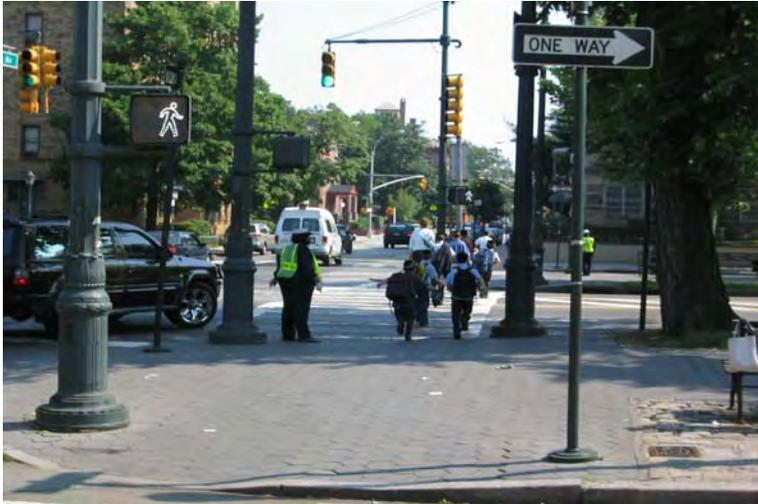
Figure 5: Crossing guards accompanying students to the median on Eastern Parkway (looking south)

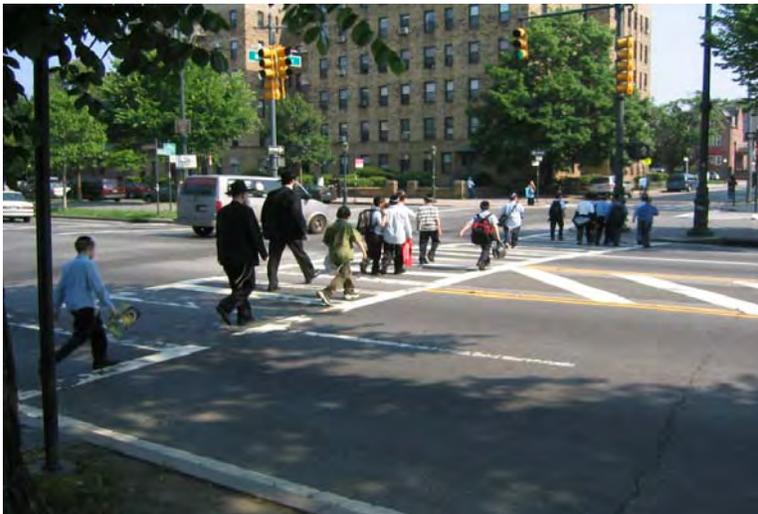
Figure 6: Students crossing the mainline of Eastern Parkway

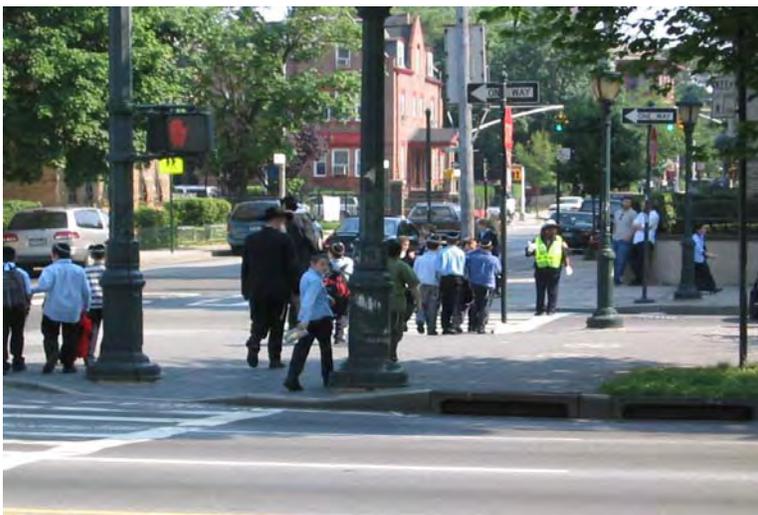
Figure 7: The second crossing guard waits for students to arrive on the south side of the Parkway

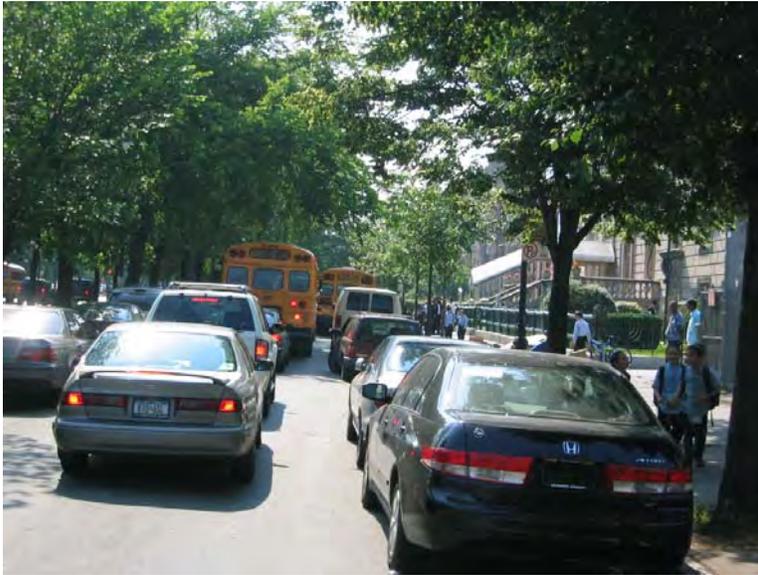
According to school representatives, 13 school buses drop students off at the school in the morning, and approximately 20 buses pick them up during afternoon dismissal time. School buses park or double-park on the North Service Road in front of the school. It was observed that the service road is often completely blocked during afternoon dismissal time (see Figure 8).

Figure 8: The Service Road in front of the school during afternoon dismissal time

- Review bus management / staging procedures

300 feet of curbside space has been provided for school bus operations. Some buses may still be required to stage at other locations until sufficient curbside space becomes available. School officials should review the bus operations at the school and consider the following:

- Restrict drop-off/pick-up of students from school buses to the designated curbside area fronting the school
- Define a staging area for buses to queue until they can safely pull into the curbside directly fronting the school for drop-off/pick-up operations.

It is important that students not enter/exit buses while the buses are in the staging area. By reducing the number of students entering or exiting the buses at one time, it may be easier to manage the students' actions at arrival and dismissal times.

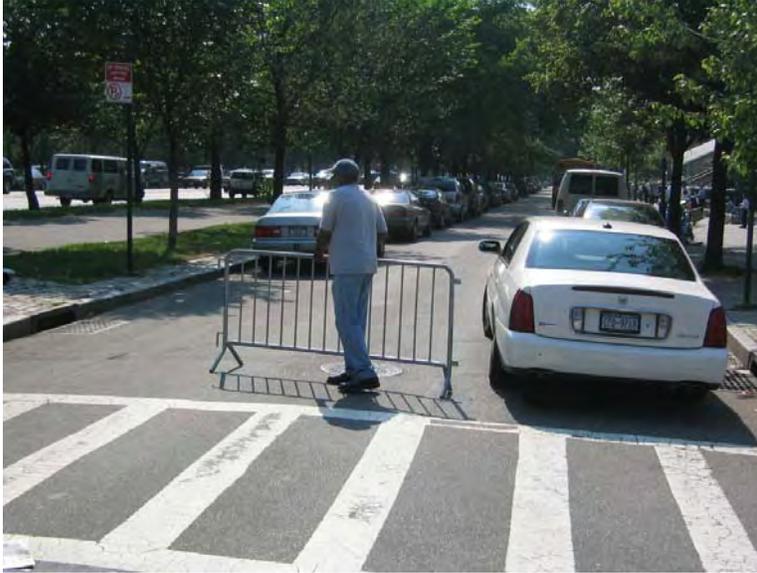
School officials reported that approximately 10 percent of students arriving at Oholei Torah School are dropped off and picked up by parents or guardians. Field observations performed in the morning of June 8, 2004 indicated that parent's vehicles share the North Service Road with school buses while dropping off students. As described in section 3.1, the North Service Road is partially or completely blocked for approximately 30-40 minutes during dismissal time. During this time, the school closes the North Service Road to traffic with a temporary metal barrier. This measure is not authorized by the NYCDOT. During this time westbound service road traffic is diverted to the mainline of Eastern Parkway (see Figure 9).

Figure 9: Temporary metal barricade being placed during school dismissal time

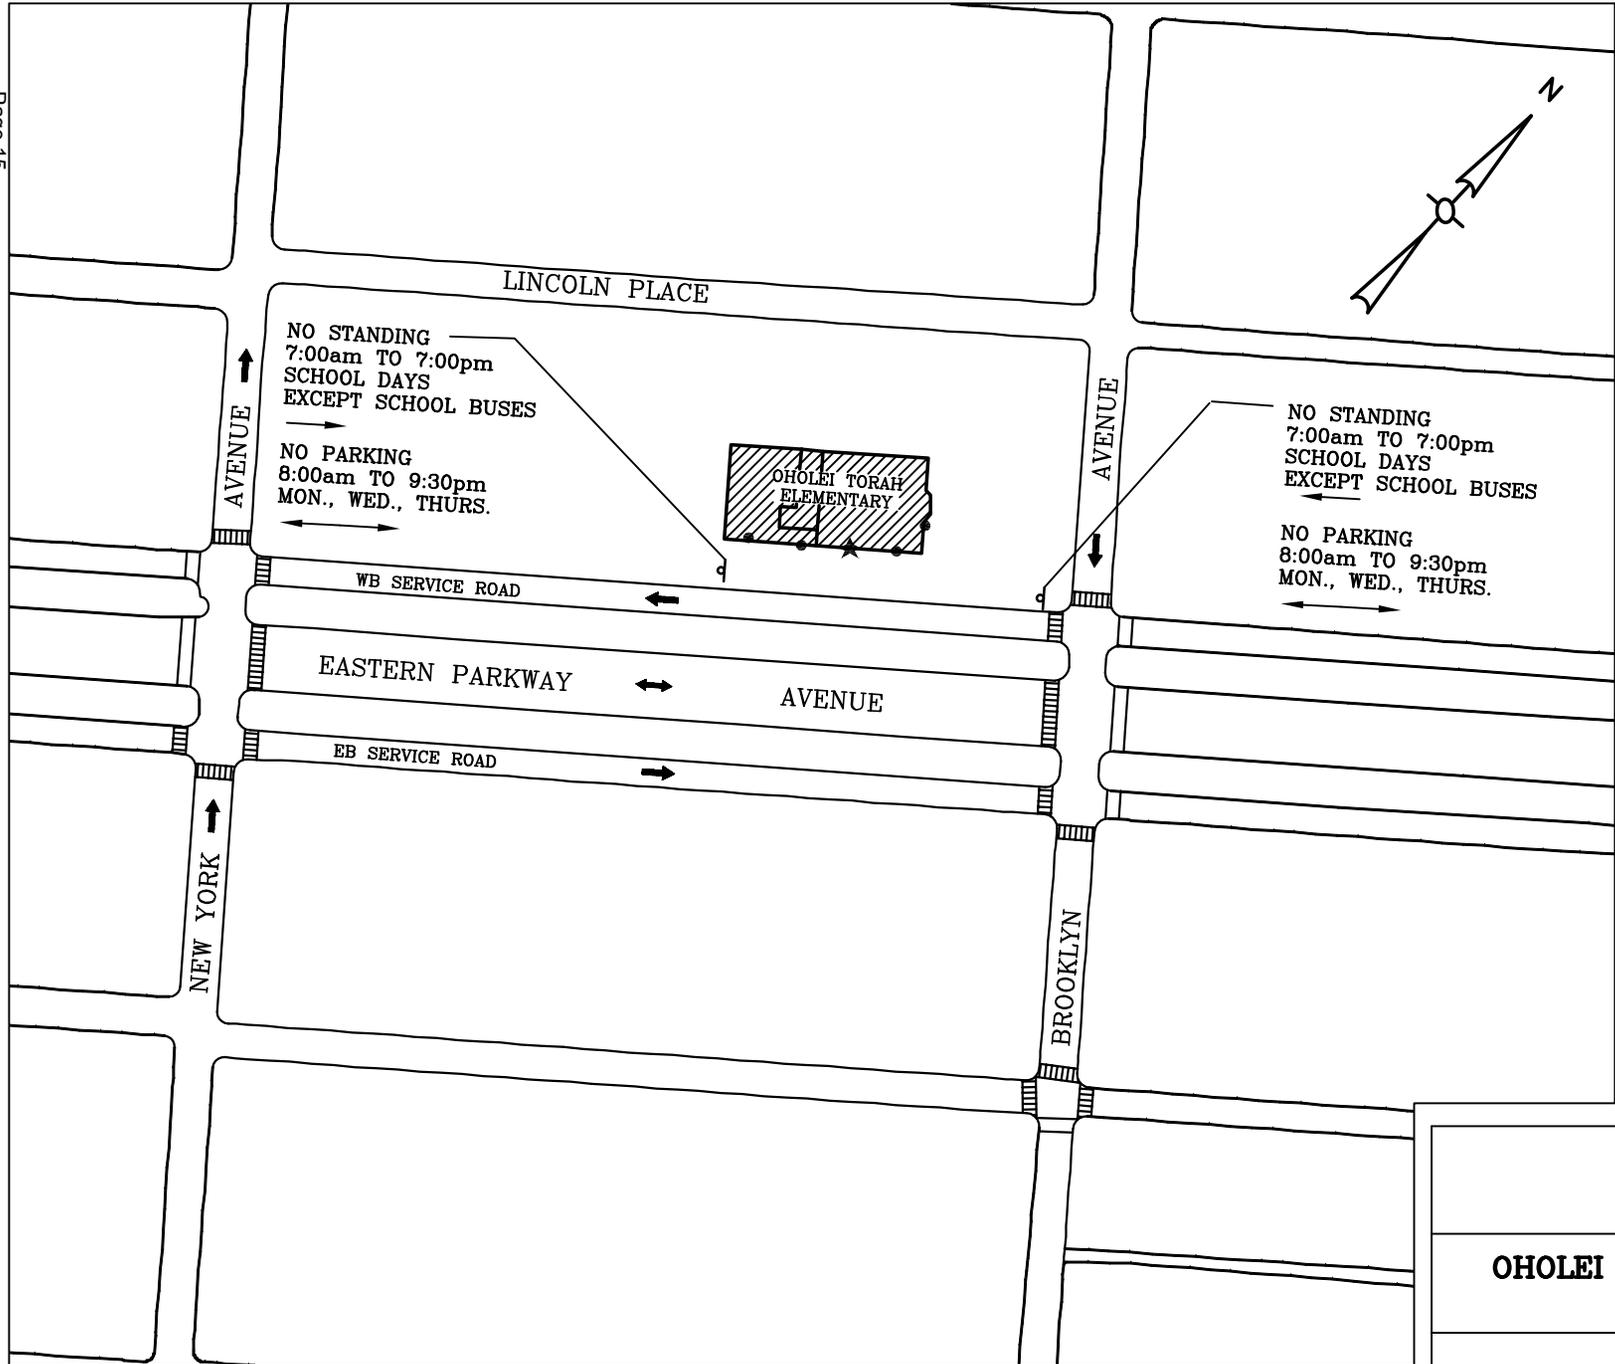
EXHIBIT 4

A “NO STANDING 7:00 AM TO 4:00 PM, SCHOOL DAYS, EXCEPT SCHOOL BUSES” parking regulation is posted on the north side of the North Service Road in front of the school. Parking is prohibited on the North Service Road of Eastern Parkway on alternating sides of the roadways between 8:30 am and 9:00 am. Exhibit 4 displays parking regulations in front of Oholei Torah School.

EXISTING PARKING REGULATIONS

“NO STANDING, 7:00 AM – 4:00 PM, SCHOOL DAYS” parking regulations should be installed for a length of approximately 300’ on both sides of the Eastern Parkway North Service Road from in front of the school to Brooklyn Avenue. This will provide sufficient clear frontage for parents to drop off and pick up students.

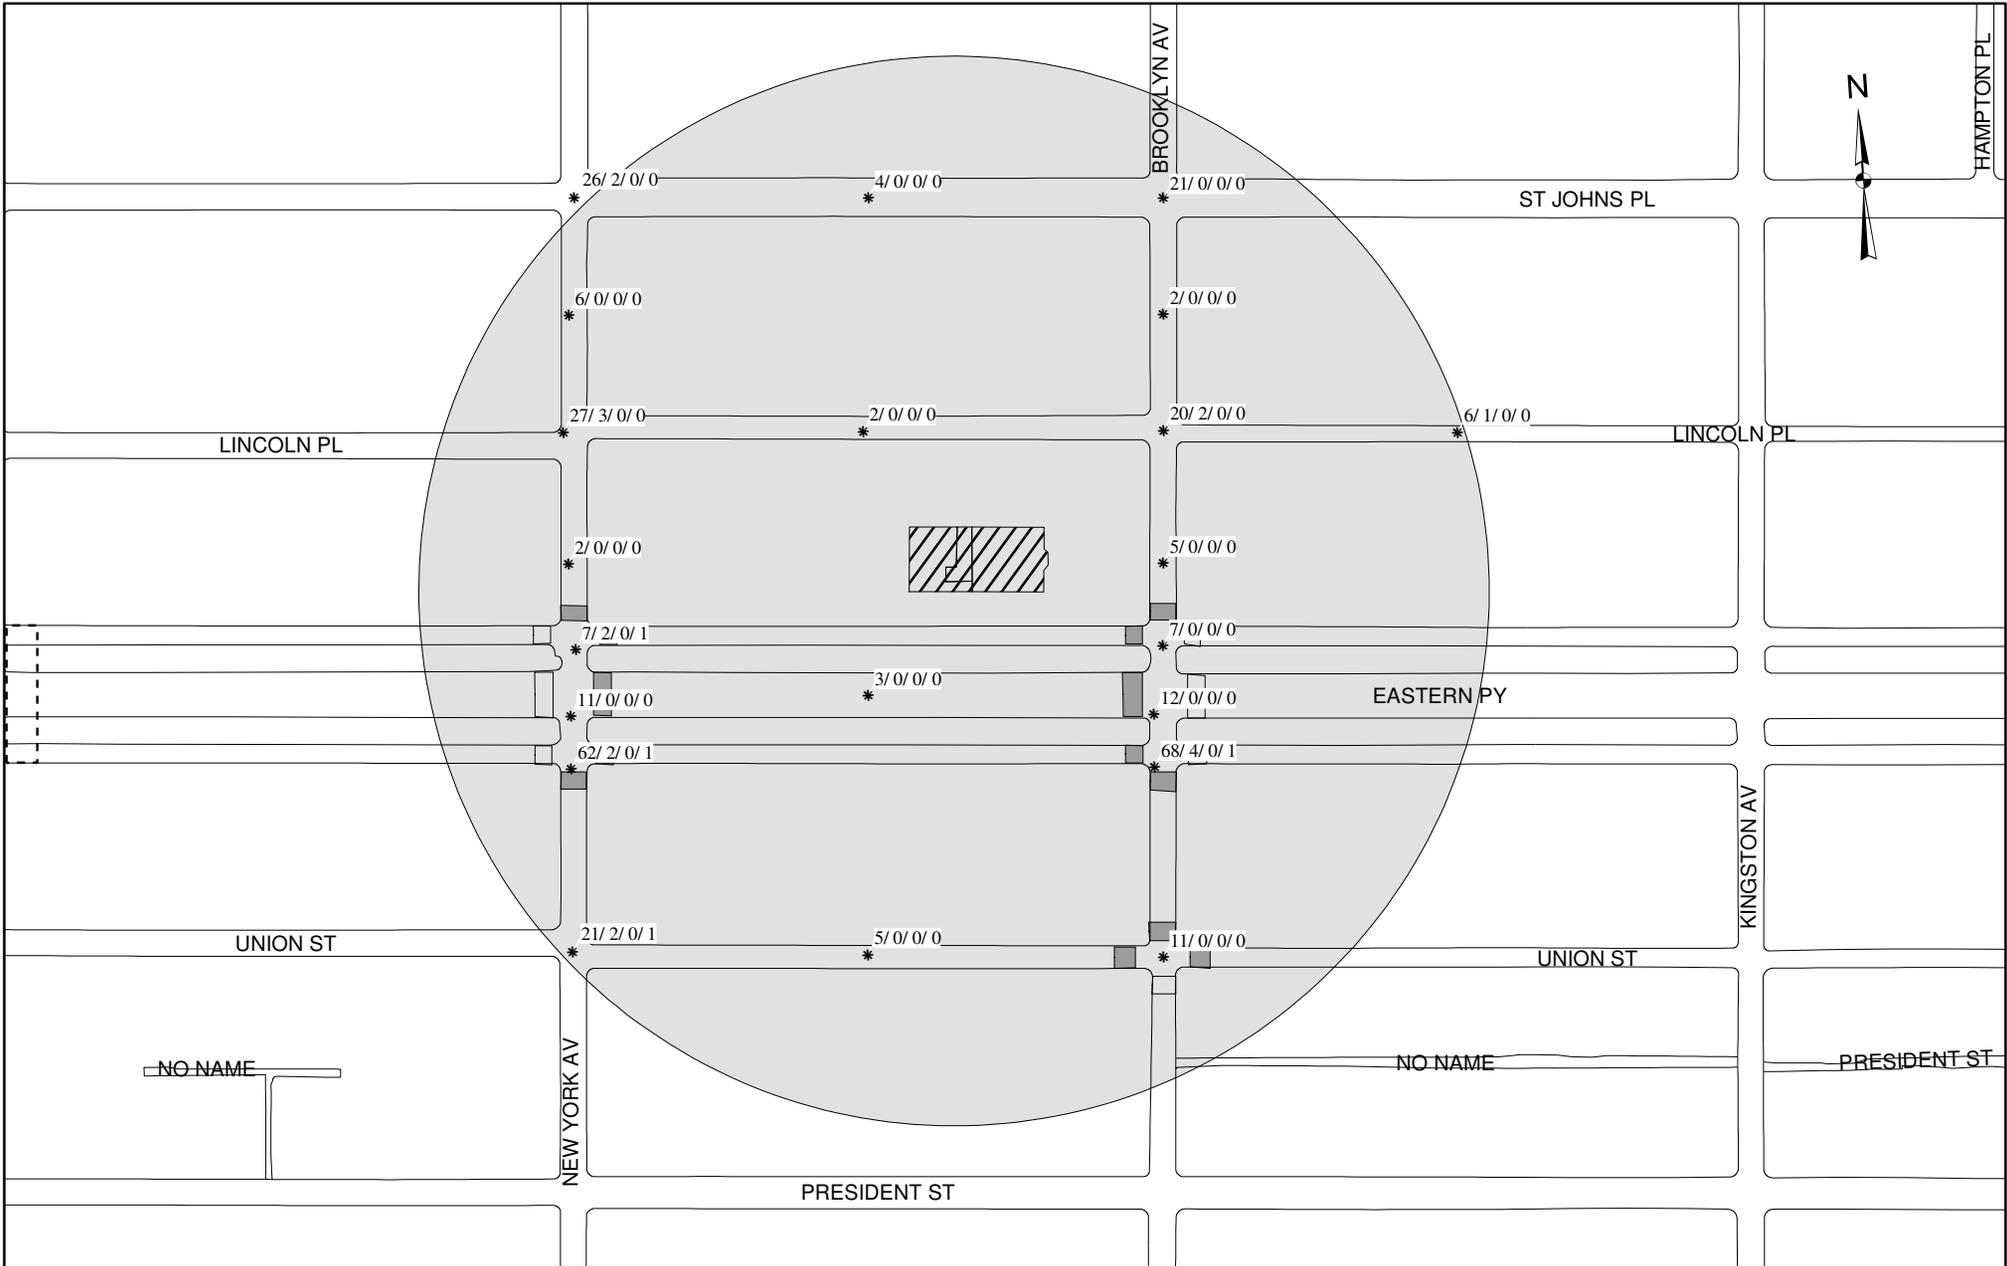
Exhibit 5 and Table 2 show a summary of accidents, as obtained from the New York State Department of Motor Vehicles (DMV), in the vicinity of Oholei Torah Elementary School for the three-year period from January 1, 1998 through December 31, 2000. The DMV data provides some detail relating to the circumstances and cause of the accidents. Table 3 is a summary of more recent accident data obtained from the NYC Police Department (NYPD). Though current through 2004, the NYPD data does not provide the same level of detail as the DMV data.

**EXHIBIT 5
OHOLEI TORAH ELEMENTARY
BROOKLYN
ACCIDENT SUMMARY
THREE YEAR PERIOD
1998-2000**

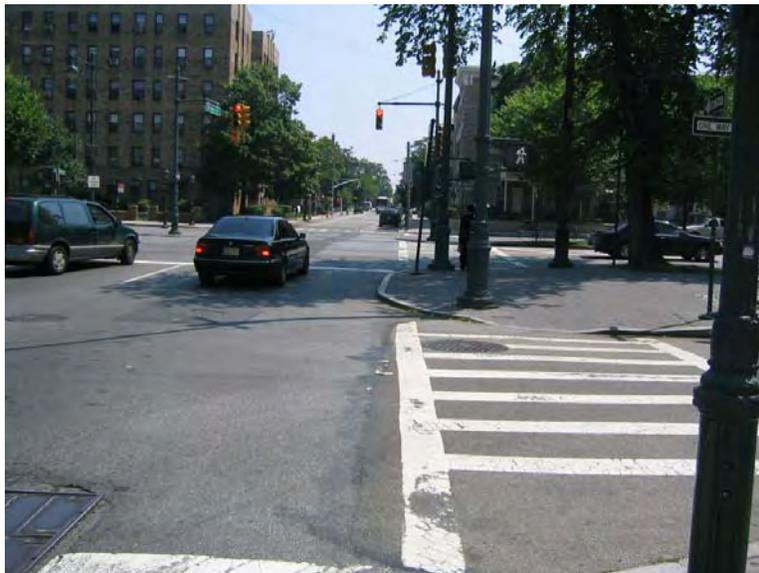
Pedestrians tend to cross the entire street (mainline and service roads) from curb-to-curb in one pedestrian signal phase, although there are two wide medians where pedestrians can wait for the next pedestrian phase. As shown in Table 4 and the signal plan for this intersection (attached in the Appendix) the signal timing at this location is structured for pedestrians to cross the street in two signal phases.

Figure 10: School crosswalk at Eastern Parkway and Brooklyn Avenue (looking south)

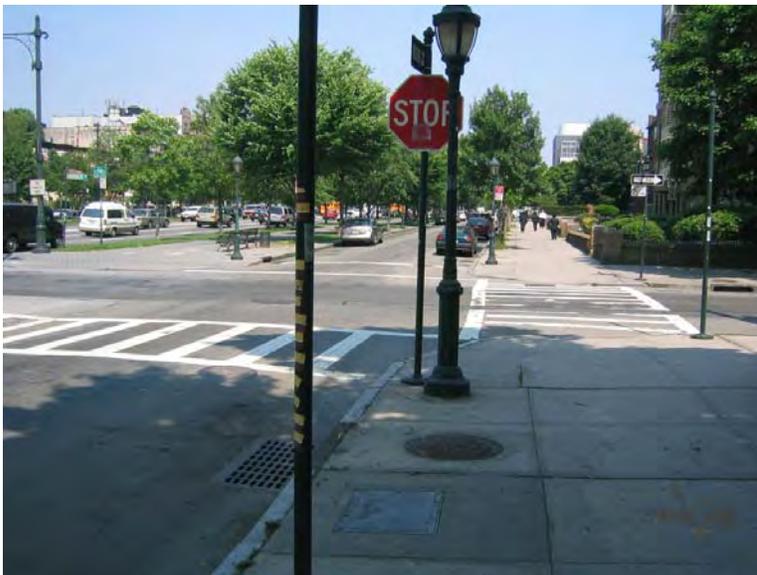
Another concern was the stop-controlled intersection of the Eastern Parkway South Service Road and Brooklyn Avenue. School officials requested that the South Service Road be signalized.

A review of traffic operations at this intersection indicates that a signal cannot be installed on the South Service Road unless left turns from the mainline are prohibited.

Therefore, even if left turns from the mainline could be prohibited, the South Service Road intersection does not meet MUTCD criteria for a traffic signal (see section 4 for alternative recommendations).

Figure 11: The Brooklyn Avenue and Eastern Parkway South Service Road (looking east)

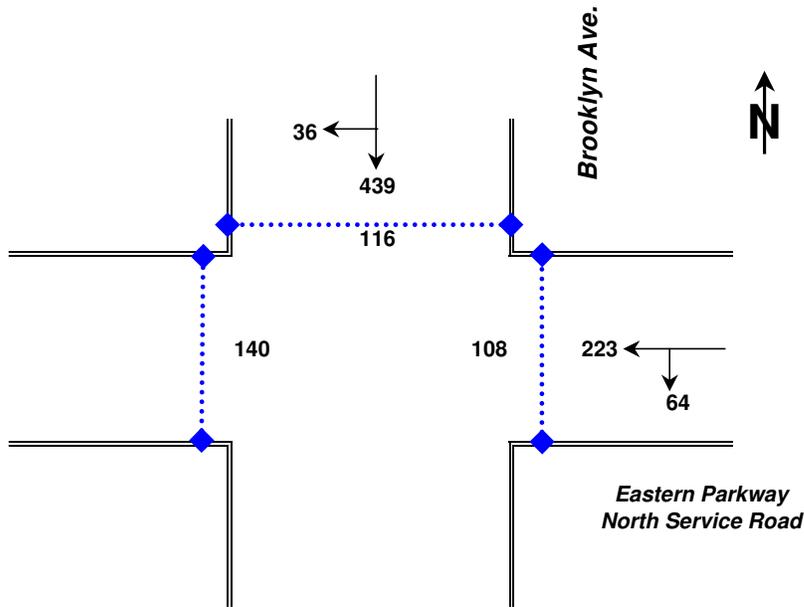
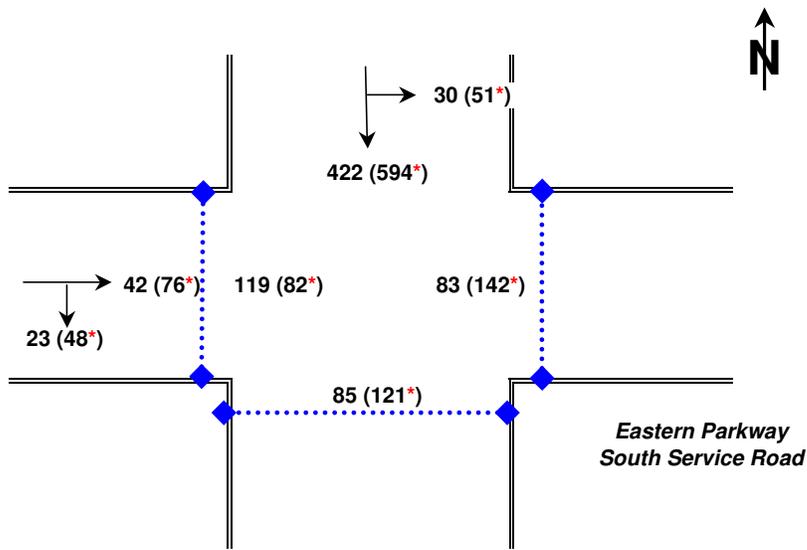
EXHIBIT 6
OHOLEI TORAH ELEMENTARY BROOKLYN
TRAFFIC COUNTS

The number of pedestrians crossing Brooklyn Avenue was 85 pedestrians/hour in the AM peak and 121 pedestrians/hour in the PM peak. In addition, a total of 109 gaps of 13 or more seconds were available to pedestrians crossing Brooklyn Avenue during the study hour. Neither of these counts, morning or afternoon, satisfies the MUTCD Section 4C.05 Signal Warrant 4 (Pedestrian Volume) criteria of 190 pedestrians/hour and less than 60 gaps per study hour.

Intersection of Eastern Parkway North S.R and Brooklyn Avenue

Intersection of Eastern Parkway South S.R and Brooklyn Avenue
 Note: * indicates 2:30-3:30 pm counts

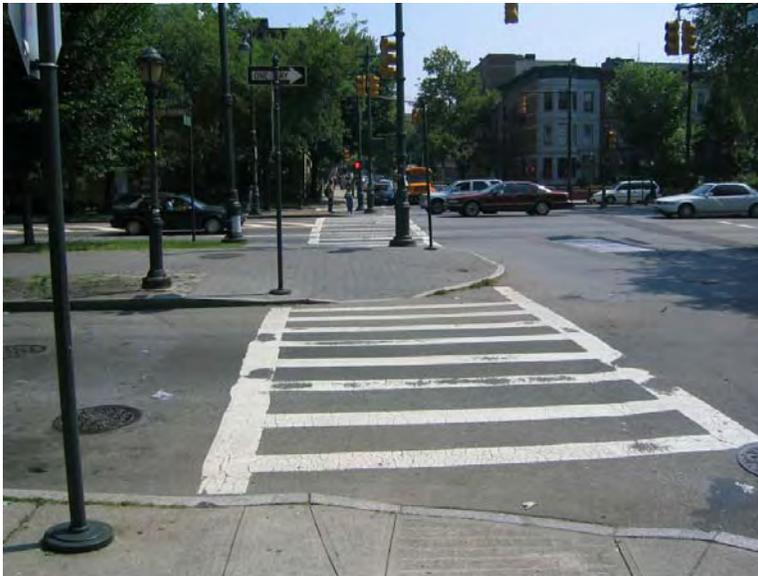
There were 80 accidents at this intersection during the 1998 and 2000 study period. Four accidents involved pedestrians, of which two were school related accidents. The school related accidents included an eight-year old student crossing Brooklyn Avenue against the signal who was struck by a northbound vehicle, and a second eight-year old student struck by an eastbound vehicle, which according to the accident data, disregarded the signal. The other pedestrian accidents at this intersection were due to pedestrians crossing against the signal.

Figure 12: New York Avenue and Eastern Parkway (looking south)

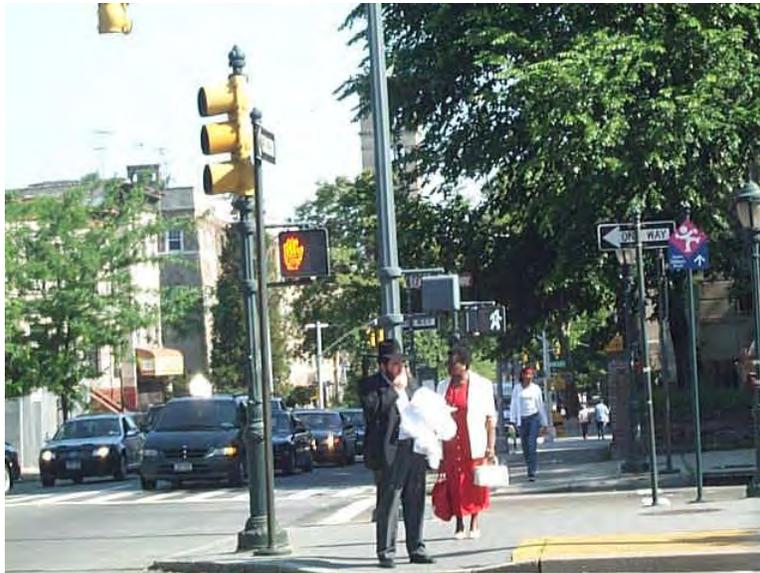
Figure 13: Shows the Do Not Walk Symbol for the mainline while the walk signal allows pedestrians to cross the service road.

Pedestrian signal head information signs should be installed at the north and south Eastern Parkway service roads at the intersection with Brooklyn Avenue. These signs will help educate pedestrians on how to cross Eastern Parkway in two cycles.
