New York City Department of Transportation

School Safety Engineering Project

FINAL REPORT: Oholei Torah Elementary School, Brooklyn

**Prepared by
The RBA Group/Urbitran Associates**

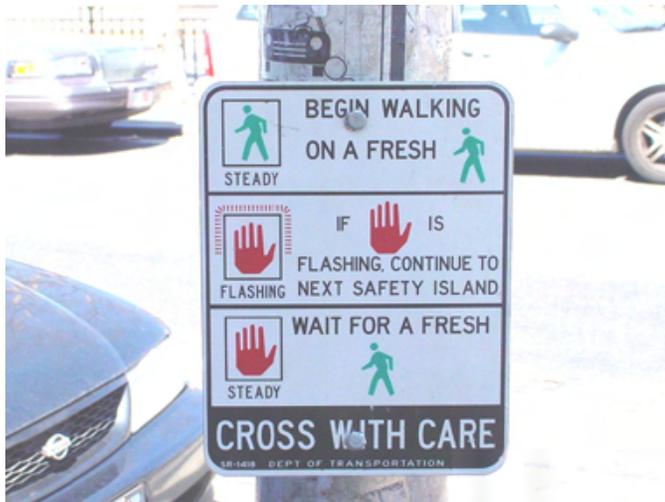
Figure 14: “Cross with Care” sign

Pedestrian signal head information signs should be installed at the north and south Eastern Parkway service roads at the intersection with Brooklyn Avenue. These signs will help educate pedestrians on how to cross Eastern Parkway in two cycles.

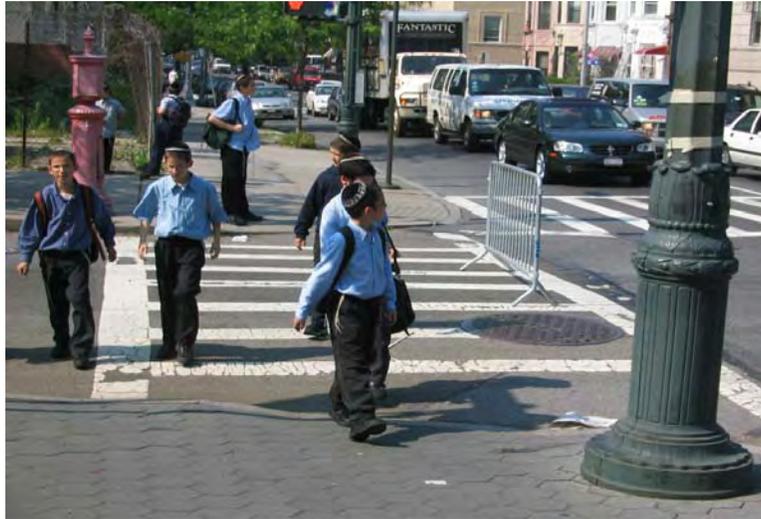
Figure 15: Temporary closure to through traffic on the North Service Road.

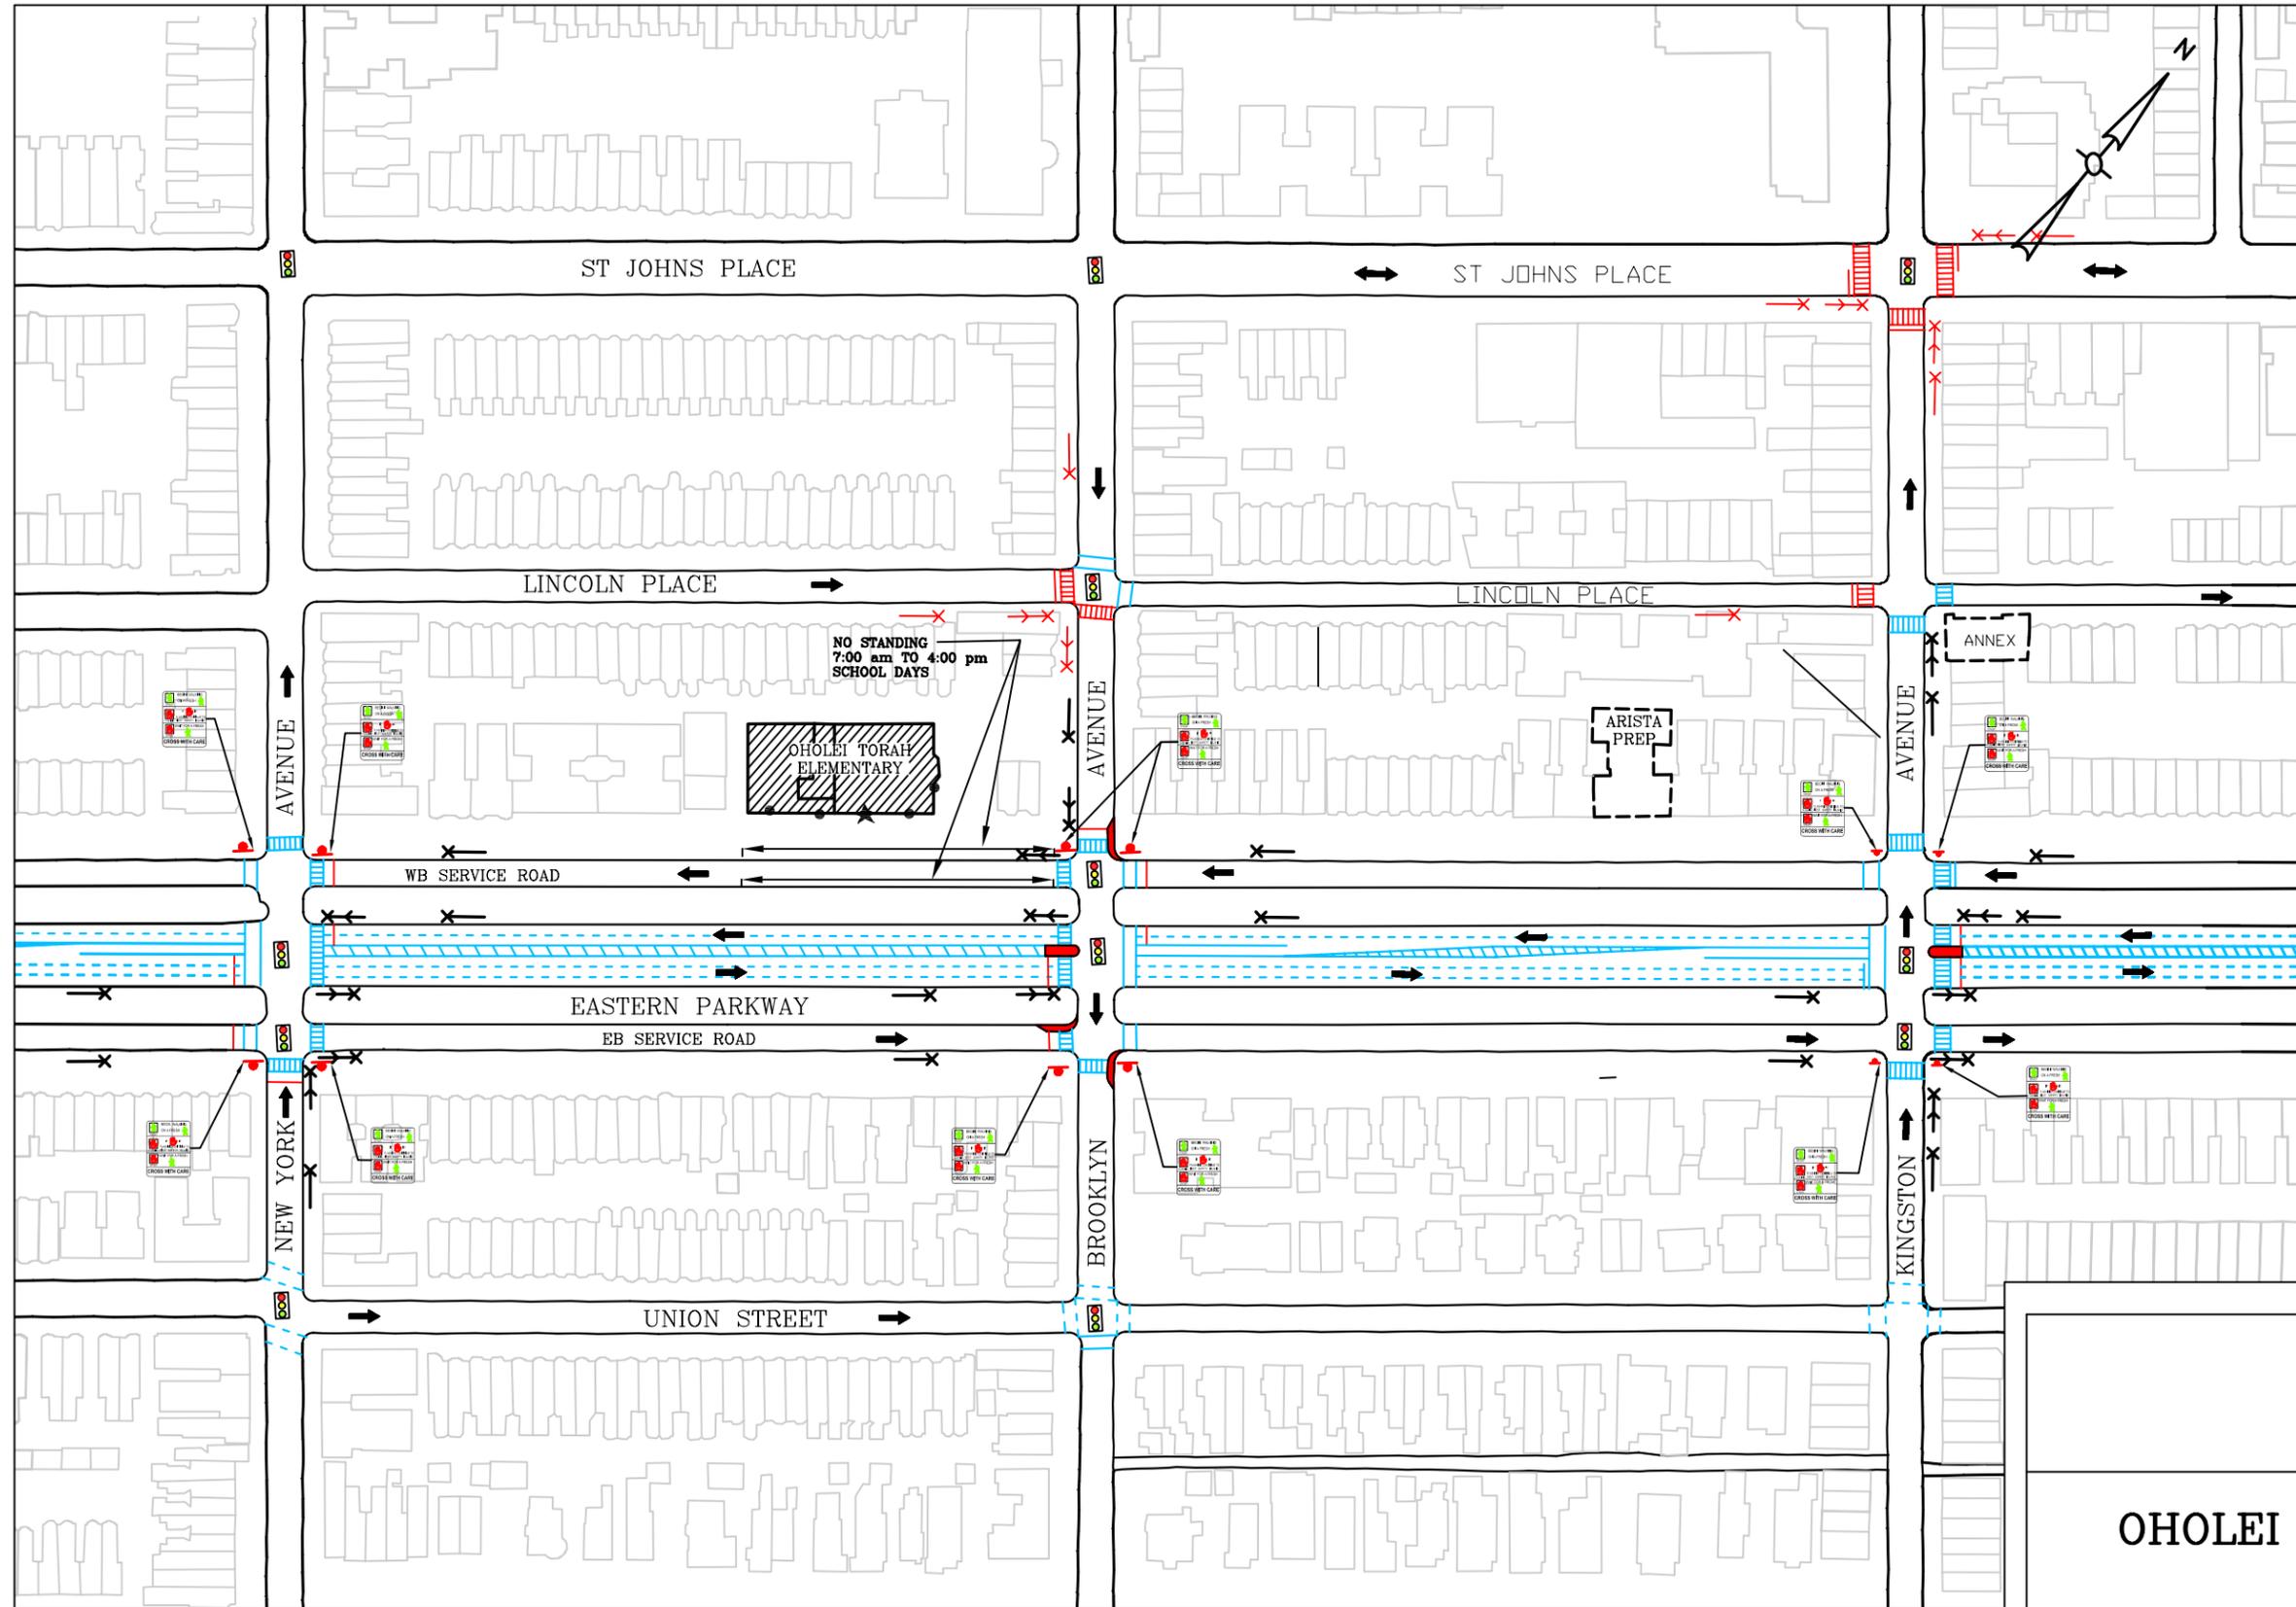
EXHIBIT 7

**PROPOSED MEASURES TO IMPROVE
STUDENT PEDESTRIAN SAFETY**

Curb extensions should be installed at the corners as shown in Exhibit 7.

The purpose of the curb extensions is to reduce speeds of vehicles approaching and turning at these heavily utilized school crosswalks.

The proposed raised median will replace the existing striped median and extend through the crosswalk to provide refuge for pedestrians (see Exhibit 7). The median should have an ADA compliant at-grade cut-through.

The proposed raised median will replace an existing painted median and extend through the crosswalk to provide refuge for pedestrians (See Exhibit 7). The median should have an ADA compliant at-grade cut-through.
