**New York City Department of Transportation
Office of School Safety Engineering**

School Safety Engineering Project

FINAL REPORT: I.S. 195, Roberto Clemente School, Manhattan

NOVEMBER 17, 2006

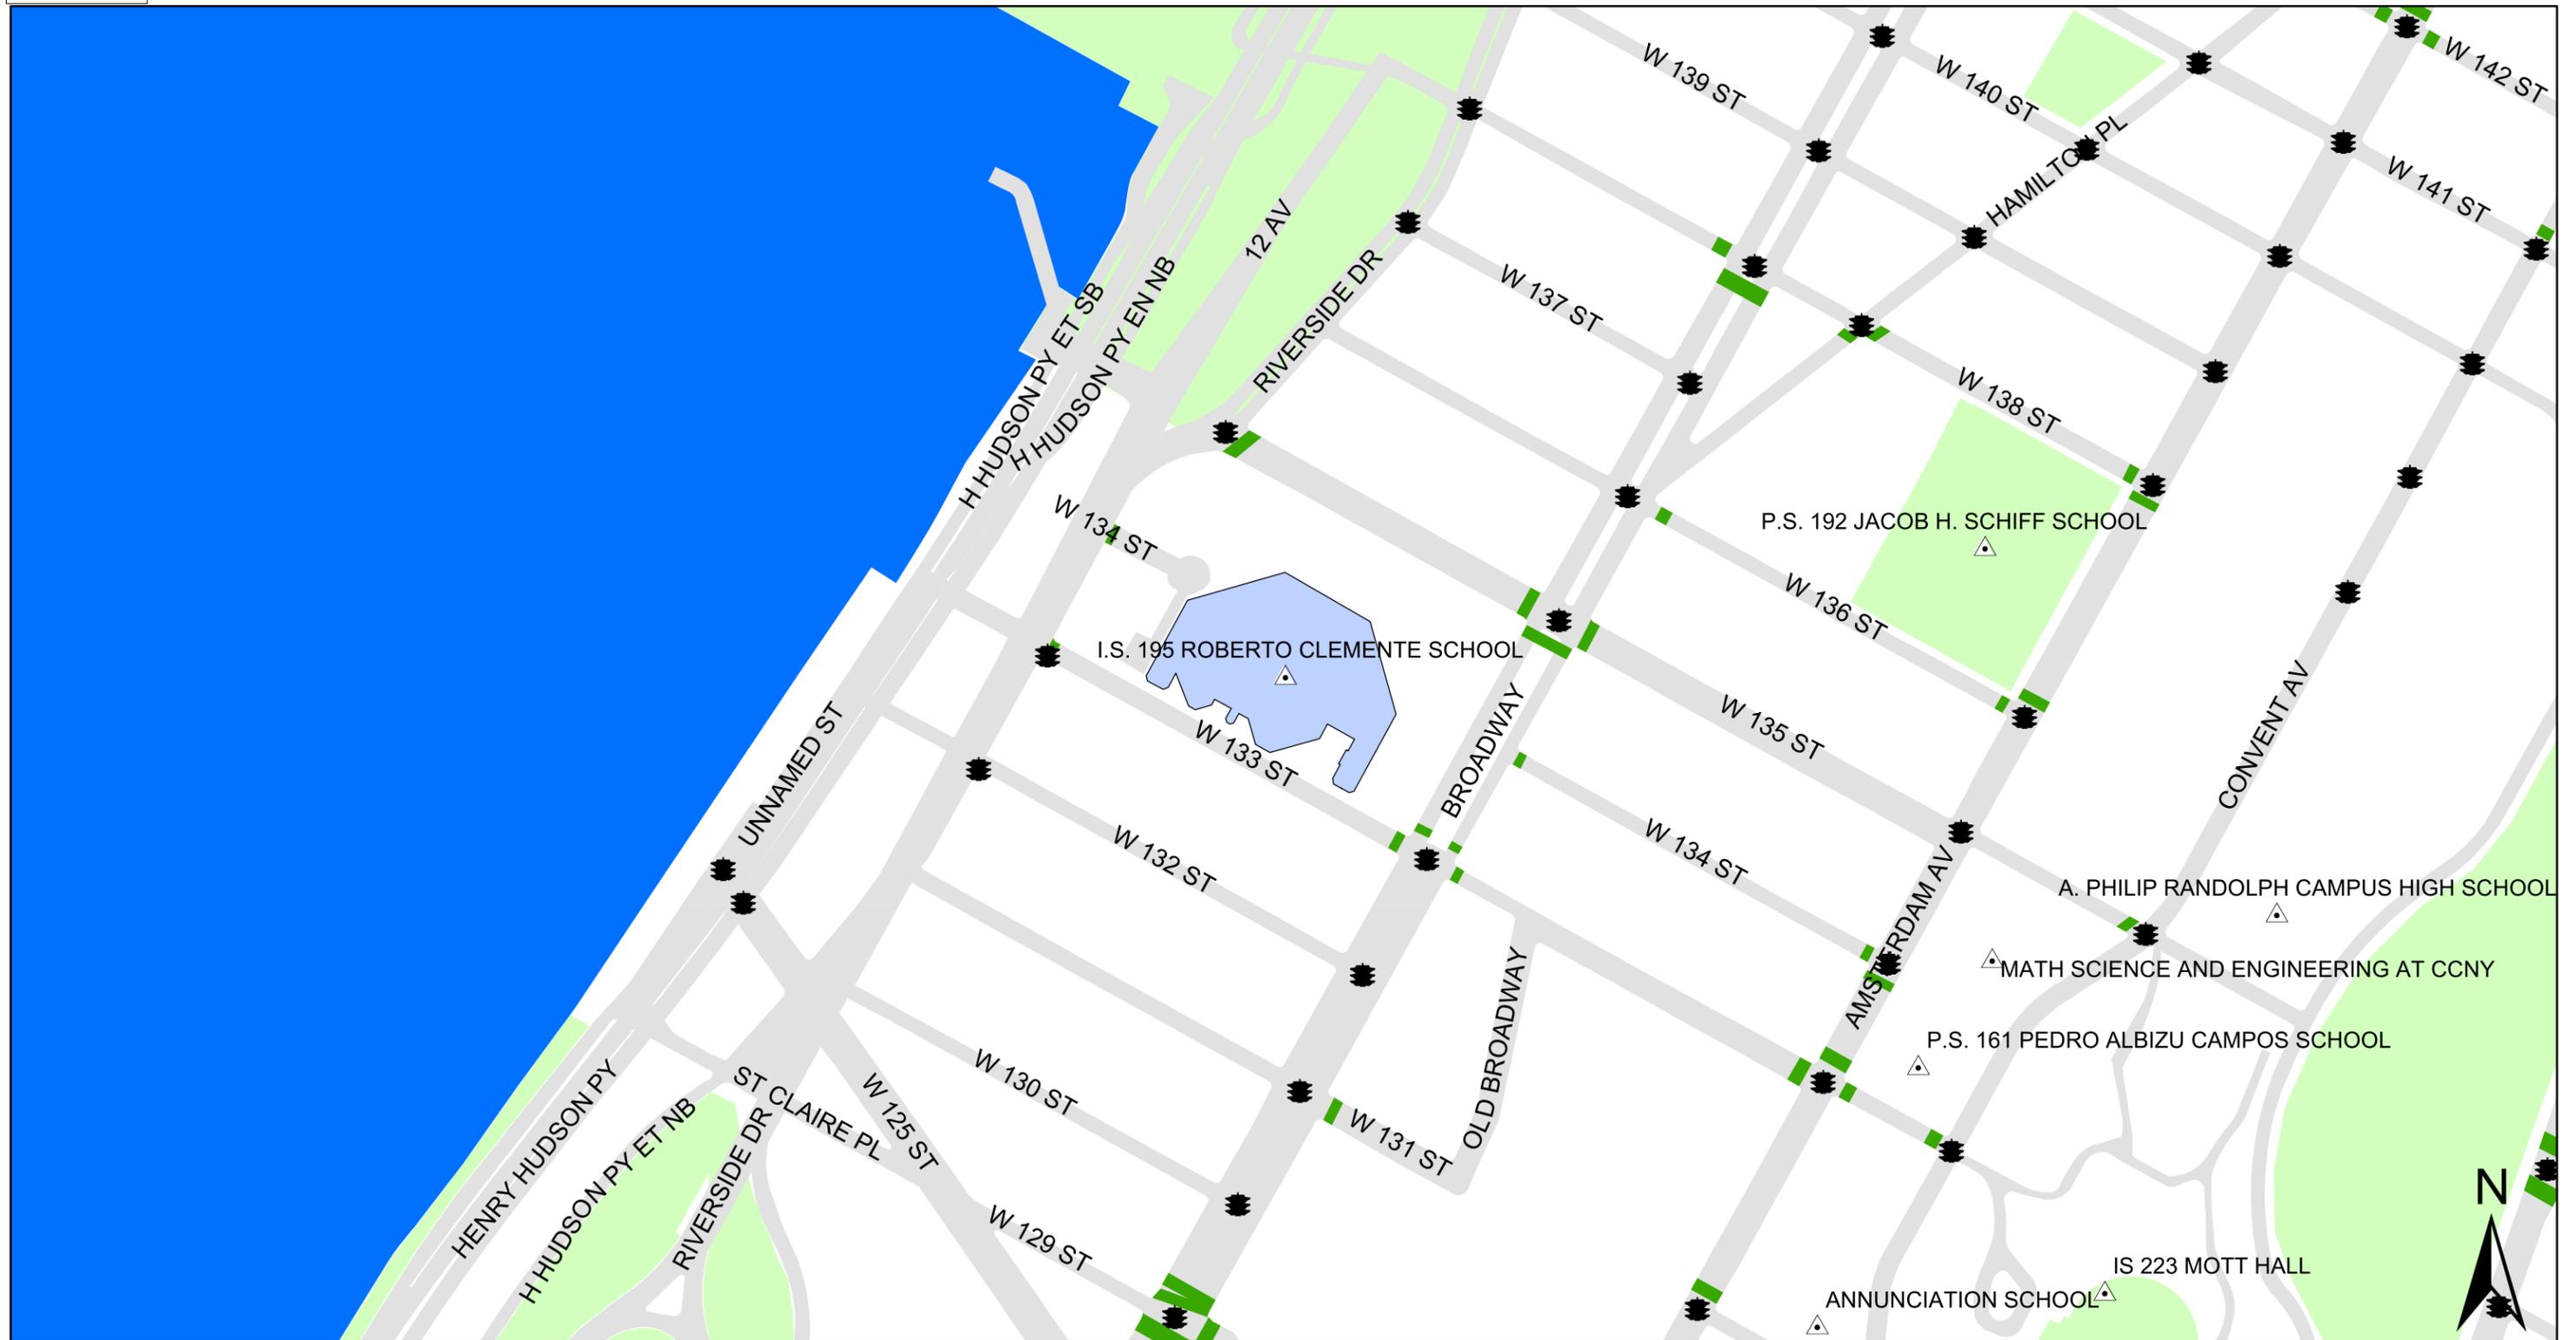
EXHIBIT 3

The School Traffic Safety Map was established to help provide the maximum degree of safety for children going to and from school - by indicating the location of speed reducers, school crosswalks and some traffic control devices. (While virtually all intersections in NYC benefit from traffic control devices - such as stop signs, traffic signals, yield signs, and all way stop signs - this map shows only traffic signals and all way stop signs.) The school crosswalks that are shown are ladder striped and make the crosswalk more visible to drivers and help make the intersection safer. These crosswalks are where school children are recommended to cross.

The Traffic Safety Plan, Exhibit 3, shows existing signals and school crosswalk pavement markings in the vicinity of the school. It is noted that a citywide signage program is currently underway to upgrade school signage to current Federal Manual of Uniform Traffic Control Devices (MUTCD) standards of fluorescent yellow-green signs accompanied by downward pointing arrows. Signs scheduled to be installed under this program are shown as "existing" on Exhibit 7.

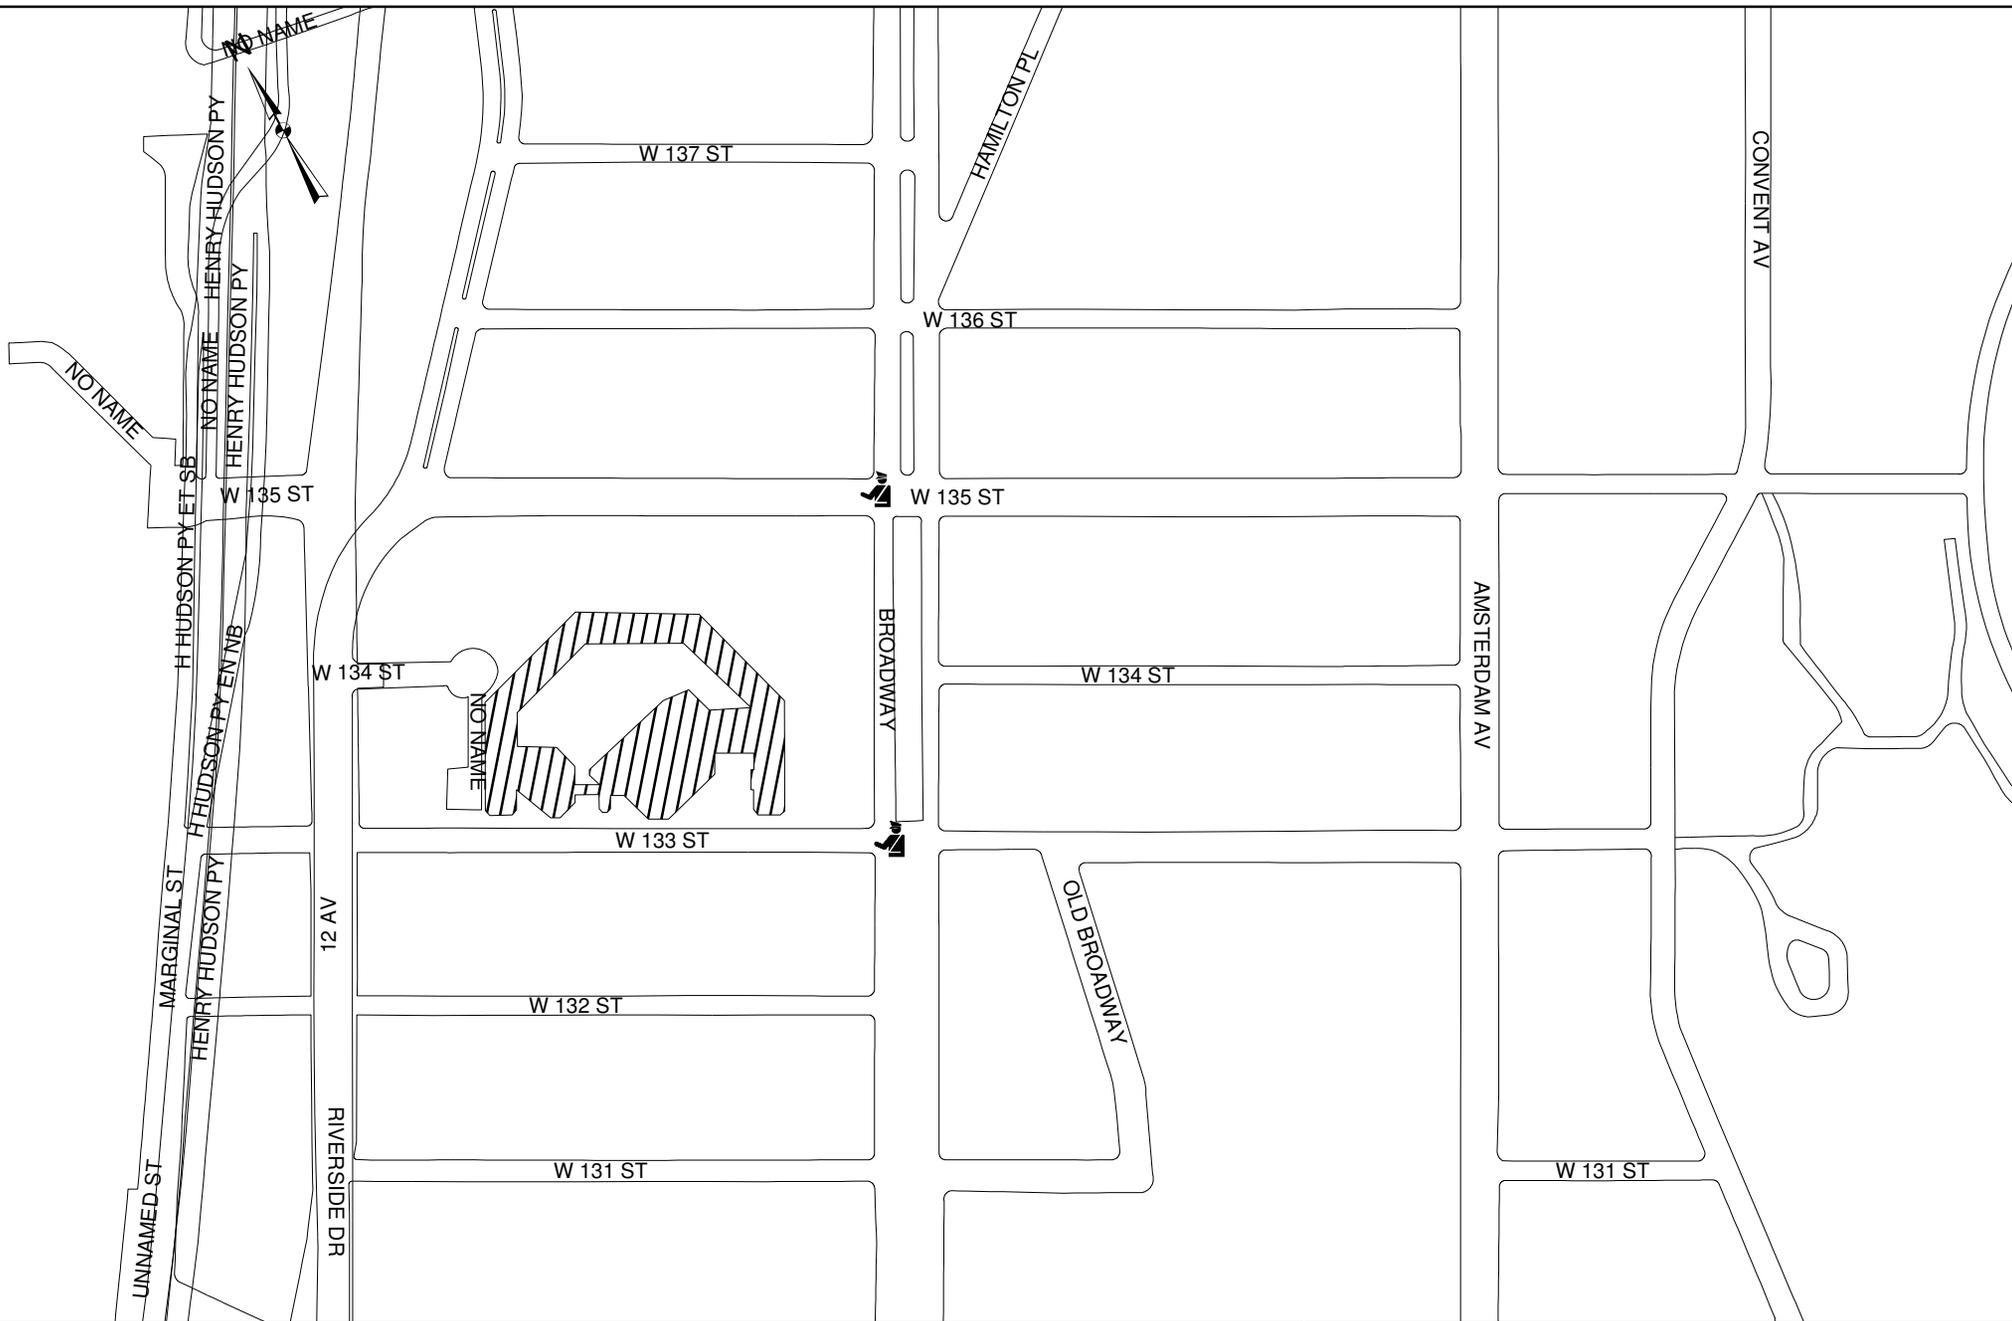
EXHIBIT 4
I.S. 195, MANHATTAN
ROBERTO CLEMENTE SCHOOL
CROSSING GUARD

There are two crossing guards assigned to I.S. 195. The crossing guards are assigned to the following intersections:

- West 133rd Street and Broadway
- West 135th Street and Broadway

See Exhibit 4 for a map of the assigned crossing guards in the vicinity of I.S. 195.

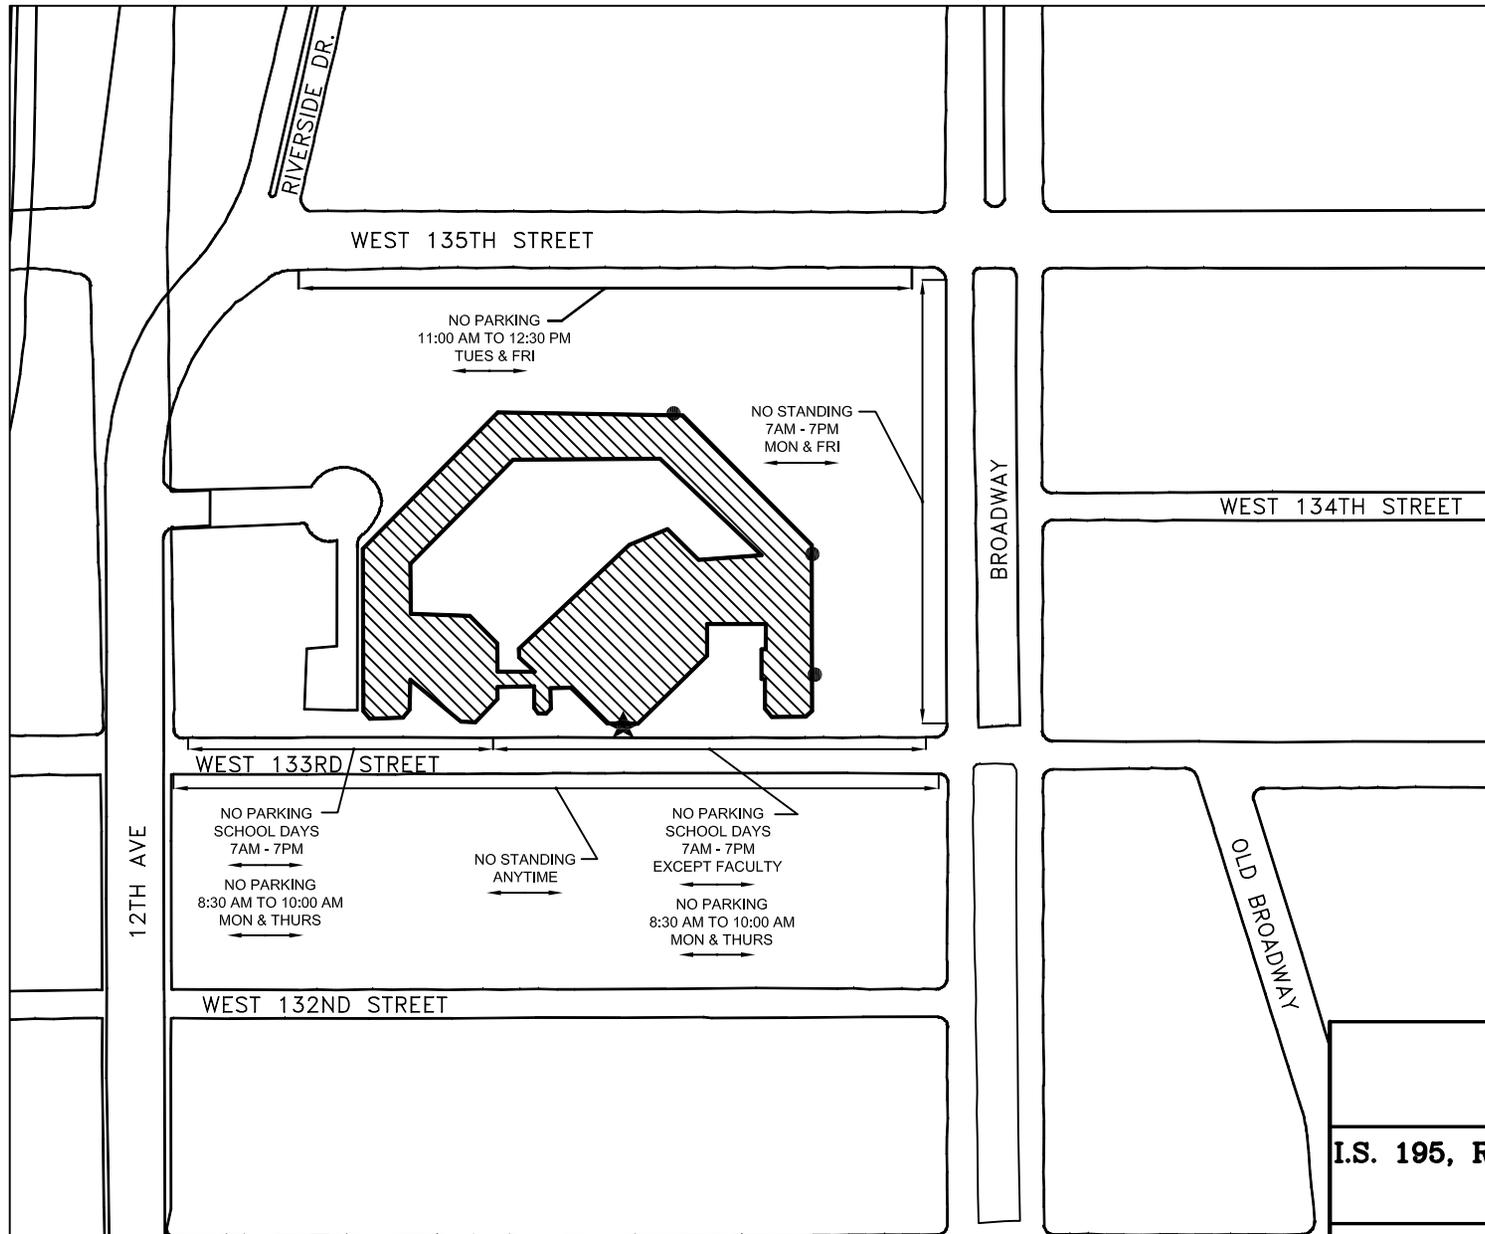
EXHIBIT 5

A “NO PARKING, 7:00 AM – 4:00 PM, SCHOOL DAYS, EXCEPT FACULTY” parking regulation is posted on the north side of West 133rd Street for approximately two-thirds of the block in front of the school. A “NO PARKING, 7:00 AM – 4:00 PM, SCHOOL DAYS” parking regulation is posted on the north side of West 133rd Street east of 12th Avenue for approximately one-third of the block.

Exhibit 5 displays existing parking regulations on West 133rd Street, West 135th Street, and Broadway.

EXISTING PARKING REGULATIONS

The parking restriction “NO STANDING, 7:00 AM – 4:00 PM, SCHOOL DAYS” should be posted for a length of 120 feet in front of school’s main entrance on West 133rd Street for buses to load and unload students.

“NO PARKING, 7:00 AM – 4:00 PM, SCHOOL DAYS, EXCEPT DEPARTMENT OF EDUCATION” parking regulations should be provided for the rest of the north side of West 133rd Street in front of the school (see Exhibit 7).

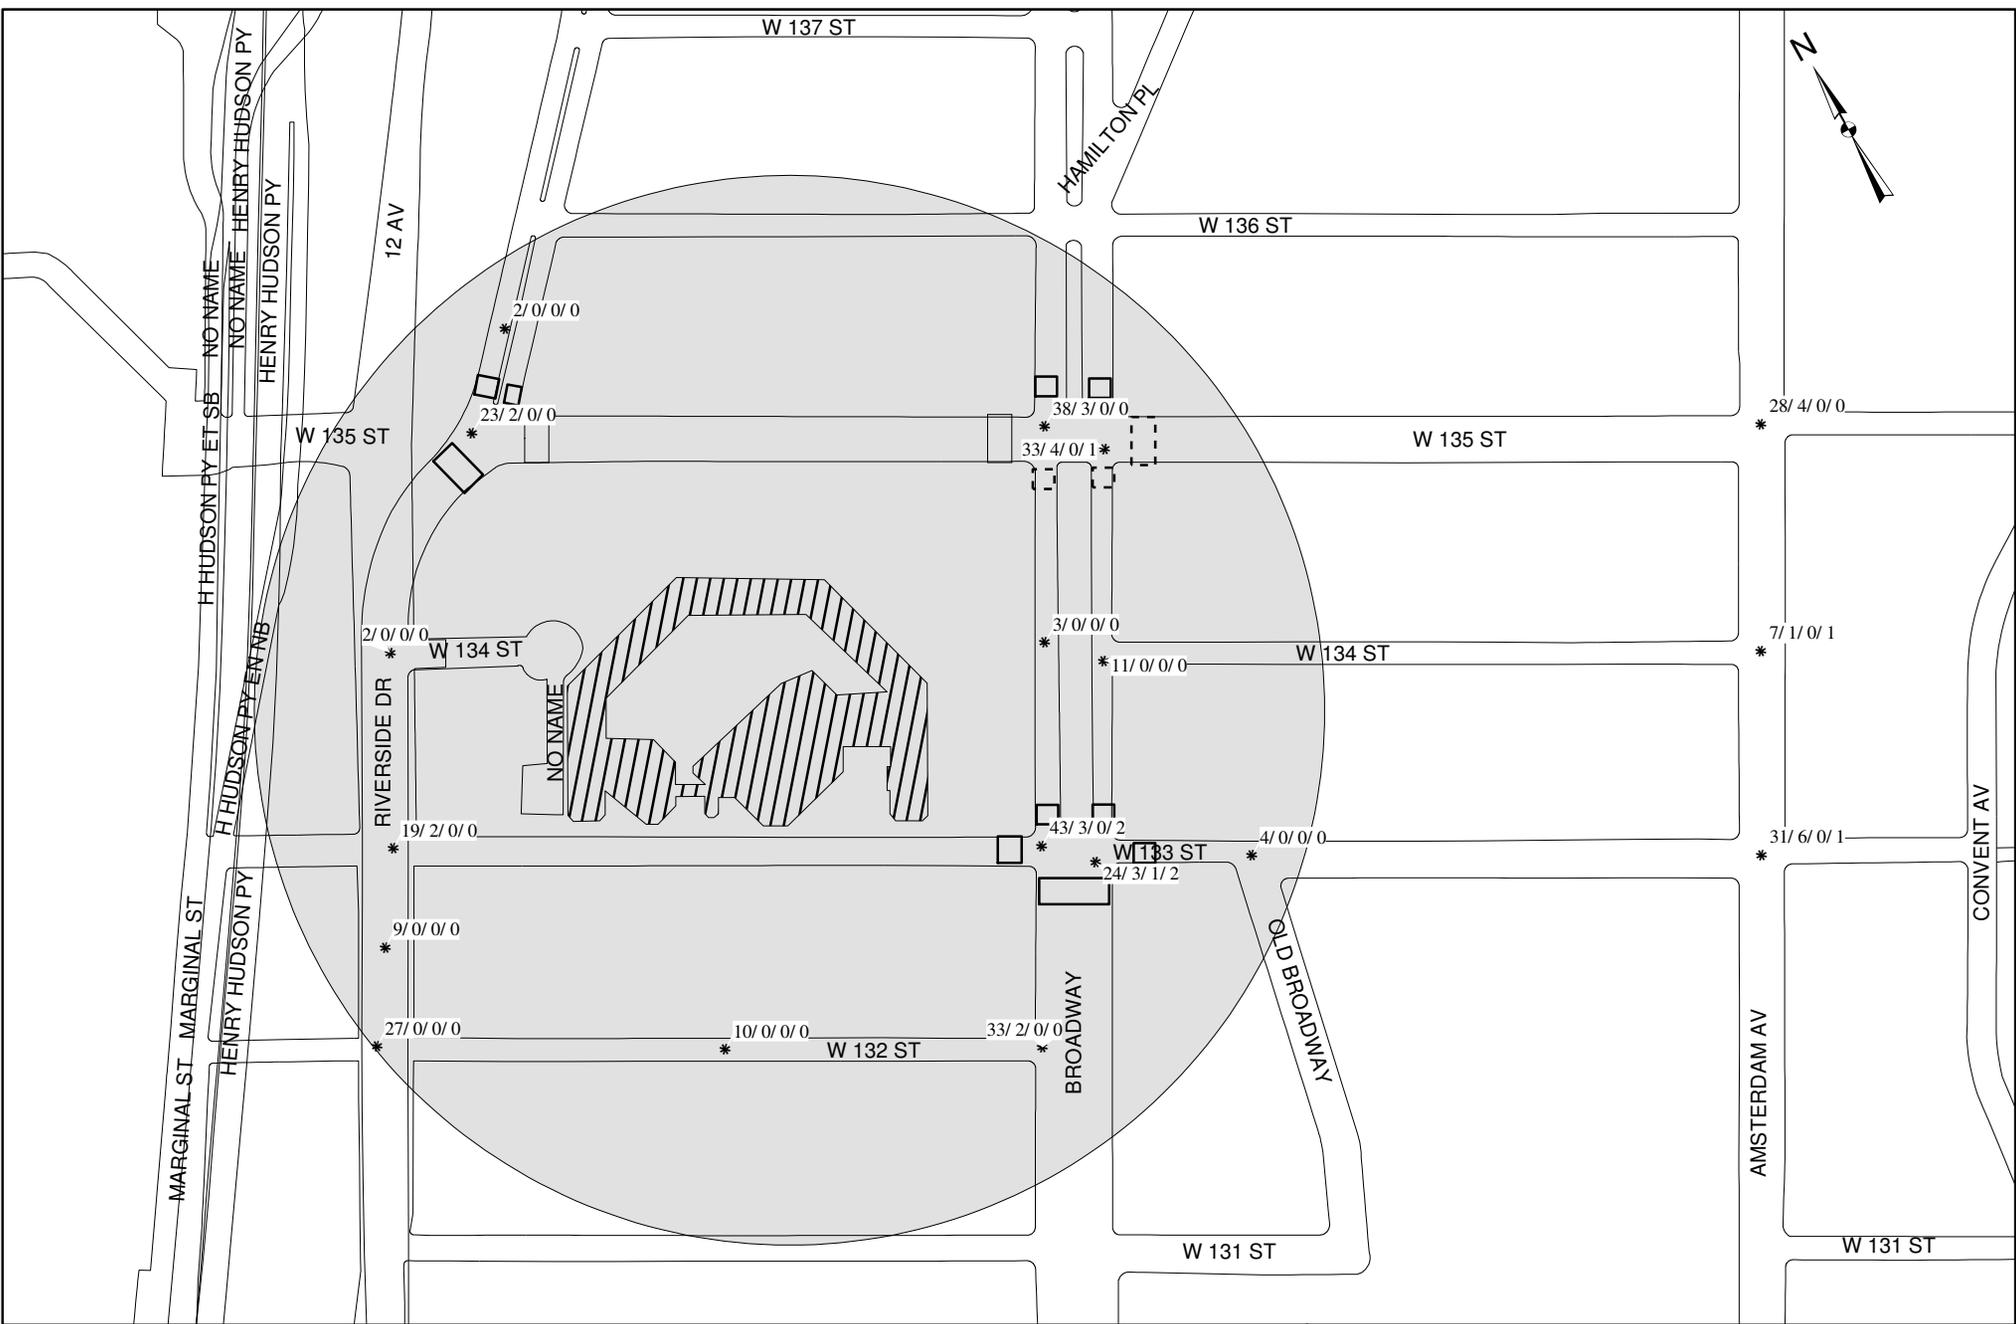
EXHIBIT 6
I.S. 195, MANHATTAN
ROBERTO CLEMENTE SCHOOL

Exhibit 6 and Table 2 show a summary of accidents, as obtained from the New York State Department of Motor Vehicles (DMV), in the vicinity of I.S. 195 for the three-year period from January 1, 1998 through December 31, 2000. The DMV data provides some detail relating to the circumstances and cause of the accidents. Table 3 is a summary of more recent accident data obtained from the NYC Police Department (NYPD). Though current through 2004, the NYPD data does not provide the same level of detail as the DMV data.

TOTAL ACCIDENTS	PED ACCIDENTS	PED FATAL	SCHOOL_PED ACCIDENTS
2/0/0/0			
23/2/0/0			
2/0/0/0			
19/2/0/0			
9/0/0/0			
27/0/0/0			
10/0/0/0			
33/2/0/0			
38/3/0/0			
33/4/0/1			
3/0/0/0			
11/0/0/0			
43/3/0/2			
24/3/1/2			
4/0/0/0			
28/4/0/0			
7/1/0/1			
31/6/0/1

ACCIDENT SUMMARY
THREE YEAR PERIOD
(1998-2000)

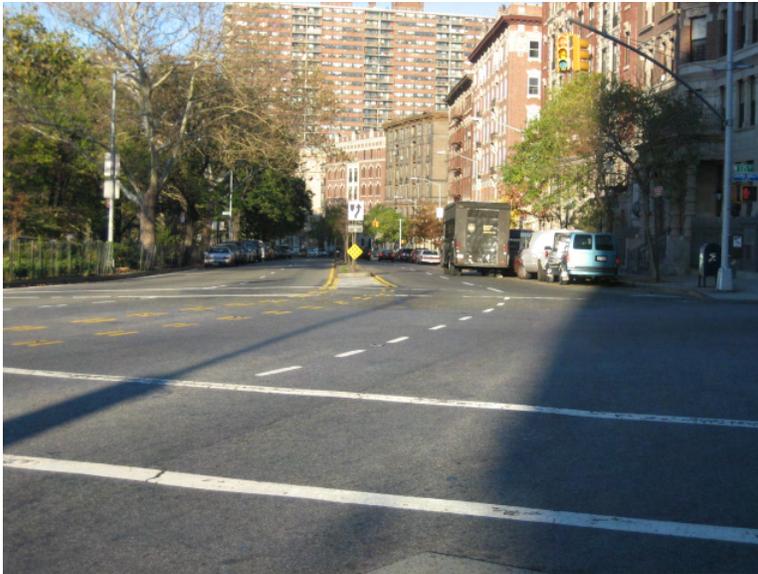
Riverside Drive is a 60-foot wide, two-way street with two moving lanes in both the northbound and southbound directions. North of the intersection with West 135th Street, there is parking on both sides and a narrow landscaped median. West 135th Street has two travel lanes in each direction and parking on both sides. Currently this T-intersection does not have school crosswalks and it is controlled by a traffic signal. There are standard pedestrian ramps at each quadrant and all are in good condition (Figure 2).

Figure 2 – Intersection of Riverside Drive and West 135th Street, looking north

There were 23 accidents at this intersection in the 1998-2000 study period. Two accidents involved pedestrians but none were school-related. According to the accident data one pedestrian was struck by a southbound left turning vehicle, while crossing against the signal. The second pedestrian was struck by an oversized vehicle backing up unsafely.

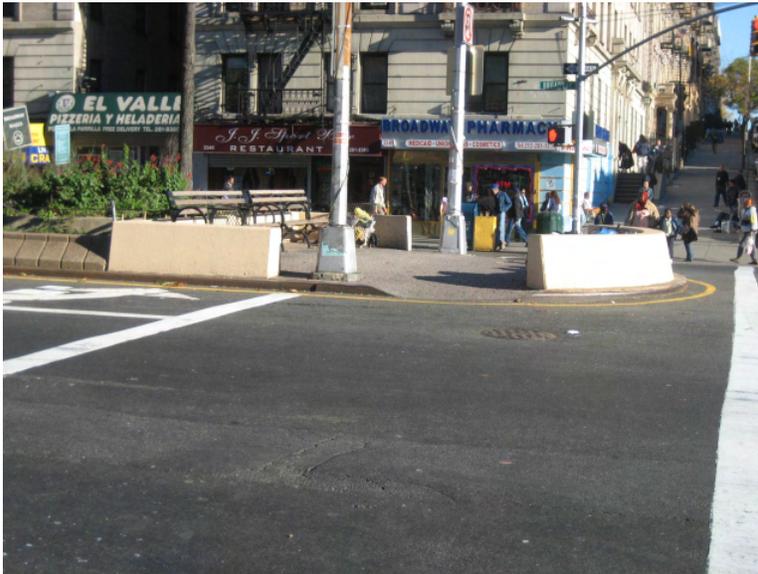
The median on the north side of this intersection has been reconstructed recently with new curbs, sidewalk, benches, and concrete barriers to create a refuge for pedestrians (Figure 3). The median on the south side of the intersection is very old and the curbs and sidewalks are in poor condition (Figure 4). There are also no formal pedestrian ramps on this median.

Figure 3 – Raised median at the intersection of Broadway and West 135th Street (north side), recently constructed

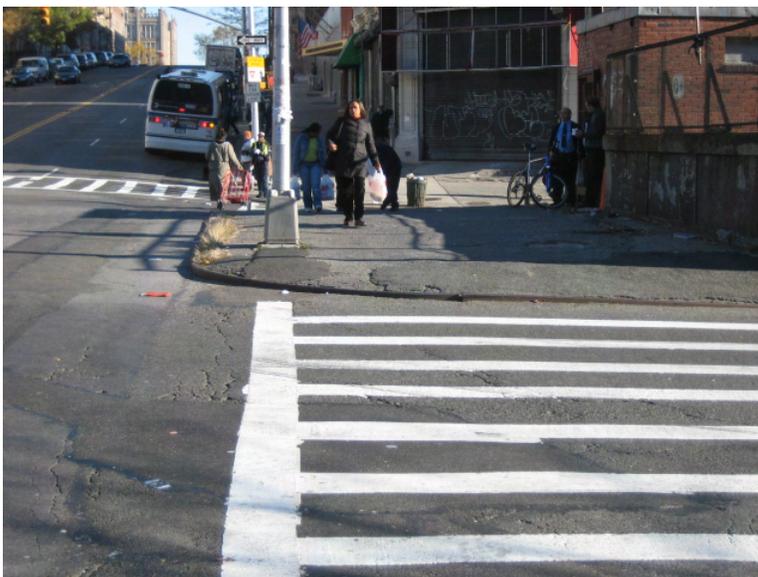
In the vicinity of I.S. 195, Broadway is divided by an elevated subway structure. In the southbound direction there are three travel lanes and parking on the right side of the street. In the northbound direction, there are two travel lanes with parking on the right side of the street. The median on the northern side of the intersection is approximately 24 feet wide while the median on the southern side is approximately 43 feet wide. This intersection is controlled by a traffic signal and has school crosswalks on the south and east legs. The two western quadrants have two pedestrian ramps each but they are in poor condition while the two eastern quadrants are in good condition.

Figure 4 – Raised median at the intersection of Broadway and West 135th Street (south side), in poor condition

- Construct new raised median at the intersection of West 135th and Broadway

The raised median on the south side of the intersection is very old and in poor condition. There are no pedestrian ramps and there is asphalt pavement instead of a concrete sidewalk. The median on the north side has recently been reconstructed.

Consideration should be given to installing a new median on the south side, provided that the Final Design confirms that construction of the recommended median would be feasible and would not interfere with traffic operations. This is the intersection where the majority of students exit and enter the school and cross Broadway. A new raised median would greatly increase the safety of the students. Final details pertaining to geometry of the median will be developed during the Final Design/Contract Document preparation.

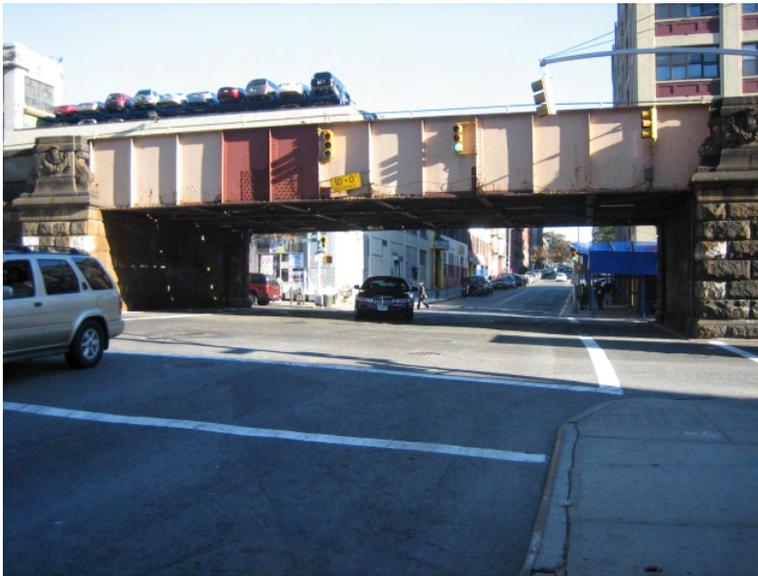
West 133rd Street west of Broadway is a 38-foot wide, two-way street with one travel lane in each direction and parking on the northern side of the roadway. West 133rd Street is a 30-foot wide, street between Broadway and Old Broadway, and it widens to 48-feet east of Old Broadway. Pedestrians crossing Broadway cross beneath the structure for the elevated subway (Figure 5). The elevated train structure obstructs pedestrian view of oncoming traffic on Broadway. The structure abuts the edge of the travel lane, making it difficult for pedestrians to see oncoming traffic.

This intersection is controlled by a traffic signal and has no school crosswalks. The western quadrants are in good condition, however the northeastern and southeastern quadrants are in poor condition.

Figure 5 – Intersection of West 133rd Street and Broadway with the elevated subway structure (view looking east)

There were 67 accidents at this location in the 1998-2000 study period. Six of these accidents involved pedestrians; and four pedestrian accidents were school-related. There was one fatality at this intersection. The victim was an intoxicated 48-year old pedestrian who was struck by a northbound vehicle while crossing with the signal.

It is recommended that a request be submitted to the Police Department for a second crossing guard at the intersection of West 133rd Street and Broadway. There is currently one crossing guard at this intersection but with the reduced visibility due to the overpass, another crossing guard would be beneficial.

- Construct raised sidewalk at West 133rd Street and Broadway

Vehicles and pedestrians on West 133rd Street cross Broadway beneath the elevated structure (see Figure 5). Currently there are only painted crosswalks for pedestrians on both sides. Therefore, it is recommended that sidewalks be constructed beneath the overpass on both the north and south sides of West 133rd Street.

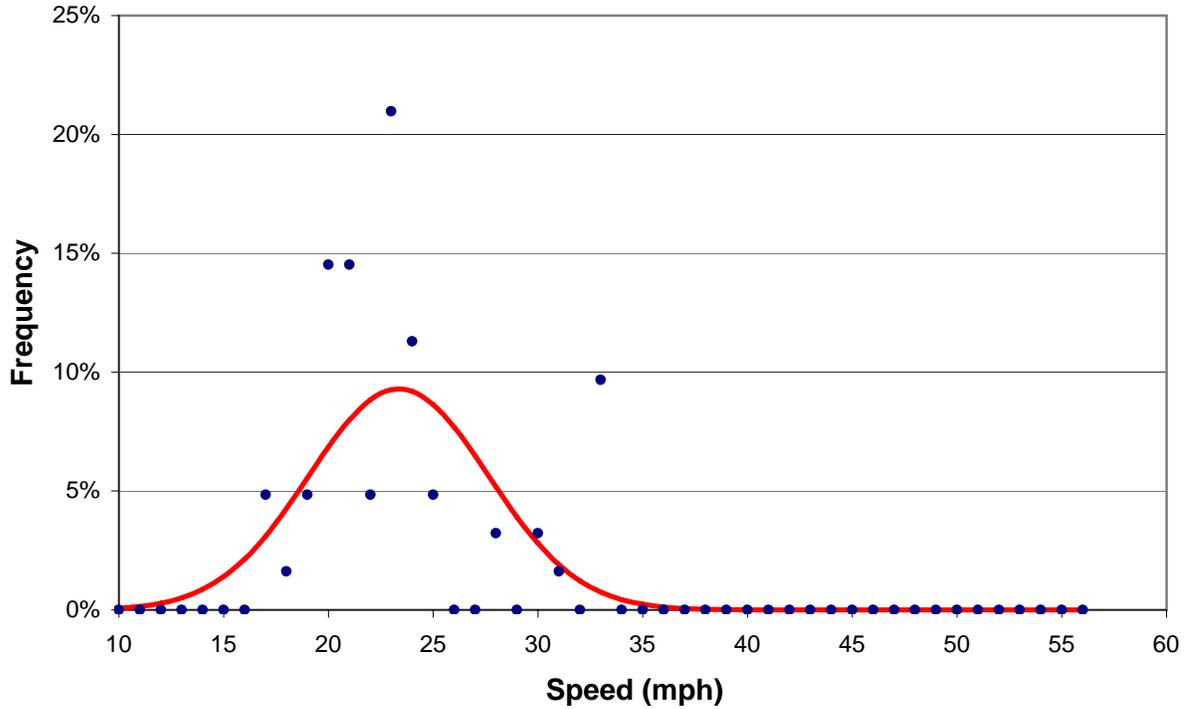
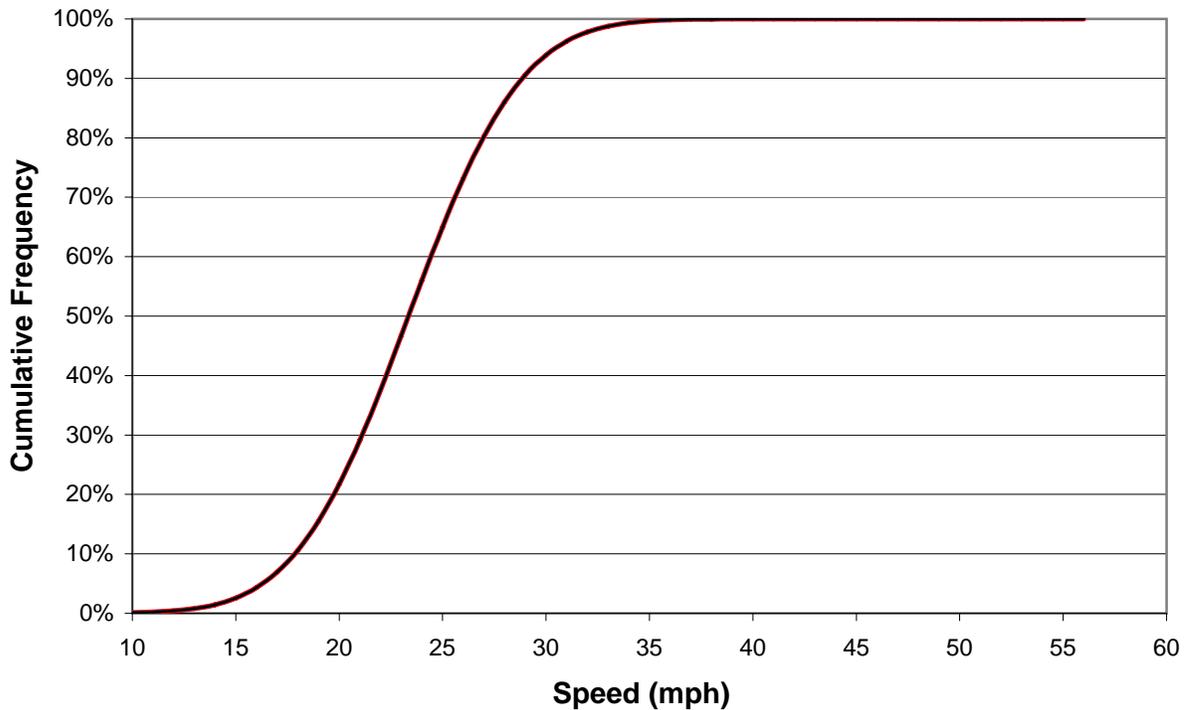
A spot speed study was conducted on West 133rd Street between Broadway and 12th Avenue on Tuesday, November 15, 2005. The results indicated that the 85th percentile speed was 28 mph, which does not exceed the statutory speed limit of 30 mph. See the following table for a summary of the results and the appendix for further discussion.

Mean Speed = 23.4 mph
Standard Deviation = 4.3 mph
Margin of Error (95% Confidence) = ± 1.1 mph

Median Speed = 23.4 mph
15th Percentile Speed = 18.9 mph
85th Percentile Speed = 27.8 mph
