**School Safety Engineering Project**

**FINAL REPORT: P.S. 132, Juan Pablo Duarte School, Manhattan**

**Prepared by  
The RBA Group/Urbitran Associates**

**OCTOBER 13, 2006**

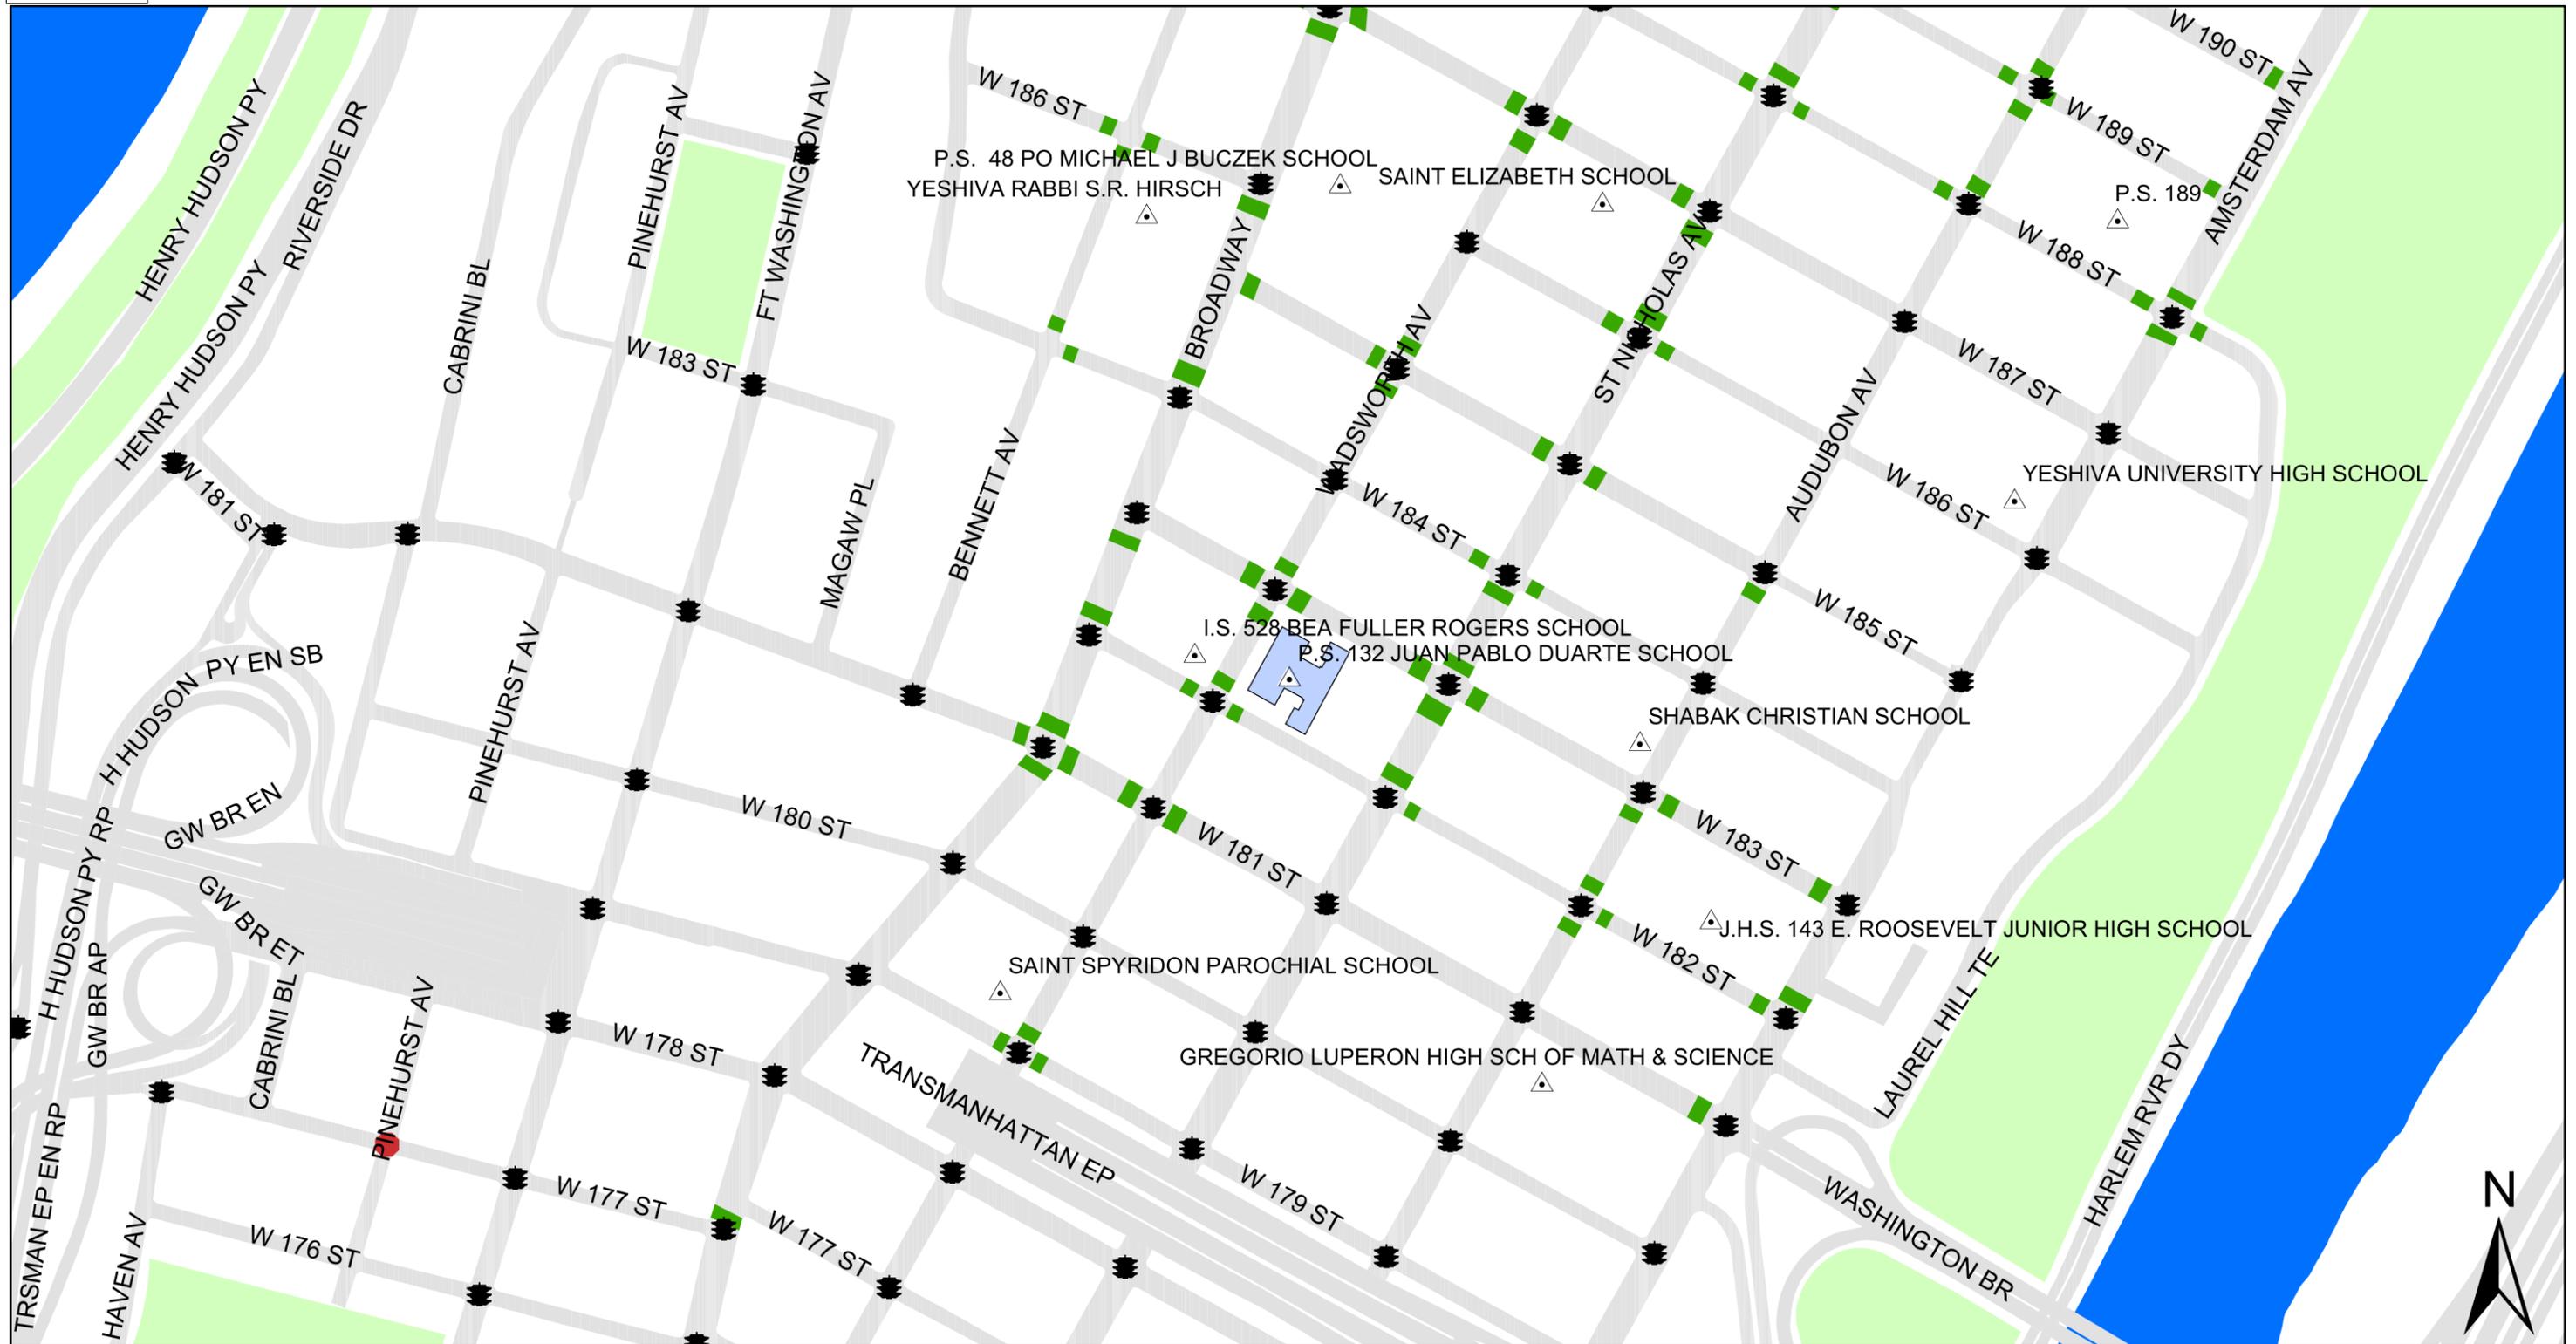
Map created on 11/16/2006 **EXHIBIT 3** COMM. BOARD: 112  
 PRECINCT: 34

The School Traffic Safety Map was established to help provide the maximum degree of safety for children going to and from school - by indicating the location of speed reducers, school crosswalks and some traffic control devices. (While virtually all intersections in NYC benefit from traffic control devices - such as stop signs, traffic signals, yield signs, and all way stop signs - this map shows only traffic signals and all way stop signs.) The school crosswalks that are shown are ladder striped and make the crosswalk more visible to drivers and help make the intersection safer. These crosswalks are where school children are recommended to cross.

The Traffic Safety Plan, Exhibit 3, shows existing signals and crosswalk pavement markings. It is noted that a citywide signage program is currently underway to upgrade school signage to current Federal Manual of Uniform Traffic Control (MUTCD) standards of fluorescent yellow-green signs accompanied by downward pointing arrows. Signs scheduled to be installed under this program are shown as "existing" on Exhibit 8.

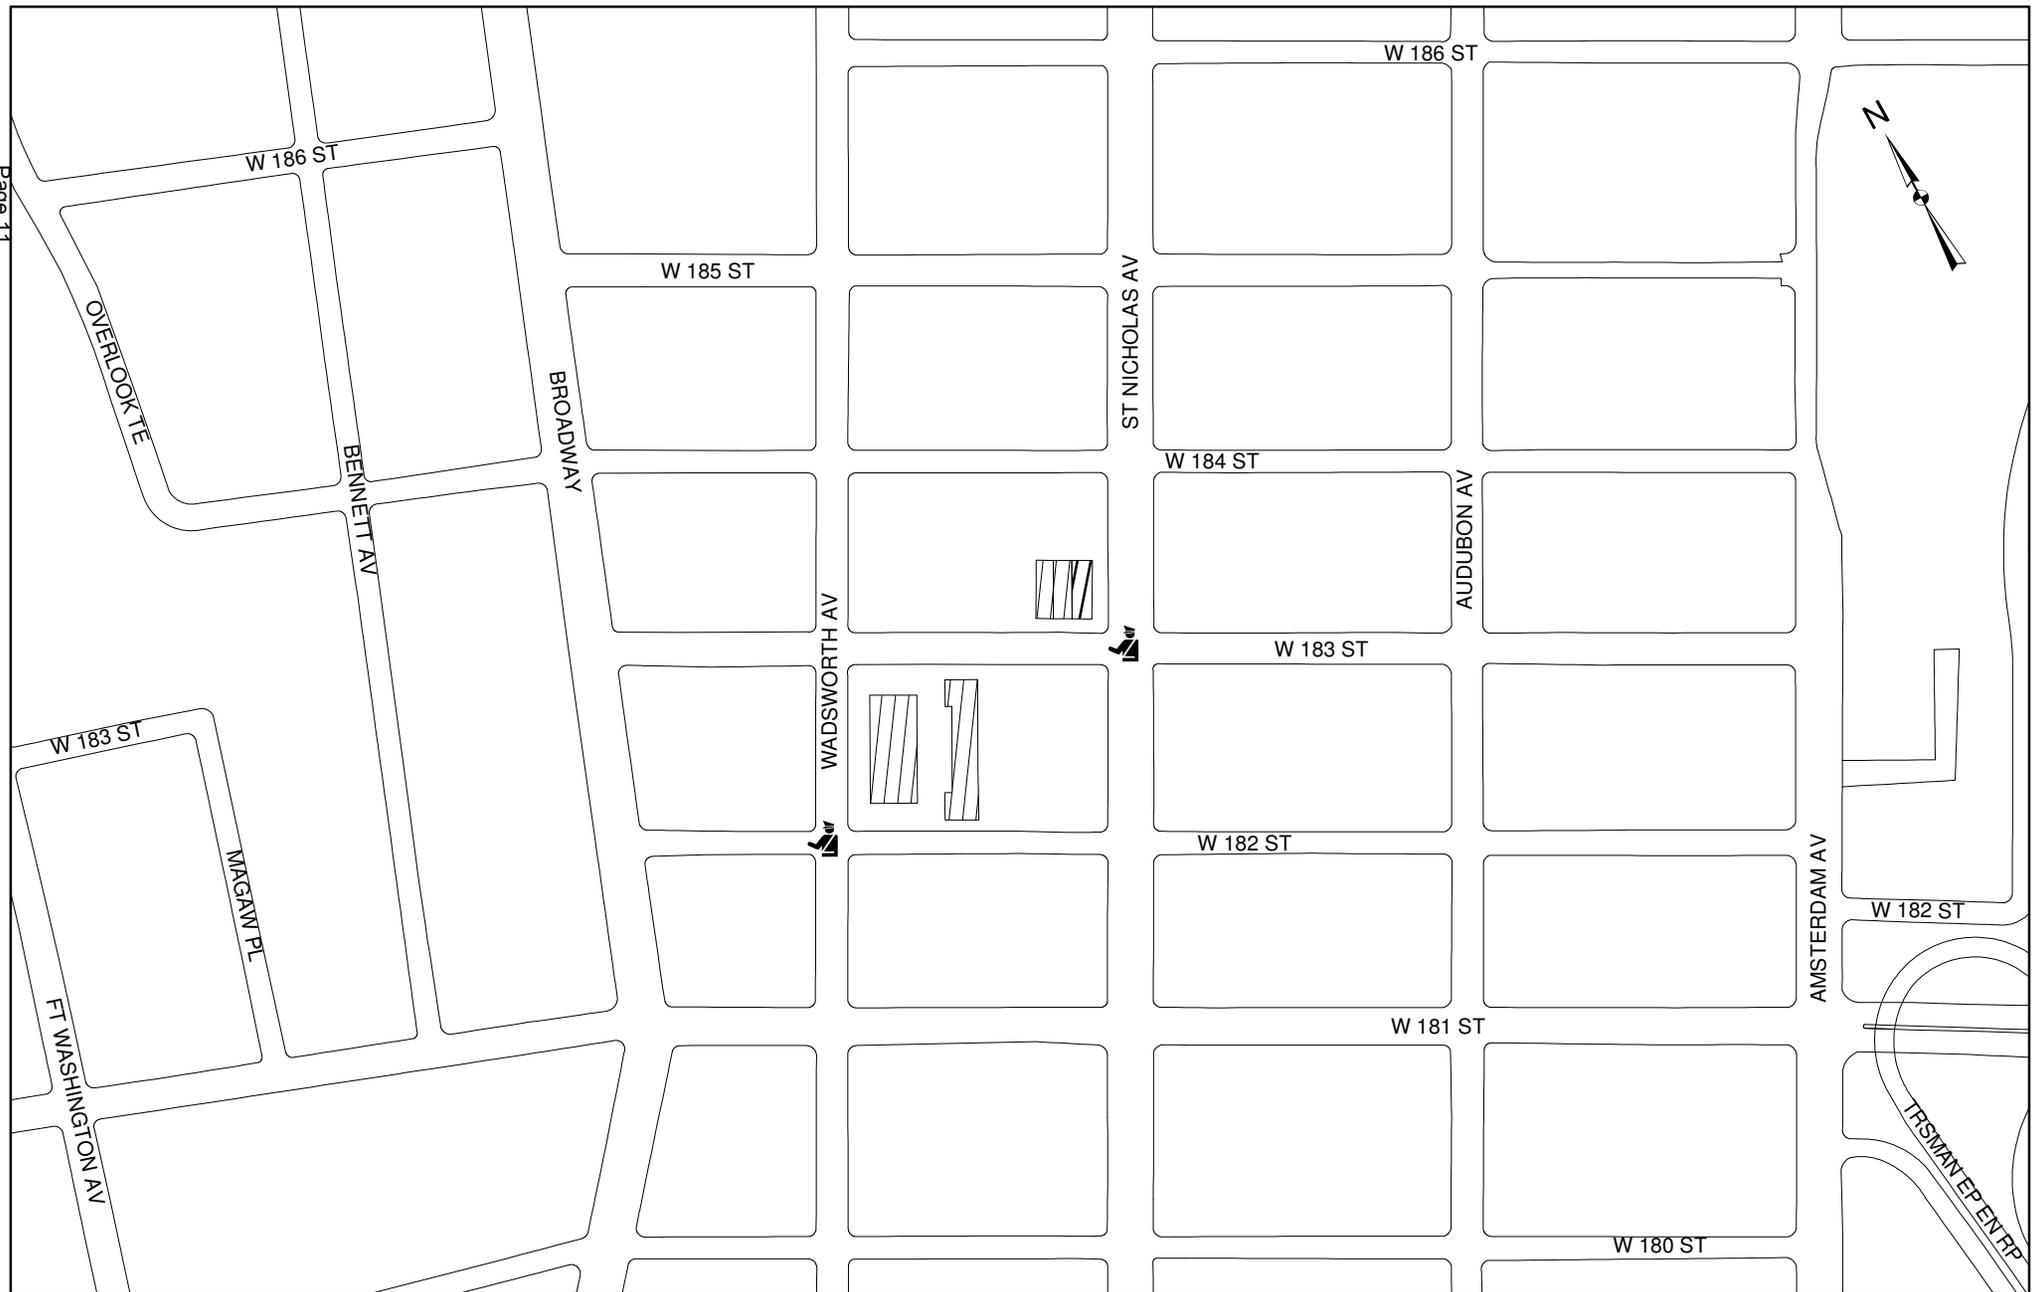
**EXHIBIT 4**

There are two crossing guards assigned to P.S. 132. They are stationed at the following intersections:

- West 182<sup>nd</sup> Street and Wadsworth Avenue
- West 183<sup>rd</sup> Street and St. Nicholas Avenue

**CROSSING GUARDS**

It is recommended that a crossing guard be requested for the following locations:

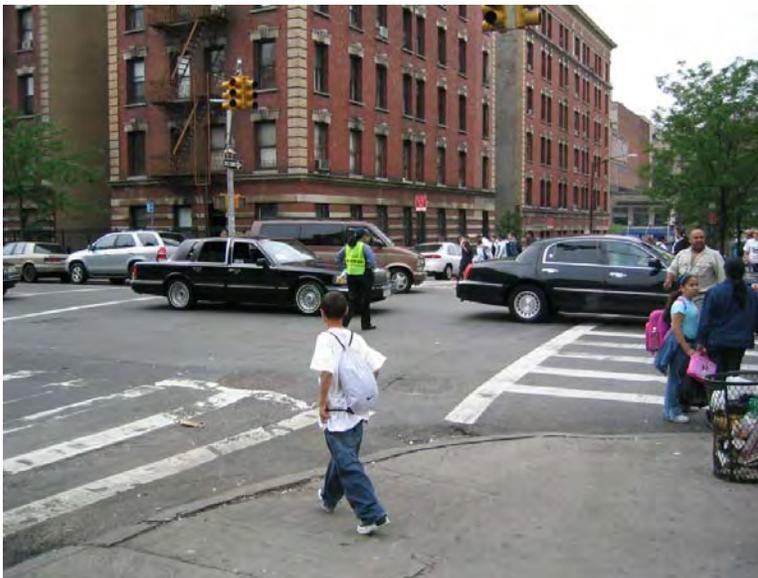
School officials have indicated that approximately 2% of P.S. 132 students are driven to and from school by parents or guardians. It was observed that most of the parents double park on Wadsworth Avenue to unload students, which blocked the moving traffic on Wadsworth Avenue between West 182nd Street and West 183rd Street. This also caused some vehicles to get caught in the middle of intersections, blocking crosswalks as well (see Figure 2).

*Figure 2 - Cars caught in the middle of the intersection of Wadsworth Avenue and West 182<sup>nd</sup> Street, due to double-parking in front of P.S. 132.*

“NO STANDING 7:00 AM – 4:00 PM, SCHOOL DAYS” parking regulations should be considered for the full length of Wadsworth Avenue between West 182<sup>nd</sup> Street and West 183<sup>rd</sup> Street.

This will allow school buses and parents a place to load and unload students at the curb, and will also improve visibility of those students arriving and leaving the school. The teacher parking now provided on Wadsworth Avenue could be relocated to West 182<sup>nd</sup> Street.

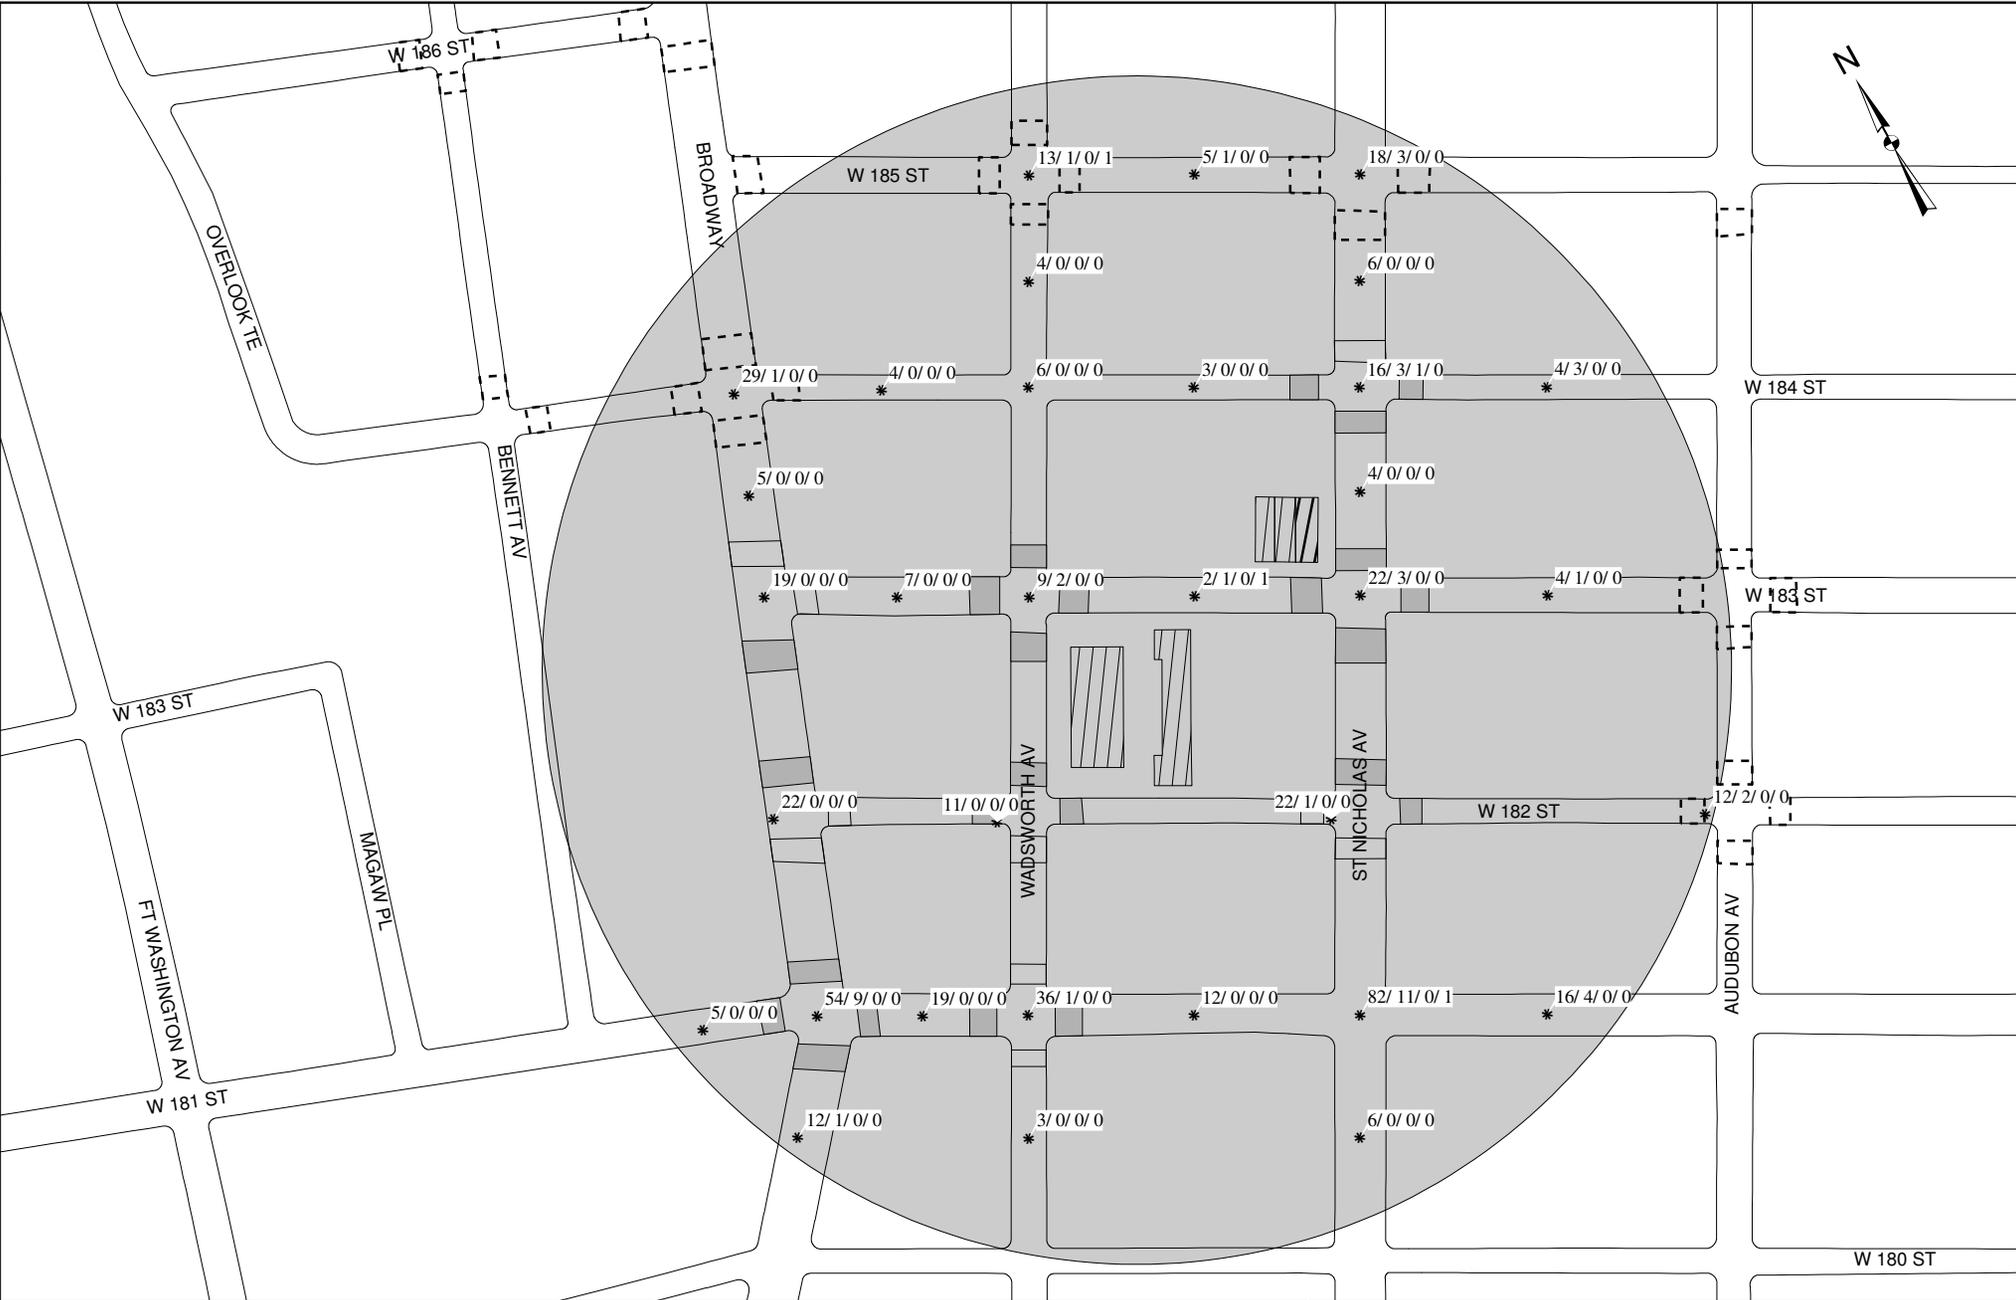
**EXHIBIT 6**

Exhibit 6 and Table 2 show a summary of accidents, as obtained from the New York State Department of Motor Vehicles (DMV), in the vicinity of P.S. 132 for the three-year period from January 1, 1998 through December 31, 2000. The DMV data provides some detail relating to the circumstances and cause of the accident. Table 3 is a summary of more recent accident data obtained from the NYC Police Department (NYPD). Though current through 2004, the NYPD data does not provide the same level of detail as the DMV data.

**ACCIDENT SUMMARY  
THREE YEAR PERIOD  
(1998-2000)**

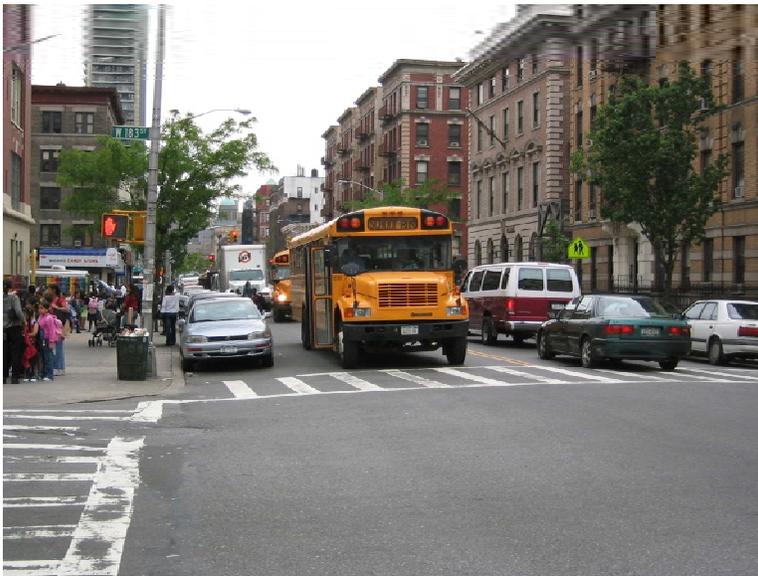
Wadsworth Avenue is a 42-foot wide, two-way street with one moving lane in each direction and parking on both sides. West 183<sup>rd</sup> Street is a 42-foot wide, two-way street with one travel lane in each direction. Parallel parking is permitted on both sides east of Wadsworth Avenue and angle parking is permitted on both sides west of Wadsworth Avenue. Wadsworth Avenue and West 183<sup>rd</sup> Street is controlled by a traffic signal. There are school crosswalks in place on all four approaches.

*Figure 3 - Wadsworth Avenue and West 183<sup>rd</sup> Street, looking east*

There were nine accidents at this intersection during the 1998-2000 study period. Two accidents involved pedestrians, none of which were school-related. One accident involved a driver making a left turn. There were no details for the second accident.

The school's main entrance is on West 183<sup>rd</sup> Street between Wadsworth Avenue and St. Nicholas Avenue. Students from the annex are also dismissed on West 183<sup>rd</sup> Street. Many students congregate at these exits during dismissal time.

A nine-year-old student was struck while crossing mid-block on West 183<sup>rd</sup> Street between Wadsworth Avenue and St. Nicholas Avenue.

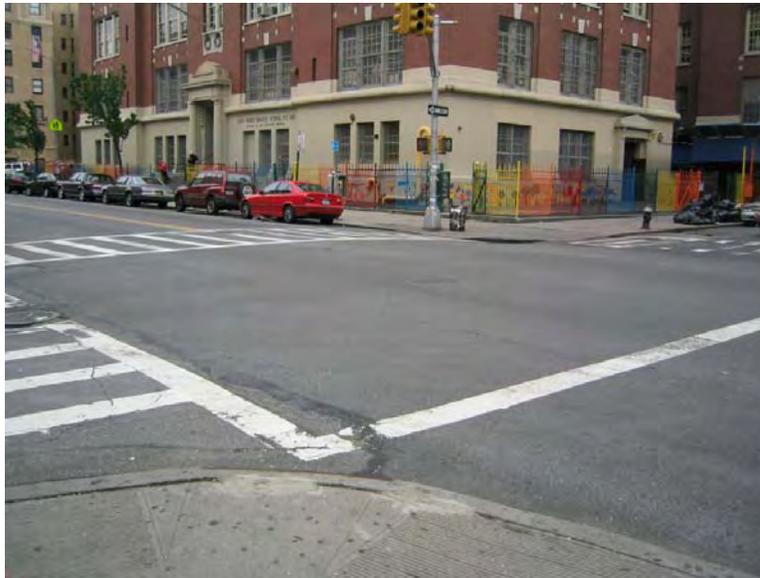
West 182<sup>nd</sup> Street is a 30-foot wide, one-way westbound street with one travel lane and parking on both sides of the roadway. Wadsworth Avenue and West 182<sup>nd</sup> Street is controlled by a traffic signal. There are school crosswalks in place on the north, east, and west legs (See Figure 4).

*Figure 4 - Wadsworth Avenue and West 182<sup>nd</sup> Street, looking northeast towards P.S. 132*

There were eleven accidents at this intersection during the 1998-2000 study period, none of which involved pedestrians.

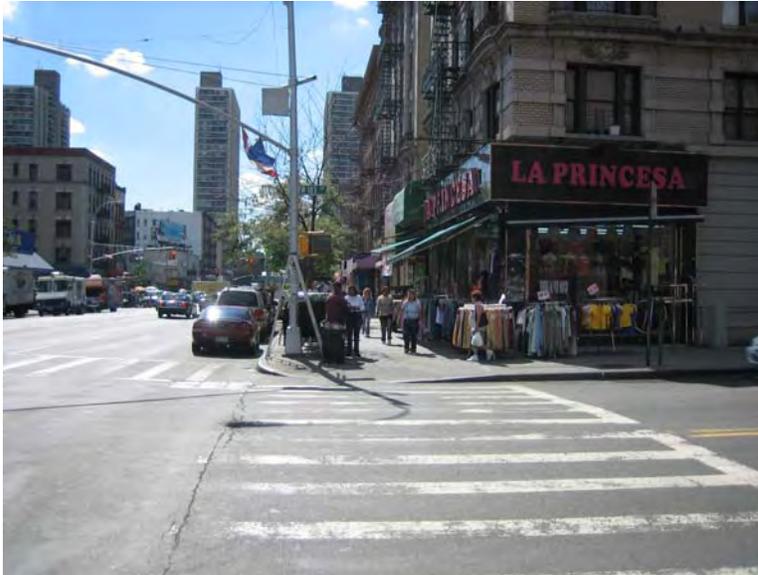
St. Nicholas Avenue is lined with restaurants and various other shops. Many shops set up stands on the sidewalk to sell their products, which constrict pedestrian traffic through this area (see Figure 5). There is only one apex pedestrian ramp at each corner due to existing utility conflicts.

Twenty-two accidents occurred at this intersection during the 1998-2000 study period. Three accidents involved pedestrians, none of which were school-related. One accident, in which a pedestrian was struck by a vehicle-traveling south, was attributed to driver error. There are no further details on the other two accidents.

*Figure 5 - Racks set up on the sidewalk of St. Nicholas Avenue and West 183<sup>rd</sup> Street.*

- St. Nicholas Avenue and West 182<sup>nd</sup> Street - all four corners
- St. Nicholas Avenue and West 183<sup>rd</sup> Street - all four corners
- St. Nicholas Avenue and West 184<sup>th</sup> Street - all four corners

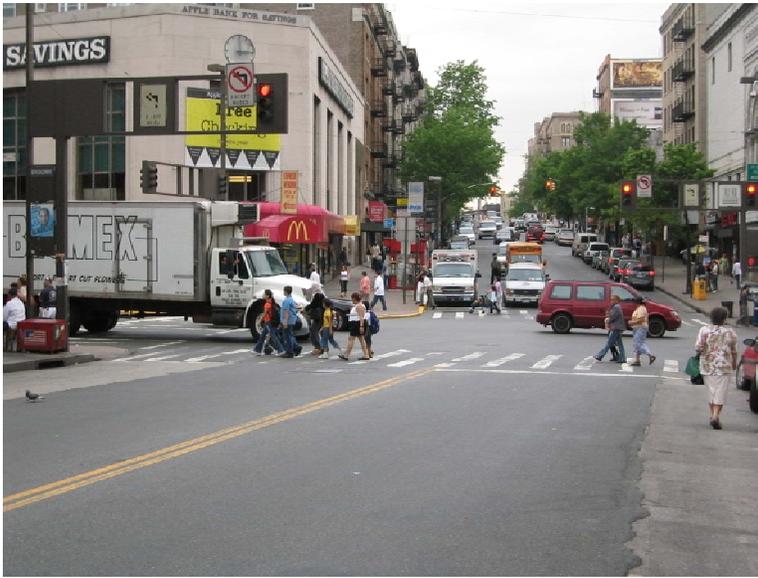
Broadway and West 181<sup>st</sup> Street is a signalized intersection. Broadway is a two-way roadway with two travel lanes and parking on both sides. There are school crosswalks in place on all four approaches.

There were 54 accidents at this intersection during the 1998-2000 study period. Nine accidents involved pedestrians, none of which were school-related. Five accidents were attributed to driver failure to yield to pedestrians. Four other accidents were due to pedestrian error.

*Figure 6 – Broadway and West 181<sup>st</sup> Street*

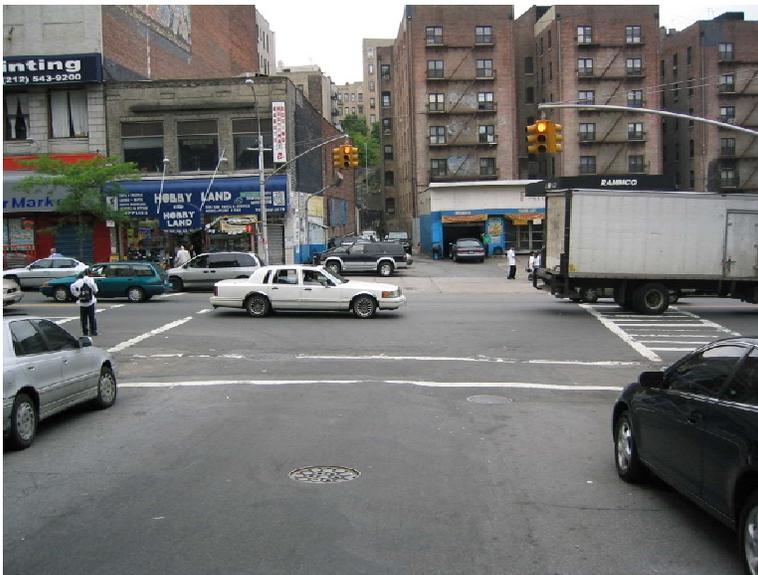
Broadway and West 182<sup>nd</sup> Street is a signalized T-intersection. On Broadway, north of West 182<sup>nd</sup> Street, the roadway is reduced to one travel lane in each direction due to 90-degree angle parking on both sides of the street. This condition continues north for two blocks and ends south of West 184<sup>th</sup> Street. There is a school crosswalk on the north leg.

Twenty-two accidents occurred at this intersection during the 1998-2000 study period. None of the accidents involved pedestrians.

*Figure 7 – Broadway and West 182<sup>nd</sup> Street, looking west*

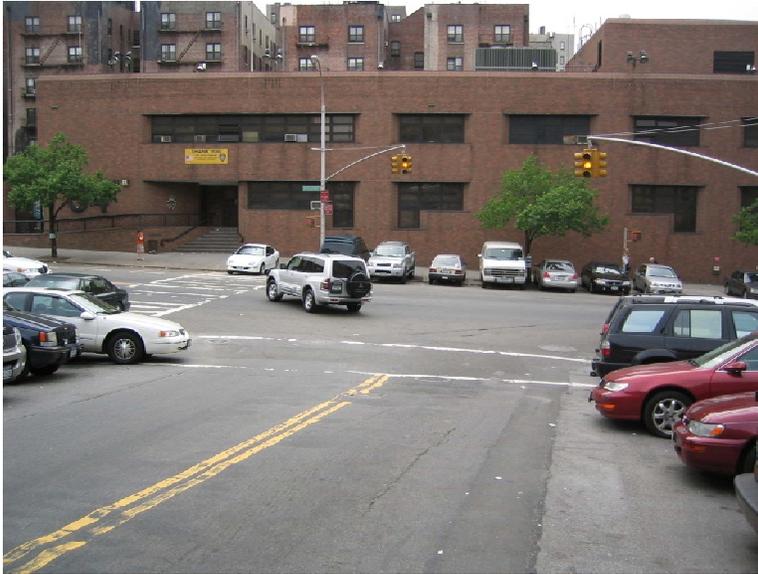
Broadway and West 183<sup>rd</sup> Street is a signalized T-intersection. The 34<sup>th</sup> Precinct of the NYPD is located at this intersection on the west side of Broadway. As noted in Section 3.6.8, Broadway is reduced to one moving lane in each direction due to the 90-degree angle parking on both sides of the street. There is a school crosswalk on the south leg.

There were nineteen accidents at this intersection during the 1998-2000 study period. None of the accidents involved pedestrians.

*Figure 8 – Broadway and West 183<sup>rd</sup> Street, looking west*

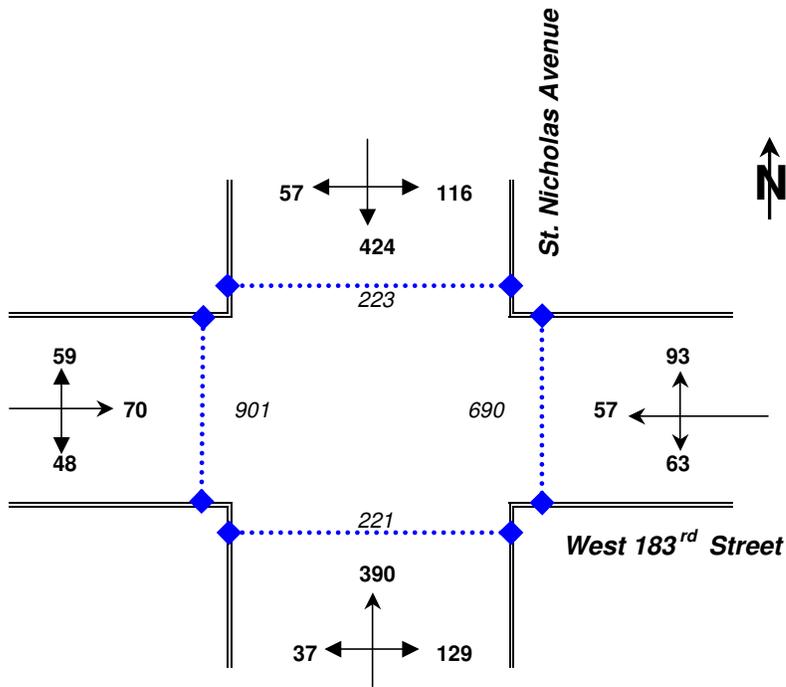
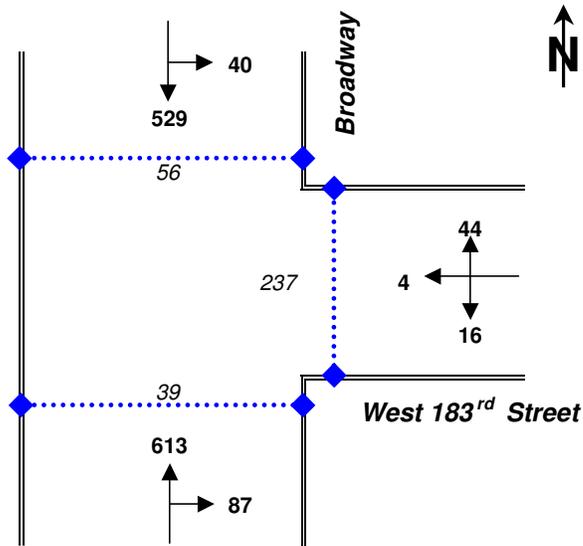
<b>EXHIBIT 7</b>
<b>P.S. 132, MANHATTAN</b>
<b>JUAN PABLO DUARTE SCHOOL</b>
<b>TRAFFIC COUNTS</b>

A one-hour traffic count was performed on October 4, 2005 from 2:30 pm to 3:30 pm (see Exhibit 7) to better understand the pedestrian and vehicle conflicts. The results show that over 1500 pedestrians crossed West 183<sup>rd</sup> Street and approximately 450 pedestrians crossed St. Nicholas at this intersection during the study hour. The number of pedestrians using this intersection is high and recommendations to improve pedestrian safety are discussed in Section 4.

**One Hour Traffic Count Volumes**  
(2:30 AM - 3:30 AM October 4, 2005)

**St. Nicholas Avenue and West 183<sup>rd</sup> Street**

**Broadway and West 183<sup>rd</sup> Street**

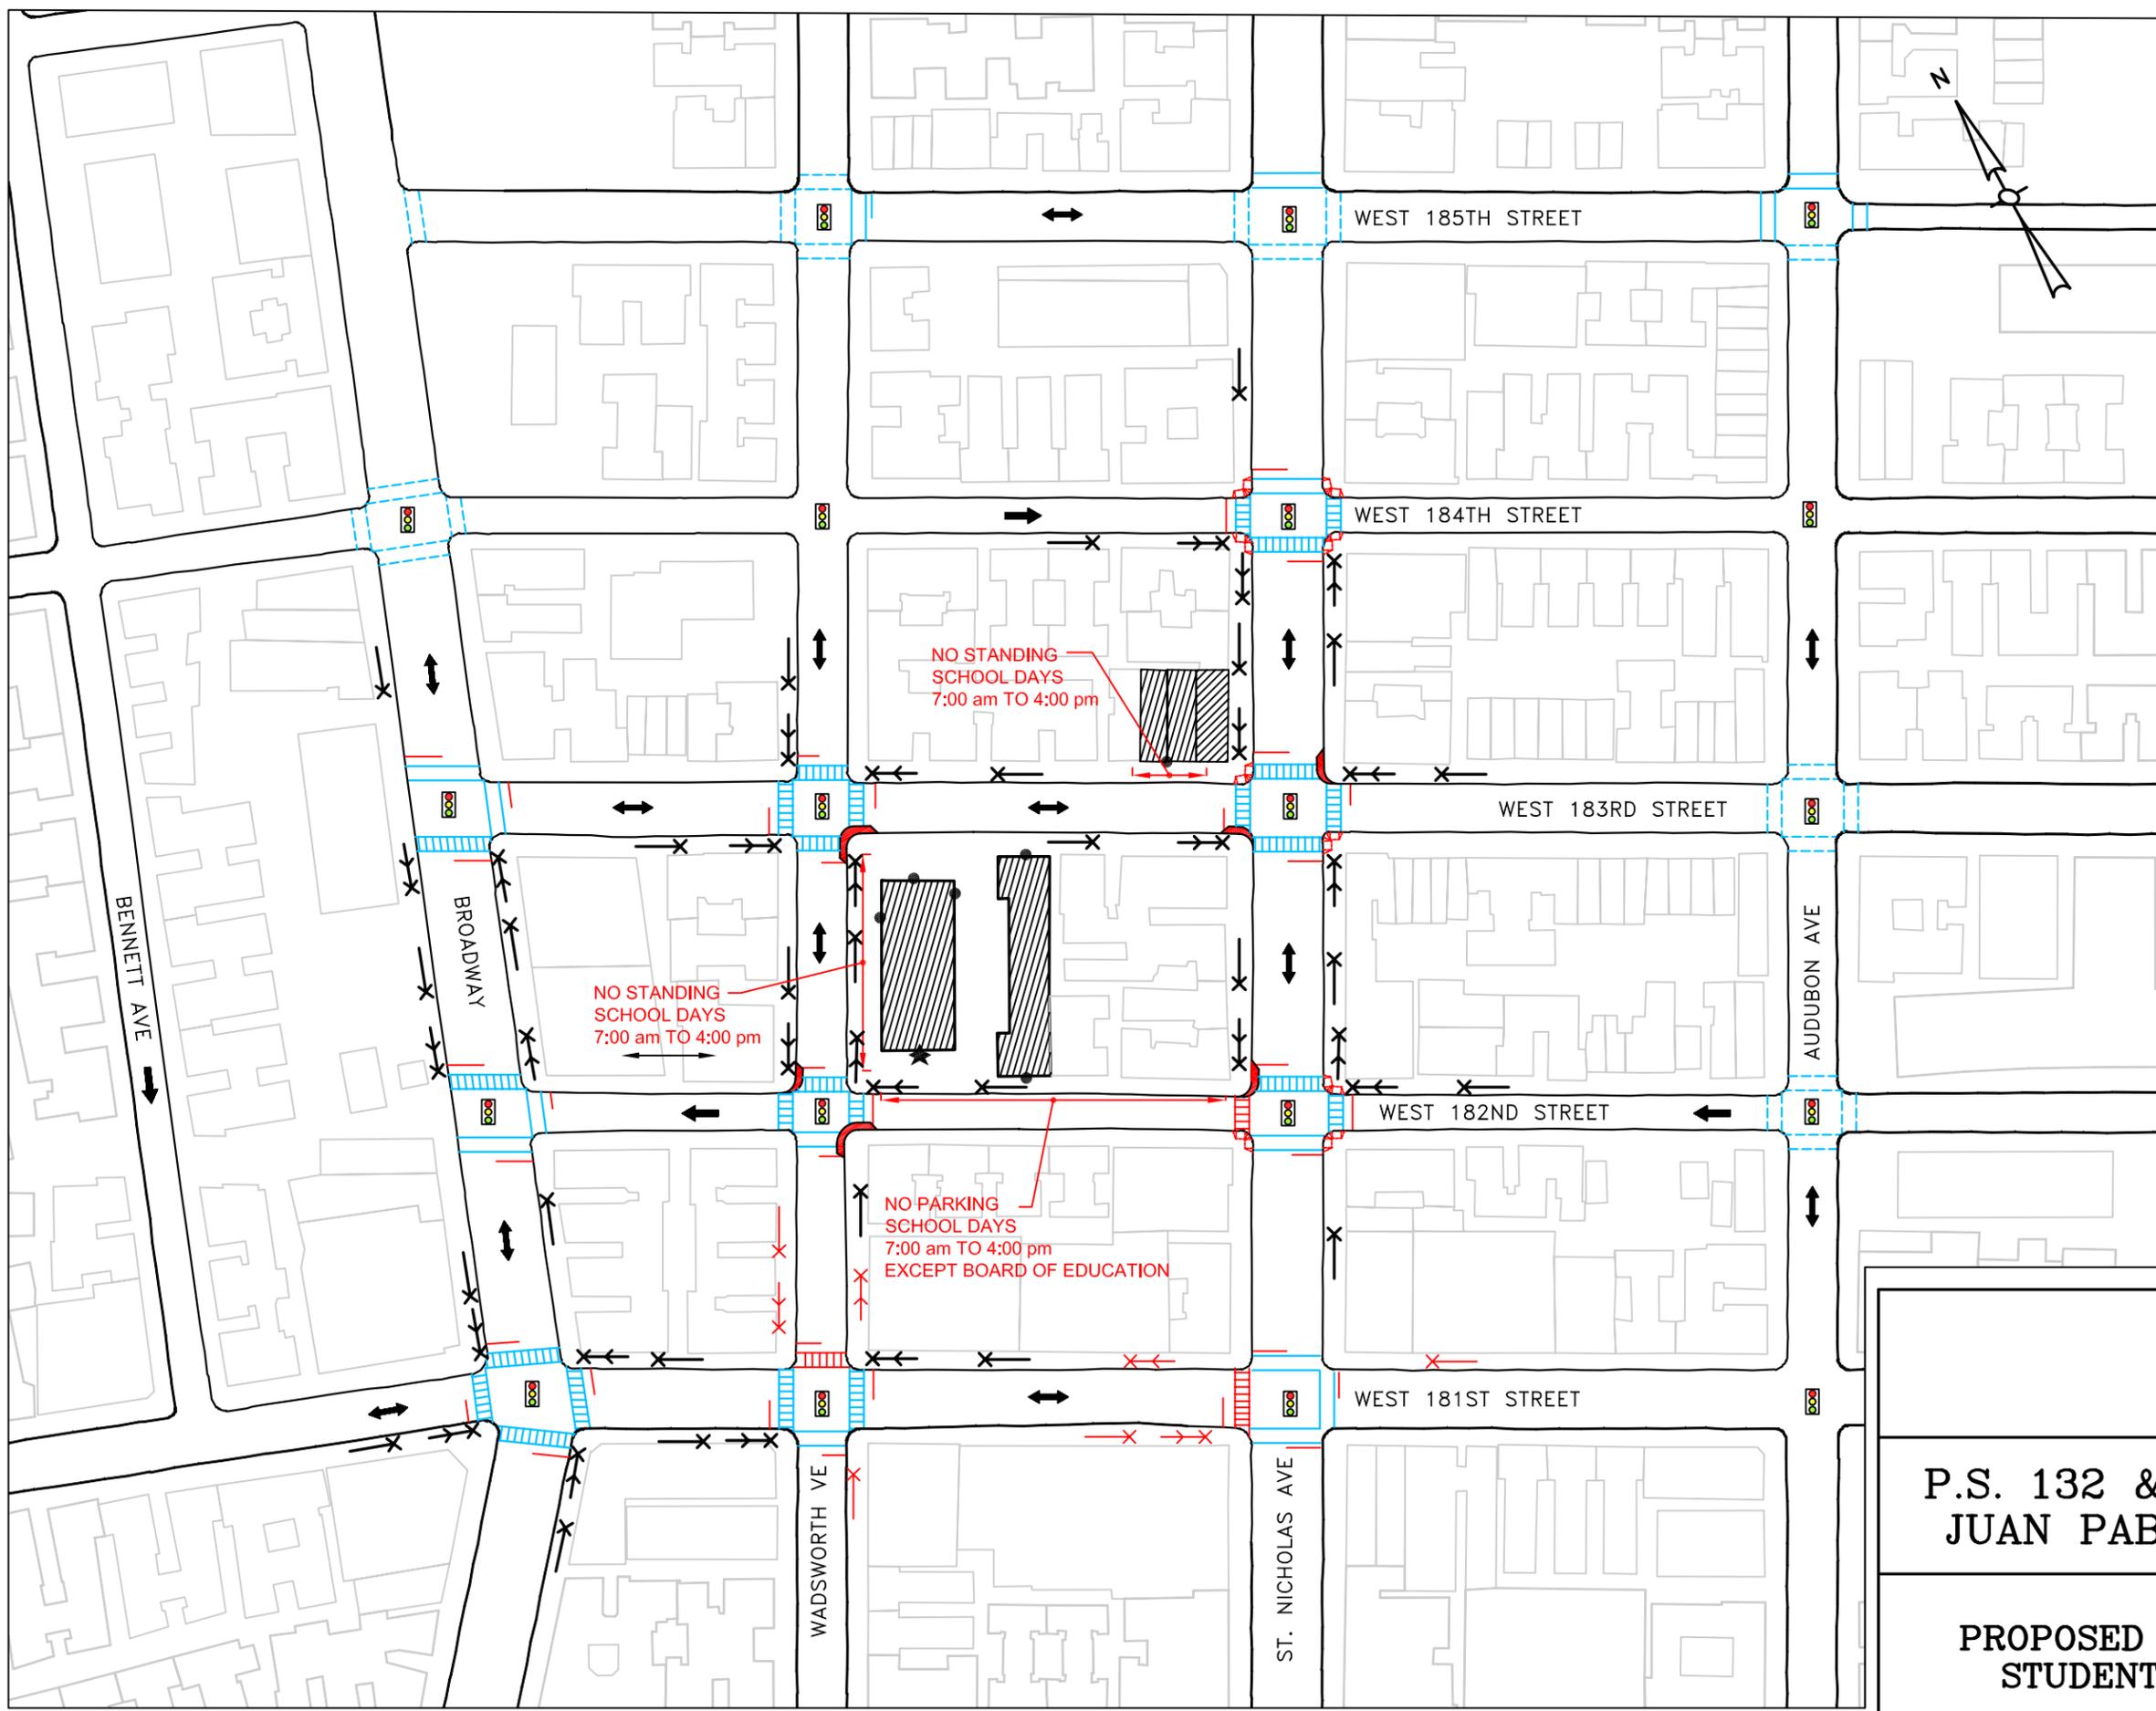
**PROPOSED MEASURES TO IMPROVE  
STUDENT PEDESTRIAN SAFETY**

“NO STANDING 7:00 AM – 4:00 PM, SCHOOL DAYS” parking regulations should be considered on the north side of West 183<sup>rd</sup> Street in front of annex for a length of 30 feet.

The MUTCD and New York City DOT standard for placement of a stop bar is four feet in advance of a marked crosswalk. At signalized (or stop controlled) crosswalks, the vehicle stop line can be placed farther back from the crosswalk in order to maximize visibility of pedestrians and to minimize the potential for pedestrian/vehicle conflicts. Therefore, it is recommended that stop bars be placed ten feet in advance of all school crosswalks.

Providing a new school crosswalk at each of this location will complete a network of contiguous school crosswalks in the immediate school vicinity. Therefore, it is recommended that school crosswalks be installed at these intersections.

Consideration should be given to installing a curb extension at the following locations, provided that the Final Design confirms that construction of the recommended curb extension would be feasible and would not interfere with traffic operations. Final details pertaining to the number, location and geometry of curb extensions will be developed during the Final Design/Contract Document preparation.

Due to existing utility conflicts, the following pedestrian ramps are considered complex. Consideration should be given to the installation of pedestrian ramps per NYCDOT standards at the following locations:
