**NEW YORK CITY DEPARTMENT OF TRANSPORTATION
Office of School Safety Engineering**

School Safety Engineering Project

FINAL REPORT: P.S. 42, The Benjamin Altman School, Manhattan

SEPTEMBER 19, 2006

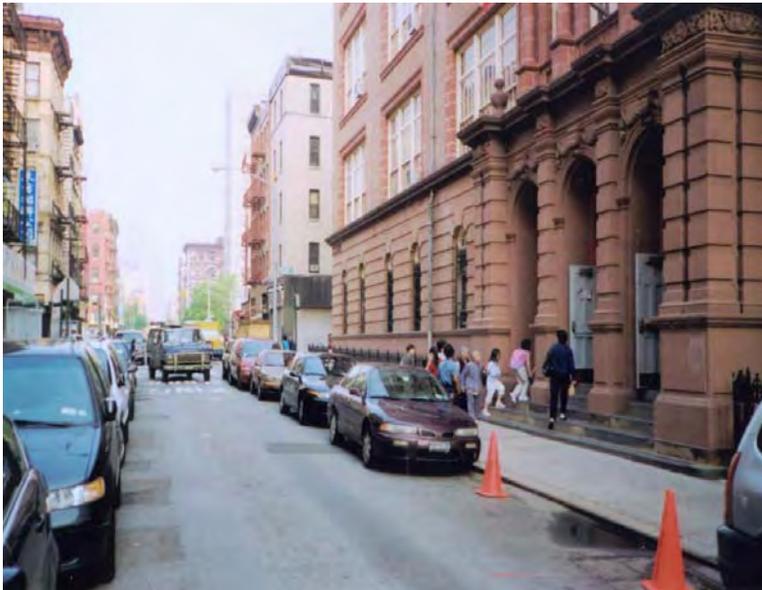
Figure 1: Hester Street looking west from Ludlow Street, P.S. 42 is on the right

Located at 71 Hester Street, P.S. 42 occupies the north side of the block between Orchard Street to the west and Ludlow Street to the east. The school's main entrance is on Hester Street. The immediate neighborhood is mostly apartment buildings with first story commercial operations (See Exhibit 1 for Aerial Photograph). There is a fish hatchery located immediately north of the school on Ludlow Street (Figure 1).

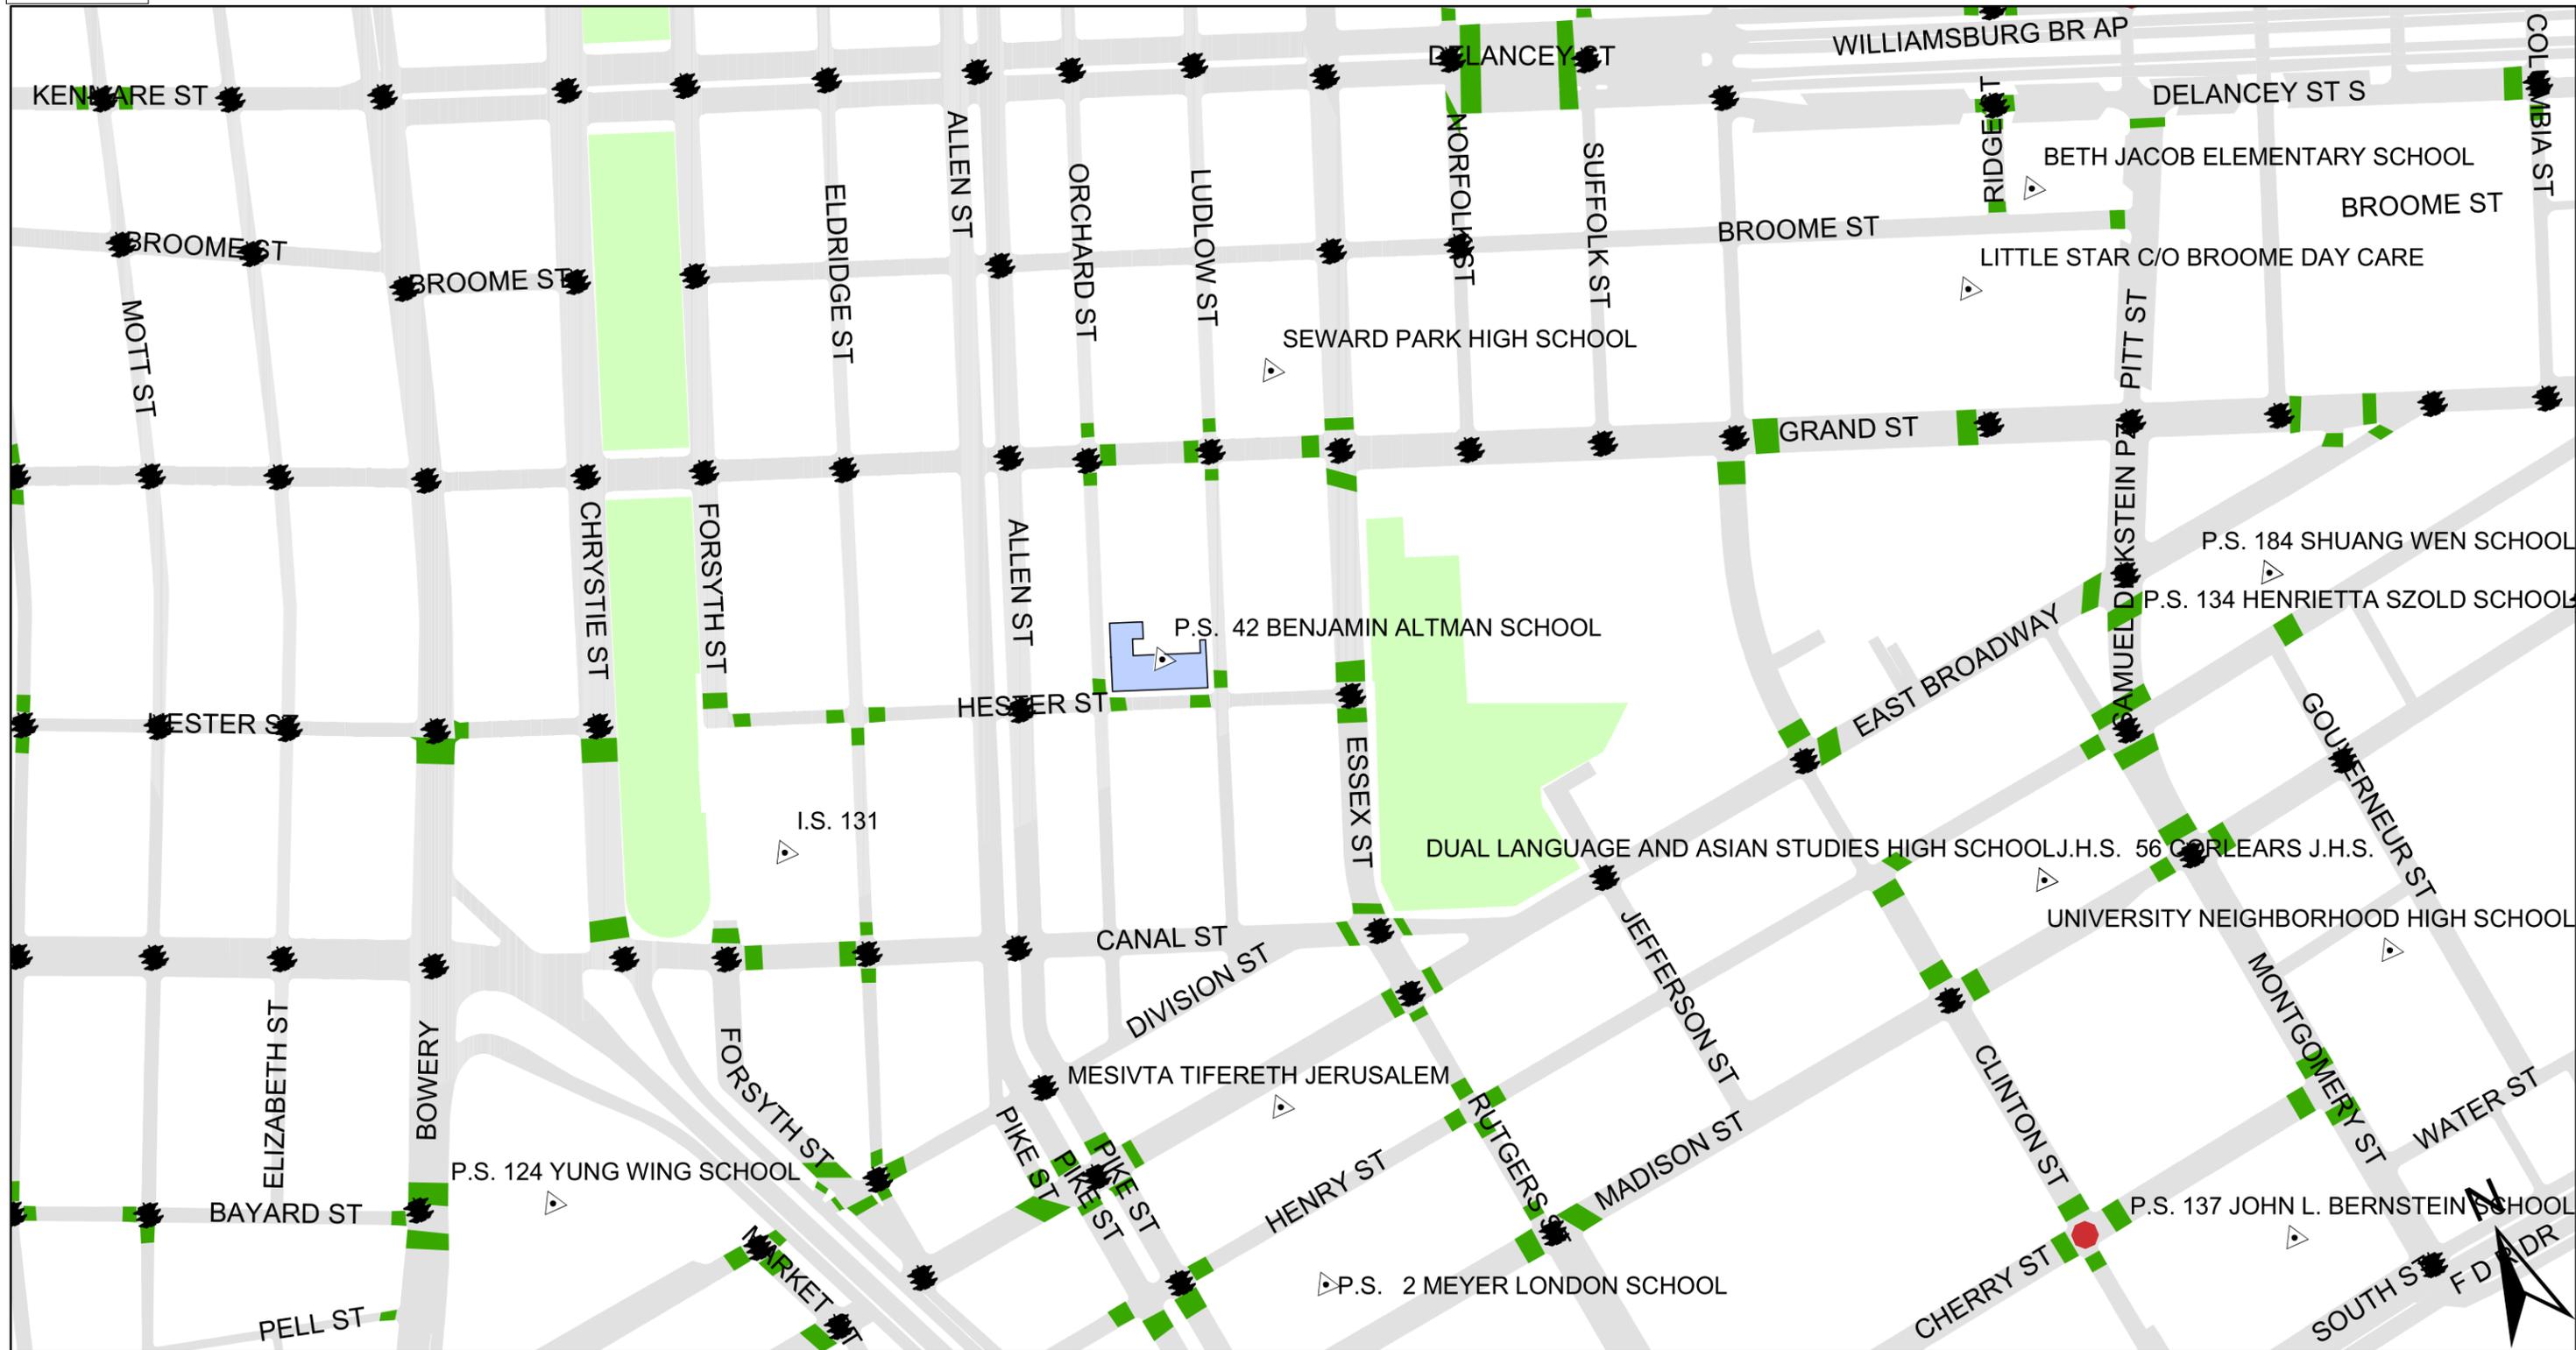
EXHIBIT 2

The School Traffic Safety Map was established to help provide the maximum degree of safety for children going to and from school - by indicating the location of speed reducers, school crosswalks and some traffic control devices. (While virtually all intersections in NYC benefit from traffic control devices - such as stop signs, traffic signals, yield signs, and all way stop signs - this map shows only traffic signals and all way stop signs.) The school crosswalks that are shown are ladder striped and make the crosswalk more visible to drivers and help make the intersection safer. These crosswalks are where school children are recommended to cross.

The Traffic Safety Plan, Exhibit 2, shows existing crosswalk pavement markings in the vicinity of the school. It is noted that a citywide signage program is currently underway to upgrade school signage to current Federal Manual of Uniform Traffic Control (MUTCD) standards of fluorescent yellow-green signs accompanied by downward pointing arrows. Signs that are scheduled to be installed under this program are shown as "existing" on Exhibit 8.

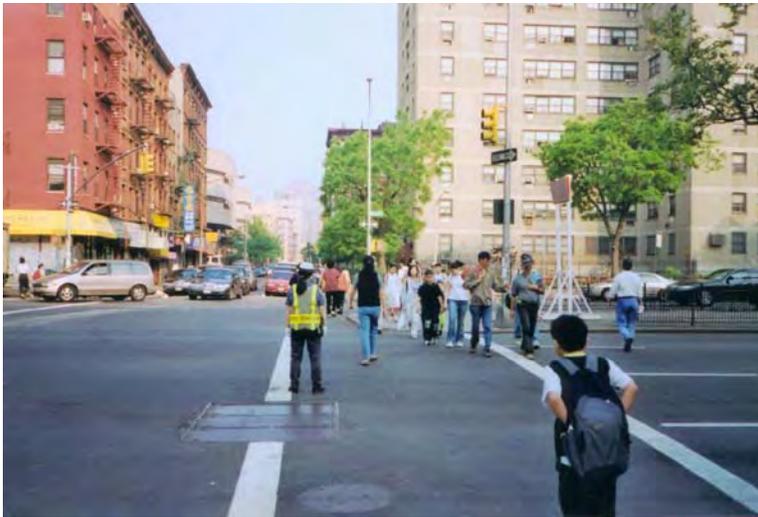
Figure 2 – Crossing guard at Allen Street and Hester Street

According to school officials and as confirmed by the field observations, there are three crossing guards assigned to this school. The crossing guards are stationed at the following locations:

- Hester Street and Allen Street
- Hester Street and Orchard Street
- Hester Street and Ludlow Street

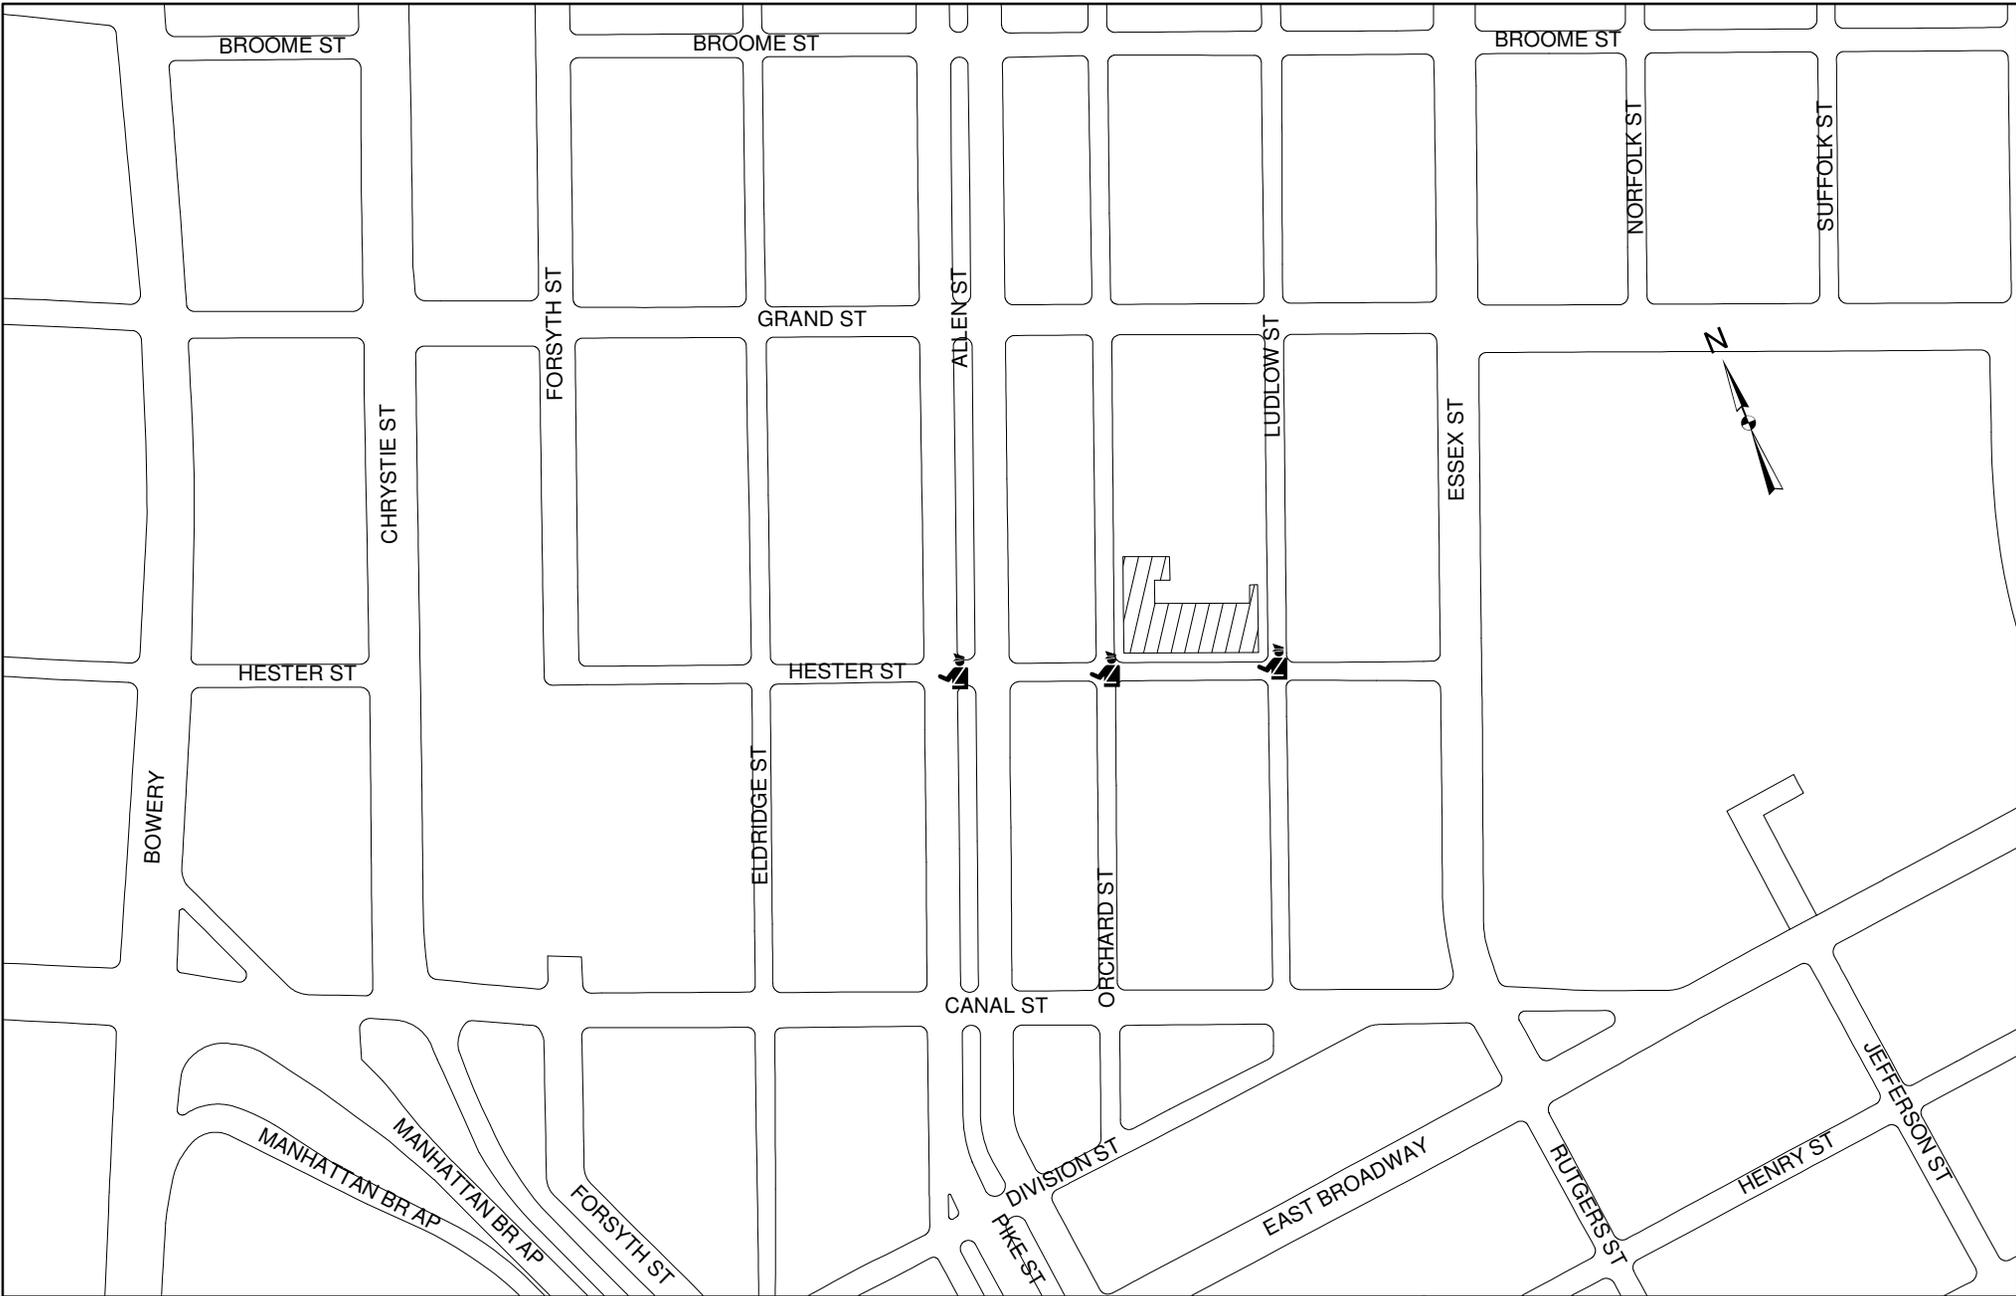
EXHIBIT 4
P.S. 42, MANHATTAN
BENJAMIN ALTMAN SCHOOL
CROSSING GUARD

Exhibit 4 shows the crossing guard locations (Figure 2).

- Submit request to the Police Department for crossing guards at the following intersections:
 - Allen Street and Grand Street
 - Hester Street and Ludlow Street

According to school officials, the safety at Grand Street and Allen Street is one of their major concerns. Grand Street and Allen Street are both wide two-way streets. In addition, some P.S. 42 students cross Hester Street at Ludlow Street, an un-controlled crossing. Therefore, it is recommended that a crossing guard be requested at each of these two locations to assist students crossing the street.

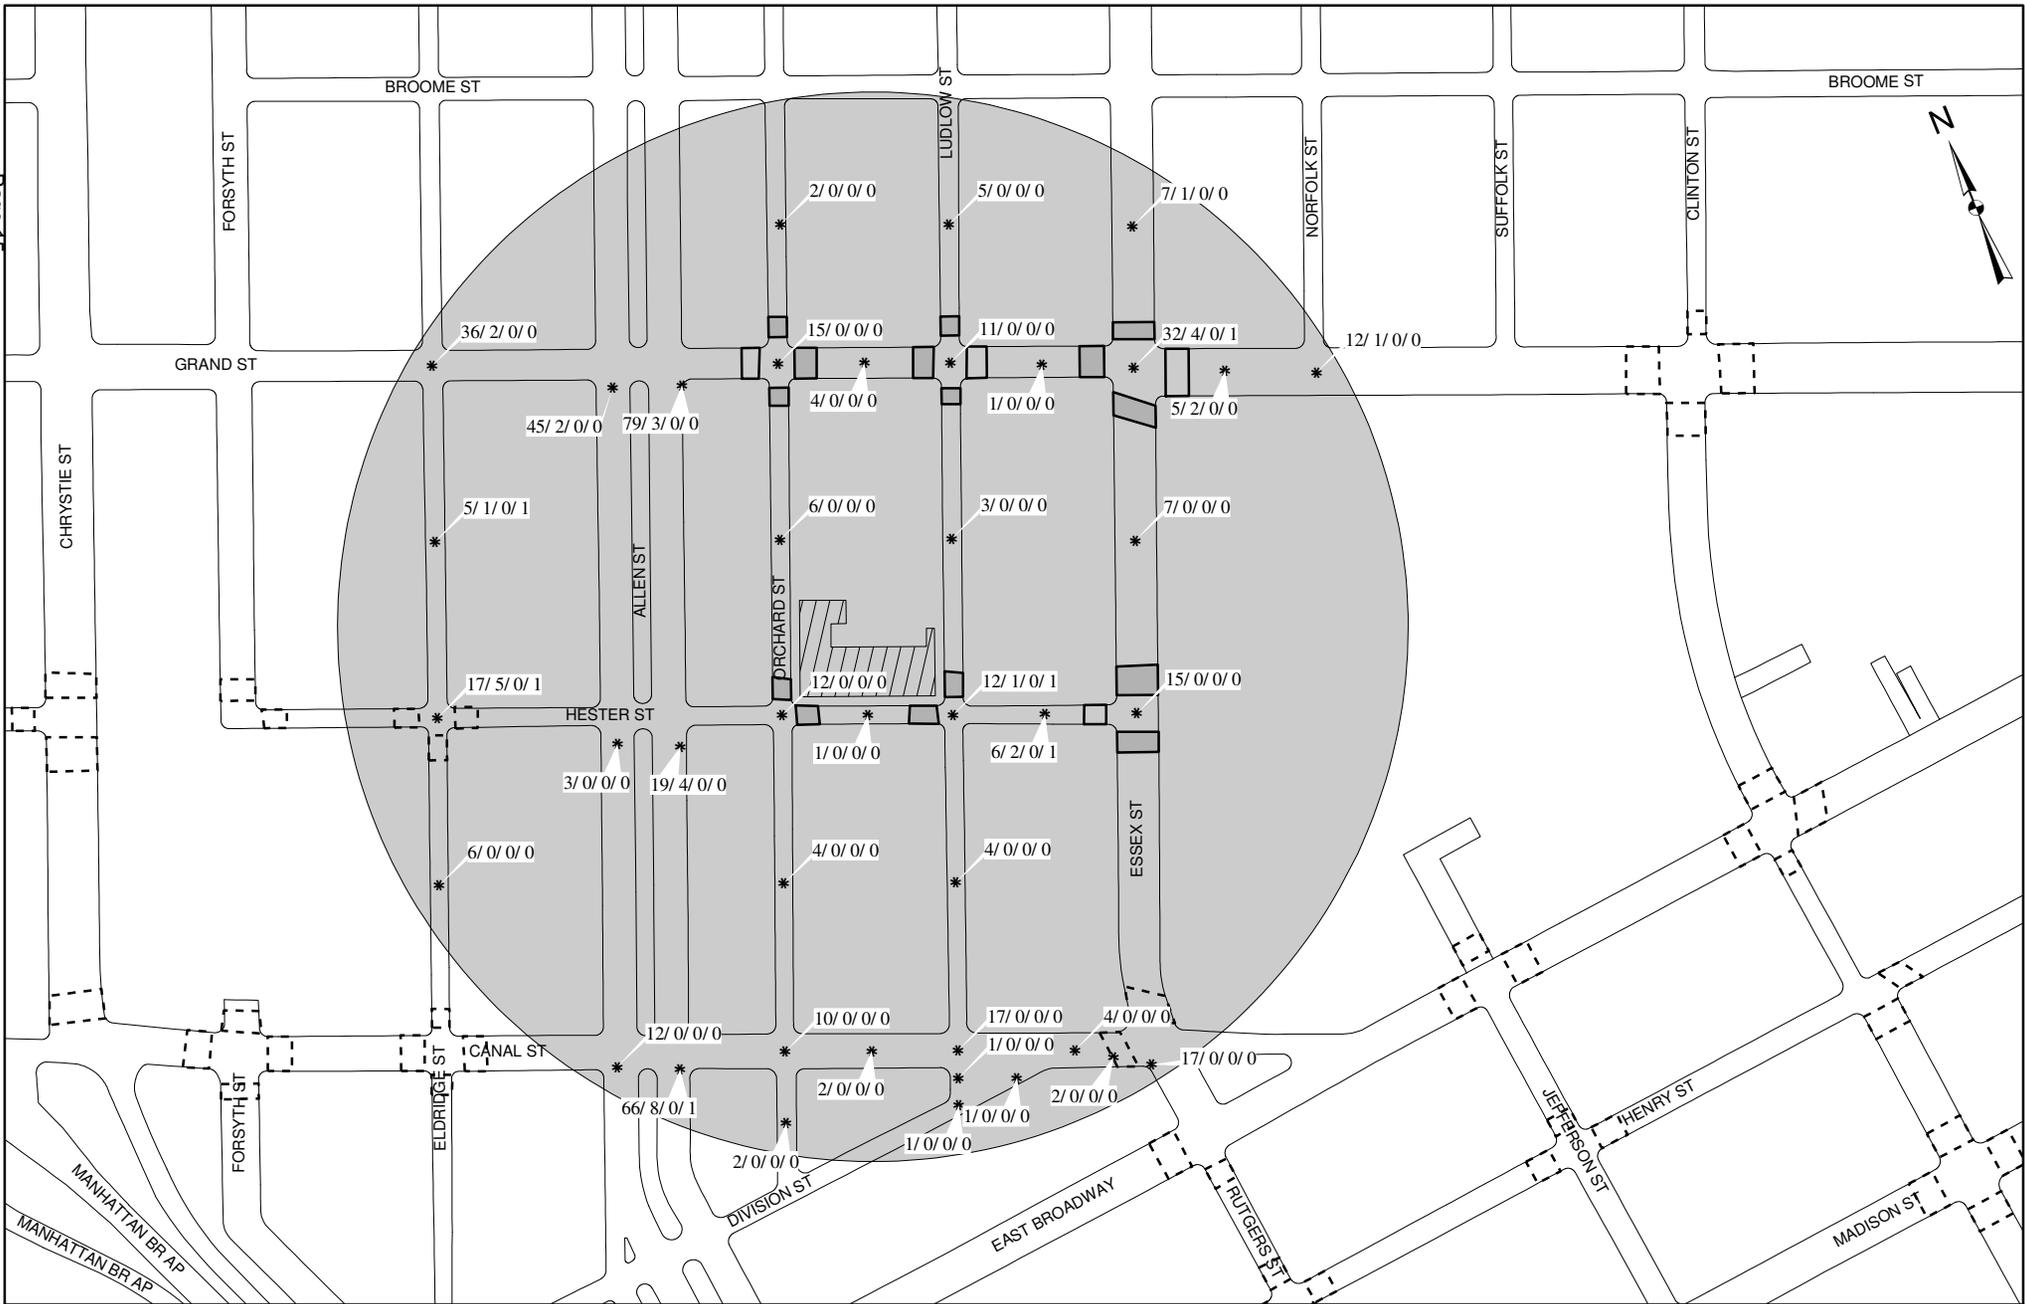
**EXHIBIT 6
P.S. 42, MANHATTAN
BENJAMIN ALTMAN SCHOOL**

Exhibit 6 and Table 2 show a summary of accidents, as obtained from the New York State Department of Motor Vehicles (DMV), in the vicinity of P.S. 42 for the three-year period from January 1, 1998 through December 31, 2000. The DMV data provide some detail relating to the circumstances and cause of the accidents. Table 3 is a summary of more recent accident data obtained from the NYC Police Department (NYPD). Though current through 2004, the NYPD data do not provide the same level of detail as the DMV data.

**ACCIDENT SUMMARY
THREE YEAR PERIOD
(1998-2000)**

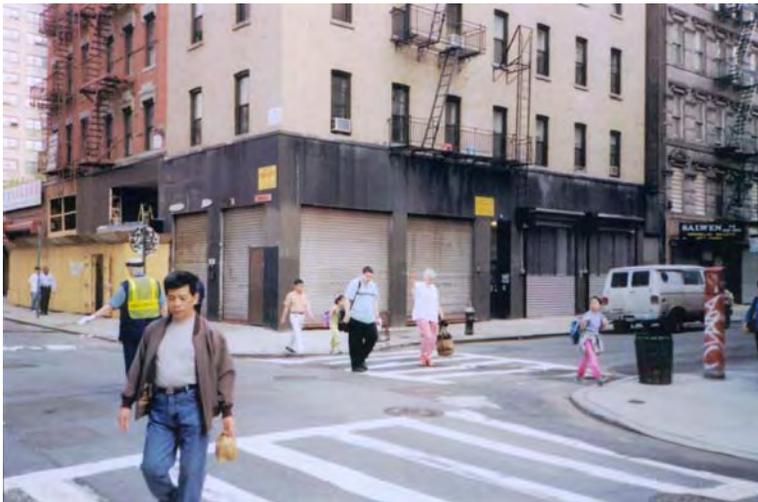
Figure 3: Hester Street and Orchard Street looking northwest

Orchard Street is a 25-foot wide, one-way northbound street with one travel lane and parking on both sides of the roadway. Hester Street is a 25-foot wide, one-way eastbound street with one travel lane and parking on both sides. At this intersection, Hester Street is controlled by a stop sign and Orchard Street is uncontrolled. There are school crosswalks on the north and east legs. The school crosswalk on the north leg is uncontrolled.

A traffic count was conducted on Wednesday May 18, 2005 to better understand vehicle and pedestrian conflicts at this intersection. The count showed that approximately 345 pedestrians used the north crosswalk during the study hour. The results also showed that 411 pedestrians used the south leg to cross Orchard Street where no crosswalk is in place. There were 99 vehicles (or less than two vehicles per minute) interfering with pedestrians crossing Orchard Street (Exhibit 7A). The low vehicle volumes do not warrant a signal control at this intersection at this time.

Twelve accidents occurred at this intersection during the 1998-2000 study period, none of which were pedestrian accidents.

Consideration should be given to installing a curb extension at the following locations, provided that the Final Design confirms that construction of the recommended curb extension would be feasible and would not interfere with traffic operations. Final details pertaining to the number, location and geometry of curb extensions will be developed during the Final Design/Contract Document preparation.

- Hester Street and Orchard Street
- Hester Street and Ludlow Street
- Allen Street and Grand Street
- Allen Street and Hester Street

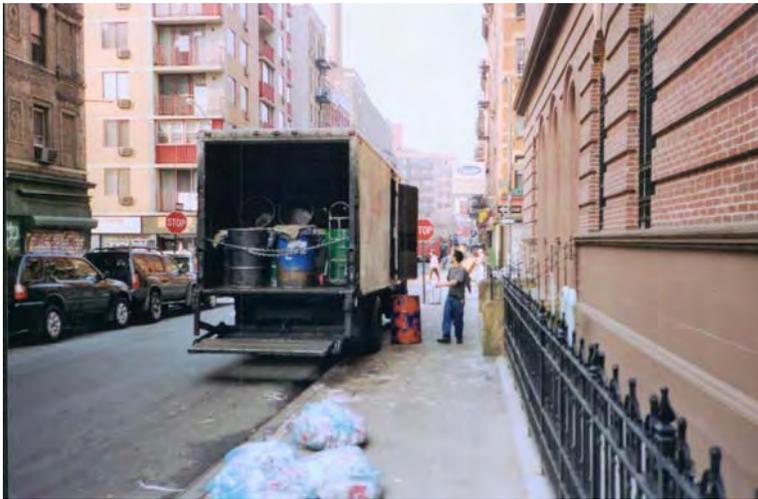
Figure 4: Ludlow Street looking south toward Hester Street

Ludlow Street is a 25-foot wide, one-way southbound street with one moving lane and parking on both sides. Hester Street and Ludlow Street is an un-signalized intersection with a stop sign on Ludlow Street for southbound traffic (See Figure 4). There are school crosswalks on the north and west legs. The school crosswalk on the west approach is uncontrolled.

vehicles traveling on Hester Street during this hour (Exhibit 7A). The number of pedestrians per hour crossing Hester Street exceeds the required MUTCD Warrant 4 – Pedestrian Volume requirement of a minimum of 190 pedestrians of any given hour. However, the gap study performed on April 27, 2006 shows that more than 60 gaps of 12 seconds (the time required to cross a 25-foot wide street at three feet per second plus three seconds of reaction time) were available for pedestrians to cross Hester Street. Therefore, the intersection does not meet the warrants for a traffic signal.

Twelve accidents occurred at this intersection during the 1998-2000 study period, one of which was a school-related pedestrian accident. A student was struck while crossing Hester Street. The location is not controlled.

A nine-year-old student was struck on Hester Street between Ludlow Street and Essex Street while emerging from between parked vehicles.

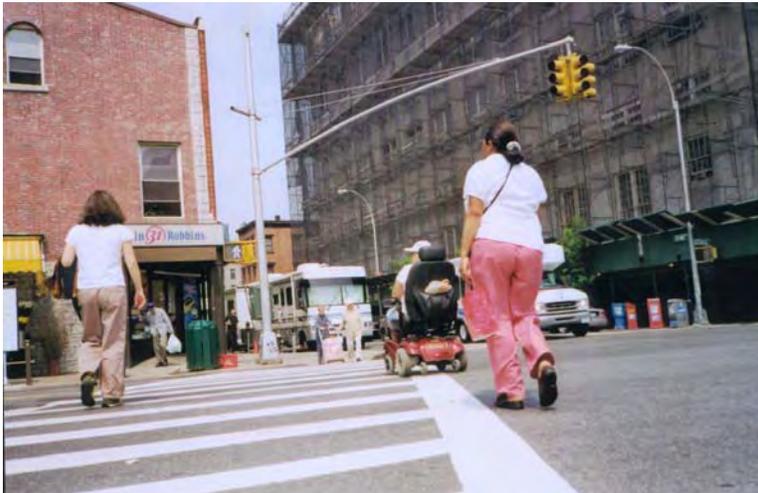
Figure 5: Grand Street at Essex Street looking west

Grand Street and Essex Street is a signalized intersection (Figure 5). There are school crosswalks in place on the west, north and south legs.

The east approach of this intersection is 62 feet wide and the west approach is 42 feet wide. This alignment shift through the intersection increases pedestrian crossing distances when students use the school crosswalk on the south leg across Essex Street.

Thirty-two accidents occurred at this intersection during the 1998-2000 study period. Four pedestrian accidents were reported, one of which was school-related. Two accidents, including the school-related accident, involved pedestrians crossing against the signal while drivers were traveling eastbound. The third involved a pedestrian crossing outside the crosswalk, and no details were available for the fourth accident.

To normalize the intersection geometry and reduce the crossing distance on the east and south legs of the intersection, it is recommended that a 12-foot-wide curb extension be installed at the southeast corner of the intersection. The narrowed east leg of the intersection will maintain one travel lane and parking in the westbound direction, and two travel lanes and parking in the eastbound direction.

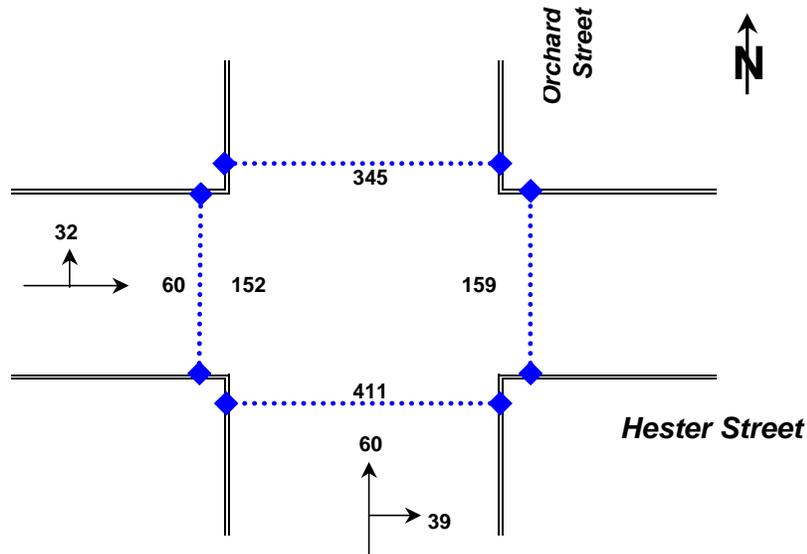
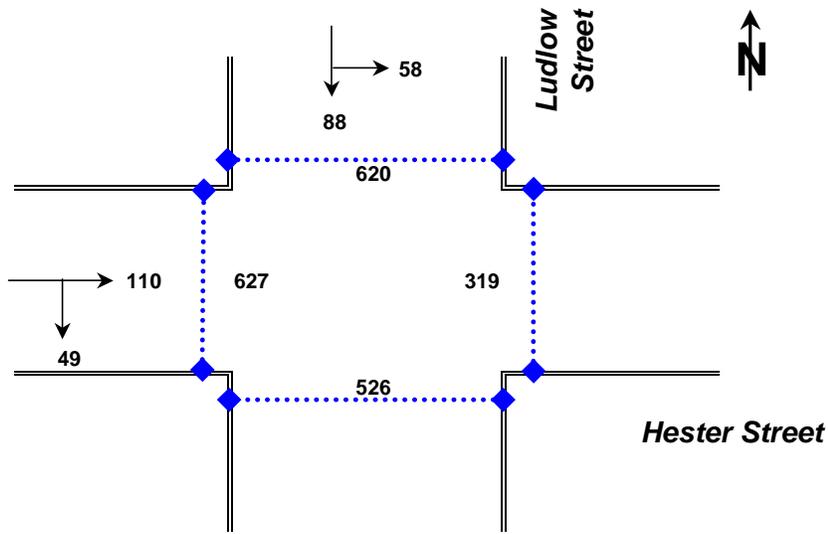
EXHIBIT 7A
P.S. 42, MANHATTAN BENJAMIN ALTMAN SCHOOL
TRAFFIC COUNTS

A traffic count conducted on Tuesday May 17, 2005 between 2:30 am and 3:30 am showed that approximately 946 pedestrians crossed Hester Street, interfering with 159

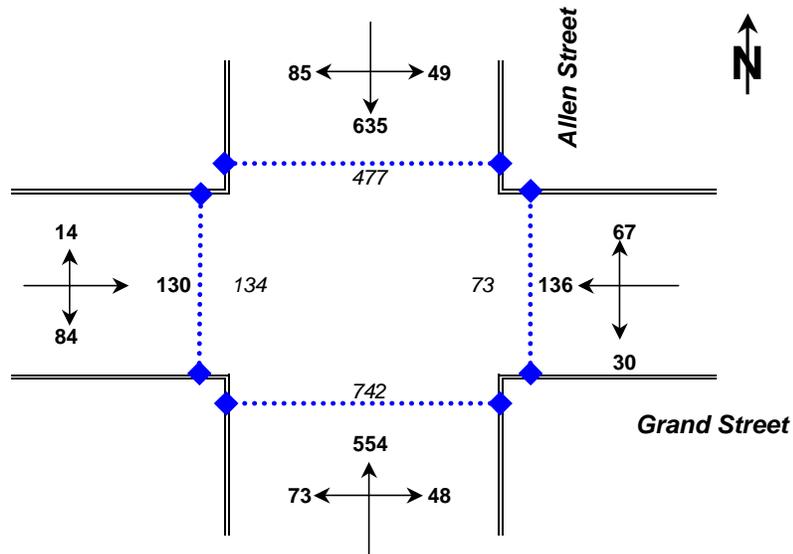
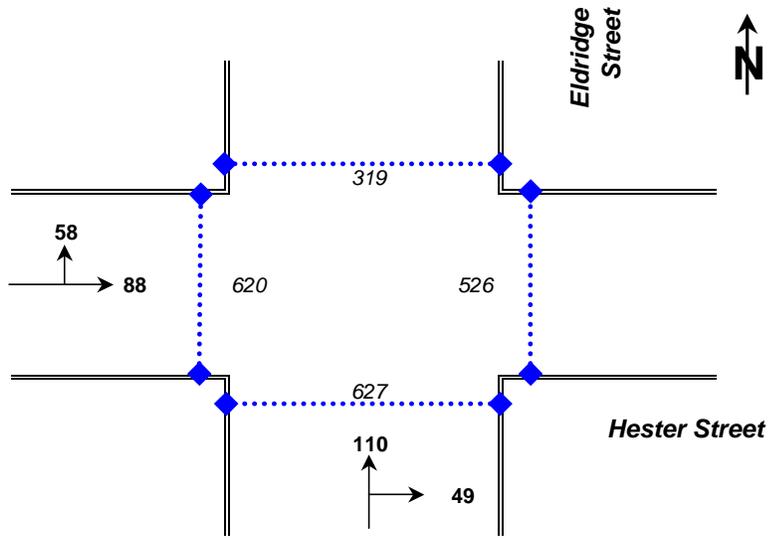
EXHIBIT 7B
P.S. 42, MANHATTAN BENJAMIN ALTMAN SCHOOL
TRAFFIC COUNTS

Traffic counts were performed on Thursday, May 16, 2005 between 2:30 pm to 3:30 pm (see Exhibit 7B). The traffic count indicated that a total of 305 vehicles per hour and 2092 pedestrians per hour utilized this intersection during the study hour, when students were being dismissed from I.S. 131. Many of the pedestrians were I.S. 131 students. In

addition, 159 (110+49) uncontrolled vehicles per hour traveled northbound on Eldridge Street, while conflicting with 946 pedestrians crossing Eldridge Street. The number of pedestrians per hour crossing Eldridge Street exceeds the required MUTCD Warrant 4 – Pedestrian Volume requirement of a minimum of 190 pedestrians of any given hour. However, the gap study performed on August 17, 2006 shows that more than 60 gaps of 12 seconds (the time required to cross a 25-foot wide street at three feet per second plus three seconds of reaction time) were available for pedestrians to cross Eldridge Street. Therefore, the intersection does not meet the warrants for a traffic signal.

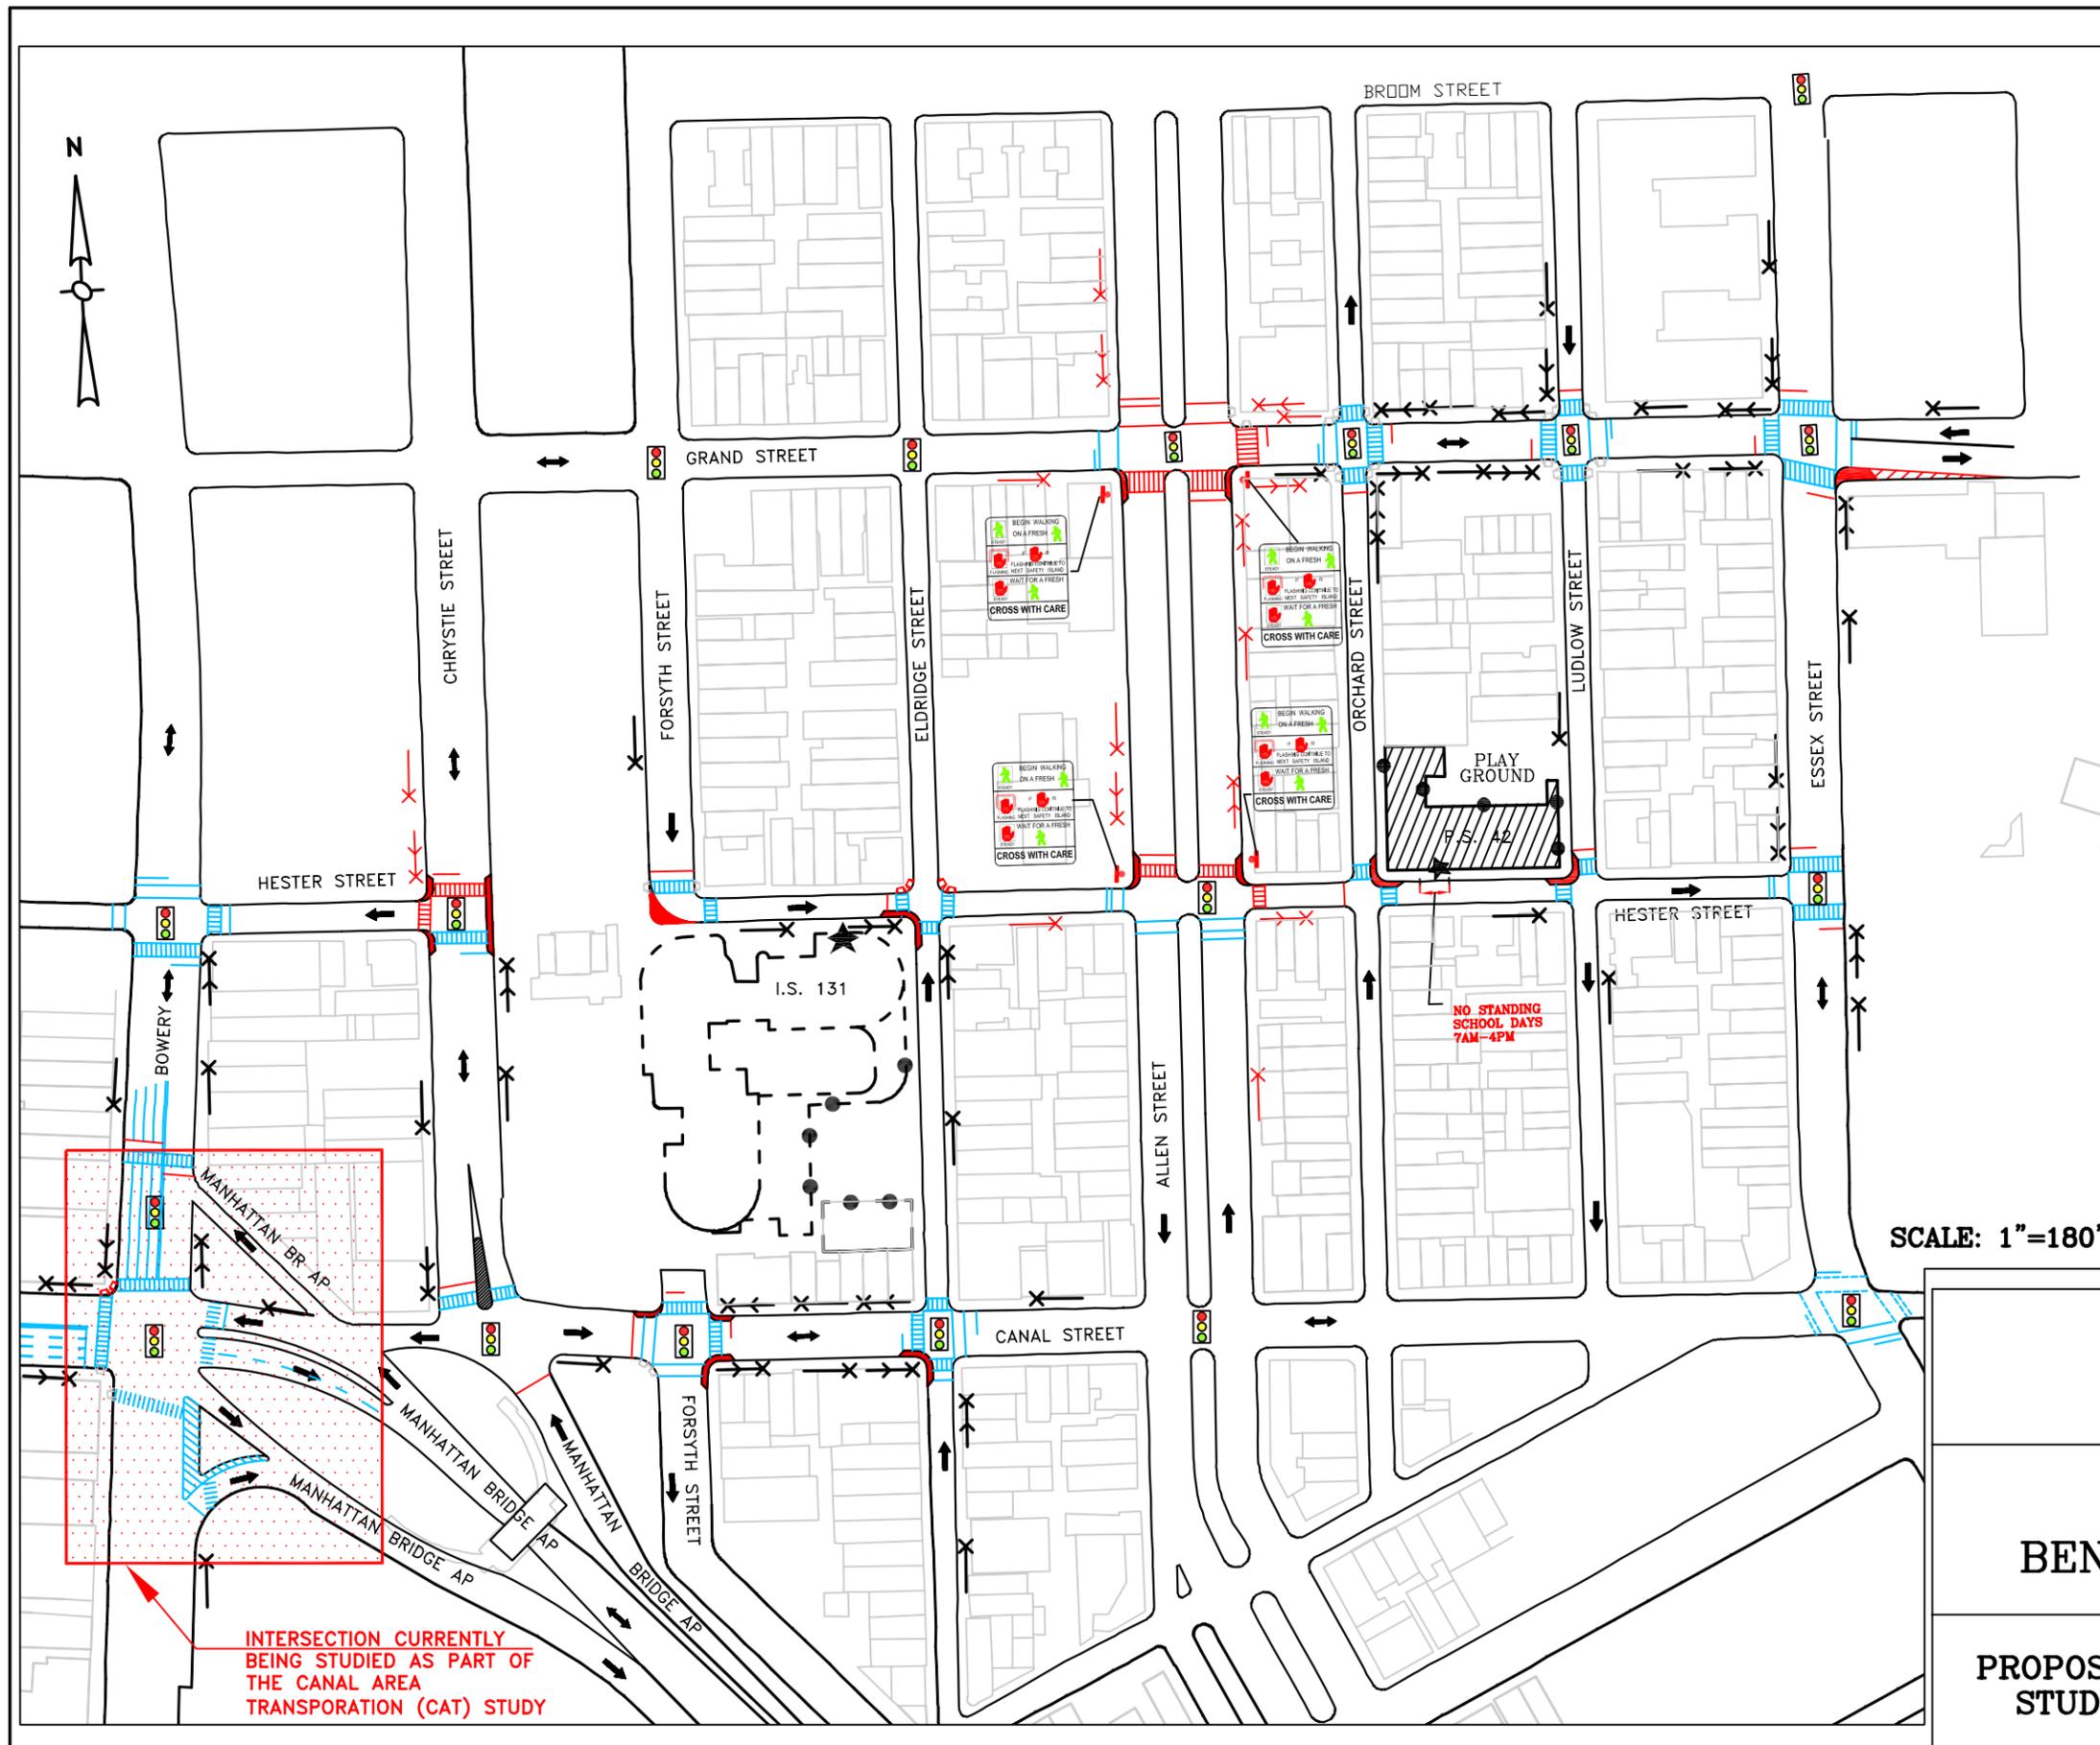
EXHIBIT 8

Curb extensions should be considered at the corners as shown in Exhibit 8.

- *Install No Standing Zone*

“NO STANDING 7AM - 4 PM, SCHOOL DAYS” parking regulations should be installed on Hester Street in front of the school’s main entrance for a length of 30 feet. This will allow school buses and parents a place to drop off and pick up students at the curb, and will also improve visibility of those students arriving and leaving the school. The lost teacher parking should be relocated to Orchard Street or Ludlow Street.

- *Install new school crosswalk at the following location*

- Allen Street and Grand Street – east and south legs
- Allen Street and Hester Street – east and north legs

- Consider curb extensions
