Morningside Avenue

2013

Commissioner Janette Sadik-Khan, New York City Department of Transportation
Presented by Division of Traffic & Planning, October 23rd, to Community Boards 9 & 10

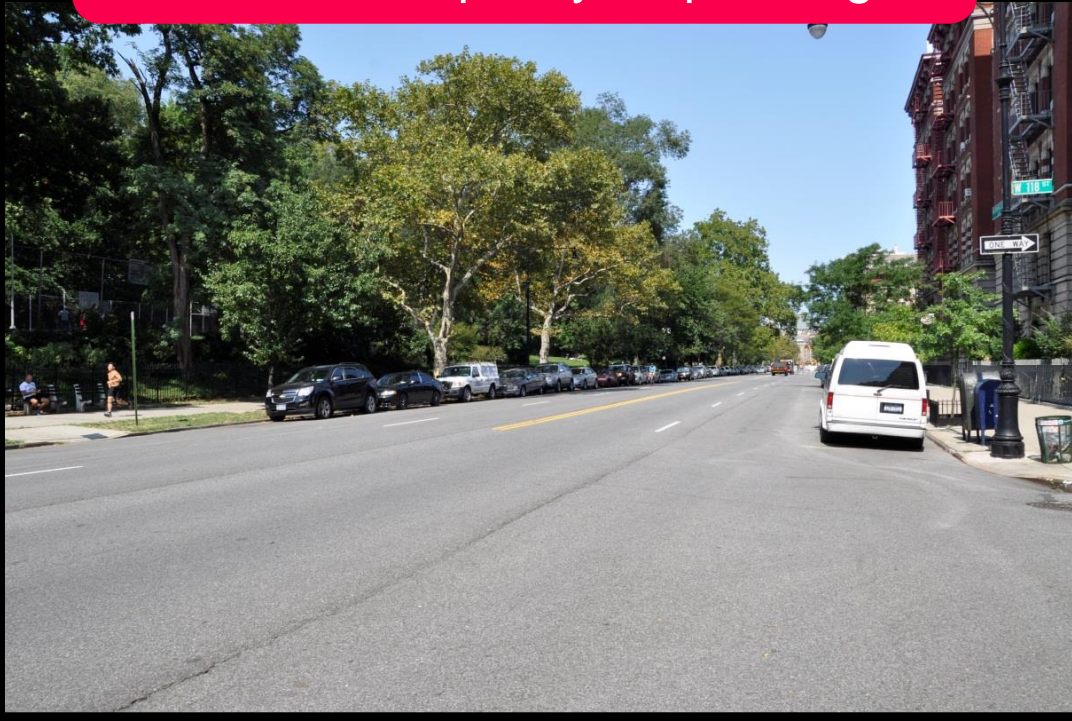
60' roadway with low traffic volumes
= excess capacity + speeding

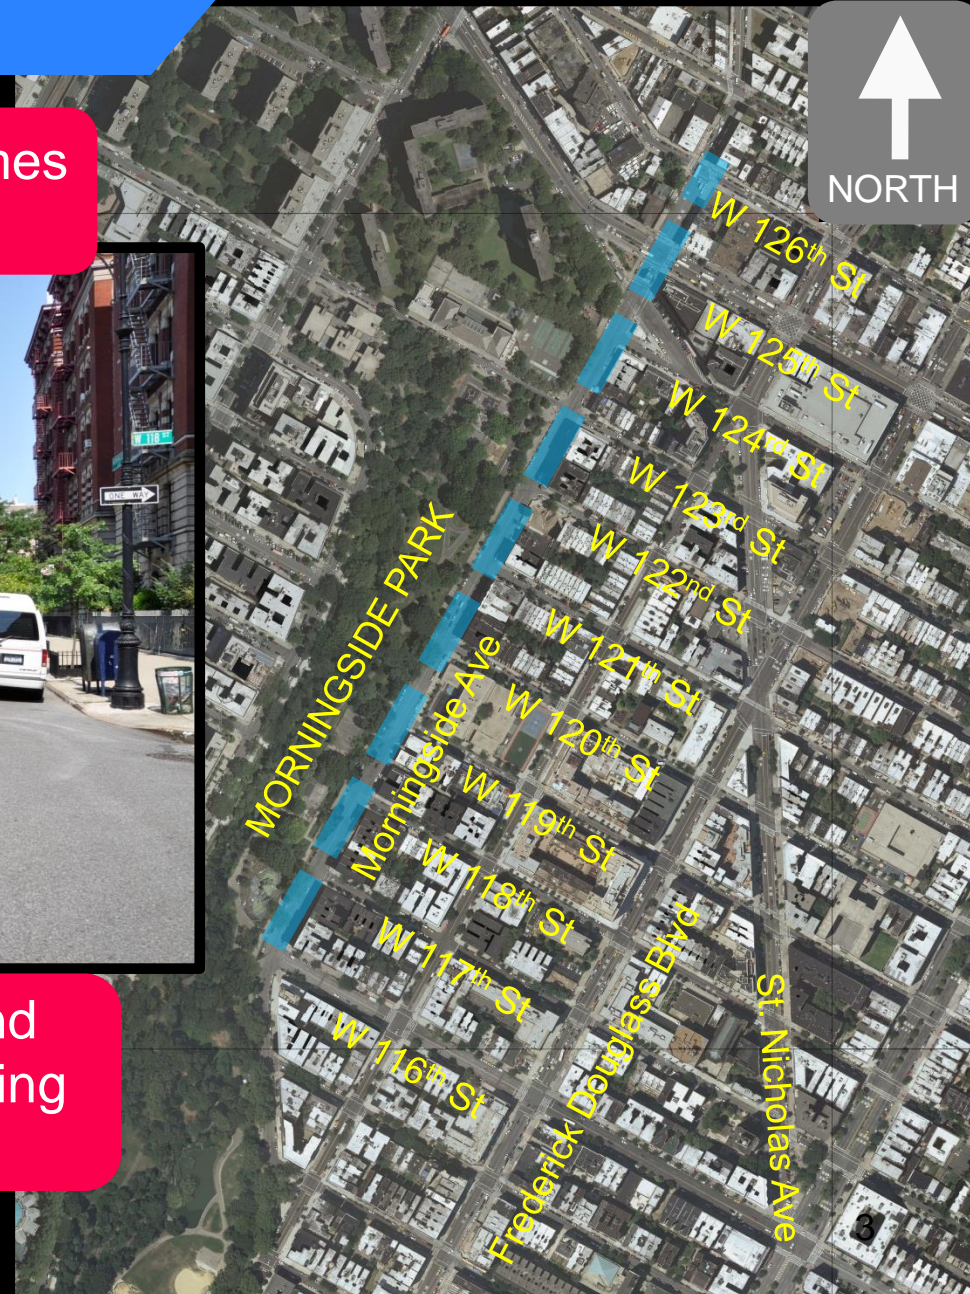
58% of northbound vehicles and
66% of southbound were speeding
during recent speed survey

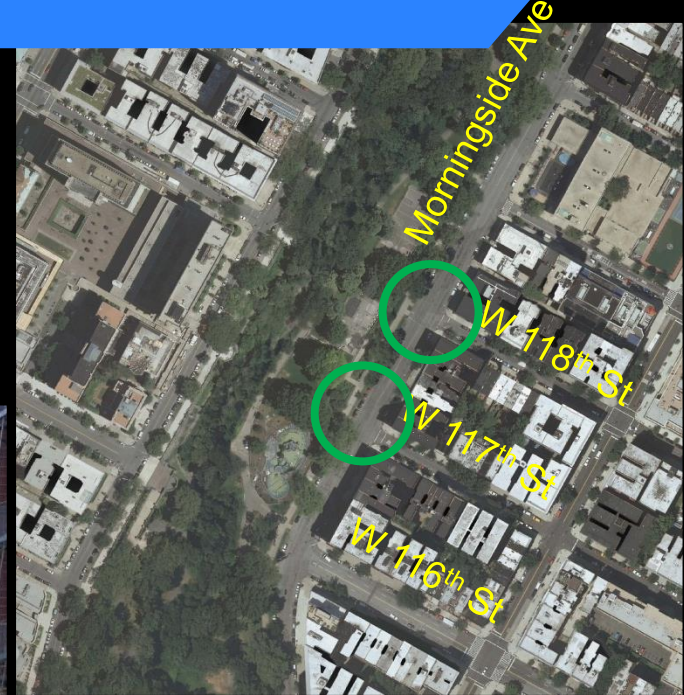
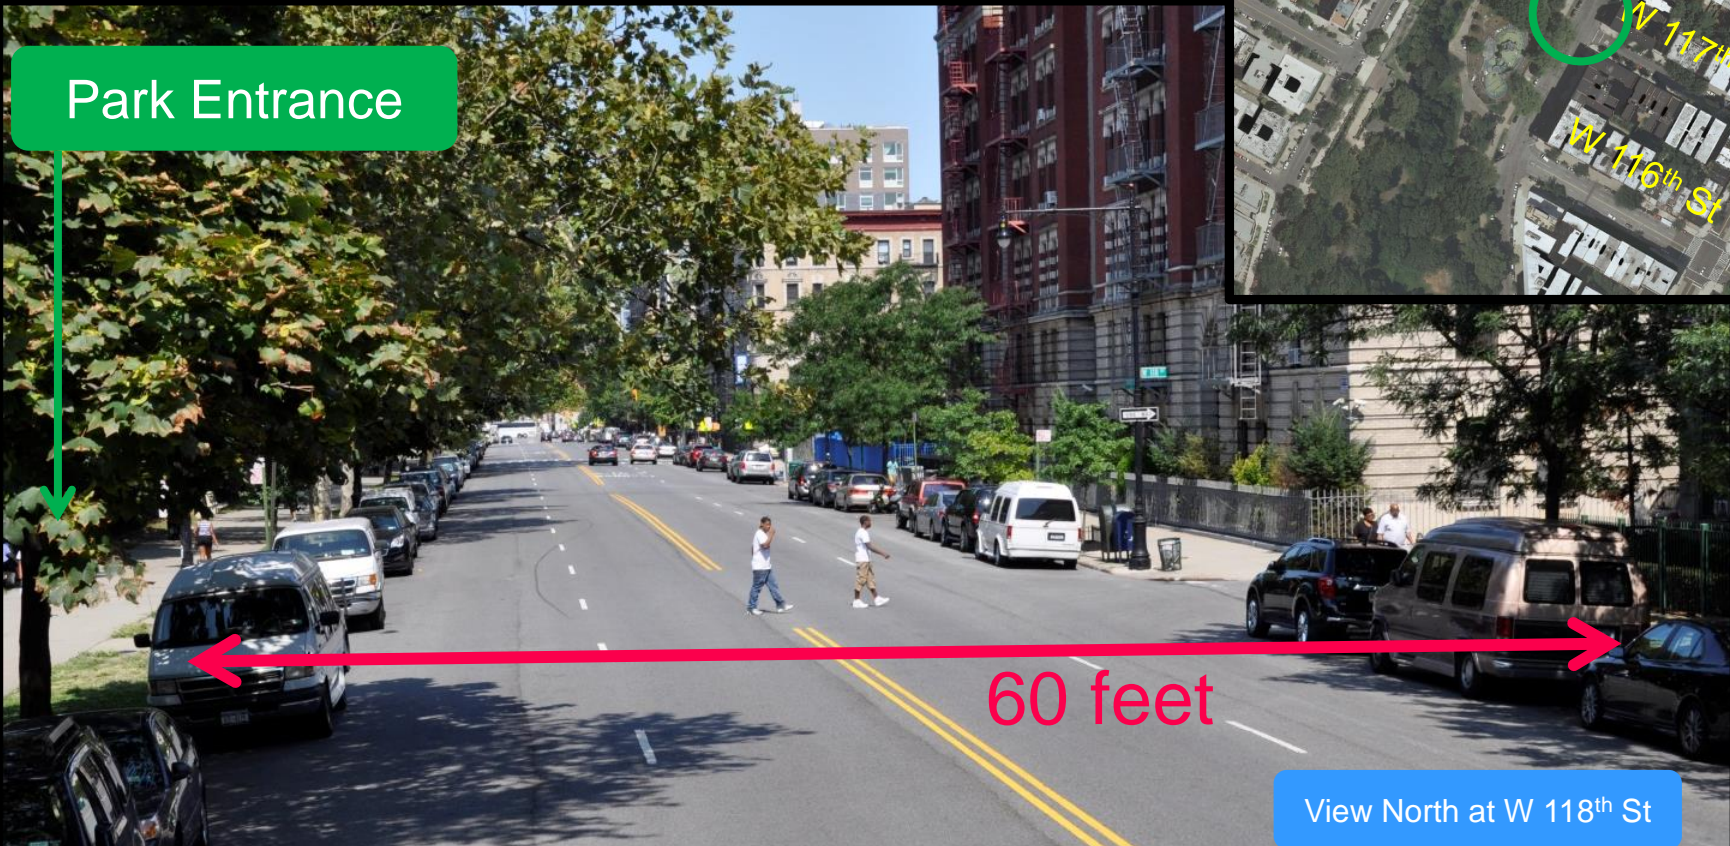
View North at W 118th St

No crosswalks or vehicle control at playground entrances

60 feet

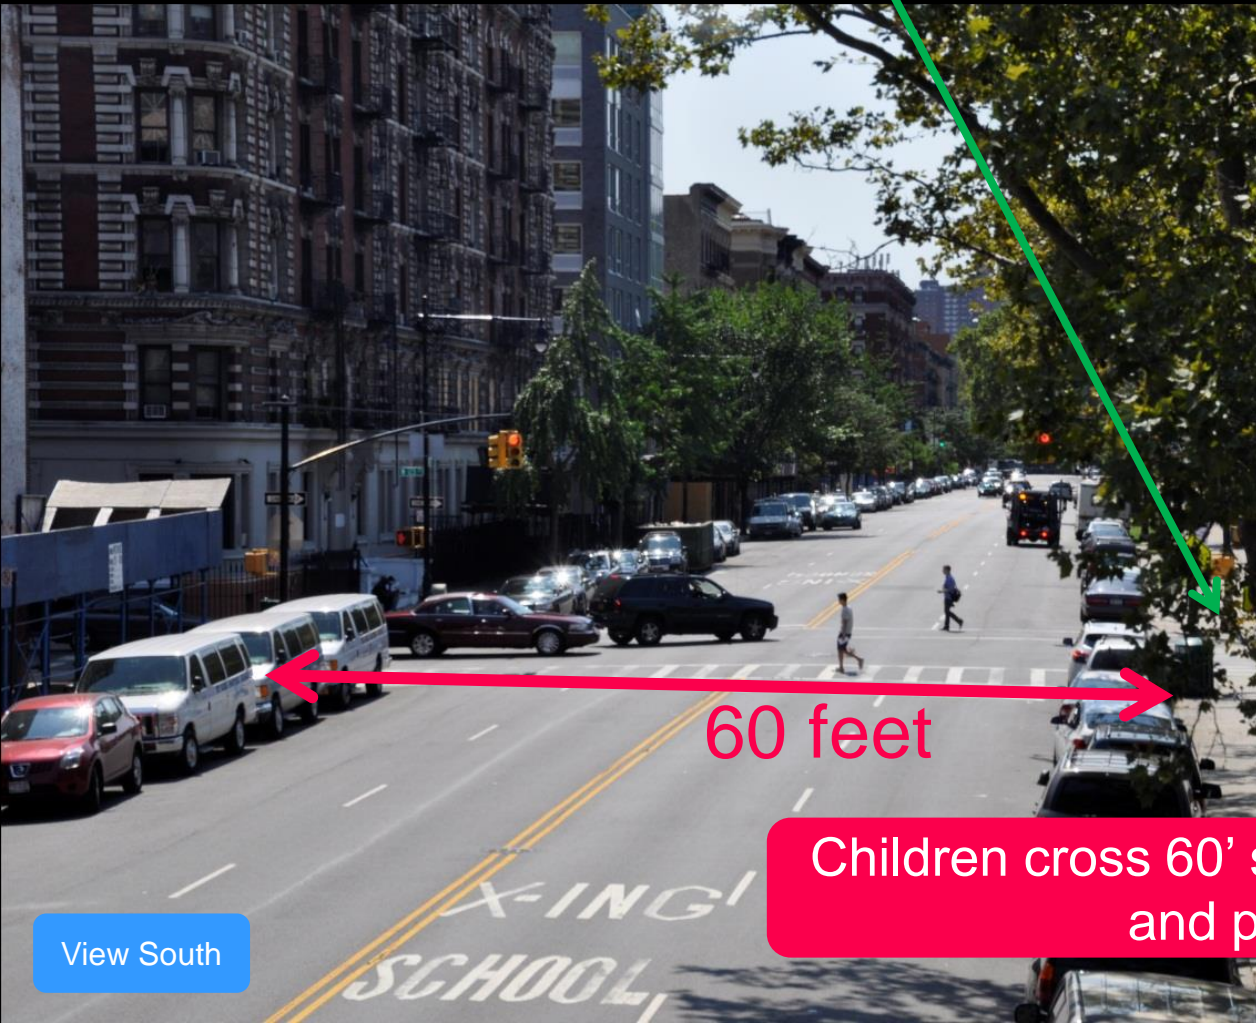
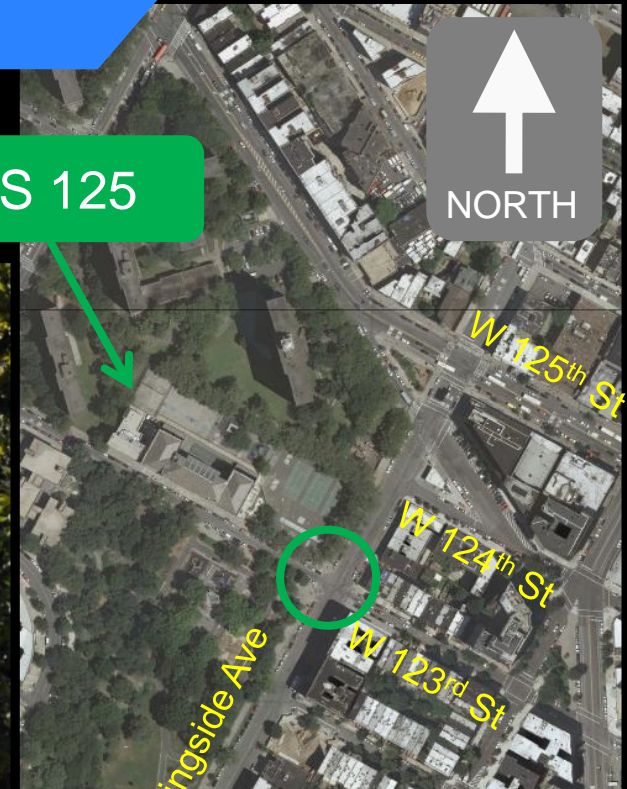
Children cross 60' street between residential and park/ PS 125

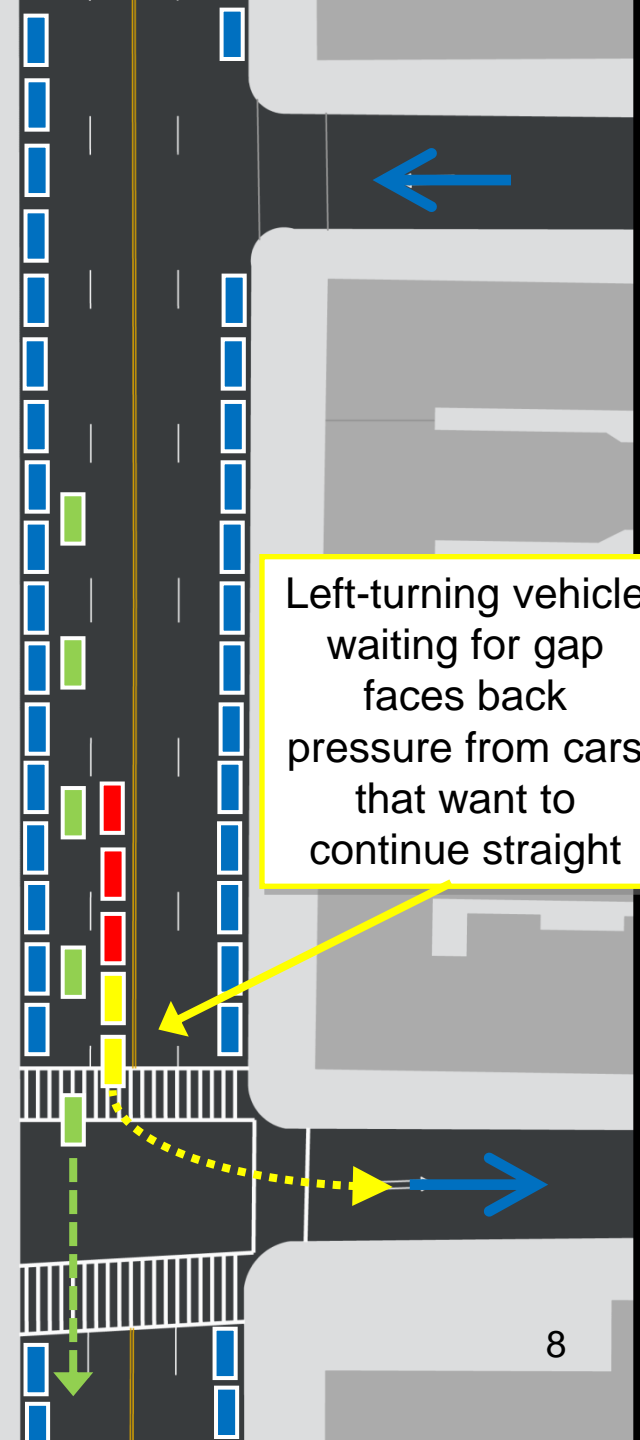
Volumes
385 AM/325 PM
10 vehicles per signal cycle

Left-turning vehicle
waiting for gap
faces back
pressure from cars
that want to
continue straight

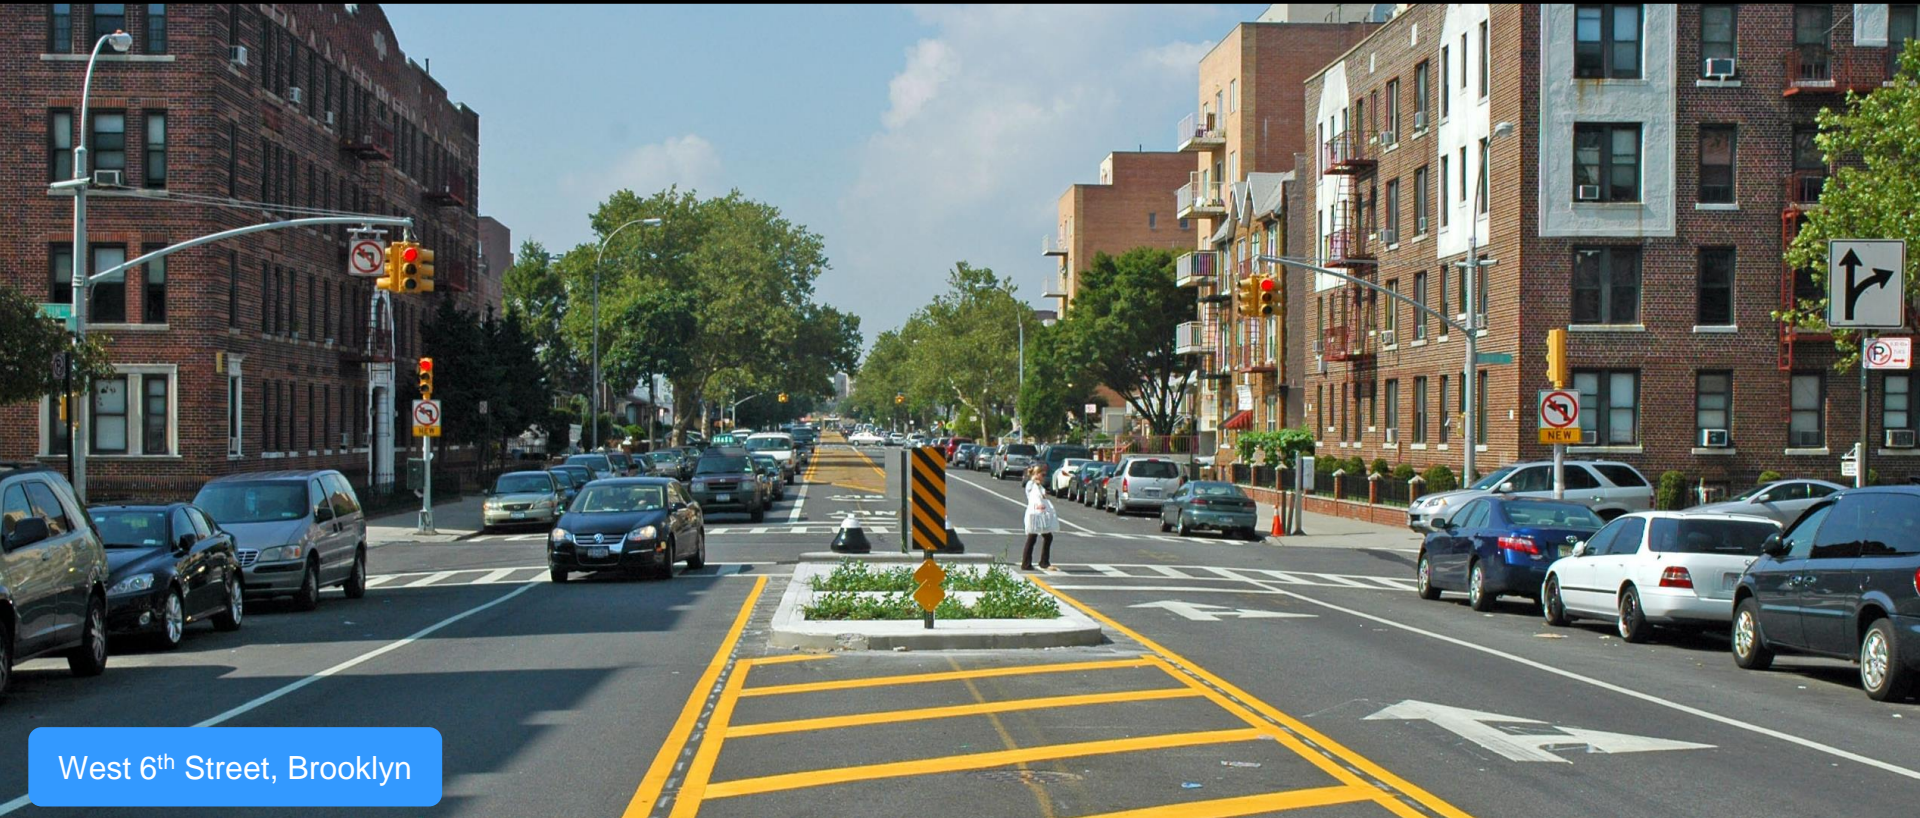
Example of Road Striping

West 6th Street, Brooklyn

One lane in
each direction

Wide parking lanes

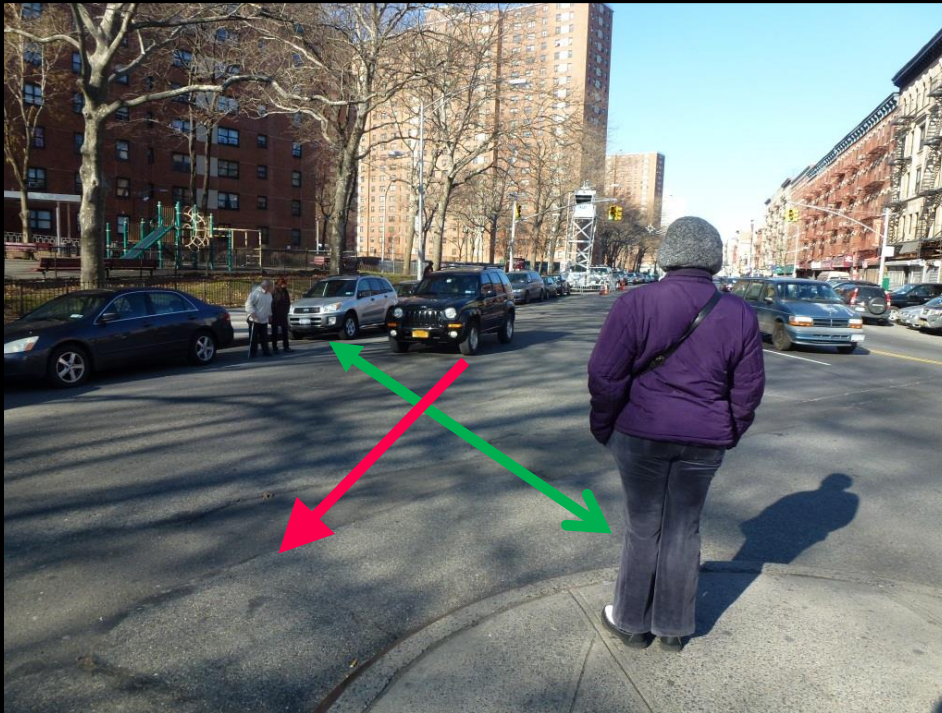
Pedestrian desire line along W 125th Street puts them in conflict with cars entering Hancock Place

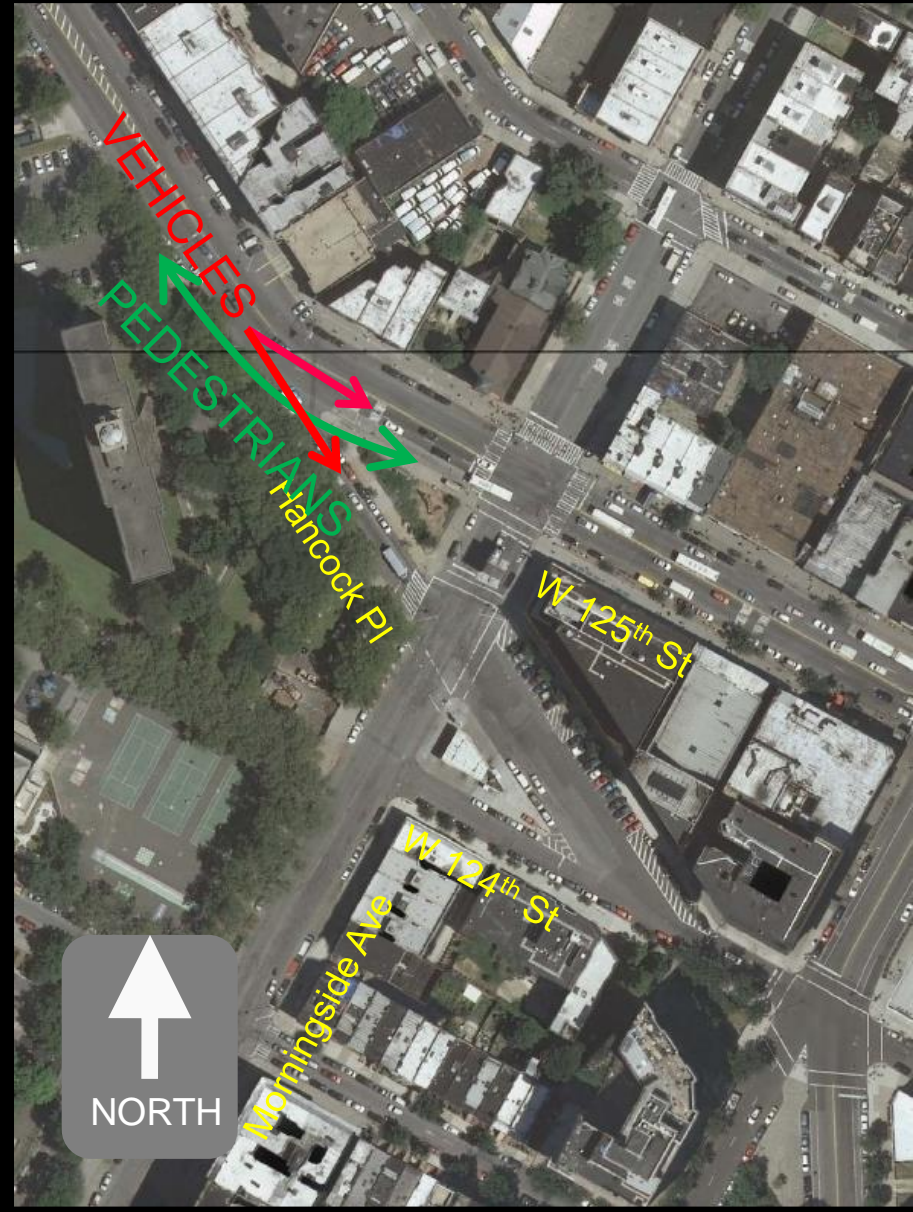
Over 500 pedestrians cross a hour during PM peak

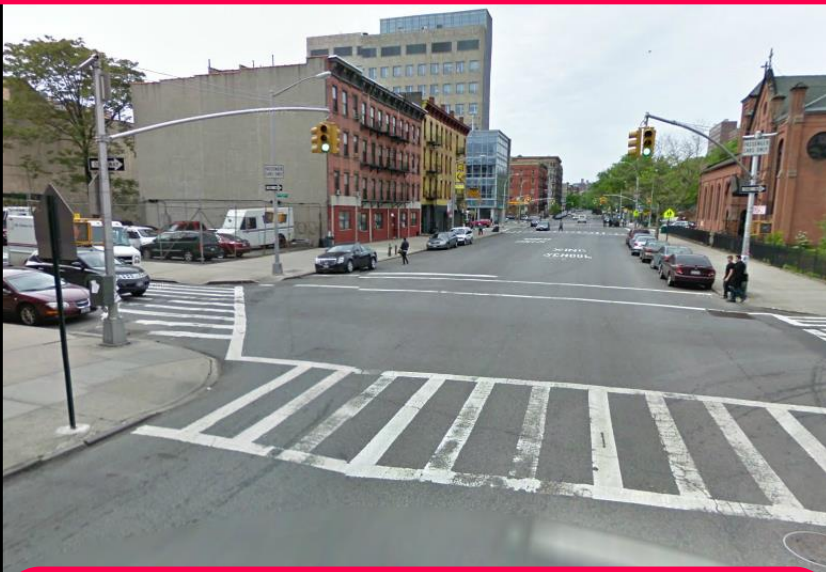
North of W 126th Street, Morningside narrows to 38' creating a skewed alignment

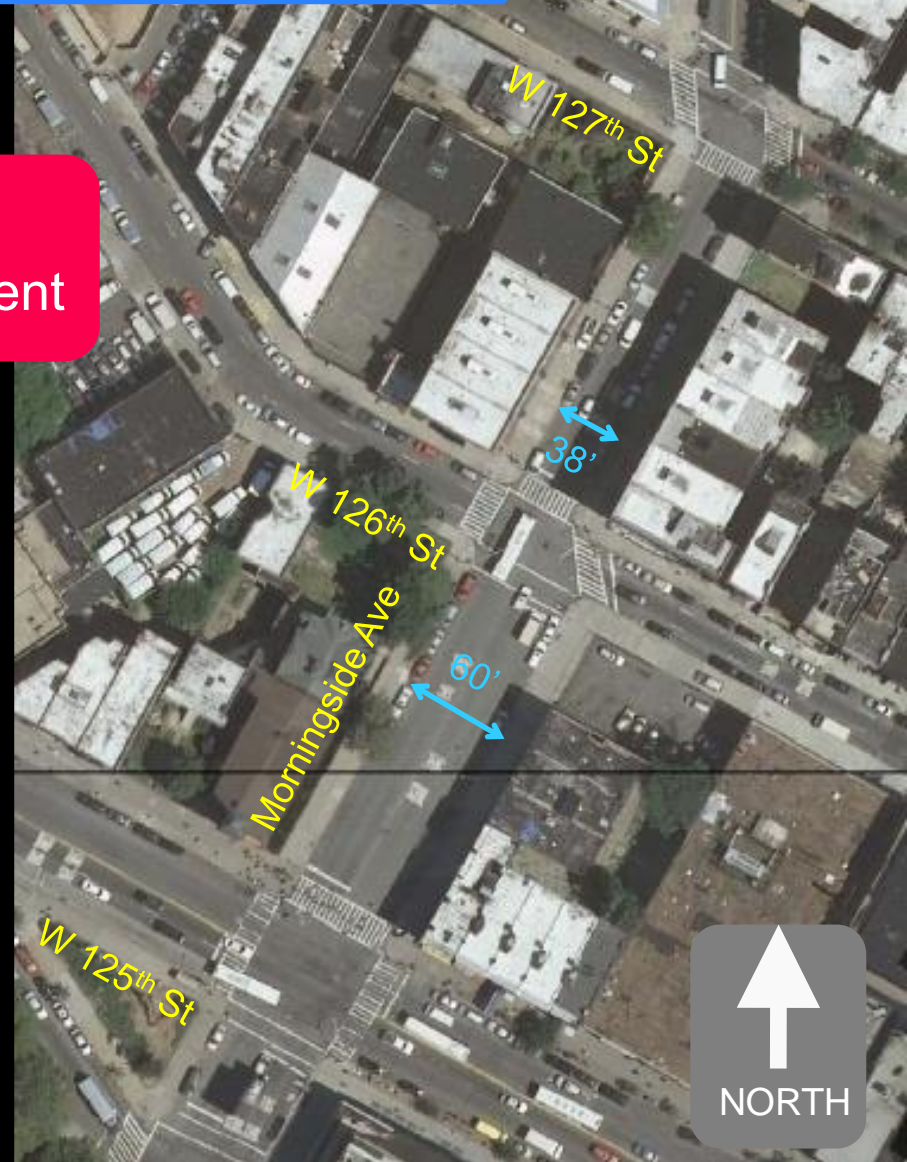
Five injuries at this intersection
in 5 year period from 2007-2011
Two were pedestrian

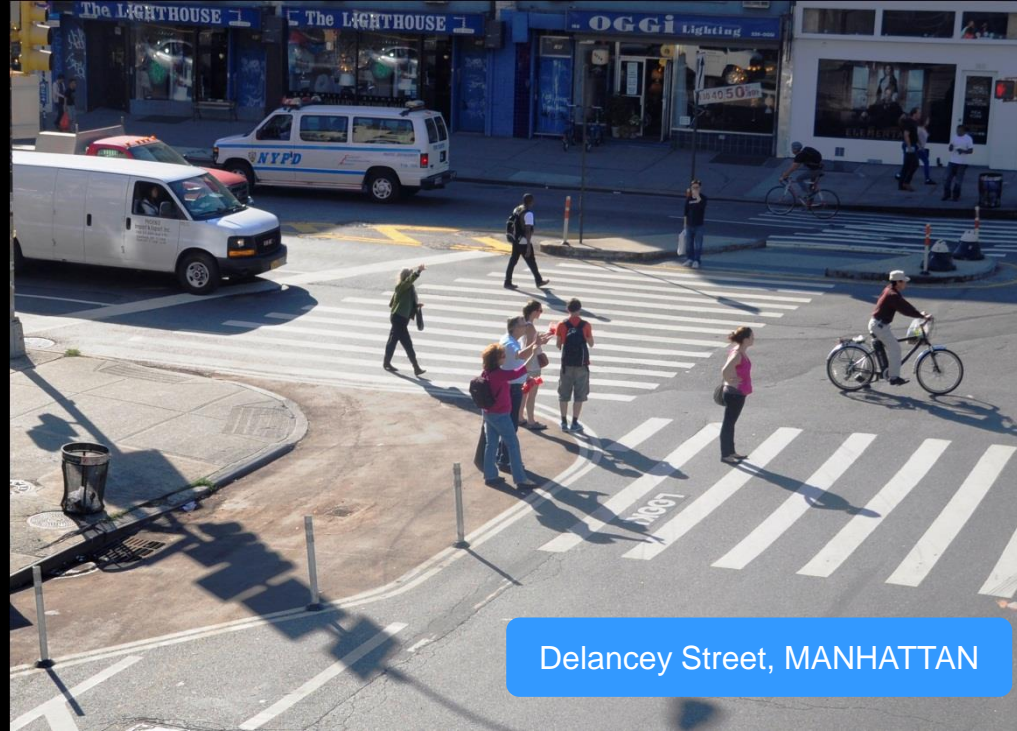
Morningside Ave and W 126th Street Proposal

New left turn lanes

Paint neckdown improves alignment

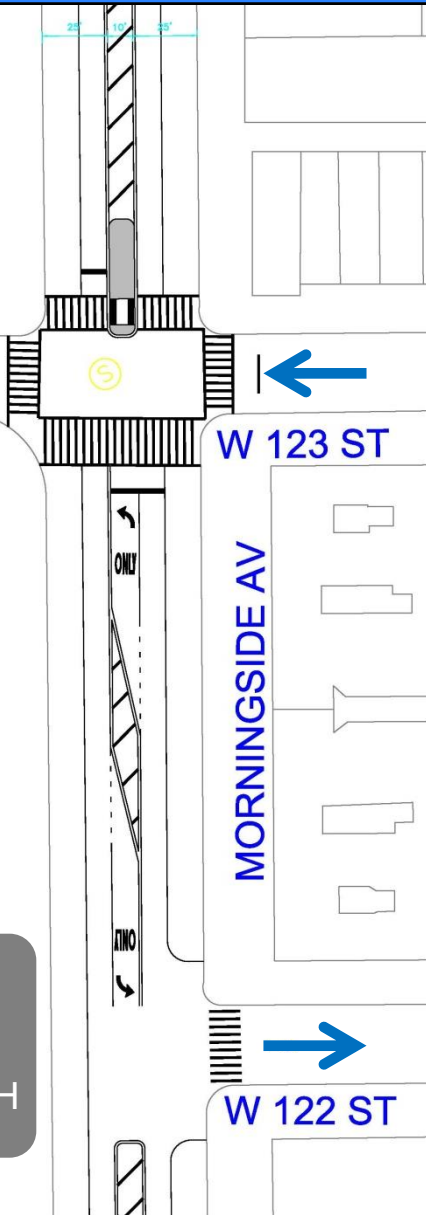
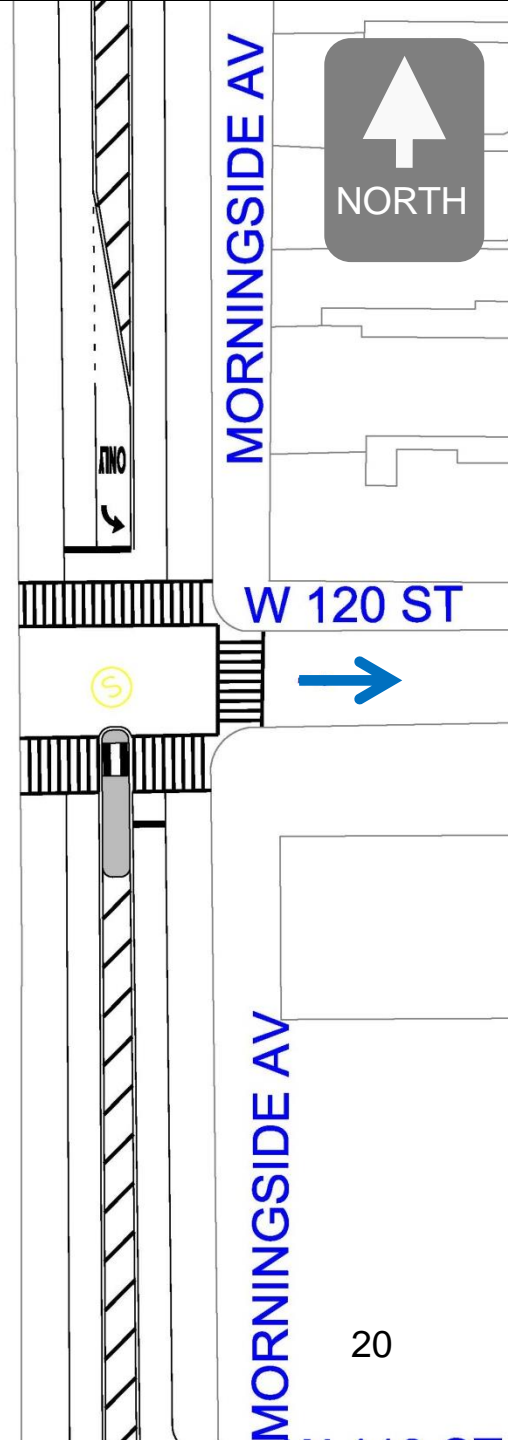
W 120th and W 123rd Streets Proposal

New left turn bays

Safer two part crossing

Wide parking lanes
