MYRTLE AVE AND BROADWAY

Brooklyn Community Board 3 Transportation Committee

April 9, 2019

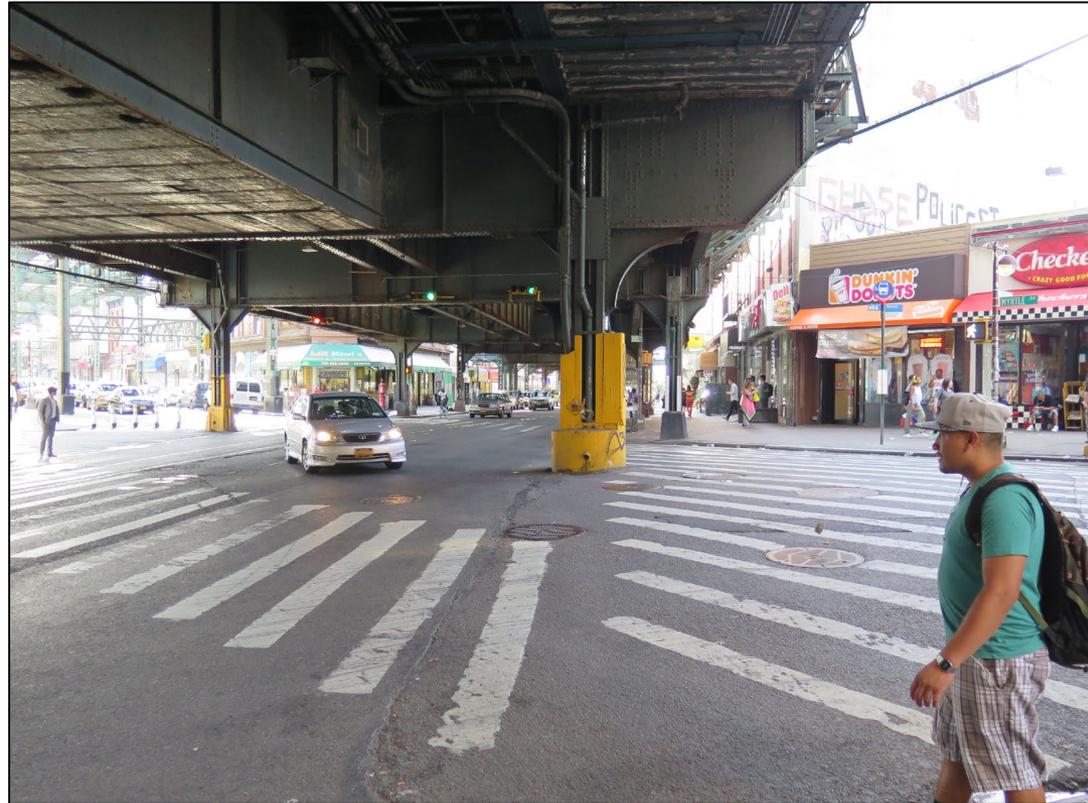
Difficult, Dangerous Movements

- Myrtle Ave and Broadway intersect at a sharp angle making turns difficult, especially for larger vehicles
- Multiple subway columns in roadway provide obstacles for turns and hide pedestrians
- Visibility challenges under the elevated tracks

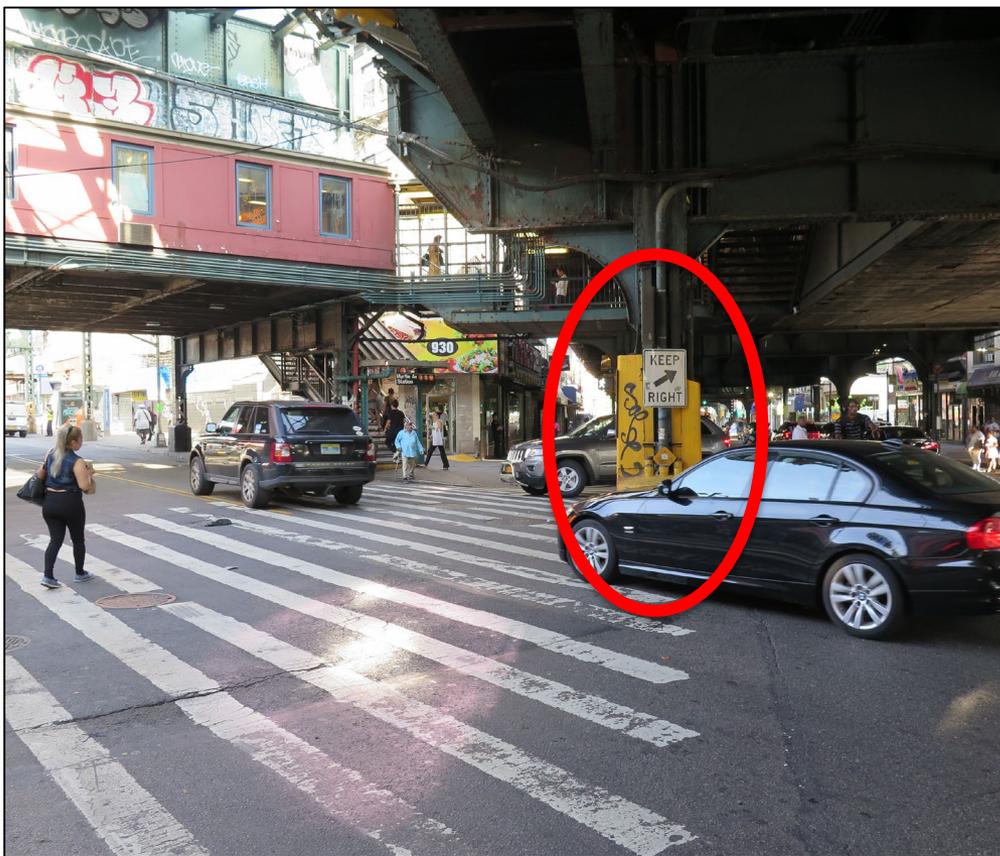
Column Placement

- Column located in the middle of westbound travel lane on Myrtle Ave
- Unpredictable vehicle movements to avoid it
- Vehicles turn and drive around either side of column
- Reduces visibility between pedestrians and drivers, increasing conflicts

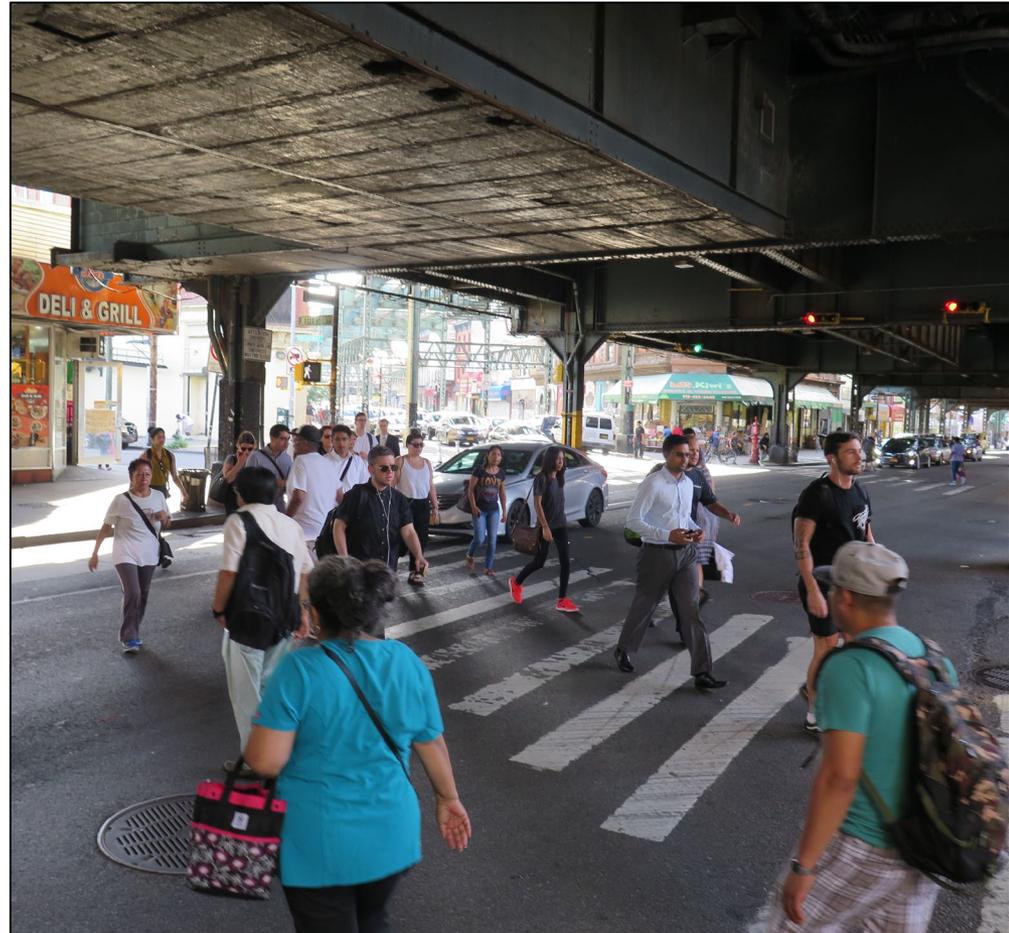
Heavy Pedestrian Volumes

- J, M, and Z Myrtle Ave / Broadway subway station
- B46, B47, and B54 bus stops at intersection
- Lack of sufficient pedestrian space, especially at rush hours

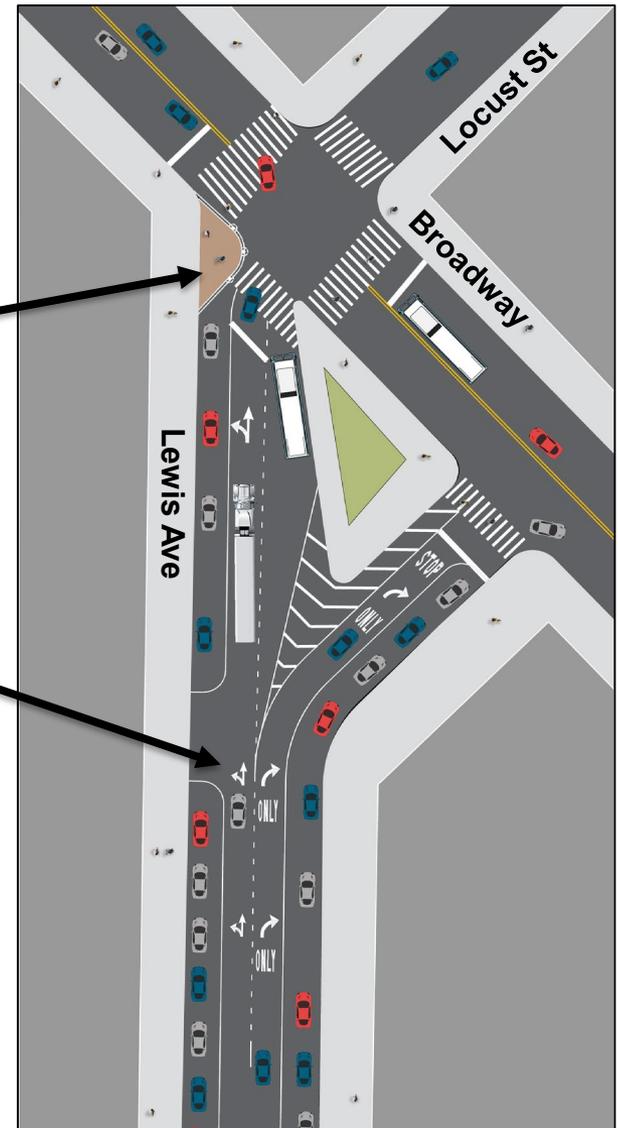
Lewis Ave

- Parking lane stripe between Myrtle Ave and Broadway organizes vehicles
- Painted curb extension at Lewis Ave and Broadway creates slower, safer turns and shortens pedestrian crossing distances
- Lane delineation and signage to clarify movements on Lewis Ave at Broadway
- Loss of 1 parking spot at intersection of Lewis Ave and Broadway

Marcus Garvey Blvd

- Stripe parking lane to define travel lanes and organize vehicles between Broadway and Myrtle Ave
