**New York City Department of Transportation
Office of School Safety Engineering**

School Safety Engineering Project

FINAL REPORT: P.S. 199 (Maurice A. Fitzgerald School), Queens

July 10, 2006

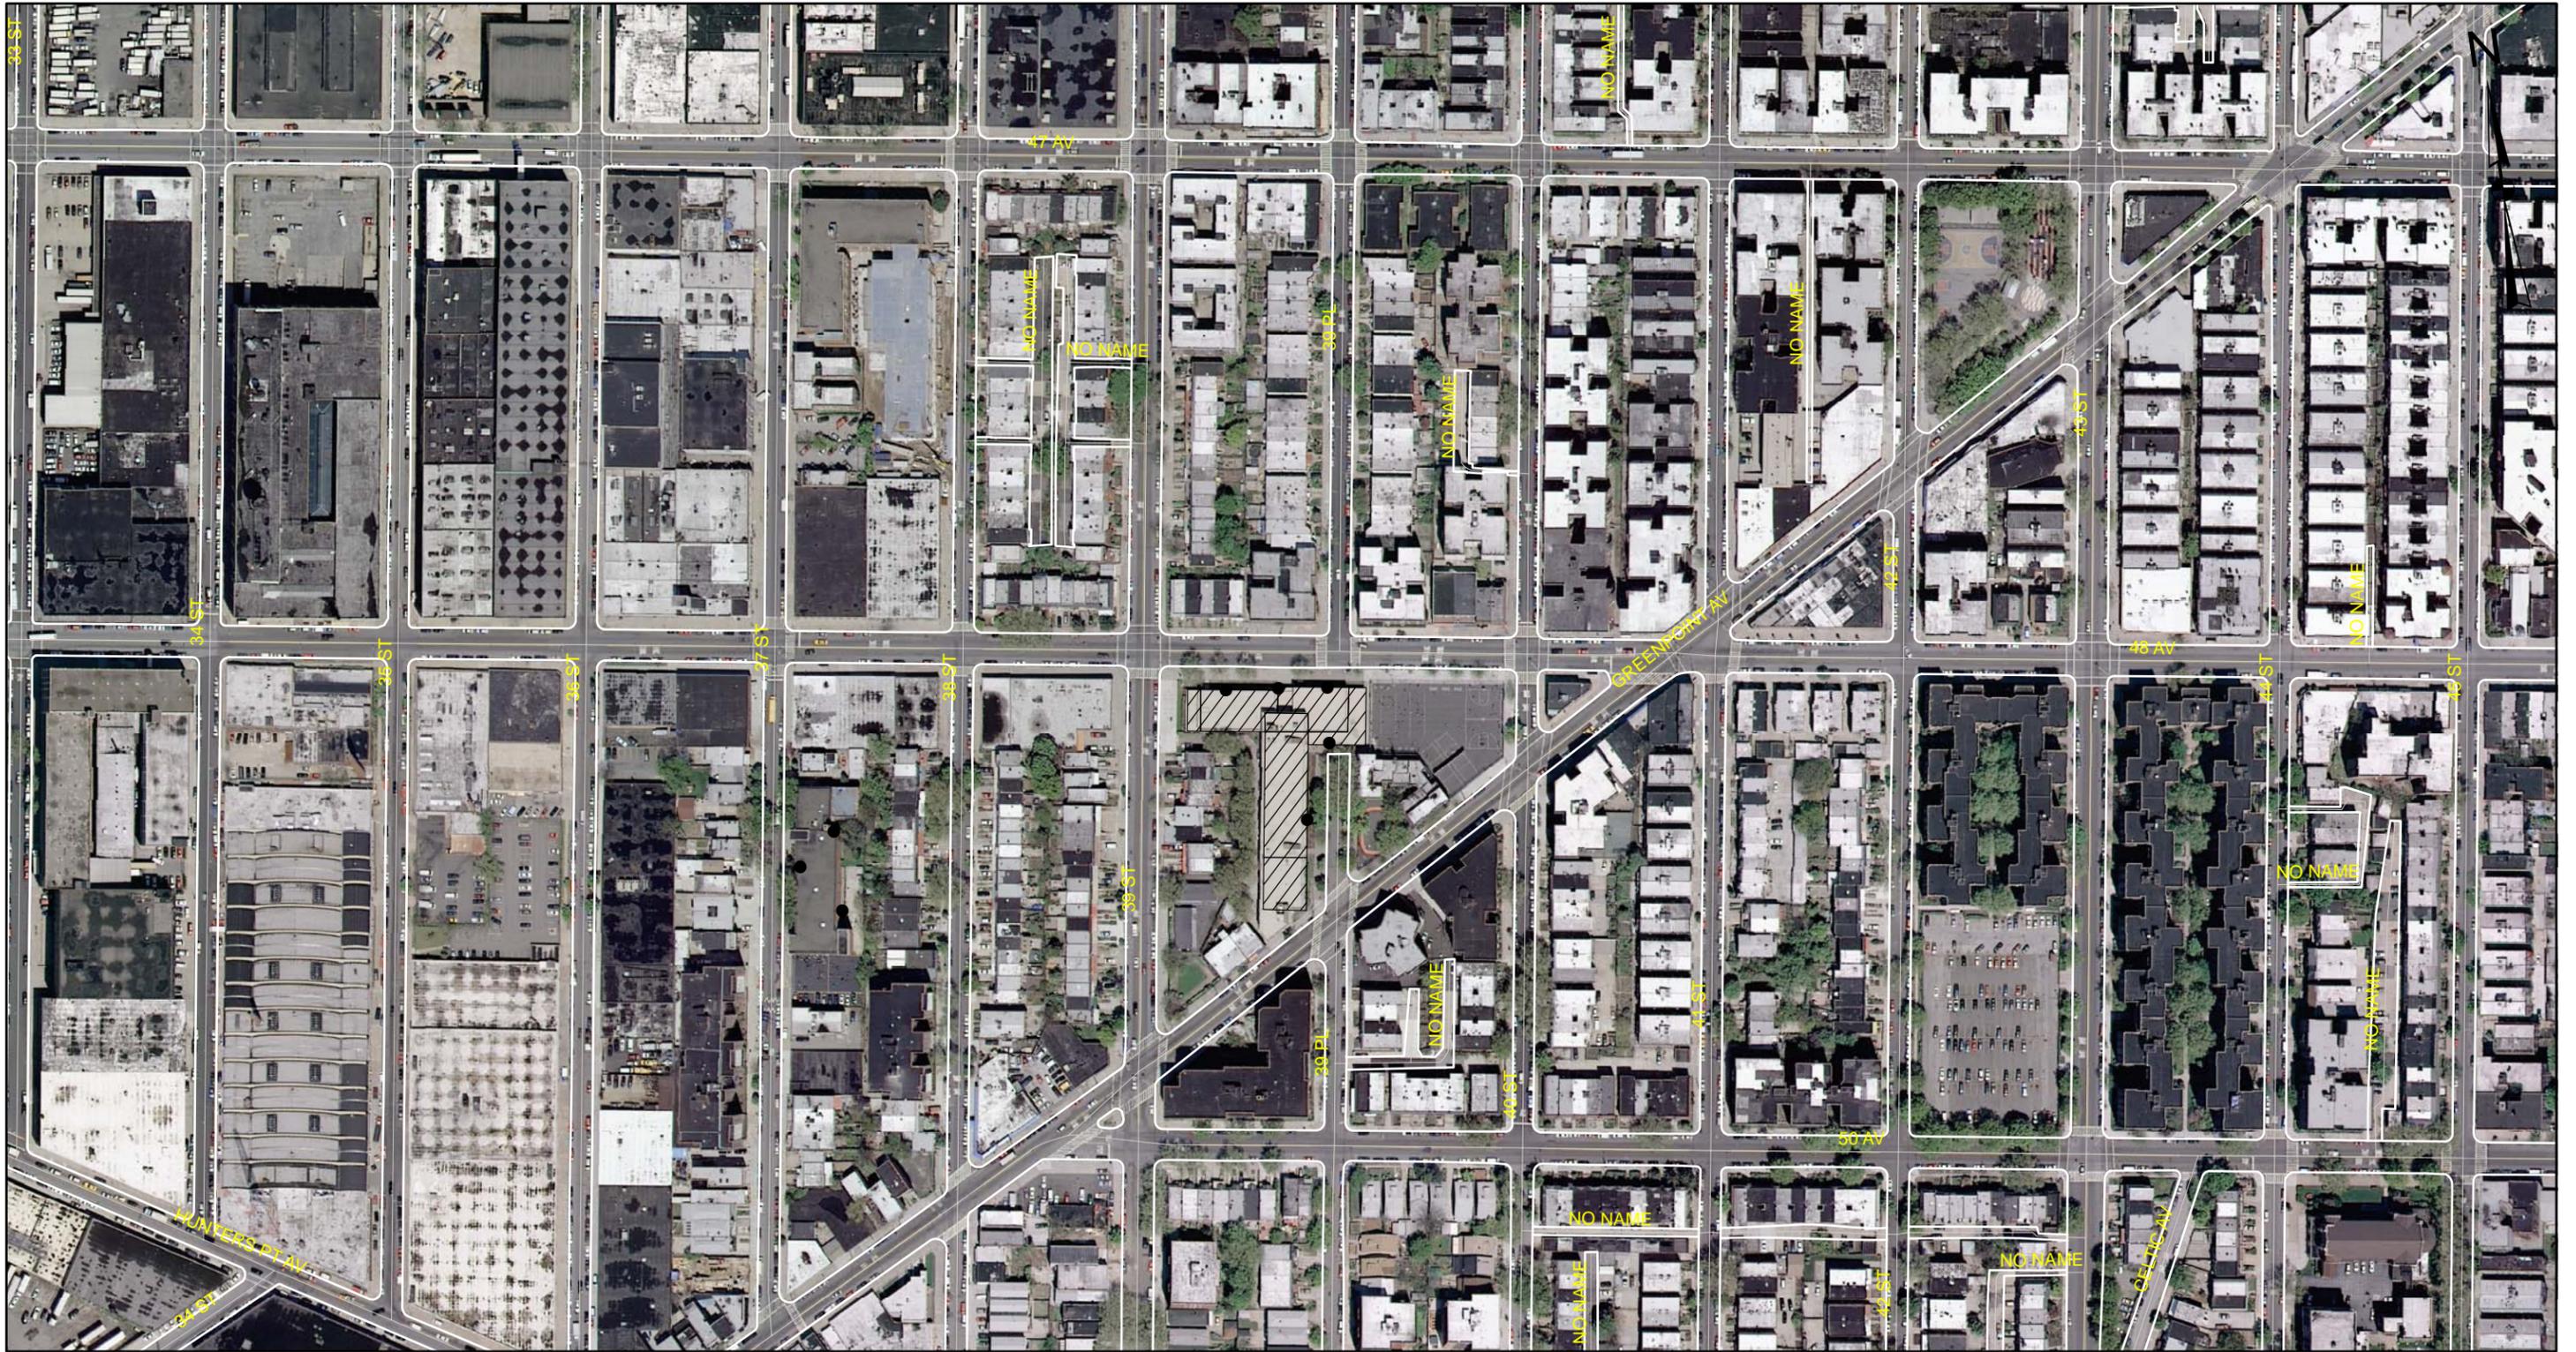
EXHIBIT 1
P.S. 199 QUEENS
MAURICE. A. FITZGERALD SCHOOL
AERIAL PHOTOGRAPH

Exhibit 1, at the end of this section, shows an aerial view of the neighborhood surrounding the school. P.S. 199 is bounded by 48th Avenue on the north, Greenpoint Avenue on the south, 40th Street on the east, and 39th Street on the west. The area surrounding the school is generally residential in character; consisting primarily of one and two family houses and multi-family apartment buildings. Some commercial activity is found on Greenpoint Avenue. Queens Boulevard, a major east-west arterial, is located about two blocks north of the school. A major interchange for the Long Island Expressway and Brooklyn-Queens Expressway is located south of the school.

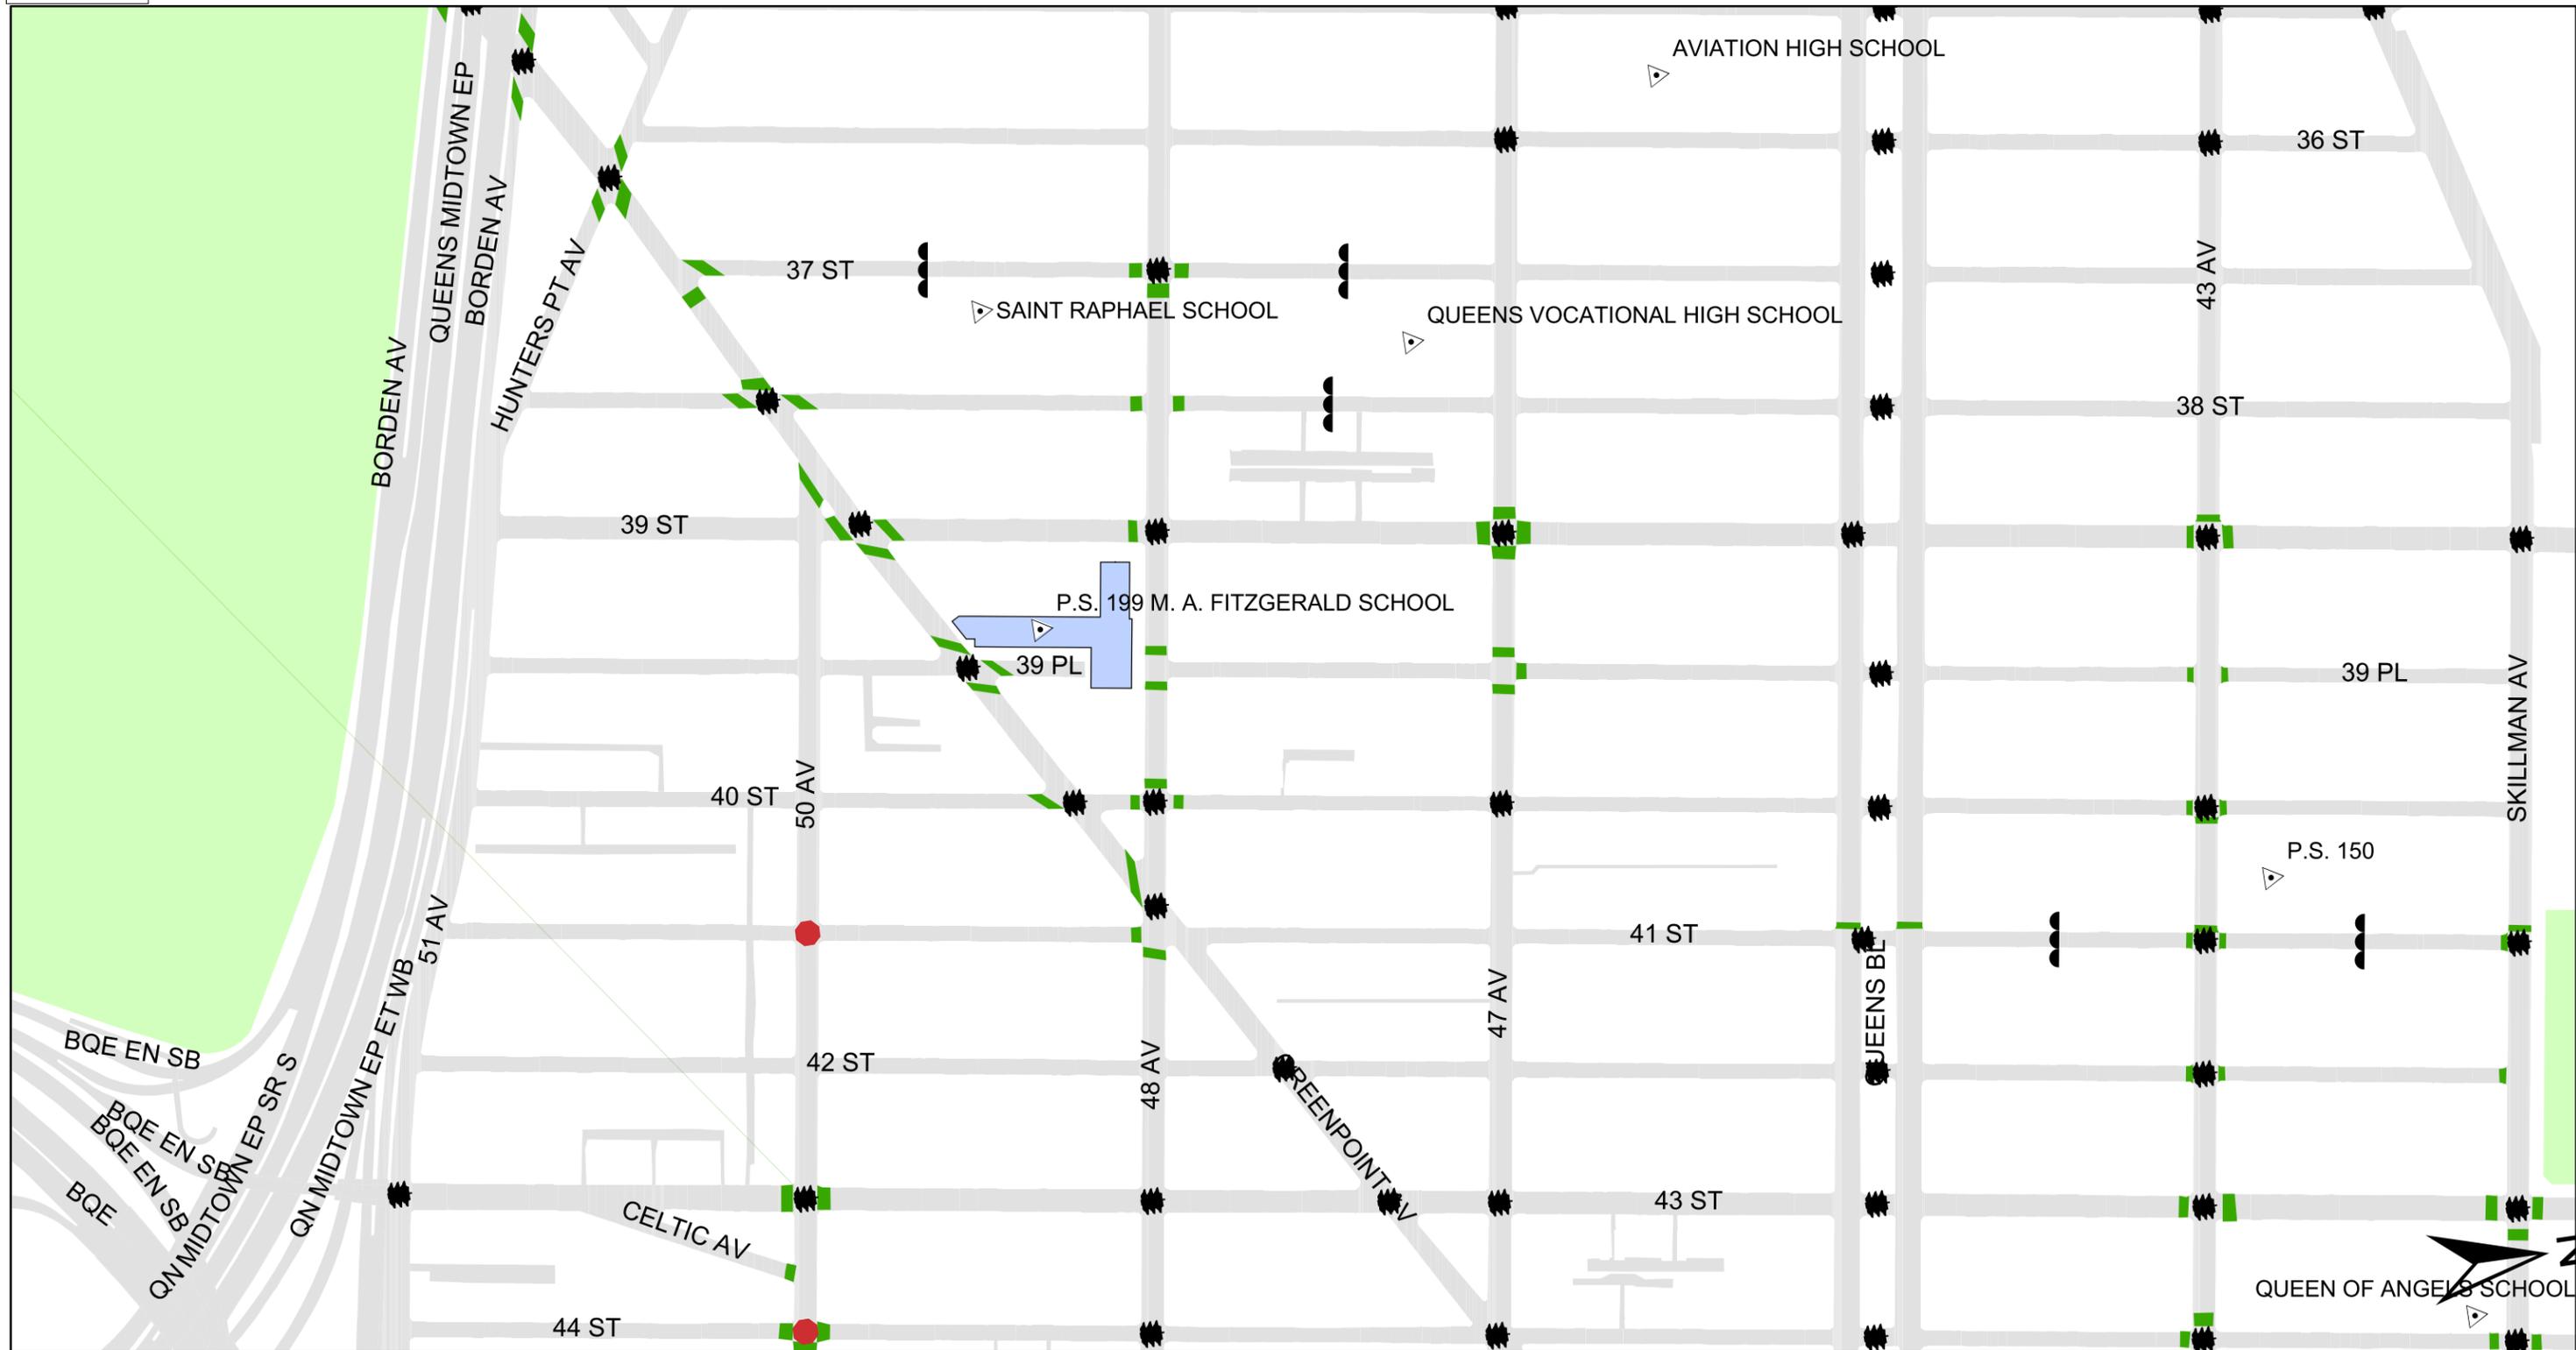
EXHIBIT 3

The School Traffic Safety Map was established to help provide the maximum degree of safety for children going to and from school - by indicating the location of speed reducers, school crosswalks and some traffic control devices. (While virtually all intersections in NYC benefit from traffic control devices - such as stop signs, traffic signals, yield signs, and all way stop signs - this map shows only traffic signals and all way stop signs.) The school crosswalks that are shown are ladder striped and make the crosswalk more visible to drivers and help make the intersection safer. These crosswalks are where school children are recommended to cross.

Exhibit 3, at the end of Section 2, shows the existing school signs, signals, and pavement markings around P.S. 199 as of May 2005. It should be noted that a citywide signage program is currently underway to upgrade school signage to current Federal Manual on Uniform Traffic Control Devices (MUTCD) standards of fluorescent yellow-green accompanied by downward pointing arrows. Signs scheduled to be installed under this program are shown as “existing” in Exhibit 8.

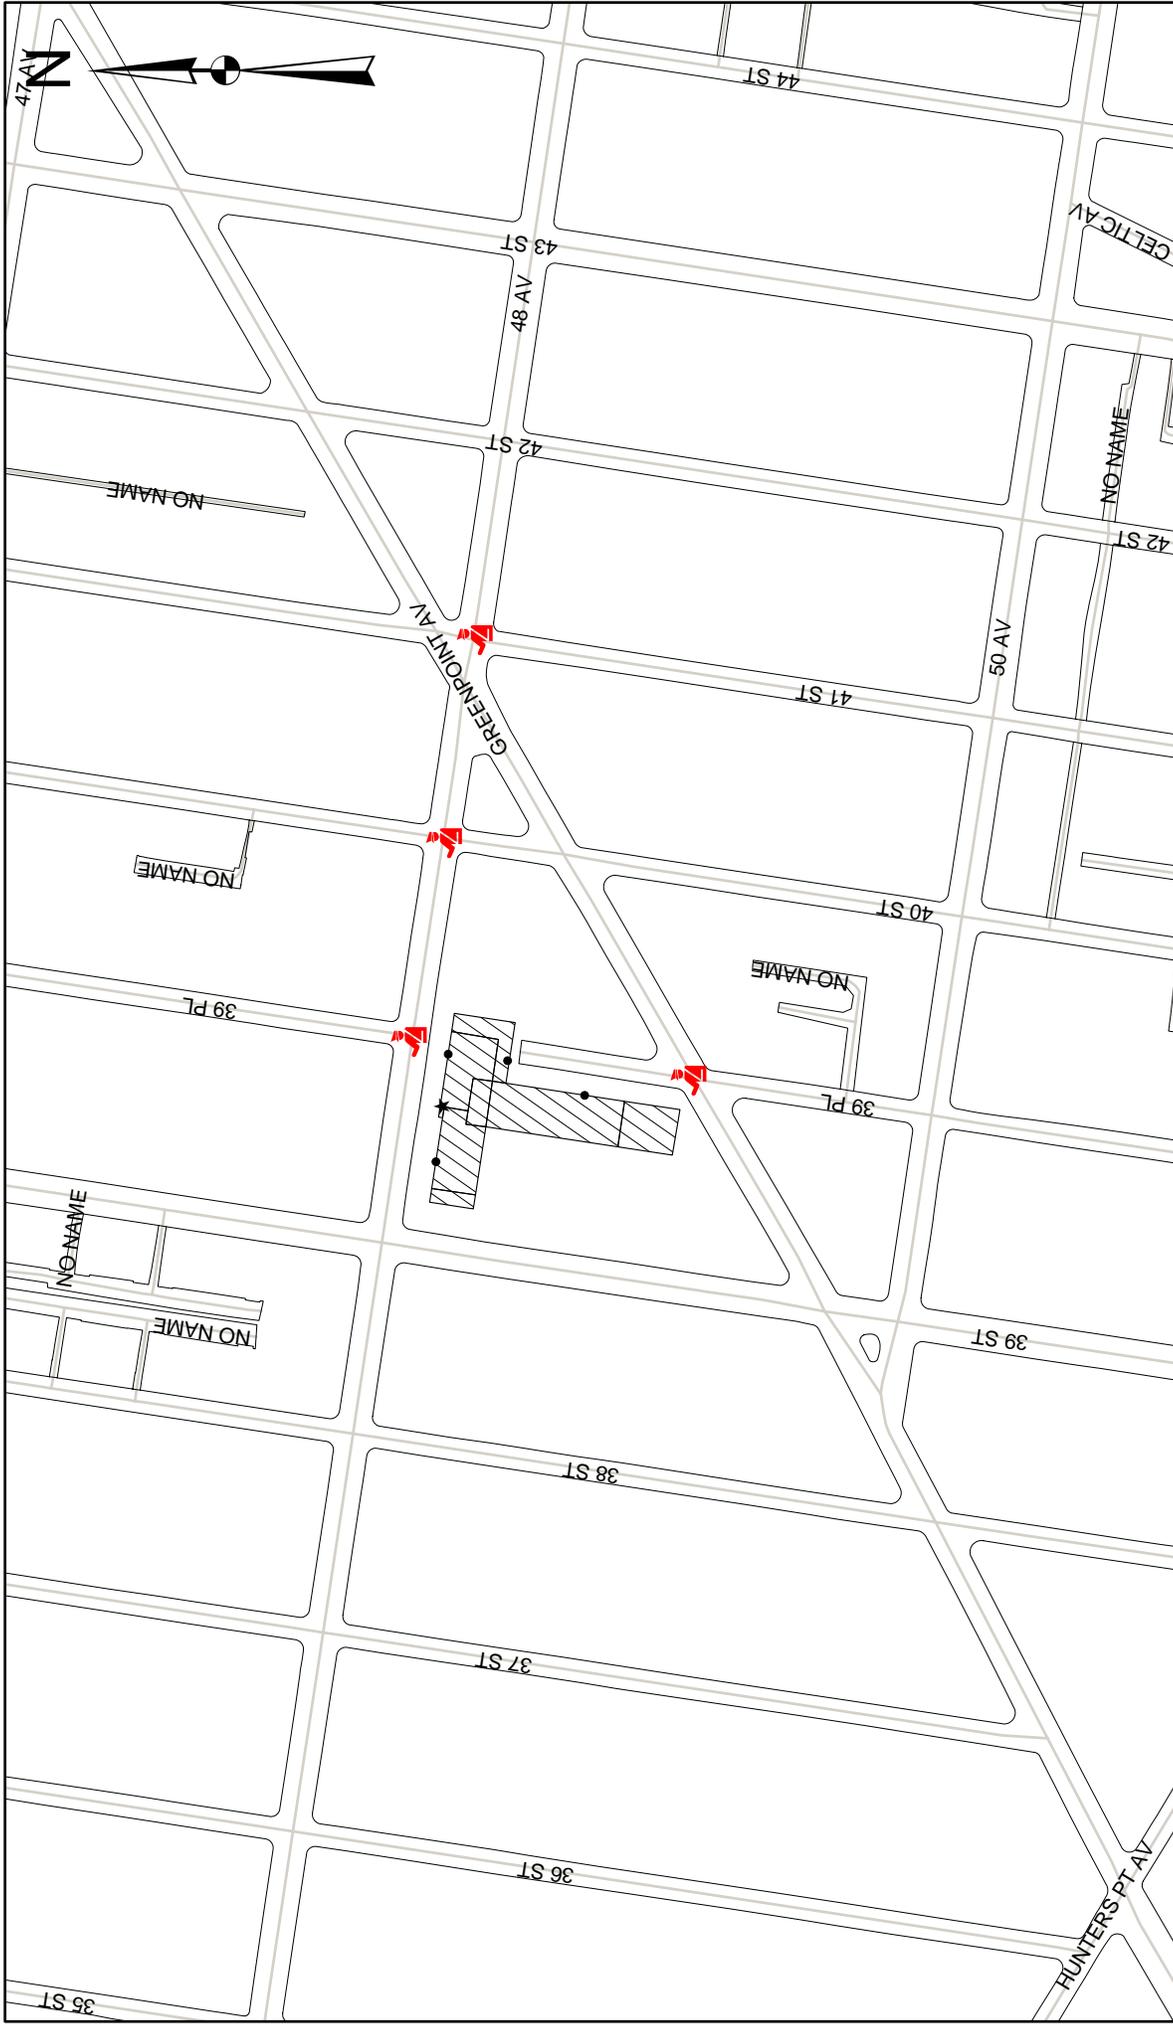
EXHIBIT 4
P.S. 199 QUEENS
MAURICE. A. FITZGERALD SCHOOL
CROSSING GUARDS LOCATION

According to school representatives, crossing guards are assigned to the following four intersections around the school:

- 48th Avenue and 39th Place (see Figure 1)
- 48th Avenue and 40th Street
- Greenpoint Avenue and 48th Avenue
- Greenpoint Avenue and 39th Place

The crossing guard locations are shown in Exhibit 4 at the end of this section.

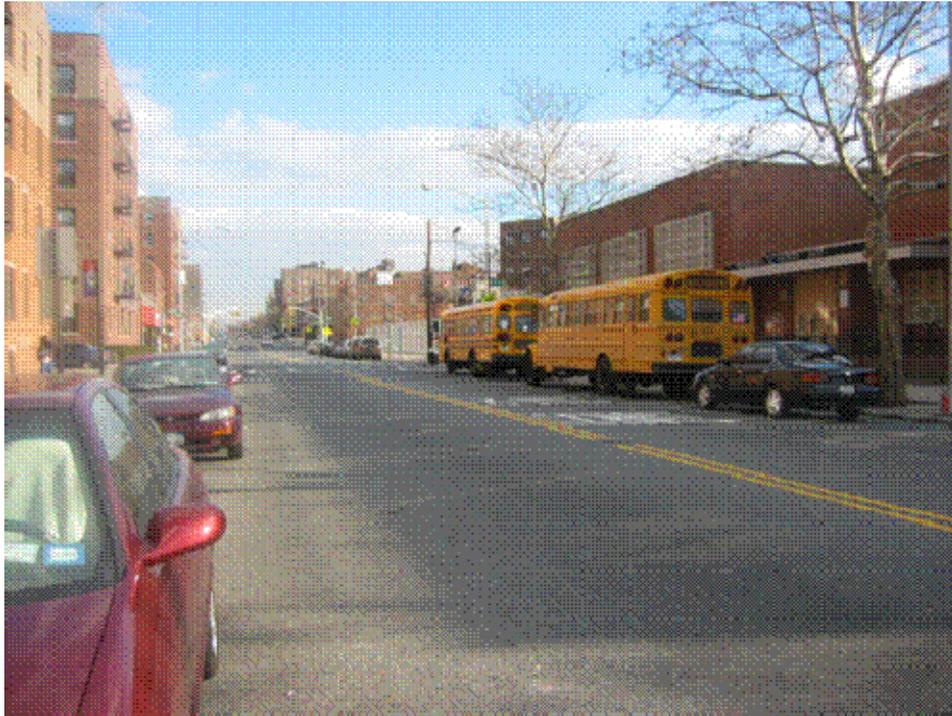
Figure 2: Public school bus transportation on 48th Avenue (school is on right)

According to school representatives, 23% of the students (approximately 230 students) ride a yellow school bus to and from school. The transportation information data provided on the Department of Education school website indicates that P.S. 199 provides general education stop to school transportation for approximately 195 students on six routes with 19 stops. These buses park in front of the school on 48th Avenue (see Figure 2). Thirteen percent (13%) of the students (approximately 130 students) use private bus transportation to and from school. These buses park on Greenpoint Avenue, west of 39th Place (see Figure 3). Three percent of the students (approximately 30 students) ride an MTA bus to and from school. In the vicinity of P.S. 199, the Q39 operates along 48th Avenue and the B24 operates along Greenpoint Avenue. The nearest subway stop is located on Queens Boulevard at 40th Street, which is served by the No. 7 train. School representatives indicated that students did not ride the subway to and from the school.

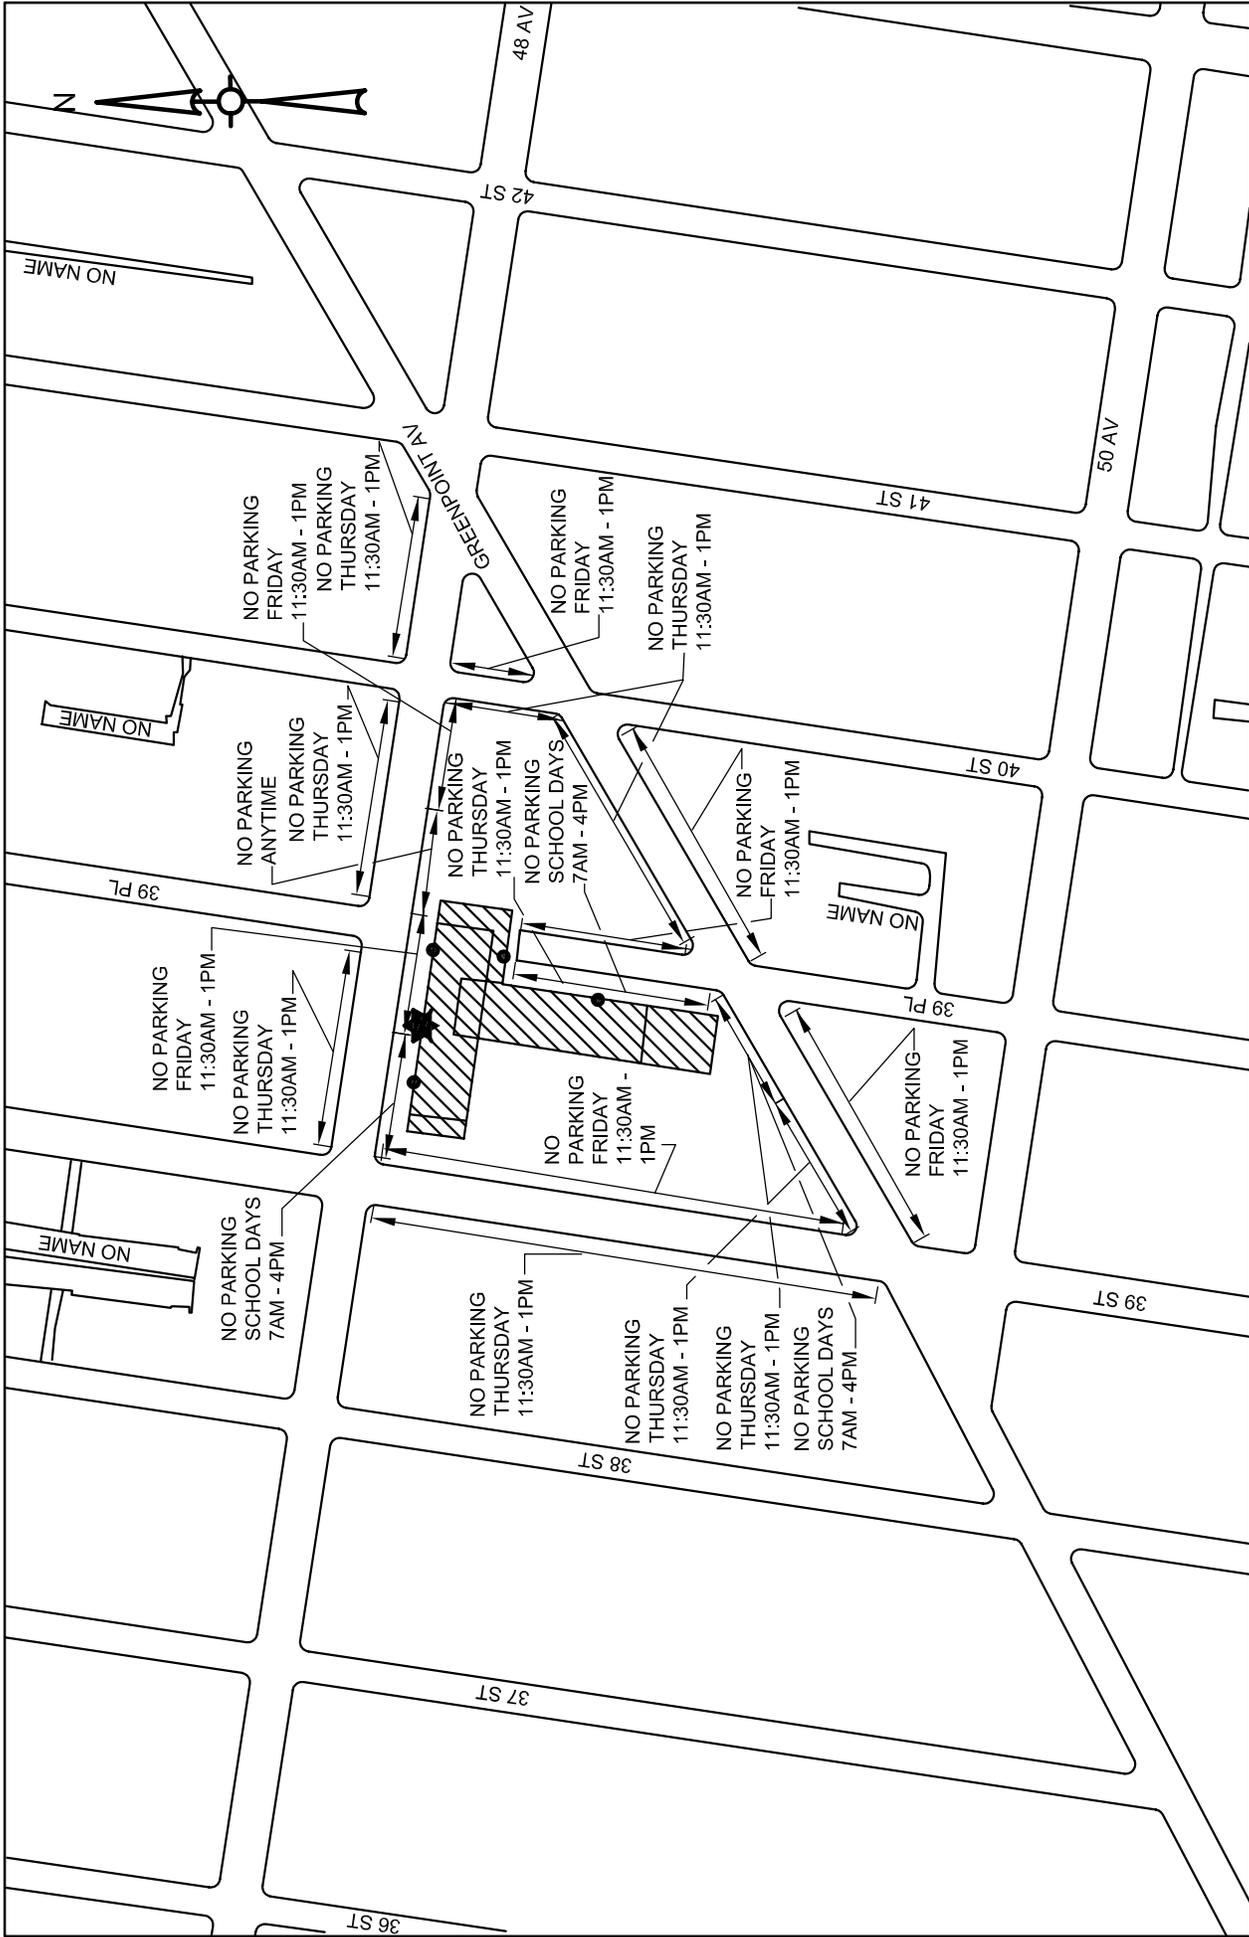
EXHIBIT 5
 P.S. 199 QUEENS
 M.A. FITZGERALD SCHOOL
 EXISTING PARKING REGULATIONS

Parking regulations around the school block are shown in Exhibit 5 of this section.

There are existing “NO PARKING 7AM-4PM SCHOOL DAYS” signs along the south curbside of 48th Avenue just west of the main entrance. These signs should be replaced with “NO STANDING 7AM-4PM SCHOOL DAYS” signs and should be extended to the entire block of 48th Avenue between 39th Place and 40th Street. In addition, there are existing “NO PARKING 7AM-4PM SCHOOL DAYS” signs along the west curb of 39th place and along the north curb of Greenpoint Avenue for about half the block. These signs are recommended to be replaced with “NO STANDING 7AM-4PM SCHOOL DAYS” signs. (A “NO STANDING 7AM-4PM SCHOOL DAYS” sign in front of a school main entrance is a typical requirement for all schools in the City in order to provide for emergency access to and from the school.)

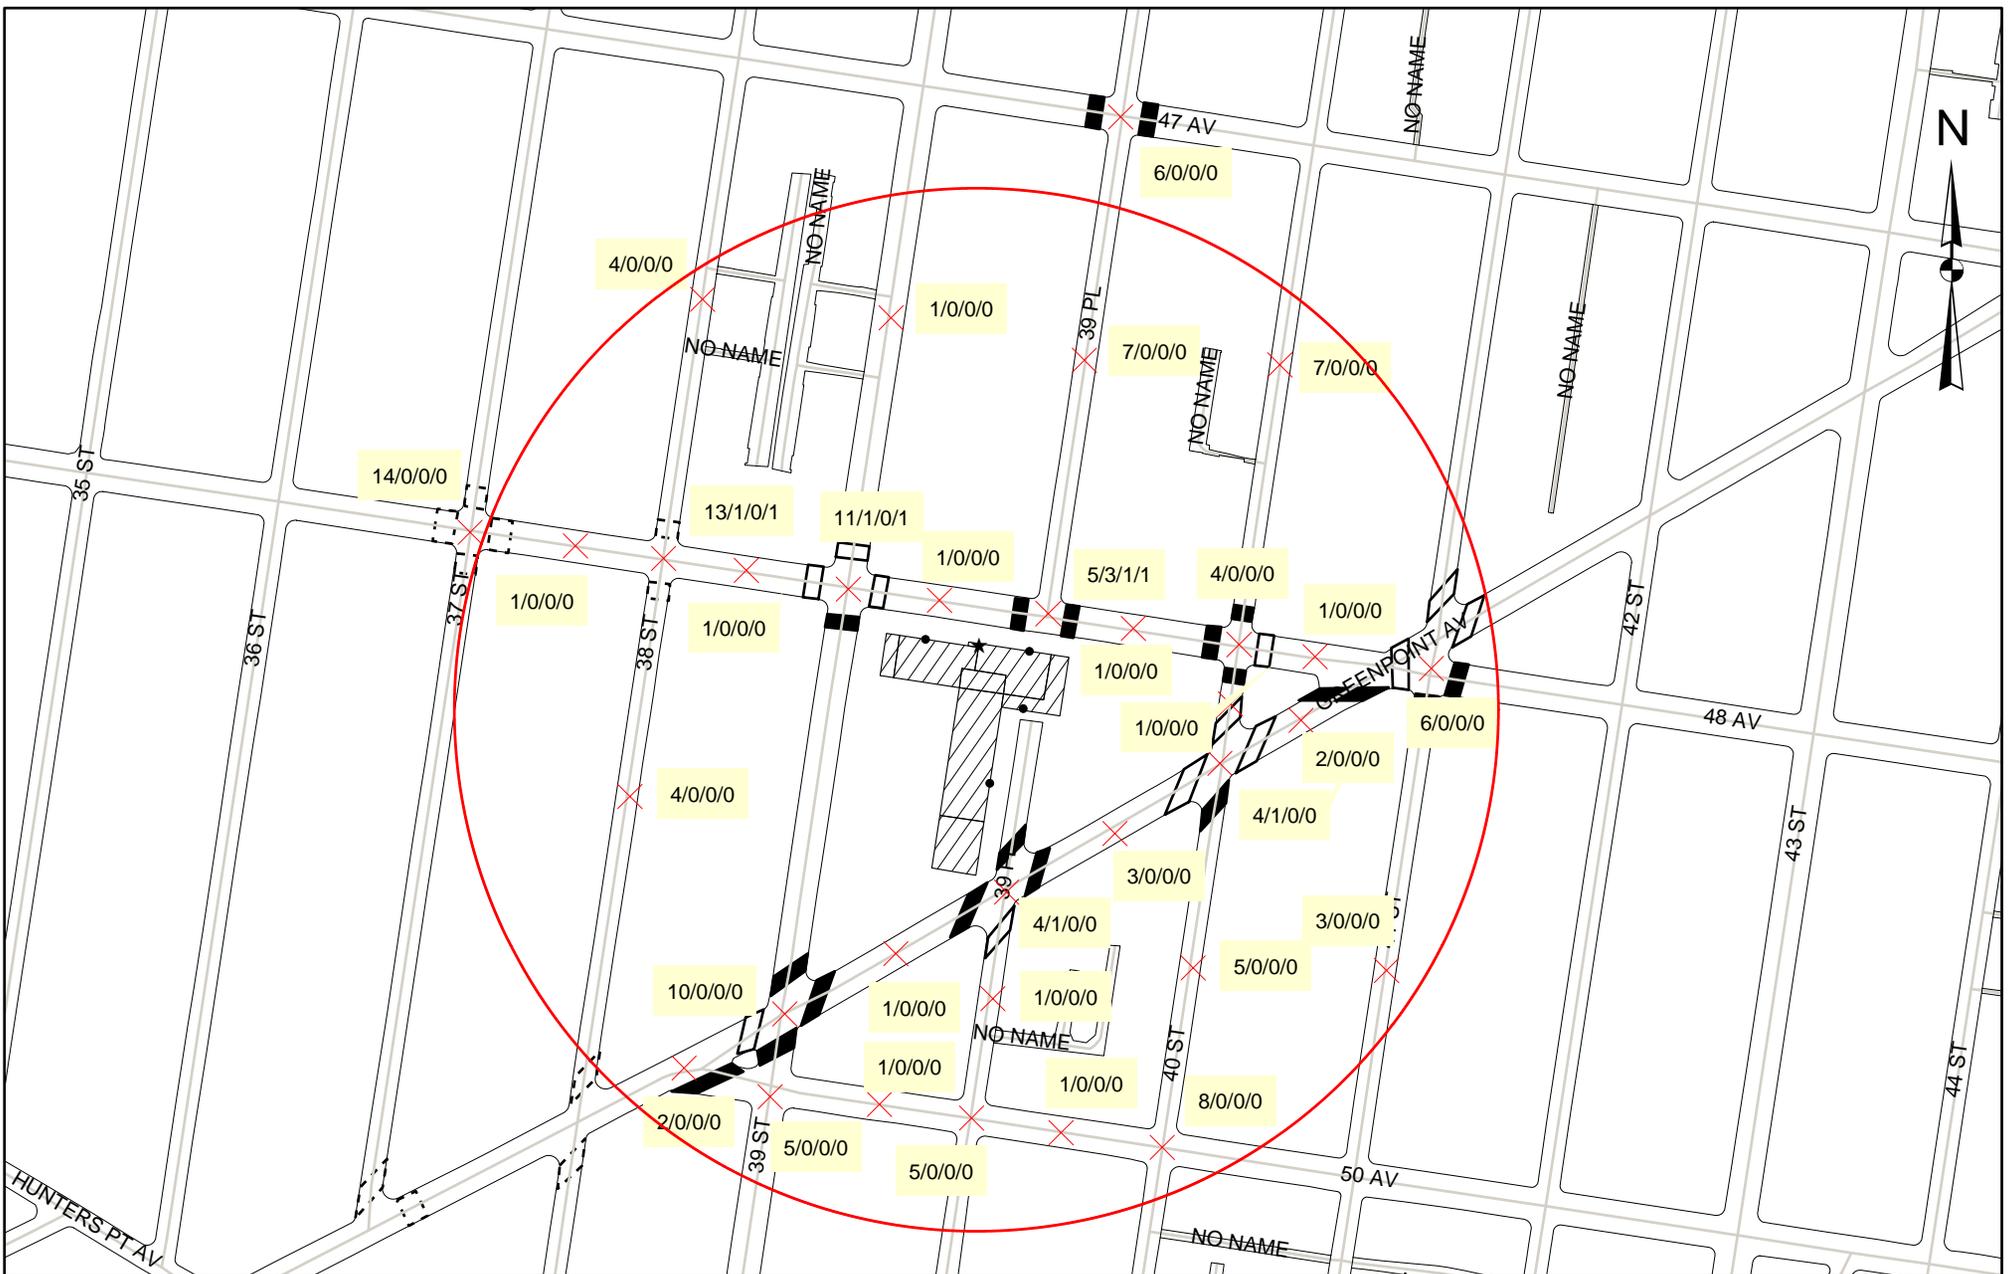
EXHIBIT 6

Exhibit 6 and Table 2 show a summary of accidents, as obtained from the New York State Department of Motor Vehicles (DMV), in the vicinity of P.S 199 for the three-year period from January 1, 1998 through December 31, 2000. The DMV data provides some detail relating to the circumstances and cause of the accident. Table 3 is a summary of more recent accident data obtained from the NYC Police Department (NYPD). Though current through 2004, the NYPD data does not provide the same level of detail as the DMV data.

This report targets intersections closest to the school where the highest concentration of student pedestrians occurs. Intersections farther from the school and locations for which detailed data was not available at the time of this study will be addressed with the ongoing work of DOT's School Safety Engineering Program. DMV Accident data is discussed in Section 3.6, Traffic Operations and Issues.

ACCIDENT SUMMARY (1998-2001)

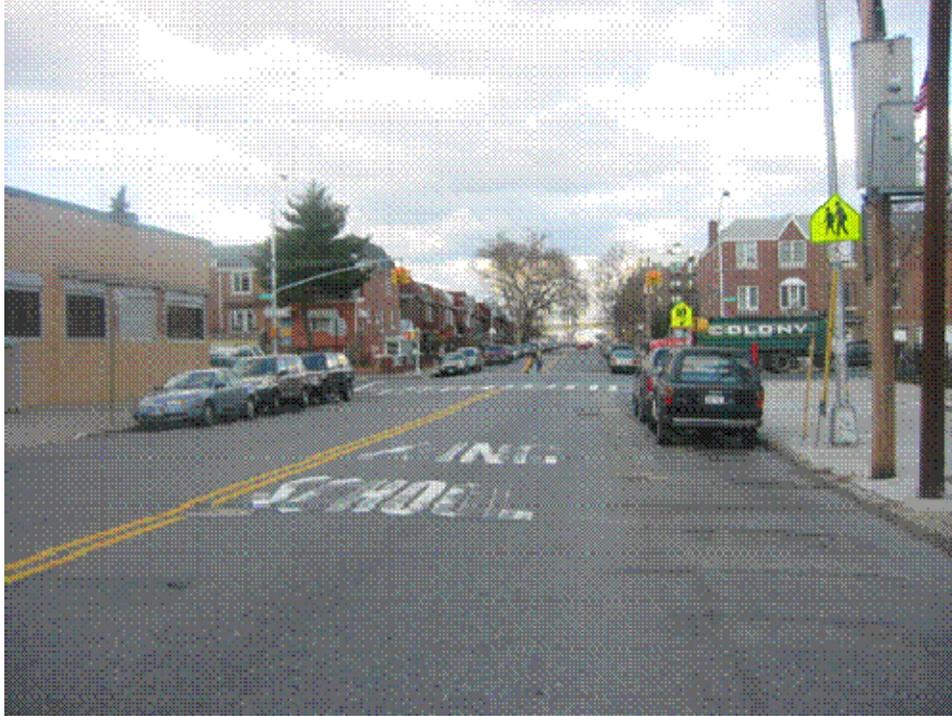
Figure 4: Looking north on 39th Street towards 48th Avenue

This is a signalized four-leg intersection with a school crosswalk located across the south leg of 39th Street and pedestrian crosswalks located across the north leg of 39th Street and east and west legs of 48th Avenue. Both 48th Avenue (east-west) and 39th Street (north-south) are two-way roadways and have one travel lane and a parking lane in each direction of travel (see Figure 4).

There were 11 accidents reported at this intersection between 1998 and 2000 (Table 2), one of which was a school-related accident involving a pedestrian. The school-related accident occurred on Friday, January 21, 2000 at 9:00 am under daylight conditions. It involved an 11-year old pedestrian who was reported struck by a vehicle while crossing the street at the intersection with the signal. The crosswalk location was not reported. The extent of injuries was reported as "non-incapacitating". The accident location was on a straight and level segment, and the roadway and weather conditions were reported as wet and clear, respectively. There were no pedestrian fatalities reported at this intersection during the same three-year period. Between 2001 and 2004 (Table 3), there were 12 accidents reported at this intersection, none of which involved pedestrians.

48th Avenue, which is about 45 feet wide, provides one travel lane in each direction and permits parking on both sides of the roadway. It is therefore recommended to:

- Provide a five-foot striped median between 39th Street and 40th Street, as shown in Exhibit 8.
- Provide a pedestrian refuge island at the east and west legs of 48th Avenue at its intersection with 39th Street.

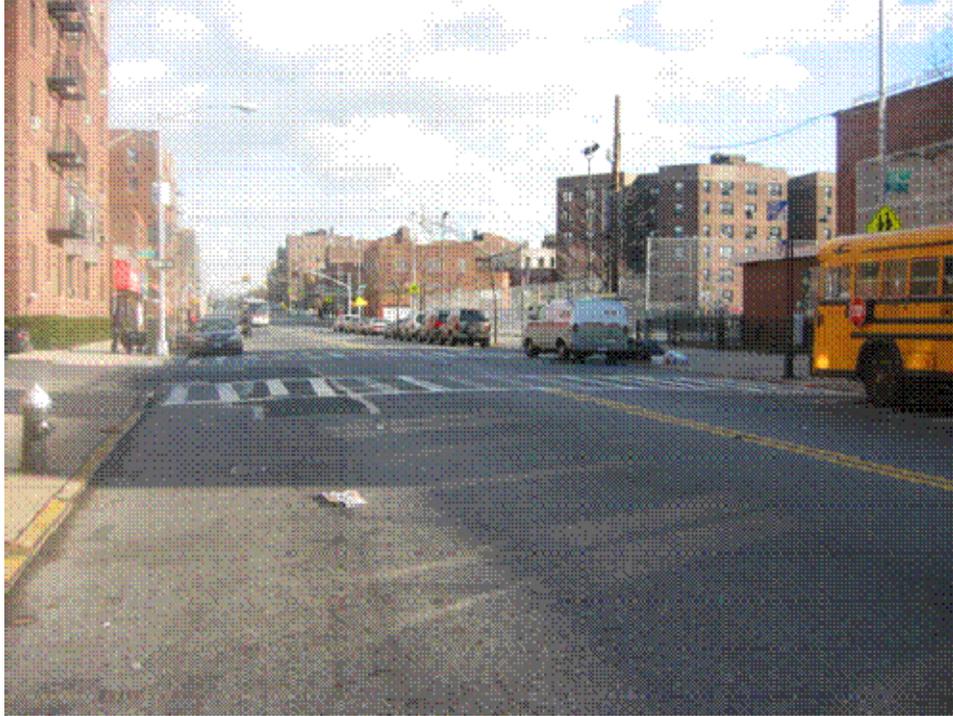
Figure 5: Looking west on 48th Avenue at 39th Place (school is on right)

This is an unsignalized, three-leg T-intersection with no traffic control. School crosswalks are located across the east and west legs of 48th Avenue in front of the main entrance of P.S. 199 (see Figure 5). There is no crosswalk across the north leg of 39th Avenue. 48th Avenue is a two-way, east-west, roadway with one travel lane and a parking lane in both directions of travel. 39th Street is a one-way, northbound, roadway with one travel lane and on-street parking permitted on both sides of the street.

There were five accidents reported at this intersection between 1998 and 2000 (Table 2), including three accidents involving pedestrians. Of these, one accident was school-related and one involved a pedestrian fatality. The school-related accident occurred on Monday, November 2, 1998 at 6:00 pm under dark-road lighted conditions. It involved a 14-year old pedestrian who was reported struck by a vehicle as he/she was crossing the street at the intersection with no traffic control and no marked crosswalk (39th Street leg). The extent of the injuries was reported as “incapacitating”. The pedestrian fatality occurred on Wednesday, October 6, 1999 at 8:00 am under daylight conditions. It involved a 56-year old pedestrian who was reported struck and killed by a vehicle while crossing the street at the intersection with no traffic control and within a marked crosswalk (east or west leg of 48th Avenue). Both accidents occurred on straight and level segments. Roadway and weather conditions were reported as dry and clear, respectively. Between 2001 and 2004 (Table 3), there were also five accidents reported at this intersection. However, none involved pedestrians.

School representatives also reported a speeding problem on 48th Avenue in front of the school. In order to verify the existence of a speeding problem and to determine its extent, a spot speed survey was conducted on 48th Avenue between 39th Street and 39th Place in both the eastbound and westbound directions. The results of the survey indicated that for the 85th percentile speeds vehicles on 48th Avenue were traveling at 34 mph in the eastbound direction and 36 mph in the westbound direction which is above the recommended 30 mph threshold.

The 85th percentile speed is considered to be the representative speed for a specified street segment. An 85th percentile speed above the 30 mph threshold would flag a potential speeding problem that may require the appropriate traffic calming measure. Recommendations to alleviate speeding on 48th Avenue in front of P.S. 199, in association with the above accident history and traffic count conducted at this intersection, are discussed in Section 4.0. Summaries of the spot speed surveys on 48th Avenue are provided in the Appendix at the end of the document.

This intersection experienced five (5) accidents during a three-year period between 1998 and 2000, including one pedestrian fatality and one school-related accident. The uncontrolled school crosswalks are located across the east and west legs of 48th Avenue at its intersection with 39th Place. I.S. 199 students were observed crossing 48th Avenue at 39th Place, and the school is immediately adjacent to the intersection. A preliminary traffic signal warrant assessment was performed that indicated the installation of a traffic signal is not warranted. It is therefore recommended to:

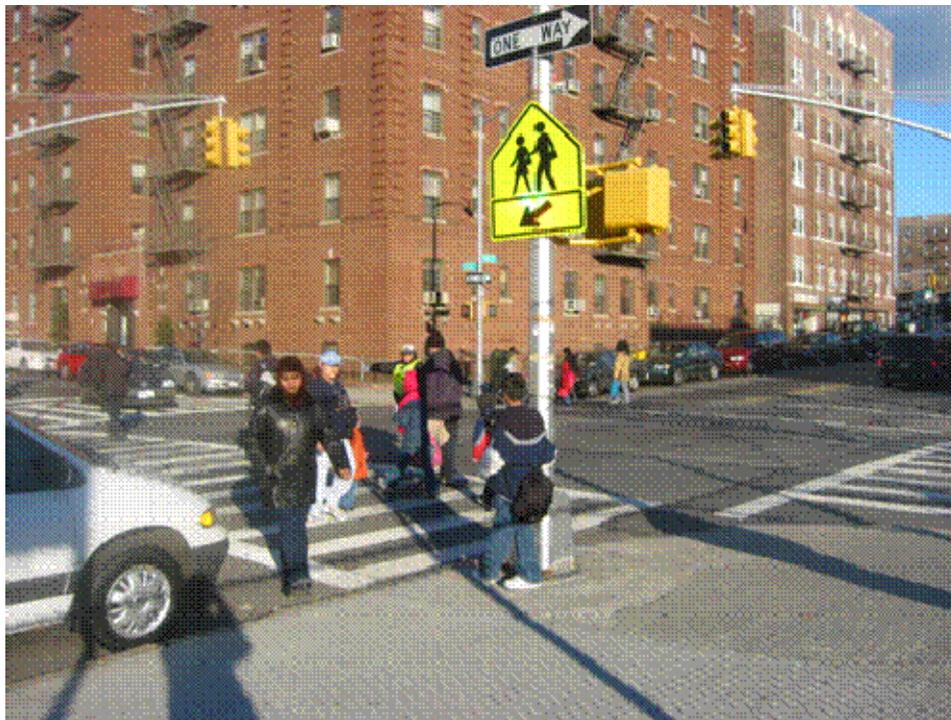
Figure 6: Looking northeast at 48th Avenue at 40th Street intersection (school crossing guard is in center)

This is a signalized, four-leg intersection with a school crosswalk located across the east leg of 48th Avenue and the north and south legs of 40th Street (see Figure 6). A pedestrian crosswalk is located across the west leg of 48th Avenue. 48th Avenue is a two-way, east-west, roadway with one travel lane and a parking lane in both directions of travel. 40th Street is a one-way, southbound, roadway with one travel lane and on-street parking permitted on both sides of the street.

There were four accidents reported at this intersection between 1998 and 2000 (Table 2), none of which involved pedestrians. Between 2001 and 2004 (Table 3), there were 11 accidents reported at this intersection, including two involving pedestrians. Neither of the pedestrian accidents was school-related. There were no pedestrian fatalities reported at this intersection during the same four-year period.

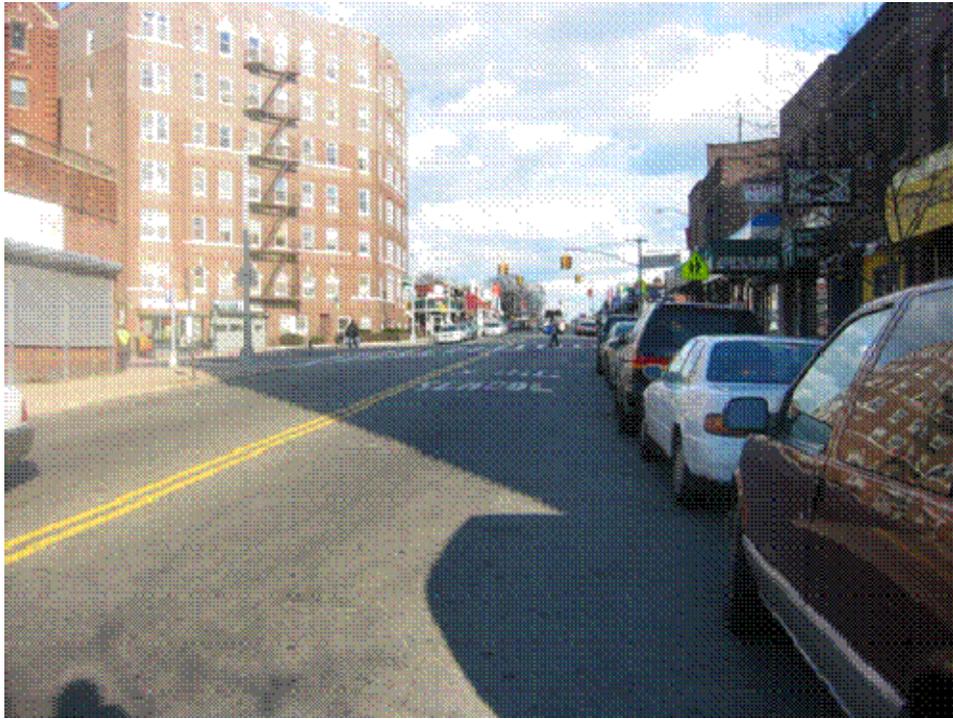
Figure 7: Looking east on Greenpoint Avenue towards 48th Avenue

This is a signalized, six-leg intersection with school crosswalks across the east leg of 48th Avenue, the southwest leg of Greenpoint Avenue, and the south leg of 41st Street. Pedestrian crosswalks are located across the west leg of 48th Avenue, the northeast leg of Greenpoint Avenue and the north leg of 41st Street. 48th Avenue (east-west) and Greenpoint Avenue (northeast-southwest) are both two-way roadways with one travel lane and a parking lane in both directions of travel (see Figure 7). 41st Street is a one-way, northbound, roadway with one travel lane and on-street parking permitted on both sides of the street. Bus stops for the Q39 (48th Avenue) and B24 (Greenpoint Avenue) are located at this intersection.

There were six accidents reported at this intersection between 1998 and 2000 (Table 2), none of which involved pedestrians. Between 2001 and 2004 (Table 3), there were five accidents reported at this intersection; none involved pedestrians.

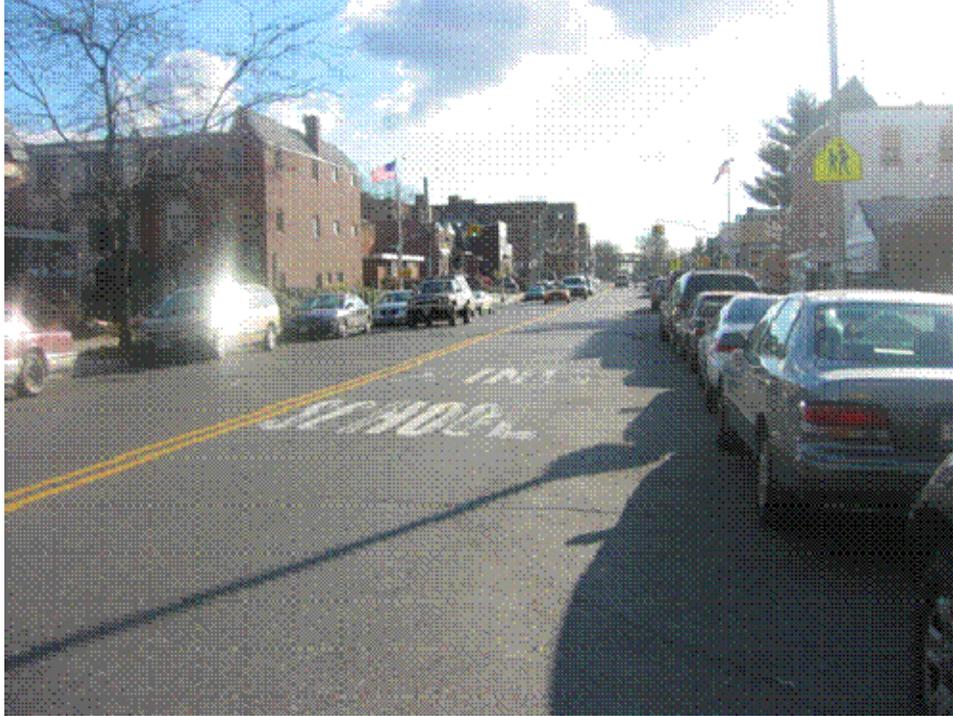
Figure 8: Looking south on 39th Street towards Greenpoint Avenue

This is a signalized, four-leg intersection with school crosswalks across the east leg of Greenpoint Avenue, the north and south legs of 39th Street, and the south leg of 50th Avenue. A pedestrian crosswalk is located across the west leg of Greenpoint Avenue. Greenpoint Avenue (east-west) and 39th Street (north-south) are both two-way roadways with one travel lane and a parking lane in each direction of travel (see Figure 8).

There were ten accidents reported at this intersection between 1998 and 2000 (Table 2), none of which involved pedestrians. Between 2001 and 2004 (Table 3), there were 19 accidents reported at this intersection, including four accidents involving pedestrians. Of these, one was school-related. However, no additional information about this school-related accident is available. There were no pedestrian fatalities reported at this intersection during the same four-year period.
