**New York City Department of Transportation
Office of School Safety Engineering**

School Safety Engineering Project

FINAL REPORT: P.S. 199 (Maurice A. Fitzgerald School), Queens

July 10, 2006

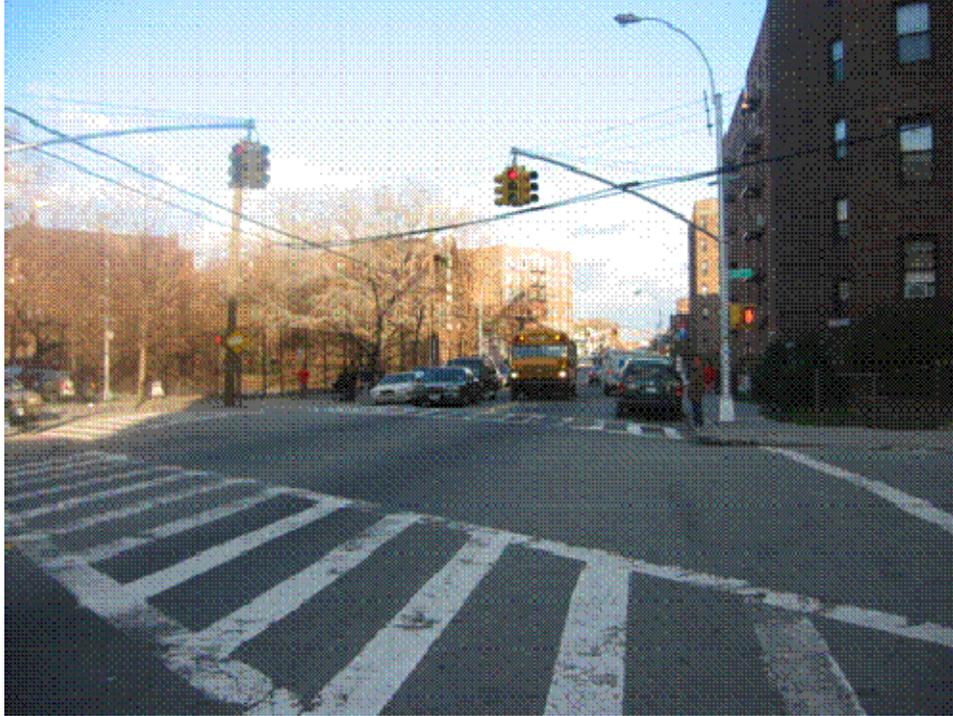
Figure 9: Looking west on Greenpoint Avenue at 39th Place

This is a signalized, four-leg intersection with school crosswalks across the east and west legs of Greenpoint Avenue and the north leg of 39th Place. A pedestrian crosswalk is located across the south leg of 39th Place. Greenpoint Avenue (east-west) and 39th Place (north-south) are both two-way roadways with one travel lane and a parking lane in each direction of travel (see Figure 9). The north leg of 39th Place is a dead-end street with access to P.S. 199 (see Figures 10 and 11).

There were four accidents reported at this intersection between 1998 and 2000 (Table 2), including one involving a pedestrian, which was not school-related. There were no pedestrian fatalities reported at this intersection during the same three-year period. Between 2001 and 2004 (Table 3), there were six accidents reported at this intersection, none of which involved pedestrians.

To address the school's concerns at Greenpoint Avenue and 39th Place, school representatives should request the assistance of NYPD officers to enforce parking regulations around the school during arrival and dismissal times, particularly at Greenpoint Avenue and 39th Place. Vehicles double-parking on Greenpoint Avenue and obstructing school crosswalks and the bus loading/unloading zone, were observed ignoring the crossing guard directions to clear the intersection. This would provide a safer environment for P.S. 199 students.

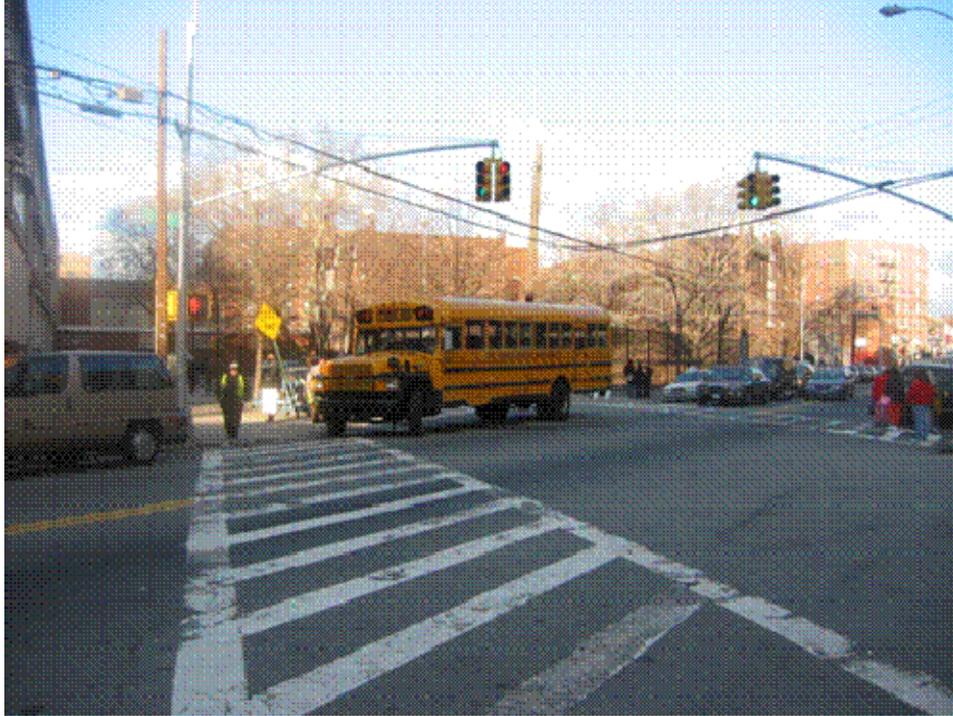
Figure 11: School bus waiting in Greenpoint Avenue at 39th Place intersection to board students at dismissal time (school crossing guard is in crosswalk in front of school bus)

- Double-parking on Greenpoint Avenue near 39th Place was reported as a problem, particularly at dismissal time. Vehicles block school entrances/exits, the bus loading/unloading zone, and school crosswalks. The representatives are also concerned about the safety of the crossing guard at this location.
- Vehicles are traveling at excessive speeds on 48th Avenue in front of the school.
- Lack of parking for school staff was reported as a problem.

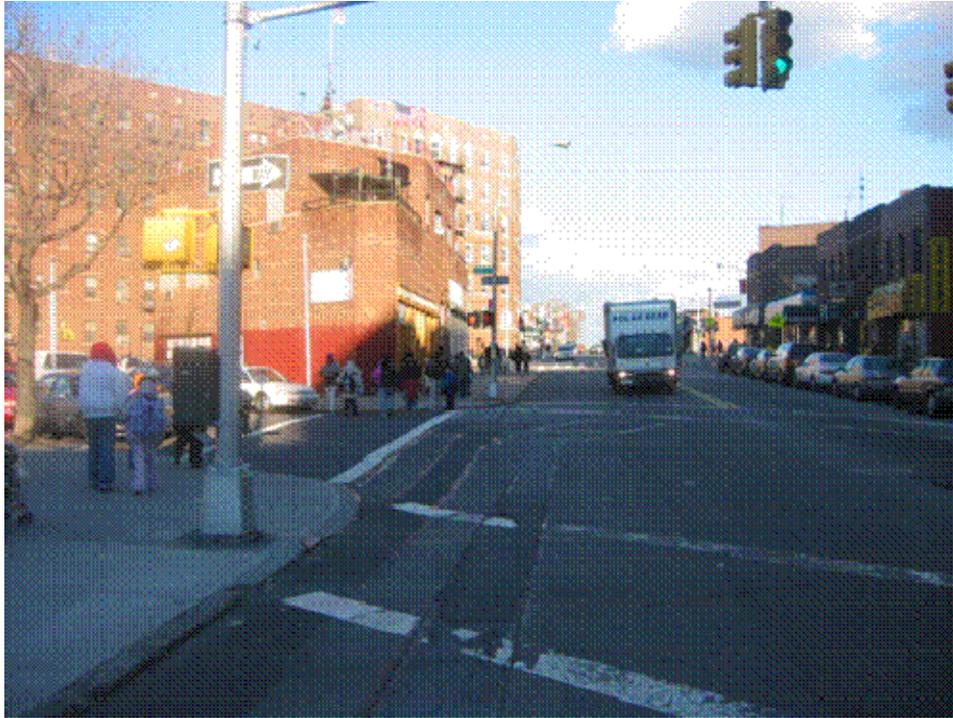
Figure 12: Looking east on Greenpoint Avenue at 40th Street

This is a signalized, four-leg intersection with a school crosswalk across the south leg of 40th Street. Pedestrian crosswalks are located across the east and west legs of Greenpoint Avenue, and the north leg of 40th Street. Greenpoint Avenue is a two-way, east-west, roadway with one travel lane and a parking lane in both directions of travel (see Figure 12). 40th Street is a one-way, southbound, roadway with one travel lane and on-street parking permitted on both sides of the street.

There were four accidents reported at this intersection between 1998 and 2000 (Table 2), including one involving a pedestrian, which was not school-related. There were no pedestrian fatalities reported at this intersection during the same three-year period. Between 2001 and 2004 (Table 3), there were also four accidents reported at this intersection, none of which involved pedestrians.

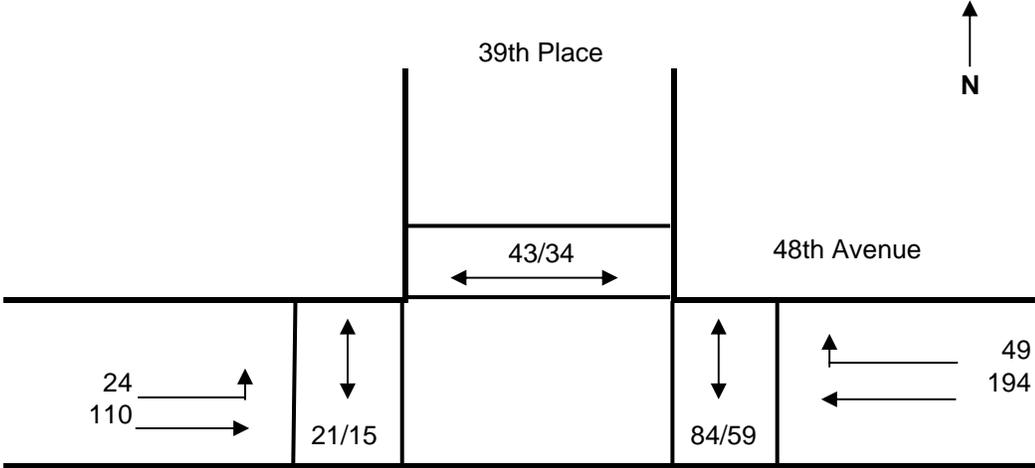
Intersection of 48th Avenue and 39th Place

In order to determine the appropriate traffic control for the school crosswalks, a preliminary traffic signal warrant assessment was performed to assess the traffic situation and determine what type of traffic control devices would be appropriate. A traffic count was at the intersection of 48th Avenue and 39th Place from 7:30 am to 9:00 am on Friday, October 7, 2005. The results of the peak hour (7:30 am to 8:30 am) count are shown in Tables 4, 5, 6 and 7 and in Exhibit 6A at the end of this section.

TABLE 4: VEHICLE VOLUMES (7:30 - 8:30 AM)				
INTERSECTION	48 th Avenue EASTBOUND		48 th Avenue WESTBOUND	
	Left	Straight	Straight	Right
48 th Avenue and 39 th Place	24	110	194	49
TOTAL	134		243

TABLE 5: PEDESTRIAN VOLUMES (7:30 - 8:30 AM)			
INTERSECTION	Crossing 39th Place NORTH -LEG CROSSWALK	Crossing 48th Avenue EAST -LEG CROSSWALK	Crossing 48th Avenue WEST -LEG CROSSWALK
48 th Avenue and 39 th Place	77 (43 / 34) *	143 (84 / 59) *	36 (21 / 15) *
* Numbers in parenthesis indicate (adults / students).

One Hour Traffic Volumes
Wednesday, October 7, 2005 7:30am - 8:30am

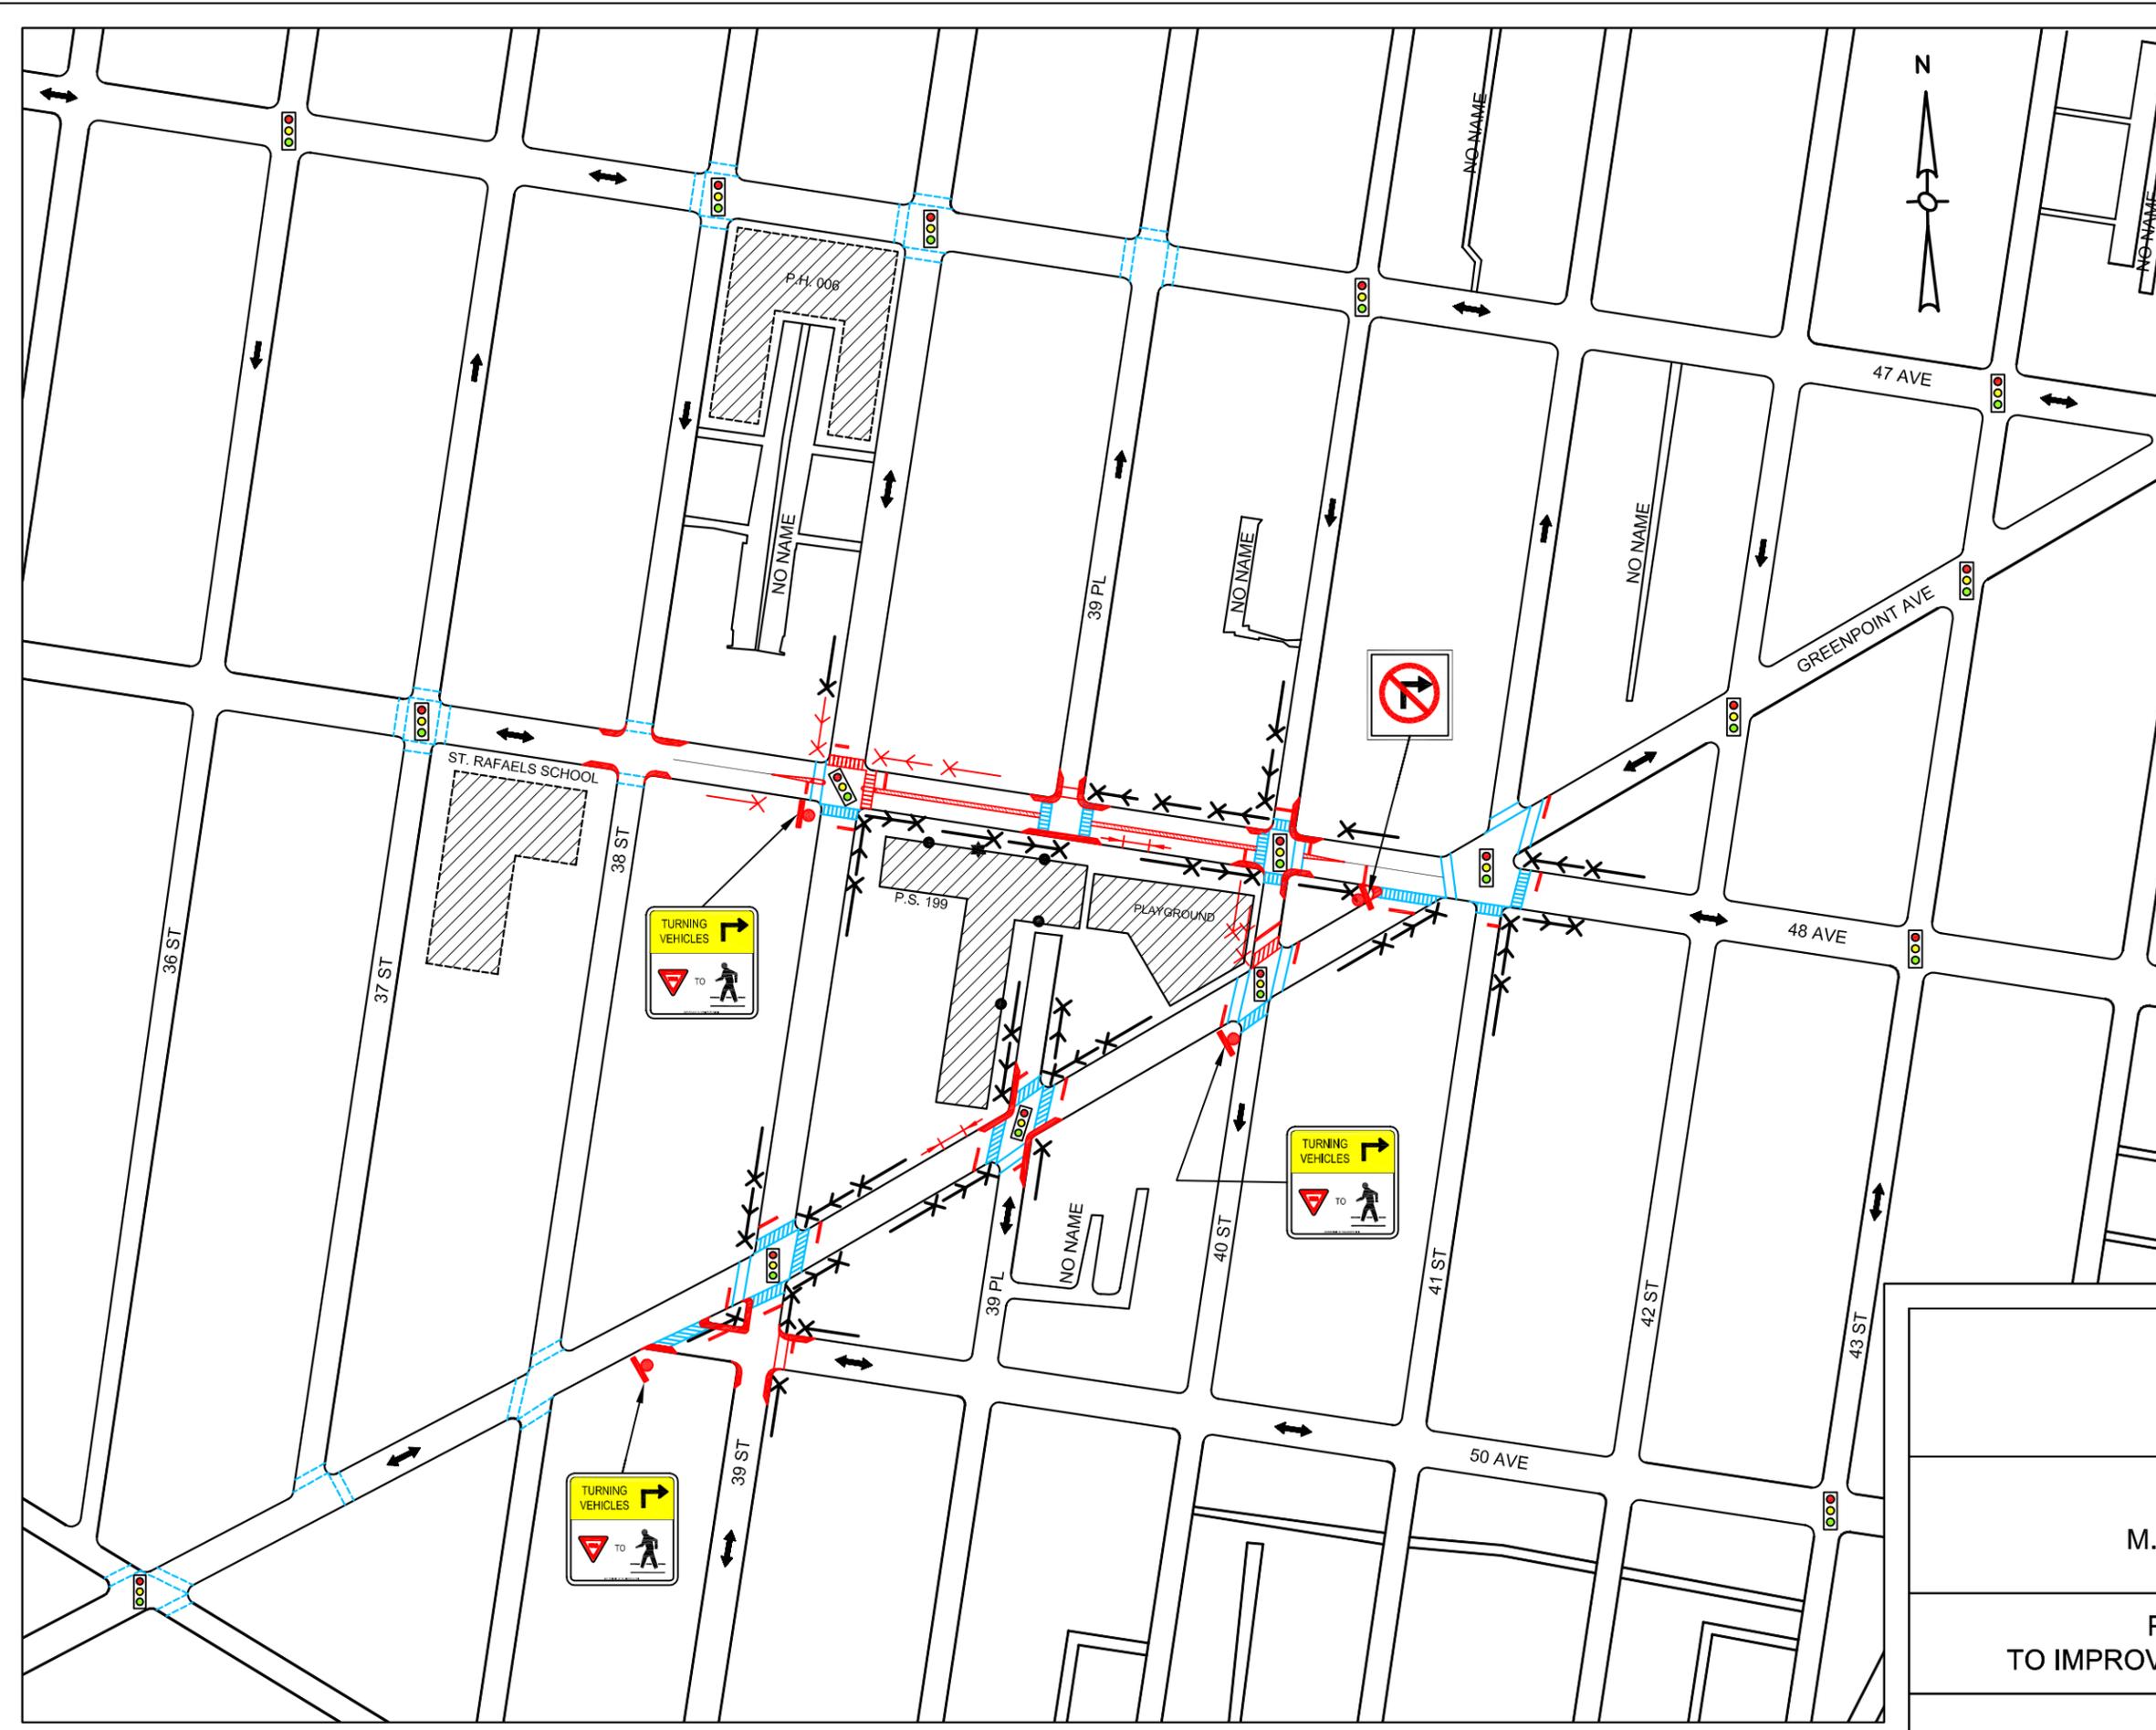
PROPOSED MEASURES
TO IMPROVE SCHOOL PEDESTRIAN SAFETY

This section describes the proposed measures to improve school pedestrian safety around P.S. 199. The proposed recommendations are divided into short-term and long-term measures. Short-term measures are those that potentially can be performed in-house. Long-term measures involve capital improvements. Each of the short- and long-term measures recommended for P.S. 199 is discussed as follows, and is shown in more detail in Exhibit 8 at the end of this section.

- Provide a five-foot striped median between 39th Street and 40th Street, as shown in Exhibit 8.
- Provide a pedestrian refuge island at the east and west legs of 48th Avenue at its intersection with 39th Street.

The refuge islands with extended medians will provide a refuge for pedestrians who do not complete the crossing during the flashing “Don’t Walk” indication. The proposed extended median should extend beyond the crosswalk, and should have at least 5-feet at grade cut through section. These medians are not proposed where they would hinder the ability of vehicles to turn. Final details pertaining to proposed extended medians will be developed during Final Design.

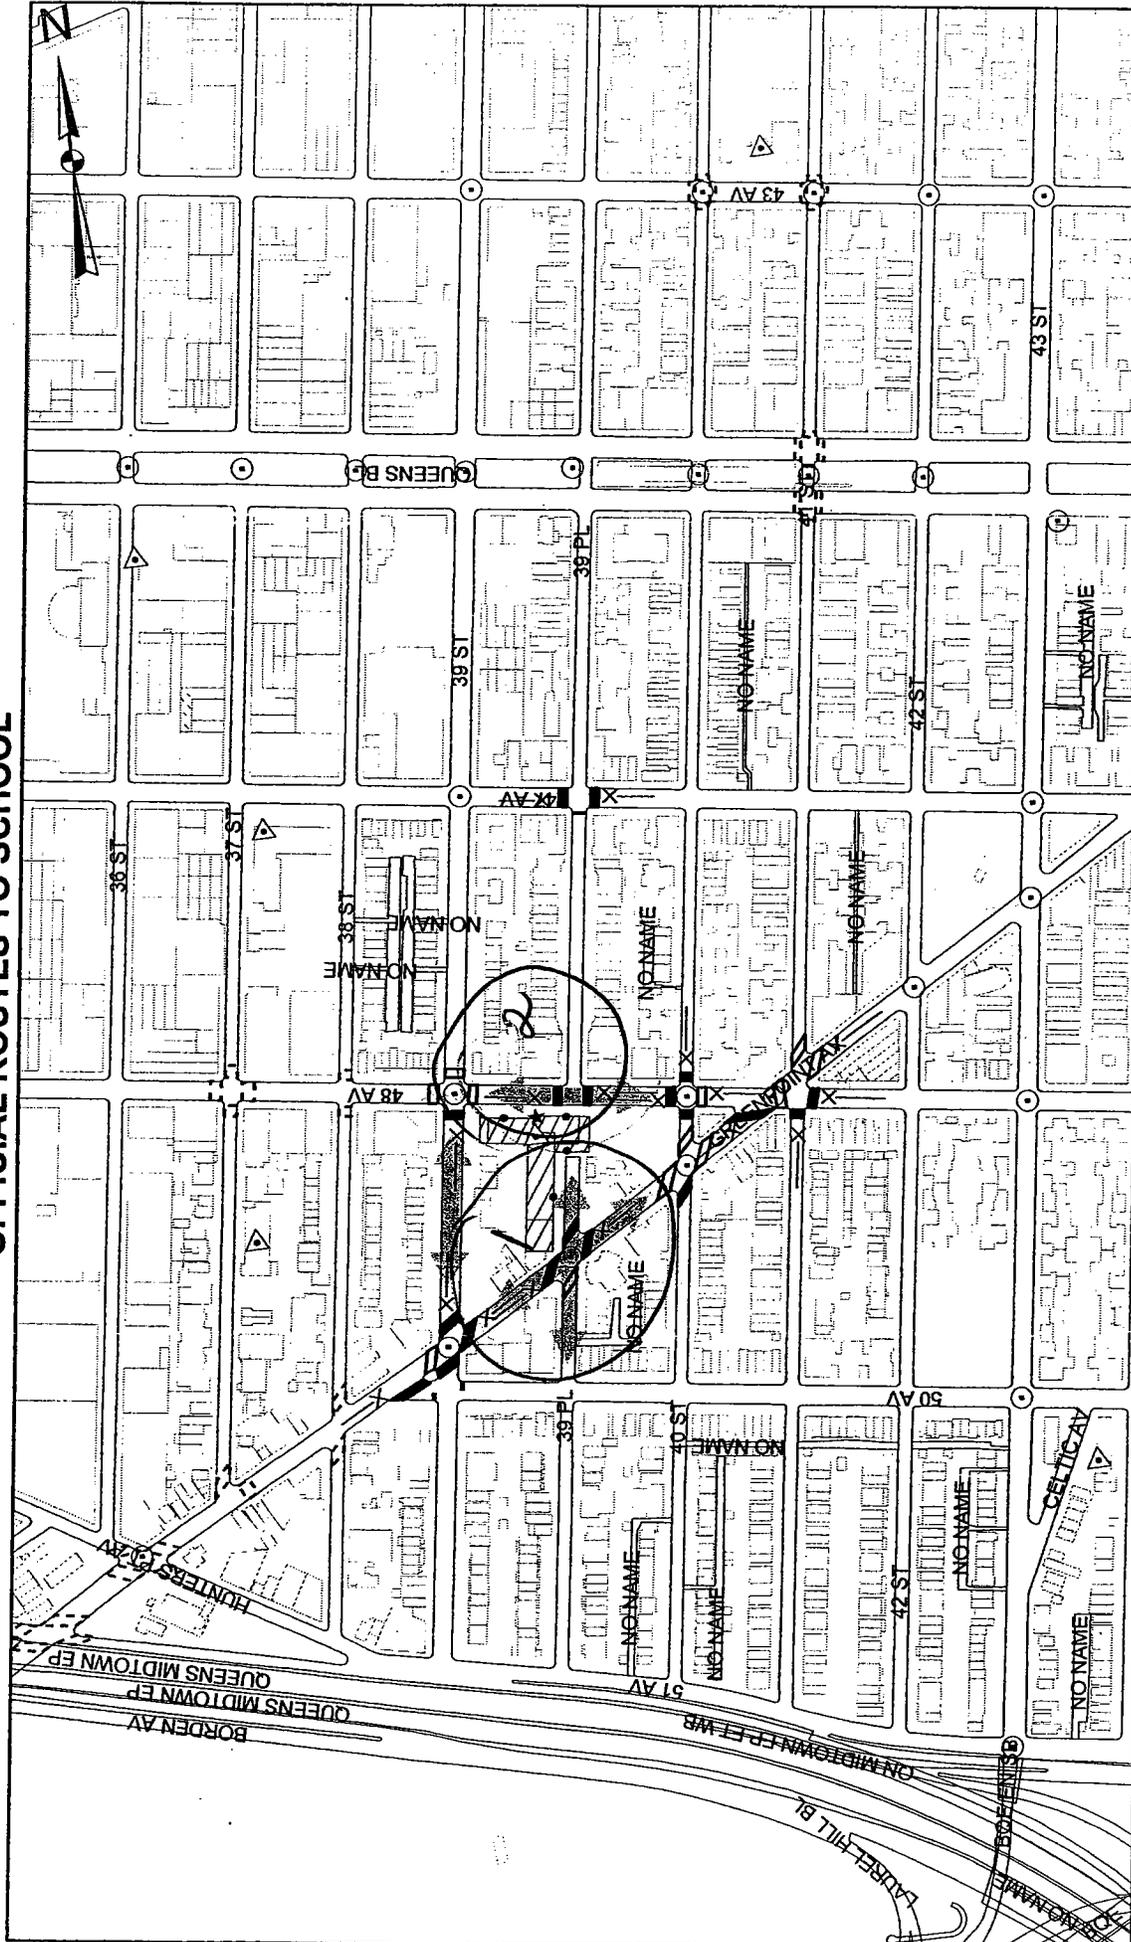
**TRAFFIC SAFETY PLAN
OFFICIAL ROUTES TO SCHOOL**

The TRAFFIC SAFETY PLAN shown on this map was established to provide the maximum degree of safety for children going to and from school. It is required that all children follow the prescribed routes and use the designated crosswalks.

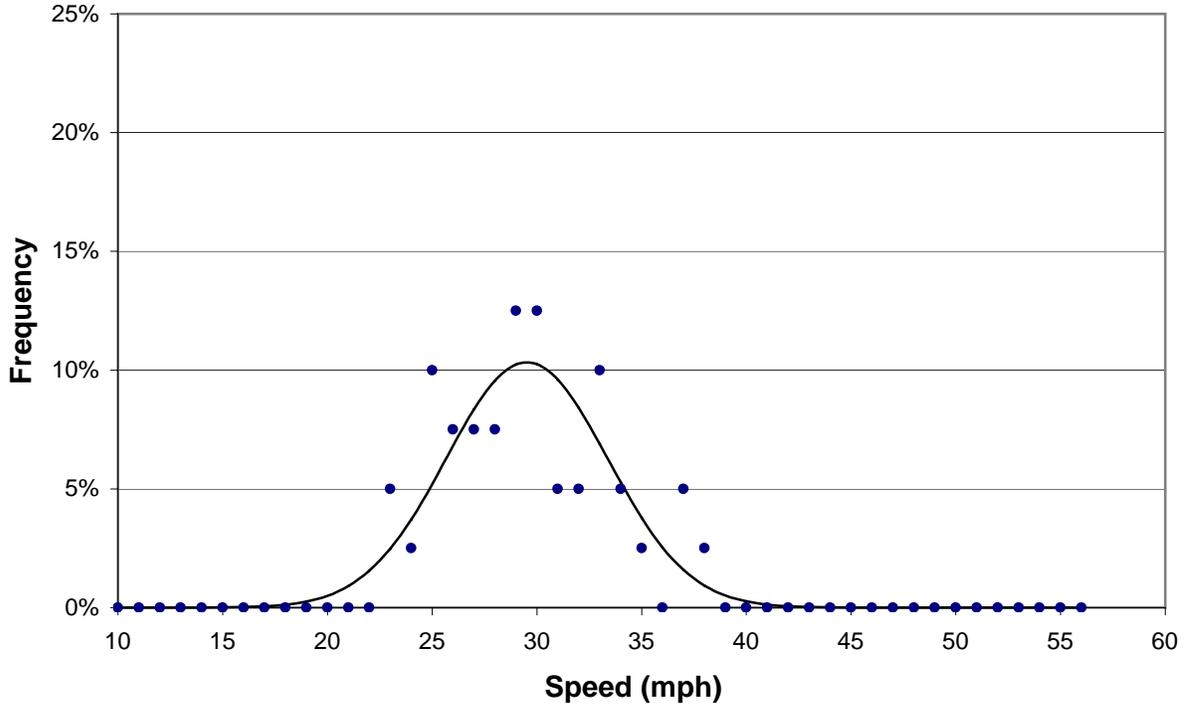
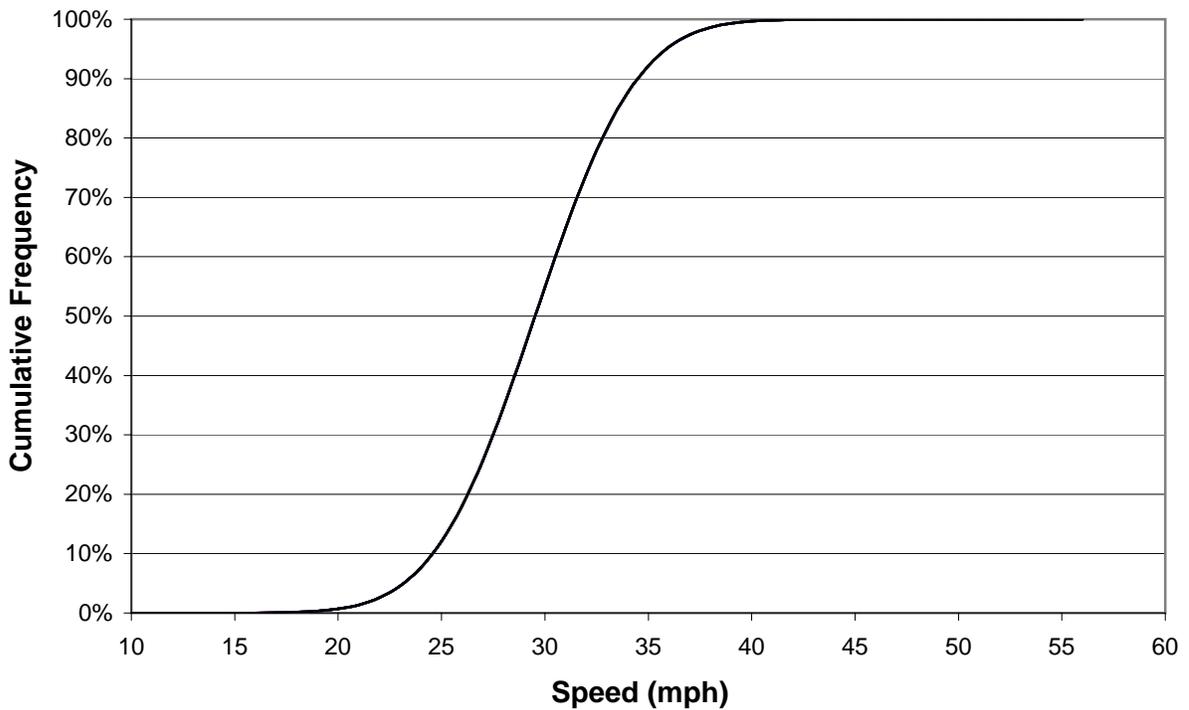
SPOT SPEED STUDY

Date: **October 7, 2005**
 Location: **48 Avenue between 39 Street & 39 Place**
 Surveyor: **R. Calvache/H. Salinas**

Mean Speed = 29.5 mph
 Standard Deviation = 3.9 mph
 Margin of Error (95% Confidence) = ± 1.2 mph

Median Speed = 29.5 mph
 15th Percentile Speed = 25.5 mph
 85th Percentile Speed = 33.5 mph

School representatives also reported a speeding problem on 48th Avenue in front of the school. In order to verify the existence of a speeding problem and to determine its extent, a spot speed survey was conducted on 48th Avenue between 39th Street and 39th Place in both the eastbound and westbound directions. The results of the survey indicated that for the 85th percentile speeds vehicles on 48th Avenue were traveling at 34 mph in the eastbound direction and 36 mph in the westbound direction which is above the recommended 30 mph threshold.

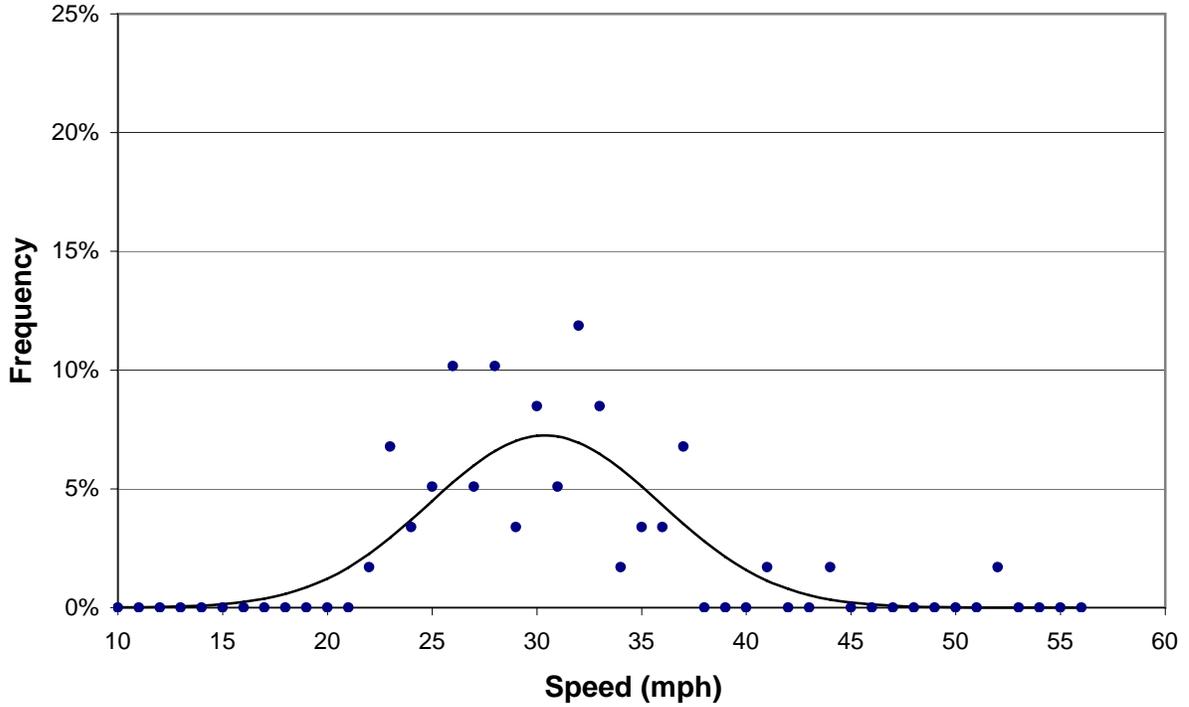
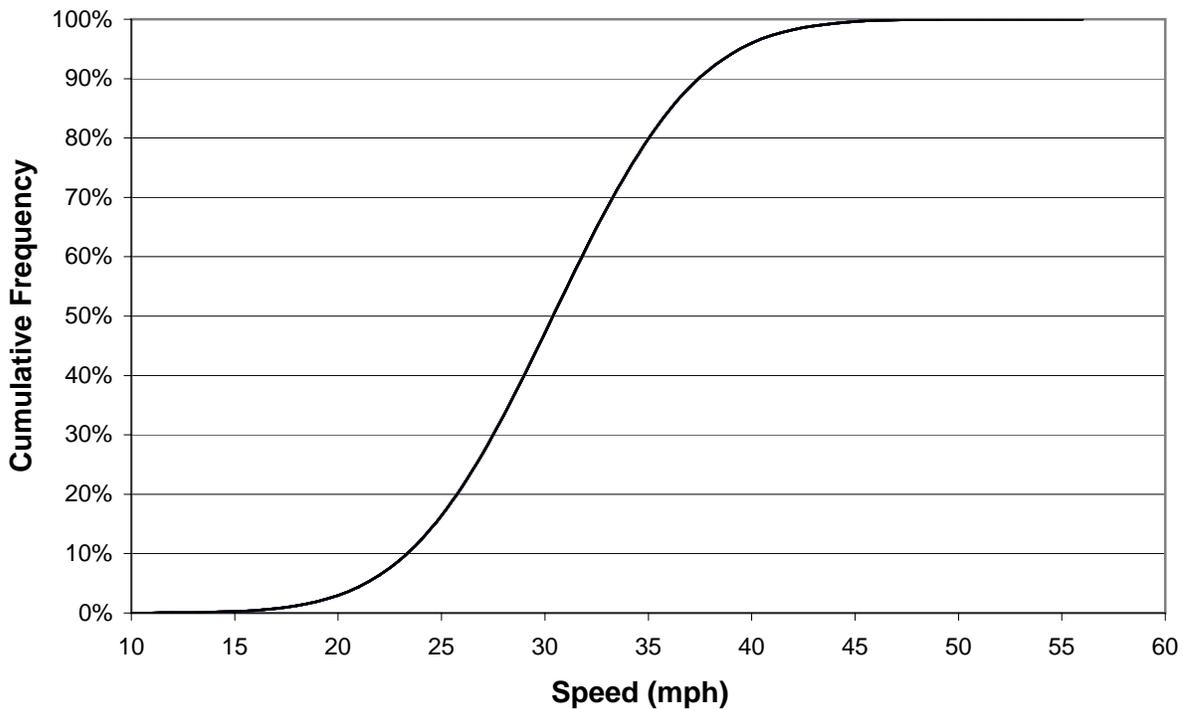
SPOT SPEED STUDY

Date: **October 7, 2005**
 Location: **48 Avenue between 39 Street & 39 Place**
 Surveyor: **R. Calvache/H. Salinas**

Mean Speed = 30.4 mph
 Standard Deviation = 5.5 mph
 Margin of Error (95% Confidence) = ± 1.4 mph

Median Speed = 30.4 mph
 15th Percentile Speed = 24.7 mph
 85th Percentile Speed = 36.1 mph
