**New York City Department of Transportation
Office of School Safety Engineering**

School Safety Engineering Project

FINAL REPORT: P.S. 220 (Edward Mandel School), Queens

October 13, 2006

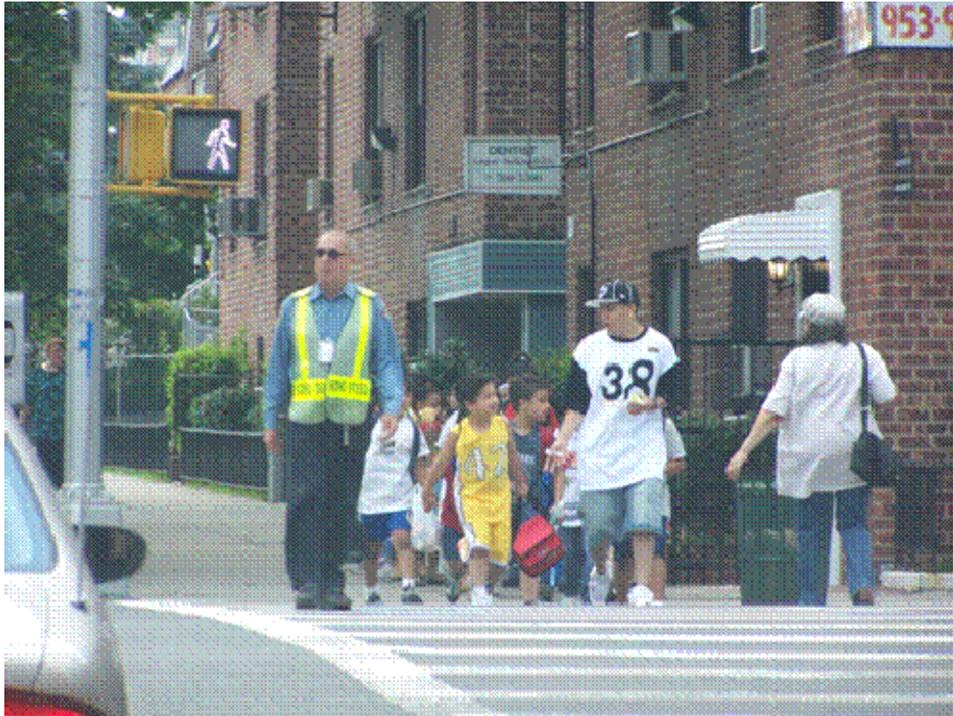
Figure 2: Looking west across north leg of the 108th Street/62nd Drive intersection, at the crossing guard

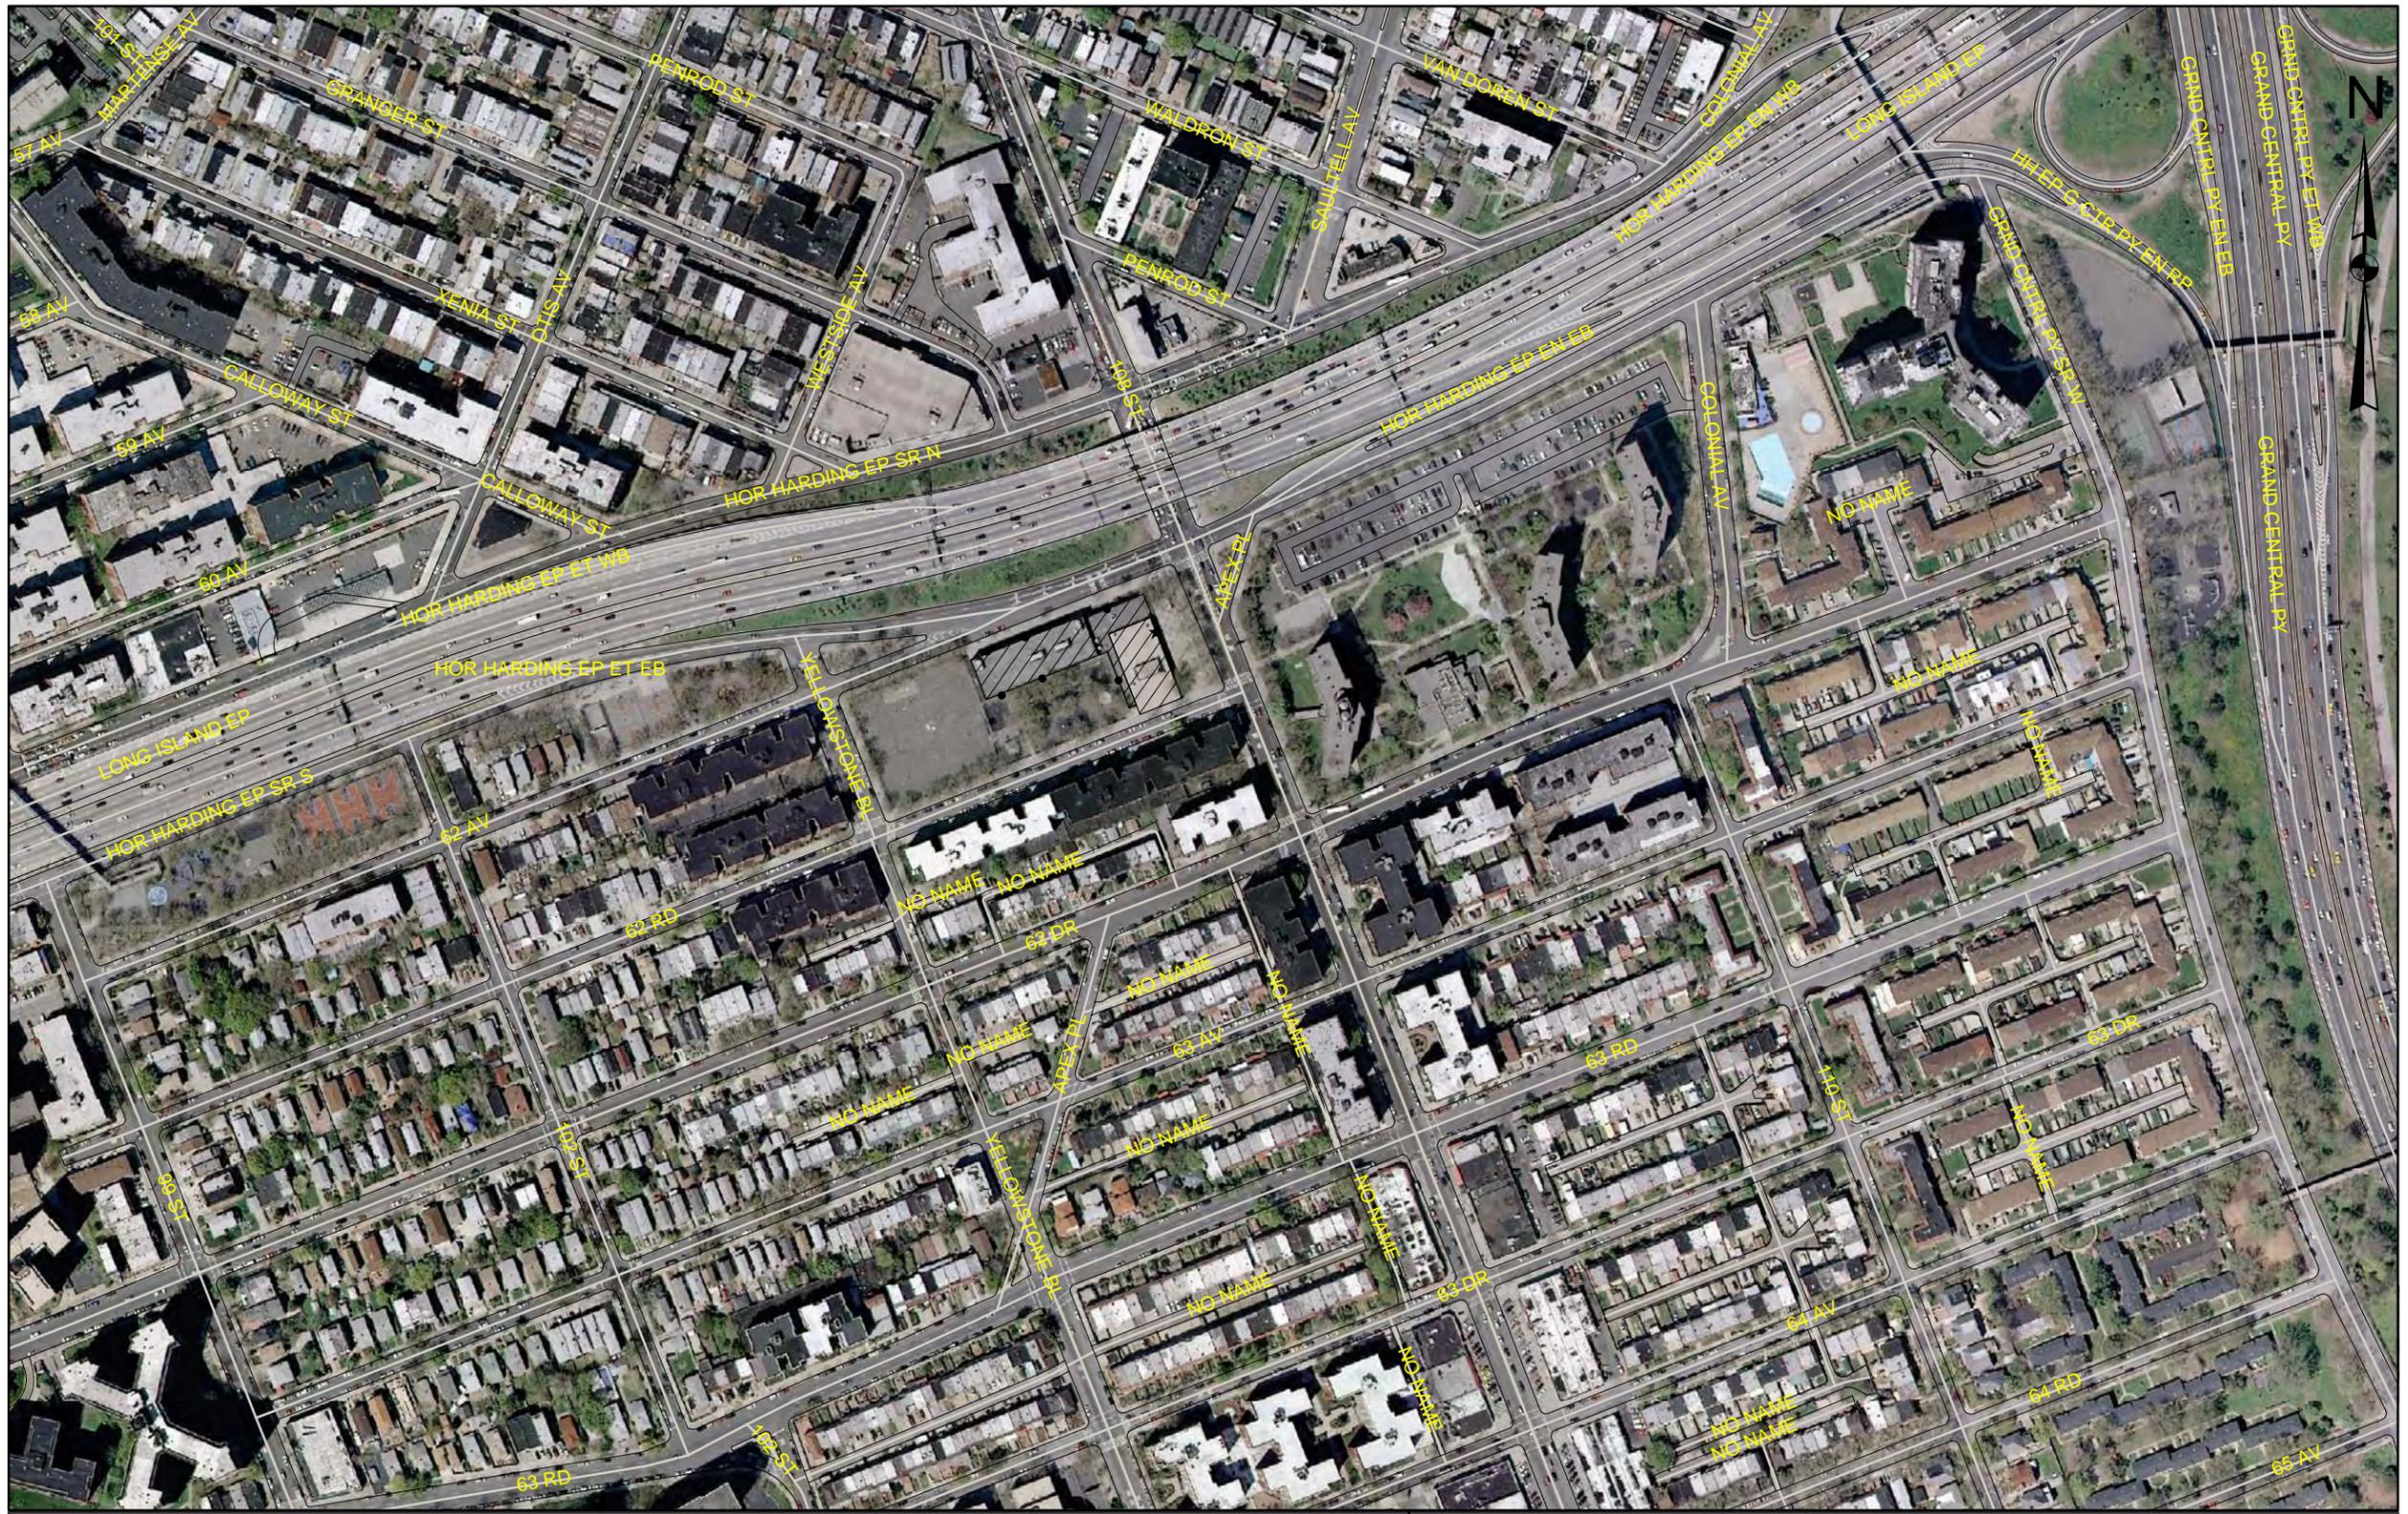
EXHIBIT 1
P.S. 220 QUEENS
EDWARD MANDEL SCHOOL
AERIAL PHOTOGRAPH

Exhibit 1 shows an aerial view of the neighborhood surrounding the school. P.S. 220 is bounded by the Horace Harding Expressway eastbound service road (Long Island Expressway) and 62nd Avenue to the north, 62nd Road to the south, 108th Street to the east, and Yellowstone Boulevard to the west. The neighborhood surrounding the school includes a mix of commercial uses and high-density residential uses.

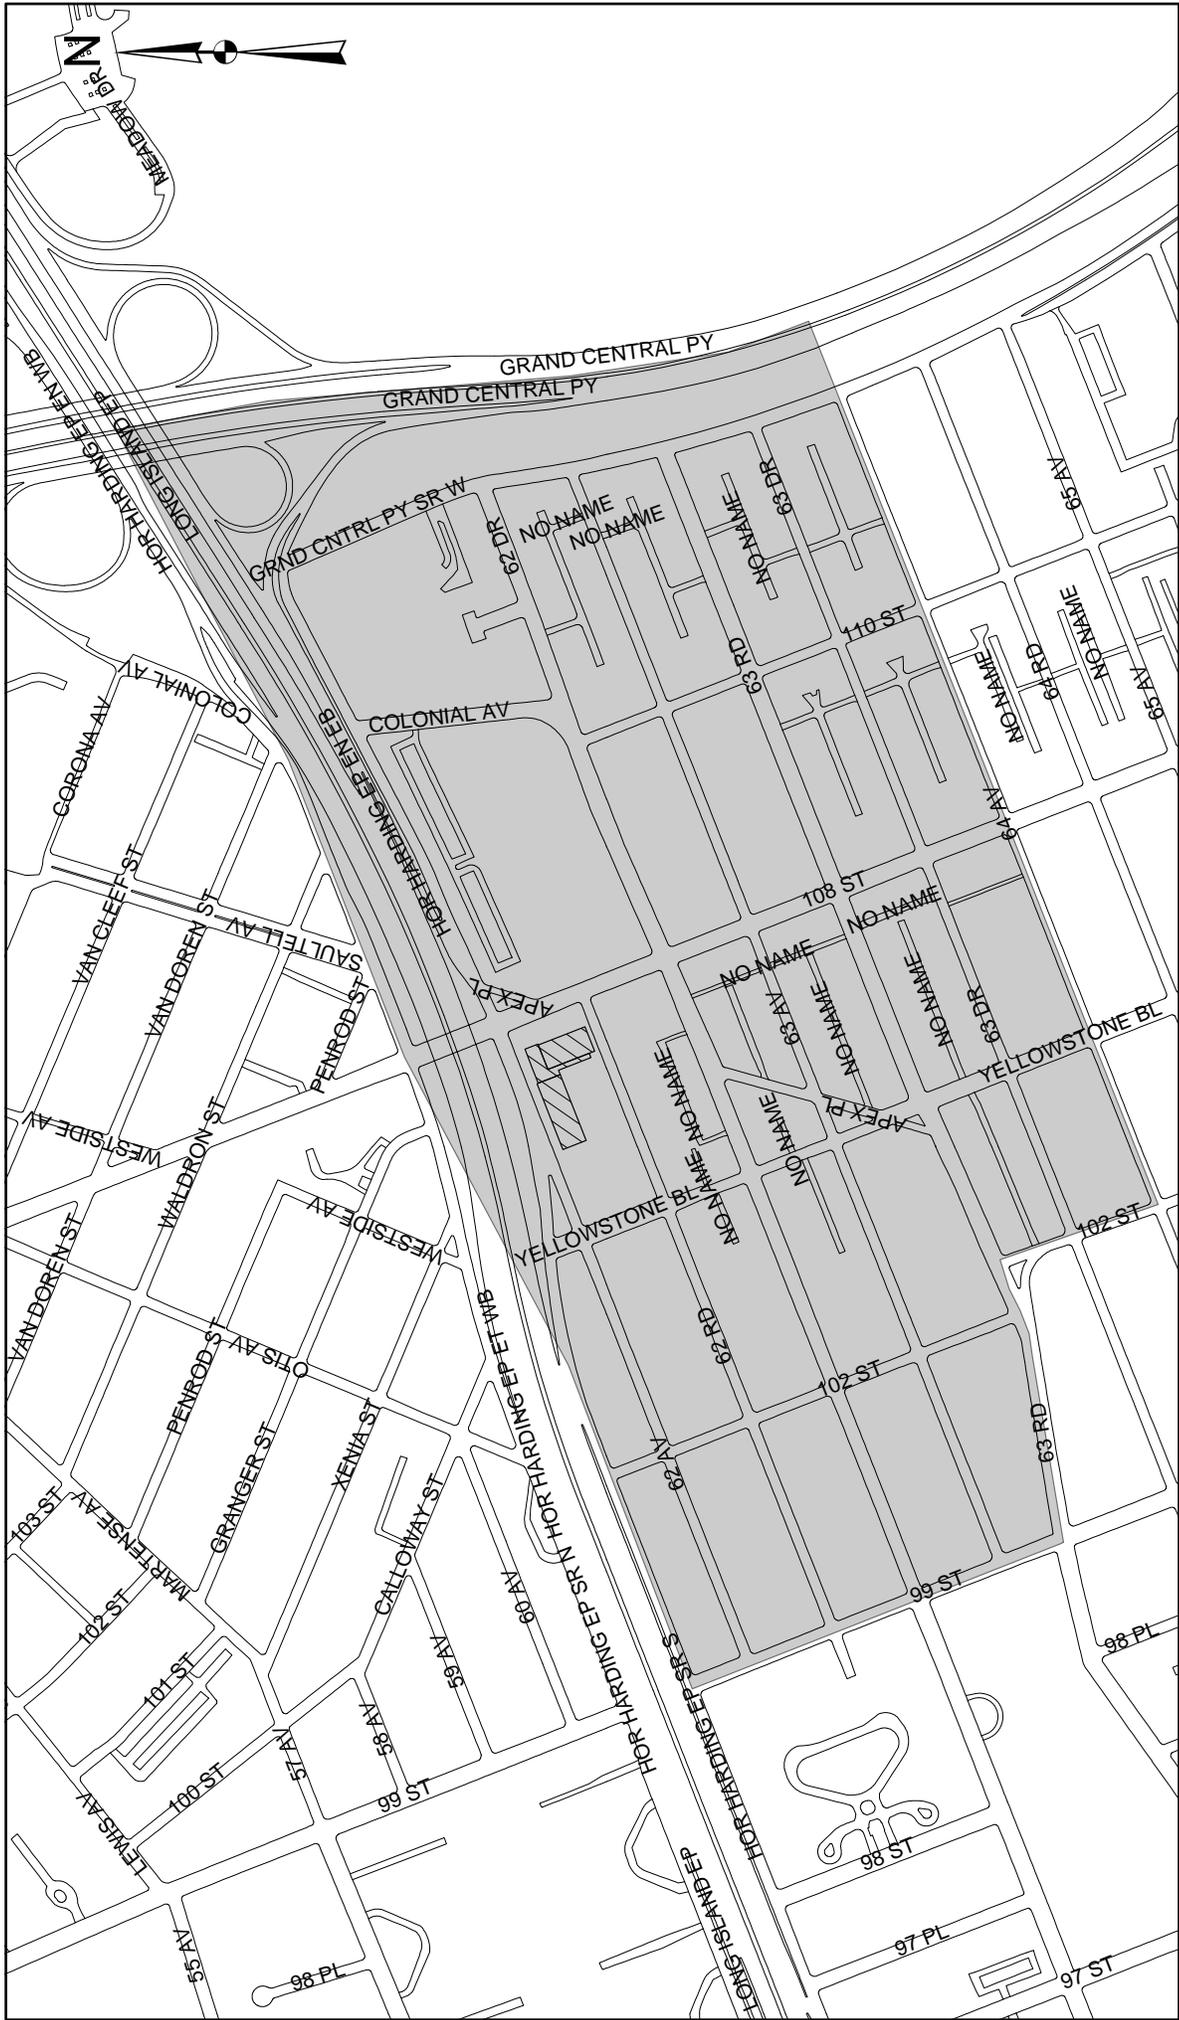
EXHIBIT 2

The school’s “catchment area” as defined by the Department of Education is shown in Exhibit 2. The catchment area is roughly bounded by the Long Island Expressway to the north, 64th Avenue to the south, the Grand Central Parkway to the east, and 102nd and 99th Streets to the west.

CATCHMENT AREA

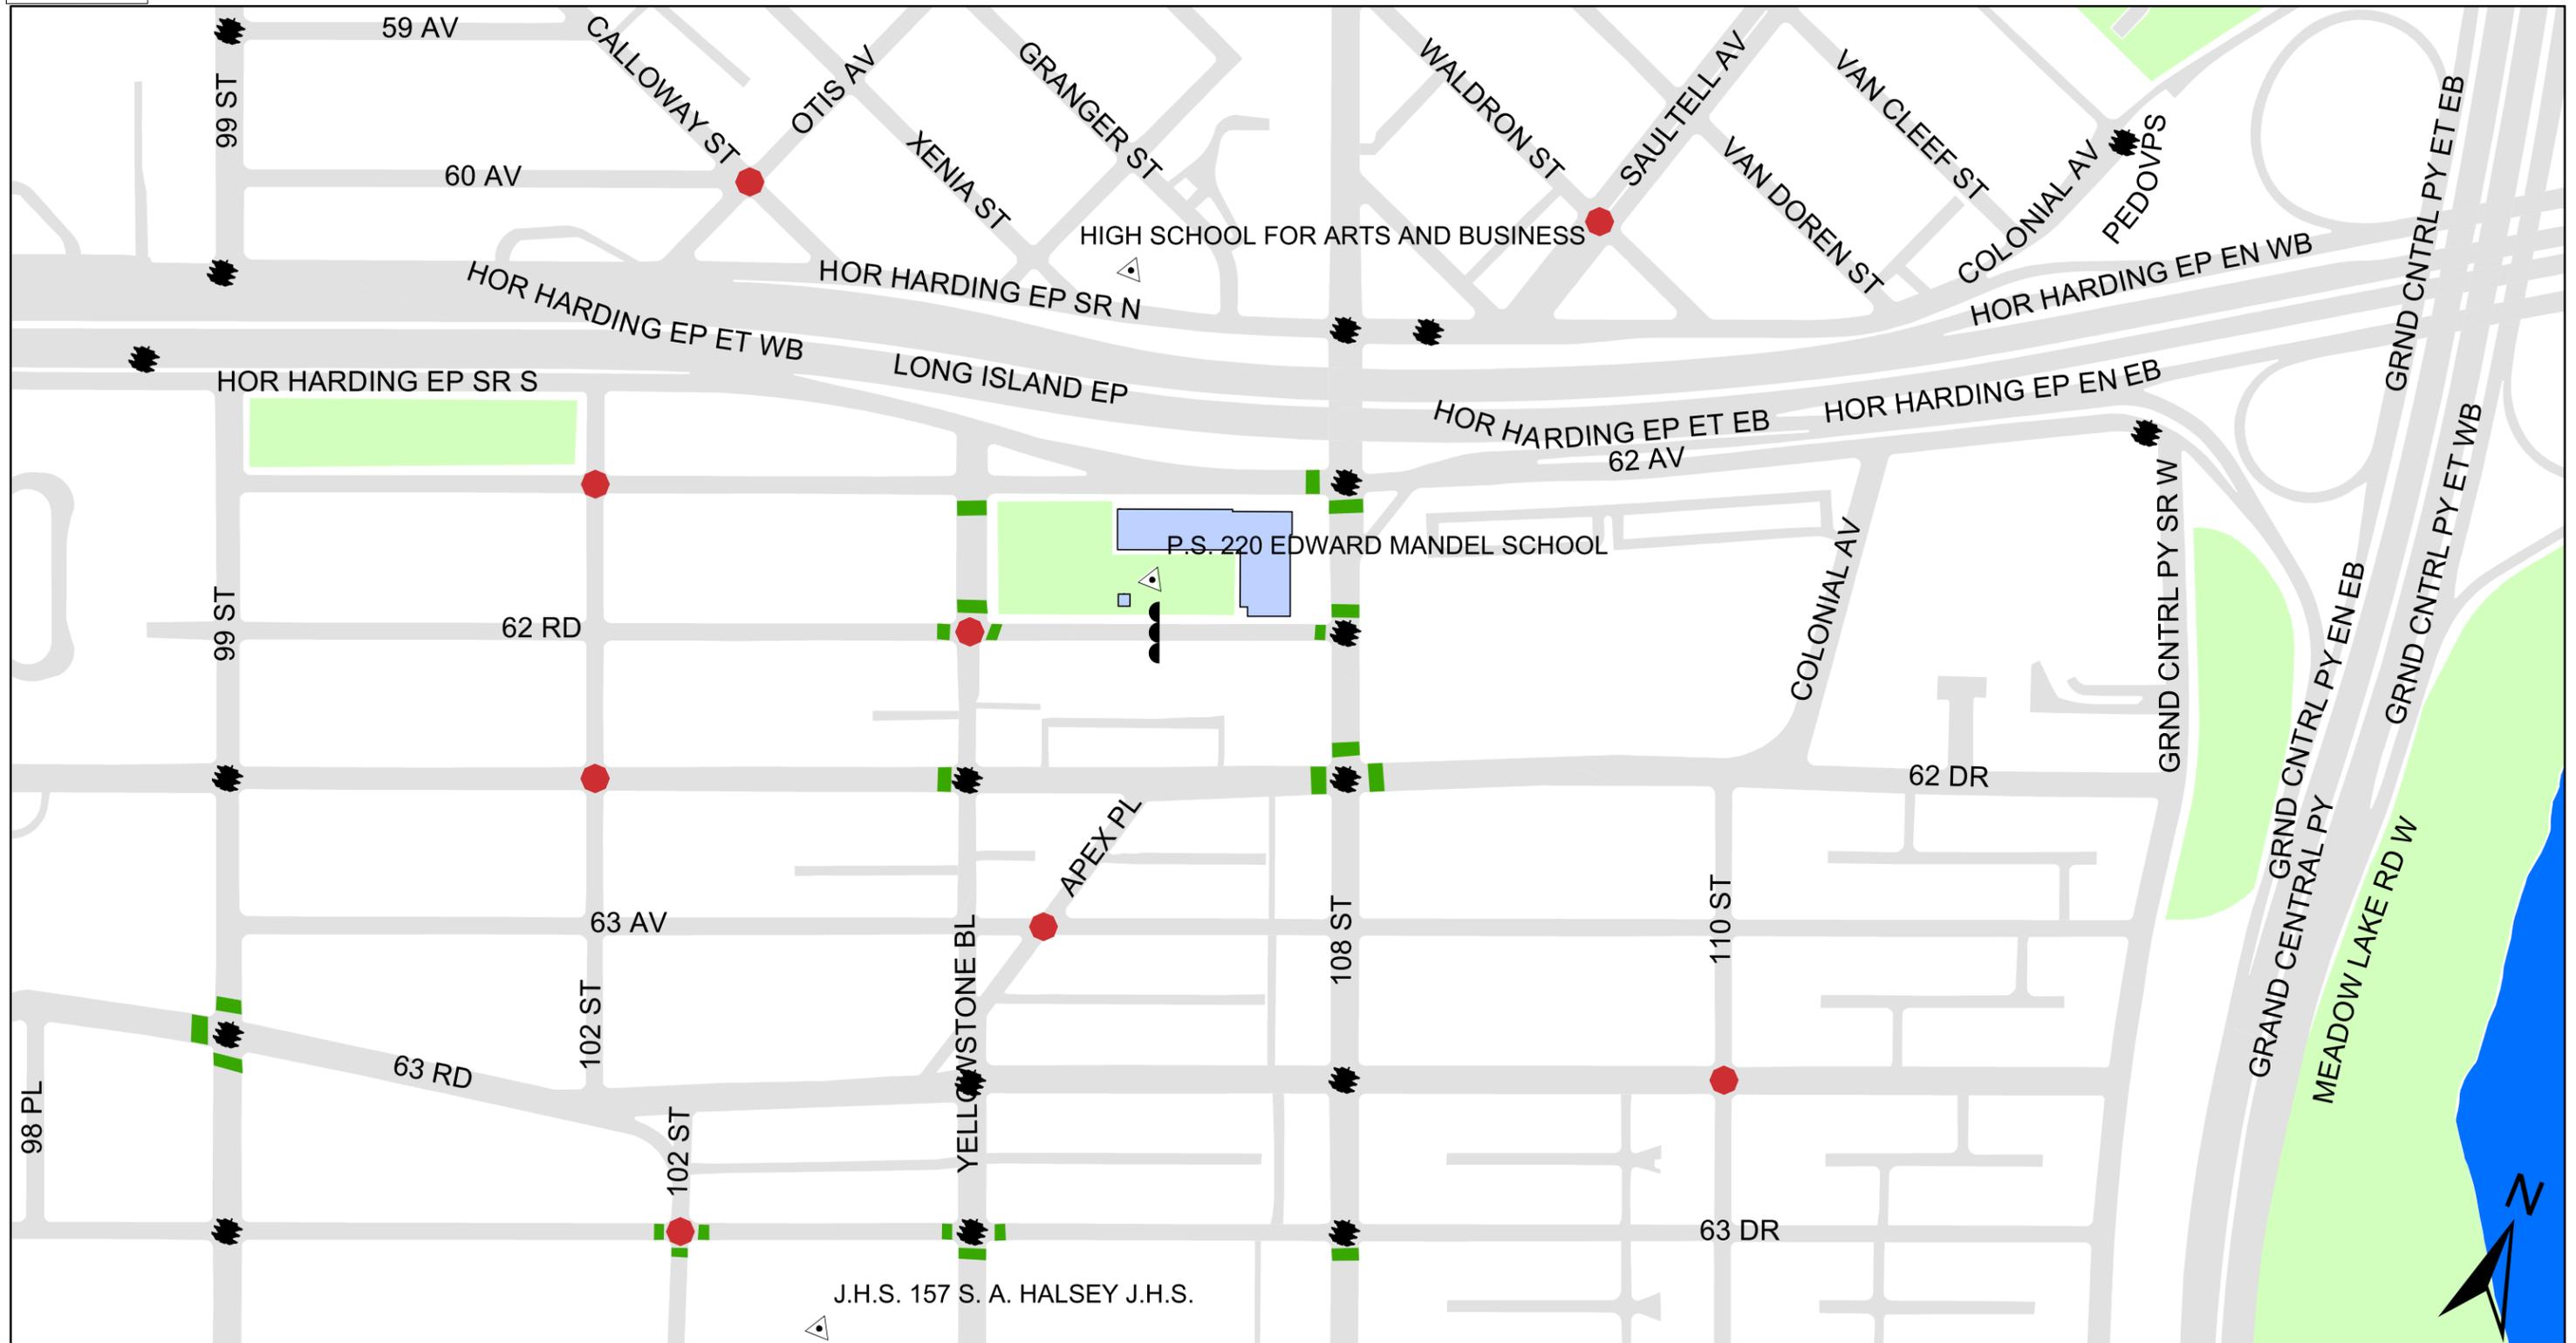
EXHIBIT 3

The School Traffic Safety Map was established to help provide the maximum degree of safety for children going to and from school - by indicating the location of speed reducers, school crosswalks and some traffic control devices. (While virtually all intersections in NYC benefit from traffic control devices - such as stop signs, traffic signals, yield signs, and all way stop signs - this map shows only traffic signals and all way stop signs.) The school crosswalks that are shown are ladder striped and make the crosswalk more visible to drivers and help make the intersection safer. These crosswalks are where school children are recommended to cross.

Exhibit 3 shows the existing signals and pavement markings in the vicinity of P.S 220. It should be noted that a citywide signage program is currently underway to upgrade school signage to the current edition of the Federal Manual of Uniform Traffic Control Devices (MUTCD) standards of fluorescent yellow-green signs accompanied by downward pointing arrows. Signs scheduled to be installed under this program are shown as "existing" in Exhibit 7.

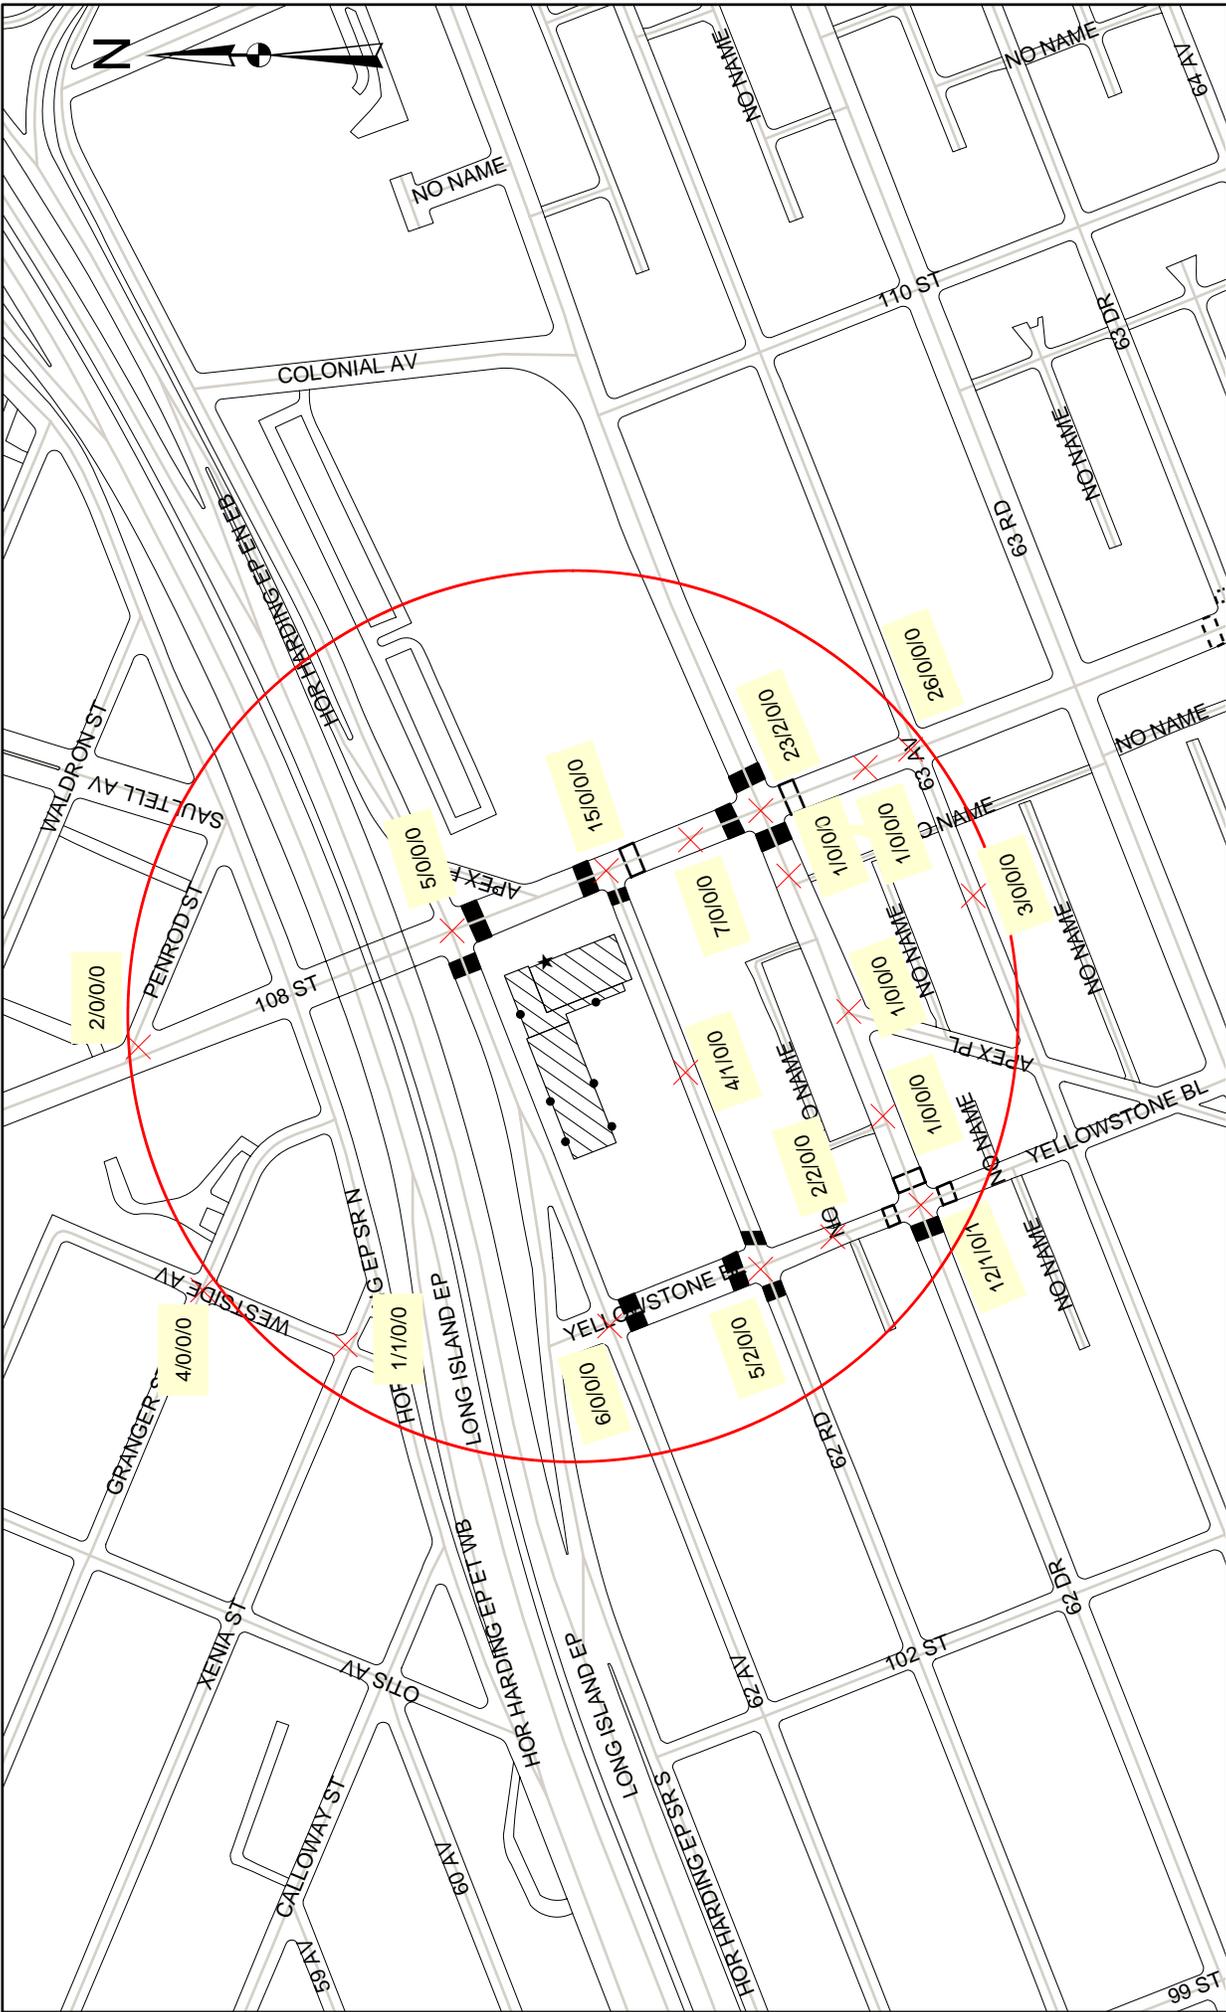
EXHIBIT 6

Exhibit 6 and Table 1 show a summary of accidents, as obtained from the New York State Department of Motor Vehicles (DMV), in the vicinity of P.S. 220 for the three-year period from January 1, 1998 through December 31, 2000. The DMV data provides some detail relating to the circumstances and cause of the accident. Table 2 is a summary of more recent accident data obtained from the NYC Police Department (NYPD). Though current through 2004, the NYPD data does not provide the same level of detail as the DMV data.

ACCIDENT SUMMARY (1998-2000)

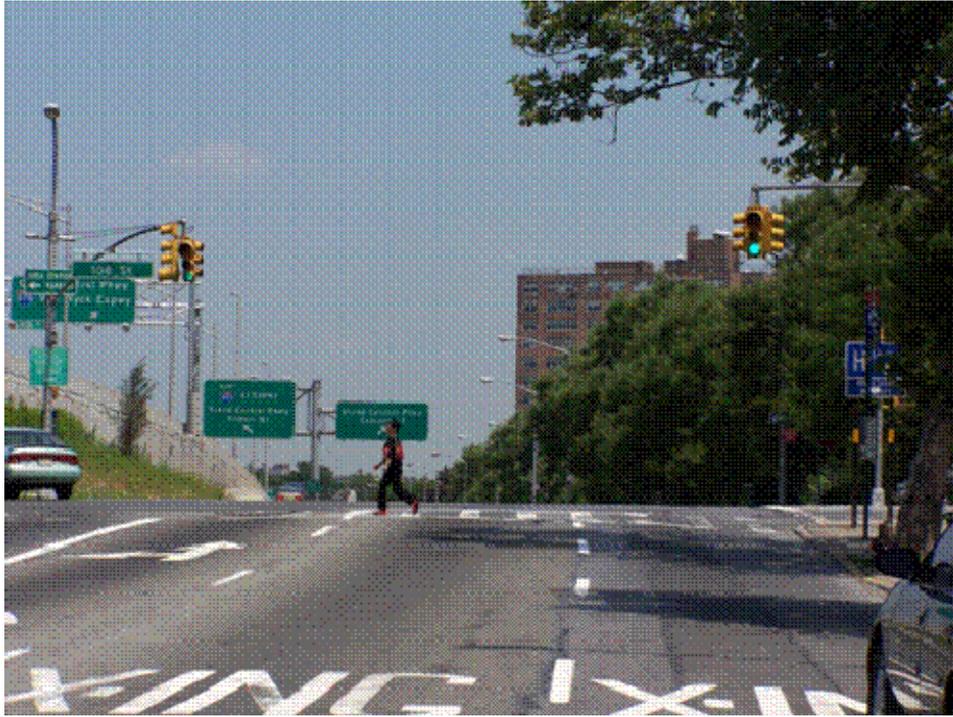
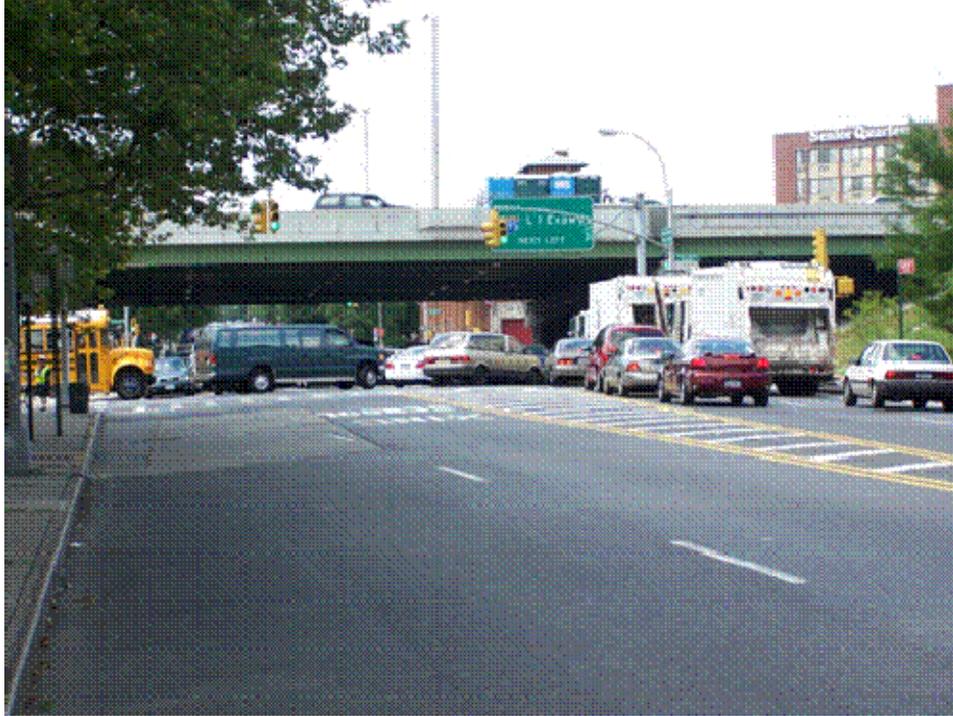
This is a signalized four-leg intersection with school crosswalks located across the west and south legs. A pedestrian crosswalk is located across the east leg of the intersection. North of P.S. 220, the Horace Harding Expressway service road merges with 62nd Avenue as a one-way eastbound street with four eastbound approach lanes west of 108th Street and three eastbound departure lanes east of 108th Street, and no on-street parking. (The northerly lane on the eastbound approach to the intersection is an exclusive left-turn lane, and therefore, does not continue through the intersection.)

South of the intersection with the Horace Harding Expressway eastbound service road, 108th Street is a two-way north-south street with two travel lanes on each side of the roadway and no on-street parking. However, north of this intersection, 108th Street has two northbound departure lanes and four southbound approach lanes, including two exclusive left-turn lanes and two exclusive through lanes. There is an on-ramp to the Long Island Expressway located east of this intersection (see Figures 3 and 4).

There was a total of five accidents reported at this intersection between 1998 and 2000 (Table 1), but none of these accidents involved pedestrians.

Figure 3: Looking east on the Horace Harding Expressway eastbound service road (62nd Avenue) to the intersection with 108th Street

Figure 4: Looking north on 108th Street to the intersection with the Horace Harding Expressway eastbound service road (62nd Avenue)

- Install two speed boards on 62nd Avenue (eastbound) between Yellowstone Boulevard and 108th Street.

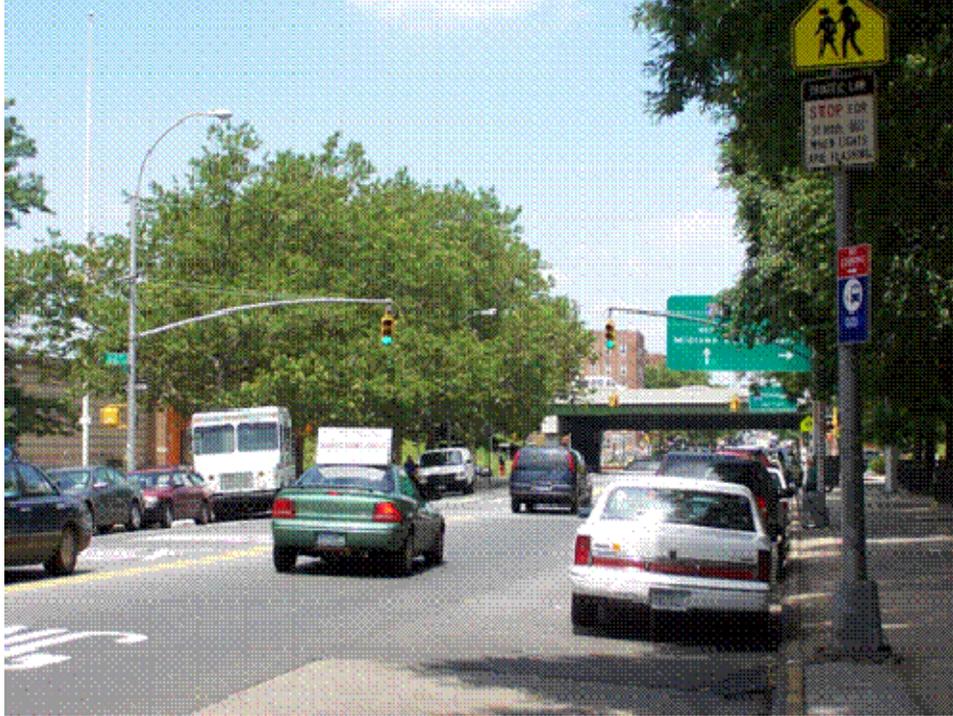
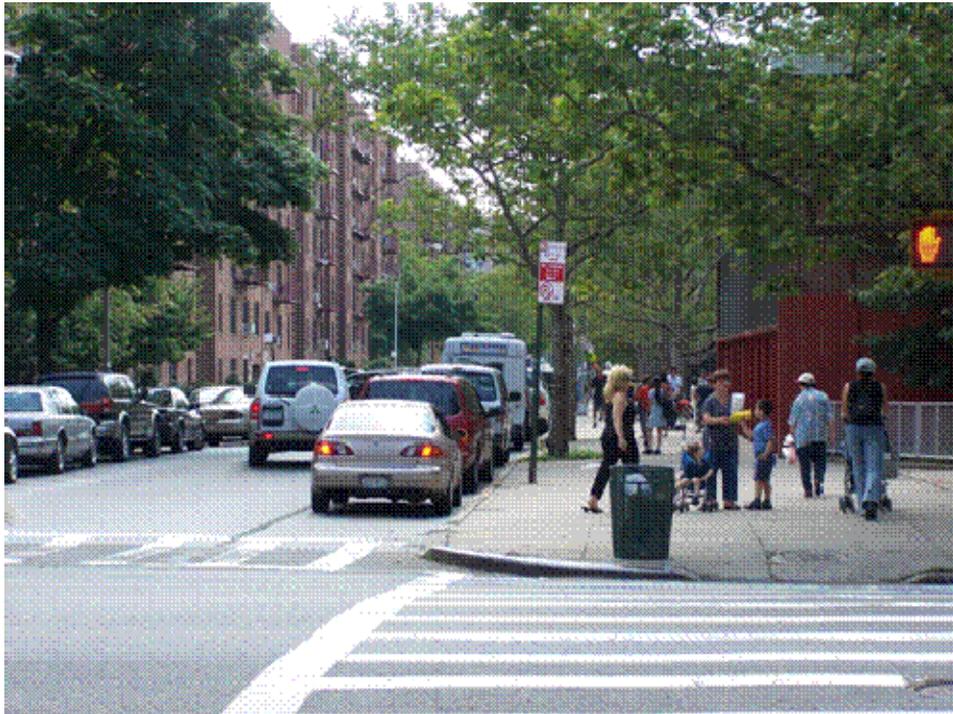
This is a three-leg signalized “T”-intersection with school crosswalks located across the north and west legs, and a pedestrian crosswalk located across the south leg. South of 62nd Road, 108th Street is a two-way north-south street with one travel lane and one on-street parking lane on each side of the roadway. Between 108th Street and Yellowstone Boulevard 62nd Road is a one-way westbound street with one travel lane and on-street parking permitted on both sides of the roadway (see Figures 5 and 6).

There was a total of 15 accidents reported at this intersection between 1998 and 2000 (Table 1), but none of these accidents involved pedestrians.

Figure 5: Looking north along the east side of 108th Street to the intersection with 62nd Road

Figure 6: Looking west across the north leg of 108th Street at the intersection with 62nd Road

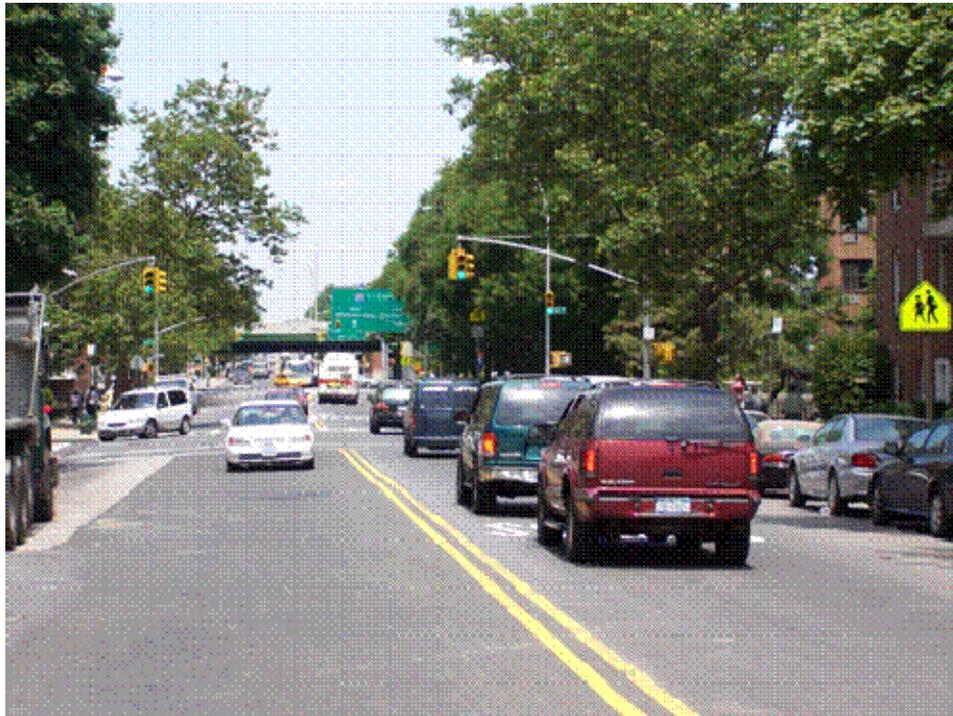
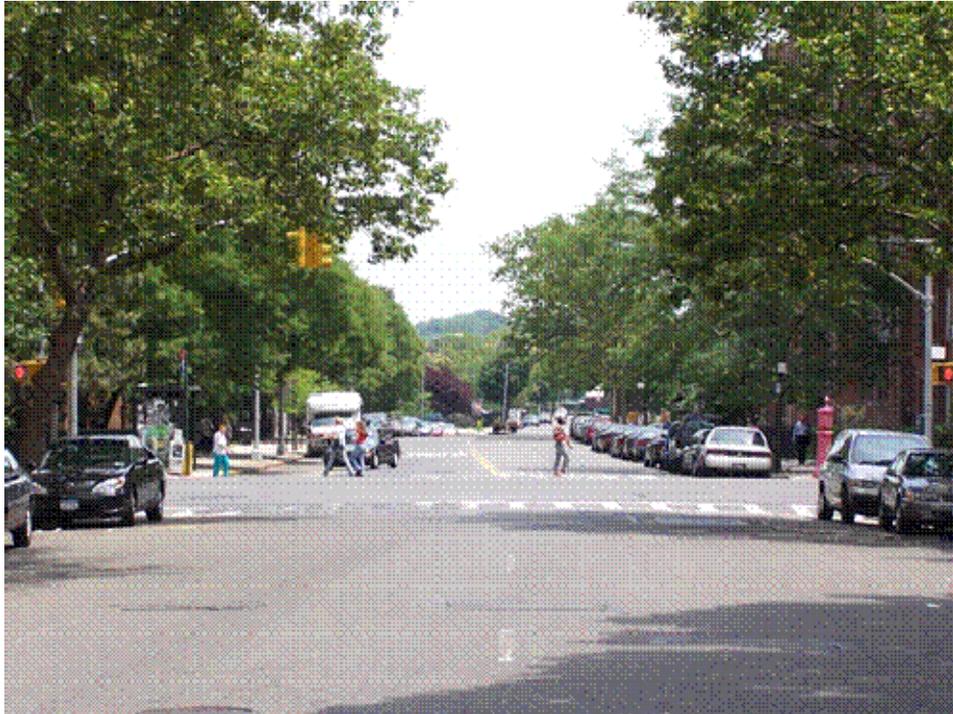
This is a four-leg signalized intersection with school crosswalks located across the north, east and west legs, and a pedestrian crosswalk located across the south leg. 108th Street is a two-way north-south street with one travel lane and one on-street parking lane on each side of the roadway. East of the intersection with 108th Street, 62nd Drive is a two-way street with one travel lane and one on-street parking lane on each side of the roadway. West of this intersection, 62nd Drive is a one-way westbound street with two travel lanes and on-street parking permitted on both sides of the roadway (see Figures 7 and 8).

There was a total of 23 accidents reported at this intersection between 1998 and 2000 (Table 1), including two pedestrian accidents, neither of which were school-related. There were no pedestrian fatalities reported at this intersection between 1998 and 2000.

Figure 7: Looking north on 108th Street to the intersection with 62nd Drive

Figure 8: Looking east on 62nd Drive to the intersection with 108th Street

- Reconstruct both pedestrian ramps on the northwest corner of the 108th Street and 62nd Drive intersection to provide standard pedestrian ramps.

- Northeast, northwest, and southwest corners of the signalized 108th Street and 62nd Drive intersection.
- Northwest and southwest corners of the signalized Yellowstone Boulevard and 62nd Drive intersection.

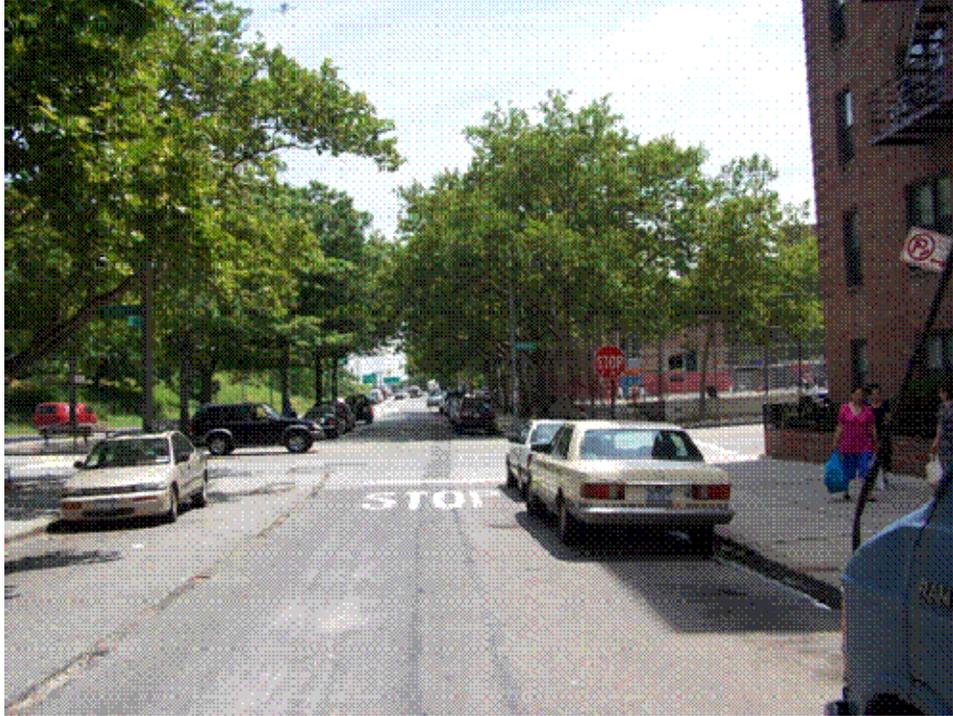
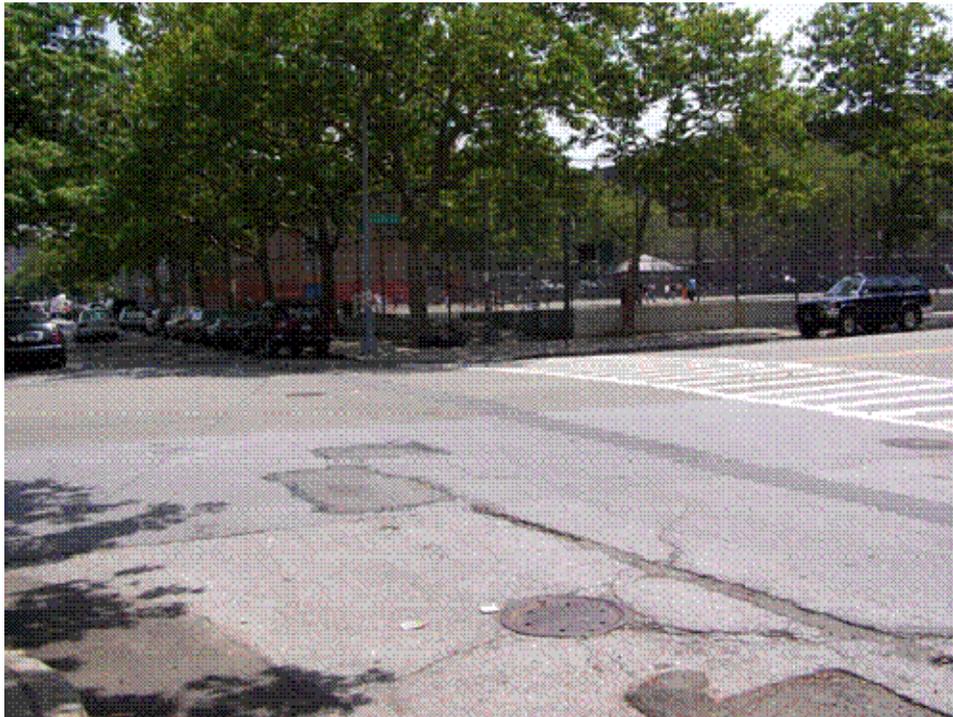
This is a four-leg unsignalized intersection with a school crosswalk located across the south leg. Yellowstone Boulevard is a two-way north-south street with one travel lane and one on-street parking lane on each side of the roadway. West of the intersection with Yellowstone Boulevard, 62nd Avenue is a two-way east-west street with one travel lane and one on-street parking lane on each side of the roadway. East of this intersection, 62nd Avenue is a one-way eastbound street with one travel lane and on-street parking permitted on both sides of the roadway. The eastbound approach on 62nd Avenue is stop-controlled at the intersection with Yellowstone Boulevard (see Figures 9 and 10).

There was a total of six accidents reported at this intersection between 1998 and 2000 (Table 1), but none of these accidents involved pedestrians.

Figure 9: Looking east on 62nd Avenue to the intersection with Yellowstone Boulevard

Figure 10: Looking southeast across the intersection of Yellowstone Boulevard/62nd Avenue (the schoolyard for P.S. 220 is visible on the opposite side of the intersection)

The school crosswalk located across the south leg of Yellowstone Boulevard at 62nd Avenue is currently uncontrolled (i.e. there is no positive traffic control for vehicles traveling on Yellowstone Boulevard across the crosswalk). Therefore, the following is recommended:

- Assign a crossing guard to the intersection of Yellowstone Boulevard and 62nd Avenue to assist students in crossing Yellowstone Boulevard.

- Northeast and southeast corners of the all-way stop-controlled Yellowstone Boulevard and 62nd Road intersection.
- Southwest and southeast corners of the Yellowstone Boulevard and 62nd Avenue intersection.

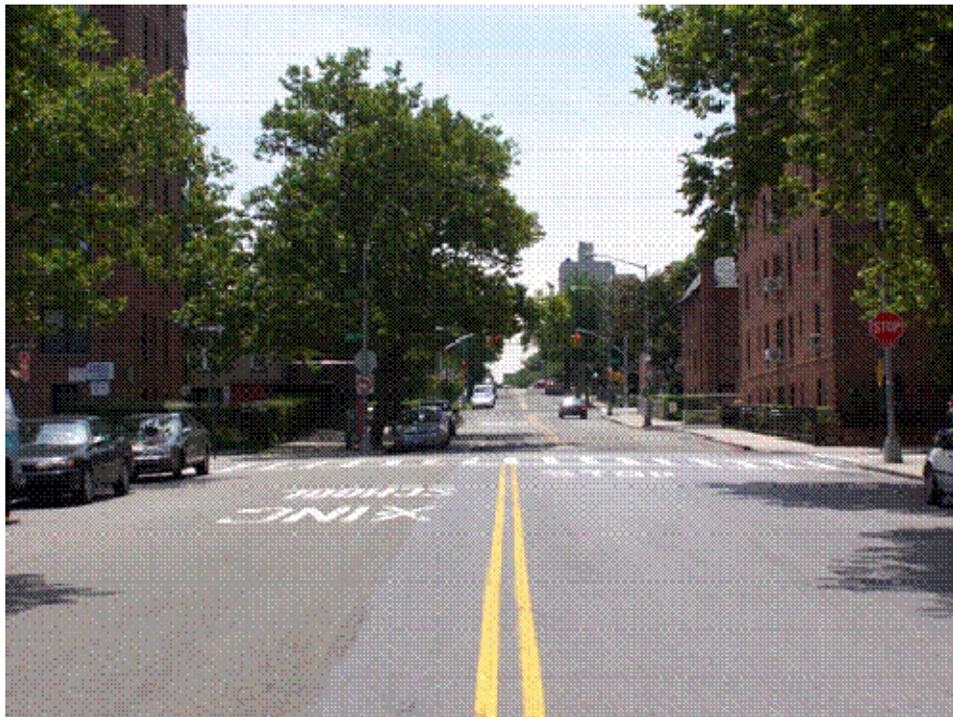
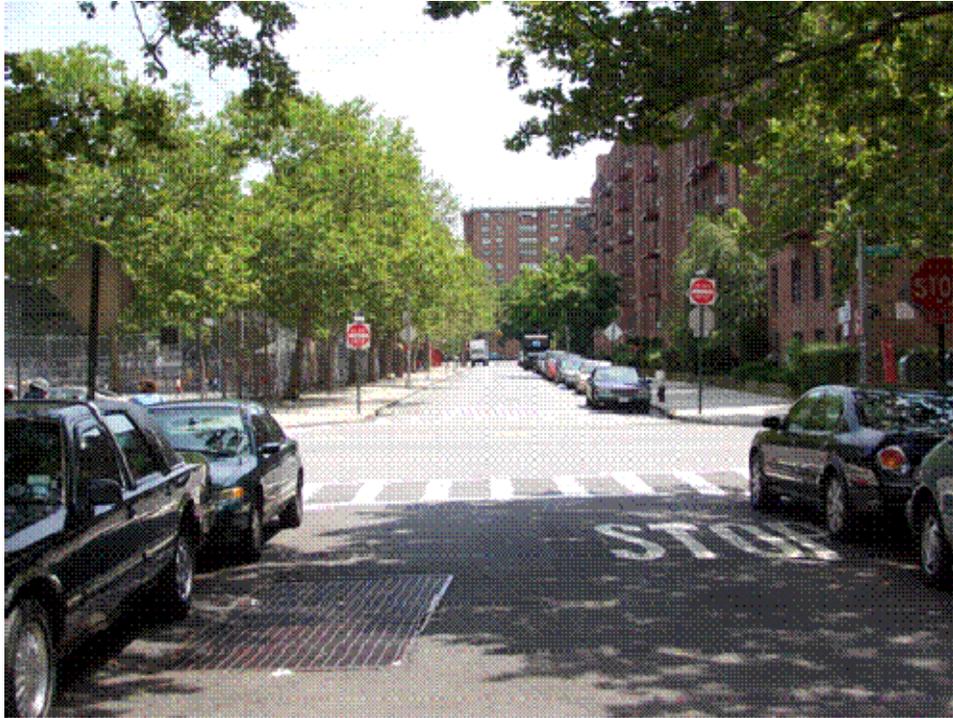
This is a four-leg unsignalized all-way stop-controlled intersection with school crosswalks located across the north, east, and west legs. Yellowstone Boulevard is a two-way north-south street with two travel lanes and one on-street parking lane on each side of the roadway. West of the intersection with Yellowstone Boulevard, 62nd Road is a two-way east-west street with one travel lane and one on-street parking lane on each side of the roadway. East of this intersection, 62nd Road is a one-way westbound street with one travel lane and on-street parking permitted on both sides of the roadway (see Figures 11 and 12).

There was a total of five accidents reported at this intersection between 1998 and 2000 (Table 1), including two pedestrian accidents, neither of which was school-related. There were no pedestrian fatalities reported at this intersection between 1998 and 2000.

Figure 11: Looking south on Yellowstone Boulevard to the intersection with 62nd Road

Figure 12: Looking east on 62nd Road to the intersection with Yellowstone Boulevard
