**New York City Department of Transportation
Office of School Safety Engineering**

School Safety Engineering Project

FINAL REPORT: P.S. 220 (Edward Mandel School), Queens

October 13, 2006

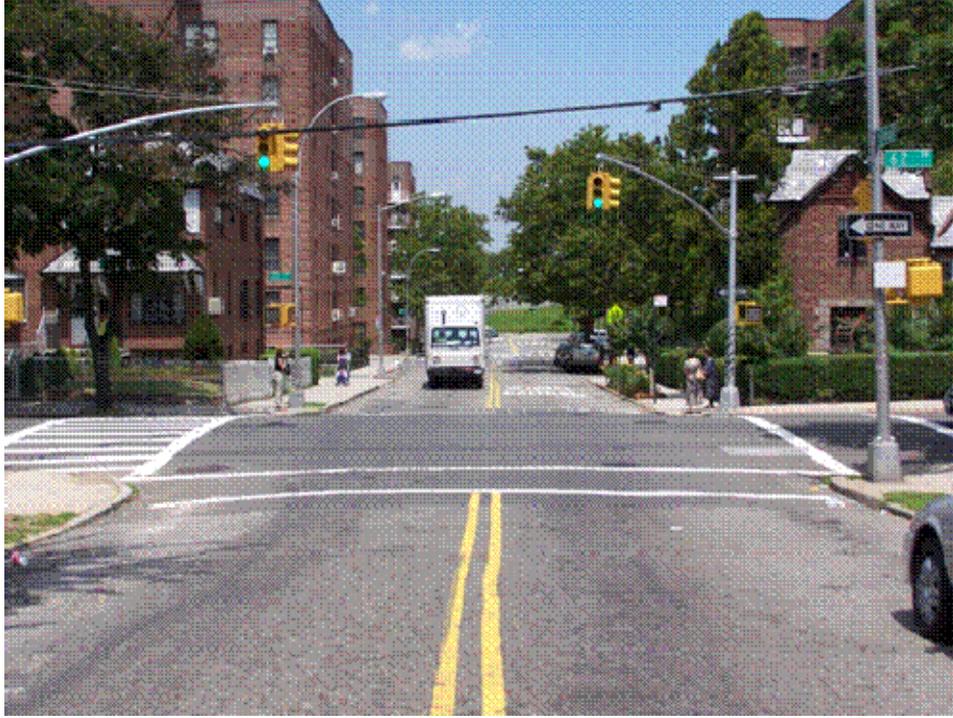
This is a four-leg signalized intersection with a school crosswalk located across the west leg, and pedestrian crosswalks located across the north, south, and east legs. Yellowstone Boulevard is a two-way north-south street with one travel lane and one on-street parking lane on each side of the roadway. 62nd Drive is a one-way westbound street with two travel lanes and on-street parking permitted on both sides of the roadway.

There was a total of 12 accidents reported at this intersection between 1998 and 2000 (Table 1), including one pedestrian accident that was also school-related. In the school related accident, an 11-year-old pedestrian was reported struck by a vehicle at approximately 6:00 pm on Monday, April 27, 1998 while crossing with the signal at the intersection. The pedestrian was reported to have sustained a “possible injury.” The roadway and weather conditions were reported as dry and clear, respectively. There were no pedestrian fatalities reported at this intersection between 1998 and 2000.

Figure 13: Looking north on Yellowstone Boulevard to the intersection with 62nd Drive

There is an existing pedestrian crosswalk located across the east leg of the signalized Yellowstone Boulevard/62nd Drive intersection. This crosswalk is on the same side of the roadway as P.S. 220, and is a logical route for students to use when traveling to and from the school. Therefore, the following is recommended:

- Convert the existing pedestrian crosswalk located across the east leg of the signalized Yellowstone Boulevard/62nd Drive intersection to a school crosswalk, and install all appropriate advance warning signs and pavement markings.

- Northeast, northwest, and southwest corners of the signalized 108th Street and 62nd Drive intersection.
- Northwest and southwest corners of the signalized Yellowstone Boulevard and 62nd Drive intersection.

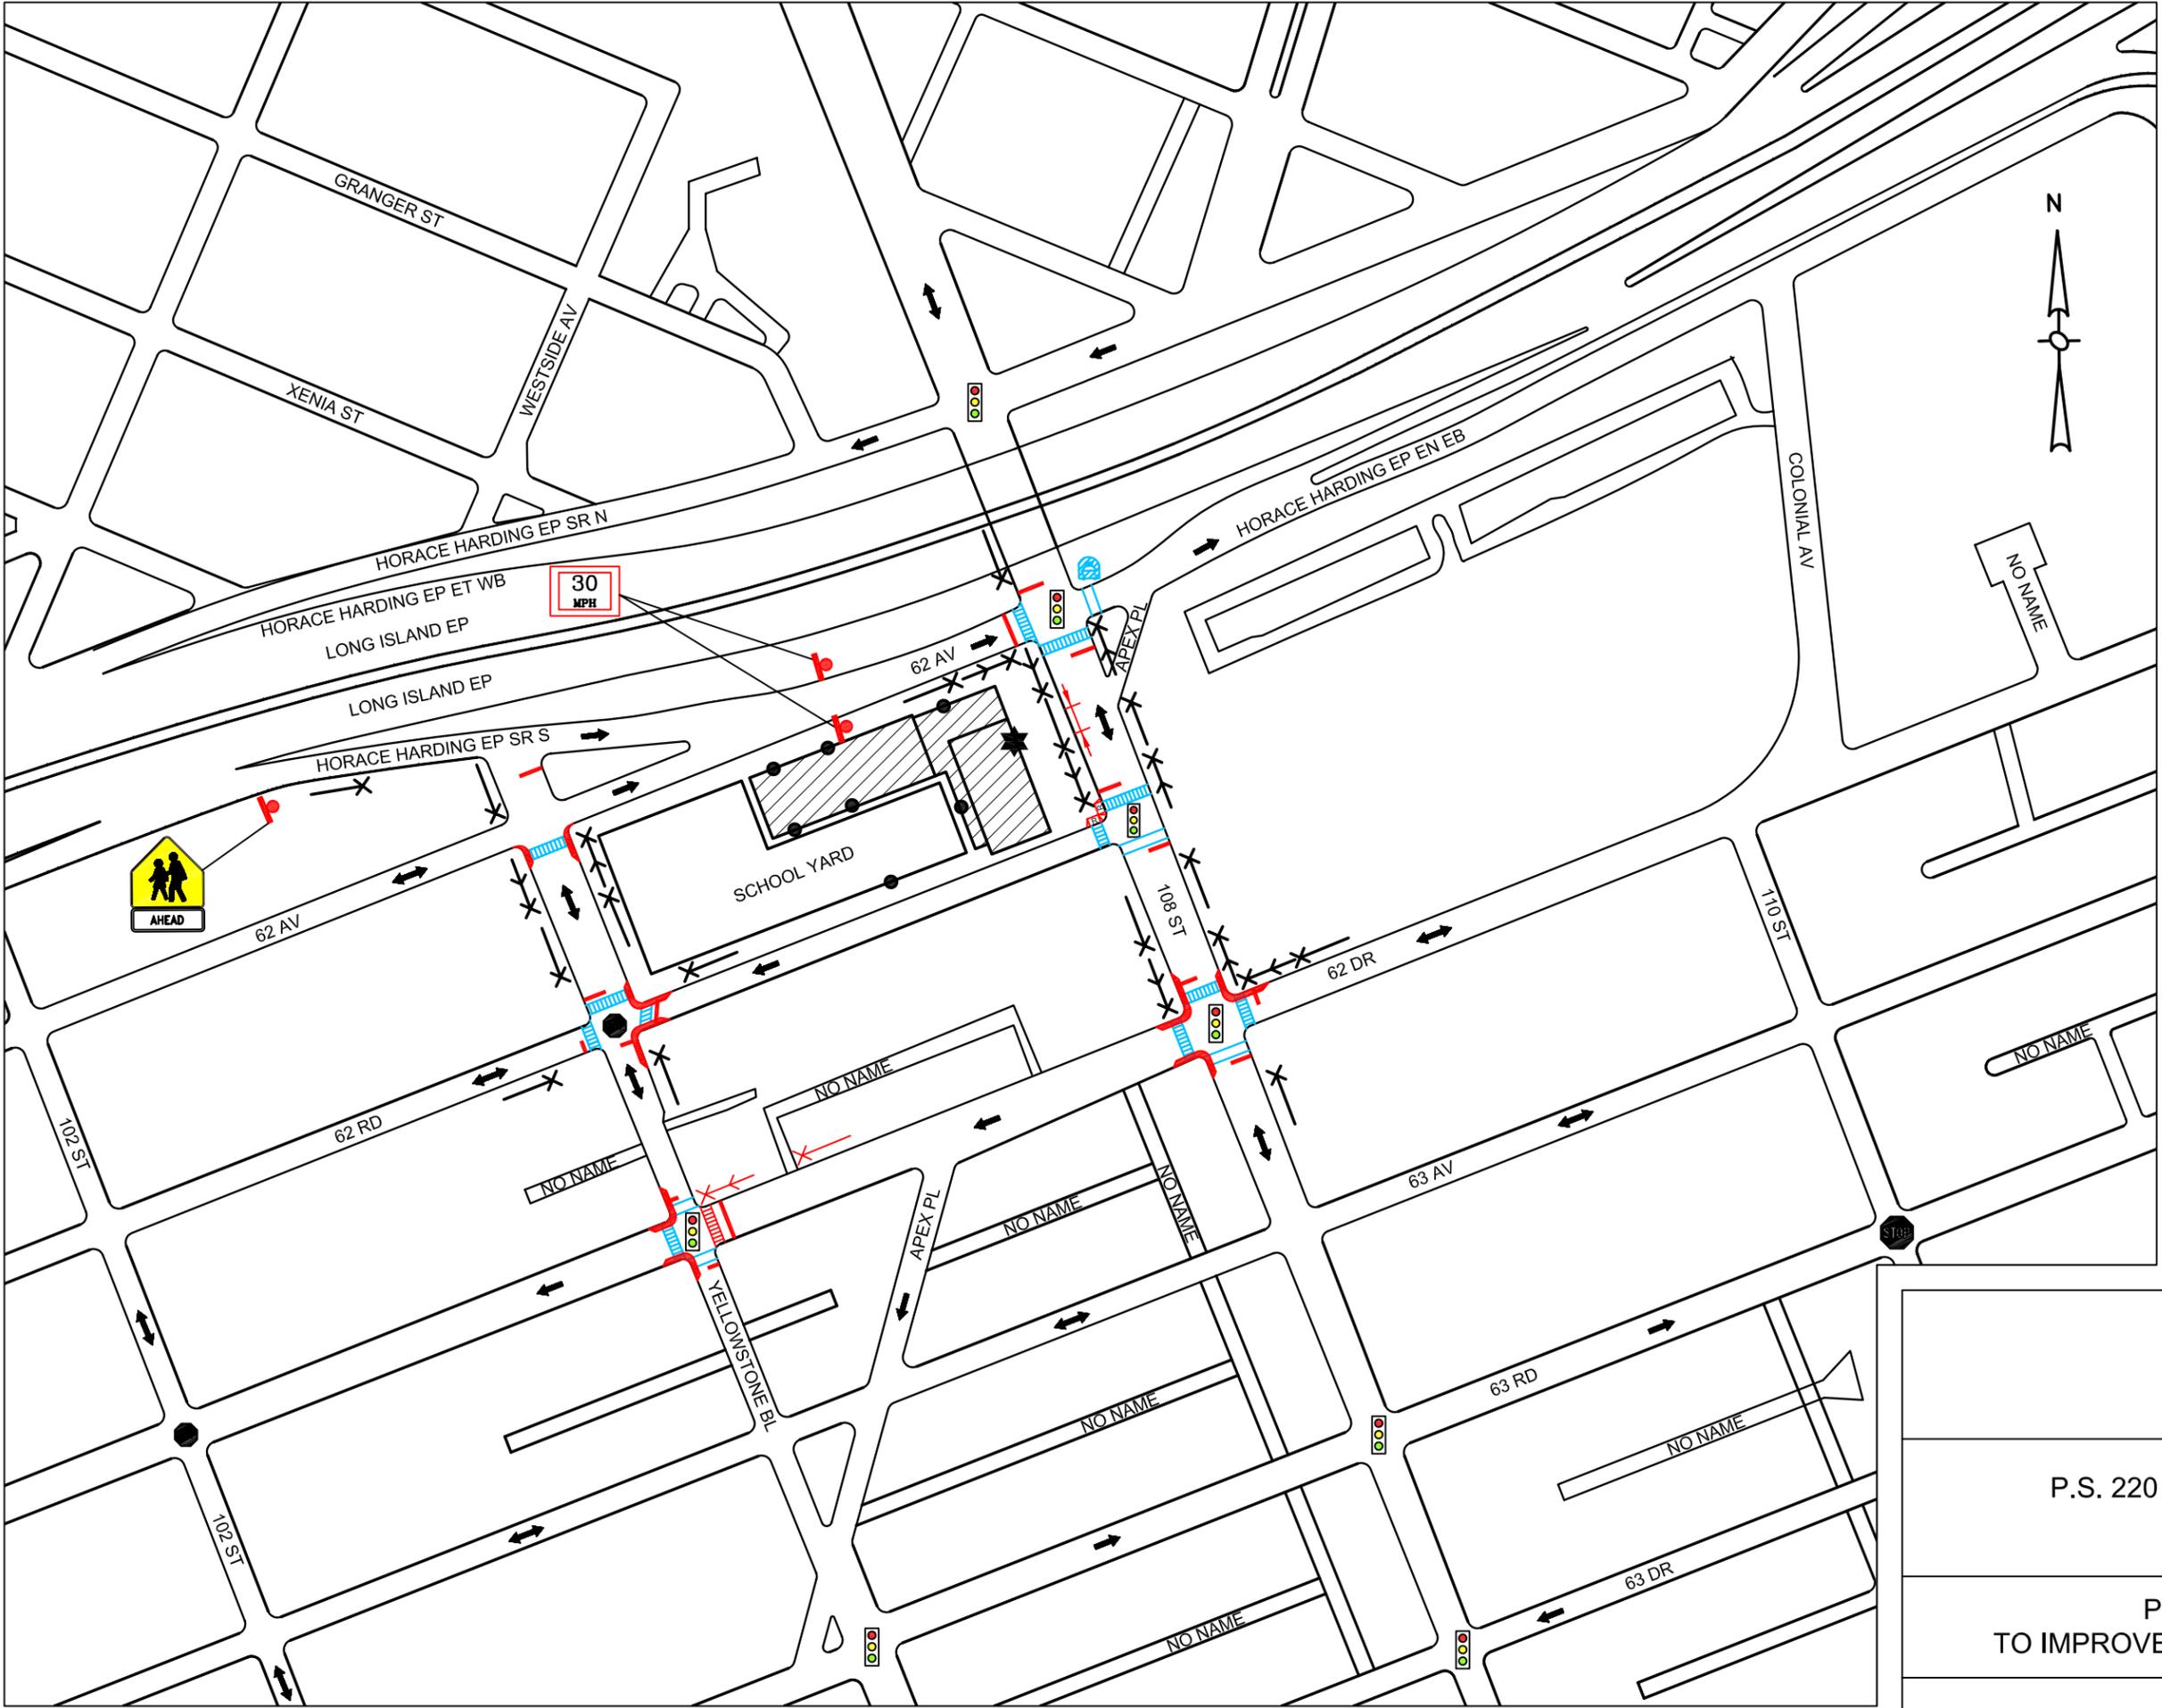
EXHIBIT 7

This section describes proposed measures to improve school pedestrian safety around P.S. 220. The proposed recommendations are divided into short-term and long-term measures. Short-term measures are those that potentially can be performed in-house. Long-term measures involve capital improvements. Each of the short- and long-term measures recommended for the P.S. 220 is discussed as follows, and is shown in more detail in Exhibit 7 at the end of this section.

POTENTIAL MEASURES
TO IMPROVE STUDENT PEDESTRIAN SAFETY

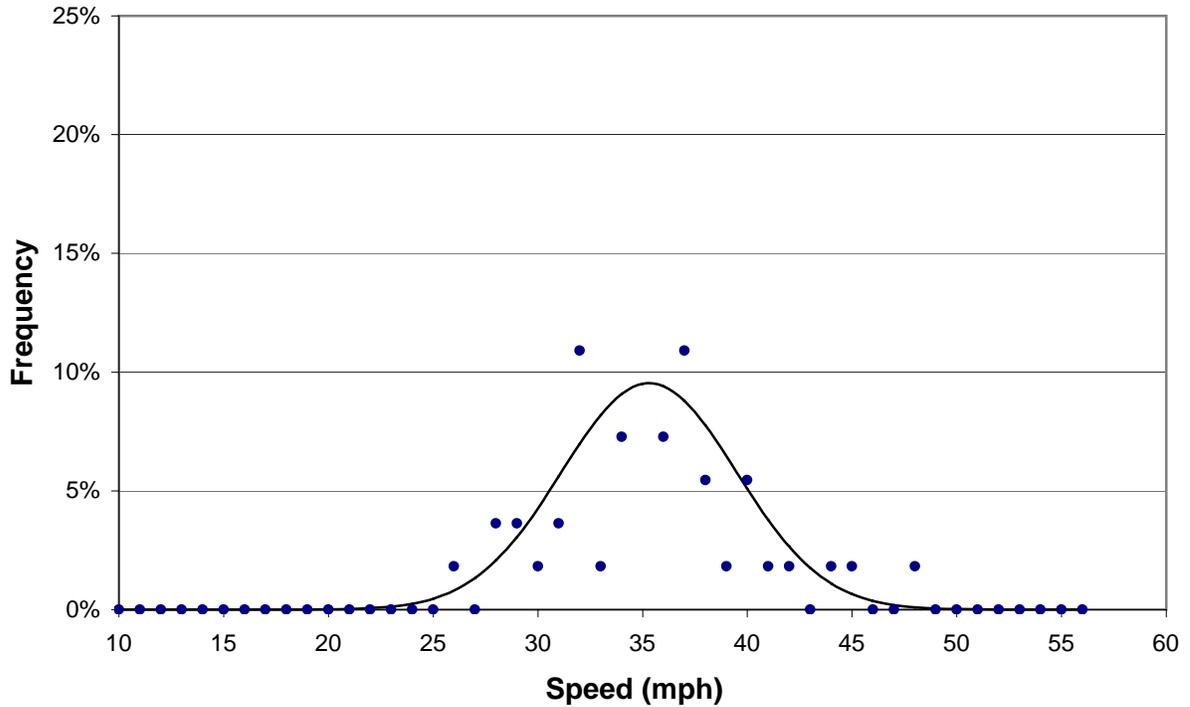
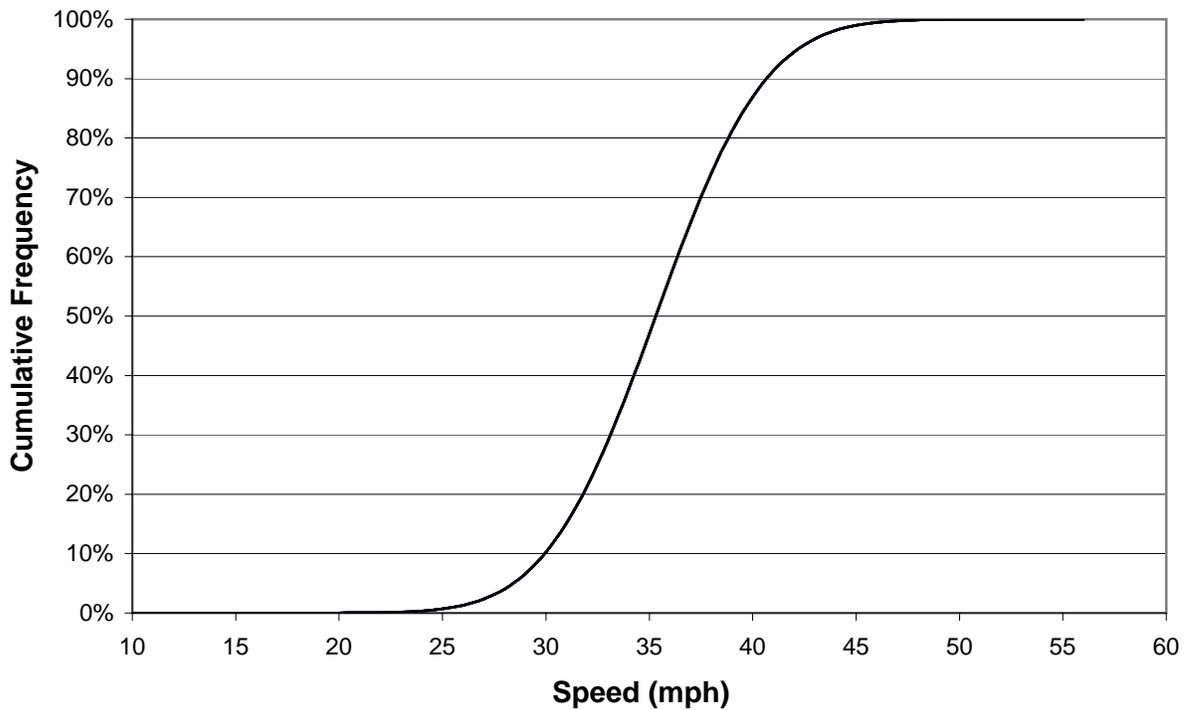
Mean Speed = 35.3 mph
Standard Deviation = 4.2 mph
Margin of Error (95% Confidence) = ± 1.1 mph

Median Speed = 35.3 mph
15th Percentile Speed = 31.0 mph
85th Percentile Speed = 39.6 mph

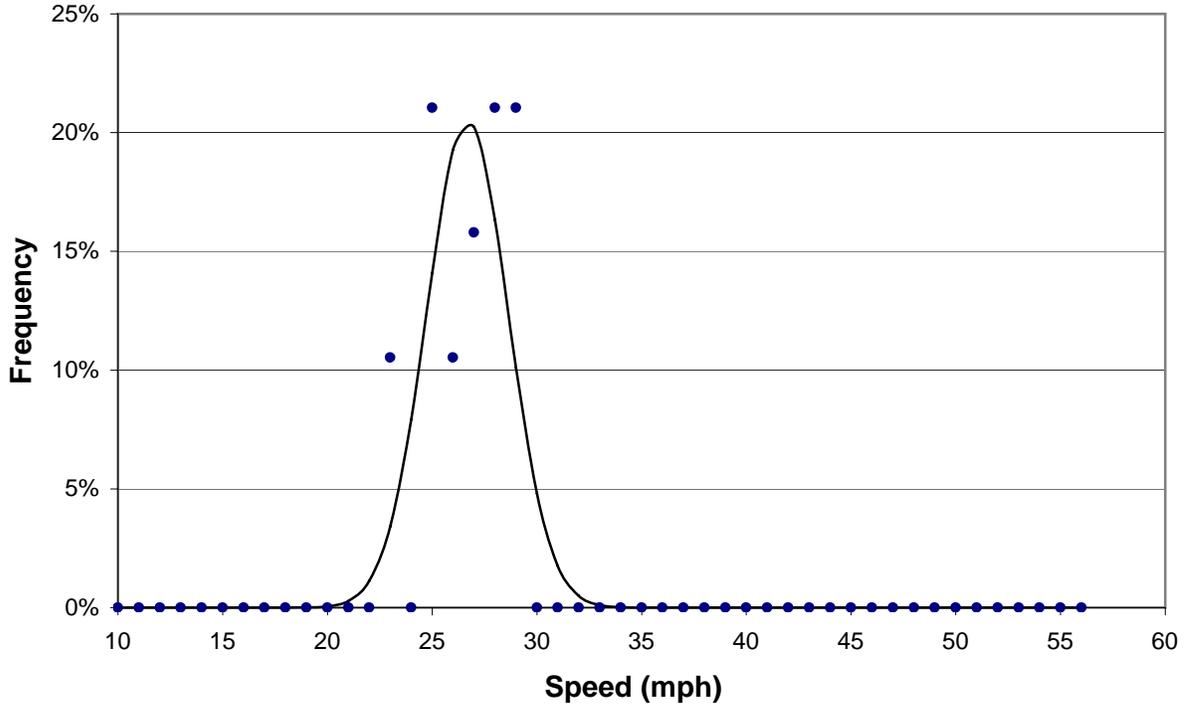
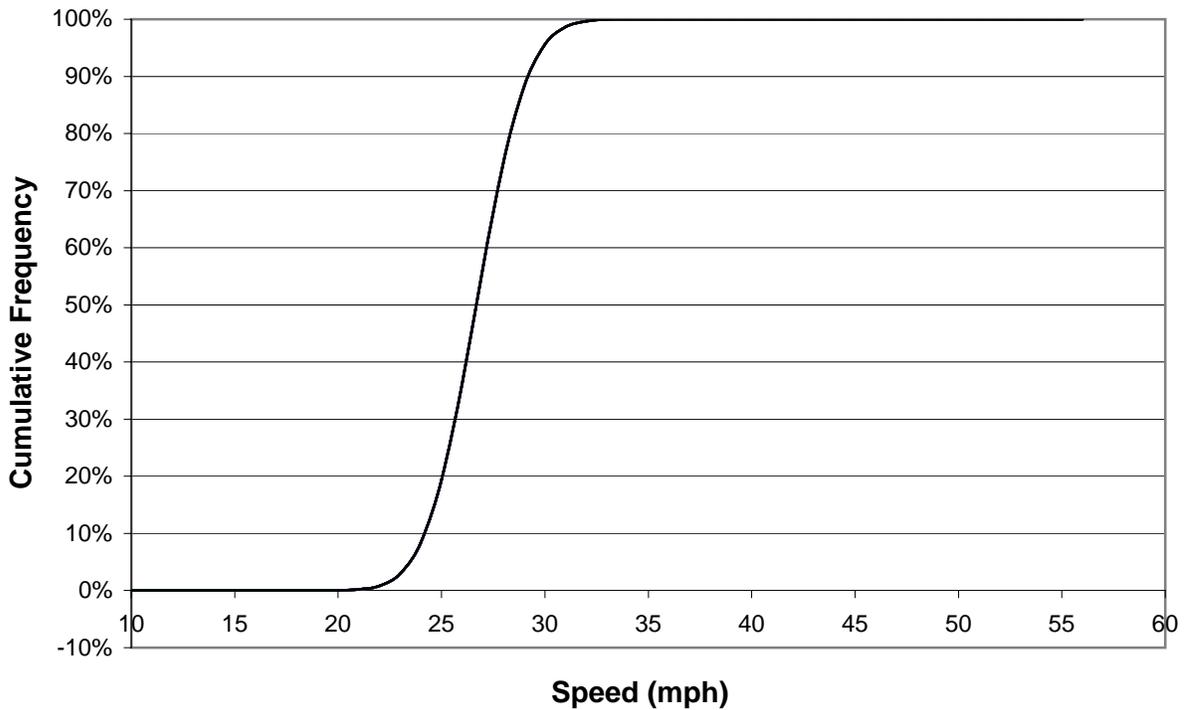
Date: **October 27, 2005** Time: **9:45 am - 10:45 am** School: **P.S. 220**
Location: **Horace Harding Expressway between Yellowstone Boulevard & 108 St** Direction: **EB 2**
Surveyor: **R. Calvache** Comments:

Mean Speed = 26.7 mph Median Speed = 26.7 mph
Standard Deviation = 1.9 mph 15th Percentile Speed = 24.7 mph
Margin of Error (95% Confidence) = ± 0.9 mph 85th Percentile Speed = 28.7 mph
