**New York City Department of Transportation
Office of School Safety Engineering**

School Safety Engineering Project

FINAL REPORT: Saint Elizabeth, Queens

**School Safety Engineering Project
Final Report: St. Elizabeth School, Queens**

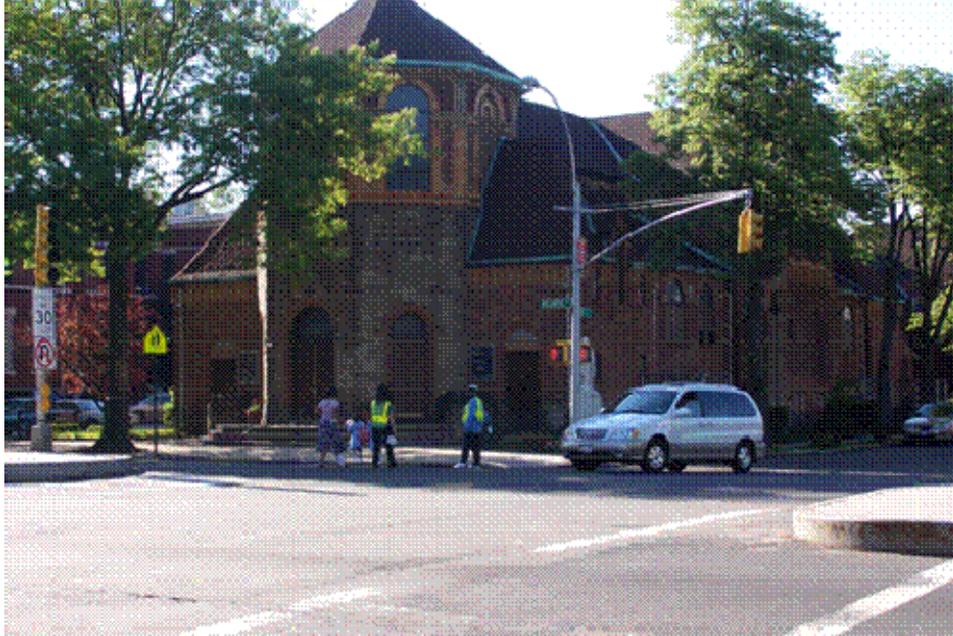
Figure 2: Looking southeast across intersection of Atlantic Avenue & 84th Street at crossing guard location

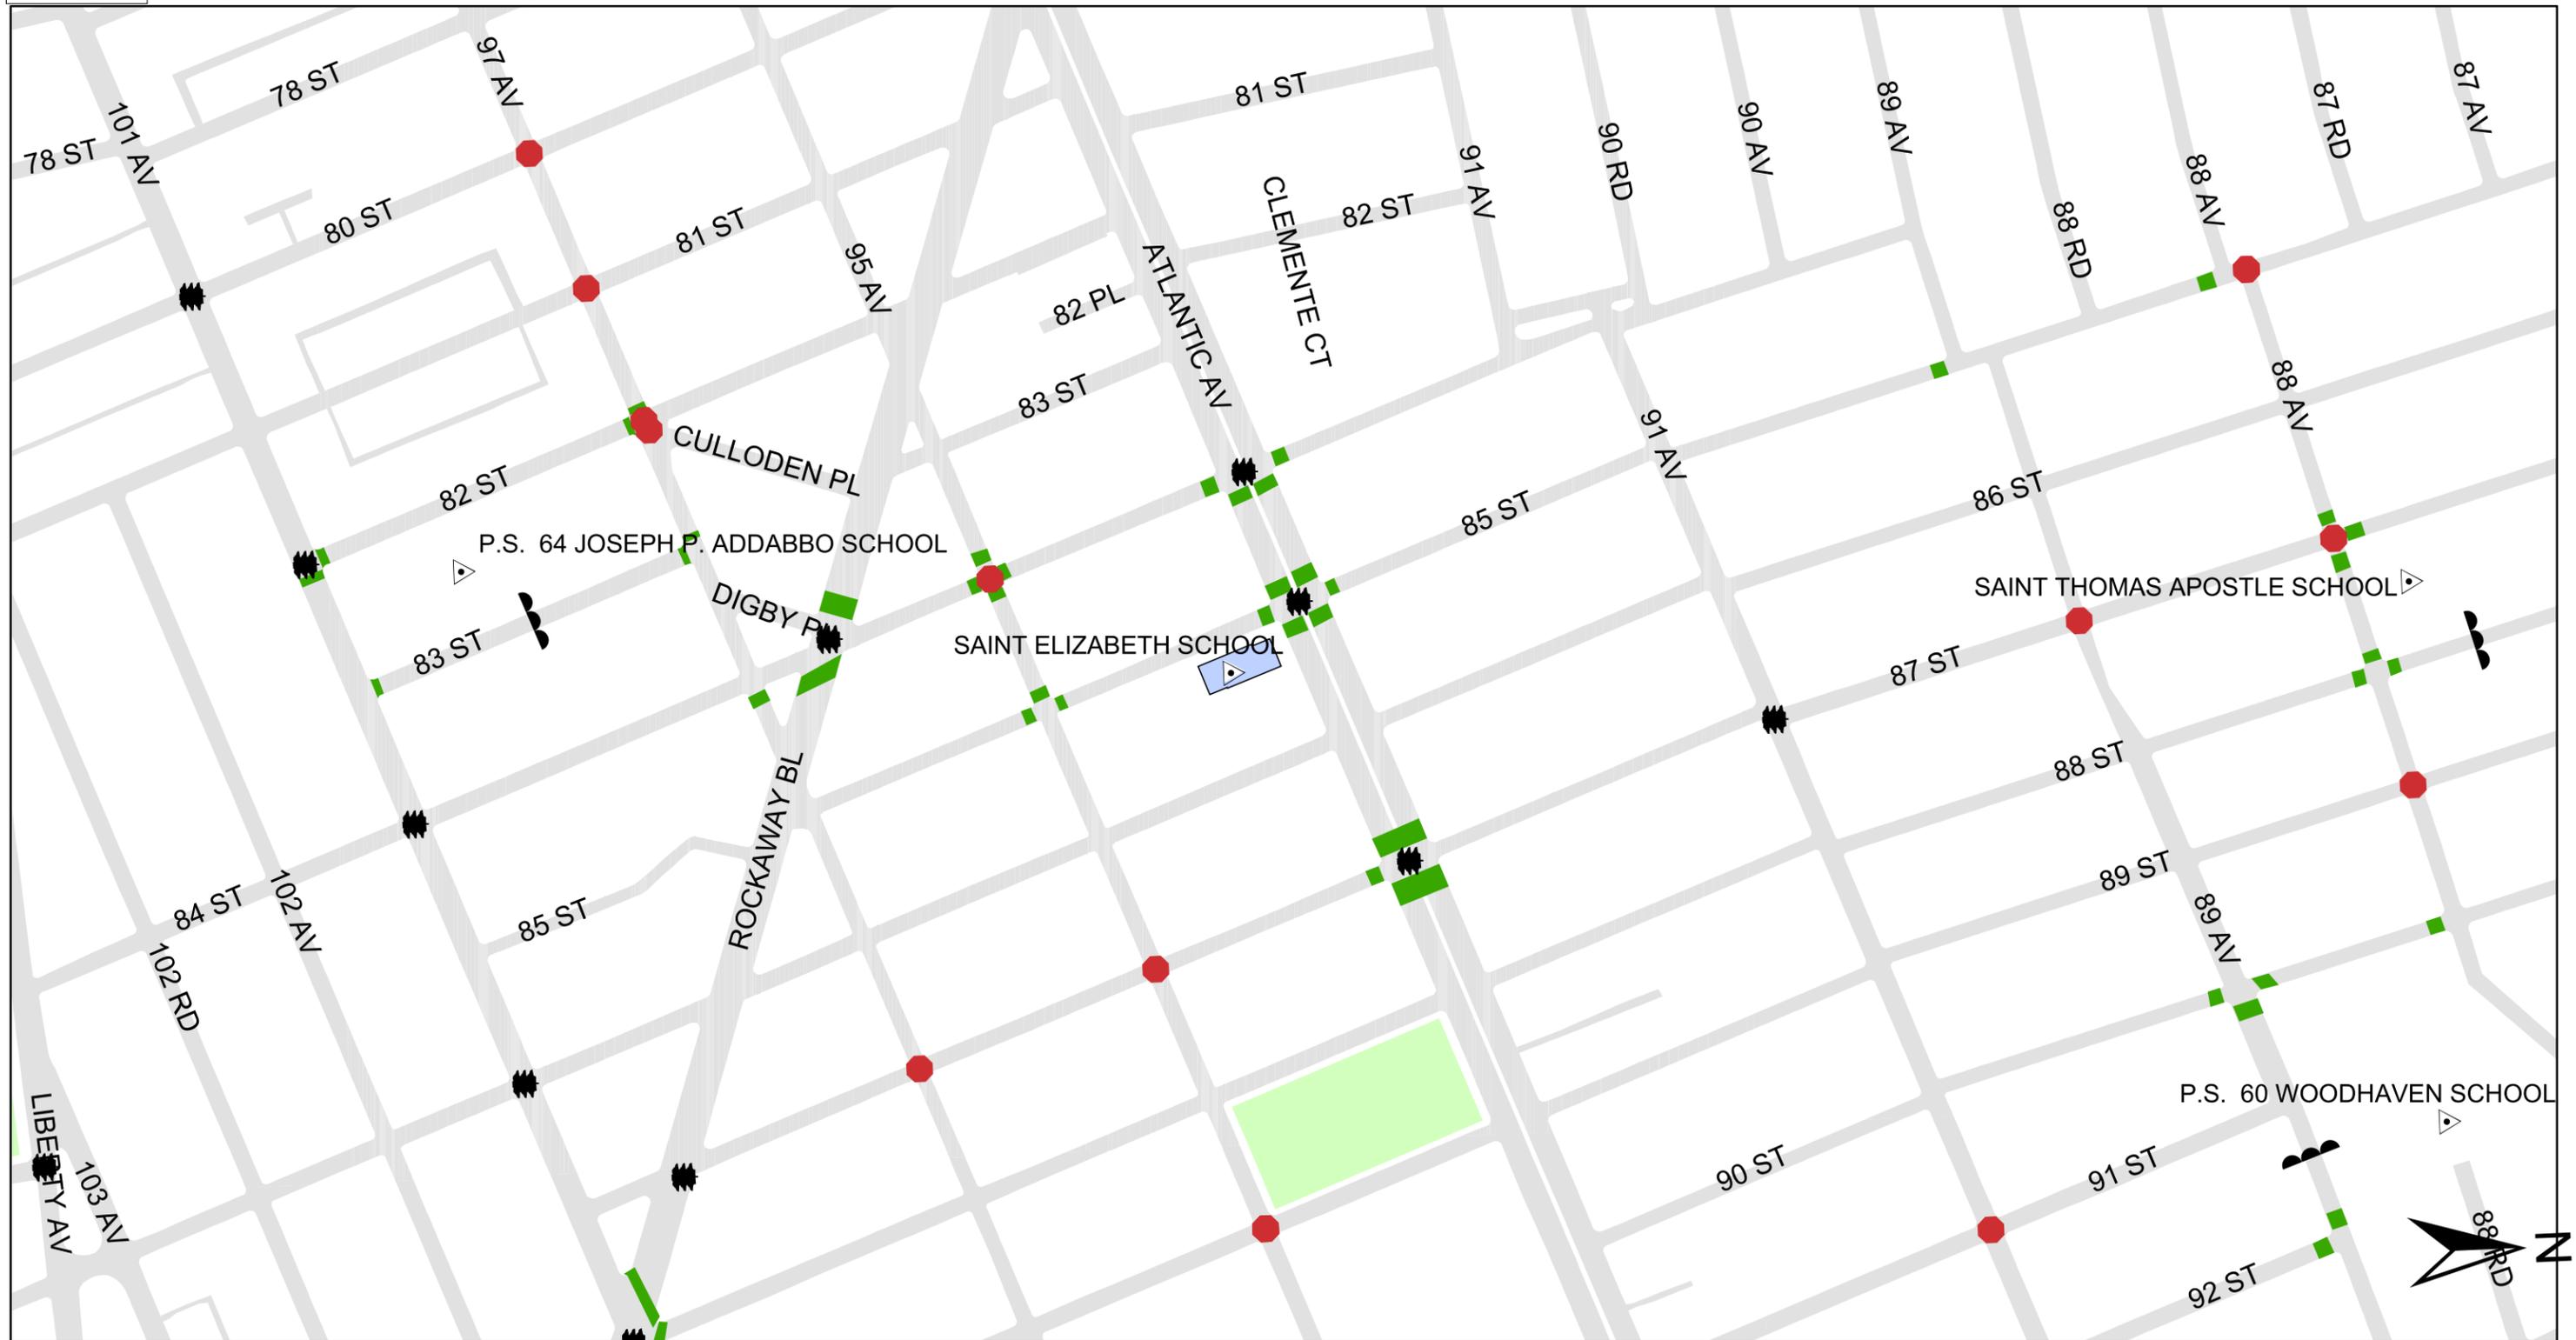
EXHIBIT 2

The School Traffic Safety Map was established to help provide the maximum degree of safety for children going to and from school - by indicating the location of speed reducers, school crosswalks and some traffic control devices. (While virtually all intersections in NYC benefit from traffic control devices - such as stop signs, traffic signals, yield signs, and all way stop signs - this map shows only traffic signals and all way stop signs.) The school crosswalks that are shown are ladder striped and make the crosswalk more visible to drivers and help make the intersection safer. These crosswalks are where school children are recommended to cross.

Exhibit 2, at the end of Section 2, shows existing traffic signals, and the school signs and markings assigned to St. Elizabeth School. It should be noted that a citywide signage program is currently underway to upgrade school signage to current Federal Manual on Uniform Traffic Control Devices (MUTCD) standards of fluorescent yellow-green accompanied by downward pointing arrows. Signs scheduled to be installed under this program are shown as “existing” in Exhibit 7.

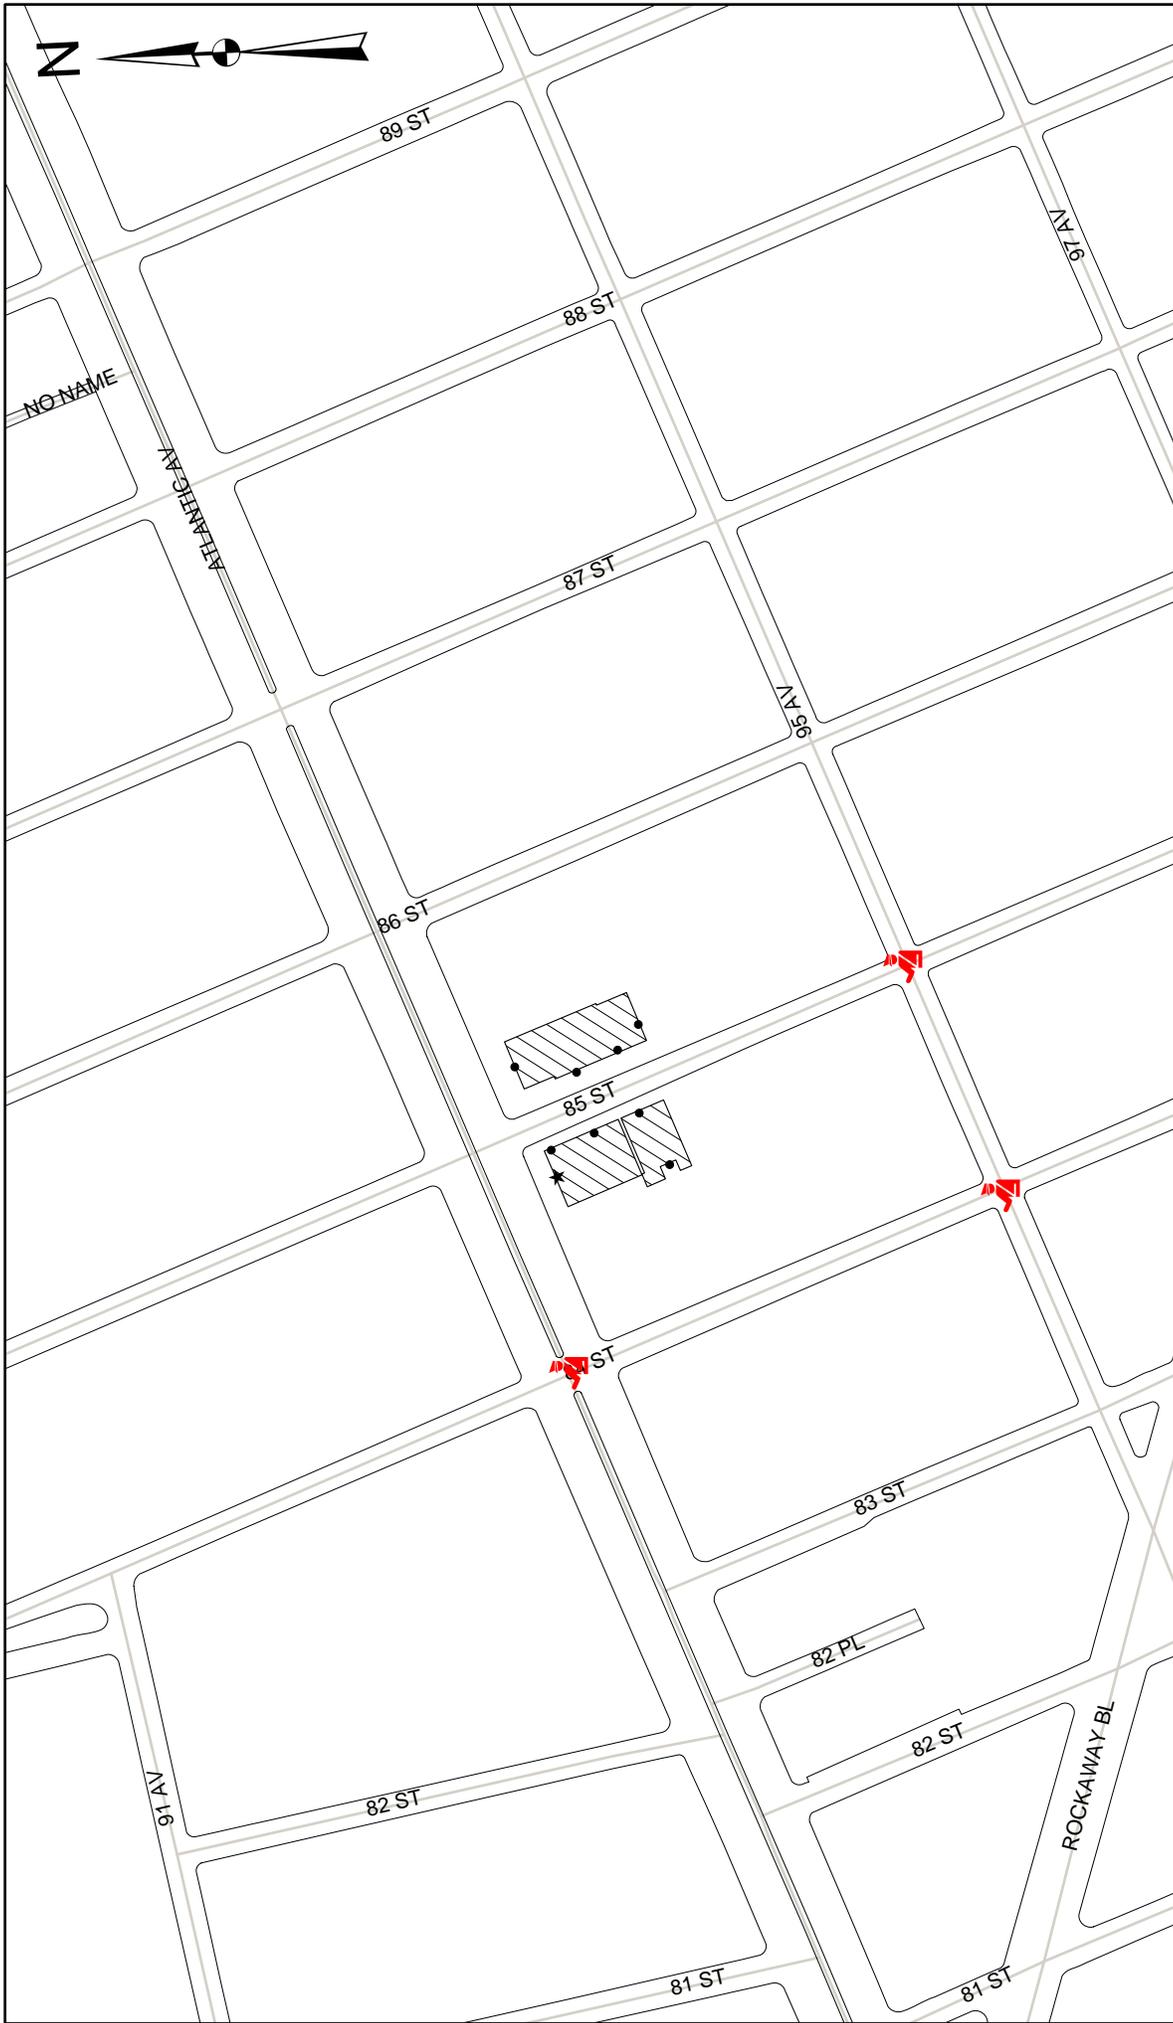
EXHIBIT 3

According to the school principal, there are three crossing guards assigned to the area. They are assigned to the following intersections:

- 84th Street & Atlantic Avenue

- 84th Street & 95th Avenue
- 85th Street & 95th Avenue

CROSSING GUARD LOCATIONS

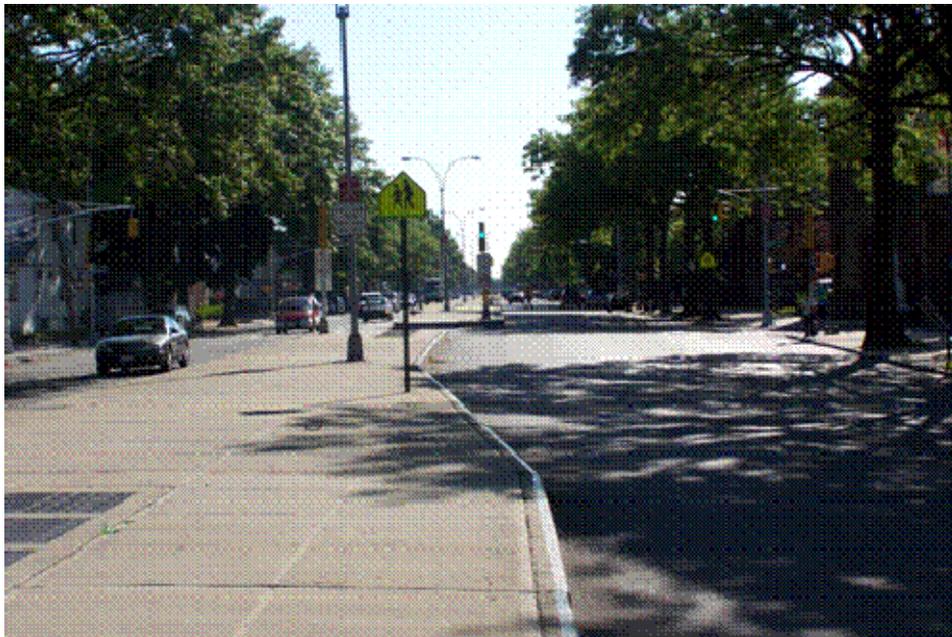
now has two travel lanes in each direction separated by an approximately eighteen (18) foot wide (at the intersection) raised concrete median, with parking on each side of the roadway. There is a dedicated left turn lane for each direction of travel on Atlantic Avenue provided by way of turn bays created in the median. Away from the intersection, the raised concrete median is approximately twenty-five feet wide. South of Atlantic Avenue, 84th Street is a two-way street with one travel lane and a parking lane on each side of the roadway. North of Atlantic Avenue, 84th Street is a one-way northbound street with one travel lane and parking on both sides of the roadway (see Figure 3).

Figure 3: Looking east on Atlantic Avenue at intersection of 84th Street

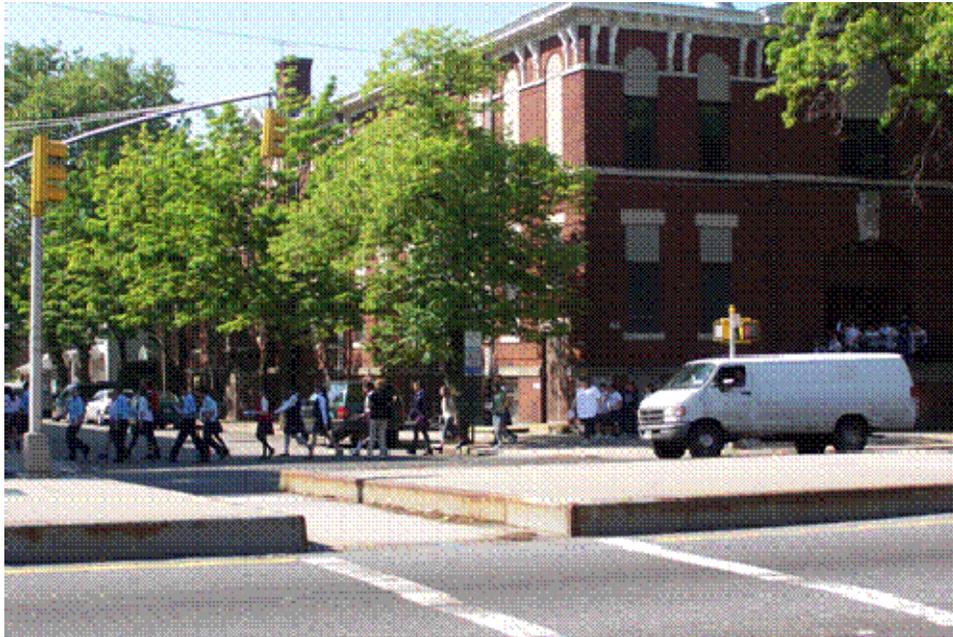
Atlantic Avenue is a two-way street with two travel lanes in each direction separated by an approximately twenty-five foot wide raised concrete median which continues across the intersection, with parking on each side of the roadway. There are no left turns from westbound Atlantic Avenue into southbound 85th Street since the raised concrete median prevents vehicular traffic from crossing Atlantic Avenue. North of Atlantic Avenue, 85th Street is a one-way northbound street with one travel lane and parking on both sides of the roadway. South of Atlantic Avenue, 85th Street is a one-way southbound street with one travel lane and parking on both sides of the roadway. Pedestrian traffic is accommodated by the traffic signal control and at-grade openings through the raised concrete median. 85th Street is closed with barricades in the area of the school from 8:00 to 9:00 am and from 11:30 am to 1:30 pm on school days. Atlantic Avenue is commercial in nature with residential uses. 85th Avenue is generally residential in character (see Figure 4).

Figure 4: Looking south across Atlantic Avenue at 85th Street intersection

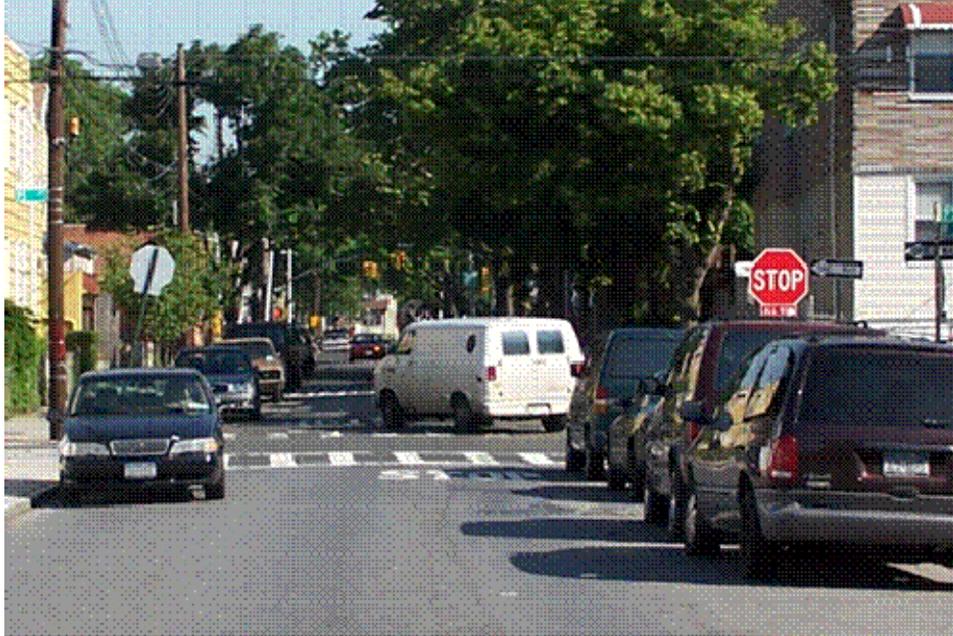
95th Avenue is a one-way westbound street with one travel lane and parking on both sides of the roadway. 84th Street is a two-way street, with one travel lane and a parking lane on each side of the roadway. 95th Avenue is generally residential in character with commercial uses. 84th Avenue is generally residential in character (see Figure 5).

Figure 5: Looking north on 84th Street toward 95th Avenue intersection

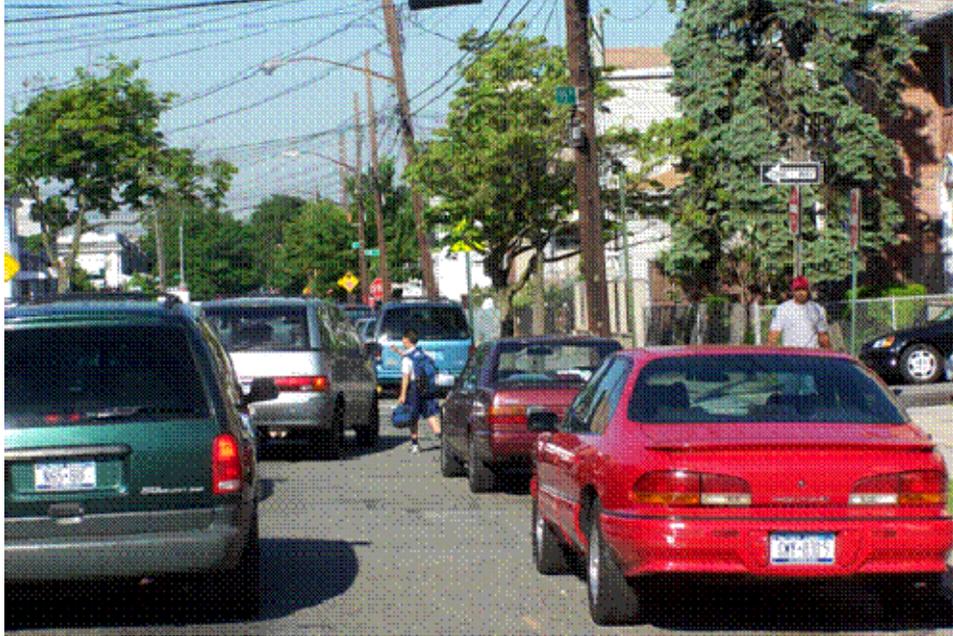
85th Street is a one-way southbound street north of 95th Avenue and a one-way northbound street south of 95th Avenue, with one travel lane and parking on both sides of the roadway. 95th Avenue is a one-way westbound street, with one travel lane and parking on both sides of the roadway. There are stop signs for northbound and southbound 85th Street. 95th Avenue is generally residential in character with commercial uses, while 85th Avenue is generally residential in character (see Figure 6).

Figure 6: Looking west on 95th Avenue at 85th Street intersection

There is an unprotected school crosswalk on the west leg of 95th Avenue at this intersection. To better determine the type of control that would be appropriate at 95th Avenue and 85th Street, a traffic count was conducted at this intersection from 7:30 to 9:00 am on Friday, October 21, 2005 including both vehicle and pedestrian volumes. The results of the peak hour (7:30 to 8:30 am) count are shown in Tables 6 and 7 and in Exhibit 6B at the end of this section.

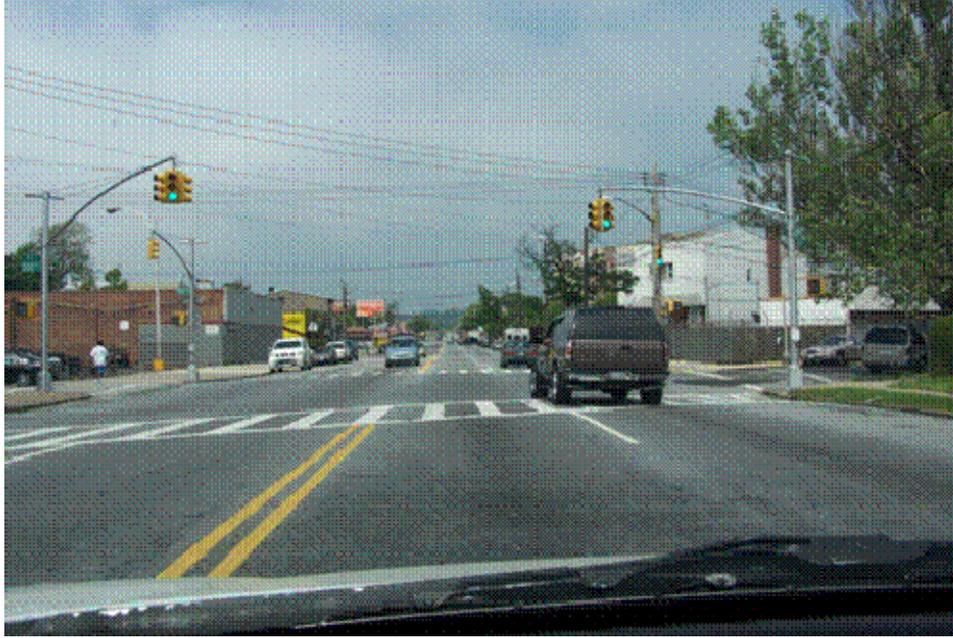
Rockaway Boulevard is a two-way street with two travel lanes and a parking lane on each side of the roadway. 84th Street is a two-way street, with one travel lane and a parking lane on each side of the roadway. Digby Place only runs the short distance between Rockaway Boulevard and 97th Avenue, intersecting with the south side of Rockaway Boulevard just west of 84th Street, forming a T-intersection. Digby Place is a one-way southbound street with one travel lane and parking on both sides of the roadway. Rockaway Boulevard is generally commercial in character, while 84th Street is generally residential in character (see Figure 7).

Figure 7: Looking north on Rockaway Boulevard toward intersections of 84th Street and Digby Place

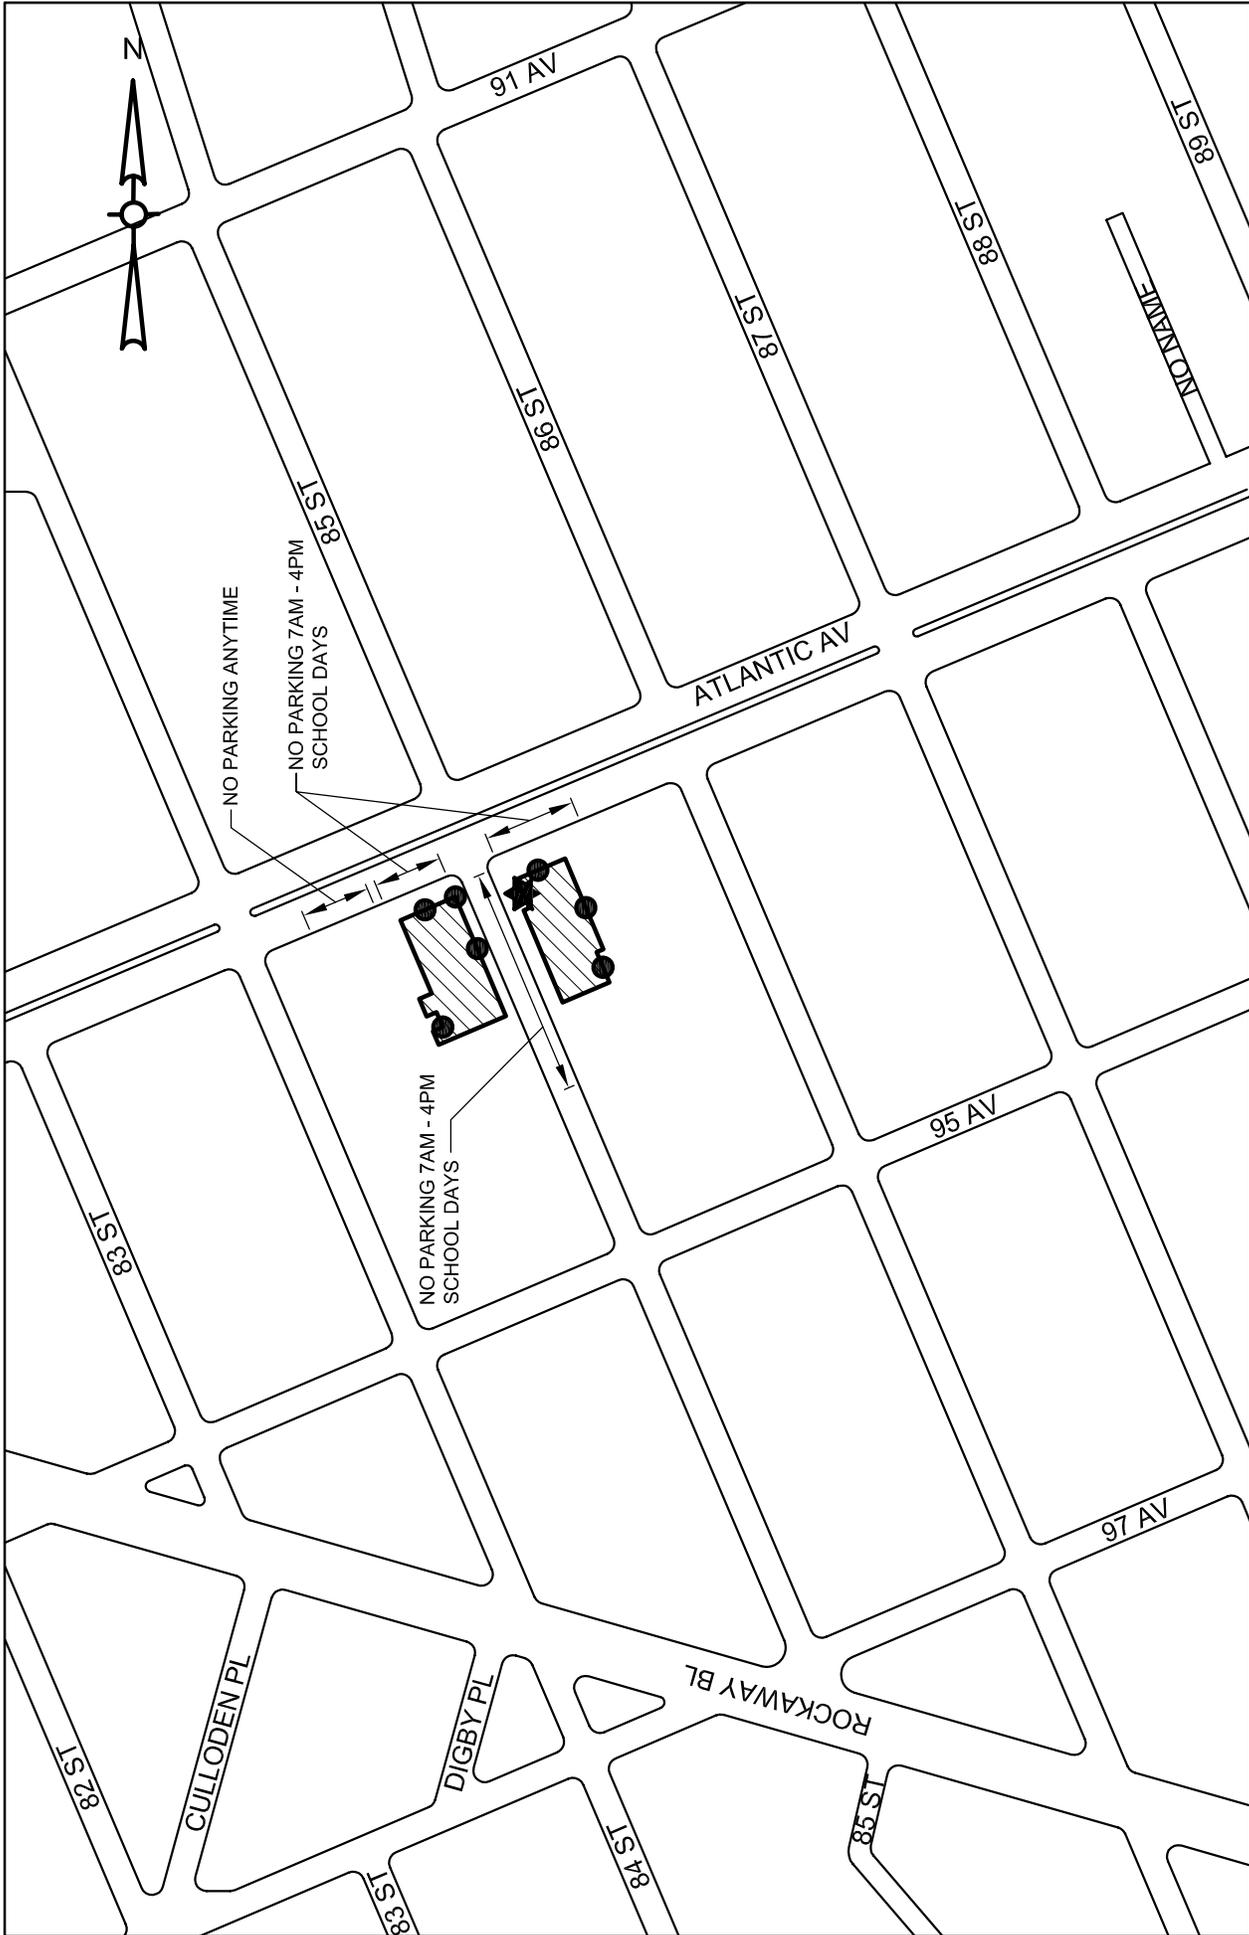
EXHIBIT 4
 ST. ELIZABETH SCHOOL
 QUEENS

Parking regulations around the school block are shown in Exhibit 4, at the end of this section. Atlantic Avenue is a “Snow Route” which prohibits standing on the street during an emergency condition. In addition, Atlantic Avenue is also a designated through truck route.

EXISTING PARKING REGULATIONS

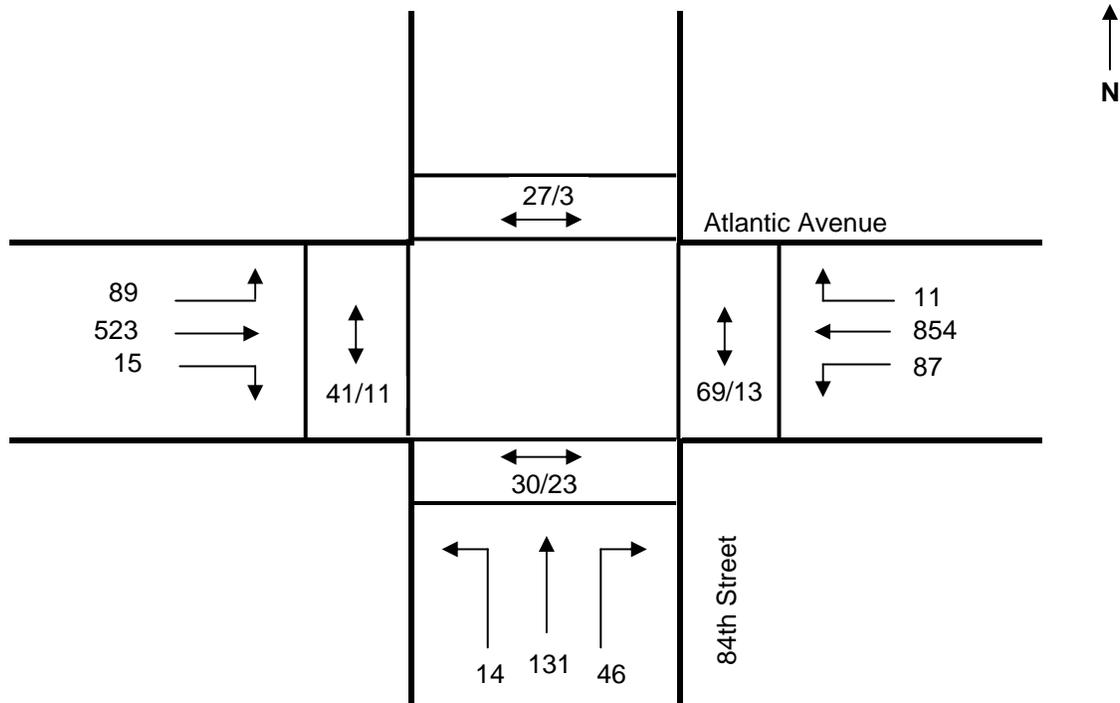
EXHIBIT 6A
St. Elizabeth School QUEENS
TRAFFIC AND PEDESTRIAN COUNTS

One Hour Traffic Volumes
Thursday, October 20th, 2005 7:30 am - 8:30 am

Intersection of Atlantic Avenue and 84th Street

The school officials reported insufficient green time to cross Atlantic Avenue; therefore, a traffic movement count was performed at Atlantic Avenue & 84th Street intersection from 7:30 to 9:00 am on Wednesday, June 22, 2005 to better determine if the traffic conditions at this intersection would permit the extending of the green time to cross Atlantic Avenue by two seconds. This would enable a child pedestrian to cross the entire roadway in one phase of the signal (see Table 10). The results of the traffic movement count are shown in Table 4 for vehicular volumes and in Table 5 for pedestrian volumes. The traffic movement count is also shown in Exhibit 6A at the end of this section.

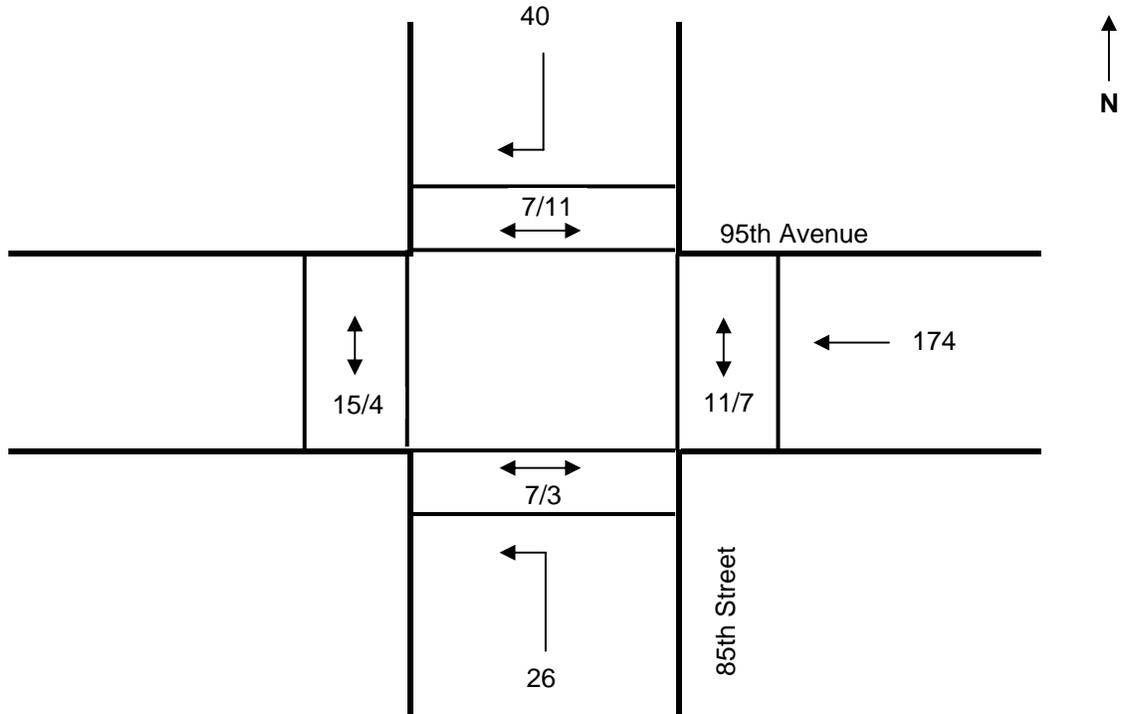
EXHIBIT 6B
St. Elizabeth School, QUEENS
TRAFFIC AND PEDESTRIAN COUNTS

One Hour Traffic Volumes
Friday, October 21, 2005 7:30 am - 8:30 am

Intersection of 95th Avenue and 85th Street

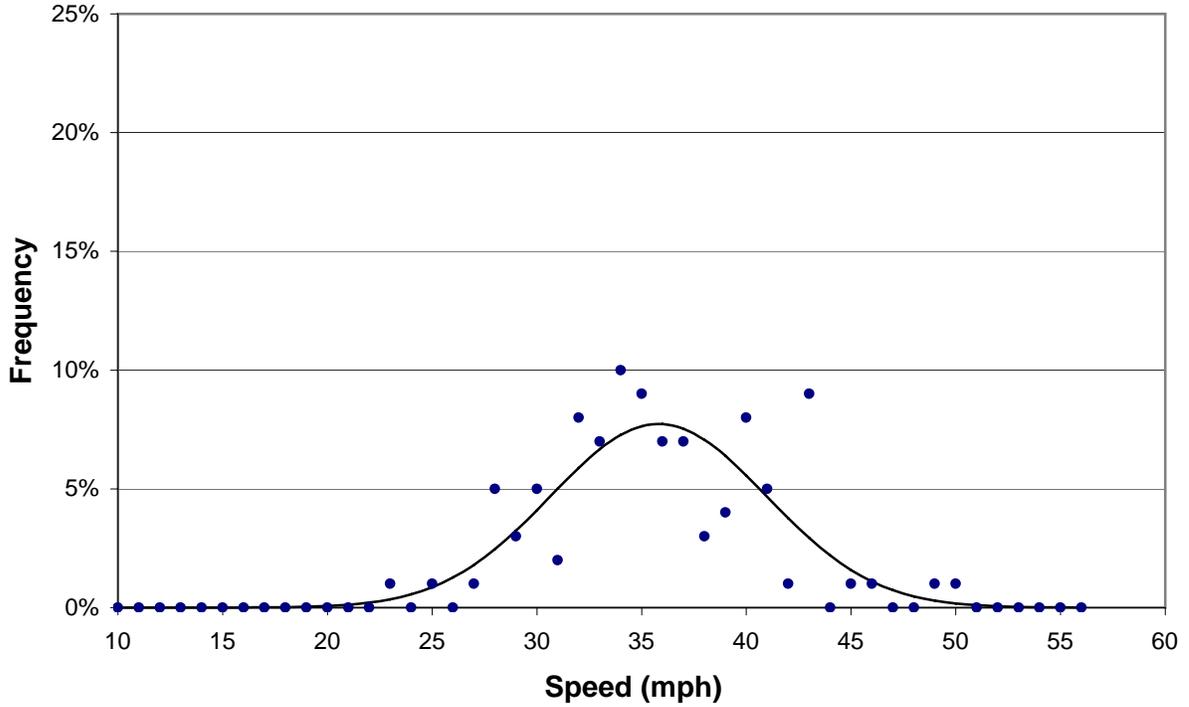
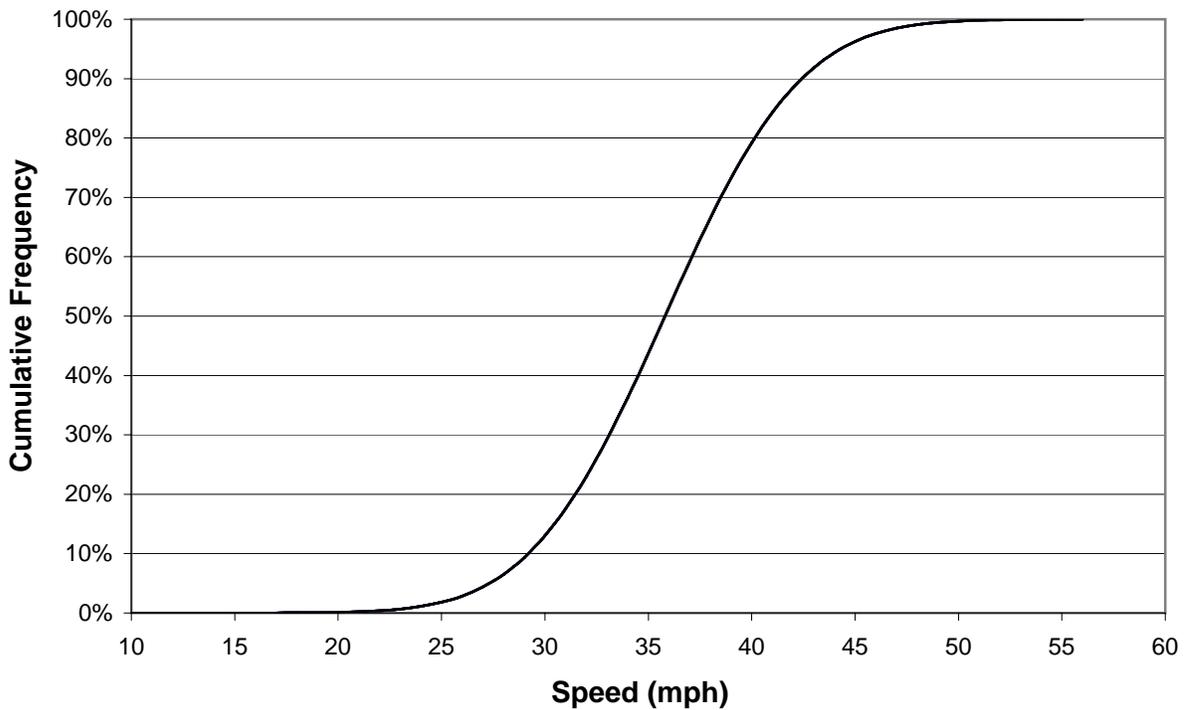
Mean Speed = 35.8 mph
Standard Deviation = 5.2 mph
Margin of Error (95% Confidence) = ± 1.0 mph

Median Speed = 35.8 mph
15th Percentile Speed = 30.5 mph
85th Percentile Speed = 41.2 mph

The 85th percentile speed for eastbound vehicles on Atlantic Avenue between 84th Street and 85th Street were found to be 41 mph. The 85th percentile speed for the westbound vehicles on Atlantic Avenue between 84th Street and 85th Street were found to be 38 mph.

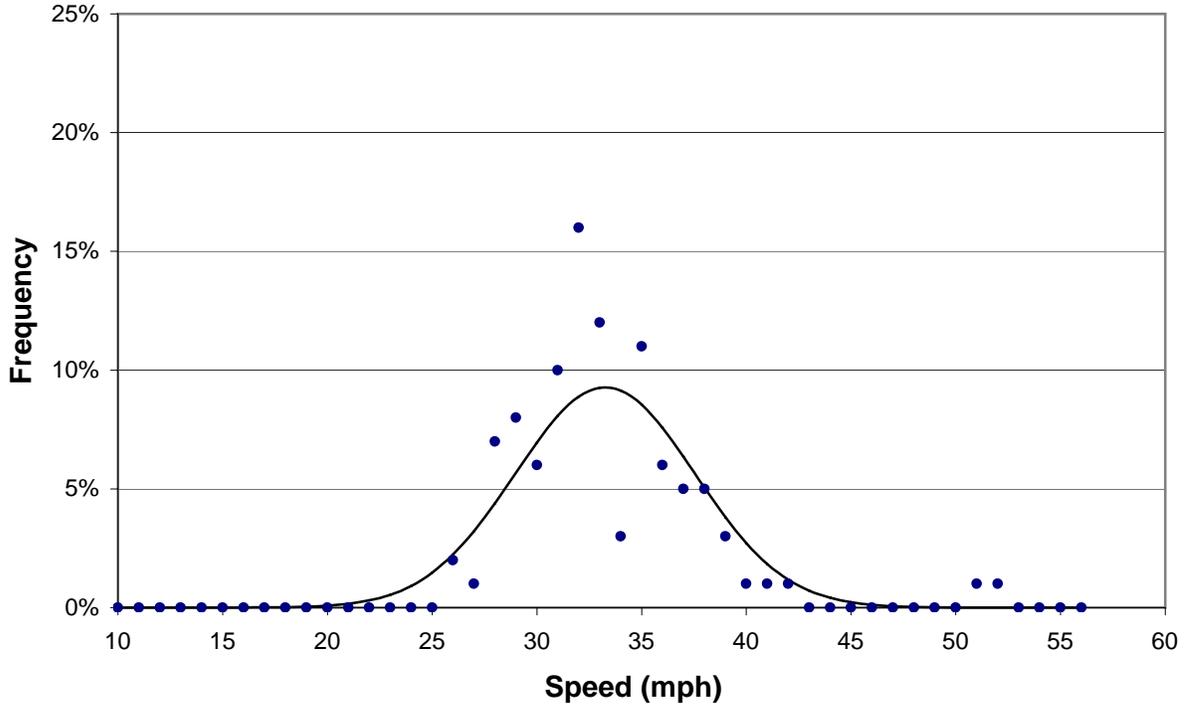
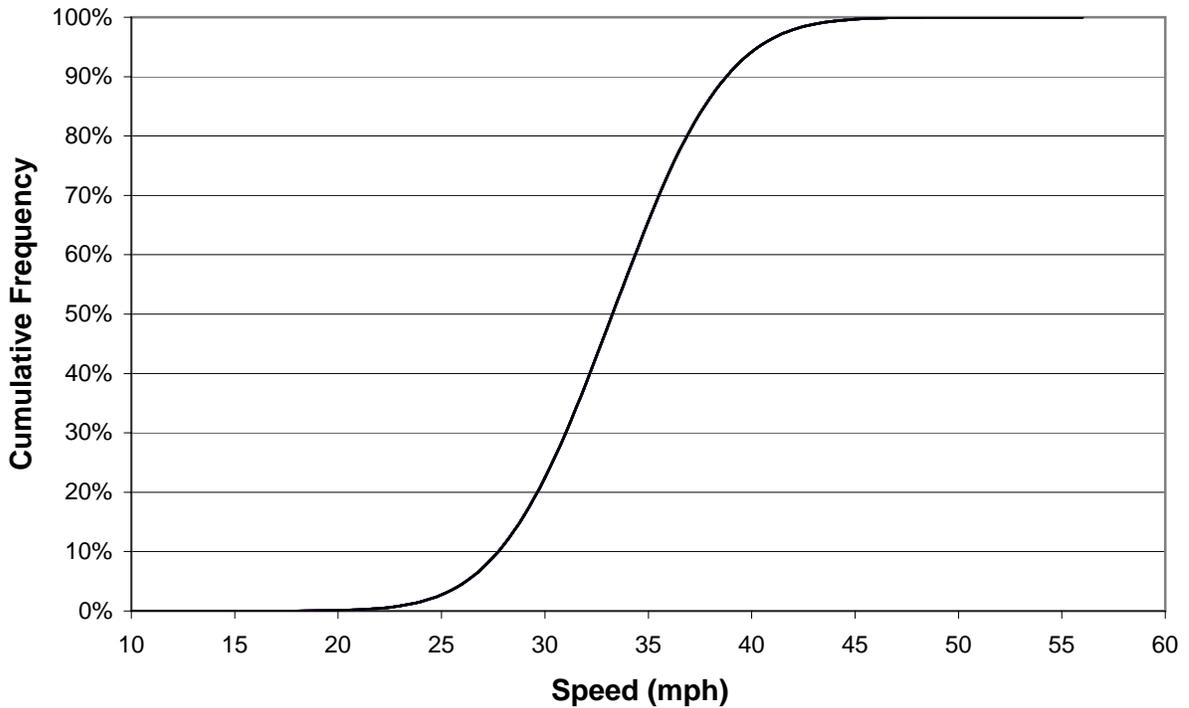
Mean Speed = 33.3 mph
Standard Deviation = 4.3 mph
Margin of Error (95% Confidence) = ± 0.8 mph

Median Speed = 33.3 mph
15th Percentile Speed = 28.8 mph
85th Percentile Speed = 37.7 mph
