**New York City Department of Transportation  
Office of School Safety Engineering**

**School Safety Engineering Project**

**FINAL REPORT: St Michael's School, Queens**

**NOVEMBER 3, 2006**

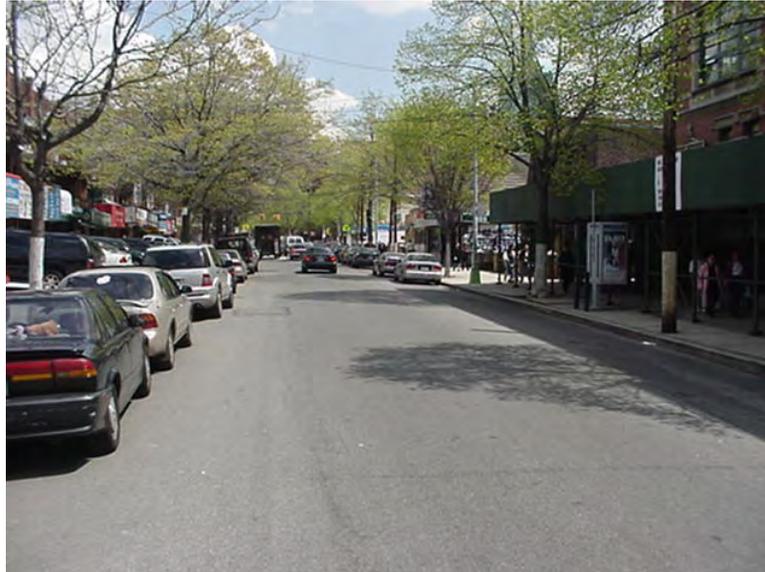
*Figure 1: 41<sup>st</sup> Avenue in front of St. Michael's*

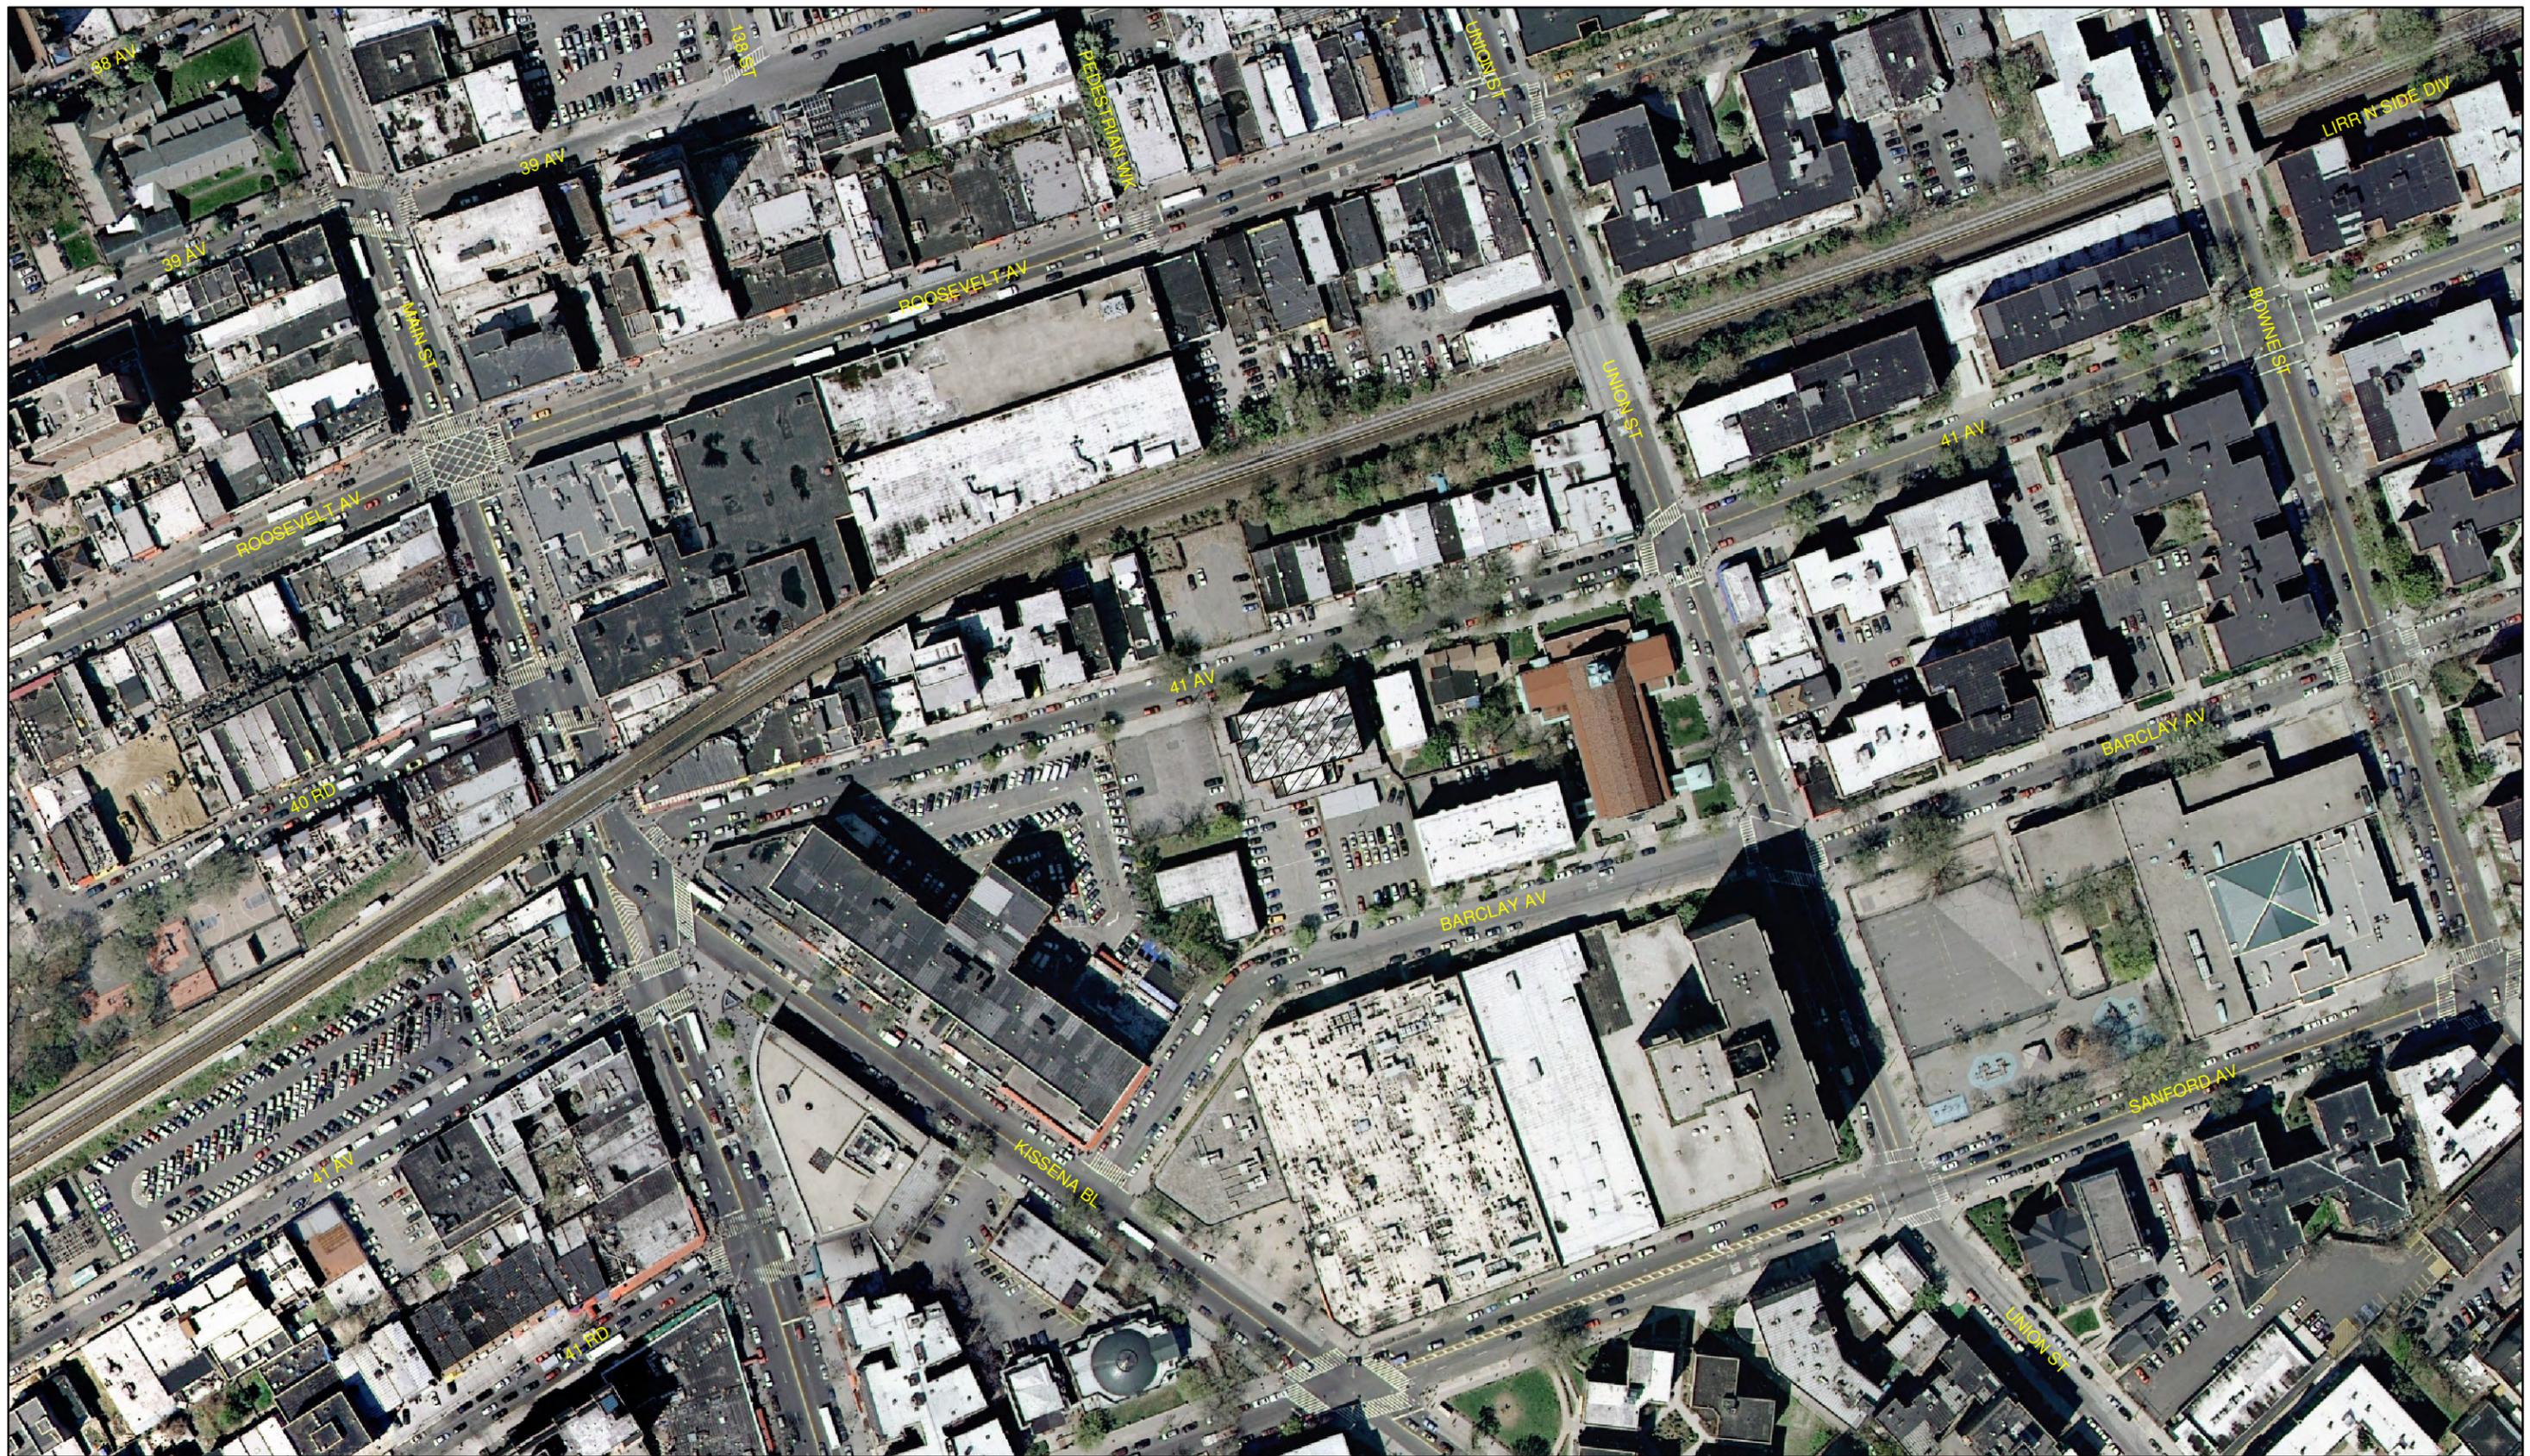
**EXHIBIT 1  
ST MICHAEL'S SCHOOL  
QUEENS  
AERIAL PHOTOGRAPH**

St. Michael's School is located at 136-58 41<sup>st</sup> Avenue, in the midst of a mix of residential and commercial buildings, anchored by church and post-war townhouses. A Time Warner warehouse, which generates a large number of trucks, is located across from St. Michael's School on Barclay Avenue (see Exhibit 1 for Aerial Photograph).

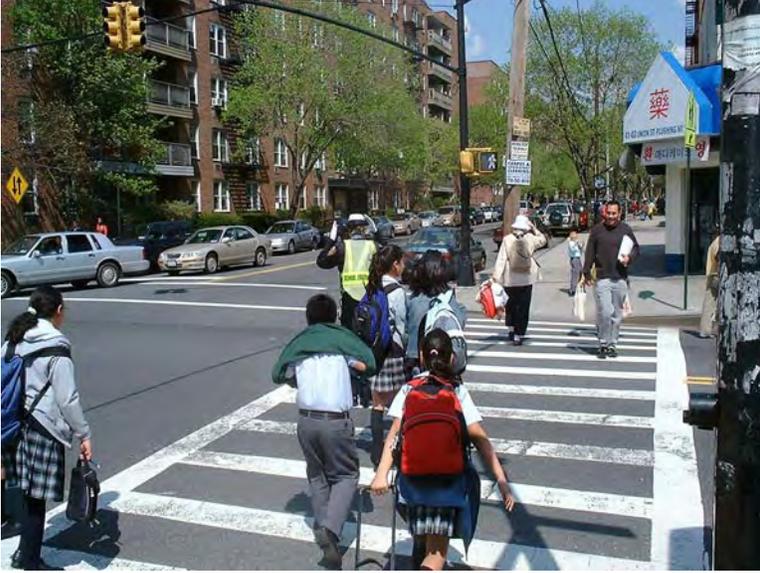
*Figure 3: Crossing guard at Sanford Avenue and Union Street intersection during dismissal time*

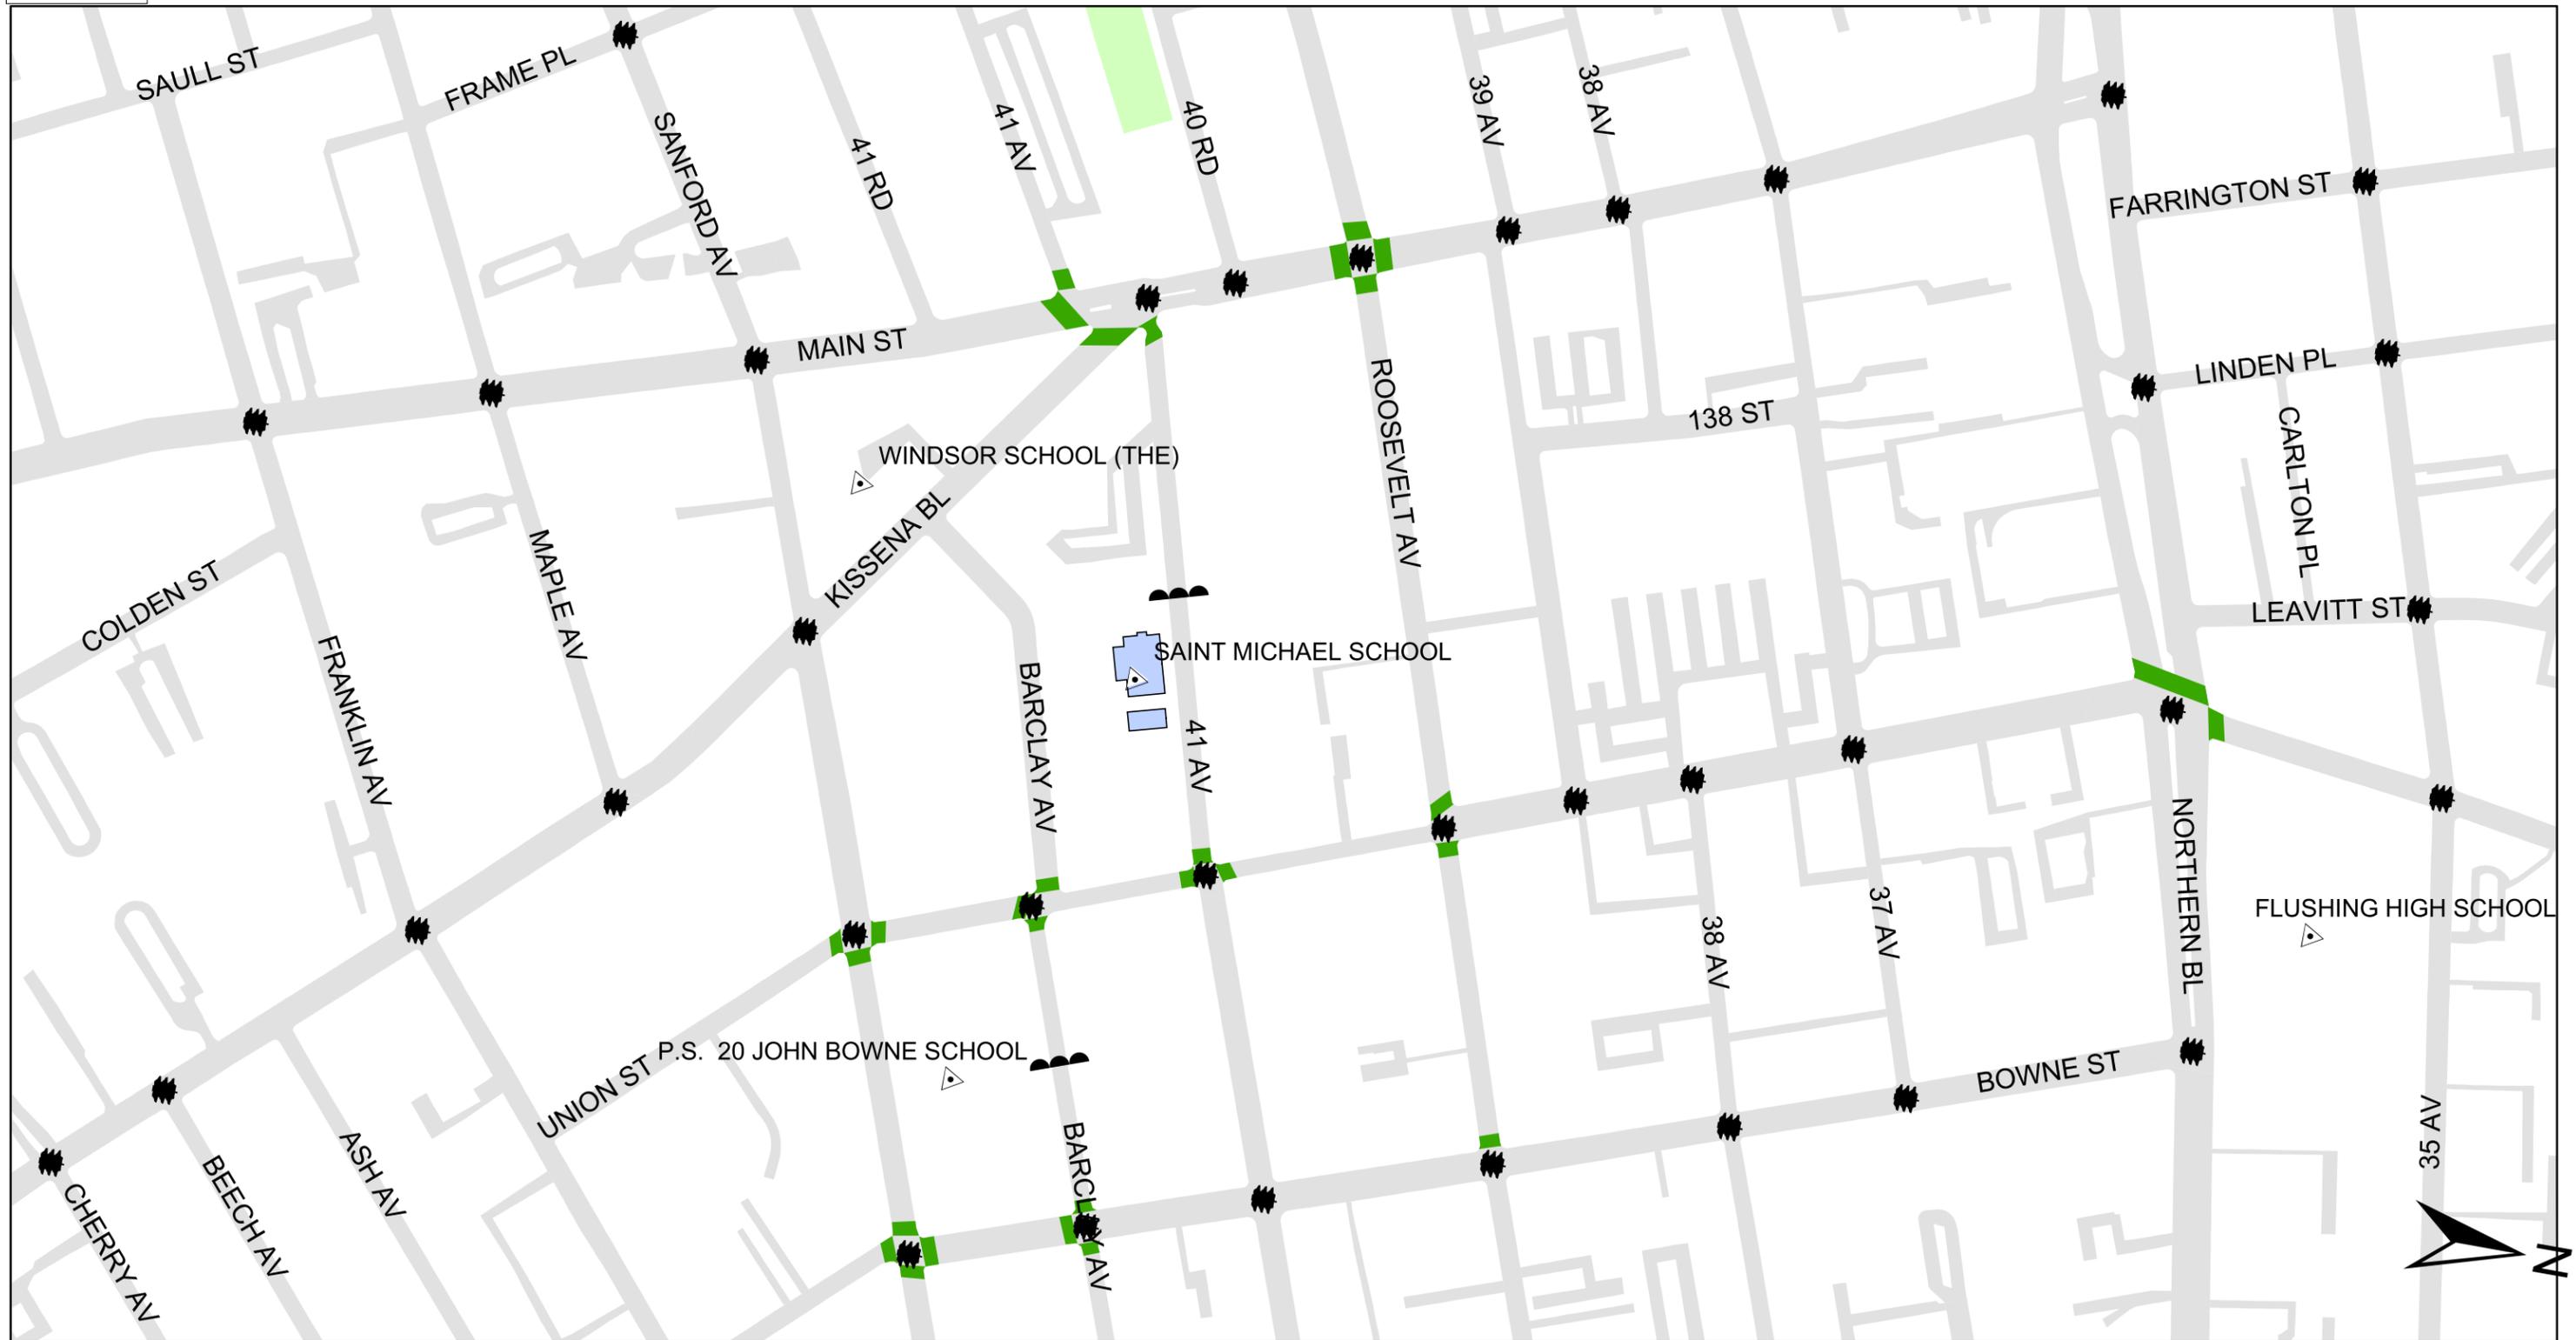
**EXHIBIT 2**

The School Traffic Safety Map was established to help provide the maximum degree of safety for children going to and from school - by indicating the location of speed reducers, school crosswalks and some traffic control devices. (While virtually all intersections in NYC benefit from traffic control devices - such as stop signs, traffic signals, yield signs, and all way stop signs - this map shows only traffic signals and all way stop signs.) The school crosswalks that are shown are ladder striped and make the crosswalk more visible to drivers and help make the intersection safer. These crosswalks are where school children are recommended to cross.

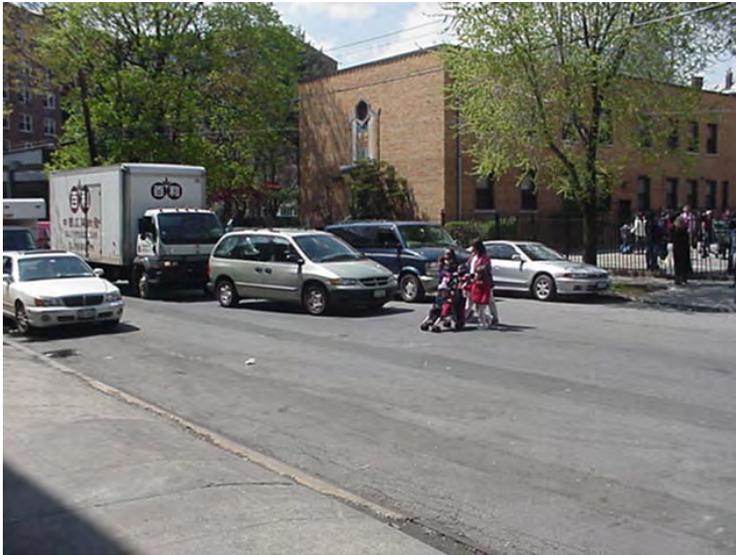
*Figure 4 – A typical crossing at an uncontrolled mid-block location on Barclay Avenue at dismissal time*

In addition, trucks loading and unloading on the north side of Barclay Avenue, as well as people shopping at the corner store, force students to cross Barclay Avenue in the mid-block to avoid the congested walking route.

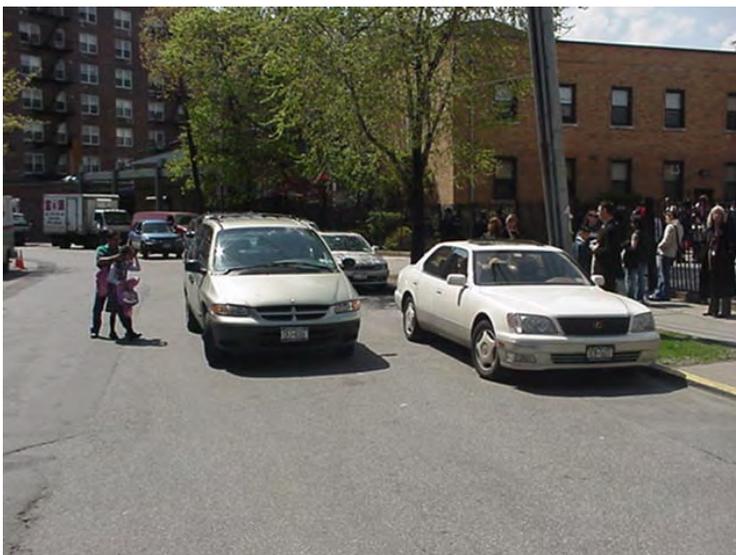
School officials have indicated that approximately 17% of St. Michael's students are driven to and from school by parents or guardians. Field observations indicated that parents use Barclay Avenue as the student pick-up and drop-off point. Barclay Avenue is at times reduced to a one-lane roadway, due to vehicles double-parking during dismissal (see Figures 3 and 4).

*Figure 5 – Double-parked vehicles on Barclay Avenue waiting for students at dismissal time*

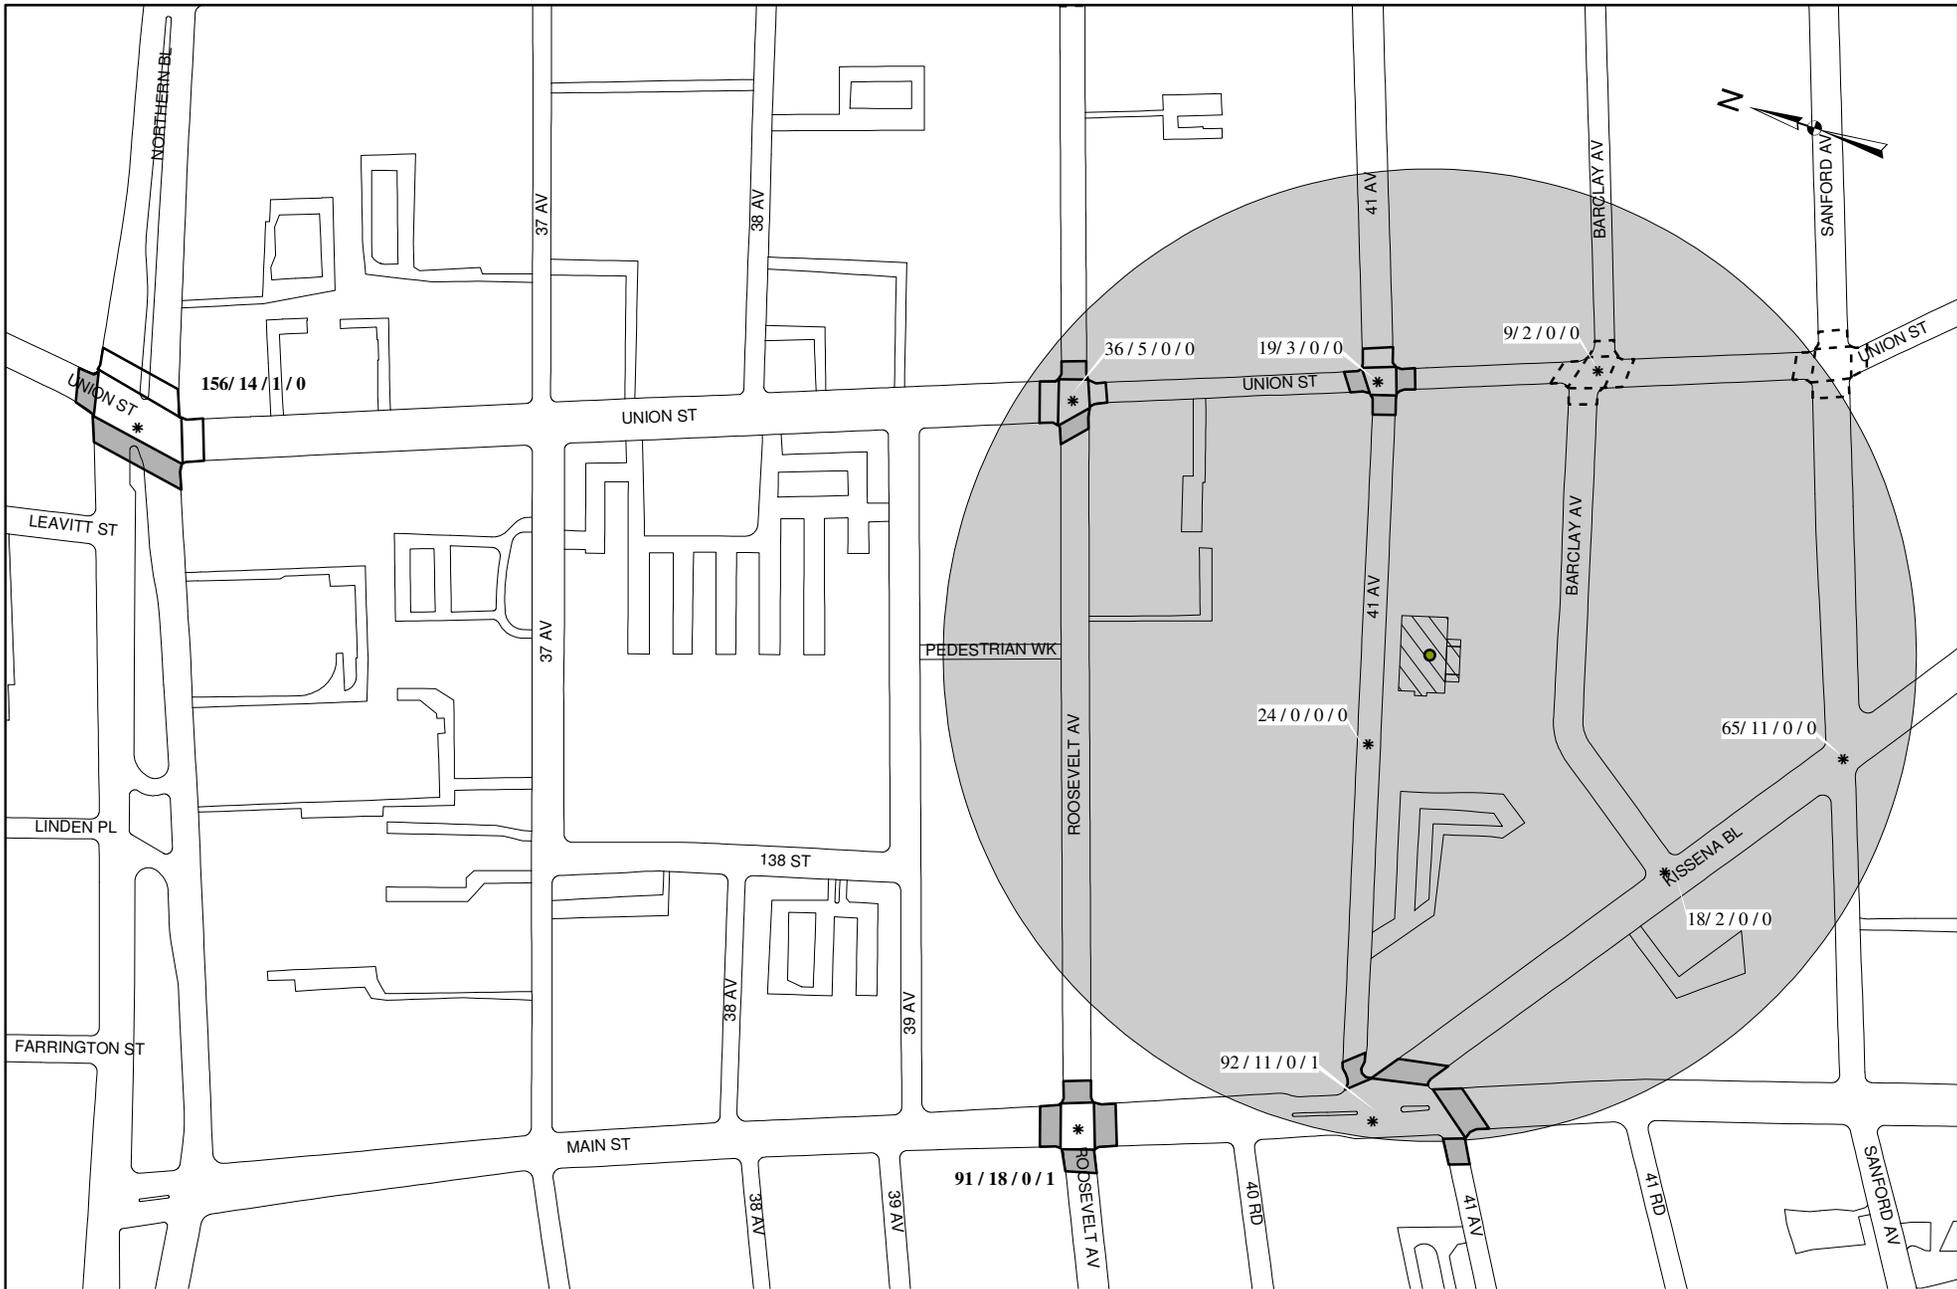
**EXHIBIT 5**

Exhibit 5 and Table 2 show a summary of accidents, as obtained from the New York State Department of Motor Vehicles (DMV), in the vicinity of St. Michael's for the three-year period from January 1, 1998 through December 31, 2000. The DMV data provides some detail relating to the circumstances and cause of the accidents. Table 3 is a summary of more recent accident data obtained from the NYC Police Department (NYPD). Though current through 2004, the NYPD data does not provide the same level of detail as the DMV data.

**ACCIDENT SUMMARY  
THREE YEAR PERIOD  
(1998-2000)**

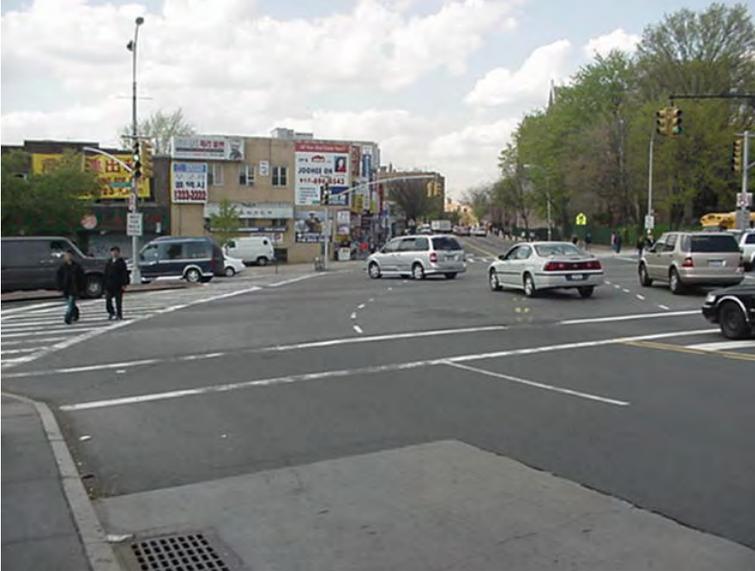
*Figure 6 – The intersection of Northern Boulevard and Union Street (looking north)*

One hundred and fifty six accidents occurred at this intersection during the 1998-2000 study period. Fourteen pedestrians were struck during this time at this intersection including one fatality. The fatal accident occurred on April 17, 1998 when a vehicle traveling westbound struck a pedestrian who was crossing Northern Boulevard with the signal. Nine more pedestrians were struck while having the right of way and crossing both with the signal and within the crosswalks. All these accidents were attributed to driver error and failure to yield to pedestrians. Four pedestrians were struck while crossing against the signal. No information was provided for one pedestrian accident.

The safety of pedestrians at the wide intersections of Northern Boulevard at Union Street is a concern. Installation of a pedestrian information sign adjacent to each school crosswalk that explains the signal phases is recommended. During a consultant field visit, it was noted that students and others attempted to cross Northern Boulevard in one pedestrian signal phase. The pedestrian should be informed to wait at the refuge island between signal cycles. Pedestrians will benefit from informational signage even though they are provided with sufficient time to cross at these intersections.

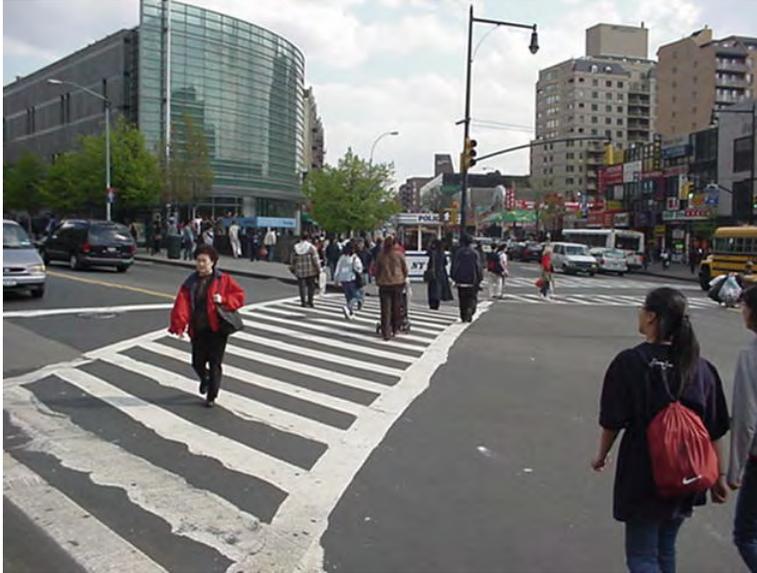
Field observations at the intersection revealed that jaywalking and failure to adhere to traffic rules by pedestrians is quite widespread. There is no striped crosswalk on the north leg of this intersection. In order for pedestrians to cross Main Street, utilizing crosswalks, they must first cross 41<sup>st</sup> Avenue, then Kissena Boulevard, and finally the southern leg of Main Street. This is a much longer route and many pedestrians were observed crossing Main Street on the northern leg without any crosswalks to save time.

There were 92 accidents at this location during the 1998-2000 study period. There were eleven pedestrian accidents, one of which was a school related accident. Five pedestrian accidents were attributed to driver error due to failure to yield to pedestrians crossing

*Figure 7 - The intersection of Kissena Boulevard at Main Street (looking south)*

Consideration should be given to extending the raised concrete median through the existing pedestrian crosswalk to provide refuge for pedestrians. The median should have an ADA compliant at-grade cut-through. Final details pertaining to the raised median will be developed during the Final Design/Contract Document preparation. In addition, a pedestrian fence should be installed on the raised median south of this intersection (adjacent to the left-turn bay) as shown on Exhibit 7 to discourage pedestrians from crossing mid-block.

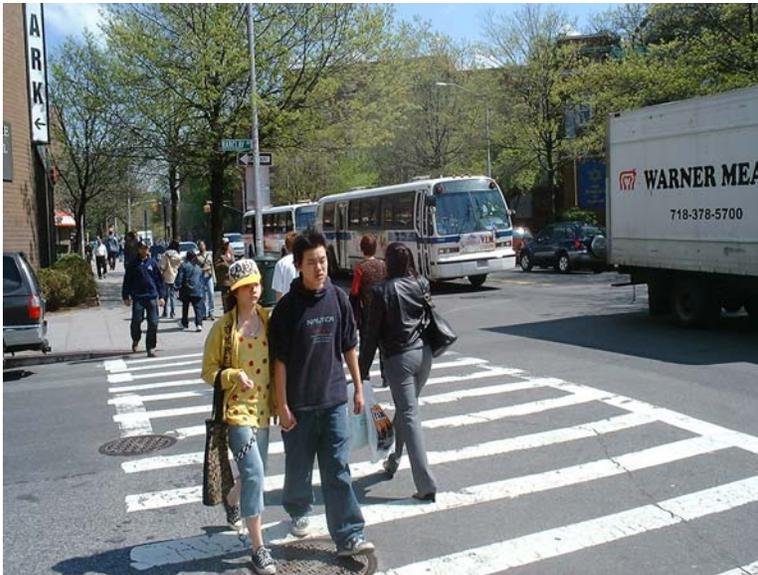
This is an un-controlled T-intersection (see Figures 7, 8, and 9). It was observed that a high percentage of the vehicular volumes are trucks and buses. School officials stated that this intersection and Barclay Avenue immediately next to the intersection are the primary concern for St. Michael’s students. They stated that northbound right turning trucks coming from Kissena Boulevard onto Barclay Avenue conflict with pedestrians crossing Barclay Avenue.

Additionally, pedestrians consistently cross Kissena Boulevard in the east-west direction, although there are no pedestrian crosswalks, or traffic control at this intersection.

*Figure 8 - The intersection of Kissena Boulevard at Barclay Avenue (looking south)*

A “YIELD TO PEDESTRIAN SIGN” should be installed at the intersection of Barclay Avenue and Kissena Boulevard (northbound approach on Kissena Boulevard).

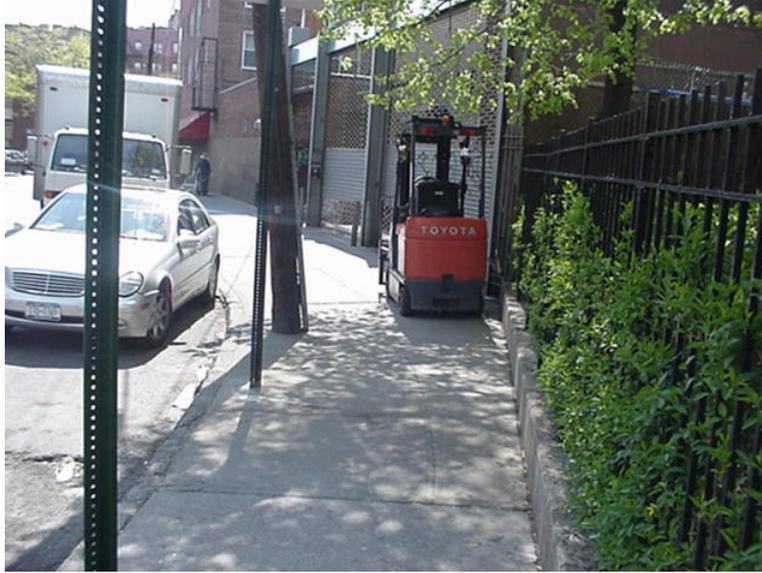
*Figure 9 – North sidewalk on Barclay Avenue ( looking west towards Kissena Boulevard)*

- Consider widening the north sidewalk on Barclay Avenue

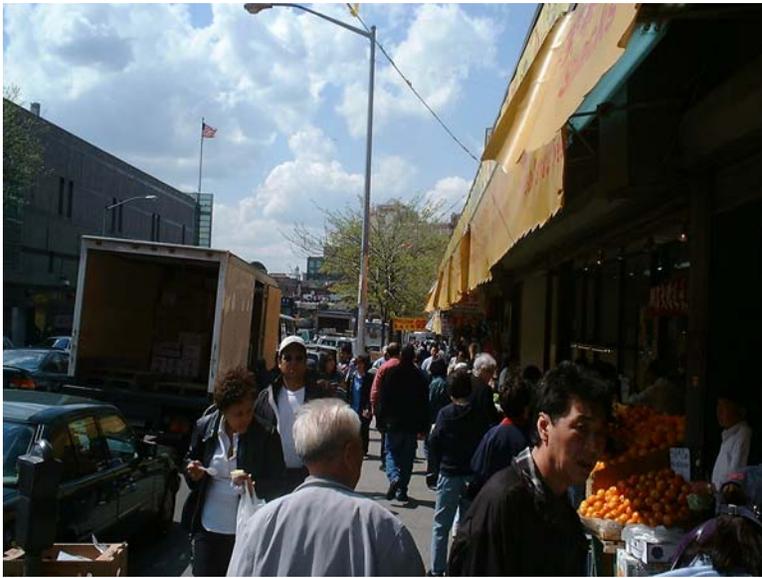
- Congested north sidewalks on Barclay Avenue (near Barclay Avenue/Kissena Boulevard intersection) with forklifts and food vendors that force students to walk on the street.
- Double-parked trucks loading and unloading on Barclay Avenue

*Figure 10 – North sidewalk on Barclay Avenue in the vicinity of Kissena Boulevard*

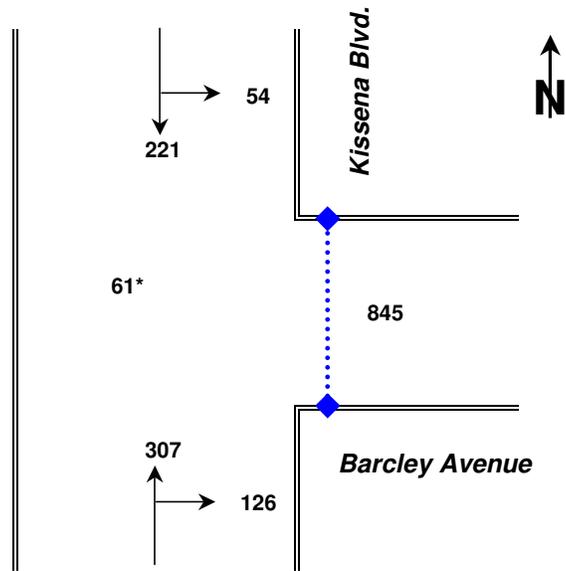
<b>EXHIBIT 6</b>
<b>ST MICHAEL'S SCHOOL QUEENS</b>
<b>TRAFFIC COUNTS</b>

One-hour traffic counts were performed at this intersection on Tuesday, October 18, 2005 between 2:30 pm and 3:30 pm (see Exhibit 6). The results show that 708 vehicles and 906 pedestrians utilized this unsignalized intersection during this hour in all directions. A total of 180 (54+126) vehicles per hour turned onto Barclay Avenue and conflicted with 845 pedestrians crossing Barclay Avenue. Approximately 61 pedestrians per hour crossed Kissena Boulevard although there are no pedestrian crosswalks on Kissena Boulevard. The gap study performed on August 10, 2006 shows that more than 60 gaps of 18 seconds (the time required to cross a 43-foot wide street at three feet per second plus three seconds of reaction time) were available for pedestrians to cross Barclay Avenue during one hour. Therefore, the existing conditions do not meet warrants for the installation of a traffic signal or all-way stop control at this time.

**One Hour Traffic Count Volumes**  
 (2:30 PM - 3:30 PM October 18, 2005)

**Intersection of Kissena Boulevard and Barclay Avenue**

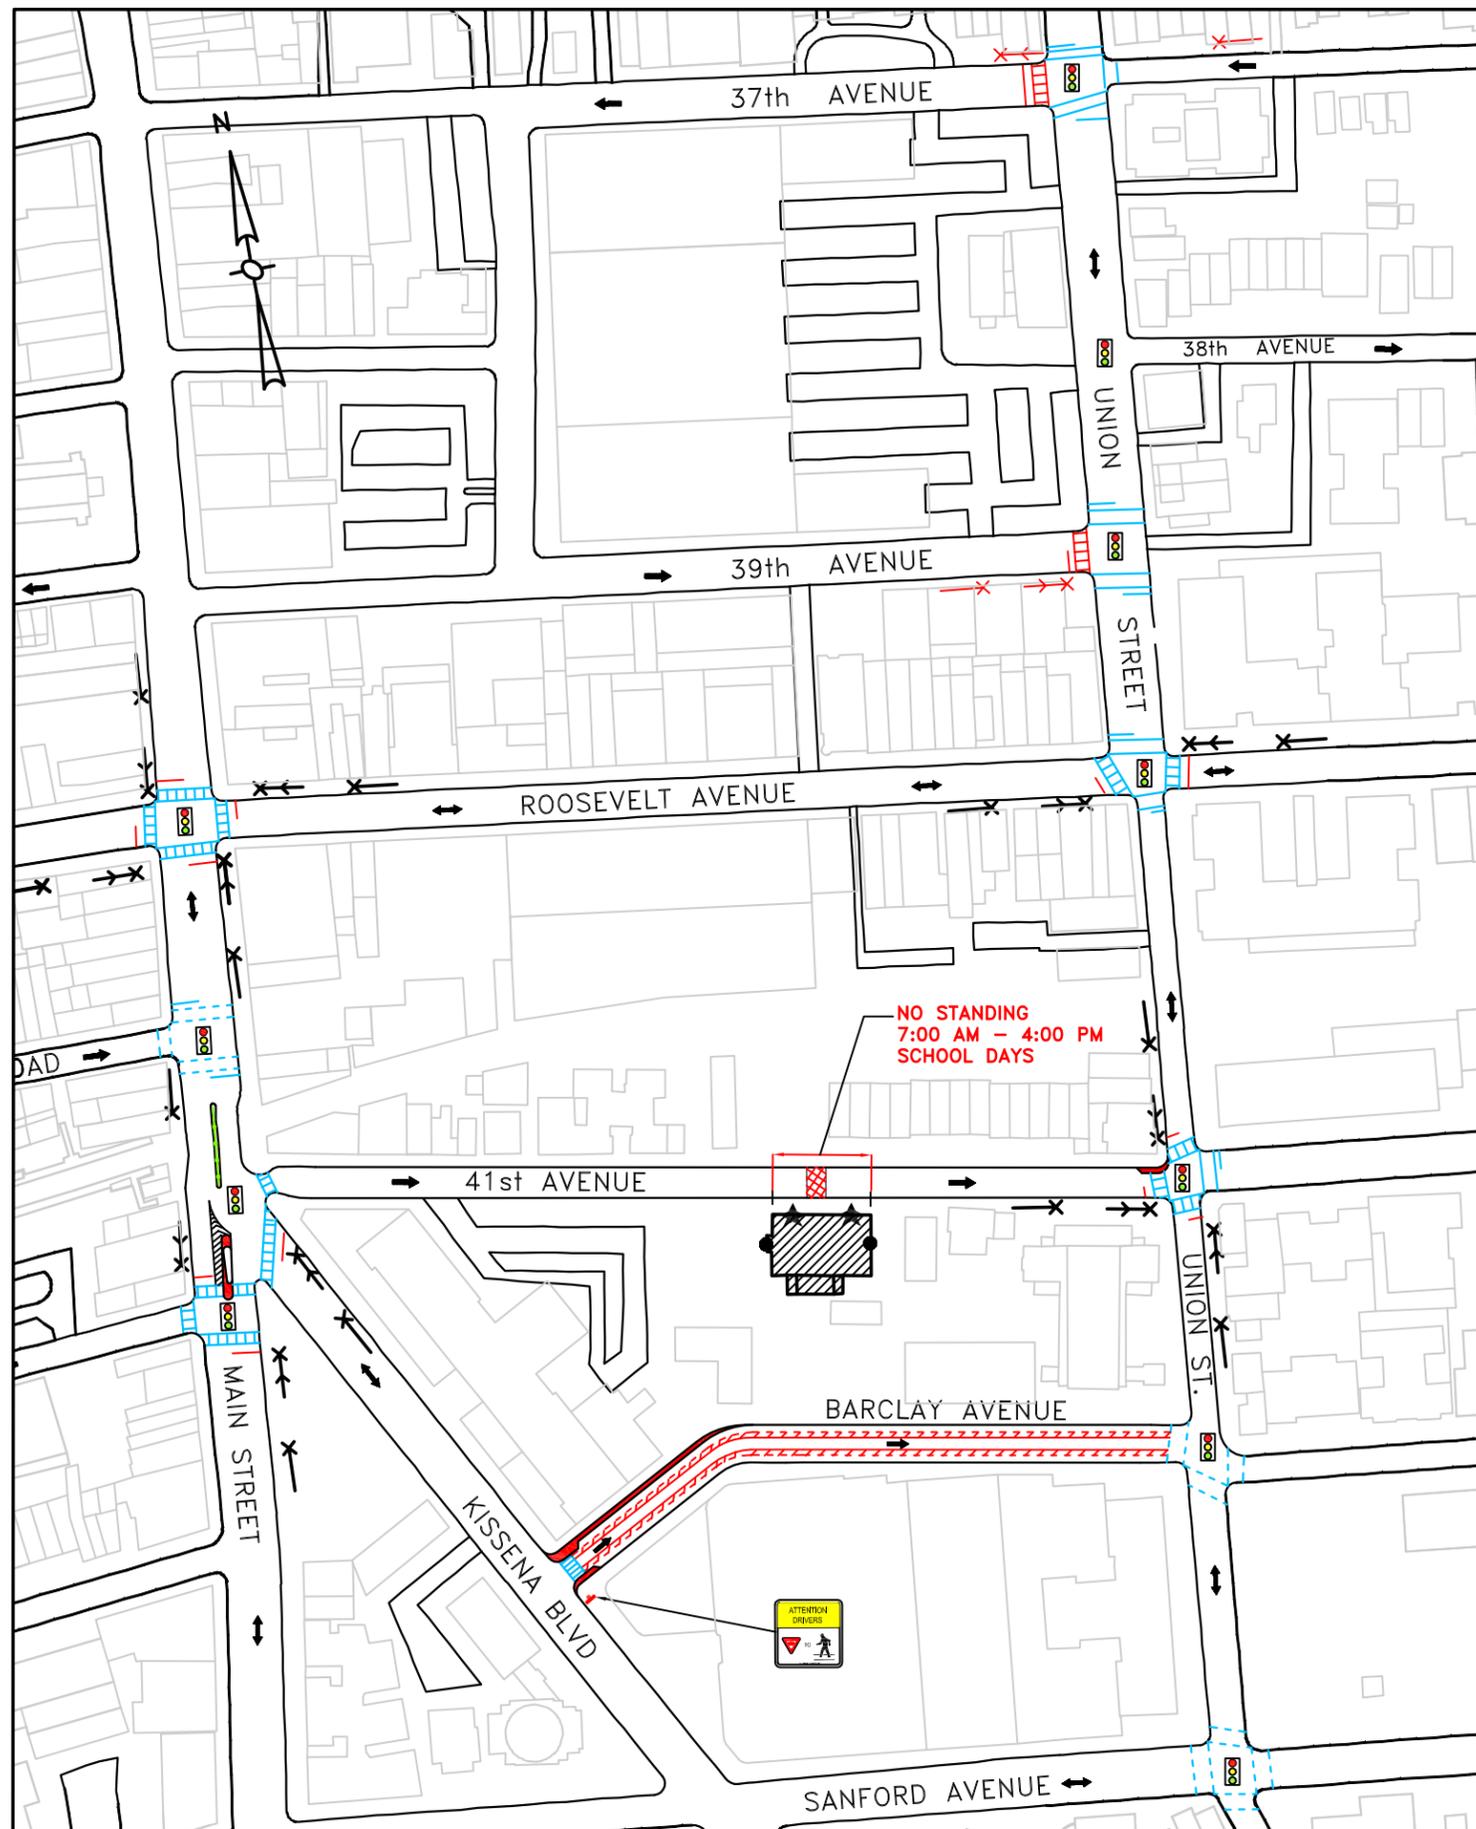
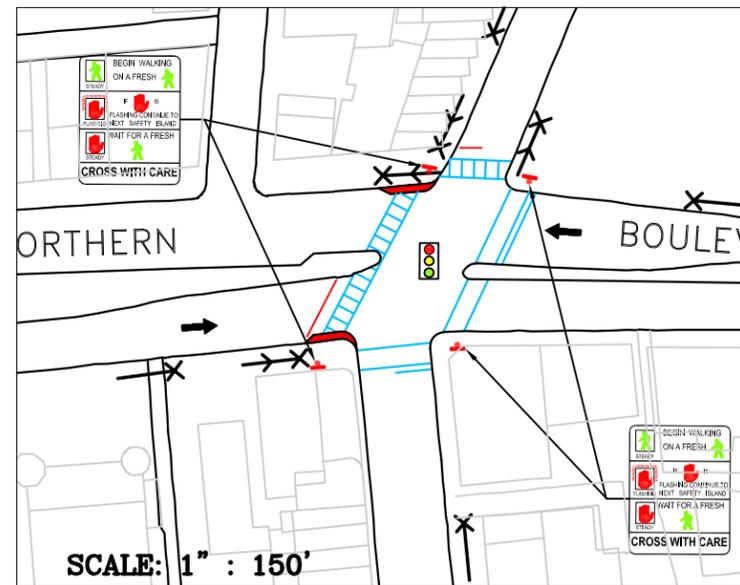
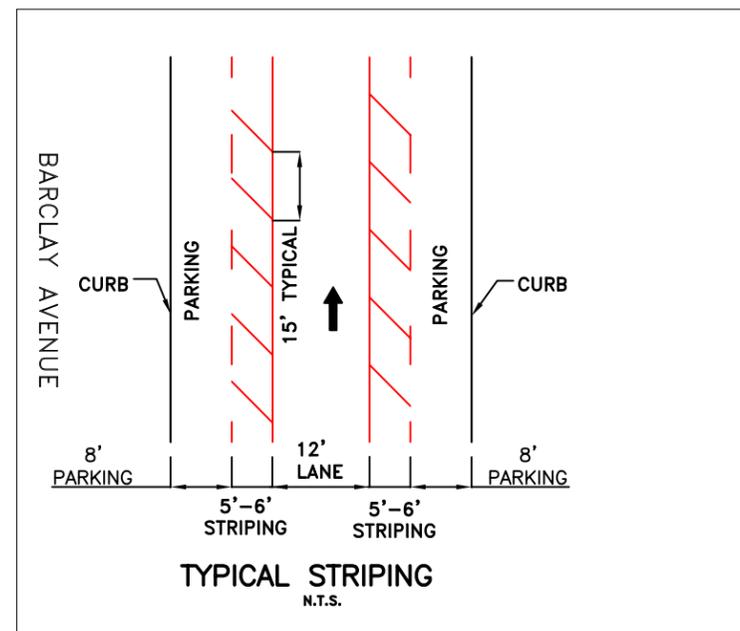
**EXHIBIT 7**

**PROPOSED MEASURES TO  
IMPROVE STUDENT PEDESTRIAN SAFETY**

Based on feedback from school officials these intersections are utilized by students of St. Michael’s School en route to school. Therefore, it is recommended that new school crosswalks be installed at these two locations (see Exhibit 7 for details).

Curb extensions should be installed at the corners as shown in Exhibit 7.
