**New York City Department of Transportation
Office of School Safety Engineering**

School Safety Engineering Project

FINAL REPORT: St. Stanislaus Kostka, Queens

**Prepared by
The RBA Group and URBITRAN Associates Inc.**

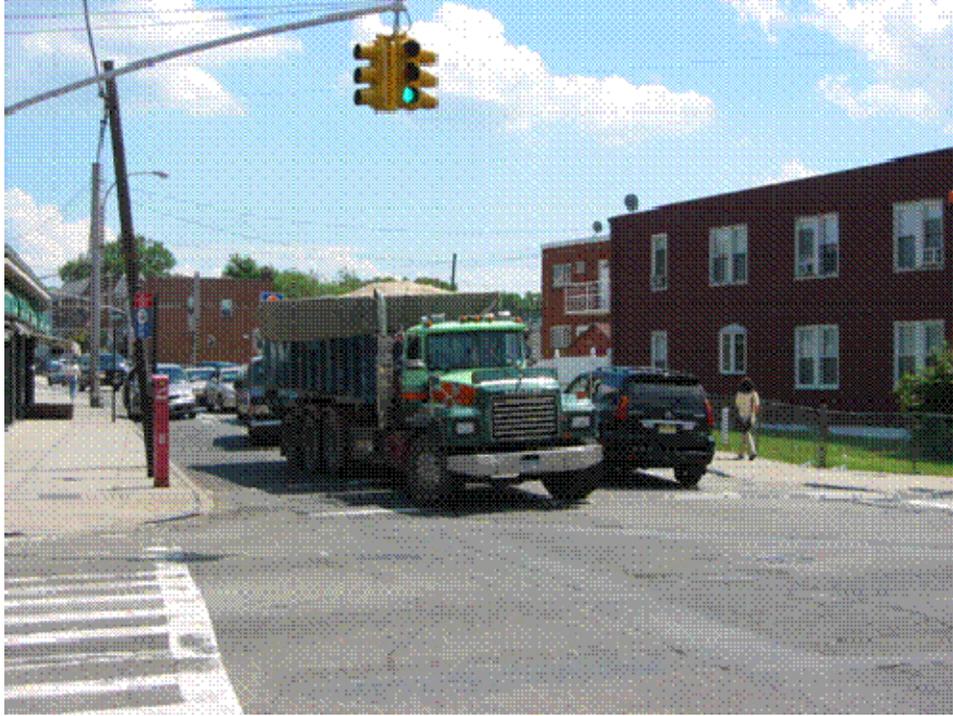
- Traffic on Grand Avenue (particularly trucks and buses) is a problem, especially in front of the school. The principal reported that the school's windows are kept shut during school hours in order to minimize the impact of noise and exhaust fumes associated with the passing trucks and buses. School representatives suggested that an alternate truck route through the area be considered (i.e., the Long Island Expressway service road, via Rust Street and Maurice Avenue).
- Traffic congestion is a problem during both arrival and dismissal times. Congestion is often experienced at the intersection of Grand Avenue/Flushing Avenue/Maspeth Avenue/64th Street (a very complex intersection), as well as at the intersections of 61st Street/Grand Avenue and 61st Street/Flushing Avenue, and along Flushing Avenue from 61st Street to Remsen Place.

Figure 1: Looking south on 61st Street at a truck turning left onto westbound Grand Avenue

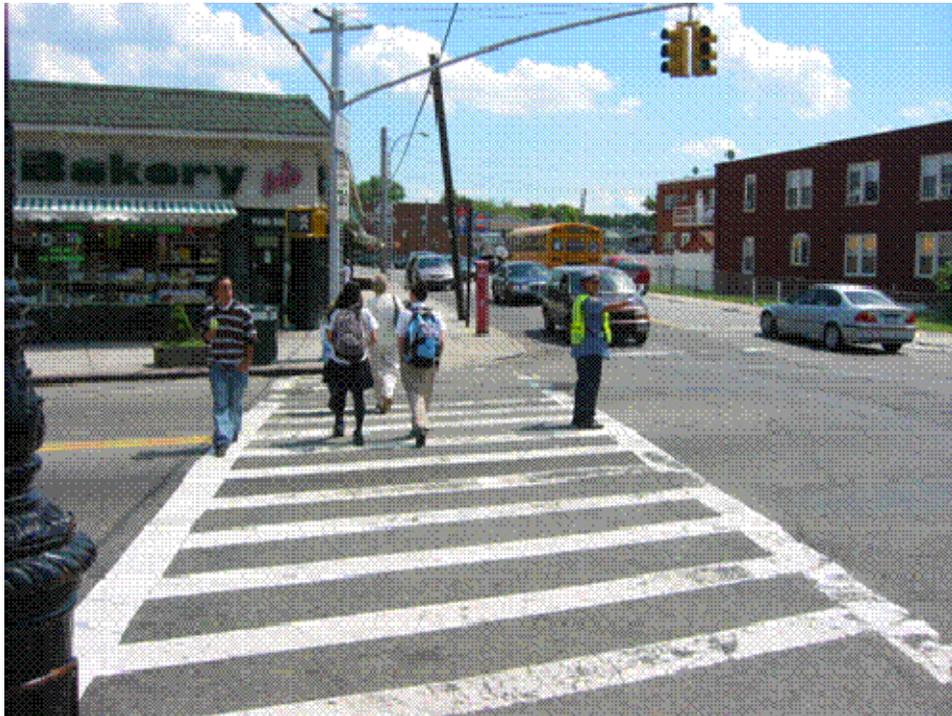
- Grand Avenue/61st Street (see Figure 3)
- Flushing Avenue/61st Street

Figure 3: School crossing guard shown assisting pedestrians crossing the east leg of the Grand Avenue/61st Street intersection

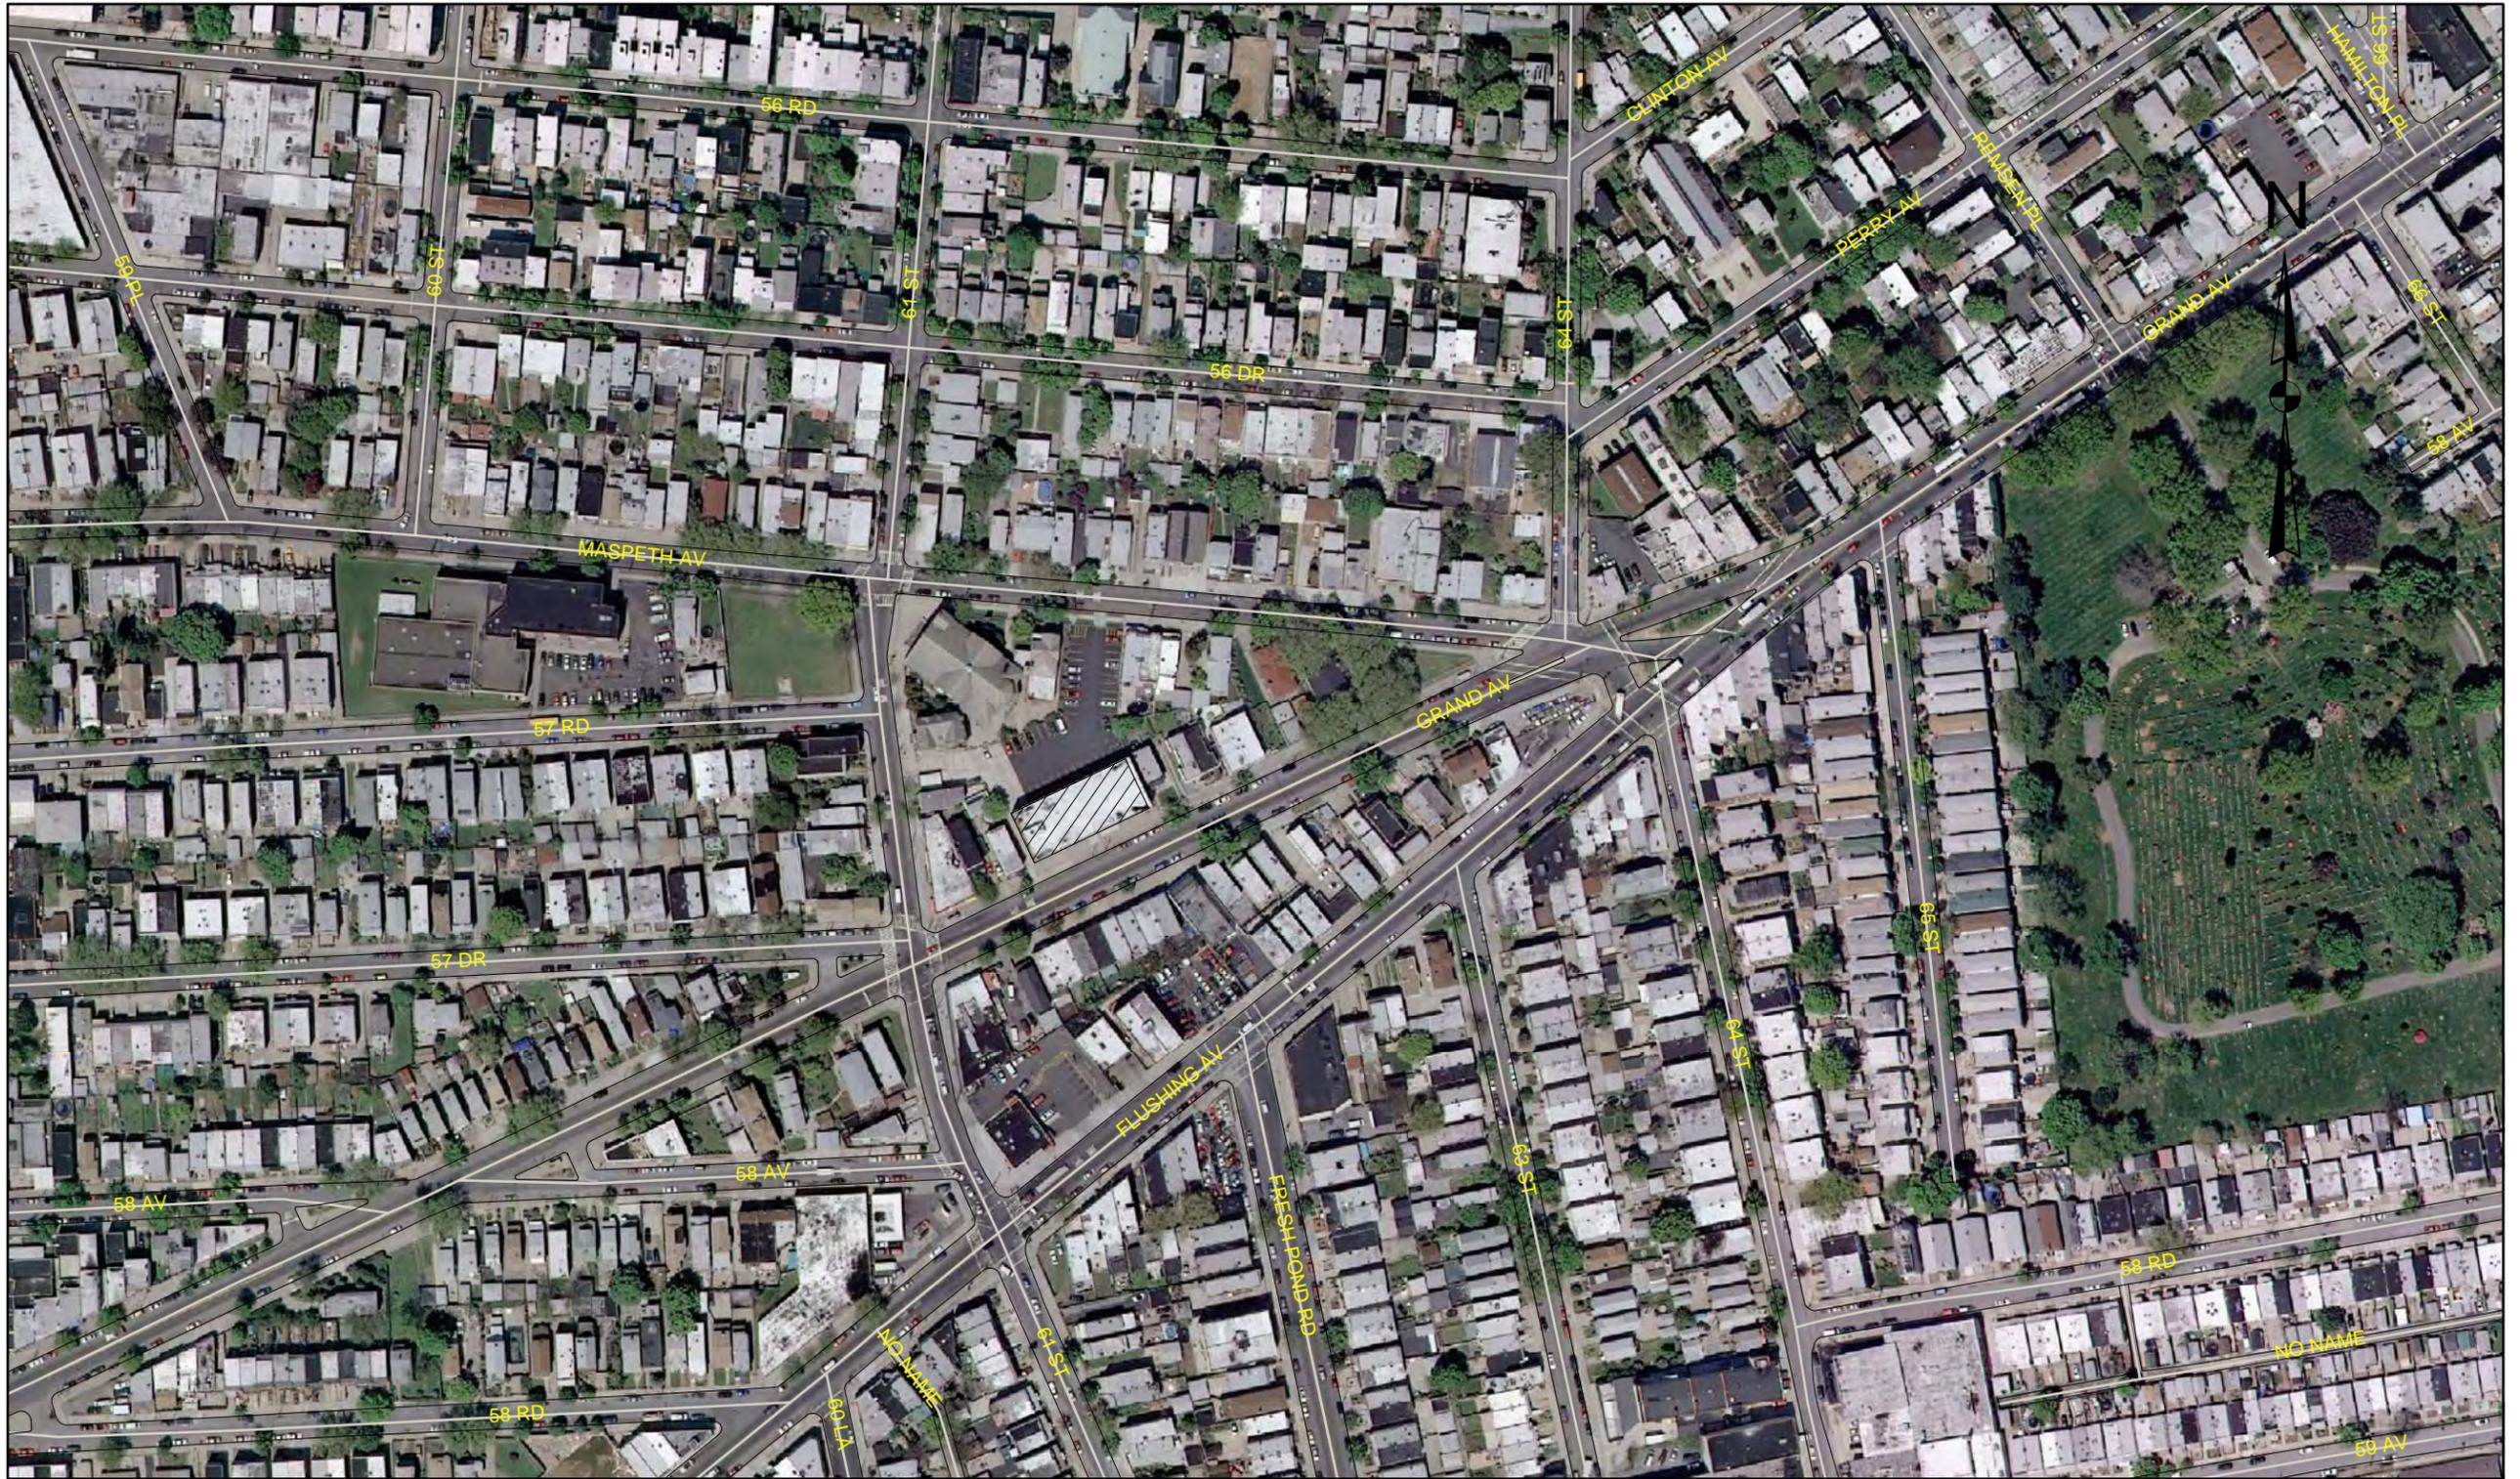
EXHIBIT 1
ST. STANISLAUS KOSTKA SCHOOL QUEENS

Exhibit 1 shows an aerial view of the neighborhood surrounding the school. St. Stanislaus Kostka is bounded by Maspeth Avenue to the north, Grand Avenue to the south, 61st Street to the west, and the intersection of Maspeth Avenue/Grand Avenue/64th Street to the east. The neighborhood surrounding the school consists mostly of one-family and two-family residences, although commercial land uses are located along Grand Avenue, east of the school.

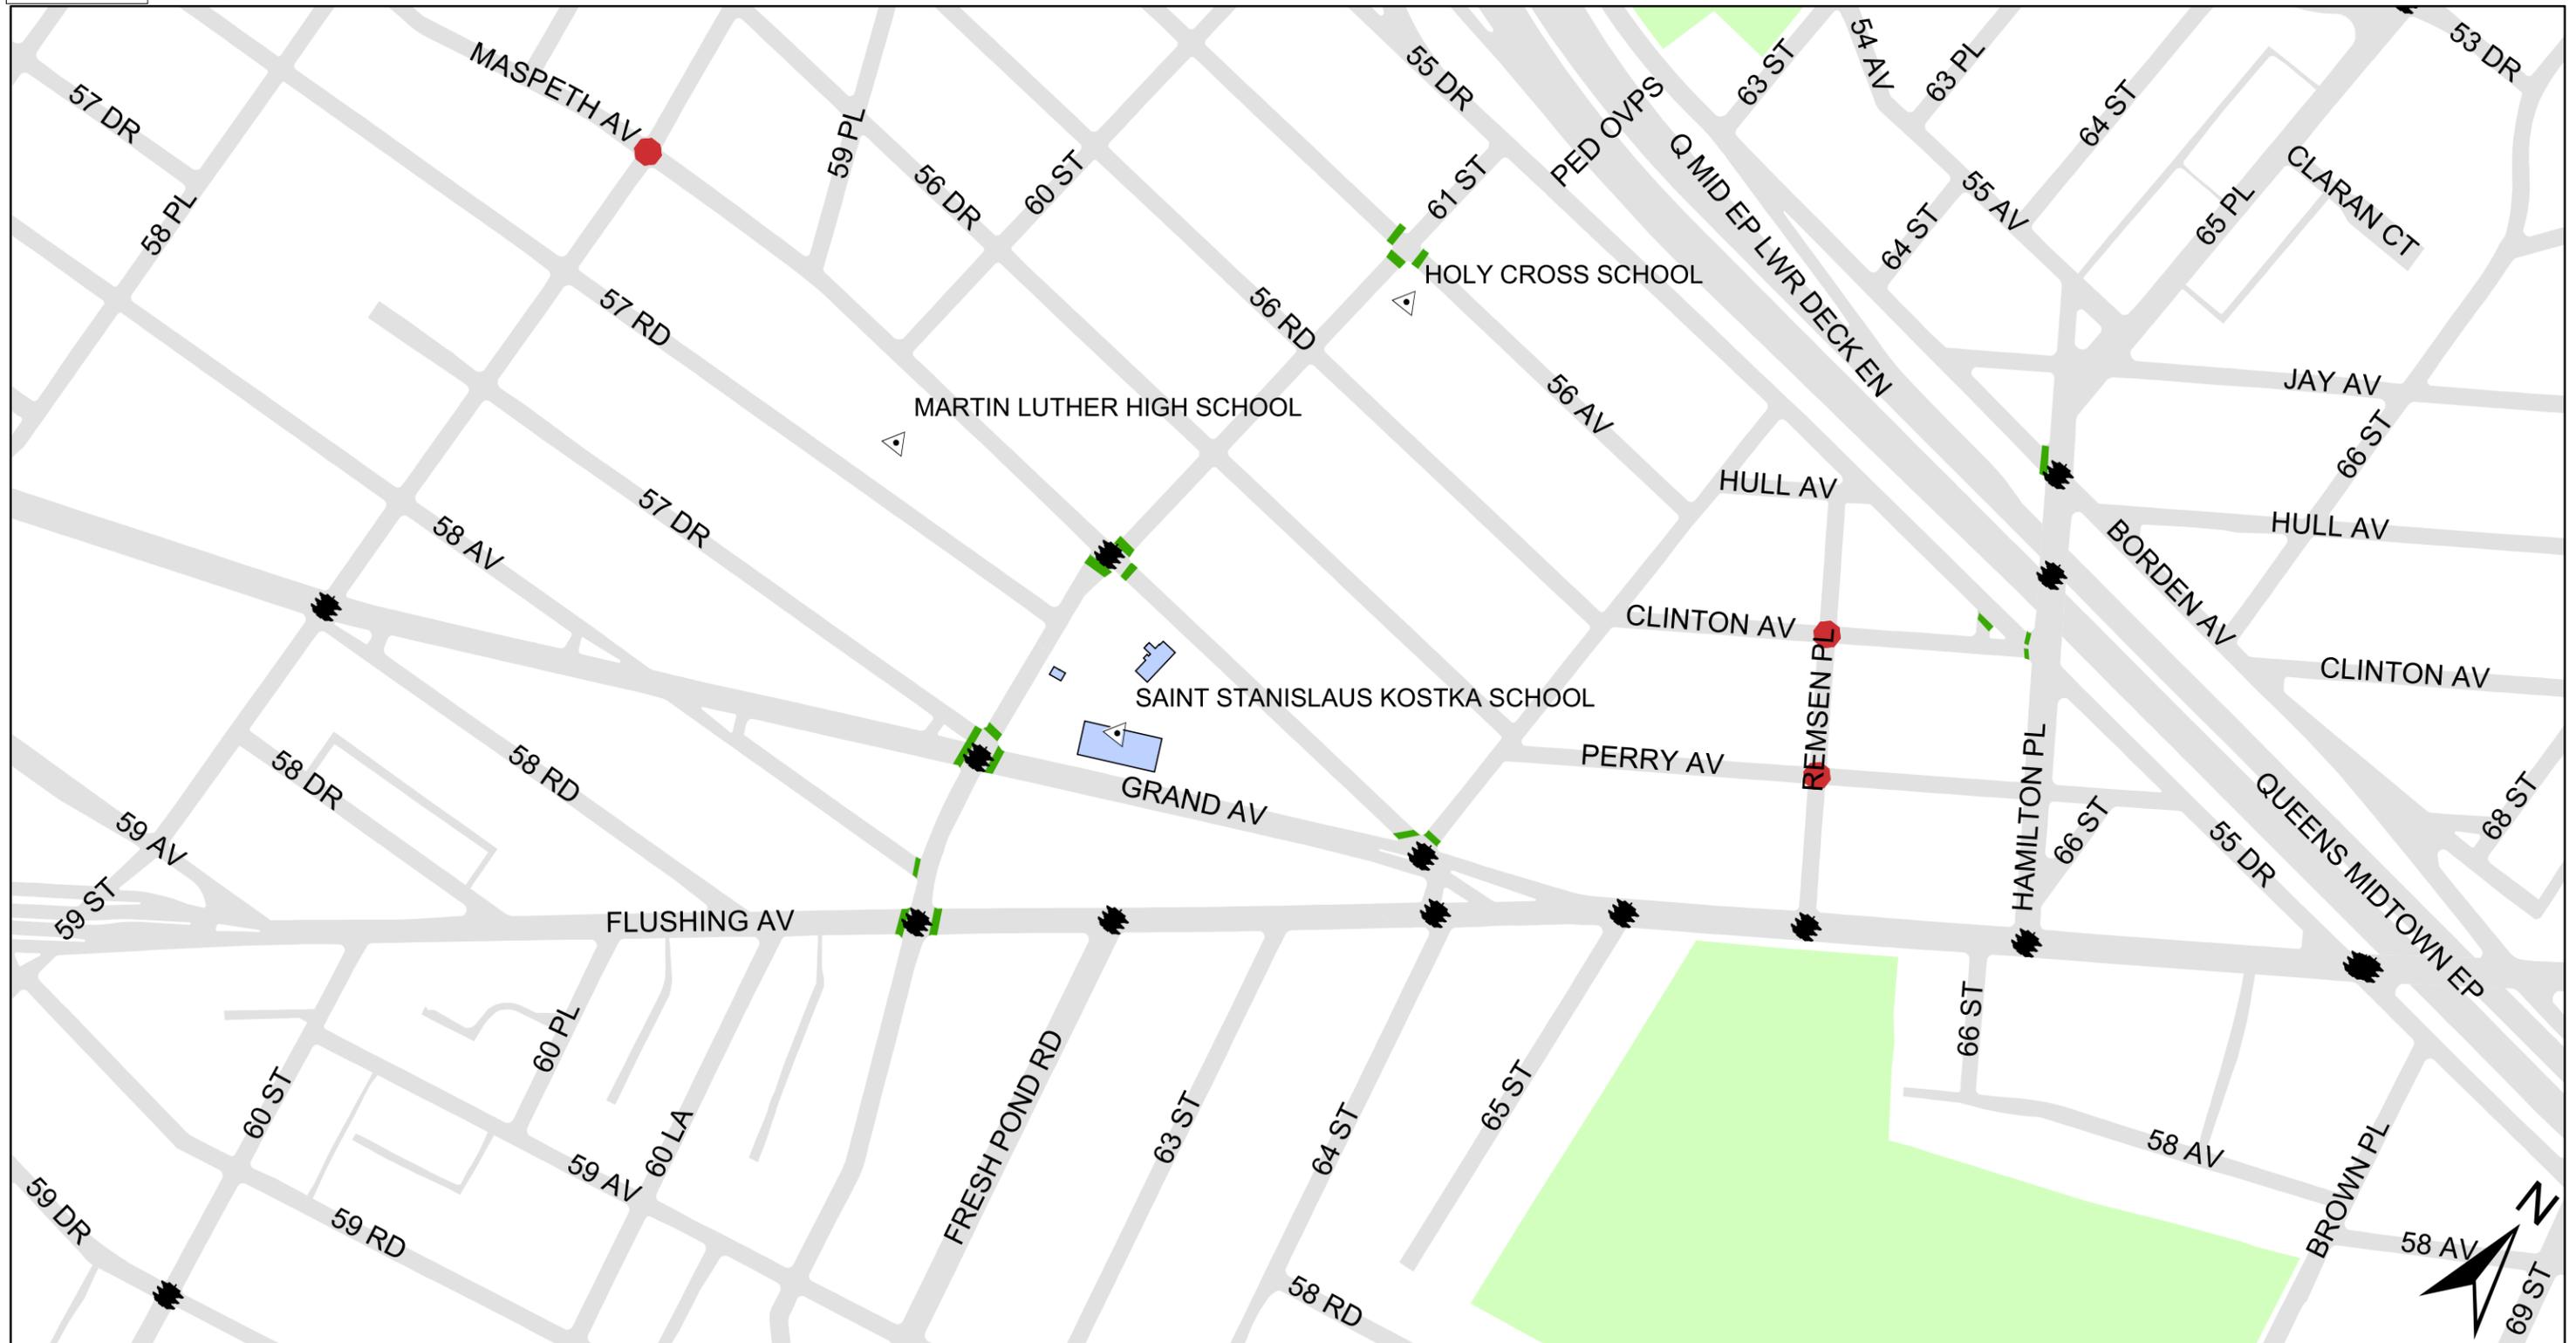
EXHIBIT 2

Exhibit 2 shows the existing signals and pavement markings around St Stanislaus Kostka. It should be noted that a citywide signage program is currently underway to upgrade school signage to current Federal Manual on Uniform Traffic Control Devices (MUTCD) standards of fluorescent yellow-green signs accompanied by downward pointing arrows. Signs scheduled to be installed under this program are shown as “existing” in Exhibit 6.

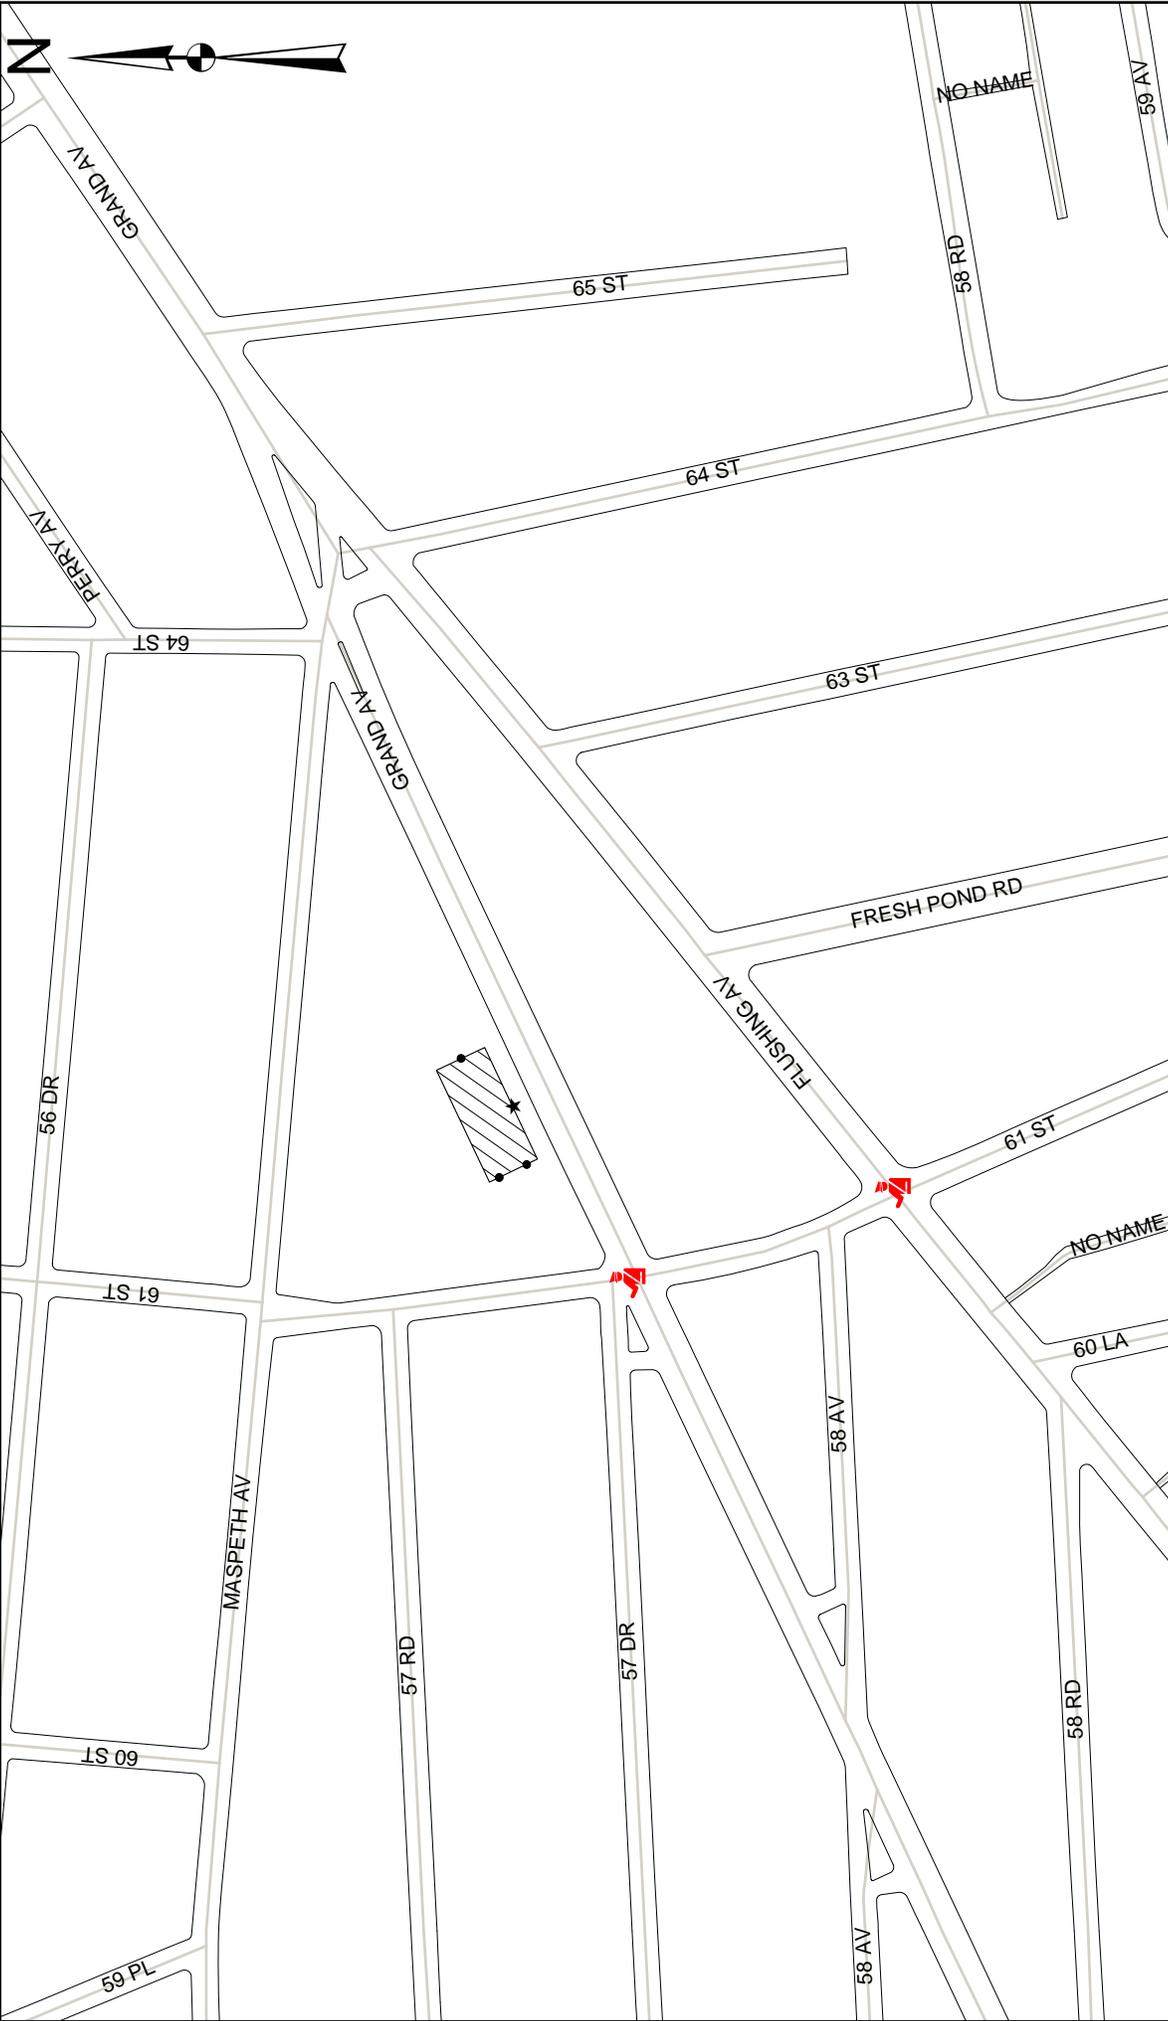
EXHIBIT 3

The crossing guard locations are shown in Exhibit 3 at the end of this section.

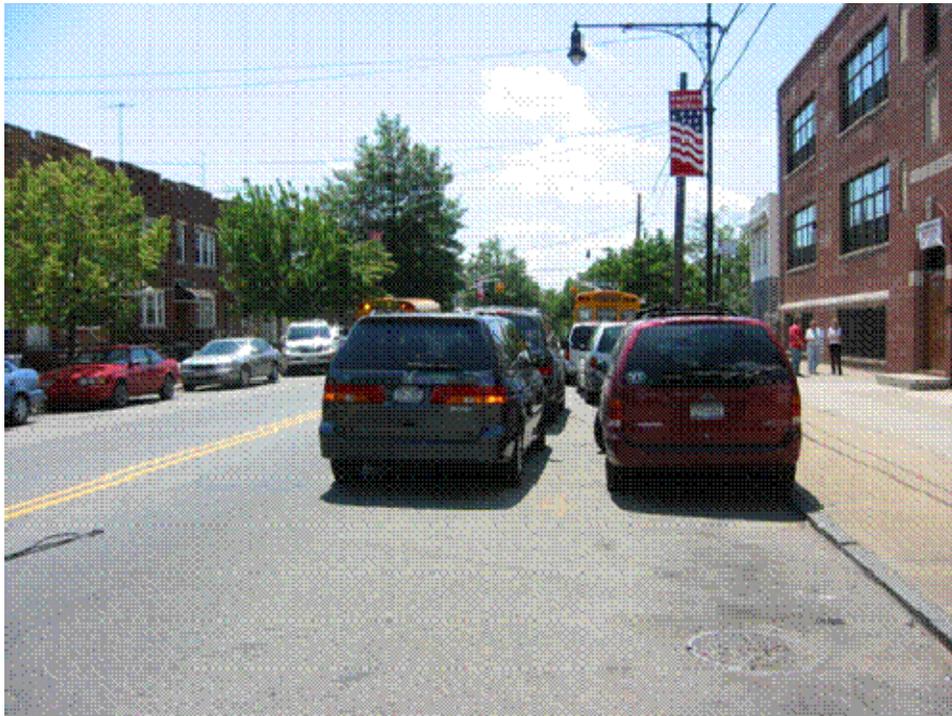
Figure 4: Looking west along Grand Avenue in front of the school at dismissal time (school shown to the right)

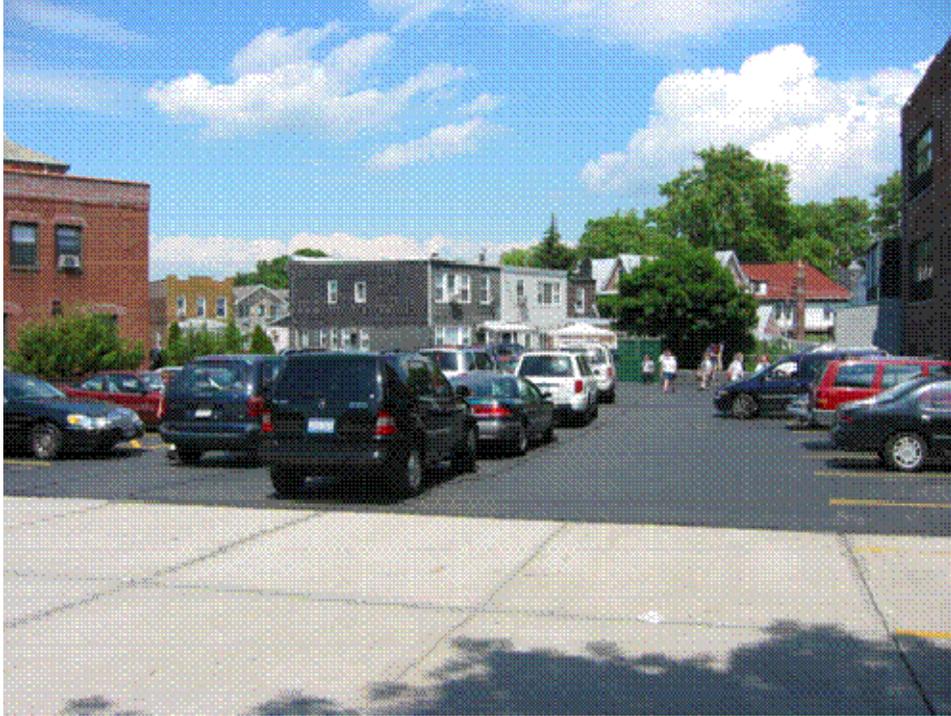
Figure 5: Parents (in vehicles) are shown awaiting students at the beginning of the afternoon dismissal

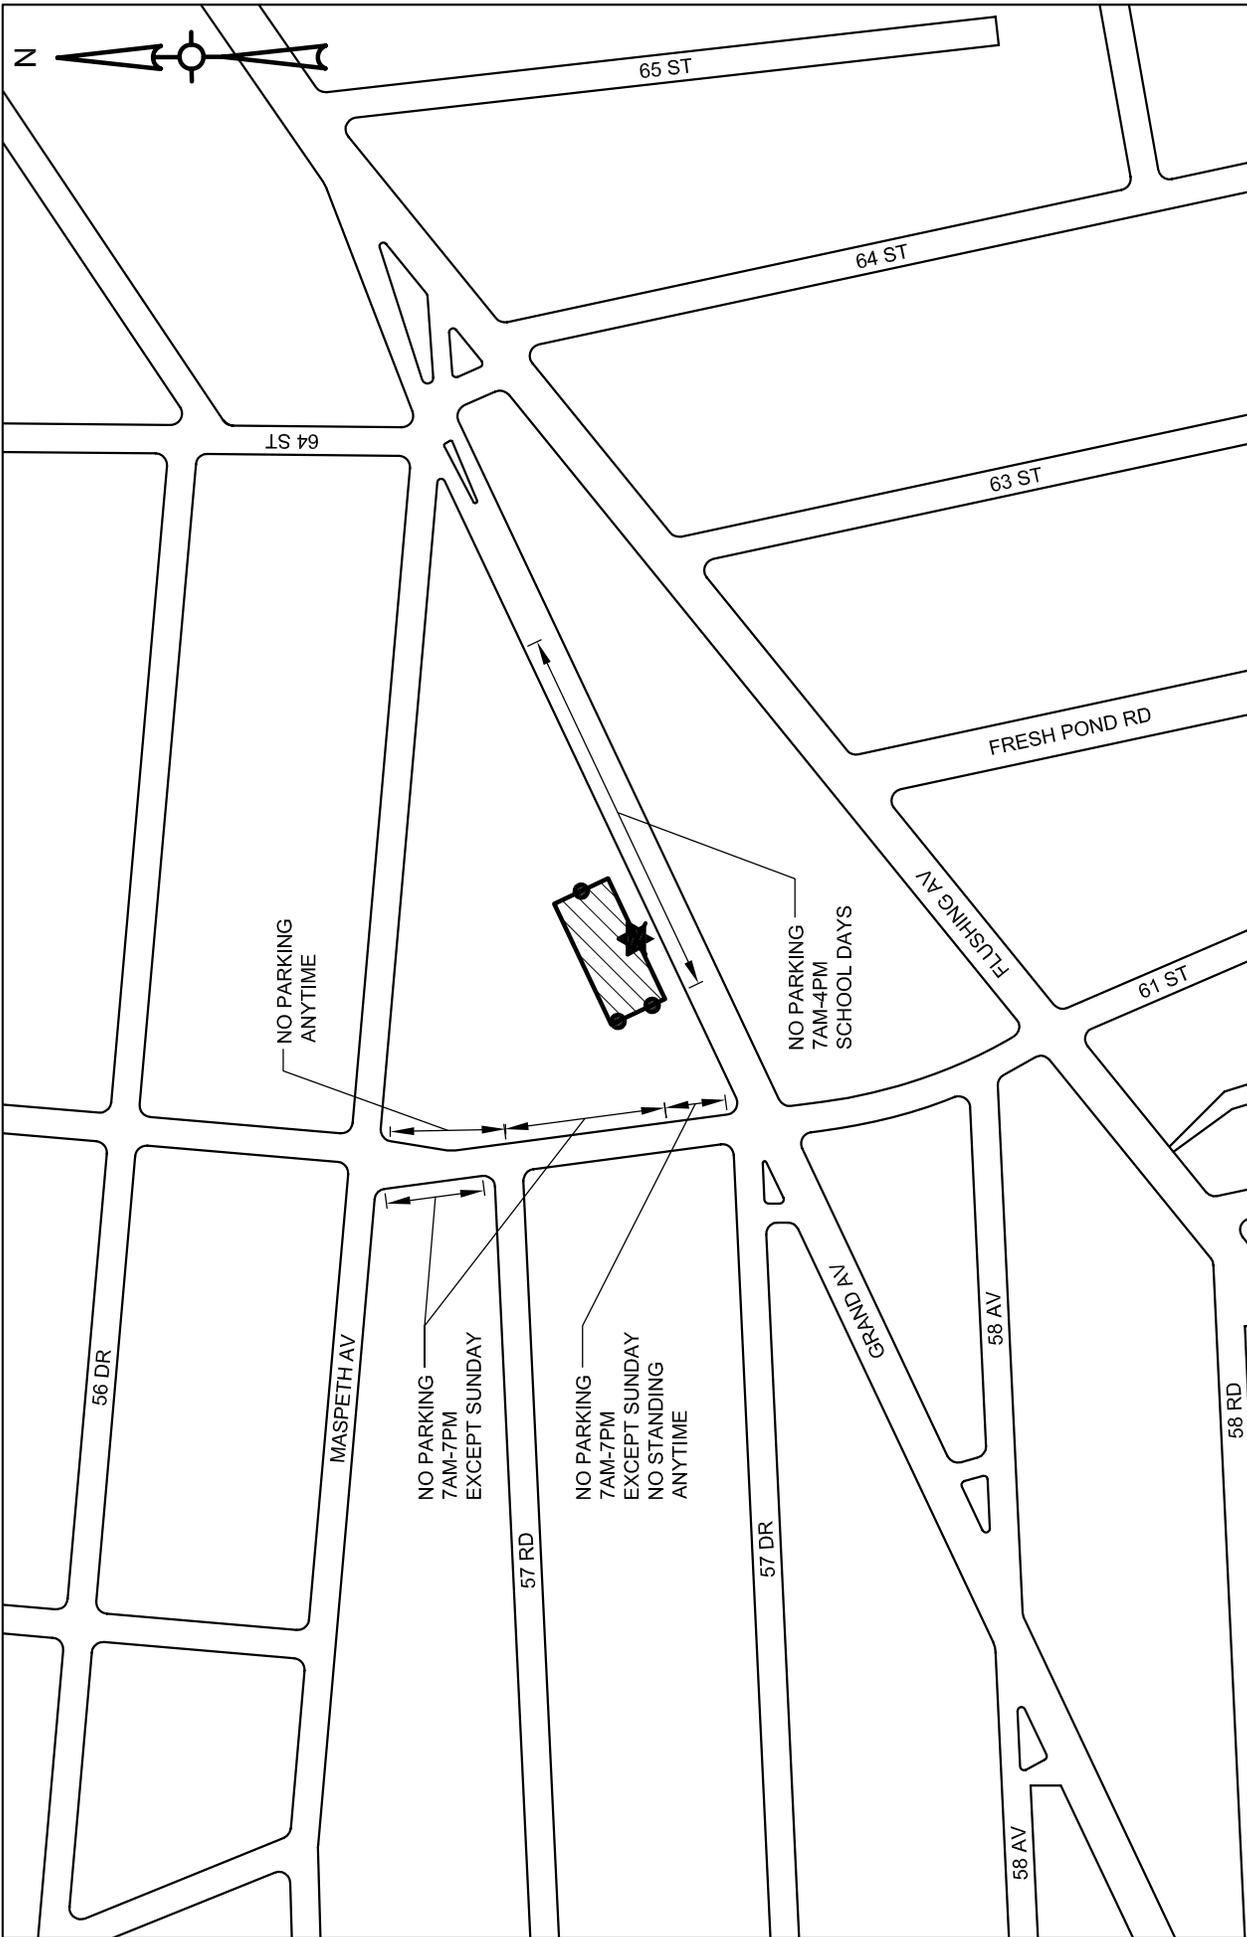
EXHIBIT 4
 ST. STANISLAUS KOSTKA SCHOOL
 QUEENS (36)
 EXISTING PARKING REGULATIONS

Parking regulations around the school block are shown in Exhibit 4.

There are existing “NO PARKING 7AM-4PM SCHOOL DAYS” signs along the north curb of Grand Avenue in front of the school. These signs should be replaced with “NO STANDING 7AM-4PM SCHOOL DAYS” signs. (This is a typical requirement for all NYC schools that standing be prohibited for a distance of 30 feet in front of the school main entrance in order to provide for emergency access to and from the school.)

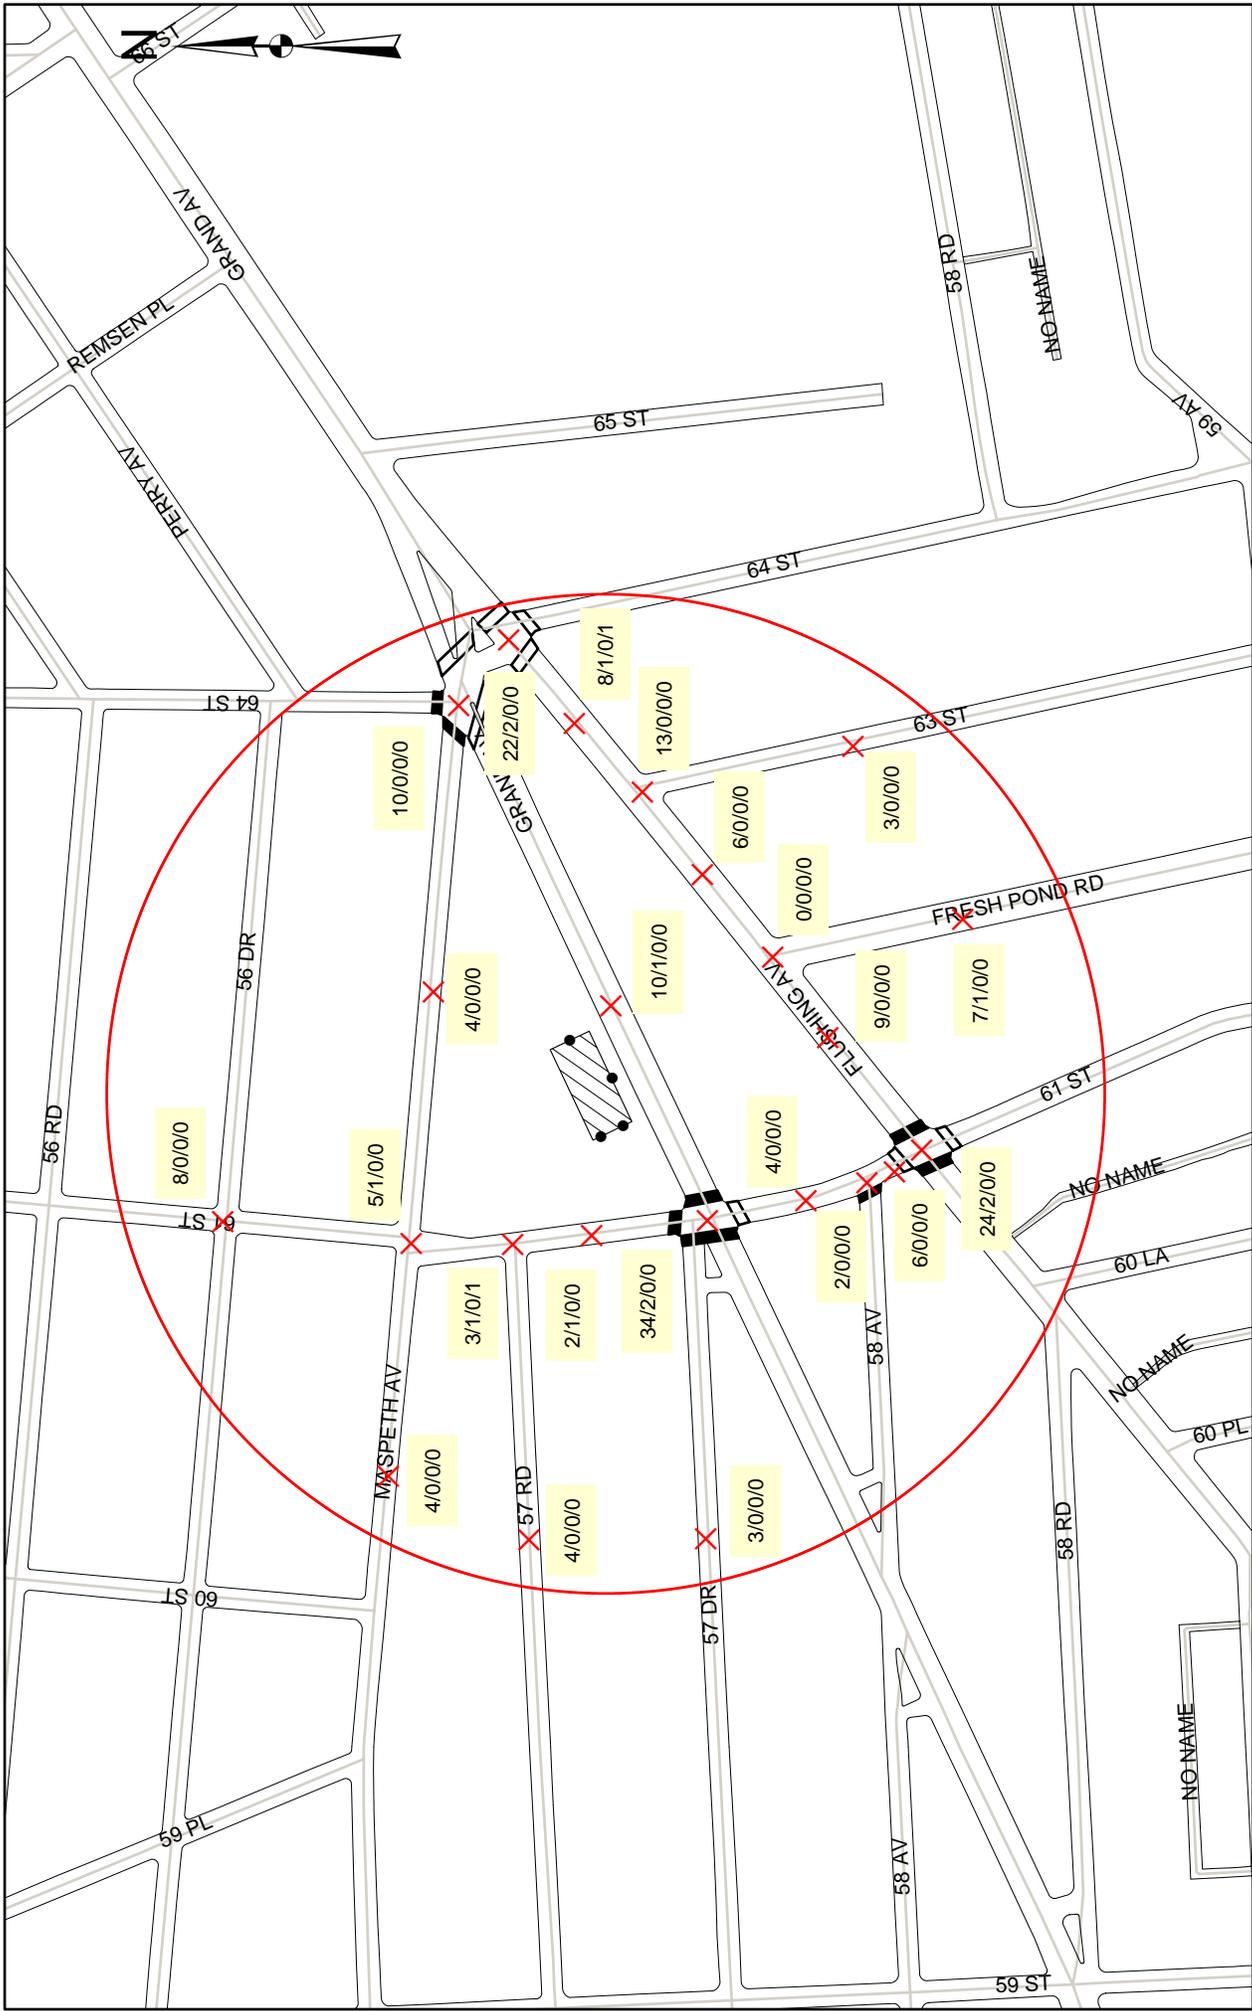
EXHIBIT 5
ST. STANISLAUS KOSTKA SCHOOL QUEENS
ACCIDENT SUMMARY (1998-2000)

Exhibit 5 and Table 2 show a summary of accidents, as obtained from the New York State Department of Motor Vehicles (DMV), in the vicinity of St. Stanislaus Kostka for the three-year period from January 1, 1998 through December 31, 2000. The DMV data provides some detail relating to the circumstances and cause of the accident. Table 3 is a summary of more recent accident data obtained from the NYC Police Department (NYPD). Though current through 2004, the NYPD data does not provide the same level of detail as the DMV data.

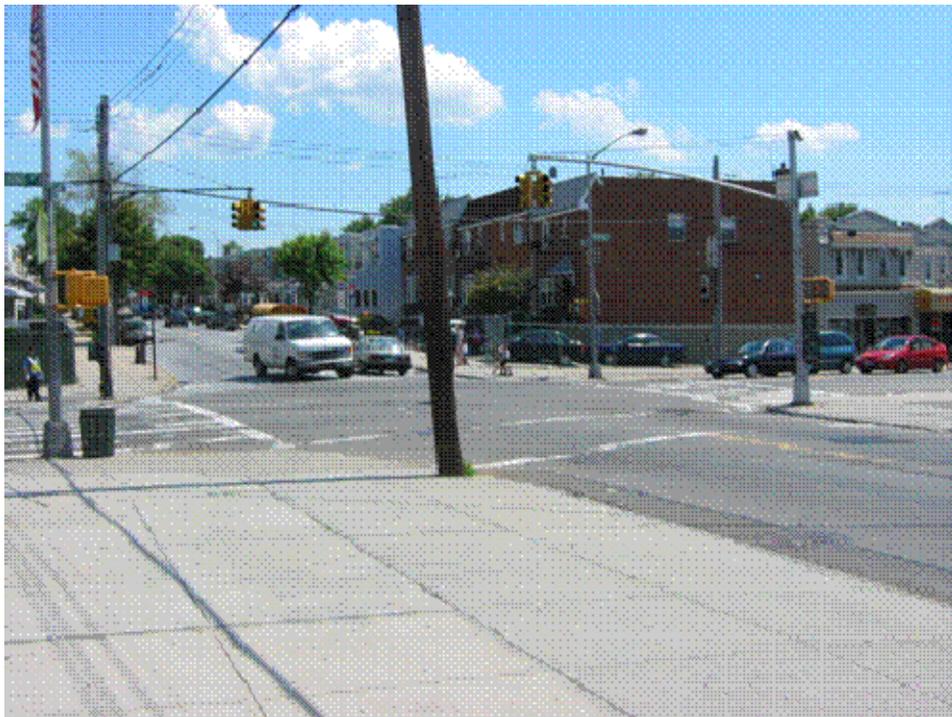
This is a four-leg signalized intersection with school crosswalks located across the east and west legs of Flushing Avenue, and pedestrian crosswalks located across the north and south legs of 61st Street. 61st Street is a two-way north-south street with one travel lane and one on-street parking lane on each side of the roadway. Flushing Avenue is a two-way east-west roadway with one travel lane and one on-street parking lane on each side of the roadway (see Figure 6). Flushing Avenue is also a designated “through” truck route in the vicinity of St. Stanislaus Kostka.

There were a total of 24 accidents reported at this intersection between 1998 and 2000 (Table 2), including two pedestrian accidents, neither of which was school-related. There were no pedestrian fatalities reported at this intersection between 1998 and 2000.

Figure 6: Looking southwest at the 61st Street and Flushing Avenue intersection

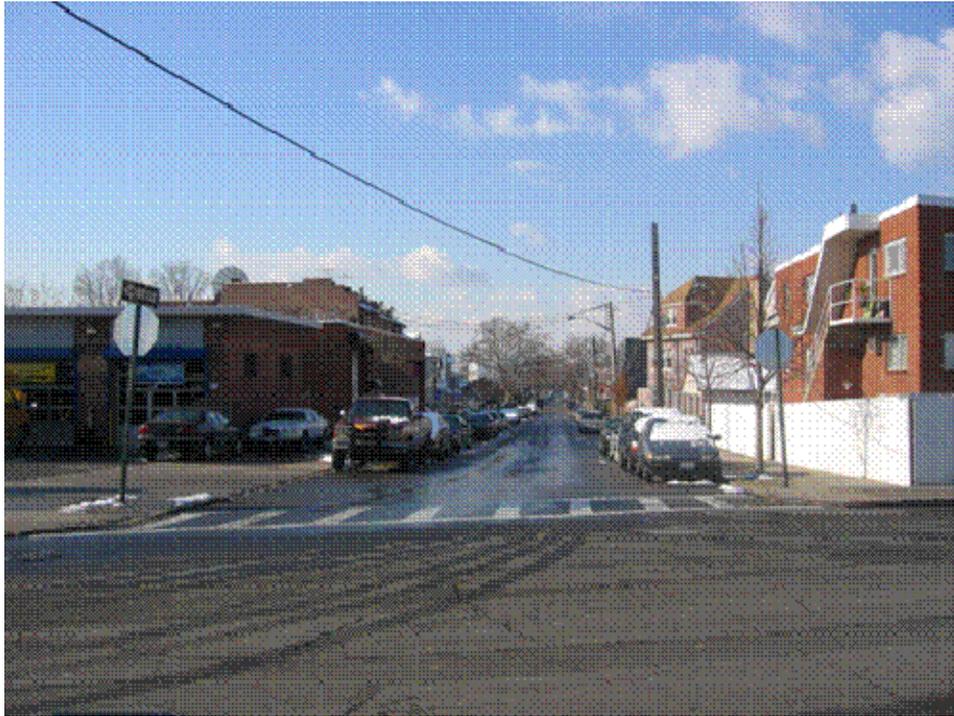
This is a three-leg unsignalized intersection with a school crosswalk located across the west leg of 58th Avenue. There are no crosswalks located across the north or south legs of 61st Street. 61st Street is a two-way north-south street with one travel lane and one on-street parking lane on each side of the roadway. 58th Avenue is a one-way eastbound street with one travel lane and on-street parking permitted on both sides of the roadway. The 58th Avenue approach is stop-controlled at 61st Street (see Figure 7).

Figure 7: Looking west along 58th Avenue from the intersection with 61st Street

- A pedestrian ramp is missing on the southwest corner of the intersection, for the school crosswalk located across the west leg (58th Avenue).
- The existing pedestrian ramp on the northwest corner of the intersection, for the school crosswalk located across the west leg (58th Avenue), is too narrow.

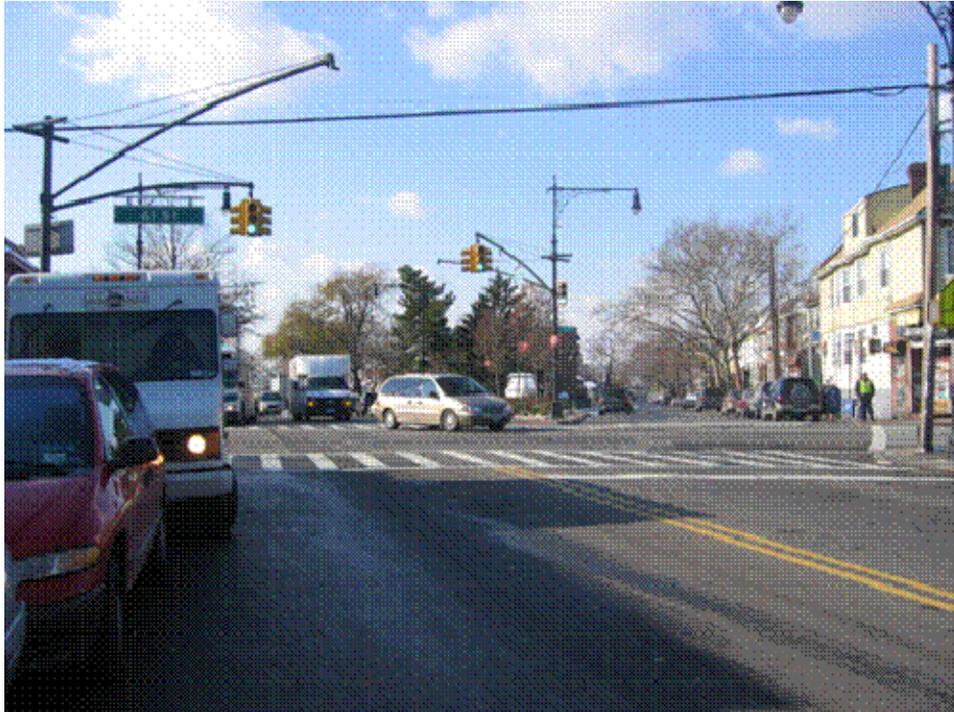
This is a five-leg signalized intersection with school crosswalks located across the east leg of Grand Avenue, the west legs of Grand Avenue and 57th Drive, and the north leg of 61st Street. A pedestrian crosswalk is located across the south leg of 61st Street. 61st Street is a two-way north-south street with one travel lane and one on-street parking lane on each side of the roadway. Grand Avenue is a two-way east-west roadway with one travel lane and one on-street parking lane on each side of the roadway. Grand Avenue is also a designated “through” truck route in the vicinity of St. Stanislaus Kostka. 57th Drive is a one-way westbound street with one travel lane and on-street parking permitted on both sides of the roadway (see Figures 8 and 9).

Figure 8: Looking west to Grand Avenue and 57th Drive at the intersection with 61st Street

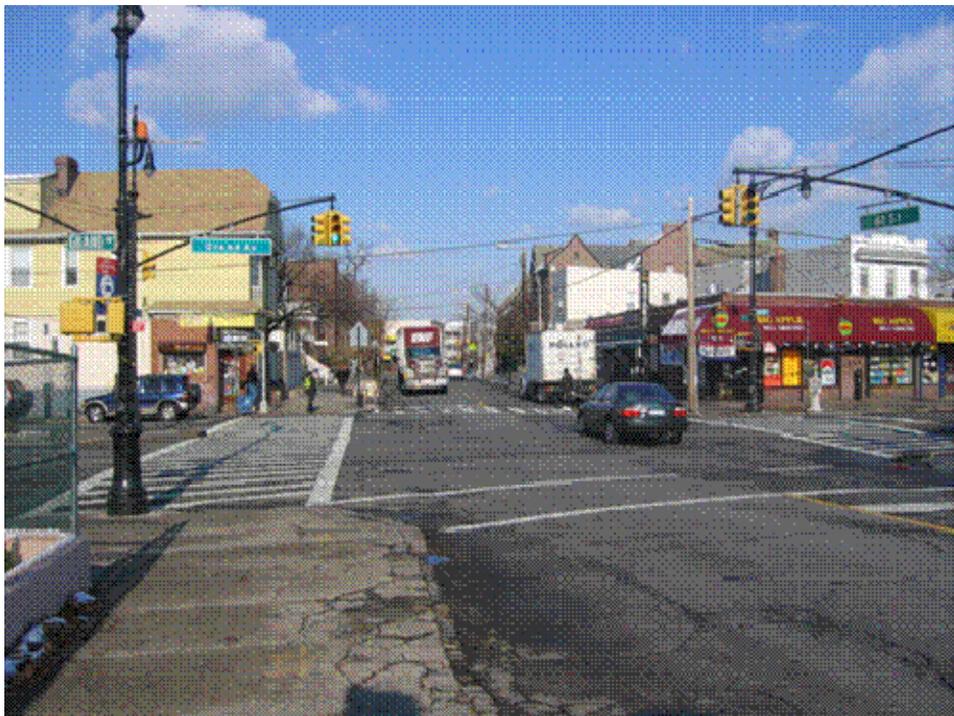
Figure 9: Looking north on 61st Street the intersection with Grand Avenue and 57th Drive

The roadways and sidewalks in the vicinity of St. Stanislaus Kostka were observed to be in fair condition. Sidewalks were found to vary from approximately 10 to 15 feet wide on the school block-faces and were observed to be in fair condition. However, there is a cracked and settled sidewalk on the west side of 61st Street at Grand Avenue (see Figure 9, showing cracked and settled sidewalk with evidence of pooling).

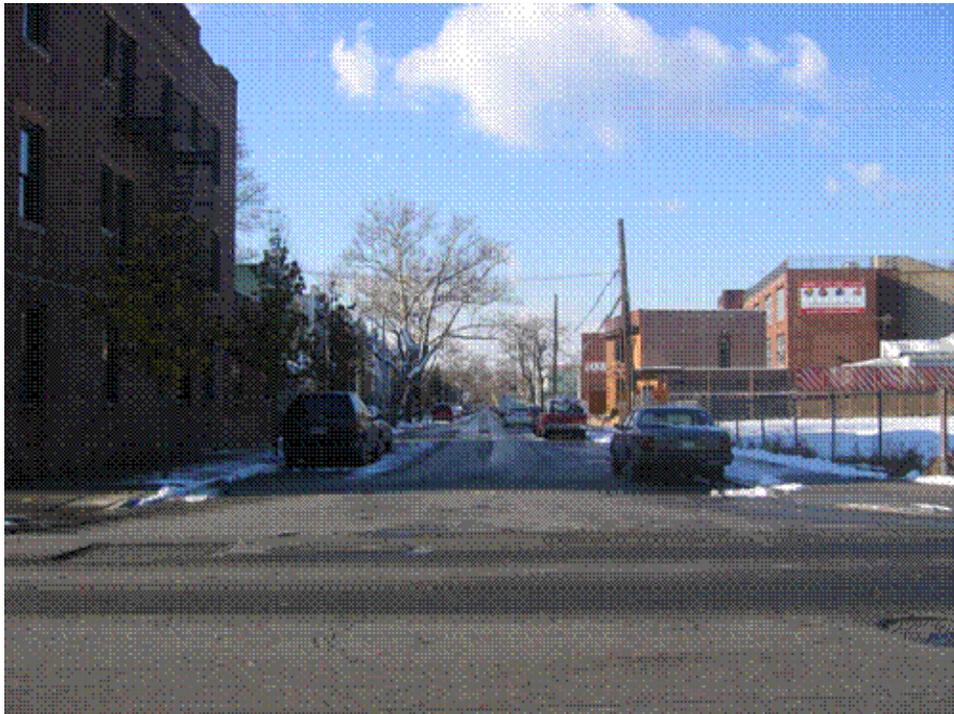
This is a three-leg unsignalized intersection with no school or pedestrian crosswalks. 61st Street is a two-way north-south street with one travel lane and one on-street parking lane on each side of the roadway. 57th Road is a one-way westbound street with one travel lane and on-street parking permitted on both sides of the roadway (see Figure 10).

There were a total of three accidents reported at this intersection between 1998 and 2000 (Table 2), including one pedestrian accident that was also school-related. The school-related accident occurred at approximately 8:00 am on Monday, November 2, 1998 under daylight conditions, and involved a 13-year old pedestrian who was reported struck by a vehicle while crossing the street within a “marked crosswalk” at the intersection. (As noted previously, however, there are no marked crosswalks at this intersection.) The specific location of the accident was not reported. The pedestrian was reported to have sustained an “incapacitating injury.” The accident occurred on a straight and level segment, and the roadway and weather conditions were reported as dry and clear, respectively.

Figure 10: Looking west on 57th Road from the intersection with 61st Street
