**New York City Department of Transportation
Office of School Safety Engineering**

School Safety Engineering Project

FINAL REPORT: St. Stanislaus Kostka, Queens

**Prepared by
The RBA Group and URBITRAN Associates Inc.**

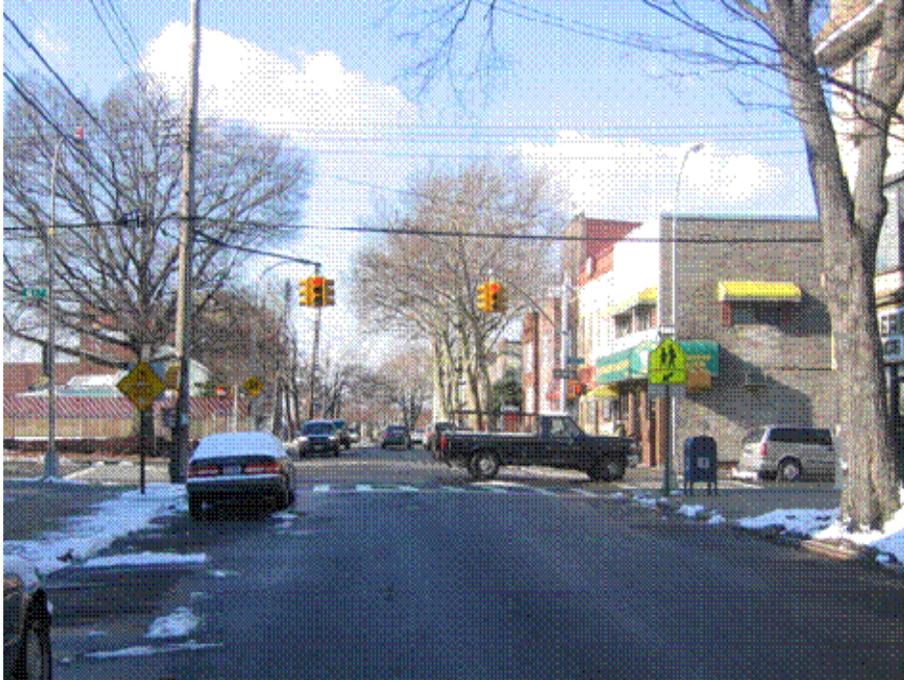
one-way westbound street with one travel lane and on-street parking permitted on both sides of the roadway. West of 61st Street, Maspeth Avenue is a two-way east-west roadway with one travel lane and one on-street parking lane on each side of the roadway (see Figures 11 and 12).

Figure 11: Looking west on Maspeth Avenue to the intersection with 61st Street

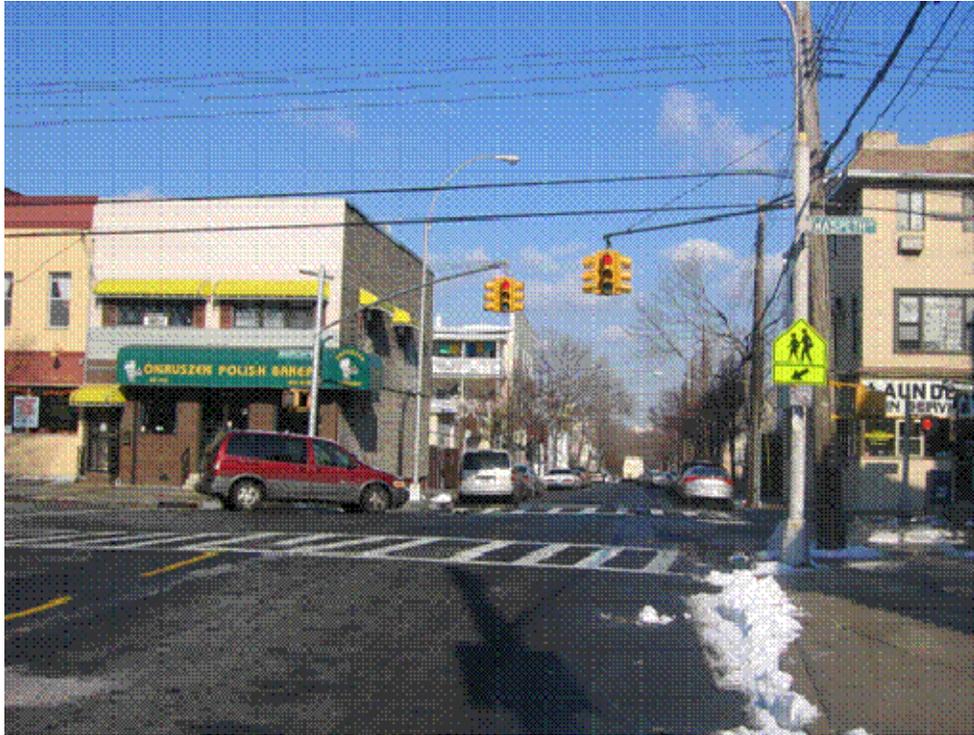
Figure 12: Looking north on 61st Street to the intersection with Maspeth Avenue

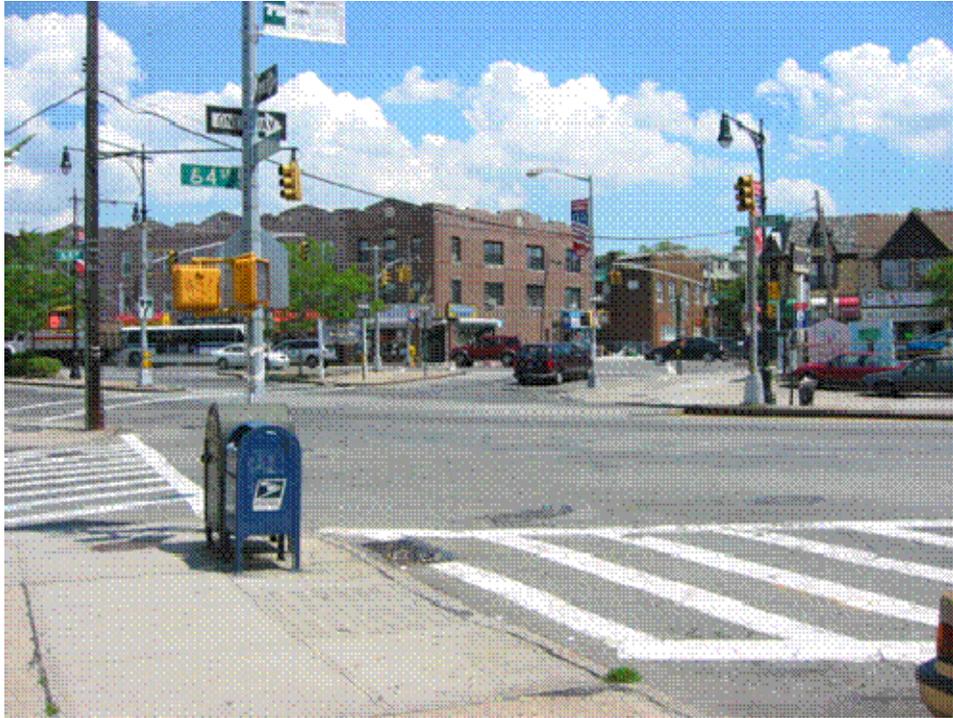
Raised concrete islands separate and channelize traffic flow between this intersection and the Flushing Avenue/64th Street intersection described below. (Refer to Exhibit 1 for an aerial view of these closely-spaced intersections.) It should be noted that there is an exclusive pedestrian interval incorporated into the timing sequence for the Grand Avenue/Maspeth Avenue/64th Street intersection that allows pedestrians to cross all legs of the intersection simultaneously. In addition, there is a standard “WALK” interval for each phase of the traffic signal.

Figure 13: Looking southeast at the Grand Avenue/Maspeth Avenue/64th Street intersection

- Relocate the curbside drainage inlet that is in the center of the pedestrian crosswalk across the west (Grand Avenue) leg of the intersection.
- Relocate the light pole that is within the path for the pedestrian crosswalk located across the west (Grand Avenue) leg of the intersection.

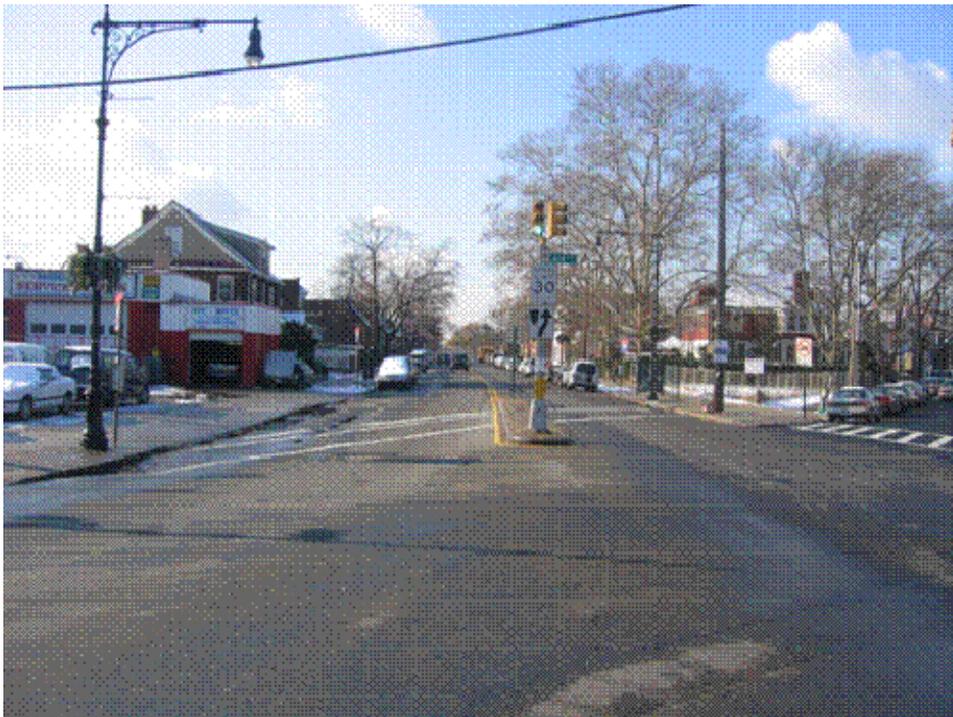
Figure 14: Looking southwest on Grand Avenue at the intersection with Maspeth Avenue/64th Street

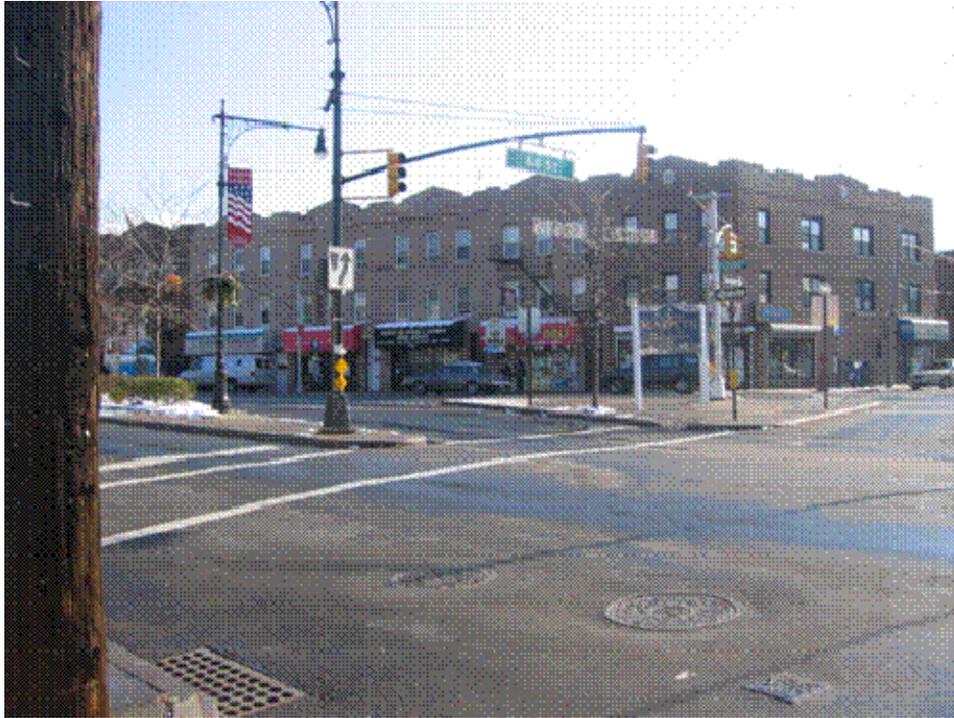
Figure 15: Looking southeast at 64th Street across Grand Avenue toward Flushing Avenue

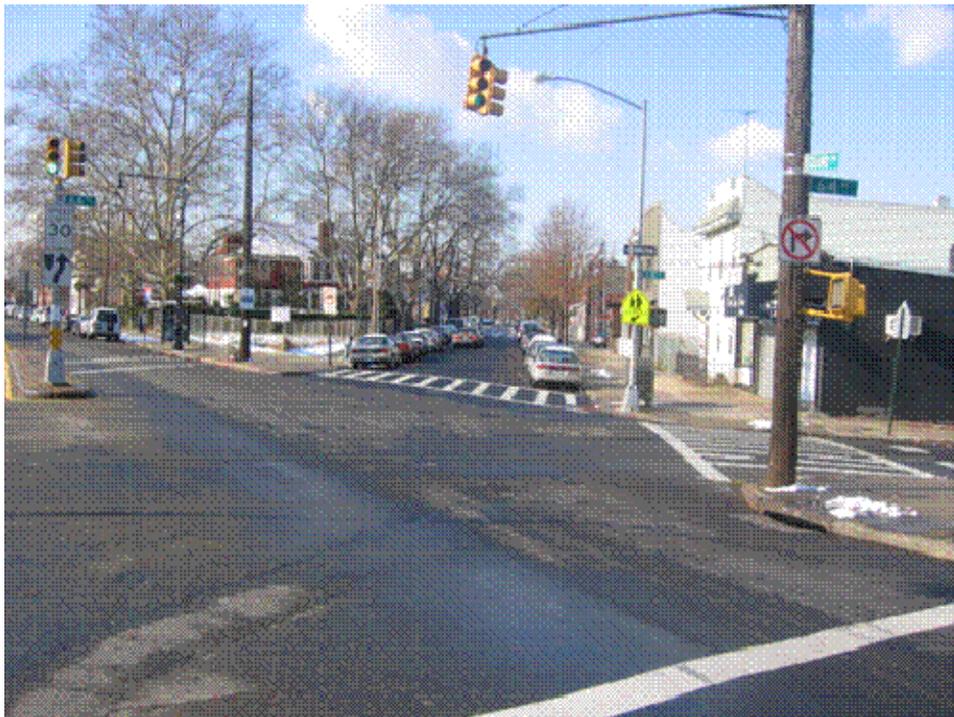
Figure 16: Looking west along Maspeth Avenue at the intersection with Grand Avenue/64th Street (Grand Avenue is shown to the left and 64th Street is to the right)

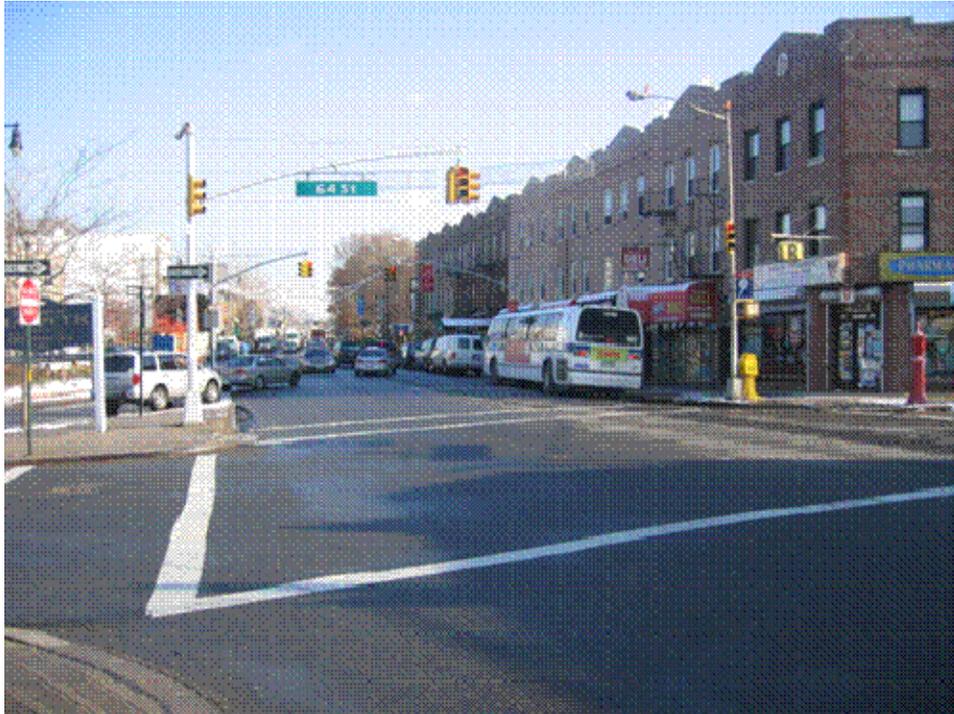
This is a four-leg signalized intersection with pedestrian crosswalks located across all four legs. Flushing Avenue is a two-way east-west roadway with one travel lane and one on-street parking lane on each side of the roadway, and is also a designated “through” truck route. South of the intersection, 64th Street is a two-way north-south roadway with one travel lane and one on-street parking lane on each side of the roadway (see Figures 17 and 18).

Figure 17: Looking northeast on Flushing Avenue across the intersection with 64th Street, to Grand Avenue

- A pedestrian ramp is missing on the southeast corner of the intersection for the crosswalk located across the east leg.
- The existing pedestrian ramp on the northeast corner of Flushing Avenue (on the raised concrete island), for the crosswalk located across the east leg of the intersection, is too narrow.

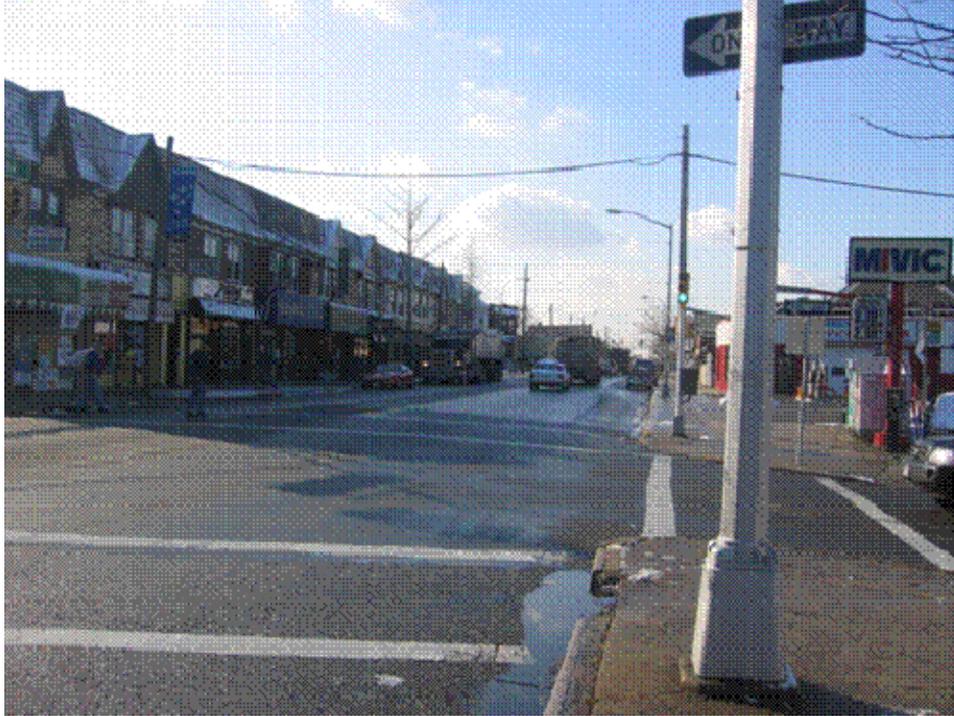
Figure 18: Looking southwest on Flushing Avenue across the intersection with 64th Street

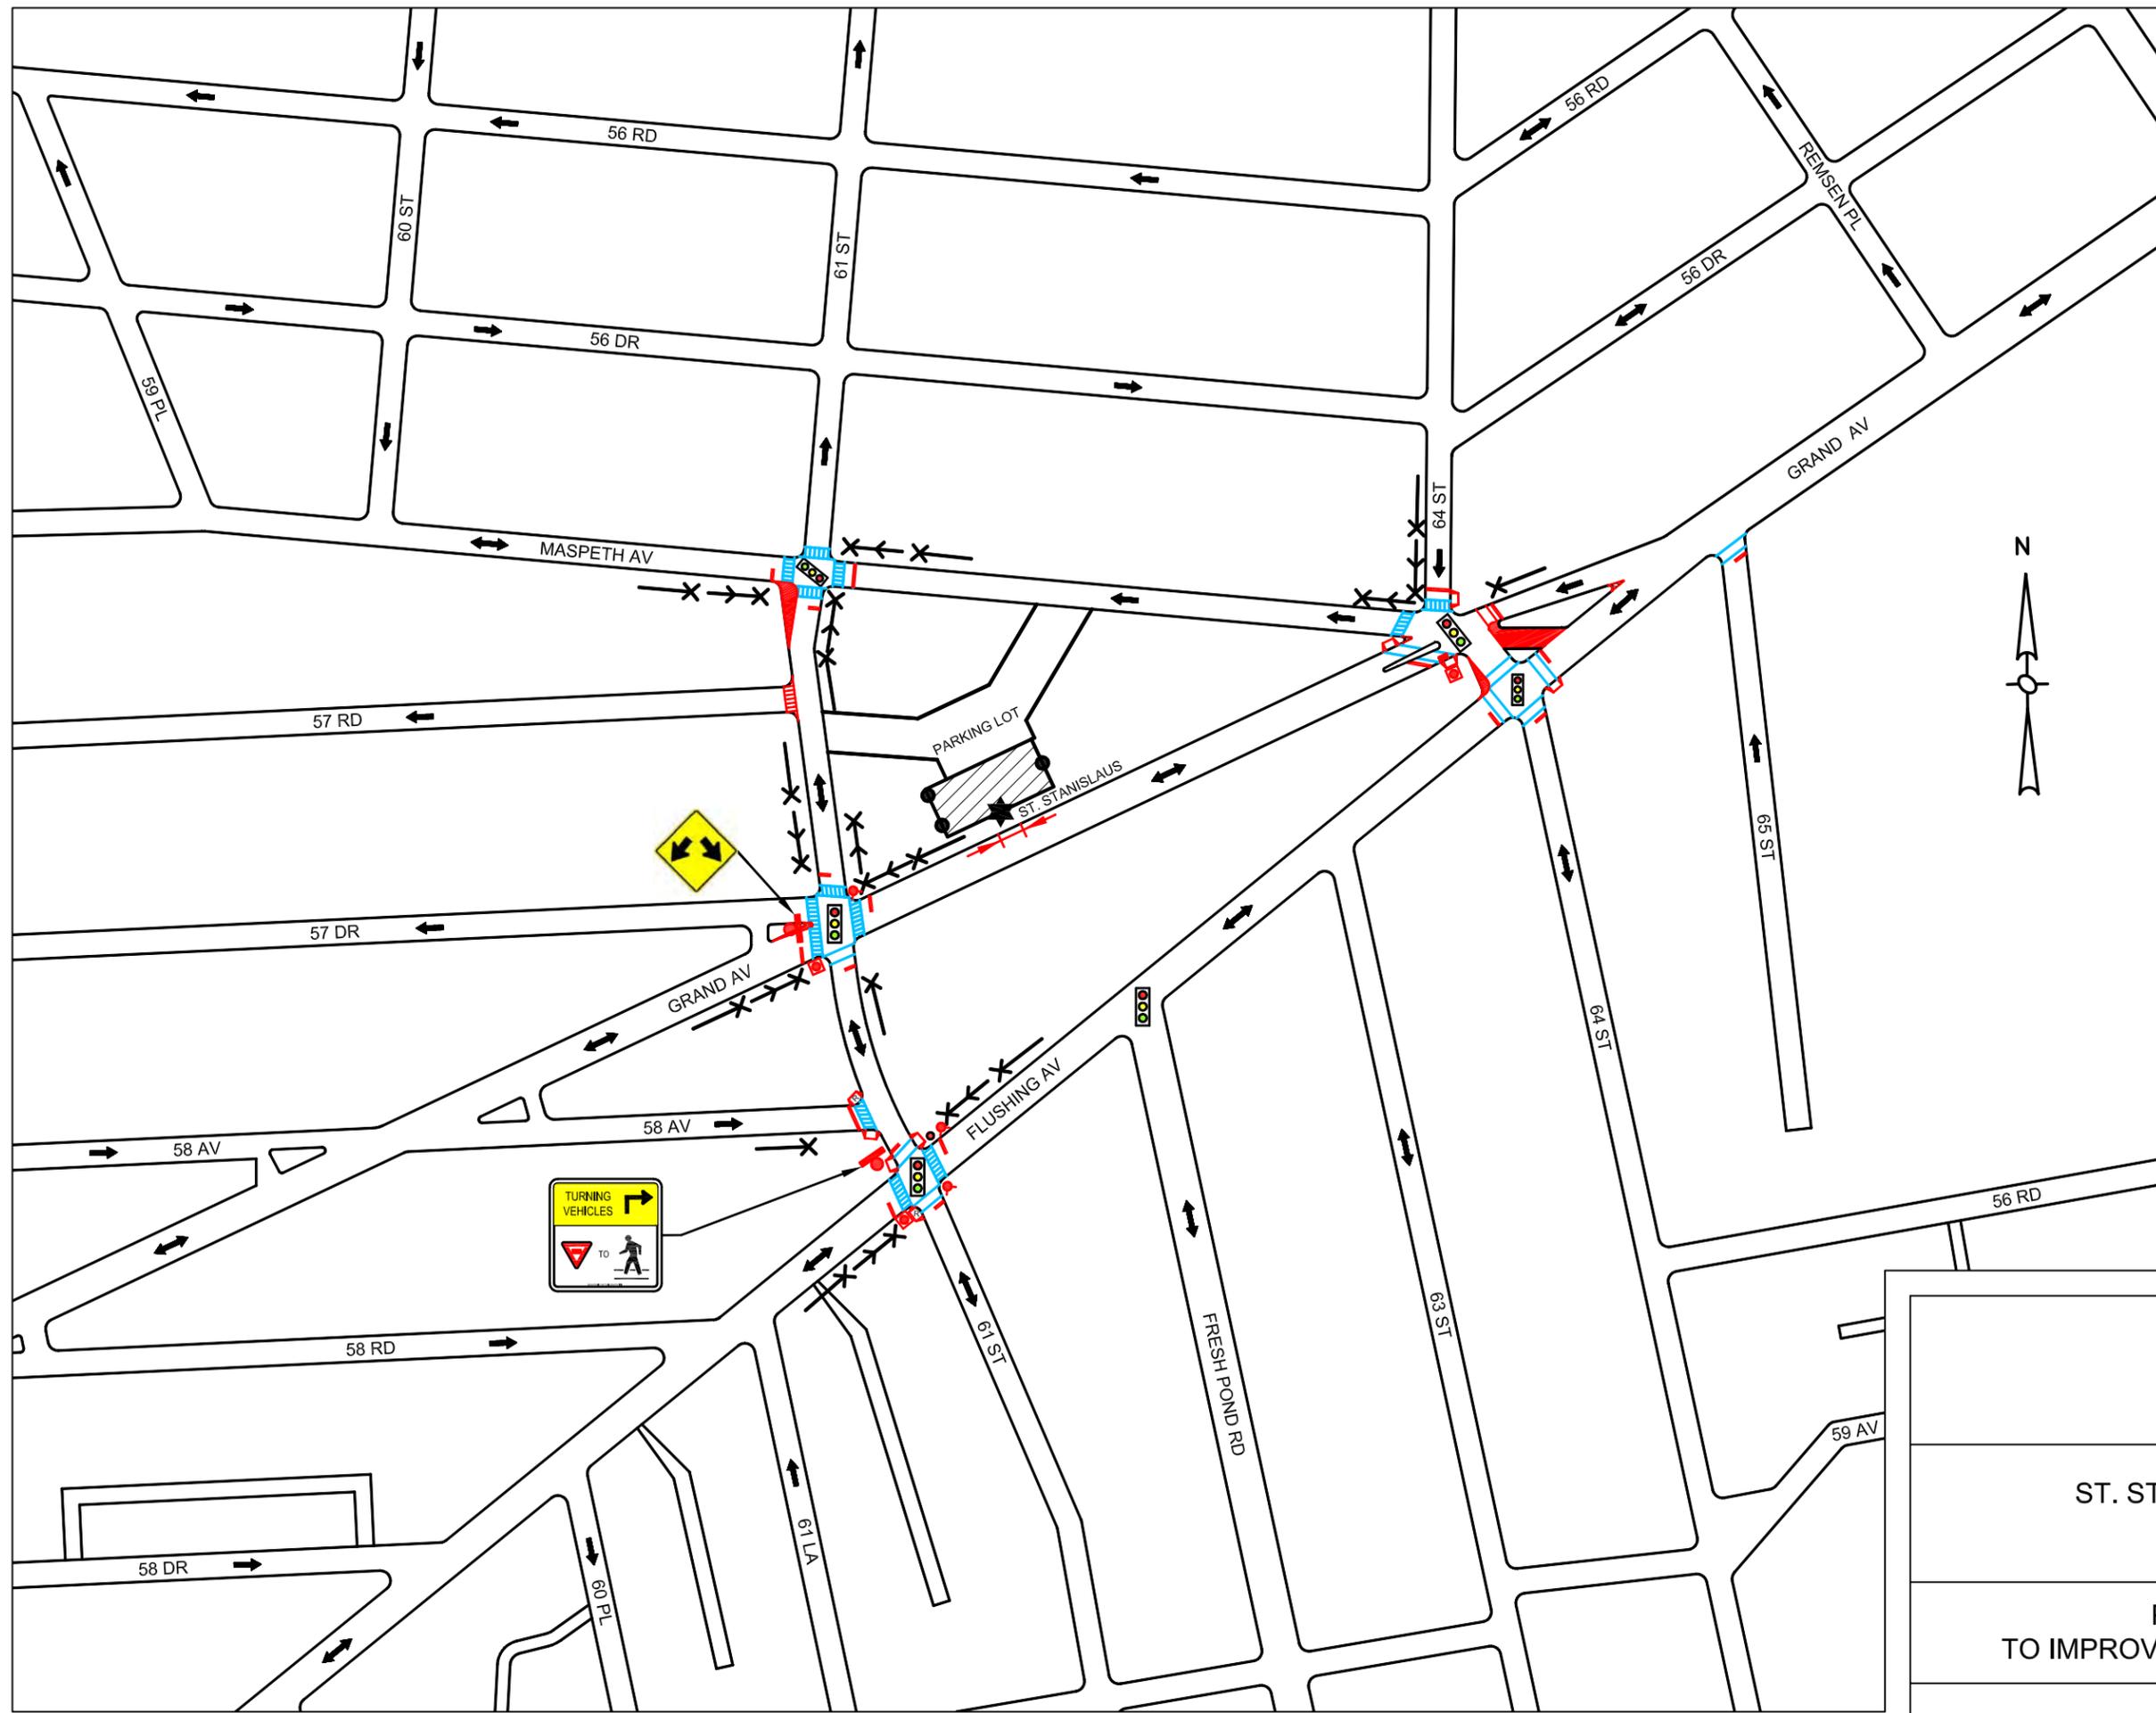
POTENTIAL MEASURES
TO IMPROVE STUDENT PEDESTRIAN SAFETY

This section describes the proposed measures to improve school pedestrian safety around St. Stanislaus Kostka. The proposed recommendations are divided into short-term and long-term measures. Short-term measures are those that potentially can be performed in-house. Long-term measures involve capital improvements. Each of the short- and long-term measures recommended for St. Stanislaus Kostka is discussed as follows, and is shown in more detail in Exhibit 6 at the end of this section.

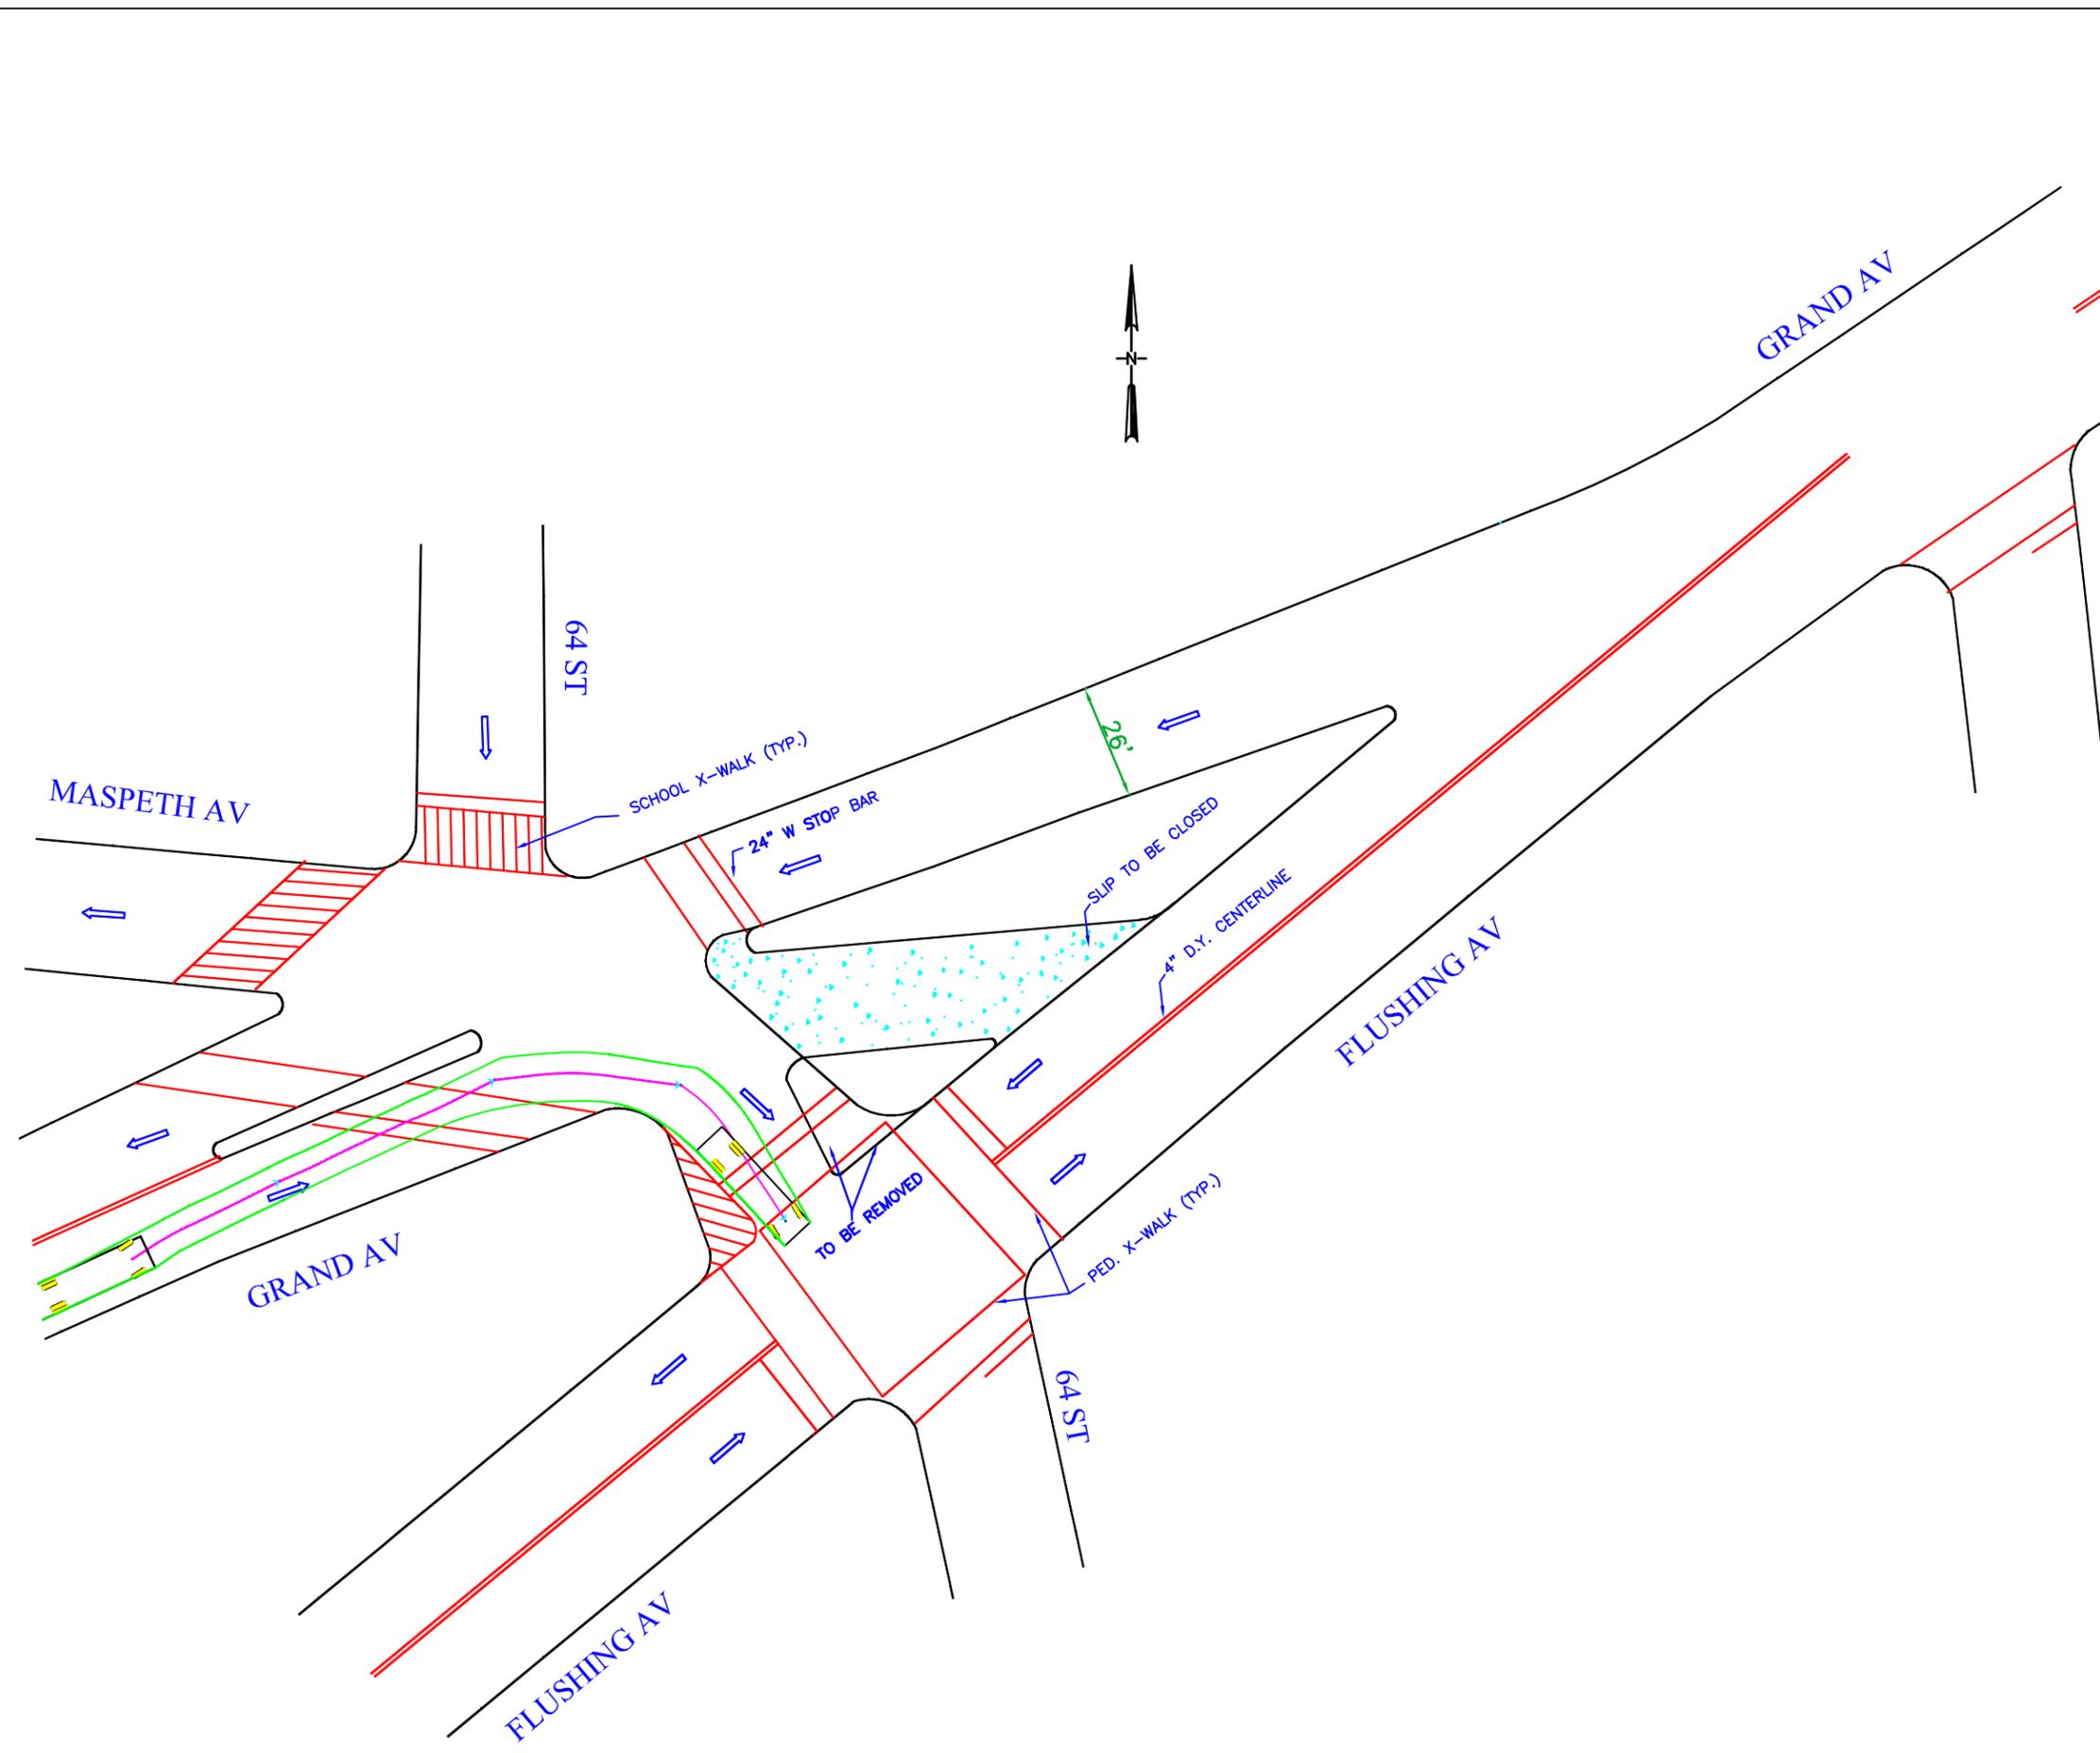
CITY OF NEW YORK DEPARTMENT OF TRANSPORTATION
 BUREAU OF TRAFFIC OPERATIONS
 28-11 Queens Plaza North L.I.C., N.Y. 11101
 INTERSECTION OF GRAND AVE/FLUSHING AVE/64 ST/MASPETH AVE
 PAVEMENT MARKINGS DETAILS

The Maspeth Bypass Study has proposed that the existing truck route on Grand Avenue be removed between Rust Street and Flushing Avenue. With a truck restriction on Grand Avenue, the study identified the need for additional signage on several corridors and approaches to nearby streets. In addition, the study recommended modifying existing traffic islands, striping, and other geometric features at the intersection of Flushing Avenue/Grand Avenue/64th Street.
