Safe Streets for Seniors

Jamaica Hills, Queens

FINAL REPORT

November 24, 2010

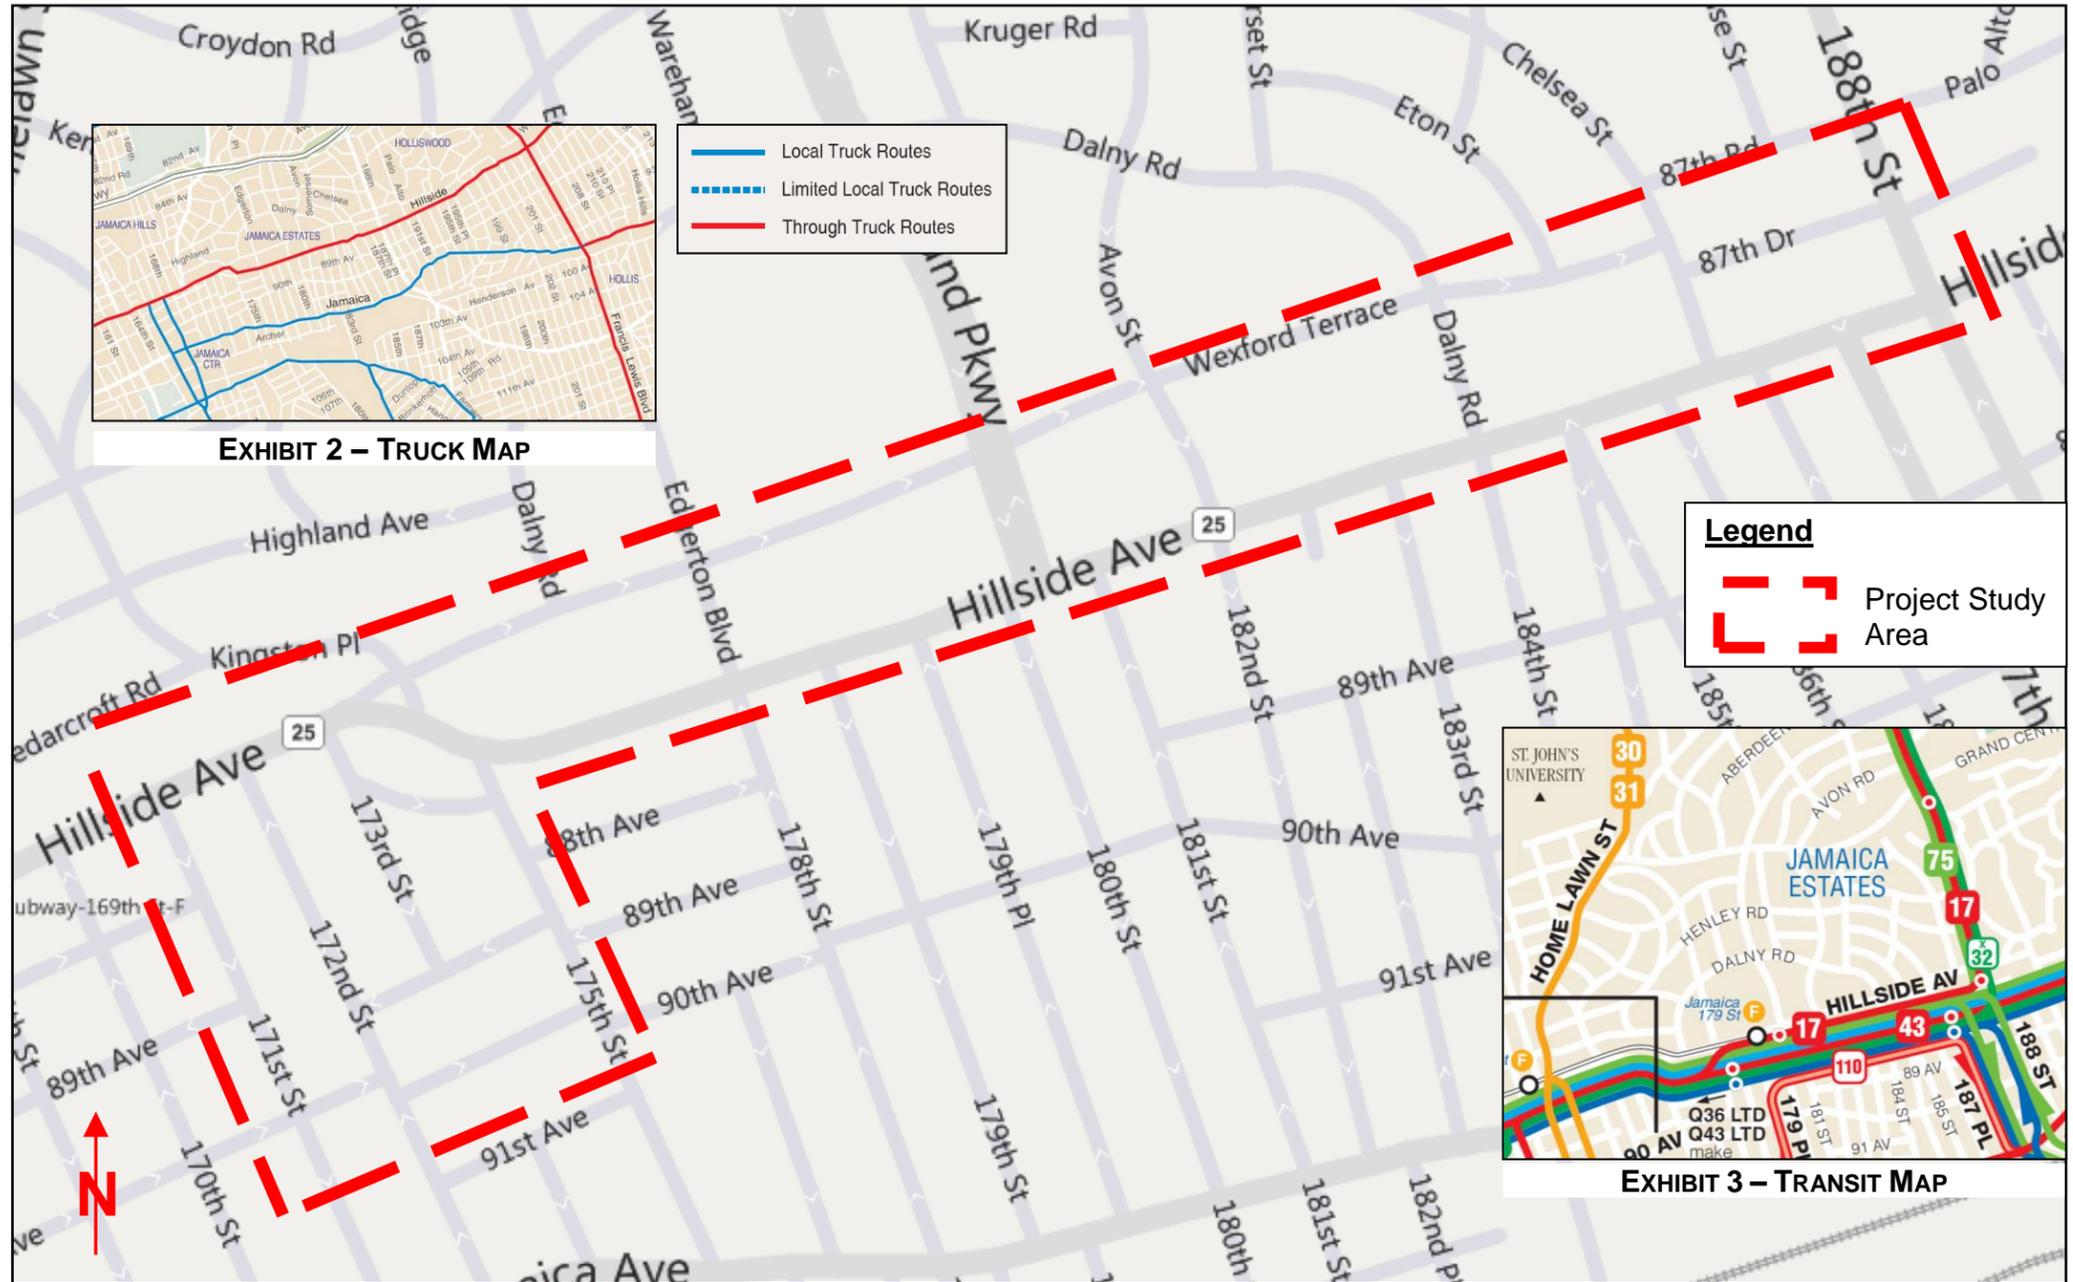
EXHIBIT 1 – ROADWAY MAP OF THE STUDY AREA

Jamaica Hills has all of the dominant elements typical of an urban setting, including vehicular, bus, subway and pedestrian modes of transportation. Subway and bus services in the study area are provided along Hillside Avenue. Subway stations are located on Hillside Avenue for the F line at its intersections with Midland Parkway, 179th Place and 179th Street. The bus operations include services for the Q1, Q2, Q3, Q17, Q36, Q43, Q75, Q76, Q77, N1, N2, N3, N6, N22, N22A, N24, N26, X32 and the X68 lines.

Significant pedestrian activity is also generated by the Susan B. Anthony School (I.S. 238), Eastwood Elementary (P.S. 095) and Mary Louis Academy schools which are located within the boundary of the project study area.

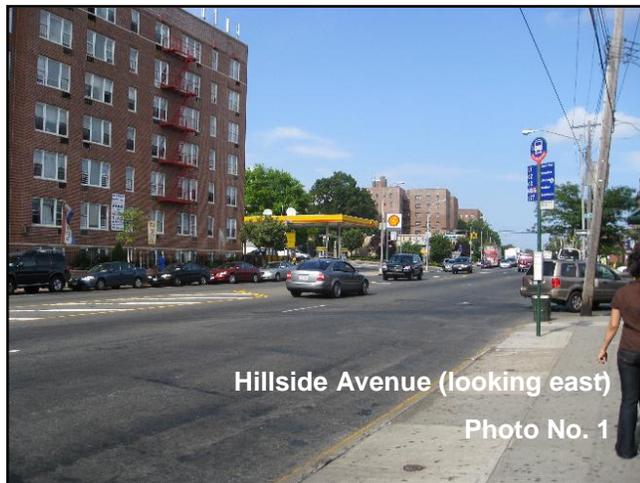
Hillside Avenue is a major two-way arterial with two moving lanes in each direction, a parking lane along each curb and left turn bays at major intersections (Photo No. 1). This corridor provides east-west access extending from Nassau County in the east to Brooklyn in the west. Parking is generally permitted on both sides of the arterial within the study area. The curb lanes are reserved for buses and right turning vehicles during weekdays, 7-9 AM westbound and 4-7 PM eastbound on Hillside Avenue. Hillside Avenue is a major through-truck route and also supports significant transit operations including buses and a subway line. Thus it is one of the most heavily traveled corridors in Queens with the greatest traffic activity during the typical AM, midday and PM peak commuting hours.

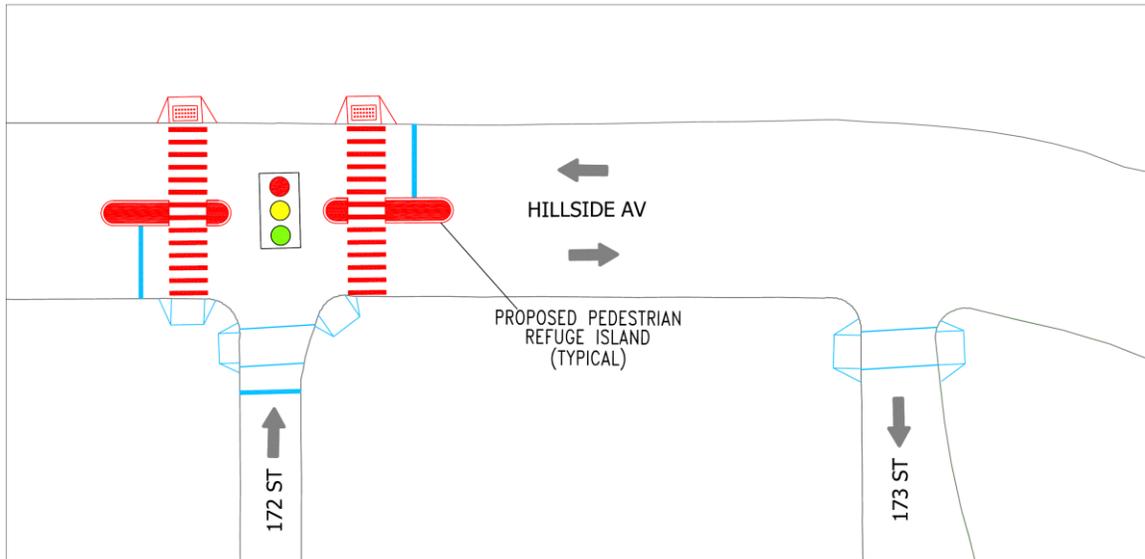
Pedestrian Refuge Island Details (Typical)

- Under the existing conditions, there is a yellow hatched median on Hillside Avenue between 188th Street and 171st Street. It is recommended that the striped median be replaced with pedestrian refuge islands at major signalized intersections and specifically at locations where these pedestrian refuge islands will not interfere with the existing left turn bays approaching intersections. The installation of pedestrian islands will provide senior pedestrians with a refuge while crossing Hillside Avenue. These traffic calming islands or raised medians will not only slow down the speed of turning vehicles but will effectively shorten the crossing distance by allowing senior pedestrians to cross the roadway in two traffic signal

cycles (if necessary). Construction details for these pedestrian refuge islands are provided in Appendix F. It is important to note that within the striped crosswalk, the raised median island should be constructed at-grade so that all pedestrians can conveniently utilize the refuge without requiring a step up to or down from the raised median curb.

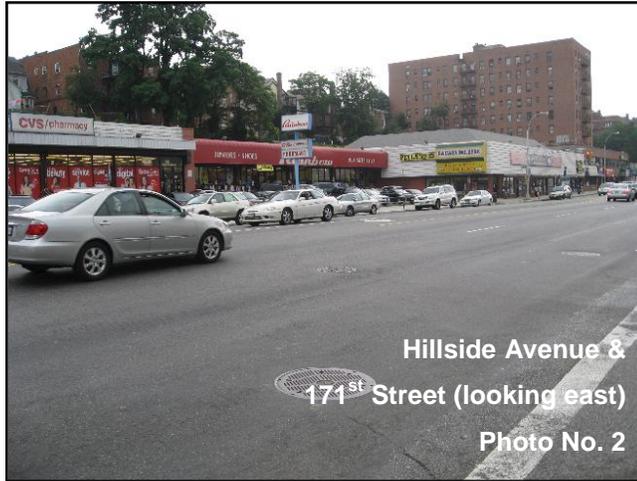
- Under the present condition, the intersection of Hillside Avenue and 171st Street is unsignalized with no crosswalk provisions across Hillside Avenue (Photo No. 2). The only crosswalk at this intersection is on the minor approach (171st Street); however, pedestrians were observed crossing Hillside Avenue at this

intersection. Consistent with past practice, it is not recommended that crosswalks be installed on Hillside Avenue at this location. It is recommended, however, that positive guidance be provided to the pedestrians so that they are guided to cross Hillside Avenue via adjacent signalized intersections. It is recommended that pedestrian signs be installed, including “No Pedestrian Crossing” (MUTCD: R9-3a) signs, supplemented with the directional “Use Crosswalk - with appropriate arrow” (MUTCD: R9-3b) signs. These signs should be appropriately located facing pedestrians on the intersection corners so that pedestrians are guided to cross Hillside Avenue from the adjacent signalized intersection.

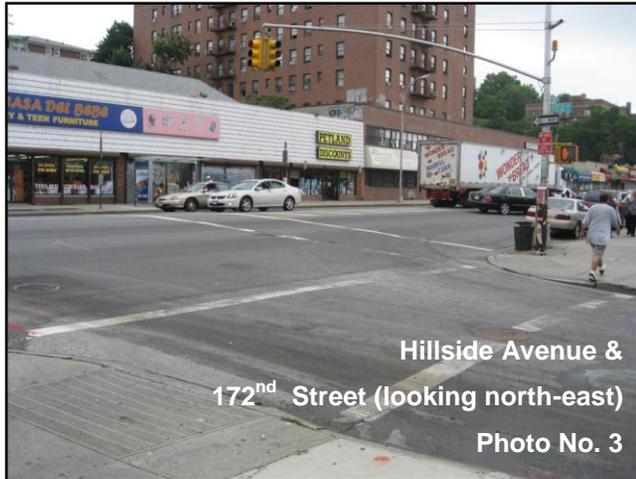
- It is recommended that the existing hatched median on Hillside Avenue be replaced by installing median pedestrian refuge islands on the east and west legs of this signalized “T” intersection (Photo No. 3). This measure will reduce the walking distance and the exposure of pedestrians to traffic operations. It is further recommended that high visibility crosswalks be installed across Hillside Avenue along with ADA-compliant pedestrian ramps along the north curb. The intersection box should also be kept clear of parking operations by the installation of “No Standing Any Time” signs.

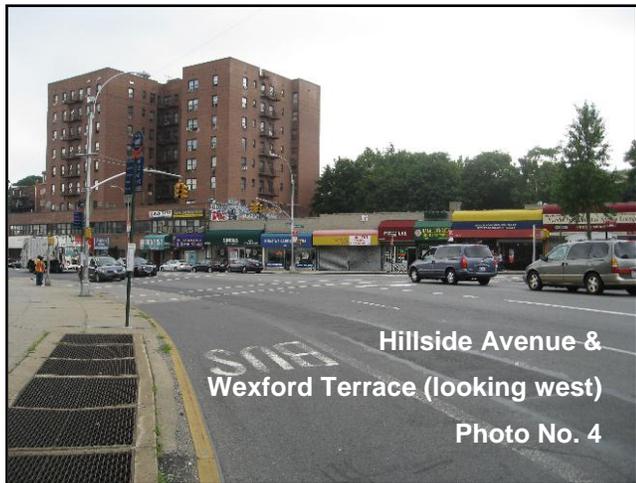
- Due to the angular intersection geometry and line-of-sight constraints at this “T” intersection, the left turns from Wexford Terrace to Hillside Avenue could potentially lead to pedestrian crashes (Photo No. 4). A photo of one such potential conflict is shown on the cover page of this document. Improvements suggested for this intersection include installing a median pedestrian refuge island on Hillside Avenue within the intersection box, installing high visibility crosswalks on the west and north sides of this intersection, and installing advanced stop bars. These improvements will eliminate the above-noted left turn conflict and would help to improve pedestrian safety at this intersection. Pedestrian count data can be viewed in Appendix D.

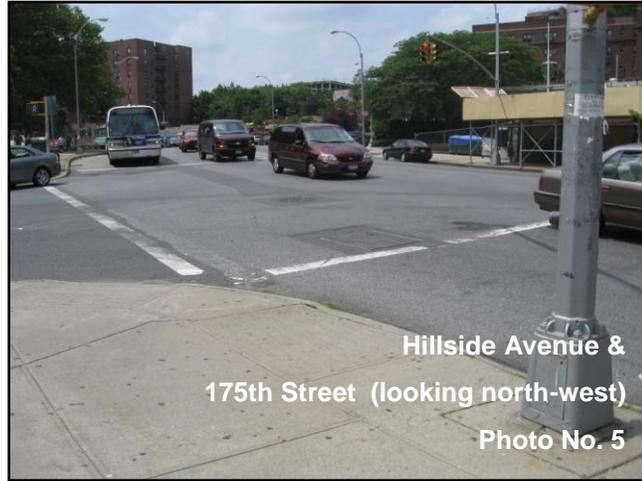
- It is recommended to reduce the pedestrian crosswalk width of the west leg of this intersection by installing a median pedestrian refuge island in place of the existing hatched median on Hillside Avenue (Photo No. 5). The east leg of this intersection currently has an active left turn bay which cannot be closed to accommodate a pedestrian refuge island. It

is further recommended that high visibility crosswalks be installed on all three legs of this signalized “T” intersection to improve pedestrian safety.

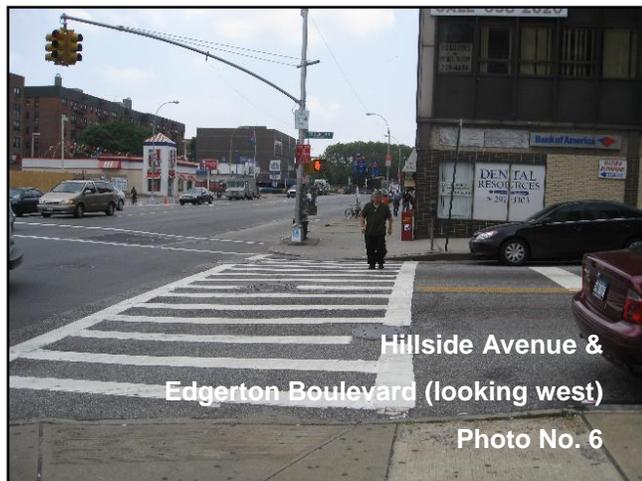
- Install a median pedestrian refuge island on the east leg of Hillside Avenue at this intersection. Relocate the east school crosswalk based upon the new refuge island alignment.
- Install a Leading Pedestrian Interval (LPI) for the north crosswalk at the intersection of Hillside Avenue and 178th Street/Edgerton Boulevard (Photo No. 6). The purpose of an LPI is to give advance, conflict-free crossing time to pedestrians in order to avoid conflicts when they are crossing the path of turning vehicles at a crosswalk. Field observations reveal significant pedestrian activity at this location, involving a

considerable number of seniors. Turning movement counts performed on 09/11/08 for the AM and PM peak periods indicate:

- During the AM peak hour, there are 172 pedestrians crossing Edgerton Boulevard, conflicting with 221 vehicles (23 eastbound left + 198 westbound right).

- During the PM peak hour, there are 270 pedestrians crossing Edgerton Boulevard conflicting with 100 vehicles (35 eastbound left + 65 westbound right). .Pedestrian count data can be found in Appendix D.

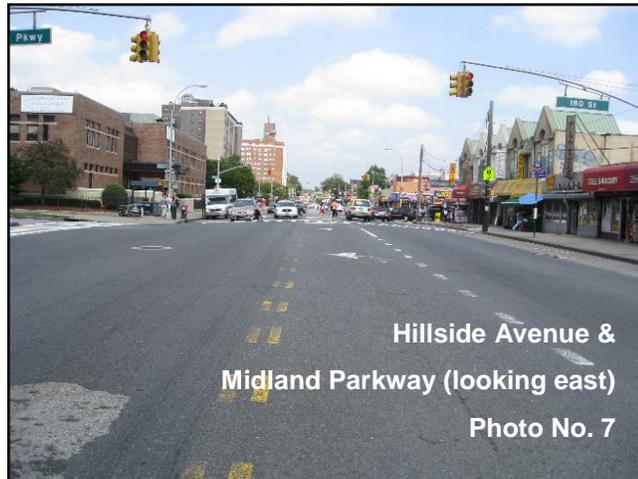
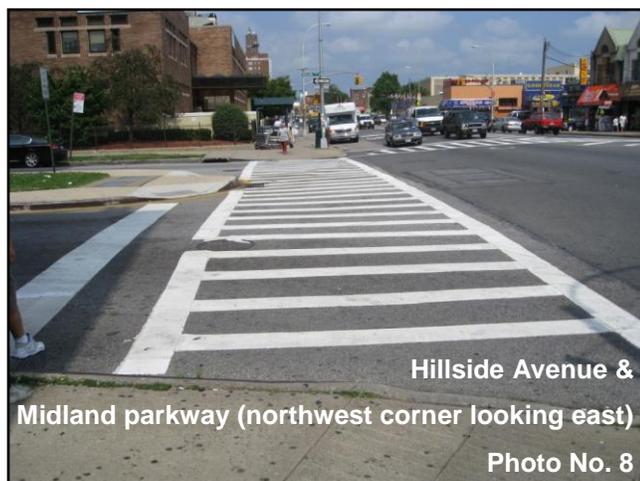
- This “T” intersection is sandwiched between the very closely spaced 180th Street and 181st Street intersections. It is located approximately 80 feet east of 180th Street and approximately 170 feet west of 181st Street. In addition, north and southbound Midland Parkway is separated by a median island which is approximately 20’ wide. Due to the constrained geometrical configuration at this intersection, the eastbound left turning vehicles from Hillside Avenue to Midland Parkway queue and frequently block the intersection box between 180th Street and 181st Street (Photo Nos. 7 & 8). This results in southbound left turning vehicles from Midland Parkway maneuvering around the vehicles blocking the intersection. As such, these vehicles are frequently in direct conflict with pedestrians utilizing Hillside

Avenue's east side crosswalk. Even without vehicular blockage of the intersection box, the southbound left turning movement from Midland Parkway is difficult as vehicles have to maneuver over the existing hatched median/left turn bay located within the intersection box. Under the school safety projects, the construction of pedestrian refuge islands has been recommended along Hillside Avenue between Midland Parkway and 182nd Street which will improve pedestrian safety in this area (see Appendix G for details). In addition to these pedestrian refuge islands, it is recommended that a left turn restriction from westbound Hillside Avenue onto 180th Street be implemented.

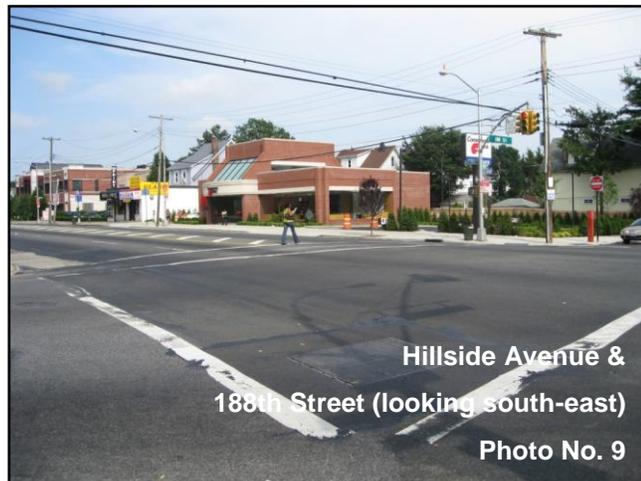
- Install a median pedestrian refuge island on the east leg of Hillside Avenue and high visibility crosswalks on all four legs of this intersection (Photo No. 9).

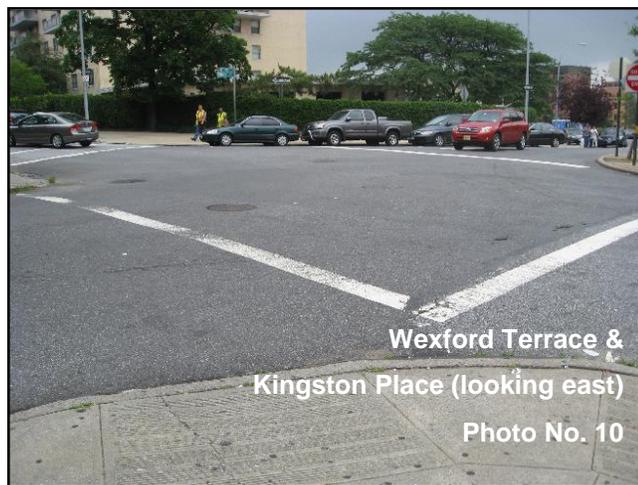
- At the intersection of Wexford Terrace and Kingston Place, the installation of high visibility crosswalks on the north, east and west side approaches is recommended, as well as an advanced stop bar on the southbound approach. The relocation of an existing “Stop Ahead” sign to 50 feet northwest of its present location on

Kingston Place is also recommended. In addition, field visits have noted vehicles parked at the southeasterly curb of the Kingston Place and Wexford Terrace intersection (right into the intersection). These vehicles block the driver’s view and could result in a serious pedestrian/vehicular conflict between vehicles turning right from Kingston Place to Wexford Terrace and pedestrians crossing at the east crosswalk (Photo No. 10). The installation of “No Standing Any Time” signs is recommended at this corner so that visibility at this skewed intersection can be improved. A new pedestrian ramp should also be installed on the northeast corner.

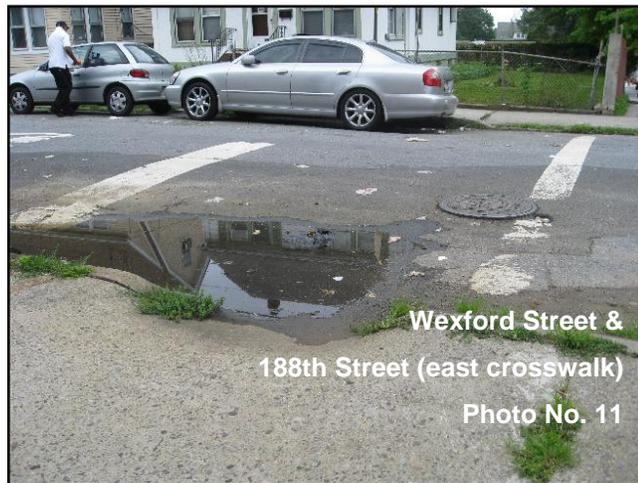
- At the intersection of Wexford Terrace and 188th Street, the installation of high visibility crosswalks on the east and west approaches is recommended. The relocation of the existing bus stop on the northbound approach is also recommended. It should be moved 5 to 10 feet south to help improve visibility for right turning

traffic against the crossing pedestrians. On the eastbound approach to this intersection, the removal of approximately 75 feet of parking spaces on both curb sides is recommended. This will create better vehicular operations by providing two moving lanes at the approach with pavement restriping. On the westbound approach, the old pedestrian ramps should be removed and new ADA compliant pedestrian ramps should be provided and aligned with the crosswalk (Photo No. 11). No crosswalks presently exist on 188th Street and it is not recommended that crosswalks be added; however, it is recommended that positive guidance be provided to pedestrians so that they are guided to cross 188th Street via adjacent signalized intersections. The installation of pedestrian signs is recommended, including “No Pedestrian Crossing” (MUTCD: R9-3a) signs, supplemented with the directional “Use Crosswalk - with appropriate arrow” (MUTCD: R9-3b) signs.

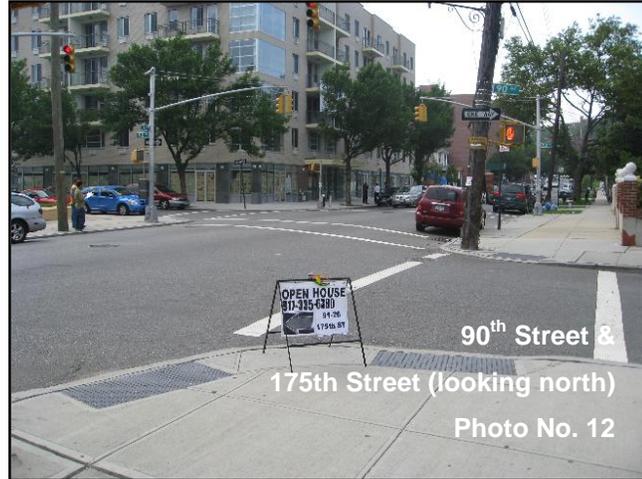
- This is a staggered 4-leg intersection that is surrounded by a residential neighborhood, including a church and a community center (Photo No.12). At this intersection, the installation of high visibility crosswalks on all four sides and advanced stop bars on the north, south, and west approaches is recommended. It is further recommended that parking

be removed from the east side of 175th Street within the intersection box fronting the 90th Avenue approach because it creates a blind spot for drivers and for crossing pedestrians. A “Yield to Pedestrian” sign should also be installed on the 90th Avenue approach. These recommendations are shown in the Site 3 illustrations.

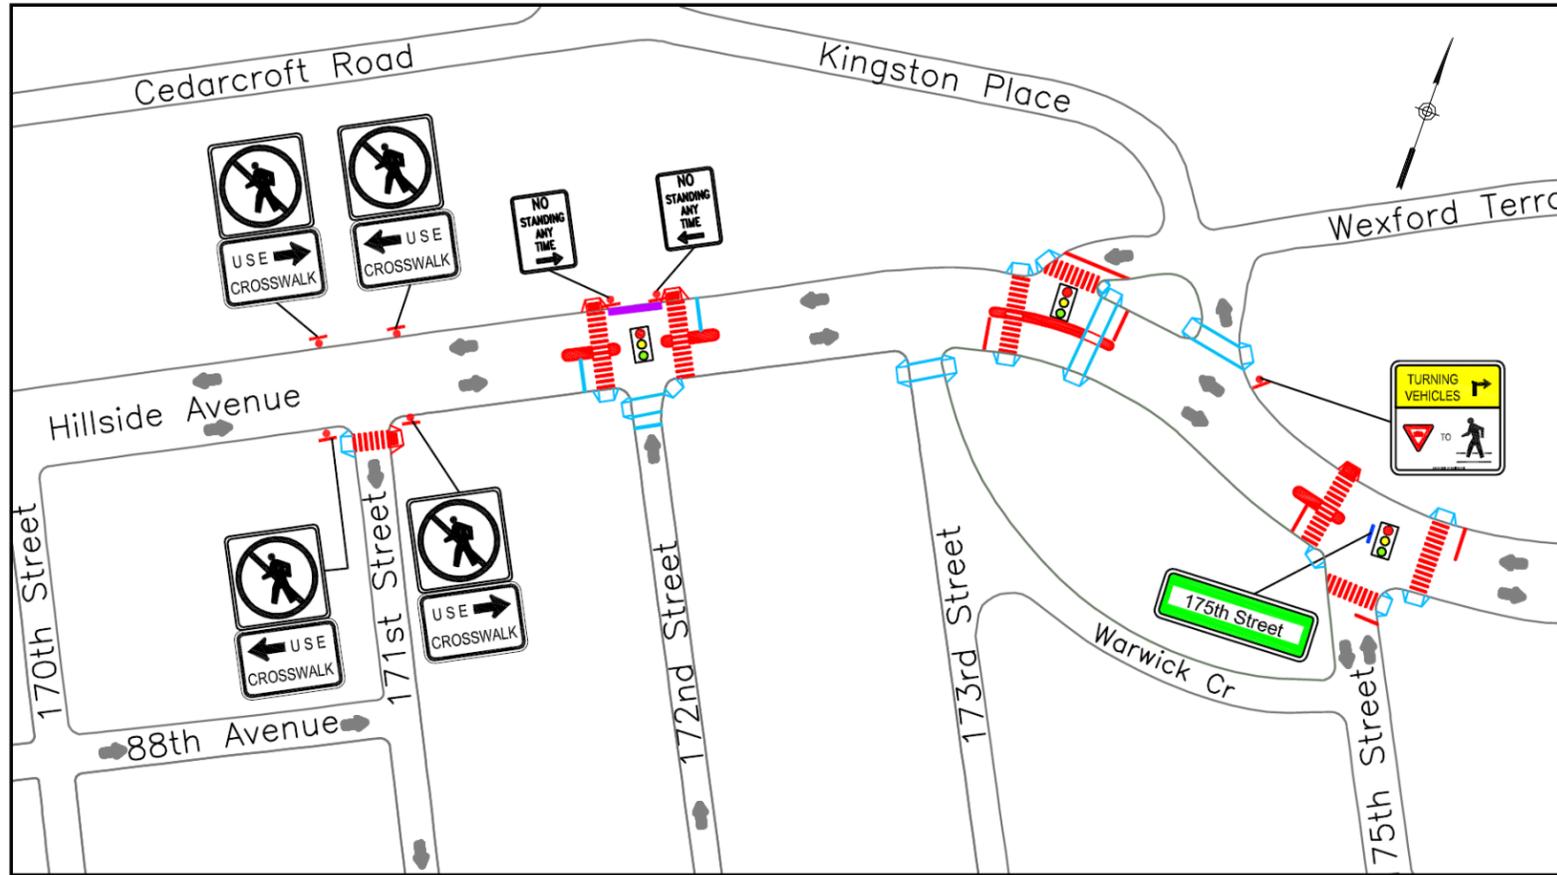
SITE 1: PLAN 1 HILLSIDE AVENUE (FROM 171ST STREET TO 175TH STREET)

Recommended improvements include:

- Time all signals for seniors and where feasible, the crossing time will be extended
- Install new high visibility crosswalks
- Install new advance stop bars

- Install new pedestrian ramps. Where proposed, align the ramps to the proposed crosswalks
- Install a new "Yield to Pedestrian" sign at the intersection shown in the illustration

- Install new oversized street name sign at the intersection of Hillside Avenue and 175th Street. This sign is to be located on the signal mast arm facing Hillside Avenue traffic in both directions

- Install new pedestrian refuge islands and raised, planted median by replacing the existing striped median island at the intersections shown along Hillside Avenue

- Install new "No Pedestrian Crossing" and "Use Crosswalk" (with appropriate arrow) signs at the intersection of Hillside Avenue and 171st Street
- Remove the parking spaces along the north side of Hillside Avenue at 172nd Street inside the intersection box

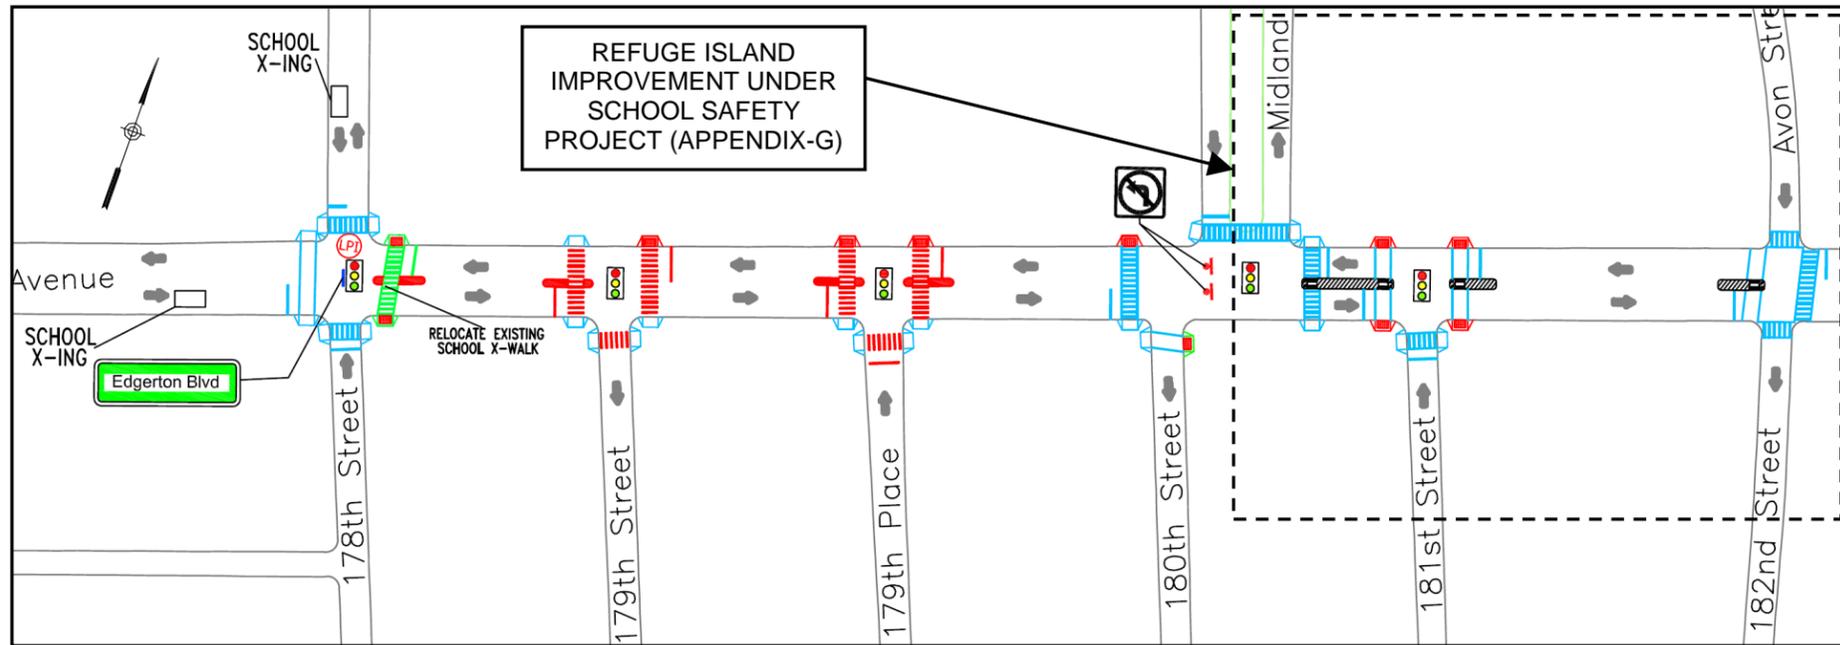
SITE 1: PLAN 2 HILLSIDE AVENUE (FROM 178TH STREET TO 181ST STREET)

- Recommended improvements include:**
- Time all signals for seniors and where feasible, the crossing time will be extended
 - Install new high visibility crosswalks

- Install new advance stop bars
 - Install new pedestrian ramps. Where proposed, align the ramps to the proposed crosswalks
 - Install new oversized street name sign at the intersection of Hillside Avenue and Edgerton Boulevard. This sign is to be located on the signal mast arm facing Hillside Avenue traffic in both directions

- Install new pedestrian refuge islands and raised, planted median by replacing the existing striped median island at the intersections shown along Hillside Avenue

- Install new No Left Turn signs at the intersection of Hillside Avenue and 180th Street facing westbound traffic
 - Consider installation of a Leading Pedestrian Interval (LPI) at Hillside Avenue and 178th Street/Edgerton Boulevard (for north crosswalk)

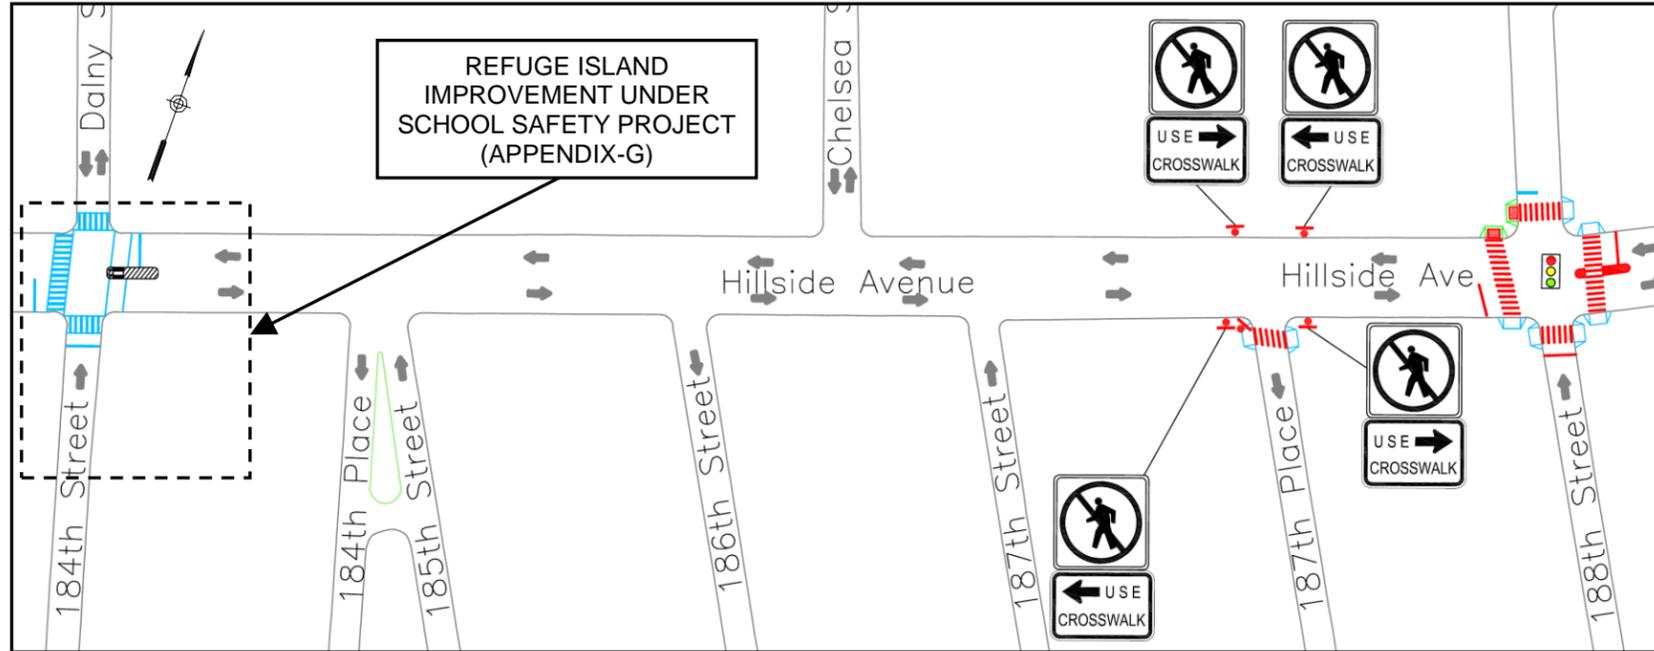
SITE 1: PLAN 3 HILLSIDE AVENUE (FROM 187TH PLACE TO 188TH STREET)

- Recommended improvements include:**
- Time all signals for seniors and where feasible, the crossing time will be extended
 - Install new high visibility crosswalks
 - Install new advance stop bars
 - Install new pedestrian ramps. Where proposed, align the ramps to the proposed crosswalks
 - Install new pedestrian refuge islands and raised, planted median by replacing the existing striped median island at the intersections shown along Hillside Avenue
 - Install new "No Pedestrian Crossing" and "Use Crosswalk" (with appropriate arrow) signs at the intersection of Hillside Avenue and 187th Place

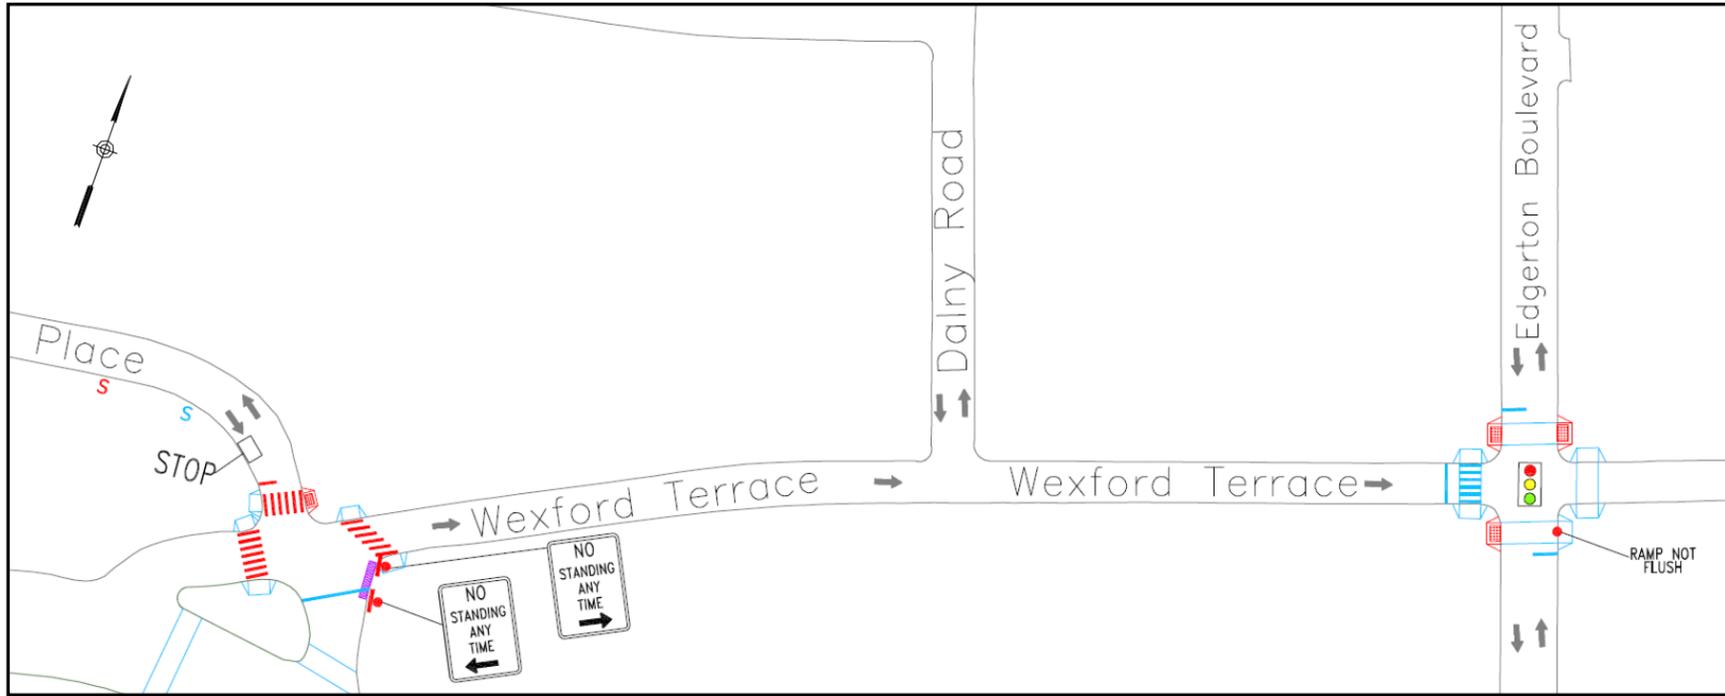
SITE 2: PLAN 1 WEXFORD TERRACE (FROM KINGSTON PLACE TO EDGERTON AVENUE)

- Recommended improvements include:**
- Time all signals for seniors and where feasible, the crossing time will be extended
 - Install new high visibility crosswalks
 - Install new advance stop bars
 - Install new pedestrian ramps. Where proposed, align the ramps to the proposed crosswalks
 - Remove 50 feet of parking from the southeast corner of Wexford Terrace as it intersects Kingston Place (parking spaces are located within the intersection box)
 - Move "Stop Ahead" sign on Kingston Place 50 feet in advance of its existing location

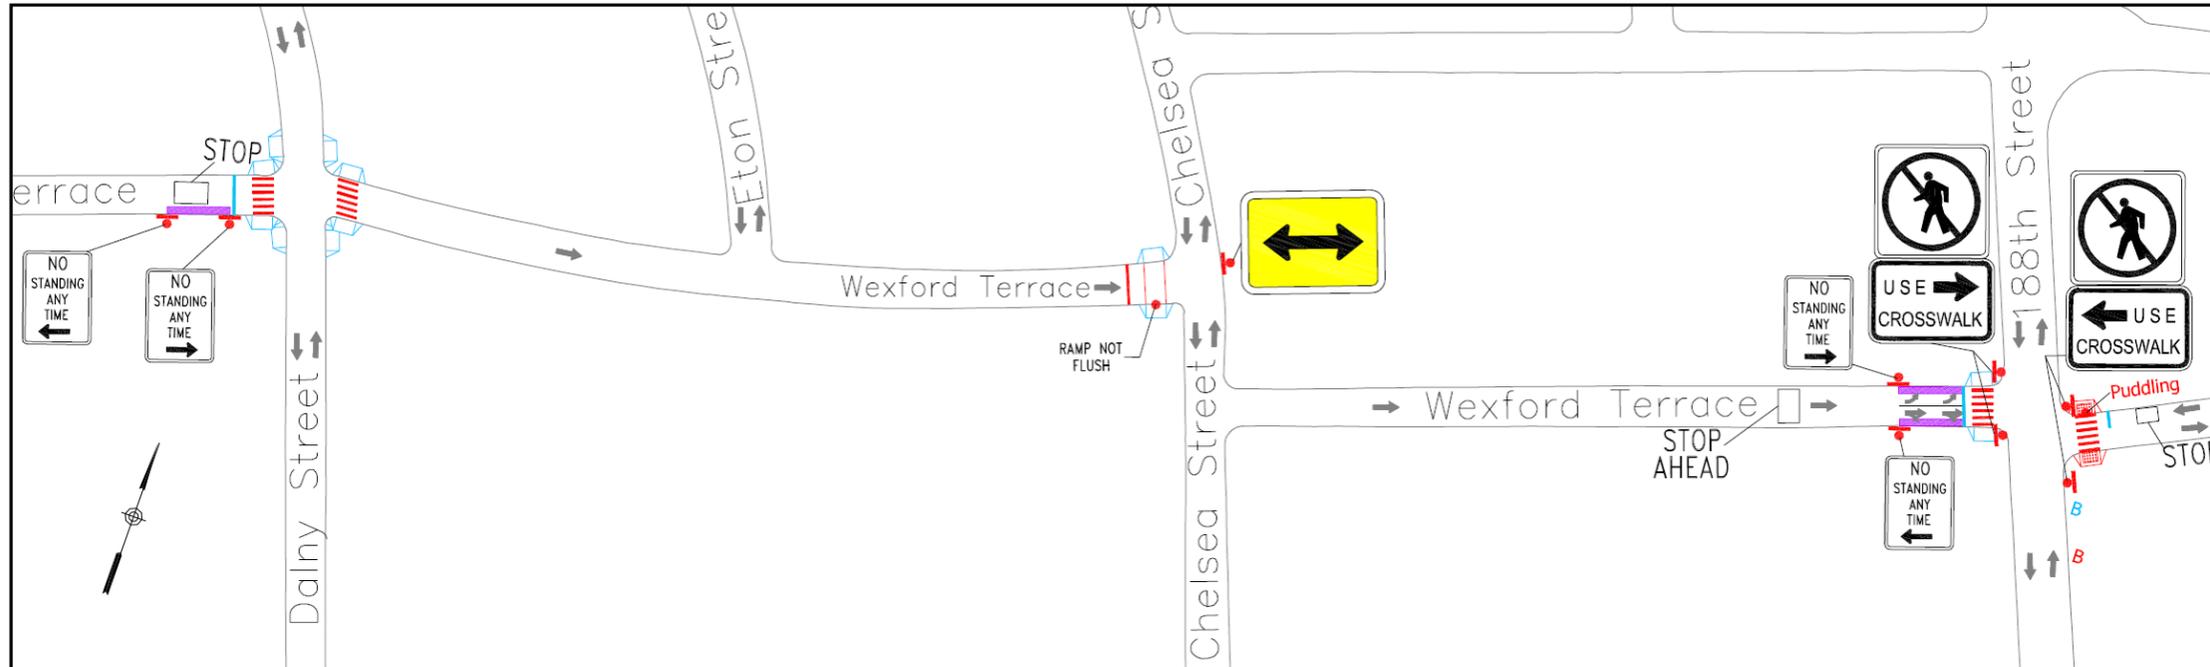
SITE 2: PLAN 2 WEXFORD TERRACE (FROM DALNY STREET TO 188TH STREET)

- Faded or missing crosswalks
- Non-standard pedestrian ramps

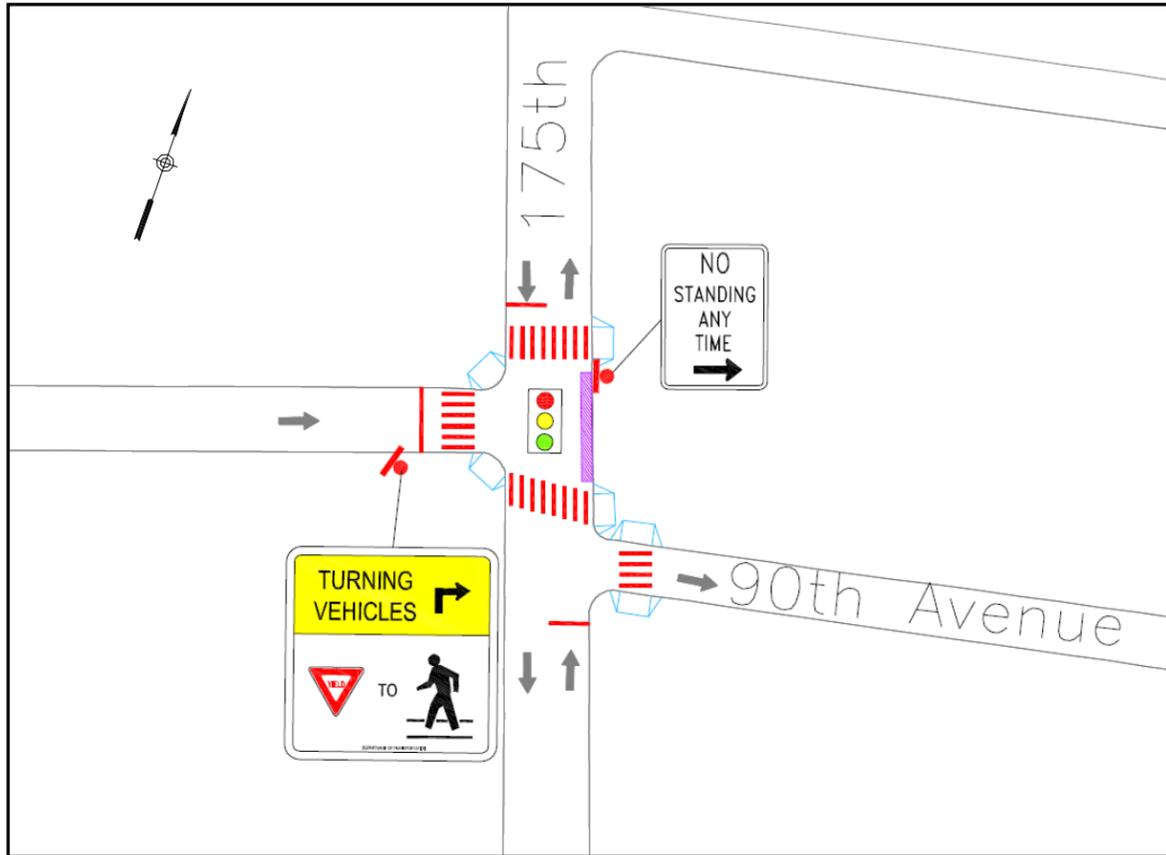
SITE 3: 90TH AVENUE & 175TH STREET

- Install new high visibility crosswalks
- Install new advance stop bars
- Install new “Yield to Pedestrian” sign as noted in the illustration
- Remove parking from the east curbside of 175th Street as it intersects 90th Avenue (parking that fronts 90th Avenue is located within the intersection box)

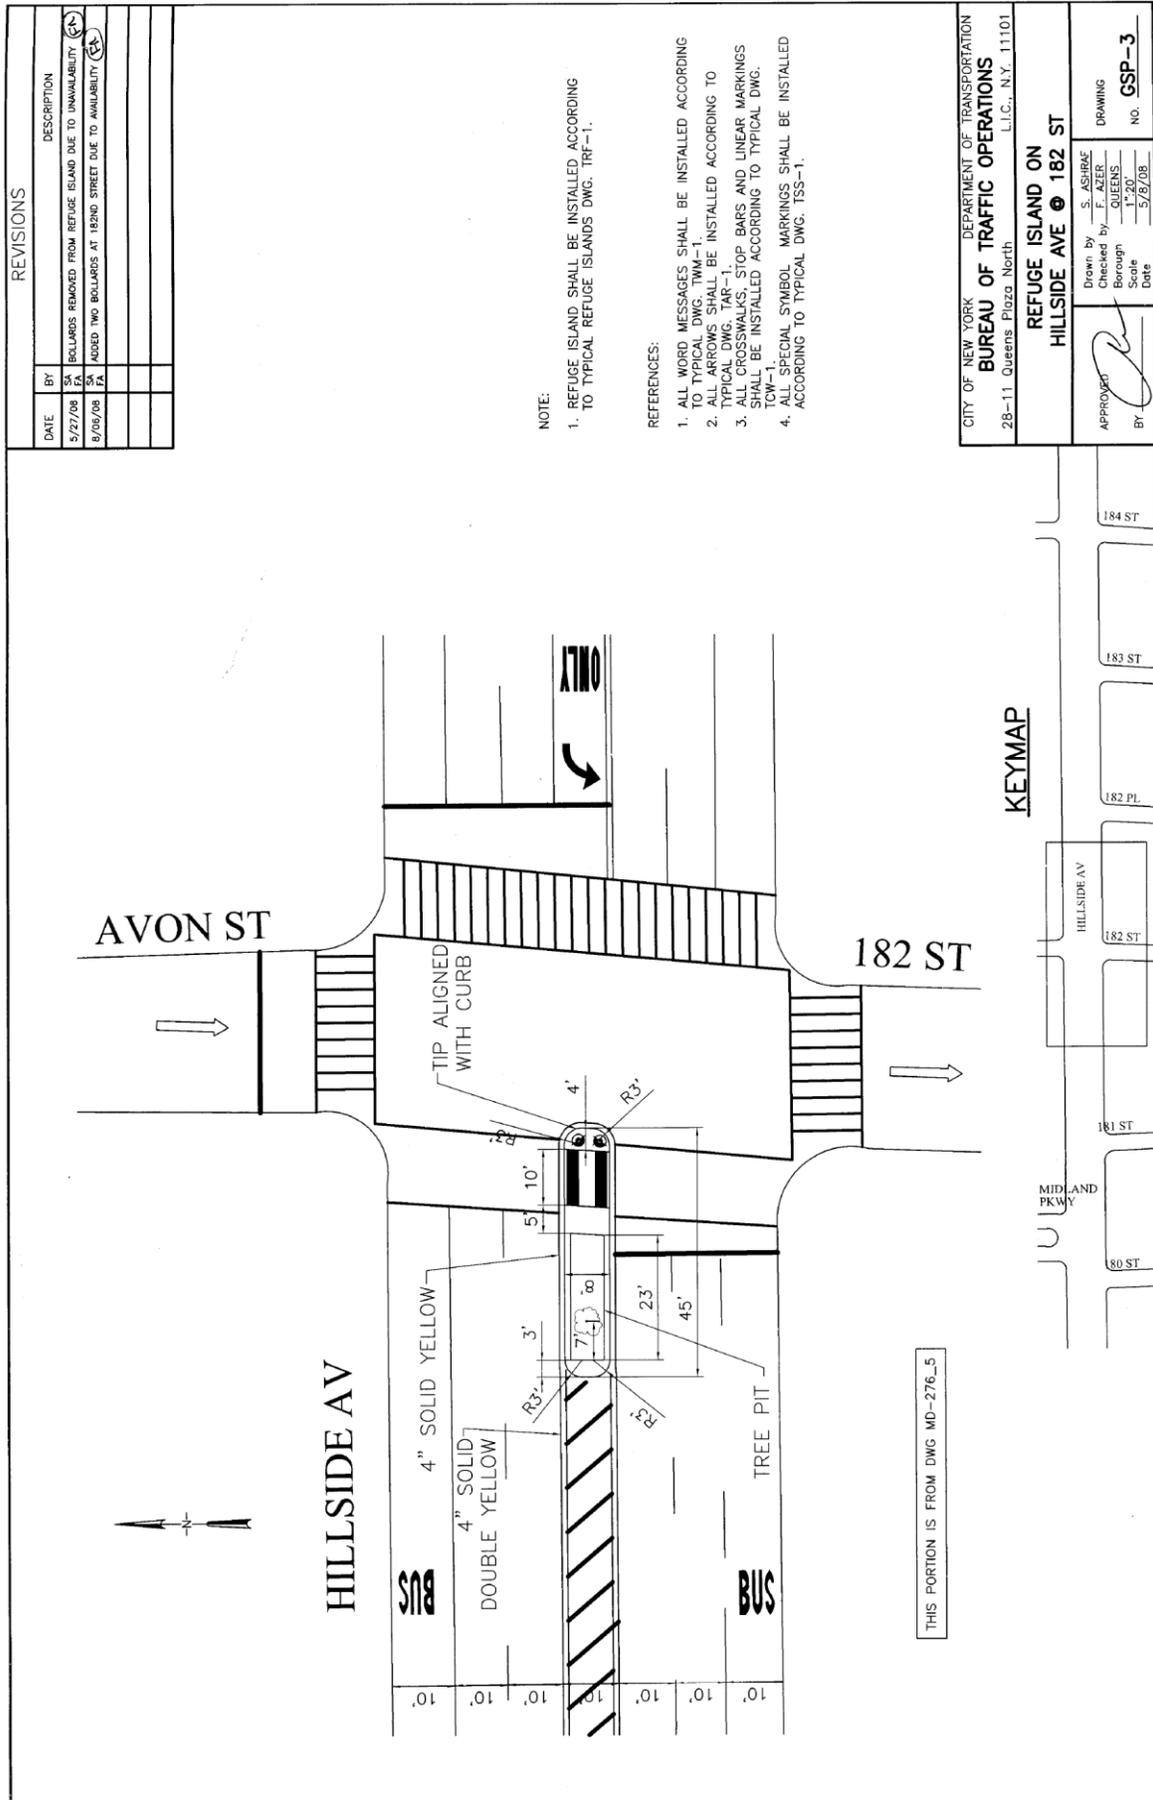
REFUGE ISLAND ON HILLSIDE AVE @ 182 ST

NOTE:
 1. REFUGE ISLAND SHALL BE INSTALLED ACCORDING TO TYPICAL REFUGE ISLANDS DWG. TRF-1.
