**ROBERT AND ANNE DICKEY HOUSE**

67 GREENWICH STREET

2016.02.16

42 TRINITY PLACE

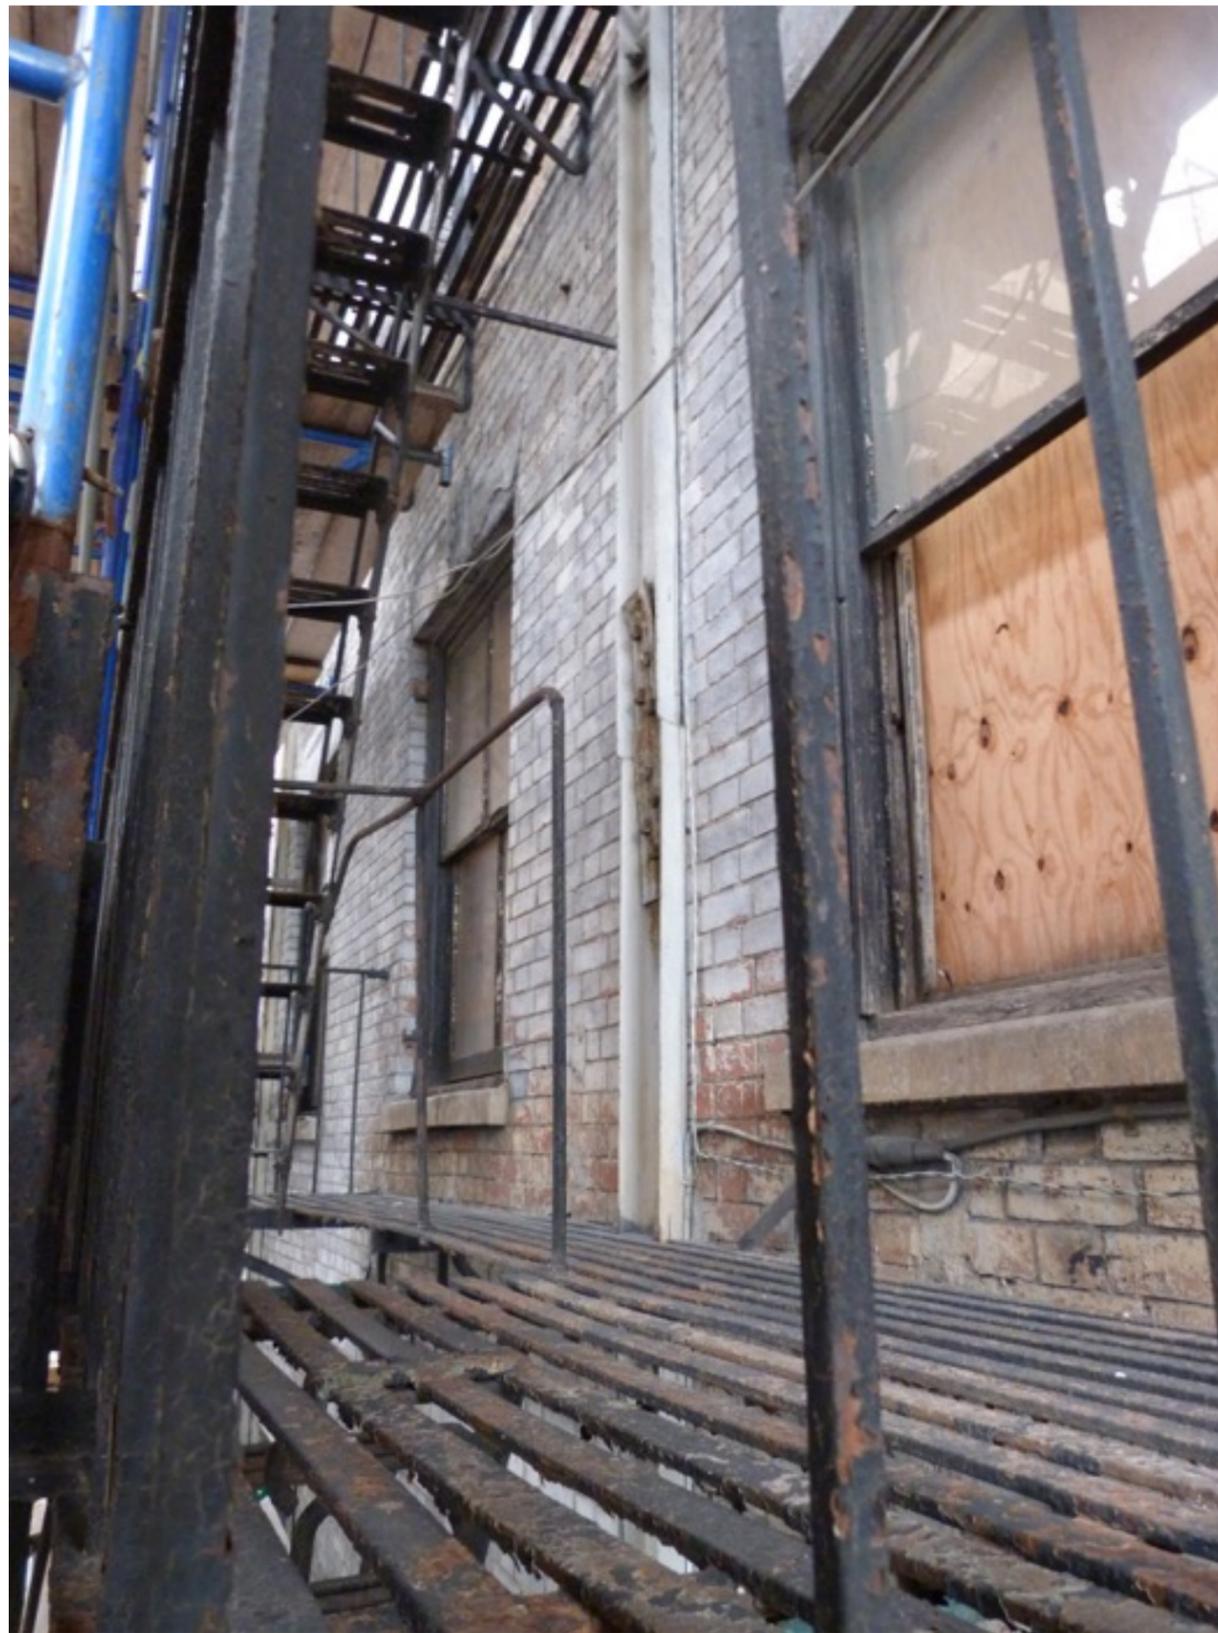
1. Greenwich Street, 3rd Floor. Bracing at center of building.

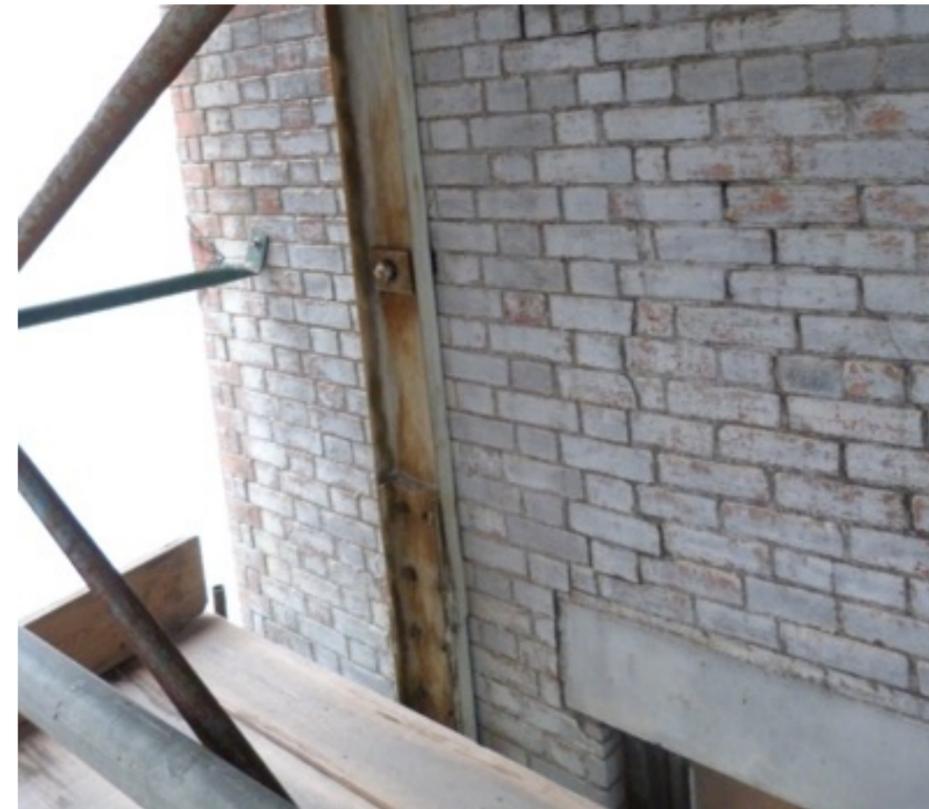
3. Greenwich Street, between 2nd and 3rd Floor. Bracing at north side of building and replacement brick.

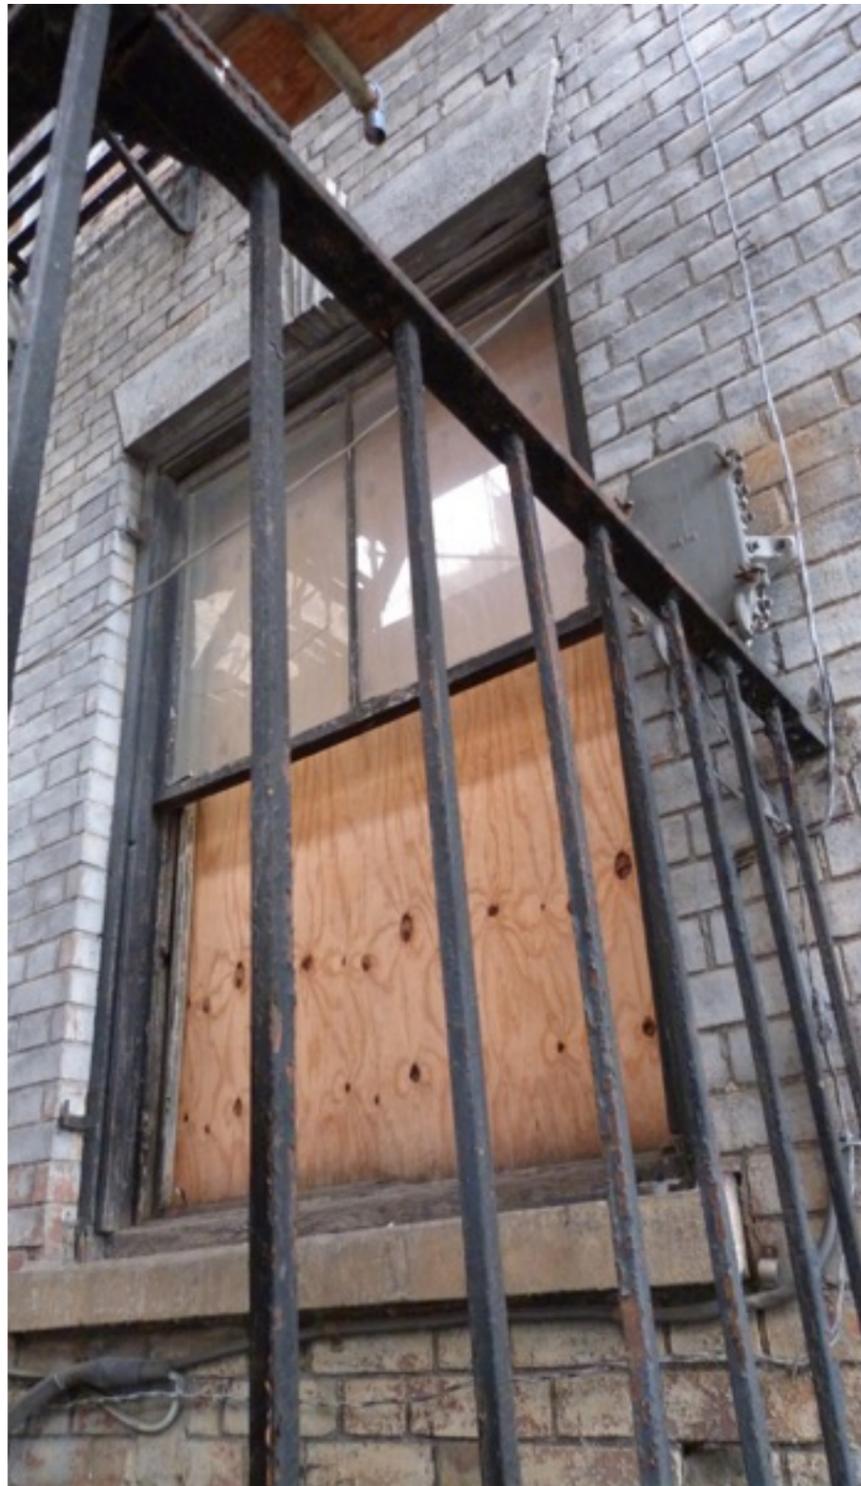
2. Greenwich Street, 3rd Floor. Two-over-two windows (missing bottom sash) and Flemish bond.

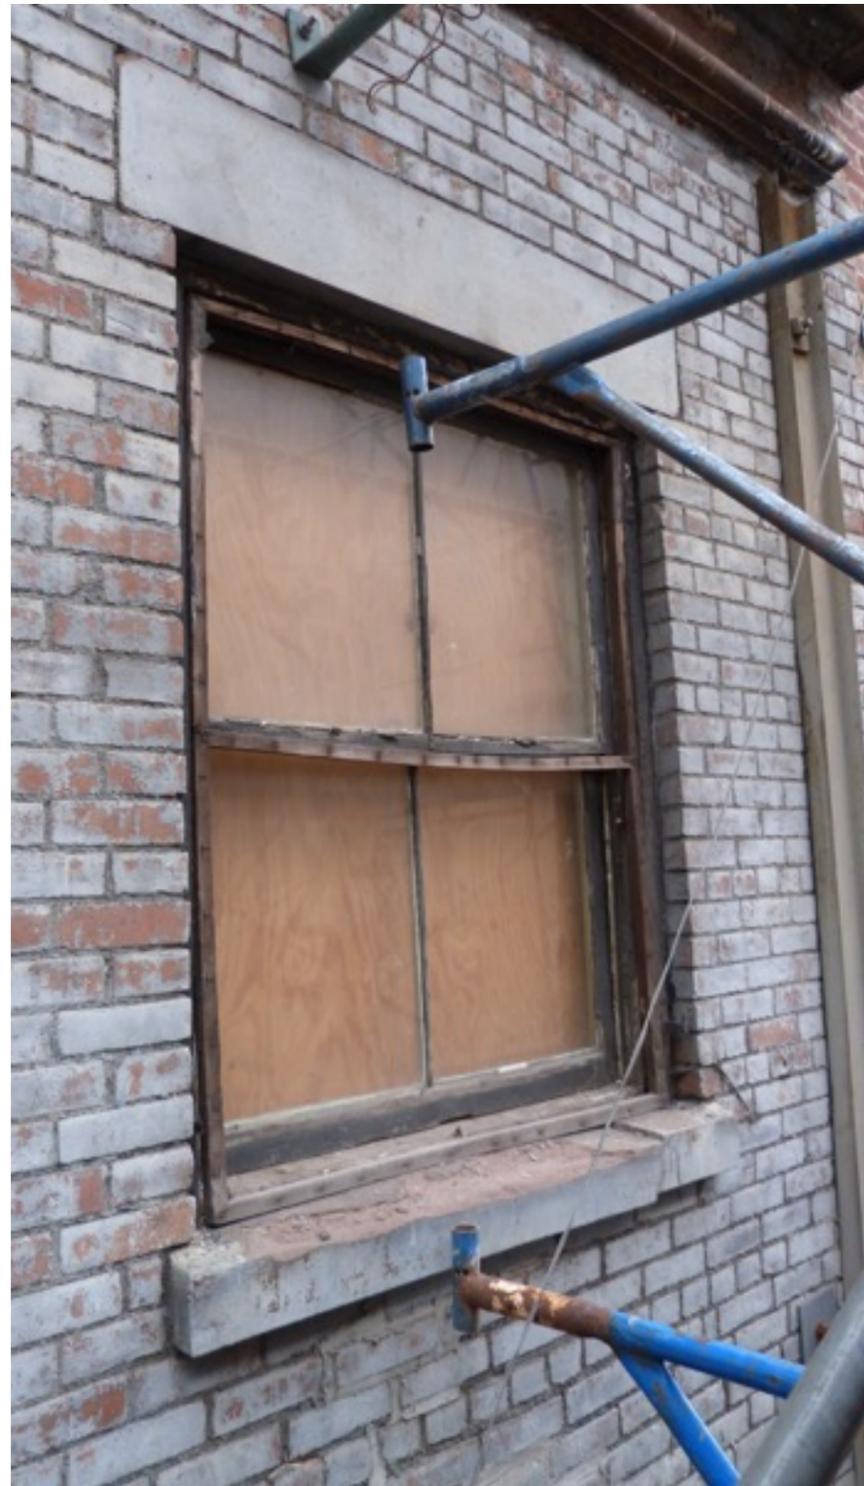
3. Greenwich Street, 4th Floor. Two-over-two windows and brick masonry laid up in running bond.

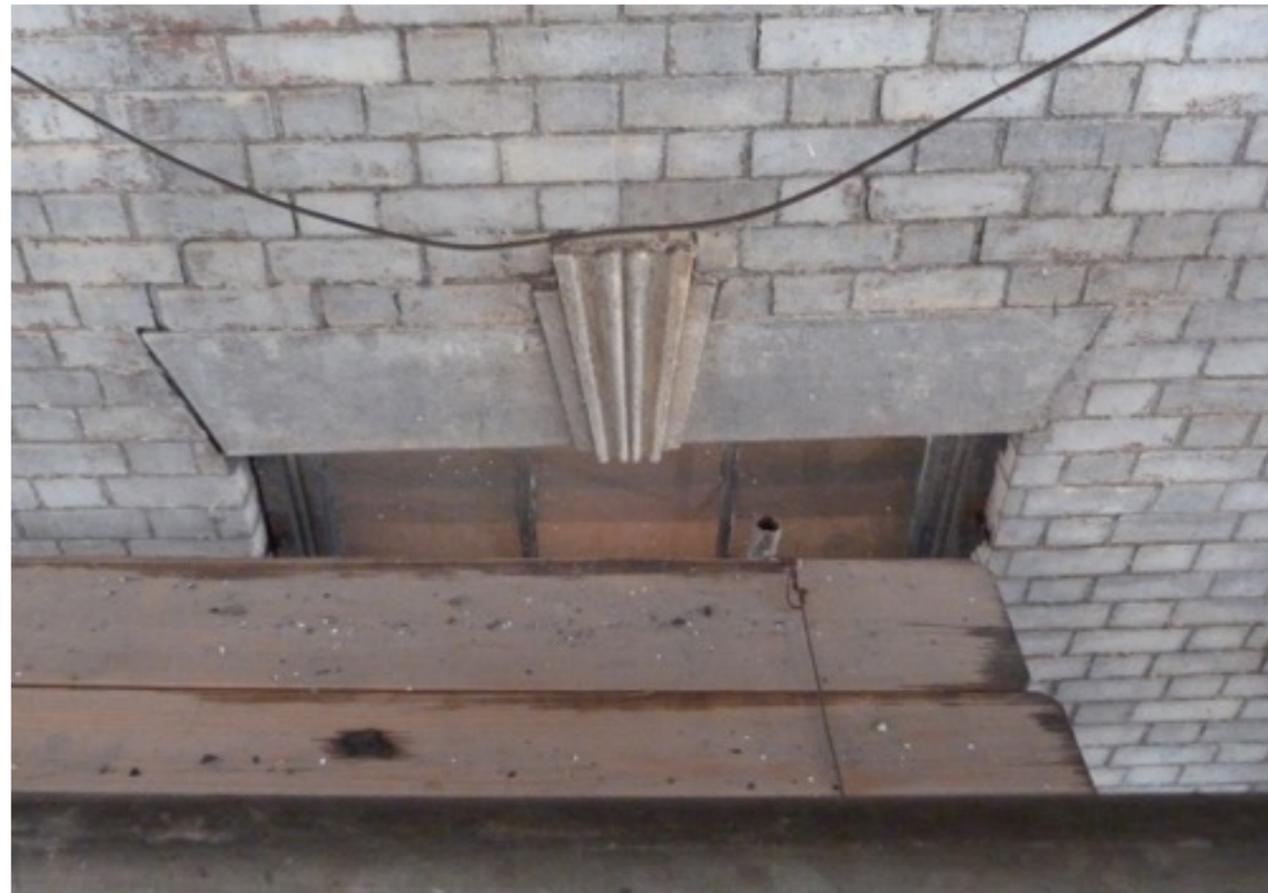
2. Greenwich Street, 2nd Floor. Brownstone splayed lintels with fluted keystones.

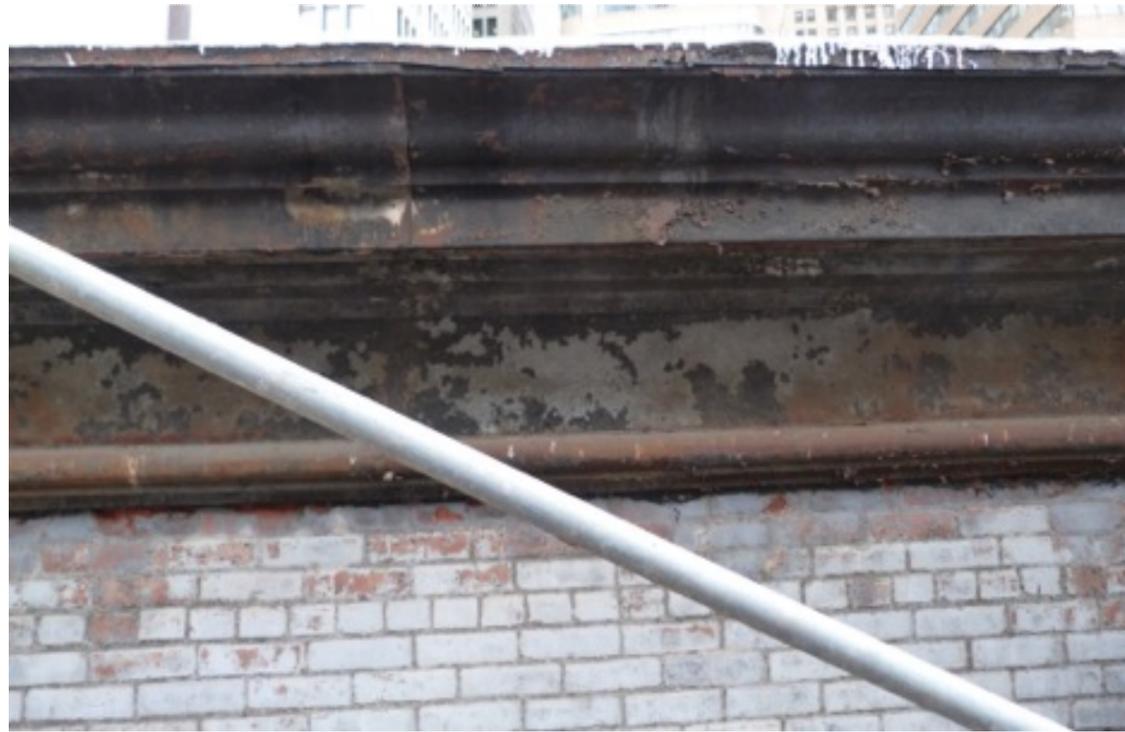
1. Greenwich Street. Cornice deterioration and brick masonry laid up in running bond.

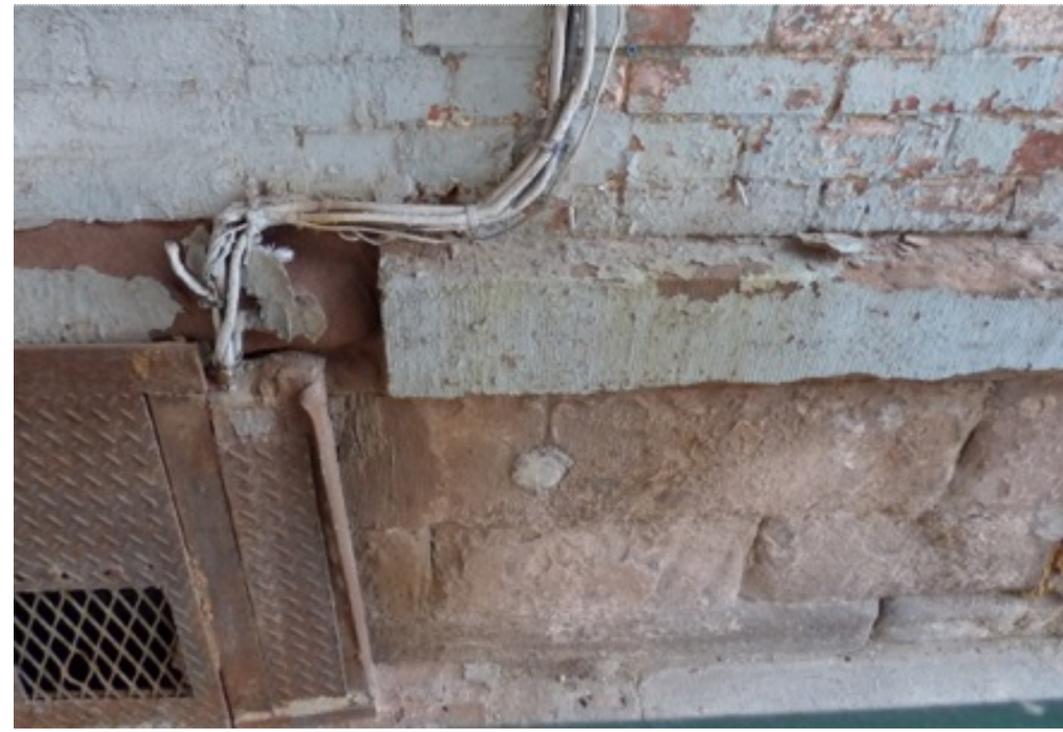
2. Greenwich Street. South of entrance. Brownstone base.

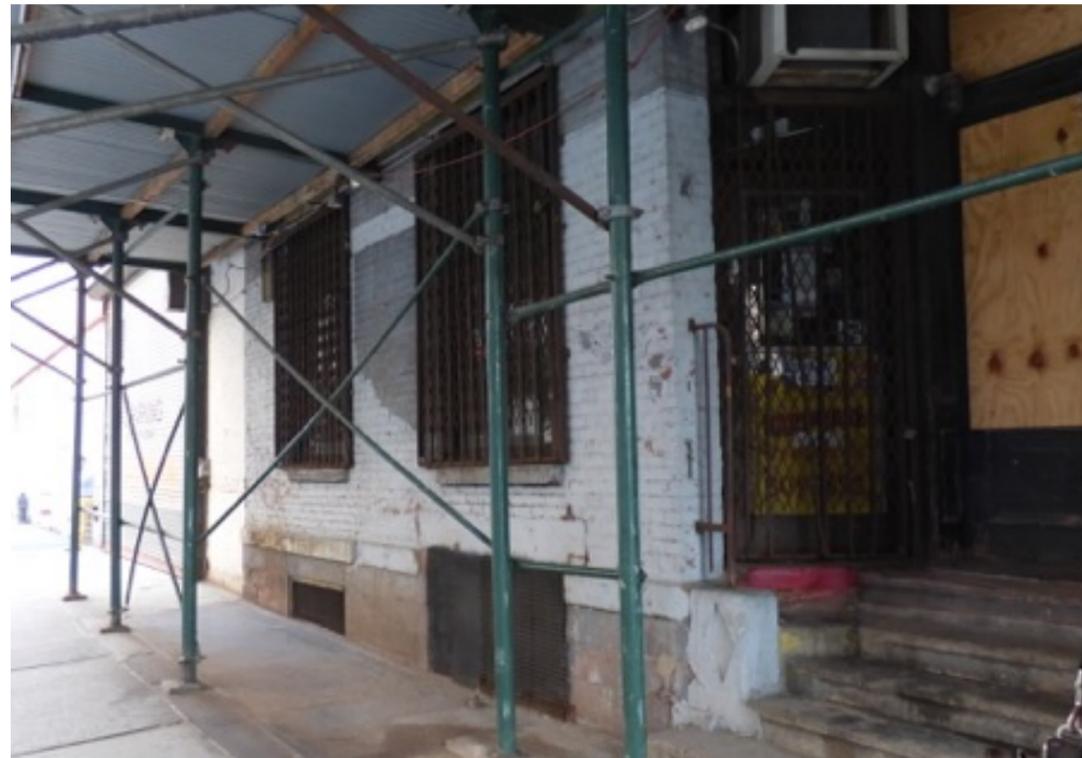
3. Greenwich Street. Brownstone base, former areaway windows, and window and door grates.

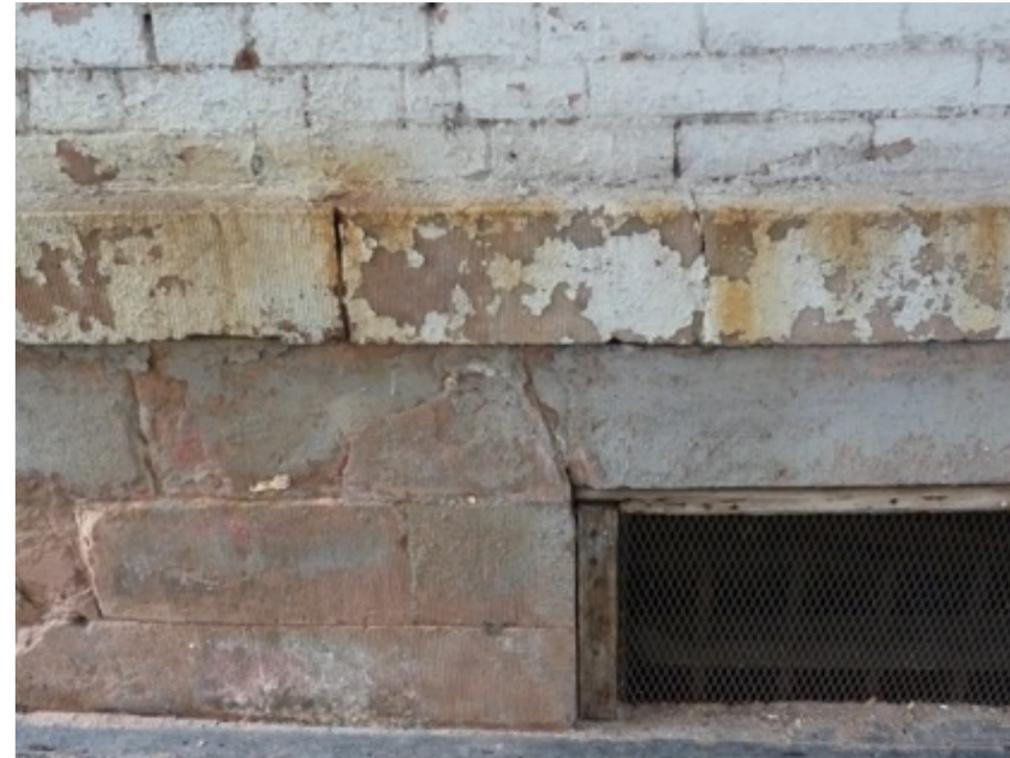
4. Greenwich Street. North of entrance. Brownstone base.

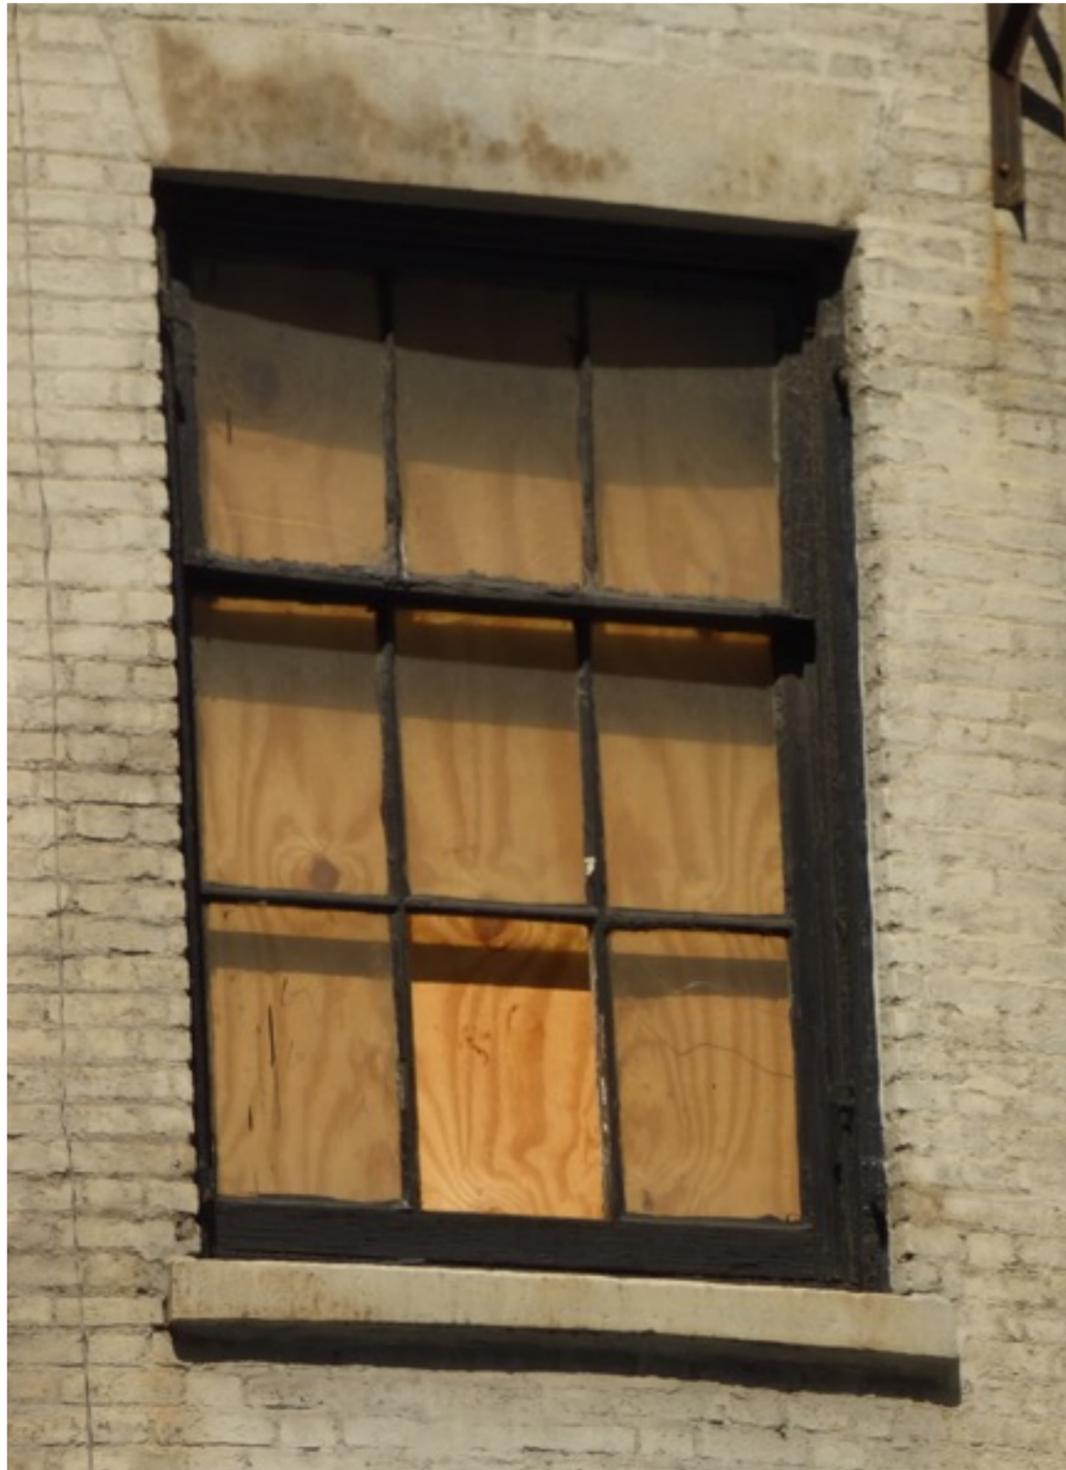
1. Trinity Place, 3rd Floor. Three-over-six window.

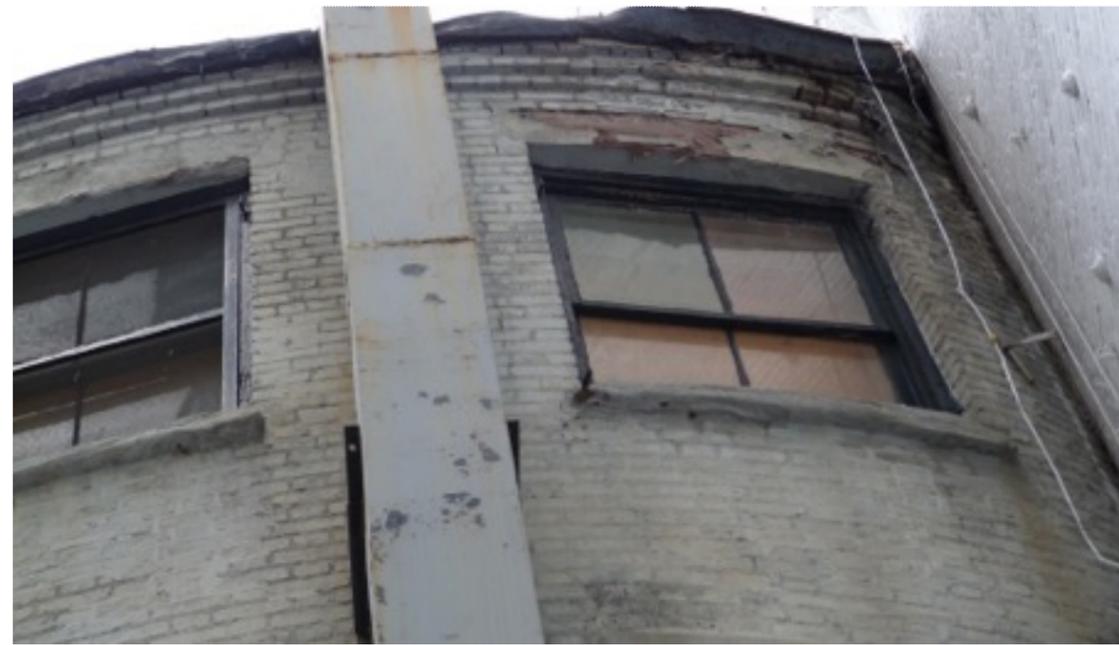
2. Trinity Place, Top floor two-over-two windows, deterioration at brownstone lintels, running bond brick masonry, and cornice deterioration.

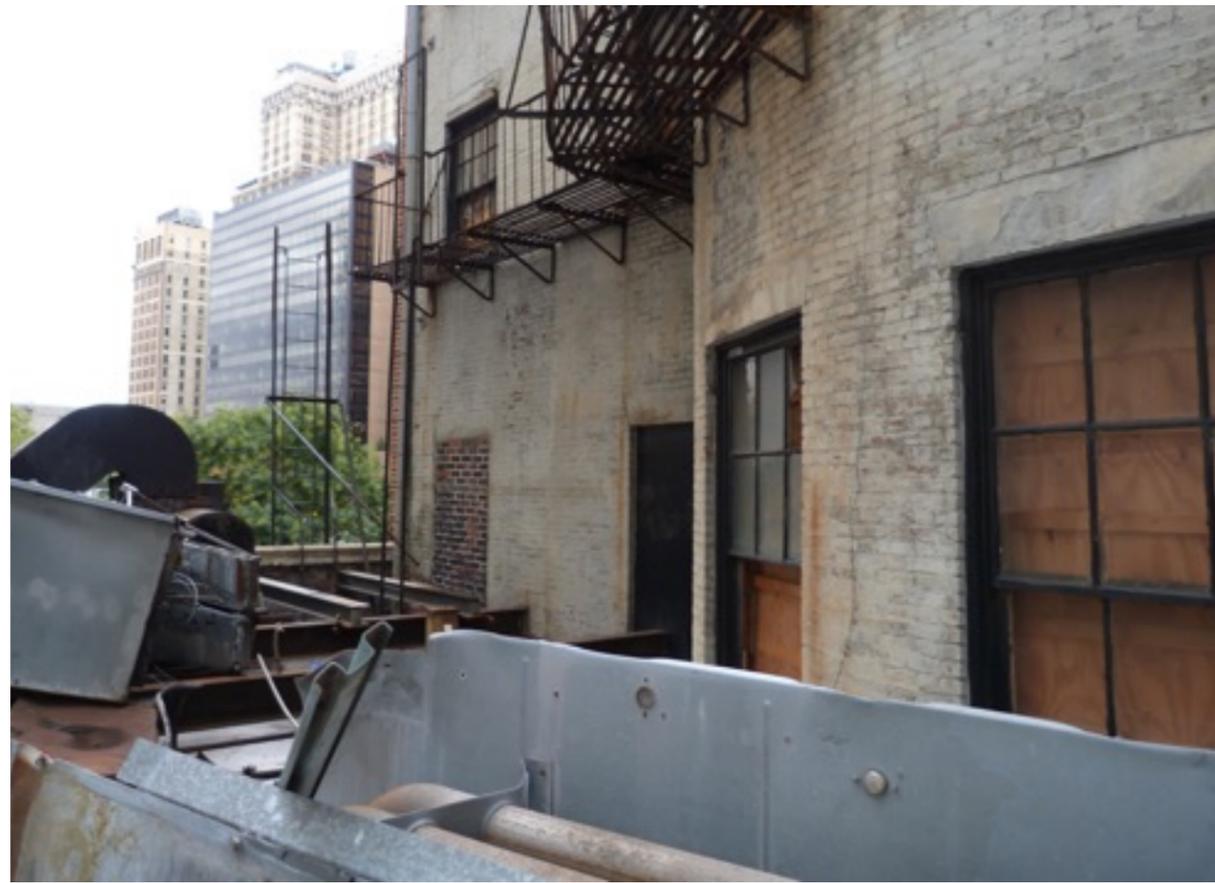
3. Trinity Place, view from roof of 1922 addition. Six-over-six windows, Flemish bond brick masonry, and filled-in windows.

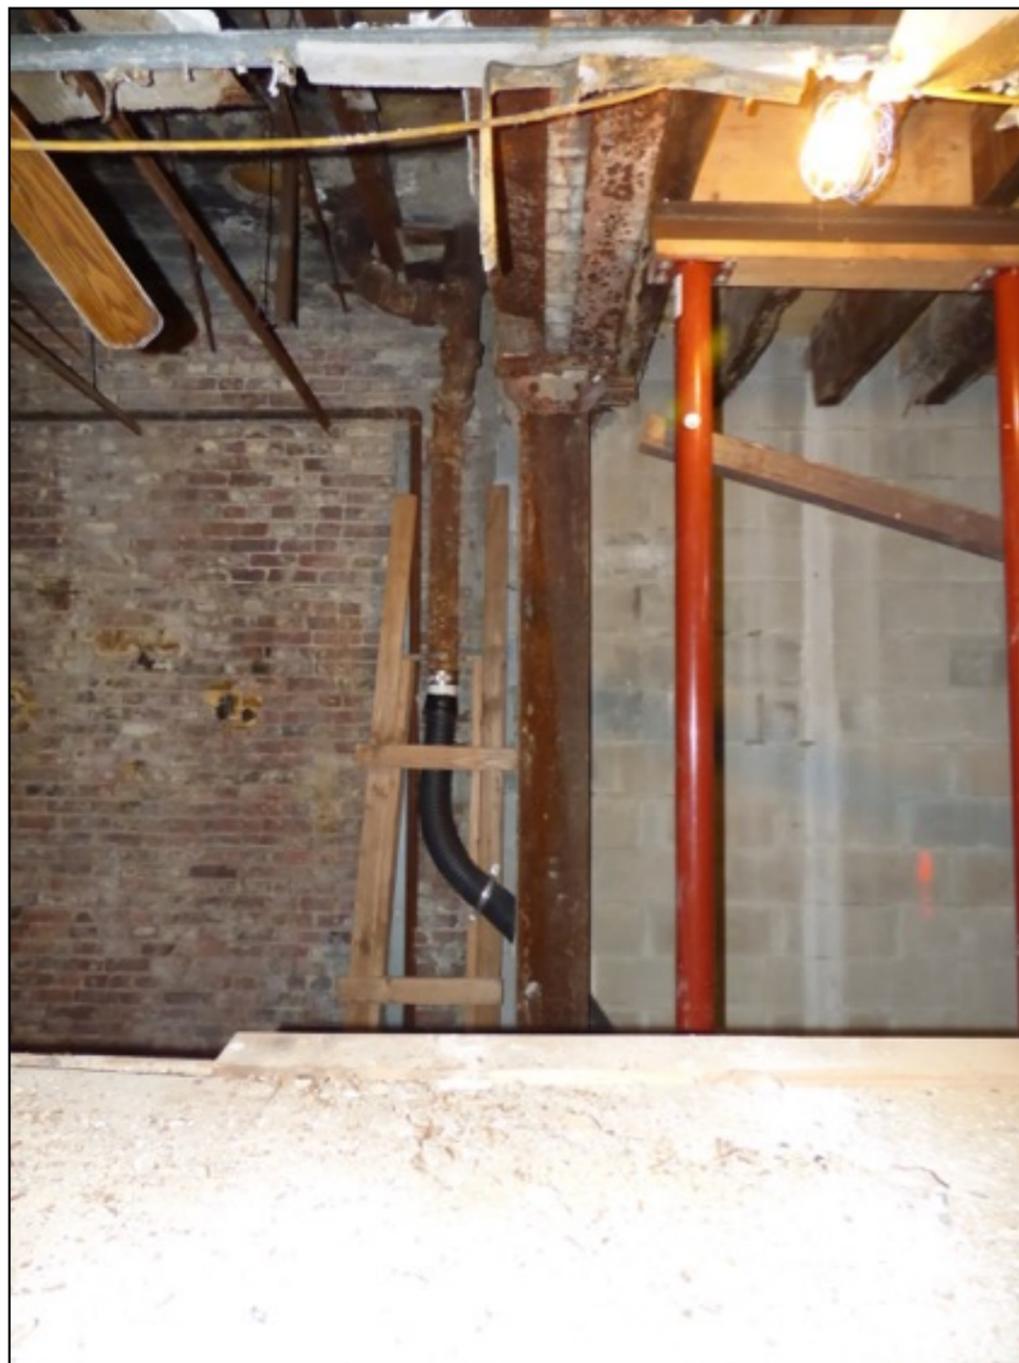
Interior: 1st Floor. Original rear wall was removed to connect 1922 addition.

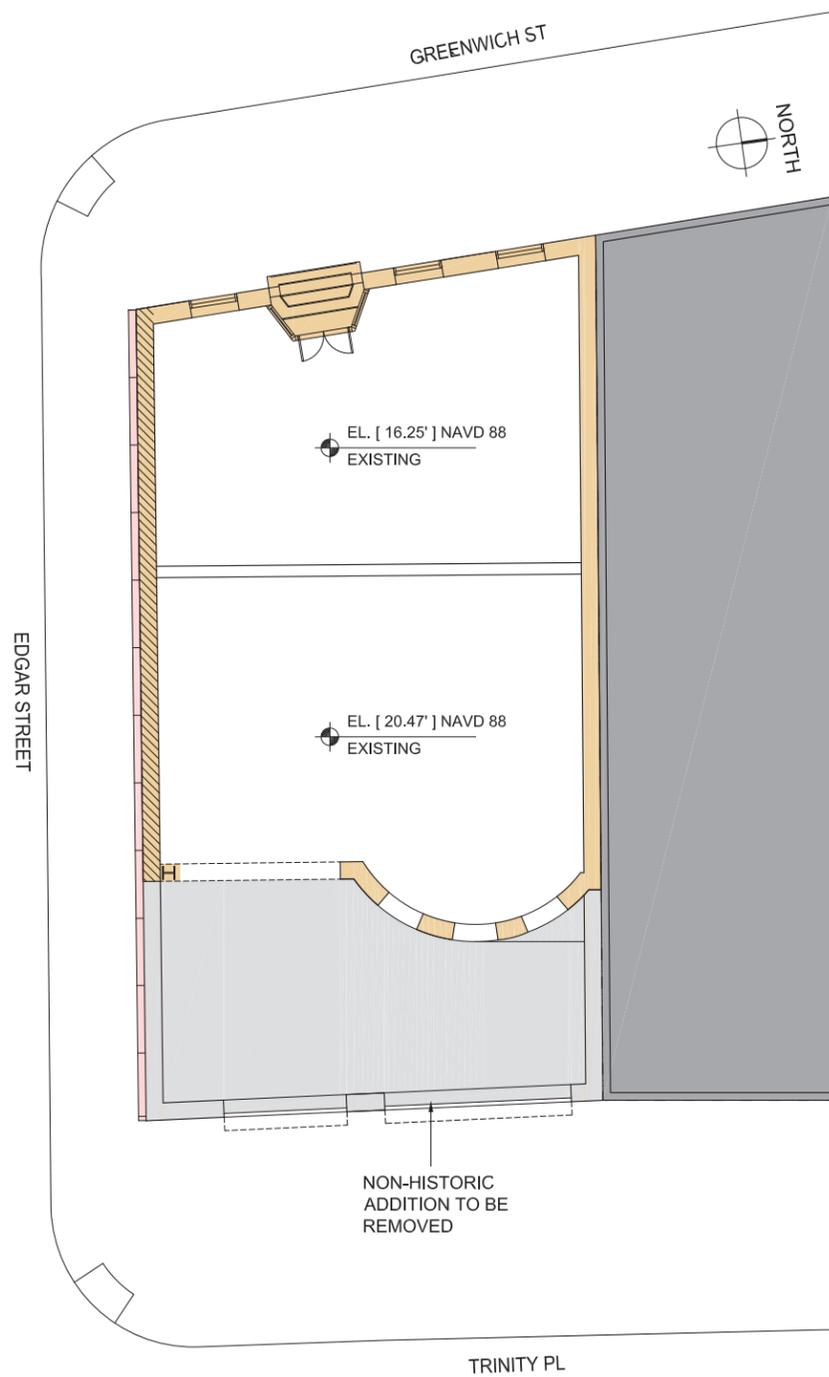
**EXISTING**

- EXISTING BUILDING - DICKEY HOUSE
- CMU W/ BRICK VENEER WALL
- LOT 8 WALL
- NON-HISTORIC ADDITION
- NEW STRUCTURE

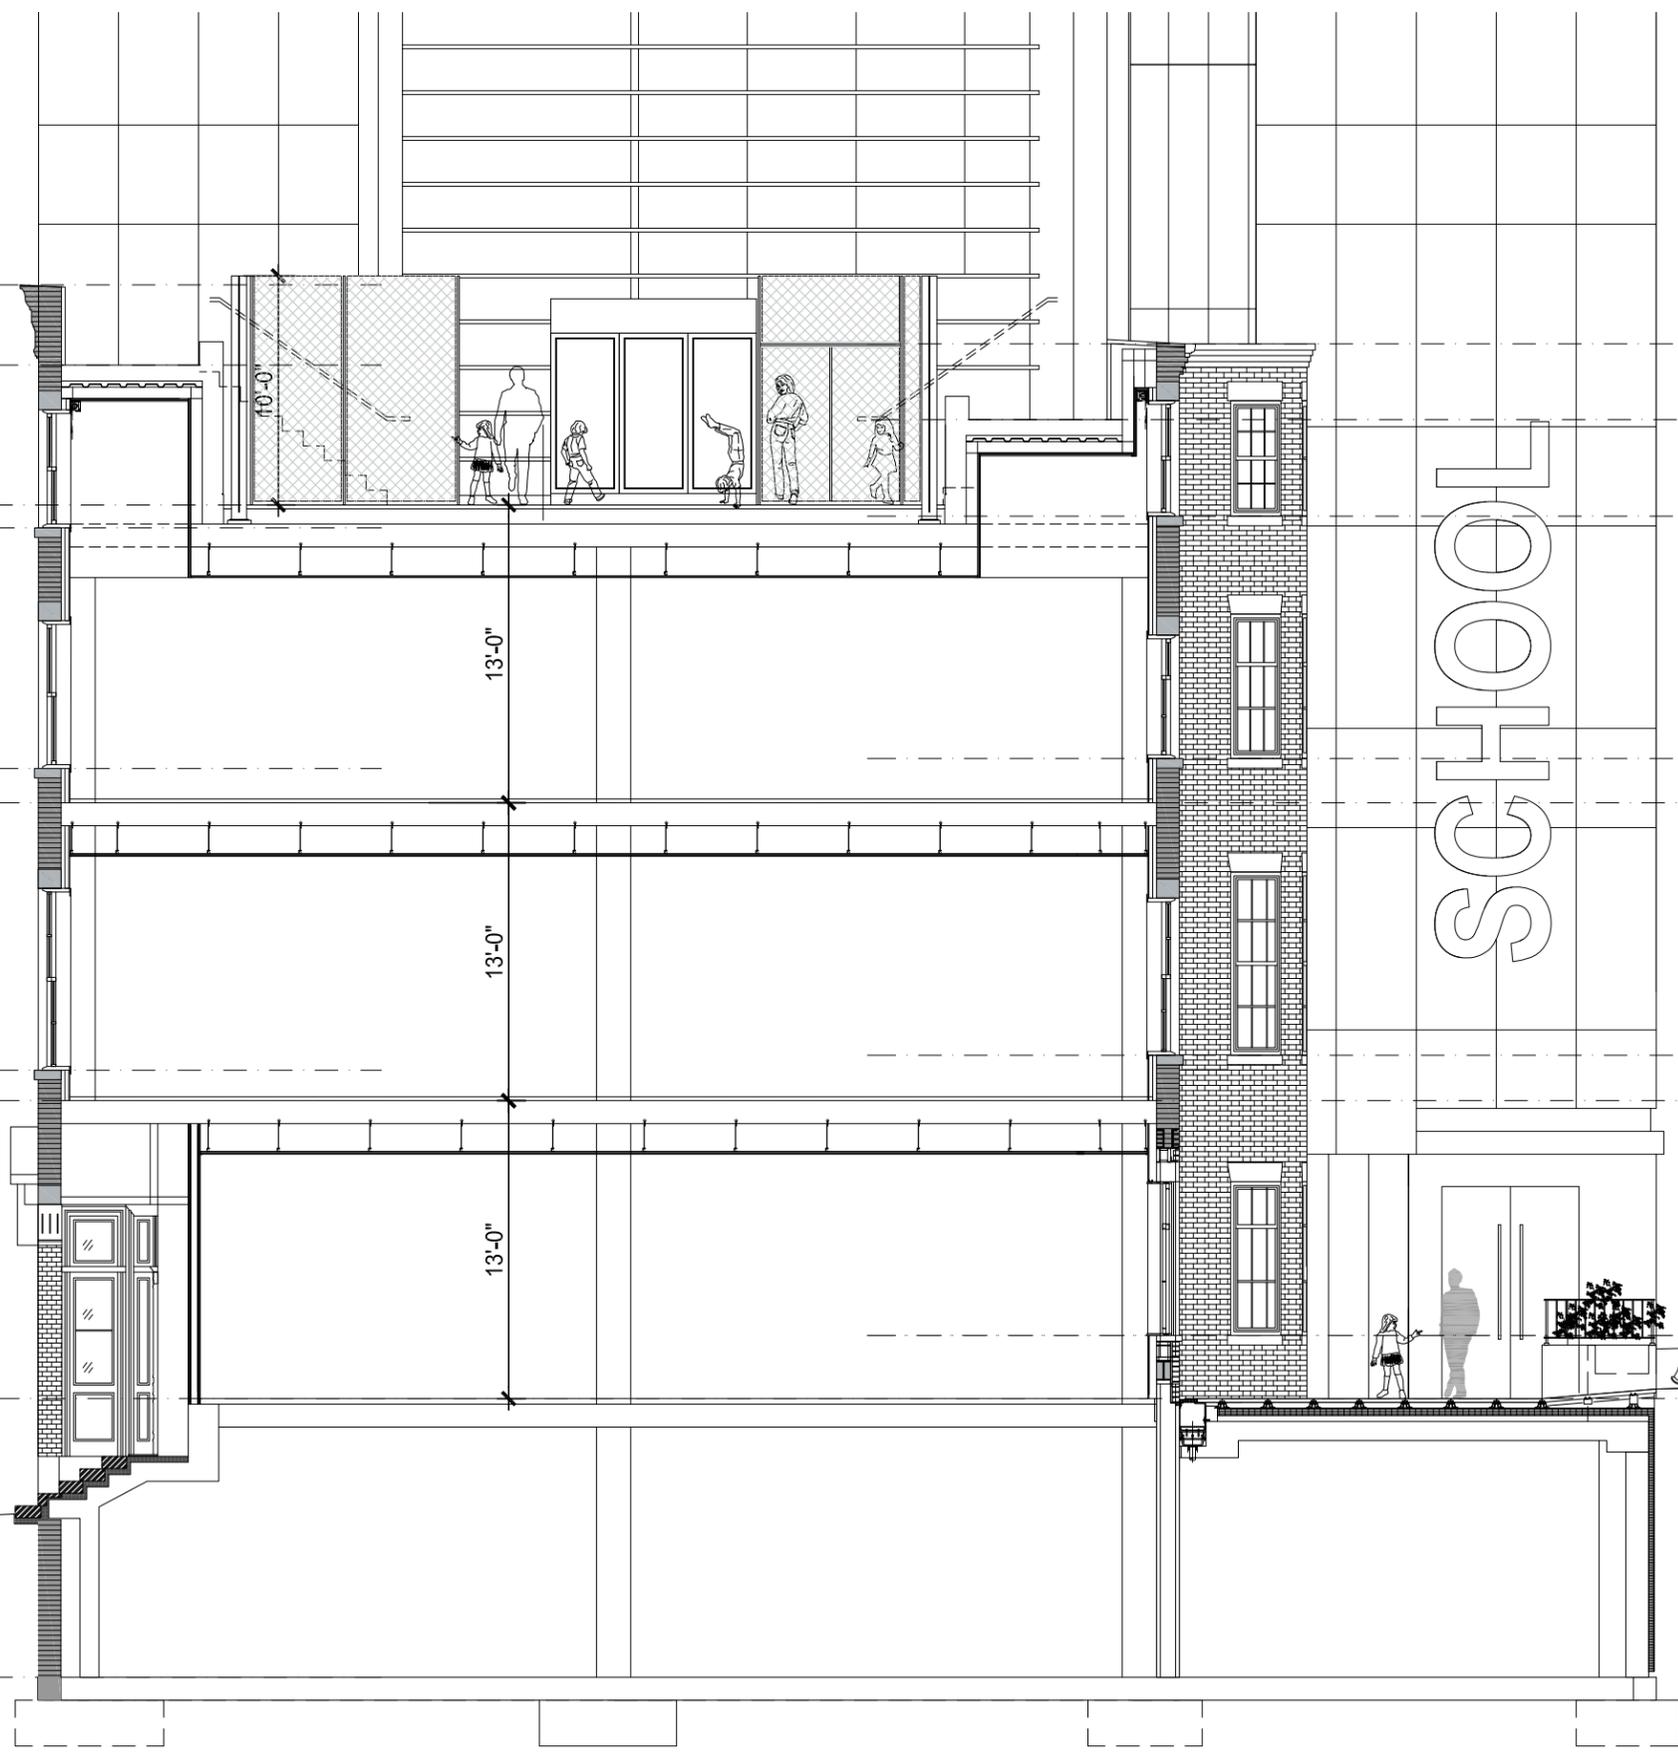
SECTION - PROPOSED

GREENWICH ST ROOF  
 EL. [ 67.01' ] MINIMUM  
 GREENWICH ST ACCESS ROOF  
 EL. [ 63.77' ]  
 FLOOR 4  
 EL. [ 57.67' ]  
 FLOOR 4 SILL @ GREENWICH ST  
 EL. [ 56.67' ]  
 FLOOR 3 SILL @ GREENWICH ST  
 EL. [ 46.17' ]  
 FLOOR 3  
 EL. [ 44.67' ]  
 FLOOR 2 SILL @ GREENWICH ST  
 EL. [ 33.00' ]  
 FLOOR 2  
 EL. [ 31.67' ]  
 GROUND FLOOR  
 EL. [ 18.67' ]  
 CELLAR  
 EL. [ 6.50' ]

TRINITY PL ROOF  
 EL. [ 64.70' ] MINIMUM  
 TRINITY PL ACCESS ROOF  
 EL. [ 61.39' ]  
 FLOOR 4 SILL @ TRINITY PL  
 EL. [ 57.18' ]  
 FLOOR 3 SILL @ TRINITY PL  
 EL. [ 46.60' ]  
 FLOOR 2 SILL @ TRINITY PL  
 EL. [ 33.65' ]  
 FLOOR 1 SILL @ TRINITY PL  
 EL. [ 21.42' ]

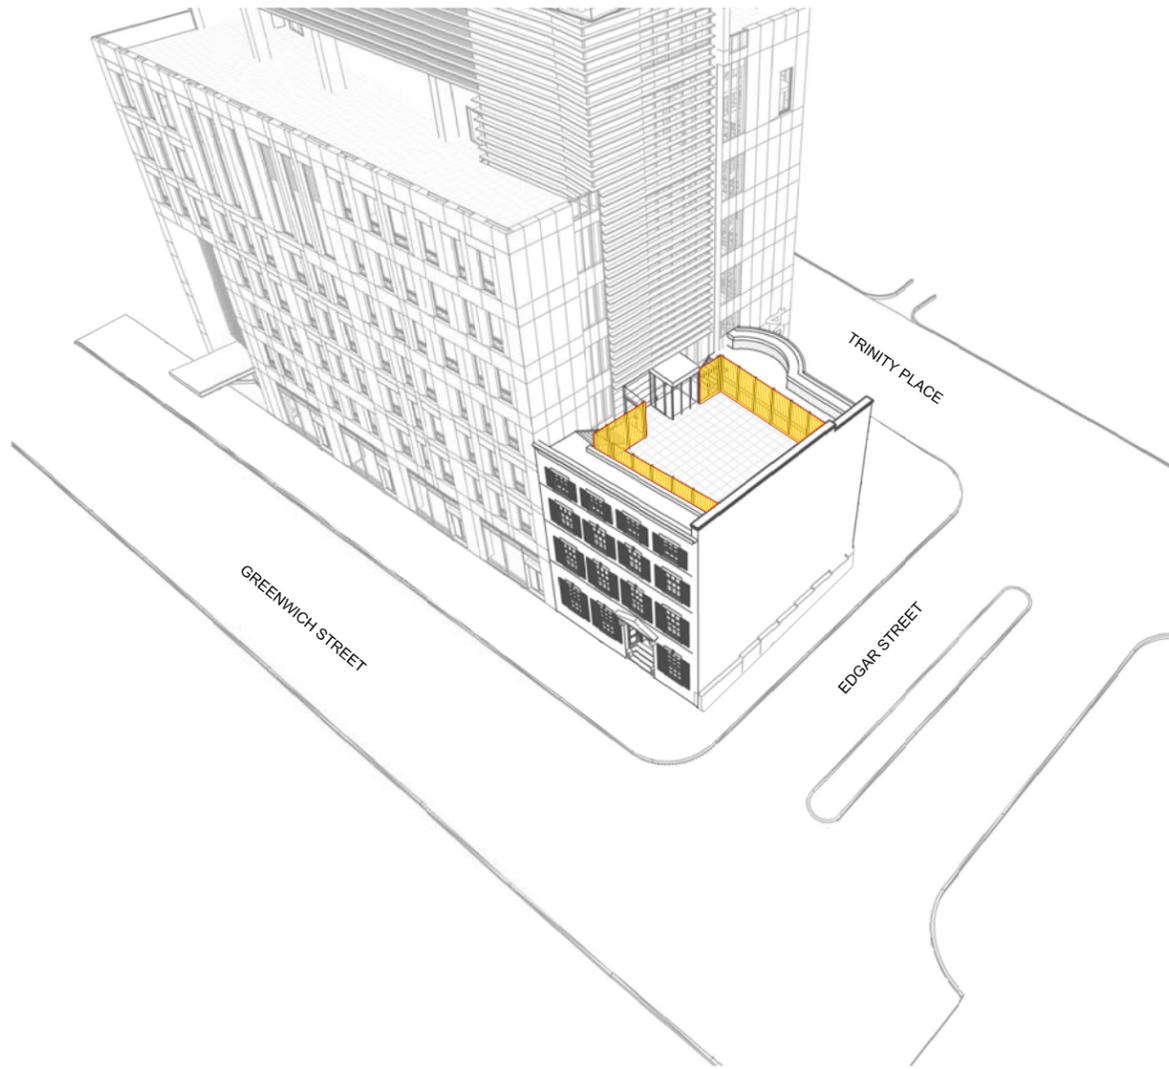
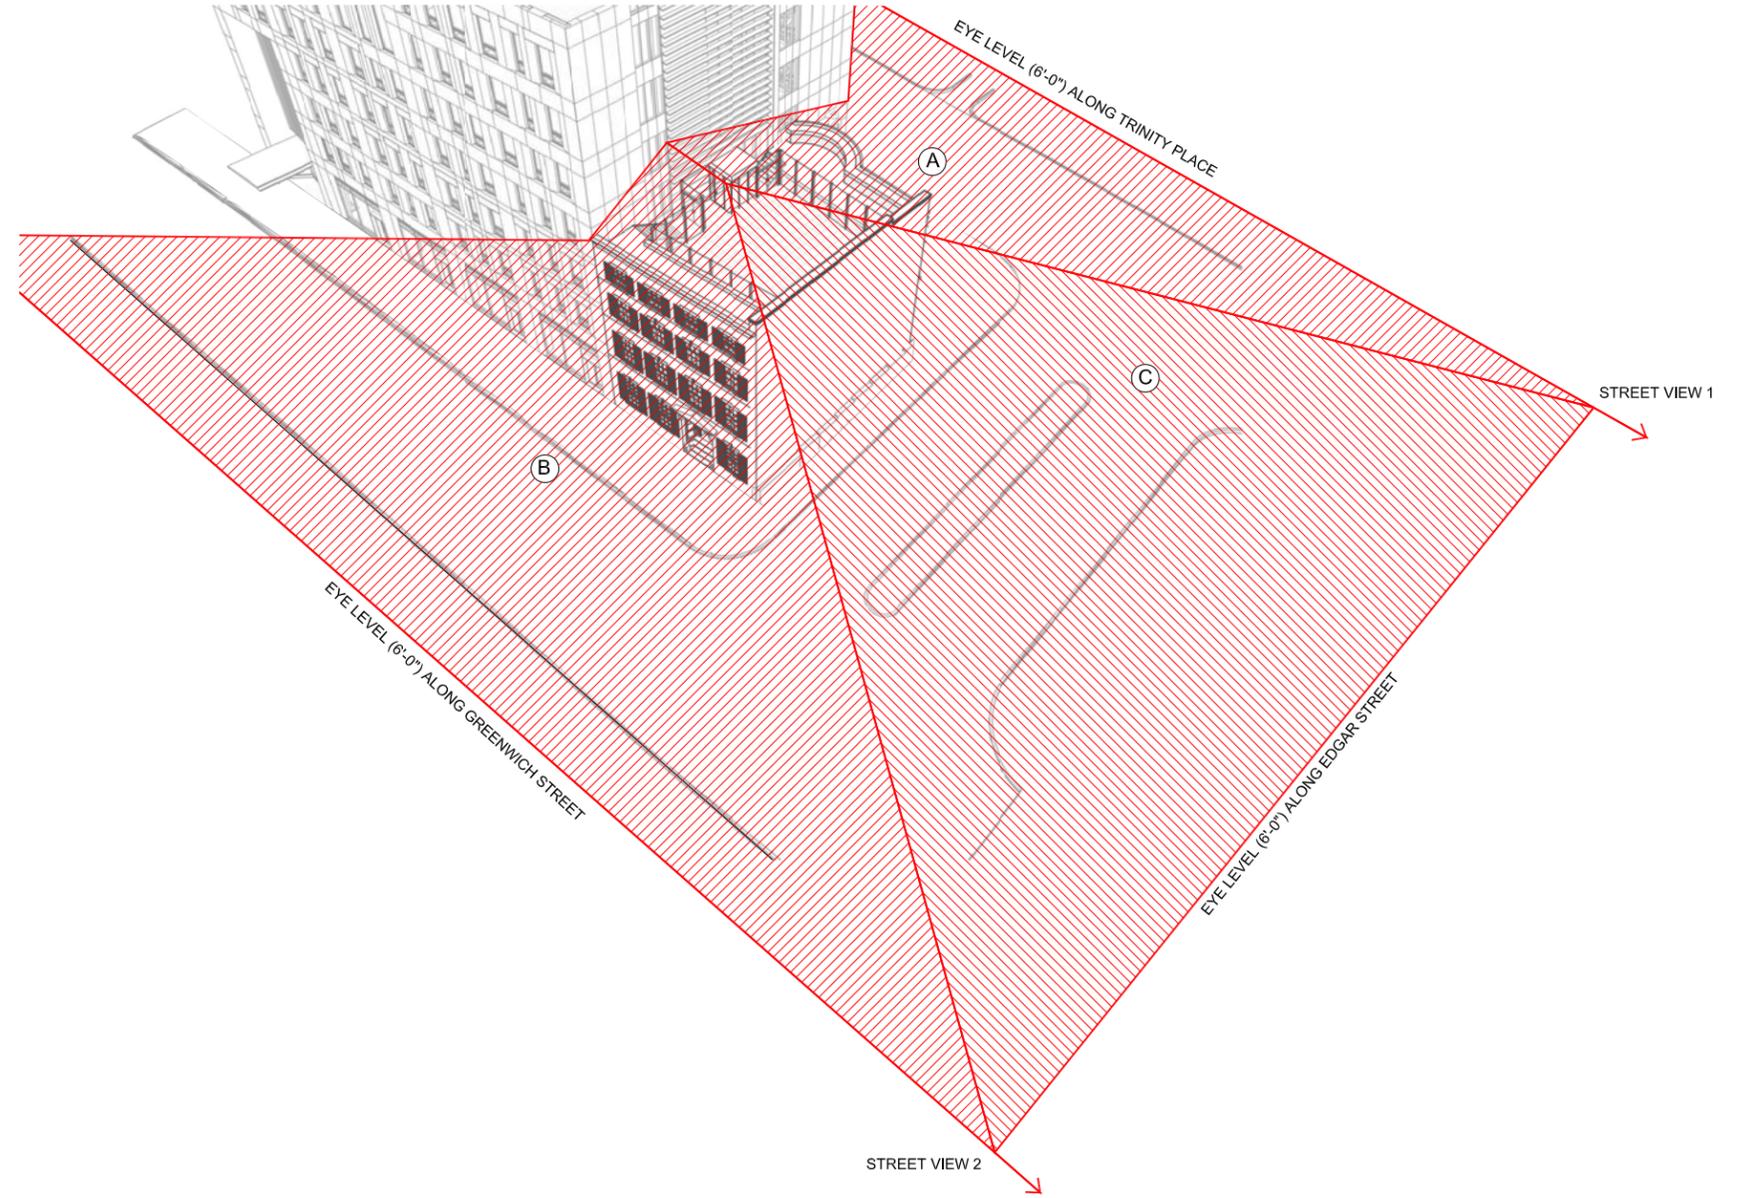
VIEW PLANE ANALYSIS FOR PROPOSED 10' FENCE
