# LANDMARKS PRESERVATION COMMISSION PRESENTATION

## 123 SULLIVAN STREET

New York, NY, 10012

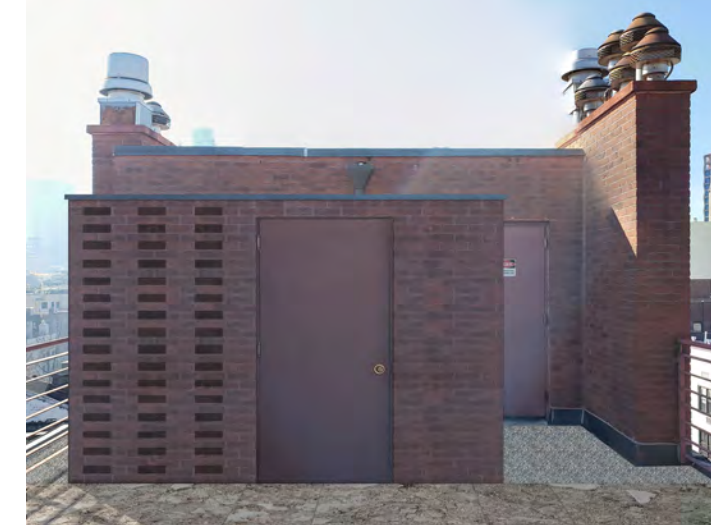
**NON-VISIBLE ROOF - Fig.1 Proposed new brick walls photomontage**

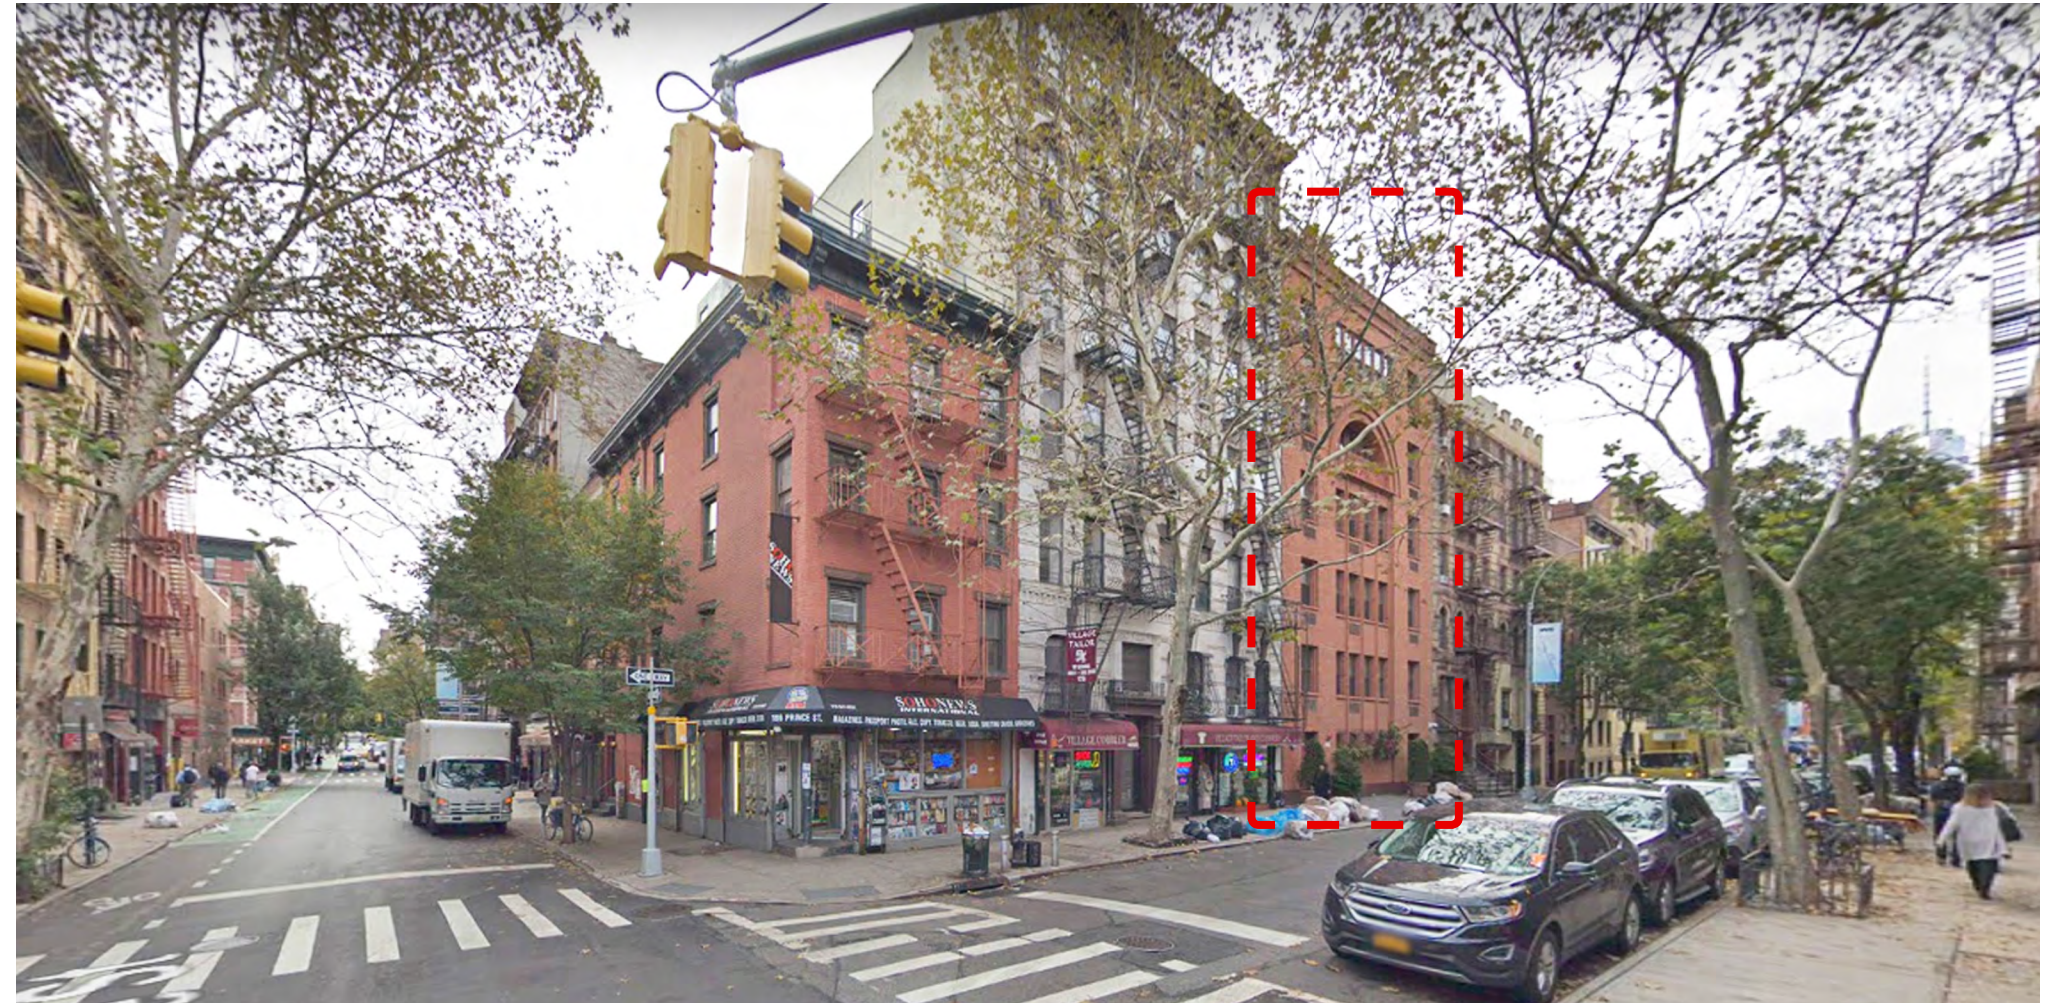
**PROJECT SITE - Fig.1 Sullivan & Prince Streets intersection - The terraces on the top of the building are not visible**

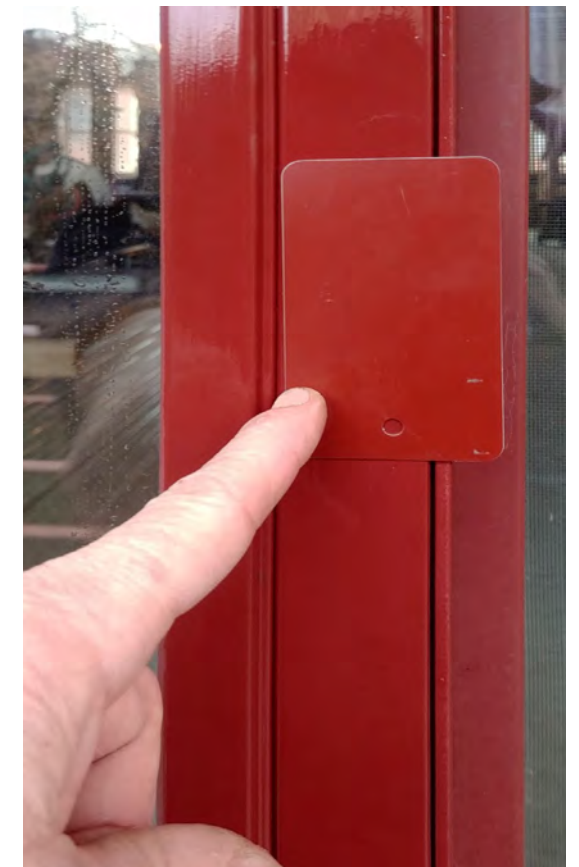
Window finish reference, same as existing: Pella Enduraclad Coating PR0033 Brick Red

**Proposed window frame finish compared to existing one**

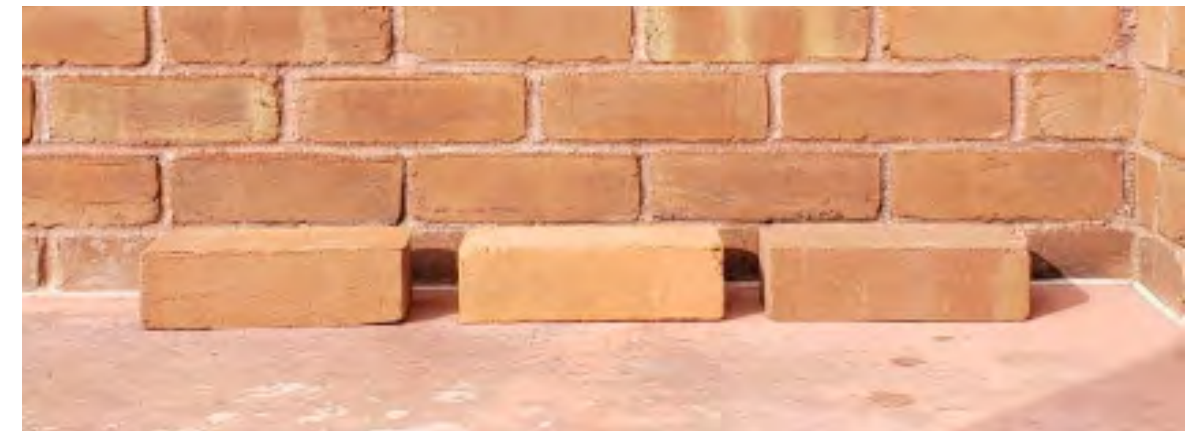
The new brick structure around the new AC units will consist of the combination of three different brick colors in order to match the existing ones. Grout color will match the existing one.

Brick references: Glen-Gery, Mid-Atlantic 56-DD, standard 3 5/8"x2 1/4"x8"  
 Glen-Gery, Jamestown, standard 3 5/8"x2 1/4"x8"  
 Watsontown Brick Company, S/M Mohawk T-2, 525/cube 3 5/8"x2 1/4"x8"

**NON-VISIBLE ROOF BRICK WALL FOR AC UNITS- Brick samples**

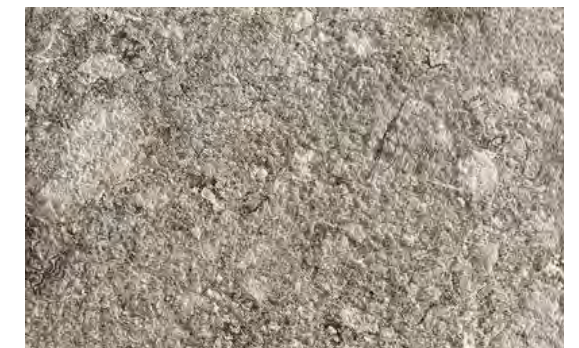
Porcelain stoneware refernce: Porcelain stoneware Mirage, NORR/GRA RR02, 24"x24"

**NON-VISIBLE PENTHOUSE AND ROOF - Porcelain stoneware floor**
