444 10TH AVENUE

MANHATTAN, NEW YORK

Remedial Action Report

NYC VCP Number: 14CVCP235M

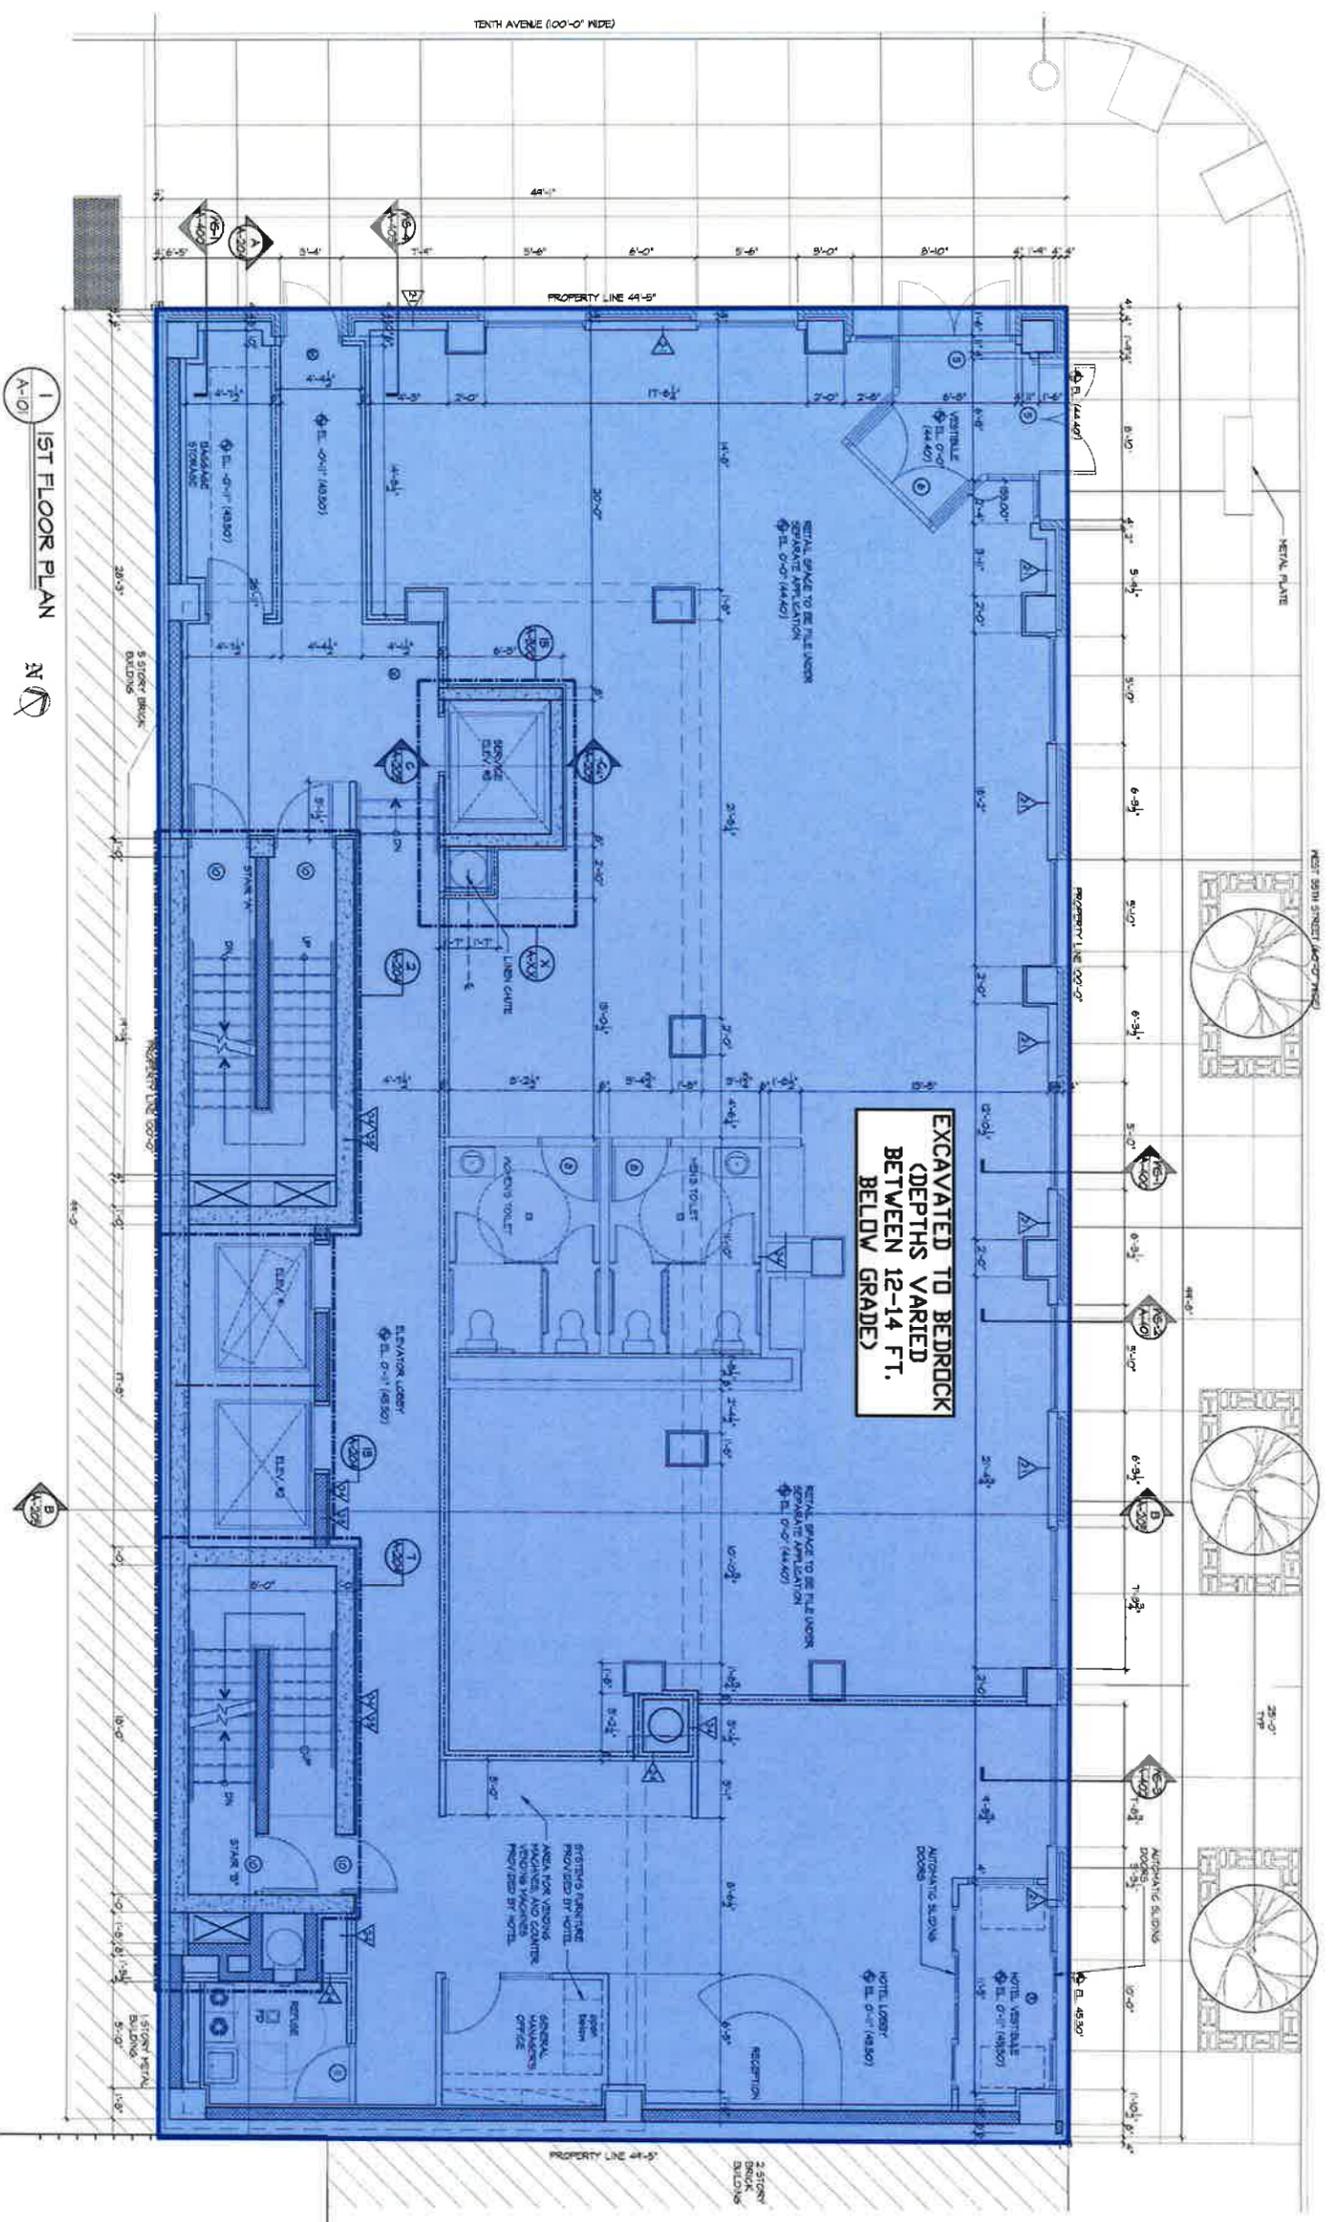
FIGURE 4
 EXCAVATION MAP
 444 10TH AVENUE
 BLOCK 732, LOT 70
 MANHATTAN, NEW YORK

EXCAVATED TO BEDROCK
 DEPTHS VARIED
 BETWEEN 12-14 FT.
 BELOW GRADE

Approximately 1,772.08 tons of non-hazardous soil (Common Fill) was disposed at the Morris Fairmount Associates Facility and approximately 3,981.58 tons of non-hazardous soil mixed with bedrock fragments was disposed at the Bayshore Recycling Corp. Facility. Copies of the soil disposal waste manifests are provided in *Appendix VII*. Prior to off-site disposal, facility approval letters were received from the designated facilities accepting soils from the site. Facility acceptance letters are provided in *Appendix VIII*. A map showing the location where excavations were performed is shown in *Figure 4*.

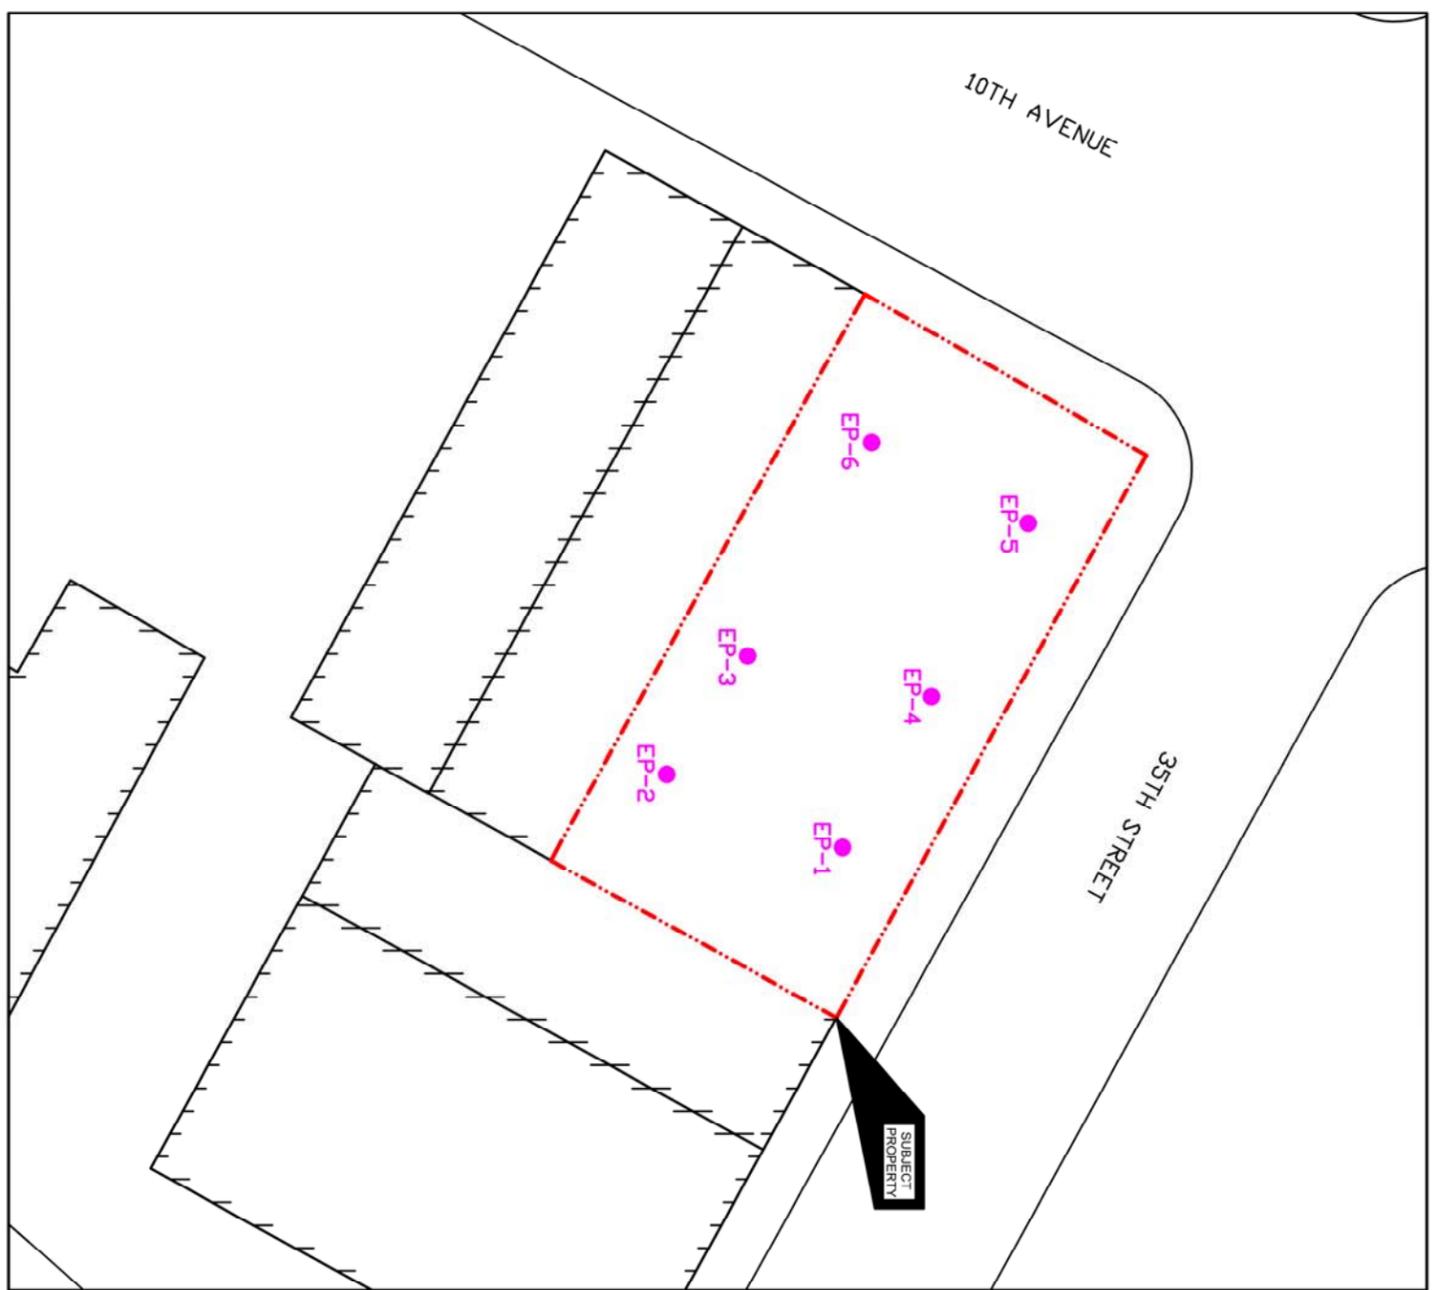
FIGURE 5
ENDPOINT SAMPLE LOCATION MAP
444 10TH AVENUE
BLOCK 732, LOT 70
MANHATTAN, NEW YORK

● - ENDPOINT SAMPLE LOCATION
EP-1

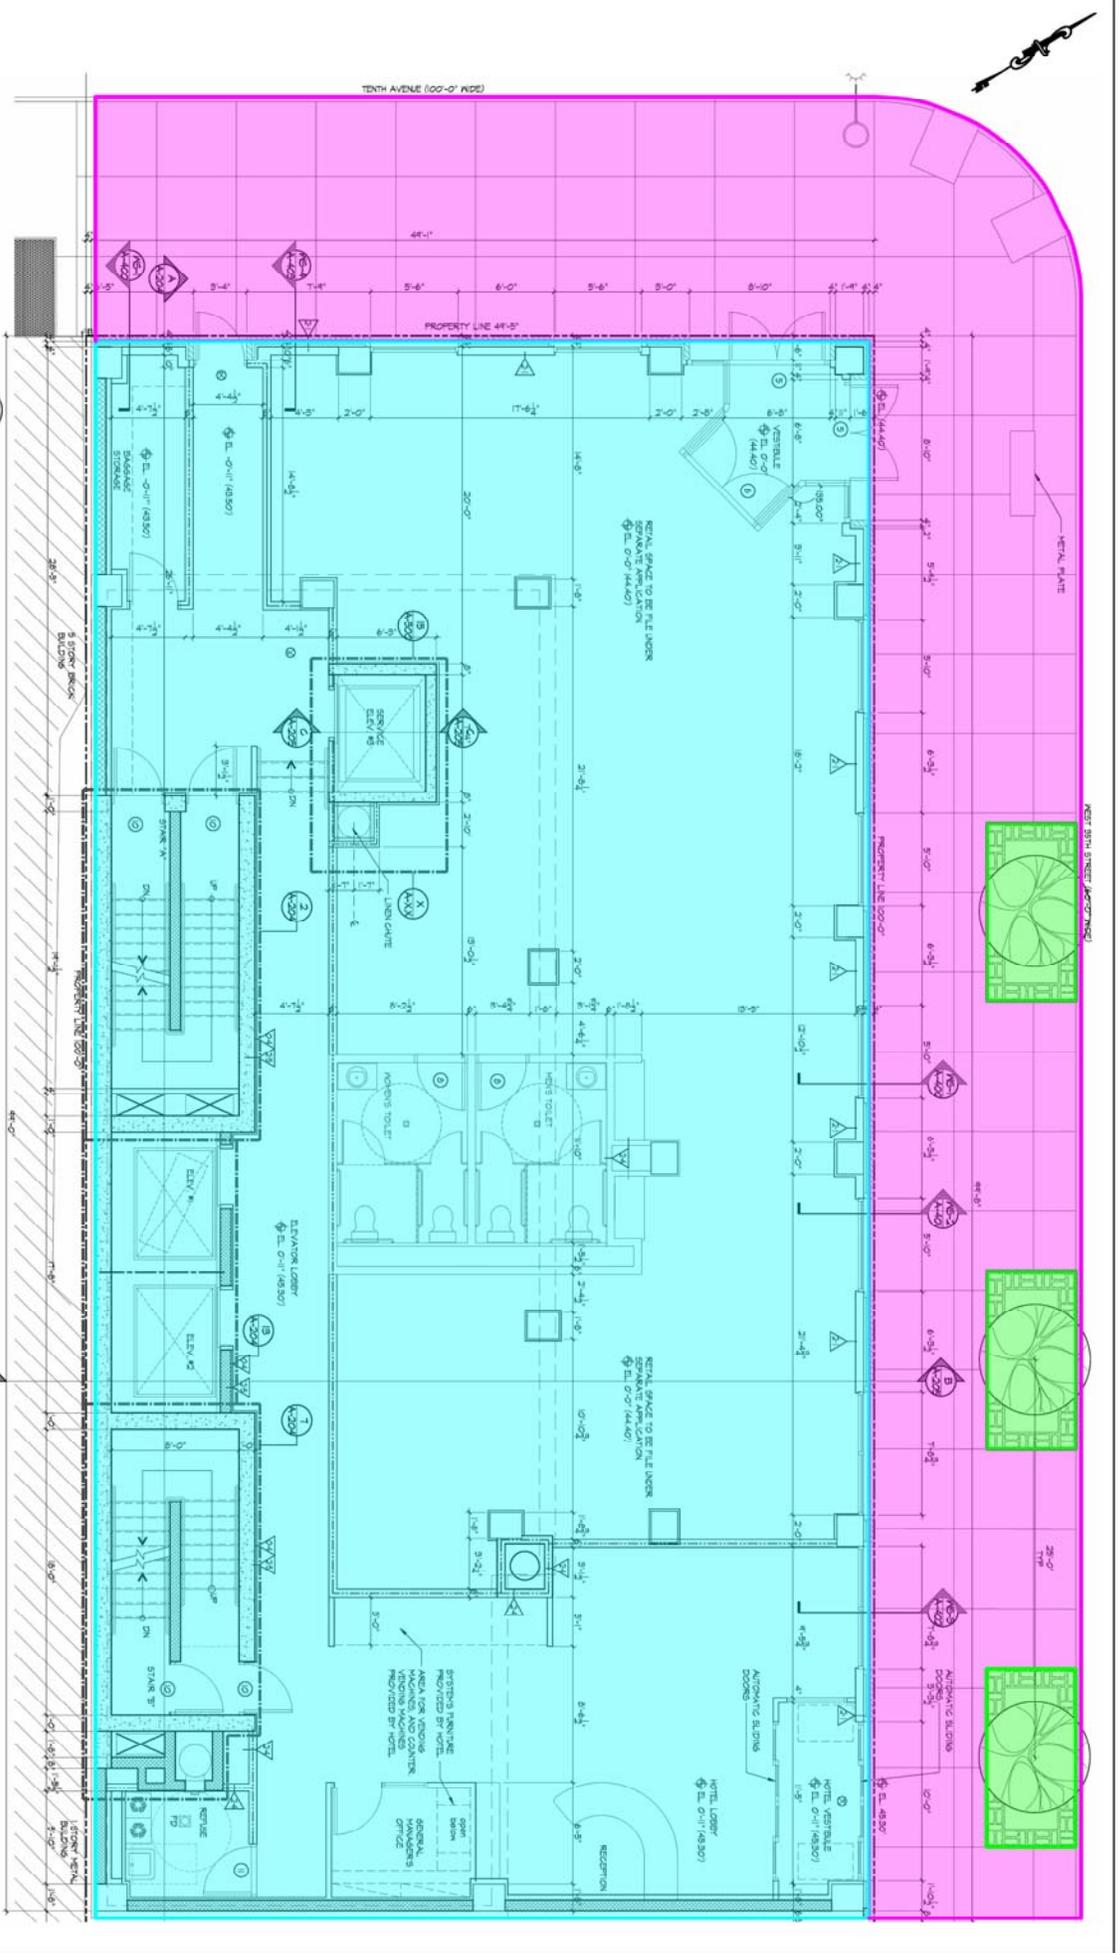
- CONCRETE COVER (SIDEWALK, GRAVEL, UNDERLYING SOILS)
- CONCRETE COVER (BUILDING, VAPOR WATERPROOFING BARRIER, GRAVEL, BEDROCK)
- CLEAN FILL (TOPSOIL)

The Waterproofing/Vapor Barrier System was installed as part of development. The SikaProof® A Waterproofing/Vapor Barrier Membrane System was utilized and consists of a highly flexible polyolefin membrane (FPO) with a sealant grid pattern and a non-woven fleece. The vapor membrane was installed beneath the site-wide foundation slab and was extended along the foundation sidewalls. The SikaProof® A membrane sheets were laid out on the concrete rat slab and were adhered together with SikaProof® Tape-150 and SikaProof® ExTape-150. The design engineer for the Waterproofing/Vapor Barrier System was Gene Santana, PE and the contractor for construction of the Waterproofing/Vapor Barrier System was Joy Construction Corp. **Figure 6** shows the location of the Waterproofing Membrane/Vapor Barrier System used on this Site and **Figure 7** shows a cross-sectional view of the system. Photographs of
