# **Remedial Investigation Report**

**546, 548, 550 West 29<sup>th</sup> Street**

**Block 700, Lots 59, 60, 61**

**OER Project Number 15EHAN008M**

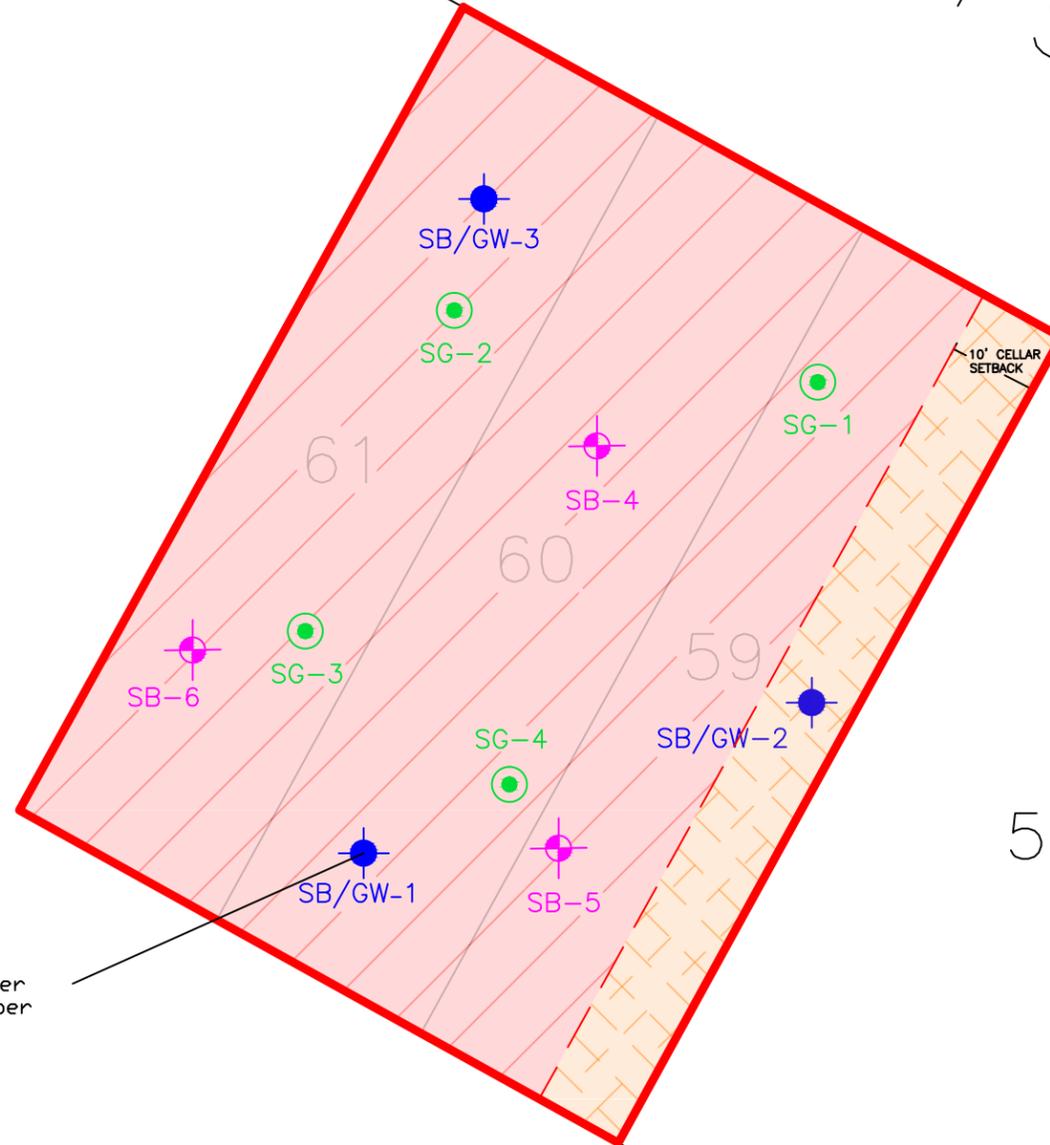
Location of former gasoline UST as per 1930 Sanborn

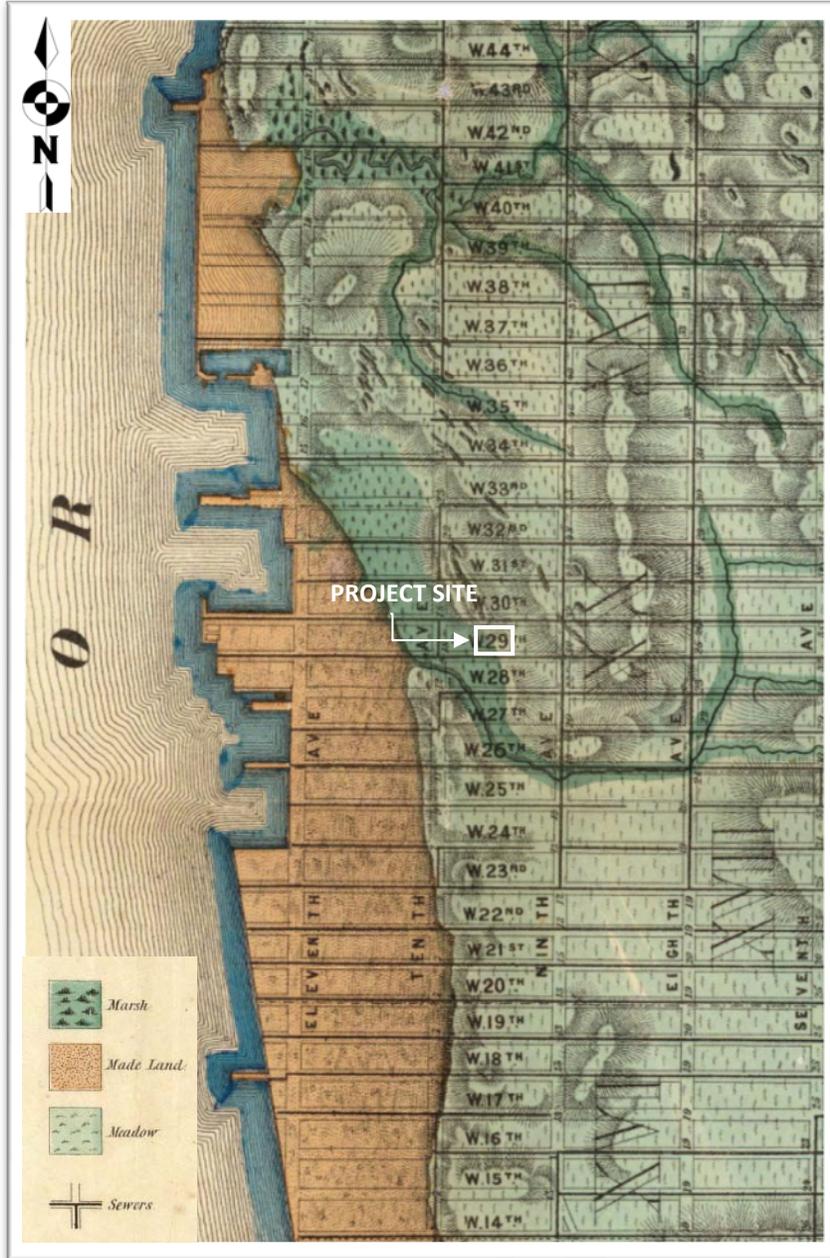
<b>550 W 29<sup>TH</sup> STREET PROJECT</b>			
NEW YORK		NEW YORK	
<b>TAMARKIN CO.</b>			
NEW YORK		NEW YORK	
<b>MUESER RUTLEDGE CONSULTING ENGINEERS</b>			
225 WEST 34 <sup>TH</sup> STREET, NEW YORK, NY 10122			
SCALE NTS	MADE BY: CH	DATE: 07-28-14	FILE NO. 12243
<b>1865 VIELE MAP</b>			SHEET NO. 2

Reference: 1865 Viele Map

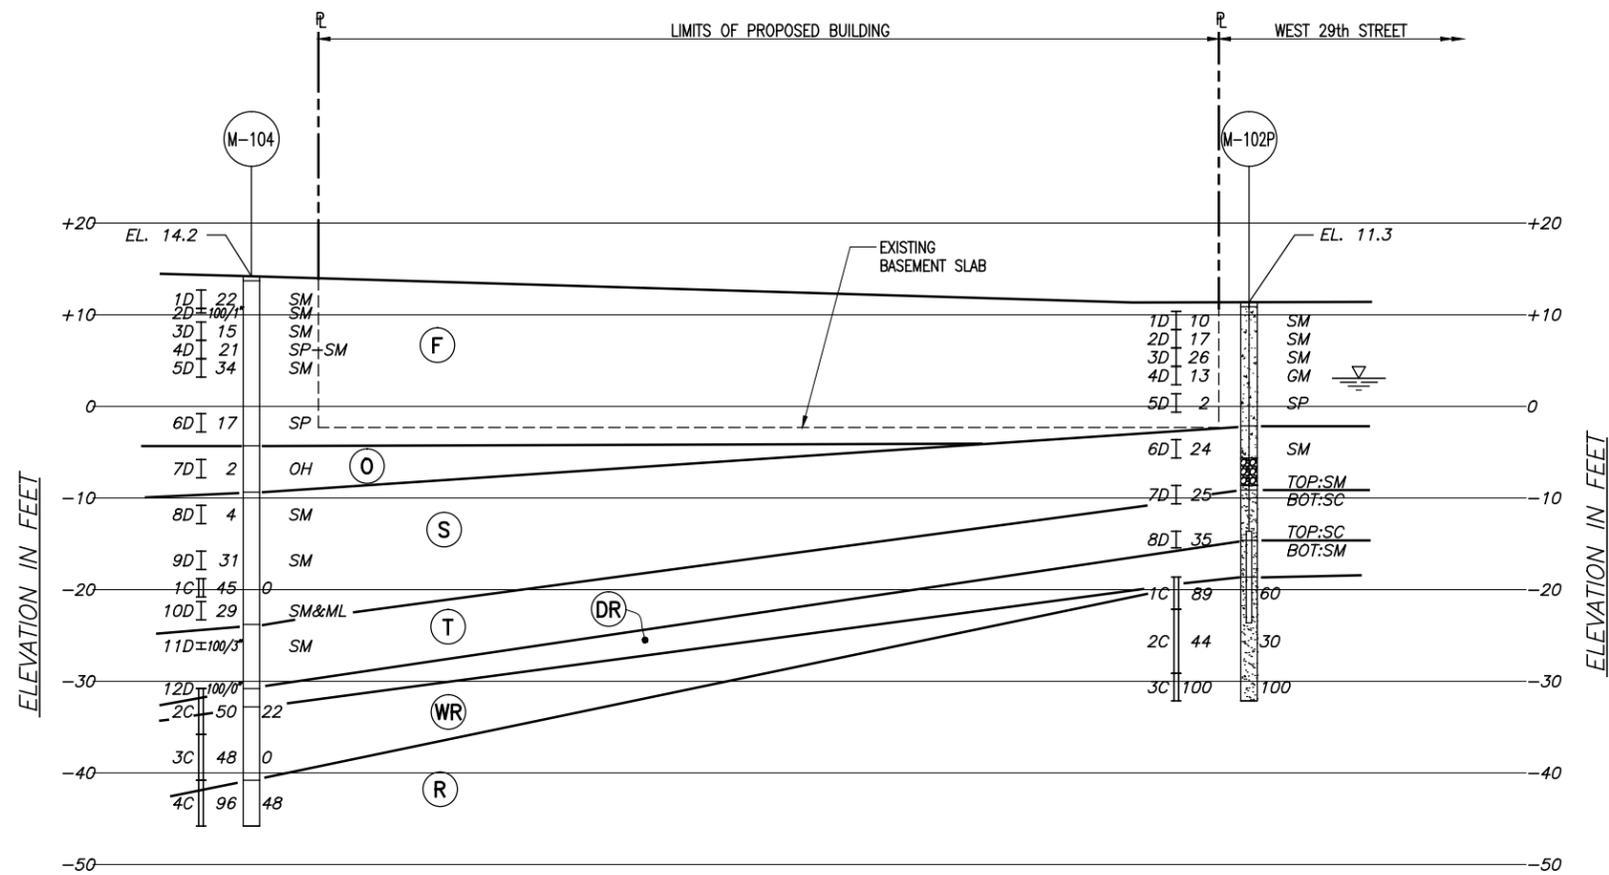
**SECTION A-A**

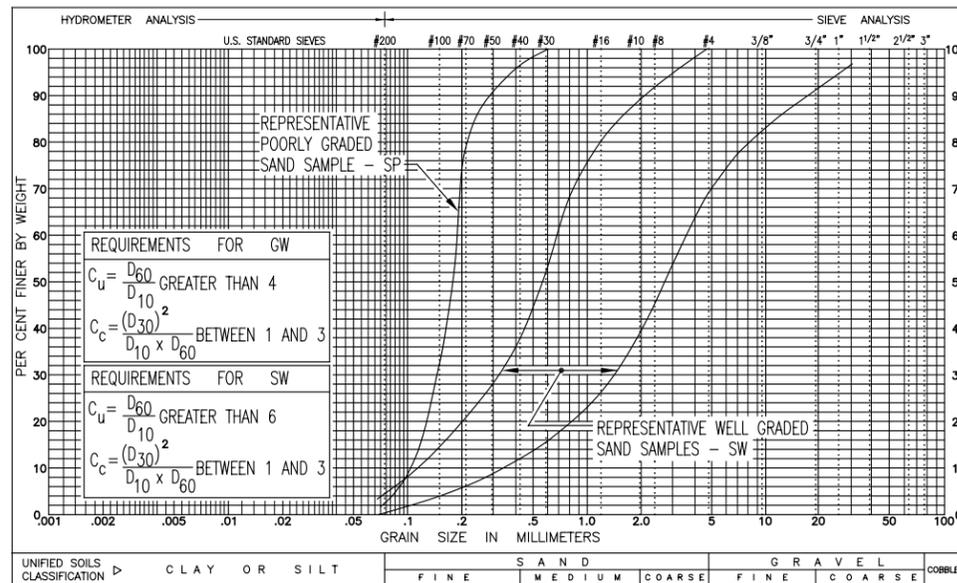
**GRAIN SIZE PLOT**

DEPENDING ON PERCENTAGE OF FINES (FRACTION SMALLER THAN NO. 200 SIEVE SIZE) COARSE GRAINED SOILS ARE CLASSIFIED AS FOLLOWS:

LESS THAN 5% GW, GP, SW, SP  
 MORE THAN 12% GM, GC, SM, SC  
 5% TO 12% BORDERLINE CASES REQUIRING USE OF DUAL SYMBOLS, I.E.: SP-SM, GP-GM.
