37-10 CRESCENT STREET

QUEENS, NEW YORK

Remedial Action Report

NYC VCP Project Number 15CVCP057Q

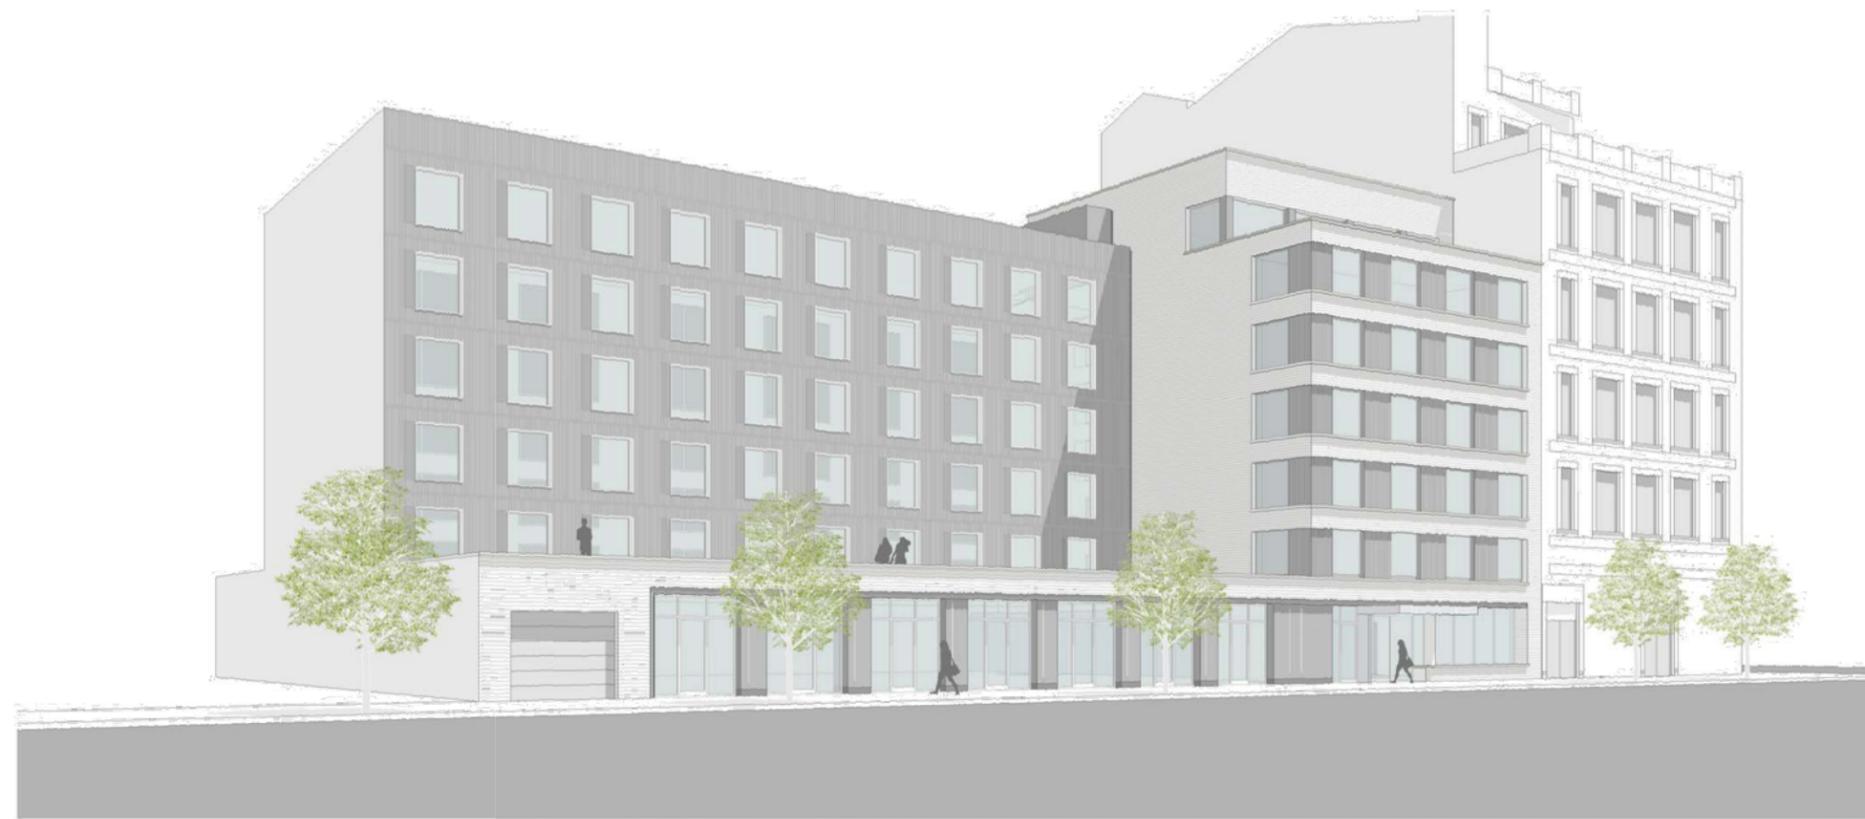
Site map:	37-10 CRESCENT STREET QUEENS, NY 11101
Figure:	3
Title:	REMEDIAL ACTION REPORT SITE REDEVELOPMENT PLAN
Date:	January 29, 2016
Drawn by:	EZGI KARAYEL
Checked by:	MAYA ZUNG
Drawing Scale:	AS NOTED
Project No.:	14-133-1037

RENDERING VIEW I
37-10 CRESCENT STREET
DECEMBER 16, 2015

The foundations of the building are spread footings. The new building footprint covers the entire Site lot. For the construction of the basement, the entire Site was excavated to a depth of 12 feet below grade surface (bgs) and to a depth of 14 feet bgs at some locations for installation of footings. Therefore, 13,250 tons of soil was removed during excavation. The current zoning designation is M1-2/R6A denoting it as mixed use manufacturing and residential. The use is consistent with existing zoning for the property. The current development plan is shown in Figure 3.

The basement is utilized as a parking garage, mechanical room and boiler room. The foundations of the building are spread footings with slab on grade. The new building footprint covers the entire Site lot. For the construction of the basement, the Site was excavated to a depth of approximately 12 feet below grade surface (bgs) and to a depth of 14 feet bgs at some locations for installation of footings. Therefore, 13,250 tons of soil was removed during excavation. The current zoning designation is M1-2/R6A denoting it as mixed use manufacturing and residential. The use is consistent with existing zoning for the property.

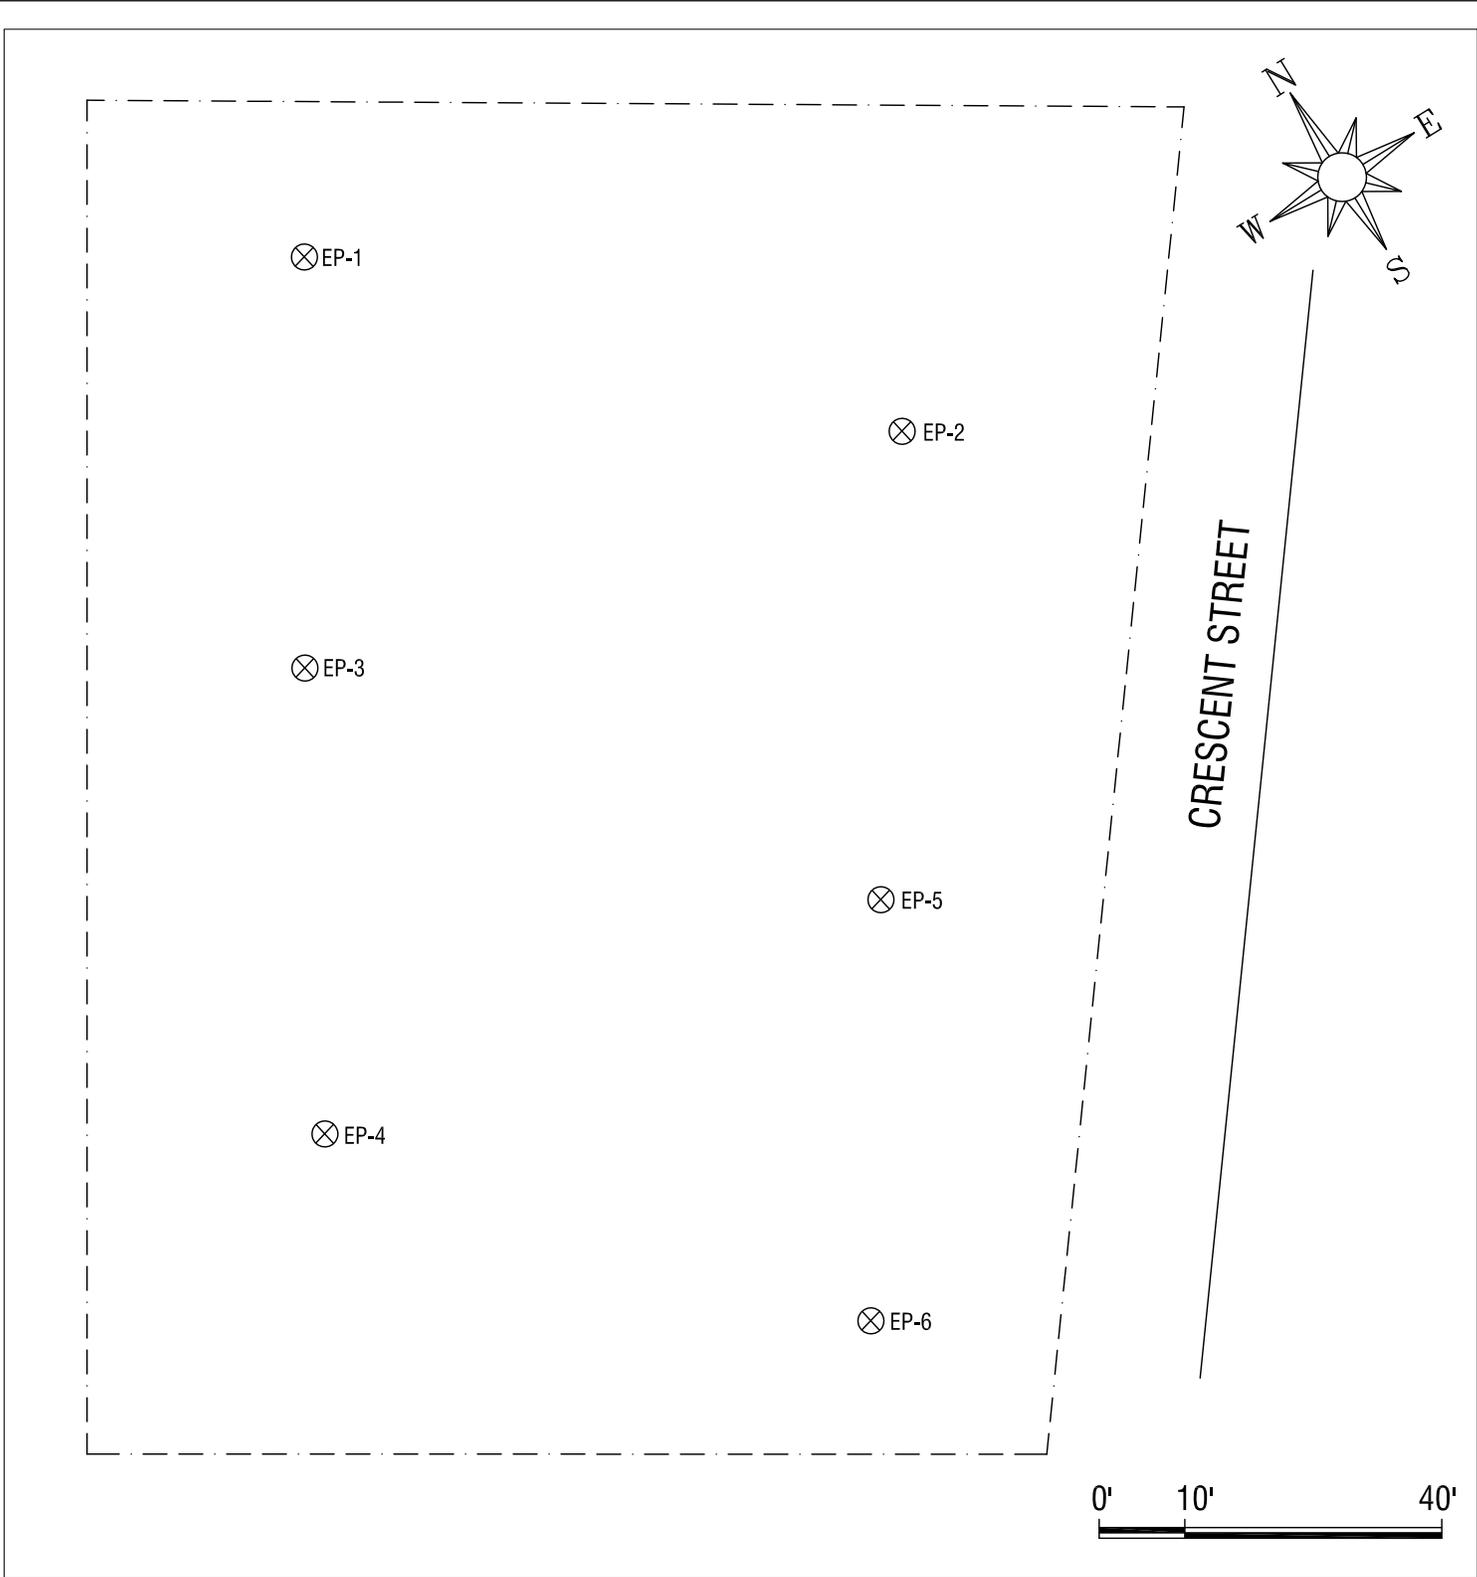
Site map:	37-10 CRESCENT STREET QUEENS, NY 11377
Figure: Title:	4 REMEDIAL ACTION REPORT END-POINT SAMPLING LOCATIONS
Date:	DECEMBER 2, 2015
Drawn by:	ETHAN RAINEY
Checked by:	EZGI KARAYEL
Drawing Scale:	AS NOTED
Project No.:	14-133-1037

⊗ EP-X	POST-EXCAVATION SOIL SAMPLING LOCATION AND DESIGNATION NUMBER
- - - - -	SITE BOUNDARY

6. Collected and analyzed end-point samples to determine attainment of SCOs. Track 1 SCO's were achieved.
7. As part of development, constructed an engineered Composite Cover System consisting of 5 inches of concrete slab underlain by compacted soil. The contractor for the Cover System construction was Abacus Building Innovations.

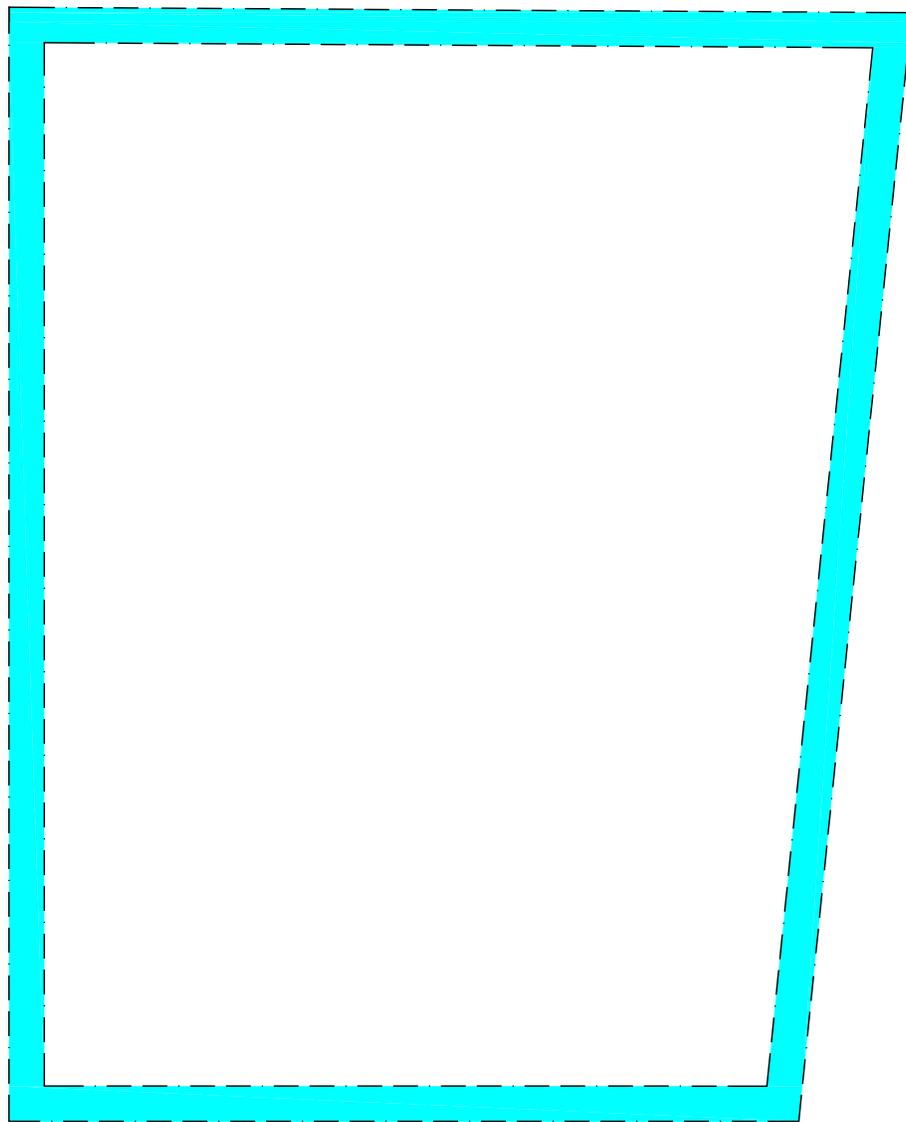
Clean native soil was reused behind all foundation walls on site

Backfill was not imported during this project. Approximately 750 tons (500 cubic yards) of clean soil was excavated and reused on Site to as backfill behind the foundation walls as shown in Figure 6.
