SOUTHWEST BROOKLYN MARINE TERMINAL STATION BULKHEAD INVESTIGATION

ANNUAL BULKHEAD INSPECTION

PROJECT NO. A077181
DOCUMENT NO.
VERSION 1
DATE OF ISSUE 11/25/2015
PREPARED DDJS
CHECKED JOAC
APPROVED JOAC

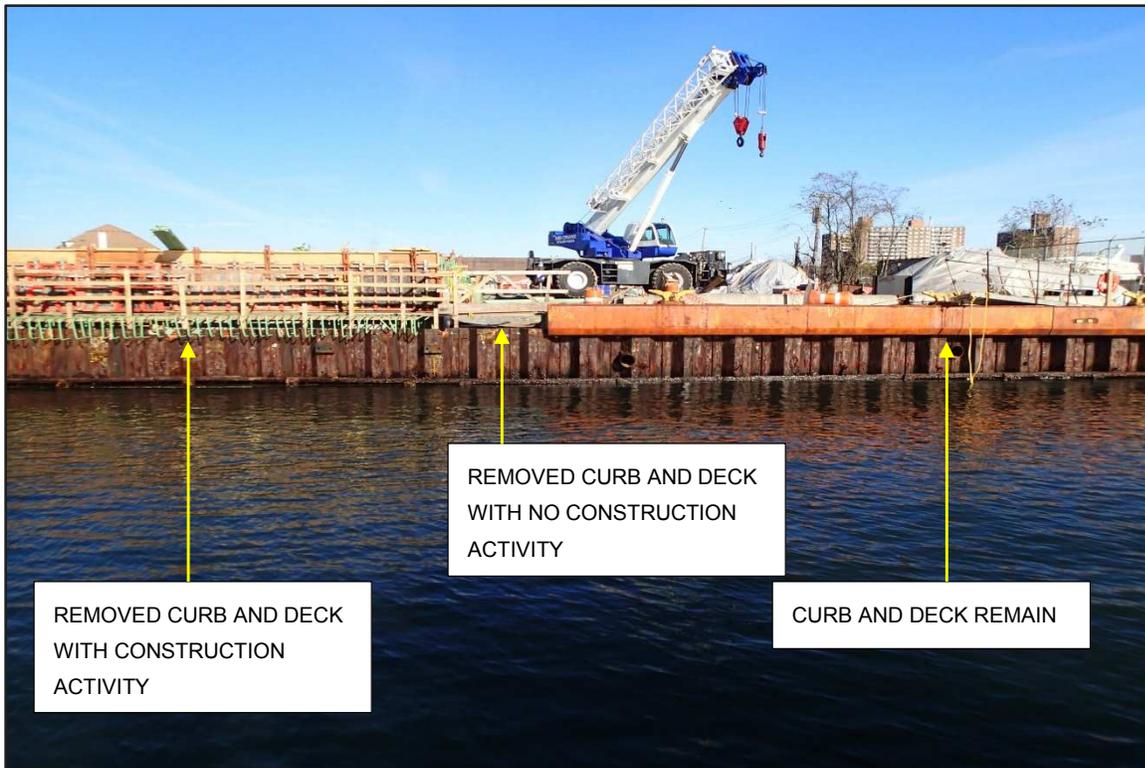
At the time of the inspection, approximately 234 LF of concrete deck and curb had been removed due to the ongoing construction inshore of the steel sheet pile bulkhead (Photograph 10). A reinforced concrete bulkhead had been installed approximately 3 LF inshore of the existing steel sheet pile bulkhead (Photograph 11). The annulus between these structures is partially filled with concrete, typically up to the anchor rod elevation, excluding one 7 LF segment located between Sta. 1+97 and Sta. 1+90,

Photograph 10: North Bulkhead – Removed curb and deck interface with active construction

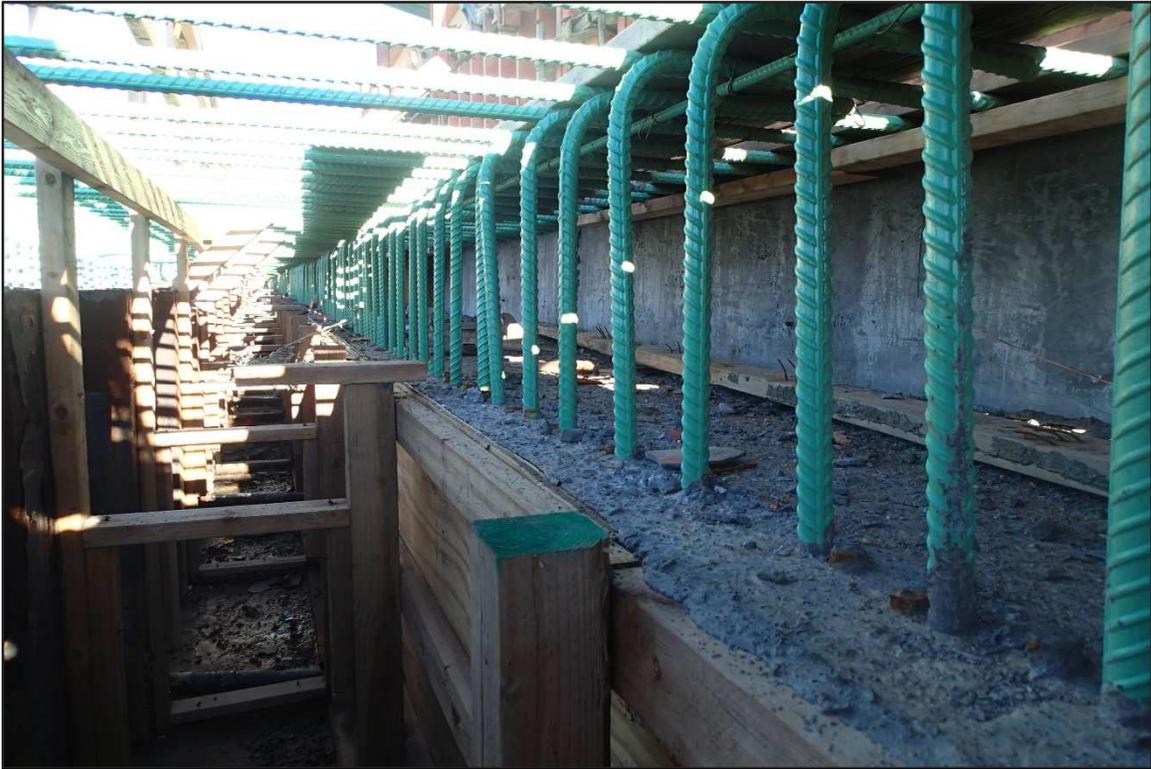
Photograph 11: North Bulkhead – Concrete bulkhead with partially filled annulus between concrete and steel sheet pile bulkheads

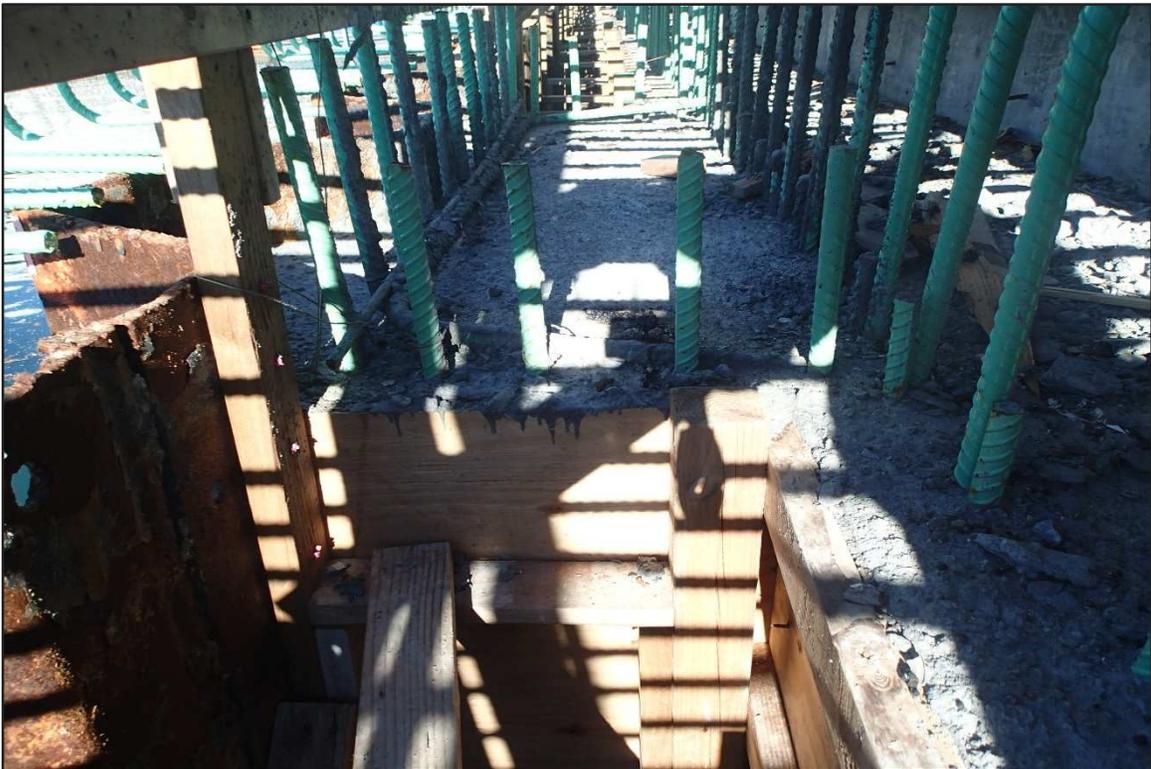
where the reinforced bulkhead extends to the face of the steel sheet pile bulkhead (Photograph 12). Embedded epoxy coated reinforcement is visible along the full length of this section (Photograph 13). The southern 9 LF of existing bulkhead and demolished curb and deck is adjacent to the new construction, but at the time of the inspection only excavation had been performed. It is not clear what will be installed at this location. The bulkhead to the south of this area (Sta. 0+96 to Sta. 0+00) remains except for a 39 inch by 20 inch section where the North and East Bulkheads intersect. This section of deck and curb has apparently been removed to allow for the installation of a transition element between the North and East bulkheads to allow for the installation of steel sheets that extend to the west (Photograph 14 and Photograph 15). Construction has occurred below water along the full length of the offshore face of the North Bulkhead. At each outer and inner flange, a minimum of two (2) elevations of shear bolts have been installed, beginning approximately 3 to 4 feet below the steel wale (Photograph 16). At the northern extent of the steel sheet pile bulkhead, threaded rods and steel brackets have been installed at each offshore double section (Photograph 17 and Photograph 18). Based on previous experience and typical waterfront construction methods, these elements will likely be utilized as a part of a partial concrete encasement of the steel sheet pile bulkhead, wale, and anchor rods.

Photograph 12: North Bulkhead – Extended concrete bulkhead between Sta. 1+90 and 1+97

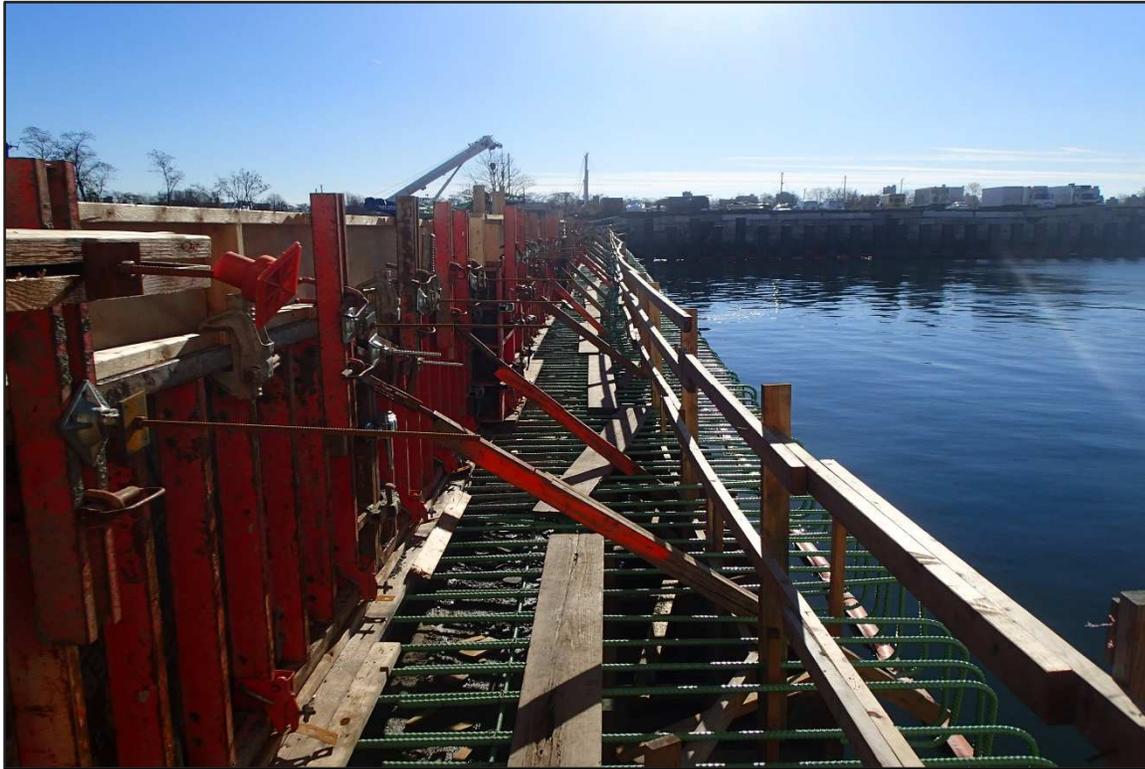
Photograph 13: North Bulkhead – Partially constructed structure with exposed epoxy coated reinforcement (looking south)

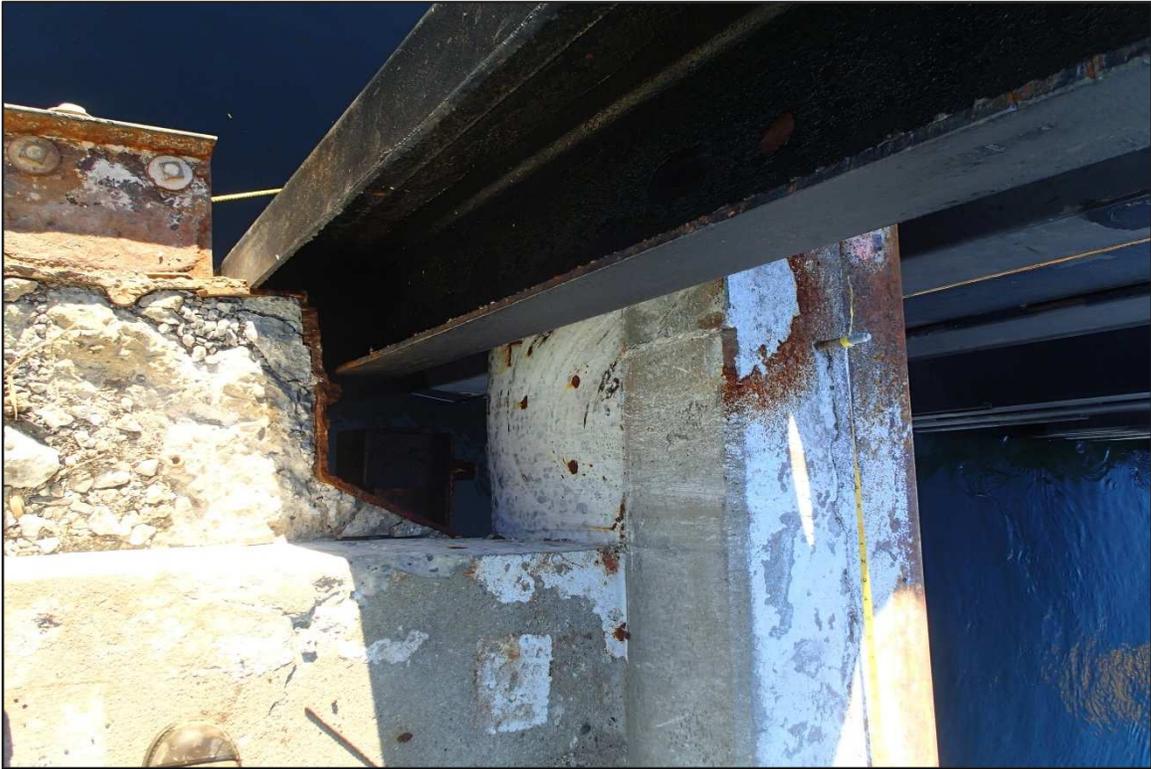
Photograph 15: North Bulkhead – Deck demolition at North and East bulkhead interface to install transition element for new steel sheet pile to the west

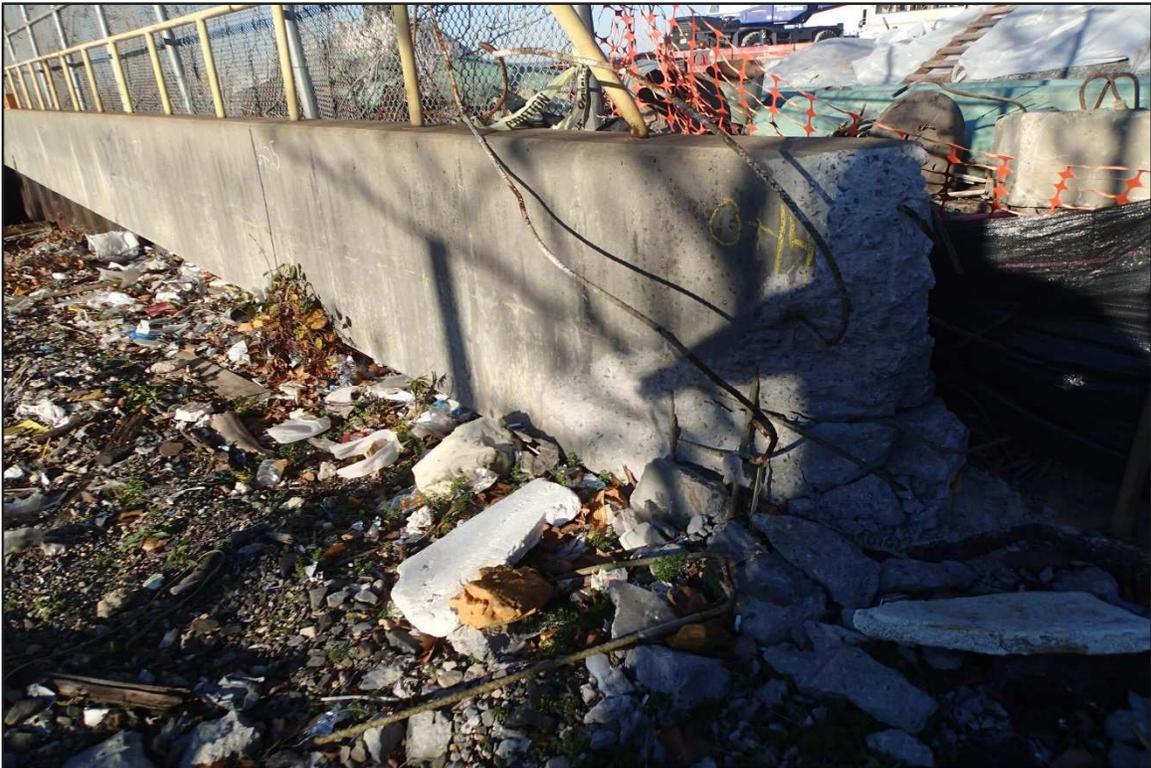
The East Bulkhead intersects the North Bulkhead along the south end and creates a corner returning inshore to the east for approximately 144 LF (Photograph 19). Approximately 14 LF of the inshore section of this bulkhead has been partially demolished, with the concrete deck and curb removed (Photograph 20). A small portion of steel sheet pile bulkhead is visible along this demolished segment (Photograph 21). The bulkhead is composed of Z-shaped steel sheet piles with an external double channel wale, which is secured with a series of steel anchor rods. As stated above, new steel sheet piles that extend west from the intersection between the East and North Bulkheads have been put in place.

Photograph 20: East Bulkhead – Demolished concrete curb and deck at Sta. 0+14 (looking northwest)

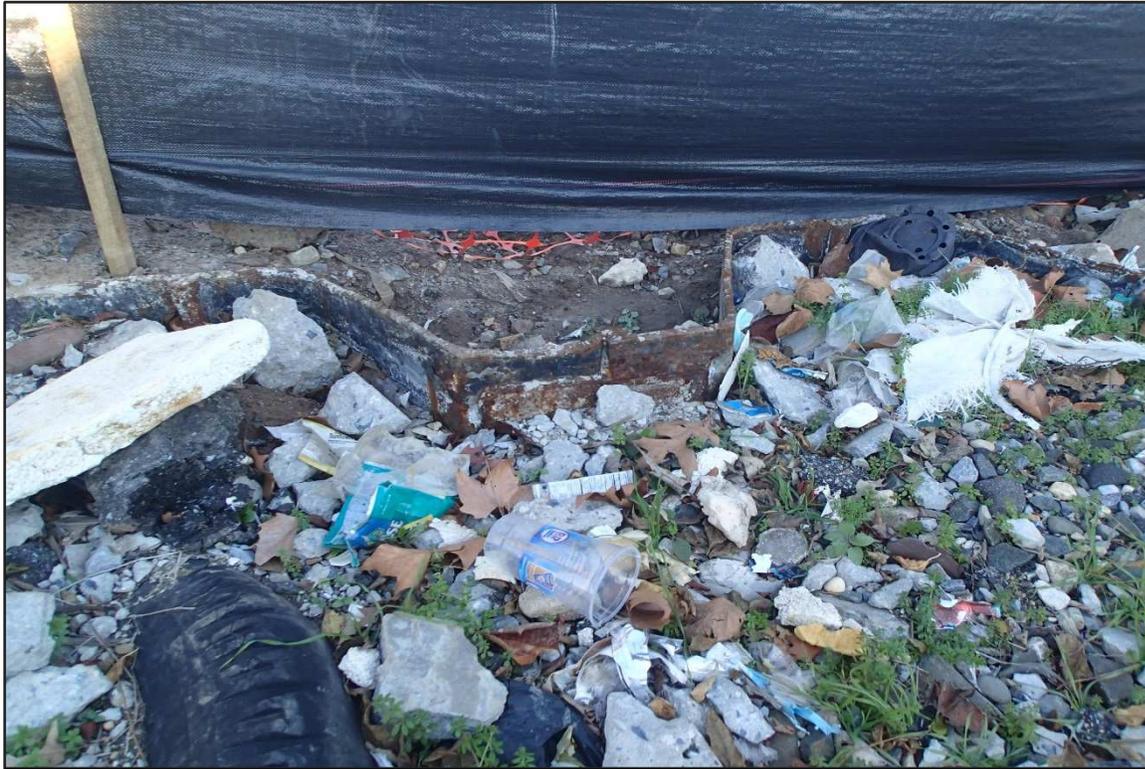
Photograph 21: East Bulkhead – Exposed steel sheet pile bulkhead where curb and deck have been removed

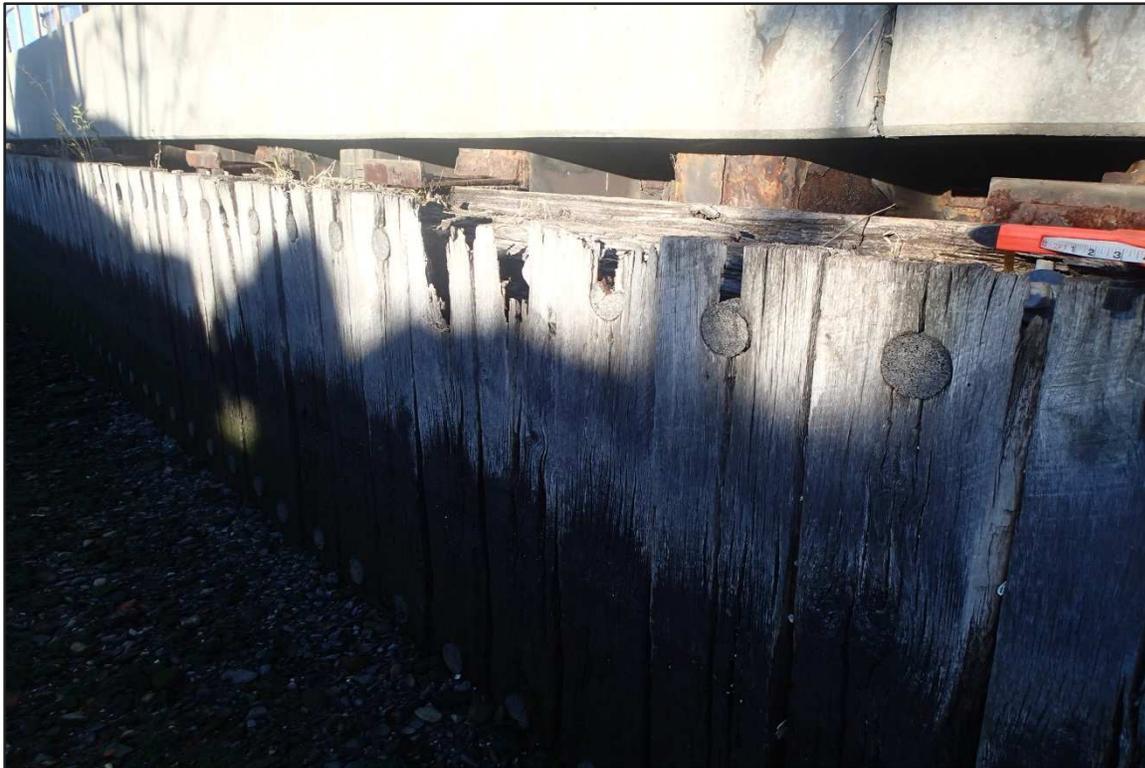
The fender system observed during previous inspection efforts has been removed from the North Bulkhead. Remnants of the removed fender system were observed along the mudline offshore of the North Bulkhead. The fender system is still present along the offshore face of the East Bulkhead. The East Bulkhead fender system consists of 6 inch by 12 inch fender planks, two elevations of 12 inch by 12 inch timber wales, and steel brackets which tie the system into the steel sheet pile bulkhead (Photograph 22).

Photograph 22: East Bulkhead – Timber fender system (looking northwest)

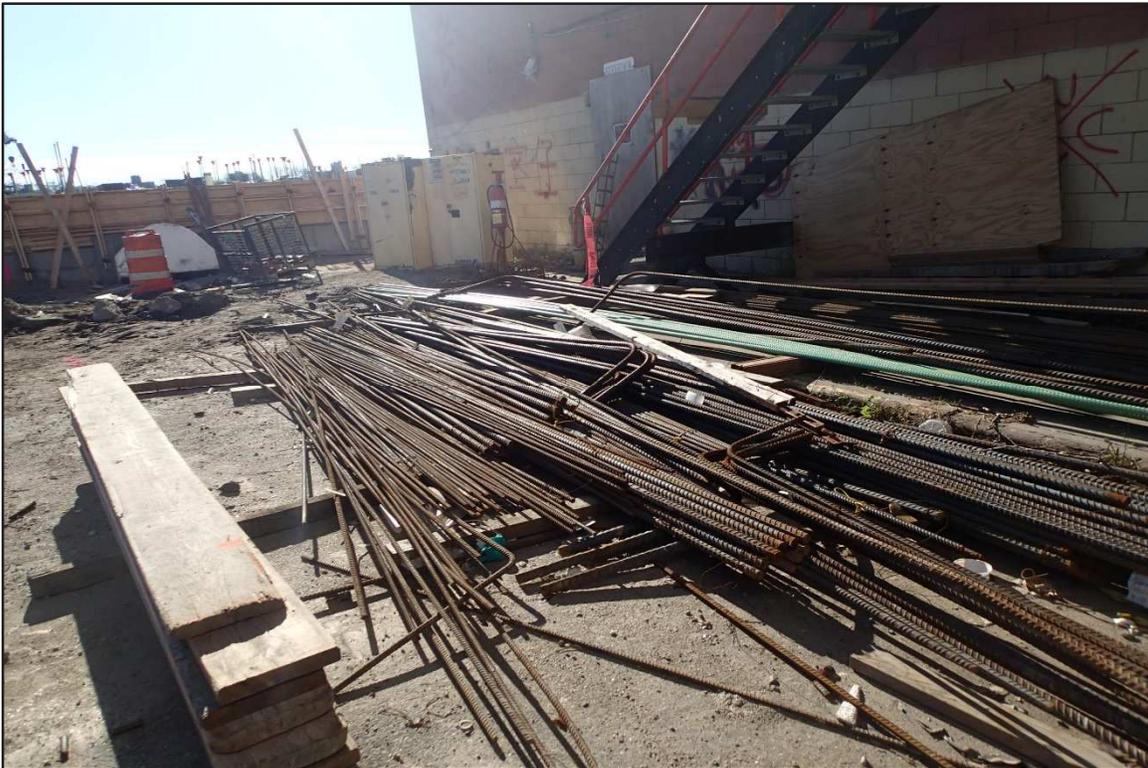
the bulkhead have been repaired with an epoxy coating along the entire exposed face of the sheets. Cut outs through the bulkhead noted during the previous inspection at Station 2+80 are still present, but since the steel sheet pile bulkhead at this elevation is no longer retaining fill due to the inshore concrete bulkhead, these openings are inconsequential. The mooring hardware in place between Sta. 0+96 and 0+00 are sound with moderate corrosion (Photograph 31). No access hatches for the cellular cofferdams were exposed, so the sand levels could not be observed or measured. The areas where the access hatches would presumably be located appear to have been paved over and are currently staging construction material for the ongoing construction effort (Photograph 32).

*Photograph 32: North Bulkhead – Construction material storage in area of cofferdam cell hatches.
Note: Previous inspections found no access to sand fill.*
