New York City Department of Sanitation
Marine Export of Solid Waste

COFFERDAM INPECTION REPORT

**SOUTHWEST BROOKLYN MARINE
TRANSFER STATION**

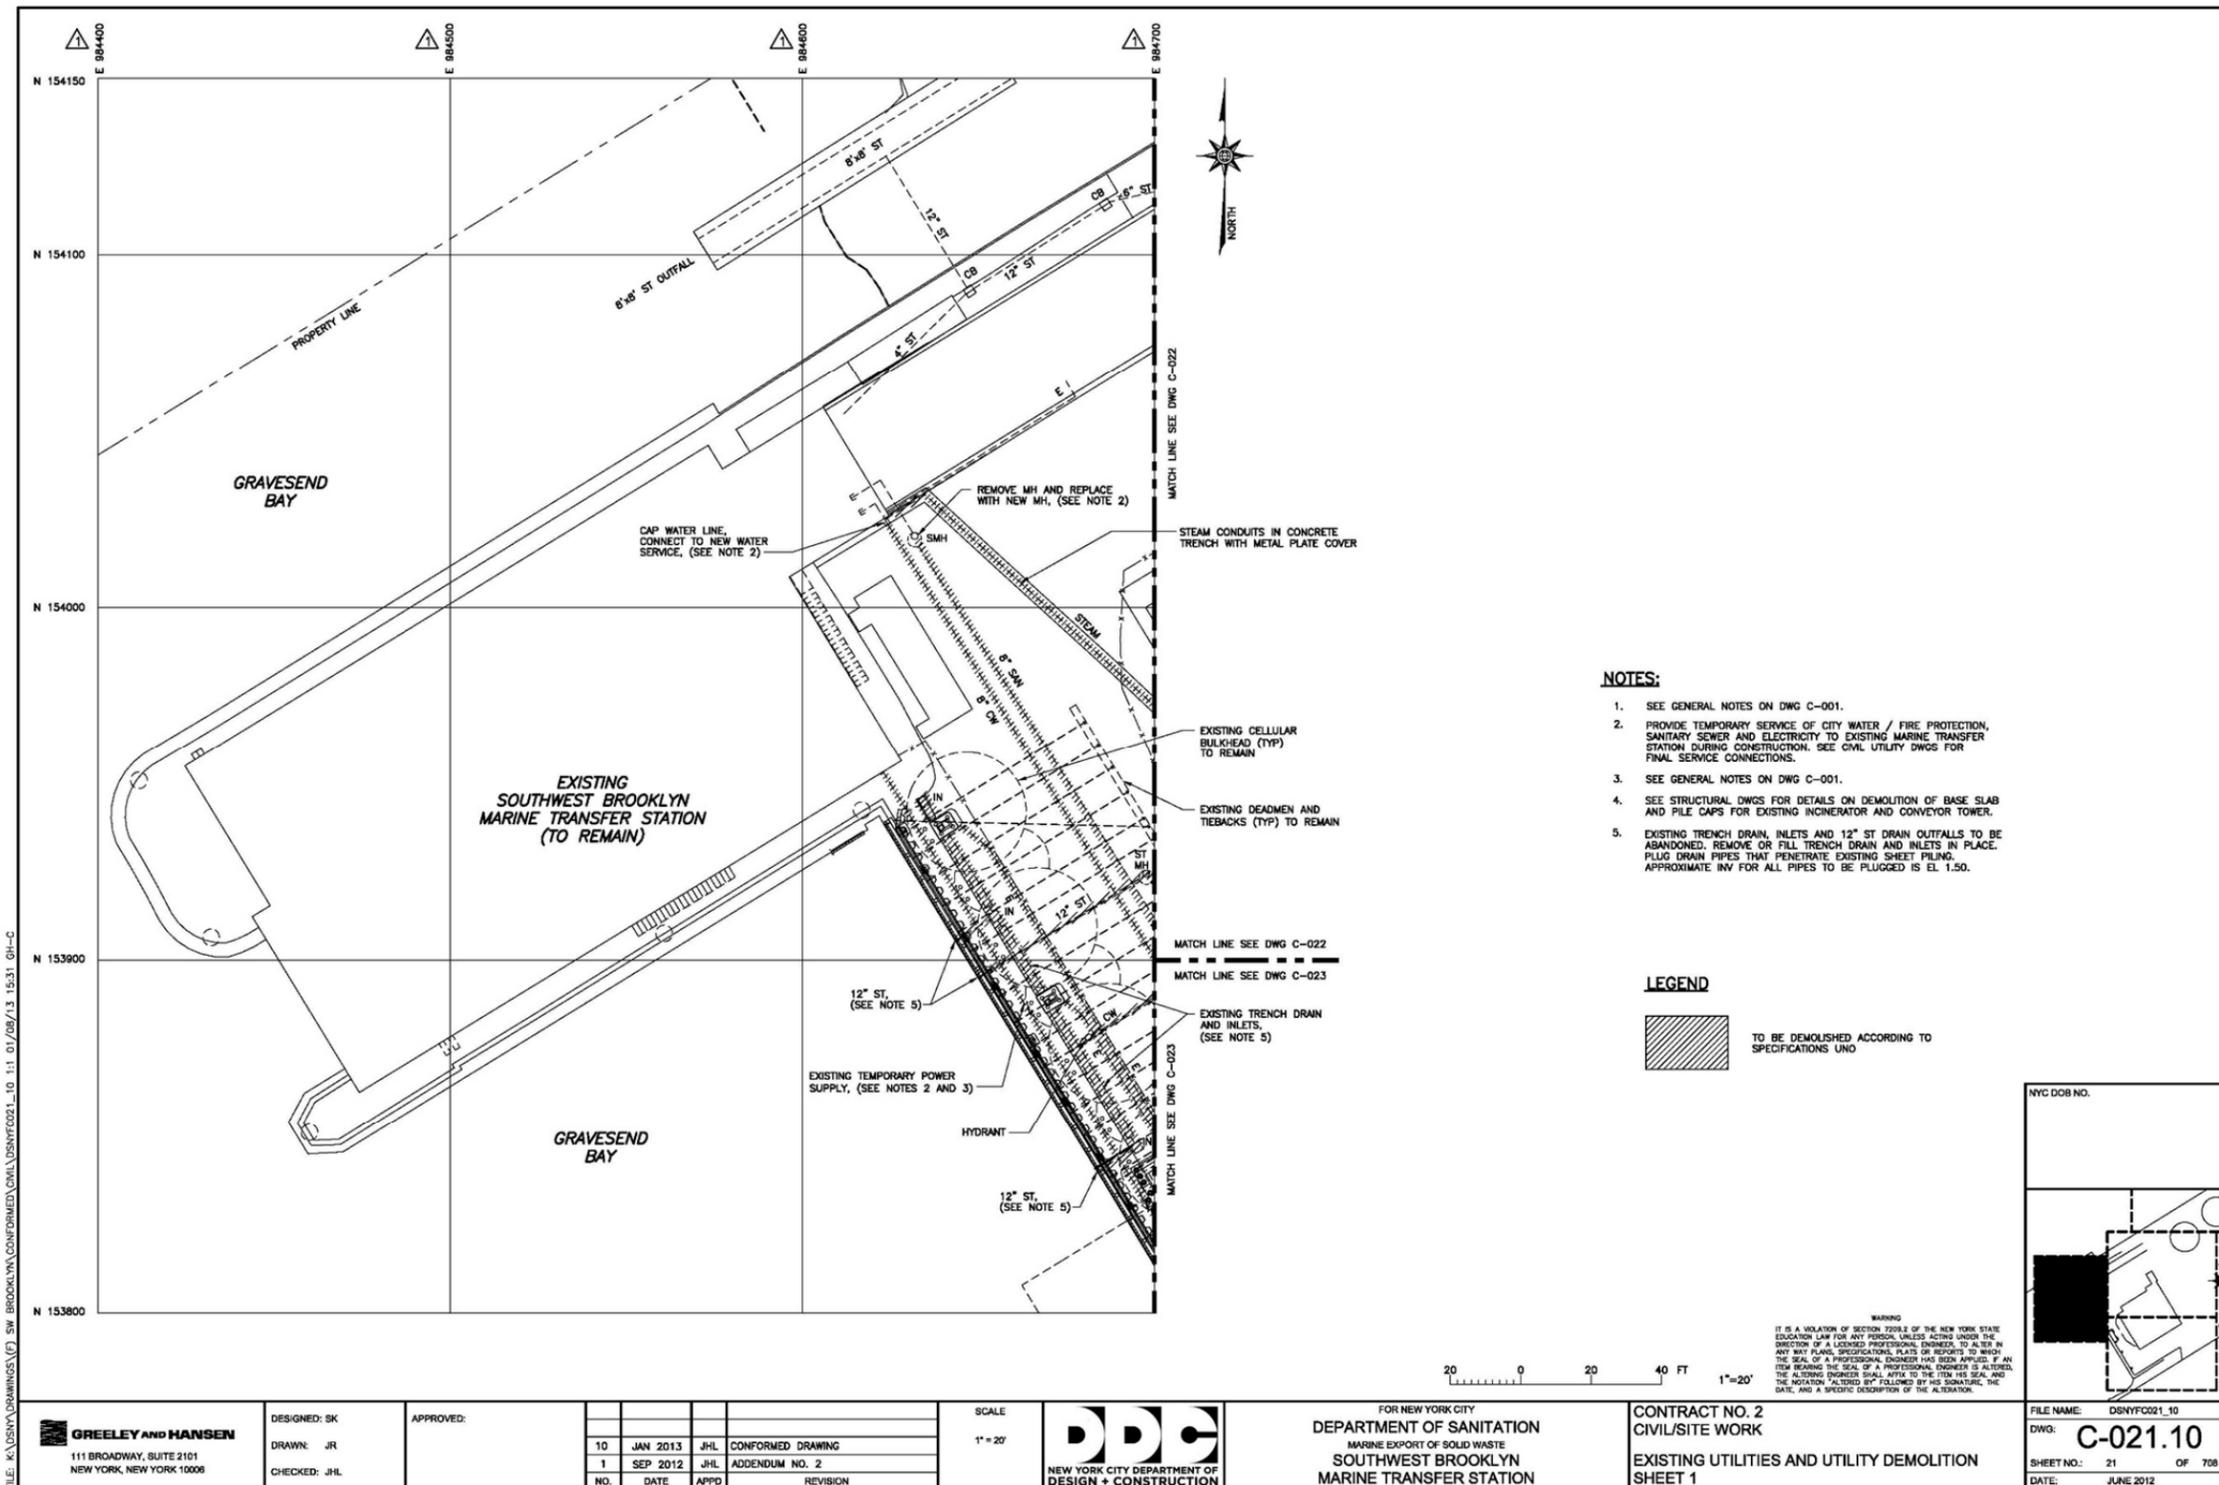
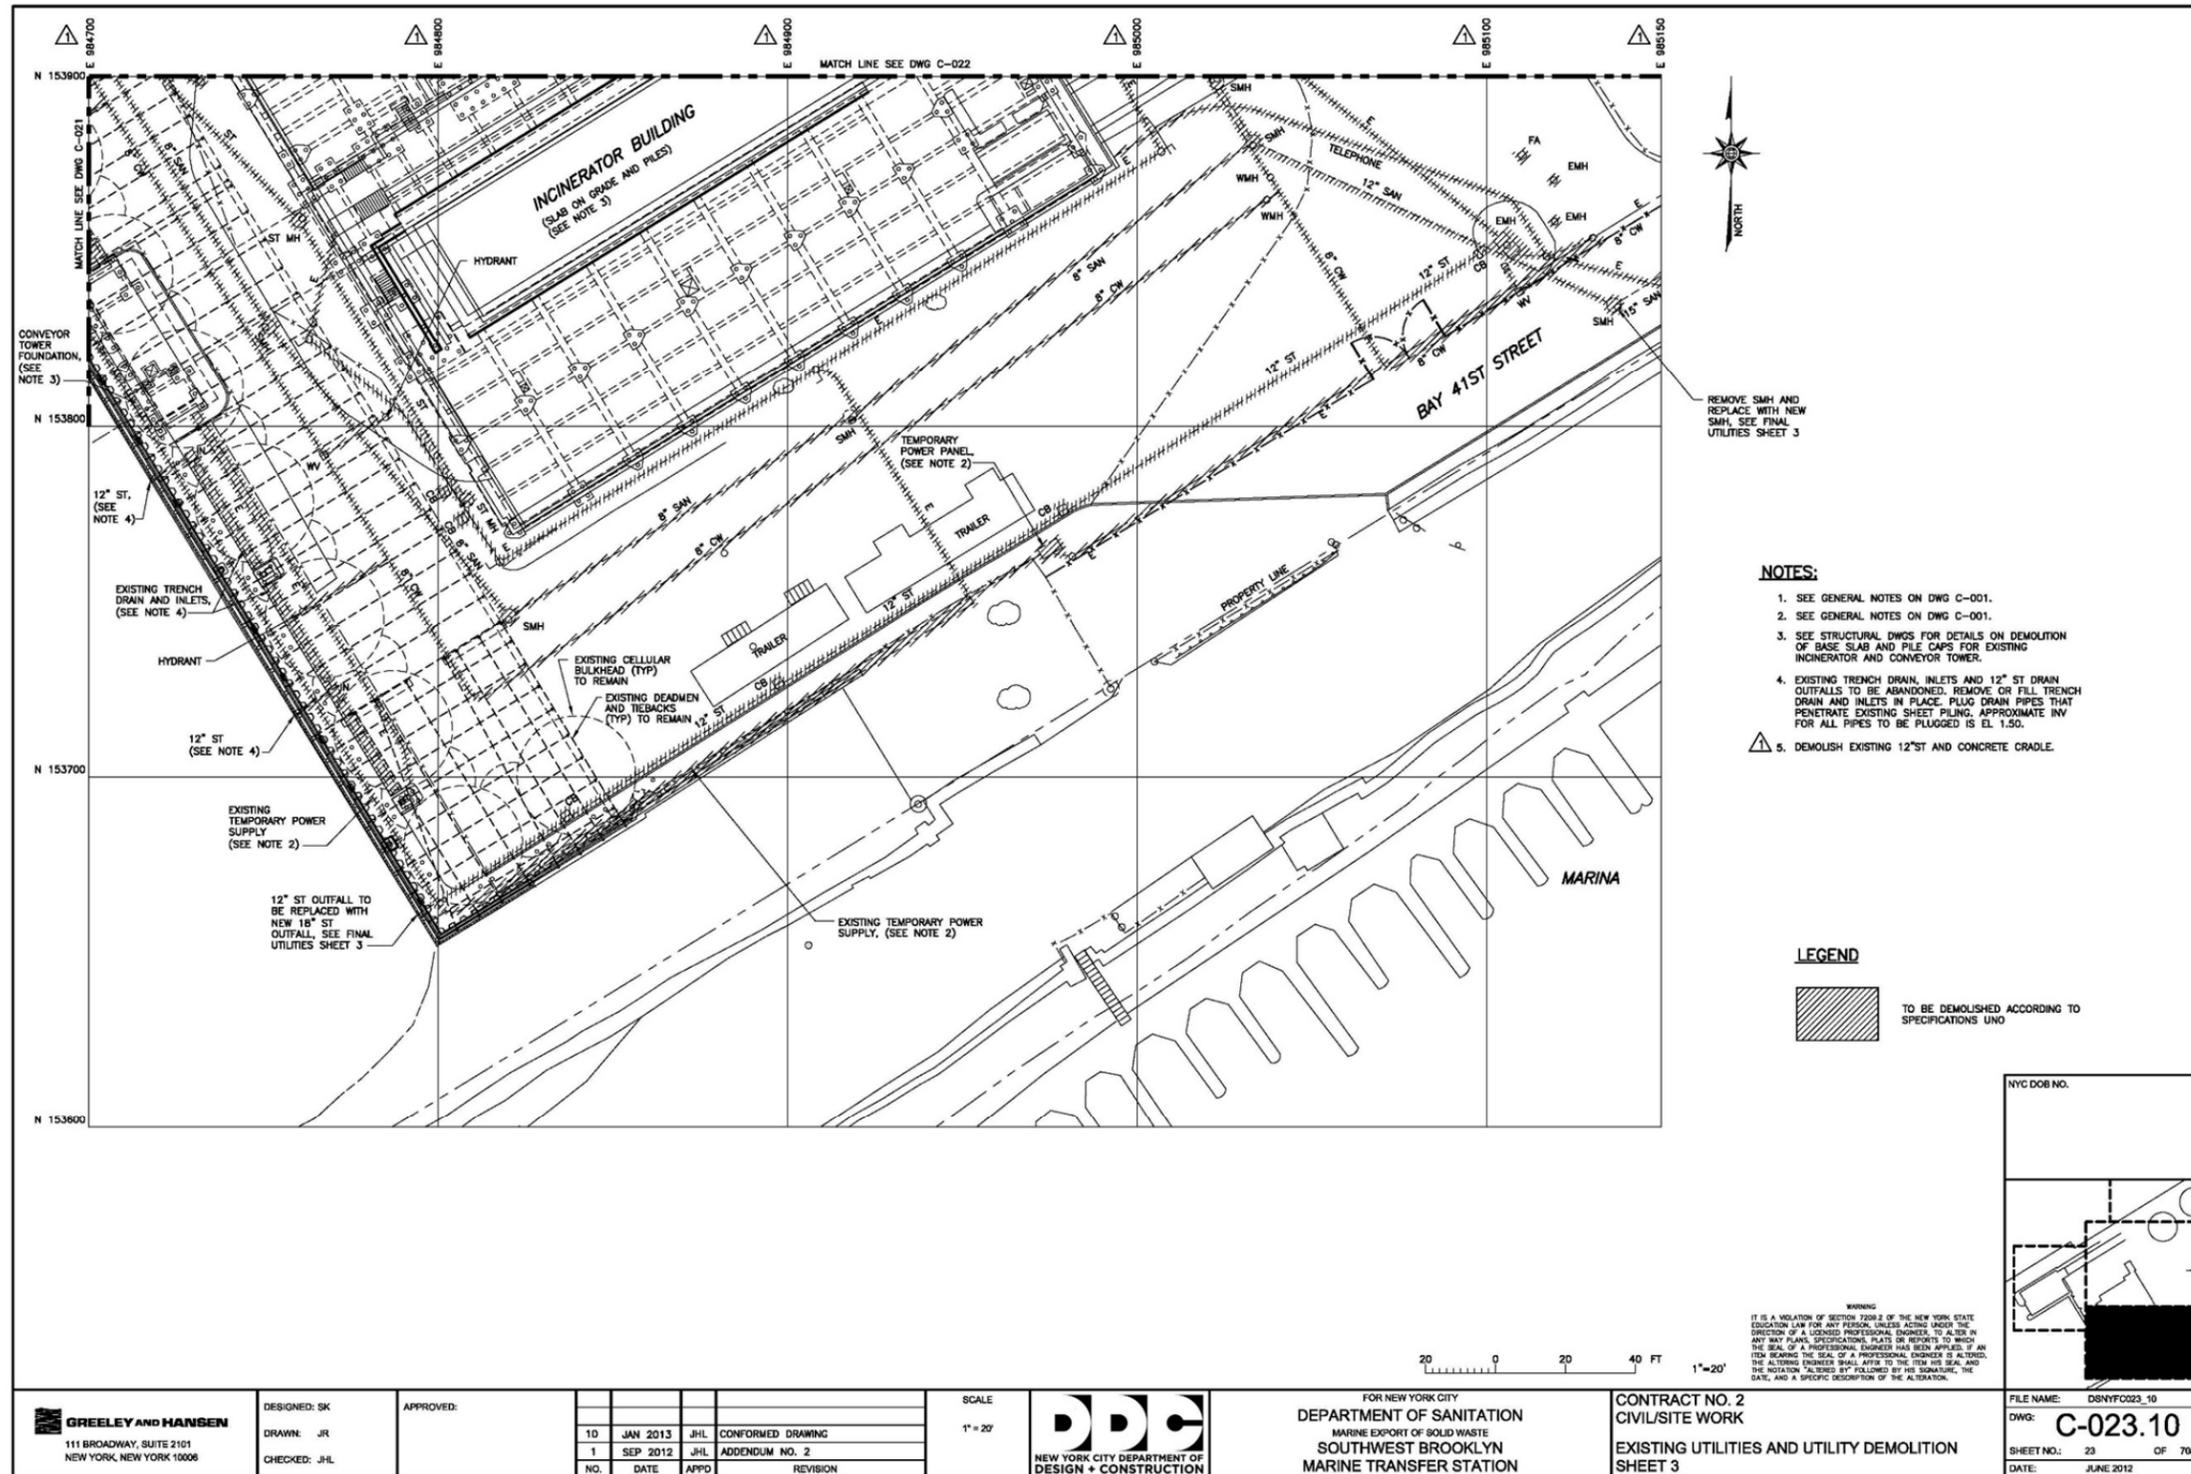
The North bulkhead is located along the offshore face of the site and is parallel to the waterway (Drawings C-021.10 and C-023.10). The bulkhead intersects the Northeast end of the South Pier and extends south. The cofferdams are located on the land side of this bulkhead. Approximately 225 feet of cofferdams were exposed for inspection in this area (Figures 2, 3 and 4).

The Contractor performed the demolition of the slab along the North bulkhead and exposed the cofferdams. The cofferdams are at approximately the same elevation as the existing bulkhead as shown on the attached photographs. A visual inspection was performed and there is no apparent loss of fill in the cofferdams.

The cofferdams appear to be in good condition with no apparent loss of fill. Therefore, no remedial action is required or recommended at this time. During construction, inspection ports will be installed in the pier deck at the location of each cofferdam and as close to the bulkhead as possible. From these ports a stick measure can be taken of the cofferdam fill level every five years as required by Special Condition 24(ii) of the Permit.
