## APPENDIX 1: SHARED-USE SIDEWALK

### Introduction

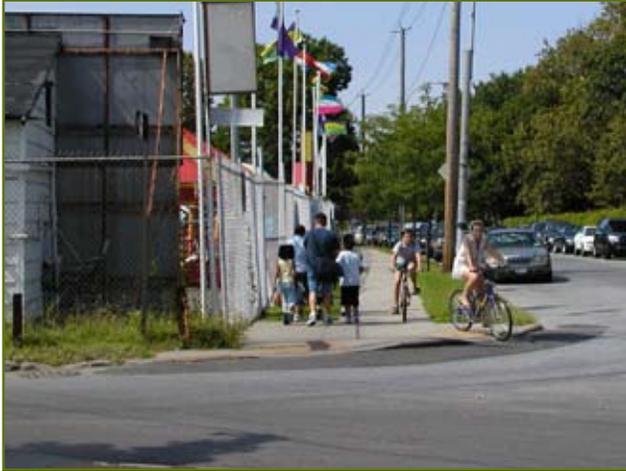
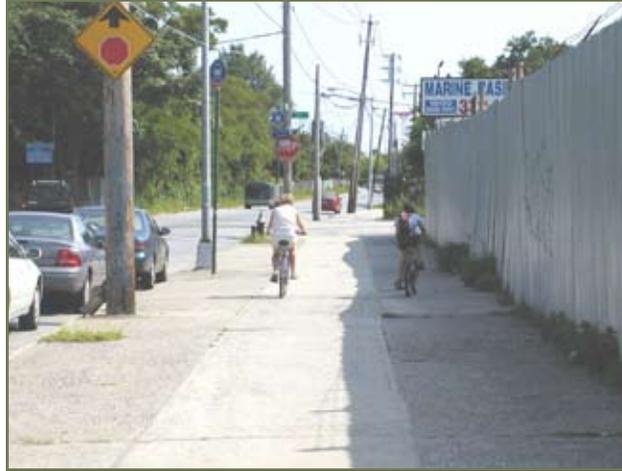
### 14. & 15. Additional Photos

Looking at the corner of Nellie Bly Park and Bay 41st Street above (14.) and the Bay 41st Street intersection with Shore Road South (15.).

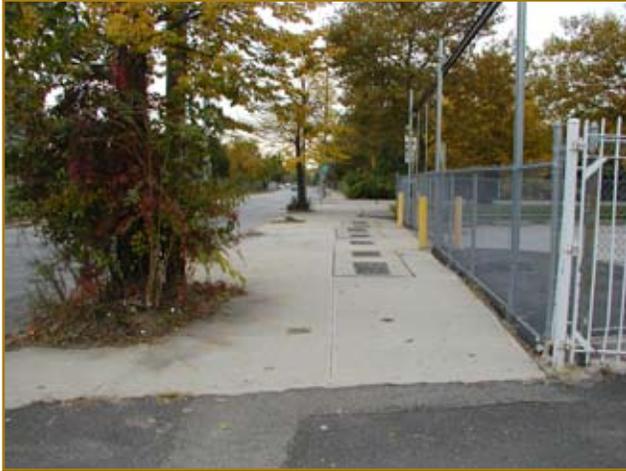
### 21. Block Institute

Segment Length: 170 feet  
 Pavement Condition: Good  
 Sidewalk Width: 18 feet  
 Driveways: 1  
 Cross Streets: Bay 44th Street  
 Photo: Looking south

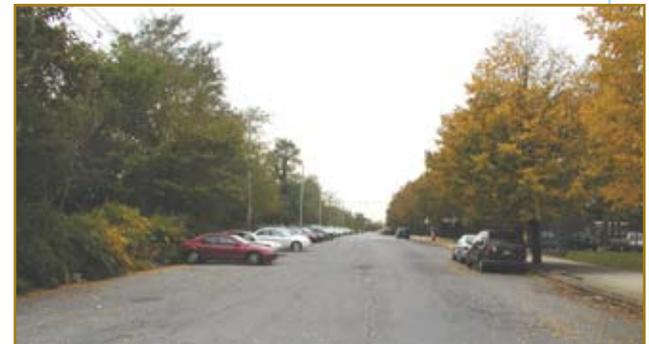
### 23. & 24. Additional Photos

Above photo (23.) shows bicyclist riding against traffic in front of park entrance. Bay 44th Street (24.) has 90-degree angled parking and is the main entrance for the Block Institute.

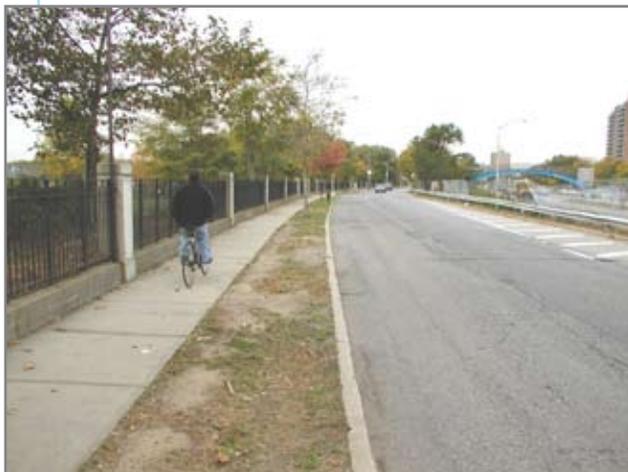
### **25. Dreier-Offerman Park II**

Segment Length: 955 feet

Pavement Condition: Good

Photo: Looking north

Issues: The paved sidewalk is 5 feet wide. Note bicyclist riding on sidewalk and the blue pedestrian bridge spanning the parkway.

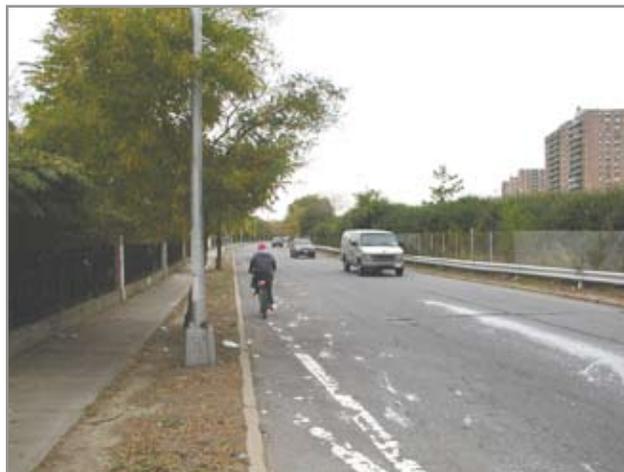
### **26. Additional Photo - Bicycle**

Looking north on Shore Road South at bicyclist riding against traffic. The park is underutilized and usually vacant, but there are occasions when the park is active.

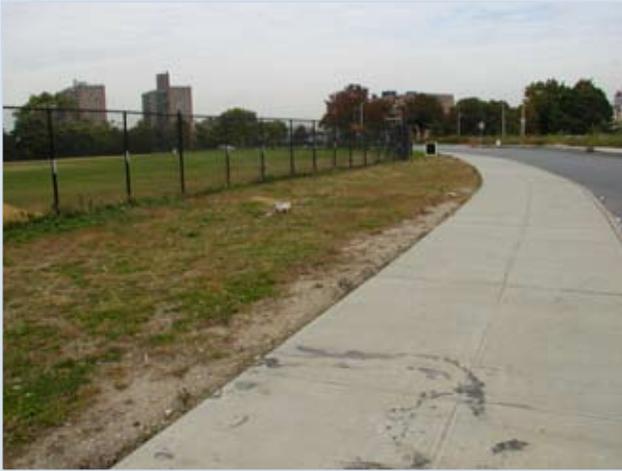
### **28. Six Diamonds Park**

Segment Length: 1,000 feet

Pavement Condition: Good
