Supplement to DEC Required EAP Post-Incident Report Form
Gilboa Dam EAP Activation, 12:15 pm, 8/28/11

SUBJECT: Gilboa Dam EAP Activation, 12:15 hours, 8/28/11
(Hurricane Irene Flood Event)

DATE: August 30, 2011

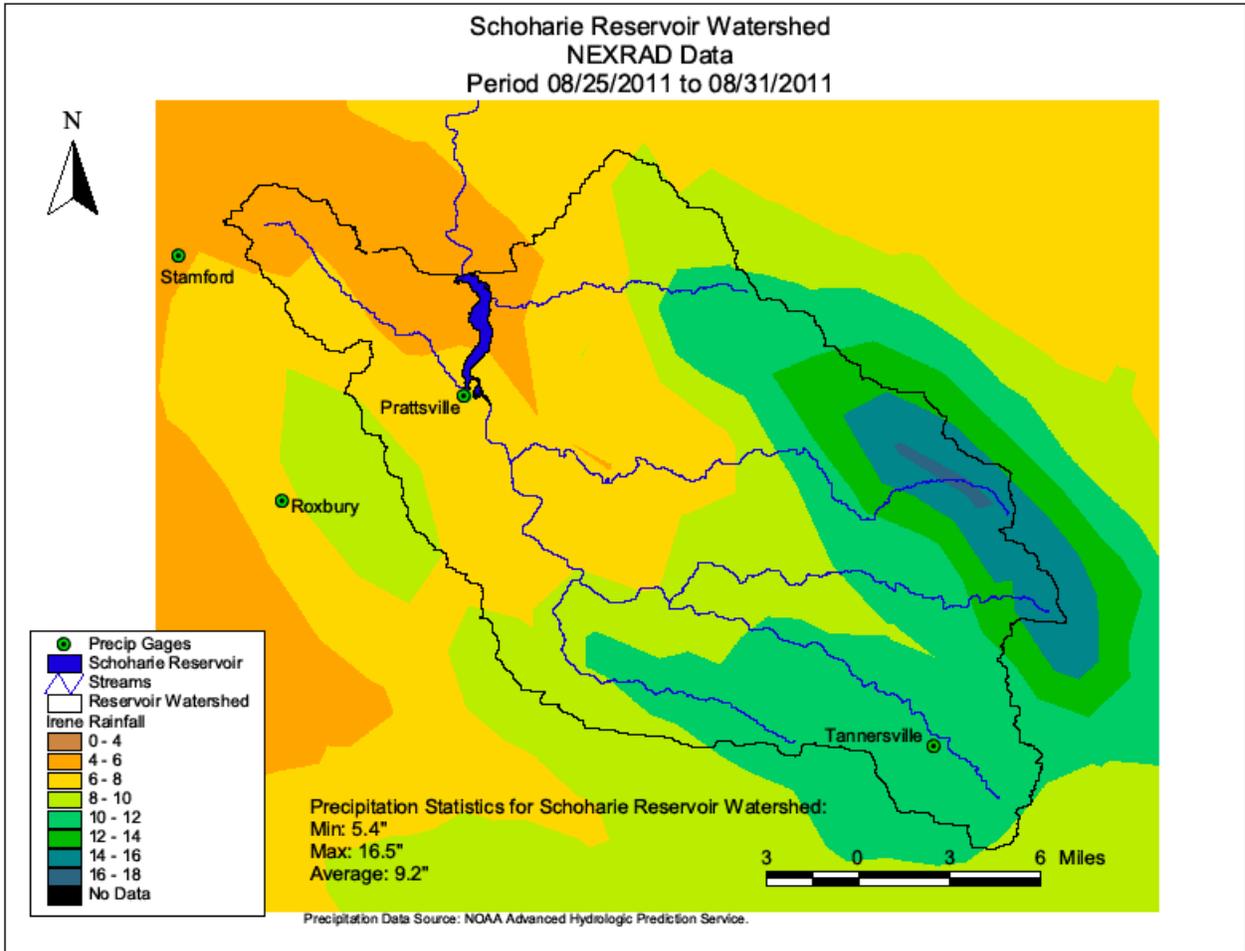
Figure 2: This figure shows a NEXRAD radar image of the precipitation that occurred within the Schoharie Reservoir watershed during Hurricane Irene to provide rainfall depth and aerial distribution information.
