**New York City Department of Transportation
Office of School Safety Engineering**

School Safety Engineering Project

FINAL REPORT: I.S. 2 (George L. Egbert School), Staten Island

September 27, 2006

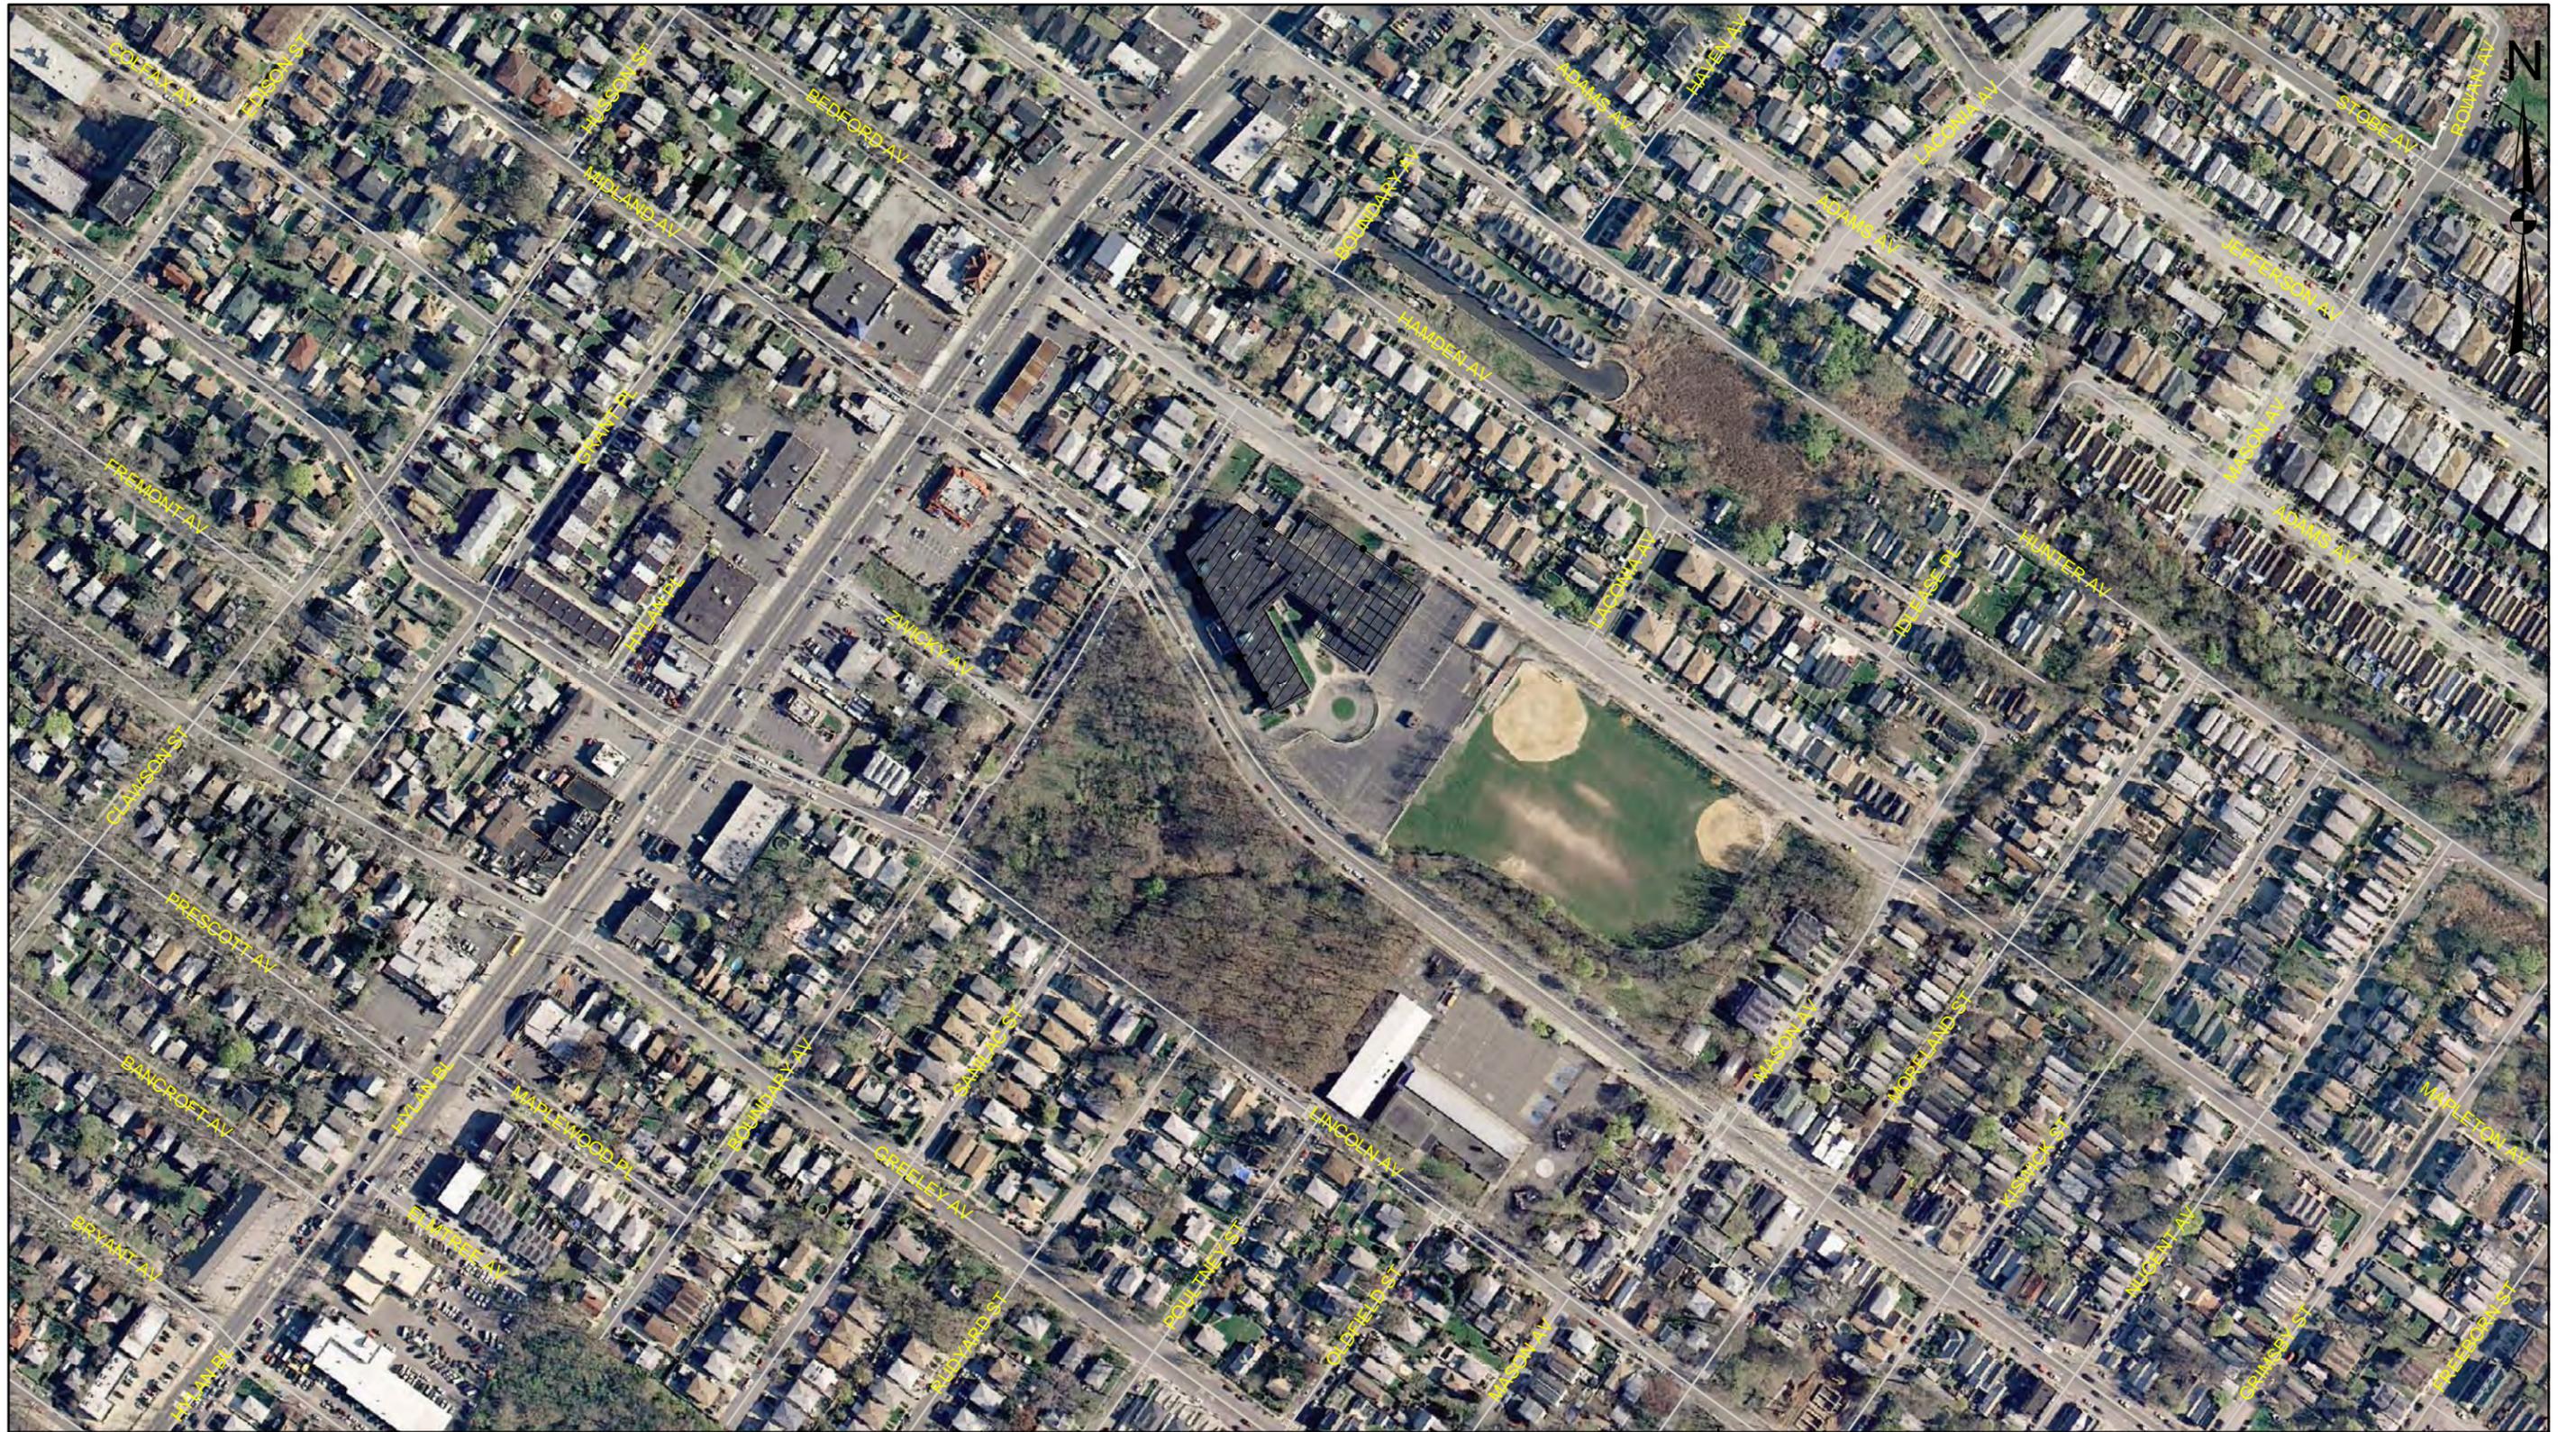
EXHIBIT 1
I.S. 02 STATEN ISLAND
GEORGE L. EGBERT SCHOOL
AERIAL PHOTOGRAPH

Exhibit 1 shows an aerial view of the neighborhood surrounding the school. I.S. 2 is bounded by Bedford Avenue to the north, Midland Avenue to the south, and Boundary Avenue to the west. The school's associated athletic facilities (including tennis and basketball courts, and baseball/softball fields) are located east of the school building, and adjacent to residential properties fronting Mason Avenue. The neighborhood surrounding the school consists primarily of residential uses, except for a wooded area directly opposite the school along the south side of Midland Avenue. I.S. 2 is also one block east of Hylan Boulevard, a roadway with many commercial uses that also carries significant traffic volumes. Another school, P.S. 38, is located east of, and adjacent to, the wooded area south of Midland Avenue.

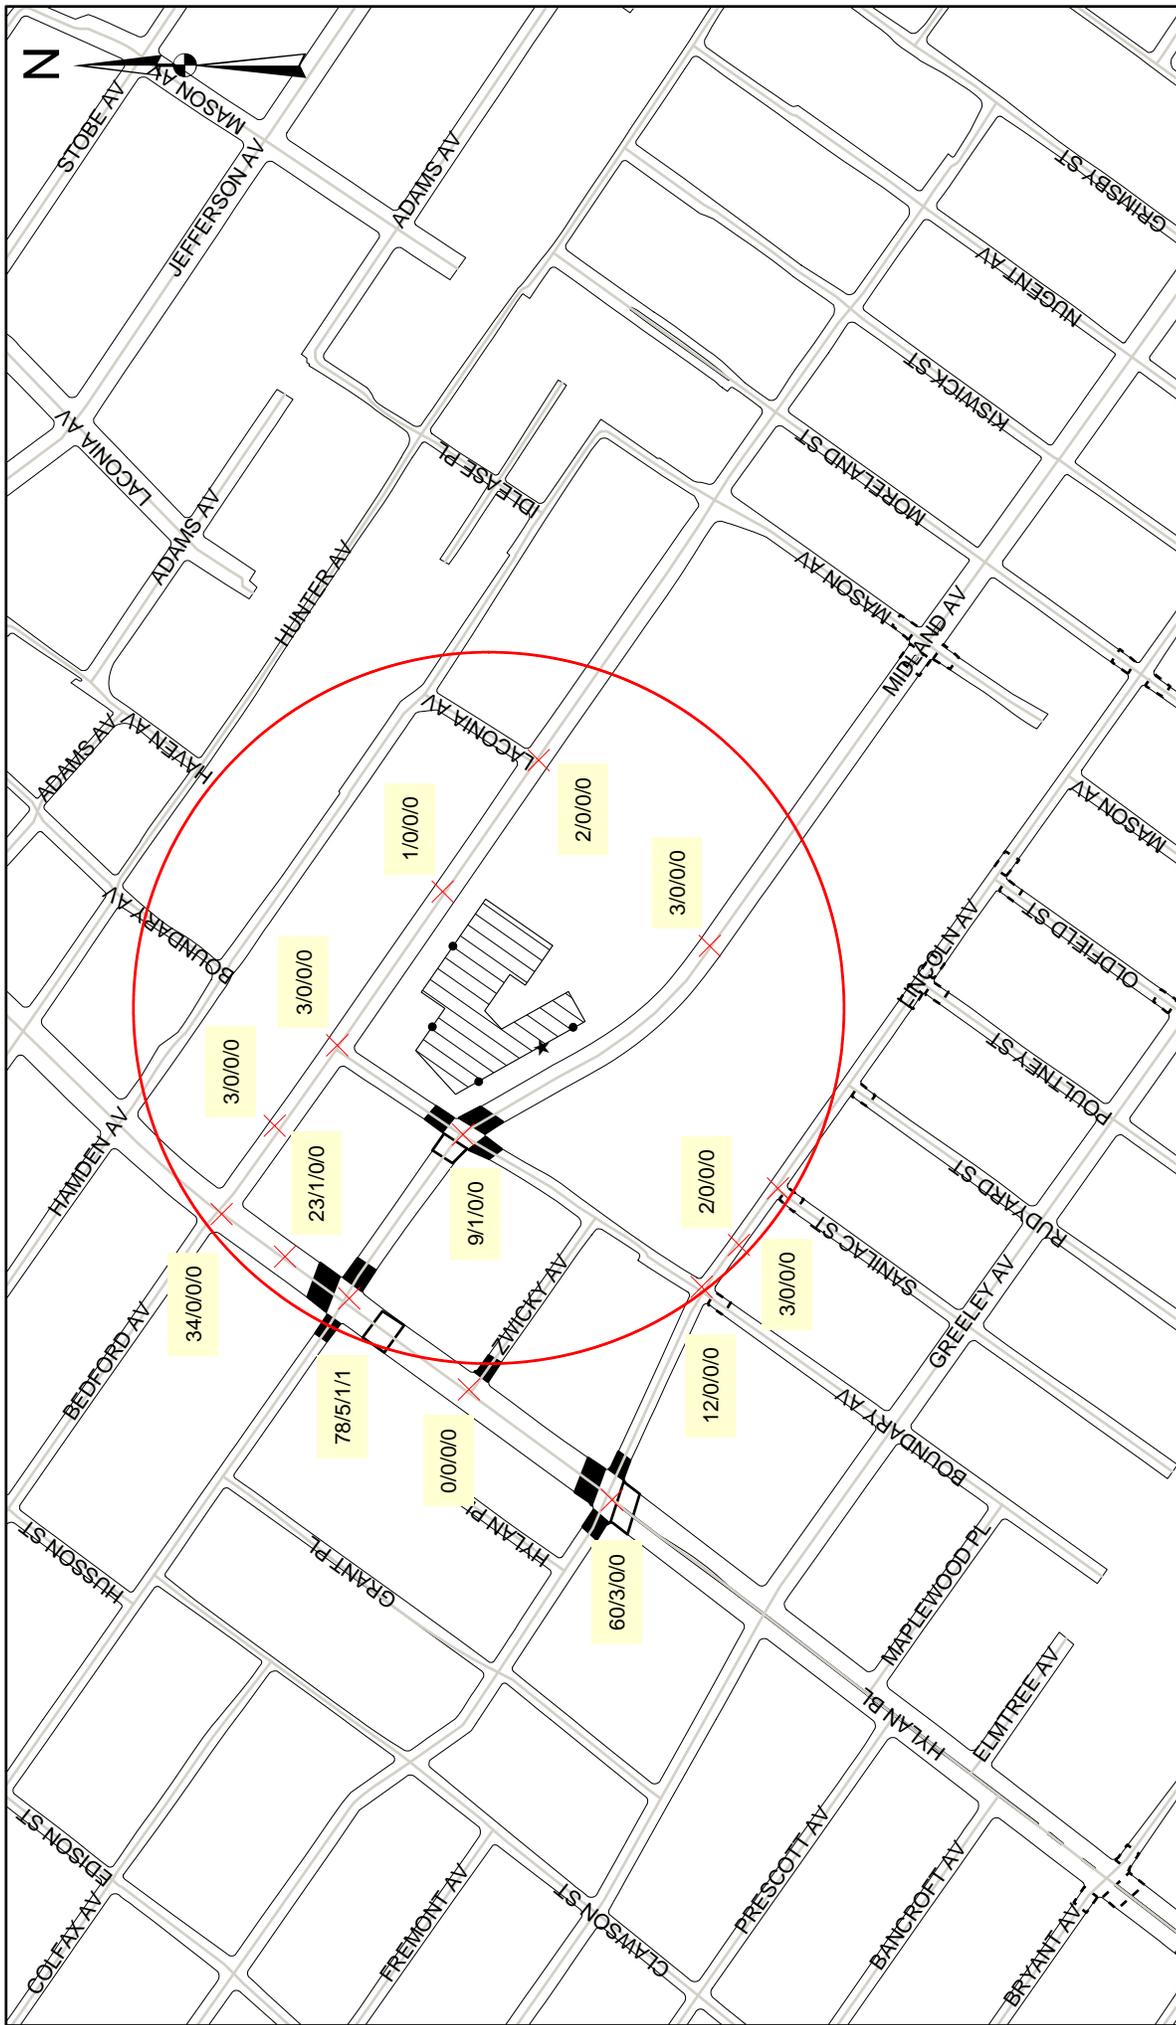
EXHIBIT 5

Exhibit 5 and Table 2 show a summary of accidents, as obtained from the New York State Department of Motor Vehicles (DMV), in the vicinity of I.S. 2 for a three-year period from January 1, 1998 through December 31, 2000. The DMV data provides some detail relating to the circumstances and cause of an accident. Table 3 is a summary of more recent accident data obtained from the NYC Police Department (NYPD). Though current through 2004, the NYPD data does not provide the same level of detail as the DMV data.

TABLE 3: ACCIDENT SUMMARY OF NYPD DATA (2001-2004)				
INTERSECTION	TOTAL ACCIDENTS	PEDESTRIAN ACCIDENTS	PEDESTRIAN FATALITIES	SCHOOL-RELATED ACCIDENTS*
Hylan Boulevard and Midland Avenue	143	9	0	4
Midland Avenue and Boundary Avenue	20	0	0	0
Hylan Boulevard and Lincoln Avenue	97	9	1	1
Hylan Boulevard and Zwicky Avenue	0	0	0	0
Boundary Avenue and Bedford Avenue	1	0	0	0
TOTAL	261	18	1	5
