**CONDITIONS ASSESSMENT**

**70 MULBERRY STREET  
NEW YORK, NY**

Prepared by:  
Jablonski Building Conservation, Inc.  
40 West 27<sup>th</sup> Street, Suite 1201  
New York, NY 10001

March 2021

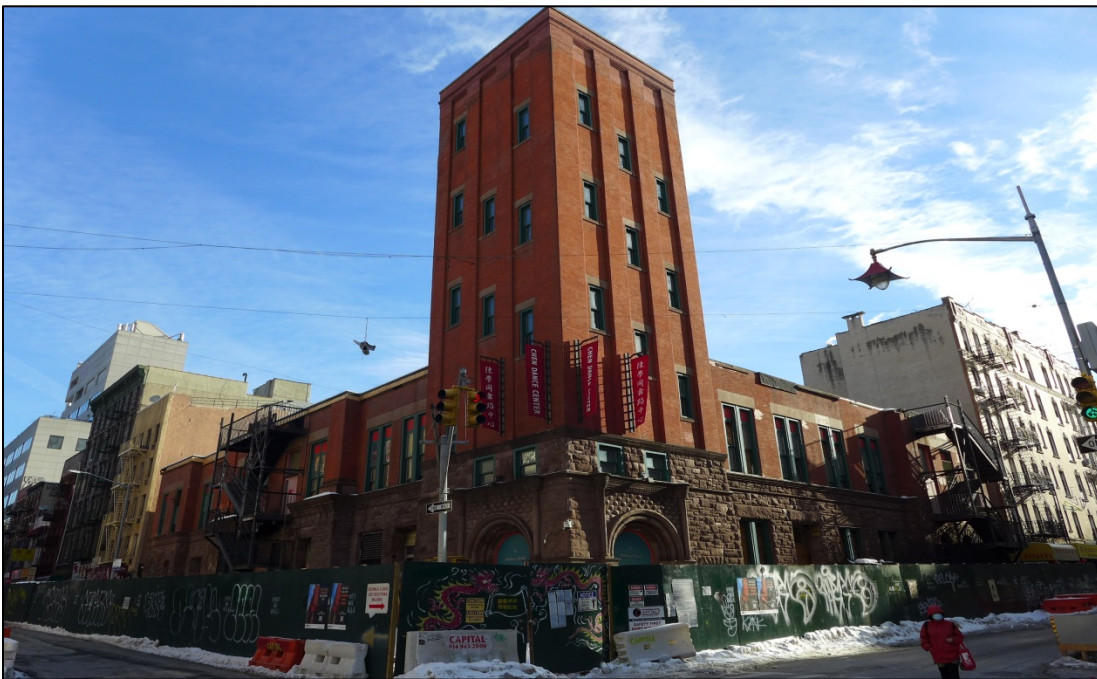
On January 23, 2020, a fire broke out in the building. The fire reportedly started on the fifth floor of the building. After the fire, the third, fourth, and fifth stories were removed leaving the brownstone base, the brick second story, and the majority of the brick stair tower (Figure 1 and

Figure 2: 70 Mulberry Street after fire and demolition.

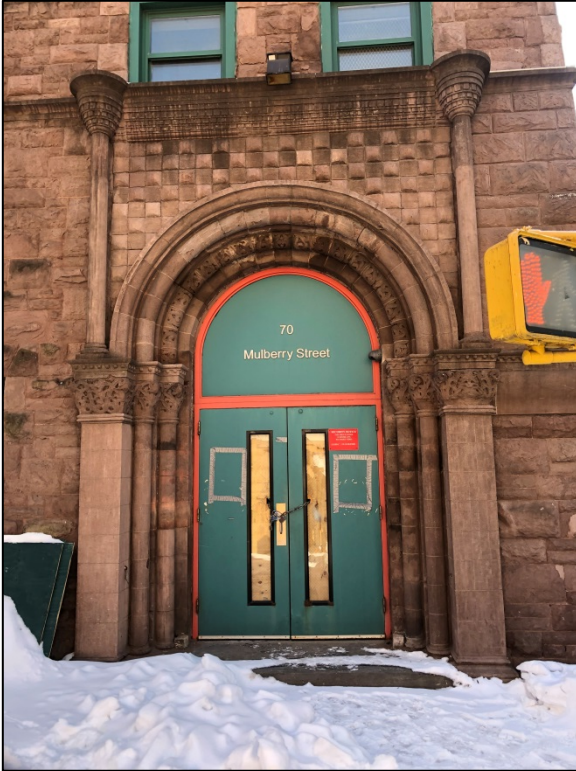
The Mulberry Street and Bayard Street elevations are connected by a stair tower at the intersection. Each elevation has a similar entrance at the tower consisting of engaged columns and capitals, an archivolt, a checkerboard block spandrel, and an ornate, three-layered dentiled cornice (Figure 4).

The cornice above the Mulberry Street entrance has heavy atmospheric soiling and there are cracks in a limited number of the blocks in the spandrel below (Figure 4 and 9). Below the cornice there is an area of patched brownstone that is in good condition (Figure 10). The engaged columns that frame the Mulberry Street entry door are in good condition with delamination and spalling at the base of the south side of the entrance and some minor delamination on the north side closest to the ground (Figure 11). The cornice above the Bayard Street entrance has light atmospheric soiling. The columns are in good condition with majority of spalling and delamination at the base of both sides of the door (Figure 7).

Figure 4: Mulberry Street entrance.

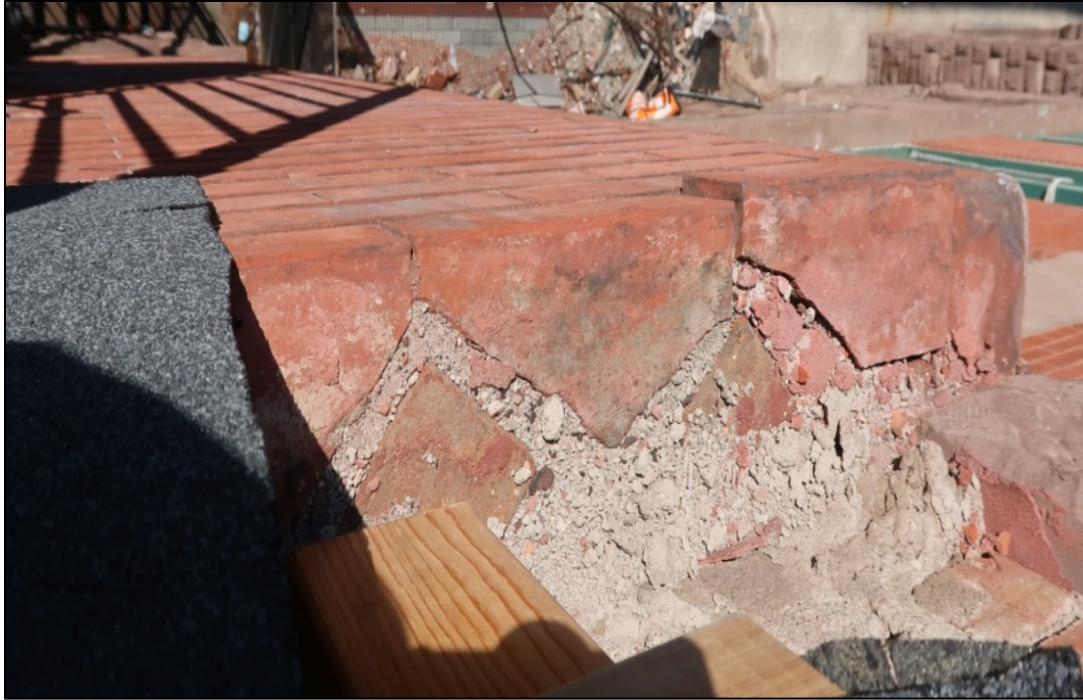
The façade bricks are pressed brick laid in a stretcher bond and are connected to the backing wall of common brick using clipped brick and blind headers (Figure 19). A header brick, laid at a sixty-degree angle, is used to tie the stretcher face to the load bearing masonry behind (Figure 20). This brick bond is not a good bond but for one story of brickwork, it is feasible to stabilize.

Figure 19: Looking down from above Pressed Brick in a stretcher bond with clipped brick bond to back-up masonry wall, Bayard Street.

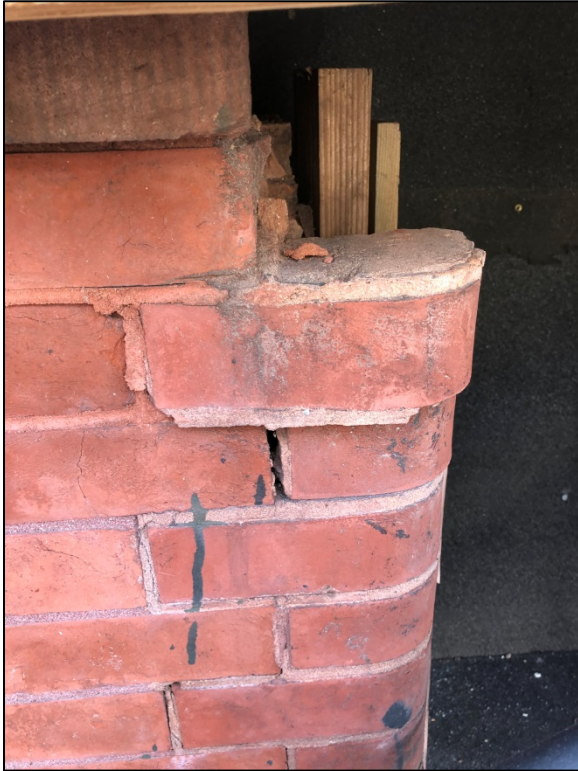
Bullnosed brick, or a brick with a rounded-off edge, is used around the windows on both elevations and on the edge of the brick pilasters on both elevations including those on the stair tower (Figure 21). A red tinted mortar is used with the pressed brick on both elevations and the stair tower. In areas of repair, both a red tinted mortar and a gray mortar has been used with the replacement brick.

Figure 21: Displaced bullnose brick at fire escape, Mulberry Street.

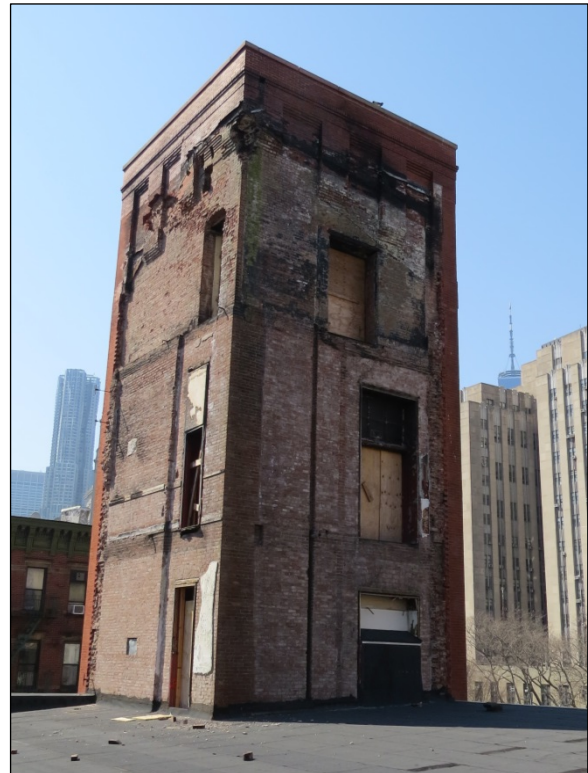
The interior walls (the north and east walls) of the stair tower have been left exposed to exterior conditions due to the demolition of the top three stories of the south and west elevations. Both interior elevations exhibit damage from this demolition throughout (Figure 24). There is broken brick spanning the entire height of the tower (above the roof) along the northwestern and southwestern edges of the stair tower where the south and west walls of the building connected to the tower (Figure 25). The fifth-floor of the stair tower has evidence of soot and charred roof flashing on the brick of both interior walls (Figure 26). The damage to brick in this area is primarily due to demolition. The brick in the top northeast corner is missing and what remains is loose, which is a potential safety issue. There is currently brick and mortar debris on the temporary roof below the damaged corner. This condition has allowed for water infiltration into the tower and resulted in biological growth along the wall (Figure 27). It may also have destabilized the parapet wall of the tower.

Figure 24: Interior exposed walls of stair tower.

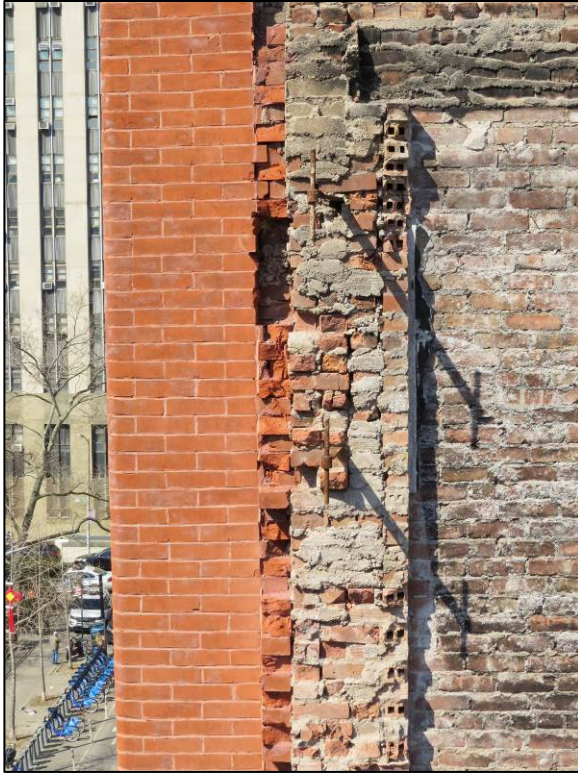
Figure 25: Demolition on corner of stair tower, Bayard Street.

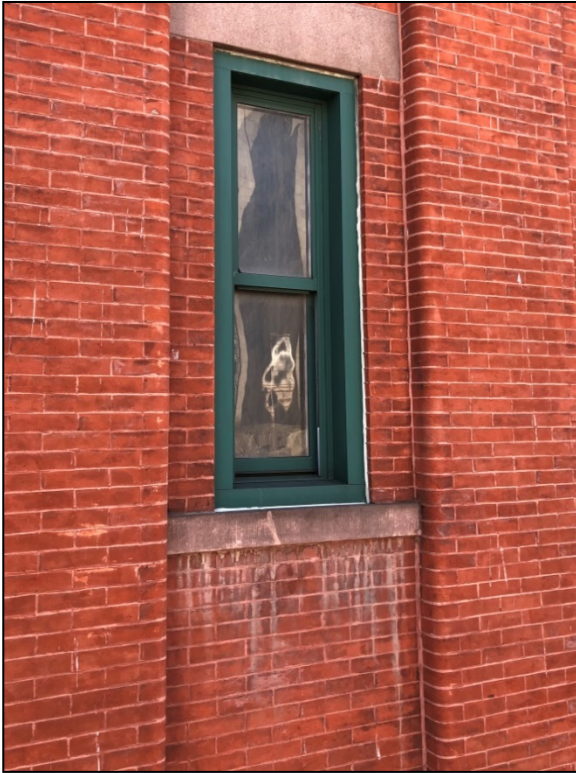
Figure 29: Atmospheric soiling and efflorescence buildup below the stone window sill stair tower, Mulberry Street.

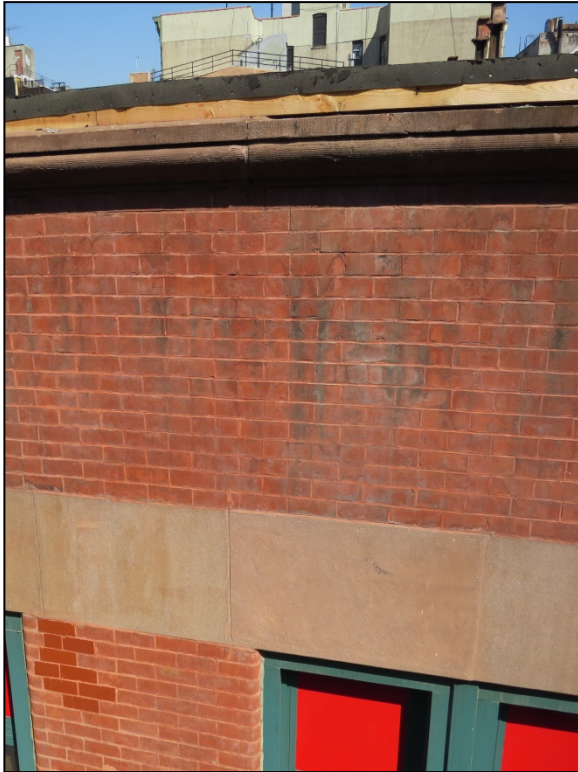
Both 2<sup>nd</sup> story elevations have atmospheric soiling and efflorescence on the brick primarily between the temporary roof and stone lintel above the windows (Figure 33 and in some areas below the windowsills on the Mulberry Street elevation. There is damage to the temporary roof and stone belt course at the northwestern corner of the Bayard Street elevation, below which there is significant atmospheric soiling and efflorescence (Figure 34). On both elevations there is either infill masonry, damaged masonry, or missing masonry at the bottom corner of most of the windows (Figure 35). The window closest to the stair tower on the Bayard Street elevation has infill masonry and is missing bricks above the window (Figure 36).

Figure 33: Atmospheric soiling and efflorescence, Bayard Street.

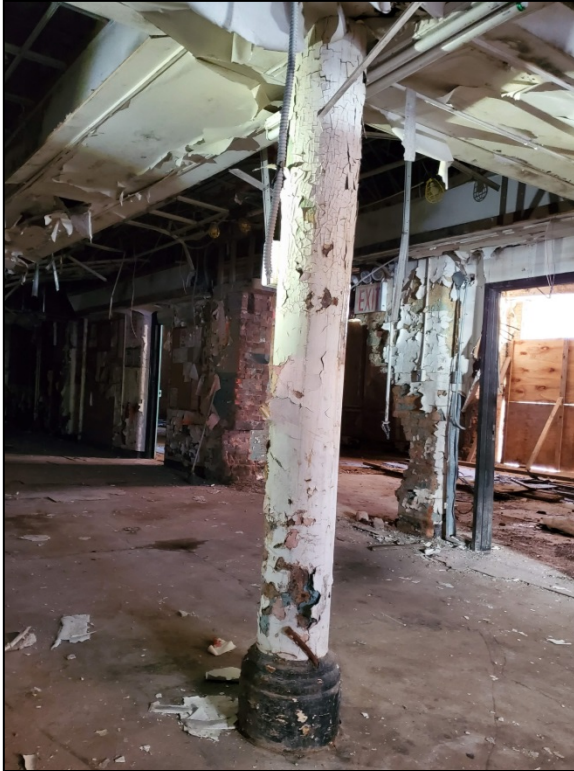
The cast iron columns, consisting of a shaft, base, and capital, are arranged in two rows of four in the middle of the central space. All eight cast iron columns are corroded with peeling paint (Figure 37). Heavy corrosion is present at the base of all columns (Figure 38). Two columns are missing bases (Figure 39). Three columns have open seams and minor separation at the base (Figure 40). In the basement, there are cast iron support columns directly below the first-story columns. The columns have many of the same conditions as the first level of rust staining and missing elements.

Figure 37: Cast Iron columns.

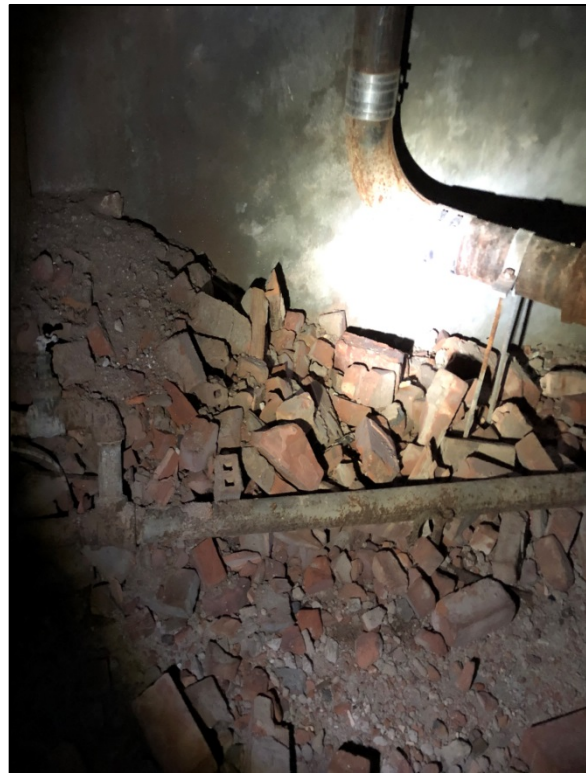
The pressed brick walls of the central space on the first story have been painted several times and have areas of peeling paint throughout, damage due to demolition, mold, and water damage (Figure 41). The brick has a red tinted mortar that can be observed under areas of peeling paint (Figure 42). The west elevation wall of the central room is the most significantly demolished with areas exposing the backup masonry wall (Figure 43). While, pressed brick was not used in the basement level, there are demolished pressed brick that have fallen into the basement level and may be salvaged for reuse (Figure 44). The basement has water infiltration and mold throughout.

Figure 44: Pressed brick pile in basement.

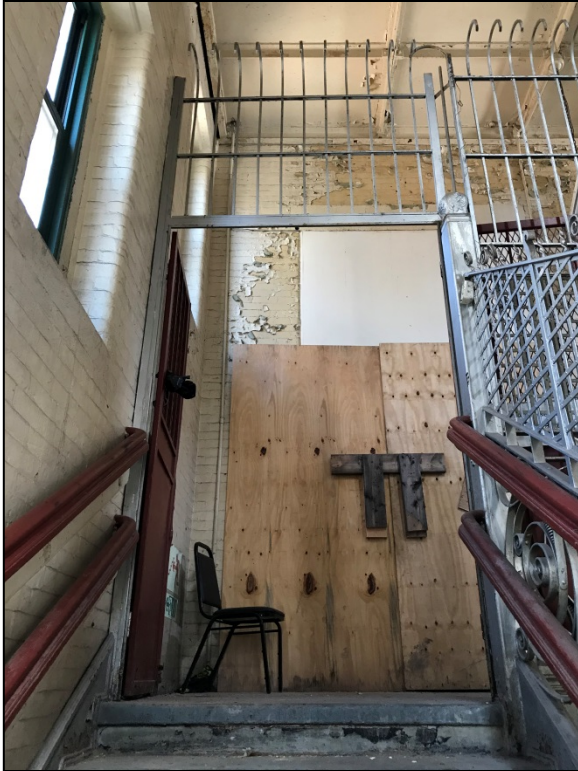
The interior of stair tower consists of five stories of painted pressed brick walls, painted metal stairs, and a wrought iron railing. The brick has been painted several times and have areas of peeling paint. The fifth floor has the largest area of peeling paint due to the fire event (Figure 45). There are some areas of peeling paint and efflorescence on the fifth floor near the ceiling (Figure 46) and mold on the second floor. The stairs have been painted both on top and underneath and have peeling paint throughout. The risers of the stairs exhibit areas of mold (Figure 47). The wrought iron railing is ornate with a metal mid-rail and hand rail. The railing is painted and in good condition with minor areas of peeling paint (Figure 48).

Figure 45: Fifth floor stair tower with peeling paint.

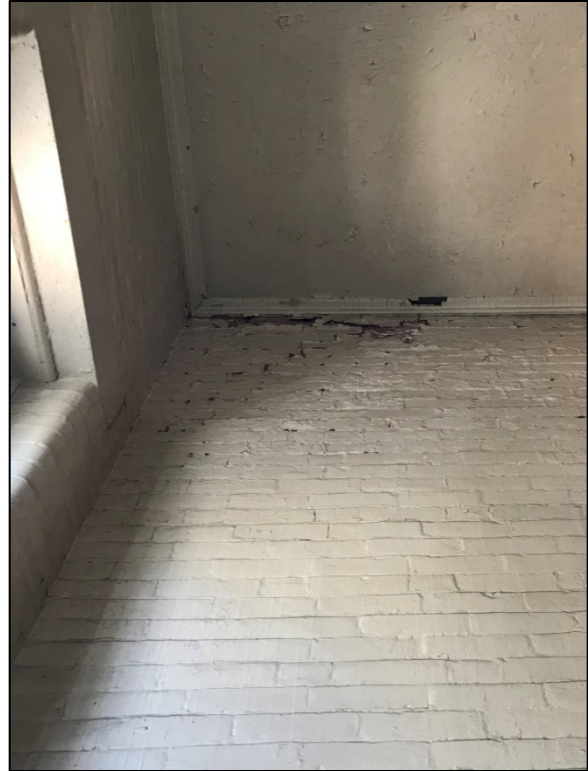
Figure 46: Fifth floor stair tower with peeling paint and efflorescence.

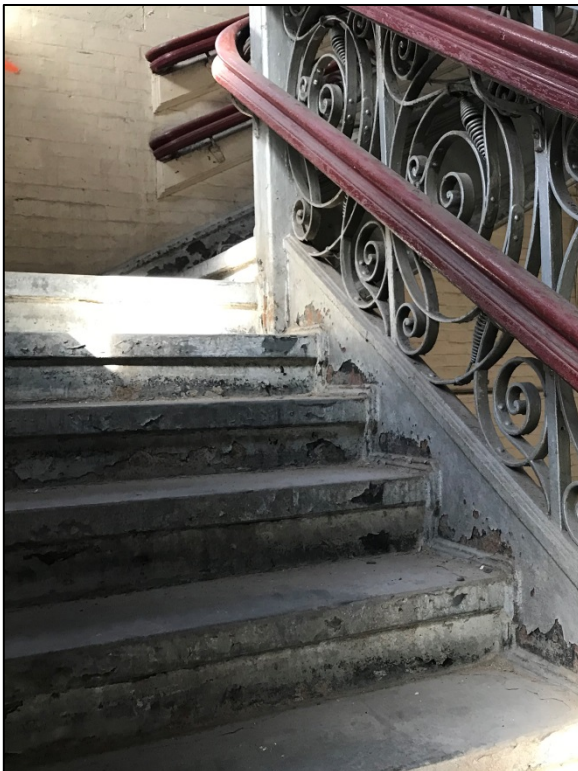
Figure 47: Stairs with peeling paint and mold.

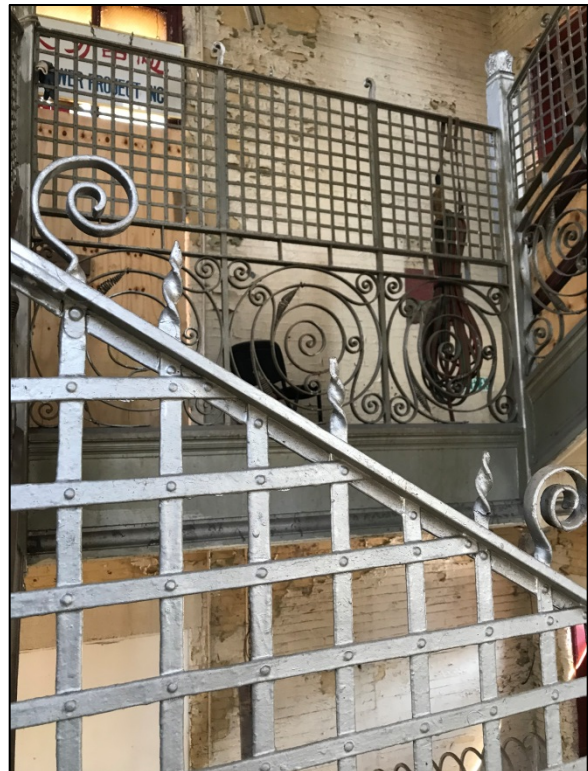
The wrought iron in the stair tower is in good condition.

Figure 48: Wrought iron railing.

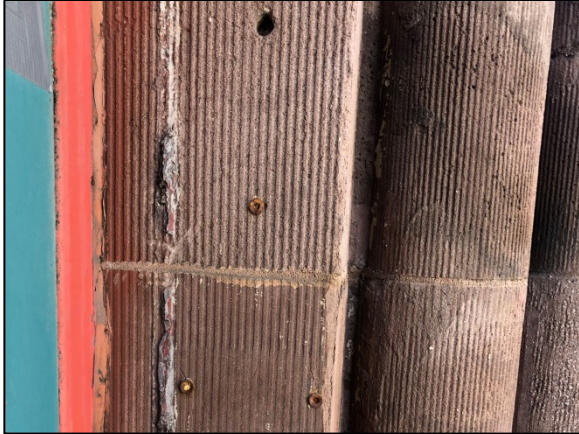
Anchor holes are typical in both brownstone and brick on the exterior façades of 70 Mulberry Street. Abandoned anchors were found in the brick immediately above the brownstone string course at the main entrances on both Mulberry Street and Bayard Street.

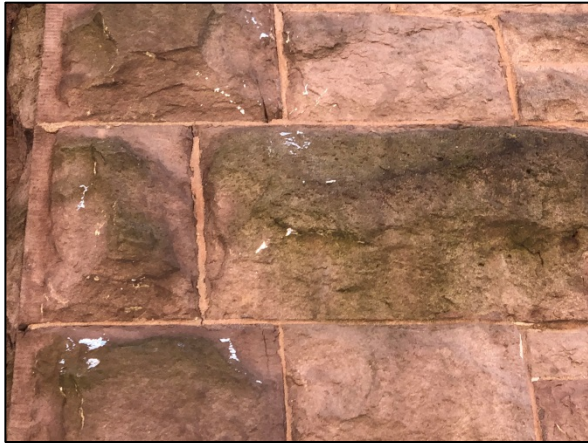
Biological growth was noted primarily on the brownstone in areas around the fire escape stairs on both Mulberry and Bayard Street facades. Some biological growth was also seen along the northeast corner of the stair tower.

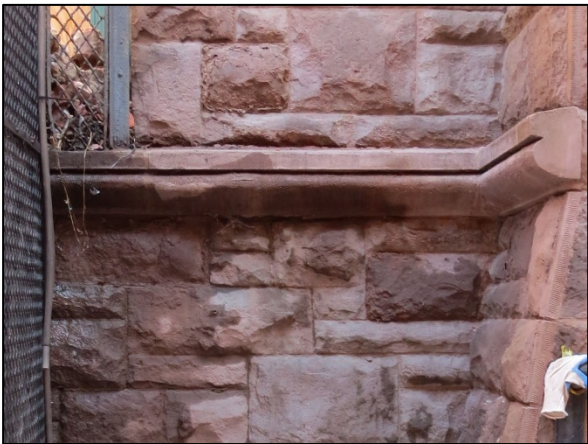
Bulging was noted in the brownstone band at the plinth level immediately on the west side of the fire escape on the Bayard Street elevation.

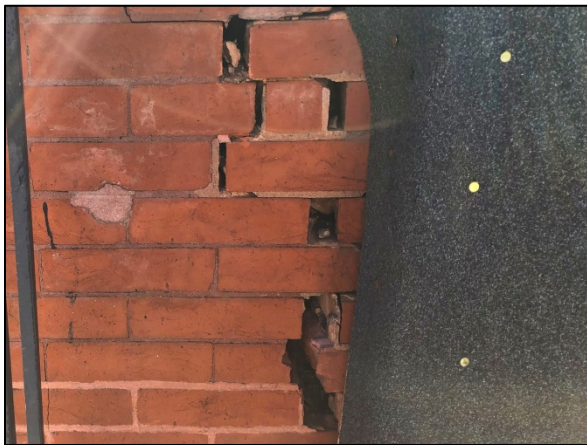
## Displacement

Displacement of bricks, most likely from demolition damage, was observed at the top corners of the fire escapes on both Mulberry Street and Bayard Street.

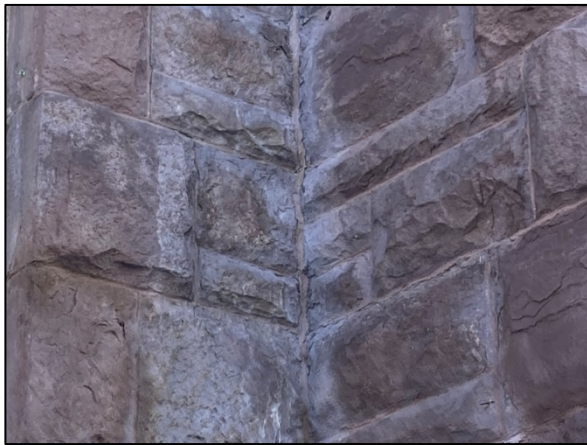
## Efflorescence

Efflorescence is present on both brownstone and brick masonry on the exterior at 70 Mulberry Street, primarily in all the returns. It was notable on the brownstone at the north side of the fire escape on Mulberry Street elevation, on the brick at the east side of the Bayard Street elevation, and under the window sills in the stair tower.

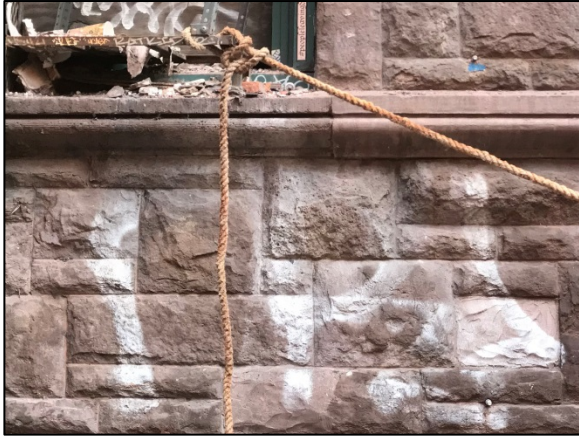
## Graffiti

Graffiti was noted on a section of brownstone at the east corner of Bayard Street elevation.

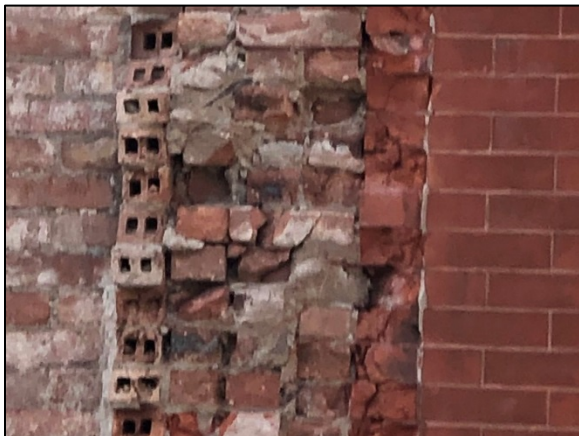
## Impact Damage

Bricks behind the fire escapes, especially below the temporary roof at the top, and on the north and east facades of the stair tower have been damaged due to demolition after the fire.

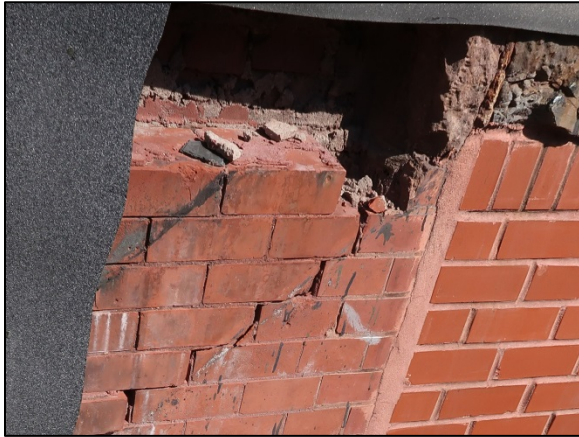
## Material Loss / Missing Elements

Some sections of the brownstone window sills of the now-demolished third story, which remain below the temporary roof on both facades at 70 Mulberry Street, are missing. There are small areas of brick missing below the temporary roof behind both the fire escapes, and at the top northeast corner of the stair tower.

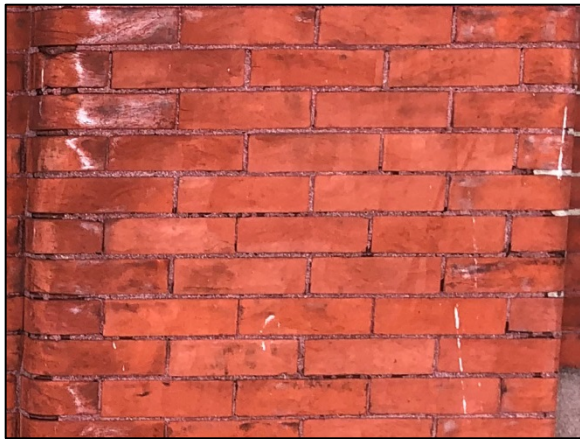
## Open Joints

Majority of the open joints were observed primarily in the brick masonry on the second story and the stair tower. There were a few locations of open joints in the brownstone masonry especially in the string course on both elevations.

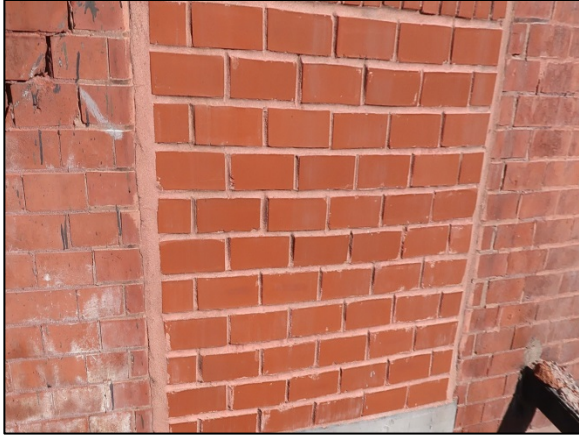
### *Infill and Non-matching Masonry*

There are few sections of infill masonry in the brick façade, primarily behind the fire escapes and around windows on the second story. Approximately twenty-five courses below the parapet of the stair tower are replacement bricks and do not replicate the bullnose edge of the rest of the stair tower. A small area of

brownstone behind the fire escape on Bayard Street has been replaced with brick.

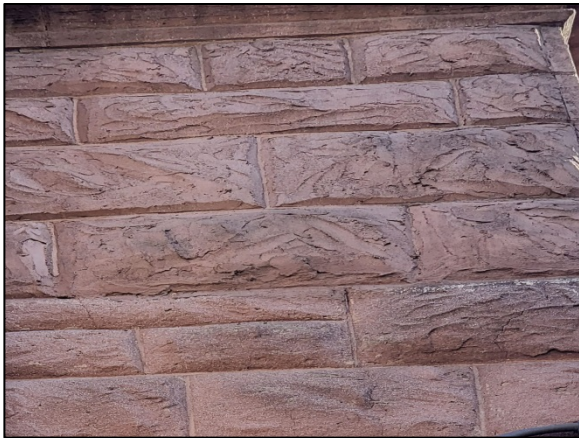
### *Patching*

Approximately 20-25% of the brownstone façade on both Mulberry Street and Bayard Street elevations has been patched and are mostly in good condition with minor cracks and spalls on some.

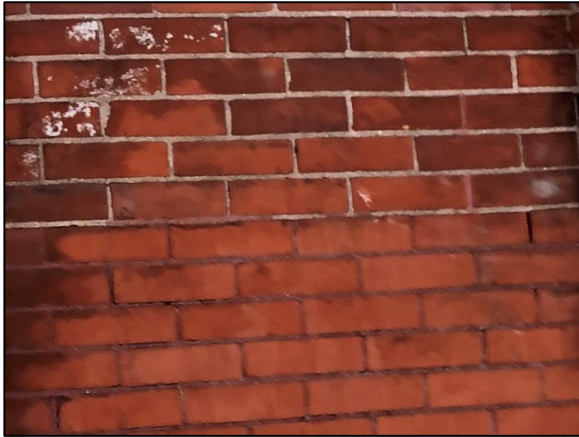
### *Repointing*

In areas of brick repair on the exterior at 70 Mulberry Street, either a red tinted mortar or a gray mortar has been used with the replacement brick.

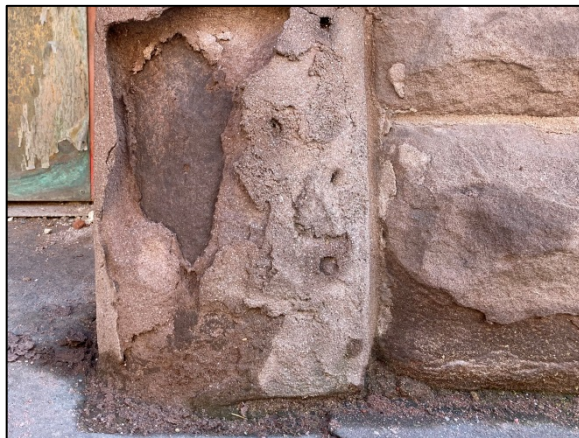
#### *Delamination*

Delamination of the brownstone is typical on both Mulberry Street and Bayard Street elevations. Surface erosion due to weathering was noted on the engaged column capitals at both the main entrances.

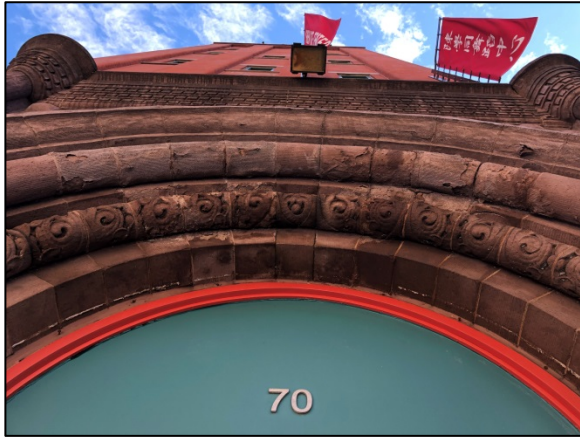
*Spall*

Spalls present at 70 Mulberry Street are primarily minor. These were found especially in areas of previous repair, in the brownstone archivolts of both entrances, arches above doors and windows on the Mulberry Street elevation. There were spalls near base of the engaged columns at both the entrances.

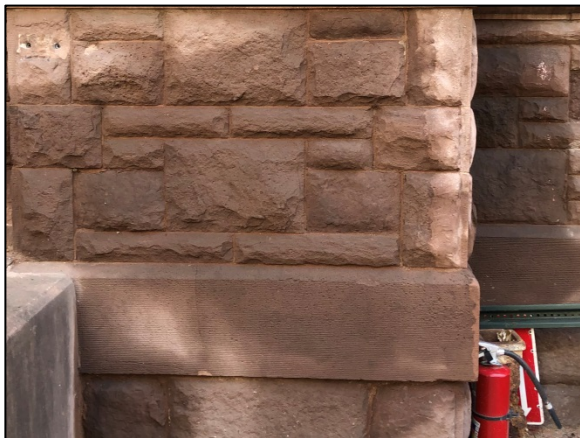
**Water Infiltration / Stains**

Visual evidence of water infiltration from the ground (following heavy snow) was noted on both facades at 70 Mulberry Street. Almost all the masonry below the brownstone band at the plinth level was damp to the touch. This indicated presence of excess moisture in the masonry that was also reflected through efflorescence and biological growth on both brownstone and brick masonry. Water staining was also noted immediately below the temporary roof on the exterior on both elevations. Ferrous metal reinforcement and anchors installed inside masonry walls can corrode due to the infiltration of moisture through the masonry that can deteriorate existing conditions of the masonry.

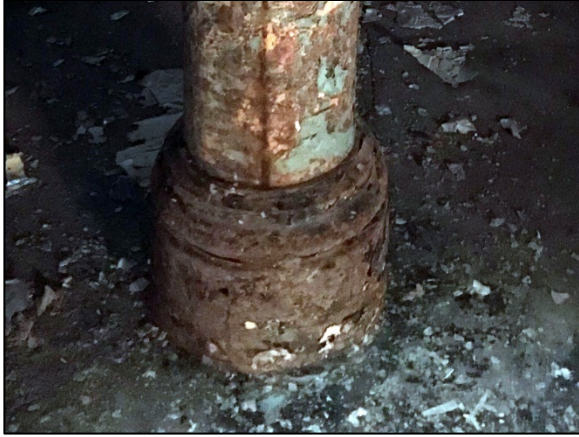
### Ferrous Metal Corrosion

Minor corrosion of the cast iron column bases is typical. The base of column 3 on the first floor was observed to have material loss due to heavy

corrosion.

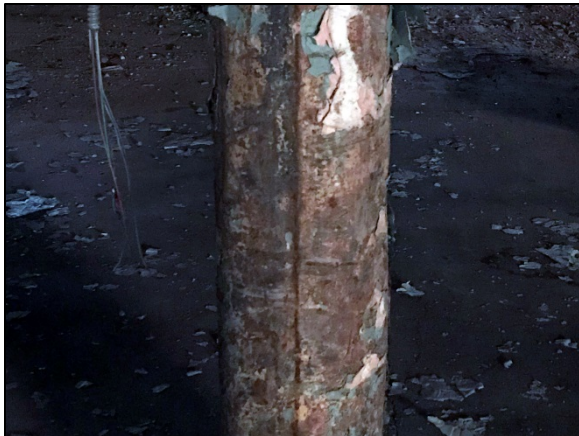
### Ferrous Metal Staining

Rust staining was noted on many of the painted cast iron column shafts.

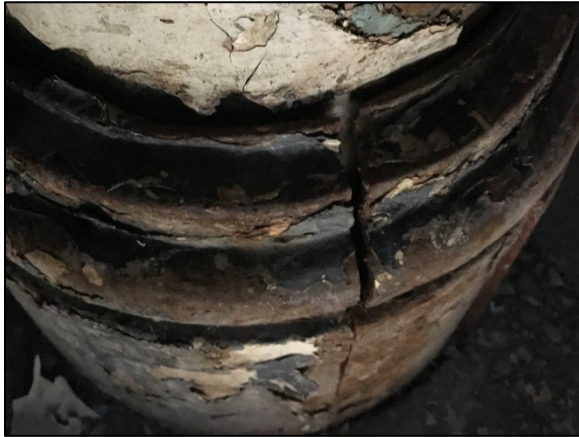
## Open Seam / Separation

Open seams were noted at the cast iron bases of columns 3, 7 and 8 in the central space on the first floor.

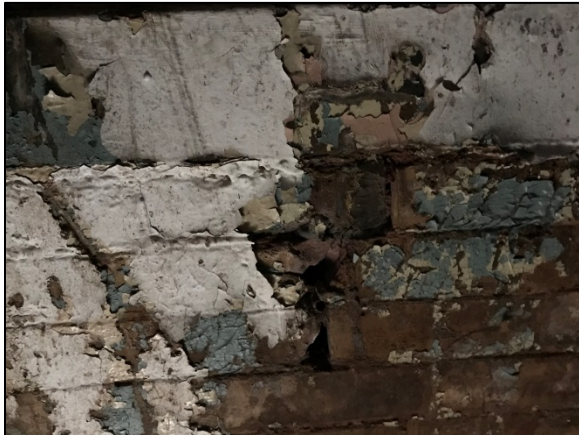
## Peeling Paint

Peeling paint is typical on majority of the painted cast iron columns and pressed brick walls on the first floor interior at 70 Mulberry Street. Peeling paint was also observed in the interior walls of the stair tower.
