Children's Museum of Manhattan

Landmarks Preservation Commission Application

Special Windows Conditions Assessment 6 December 2019

361 CPW – SPECIAL WINDOWS CONDITIONS ASSESSMENT (STAINED GLASS)

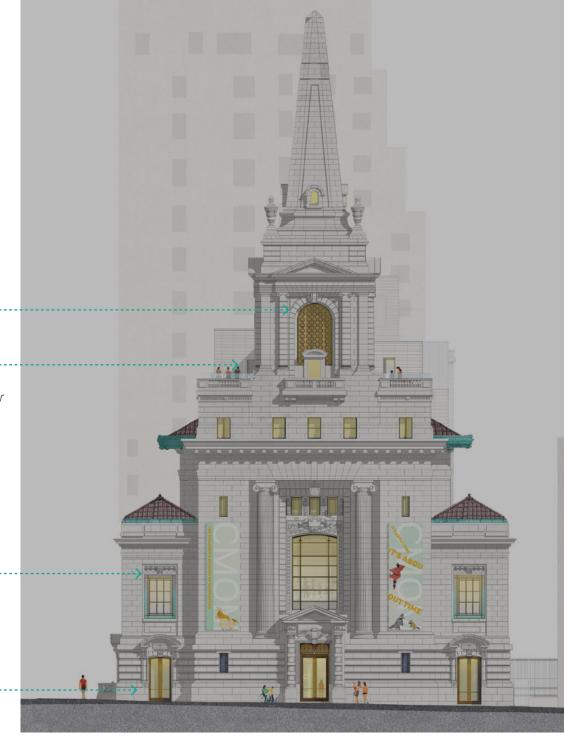
EAST ELEVATION

glow from interior to highlight lantern behind reconstructed lattice

low level soft light on terrace

light glow through hostoric stained glass border around windows

light from interior promoting new activity within

soft light at entries to welcome visitors

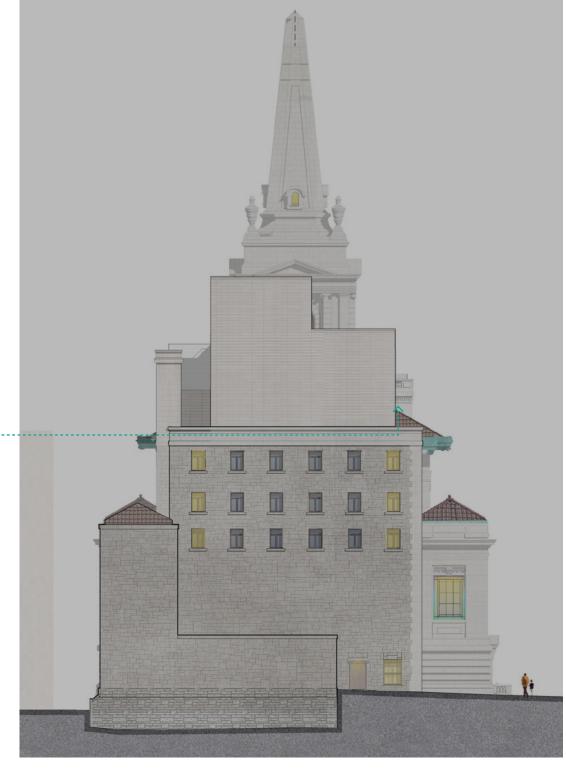
WEST ELEVATION

glow from interior to highlight lantern behind reconstructed lattice

low level soft light on terrace

light glow through hostoric stained glass border around windows

light from interior promoting new activity within

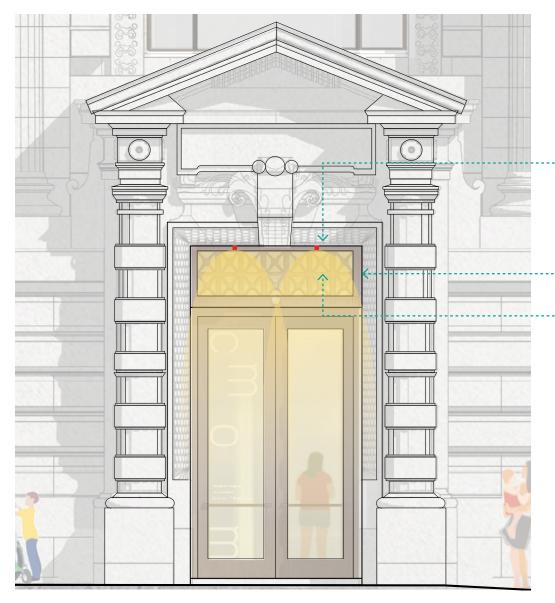
PROPOSED CONDITION

no fixtures to be installed in existing

glow from interior architectural lighting

small fixture to be integrated into new door frame

remove existing j-box and conduit

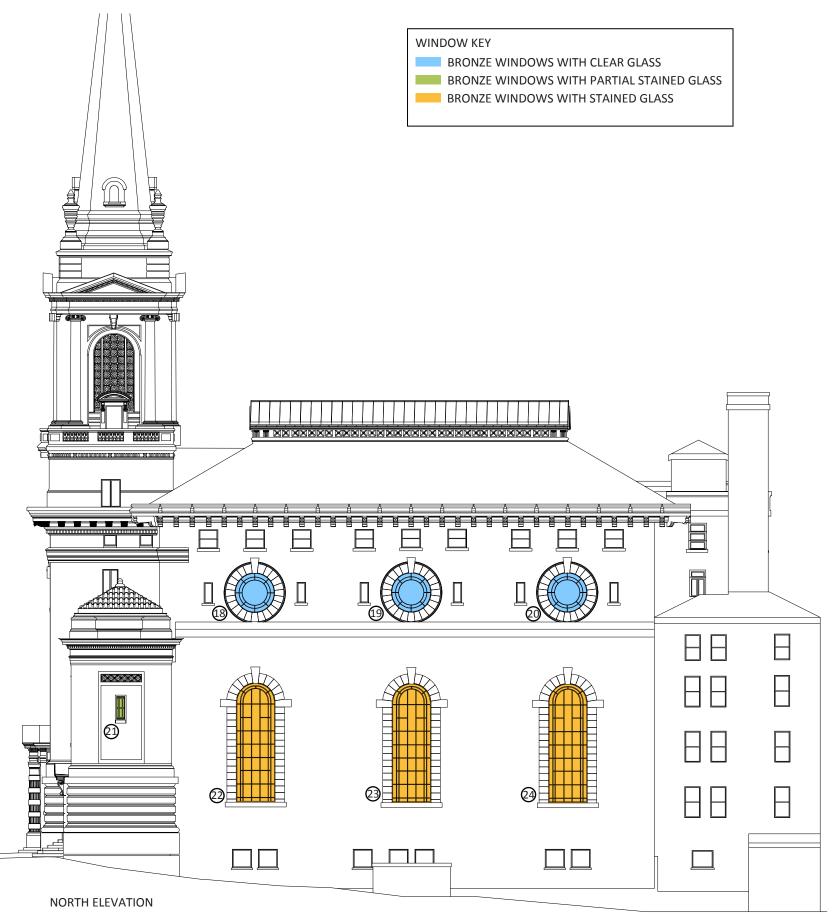
WINDOWS 18, 19, & 20 - BRONZE WITH CLEAR GLASS:

Rust & staining on bronze from inside (window 20 shown)

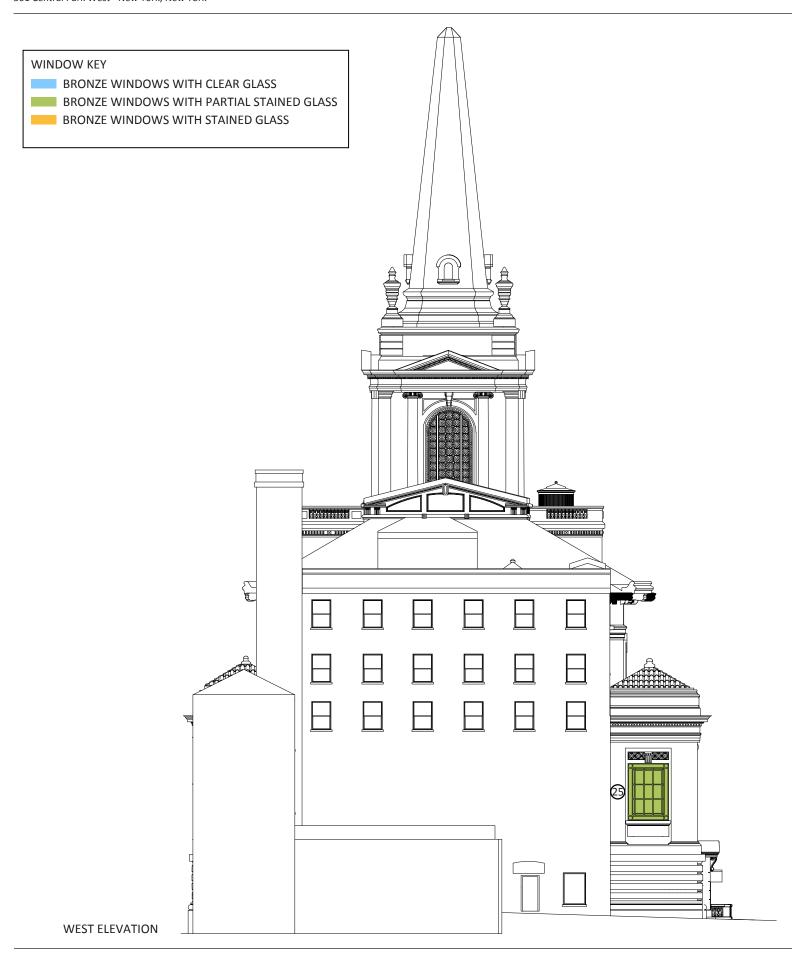
■ WINDOW 25 - BRONZE WITH STAINED GLASS AT PERIMETER ONLY:

View of window 25

Typical bowing stained glass (window 25)

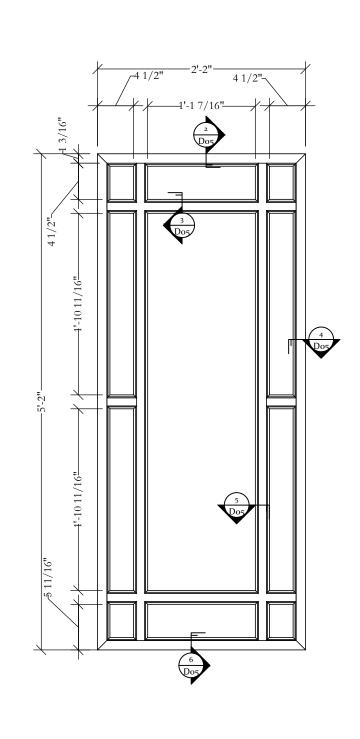
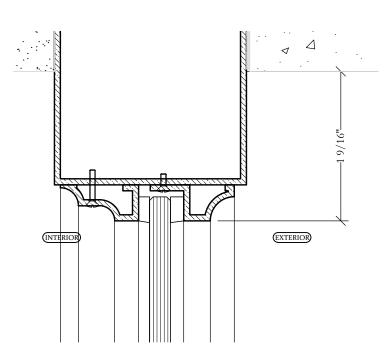
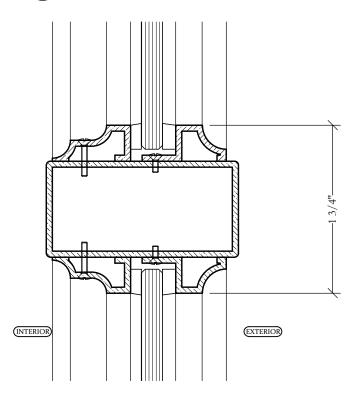
TYPICAL MULLION DETAIL

- d) A concerning amount of bronze members at the mullions (especially at the large arched windows 5, 6, 7, 22, 23, 24) have split in two. This could be due to some corrosion and the fact that these members appear to have been "welded" together to create a hollow profile. The weld seams have cracked, creating infiltration issues and structural issues.

- Secure all frame cracked and weakened members by repairing or replacing sections with matching frames.
- 2. Reinforce the main members with additional transom or frames.
- 3. Replace all corroded iron fastening brackets and splices with new stainless-steel brackets and splices.

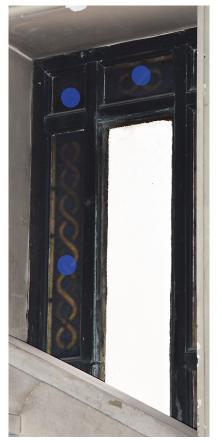
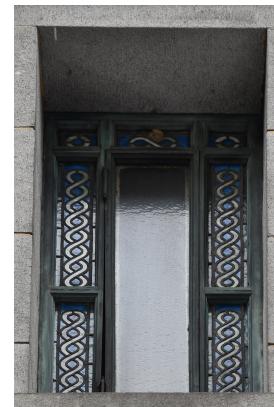
WINDOW 4 - BRONZE WITH STAINED GLASS AT PERIMETER ONLY

- Area of severe dirt and debris accretions. This accretion is hygroscopic, attracting water. Standing water adversely affects the lead cames, the framing, and in the long term, contributes to the corrosion of the glass.
- Area where the original glass is missing (interior plate) has been replaced with a poor color match.
- Area of broken glass.

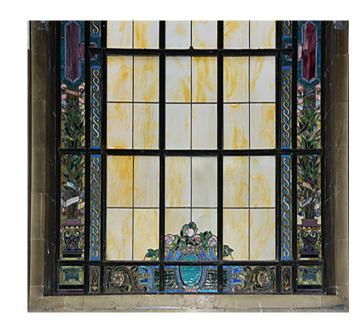
GENERAL CONDITION

The window is in good to very good condition. Most of the original glass is present (see notes below). There is a great accretion of dirt on the exterior and some dirt on the interior surfaces of the panels. This dirt is hygroscopic and is attracting water. There are previous replacements.

- Area of severe dirt and debris accretions. This accretion is hygroscopic, attracting water. Standing water adversely affects the lead cames, the framing, and in the long term, contributes to the corrosion of the glass.
- Area where the original glass is missing (interior plate) has been replaced with a poor color match.
- Area of broken glass.

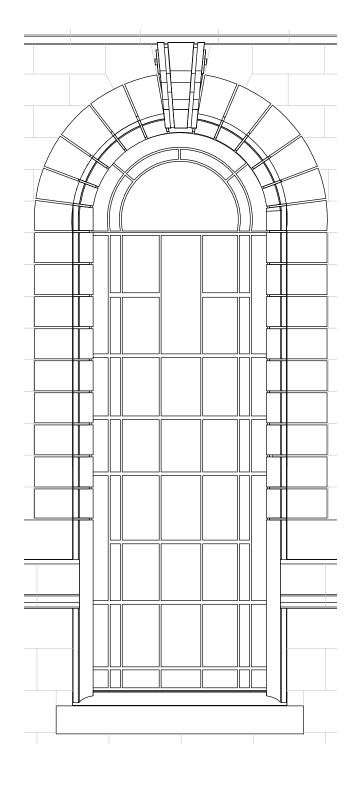
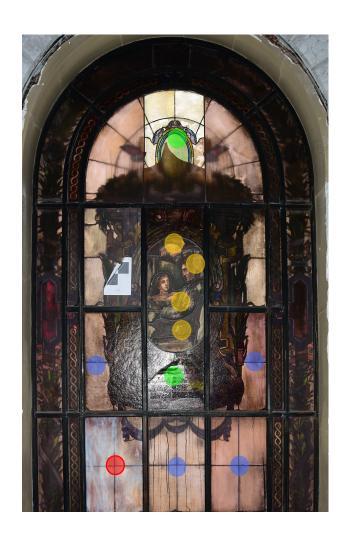
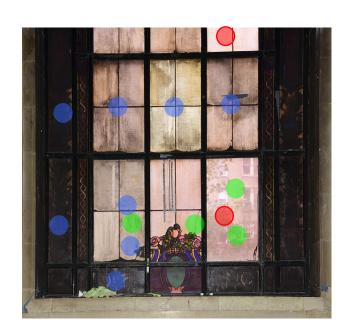
GENERAL CONDITION

The window is in fair condition. There is minimal deflection in the panels. Most of the original glass is present (see notes below). The interior plating has has solarized (turned a pinkish-purple color) due to an excess of manganese in the glass batch and exposure to ultra-violet radiation. There is a great accretion of dirt and debris on the exterior and interior surfaces of the panels and trapped between the plates. This dirt is hygroscopic and is attracting water. There are condensation/leak trails on the interior surface and between the plates. There is broken glass and previous poor replacements.

- Area of severe dirt and debris accretions. This accretion is hygroscopic, attracting water. Standing water adversely affects the lead cames, the framing, and in the long term, contributes to the corrosion of the glass.
- Area where the original glass is missing (interior plate) has been replaced with a poor color match.
- Area of broken glass.
- Area of vitreous paint loss.

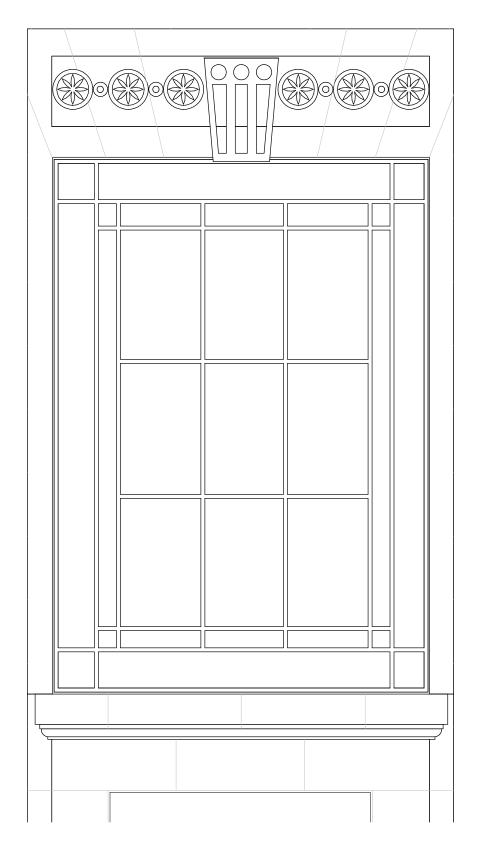
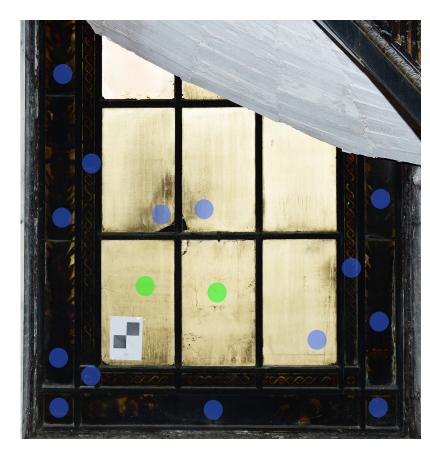
GENERAL CONDITION

The window is in fair condition. There is minimal deflection in the panels. All of the original glass is present, but some of it is broken. (see notes below). Some of the interior plating has has solarized (turned a pinkish-purple color) due to an excess of manganese in the glass batch and exposure to ultra-violet radiation. There is an accretion of dirt and debris on the exterior and interior surfaces of the panels and trapped between the plates. This dirt is hygroscopic and is attracting water. There are condensation/leak trails on the interior surface and between the plates.

- Area of severe dirt and debris accretions. This accretion is hygroscopic, attracting water. Standing water adversely affects the lead cames, the framing, and in the long term, contributes to the corrosion of the glass.
- Area where the original glass is missing (interior plate) has been replaced with a poor color match.
- Area of broken glass.

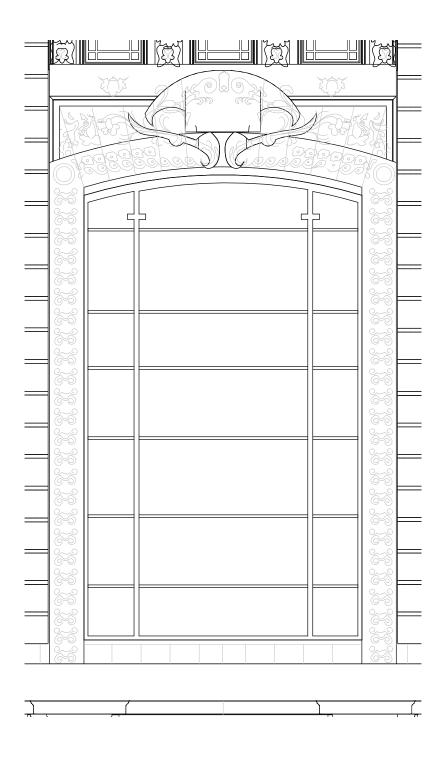
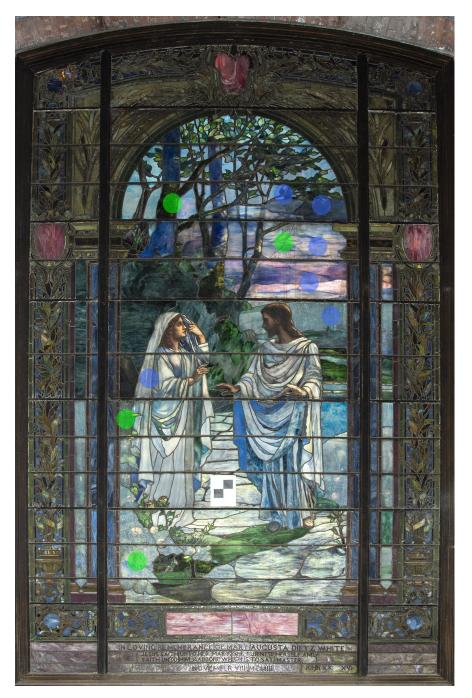
GENERAL CONDITION

The window is in fair to good condition. There is minimal deflection in the panels. Almost all of the original glass is present (see notes below). There is a great accretion of dirt and debris on the exterior and interior surfaces of the panels and trapped between the plates. This dirt is hygroscopic and is attracting water. There are condensation/leak trails on the interior surface and between the plates. There is broken glass and some previous poor replacements, but not many.

- Area of severe dirt and debris accretions. This accretion is hygroscopic, attracting water. Standing water adversely affects the lead cames, the framing, and in the long term, contributes to the corrosion of the glass.
- Area where the original glass is missing (interior plate) has been replaced with a poor color match.
- Area of broken glass.

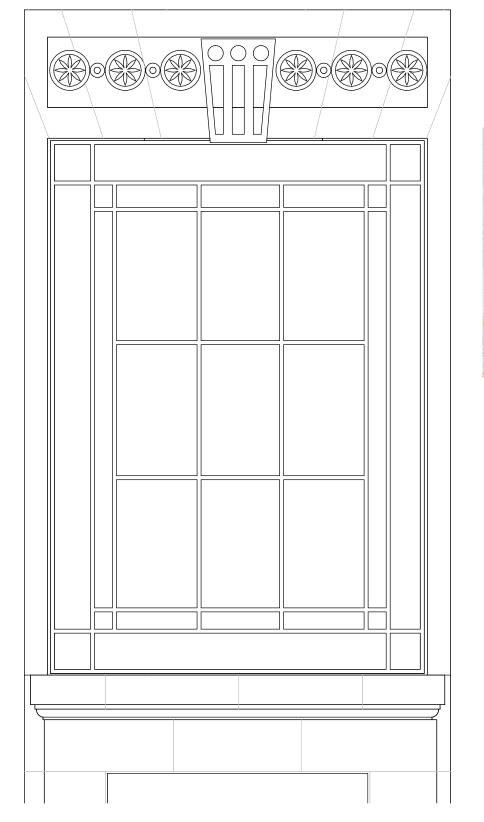
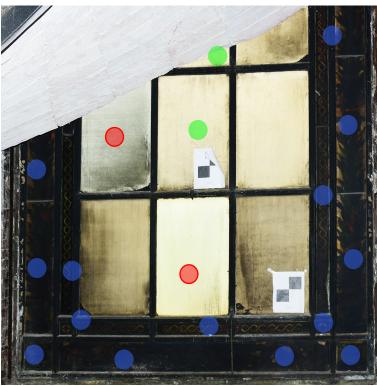
WINDOW 10 - BRONZE WITH STAINED GLASS AT PERIMETER ONLY

GENERAL CONDITION

The window is in fair condition. There is minimal deflection in the panels. All of the original glass is present, but some of it is broken. (see notes below). Some of the interior plating has has solarized (turned a pinkish-purple color) due to an excess of manganese in the glass batch and exposure to ultra-violet radiation. There is an accretion of dirt and debris on the exterior and interior surfaces of the panels and trapped between the plates. This dirt is hygroscopic and is attracting water. There are condensation/leak trails on the interior surface and between the plates.

- Area of severe dirt and debris accretions. This accretion is hygroscopic, attracting water. Standing water adversely affects the lead cames, the framing, and in the long term, contributes to the corrosion of the glass.
- Area where the original glass is missing (interior plate) has been replaced with a poor color match.
- Area of broken glass.

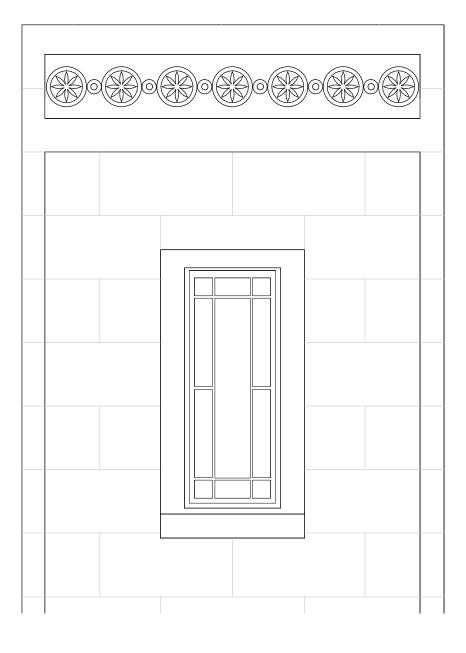
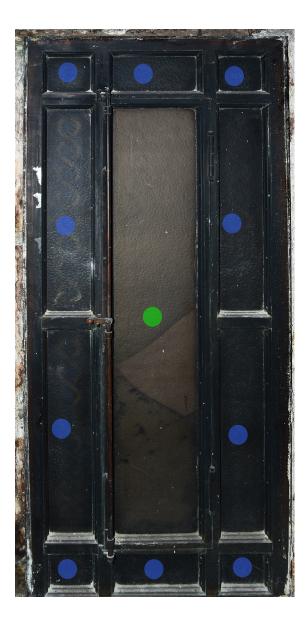
GENERAL CONDITION

The window is in fair to good condition. There is minimal deflection in the panels. All of the original glass is present (see notes below). The interior plating has has solarized (turned a pinkish-purple color) due to an excess of manganese in the glass batch and exposure to ultra-violet radiation. There is an accretion of dirt and debris on the exterior and interior surfaces of the panels and trapped between the plates. This dirt is hygroscopic and is attracting water. There are condensation/leak trails on the interior surface and between the plates.

- Area of severe dirt and debris accretions. This accretion is hygroscopic, attracting water. Standing water adversely affects the lead cames, the framing, and in the long term, contributes to the corrosion of the glass.
- Area where the original glass is missing (interior plate) has been replaced with a poor color match.
- Area of broken glass.

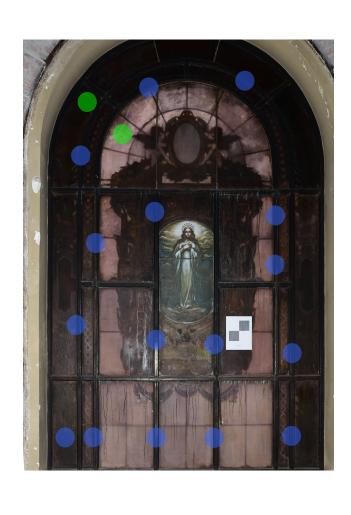
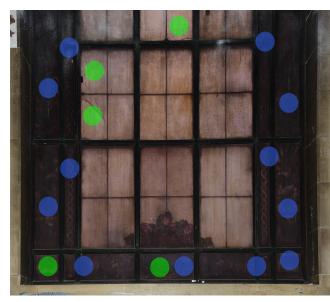
GENERAL CONDITION

The window is in fair to good condition with the exception of the dirt. There is minimal deflection in the panels. Most of the original glass is present (see notes below). The interior plating has has solarized (turned a pinkish-purple color) due to an excess of manganese in the glass batch and exposure to ultra-violet radiation. This is less than the South side due to the limited UV it has been exposed to. There is a great accretion of dirt and debris on the exterior and interior surfaces of the panels and trapped between the plates. This dirt is hygroscopic and is attracting water. There are condensation/leak trails on the interior surface and between the plates. There is broken glass and previous poor replacements.

- Area of severe dirt and debris accretions. This accretion is hygroscopic, attracting water. Standing water adversely affects the lead cames, the framing, and in the long term, contributes to the corrosion of the glass.
- Area where the original glass is missing (interior plate) has been replaced with a poor color match.
- Area of broken glass.

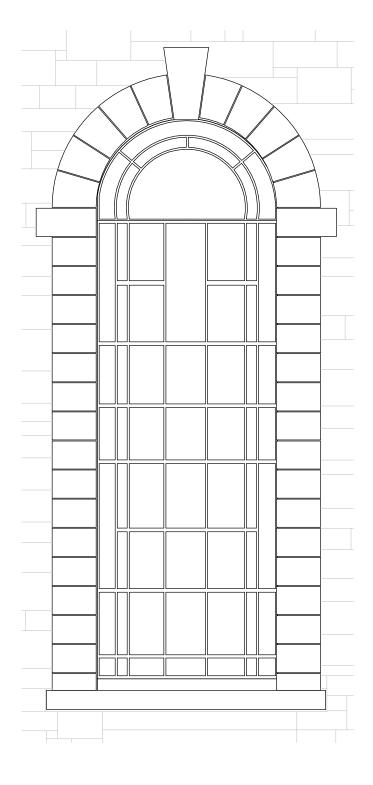
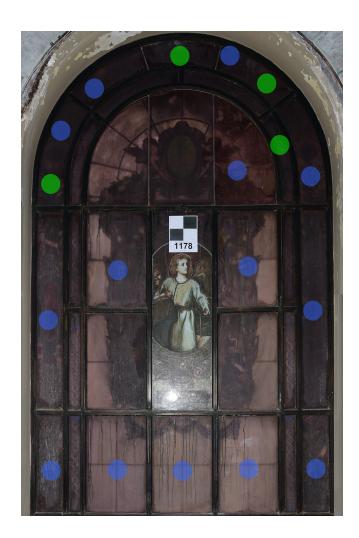
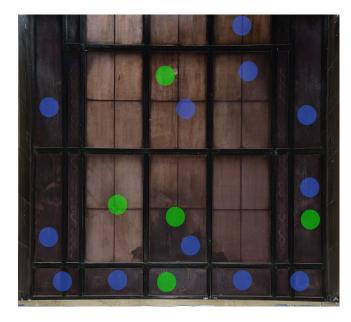
GENERAL CONDITION

The window is in fair to good condition with the exception of the dirt. There is minimal deflection in the panels. Most of the original glass is present (see notes below). The interior plating has has solarized (turned a pinkish-purple color) due to an excess of manganese in the glass batch and exposure to ultra-violet radiation. This is less than the South side due to the limited UV it has been exposed to. There is a great accretion of dirt and debris on the exterior and interior surfaces of the panels and trapped between the plates. This dirt is hygroscopic and is attracting water. There are condensation/leak trails on the interior surface and between the plates. There is broken glass and previous poor replacements.

- Area of severe dirt and debris accretions. This accretion is hygroscopic, attracting water. Standing water adversely affects the lead cames, the framing, and in the long term, contributes to the corrosion of the glass.
- Area where the original glass is missing (interior plate) has been replaced with a poor color match.
- Area of broken glass.

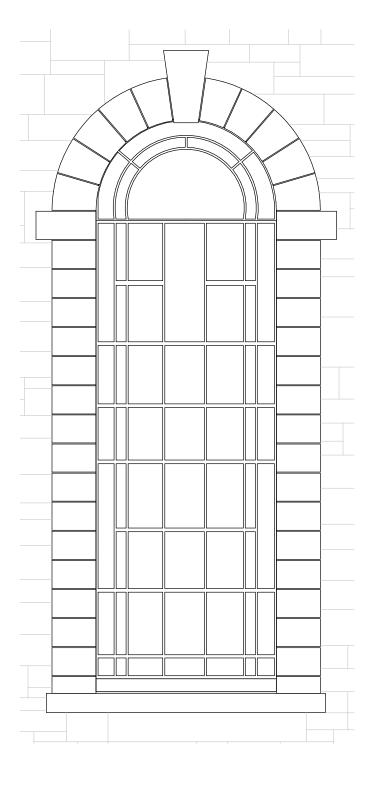
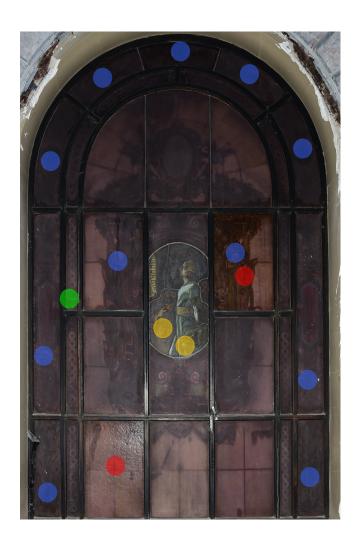
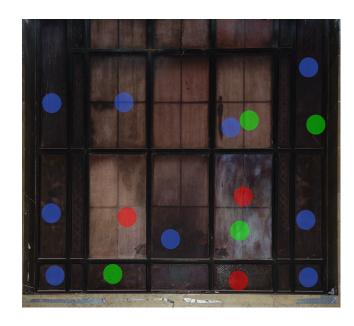
GENERAL CONDITION

The window is in fair to good condition with the exception of the dirt. There is minimal deflection in the panels. Most of the original glass is present (see notes below). The interior plating has has solarized (turned a pinkish-purple color) due to an excess of manganese in the glass batch and exposure to ultra-violet radiation. This is less than the South side due to the limited UV it has been exposed to. There is a great accretion of dirt and debris on the exterior and interior surfaces of the panels and trapped between the plates. This dirt is hygroscopic and is attracting water. There are condensation/leak trails on the interior surface and between the plates. There is broken glass and previous poor replacements.

- Area of severe dirt and debris accretions. This accretion is hygroscopic, attracting water. Standing water adversely affects the lead cames, the framing, and in the long term, contributes to the corrosion of the glass.
- Area where the original glass is missing (interior plate) has been replaced with a poor color match.
- Area of broken glass.
- Area of paint loss.

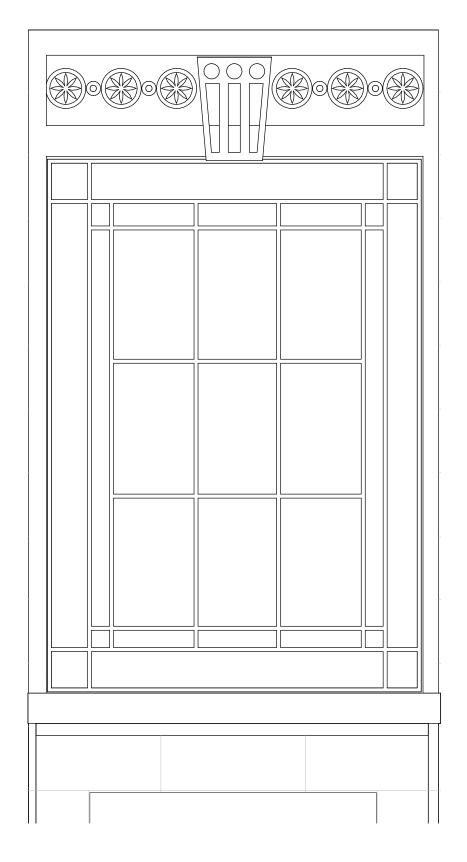
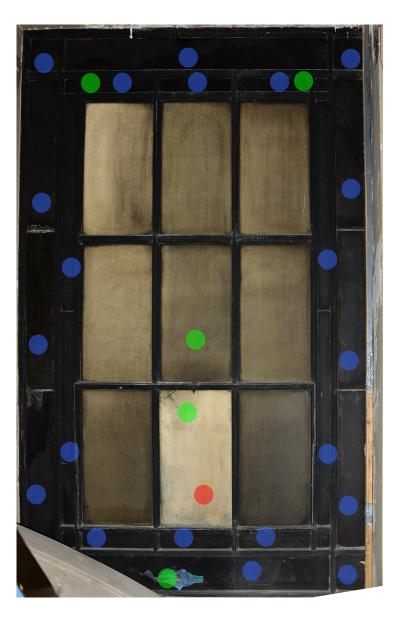
GENERAL CONDITION

The window is in fair to good condition. There is minimal deflection in the panels. All of the original glass is present, but some of it is broken. (see notes below). Some of the interior plating has has solarized (turned a pinkish-purple color) due to an excess of manganese in the glass batch and exposure to ultra-violet radiation. There is an accretion of dirt and debris on the exterior and interior surfaces of the panels and trapped between the plates. This dirt is hygroscopic and is attracting water. There are condensation/leak trails on the interior surface and between the plates.

- Area of severe dirt and debris accretions. This accretion is hygroscopic, attracting water. Standing water adversely affects the lead cames, the framing, and in the long term, contributes to the corrosion of the glass.
- Area where the original glass is missing (interior plate) has been replaced with a poor color match.
- Area of broken glass.
