**1 West 29th Street, aka 270-272 Fifth Avenue – Marble  
Collegiate Church – Individual Landmark  
Borough of Manhattan**

# Marble Collegiate Church Visible West Façade

Public Meeting February 13, 2024

Project: MARBLE COLLEGIATE CHURCH  
1 WEST 29<sup>TH</sup> STREET  
NEW YORK, NY 10001  
EXTERIOR RESTORATION

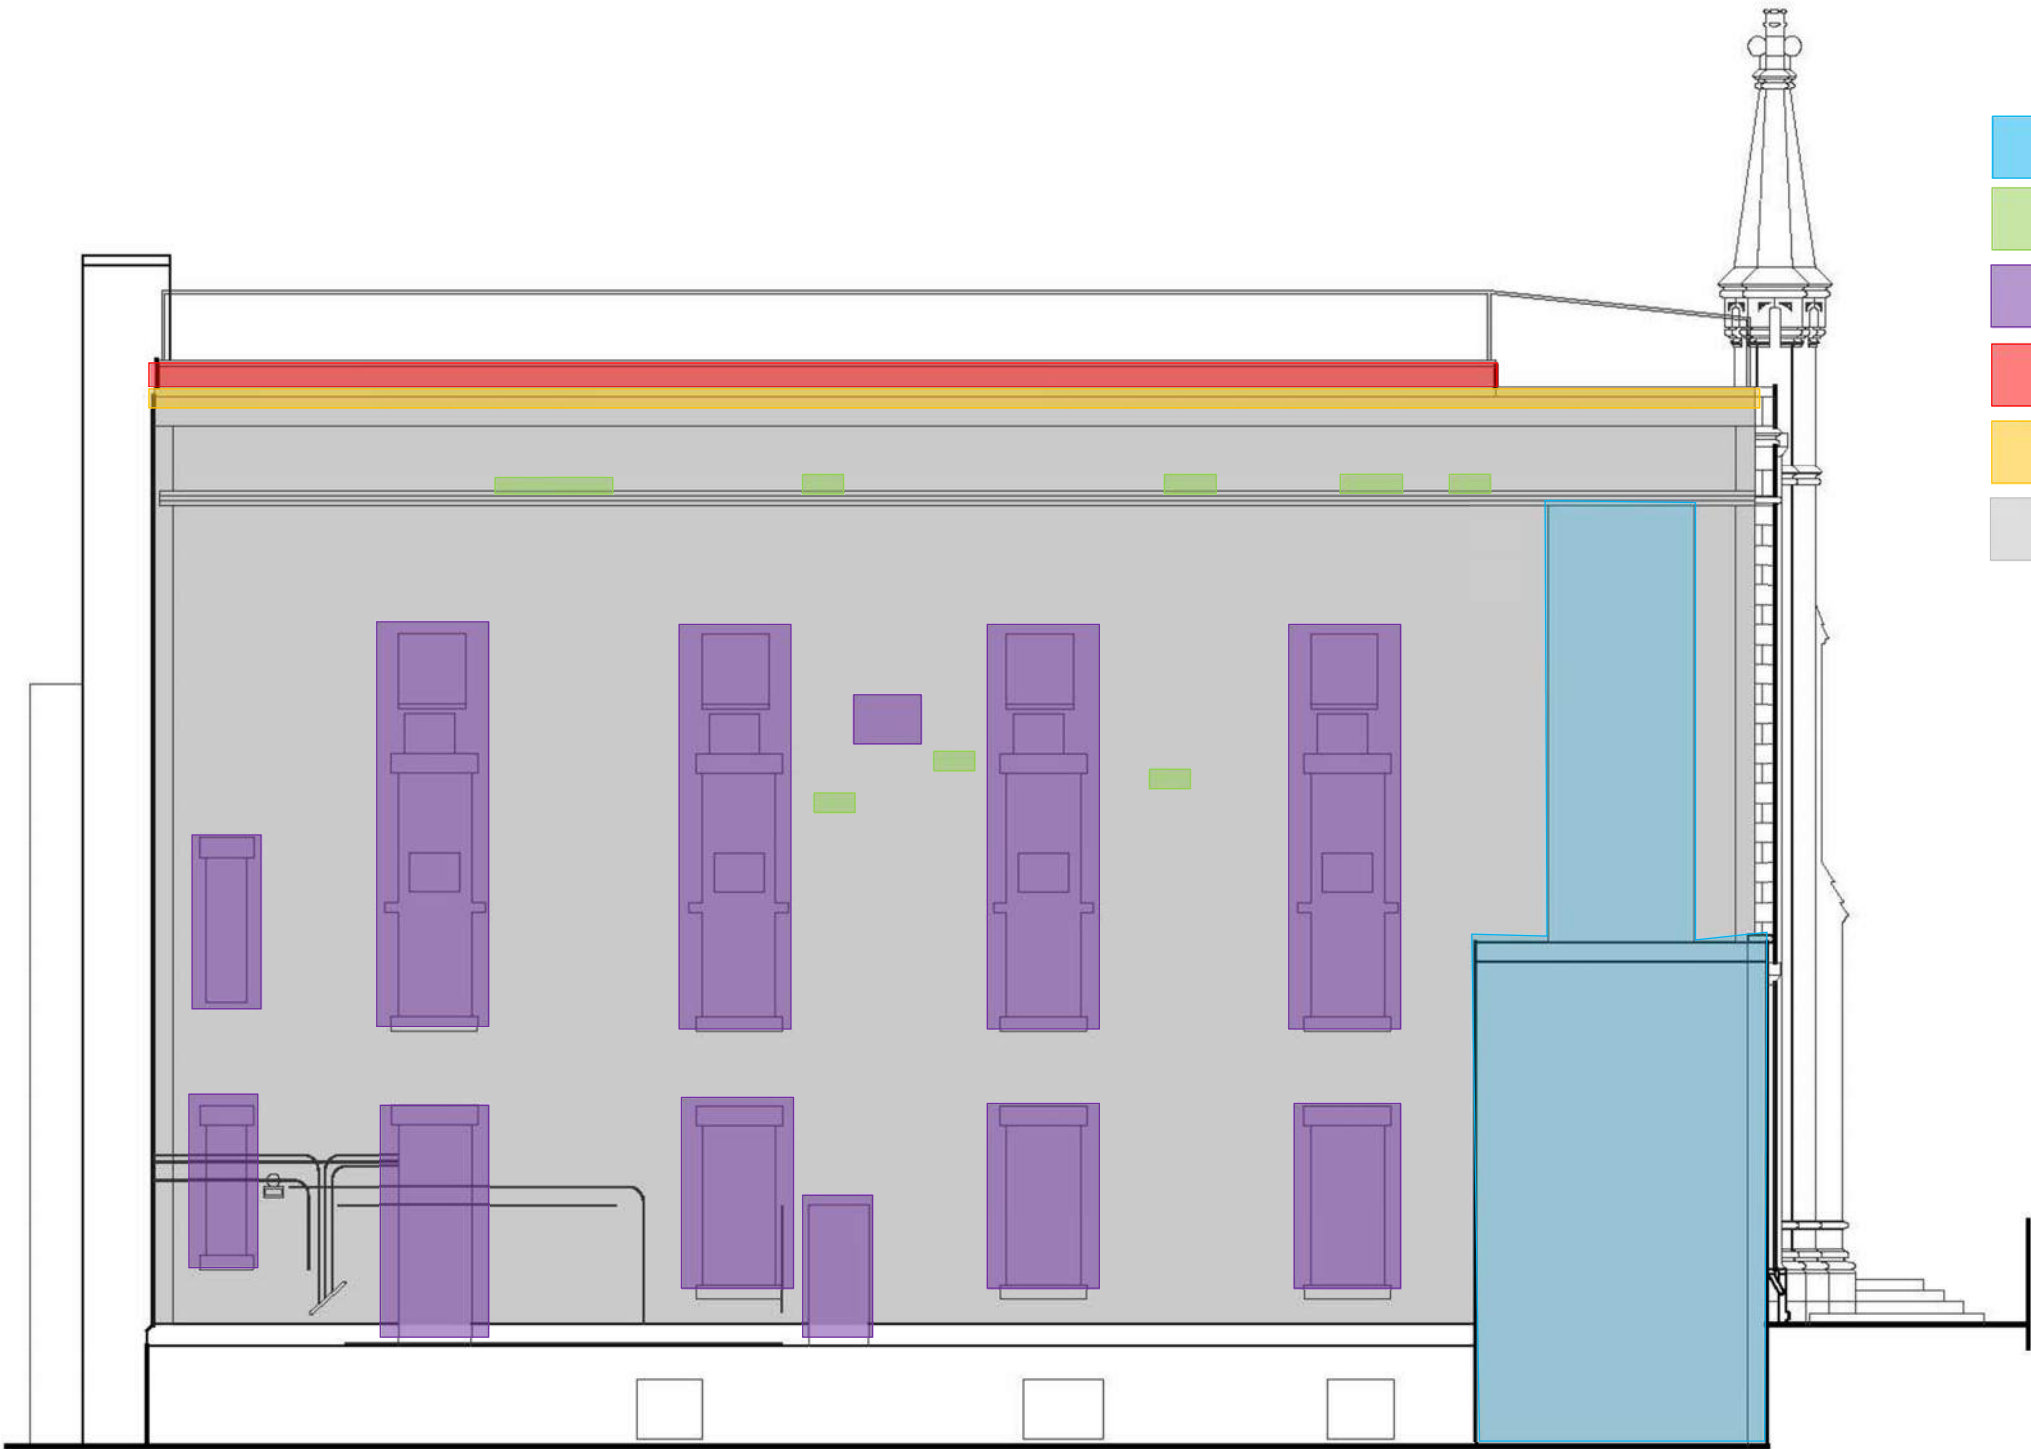
- Non-masonry infill at building tie-ins (10% of Wall Area)
- Broken/Missing Brick Masonry (1% of Wall Area)
- Mismatched Masonry Infilled Openings (17% of Wall Area)
- CMU Parapet (4% of Wall Area)
- Cementous Coating (5% of Wall Area)
- Waterproofing coating(s) over deteriorated brick (63% of Wall Area)

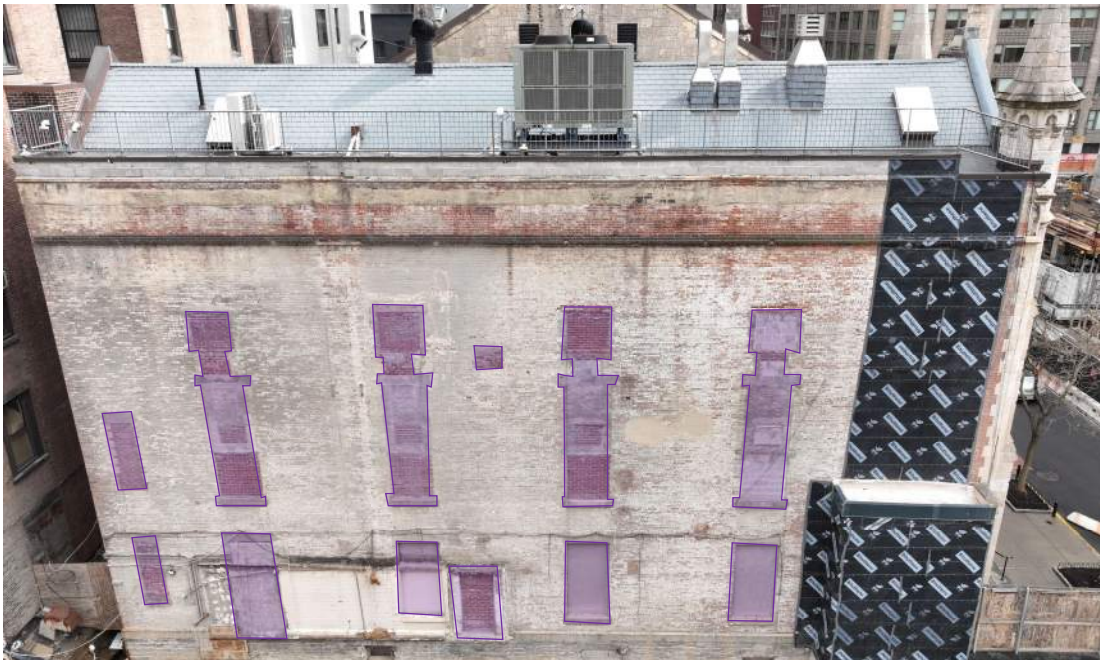
Overview of West Elevation Current Condition

There is mismatched window and door masonry infill present throughout the West Elevation. The infill consists of a mix of brick masonry, CMU, and recessed CMU finished with a cementitious coating.

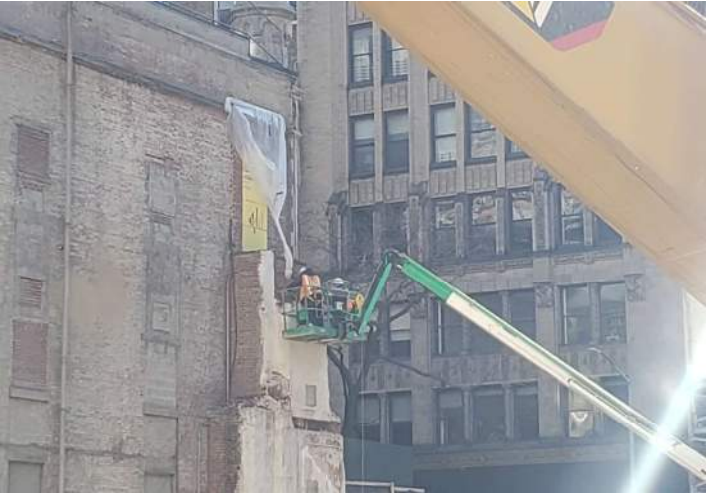
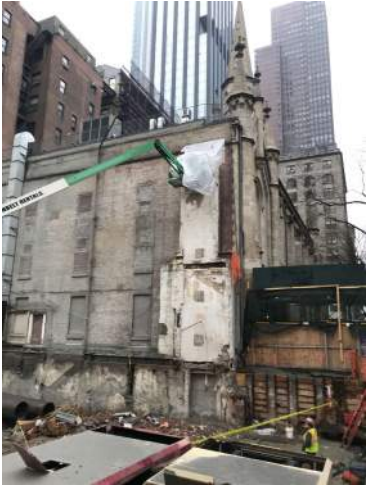
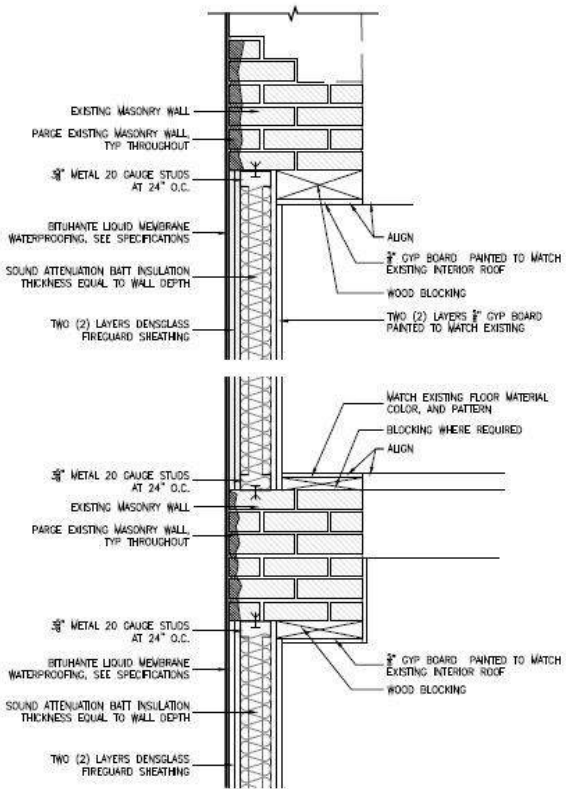
Infill wall assembly detail

In 2019 the building tie-in corridors were demolished at the second and third floors and infilled with a wall assembly installed flush with the surrounding original brick. This assembly leaves no space for a layer of face brick to be installed in front of the wall assembly without projecting off the existing plane of the brick façade.

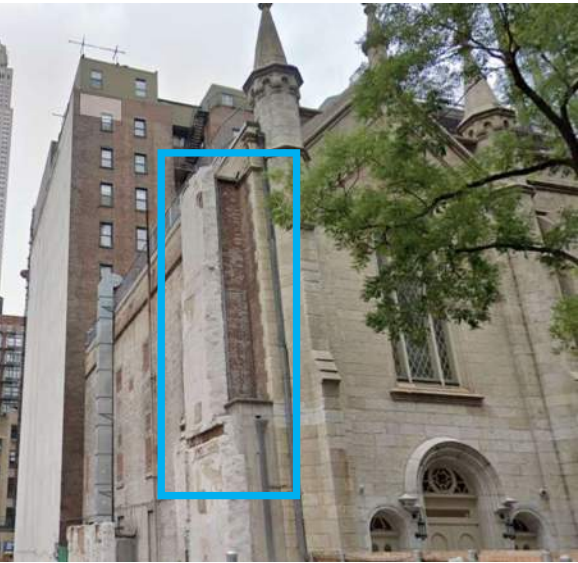
2019 Before removal of building tie-ins

Overview of DensGlass infill wall assembly installation in progress

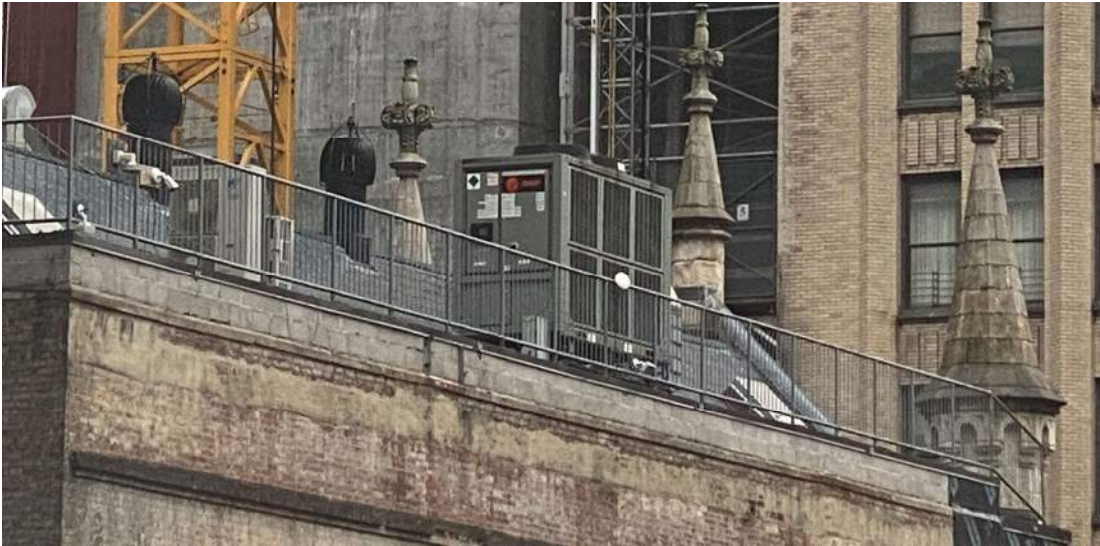
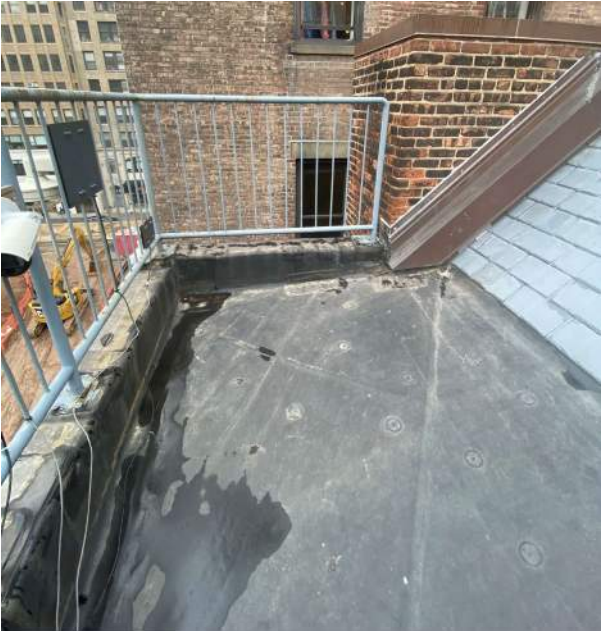
The existing non-historic CMU parapet was installed in 2012, to allow for the existing code compliant roof pitch. Railings were also installed at this time atop the CMU parapet in accordance with fall protection requirements. There appears to be an original stone coping or band course below the CMU material.

Overview of North Elevation parapet

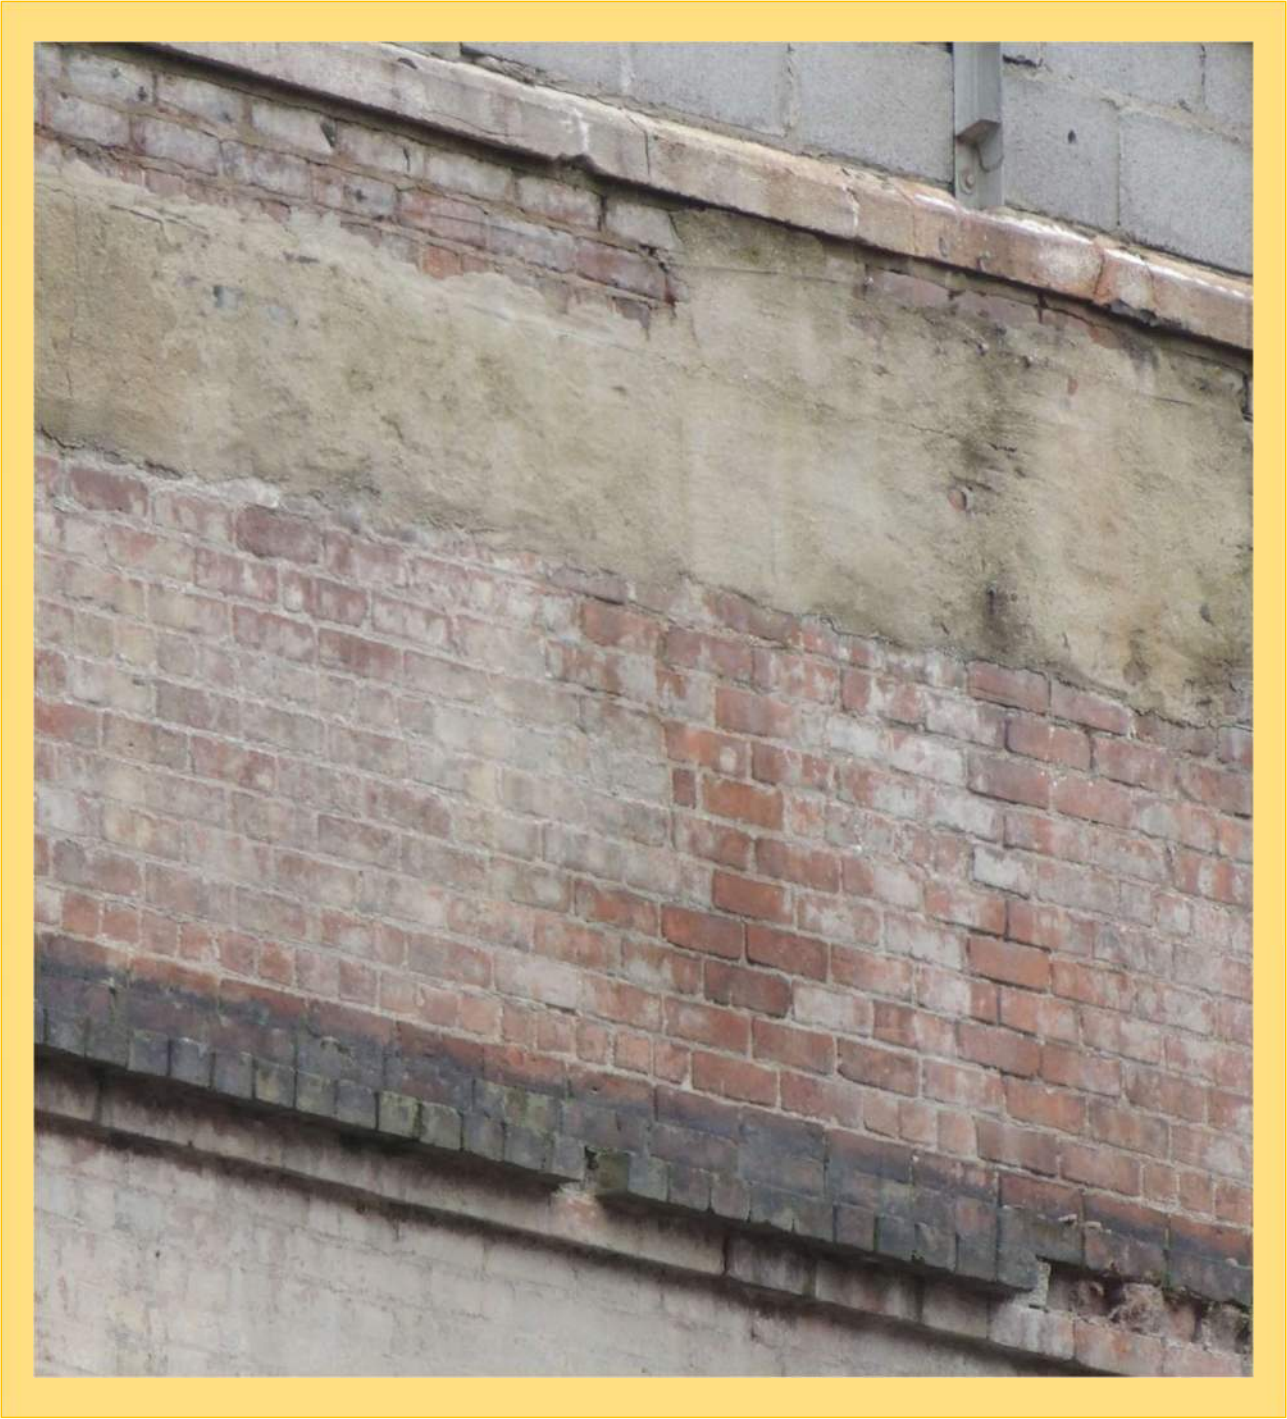
Close-up of Cementitious Coating

There is an existing cementitious parge coat on the full length of the upper portion of the West Elevation, this cannot be removed without further damaging the existing brick masonry.

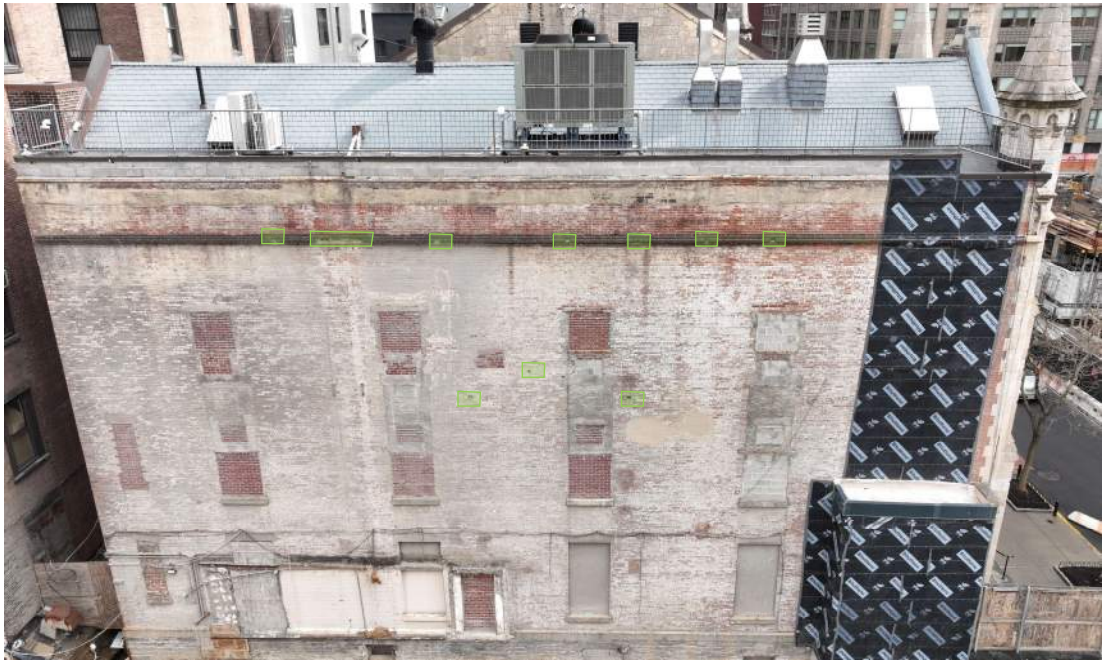
Overview of West Elevation Current Condition

Damaged and spalled brick masonry is present throughout the façade primarily at the projecting brick band-course present at the upper portion of the West Elevation.
