## **Landmarks Presentation**

January 09, 2018

520 & 550 Clinton Avenue Brooklyn, NY

## PROPOSED DESIGN

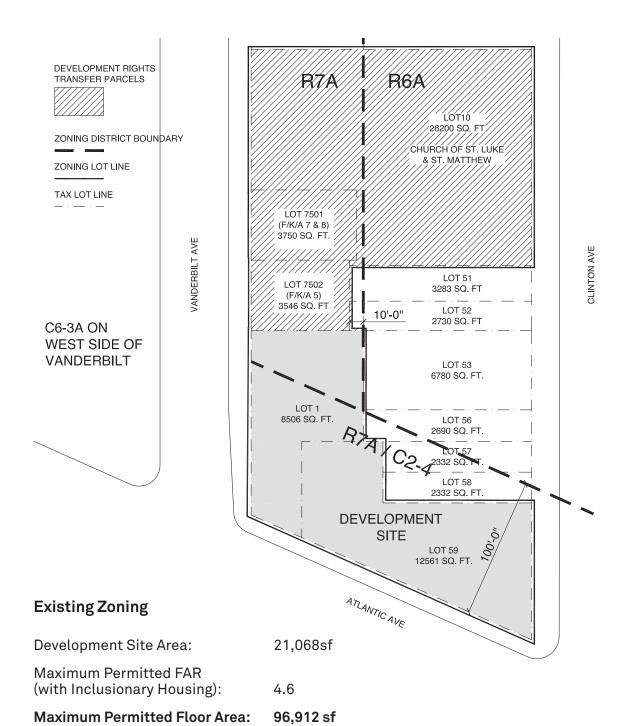
DEVELOPMENT RIGHTS TRANSFER PARCELS

TRANSFER PARCELS R6A LOT10 26200 SQ. FT ZONING DISTRICT BOUNDARY CHURCH OF ST. LUKE & ST. MATTHEW ZONING LOT LINE TAX LOT LINE LOT 7501 (F/K/A 7 & 8) 3750 SQ. FT LOT 51 LOT 7502 3283 SQ. FT (F/K/A 5) 3546 SQ FT LOT 52 10'-0" 2730 SQ. FT C6-3A ON WEST SIDE OF **VANDERBILT** LOT 53 6780 SQ. FT. LOCATION OF LOT 1 PROPOSED DISTRICT 8506 SQ. FT. BOUNDARY TO BE LOT 56 CONFIRMED BY DCP 2690 SQ. FT. 5 2332 SQ. 2332 SQ. FT. **DEVELOPMENT** SITE LOT 59 12561 SQ. FT. ATLANTIC AVE **Proposed Zoning** Development Site Area: 21,068 sf Maximum Permitted FAR 8.0

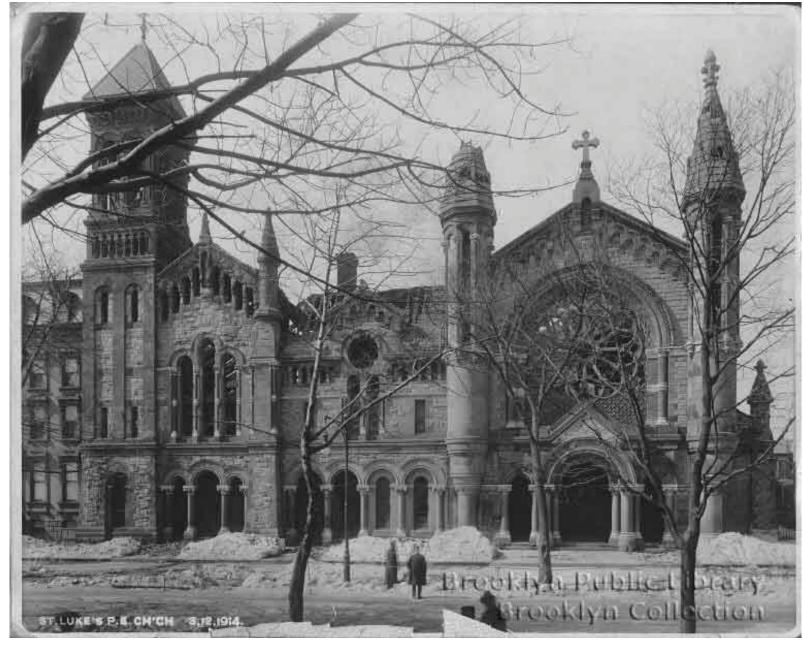
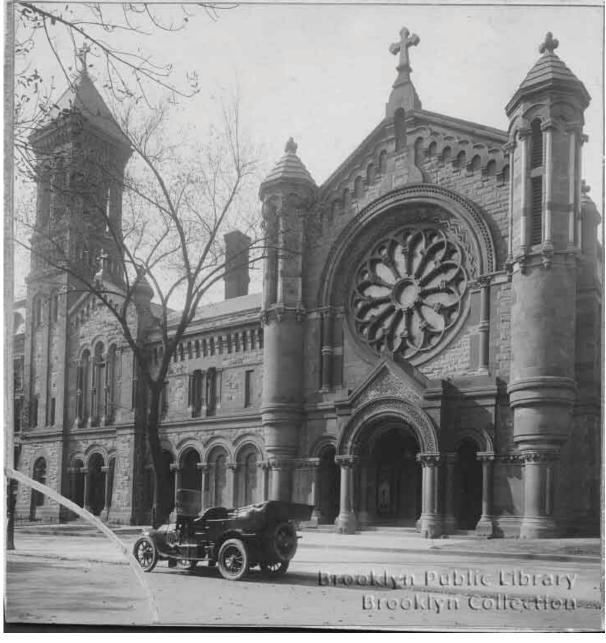
Constructed 1888-1891; John Welch, Architect / Damaged by fire 1914

1927 photo showing post-fire reconstruction; Dodge & Morrison, Architects

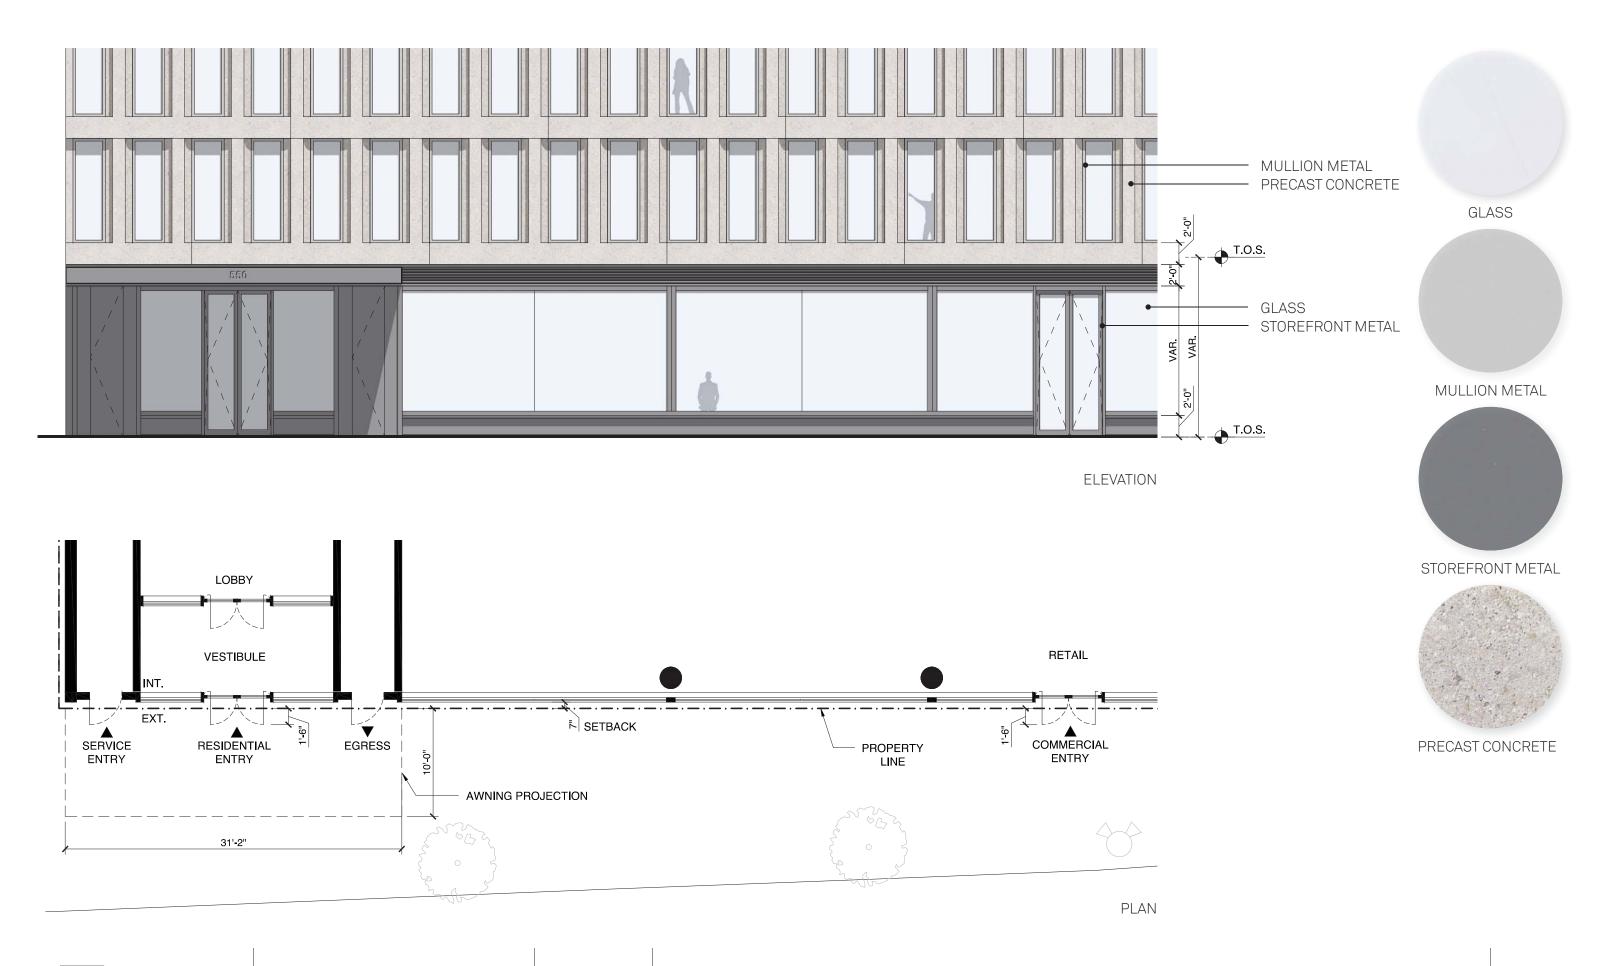
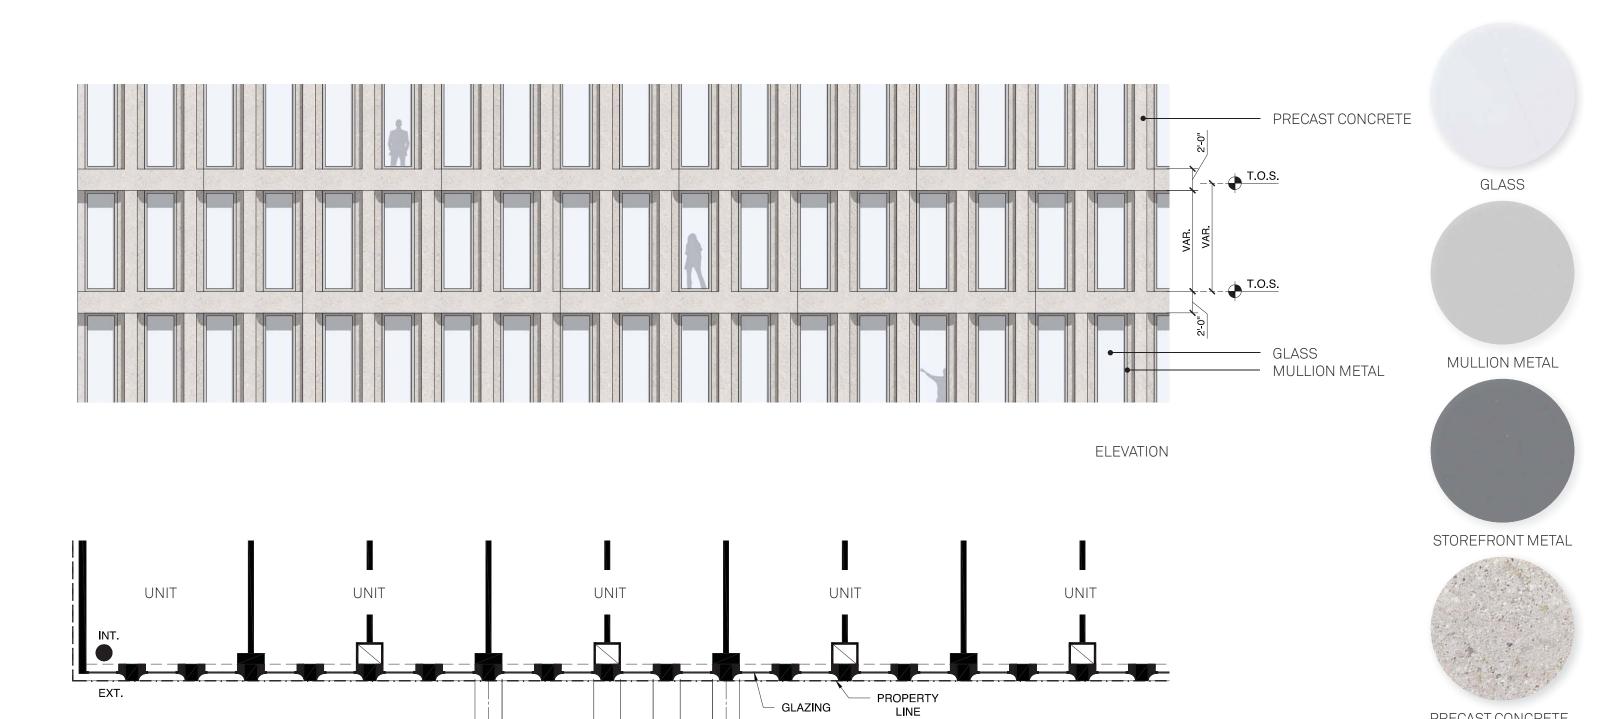
22'-0" TYPICAL BAY

8'-6"

2'-6" 3'-0" 2'-6" 3'-0" 2'-6"

PLAN

PRECAST CONCRETE

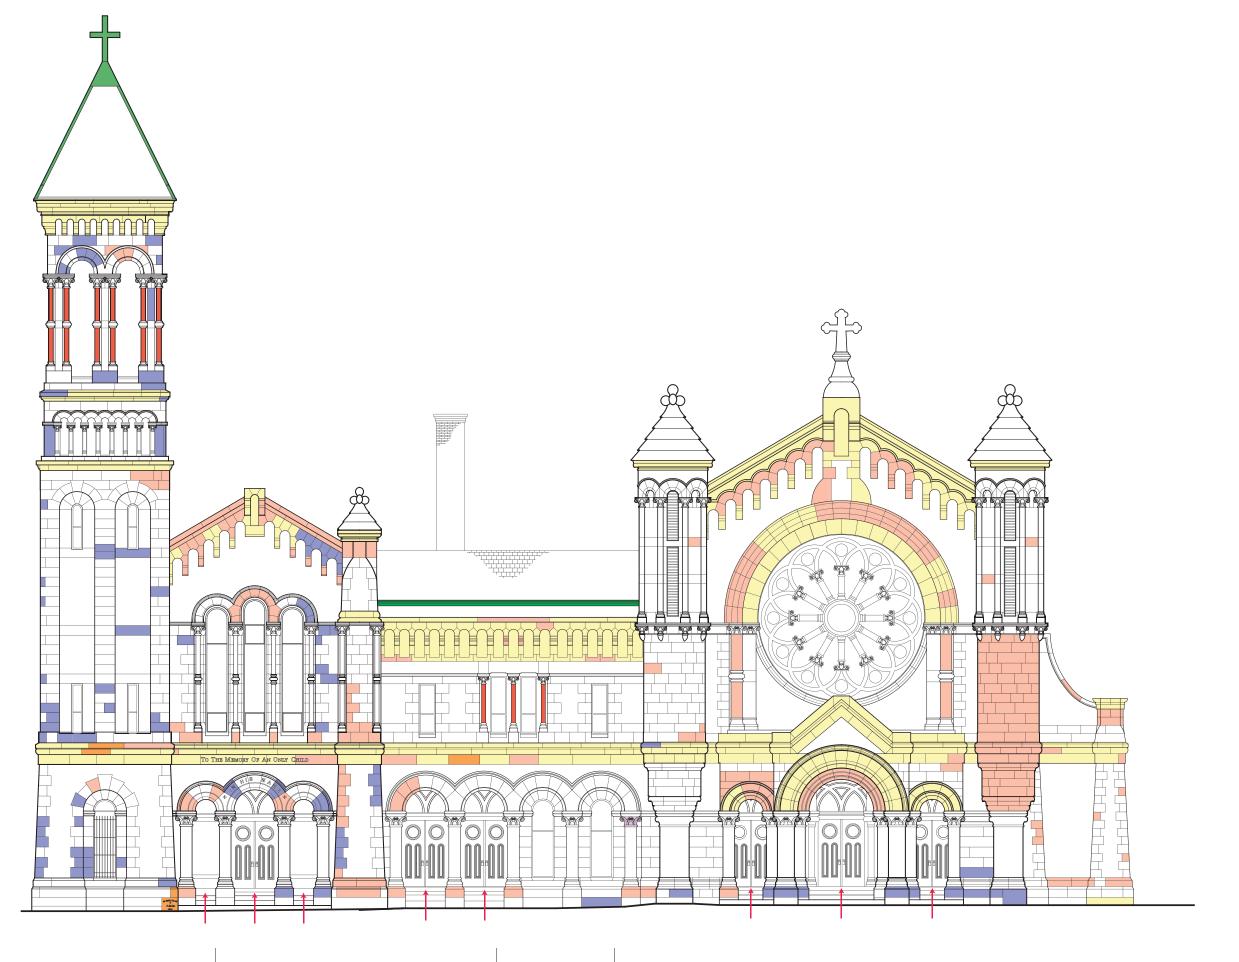
REPLACE DAMAGED COPPER GUTTER WITH NEW COPPER GUTTER TO MATCH ORIGINAL. REPLACE DAMAGED SHEET METAL CROSS AND FLASHING ON BELFRY WITH NEW COPPER CROSS AND FLASHING.

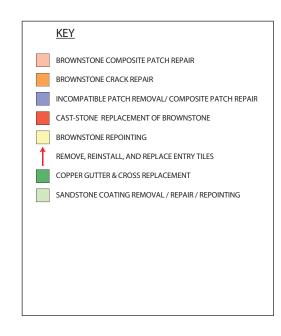
COATING REMOVAL, REPAIR, AND REPOINTING OF SANDSTONE

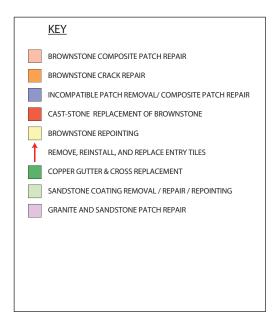
SANDSTONE AND GRANITE PATCH REPAIR

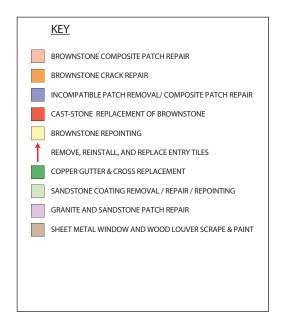
SCRAPE, PRIME, REPAINT, AND SEAL SHEET METAL WHEEL WINDOW. SAND AND REPAINT WOOD TURRET LOUVERS

- Clean Windows
- Scrape and Paint Deteriorated Window Frames
- Replace Damaged Protective Glazing
- Provide New Caulking at Window Perimeter
- Scrape and Repaint Sheet Metal Wheel Window

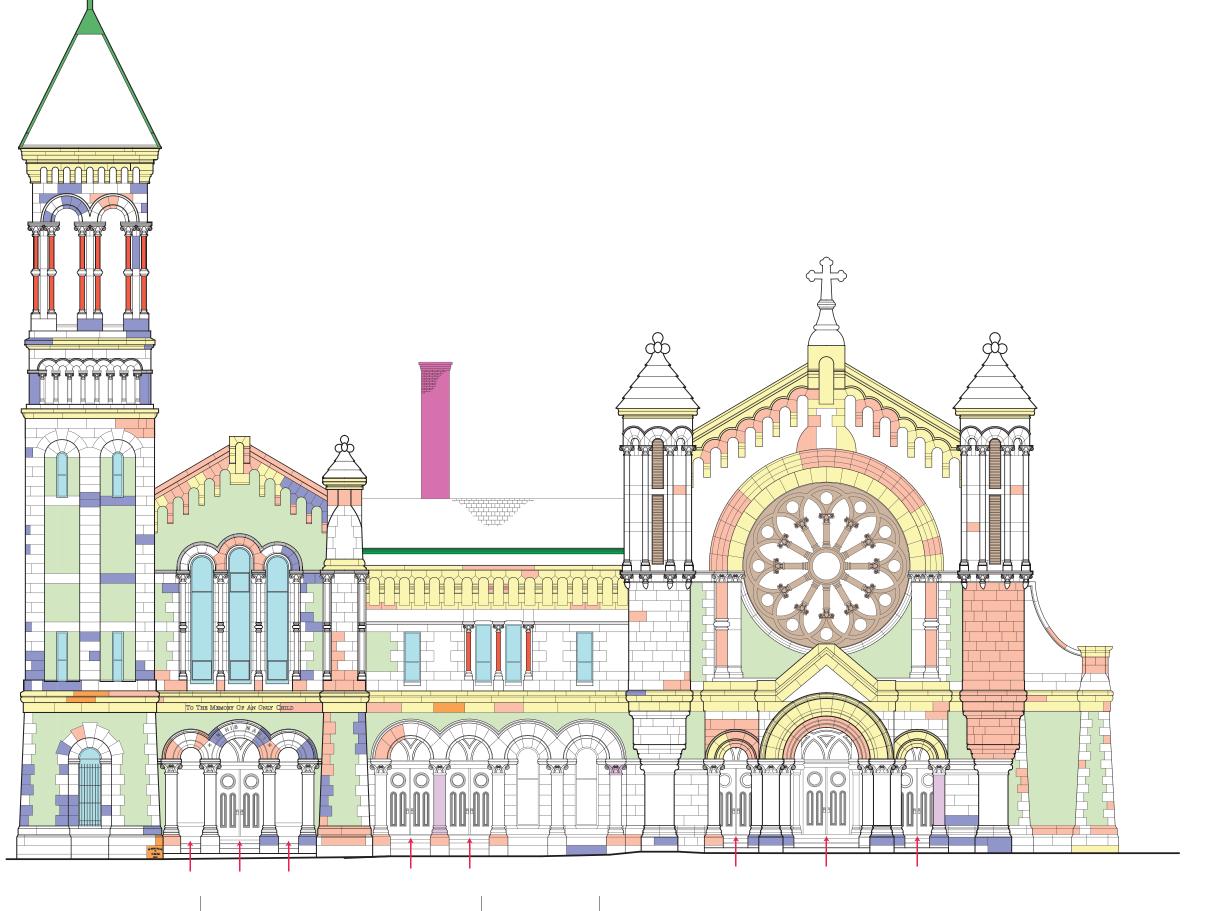
REPLACE DAMAGED COPING STONES WITH NEW CAST STONE COPING STONES. REPAIR BRICK CRACKS ON CHIMNEY

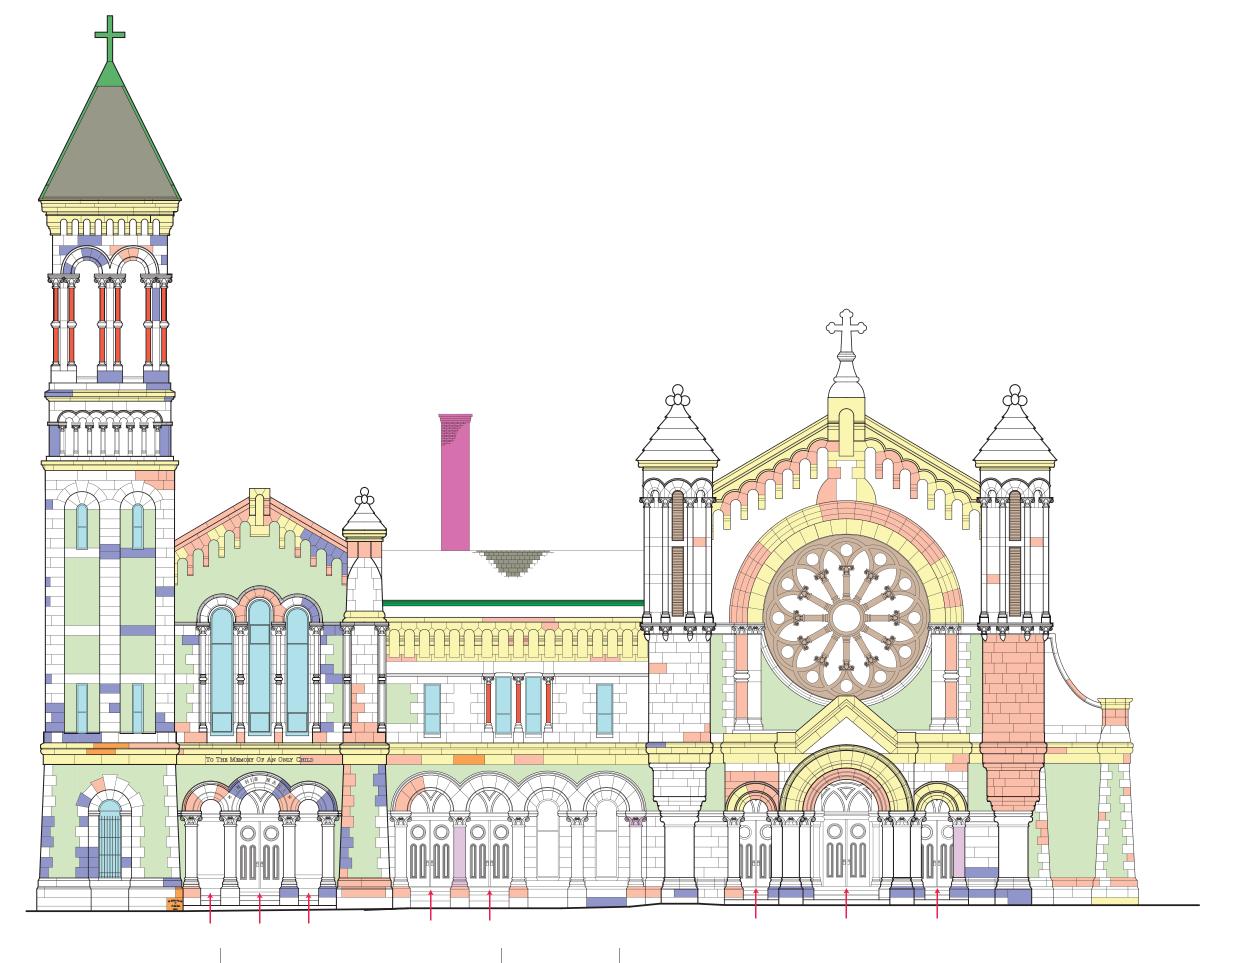
REPLACE BELFRY ROOF WITH NEW SLATE TO MATCH EXISTING SLATE PRESENT ON CLOISTER ROOF. SELECTIVE REPLACEMENT OF SLATE SHINGLES AT CLOISTER ROOF, ASSUME 10%.

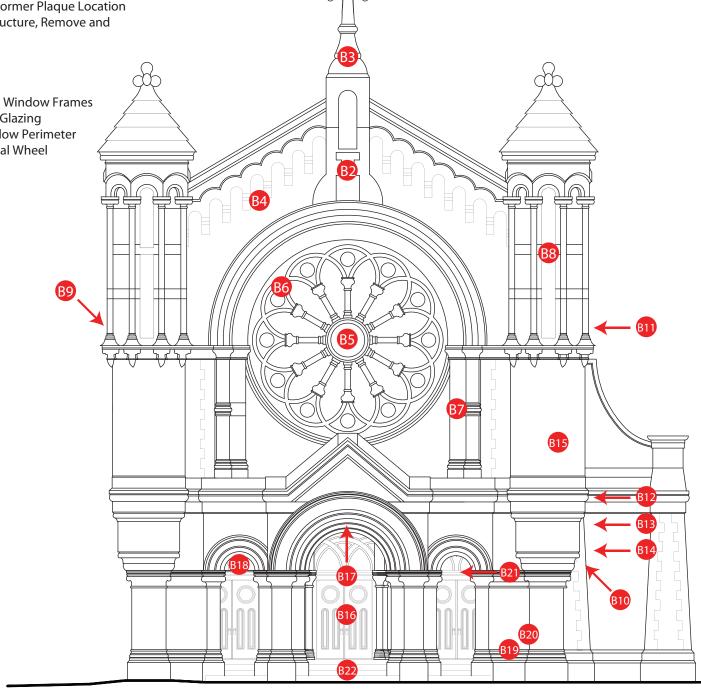
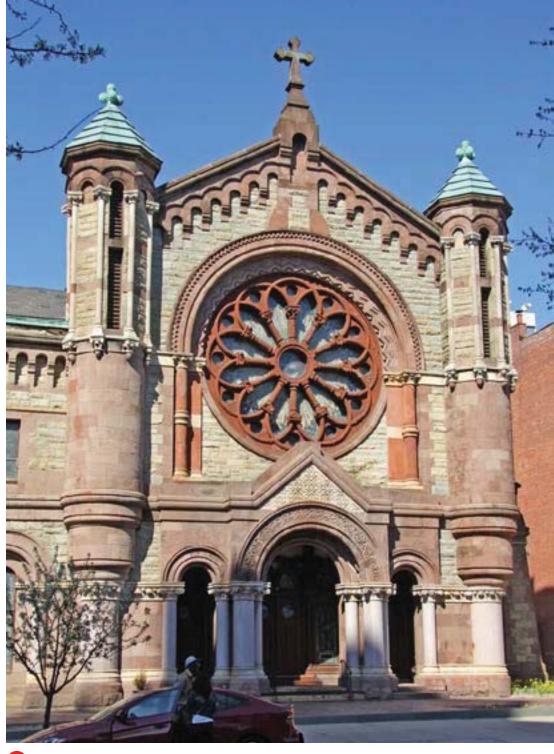
# CHURCH

### **MASONRY SCOPE OF WORK:**

- Clean Facade
- Repoint Deteriorated Masonry Joints to Match Original Mortar
- Remove Incompatible Patching
- Retool or Composite Patch Deteriorated Stone
- Patch Brownstone/Sandstone to Match Original
- Repair Cracks in Brownstone
- Repair Granite Columns
- Remove Ferrous Materials at Former Plaque Location
- Stabilize Entry Landing Substructure, Remove and Reinstall Tiles.

## **WINDOW SCOPE OF WORK:**

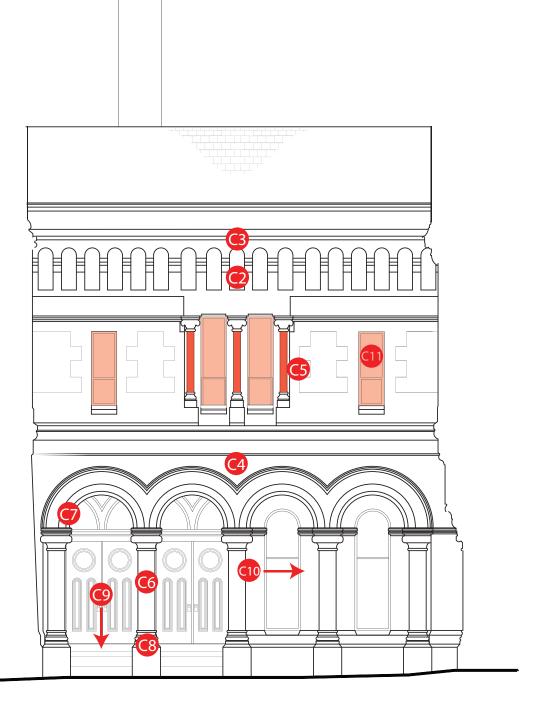
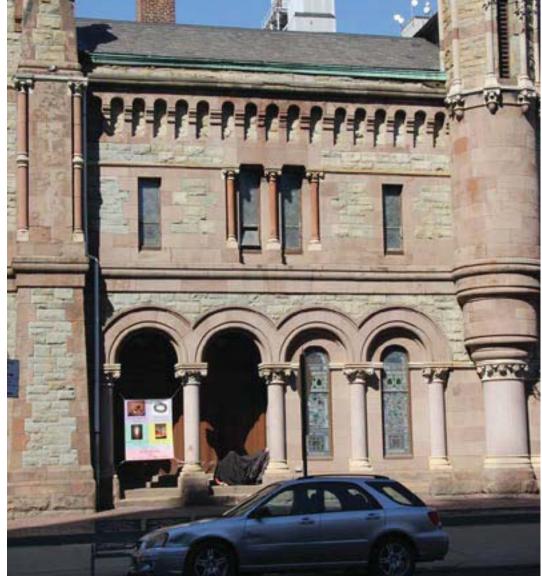
# **CLOISTER**

### **MASONRY SCOPE OF WORK:**

- Clean Facade
- Repoint Deteriorated Masonry Joints to Match Original Mortar
- Remove Incompatible Patching
- Patch Brownstone/Sandstone to Match Original
- Repair Cracks in Brownstone
- Repair Granite Columns
- Replace Brownstone Colonette Shaft
- Stabilize Entry Landing Substructure, Remove and Reinstall Tiles.

### **ROOF SCOPE OF WORK:**

• Repair/Replace Gutter

### WINDOW SCOPE OF WORK: (SELECTIVE WINDOWS)

- Clean Windows
- Scrape and Paint Deteriorated Window Frames
- Replace Damaged Protective Glazing
- Provide New Caulking at Window Perimeter Repair Second Floor Stained Glass Windows

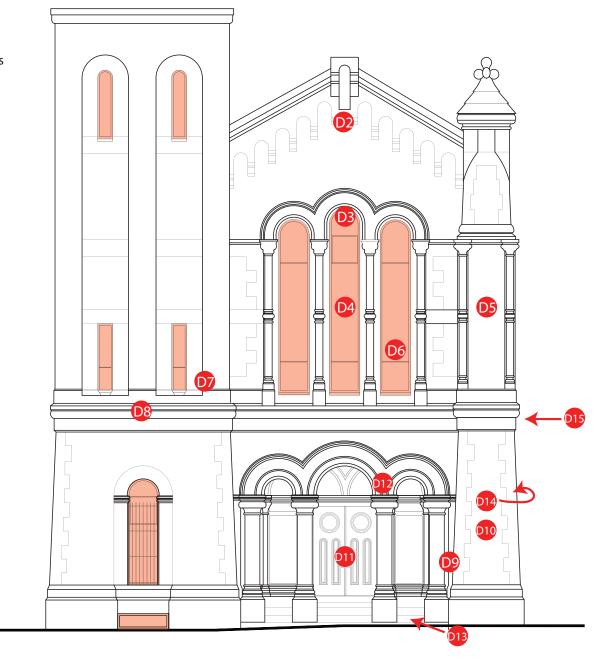
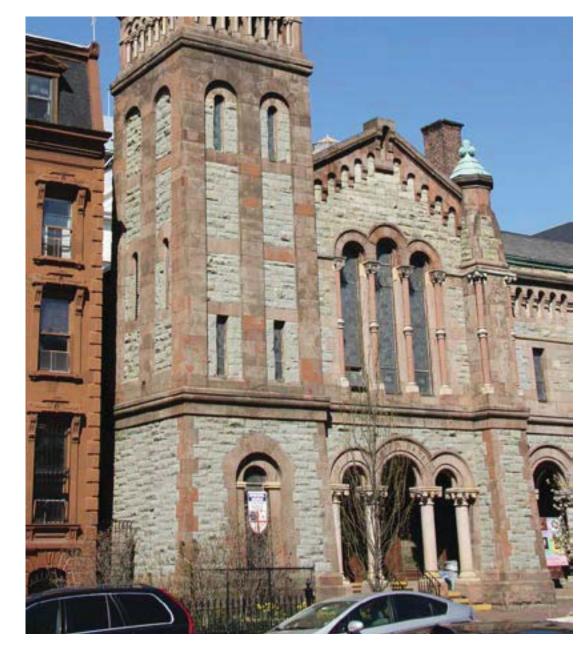
# CHAPEL

### MASONRY SCOPE OF WORK:

- Clean Facade
- Repoint Deteriorated Masonry Joints to Match Original Mortar
- Remove Incompatible Patching
- Retool or Composite Patch Deteriorated Stone
- Patch Brownstone/Sandstone to Match Original
- Repair Cracks in Brownstone
- Repair Granite Columns
- Replace Missing Stone Cross

### WINDOW SCOPE OF WORK:

- Clean Windows
- Scrape and Paint Deteriorated Window Frames
- Replace Damaged Protective Glazing
- Provide New Caulking at Window Perimeter

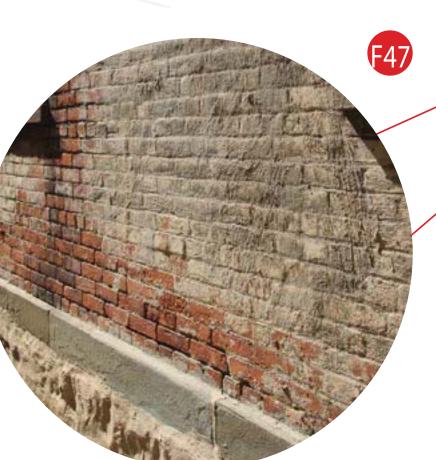
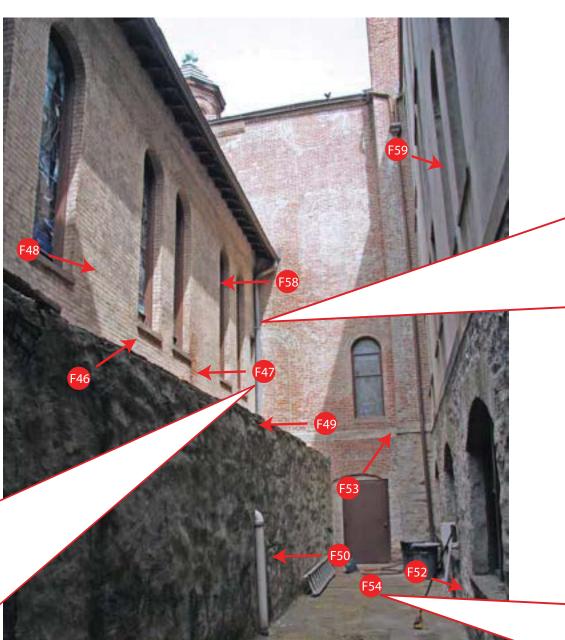
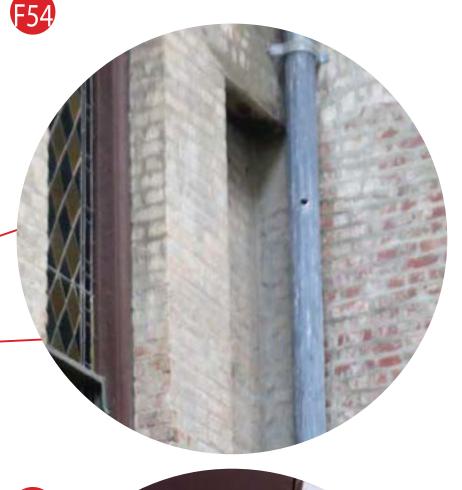
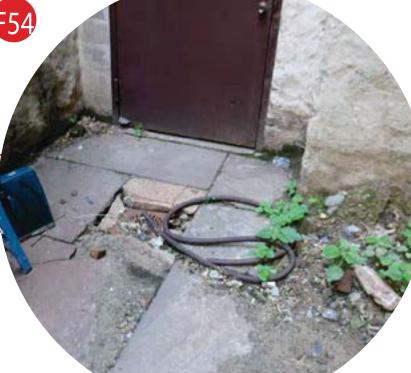
# COURTYARD

### **DETAILS:**

- F47 Repoint Deteriorated Masonry Joints
   F54 Restore Drainage System From Church Roof to Courtyard Pavers
   F58 Major Restoration Work Required at Sanctuary Window 113
   F59 Repair and Secure All Operable Windows in Parish Hall

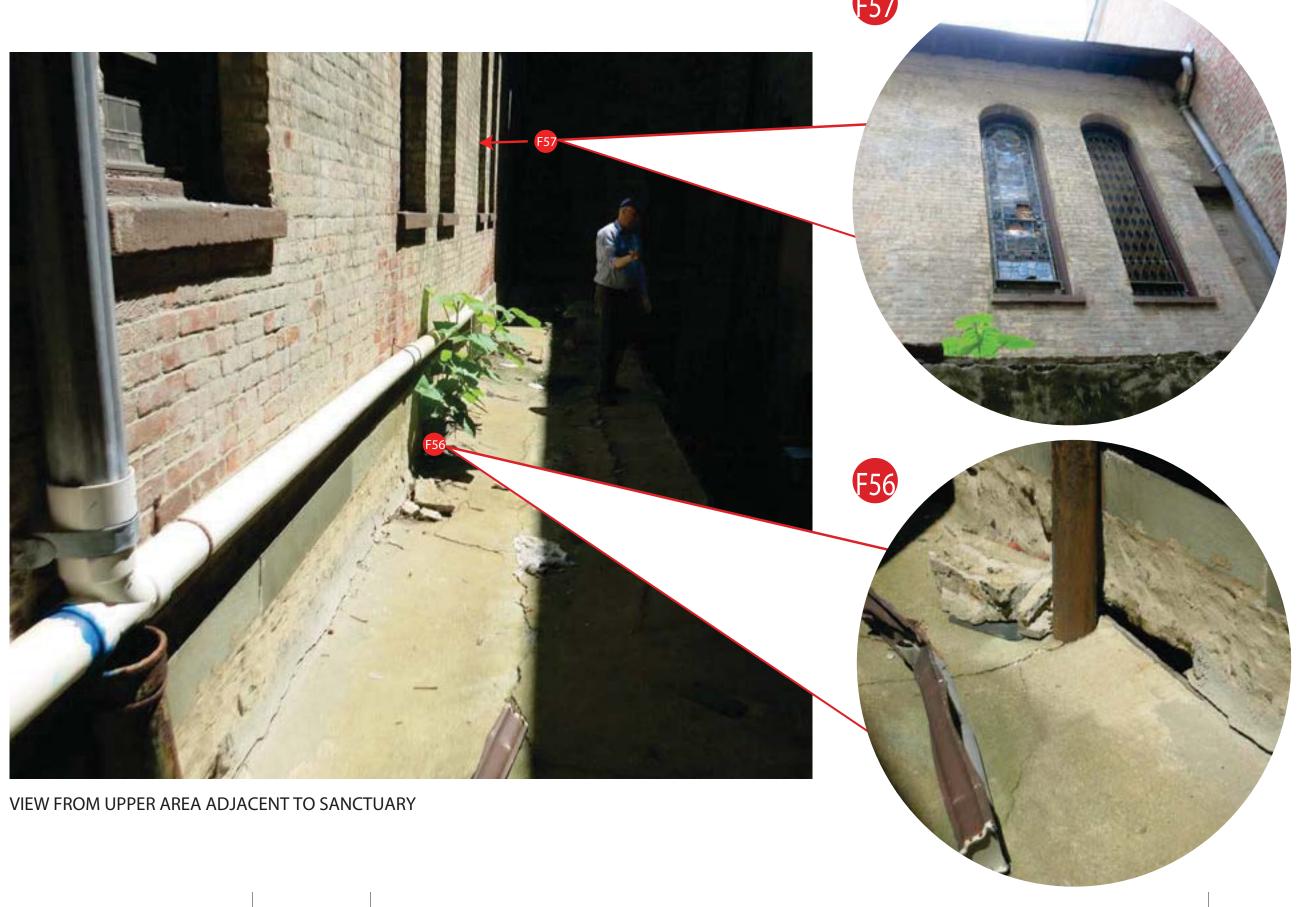
# **COURTYARD**

- <u>DETAILS:</u>

F49 Provide New Roof /Concrete on Elevated Area Adjacent to Sanctuary
  • F56 Seal Openings Along Exterior Wall
- F57 Stained Glass Windows in Sanctuary Facing Courtyard to Receive Protective Glazing

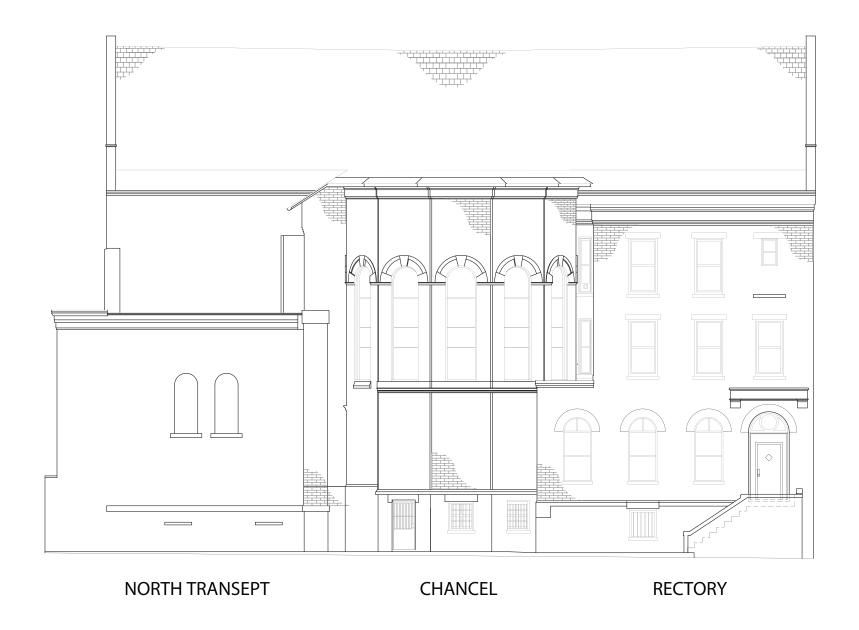
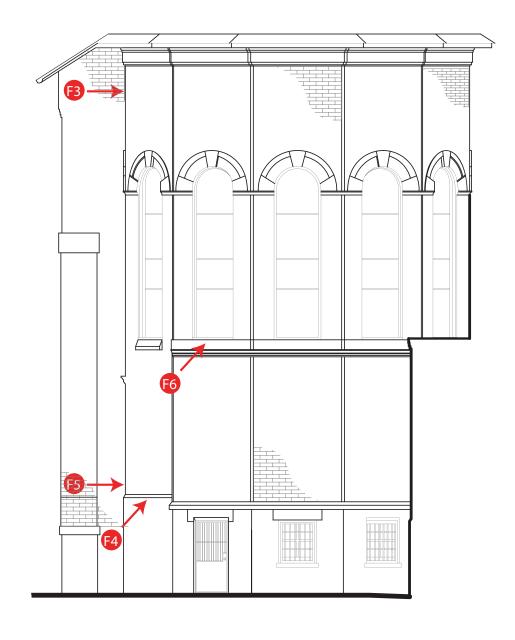
# CHANCEL

### MASONRY SCOPE OF WORK:

- Patch Brownstone Match OriginalRebuild Brownstone to Match Original

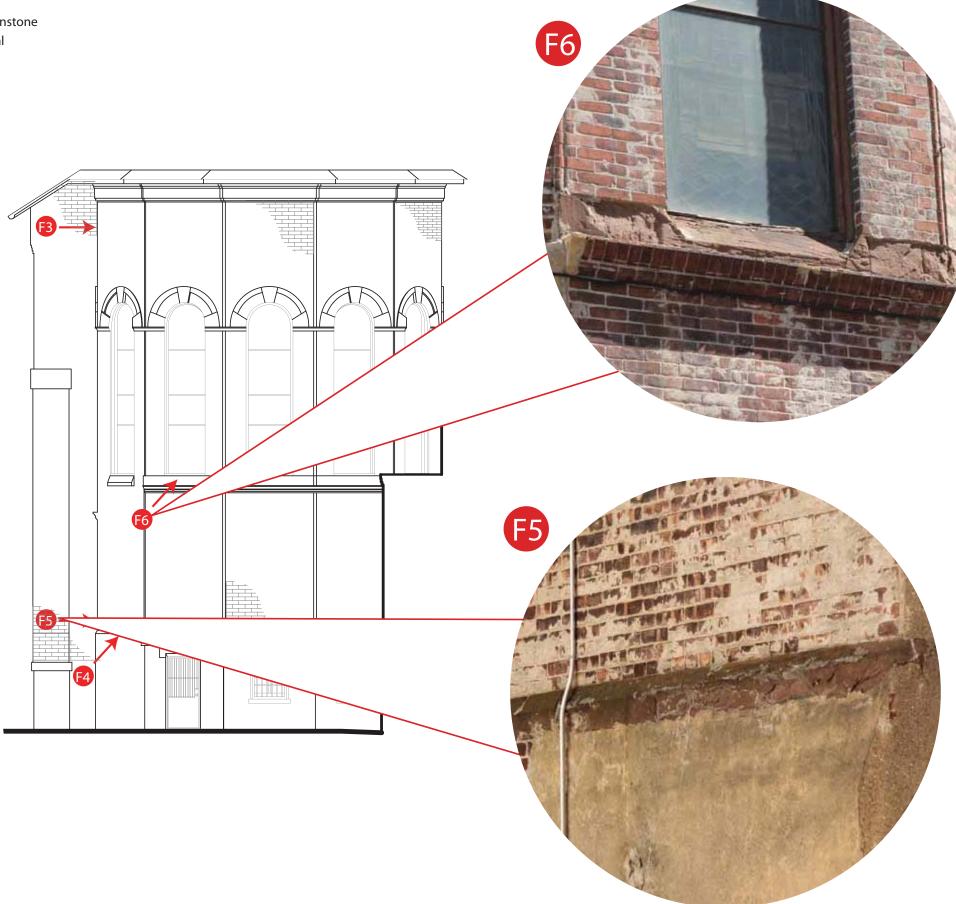
# CHANCEL

### DETAILS:

• F5 Rebuild Areas of Deteriorated Brownstone

• F6 Patch Brownstone to Match Original

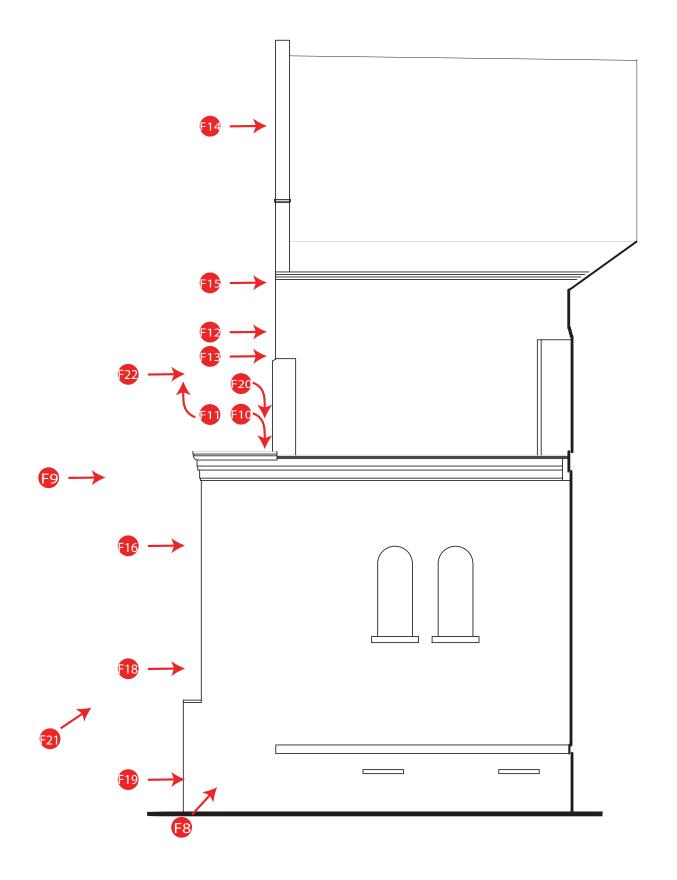
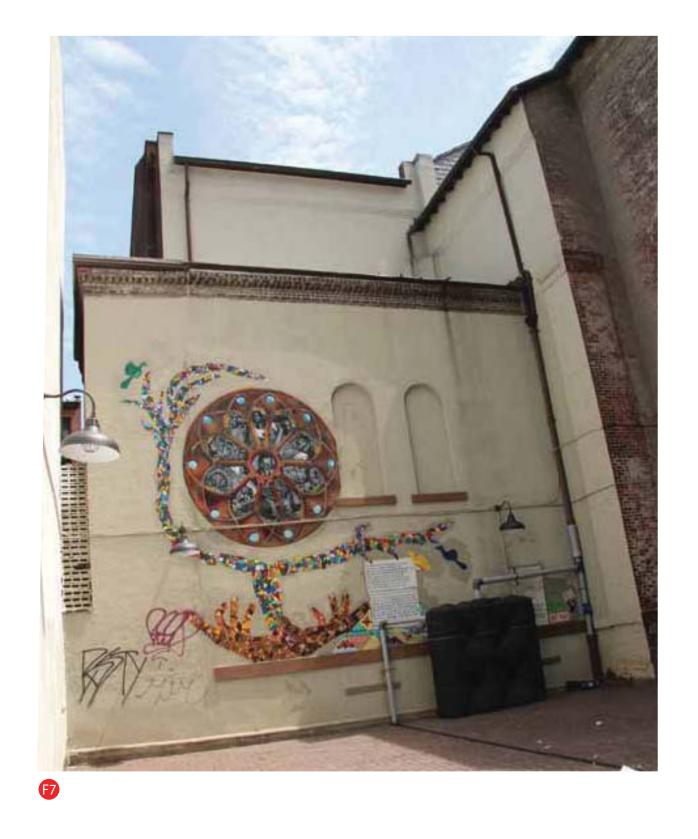
## NORTH TRANSEPT

#### DETAILS:

• F8 General Facade Cleaning/Remove Graffiti

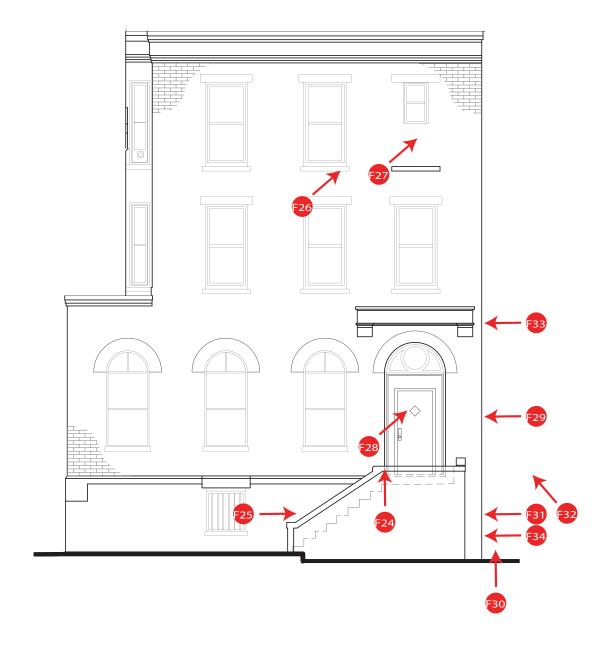
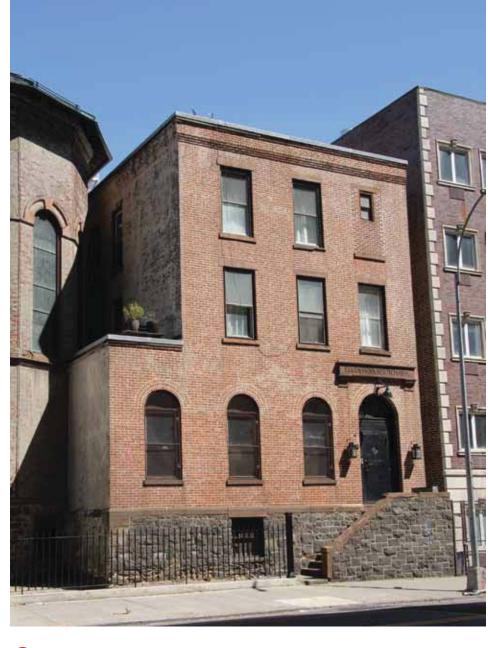
## RECTORY (Vanderbilt Avenue)

#### MASONRY SCOPE OF WORK:

- Patch Brownstone Match Original
- Repair Cracks in Brownstone

#### DOOR SCOPE OF WORK:

Replace Metal Door with Historically Appropriate Wood Door

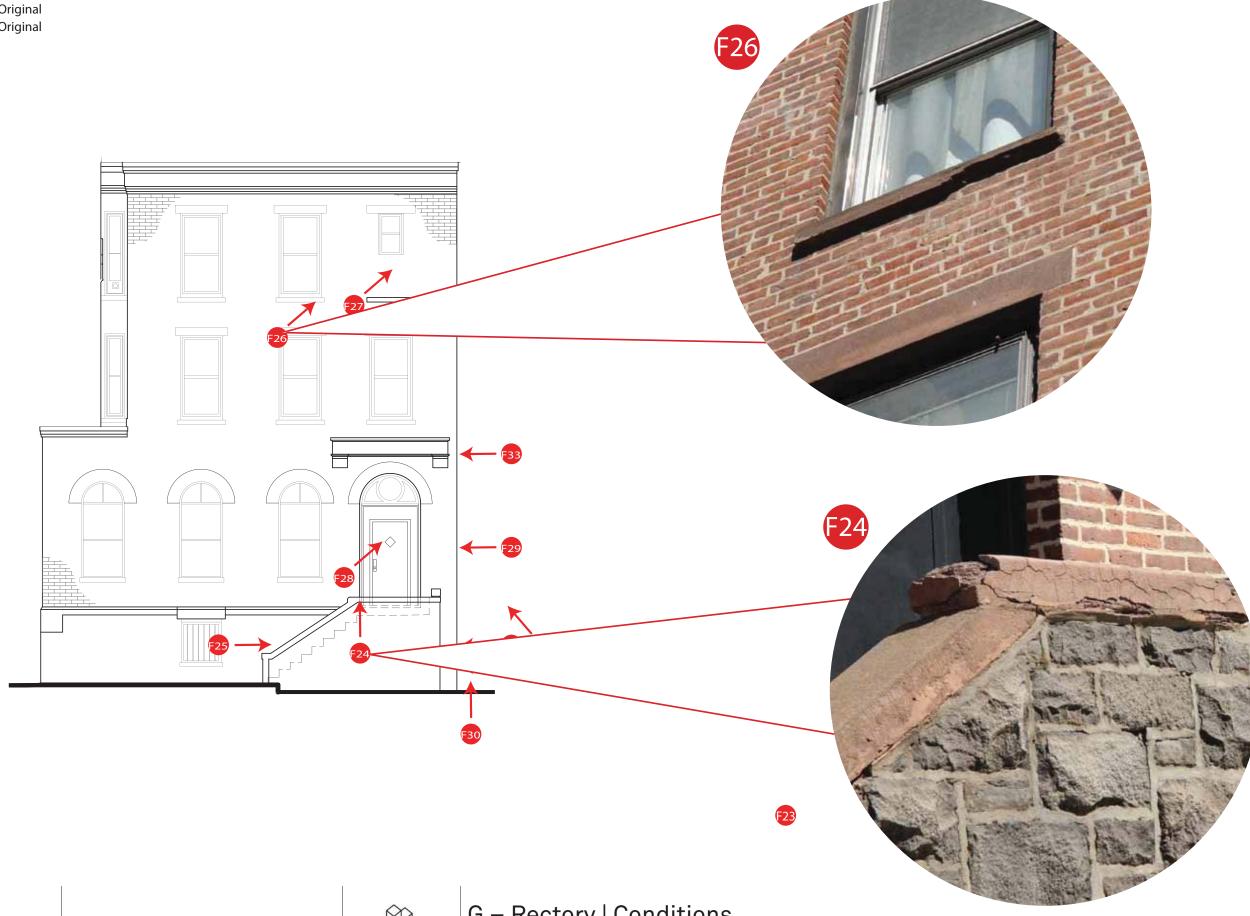
# RECTORY

#### **DETAILS**:

- F24 Patch Brownstone to Match Original
- F26 Patch Brownstone to Match Original
