370 Riverside Drive **WINDOW MASTER PLAN**

370 RIVERSIDE DRIVE, NEW YORK, NY

LPC Public Hearing Presentation - February 19, 2019

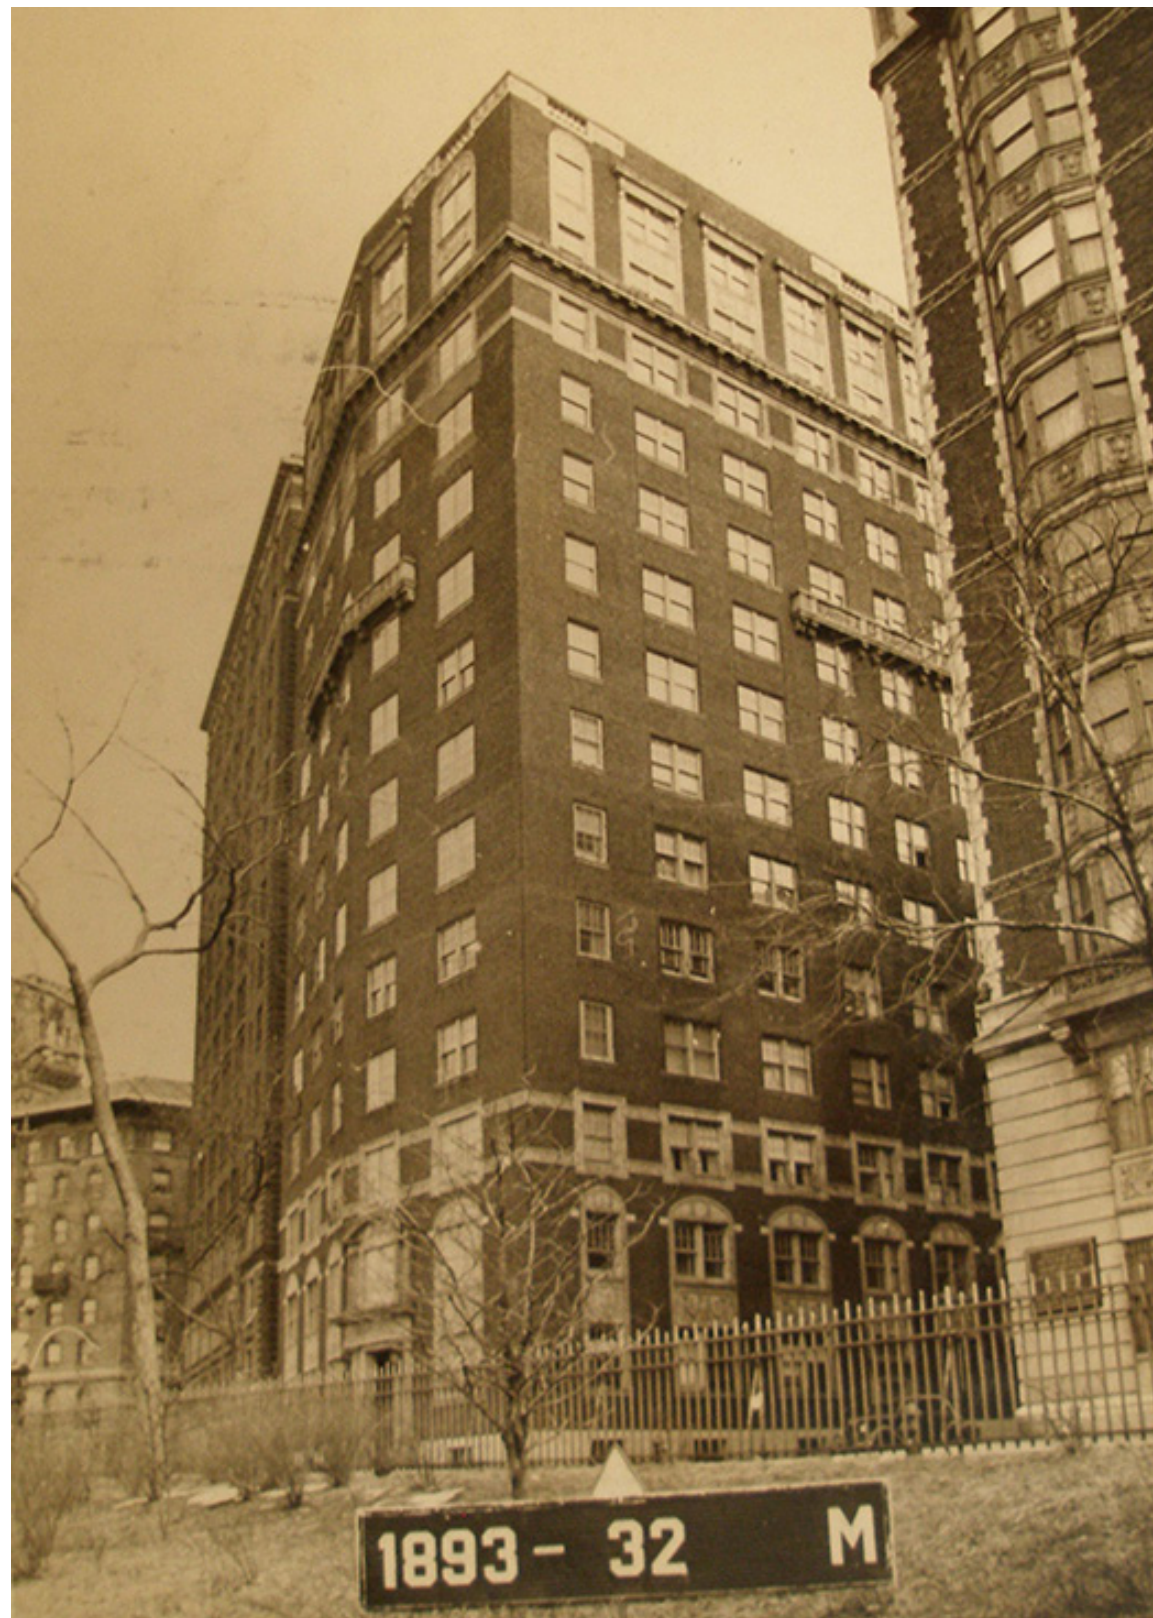
370 Riverside Drive, View from Riverside Park, circa 1939
Source: NYC Municipal Archives Tax Photo Collection

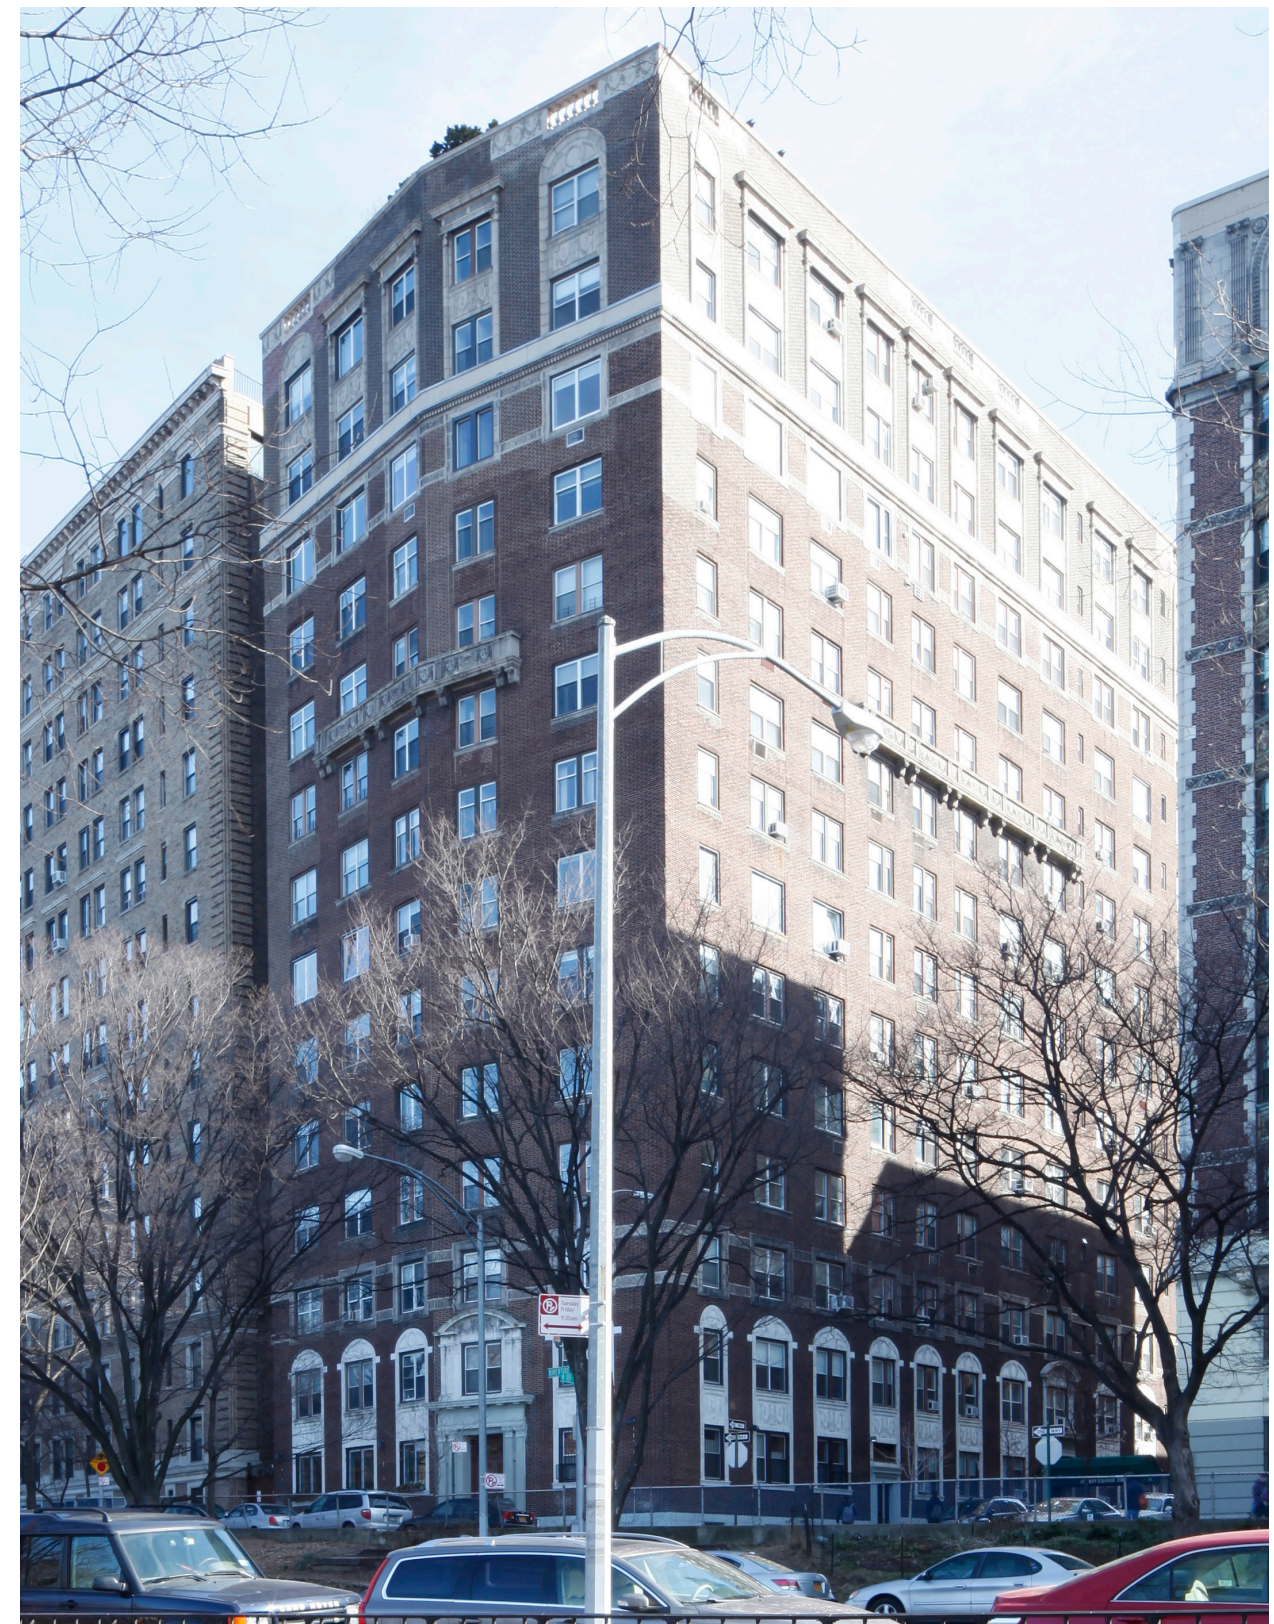
West 109th Street South Elevation Designation photo, 2017
Source: Landmarks Preservation Commission

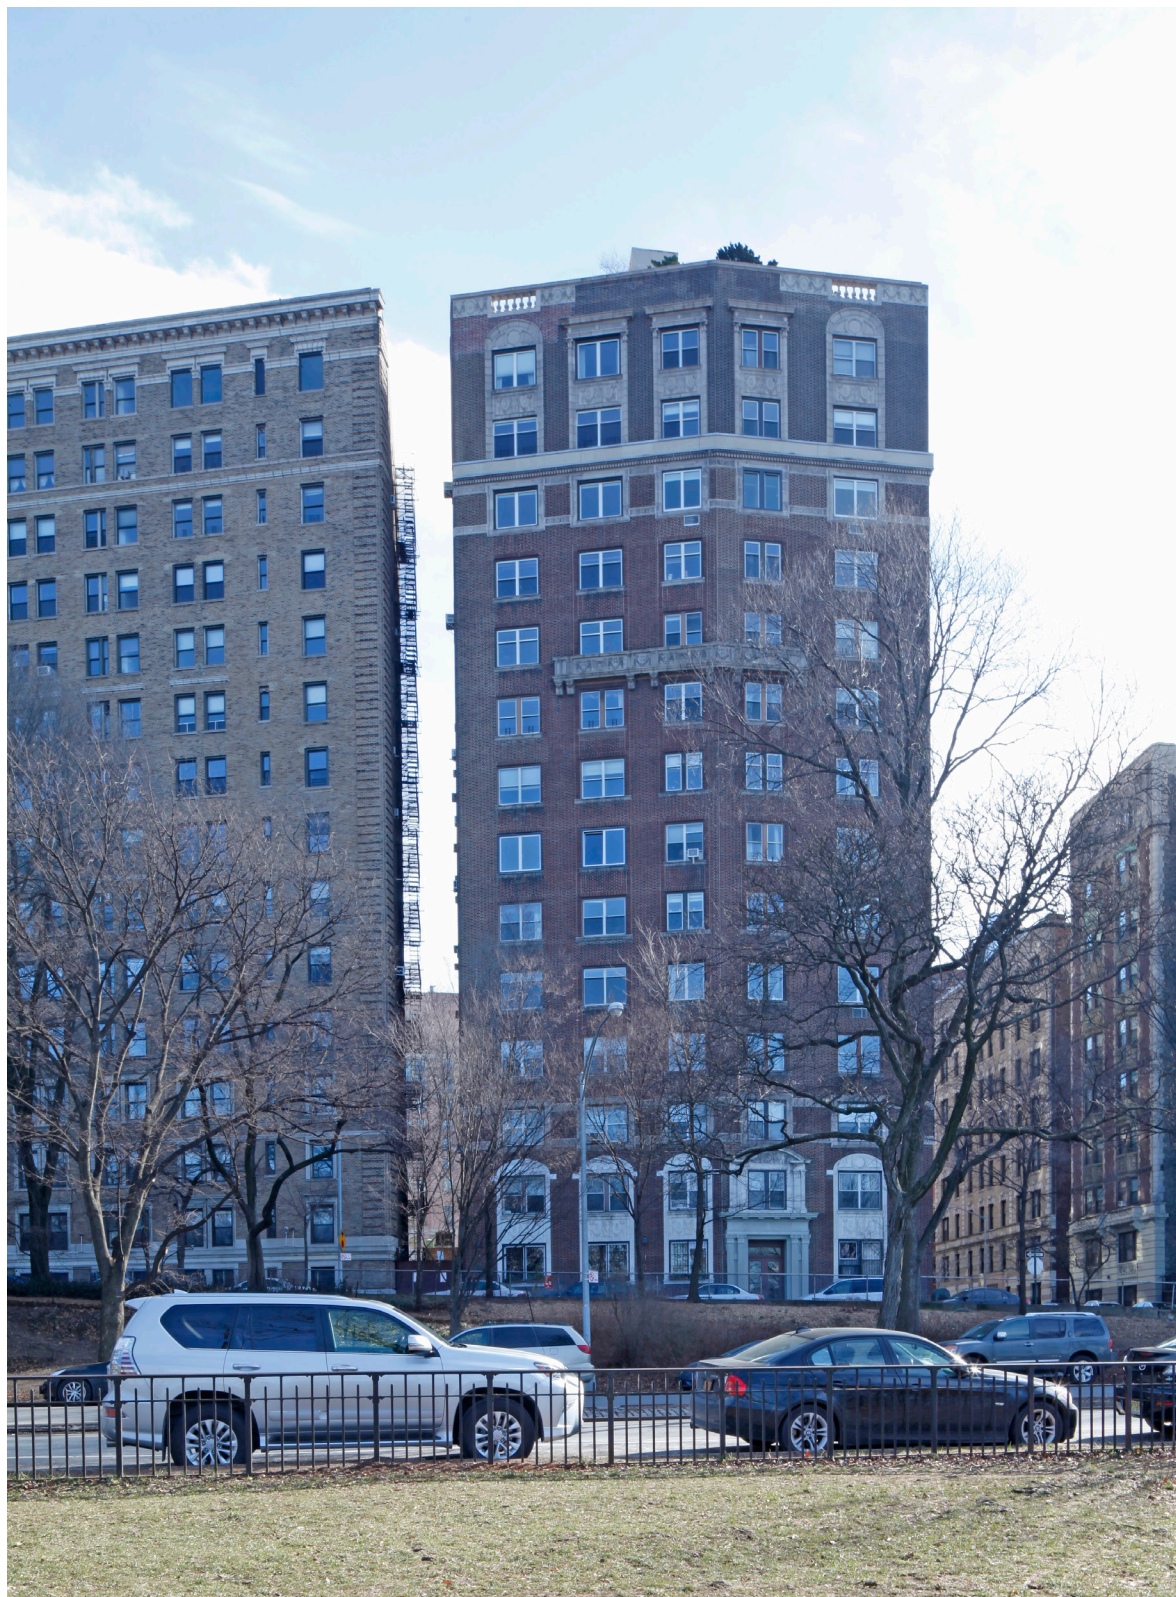
Riverside Drive West Elevation Designation photo, 2017
Source: Landmarks Preservation Commission

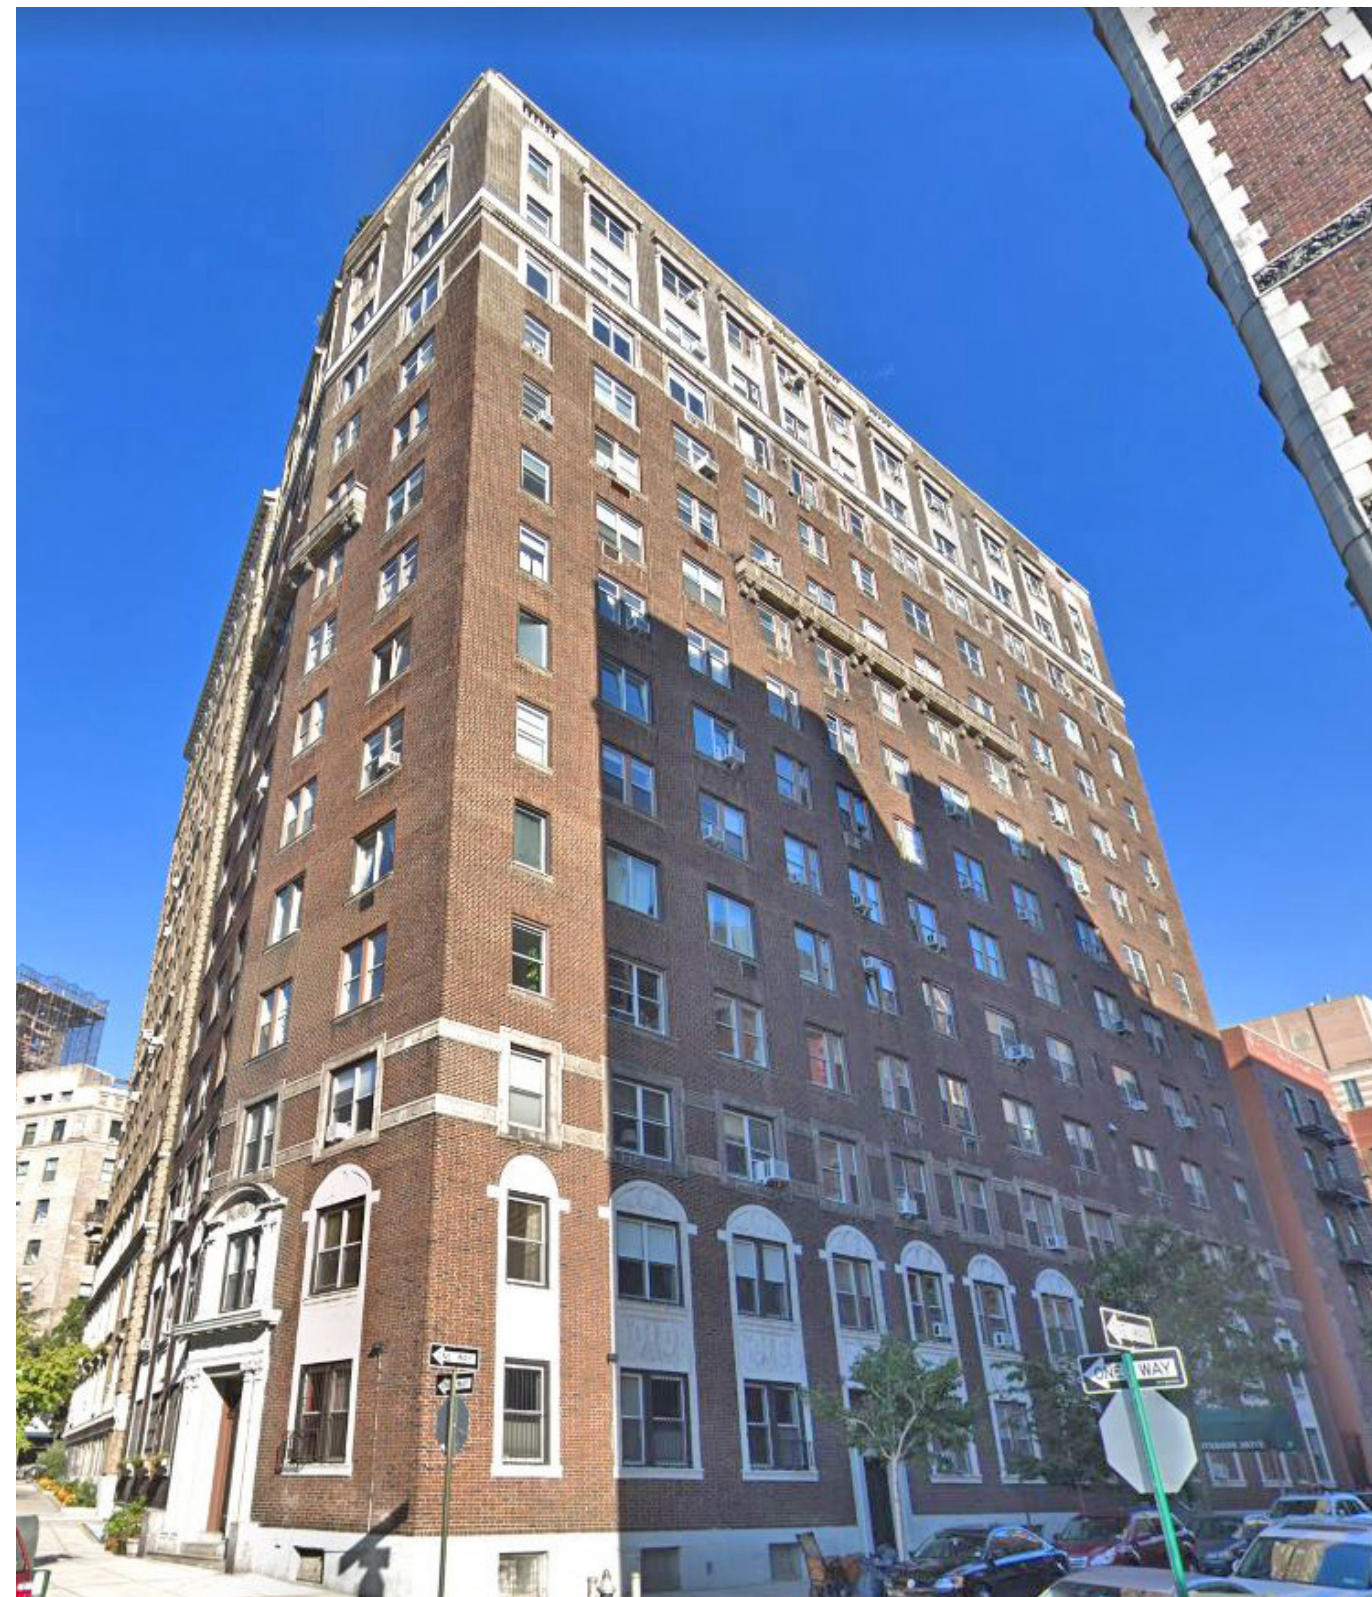
West 109th Street South Elevation Designation photo, 2018
Source: Google Maps

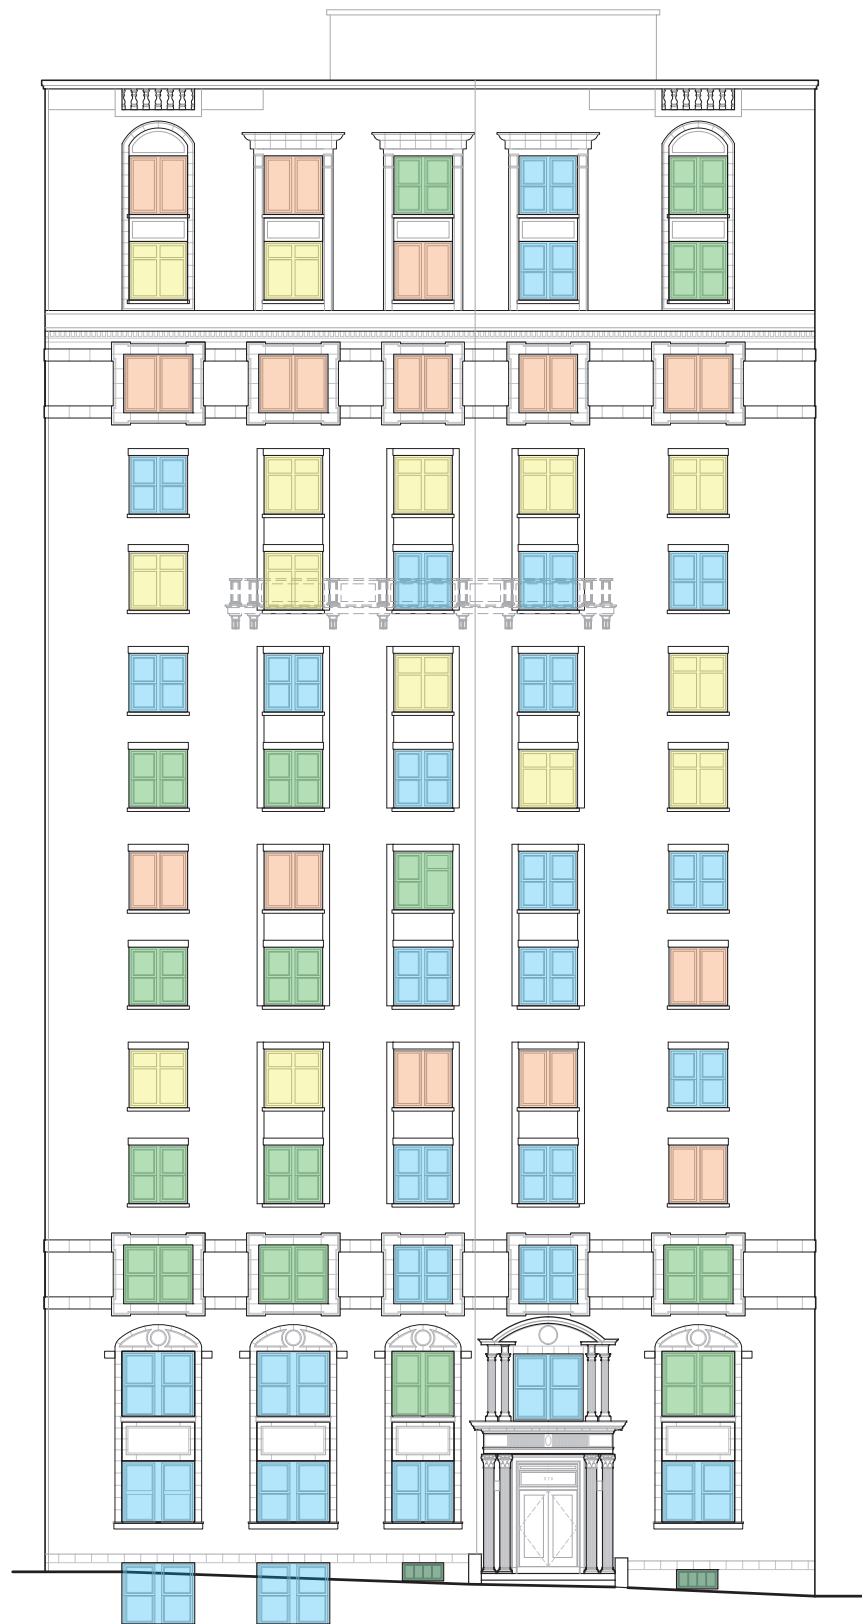
Existing West Elevation

Existing Window Types (By Quantity):

- Type A - Aluminum Paired 1/1 Double hung window w/ wide mullion (84 Units)
- Type B - Aluminum Paired 1/1 Double Hung windows wide mullion removed (45 Units)
- Type H - Aluminum 1/1 Double Hung windows (small) (26 Units)
- Type E - Aluminum 1/1 Double Hung windows (Large) (24 Units)
- Type A1 - Aluminum Paired 1/1 Double Hung windows non-central wide mullion (23 Units)
- Type C - Aluminum Paired casement windows (19 Units)
- Type C1 - Aluminum Paired casement w/ Transom (18 Units)
- Type I - Aluminum Tripartite Double Hung windows (rear facade only - not shown) (14 Units)
- Type D - Wood multi-light Awning windows (7 Units)
- Type C2 - Aluminum Paired windows - 1 casement, 1 Double Hung (5 Units)
- Type F - Aluminum single casement windows (4 Units)
- Type G - Aluminum 1/1 Double Hung windows (medium) (2 Units)

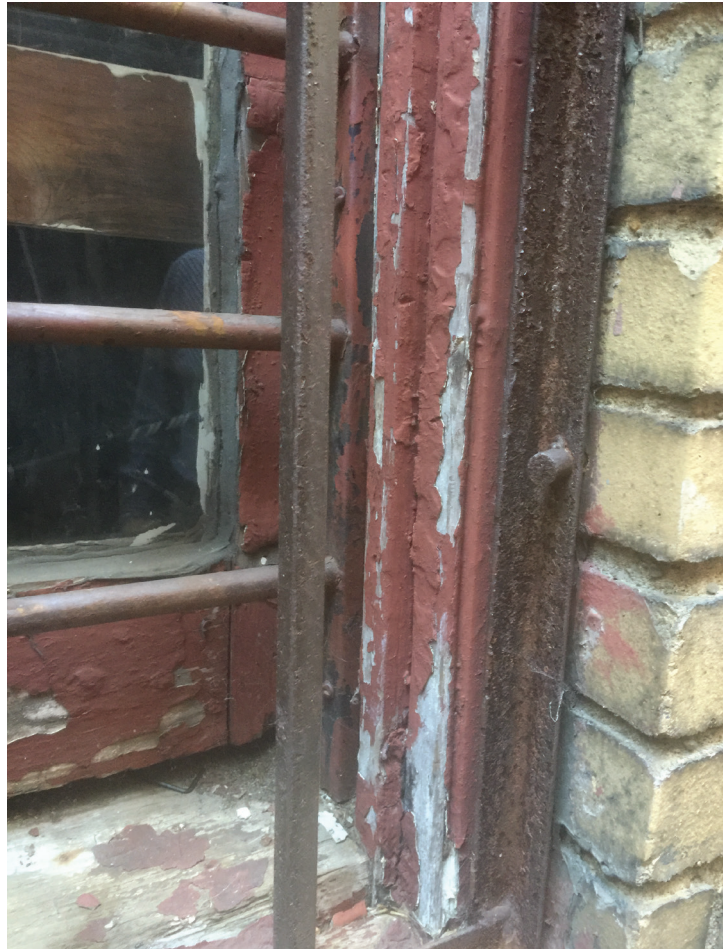
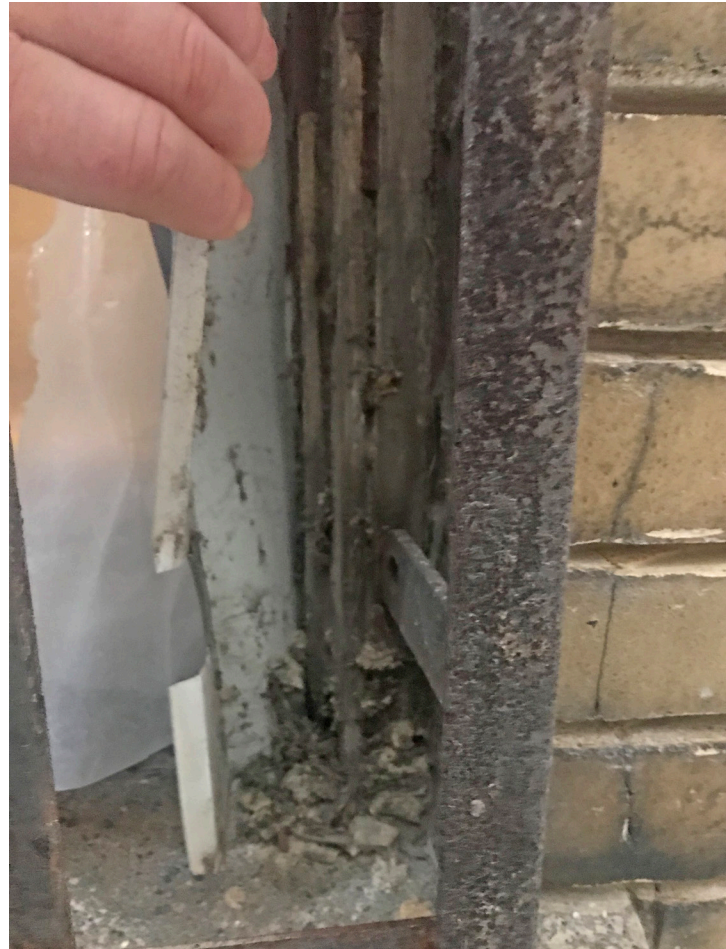
Detail views of extant historic “beaded casing” wood brick molding present on rear elevations

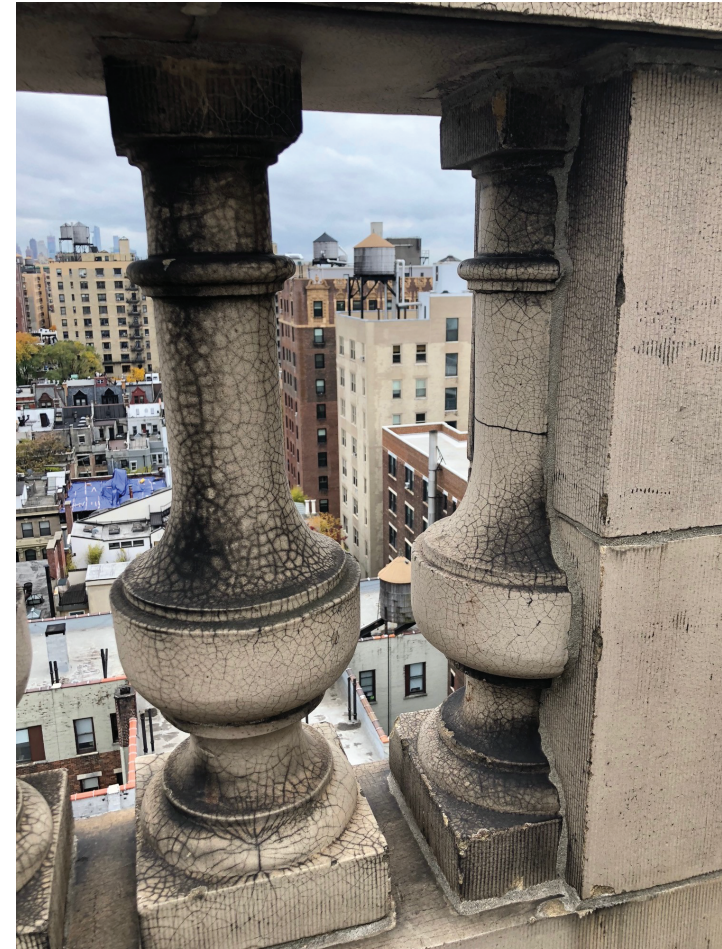
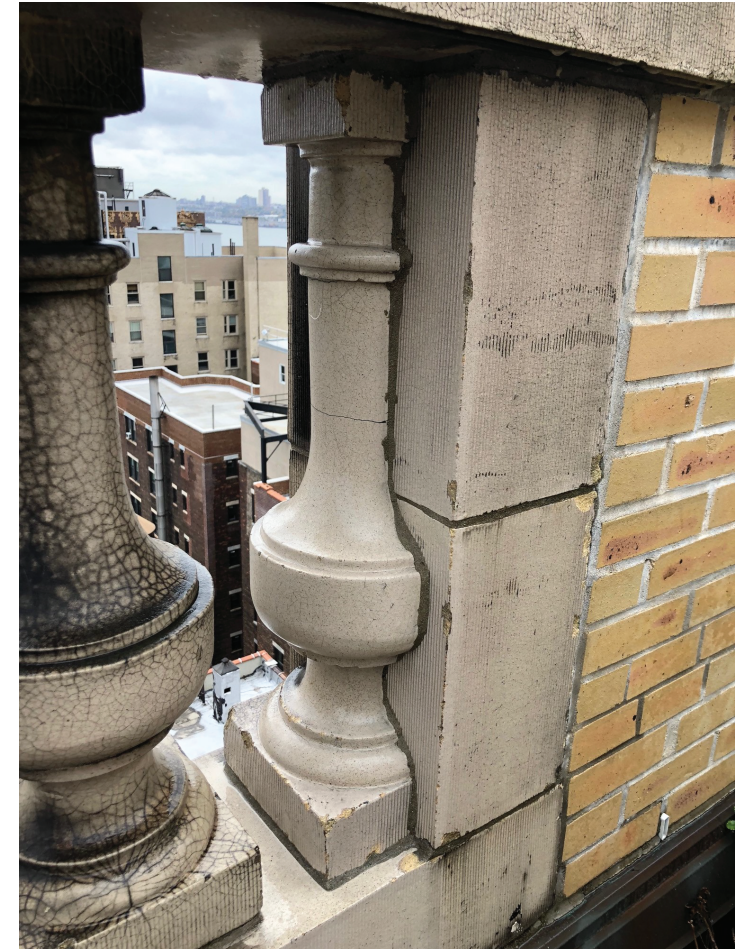
Detail views of extant historic terra cotta baluster prior to and after cleaning with CPS Heavy Duty Cleaner. Proposed windows will be finished to match this cleaned historic terra cotta.

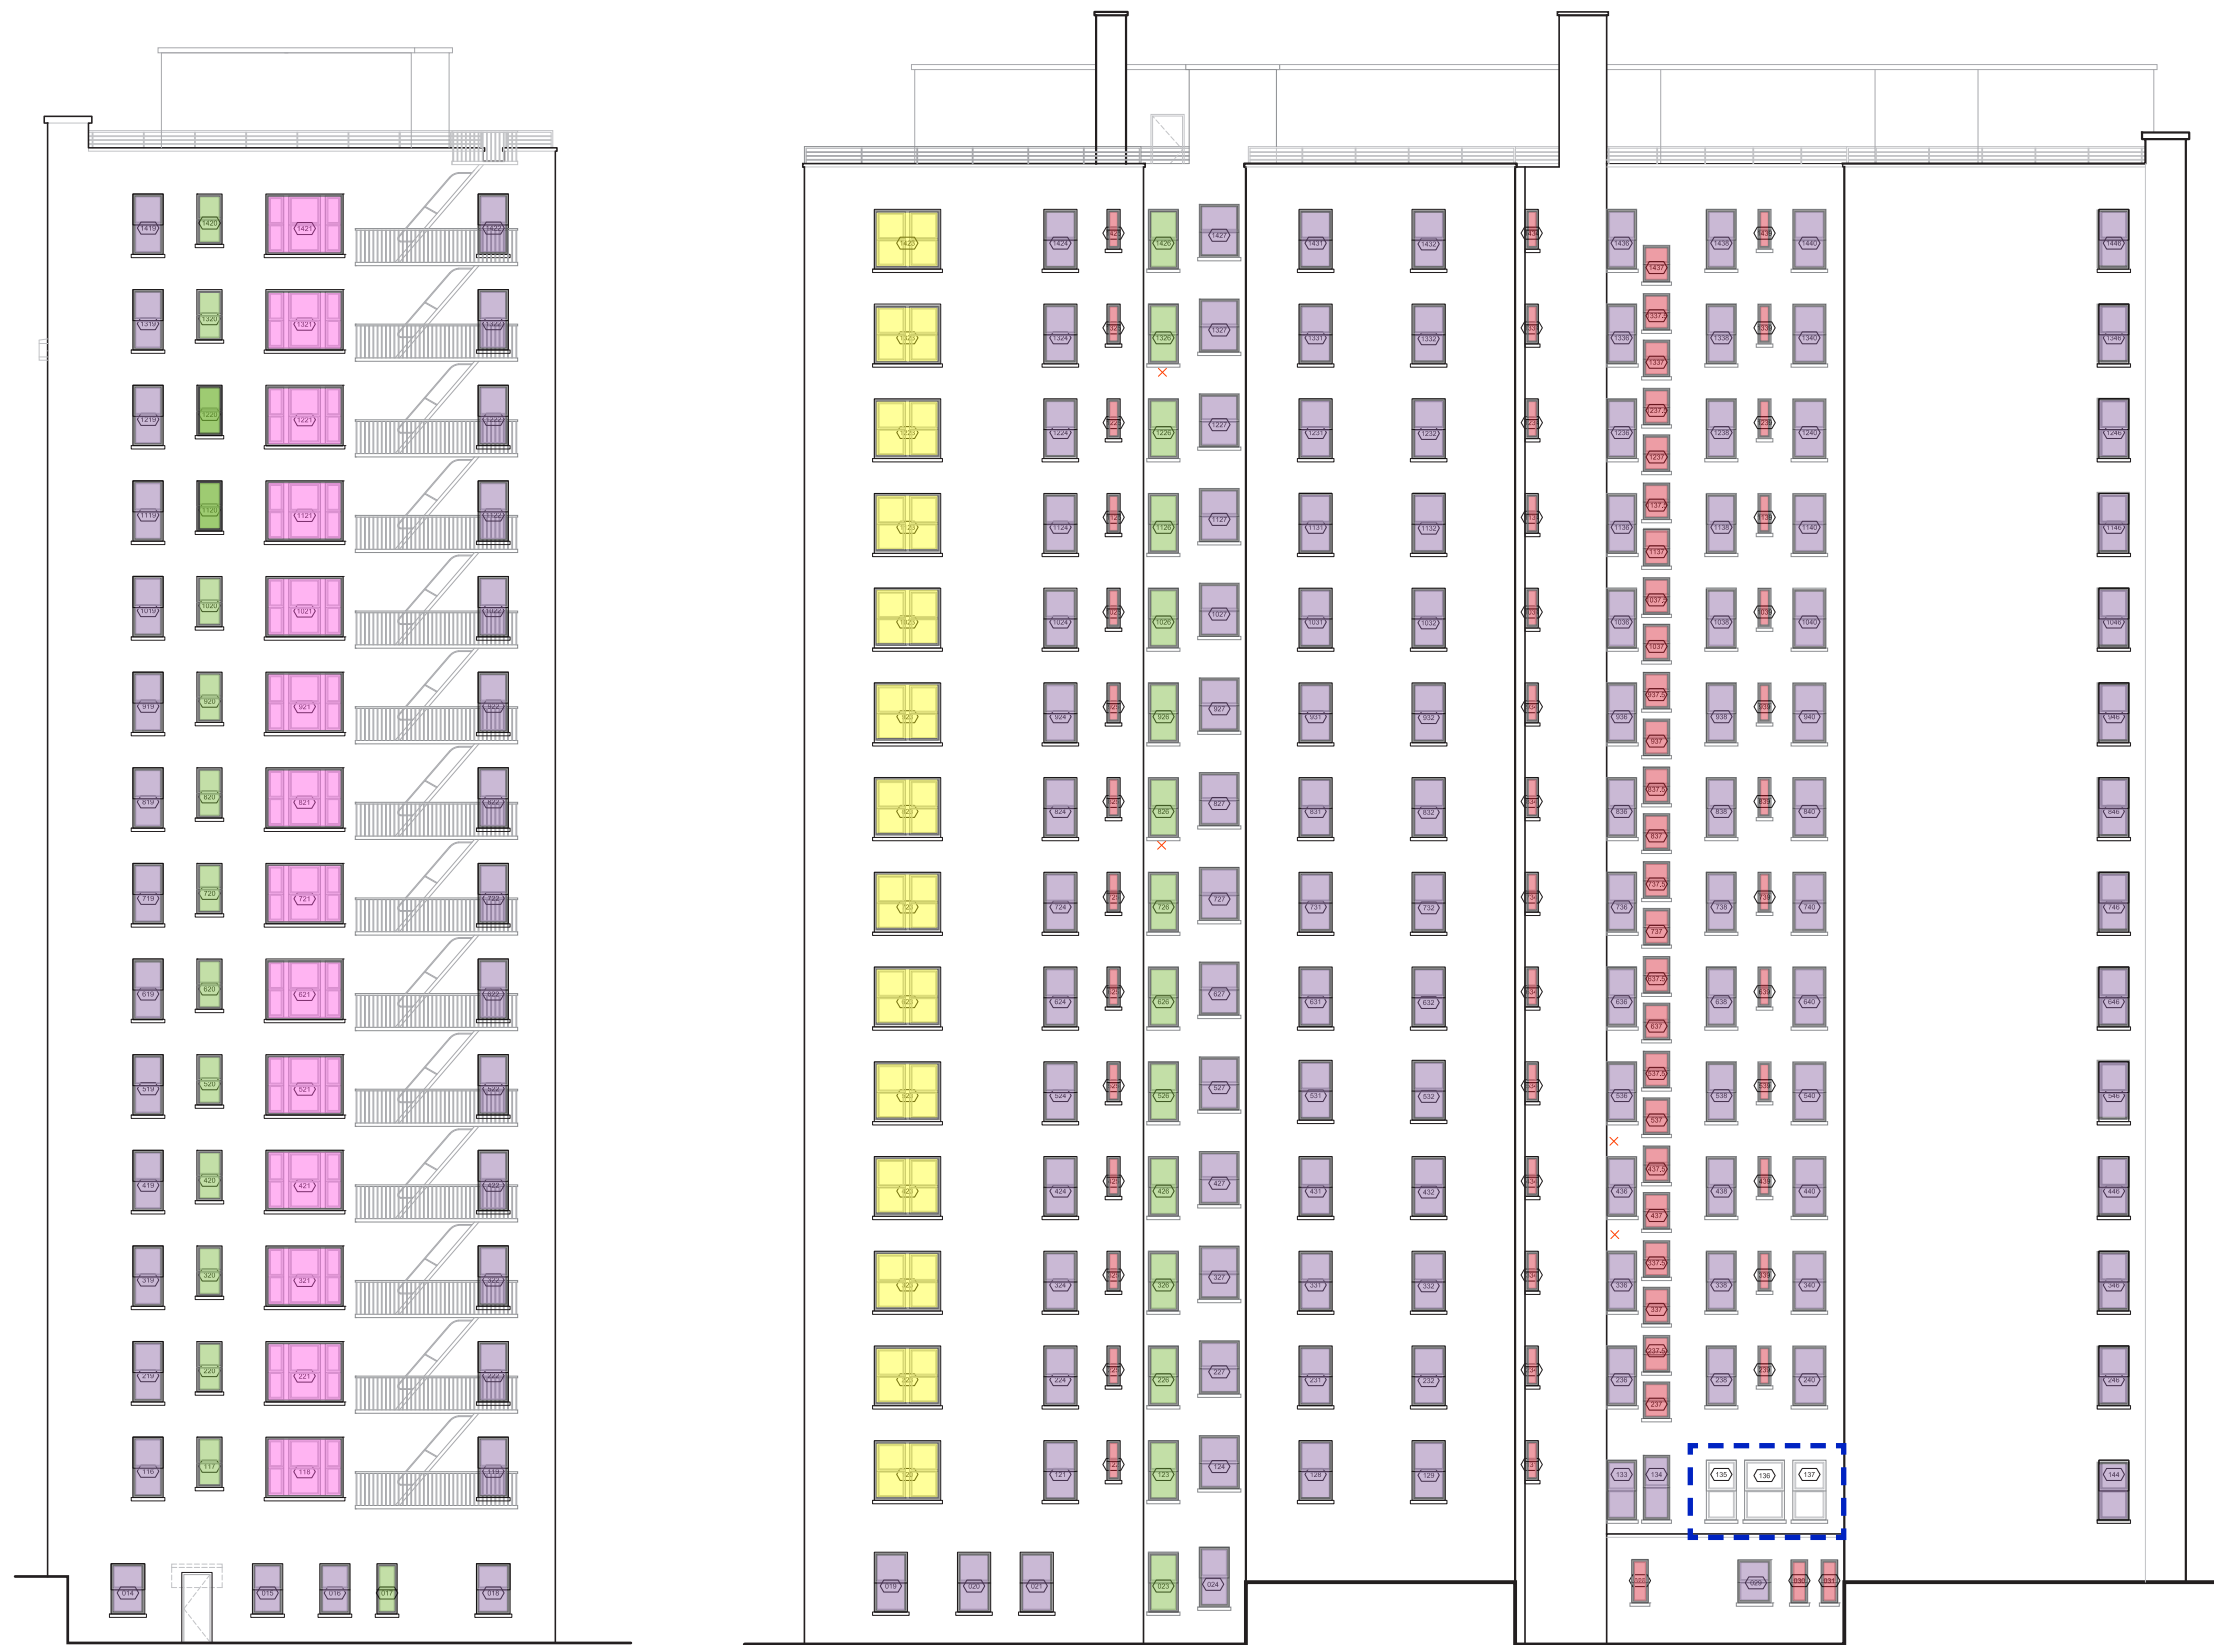
Window Types:

- Type 1 - Paired 1/1 Double Hung aluminum clad wood windows w/ central mullion (14 units)
- Type 2 - Paired 1/1 Double Hung aluminum clad wood windows w/ non-central mullion (0 units)
- Type 3 - 1/1 Double Hung aluminum clad wood windows (Large) (182 units)
- Type 4 - 1/1 Double Hung aluminum clad wood windows (Medium) (30 units)
- Type 5 - 1/1 Double Hung aluminum clad wood windows (Small) (68 units)
- Type 6 - Tripartite. 1/1 Double Hung aluminum clad wood windows (14 units)
- Type 7 - Multi-light wood awning windows (0 units)

Proposed East Elevation

Proposed North Elevation

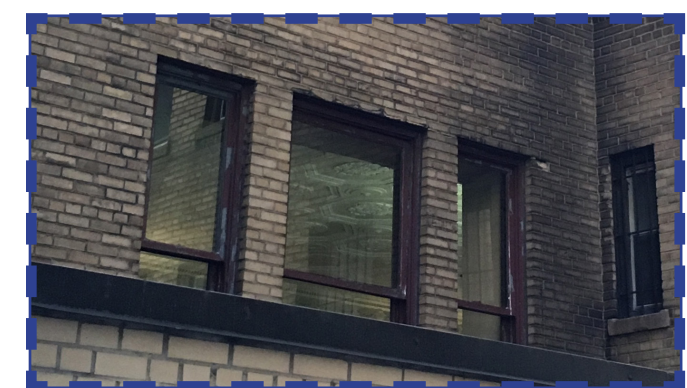
Existing Historic Windows to Remain

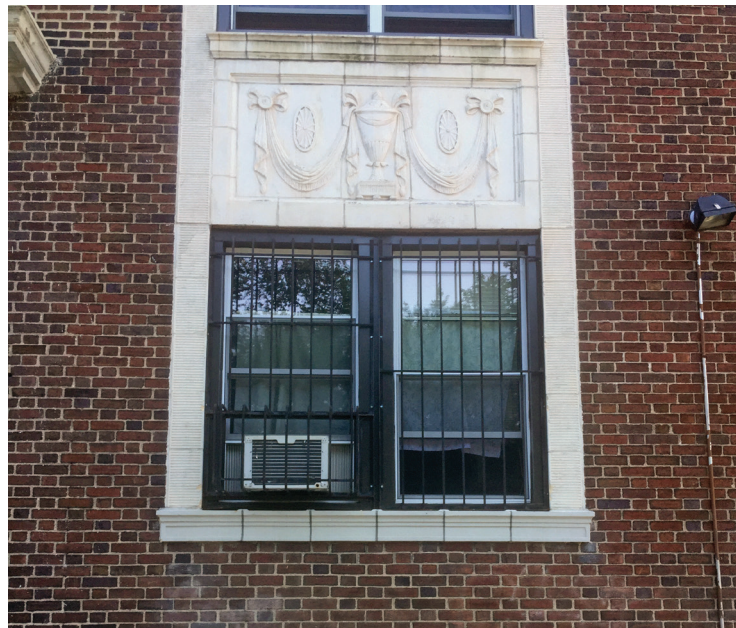
Typical Existing Type A Window - Paired 1/1 Double-Hung aluminum clad wood windows with Wide Mullion

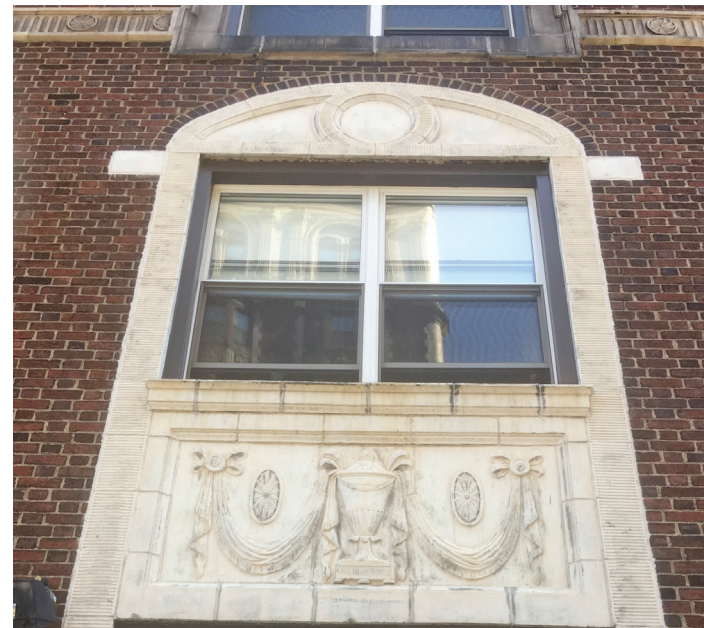
Typical Existing Type B Window - Paired 1/1 Double-Hung aluminum clad wood window, Wide Mullion removed

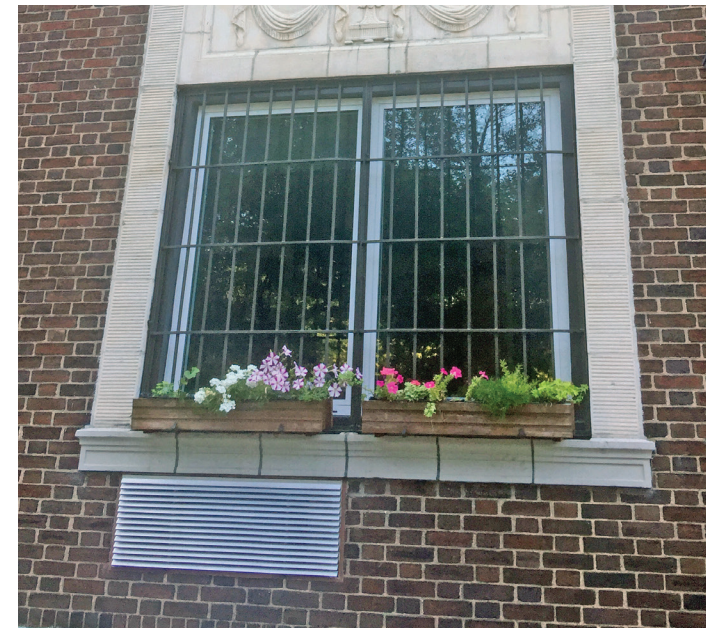
Typical Existing Type C Window - Paired Casement Windows

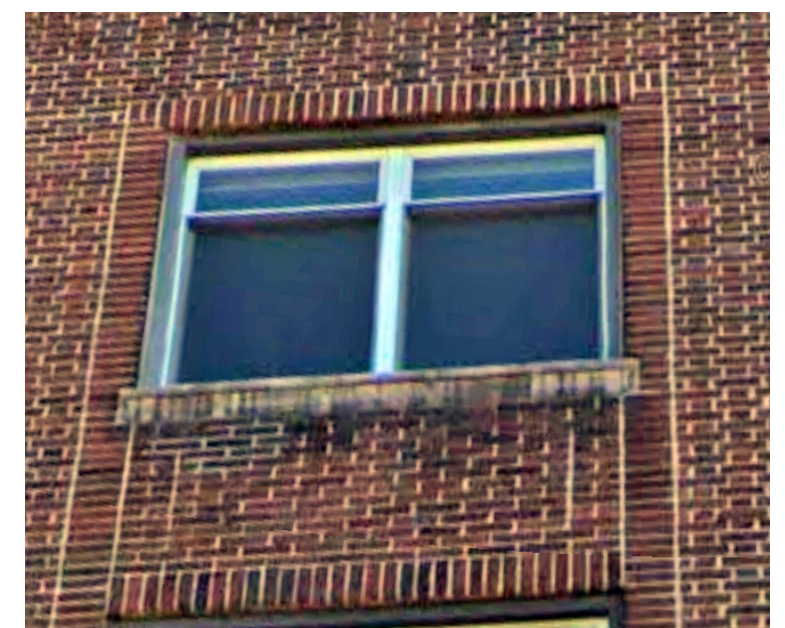
Typical Existing Type C1 - Paired Casement Windows with Transom

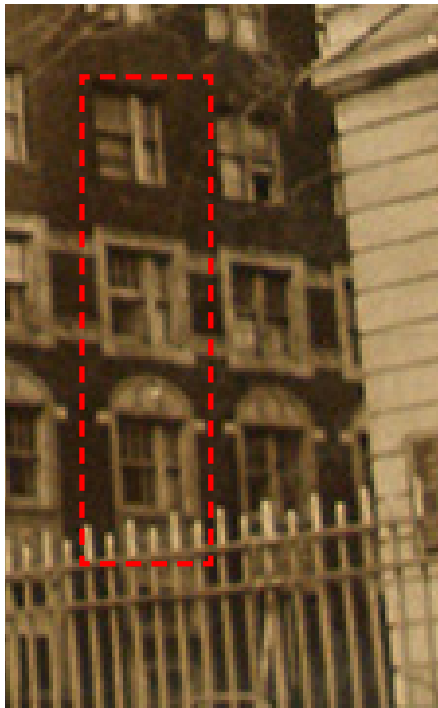
Historic Photo of Window Type 2

Total - 26 Units

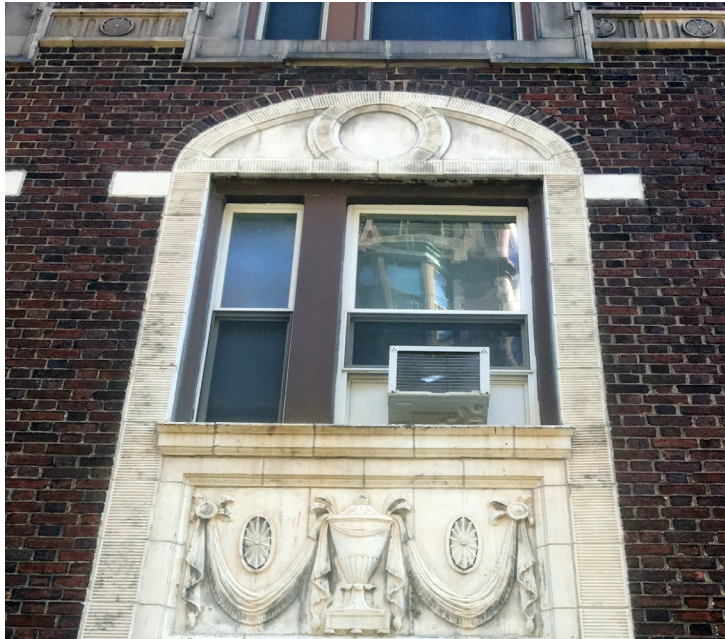
Typical Existing Type 2A Window - Paired 1/1 Double-Hung aluminum clad wood windows with non- central wide mullion to left

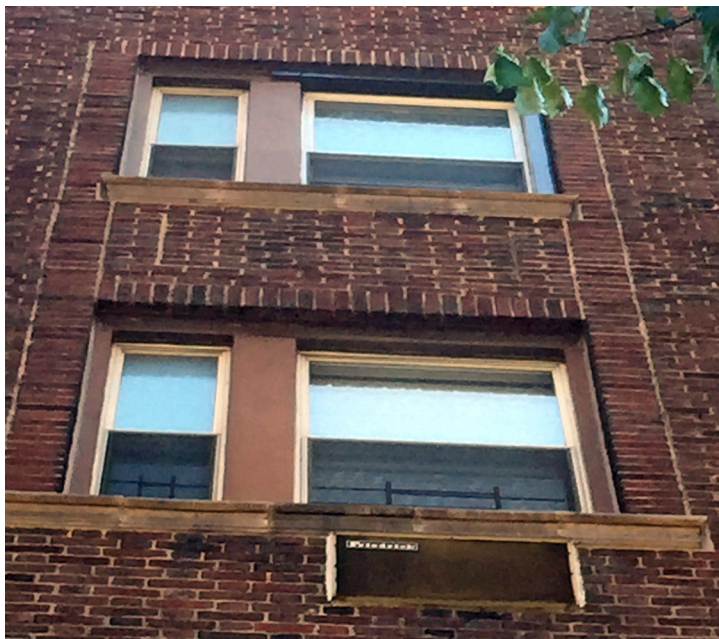
Typical Existing Type 2A Window - Paired 1/1 Double-Hung aluminum clad wood windows with non- central wide mullion to left

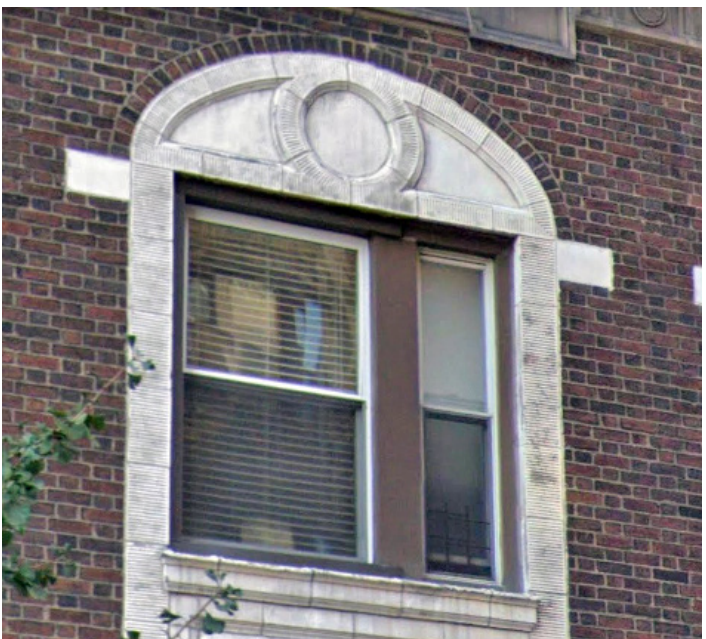
Typical Existing Type 2A Window - Paired 1/1 Double-Hung aluminum clad wood windows with non- central wide mullion to right

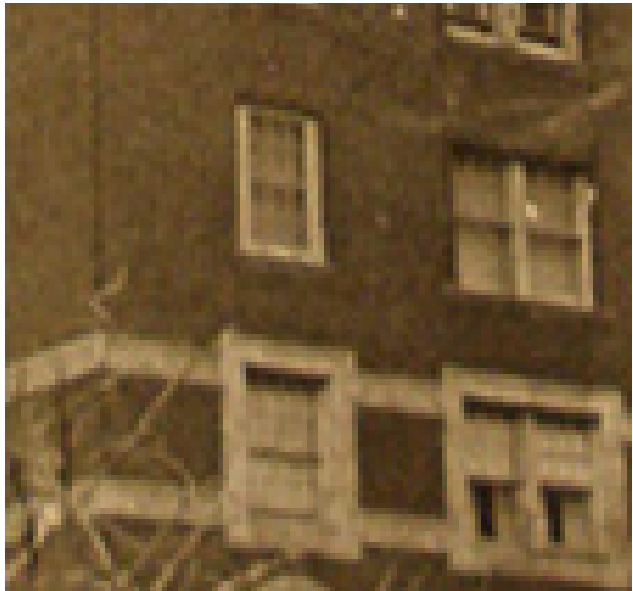
Historic Photo of Window Type 3

Total
Type 3 - 273 Units
Type 4 - 74 Units
Type 5 - 94 Units

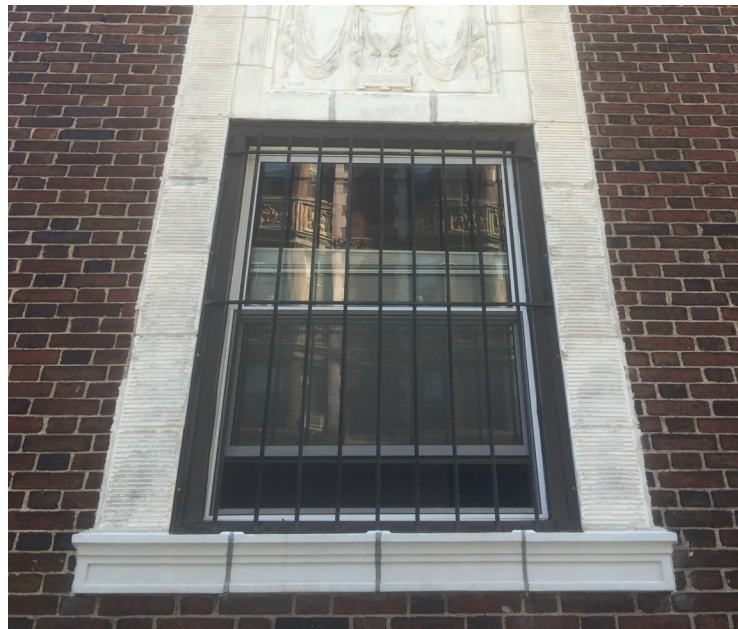
Typical Existing Type E Window - 1/1 Double Hung aluminum window (Large)

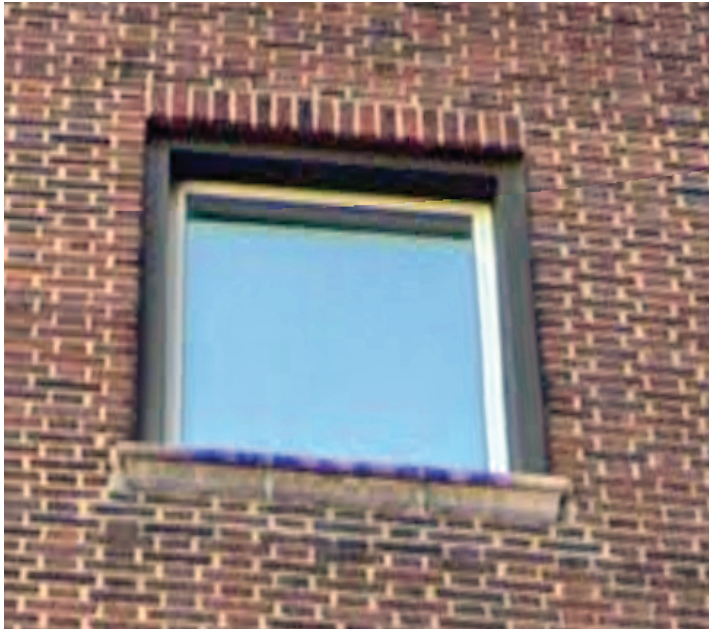
Typical Existing Type F Window - Aluminum casement

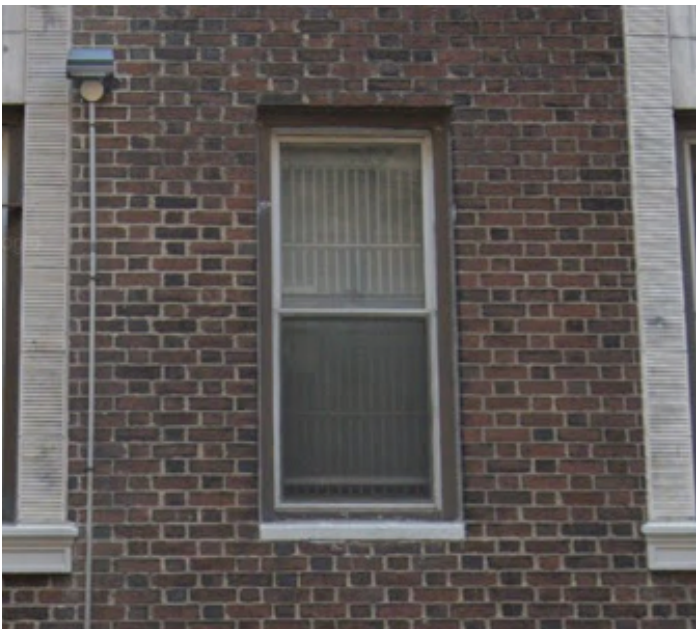
Typical Existing Type G Window - 1/1 Double Hung aluminum window (Medium)

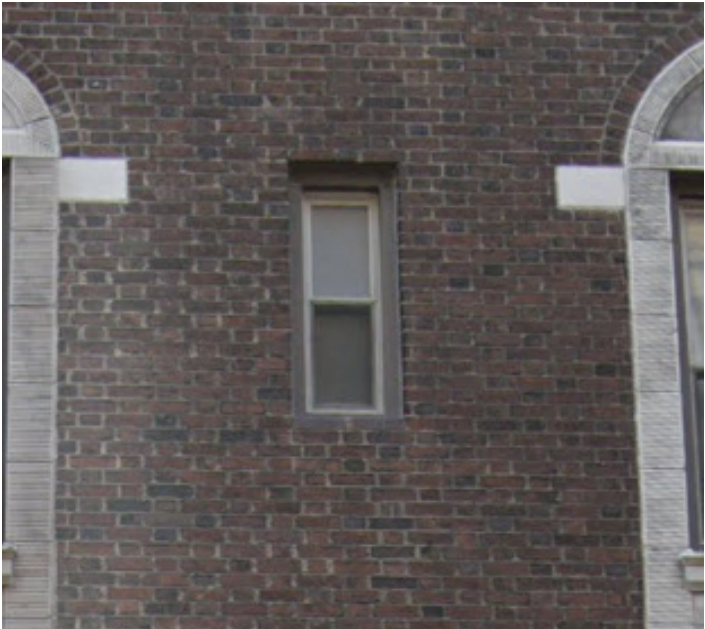
Modified Existing Type H Window - 1/1 Double Hung aluminum window (Small)

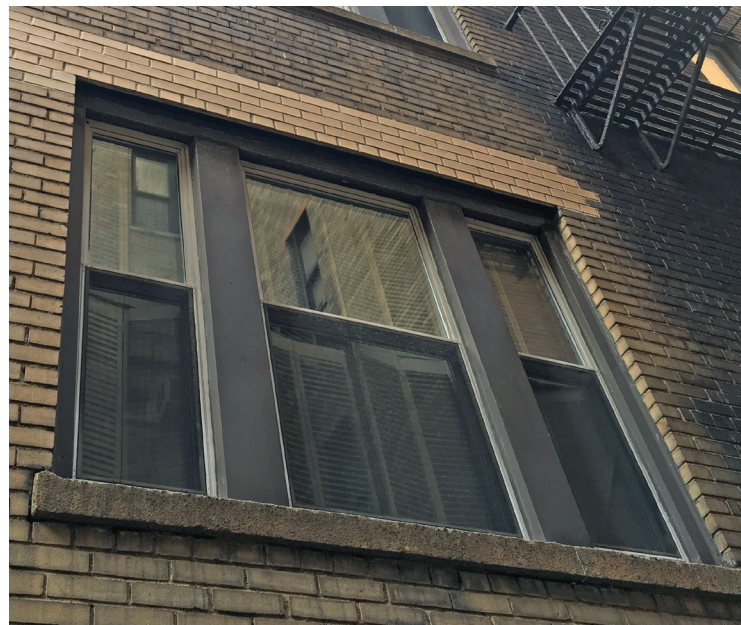
Typical Existing Type I Window - Tripartite 1/1 Double-Hung
