370 Riverside Drive **WINDOW MASTER PLAN**

370 RIVERSIDE DRIVE, NEW YORK, NY

LPC Public Hearing Presentation - February 19, 2019

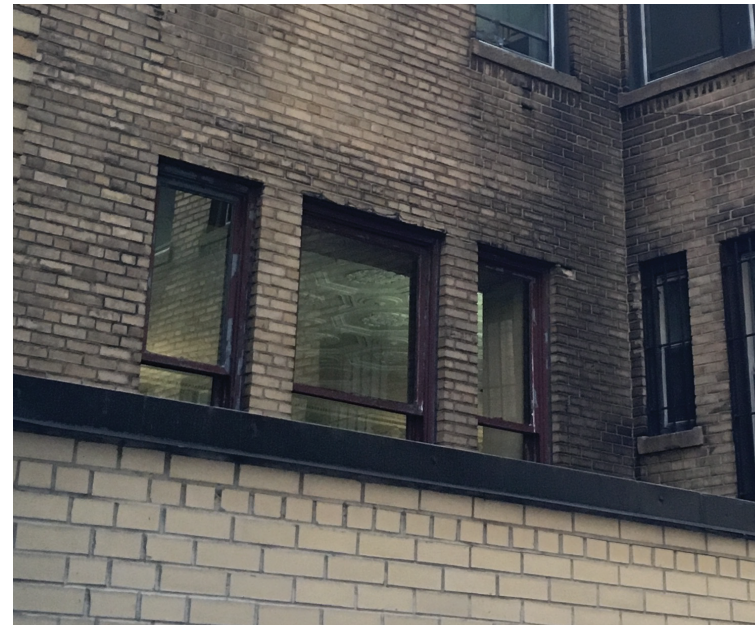
Existing Historic Wood Tripartite 1/1 Double Hung windows with original Brick molding present

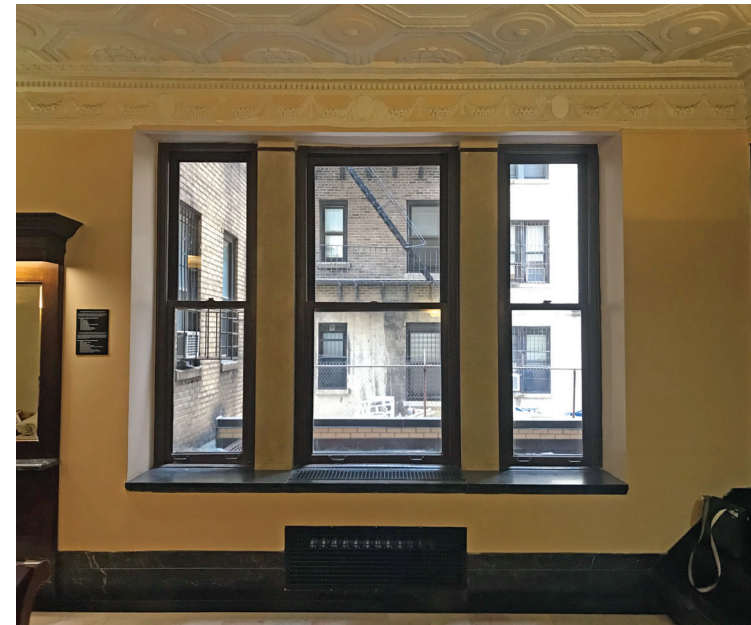
Existing Historic Wood Tripartite 1/1 Double Hung window in Lobby (only remaining)

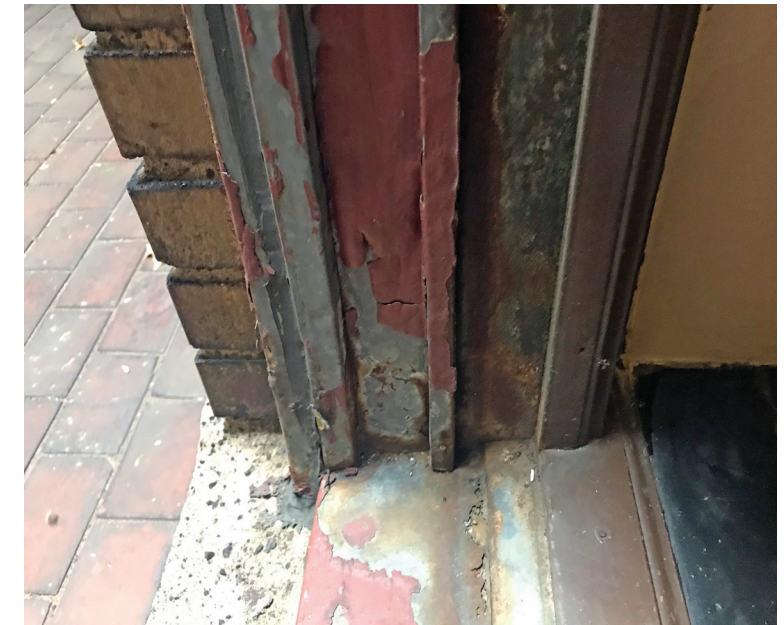
View of Historic Metal Clad wood 1/1 Double Hung window jamb at Lobby

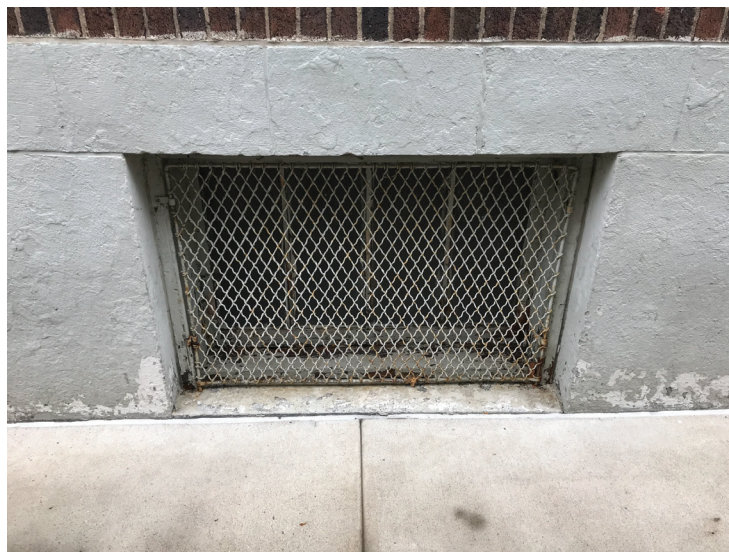
Typical Existing Type D Window -
Wood Multi-light Awning

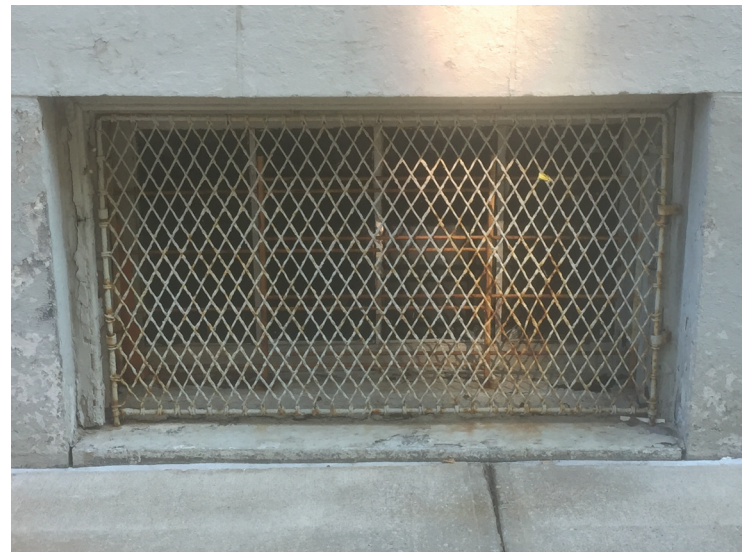
Typical Existing Type D Window -
Wood Multi-light Awning

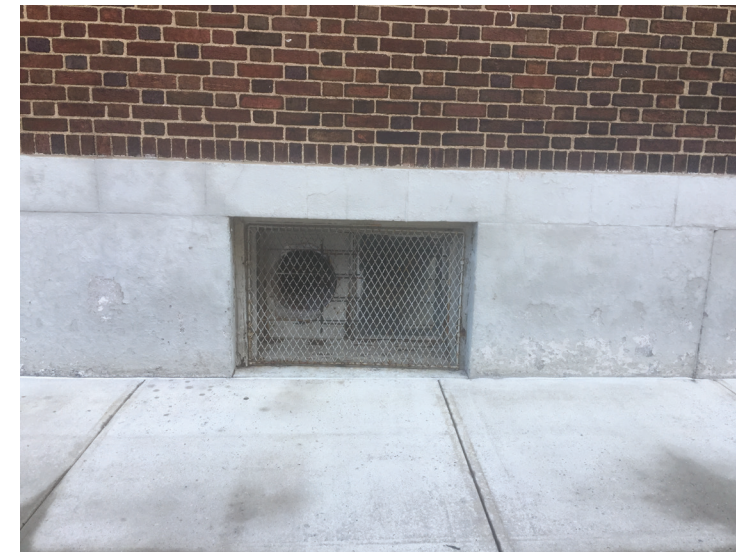
Modified Existing Type D Window -
Exhaust

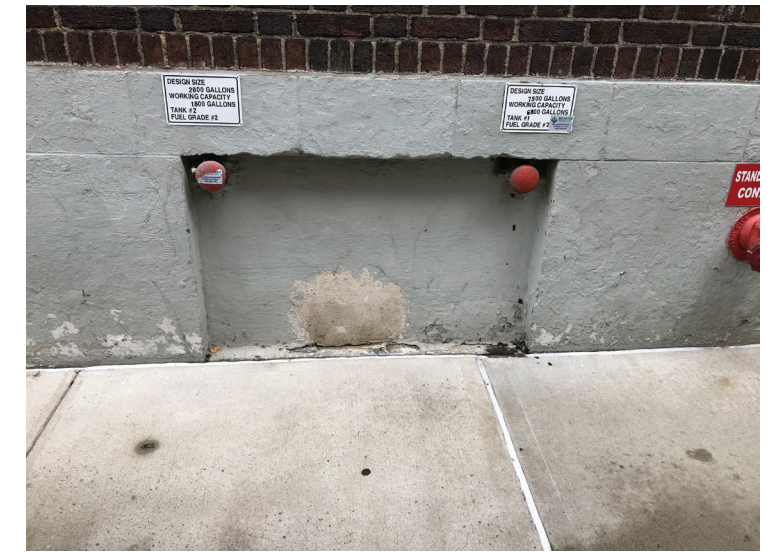
Modified Existing Type D Window -
Infilled

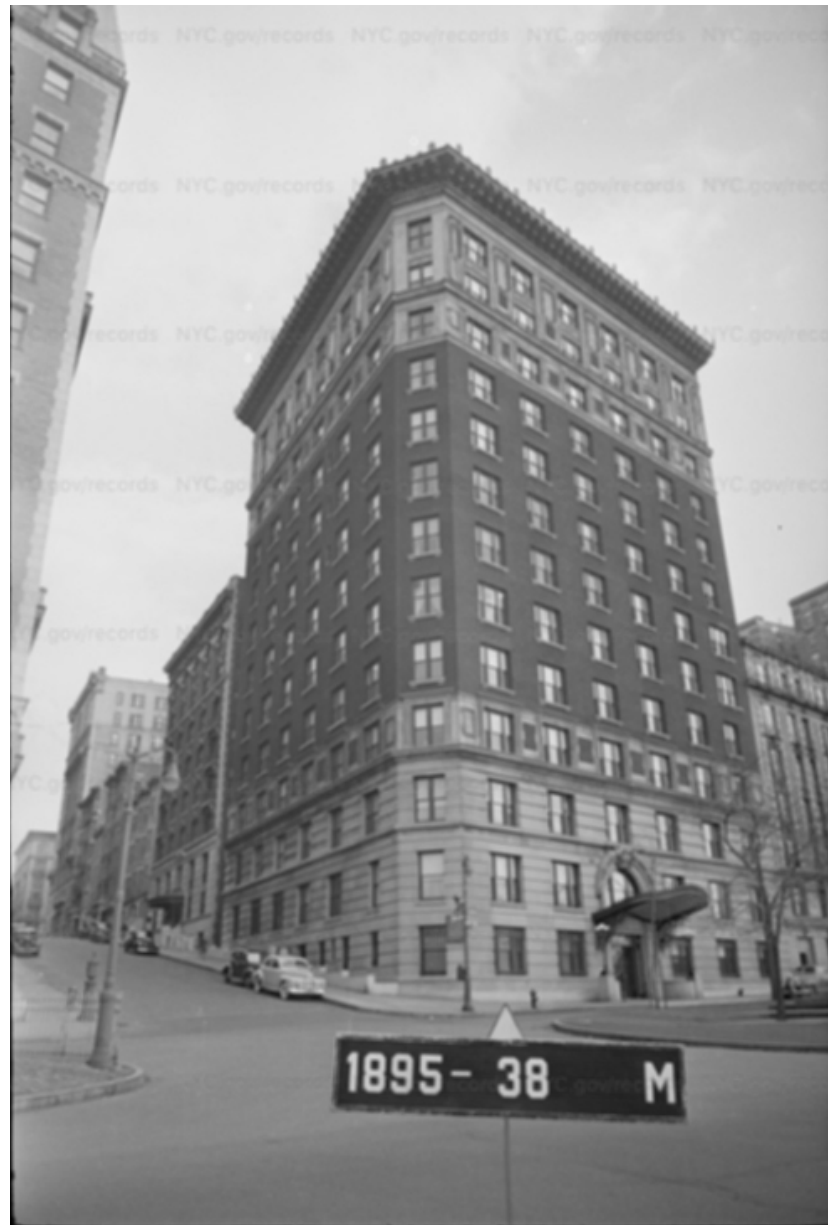
404 Riverside Drive, circa 1939
 Source: NYC Municipal Archives Tax Photo Collection
 Architect: Schwartz & Gross
 Historic District: Morningside Heights
 Fenestration: 1/1 Double-Hung windows

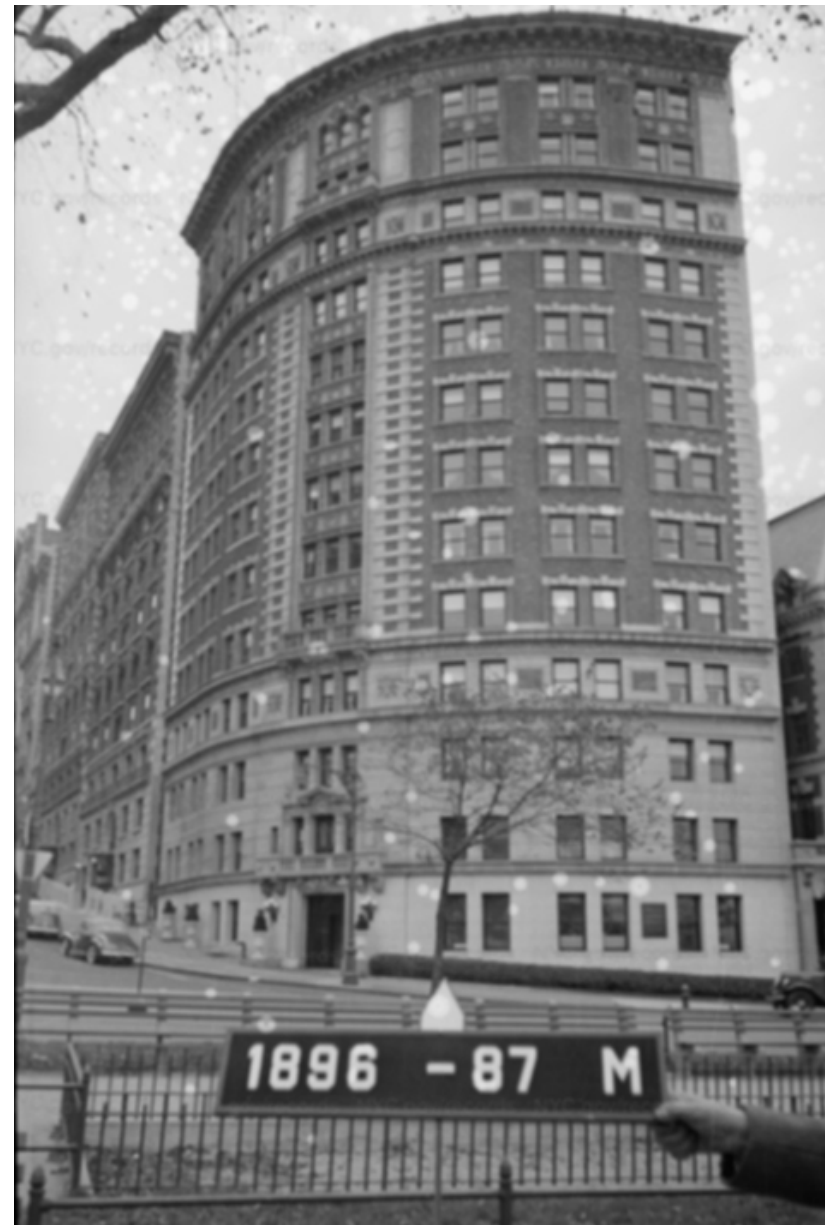
435 Riverside Drive, circa 1939
 Source: NYC Municipal Archives Tax Photo Collection
 Architect: Schwartz & Gross
 Historic District: Morningside Heights
 Fenestration: 1/1 Double-Hung windows

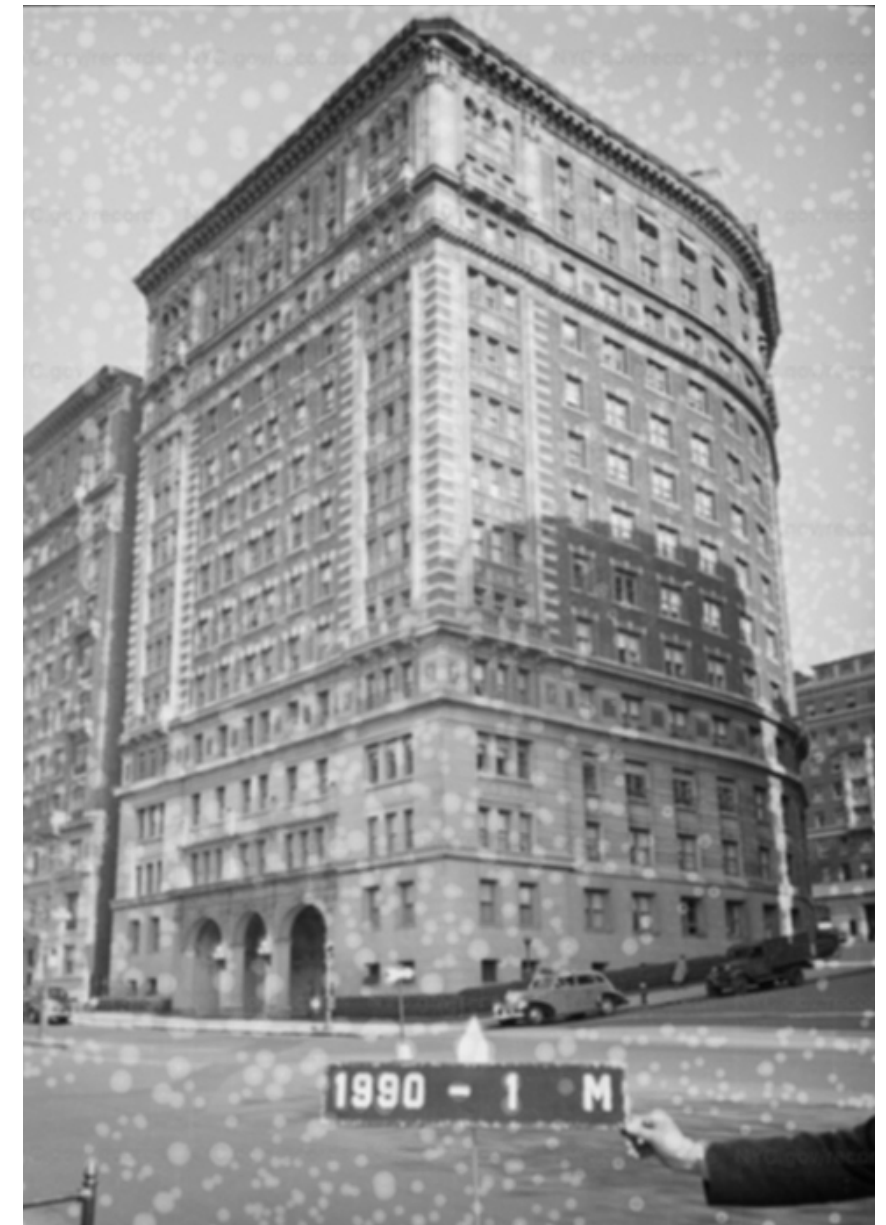
440 Riverside Drive, circa 1939
 Source: NYC Municipal Archives Tax Photo Collection
 Architect: Schwartz & Gross
 Historic District: Morningside Heights
 Fenestration: 1/1 Double-Hung windows
