24. Prospect Park Bicycle Lanes

25. St. Marks Avenue Bicycle Lane

26. Sunset Park Bicycle Lanes

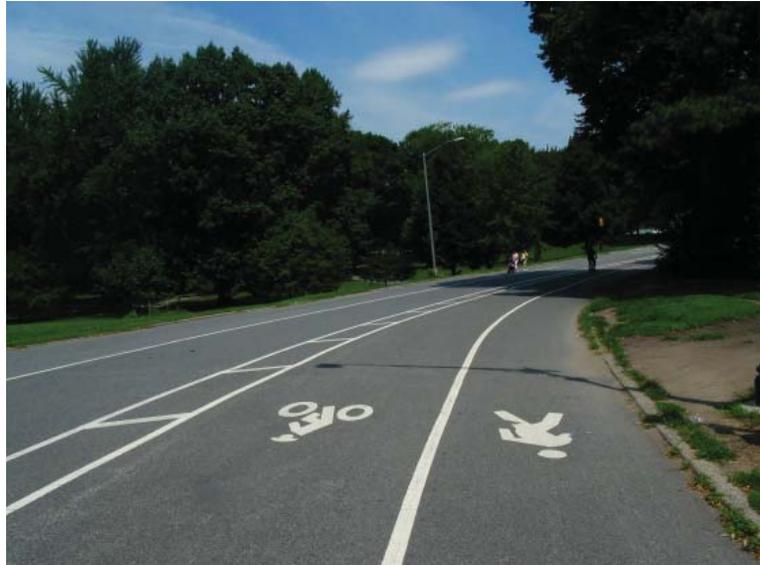
From/ To Street:	Bicycle lanes within Prospect Park
Length:	3.56 miles
Signs Condition: Observed: 8/25/06	100% Good 0% Fair 0% Poor Visibility of signs: 1 blocked Bike signs = 10 regulatory, 12 informational
Lane Marking Condition: Observed: 7/31/06	92% Good 2% Poor 0% Patches 5% No Marking
Symbols Condition: Observed: 7/31/06	76% Acceptable 24% Poor Symbols: (83 Bicyclist, 105 Other)
Pavement Condition: Observed: 9/28/06	100% Good Condition 0% Fair Condition 0% Poor Condition Material: Asphalt
2005 Bicycle Accidents:	No bicycle accidents reported along the Prospect Park bike lanes.
2005 Average Daily Bicycle Ridership:	N/A
