Manhattan

Manhattan Bicycle Lanes and Trails

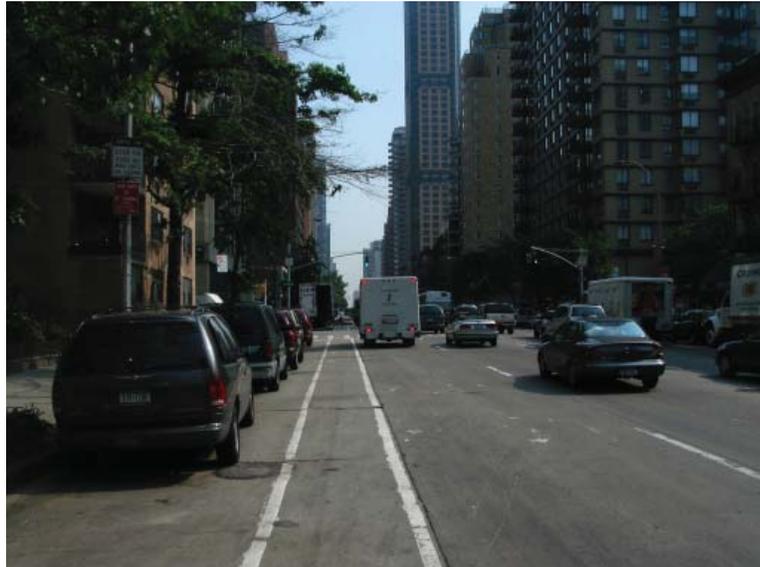
1. First Avenue Bicycle Lane

From Street:	E. 125 th Street
To Street:	E. 72 nd Street
Length:	2.70 miles
Signs Condition:	100% Good
Observed: 9/12/06 / 9/26/06	0% Fair
	0% Poor
	Visibility of signs: 1 blocked
	Bike signs = 42 regulatory
Lane Marking Condition:	6% Good
Observed: 7/11/06	91% Poor
	0% Patches
	3% No marking
Symbols Condition:	7% Acceptable
Observed: 7/11/06	93% Poor
	Symbols: (90 Diamond)
Pavement Condition:	0% Good Condition
Observed: 10/31/06	100% Fair Condition
	0% Poor Condition
	Material: Asphalt
2005 Bicycle Accidents:	17 bicycle accidents reported along the First Avenue bike lane-
	2 reported each at the East 87 th Street and East 77 th Street intersections, and
	One reported each at 13 separate intersections.
2005 Average Daily Bicycle Ridership:	491 bicyclists

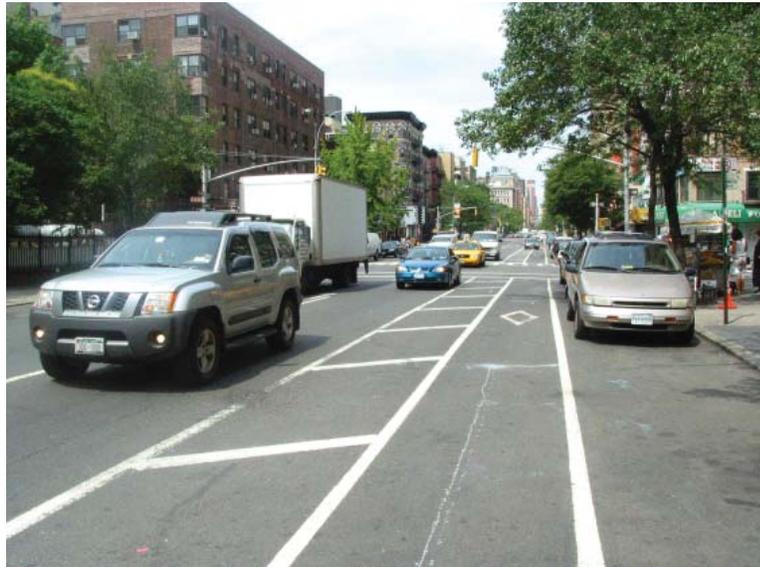
2. Second Avenue Bicycle Lane

From Street:	E 14 th Street
To Street:	E. Houston Street
Length:	0.75 miles
Signs Condition:	100% Good
Observed: 7/31/06	0% Fair 0% Poor Visibility of signs: 1 blocked Bike signs = 11 regulatory
Lane Marking Condition:	79% Good
Observed: 7/7/06	15% Poor 0% Patches 6% No Marking
Symbols Condition:	35% Acceptable
Observed: 7/7/06	65% Poor Symbols: (23 Diamond)
Pavement Condition:	0% Good Condition
Observed: 10/31/06	100% Fair Condition 0% Poor Condition Material: Asphalt
2005 Bicycle Accidents:	10 bicycle accidents reported along the Second Avenue bike lane- 3 reported at the East 6 th Street intersection, 2 reported at the East 11 th Street intersection, and One reported each at 5 separate intersections.
2005 Average Daily Bicycle Ridership:	1,027 bicyclists

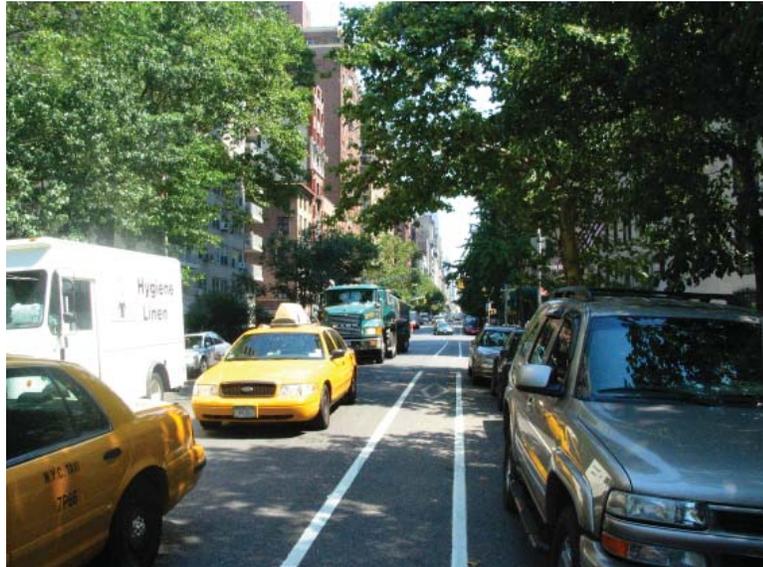
3. Fifth Avenue Bicycle Lane

From Street:	Broadway
To Street:	Washington Square North
Length:	0.80 miles
Signs Condition: Observed: 10/17/06	89% Good 11% Fair 0% Poor All signs clearly visible to users Bike signs = 6 regulatory, 3 informational
Lane Marking Condition: Observed: 7/17/06	100% Good 0% Poor 0% Patches 0% No Marking
Symbols Condition: Observed: 7/17/06	11% Acceptable 89% Poor Symbols: (28 Diamond)
Pavement Condition: Observed: 11/30/06	100% Good Condition 0% Fair Condition 0% Poor Condition Material: Asphalt
2005 Bicycle Accidents:	10 bicycle accidents reported along the Fifth Avenue bike lane- 3 reported at the East 14 th Street intersection, 2 reported at the West 16 th Street intersection, and One reported each at 5 separate intersections.
2005 Average Daily Bicycle Ridership:	986 bicyclists

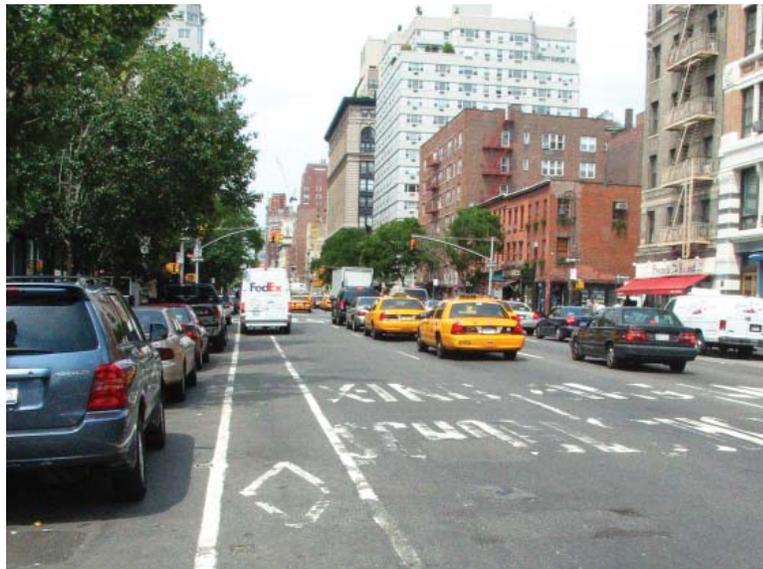
4. Sixth Avenue Bicycle Lane

From Street:	W. 40 th Street
To Street:	W. 8 th Street
Length:	1.65 miles
Signs Condition:	100% Good
Observed: 10/19/06	0% Fair 0% Poor All signs clearly visible to users Bike signs = 15 regulatory, 2 informational
Lane Marking Condition:	13% Good
Observed: 7/7/06	6% Poor 0% Patches 0% No Marking*
Symbols Condition:	29% Acceptable
Observed: 7/7/06	71% Poor Symbols: (10 Diamond, 4 Bicyclist)
Pavement Condition:	81% Good Condition
Observed: 11/30/06	19% Fair Condition 0% Poor Condition Material: Asphalt
2005 Bicycle Accidents:	24 bicycle accidents reported along the Sixth Avenue bike lane- 2 reported at the West 29 th Street intersection, and One reported each at 22 separate intersections.
2005 Average Daily Bicycle Ridership:	1,179 bicyclists

* **Note** : 81% (6,745 ft) of the route was under repair/construction when lane markings data were collected.

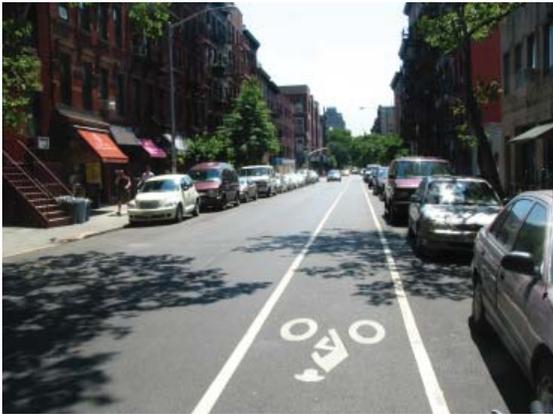
5. Ninth Street Bicycle Lane

From Street: 6th Avenue
 To Street: Avenue A
 Length: 0.99 miles
 Signs Condition: 90% Good
 Observed: 8/8/06 10% Fair
 0% Poor
 All signs clearly visible to users
 Bike signs = 10 regulatory

Lane Marking Condition: 41% Good
 Observed: 7/17/06 59% Poor
 0% Patches
 0% No Marking

Symbols Condition: 88% Acceptable
 Observed: 7/17/06 12% Poor
 Symbols: (24 Bicyclist)

Pavement Condition: 100% Good Condition
 Observed: 10/31/06 0% Fair Condition
 0% Poor Condition
 Material: Asphalt

2005 Bicycle Accidents: 2 bicycle accidents reported along the Ninth Street bike lane, each at separate intersections.

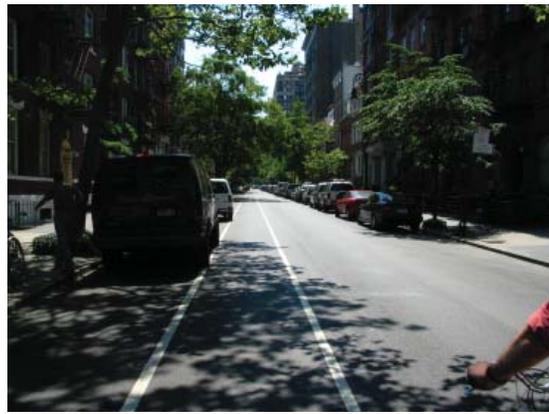
Tenth Street Bicycle Lane

From Street: 6th Avenue
 To Street: Avenue A
 Length: 0.98 miles
 Signs Condition: No Signs
 Observed: 8/8/06

Lane Marking Condition: 94% Good
 Observed: 7/17/06 0% Poor
 0% Patches
 0% No Marking*

Symbols Condition: 90% Acceptable
 Observed: 7/17/06 10% Poor
 Symbols: (21 Bicyclist)

Pavement Condition: 100% Good Condition
 Observed: 10/31/06 0% Fair Condition
 0% Poor Condition
 Material: Asphalt

2005 Bicycle Accidents: No bicycle accidents reported along the Tenth Street bike lane.

* **Note:** 6% (339ft) of the route was under repair/ construction when lane markings data were collected.

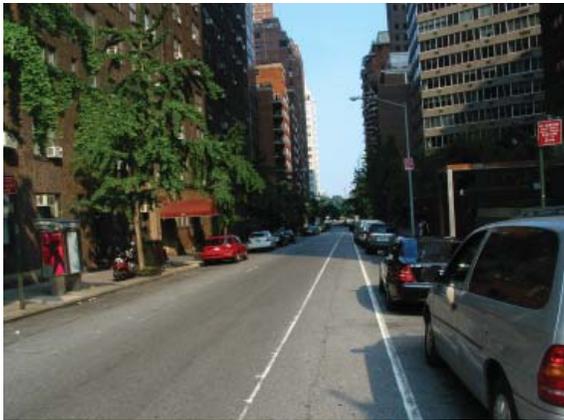
7. 54th Street Bicycle Lane

From Street: 1st Avenue
 To Street: Sutton Place South
 Length: 0.12 miles
 Signs Condition: 100% Good
 Observed: 7/20/06 0% Fair
 0% Poor
 All signs clearly visible to users
 Bike signs = 1 informational, 2 greenway

Lane Marking Condition: 0% Good
 100% Poor
 Observed: 7/10/06 0% Patches
 0% No Marking

Symbols Condition: 0% Acceptable
 100% Poor
 Observed: 7/10/06 Symbols: (4 Bicyclist)

Pavement Condition: 100% Good Condition
 0% Fair Condition
 Observed: 7/20/06 0% Poor Condition
 Material: Asphalt

2005 Bicycle Accidents: No bicycle accidents reported along the 54th Street bike lane.

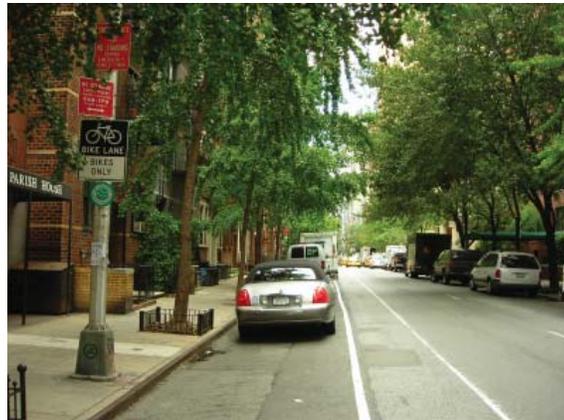
55th Street Bicycle Lane

From Street: 2nd Avenue
 To Street: Sutton Place South
 Length: 0.26 miles
 Signs Condition: 100% Good
 Observed: 7/20/06 0% Fair
 0% Poor
 Visibility of signs: 1 blocked
 Bike signs = 3 regulatory, 1 informational, 3 greenway

Lane Marking Condition: 49% Good
 51% Poor
 Observed: 7/10/06 0% Patches
 0% No Marking

Symbols Condition: 0% Acceptable
 100% Poor
 Observed: 7/10/06 Symbols: (5 Bicyclist)

Pavement Condition: 100% Good Condition
 0% Fair Condition
 Observed: 7/20/06 0% Poor Condition
 Material: Asphalt

2005 Bicycle Accidents: No bicycle accidents reported along the 55th Street bike lane.
