WEST SIDE MANHATTAN TRANSPORTATION STUDY

Technical Memorandum No. 2 Future Conditions & Recommendations

P.I.N. - PTDT09D00.G06

September 2011

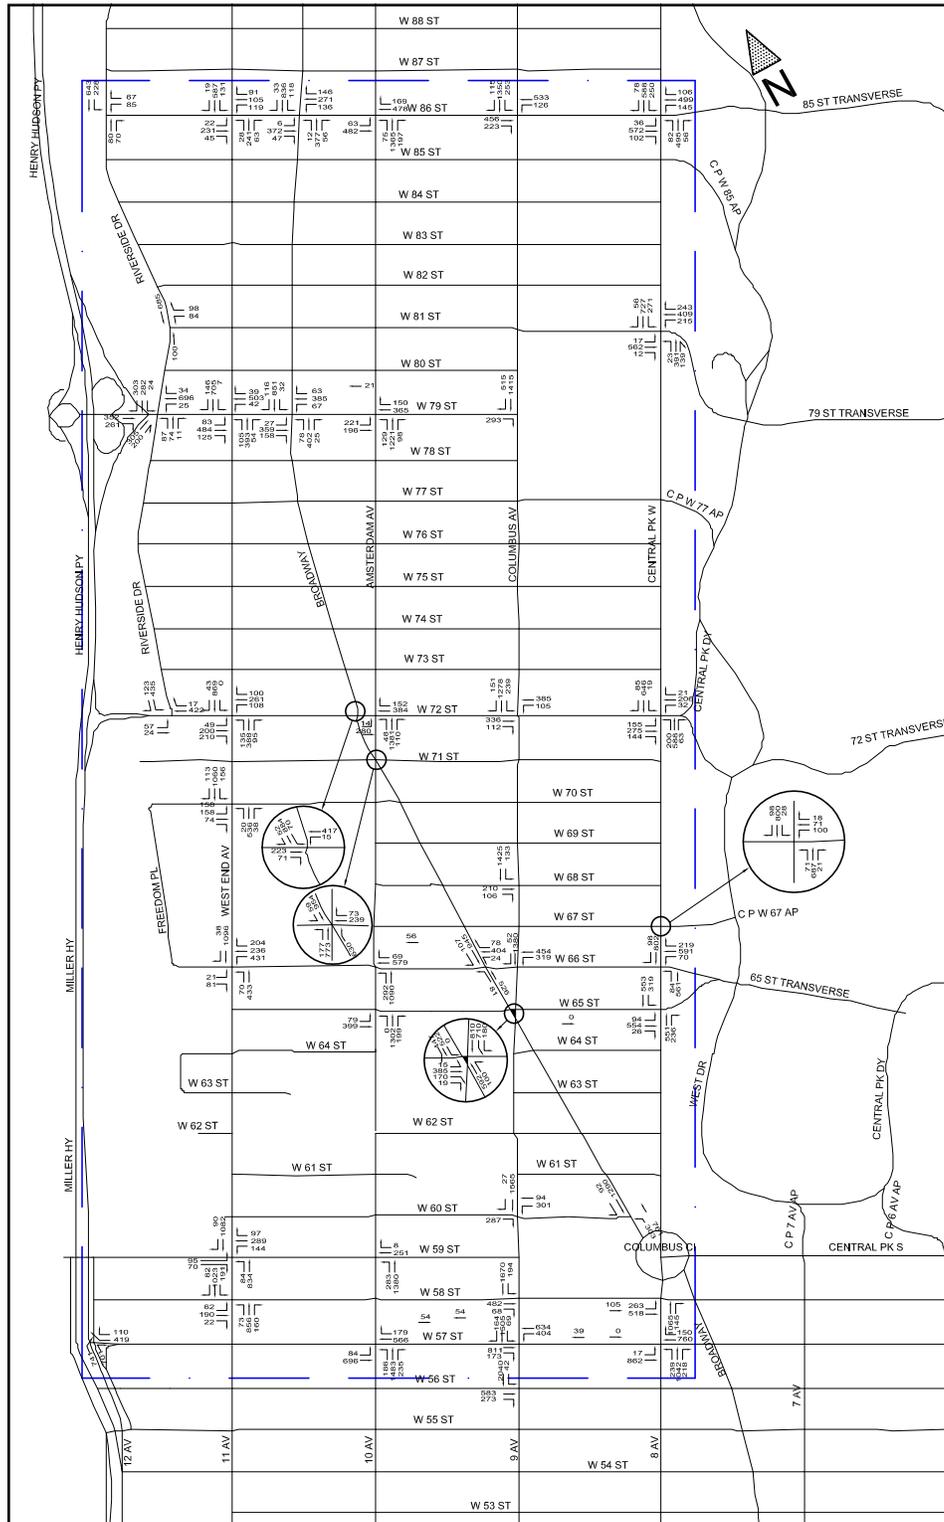
Figure 2.3-1: Projected 2018 AM Peak Hour Traffic Volume

Figures 2.3-1 to 2.3-4 present the 2018 projected peak hour traffic volumes for the four peak hours.

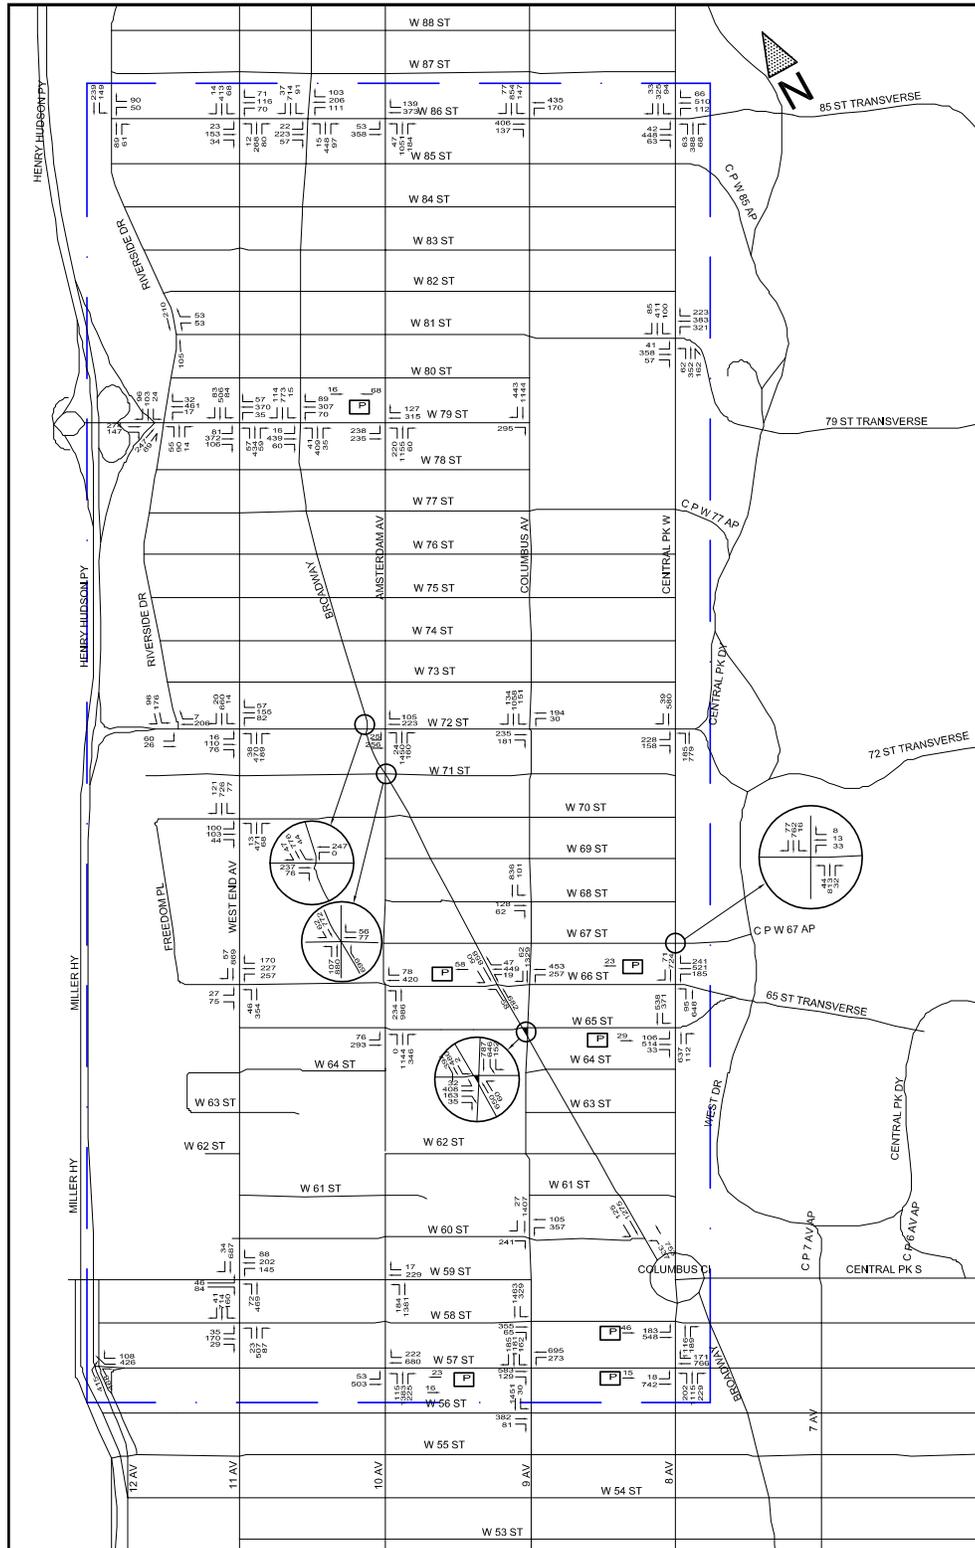
Figure 2.3-2: Projected 2018 MD Peak Hour Traffic Volume

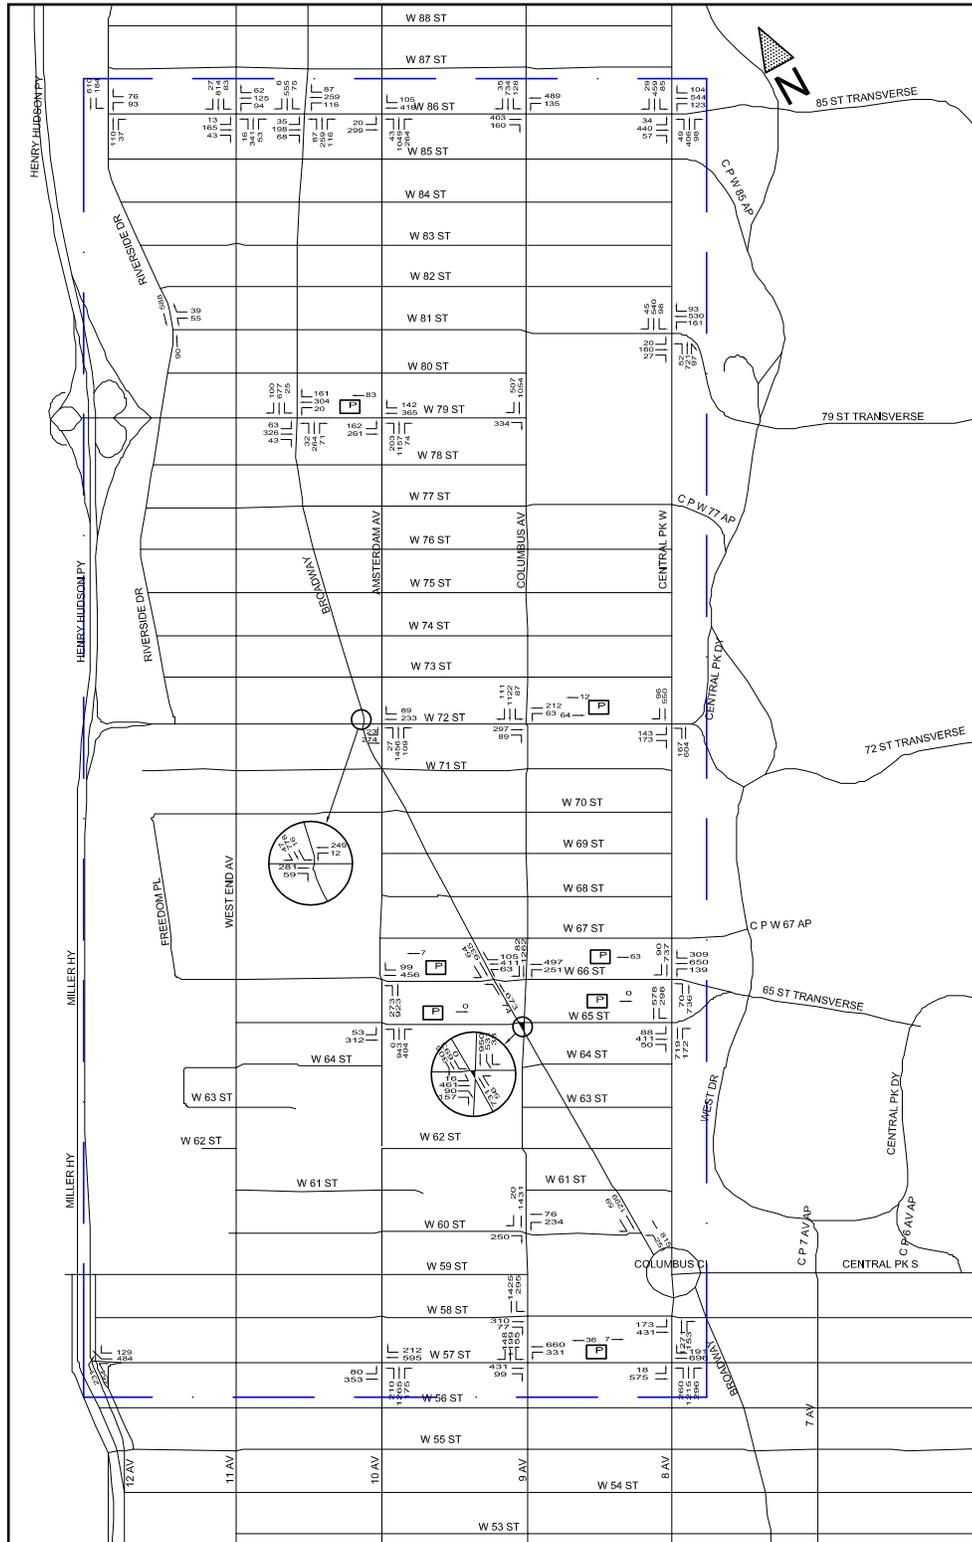
Figure 2.3-4: Projected 2018 Saturday MD Peak Hour Traffic Volume

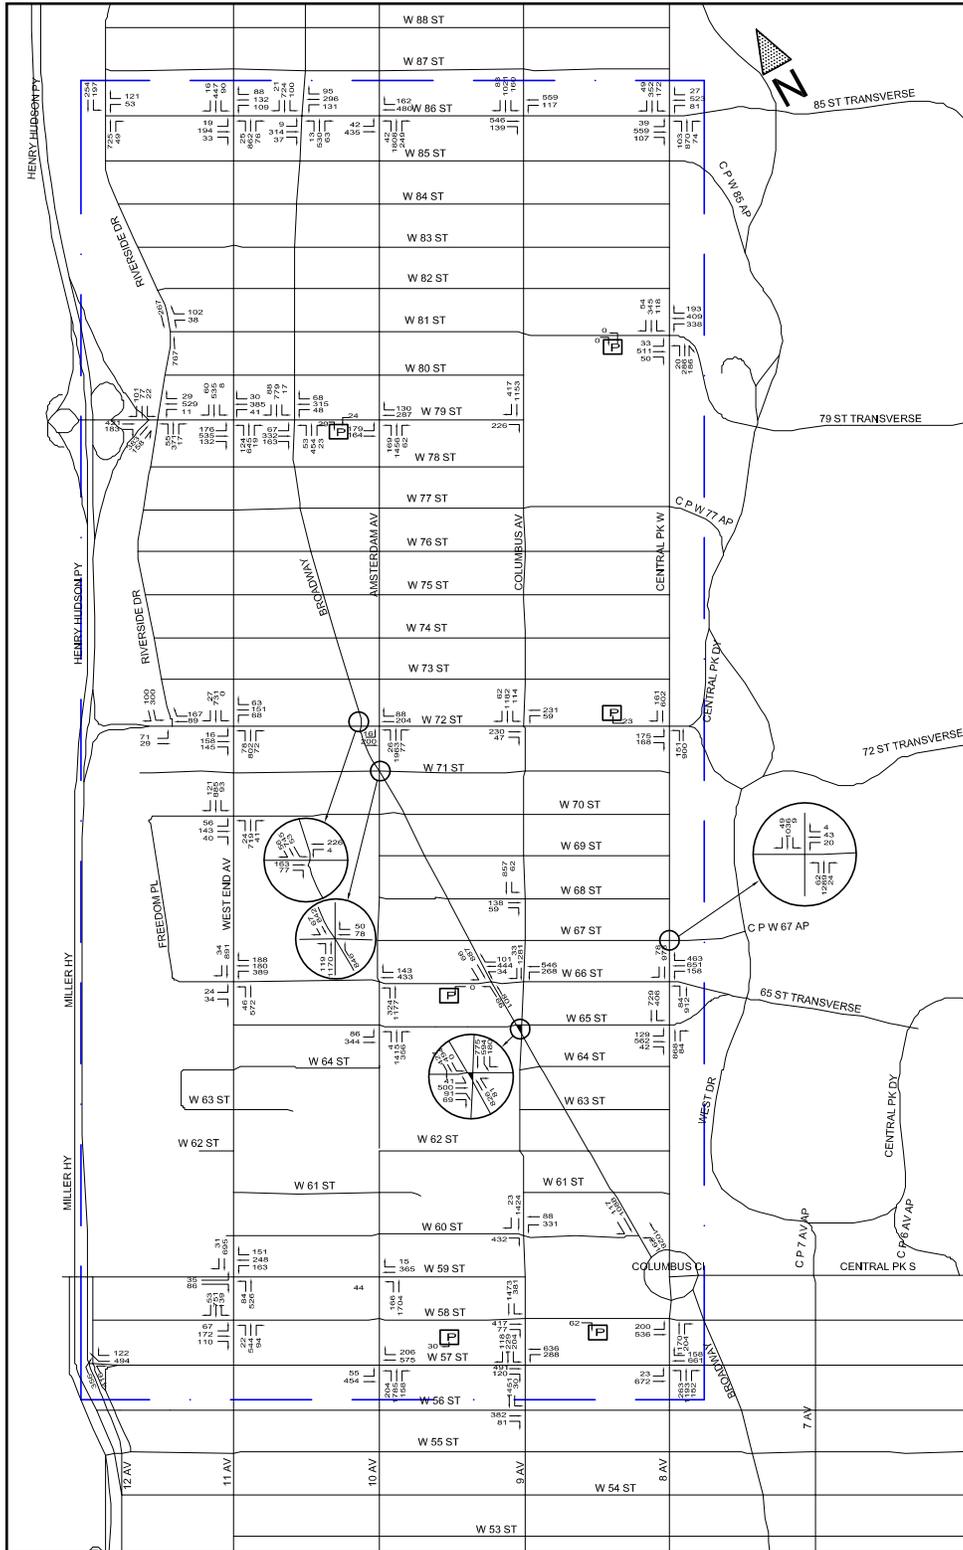
Figure 2.3-3: Projected 2018 PM Peak Hour Traffic Volume

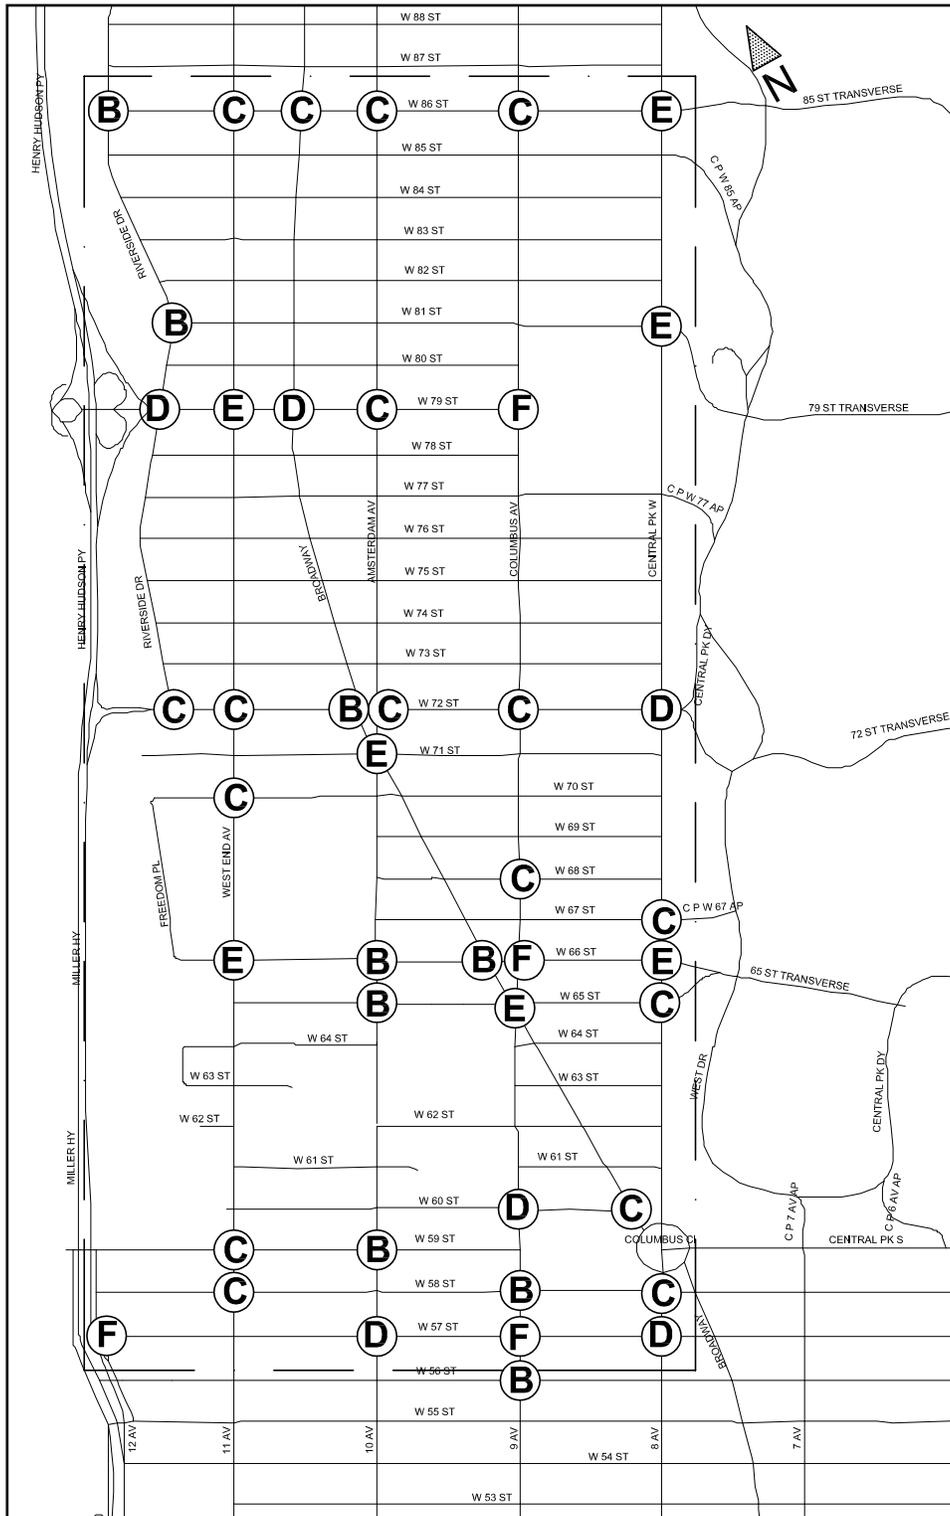
Figure 2.3-5: AM Peak Hour Level of Service

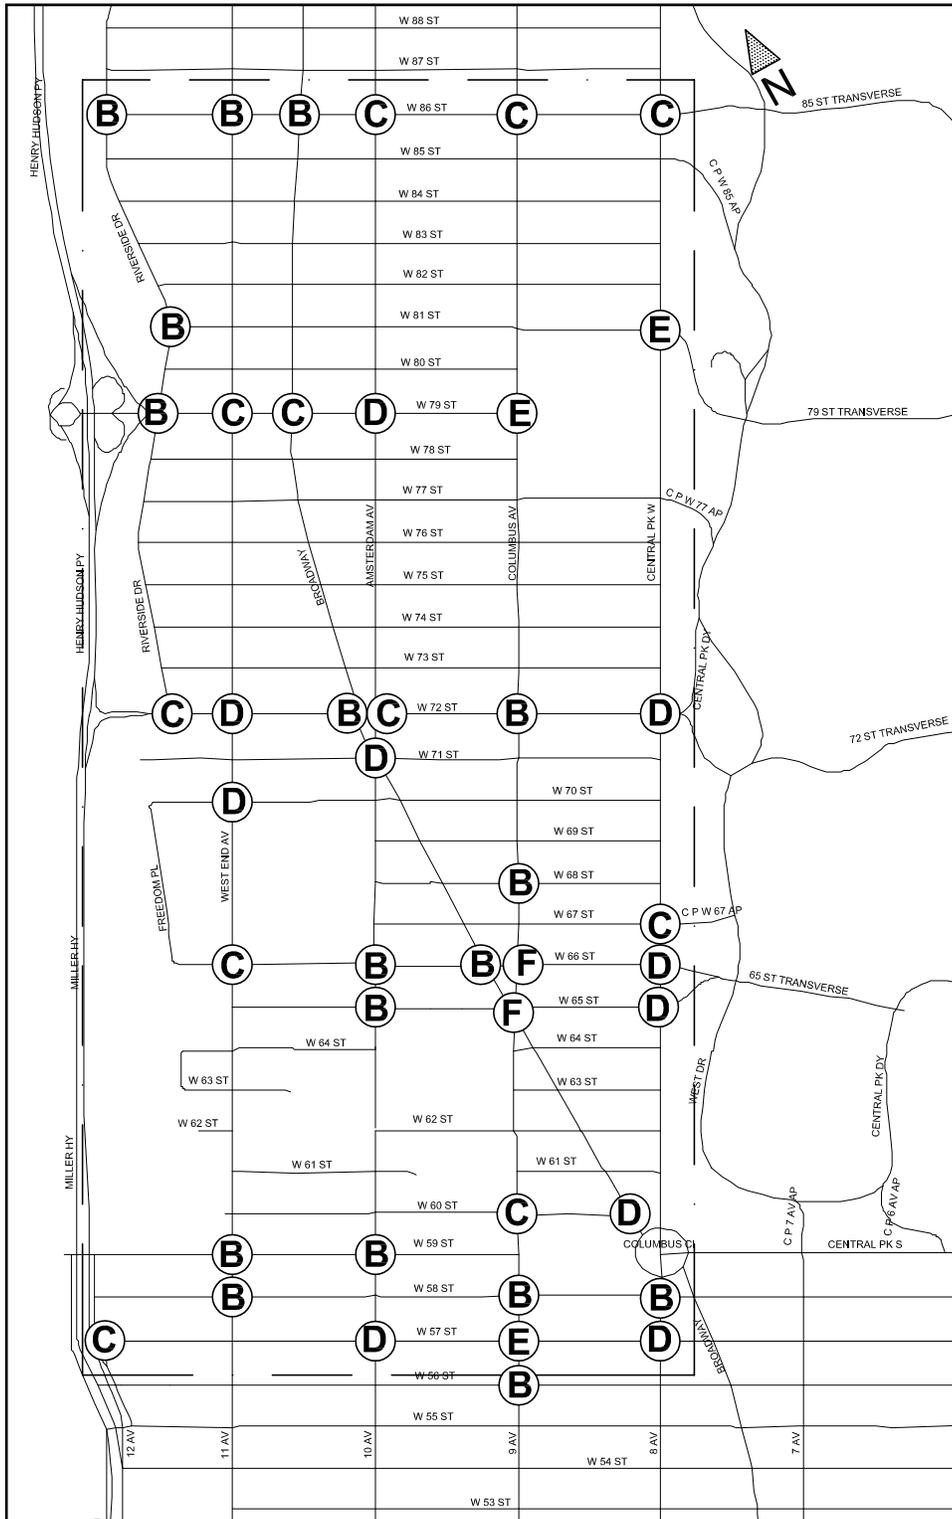
Figure 2.3-6: MD Peak Hour Level of Service

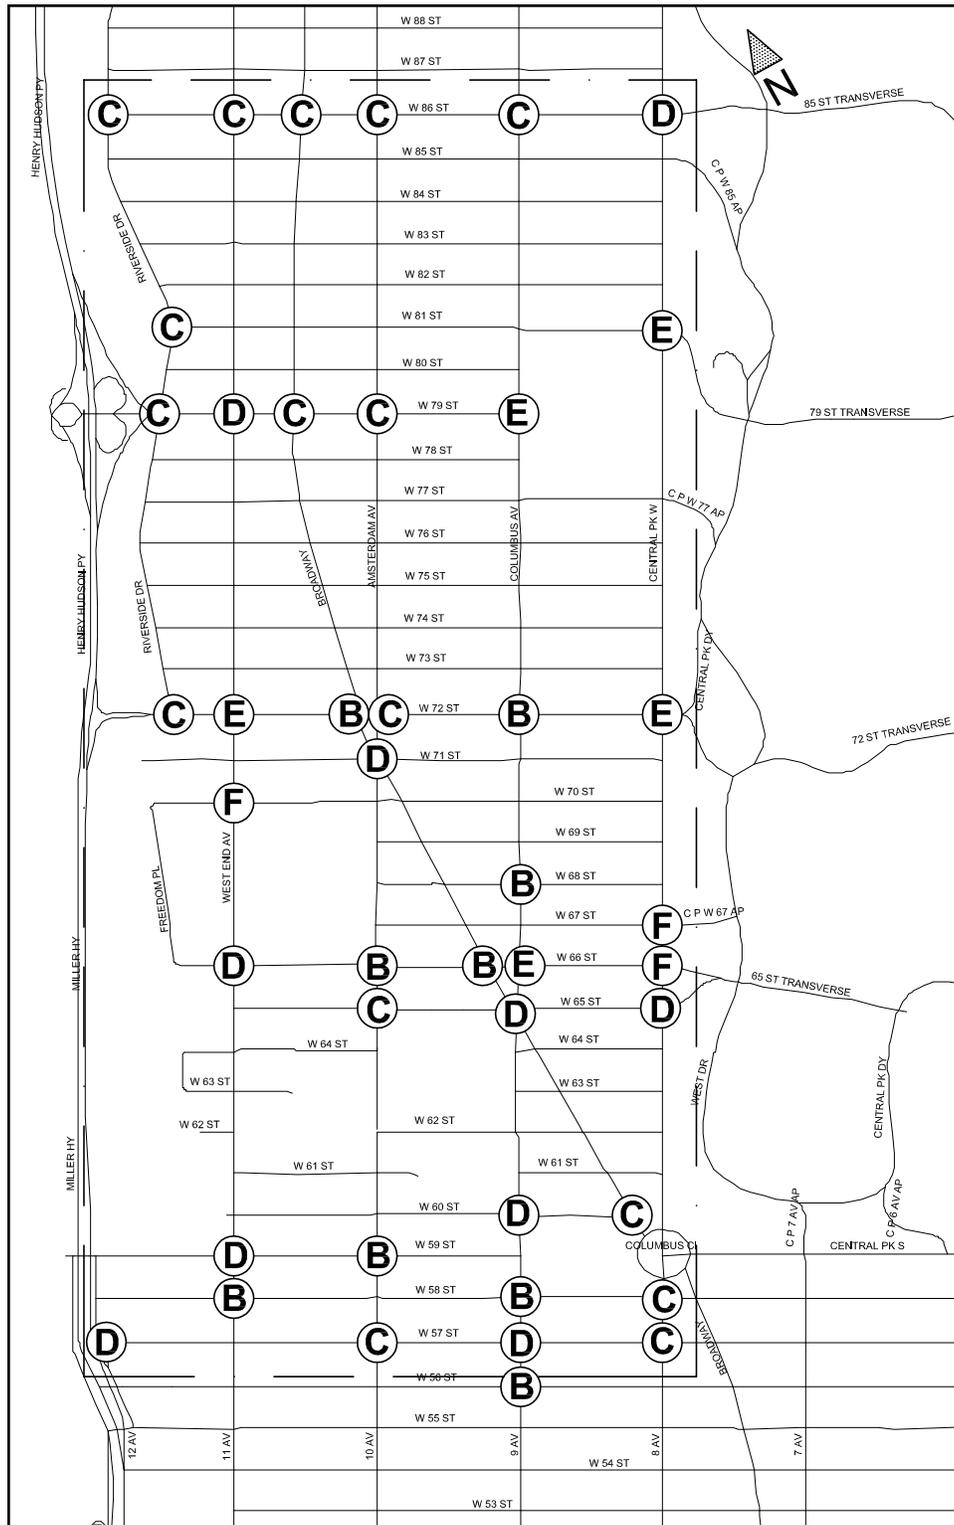
Figure 2.3-7: PM Peak Hour Level of Service

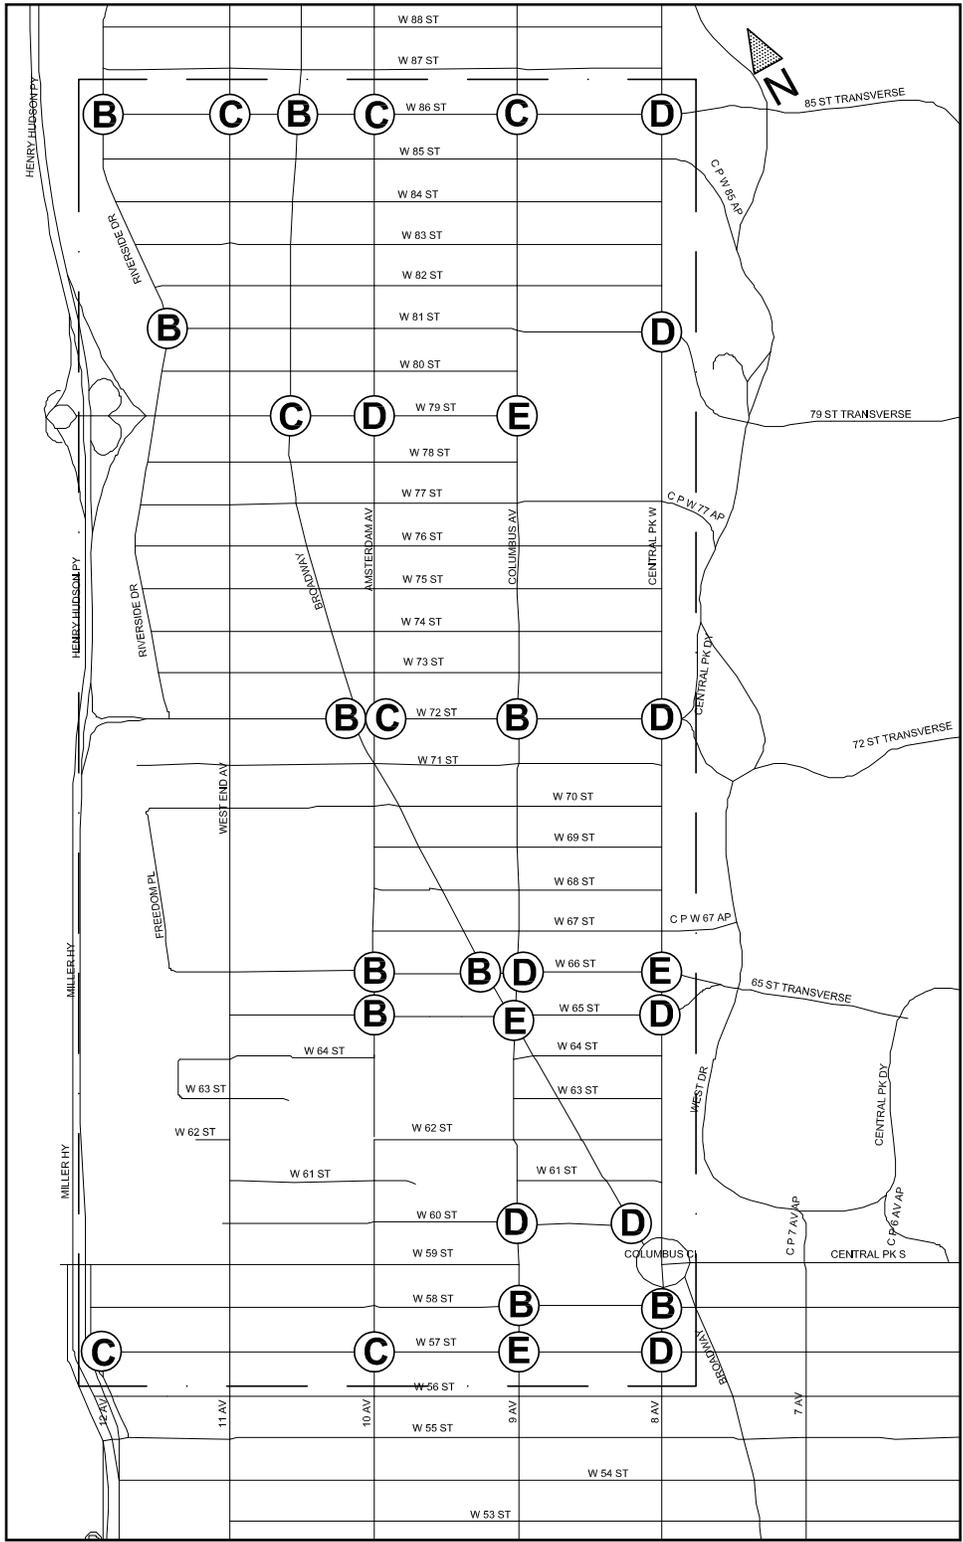
Figure 2.3-8: Saturday MD Peak Hour Level of Service

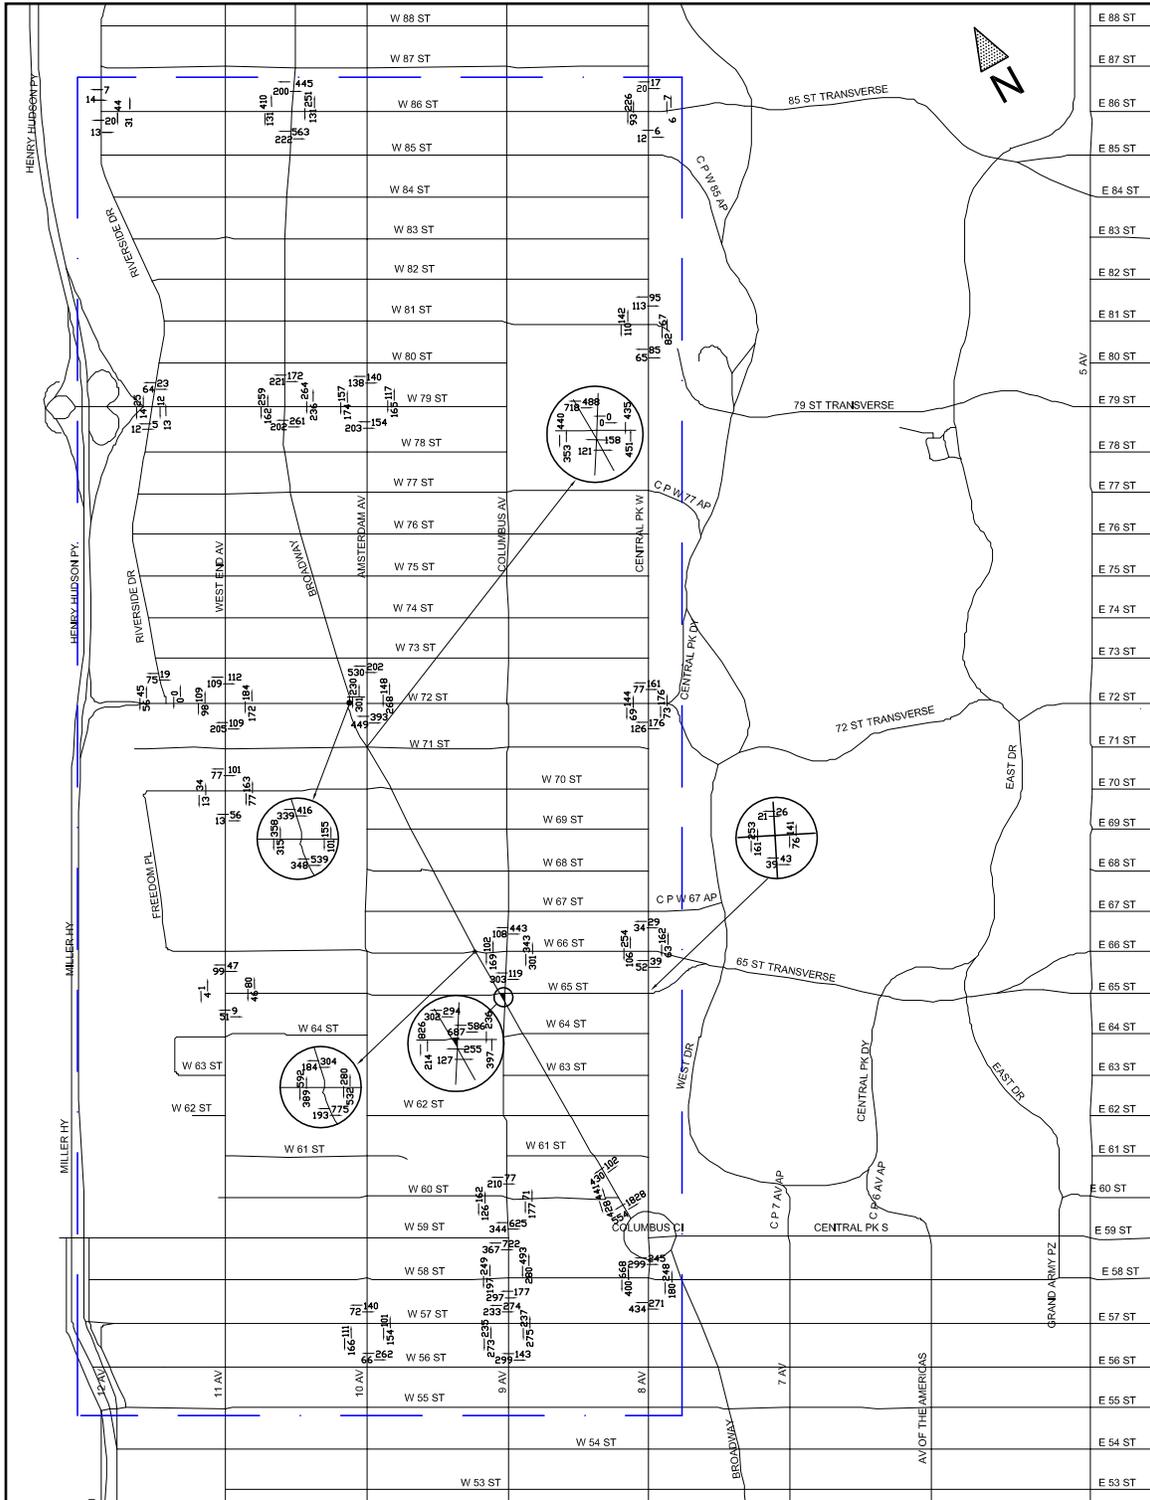
Figure 2.6-1: AM Peak Hour Pedestrian Volumes (2018)

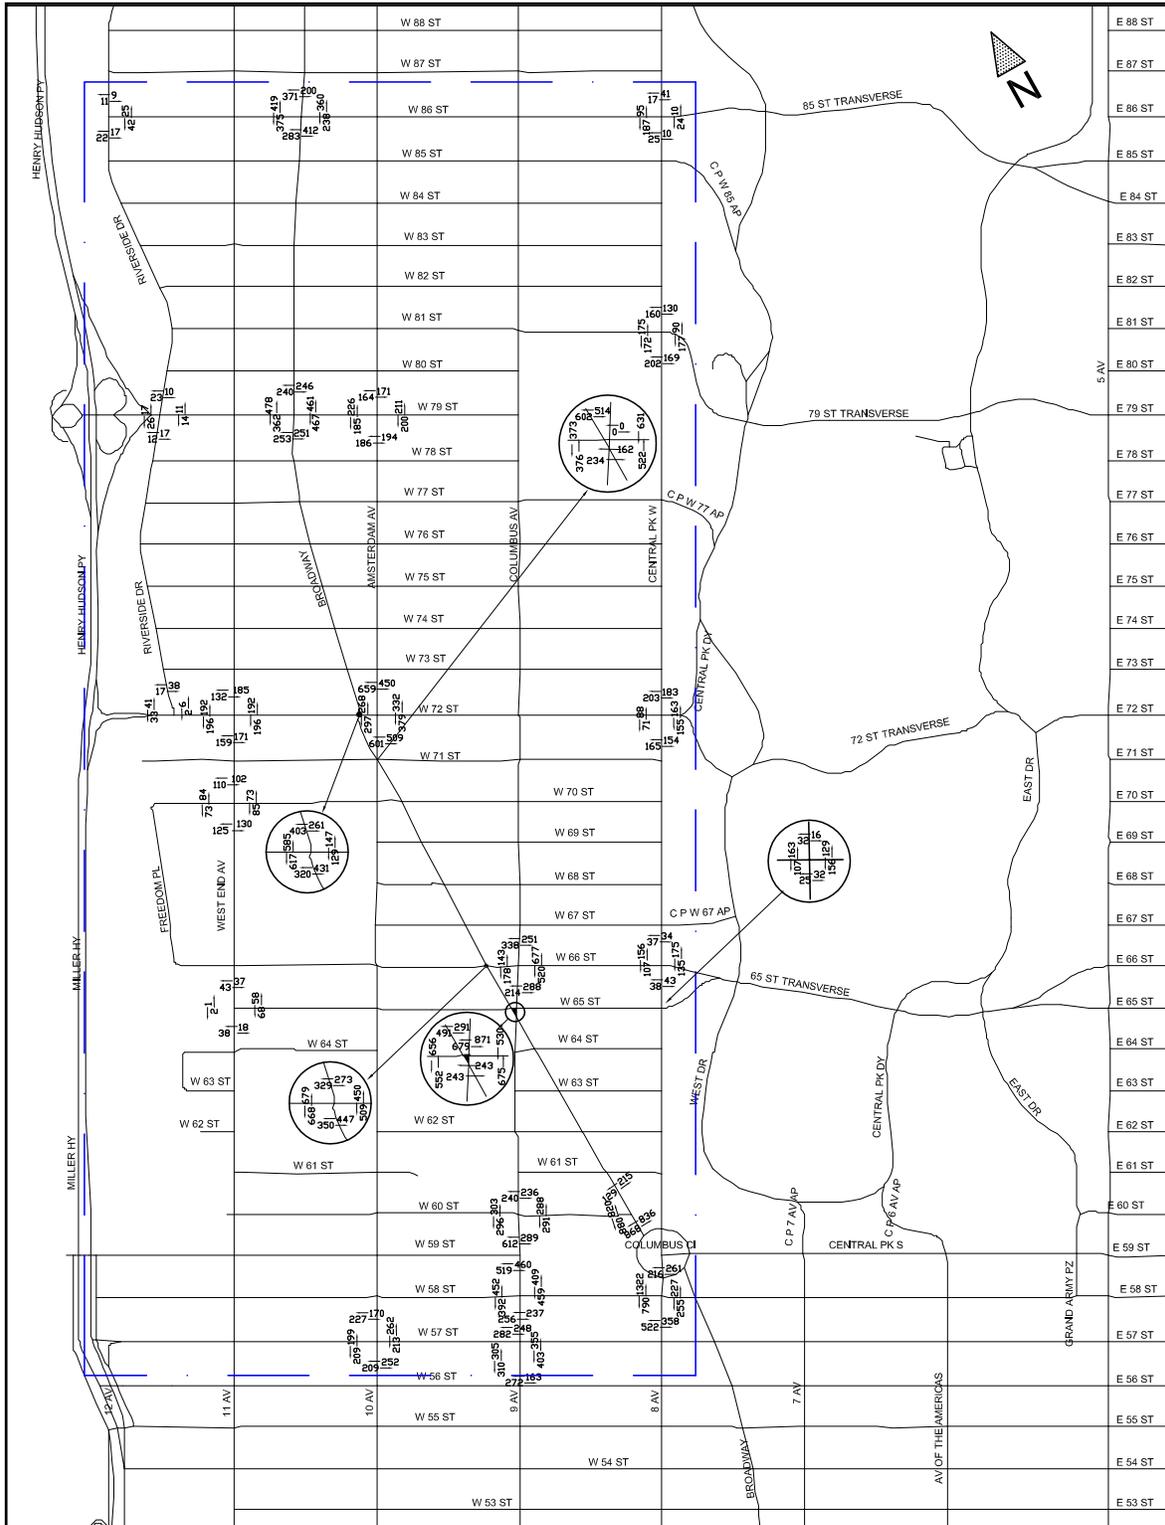
Figure 2.6-2: MD Peak Hour Pedestrian Volumes (2018)

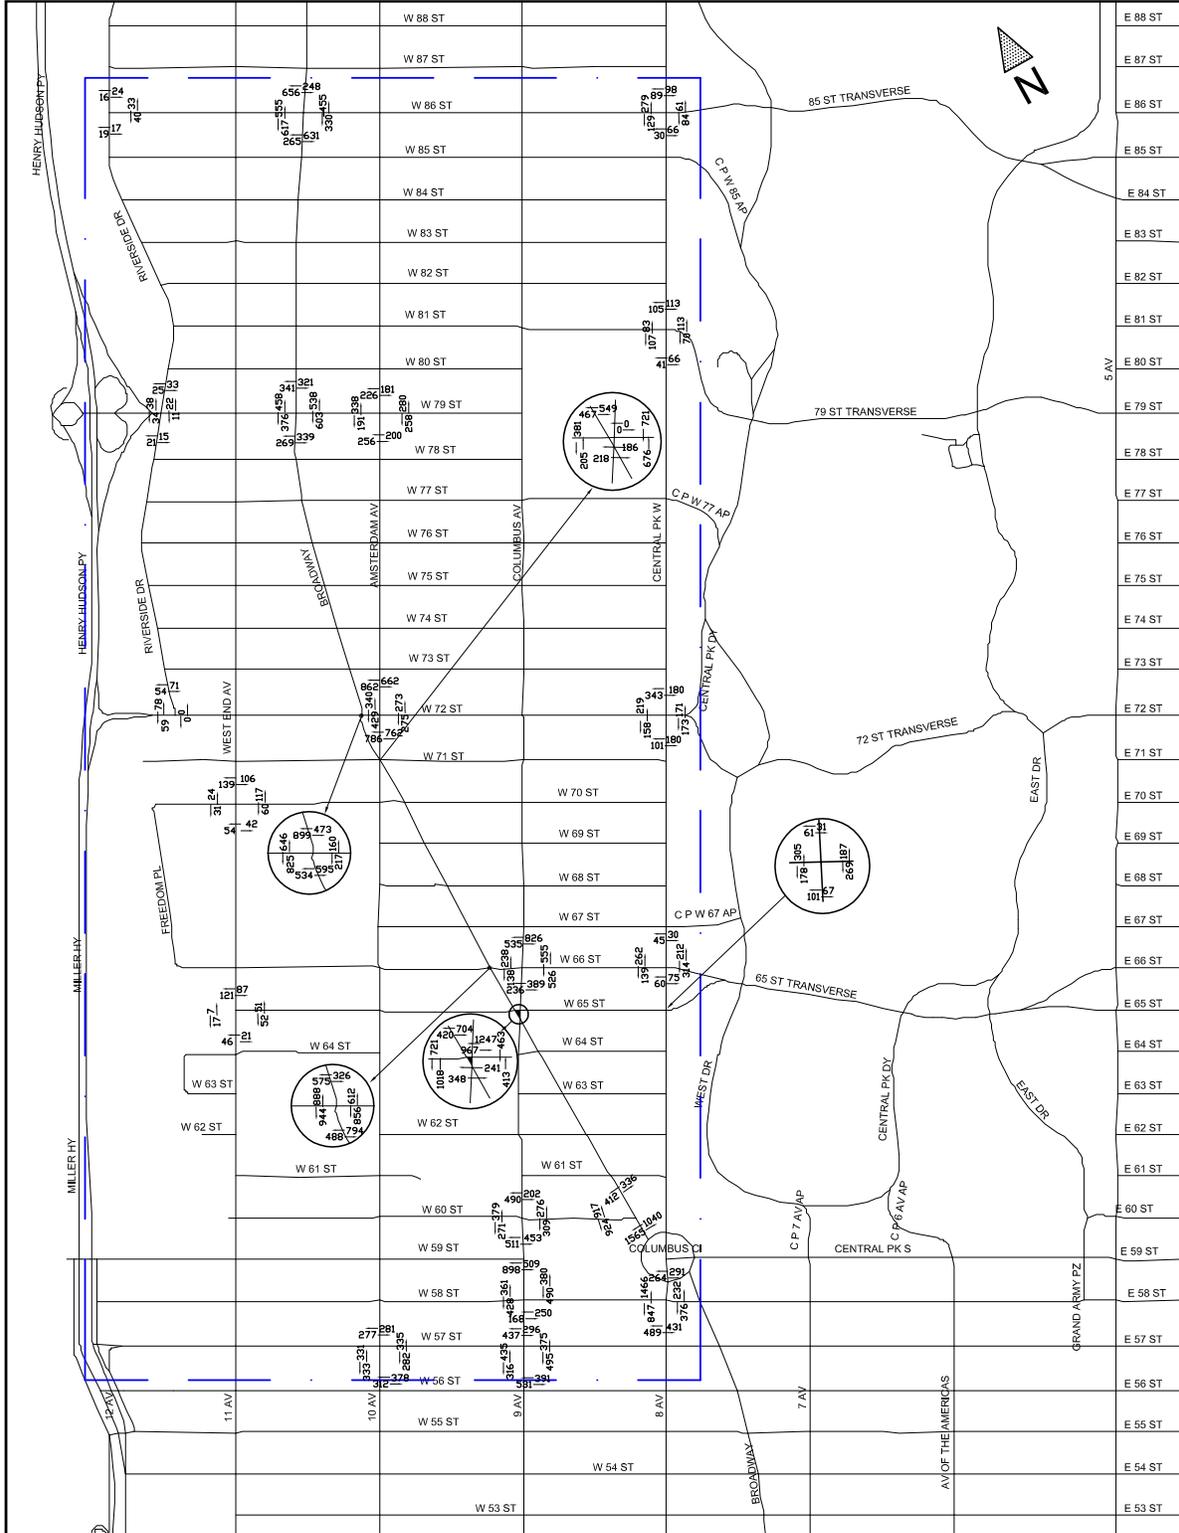
Figure 2.6-3: PM Peak Hour Pedestrian Volumes (2018)

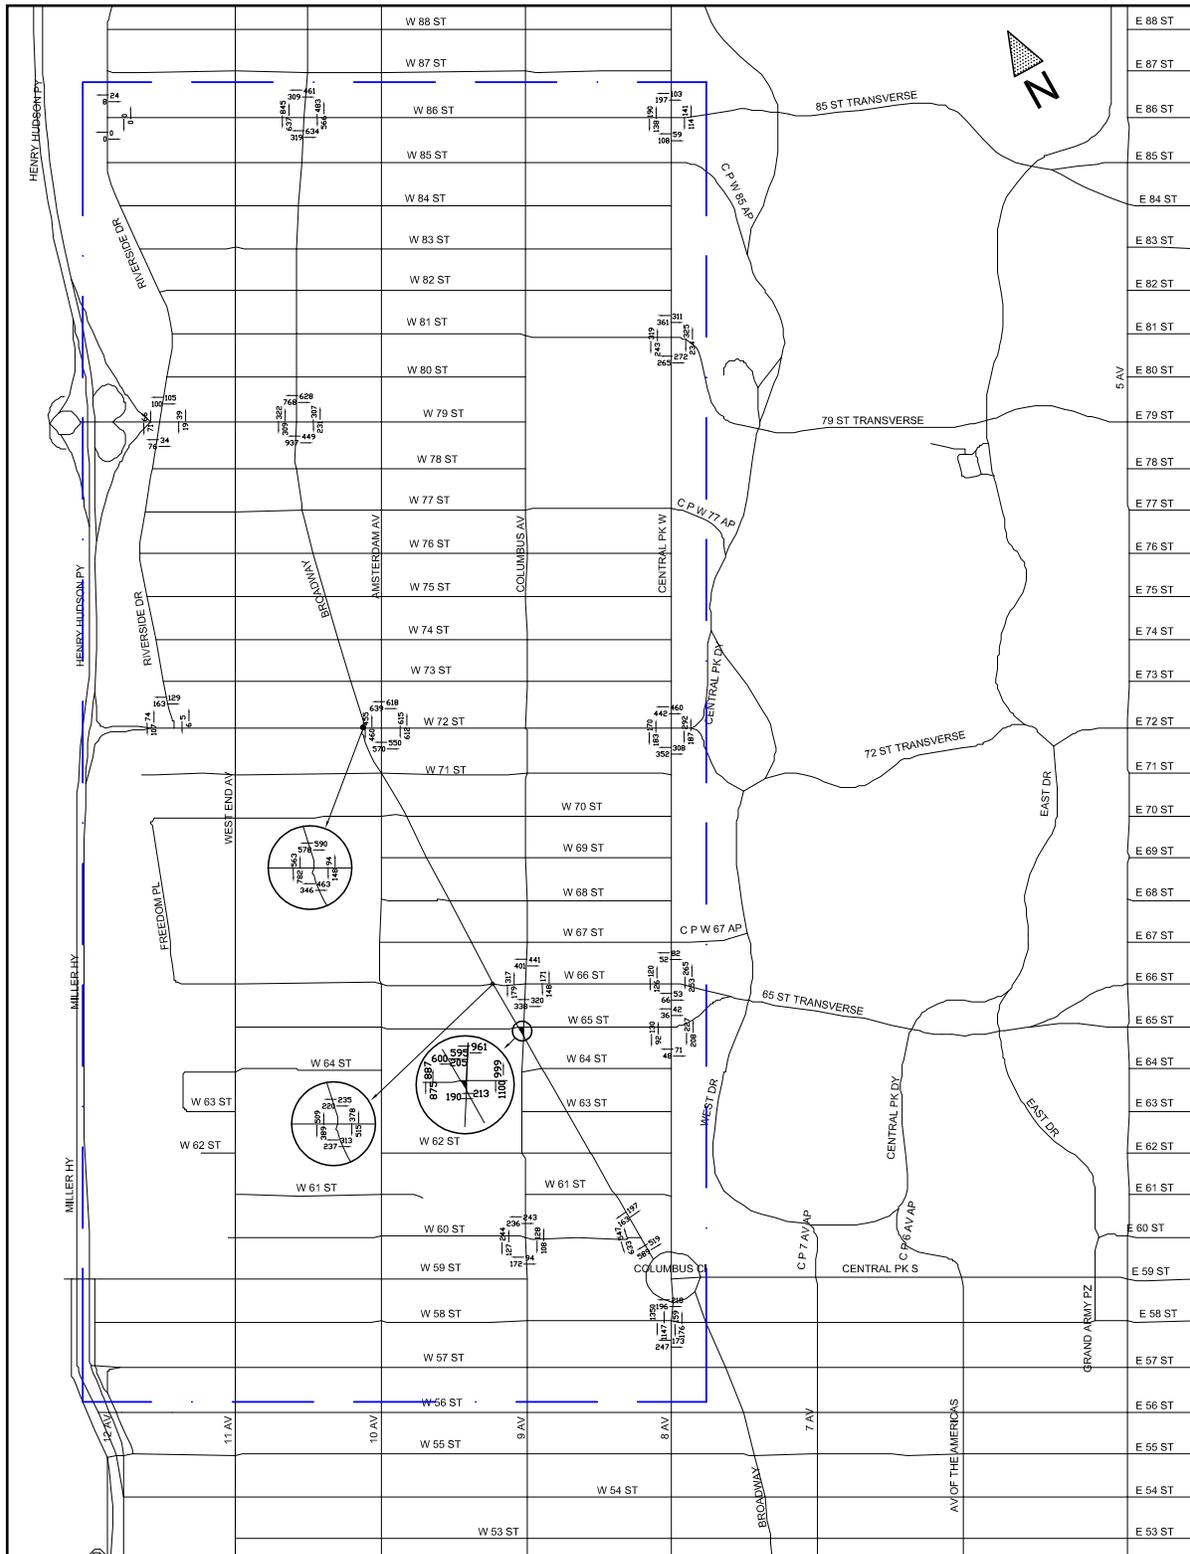
Figure 2.6-4: Saturday MD Peak Hour Pedestrian Volumes (2018)

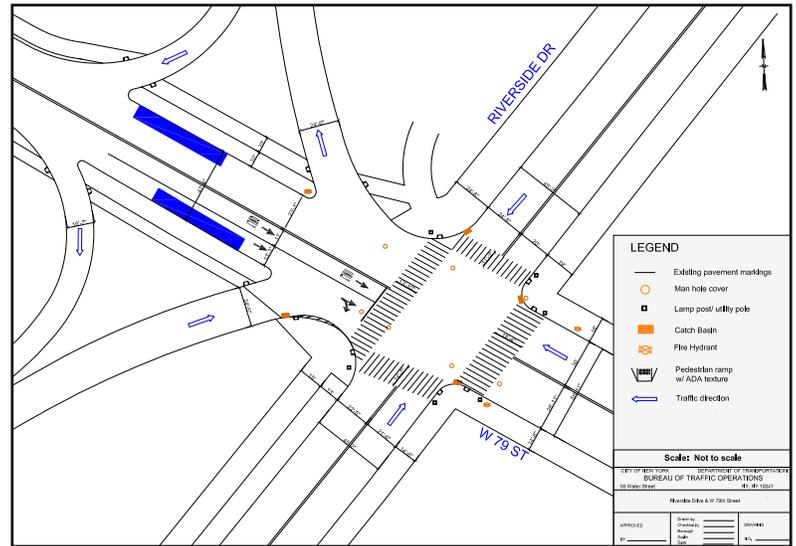
Figure 3-2a: Existing Condition

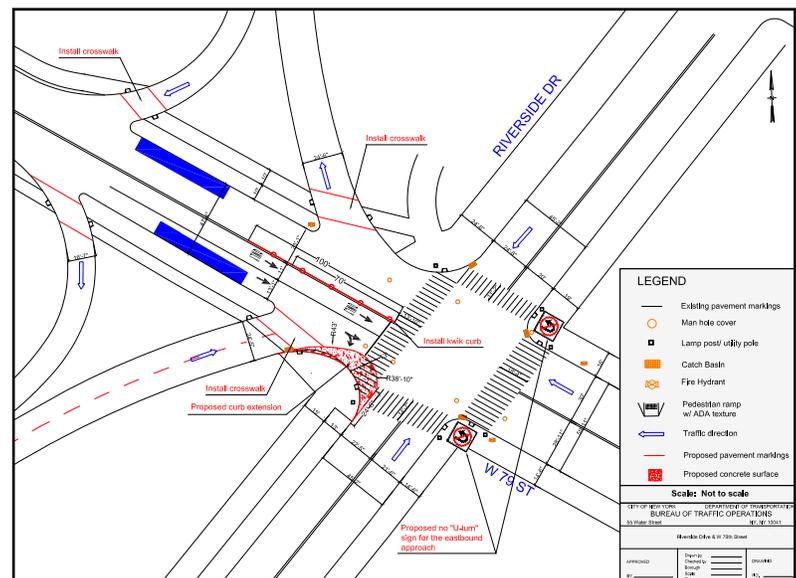
- During the AM peak hour shift 4 seconds from the EB/WB phase to the NB/SB phase.
- Install kwik curb on the eastbound approach along West 79th Street for about 100 feet west from the existing stop bar to eliminate illegal EB left turn to Riverside Drive and U-turn to Henry Hudson Parkway NB.
- Install crosswalk for pedestrian to cross the Henry Hudson Parkway entry and exit ramp;
- Extend the curb at the southwest corner to restrict vehicle to two travel lanes on the eastbound approach and shorten the pedestrian crossing distance.

Figure 3-2b: Proposed Recommendations

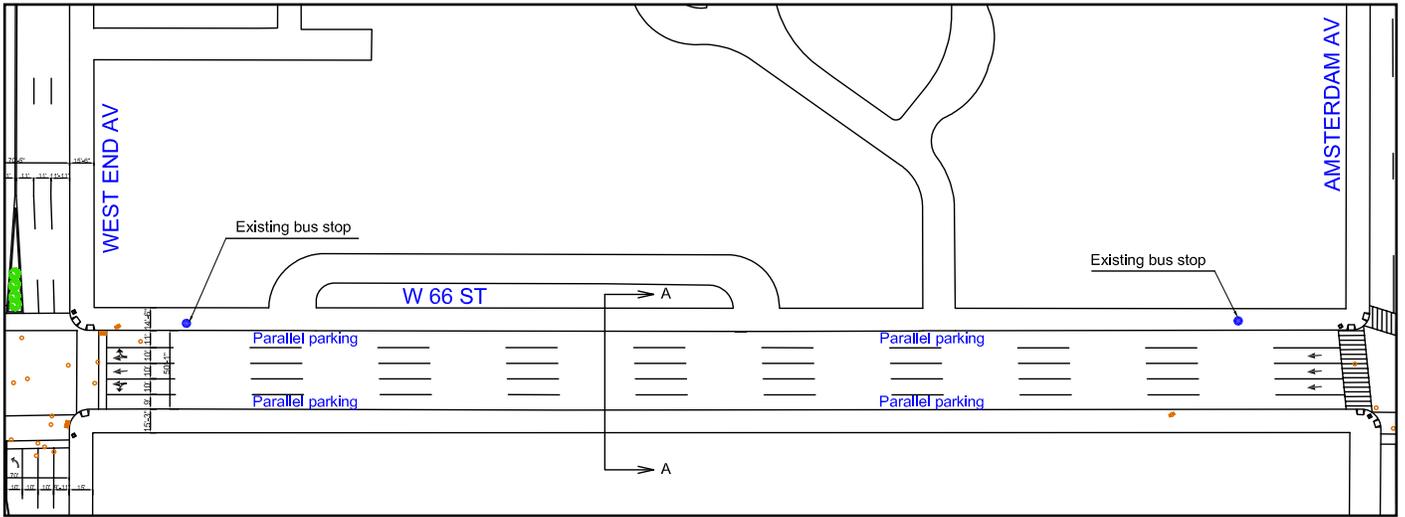
Figure 3-3a: Existing conditions on West 66th Street between Amsterdam Avenue and West End Avenue

Figure 3-3a and 3-3b show the existing and proposed configuration; also, Figures 3-4a to 3-4c illustrate the cross-section view under existing and proposed conditions.

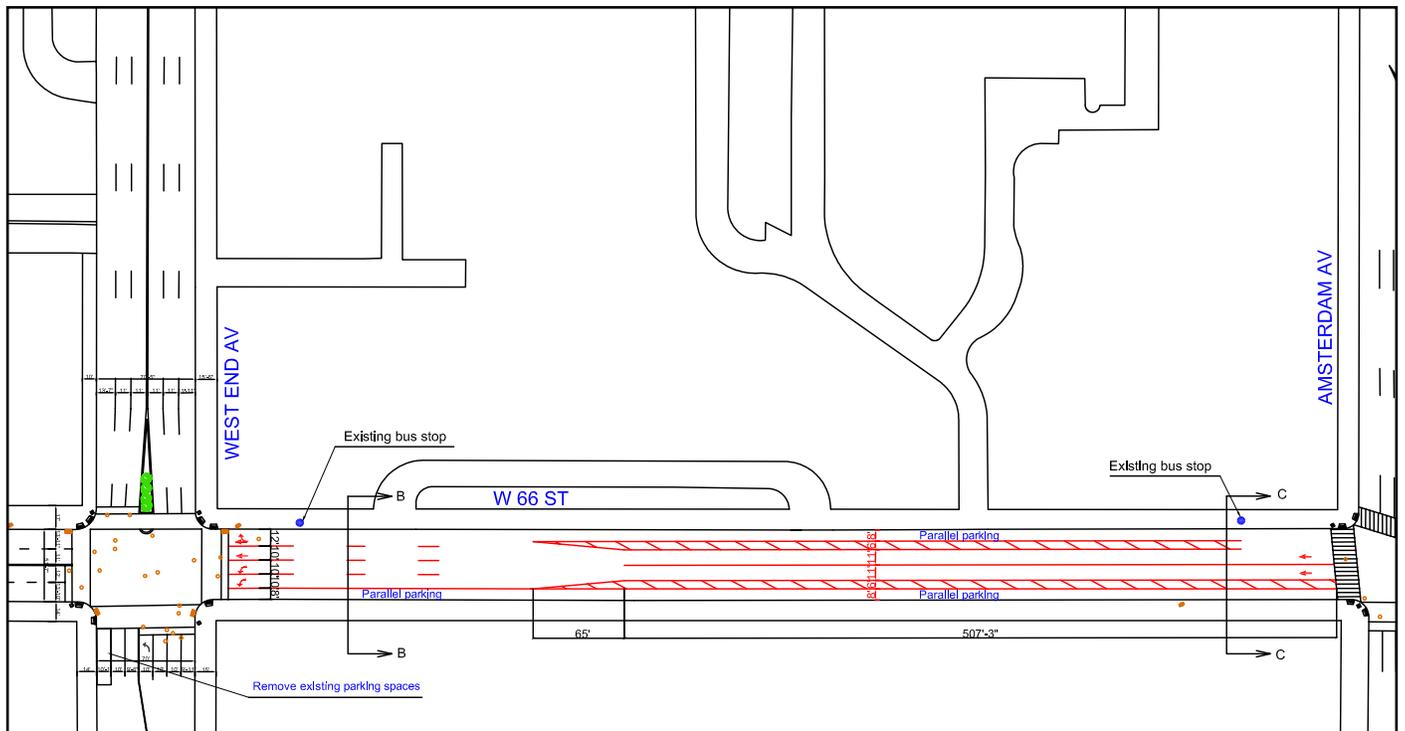
Figure 3-3b: Proposed Condition on West 66th Street between Amsterdam Avenue and West End Avenue

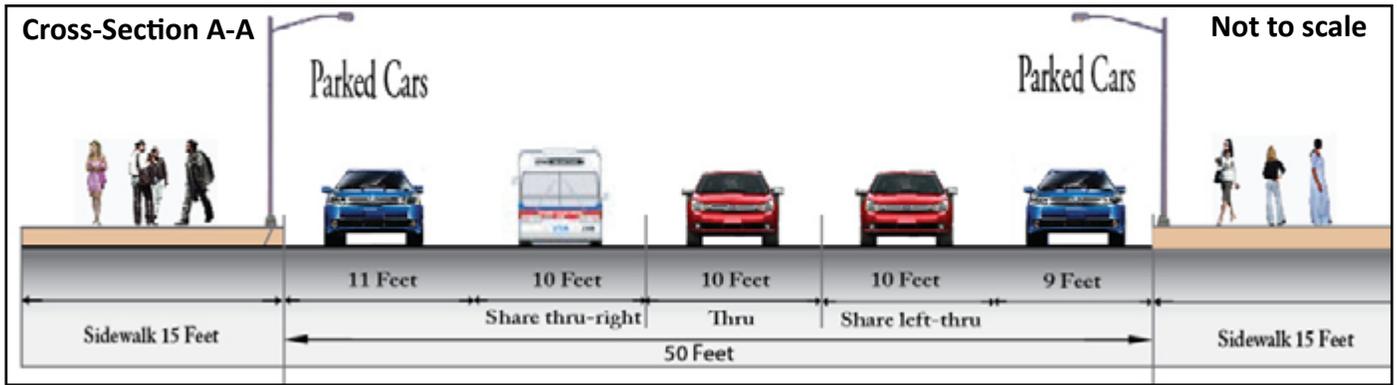
Figure 3-4a: West 66th Street between Amsterdam and West End Avenues (Existing Condition)

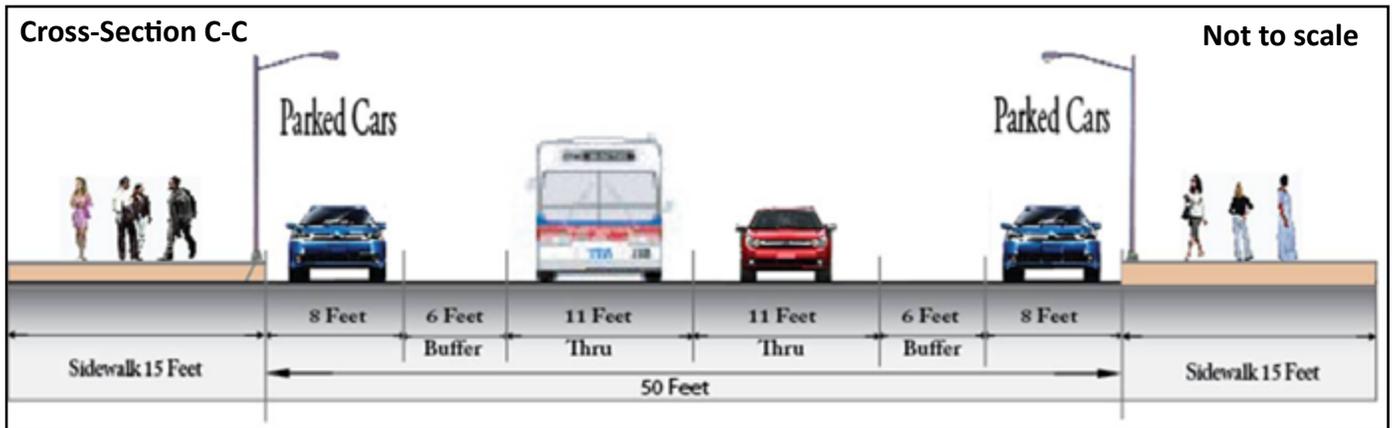
Figure 3-4b: Proposed Configuration for West 66th Street west of Amsterdam Avenue
