WEST SIDE MANHATTAN TRANSPORTATION STUDY

Technical Memorandum No. 2 Future Conditions & Recommendations

P.I.N. - PTDT09D00.G06

September 2011

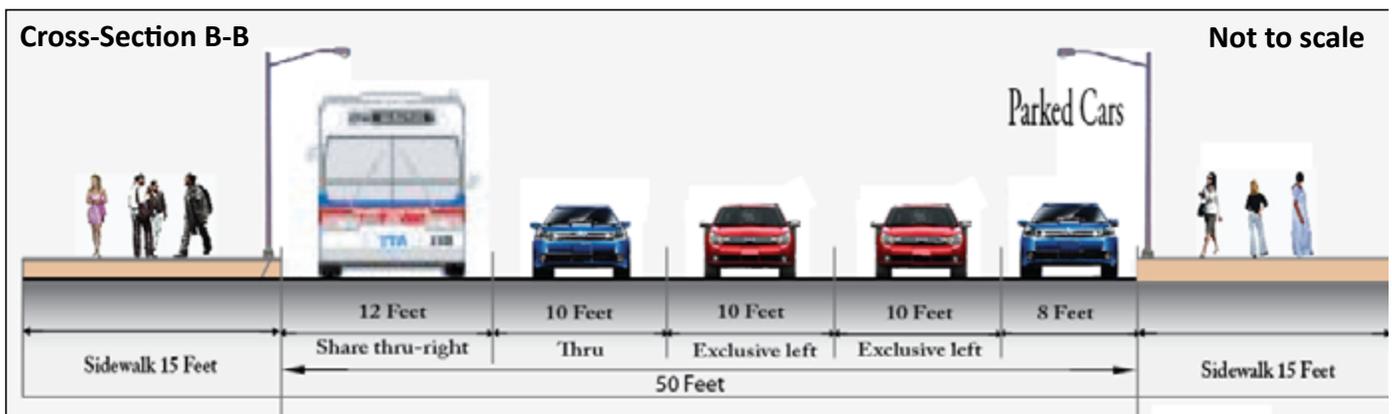
Figure 3-4c: Proposed Configuration for West 66th Street approaching West End Avenue

Figure 3-3a and 3-3b show the existing and proposed configuration; also, Figures 3-4a to 3-4c illustrate the cross-section view under existing and proposed conditions.

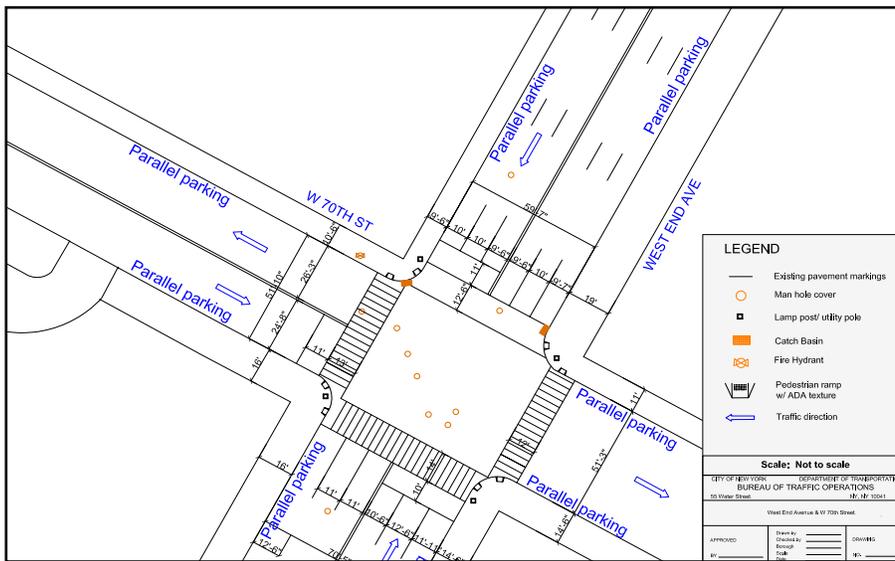
Figure 3-5a: Existing Condition - West End Ave & West 70th Street

The existing and proposed conditions are shown in Figure 3-5a and 3-5b.

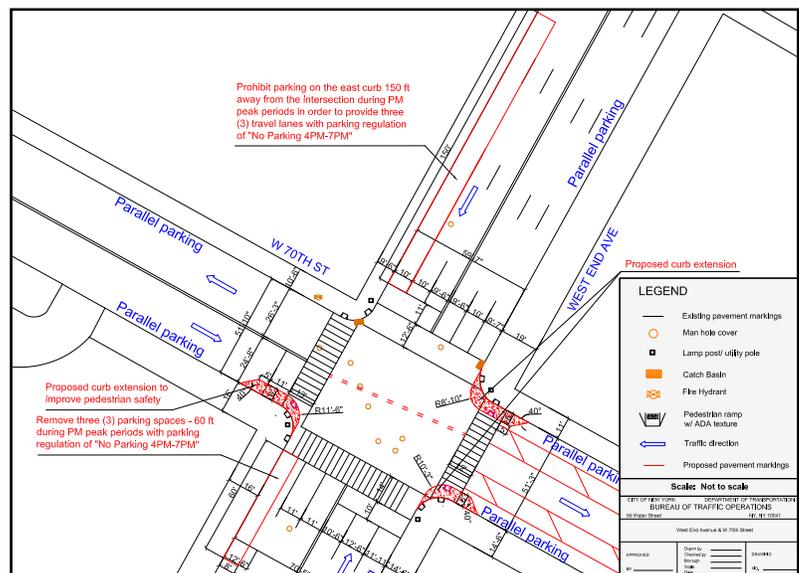
Figure 3-5b: Proposed Lane Configuration on West End Ave & West 70th Street (SB Approach)

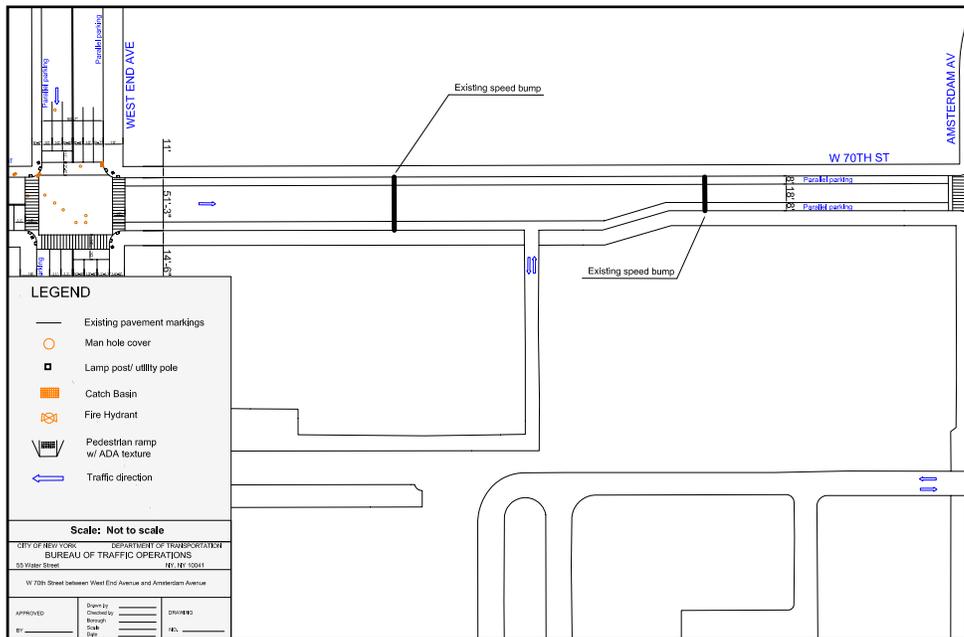
Figure 3-6a: Existing conditions on West 70th Street between Amsterdam Avenue and West End Avenue

- Create 8.5 foot buffers between the parking and moving lanes on the north and south curbs for approximately 465' from West End Avenue.
- Figure 3-6a and 3-6b show the existing and proposed configuration.

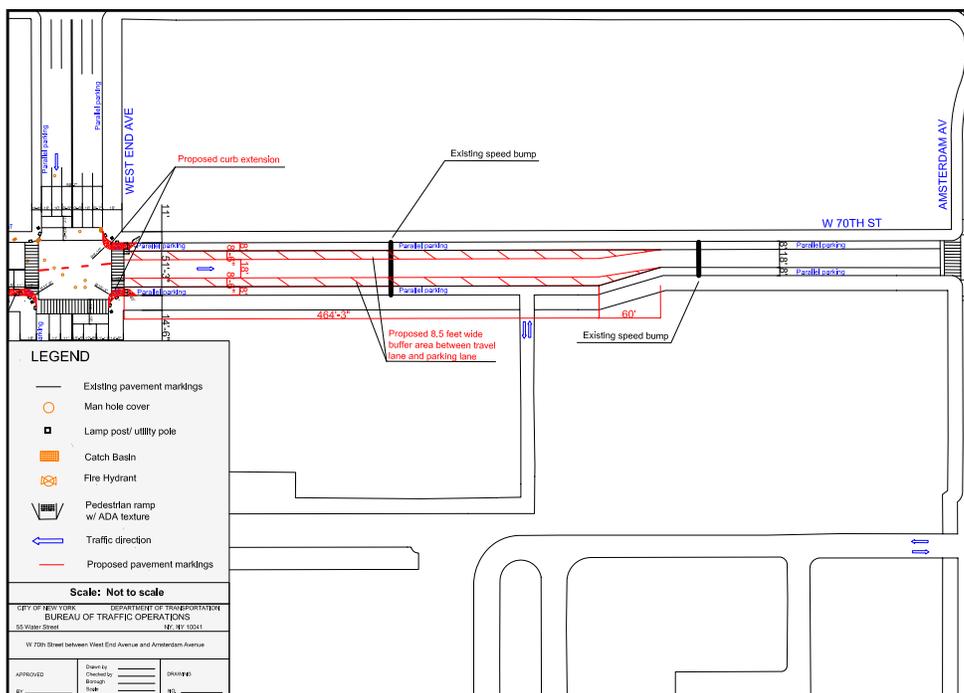
Figure 3-6b: Proposed conditions on West 70th Street between Amsterdam Avenue and West End Avenue

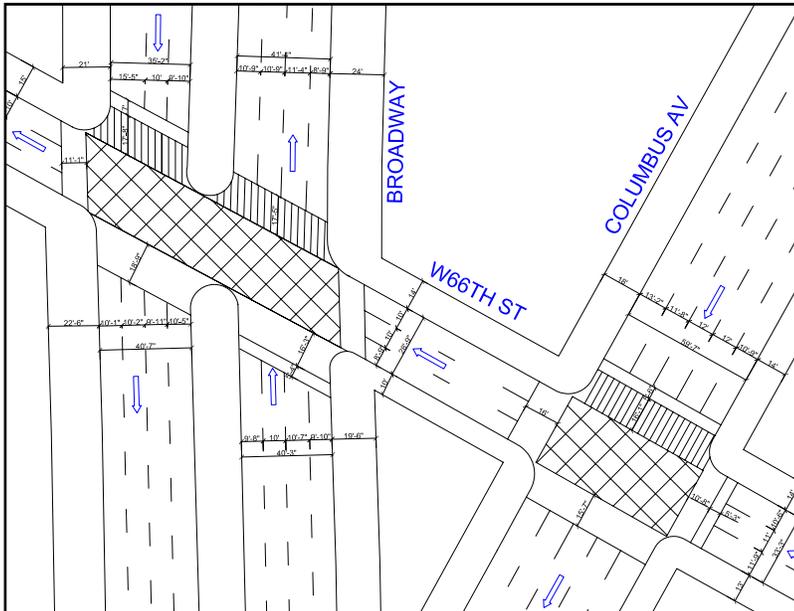
Figure 3-7a: Existing Condition - W 66th Street & Broadway

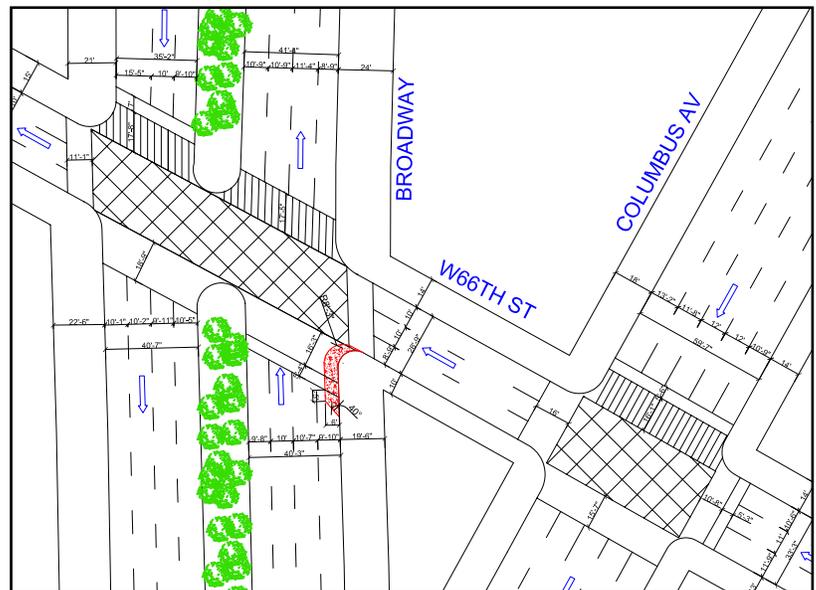
- Install single neckdown at the southeast corner along Broadway.

Figure 3-7b: Proposed Recommendation - W 66th Street & Broadway

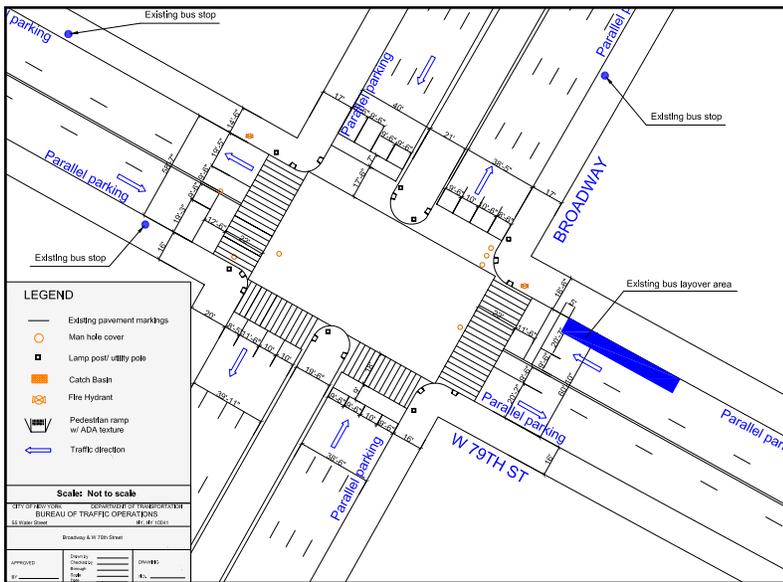
Figure 3-8a: Existing Condition - Broadway & West 79th Street

The existing and proposed conditions are shown in Figure 3-8a and 3-8b.

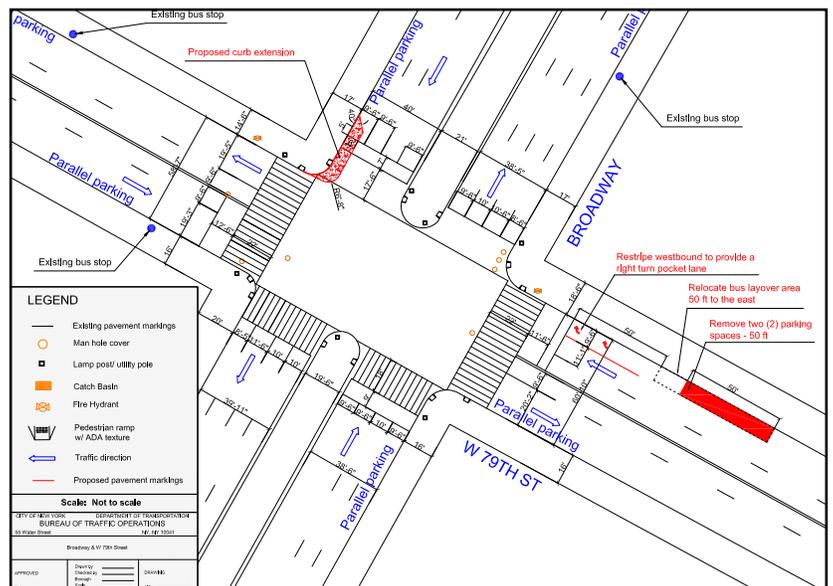
Figure 3-8b: Proposed Lane Configuration - Broadway & West 79th Street

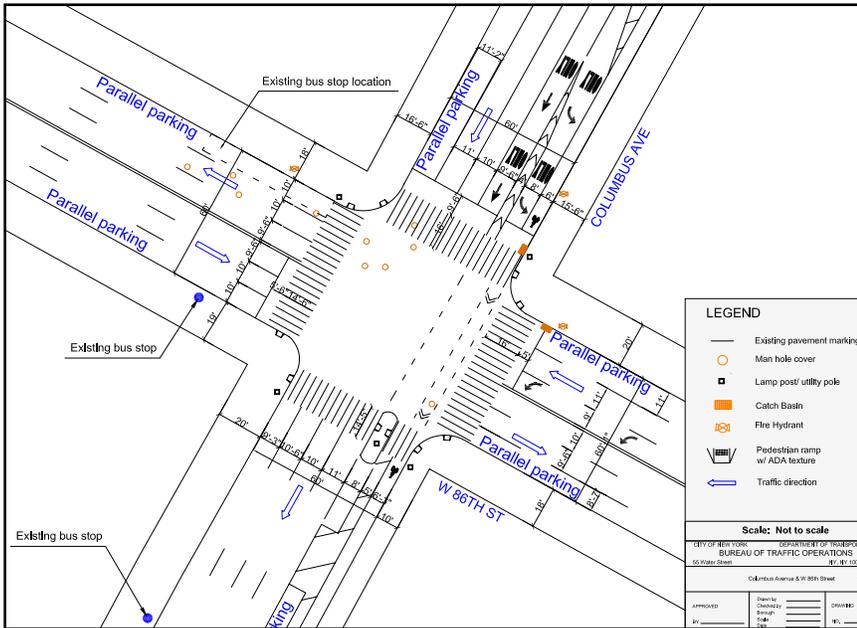
Figure 3-9a: Existing Condition - West 86th Street & Columbus Avenue

The existing and proposed conditions are shown in Figure 3-9a and 3-9b.

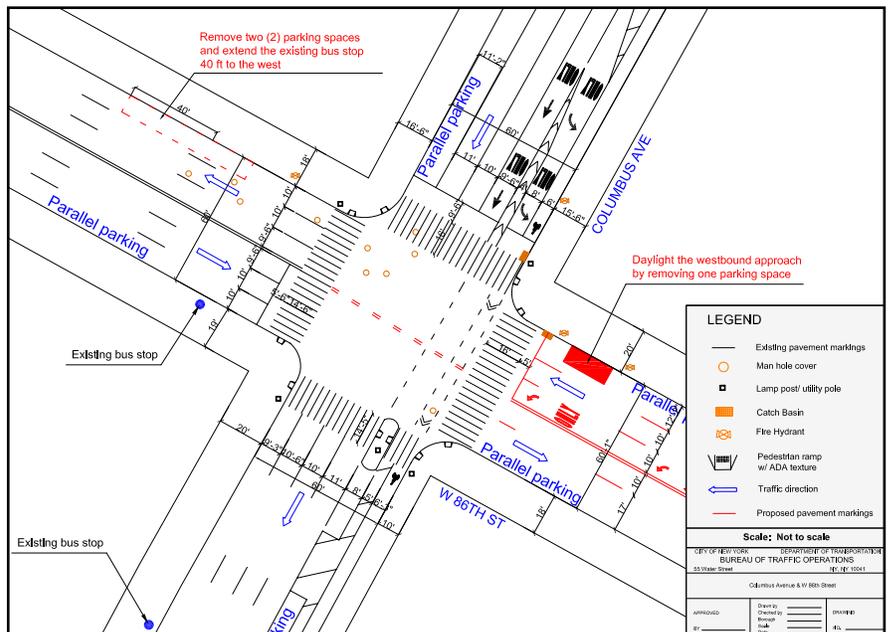
Figure 3-9b: Proposed Condition - West 86th Street & Columbus Avenue

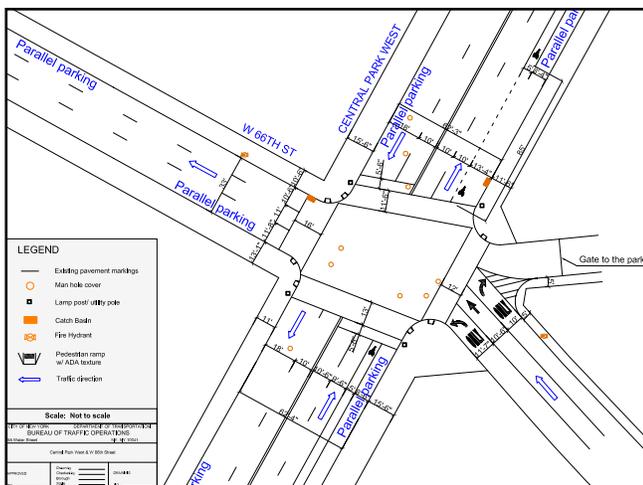
Figure 3-10a: Existing Condition - Central Park West & West 66th Street

The existing and proposed conditions are shown in Figure 3-10a and 3-10b.

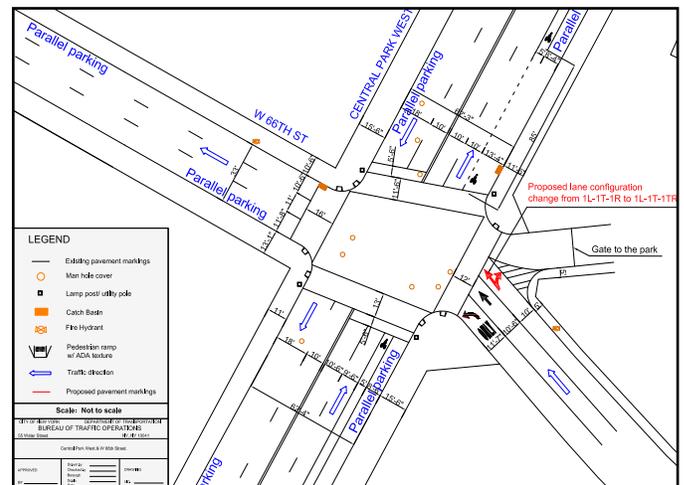
Figure 3-10b: Proposed Lane Assignment - Central Park West & West 66th Street

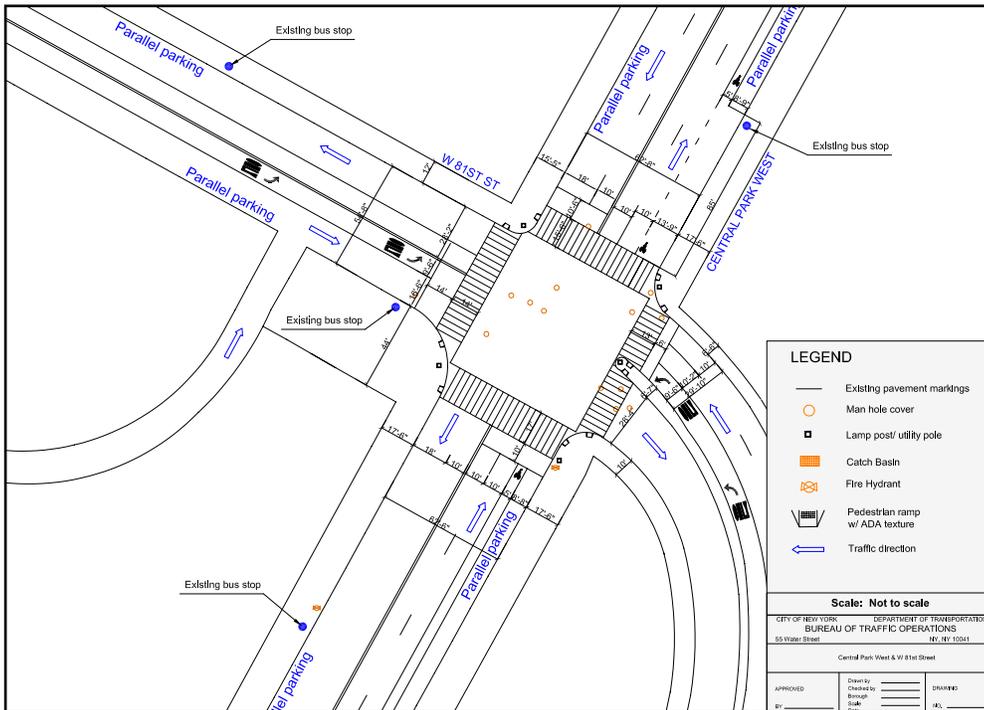
Figure 3-11a: Existing Condition - Central Park West & West 81st Street

The existing and proposed conditions are shown in Figure 3-11a and 3-11b.

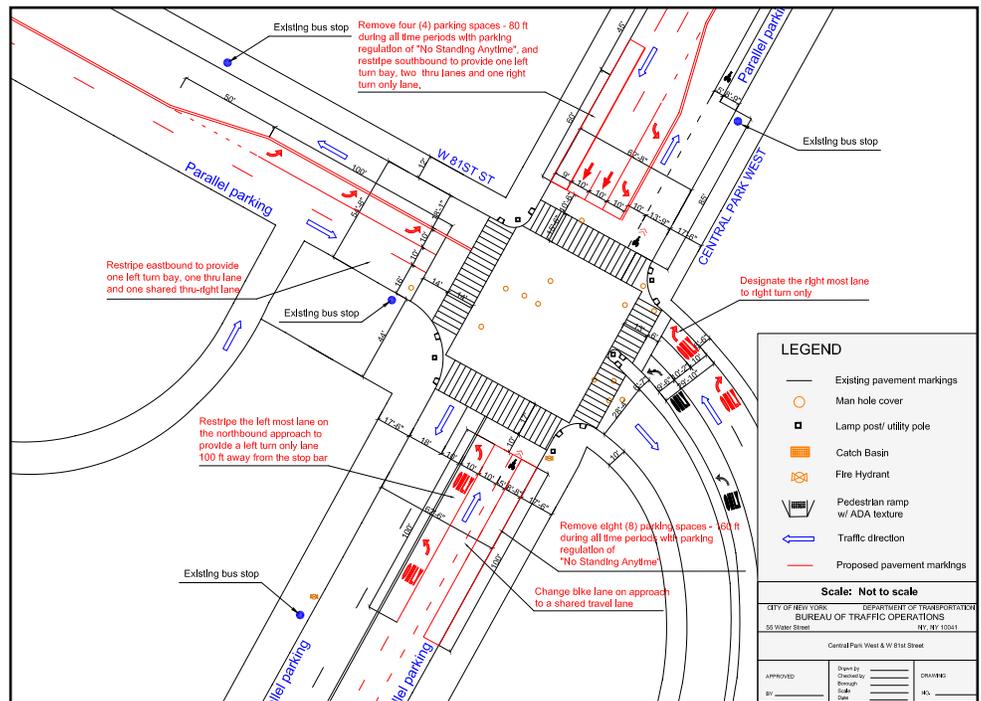
Figure 3-11b: Proposed Roadway Configuration - Central Park West & West 81st Street

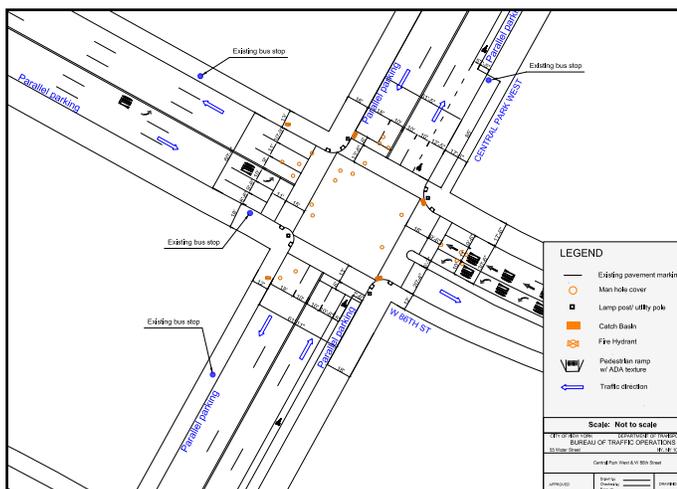
Figure 3-12a: Existing Condition - Central Park West & West 86th Street

The existing and proposed conditions are shown in Figure 3-12a and 3-12b.

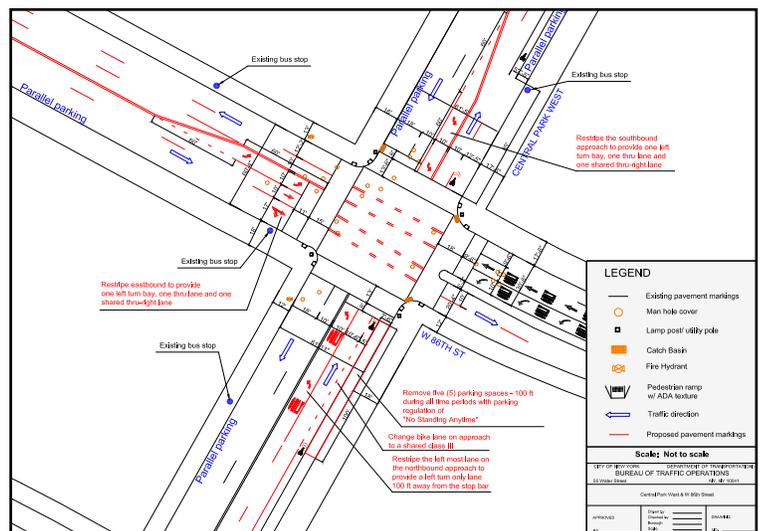
Figure 3-12b: Proposed Roadway Configuration - Central Park West & West 86th Street

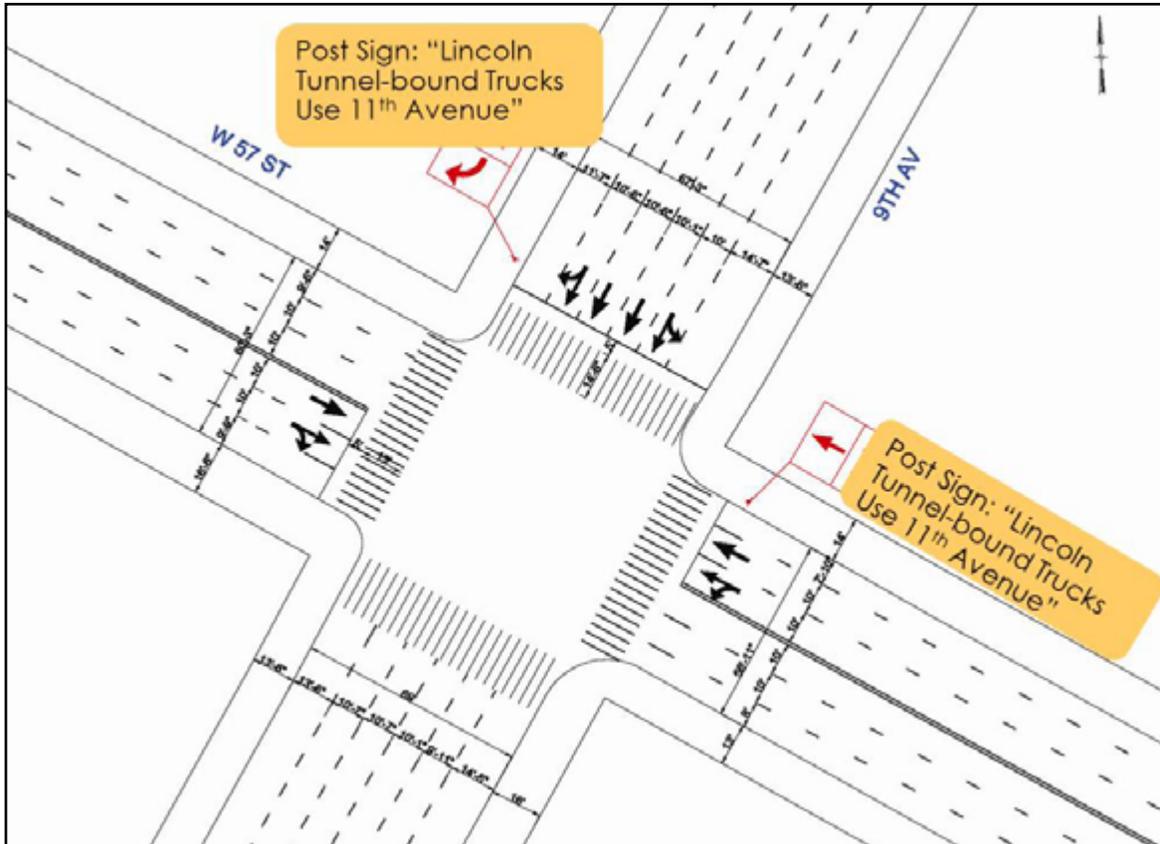
- Post advisory sign(s) on the southbound and westbound approaches directing Lincoln Tunnel bound trucks to use 11th Avenue to access the tunnel.

Figure 3-13: Truck Advisory – Ninth Avenue & West 57th Street

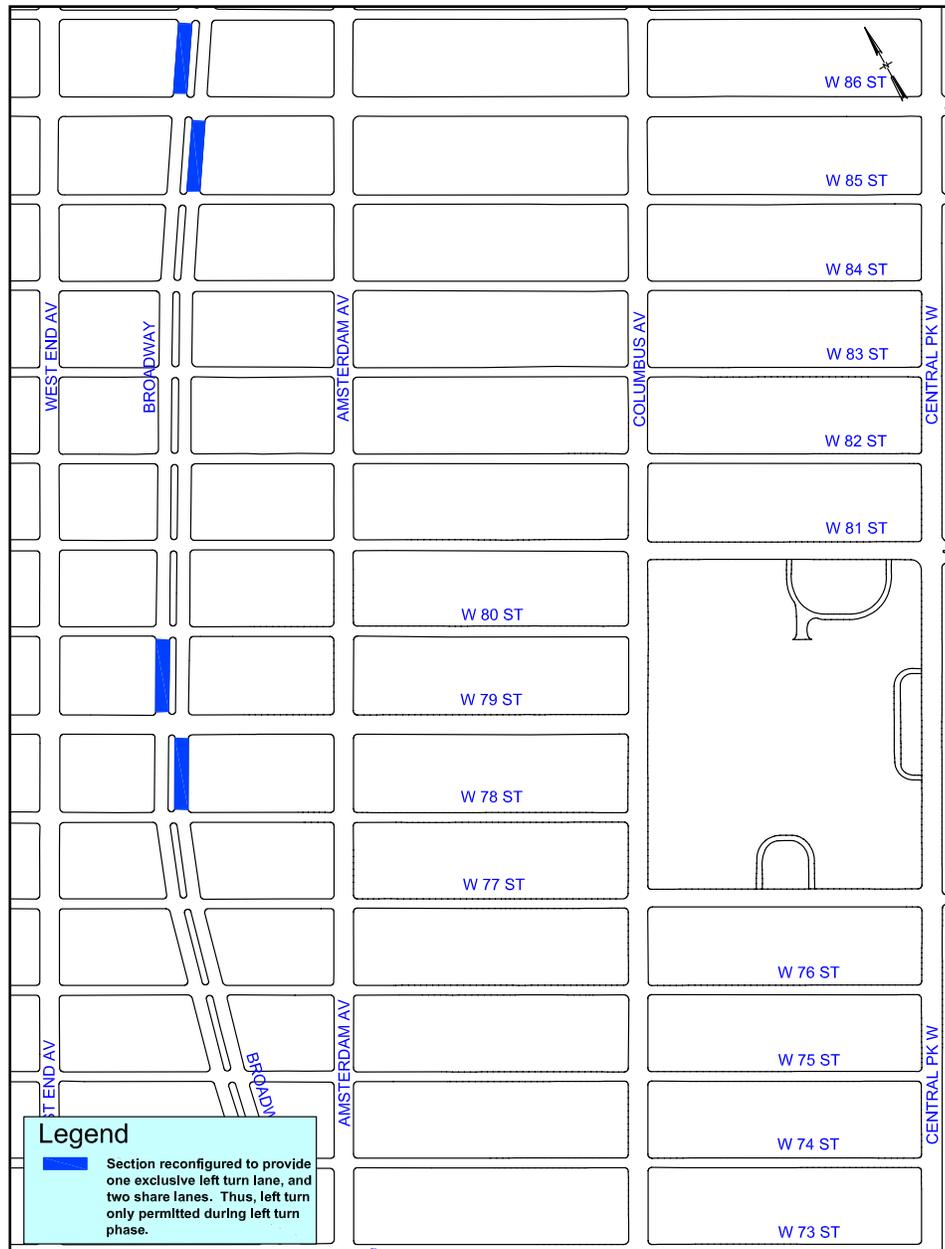
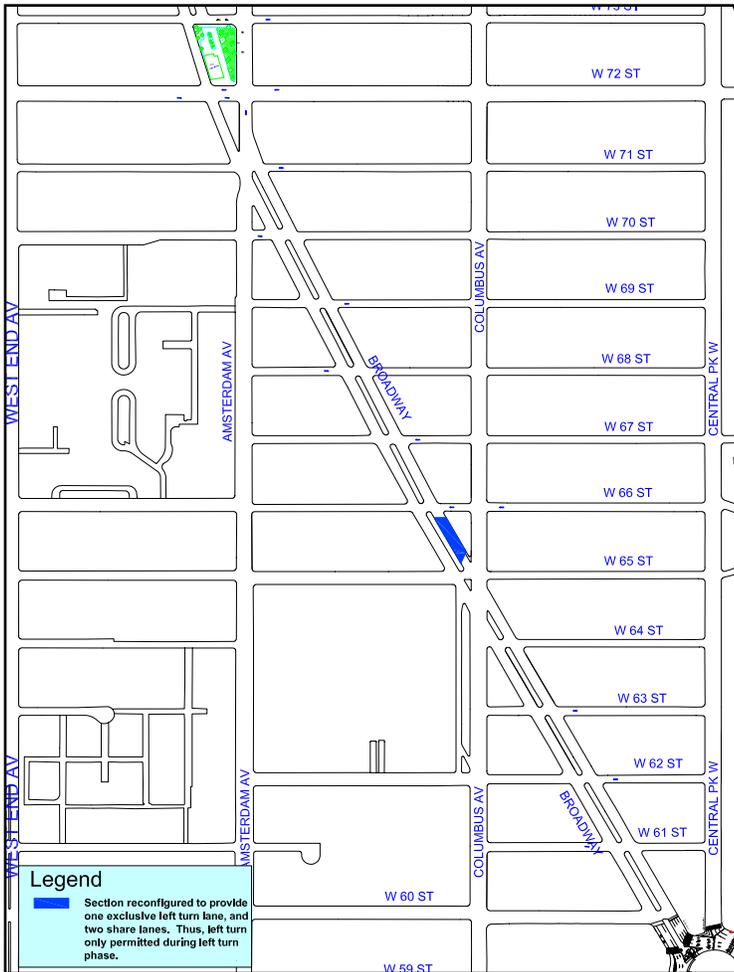
Figure 3-14a: Proposed Designated Left Turn Lane on Broadway at Major Intersections

This recommendation is illustrated in Figure 3-14a and 3-14b.

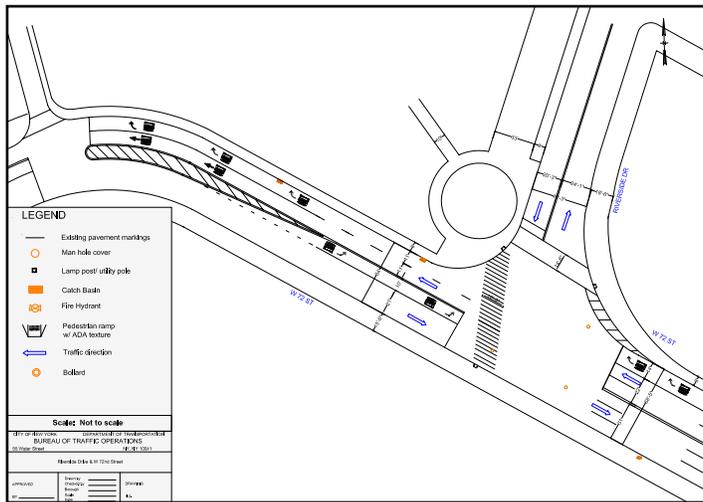
Figure 3-15a: Existing Condition - Riverside Drive & West 72nd Street

Figure 3-15a and 3-15b show the existing and proposed conditions at this location.

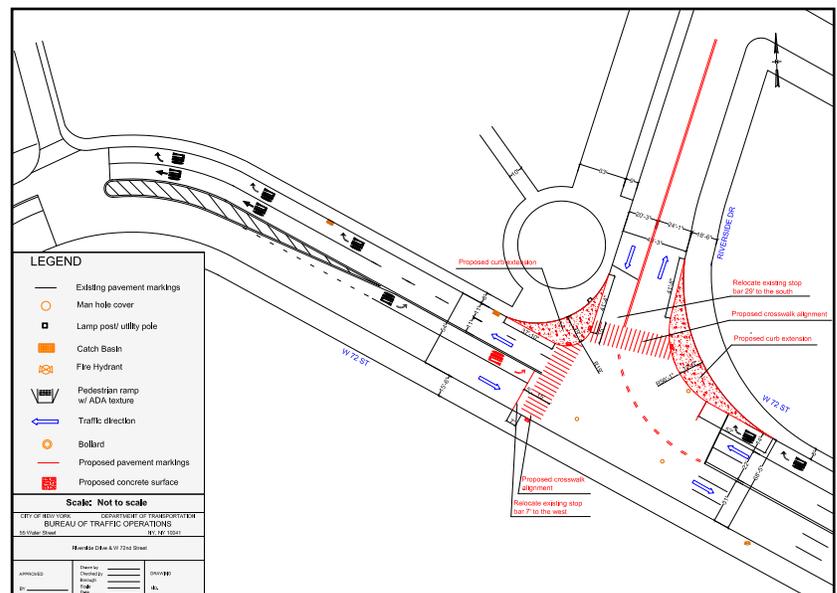
Figure 3-15b: Proposed Condition - Riverside Drive & West 72nd Street

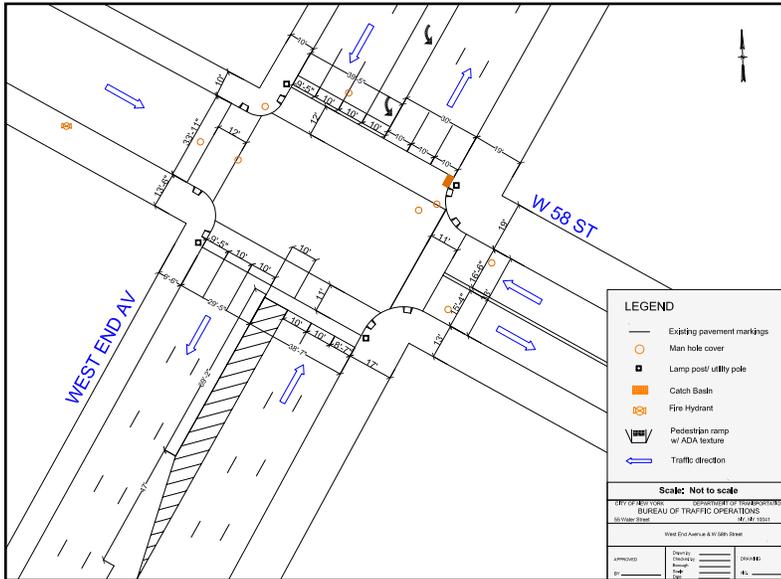
Figure 3-16a: Existing Condition - West End Avenue & West 58th Street

Figure 3-16a and 3-16b show the existing and proposed conditions at this location.

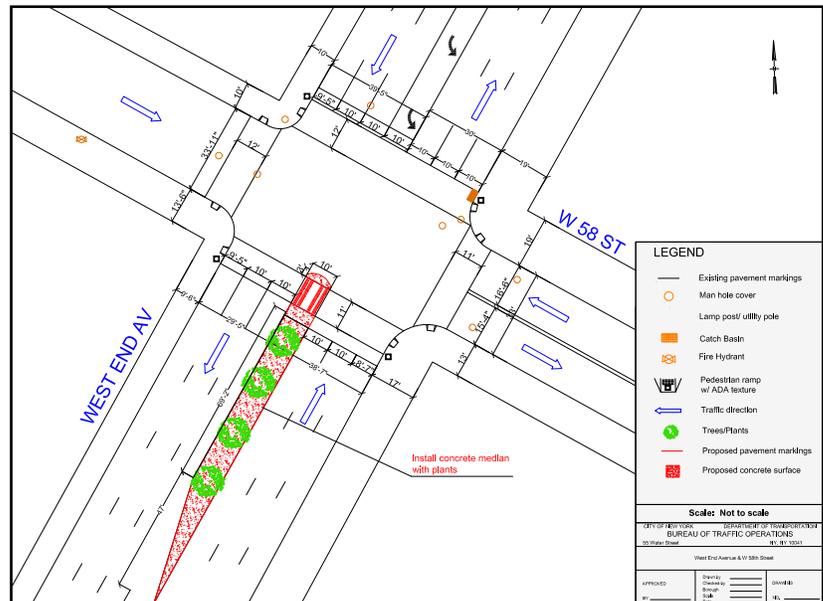
Figure 3-16b: Proposed Condition - West End Avenue & West 58th Street

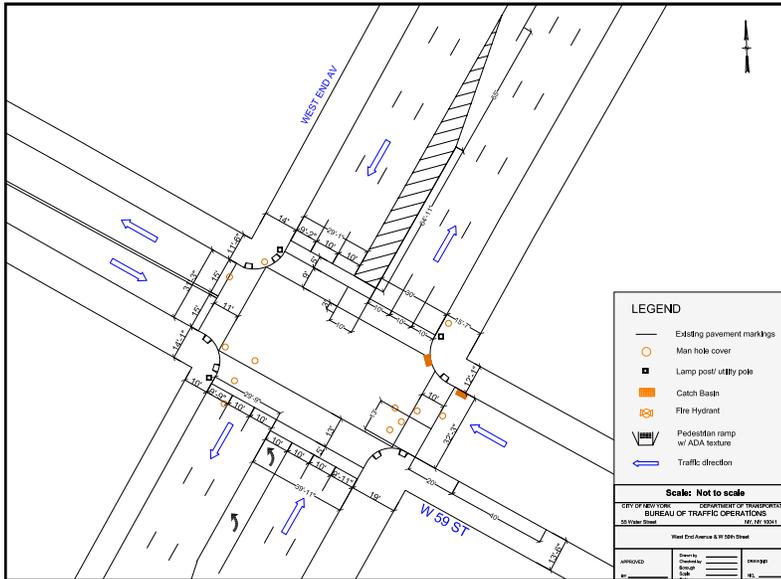
Figure 3-17a: Existing Condition - West End Avenue & West 59th Street

Figure 3-17a and 3-17b show the existing and proposed conditions at this location.

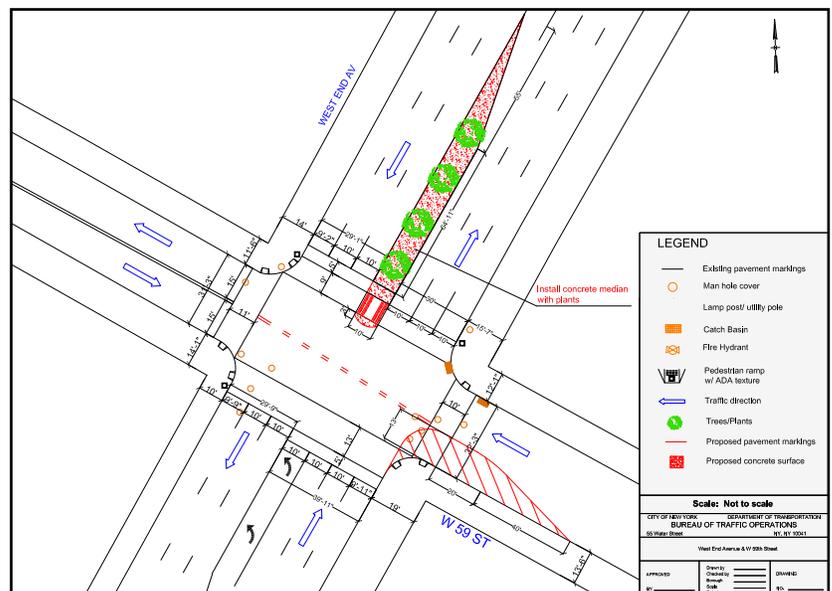
Figure 3-17b: Proposed Condition - West End Avenue & West 59th Street

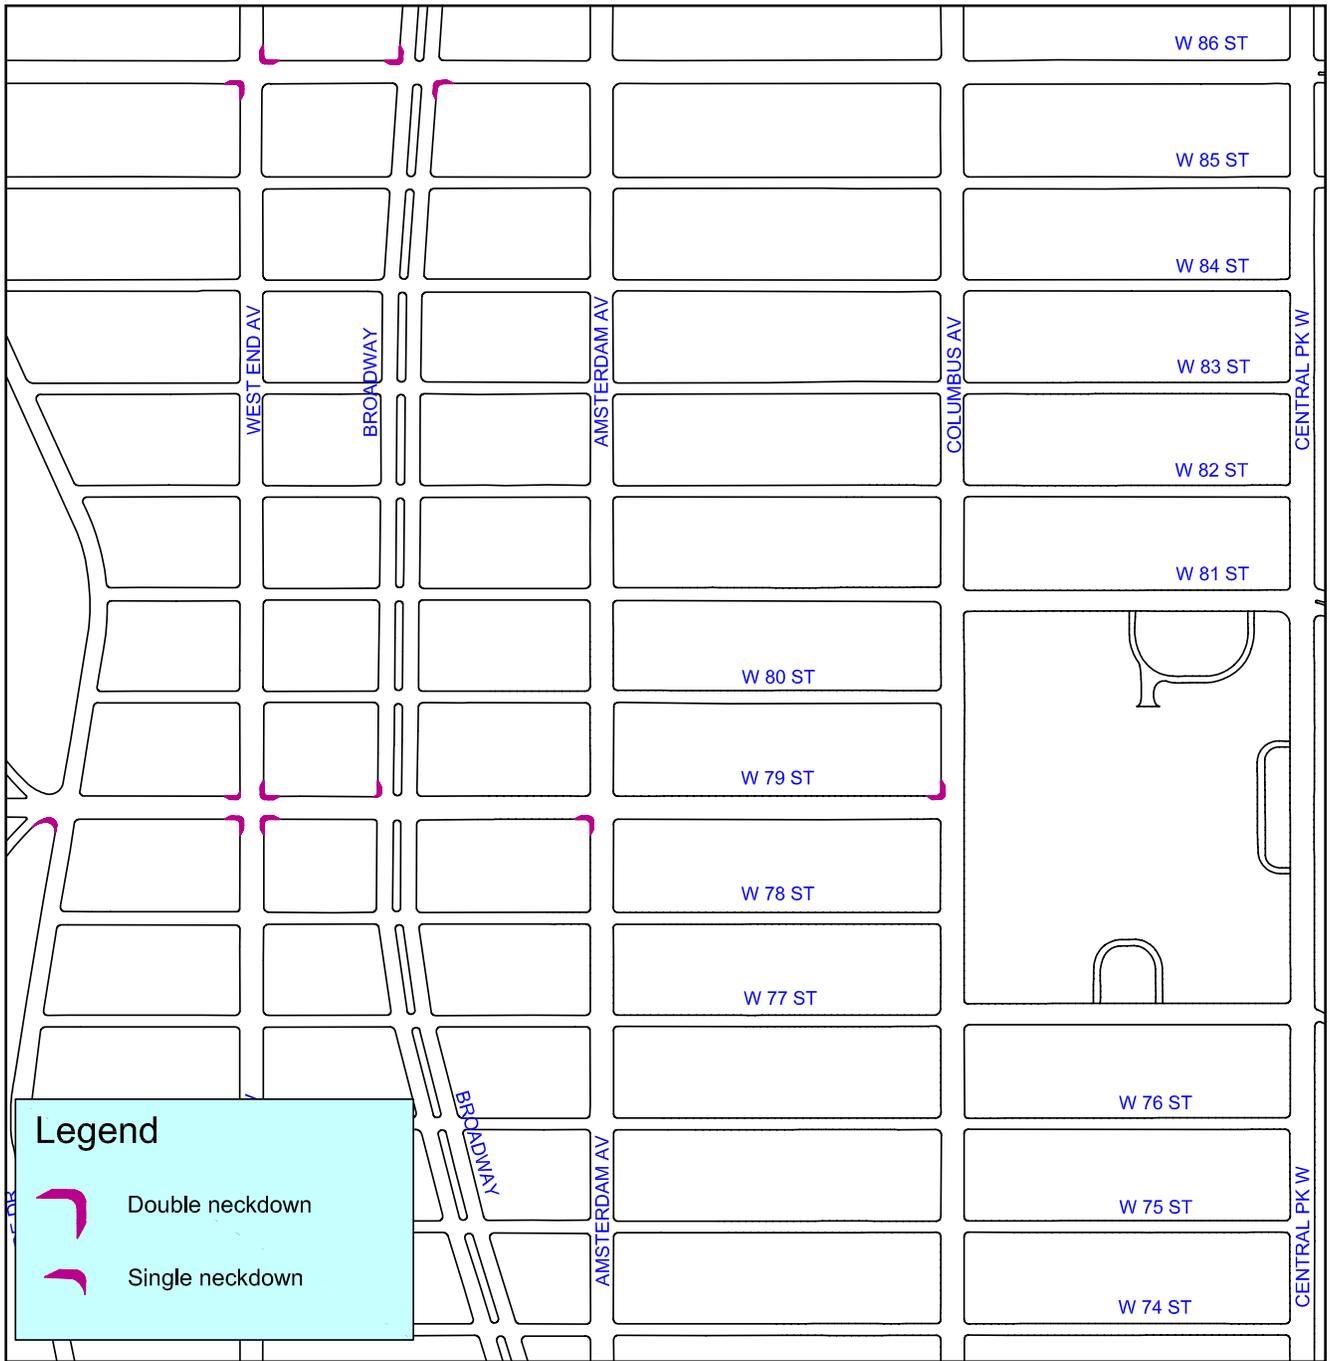
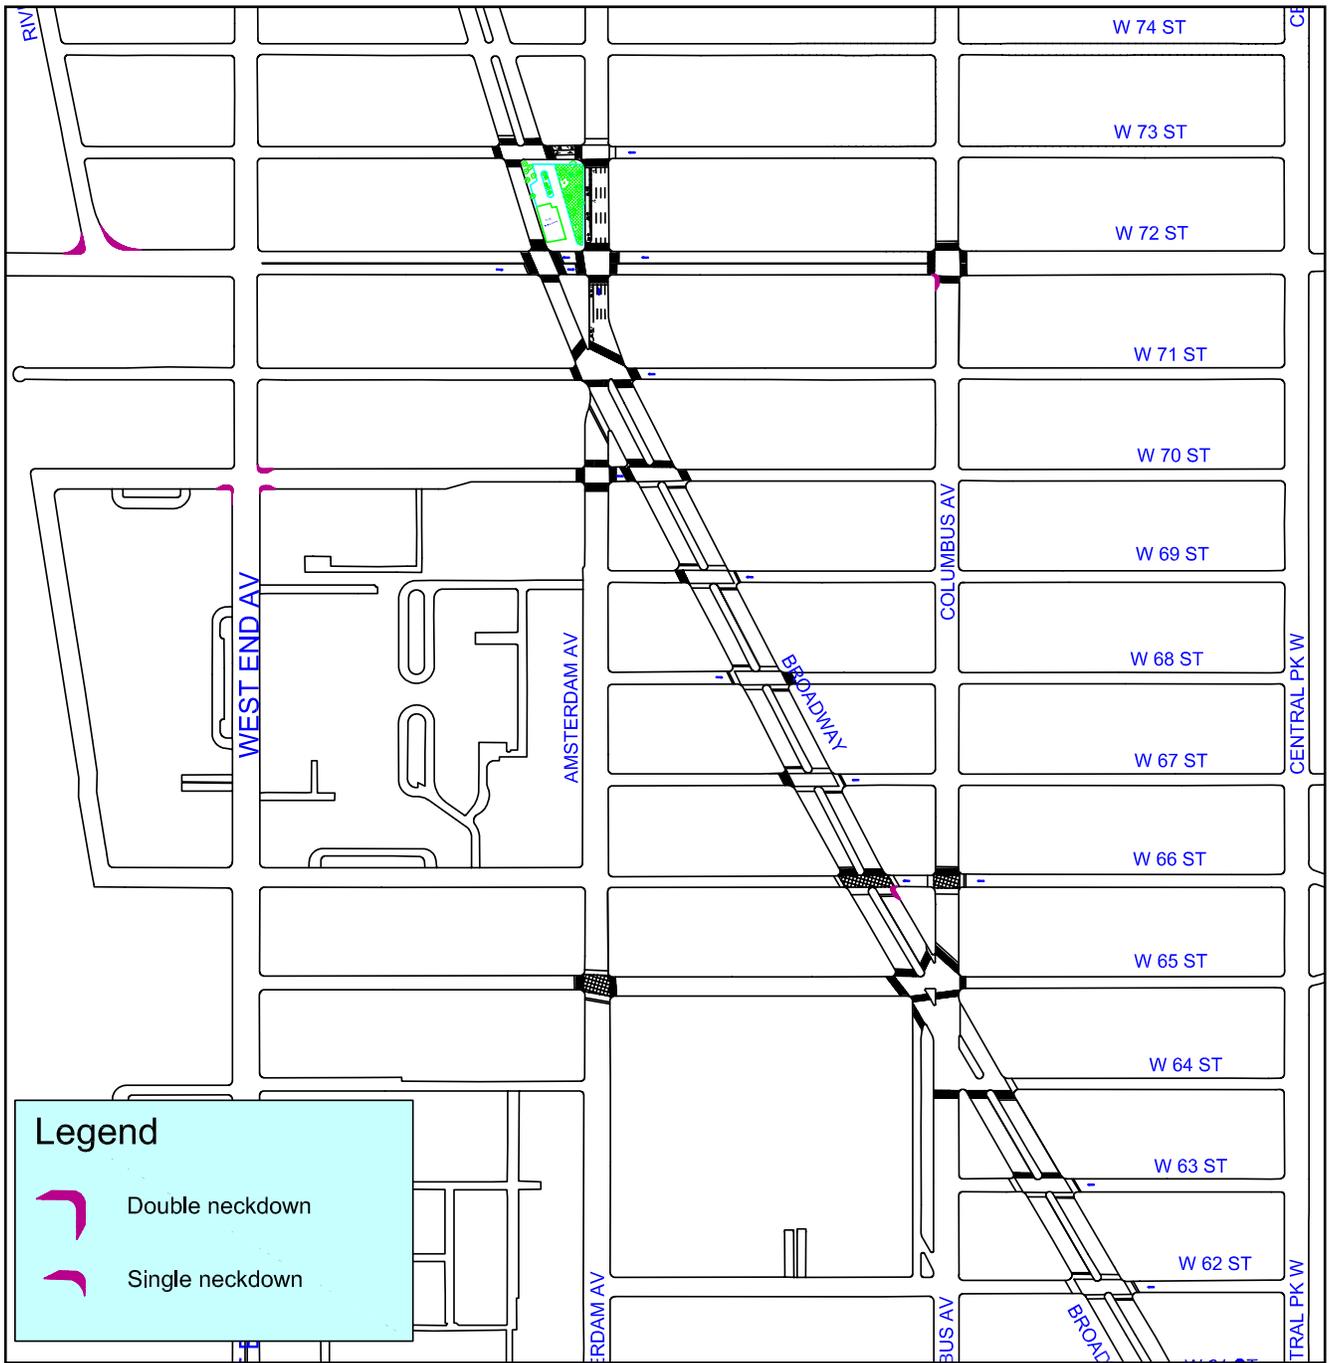
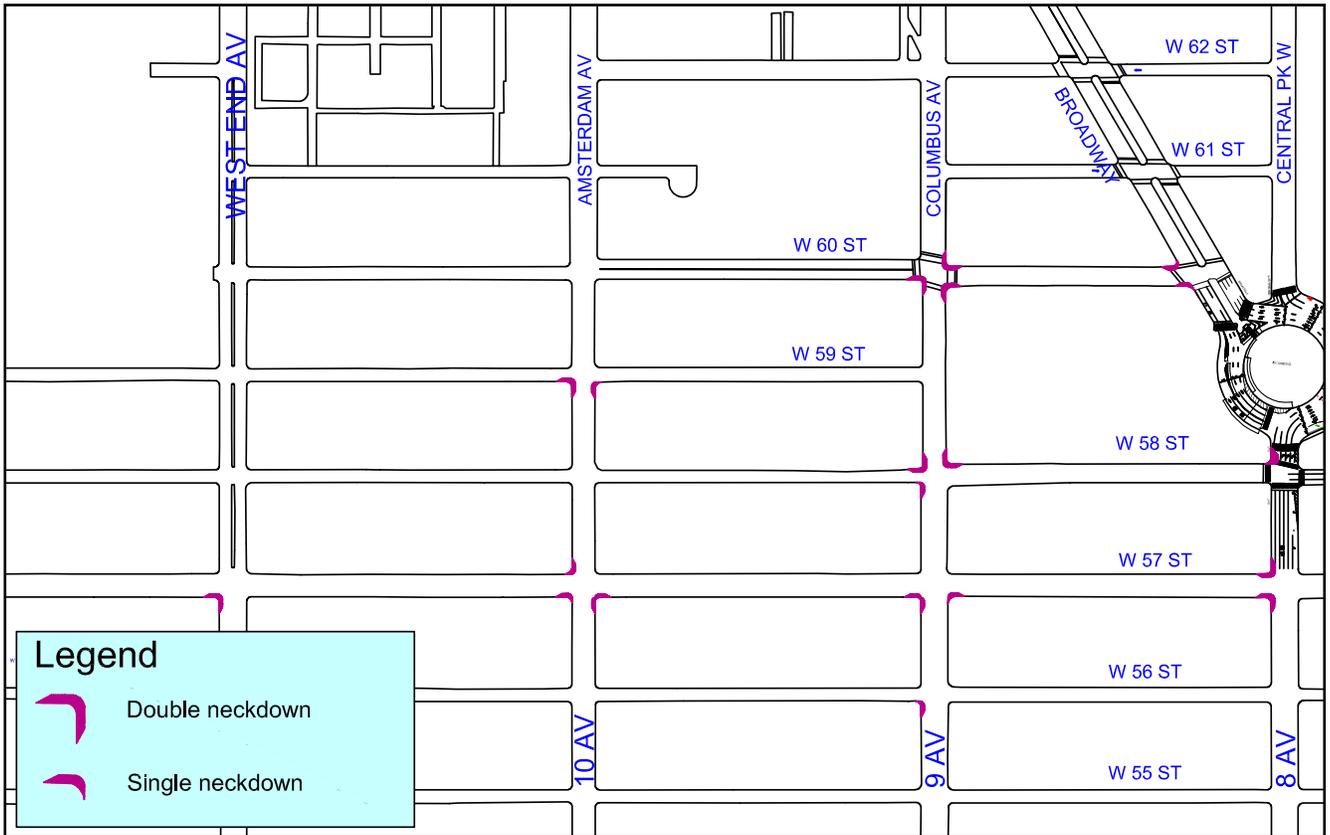
Figure 3-18a: Proposed Neckdowns or Street Furniture
(Page 1 of 3)

Table 3-1 lists the locations where neckdowns or the installation of street design furniture is recommended; and, Figures 3-18a and b illustrate the recommendation. These locations will be subjected to detail design evaluation.

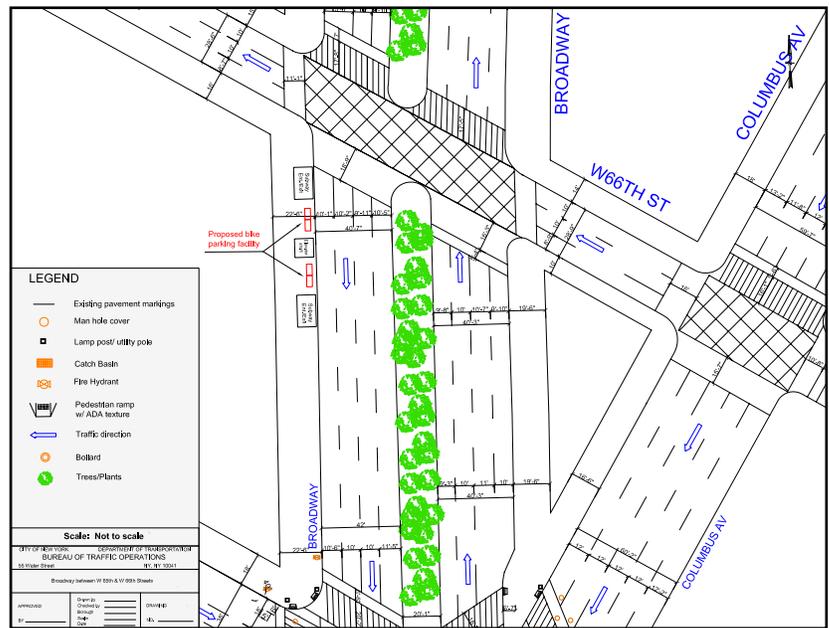
1. West sidewalk on Broadway between West 65th and West 66th Streets
 - Install bike parking amenities in “dead space” on sidewalk between elevator shaft and stairwell.

Figure 3-20: Proposed Sidewalk Bicycle Parking – Broadway between West 65th Street and West 66th Street

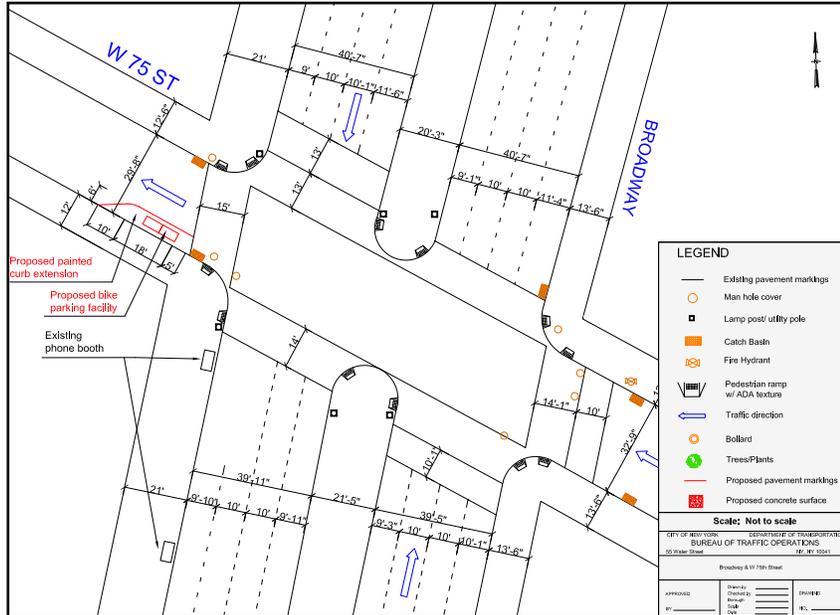
Figure 3-21: Proposed On-Street Bicycle Parking – West 75th Street & Broadway

The proposed condition is shown in Figure 3-21.

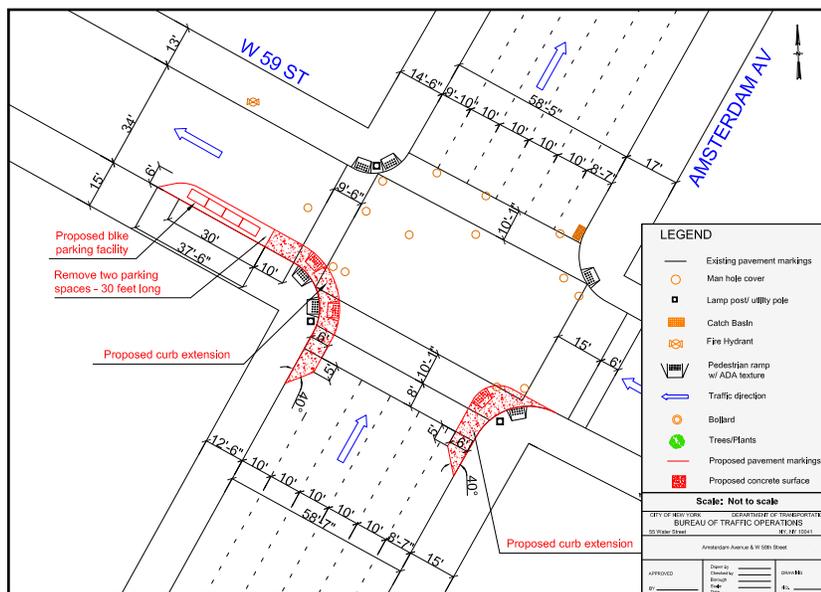
Figure 3-22: Proposed On-Street Bicycle Parking – West 59th Street & Amsterdam Avenue

The proposed condition is shown in Figure 3-22.

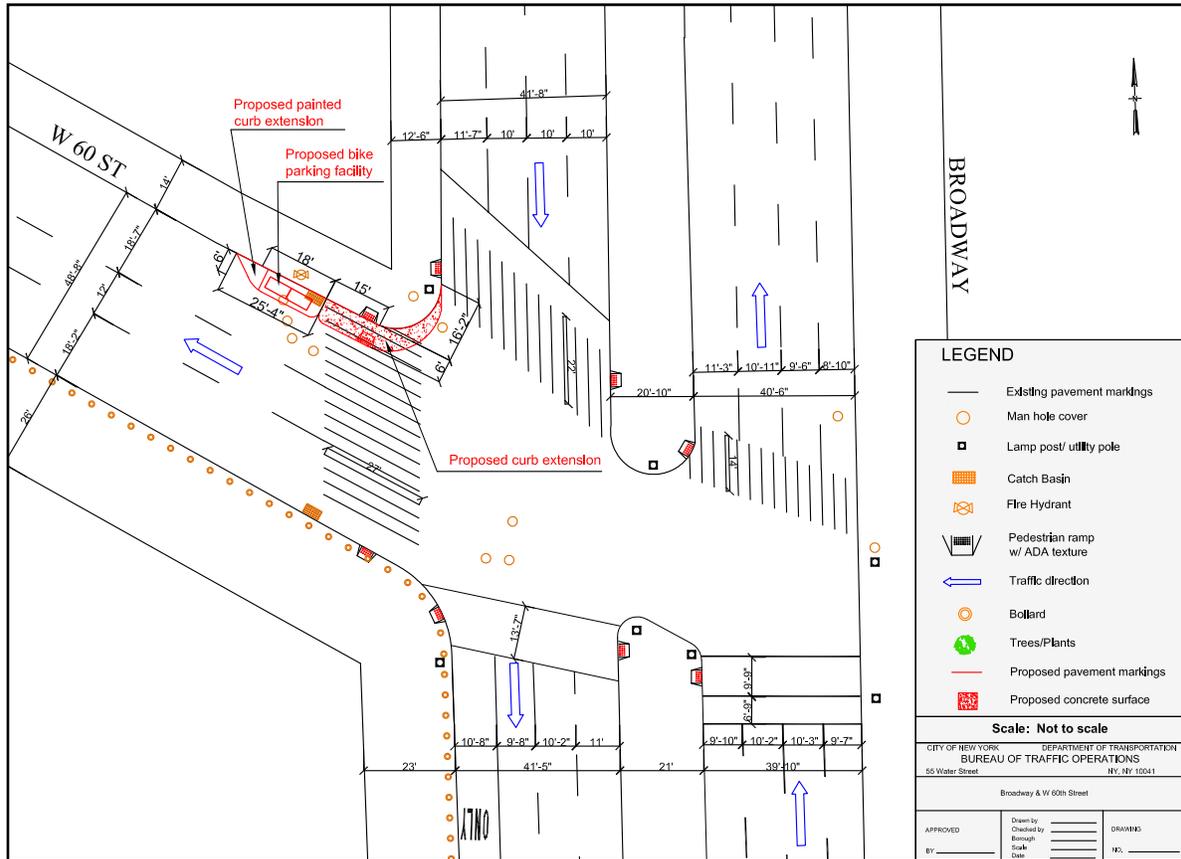
Figure 3-23: Proposed On-Street Bicycle Parking – West 60th Street & Broadway

The proposed condition is shown in Figure 3-23.
