WEST SIDE MANHATTAN TRANSPORTATION STUDY

Technical Memorandum No. 2 Future Conditions & Recommendations

P.I.N. - PTDT09D00.G06

September 2011

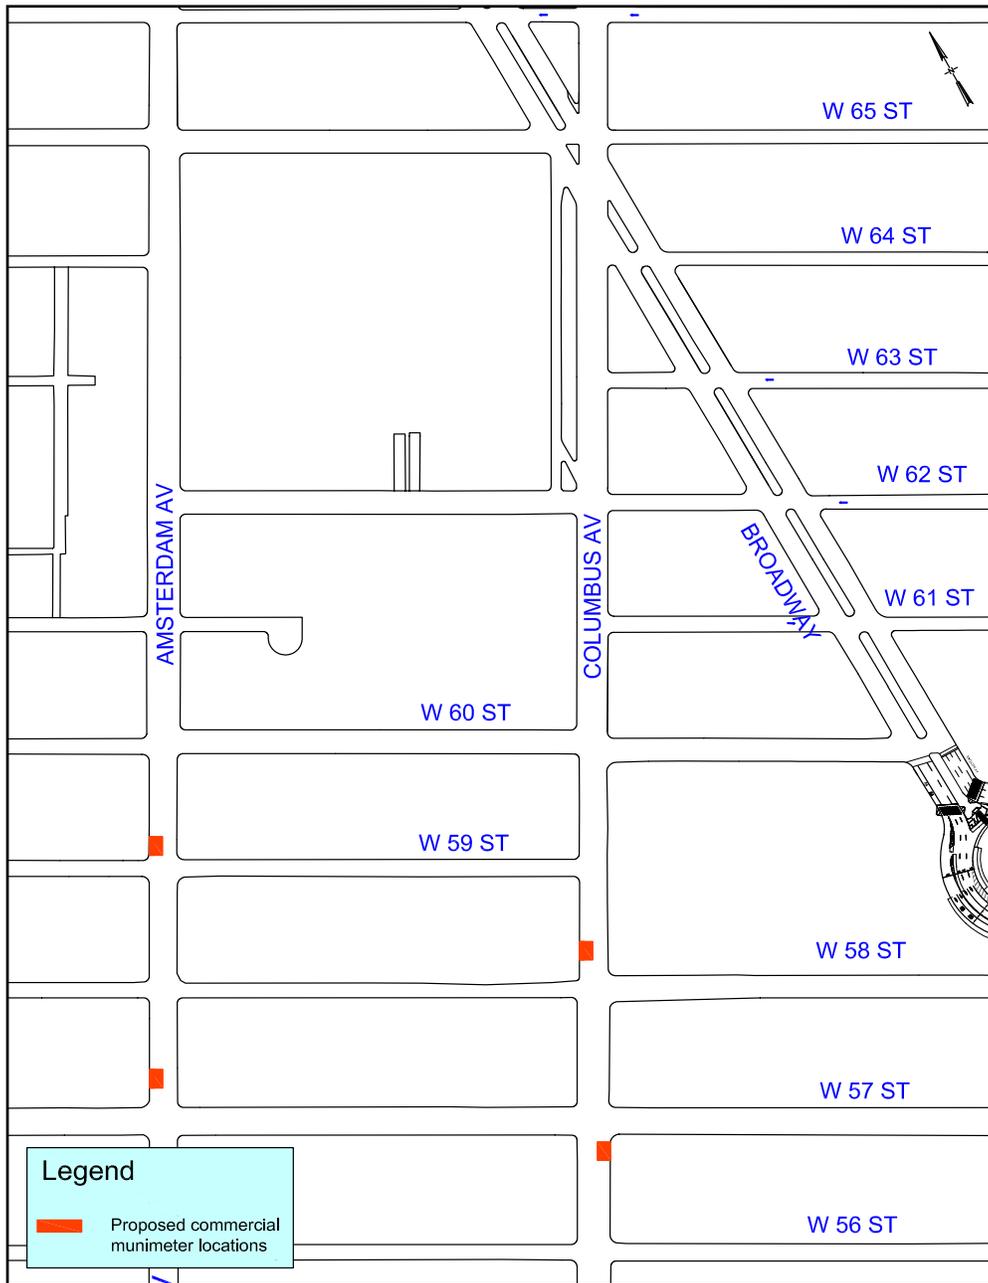
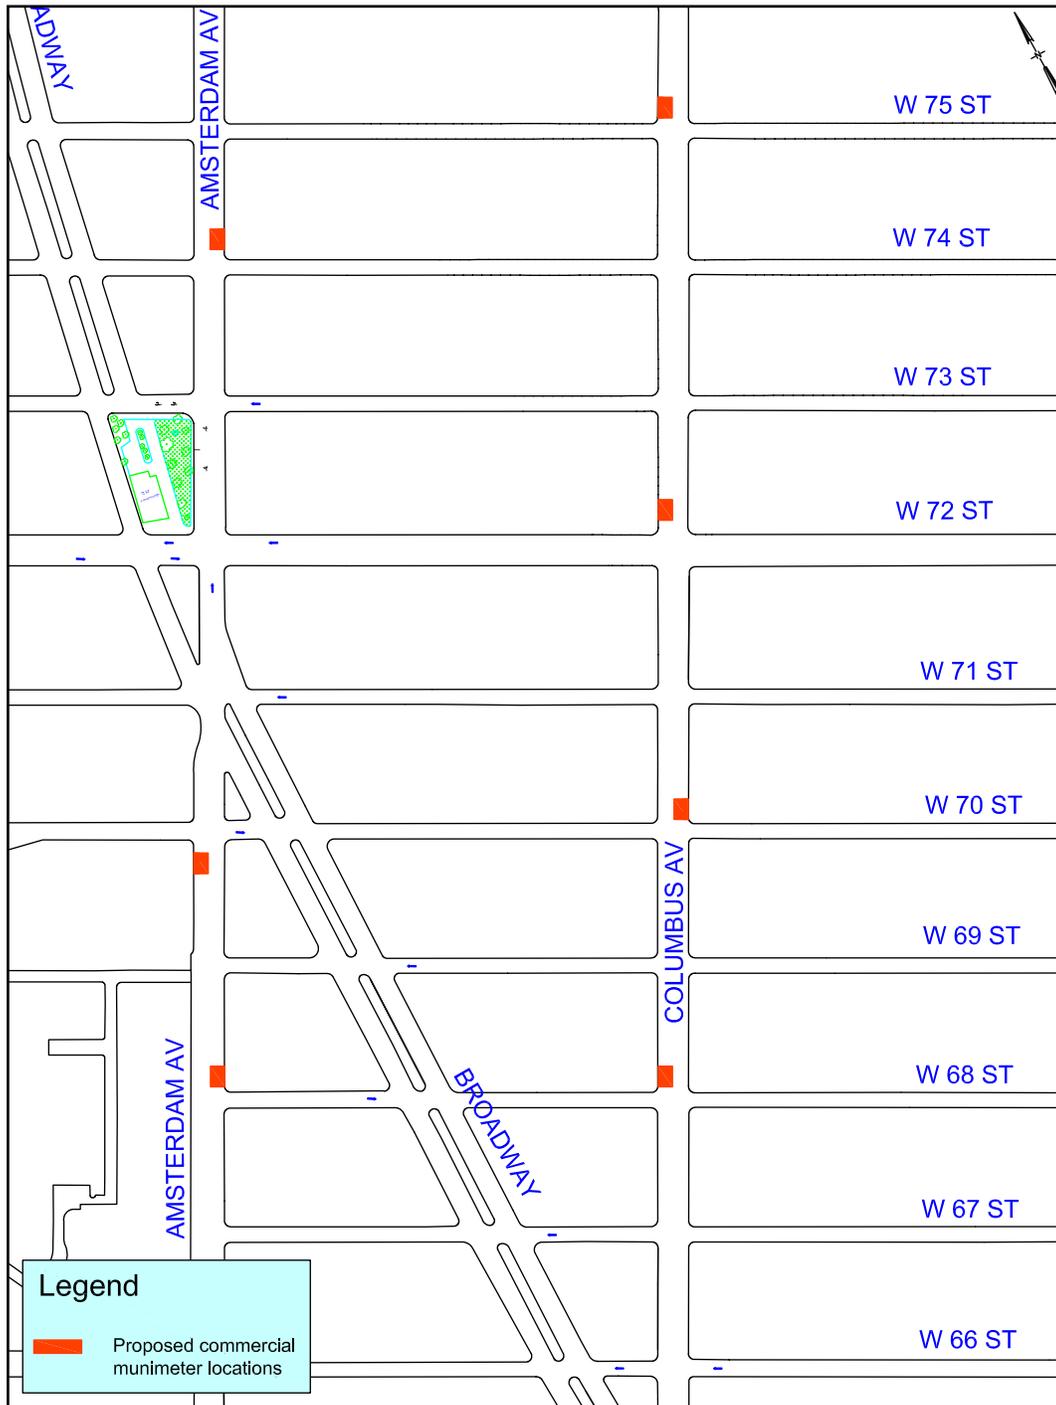
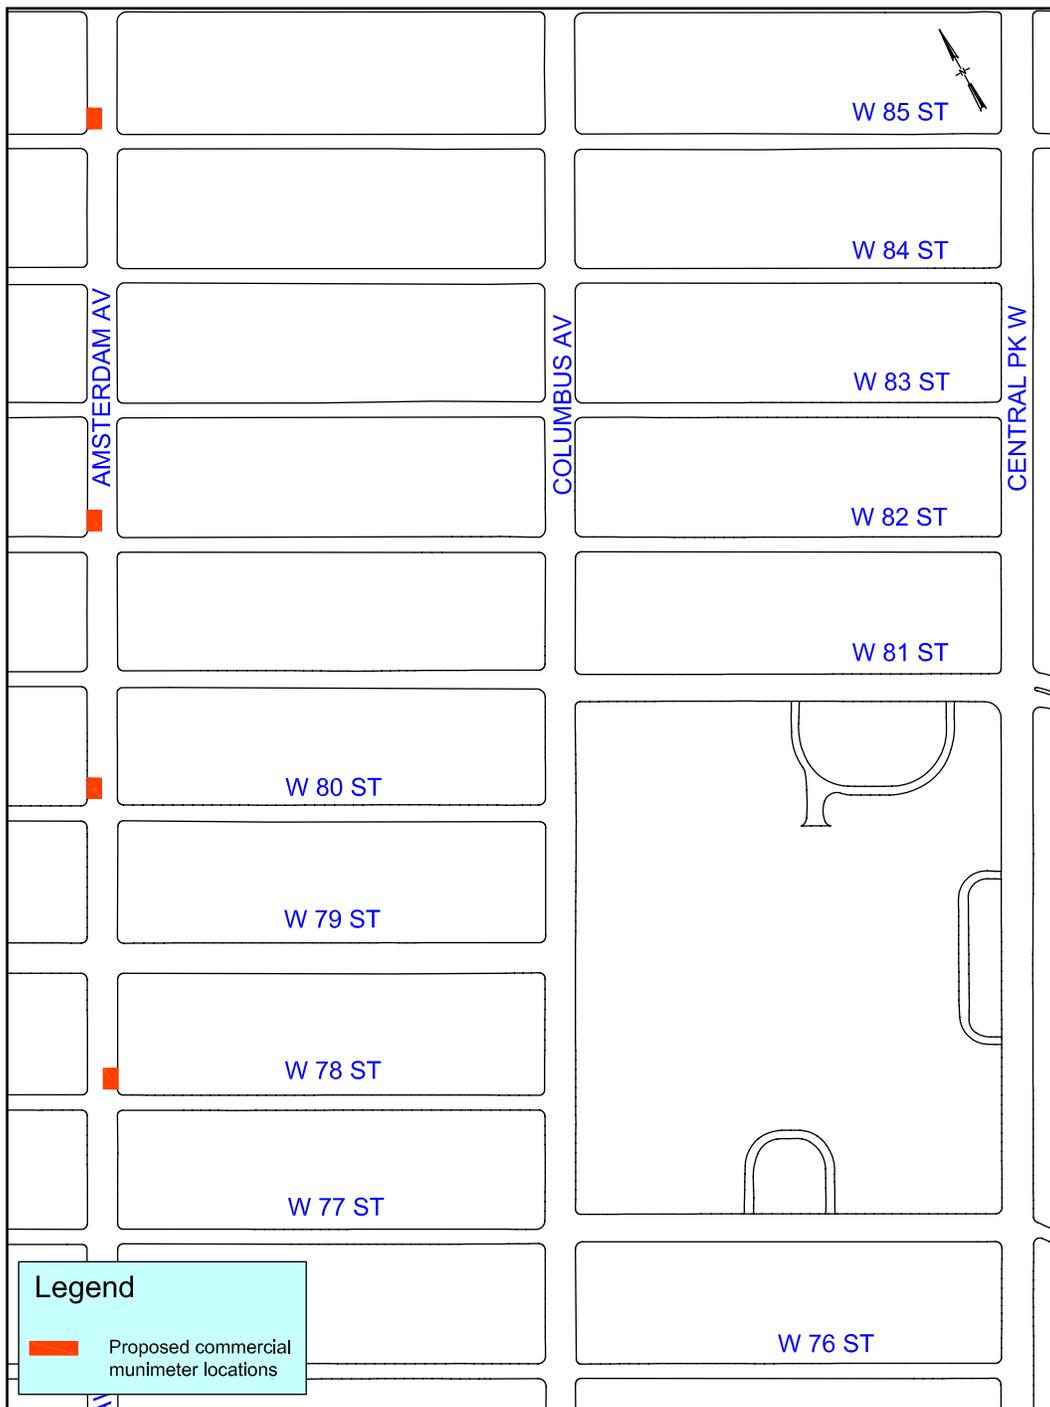
- Designate commercial parking zones (50 feet long/ two car parking spaces) along both corridors, as shown in Figure 3-24, to be regulated with commercial muni-meters.

Figure 3-24: Proposed Commercial Muni-Meter Sites
(Page 1 of 3)

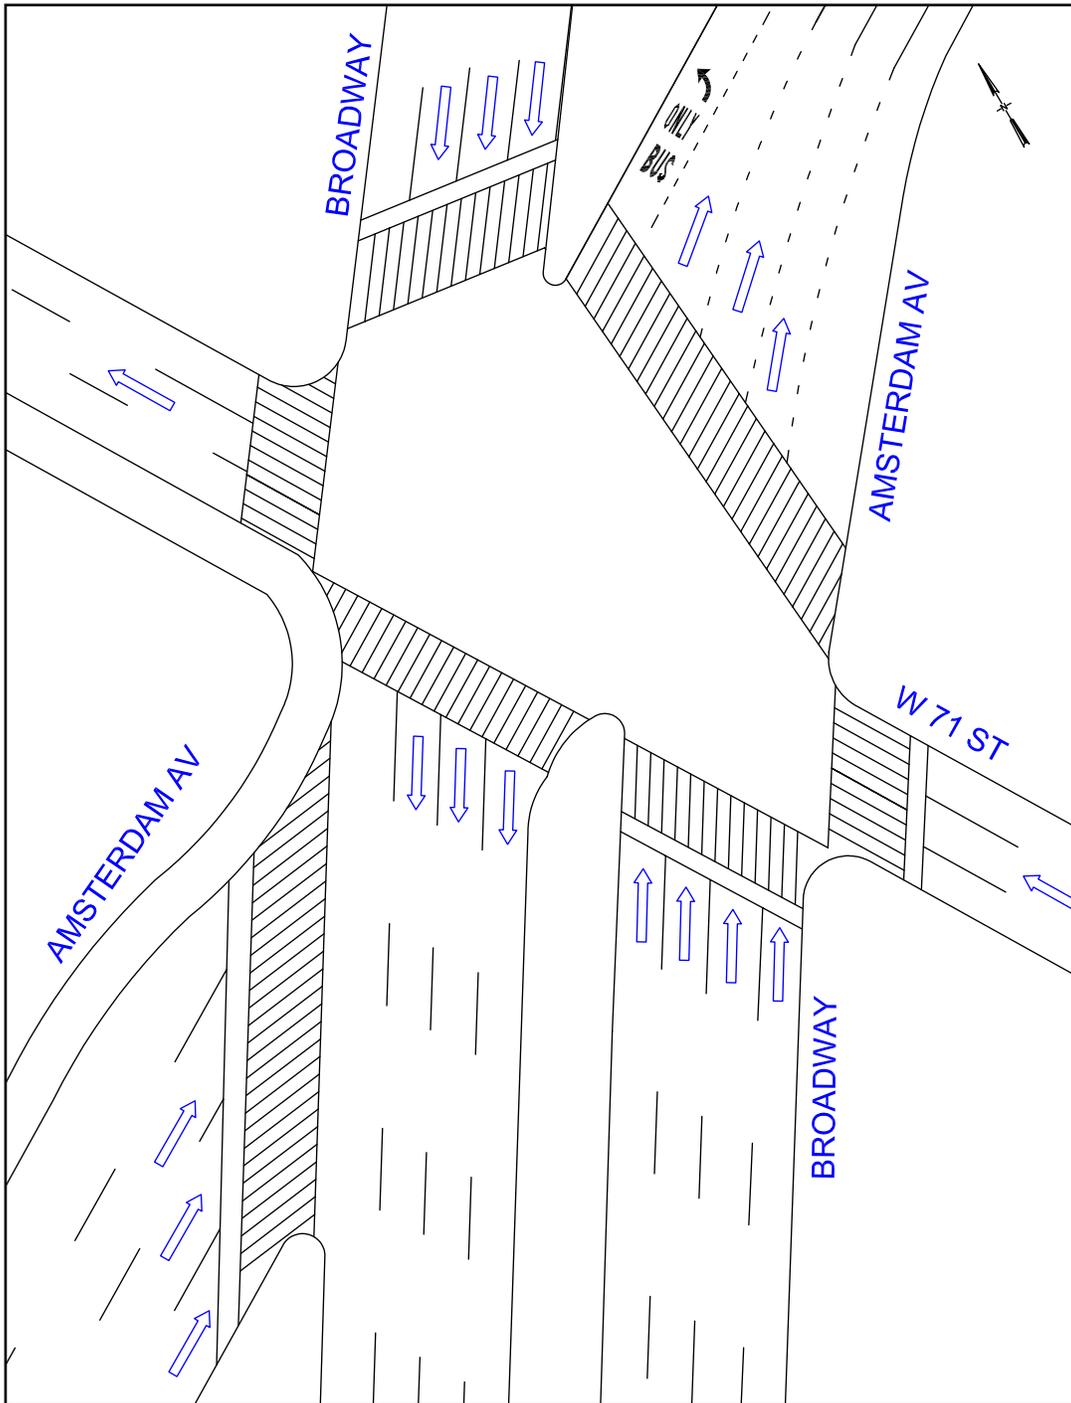
Figure 3-25a: Broadway/West 71st Street/Amsterdam Avenue (Pre-Existing Conditions)

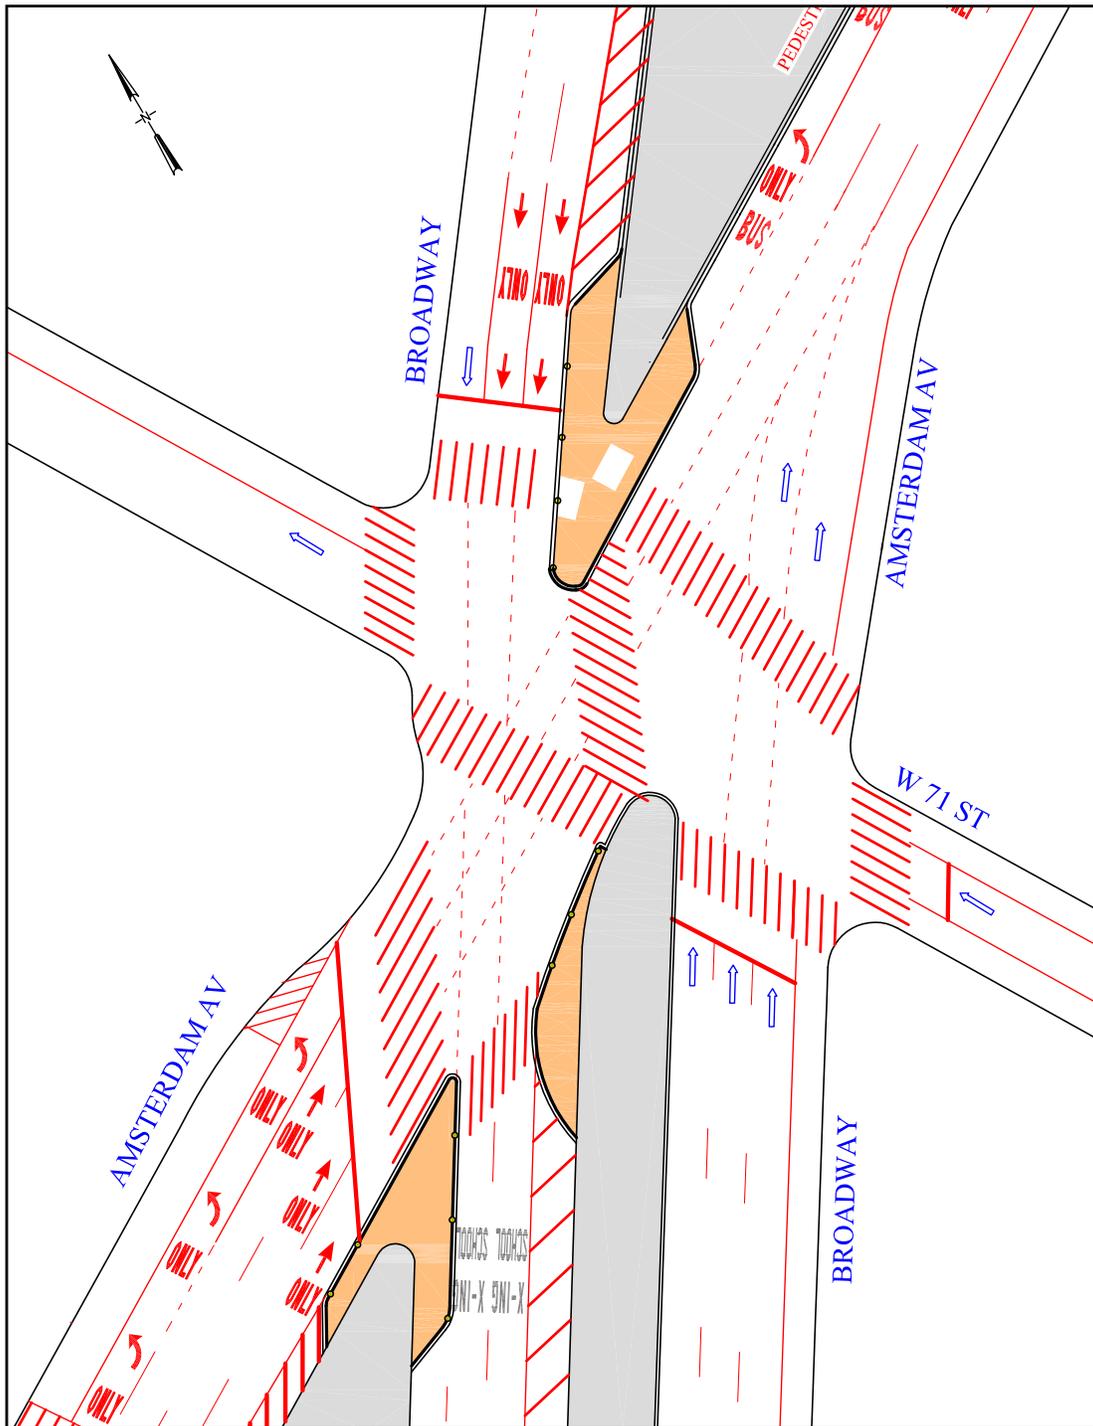
Figure 3-25b: Broadway/West 71st Street/Amsterdam Avenue (Existing Condition)
