4TH AVE AND ATLANTIC AVE

Project Details

Presented to CB2, January 19th, 2017

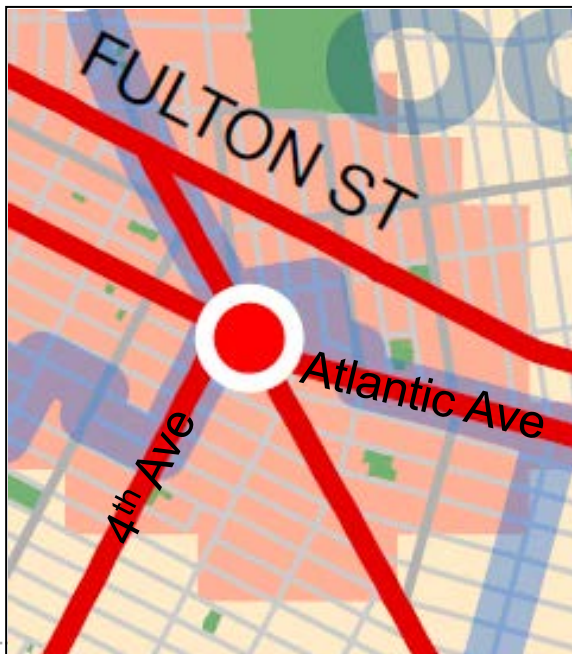
BEFORE CONDITIONS

4th Ave and Atlantic Ave

- High Crash Intersection
- Long Crossing (80')
- Subway infrastructure made concrete island difficult to install
- Vision Zero Priority Area and Corridors

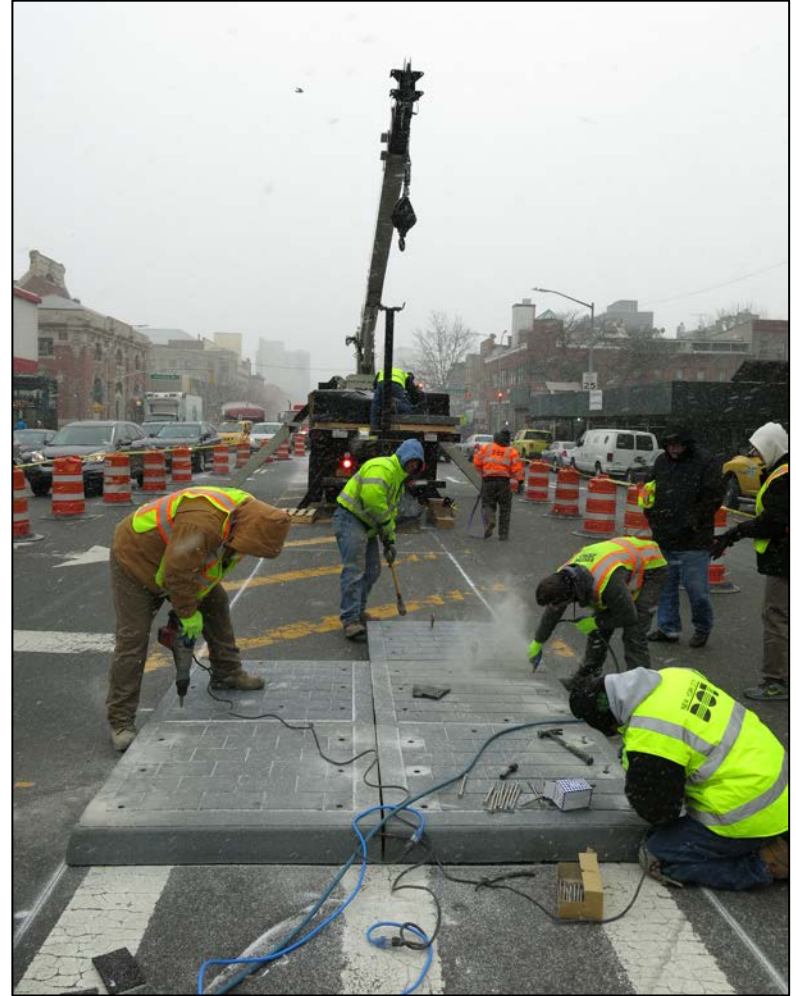
RUBBER ISLAND INSTALLATION

Installed December 15th, 2016

- 2016 Pilot treatment in NYC
- Quick 3 1/2 hour installation
- Typical Signs on island
- Island screwed directly into asphalt, no excavation
- Can be installed in any weather condition
- No operational changes

Benefits

- Safer and shorter two-part pedestrian crossing
- Rapid response at Vision Zero area and corridors
