INNOVATIONS & ACCOMPLISHMENTS

East River Bridges

A \$3.47 billion reconstruction program is underway to rehabilitate all four East River crossings. In 2007, these bridges carried some 496,666 vehicles per day. In 2002, working in coordination with the NYPD and other law enforcement agencies, the Division implemented enhanced security measures on these bridges. This work is ongoing.

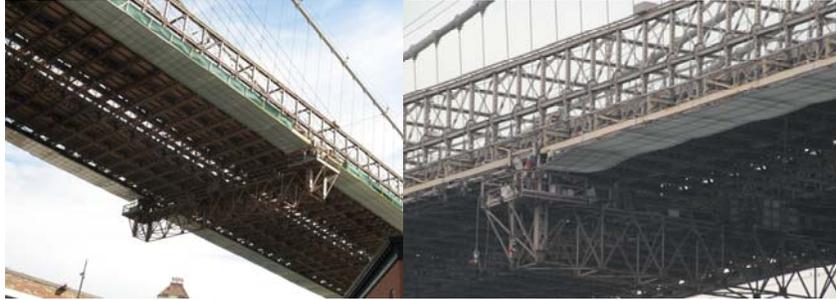
2007: Brooklyn Side Traveler. (Credit: Michele N. Vulcan)
2007: Working on a Traveler. (Peter Basich)

The \$21 million current construction contract will replace the four existing travelers with a new state-of-the-art technology system including motors, reducers, braking systems, electrical controls, programmable logic controller system, and trouble shooting devices, as well as AC motors that provide enhanced operational performance and gear boxes that increase life cycle and reliability of the new travelers. A Notice to Proceed was issued to the contractor with a start date of November 22, 2006. During 2007, the existing track beams, supports and electrical equipment (including conductor bars, transformers, conduits, wires and breaker boxes) were

removed. All four travelers were removed in November 2007. The fabrication work for the new travelers to be installed was underway at the end of 2007.

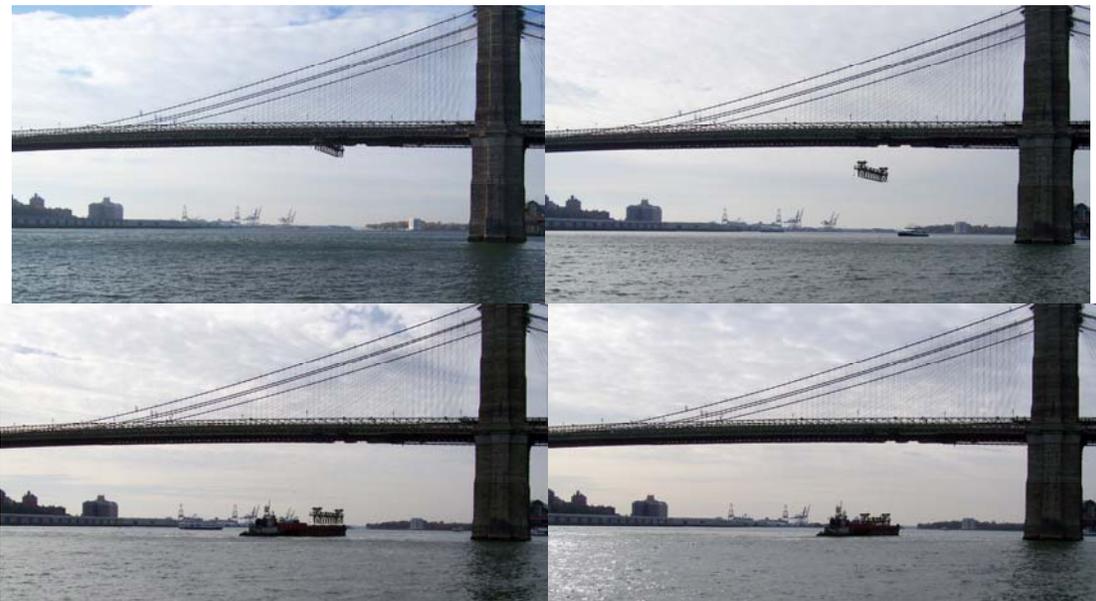
Removing the Brooklyn Bridge Main Span Travelers in 2007.

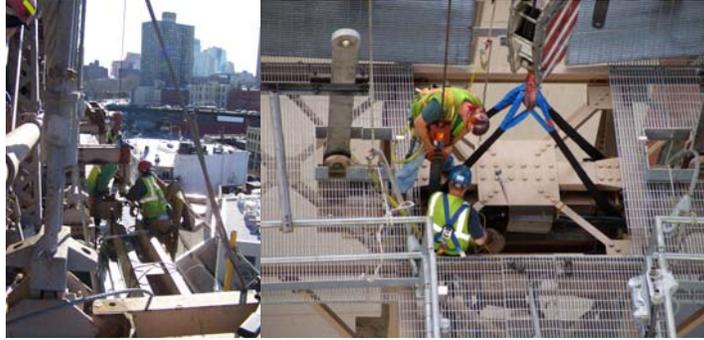
Track Beam Removal in January 2008. First Platform Lift in June 2008.

During 2008, approximately 2,500 feet of new track beams, their supports and new electrical equipment were installed. The first new traveler was installed in June 2008, and the remaining three were installed in November and December of 2008. By the end of 2008, approximately 80% of the contract work was complete.

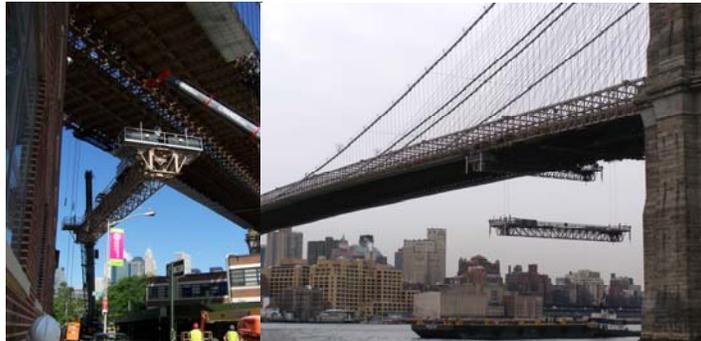
Lifting Traveler #4 in June 2008. Lifting the New Manhattan Main Span Traveler to the Underside of the Bridge on November. 20, 2008.
(Main Span Credit: Bojidar Yanev)

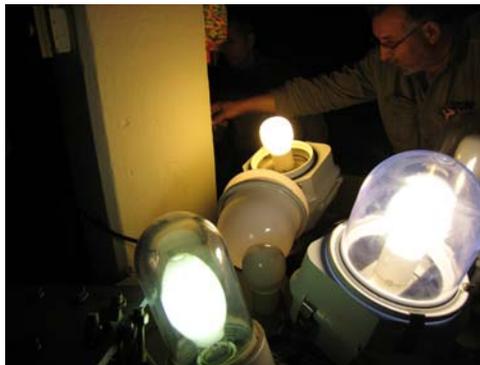
Supervisor Electrician Ben Cipriano With Both Mild and Bright Induction Light Fixtures for Testing. For Comparison Purposes, There is a Mix of Clear and Frosted Globes. (Credit: Russell Holcomb)

In the fall of 2008, to compare options for energy efficiency, we replaced 20 100-watt mercury vapor lamps of the necklace lights on the Brooklyn and Manhattan Bridges with 10 LED fixtures and 10 induction fixtures. We will test them through the spring of 2009, and will choose a technology in time to purchase fixtures before the end of fiscal year 2010.

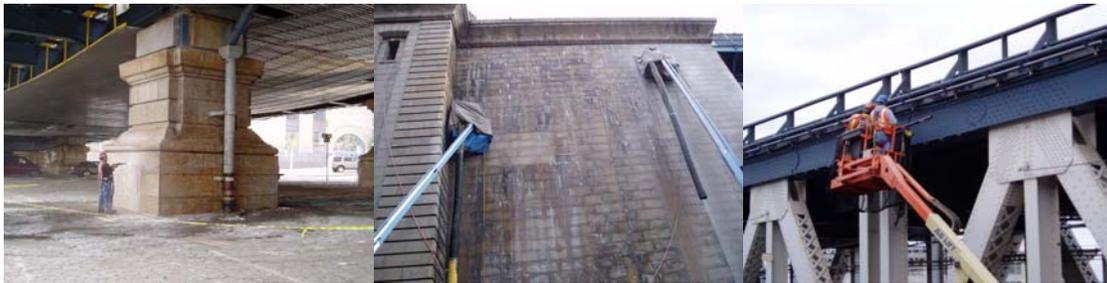
Contract #11 in 2005: Masonry Cleaning of the Brooklyn Granite Pier and of the North Face of the Brooklyn Anchorage. Installing Conduit for the New North Upper Roadway Street Lighting.

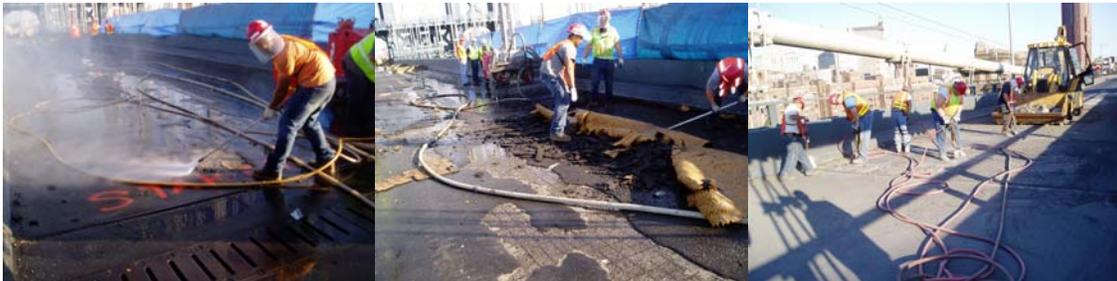
Contract #11 in 2005: Waterblasting to Remove Existing Microsurfacing From the South Upper Roadway. Manually Removing the Microsurfacing.

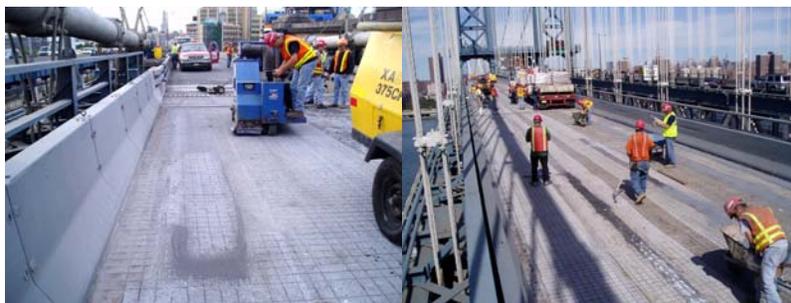
Contract #11 in 2005: Preparing the Deck for New Microsurfacing on the South Upper Roadway.

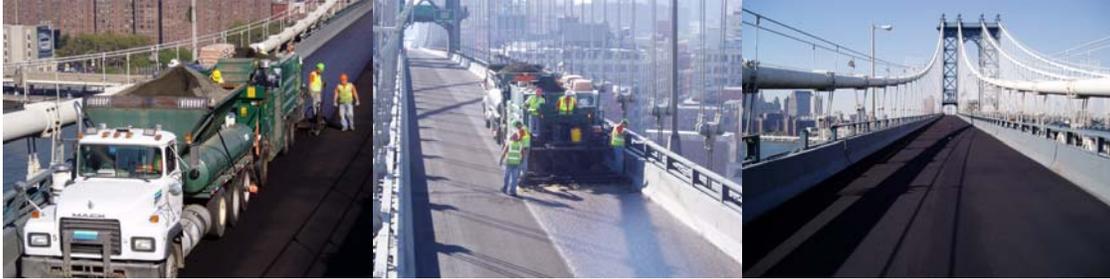
Contract #11 in 2005: Placing the New Microsurfacing on the South Upper Roadway. Newly Resurfaced Roadway.

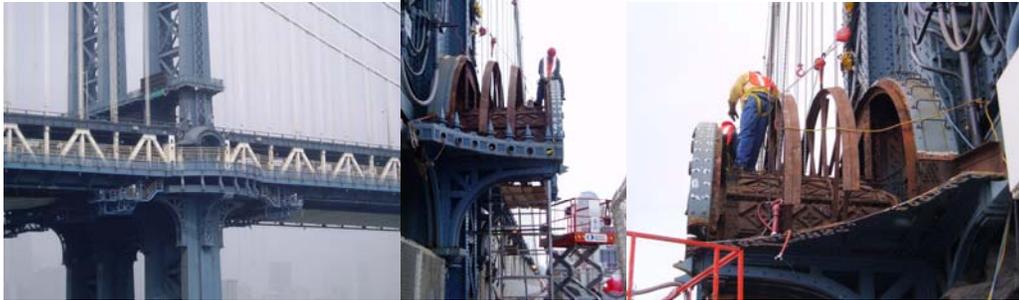
Contract #11 in 2005: The Brooklyn Tower Canopy. Removing the Canopy.

In 2005 and 2006, the rehabilitation of the interior of the anchorages proceeded with the contractor repairing and replacing concrete slabs, patching spalled concrete areas, and performing vacuum-injected epoxy crack repairs to mitigate the problem of moisture seeping into the anchorage chambers. In addition, masonry cleaning work was performed on the exterior of the anchorages, piers, and abutments, as well as on the retaining walls on the approach spans. This cleaning was followed by masonry joint pointing and repairs to the damaged granite stones of these structures. Other significant tasks underway in 2006 were the installation of new street lighting on the lower and north upper roadways, and the rehabilitation of the canopy and balcony areas at both towers.

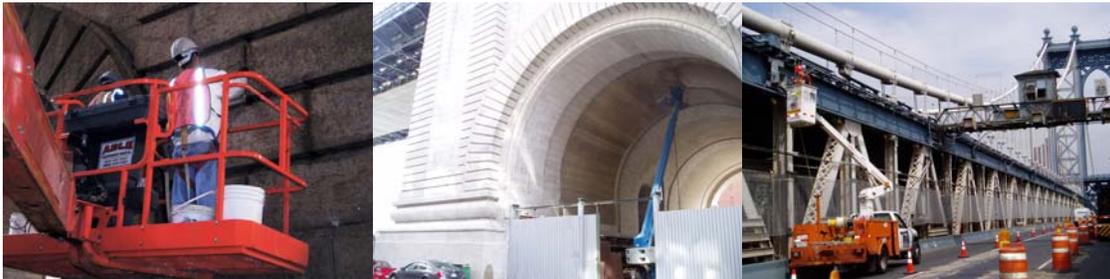
Contract #11 in 2006: Pointing Joints on East Face of Brooklyn Anchorage. Masonry Cleaning Inside Archway of Brooklyn Anchorage. Installing Conduit and Wire for New Lower Roadway Lighting.

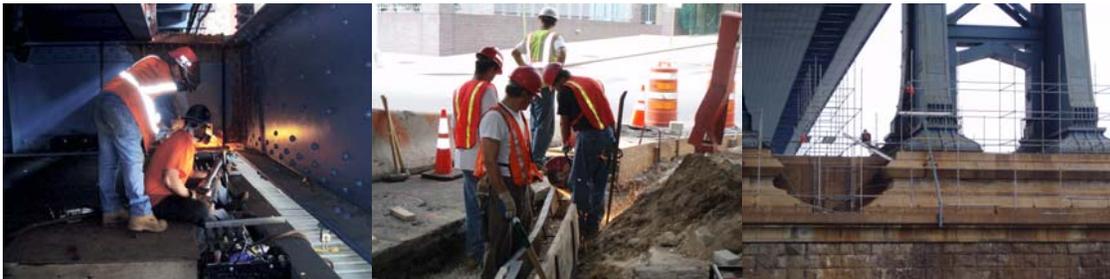
Contract #11 in 2006: Ironworkers Removing Existing Rivets in Preparation for Replacement of Lower Roadway. Installing Steel-Faced Curb for Sands Street Realignment. Erecting Scaffold to Build Painting Containment at Base of Brooklyn Tower.

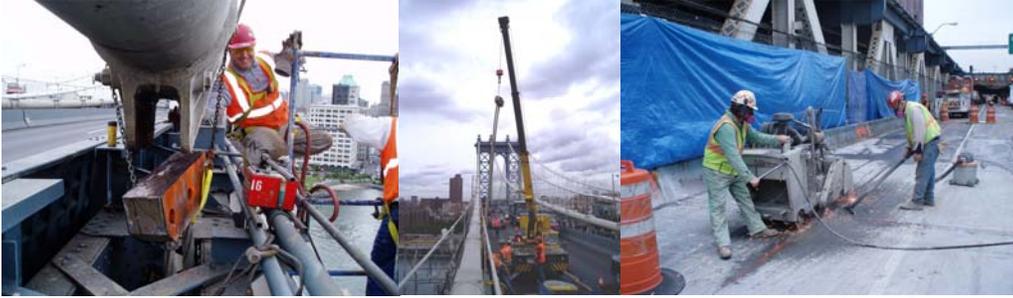
Contract #11 in 2006: Removal of Existing Suspender Rope From Cable Band on Main Span. Sawcutting Lower Roadway Deck on Manhattan Approach Span.

In preparation for the major steel removal and replacement work on the lower roadway, which began in October of 2006, the contractor fabricated steel (floorbeam, stringers, grid deck, and barrier), completed the installation of a temporary underdeck platform, and performed abrasive blasting operations to remove the paint from the existing steel connection areas. Effective October 15, 2006, the lower roadway was closed to traffic for one year. The first floorbeam was removed on October 17, 2006 at the Manhattan approach.

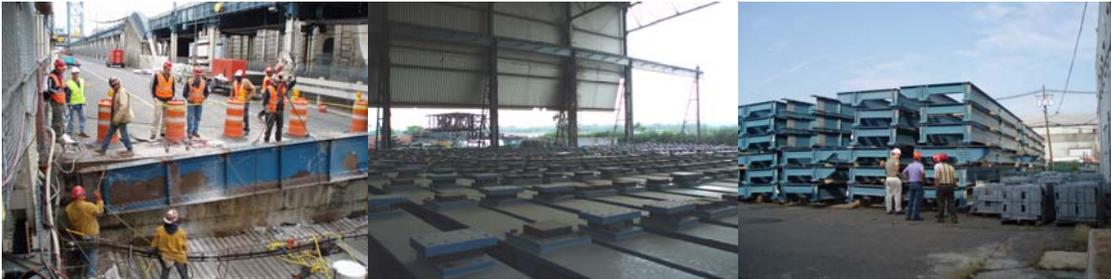
Contract #11 in 2006: Removal of First Floorbeam for Lower Roadway Reconstruction. The Fabricated Steel, Complete With Bearings, In The Contractor's Storage Yard.

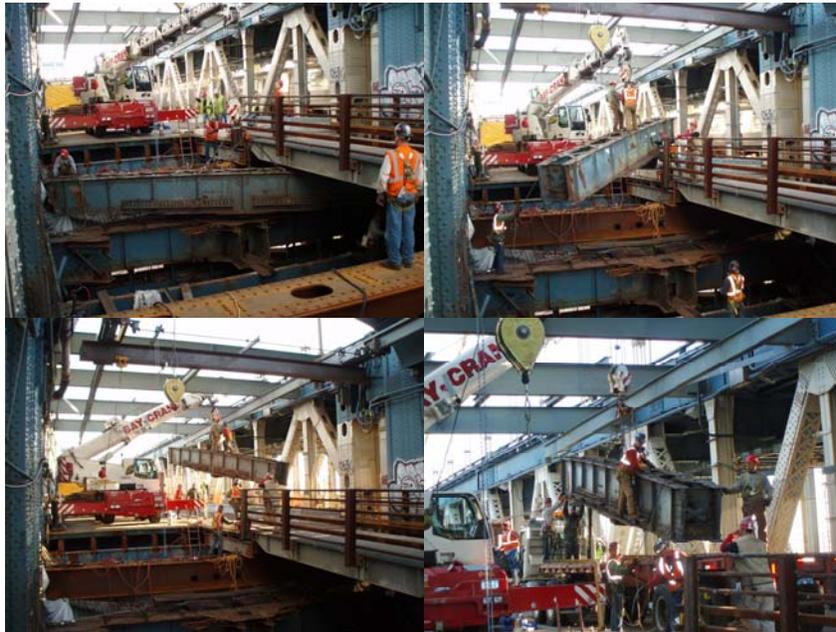
Contract #11 in 2006: Sequence of Removing Existing Floorbeam at Brooklyn Tower.

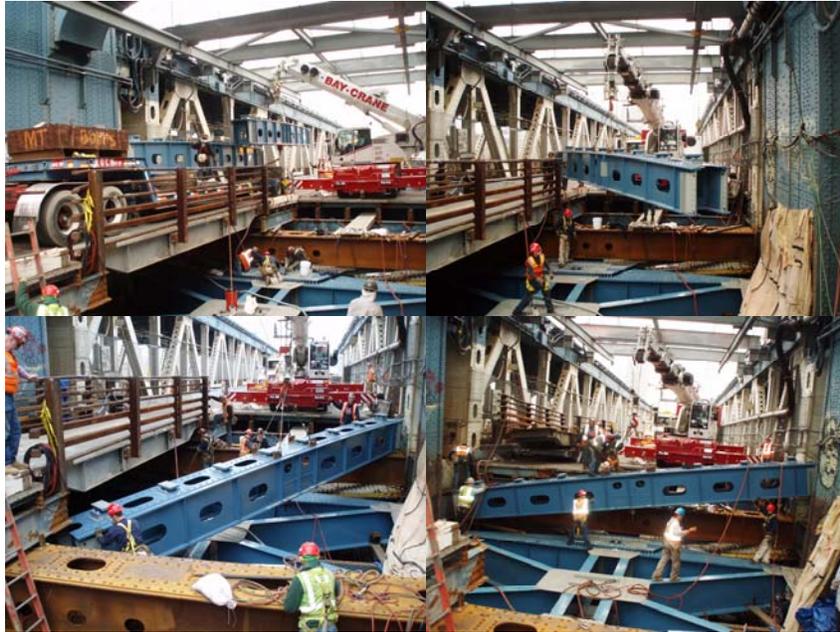
Contract #11 in 2006: Sequence of Installing New Double Floorbeam at Brooklyn Tower.

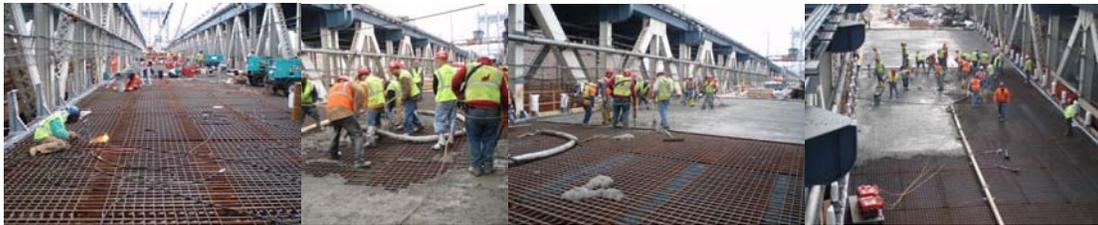
Contract #11 in 2006: Installation of Full Width Grid Deck Panels.
Lower Roadway Grid Deck Concrete Pour in December 2006.

The complete closure of the lower roadway eliminated the need for construction joints in the grid deck and concrete placements were made from deck joint to deck joint – no cold joints were required. The grid deck panels run the complete width of the roadway with no need for splicing of the main bars.

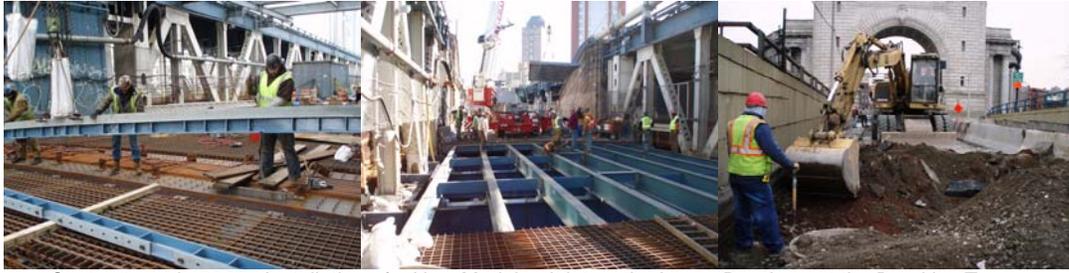
Contract #11 in 2007: Installation of a New Modular Joint on the Lower Roadway at the Brooklyn Tower. Installation of New Lower Roadway Grid Deck Panels on the Brooklyn Side Span. Removal of the Existing Roadway at the Manhattan Transition.

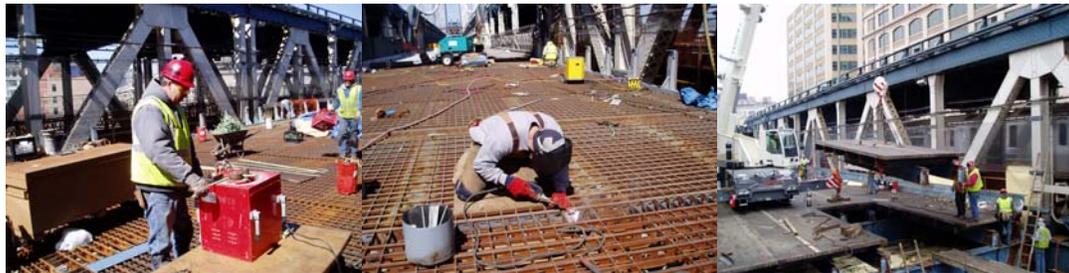
Contract #11 in 2007: Bending a Reinforcing Bar for the New Lower Roadway Grid Deck. Welding of the New Lower Roadway Grid Deck. Removal of the Existing Lower Roadway Grid Deck and Stringers on the Brooklyn Approach Span.

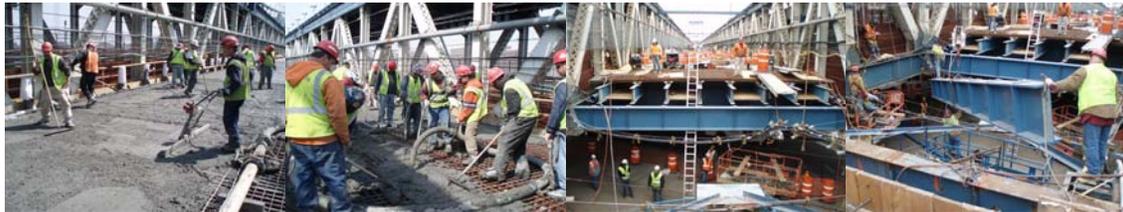
Contract #11 in 2007: Concrete Placement in the New Lower Roadway Grid Deck on the Main Span. New Lower Roadway Floorbeams, Stringers and Grid Deck on the Brooklyn Approach Span.

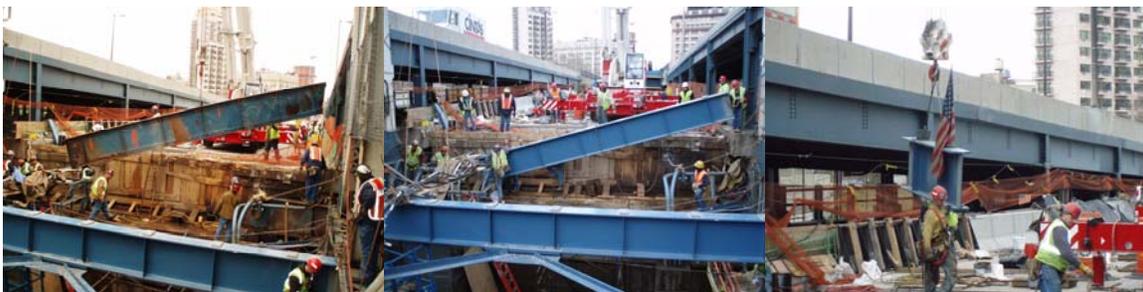
2007: Removal and Replacement of the Final Existing Manhattan Bridge Lower Roadway Floorbeam.

The final existing floorbeam of the lower roadway was removed and replaced on April 18, 2007.

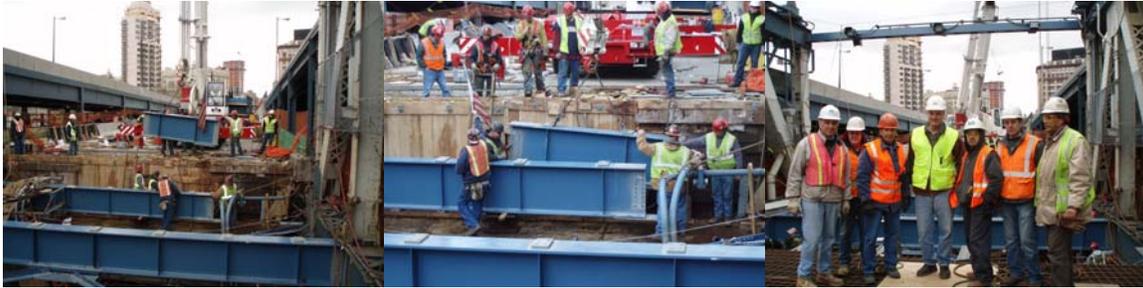
2007: Placing the Final Floorbeam Into Position. Engineer-In-Charge Brian Gill (in Center) and Inspection Staff on the Lower Roadway.

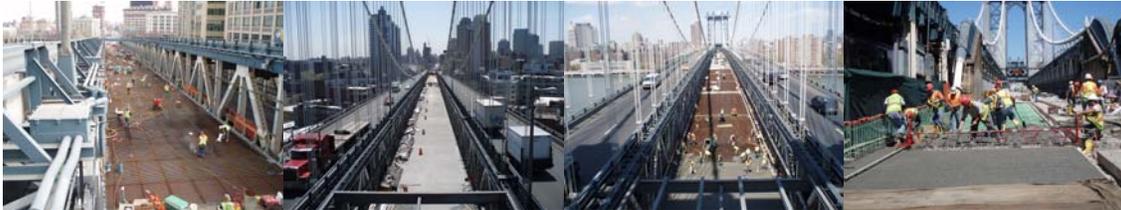
Contract #11 in 2007: The New Lower Roadway Grid Deck on the Brooklyn Approach Span. The New Lower Roadway on the Brooklyn Side Span After Concrete Placement. New Lower Roadway Concrete Placement on the Brooklyn Main Span, and at the Brooklyn Anchorage.

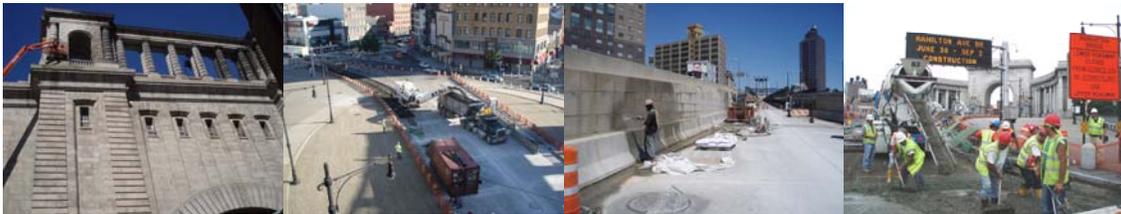
Contract #11 in 2007: Masonry Cleaning of the Upper Section of the South Face of the Manhattan Anchorage. Milling of the Existing Lower Roadway Pavement at the Manhattan Plaza. Masonry Cleaning of the Lower Roadway Wall at the Brooklyn Transition. Concrete Placement in Manhattan Plaza at the Entrance to the Lower Roadway.

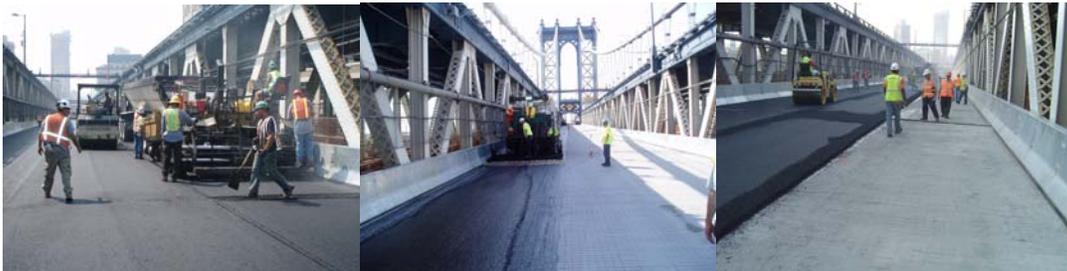
Contract #11 in 2007: Placement of New Asphalt on the Lower Roadway at the Brooklyn Approach Span. Placement of New Microsurfacing on the Lower Roadway at the Manhattan Side Span. Quality Assurance Engineers Yuliy Zak and Javed Sarwar Inspecting the Asphalt and Concrete on the Manhattan Approach of the Manhattan Bridge. (QA Credit: Masroor Mahmood)

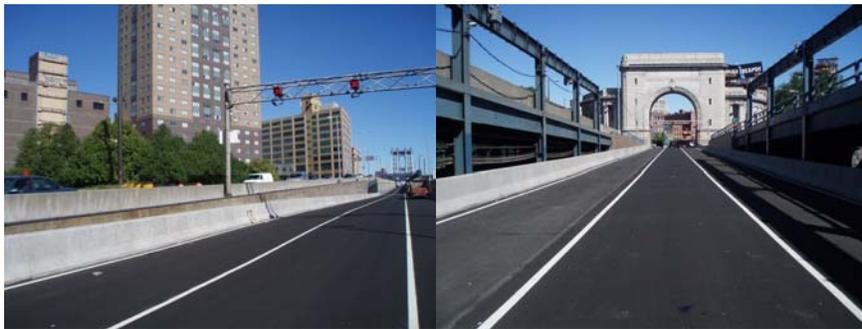
Contract #11 in 2007: The Completed Lower Roadway on the Brooklyn Side And Near the Manhattan Colonnade.

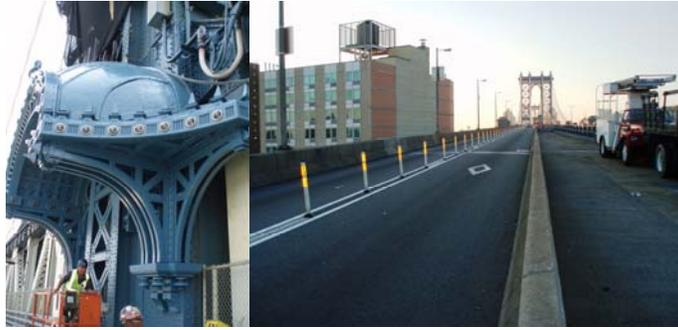
Contract #11 in 2007: View of the Restored Canopy at the Brooklyn Tower. Manhattan Bridge North Upper Roadway With HOV Lane Delineators.

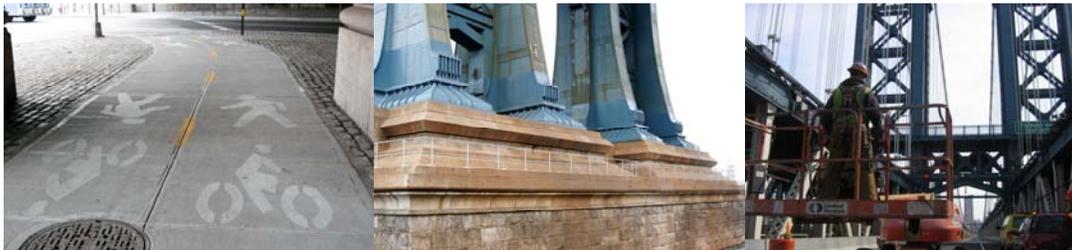
Contract #11 in 2008: Renovated Sands Street Bicycle Path in Brooklyn. New Railing at Base of Tower. Working on the Roadway. (Roadway Credit: Peter Basich)

Contract #11 work performed in 2008 included the replacement of the north upper roadway lighting, the reinstallation of the traffic radar sensors, the removal of the temporary under-deck work platforms, the rehabilitation of the main bridge travelers, the completion of the new fire standpipe system, and the completion of the rehabilitation of the Brooklyn Plaza. Manhattan Bridge Contract #11 was substantially completed on April 29, 2008.

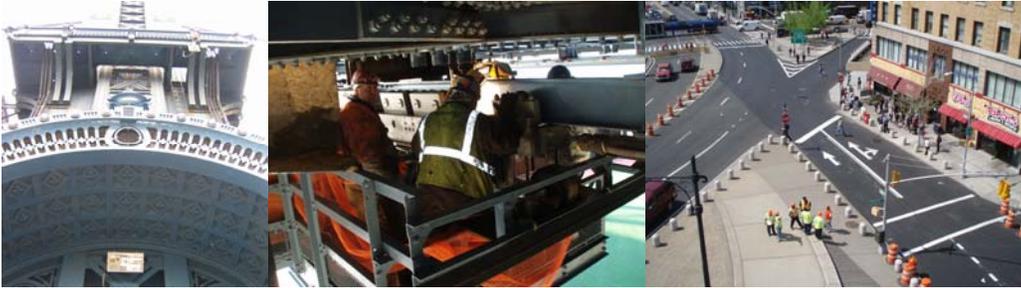
Contract #11 in 2008: Renovated Tower Canopy. (Credit: Peter Basich) Rehabilitating the Maintenance Traveler Platforms. Striping for the New Traffic Pattern in Manhattan Plaza.

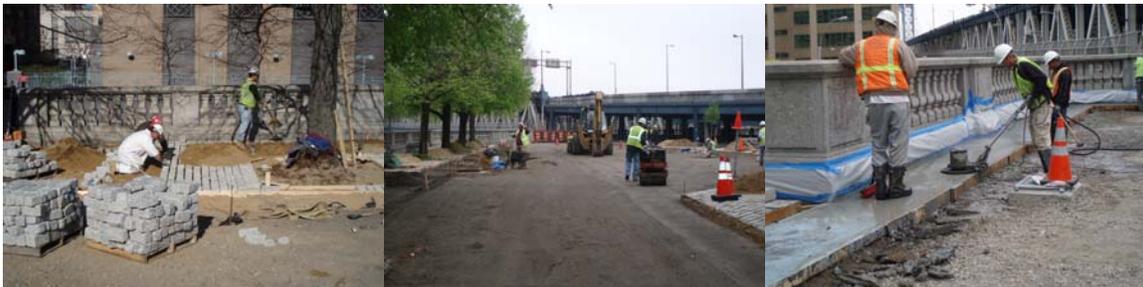
Installation of New Granite Blocks for the Plaza. Renovating the Plaza.

The Brooklyn Plaza, at the terminus of the south walkway of the Manhattan Bridge, had been used since 1985 as a staging area for contractors, when it was closed to the public. As part of Contract #11, the plaza was reconstructed following plans submitted to and approved by the Public Design Commission, which included new benches, trees, ground cover, decorative lighting, granite block, and decorative concrete. The Plaza was opened in July 2008, and marks ADA compliance of the south walkway on the Manhattan Bridge connecting the DUMBO neighborhood in Brooklyn with Chinatown in Manhattan.

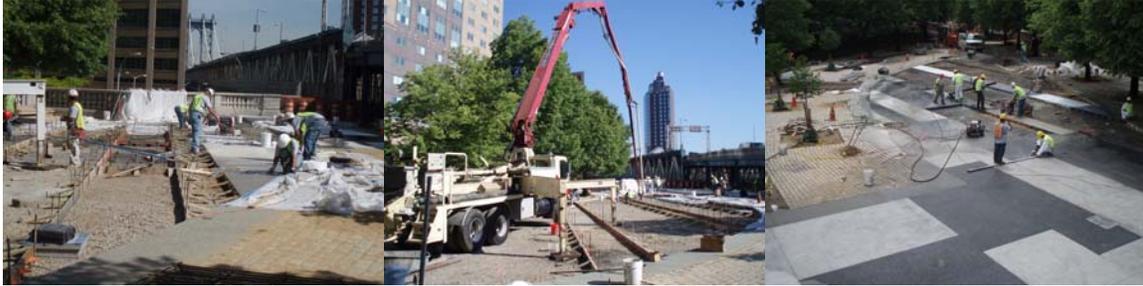
Installation of New Concrete at the Plaza.

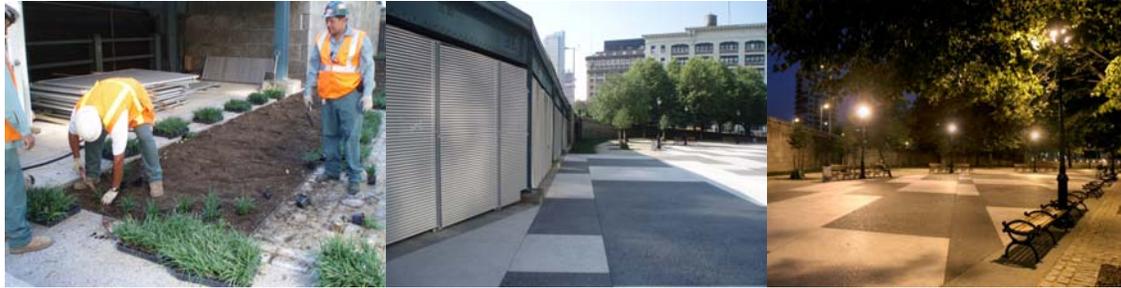
Installing New Plants. Completed Renovations. Evening View of the Plaza Looking Southeast With Benches, Lights, and Granite Pavers in Foreground.

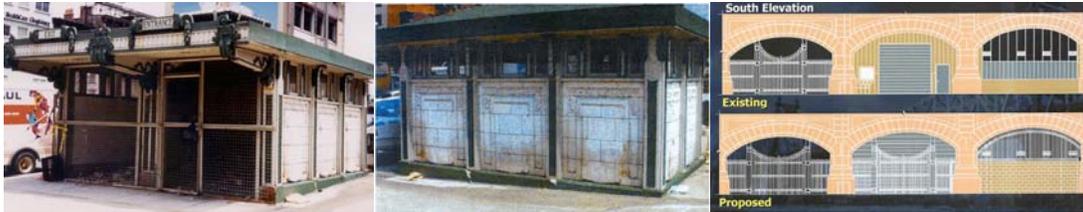
Views of the Queensboro Plaza Kiosk in 2003. Proposed Rehabilitation of the Arch Infill for the Sanitation Department.

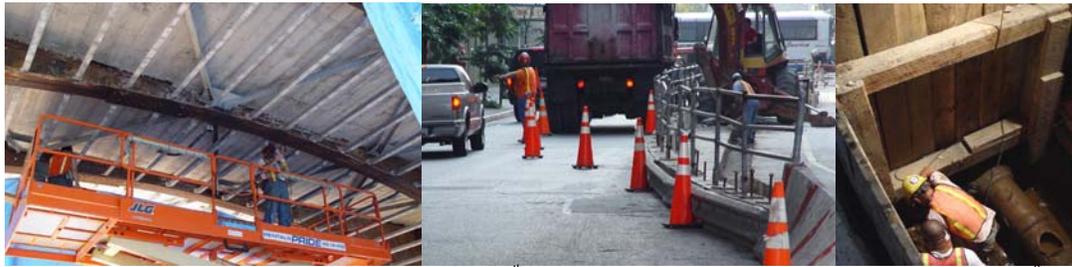
Contract #6 in 2004: Repairing the Steel of the 59th Street Arch Ceiling. Starting Curb Replacement at 60th Street. Improving the Drains at the Vehicle Storage Area.

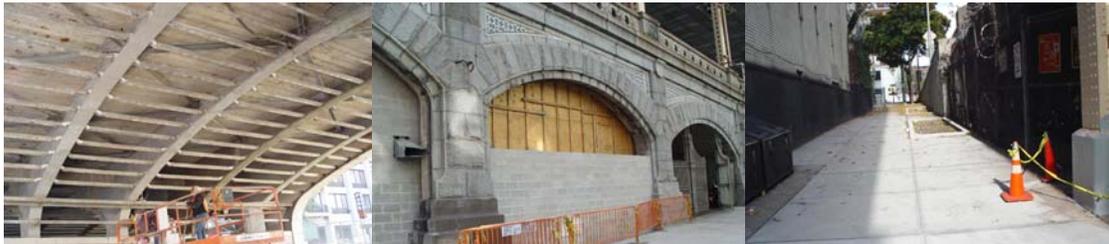
Contract #6 in 2004: Repairing Spalled Concrete at the 59th Street Overpass. Sanitation Arch Infill Work Progressing at 60th Street. Repaired Sidewalk Between 61st & 62nd Streets.

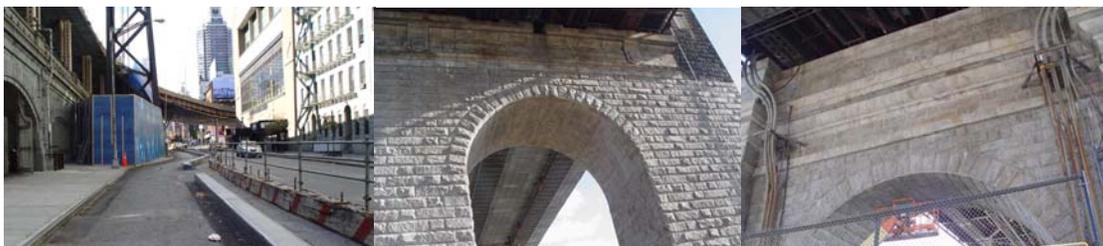
Contract #6 in 2004: Repaired Curb at 60th Street. Anchor Pier Granite Cleaning in Progress.

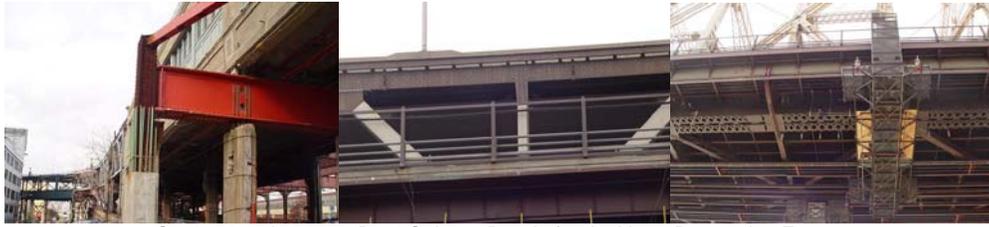
Contract #6 in 2005: Bent Column Ready for Jacking. Decorative Fence. Repairing the Drainage Pipes.

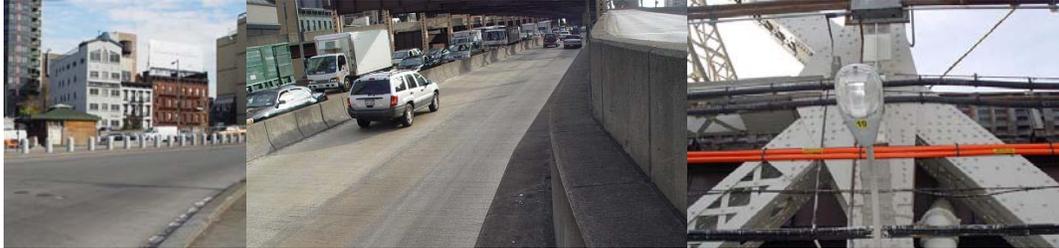
Contract #6 in 2005: Manhattan Plaza Bollards. Full Width Deck Repair on South Inner Roadway. New Luminaire on North Upper Roadway.

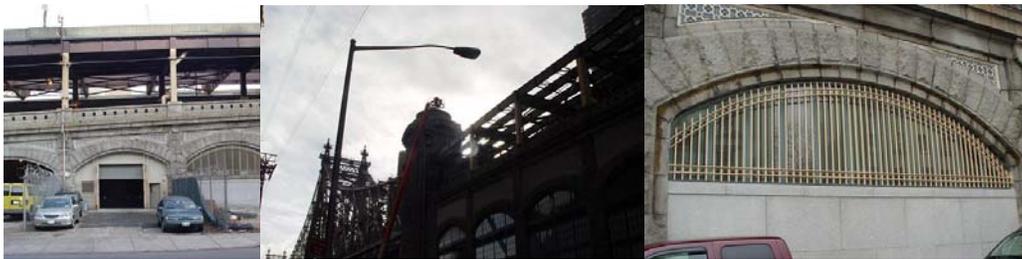
Contract #6 in 2005: Rehabilitated Sanitation Department Arch Infill.

In 2004, work was completed at the retaining wall at York Avenue. In 2005, work was completed on the kiosk bollards on the Manhattan plaza, the sidewalk between 61st and 62nd Streets, the rehabilitation of the Sanitation Department area arch infill, and the modifications to the maintenance facility beneath the Manhattan approach plaza.

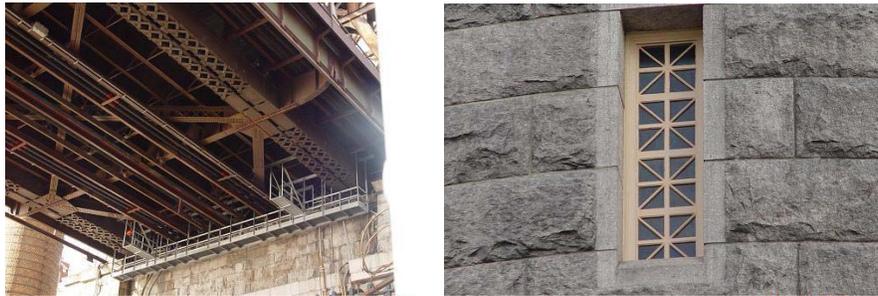
Contract #6 in 2005: Traveler Platform. New Window.

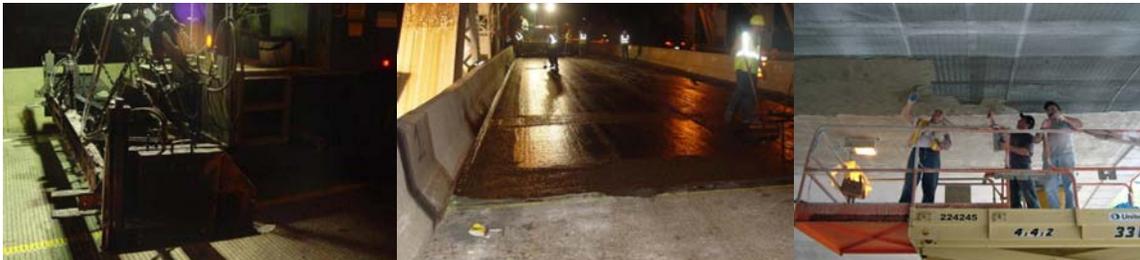
Contract #6 in 2006: Microsurfacing the North Upper Roadway. Repairing the 59th Street Overpass.

In 2006, work was completed on the protective screening, the aviation warning lights, the drainage improvements, the repair of the south upper roadway concrete overfill and overlay, the underside of the 59th Street overpass, and the condition inspection of the eyebar heads and pins.

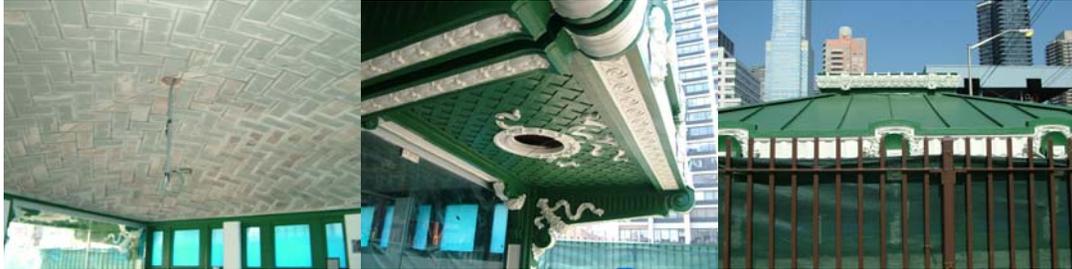
Contract #6 in 2006: Restored Queensboro Kiosk Ceiling and Other Elements.

The kiosk in the plaza on the Manhattan side of the bridge was originally built in 1908 and is constructed primarily of terracotta panels set between ornate cast iron columns, with copper roofs and cast iron fascias. The interior walls and Guastavino timbrel arch ceiling are covered with glazed tile. The open front (now glassed in) originally served as the entrance and exit to the old subway station. There is no floor in the kiosk, as it served only to shelter the stairways leading to the station below. The restoration of the kiosk was completed in September 2006.

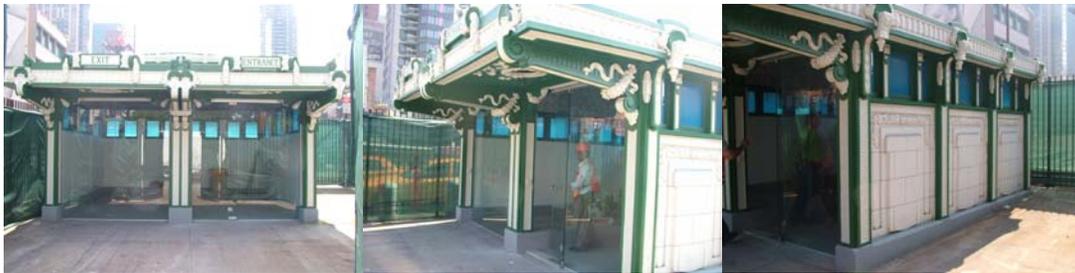
Contract #6 in 2006: Restored Queensboro Bridge Kiosk.

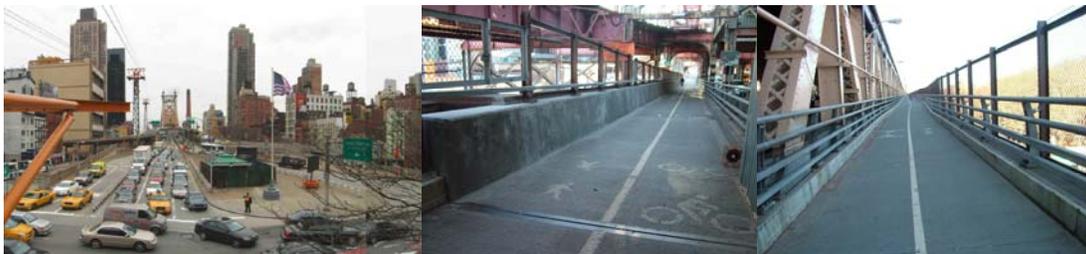
Contract #6 in 2007: Rendering of Bridge Flag Site. Protective Screening at the Queens Approach. Protective Screening and Roadway Lighting Upgrade on the North Outer Roadway. (Screening Credit: Adam Caplan)

In 2007, work was completed on the geometric improvements at Crescent Street and Queens Plaza South, the installation of concrete barriers and protective screening at the Queens approach on the north outer roadway, and the repair of the north and south upper roadway overlay. The upgrading of the roadway lighting was substantially completed by the end of 2007.

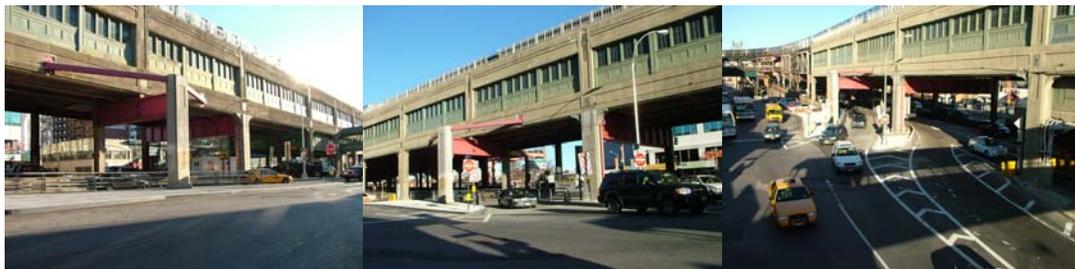
Contract #6 in 2007: Rendering Geometric Improvements at Crescent Street (Credit: Adam Caplan)

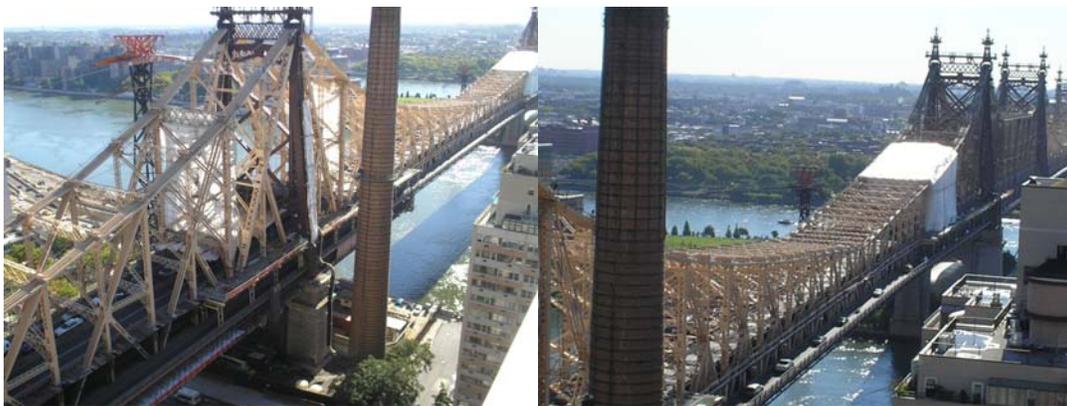
Bridge Painting in Progress: July 2007.

The \$168 million Queensboro Bridge painting contract commenced in January 2004. The Department and its contractor strictly adhere to the safety requirements regarding lead paint removal as approved by the United States Environmental Protection Agency and the Occupational Safety and Health Administration, New York City Departments of Health and Environmental Protection, and the New York State Departments of Health and Environmental Conservation.

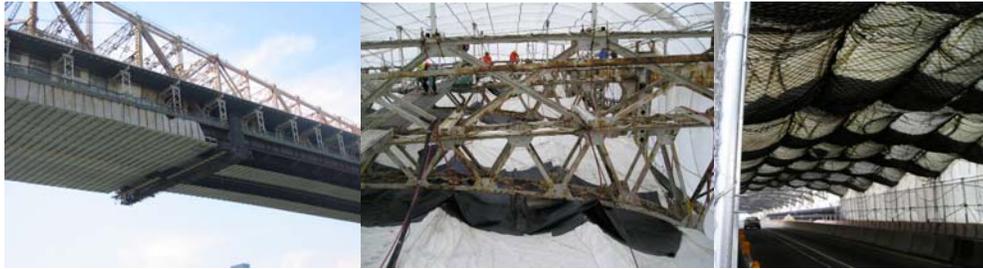
Platform Installed for Painting of the Queensboro Bridge. (Credit: Vadim Sokolovsky)
Working Inside the Containment. Protected Roadway.

The work is performed within an entirely sealed Class 1A containment system (under negative pressure) which acts as an added safety measure to prevent any materials from escaping into the air. Filtration of the enclosed air prevents paint waste dust from being released. The Department has placed several air monitoring stations in the area around the bridge. The Department performs continuous monitoring and testing of the soil and air quality as well as noise levels in the area surrounding the containment enclosure to minimize impacts and ensure the safety and quality of life for workers and residents nearby.

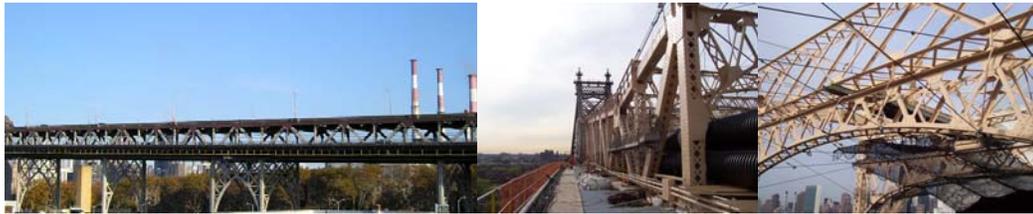
View of Roadway Platform. Painted Area.

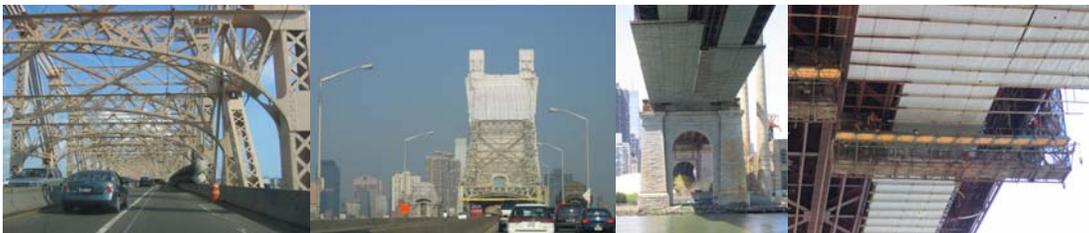
Protective Coating in 2005: Newly Painted Section Along the Upper Roadway. Containment on the Queens Side Tower. (Credit: Peter Basich) Queensboro Bridge Work Platform. Painters Arriving at the Platform. (Credit: Michele N. Vulcan)

By the end of 2005, the contractor completed cleaning and painting the Manhattan and Queens anchor piers; the Manhattan approach; ramp A; the off ramp and ramp B over the Silver Cup Studio parking lot; the off ramp over Queens Plaza South towards 13th Street; approaches B and C from 23rd Street to Thompson Avenue (except over the railroad tracks); the Queens approach underside of the lower roadways (from 21st Street to Vernon Boulevard); the main bridge underside of the lower and upper roadways from PP123 to PP68; and the main bridge above the upper roadway from PP77 to PP109.

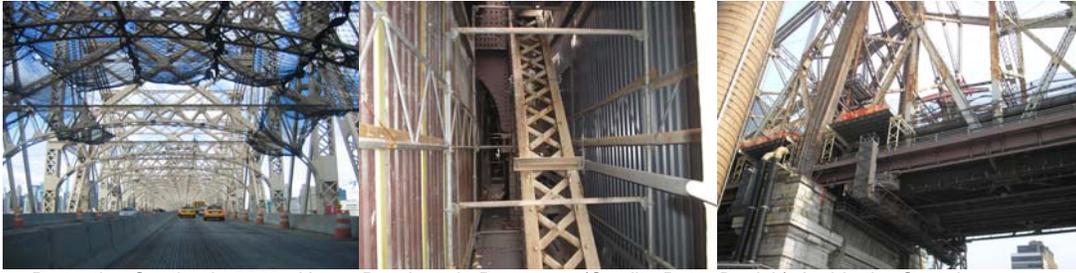
Protective Coating in 2006: Upper Roadway in Progress. (Credit: Peter Basich) Inside the Containment on the North Side of the Inner Roadway. Installed Platform Above South Outer Roadway.

By the end of 2006, the contractor completed cleaning and painting the Queens approach at the inner roadways from PP0 to PP39; at the main span's inner and under upper roadways above Roosevelt Island and one half of span #2 from PP75 to PP37; the main span trusses above the upper roadway from the Manhattan anchor pier to the Roosevelt Island west tower has been completed from PP0-PP15, PP30-PP47, and PP109-PP123; and the ramps on the Queens side over the LIRR tracks. Installation of cables and platform, on the main span under the lower roadway from PP17 to PP37, was also underway.

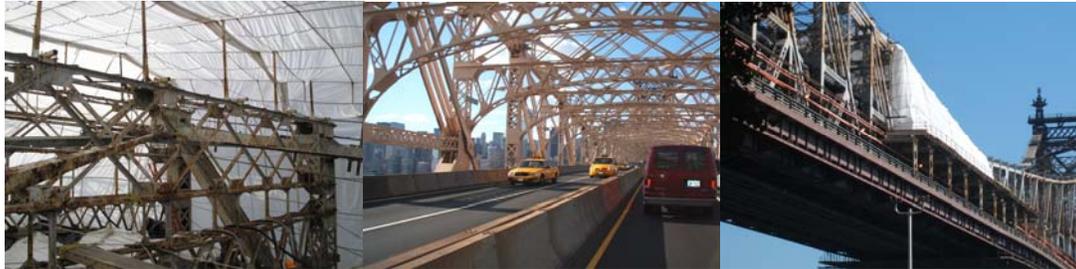
Protective Coating in 2006: Inside the Containment Rigging at Span #1. Finish Coat on the Trusses at Span #5 on the Upper Roadway. Class 1A Containment Installed on the Trusses at Span #2, And the Working Platform Above the South Outer Roadway.

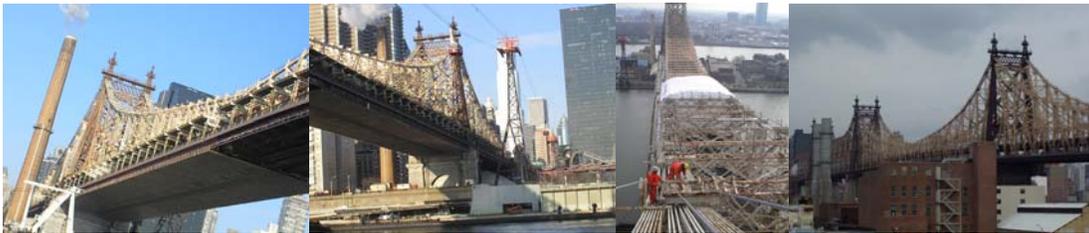
Protective Coating in 2007: First Part of the Year.

By the end of 2007, the contractor completed cleaning and painting the Queens approach at the inner roadways from PP90 to PP39; at the main span's inner and upper roadways from PP1 to PP37; and the main span trusses above the upper roadway from PP30-PP15 and PP47-PP55. The installation of containment rigging along the upper roadway on Span 3 was also underway.

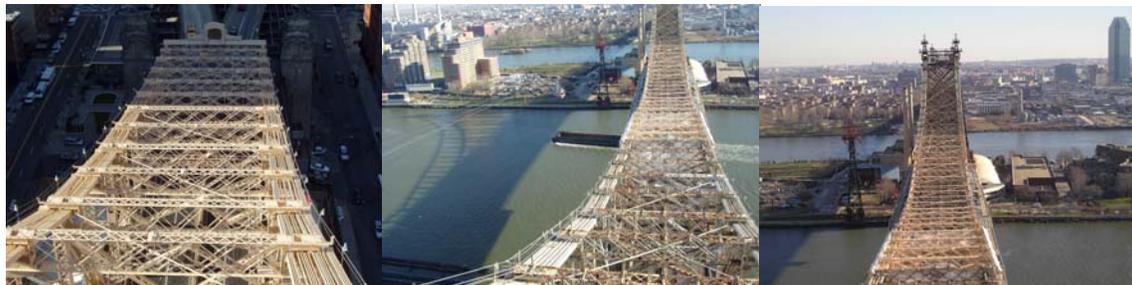
Protective Coating in 2007: Spans 1 and 2 Upper Level.

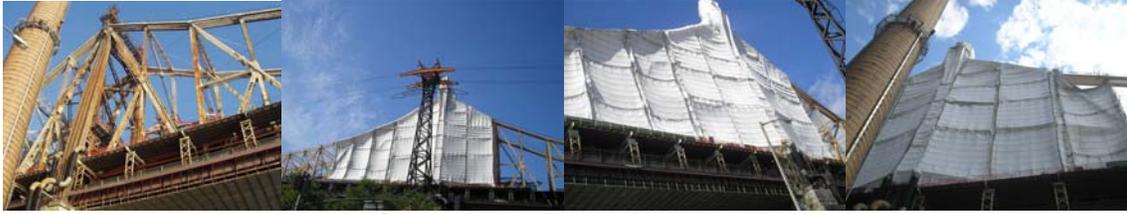
Protective Coating in 2007: First and Middle Part of the Year.

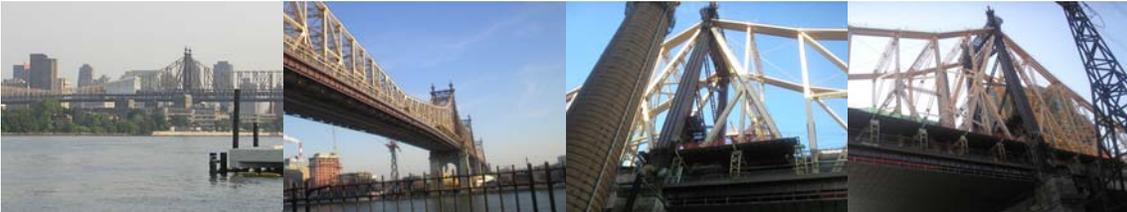
Protective Coating in 2007: Middle and Last Part of the Year.

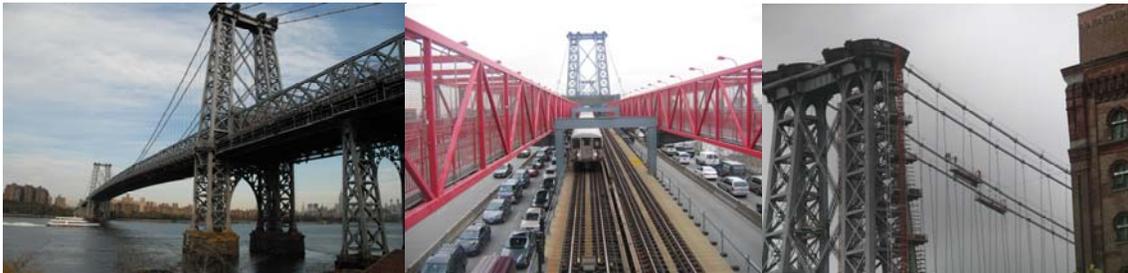
Williamsburg Bridge. Bridge Subway Structure. (Credit: Peter Basich).
Contract #8 in 2004: Looking South at a Cable Band Retensioning Crew.

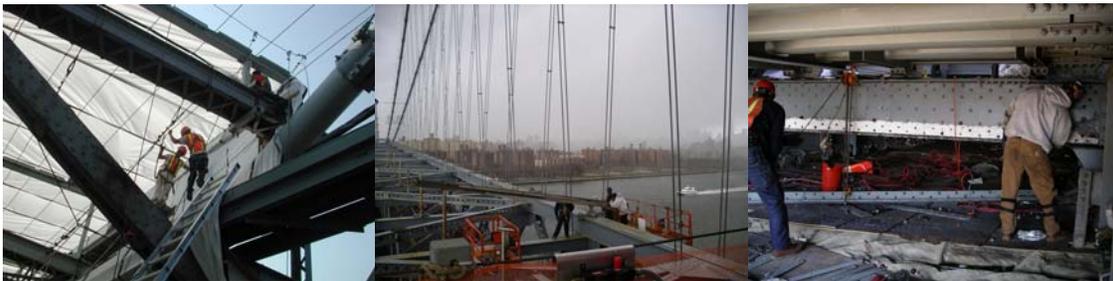
Contract #8 in 2003: North Stiffening Truss Containment Erection and Removal. South Truss Bottom Chord Rehabilitation.

Painting of the south side stiffening trusses, which began on June 1, 2003, was completed on September 6, 2003. Painting of the north side stiffening trusses, which began on September 6, 2003, was completed on November 25, 2003. Steel replacement on both main towers began in 2003 and was completed by the end of 2004. Steel replacement on both the intermediate towers and the upper and lower chords of the stiffening trusses began in 2003 and was completed in 2005.

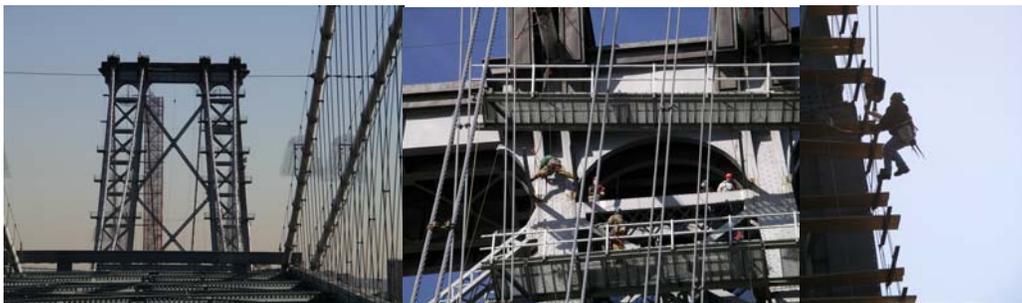
Contract #8 in 2004: Looking East at the Brooklyn Main Tower Temporary Work Platforms. Manhattan Main Tower Temporary Platform Erection. Strengthening Plate Operation on Brooklyn Main Tower.

Installation of the strengthening plates on the four river-side column legs of each of the main towers was completed in 2004. This operation began with the hoisting of the plates from the roadway to the highest level of each tower and was completed during weekends on which the transit tracks were removed from service. This work included over 800,000 pounds of steel attached through over 30,000 individual bolt holes drilled into the existing steel.

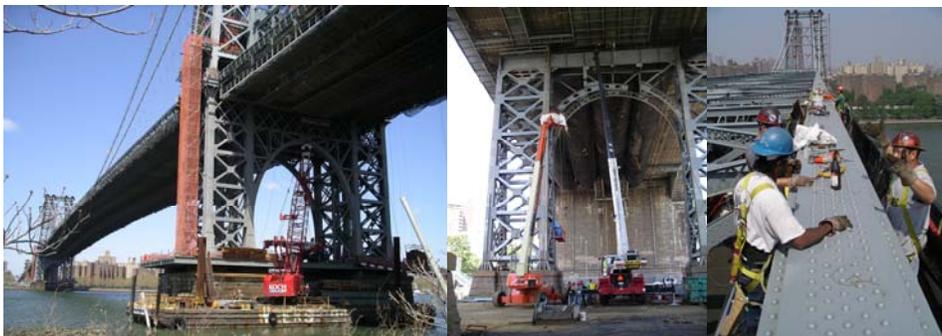
Contract #8 in 2004: Pier Stationed & Barge Mounted Cranes at Brooklyn Main Tower Pier. Steel Arch Replacement. Looking West at the North Truss Top Chord Steel Rehabilitation.

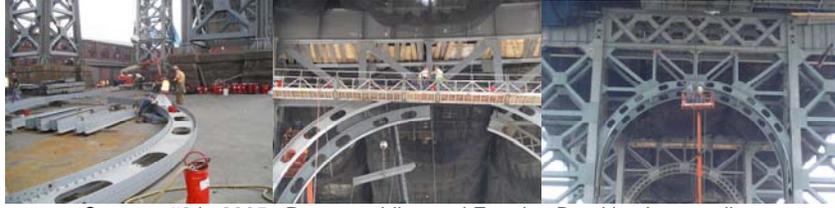
Contract #8 in 2005: Preassembling and Erecting Brooklyn Intermediate Tower Arch Steel.
