INNOVATIONS & ACCOMPLISHMENTS

East River Bridges

A \$3.47 billion reconstruction program is underway to rehabilitate all four East River crossings. In 2007, these bridges carried some 496,666 vehicles per day. In 2002, working in coordination with the NYPD and other law enforcement agencies, the Division implemented enhanced security measures on these bridges. This work is ongoing.

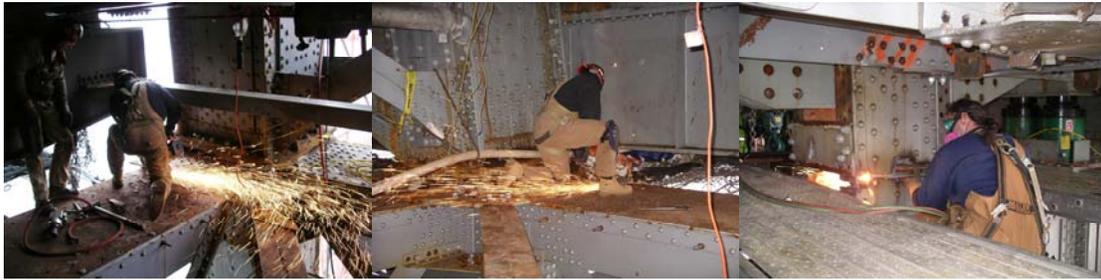
Contract #8 in 2005: Rehabilitation of the Brooklyn Main Tower Steel. Torch Cutting on the Tower.

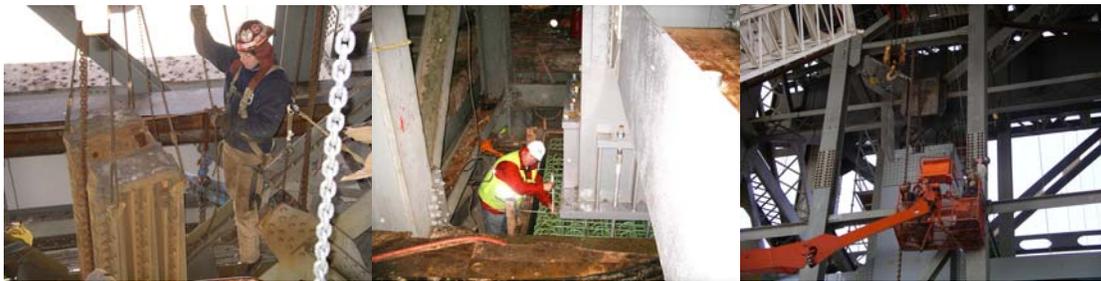
Contract #8 in 2005: Removing the Existing Steel of the Brooklyn Main Tower. Inspecting a Rebar Cage at the Manhattan Main Tower. Installing a Column at the Brooklyn Main Tower.

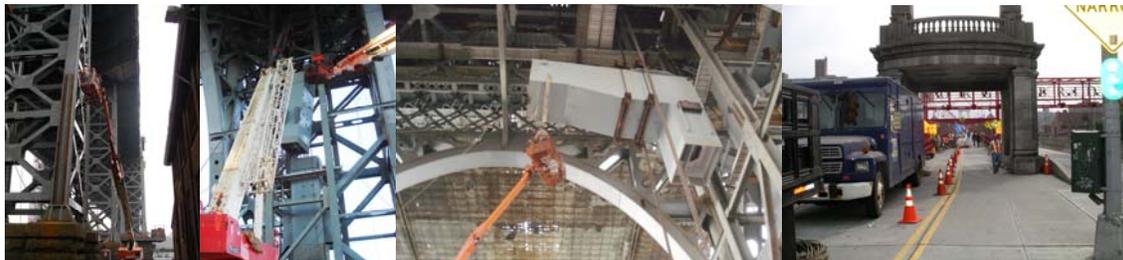
Contract #8 in 2005: Torque Testing Bolts at the Brooklyn Intermediate Tower. Erecting a Leg of the Brooklyn Main Tower. Erecting Brooklyn Main Tower Leg Bearing Support Steel. Replacing the Manhattan Approach Footwalk Expansion Joint Covers.

During the fall of 2005 the work of replacing the footwalk expansion joint cover plates began and the 24 joints on the Manhattan approach and south foot walk were completed. The work on the seven joints on the north foot walk was completed in early 2006.

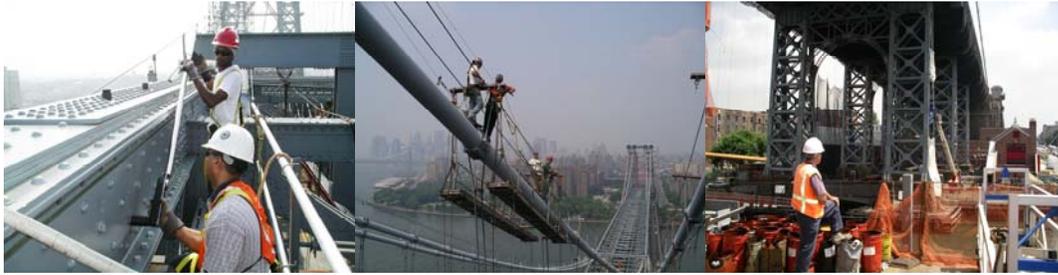
Contract #8 in 2004: High Strength Bolt Torque Inspection. Cable Band Bolt Retensioning. Steel Bracing Replacement Operation at the Brooklyn Intermediate Towers.

Twenty-eight wire rope cable suspenders and 56 tension rods were replaced during 2004 on the suspended main span. All of the suspenders were systematically adjusted in 2005 to optimize

the profile of the bridge. In addition, the truss bearings at the anchorages were replaced in 2005.

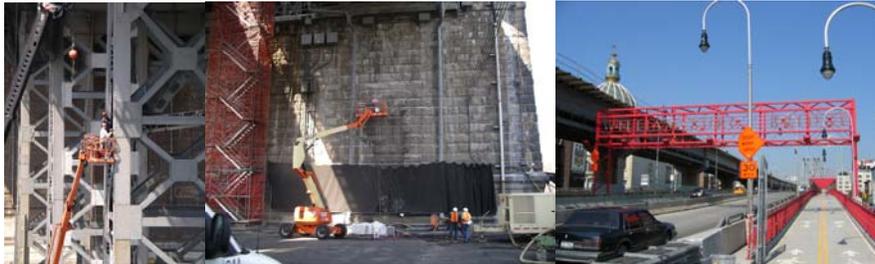
Contract #8 in 2004: Ironworkers Bolting up New Steel on Intermediate Tower. Cleaning the Brooklyn Anchorage Exterior Granite Surface. Entrance to North Walkway. (Walkway Credit: Peter Basich)

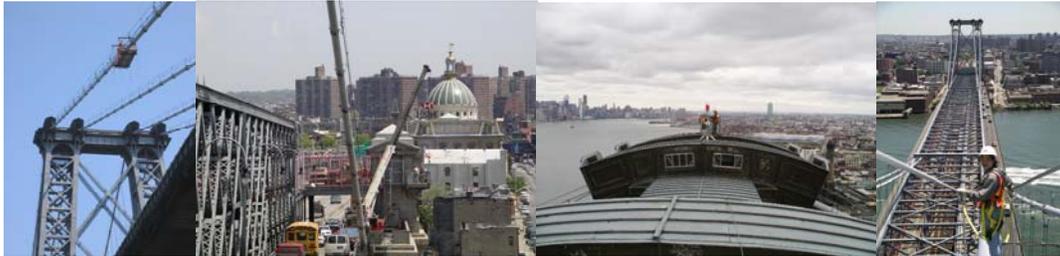
Contract #8 in 2005: Cable Band Bolt Retensioning. (Credit: Bojidar Yanev) Demolition of the Brooklyn South Comfort Station Balcony. Installing Brooklyn Main Tower Aviation Lights. FHWA Engineering Intern River Hwang Inspecting the Cable Wrapping.

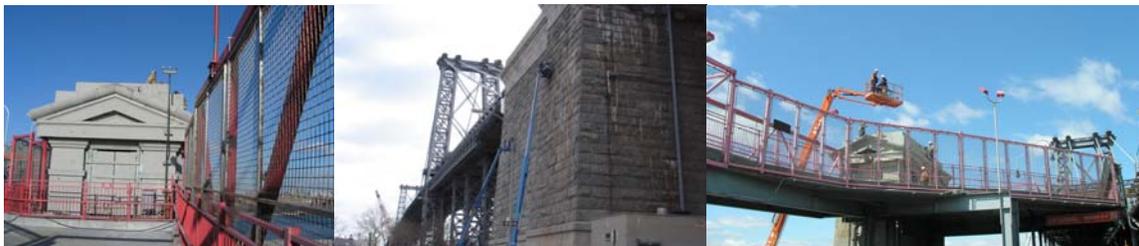
Contract #8 in 2006: North Comfort Station. Manhattan Anchorage Joint Cleaning and Painting. Pointing of Comfort Station Roof.

Rehabilitation of the north comfort stations began on February 21, 2006. The south outer roadway of the bridge was closed on June 1, 2006 for the removal and replacement of the asphalt overlay. Work was completed on the Manhattan side on June 6, 2006, and on the Brooklyn side on June 14, 2006. Installation of the balconies on both main towers began on June 22, 2006. The first traveler platform for the bridge was brought to the contractor's facility in Carteret, New Jersey on December 05, 2006.

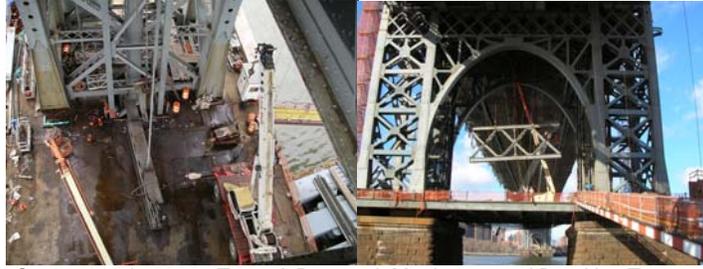
Contract #8 in 2006: Truss A Removal, Manhattan and Brooklyn Towers.

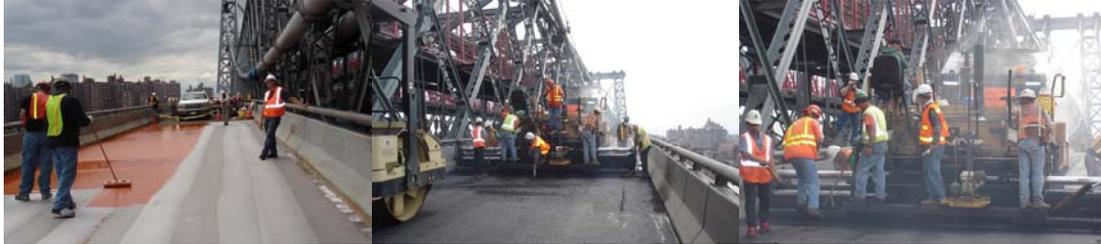
Contract #8 in 2006: Priming Application and Asphalt Paving Operation on the South Outer Roadway.

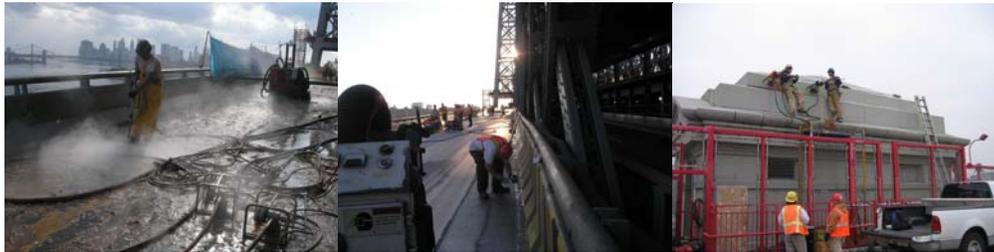
Contract #8 in 2006: Water Blasting. Curb Angle Cleanup and Tack Coat. Core Drilling The Brooklyn North Comfort Station.

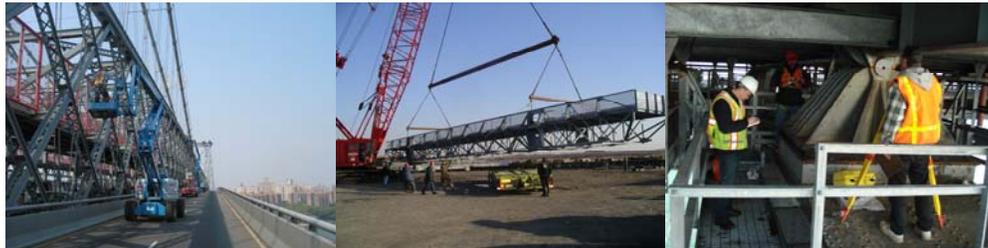
Contract #8 in 2006: Touchup Painting on the North Truss. First Traveler Platform. Bearing Survey.

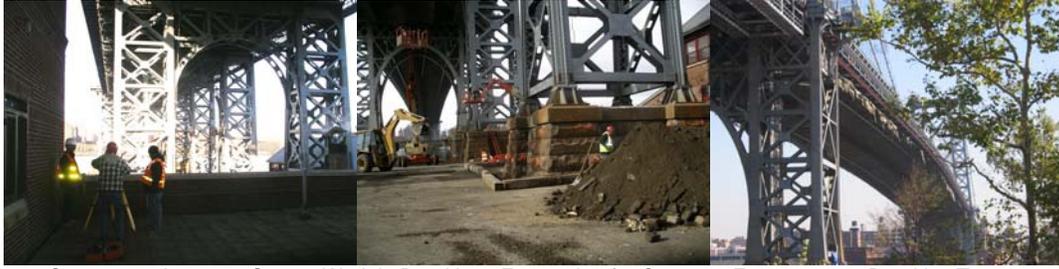
Contract #8 in 2007: Survey Work in Brooklyn. Excavation for Concrete Encasement. Brooklyn Tower.

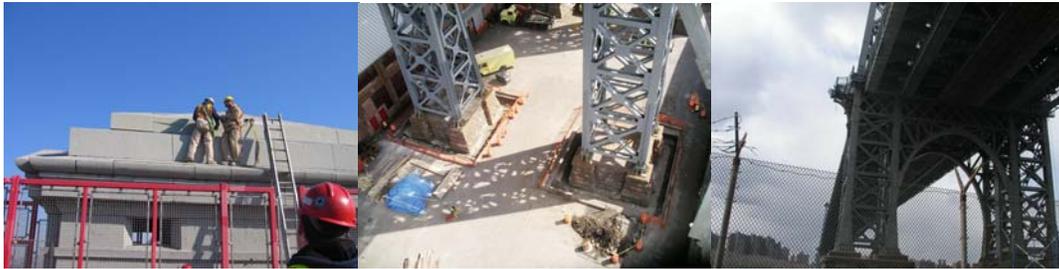
Contract #8 in 2007: Checking the Progress of the Brooklyn North Comfort Station. Seismic Retrofit Concrete Work in Brooklyn. Brooklyn Tower Balcony (South).

The seismic retrofitting of the steel portions of the intermediate towers was completed on July 20, 2007. The Brooklyn and Manhattan maintenance travelers were delivered on barges and raised into position in August and October 2007. The maintenance travelers are currently undergoing pre-operational testing and inspection and are expected to be completed in spring 2009. Installation of the top chord transverse bearings at the main towers was completed in October 2007. Installation of the Brooklyn anchorage maintenance platforms, the Manhattan anchorage hoist and new staircases for both anchorages were also completed in 2007.

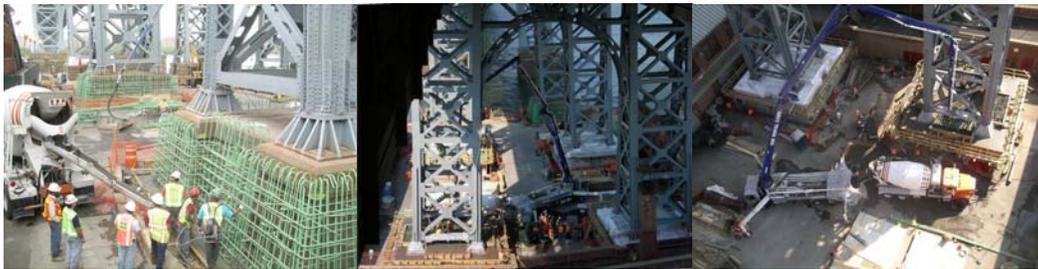
Contract #8 in 2007: Seismic Retrofit Concrete Work at the Intermediate Piers in the Kent Avenue Yard.

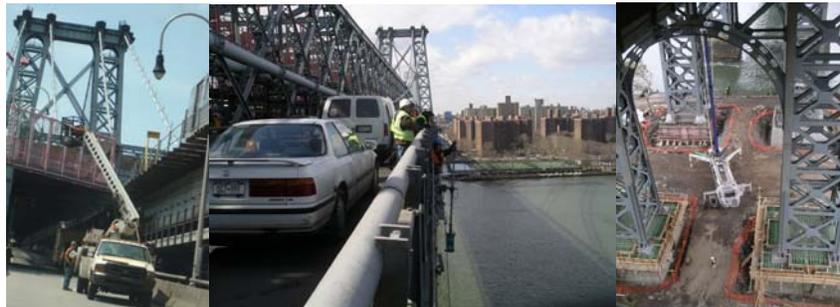
Contract #8 in 2007: Modifying the South Footwalk Drainage. Repairing the Navigation Lights. Seismic Retrofit Concrete Work in Manhattan.

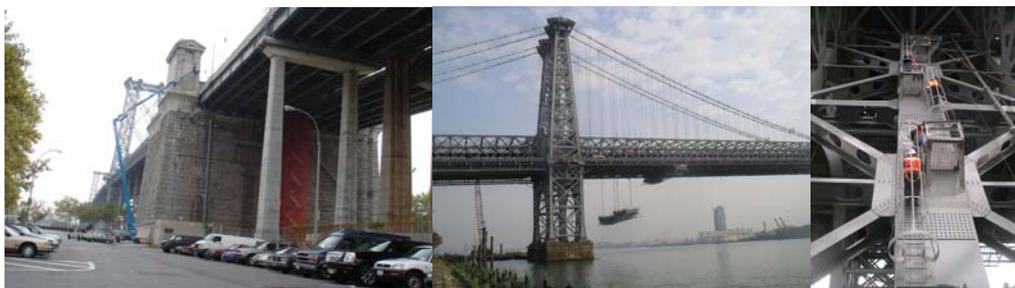
Contract #8 in 2007: Brooklyn South Comfort Station Rehabilitation. Raising the Manhattan Side Traveler at the Manhattan Tower. Manhattan Tower North.

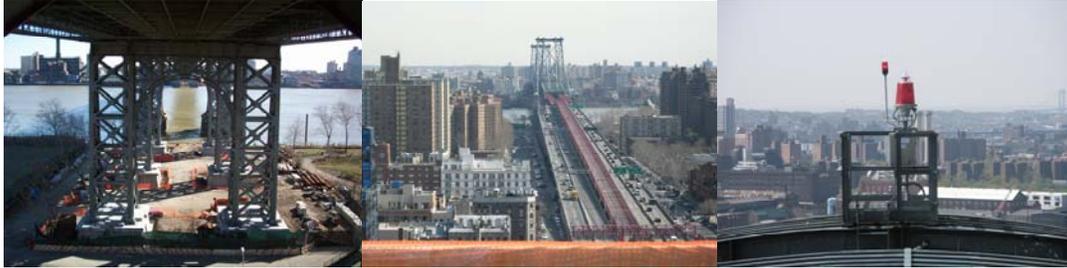
Contract #8 in 2008: East River Park Piers. Manhattan Approach. Aviation Light on the Manhattan Main Tower.

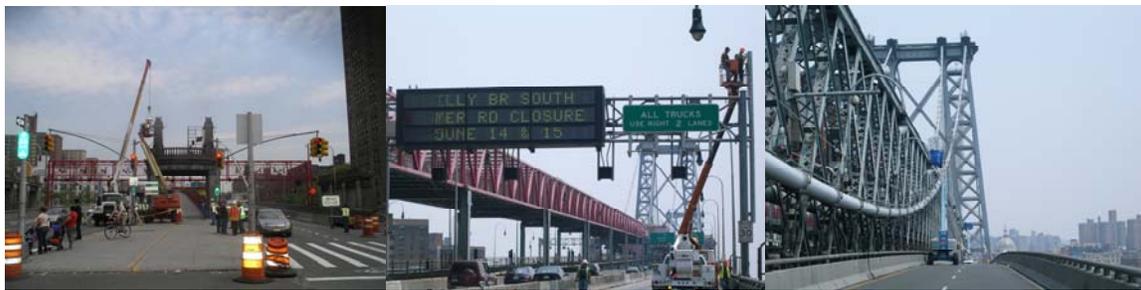
Contract #8 in 2008: Installation of Luminaires at the Manhattan Plaza Bridge Entrance. Installing a Video Camera at the Manhattan Approach of the South Outer Roadway. Painting the South Upper Truss on the South Outer Roadway.

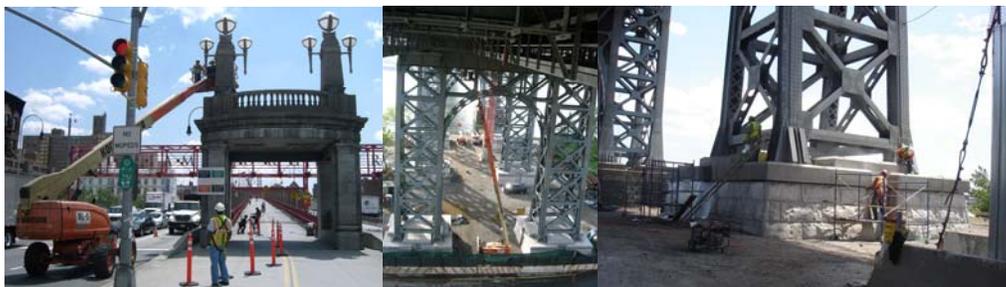
Contract #8 in 2008: Continuing the Installation of Luminaires at the Manhattan Plaza Bridge Entrance. New Bearing Replacement Preparatory Work. New Granite Cladding at Pier 15W.

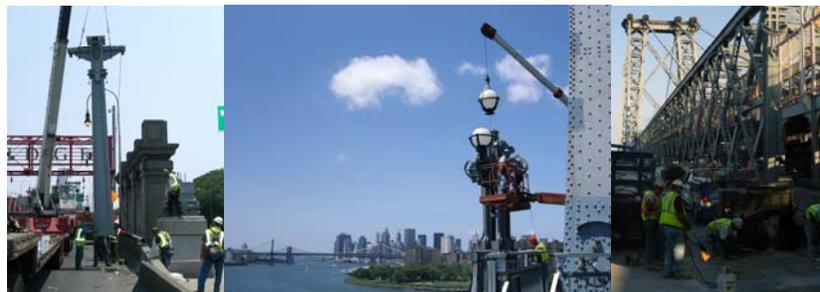
Contract #8 in 2008: Erection of the Manhattan Entry Electrolier. Installation of Electrolier Luminaires at the Brooklyn South Main Tower. South Outer Roadway Overlay Repairs.

Work completed in 2008 includes the installation of the Brooklyn anchorage hoist, the bridge identification system, the barrier transfer machine, the removal of the main bridge flexible shield system, the top chord transverse truss bearings, the erection of the new Manhattan entry electroliers and rehabilitated main tower electroliers, and the seismic retrofit of the intermediate tower bases.

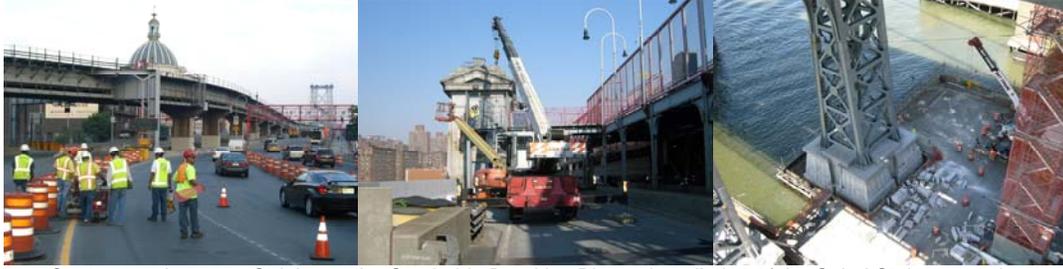
Contract #8 in 2008: Striping at the Southside Brooklyn Plaza. Installation of the Spiral Staircase at the Manhattan South Comfort Station. New Granite Cladding at Pier 20E.

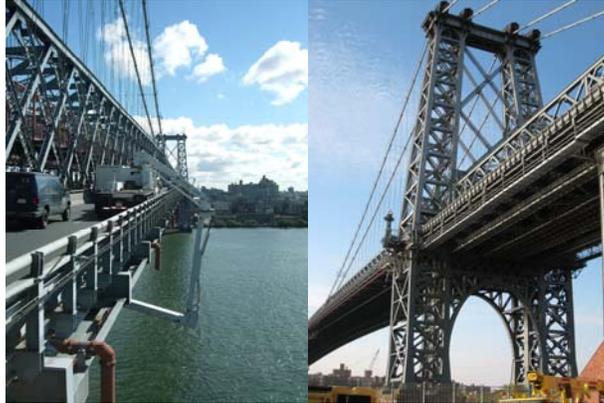
Contract #8 in 2008: Biennial Inspection of the South Roadway Under the Deck Using a Snooper Boom Truck. Brooklyn Tower in October 2008. (Tower Credit: Russell Holcomb)

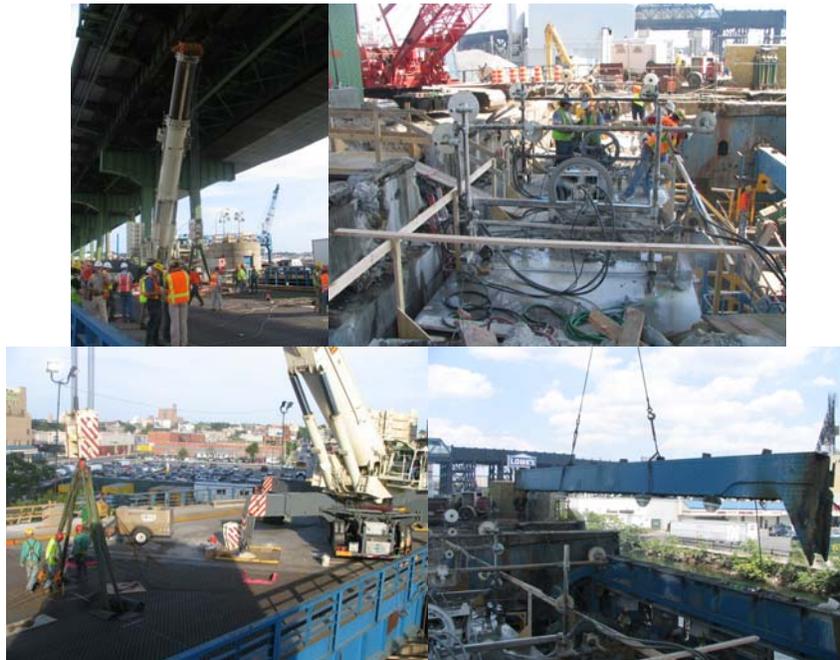
Removing the East Span in July 2007.

In Stage I, the Manhattan-bound span was closed from June 29, 2007 to August 31, 2007, and it was replaced. The Manhattan-bound bascule span was removed in halves on July 2 and July 6, 2007. Due to the contractor's chosen means and methods, the new east leaf of the Hamilton Avenue Bridge was not "floated-in" as originally proposed, but was trucked-in, and assembled at the site. The Manhattan-bound span reopened three days earlier than scheduled on the morning of August 31, 2007. The contractor will earn an incentive for early completion of this milestone.

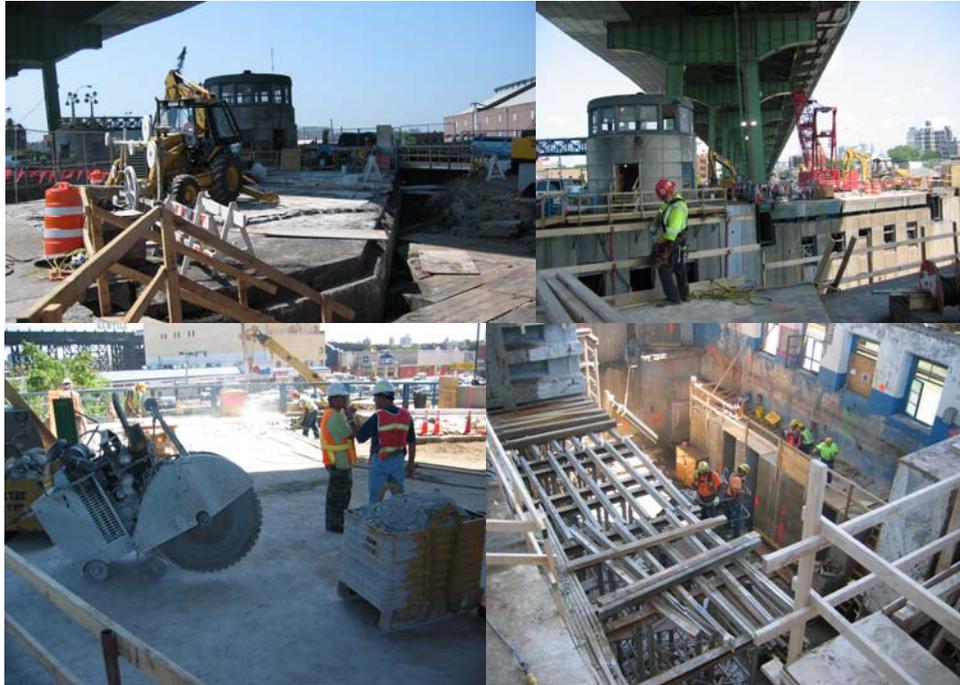
2007: Hamilton Avenue Bridge Construction.

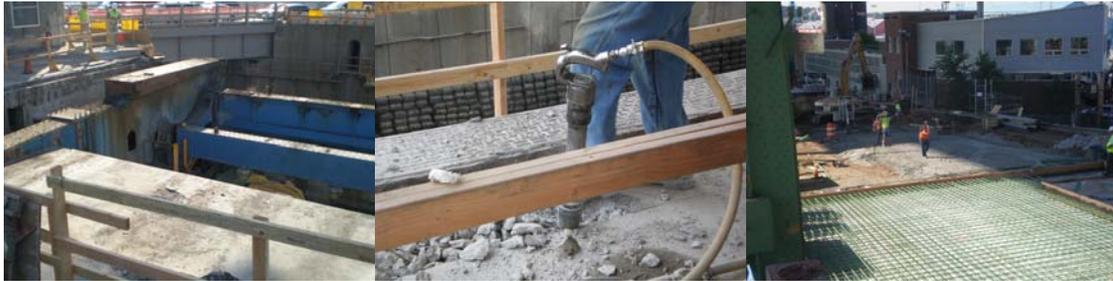
Removing the Existing Hamilton Avenue West Bridge Structural Steel in June 2008. Removing the Existing Southwest Toe Joint and Installing New Reinforcement of the Southwest Approach Slab in July 2008.

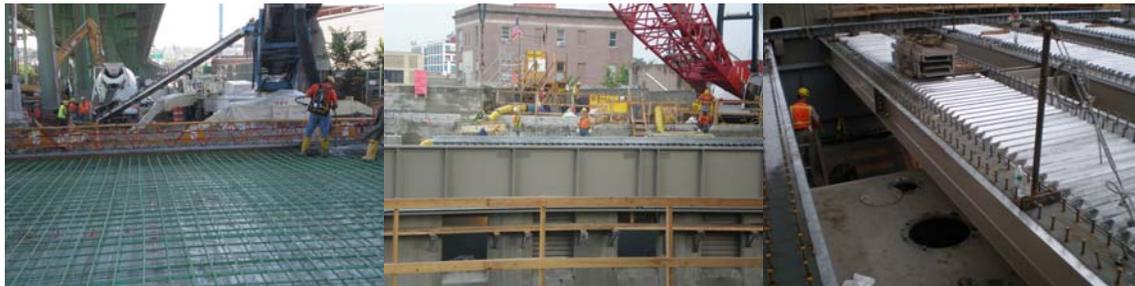
Placement of New Concrete on the Hamilton Avenue Southwest Approach Slab, Installation of New West Bridge Structural Steel, and Installation of New West Bridge Deck and Counterweight in July 2008.

In Stage 2, the Brooklyn-bound span was closed from June 29, 2008 to August 16, 2008, and it was replaced. The Gowanus Canal was reopened to navigable vessels on August 12. Utilizing the lessons learned from the Manhattan-bound span, the contractor was able to complete the work 16 days early and will earn the maximum incentive of \$216,000 for early completion of the work relating to early opening of the west bridge to traffic.

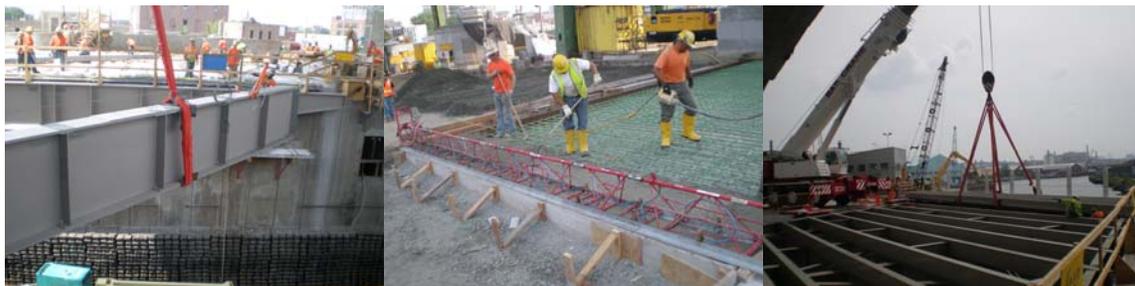
Installation of New Hamilton Avenue West Bridge Structural Steel, and Placement of Concrete for the New Northwest Sleeper Slab in July 2008. Installation of New Southwest Sidewalk in August 2008.

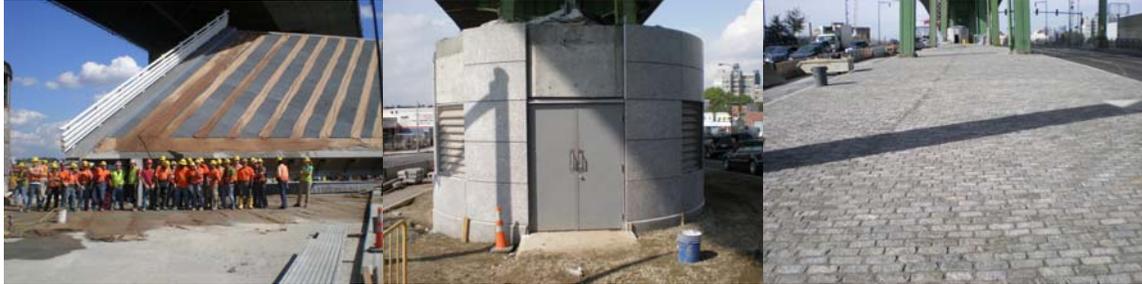
Completion of the New Hamilton Avenue West Bridge Installation in August 2008. Construction of the New Back Up Generator Building in September 2008. New Granite Pavers at the South Median Area in October 2008.

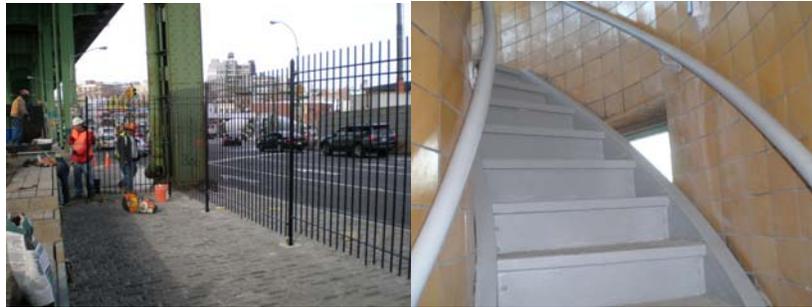
Installation of New Hamilton Avenue Parking Fence at the North Median Area in November 2008. Painting the Existing Control House Staircase in December 2008.

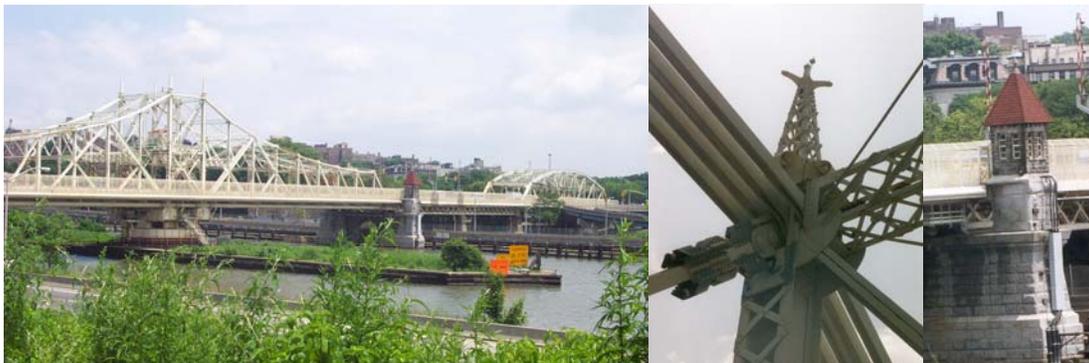
2004: East View of Macombs Dam Bridge Swing Span and Camelback Truss. (Credit: Peter Basich)
Architectural Detail of the Bridge. (Credit: Michele N. Vulcan) Close-up of a Gate House. (Credit: Peter Basich)

The Macombs Dam Bridge, which has one of the longest swing spans in the world, was opened in 1895. In 2007, the bridge carried 40,749 vehicles per day. The \$145 million reconstruction of this landmark bridge, which was completed in May 2007, included the West 155th Street viaduct, the west approach plaza over the Harlem River Drive and Seventh Avenue, the swing span over the Harlem River, the deck and camelback trusses over Metro-North Railroad and Conrail, the Major Deegan interchange (consisting of the east approach and four ramps), and the Jerome Avenue viaduct. The rehabilitation work not only strengthened the structure, it returned the bridge's appearance to its turn of the century grandeur.

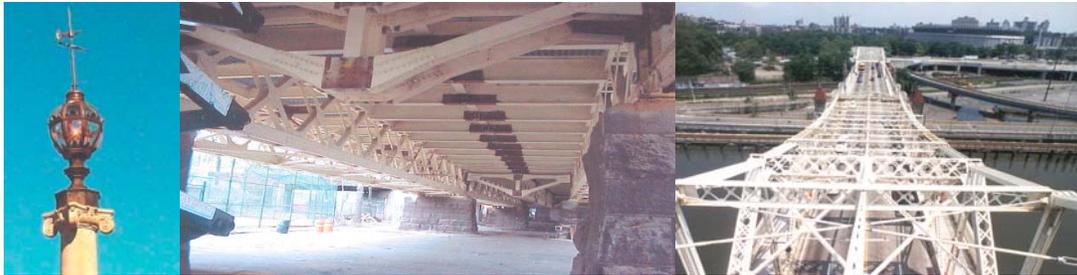
2000 – 2002: John Hooper Fountain Globe. New Trusses at the Jerome Avenue Approach to the Bridge. View of the Roadway in 2004 From Above the Control House – Old Yankee Stadium is on the Right. (Roadway Credit: Peter Basich)

As part of this project, the historic John Hooper Fountain, which dates from 1894, was fully rehabilitated in 2000. After studying detailed old photographs, the globe and weather vane were recast and replicated. Cast aluminum was used with high impact glazing similar to the lanterns installed in Central Park in the 1980's. Just east of the fountain, a garden of rose bushes was added for the community's pleasure. Other additions included a new paved island, new curbs, and a steel fence. Bollards were installed at the western end of the island to protect the fountain from vehicular traffic.

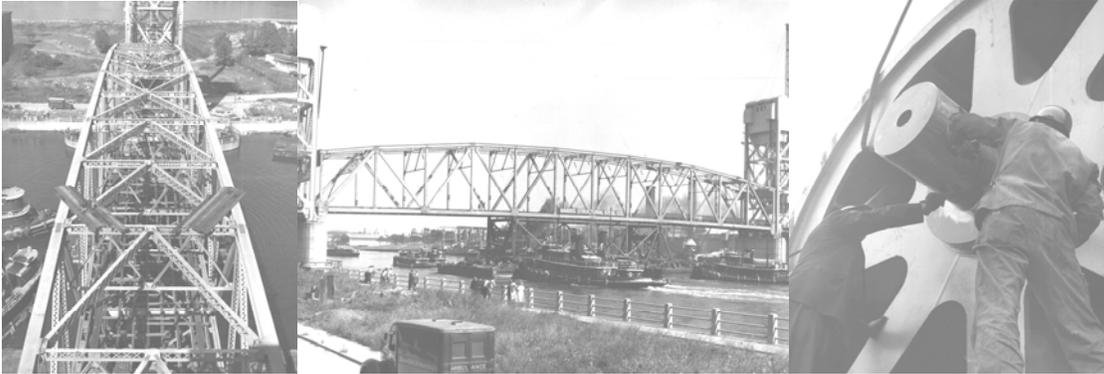
Roosevelt Island Bridge Under Construction in 1952.

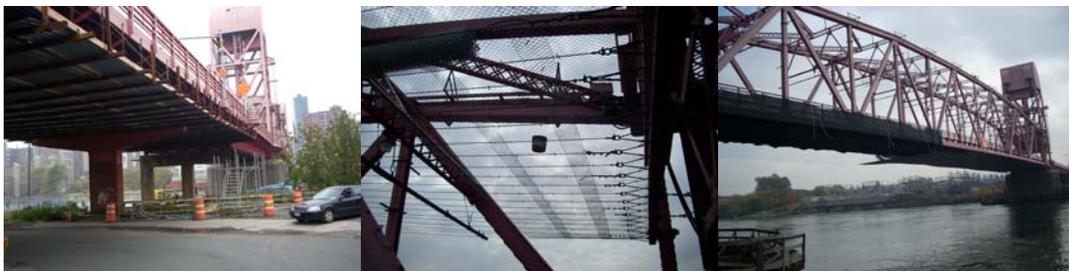
2007: Construction of the Below Deck Shield for the Queens Approach of the Roosevelt Island Bridge. Above Deck Containment on the Lift Span. The Lift Span Shield Looking Northeast.

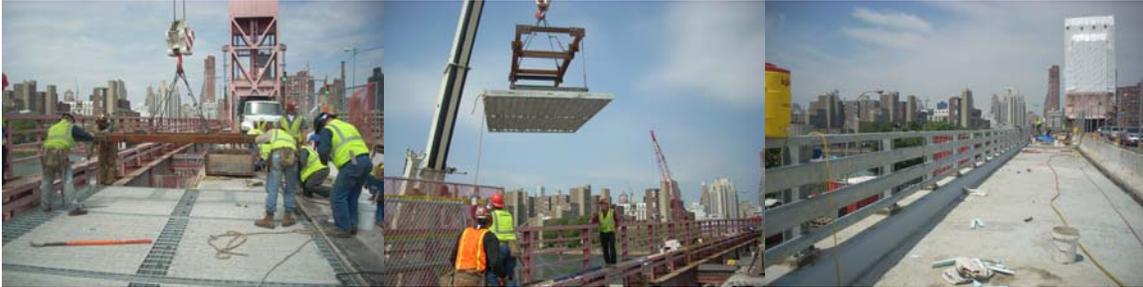
Concrete Filled Grid Deck of the Queens Approach in April and May 2008. Stage I Roadway Construction of the Queens Approach in July 2008.

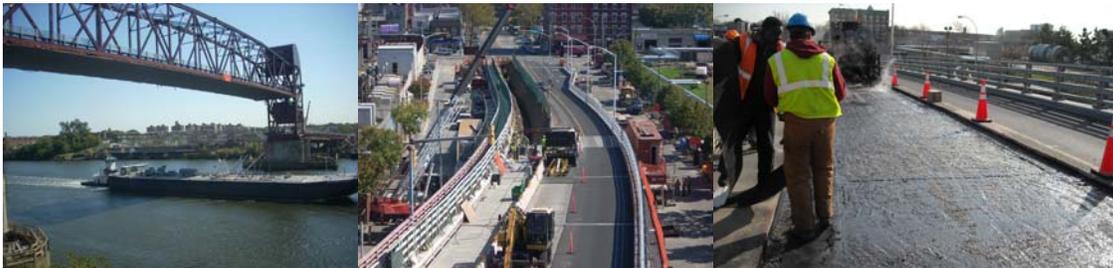
Open Lift Span During United Nations General Assembly Week in September 2008. Stage II Roadway Construction of the Queens Approach in October 2008. Asphalt Placement on the Queens Approach in November 2008.

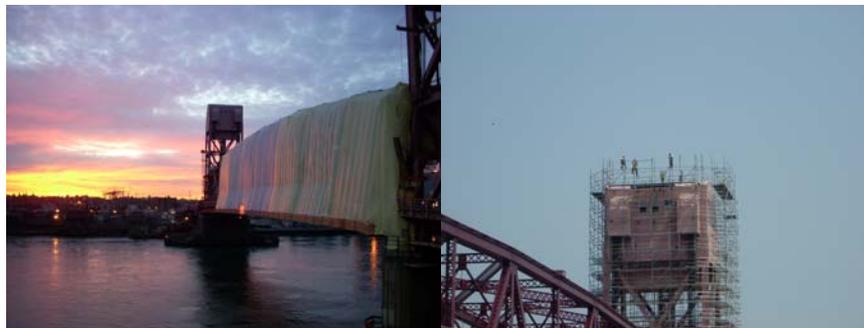
Lead Paint Removal Containment on the Lift Span in January 2008. Scaffolding Erection on the East Tower in July 2008.

The work is performed within an entirely sealed Class 1A containment system (under negative pressure) which acts as an added safety measure to prevent any materials from escaping into the air. Filtration of the enclosed air prevents paint waste dust from being released. The Department has placed several air monitoring stations in the area around the bridge. The Department performs continuous monitoring and testing of the soil and air quality as well as noise levels in the area surrounding the containment enclosure to minimize impacts and ensure the safety and quality of life for workers and residents nearby.

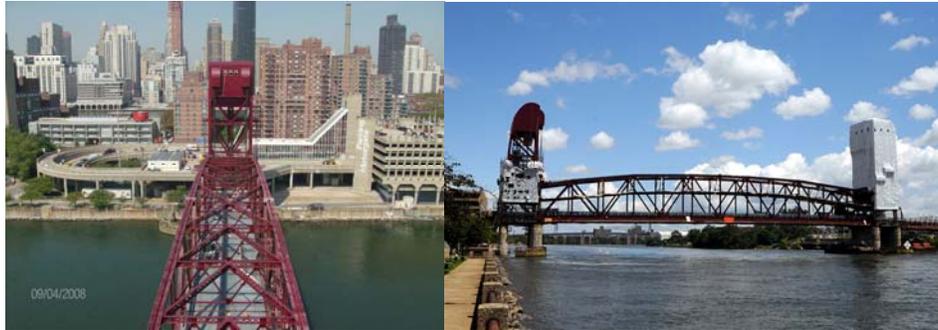
Tower Containment in August 2008. (Credit: Bernard Ente) Lift Span and West Tower in September 2008.

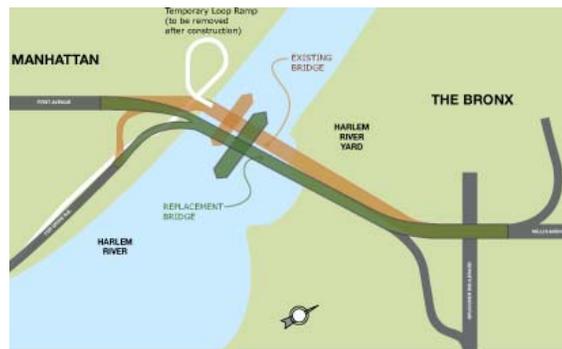
Willis Avenue Bridge Project Map.

The project will also replace the FDR Drive approach ramp and the ramp onto Bruckner Boulevard. NYCDOT will also reconstruct Willis Avenue over the Major Deegan Expressway for the New York State Department of Transportation.

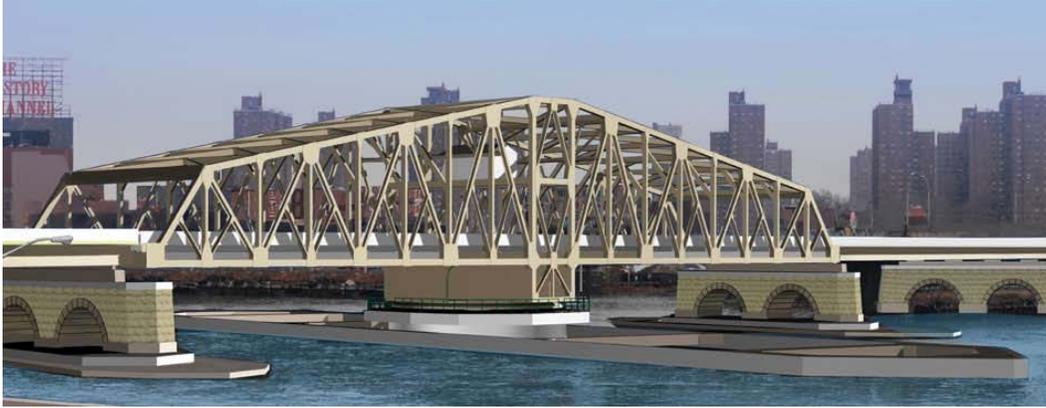
Rendering of the New Willis Avenue Bridge.

Because of the advanced age and condition of the Willis Avenue Bridge, the City of New York will replace the existing bowstring truss swing bridge with a new swing span bridge constructed just to the south of the existing bridge. Elimination of the center median on the main span will greatly improve the traffic flow on the bridge.

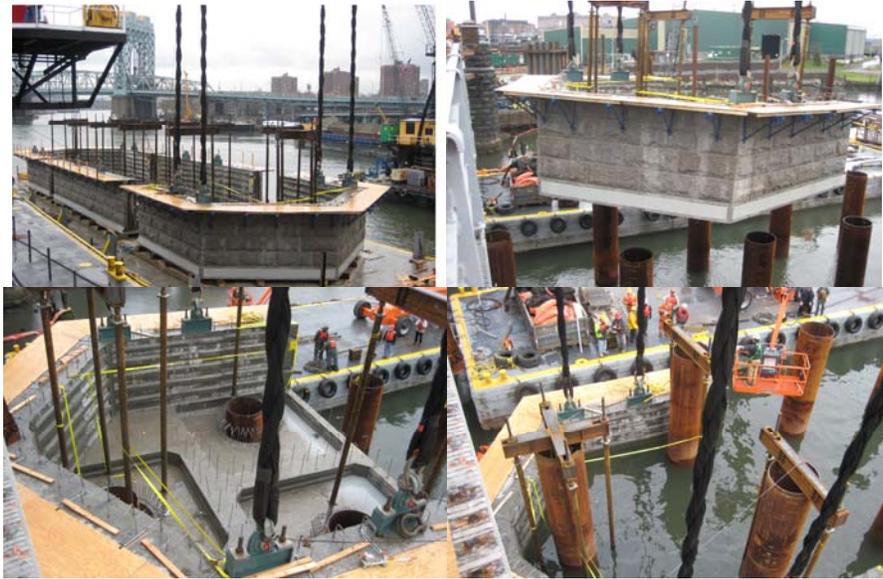
The First River Pier in November 2008.

In 2008, the project focused on foundation construction work, along with construction of a temporary ramp from the north-bound FDR Drive onto the bridge. At the end of 2008 the loop ramp was nearing completion. It went into service on January 24, 2009. This will allow the removal of the existing ramp and the construction of the new ramp to proceed. One half of the foundations for the new FDR Ramp were installed. Additionally one of the four piers in the river is in place, and work on a second has begun. The foundations in the Harlem River Rail Yard are more than 50 percent complete, and work has begun on the footings for the new Bruckner Boulevard Ramp.

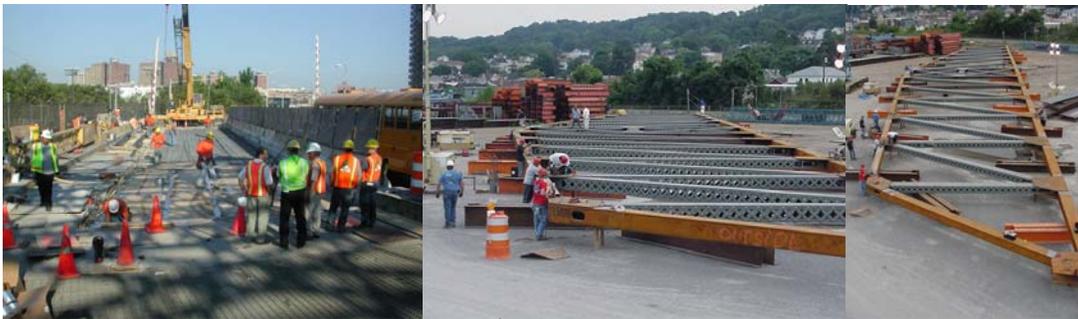
2005: Replacing Span #3 of the 145th Street Bridge. Swing Span Truss Assembly.

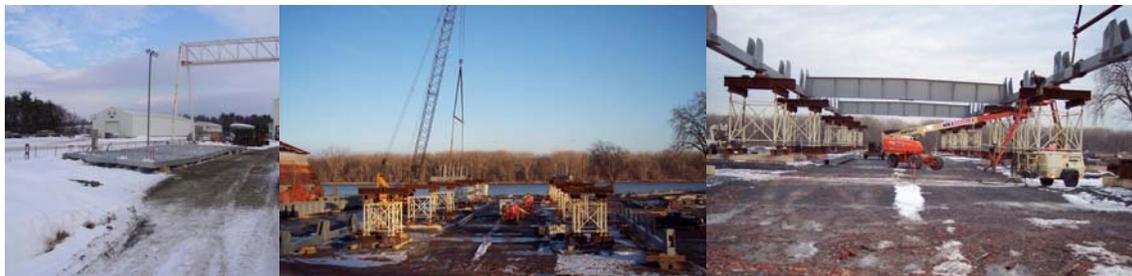
2005: Precast Deck Units for the 145th Street Bridge at the Fabrication Facility. Placing the Bottom Chord of the Swing Span on the Supporting Towers.

A Notice to Proceed for the \$69.4 million reconstruction of this bridge was issued to the contractor with a start date of July 15, 2004. Fabrication of steel components for the approach and new swing span occurred in Pennsylvania. Fabrication and assembly of mechanical and electrical components began in 2005. Installation of mini-piles at the rest and center piers of the bridge began in November 2004, and was completed in March 2005. In 2005, the contractor also completed the survey and the tieback borings. In 2006, the contractor replaced most of the north half of the bridge in the approaches as well as on spans 1, 2, 3, 6, 7, and 8. The new swing span was assembled in Albany, New York in late 2005, and was floated-in on February 9, 2007.

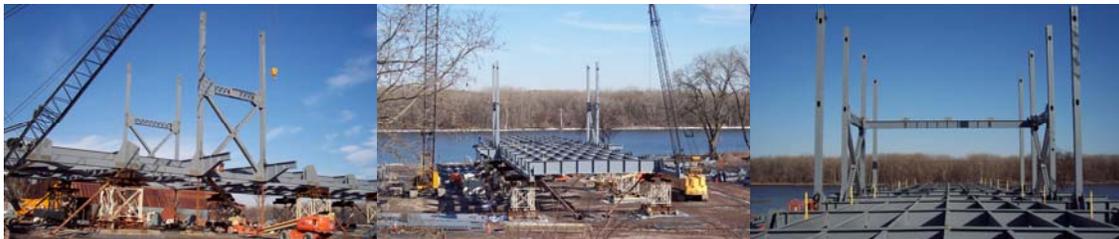
2006: Assembling the New 145th Street Bridge Swing Span in Albany.

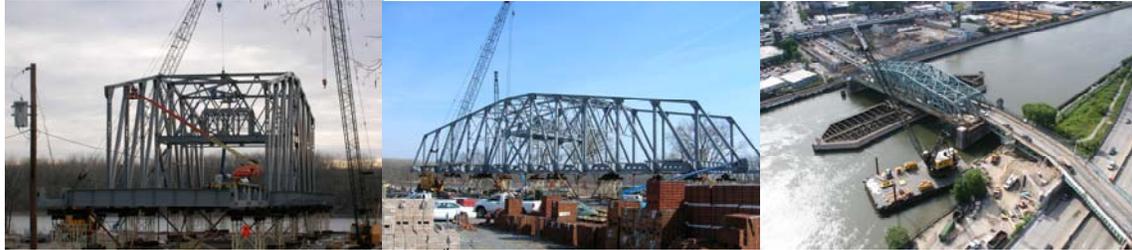
2006: Continued Assembly of the New 145th Street Bridge Swing Span. Removing Steel Girders Over the Harlem River Drive.

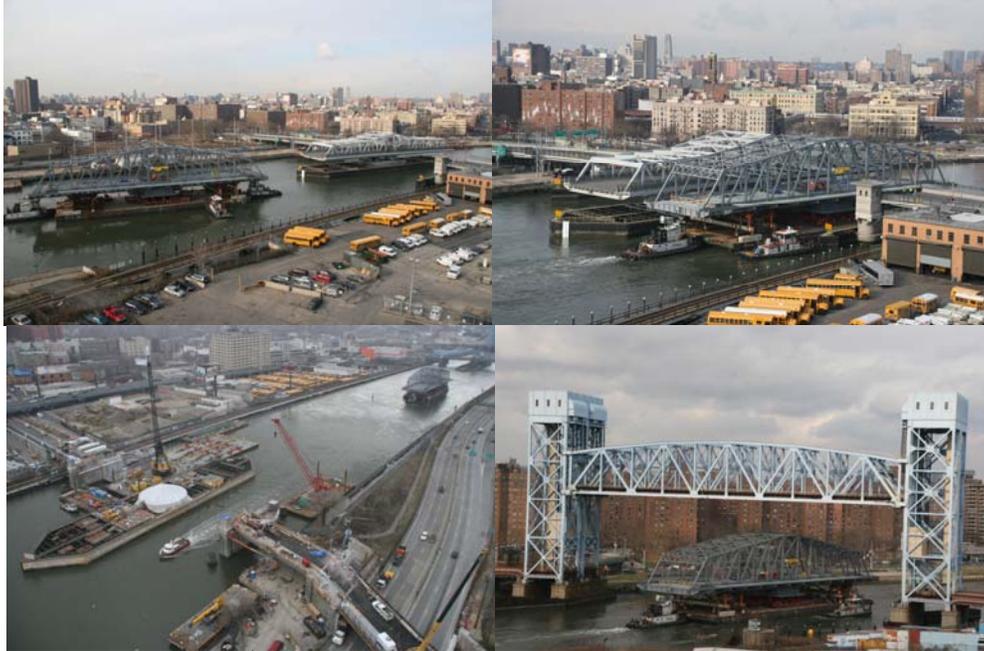
Moving the New 145th Street Swing Span From South of the Third Avenue Bridge to the Site in January 2007. Passing Under a Metro-North Railroad Bridge.

Various construction activities, including the installation of the grid deck, took place while the swing span truss was moored south of the Third Avenue Bridge. The float-in of the swing span was successfully performed on February 9, 2007.

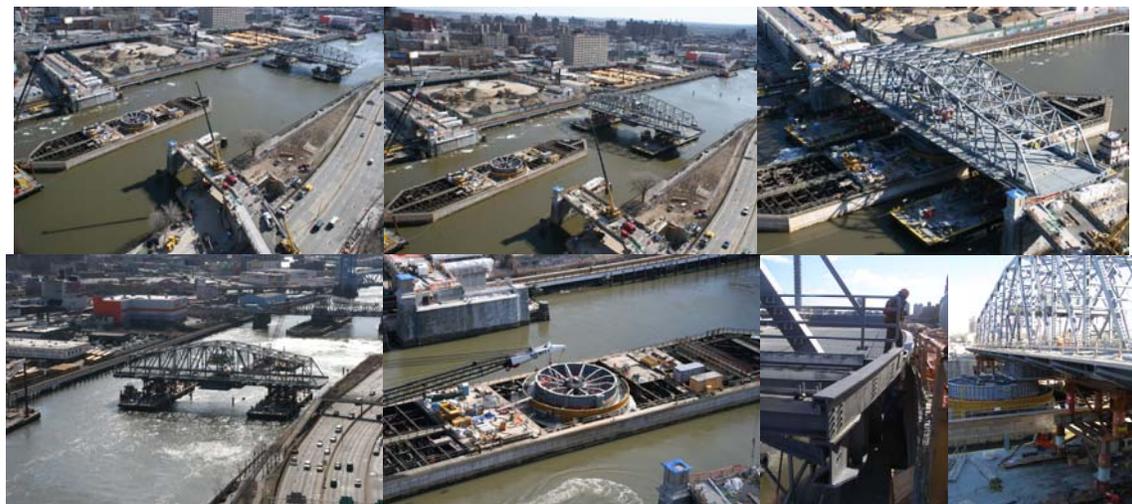
Floating In the New 145th Street Span in February 2007. (Close-up Credit: Bojidar Yaney)

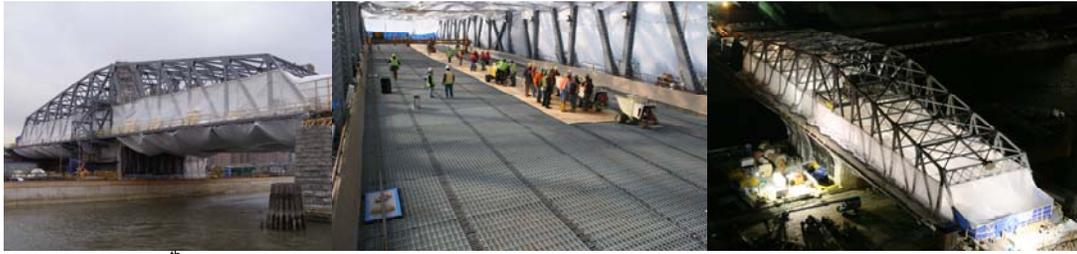
2007: New 145th Street Bridge Swing Span Wrapped in Plastic During the Lightweight Concrete Curing Period. Preparing for the Concrete Deck Placement. Night View of the Encapsulated Deck.

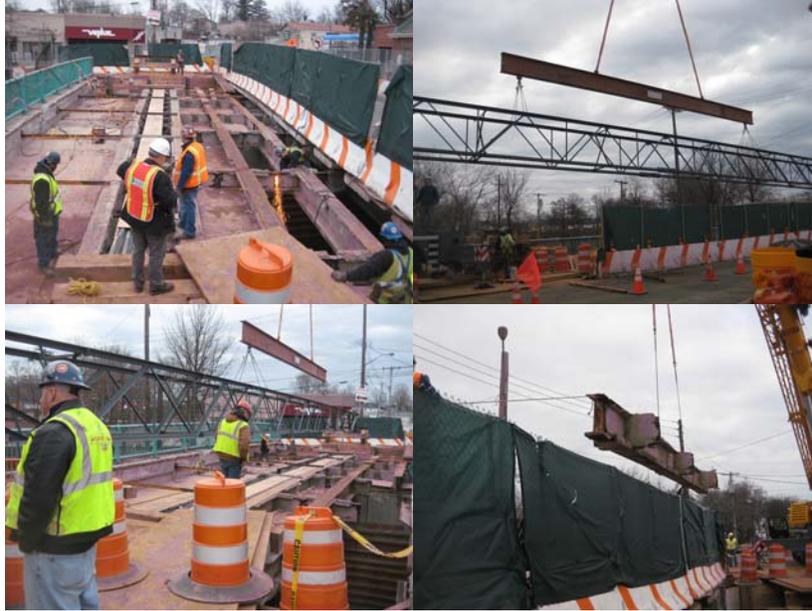
Annadale Road: Stage I Construction. Saw Cutting the Diaphragms, Removing the Stringers, And Placing a Temporary Truss to Support Utility Conduits.

The contractor completed Stage I deck removal on November 26, 2008.

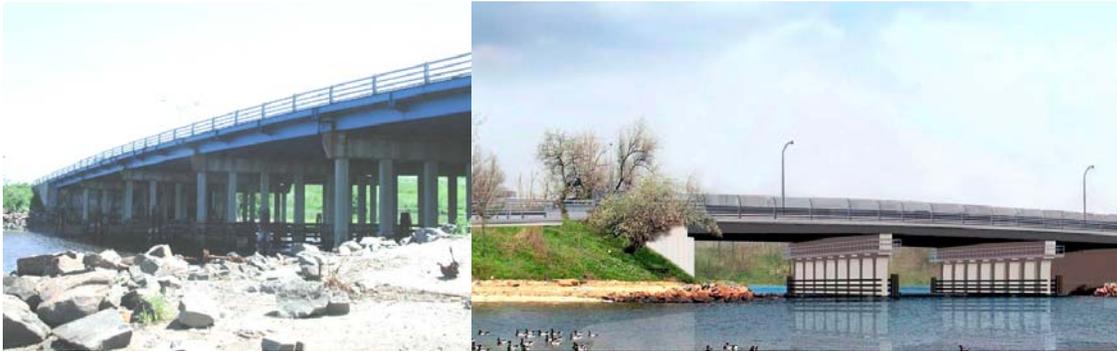
Fresh Creek Bridge in 2002. (Credit: NYSDOT) Proposed Fresh Creek Bridge.

The existing Fresh Creek Bridge is a 264.5 foot, 5 span, multi-girder, simple supported steel superstructure, supported on pre-cast concrete columns founded on four reinforced concrete piers on concrete piles with concrete gravity abutment walls on timber piles. The bridge has two 34'-2" wide roadways, a 5-foot wide center median/barrier, and a 10-foot wide south sidewalk. The parkway east and west of the bridge has a 10-foot wide bike footpath on the south side. The existing structure and immediate approaches will be demolished and replaced.

The replacement bridge will be a 309-foot, 3 span structure; the new structure will have only two support piers, resulting in a wider channel. The proposed construction will result in improved landscaping on the bridge approaches. The bridge deck and approaches will be widened to 120 feet from the existing 86 feet to accommodate three 12-foot lanes in each direction, 12-foot wide shoulders, and a 12-foot wide bike path, separated from the traffic lanes by a barrier system. The pedestrian and bicycle pathway will be maintained at all times.

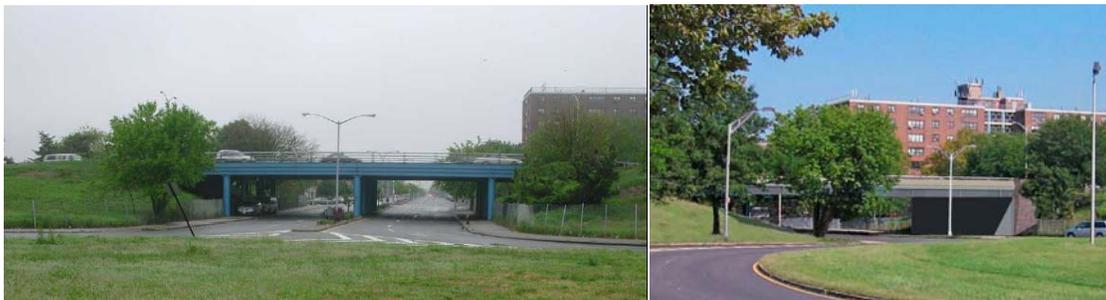
Rockaway Parkway Bridge in 2002. (Credit: NYSDOT) Proposed Rockaway Parkway Bridge.

The existing Rockaway Parkway Bridge is a 150-foot, 4 span, multi-stringer, simple supported steel superstructure, supported on steel cap beams on concrete filled steel pipe columns, and reinforced concrete abutment walls supported by concrete pile foundations. The bridge has two 34'-2" wide roadways, a 5-foot wide center median/barrier, and a 10-foot wide south sidewalk. The existing structure and immediate approaches will be demolished and replaced.

The replacement bridge will be a single span structure to improve visibility along Rockaway Parkway. The new structure will be built in the same alignment as the existing bridge. The bridge deck will be widened to 109 ½ feet from the existing 84 feet to accommodate three 12-foot lanes with a 12-foot wide right shoulder and 4-foot left shoulder in each direction, including 5 ½ feet for median and parapet width. The right shoulder lane on each approach will be 10 feet (while the width of the right shoulders on the bridge structure will be 12 feet), with the other dimensions the same width as those on the bridge. In addition to reconstruction of the bridge, four access ramps will also be reconstructed as will Rockaway Parkway in the vicinity of the Belt Parkway.

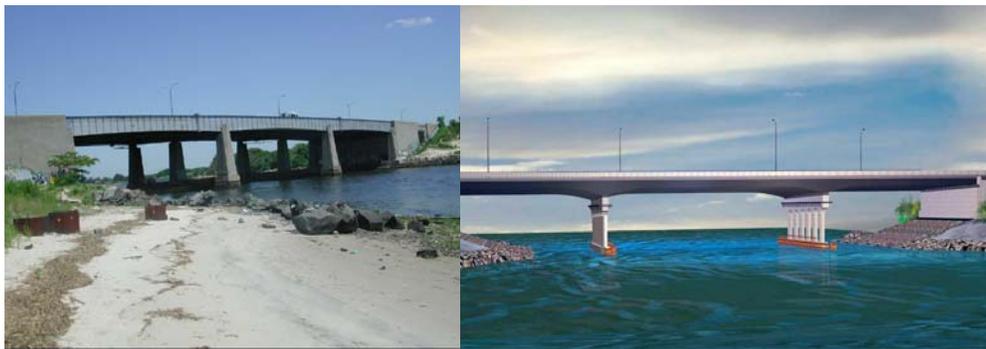
Gerritsen Inlet Bridge in 2002. (Credit: NYSDOT) Proposed Gerritsen Inlet Bridge.

The existing Gerritsen Inlet Bridge is a 520-foot long, 9 span, steel girder and reinforced concrete beam superstructure, supported on reinforced concrete piers, and abutments supported on timber piles. The existing structure and immediate approaches will be demolished and replaced.

The replacement bridge will be a consist of a 496-foot, 3 span bridge, aligned 10'-6" north of the centerline of the existing structure, and remaining 35 feet over the navigable channel. The bridge will have a 36-foot wide roadway with a 12-foot wide right shoulder and a 4-foot wide left shoulder in each direction. The eastbound side will carry a dedicated pedestrian/bike path along the south fascia.

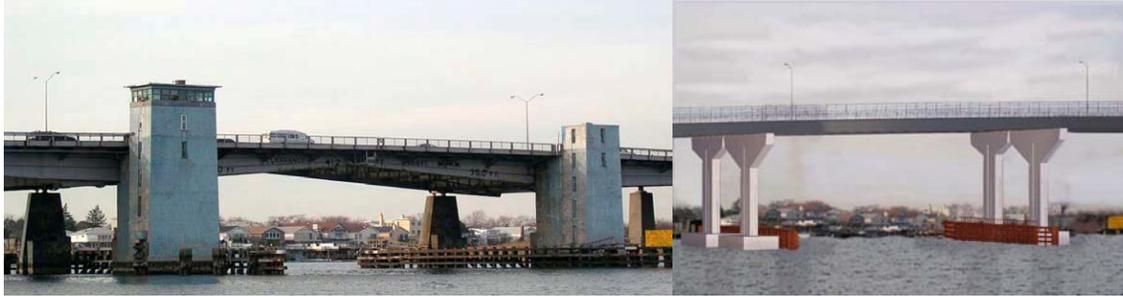
Mill Basin Bridge. Proposed Mill Basin Bridge.

The existing Mill Basin Bridge is 864-foot long and 14 spans, including double movable leaf bascule spans and a steel superstructure, supported on reinforced concrete pier on timber piles, and abutments supported on pre-cast concrete piles. The existing structure and immediate approaches will be demolished and replaced.

The replacement will be a 1,757-foot, 11 span fixed bridge, north of the existing structure. The bridge will have a 36-foot wide roadway with a 12-foot wide right shoulder and a 4-foot wide left shoulder in each direction. The eastbound side will carry a dedicated pedestrian/bike path along the south fascia. The new bridge will be a fixed structure with a 60-foot clearance over Mean High Water, obviating the need for opening and closing the structure to accommodate tall vessels. The new design of the bridge will result in increased sight distances, an increase in lane width from 11-feet 4-inches to 12-feet, and the inclusion of safety shoulders in both directions. The channel will remain navigable during construction, and the clear channel width will remain the

same after the new structure is in place. A new fender system will be installed to protect the bridge substructure from marine traffic.
