INNOVATIONS & ACCOMPLISHMENTS

East River Bridges

A \$3.47 billion reconstruction program is underway to rehabilitate all four East River crossings. In 2007, these bridges carried some 496,666 vehicles per day. In 2002, working in coordination with the NYPD and other law enforcement agencies, the Division implemented enhanced security measures on these bridges. This work is ongoing.

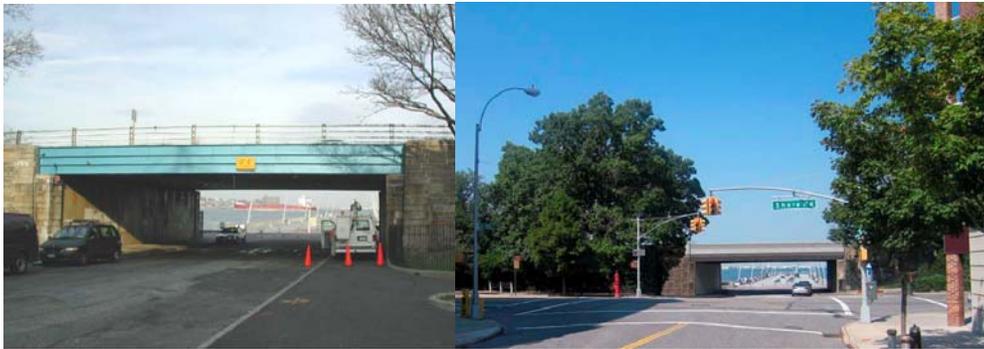
Bay Ridge Avenue Bridge in 2002. (Credit: NYSDOT) Proposed Bay Ridge Avenue Bridge.

The existing Bay Ridge Avenue Bridge is a 58-foot long, single span, reinforced concrete deck on a multi-girder system superstructure over Bay Ridge Avenue. The superstructure is supported by concrete gravity type abutments on pile foundations. The underpass is access to the NYCDEP Owl's Head Waste Treatment Plant. The existing superstructure will be demolished and replaced.

The replacement bridge superstructure will consist of pre-stressed concrete box beams and a reinforced concrete slab. The bridge will have three 12-foot wide lanes in the eastbound direction and two 12-foot wide lanes separated by a 4-foot wide painted stripe flush median in the westbound direction. There is no pedestrian/bike path on the structure. The existing bridge will be reconstructed using pre-cast deck sections. The clearance will be increased to 14-feet 6-inches, which removes the need for clearance signs currently posted for a substandard condition and will obviate the need for underdeck wood shielding.

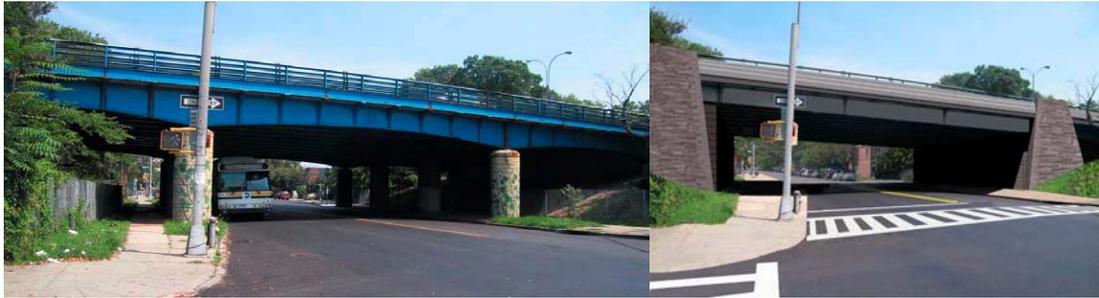
Nostrand Avenue Bridge. Proposed Nostrand Avenue Bridge.

The existing Nostrand Avenue Bridge is a 140-foot long, 3 span, multi-girder superstructure, consisting of a concrete deck with an asphalt overlay over Nostrand Avenue. The superstructure is supported by concrete pier columns with a steel cap beam, and abutments on concrete filled steel pile foundations. The existing structure and immediate approaches will be demolished and replaced.

The replacement will be a single span bridge consisting of standard steel girders with a cast-in-place deck superstructure and reinforced concrete abutments on pile footings, thus eliminating the need for intermediate support piers and resulting in improved sight lines on Nostrand Avenue. The bridge will have three 12-foot wide lanes with a 12-foot wide right shoulder. The approaches will have a 10-foot wide right shoulder and a 4-foot wide left shoulder in each direction. Nostrand Avenue will be widened to 81 feet and realigned with the existing approaches. On the Belt Parkway, the bridge will be widened in order to provide new safety shoulders in both directions.

New safety-shape parapets will be installed and the existing corrugated metal center guide-rails will be replaced with a reinforced concrete center median, which will result in a safer condition.

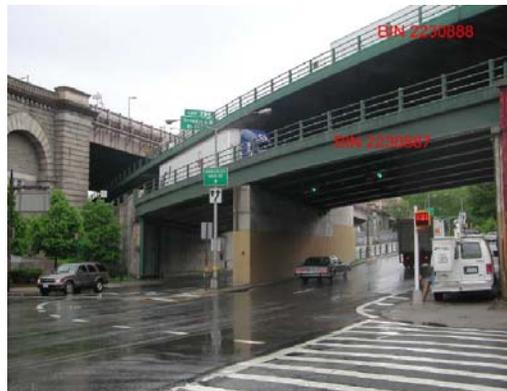
BQE Bridge Over Cadman Plaza in 2002 – Upper Level is Eastbound, Lower Level is Westbound.
(Credit: NYSDOT)

The Brooklyn-Queens Expressway over Cadman Plaza and Old Fulton Street, oriented East to West, and located just west of the Brooklyn Bridge, consists of two-level two-span superstructures, one above the other, founded on concrete abutments and piers sharing a common footing on H piles. The bridge was constructed in 1948.

The westbound side (the lower of the two-level structure) is a two-span continuous steel stringer, concrete deck superstructure supported by concrete abutments and a solid concrete center pier. The stringers are supported by fixed bearings at the center pier and with expansion bearings at the abutments. The bridge deck is a reinforced concrete slab overlaid with an asphalt wearing surface.

The eastbound side (located on the upper level) is a cantilever two span continuous steel rigid frame structure of built-up riveted girders. The girders are concrete-encased and rigidly framed into the framing at both abutments and center pier. The existing railings are substandard, and the granite veneer on the substructures has been removed from both of the abutment stems and the south side wing walls.

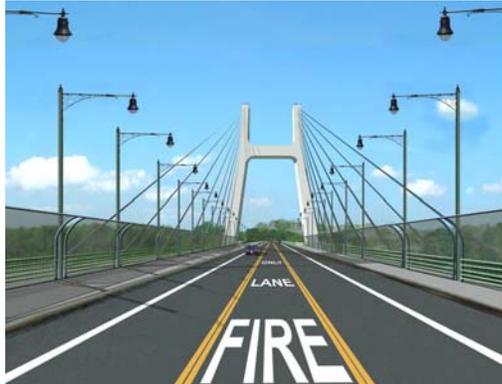
Rendering of New City Island Road Bridge.

The existing bridge will be replaced along the same alignment with a new single span, single tower cable-stayed bridge which will be a unique structure type in the NYC area. The new bridge will be approximately 17 feet wider than the existing one to accommodate three standard 12-foot wide traffic lanes, a 6-foot wide bicycle lane and a 6-foot wide pedestrian walkway on each side. The tower and concrete counterweight for backstay anchorage of the new bridge will be located in Pelham Bay Park. The new bridge will be designed to current standards and with its wider roadway width, will allow future repair and rehabilitation to be carried out while maintaining one 12-foot lane in each direction. In order to maintain traffic during the demolition of the existing bridge and construction of the new bridge, a temporary bridge will be constructed on the south side of the existing bridge.

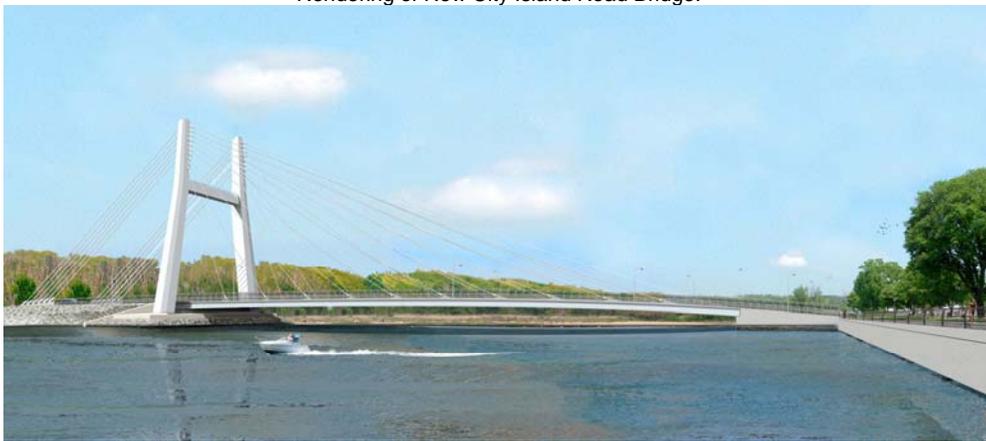
Side View Rendering of New City Island Road Bridge.

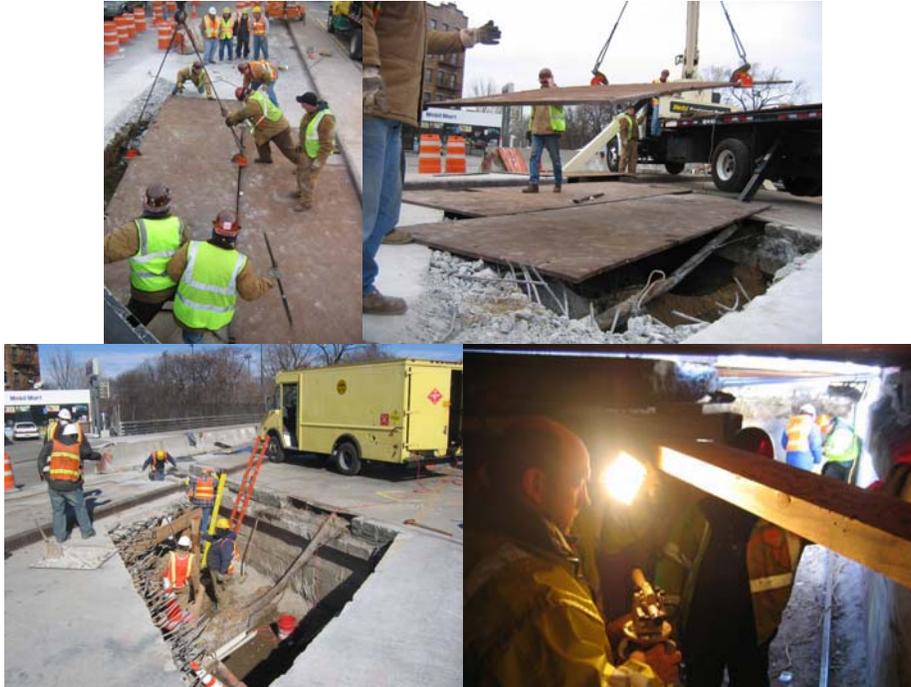
Red Flag Repairs in February 2006: Ironworkers Removed the Plates From the Holes and Replaced Them at the End of Each Day. They Also Placed Reinforcing Bars for the New Concrete Slab. Supervisor Bridge Repairer and Riveter Gean Pilipiak Monitoring Red Flag Repairs in 2006. (Credit: Peter Basich)

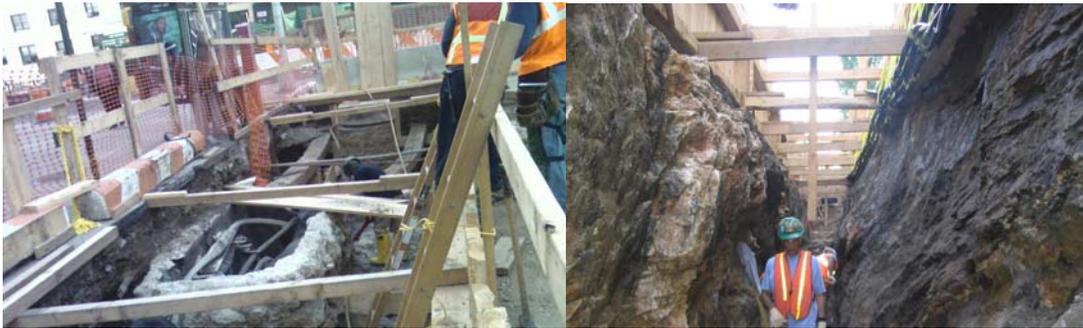
2006: Grand Concourse Bridge: Demolition of Existing Con Ed Vault. Backfill and Compaction of Sewer Manhole.

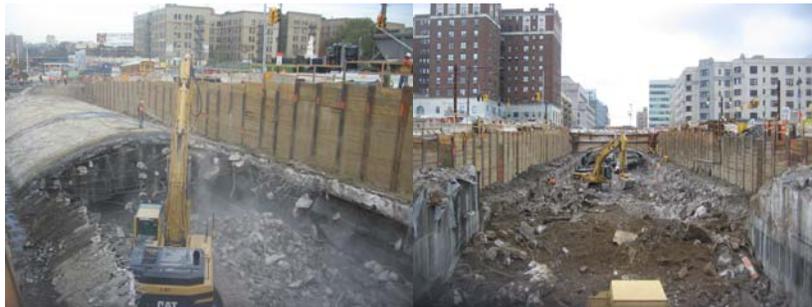
2006: Demolition of the Bridge. Removing Debris From the Bridge.

Stage II reconstruction of the bridge began on October 26, 2006. The underpass was closed to traffic as part of this stage, which was completed in April 2007.

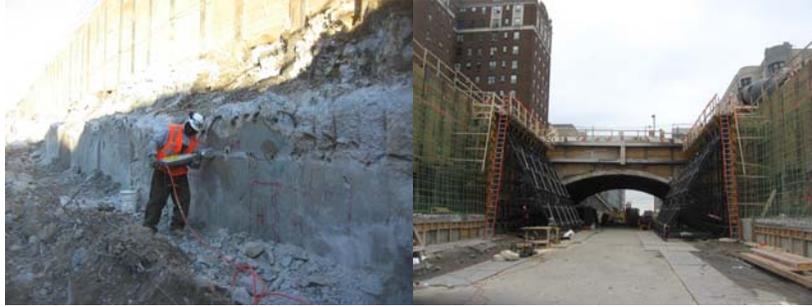
2006: Removing Concrete at the Springline of the South Abutment Stem. Formwork and Concrete Placement at South Abutment.

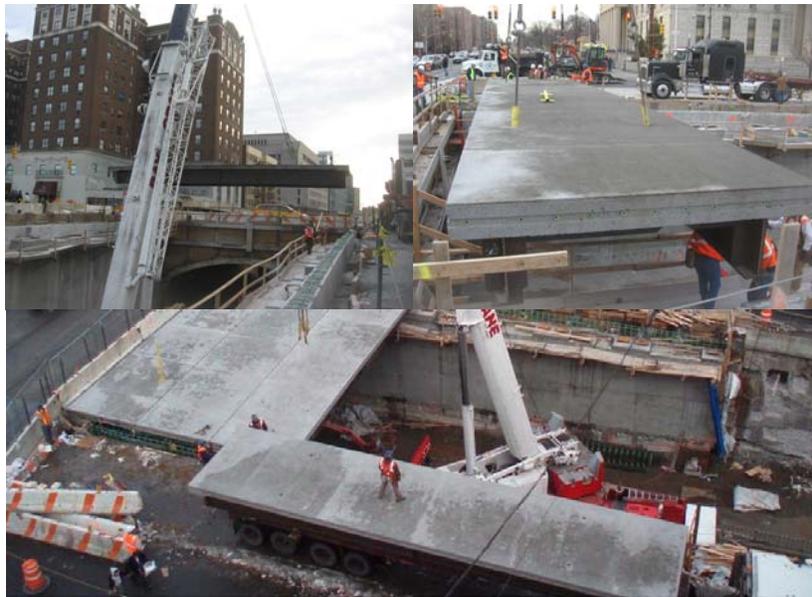
2006: Installing the Precast Panels.

Installation of precast panels began in the intersection of the Grand Concourse and 161st Street on December 19, 2006. Construction of the west side of the Grand Concourse was nearly complete by the end of 2006.

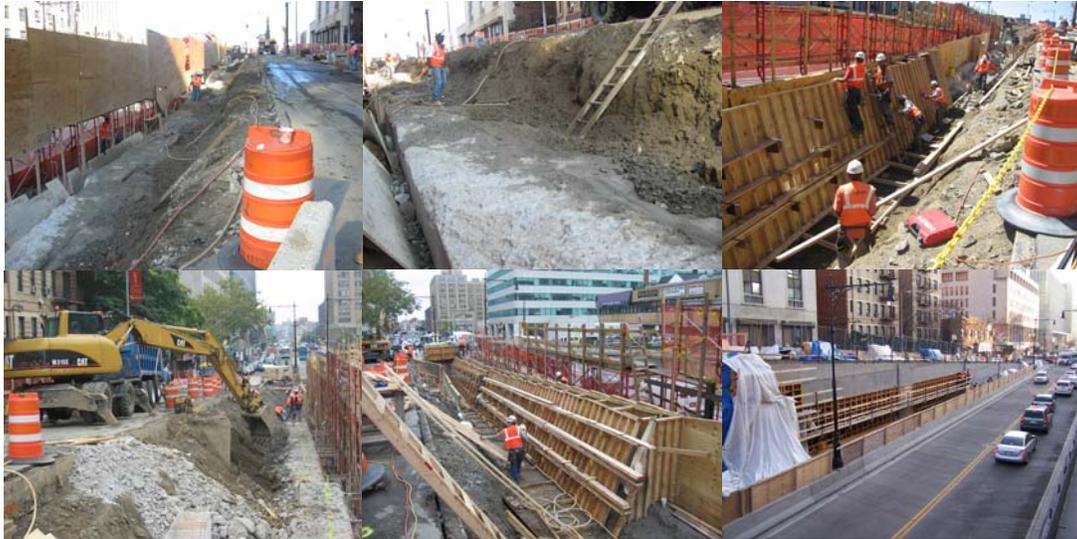
2007: Demolition and Reconstruction of the Northeast Retaining Wall of 161st Street Between the Grand Concourse and Sheridan Avenue.

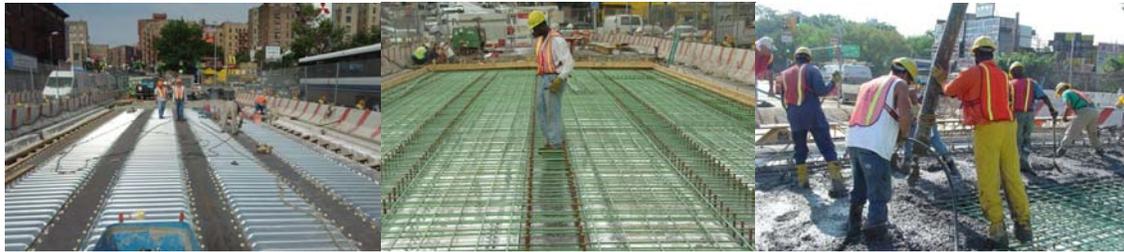
2005: Project Engineer Muhammad Siddiqui Inspecting the Stay-in-Place Formwork for the New Gun Hill Road Bridge Deck. Installing Deck Reinforcement. Concrete Placement.

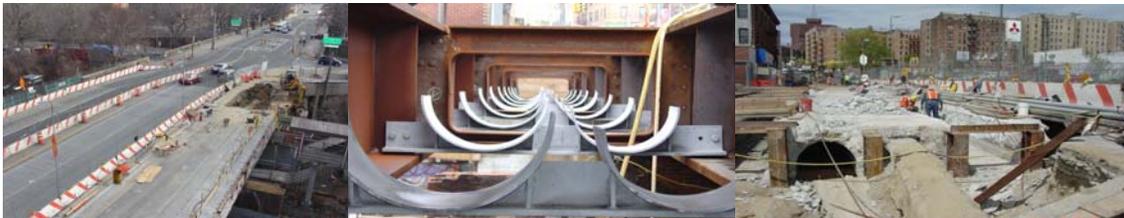
Gun Hill Road Bridge in January 2006: Stage 2 Construction Zone, South Side of Bridge. March 2006: Looking West From The East Abutment at The Utility Supports for The Gas mains. May 2006: Stage 2B Installing Shielding on Utility Bay.

Effective March 9, 2005, the southbound off ramp of the Bronx River Parkway at Gun Hill Road was closed to traffic for a three year duration. Stage II reconstruction of the bridge began on November 3, 2005. At the end of 2006, the project was in Stage III which consisted of the reconstruction of the northern 1/3 of the bridge.

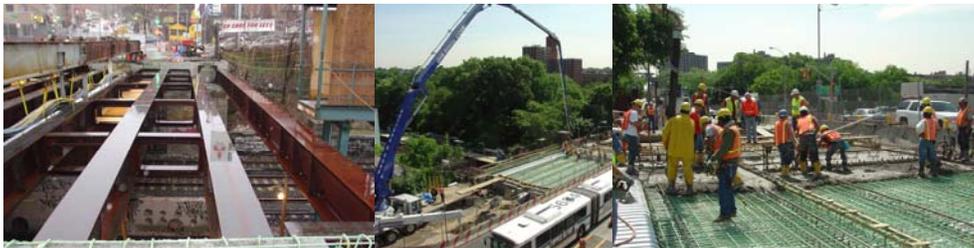
April 2007: Looking West – Gun Hill Road Bridge Stage III Girders and Temporary Support for Existing ECS Cables. June 2007: Using a Pump to Place Stage III Bridge Deck Concrete.

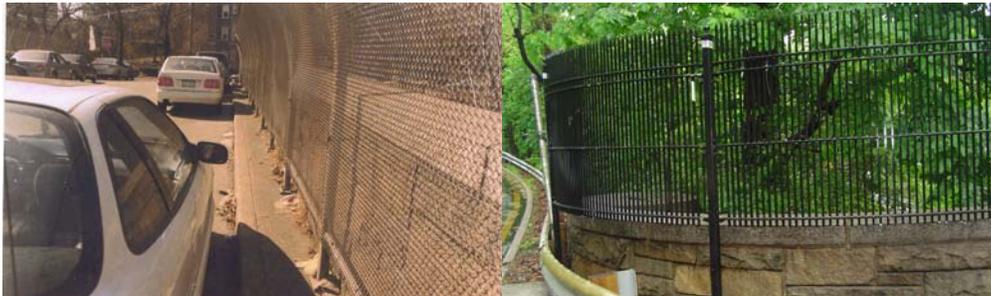
Old Fence on the Manhattan College Parkway Bridge. Newly Installed Picket Fence.

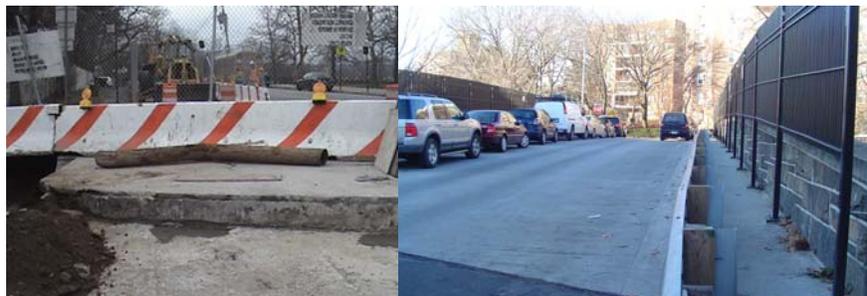
Manhattan College Parkway Bridge Deck During Construction. Completed Bridge.

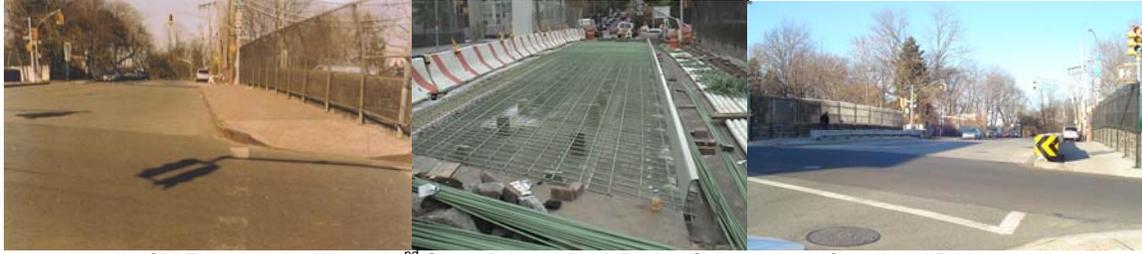
Old Fence on the West 232nd Street Bridge. Deck During Construction. Completed Bridge.

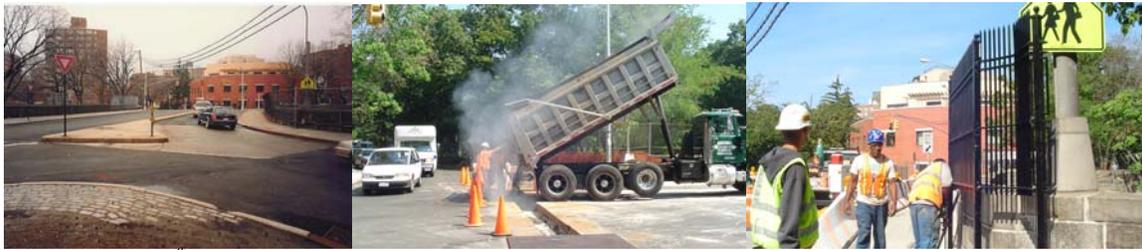
West 239th Street Bridge Before Reconstruction. During Construction. Installing the New Picket Fence.

On West 239th Street, the work was completed in three stages, with one lane of vehicular traffic maintained in the each direction during construction. Stage I reconstruction (northern half) of the bridge began on April 25, 2005. Stage II reconstruction began on September 22, 2005. The bridge re-opened to traffic on April 20, 2006. The reconstruction of the West 239th Street Bridge was substantially completed on December 5, 2006.

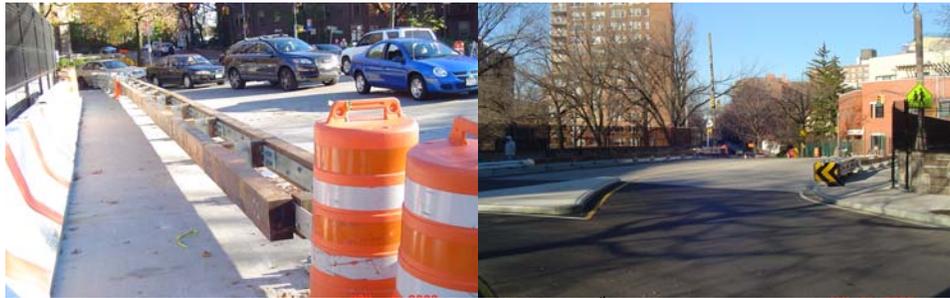
Newly Installed Steel-Backed Timber Guide Rail at West 239th Street Bridge. Completed Bridge.

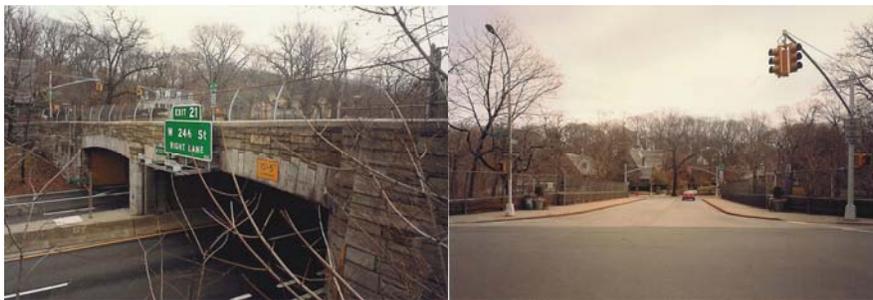
West 252nd Street Bridge Before Reconstruction.

Work on the West 252nd Street Bridge will include the demolition of the existing concrete arch bridge deck, and replacing it with a new prestressed concrete box beam superstructure. In addition, the reconstruction of this bridge will include installing a new 12 inch diameter water main, improving the under deck lighting systems, private utility work, partial removal of the pier and abutments, new roadway lighting, and adjustment of the existing drain inlets, manholes, and catch basins. The work will be completed in four stages. The work on this bridge began with Stage I on January 3, 2006.

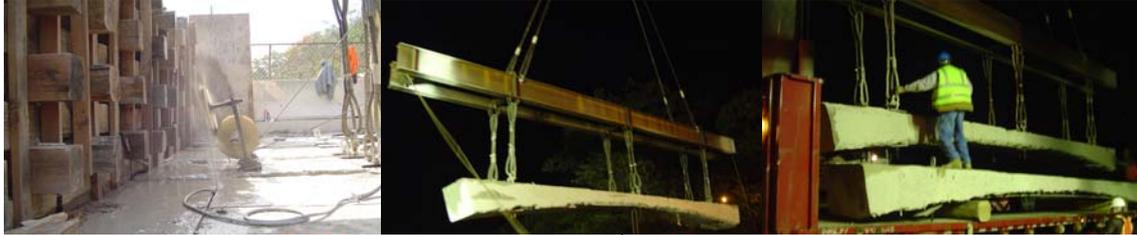
2006: Cutting and Removing the Existing West 252nd Street Bridge Sections Over the Parkway.

The removal of the existing bridge sections over the northbound Henry Hudson Parkway was performed at night on October 25 and 26, 2006. The removal of the sections over the southbound Henry Hudson Parkway was performed at night on October 31 and November 1, 2006. The demolition of the north half of the bridge was completed in November 2006.

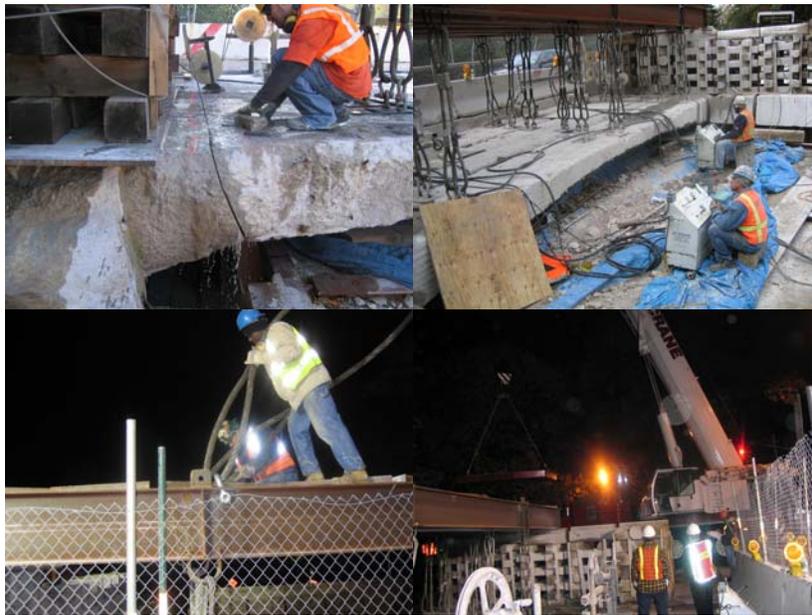
2006: Wire Sawing the Deck and Removing the Existing West 252nd Street Bridge Sections Over the Parkway.

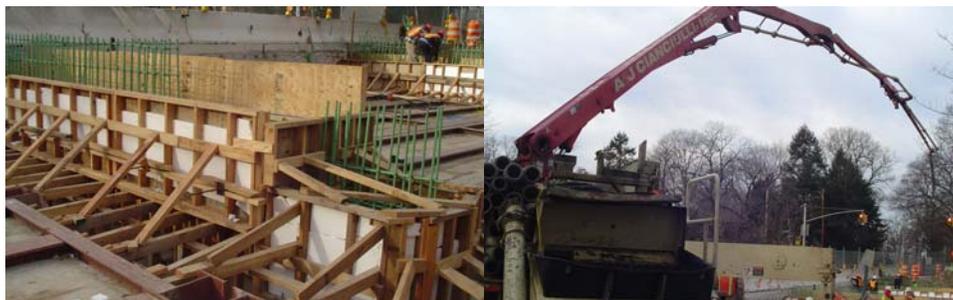
2007: West 252nd Street Bridge Formwork and Rebar Fabrication at the Pier and West Abutment. Concrete Placement in Progress.

The new superstructure for the north half of the bridge, comprised of pre-stressed concrete beams and cast-in-place reinforced concrete deck and sidewalks, was completed in May 2007. The approach pavements, steel-backed timber guide rails and ashlar veneer parapet wall on the bridge were completed in October 2007.

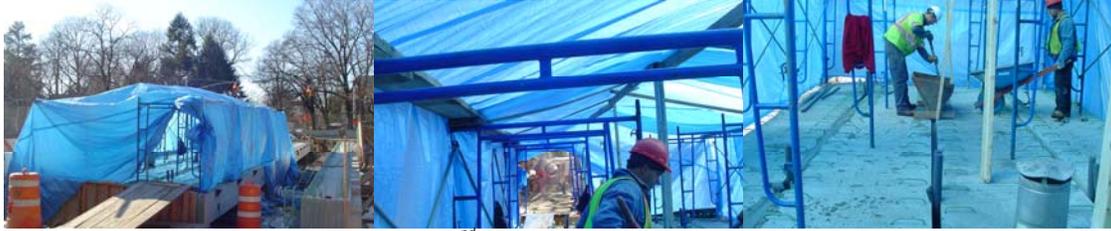
Grouting of the West 252nd Street Bridge Box Beams in February 2007.

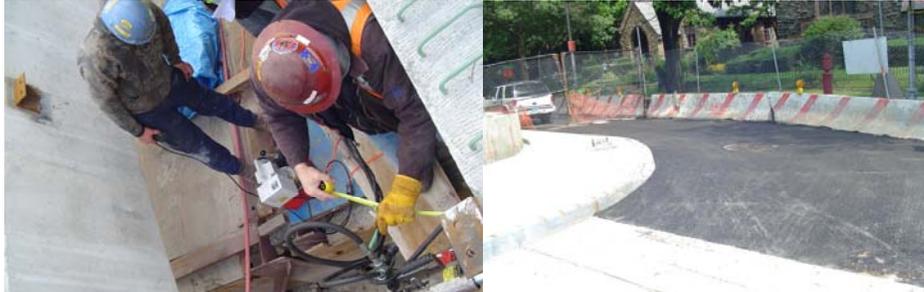
West 252nd Street Bridge: Transverse Post-Tensioning of the Pre-Cast Concrete Beams in March 2007. Installed Asphalt on Bridge Approach in July 2007.

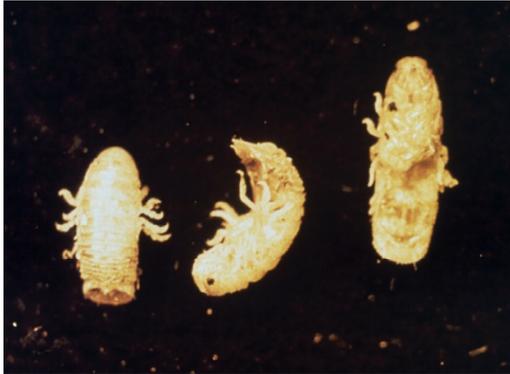
Marine Borer – Limnoria Species

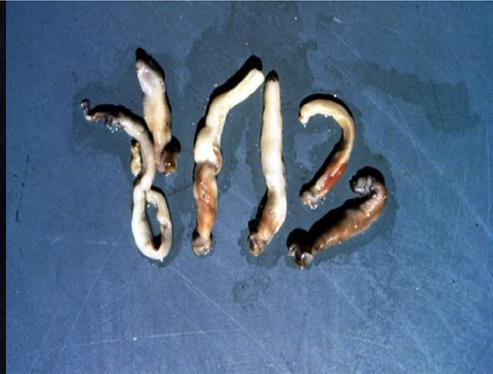
Marine Borer – Teredo Species

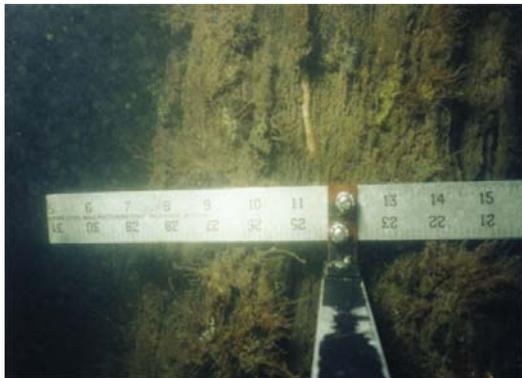
Medium Limnoria Infestation

In October 1999, the Department began a study to assess the existing damage caused by marine borers as well as the potential for future damage at several waterfront DOT structures, including the supporting structures of the relieving platforms along the FDR and Harlem River Drives, and the timber piles and structures of the Carroll Street and Ocean Avenue bridges in Brooklyn. The underwater inspection of timber piles supporting the FDR Drive began on May 8, 2000. Inspection of the Brooklyn sites was conducted during the week of October 23, 2000. The inspections were completed in October 2000, and the Marine Borer Evaluation Report was published in June 2001. Using the results of the underwater inspections, preliminary plans were developed for the implementation of repairs and remediation measures to protect the structures from attack. These preliminary plans were completed in December 2001. The final design is complete. Mitigation work for the impact of the construction on the bodies of water will be done under a separate contract. The construction work is expected to commence in summer 2009, and to be complete in 2013.

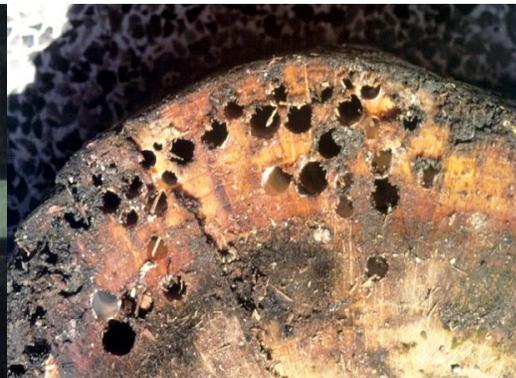
Teredo Damage (holes up to ¼" diameter)

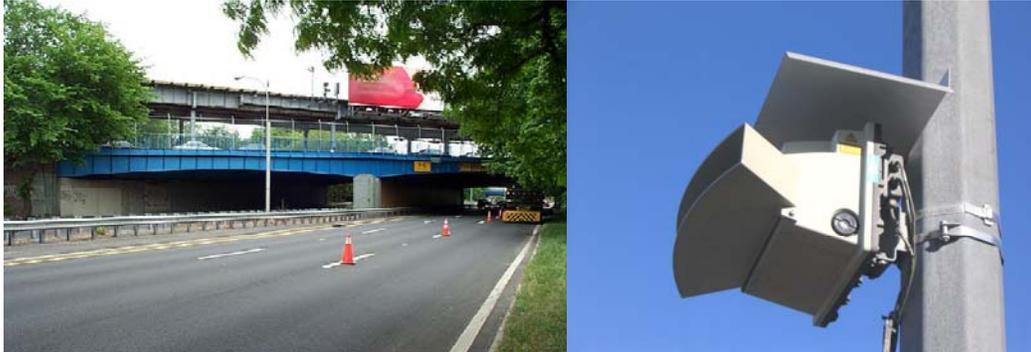
Westchester Avenue Bridge in 2001. (Credit: NYSDOT) Overheight Sensor Unit on the Hutchinson River Parkway. (Credit: Roly Parroco)

The Westchester Avenue Bridge's vertical clearance over the Hutchinson River Parkway is sub-standard. Due to the number of truck and bus vehicles that mistakenly enter the Hutchinson River Parkway, where commercial vehicles are not allowed, the fascia steel girders of the bridge have been severely impacted and damaged numerous times. The planned lowering of the parkway will make it possible to eliminate the existing sub-standard vertical clearance of the bridge over the parkway without adversely impacting the NYCT elevated structure and its transit train operations. The total length for the lowering of the parkway will be 1000 feet (north and south), with a maximum lowering of the parkway of 2.5 feet under the Westchester Avenue Bridge.

The rehabilitation of the bridge will include the replacement of the existing reinforced concrete deck slab with a new reinforced concrete deck, steel faced curbs, a new parapet wall and

protective screenings, concrete sidewalks, rehabilitation of the damaged steel fascia girders, and replacement of the diaphragms and other bridge elements, including a new steel water main.

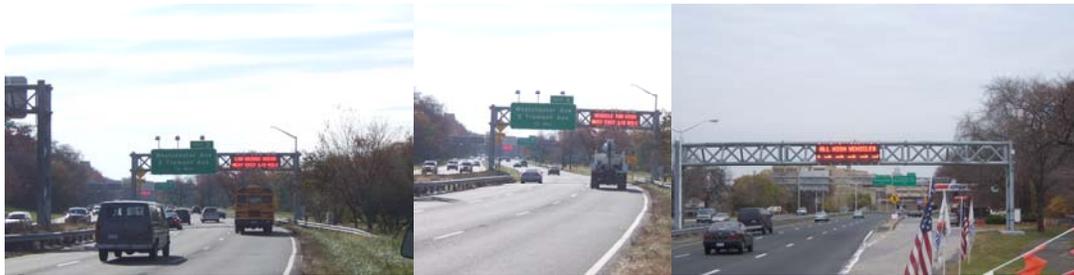
New Vehicle Detection System.

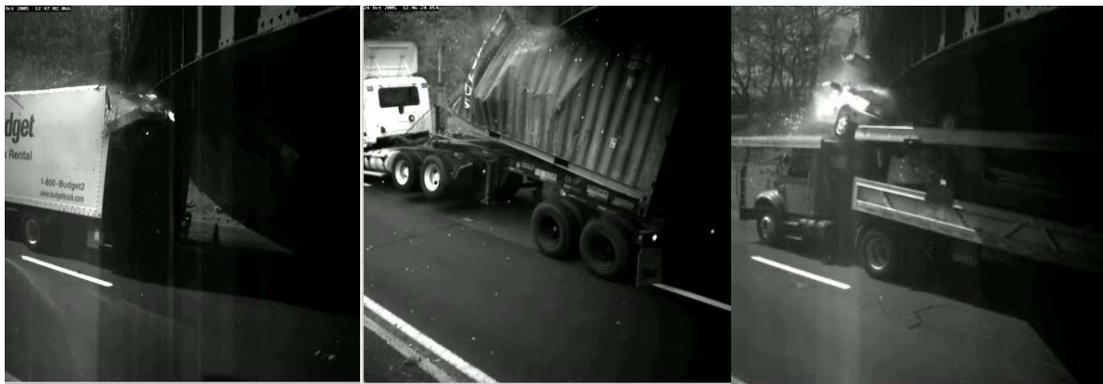
Video Stills From the Westchester Avenue Bridge BDSS.

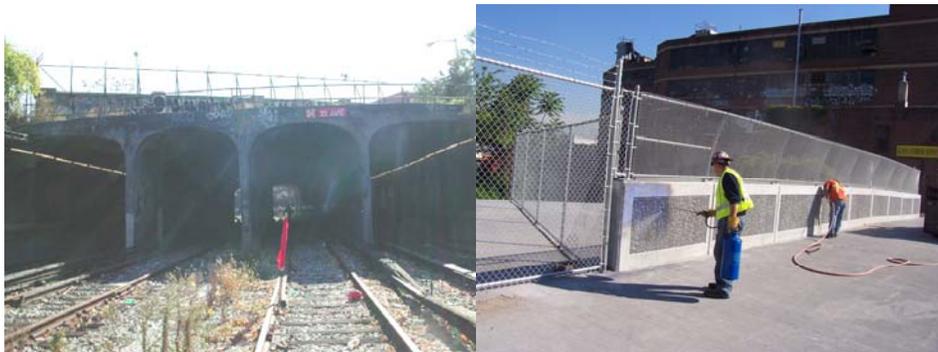
A Notice to Proceed for the \$17.7 million reconstruction of these four bridges was issued to the contractor with a start date of September 29, 2003. The 15th Avenue Bridge is an arch barrel bridge, constructed in 1912-1913 between 63rd and 64th Streets. Age, weather and increased traffic had affected the bridge. The roadway slab, concrete abutments and concrete piers were severely deteriorated. The bridge had outlasted its useful life. The scope of this project included the removal of the existing pavement, sidewalk, piers, columns, roof beams, portions of the abutments and the concrete arches over the NYCT tracks. The reconstruction included portions of the abutments, installation of precast reinforced concrete pier wall and deck panels, construction of a reinforced concrete deck on top of precast deck panels, and the installation of a 300 mm water main, 408 mm gas main and electric facilities. The approach slabs and bridge joints were replaced. In addition, new roadways, sidewalks, steel faced curbs, and a concrete parapet with pedestrian fencing and street lighting were constructed. The 15th Avenue Bridge was substantially completed on February 8, 2005.

15th Avenue Bridge in 2002. (Credit: NYSDOT). Final Touches on Completed Bridge.

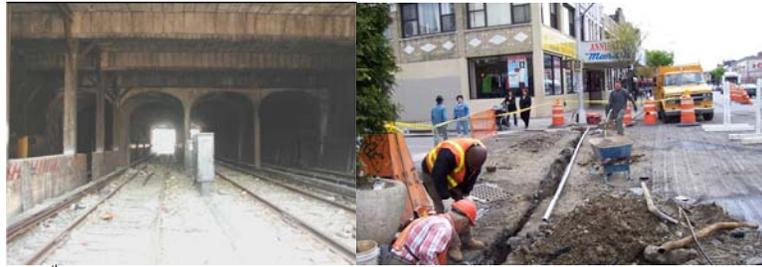
The 18th Avenue Bridge is also an arch barrel bridge, constructed in 1912-1913 between 63rd and 64th Streets. Age, weather and increased traffic had affected the bridge. The roadway slab, concrete abutments and concrete piers were severely deteriorated. The bridge had outlasted its useful life. The scope of this project included sewer work, the removal of a portion of the existing abutments, columns, roof beams, piers and the arches over the NYCT tracks. Cast-in place concrete piles, a steel superstructure, and new integral abutments were installed. The water main, gas main, and sewer were removed and relocated. A new concrete deck, approach slabs, and sidewalks were also part of this reconstruction project. The bridge was constructed in four stages, with one lane open in each direction at all times, as well as pedestrian access to local businesses. The 18th Avenue Bridge was substantially completed on May 16, 2005.

18th Avenue Bridge in 2003. (Credit: NYSDOT) Bridge Nearing Completion.

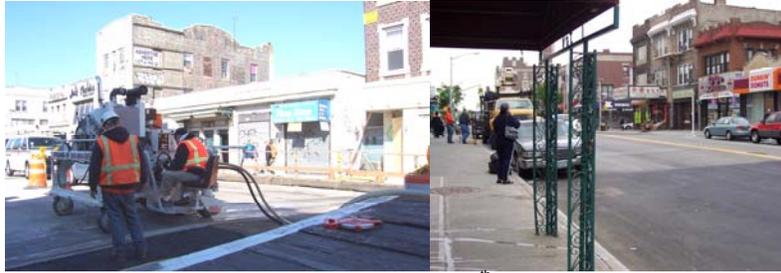
Finishing the Road. Completed 18th Avenue Bridge.

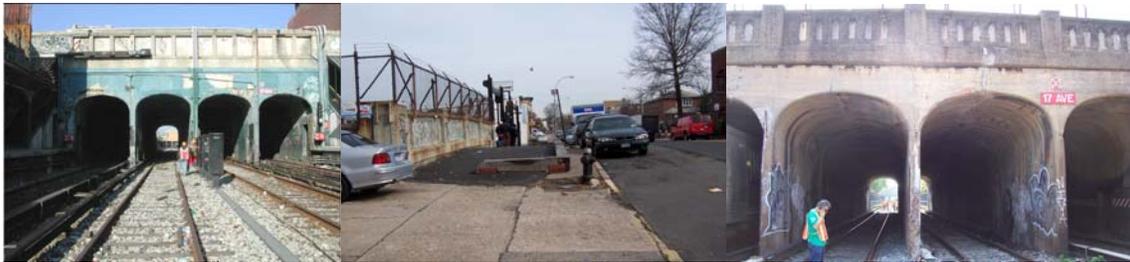
17th Avenue Bridge in 2002. (Credit: NYSDOT) Prior to Reconstruction in 2005.
Inspecting the Bridge Before Construction.

Similar construction at the 17th Avenue and 20th Avenue Bridges began after the completion of the 15th and 18th Avenue Bridges. The reconstruction of the 17th Avenue Bridge began on May 17, 2005. Effective July 13, 2005, the bridge was closed to vehicular traffic. The work included the demolition of the existing concrete arch superstructure and the existing concrete piers to top of footings. The superstructure was replaced with a new four span reinforced pre-cast pre-stressed rigid frame with new reinforced pre-cast pre-stressed concrete piers and slabs. Utilities were upgraded by installing additional 300 mm water main, gas main and electrical ducts. The bridge was re-opened to vehicular and pedestrian traffic on December 13, 2005, 29 days ahead of schedule. The 17th Avenue Bridge was substantially completed on February 24, 2006. The sidewalks were reopened to pedestrian use 16 days ahead of schedule earning the contractor the maximum incentive payment of \$150,000. The total 17th Avenue Bridge project was completed 45 days ahead of schedule.

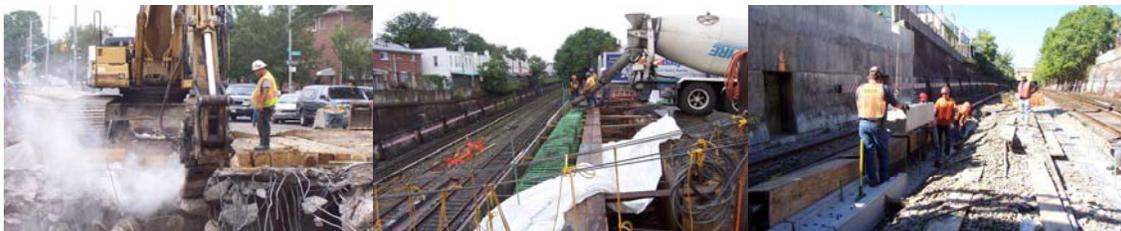
Demolition of the 17th Avenue Bridge Deck. Casting the New East Abutment Wall.
Installing Precast Concrete Footings.

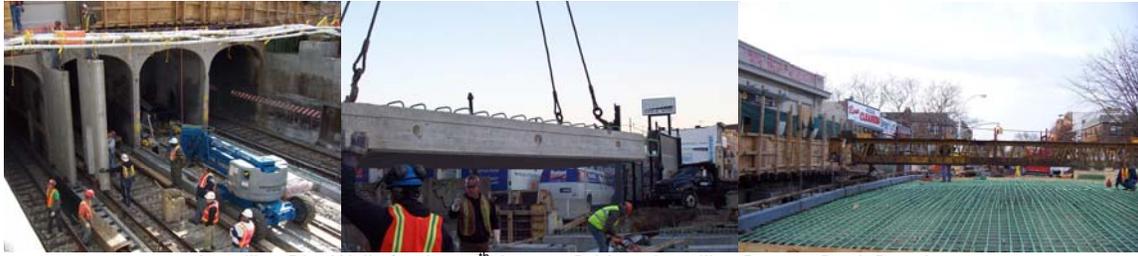
Installing Pier Walls for the 17th Avenue Bridge. Installing Precast Deck Panels.
Placing the Reinforced Concrete Bridge Deck.

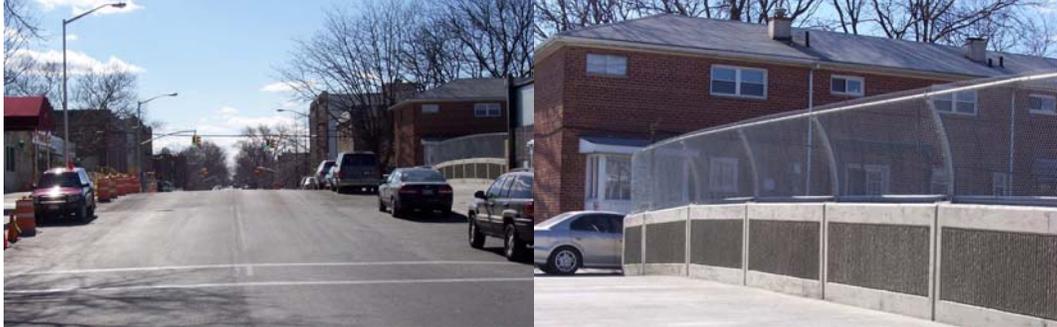
Completed 17th Avenue Bridge and Fence.

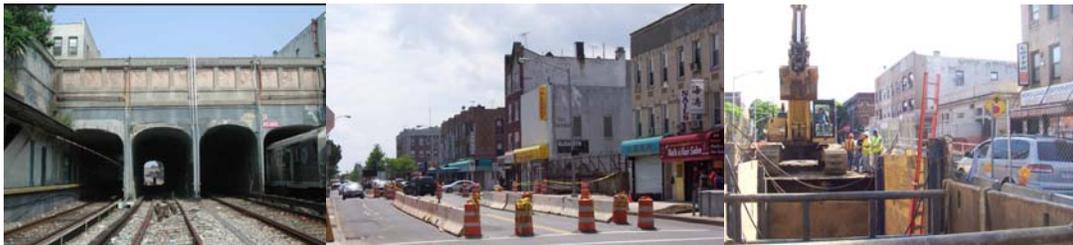
20th Avenue Bridge in 2002. (Credit: NYSDOT) Initial Bridge Staging in May 2006. Stage I Sewer Work in 2006.

Work on the 20th Avenue Bridge began on May 15, 2006 after the utility company performed extensive work on the gas main. The bridge was completed in fall 2008. The scope of this project included the demolition of the existing six span reinforced concrete arch superstructure and replacing it with a single span integral abutment reinforced-concrete composite superstructure. Work was performed on the bridge in stages, maintaining two lanes traffic flow on 20th Avenue at all times. Utilities were upgraded by installing new combined sewer pipes, manholes, and a water main.

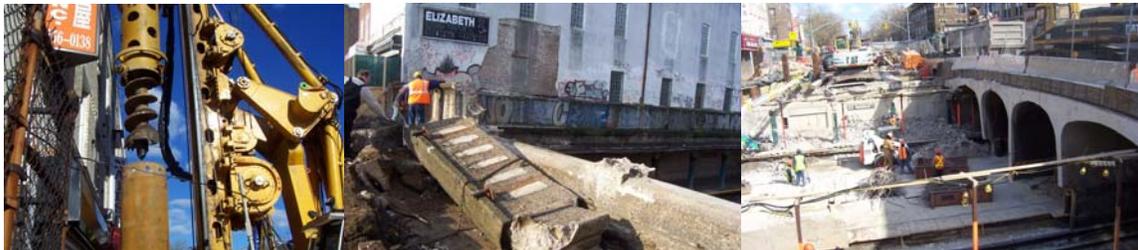
Removing the 20th Avenue Bridge Arch Overburden in January 2007. Bridge demolition in February 2007.

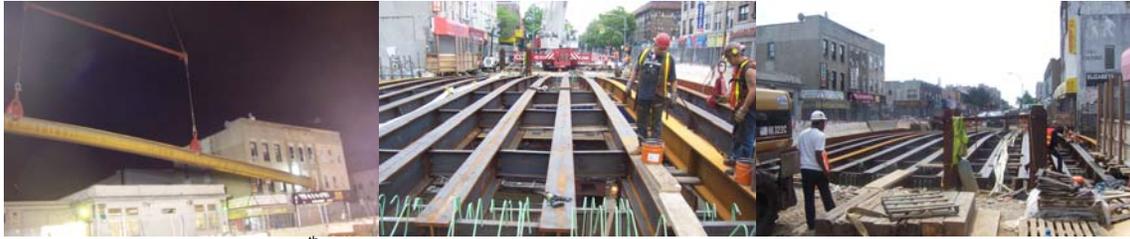
20th Avenue Bridge Structural Steel Erection in August 2007.

At the end of 2007, the contractor had completed sewer work, pile driving for the new abutments, soldier piles and lagging. The installation of steel girders and new abutments for the north side of the bridge was also complete, and installation of stay-in-place deck forms and gas main work was in progress.

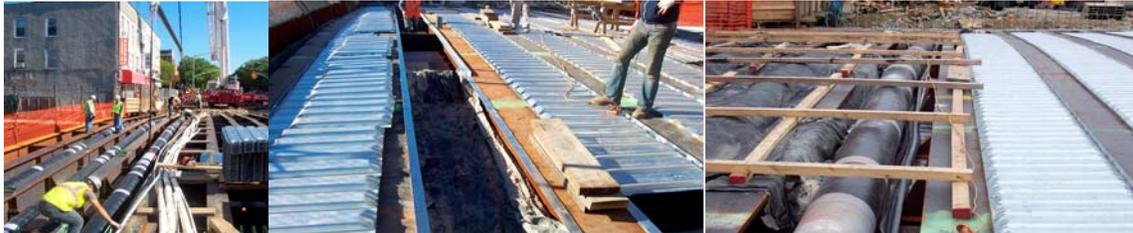
Installing the Gas Main Under the 20th Avenue Bridge North Sidewalk in September 2007. Installing Metal Forms for the Bridge Deck in November 2007. Gas Mains Prior to Modification in December 2007.

Deck rebar installation was completed on February 4, 2008, and concrete placement began on February 7, 9, and 10, 2008. Concrete was placed for the west approach slab on February 27, for the north bridge sidewalk on March 3, the west roadway base on March 4, the east roadway concrete base on March 7, and the east and west sidewalks of the north bridge on April 8, 2008. The contractor completed construction of the lagging walls on both sides of the bridge on May 29 and completed demolition of the eastern half of the bridge over the weekend of May 31, 2008. On June 16, concrete was poured for the abutment bearing piles. The remaining six steel girders over NYCT tracks were erected on July 12, 2008. The concrete placement for the bridge deck was completed on August 18, 2008.

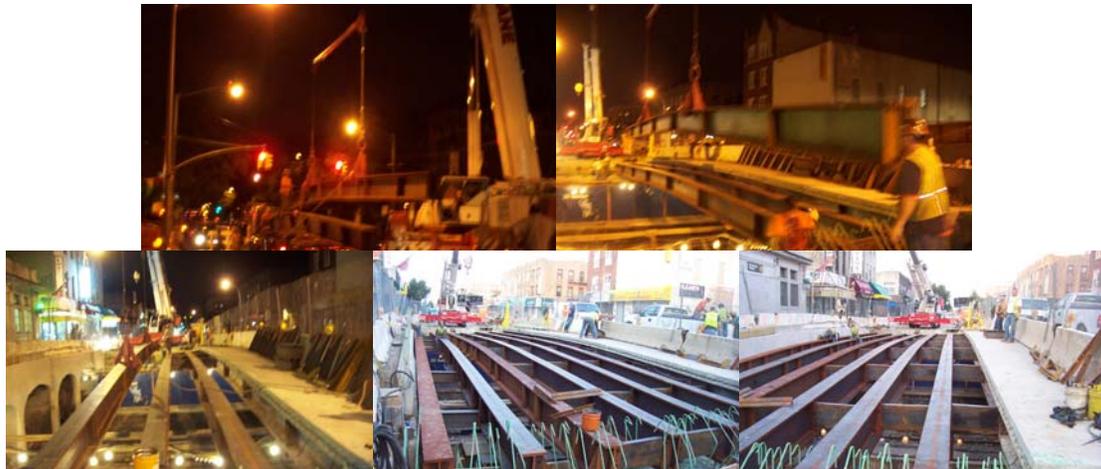
Erecting Steel Stringers on the 20th Avenue Bridge in July 2008.

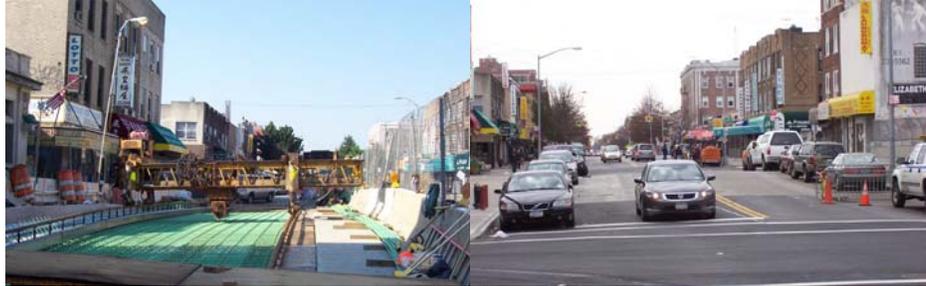
Installation of Slab Rebars in August 2008. New Bridge Open to Traffic.

The 20th Avenue Bridge was substantially completed on November 20, 2008.

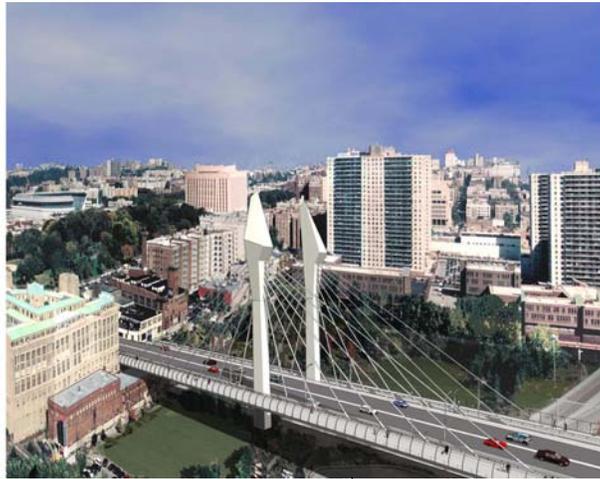
Rendering of New 153rd Street Bridge

This project, currently in the final design stage, will construct a two-span, single tower, cable stayed vehicular bridge. It will be the first of its kind in New York City. The new four lane bridge will extend East 153rd Street in the Bronx across the Mott Haven rail yards from Morris Avenue to the Grand Concourse just north of Hostos Community College in the Melrose Section of the Bronx. This bridge will complete a link the street lost in the early 1980's when the old turn-of-the-century bridge was closed and demolished because of its age and deterioration. Construction of the new bridge is tentatively scheduled to begin in the spring of 2014 and be completed by the end of 2017.

lanes will be located on cantilever sections outside of the towers. This will reduce the overall depth of the superstructure by reducing the floor beam depths.

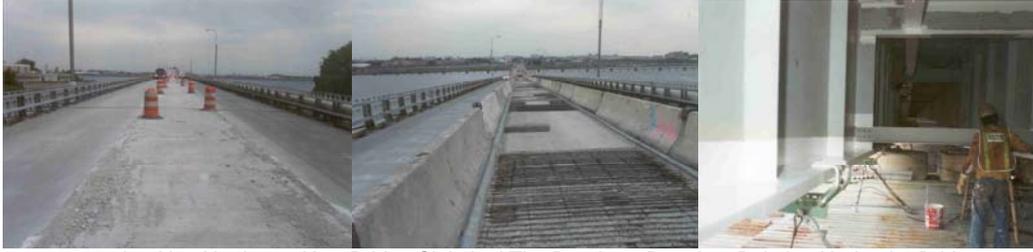
2006: Looking North at a New Bridge Slab And The Roadway Repairs. Painting Under the Bridge.

The project work was expanded to include superstructure painting, various superstructure repairs, and repairs of the pier caps. The rehabilitation of the bridge deck was substantially completed on December 22, 2006. The painting was completed in 2006, and all of the other repairs were completed in summer 2007. This rehabilitation will allow the extension of the bridge's useful life to at least 2017, when the existing bridge will be replaced.

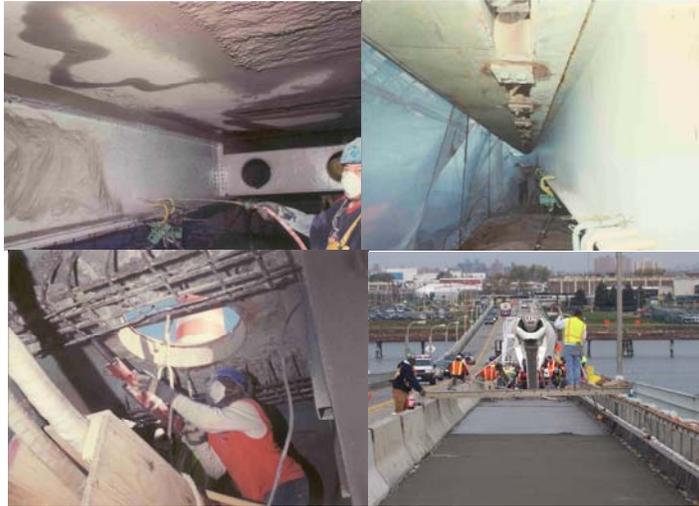
2006: Performing Underdeck Repairs. Working Inside the West Rebar Box Frame. Beam Repair. Concrete Placement.

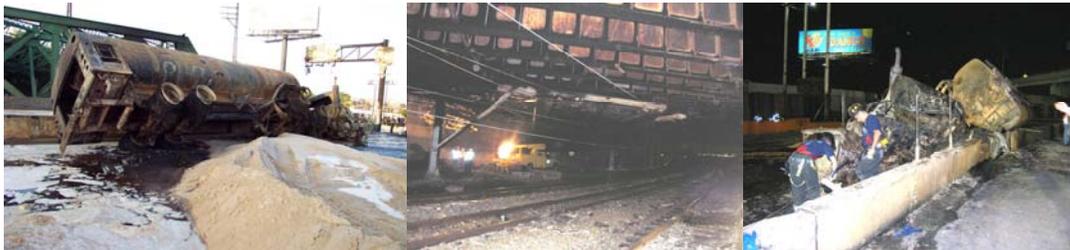
2005: The Tanker Truck. Repairs and Cleanup. (Credit: Bojidar Yanev)

samples of the concrete from the fire-affected deck were tested. Division crews assisted in emergency repairs and clean-up, re-setting all expansion plates on the abutment, and performing deck repair. The crews worked continuously, and the roadway was reopened in time for the morning rush hour on October 6, 2005.

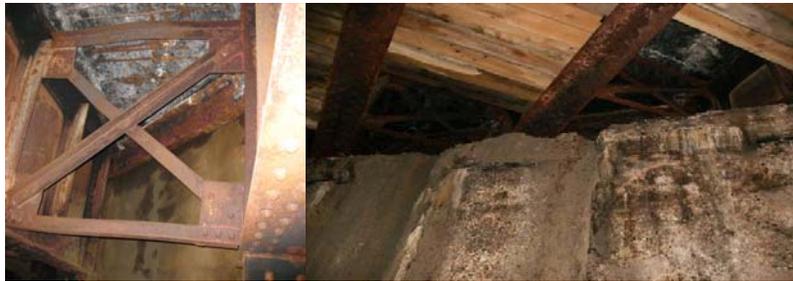
Deteriorated Bridge Deck With Exposed Rebar and Warped Steel Bracing Due to the Heat From the Fire. Timber Shielding on the Underside of the Bridge.

To protect the trains and railroad facilities below the bridge after the October 4, 2005 tanker truck fire, contractor crews began the nighttime installation of protective timber shielding under the bridge on October 5, 2005. The project was completed on November 8, 2005. The Division's Surveying Unit assisted the Inspections Unit in monitoring the deflection of the bridge.

The fire on the bridge weakened its members. While the immediate results of the fire were addressed by in-house forces, the aftereffects remain unresolved. The most recent inspection conducted on September 14, 2006 revealed that at least four girders have sagged and they are hit by CSX railroad cars below. The concrete deck has separated from the steel girder and there is a one to two inch gap between the top of the flange and the bottom of the haunches. In addition, the diaphragms between the girders have been burned and their capacity has been weakened. Repairs requiring immediate attention were handled by the When and Where contractor. The contractor installed additional timber bracing of the bridge's timber shielding in January and February 2007, performed emergency removal of loose underdeck concrete in July and August 2007, and repaired a red flag condition at the bridge stringers in September 2007. This will be followed up by the replacement of the bridge's northbound superstructure and the southbound deck, which will be done under a Design-Build contract. A Notice to Proceed was issued to the contractor with a start date of October 27, 2008. Construction is expected to be complete in November 2010. The bridge carries approximately 140,000 motorists and pedestrians per day.

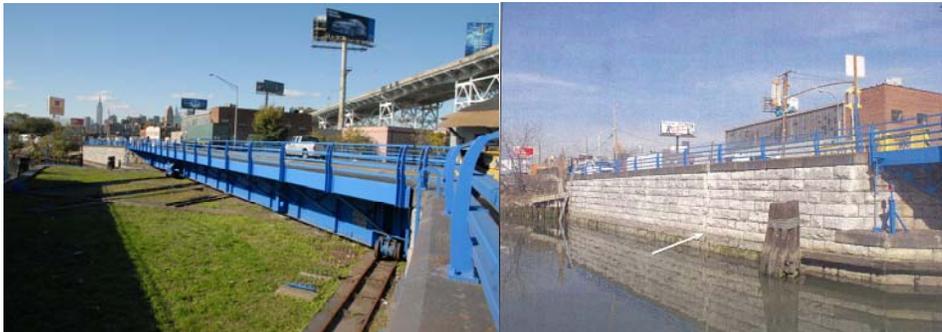
Borden Avenue Bridge. (Credit: Peter Basich) General View of the Crack in the Wingwall.

In the spring of 2008, the Department determined that an existing crack in the west abutment's wingwall had opened up further. Following a series of subsequent inspections, it was determined that there is continuing movement of the west abutment wall. In an effort to mitigate this condition, two pressure relief joints were installed in the roadway, and the speed limit for eastbound traffic was posted at 15 miles per hour. Unfortunately, these measures did not stop or slow the abutment wall's movement.

On September 11, 2008, the Department and its consultant met to discuss the problem, and it was determined that there were two possible solutions: either to install a tieback-supported anchoring system, which would restrain the west abutment wall's movement, or, to fully replace the bridge's west abutment wall and its wingwalls. The Department would not be able to determine which solution would be the best long-term solution until detailed inspections of the abutment wall and wingwalls were performed.

In early 2009, based on the findings of the underwater inspection, the consultant provided its recommendation to the Department to proceed with the second option, and the Department concurred.

The movement of the wall is undermining the stability of the bridge. Due to the potentially serious danger to life, public safety and property posed by the current condition, it is critical that the repair work be performed as expeditiously as possible.

The repairs will include the following: removal of the fill material under the roadway and sidewalks from behind the west abutment and between the wingwalls; relocation of the existing utilities; digging of a test pit to inspect the supporting piles; inspection of the condition and the taking of measurements; and the implementation of the appropriate repair solution based on the inspection findings.
