INNOVATIONS & ACCOMPLISHMENTS

East River Bridges

A \$3.47 billion reconstruction program is underway to rehabilitate all four East River crossings. In 2007, these bridges carried some 496,666 vehicles per day. In 2002, working in coordination with the NYPD and other law enforcement agencies, the Division implemented enhanced security measures on these bridges. This work is ongoing.

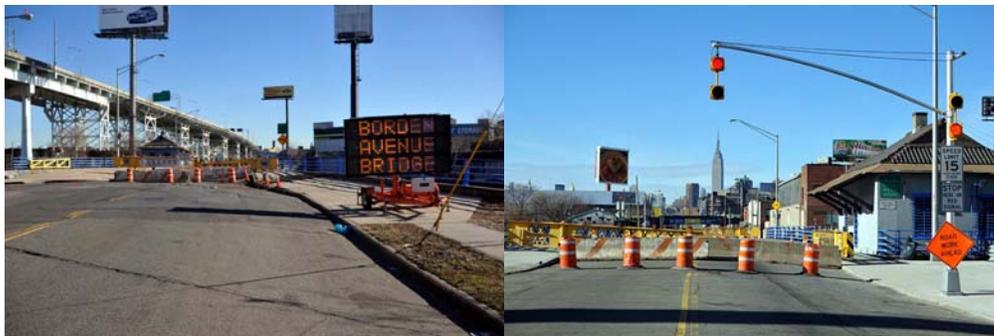
Borden Avenue Bridge Closed for Emergency Repairs. (Credit: Bernard Ente)

In the spring of 2008, the Department determined that an existing crack in the west abutment's wingwall had opened up further. Following a series of subsequent inspections, it was determined that there is continuous movement of the west abutment wall. In an effort to mitigate this condition, two pressure relief joints were installed in the roadway, and the speed limit for eastbound traffic was posted at 15 miles per hour. Unfortunately, these measures did not stop or slow the abutment wall's movement.

The repairs will include the following: removal of the fill material under the roadway and sidewalks from behind the west abutment and between the wingwalls; relocation of the existing utilities; digging of a test pit to inspect the supporting piles; inspection of the condition and the taking of measurements; and the implementation of the appropriate repair solution based on the inspection findings.

The bridge was closed at noon on December 31, 2008. A Letter of Intent for the emergency repair of this bridge was issued to the contractor with a start date of January 6, 2009. Construction is expected to be complete by June 2009.

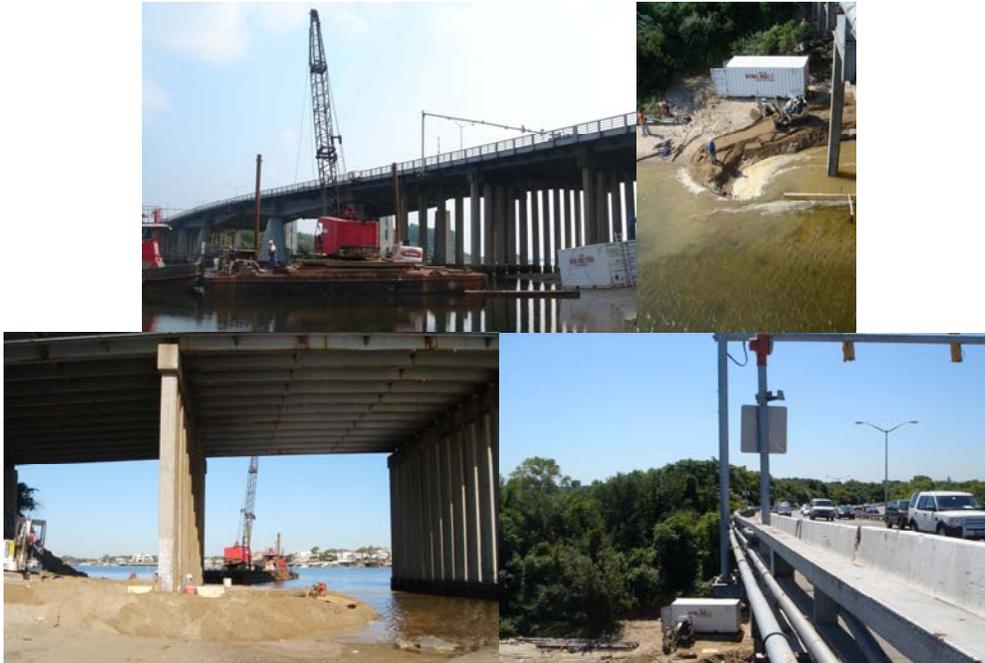
Mobilizing the Barge and Container. Installing the Barrier Wall Around Columns 13 and 14. The Barrier Wall System at Low Tide. General View of Belt Parkway over the Work Area Below. (Credit: Thomas Leung)

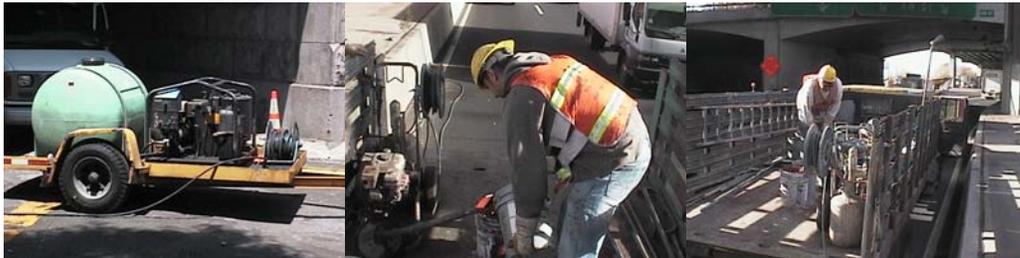
Pressure Washing Machine Used for Graffiti Removal. It is Set to 2500 psi and 212° F. Bridge Painters Frank Duic and Russell Newme Feeding the Spray Pump and Preparing the Paint.

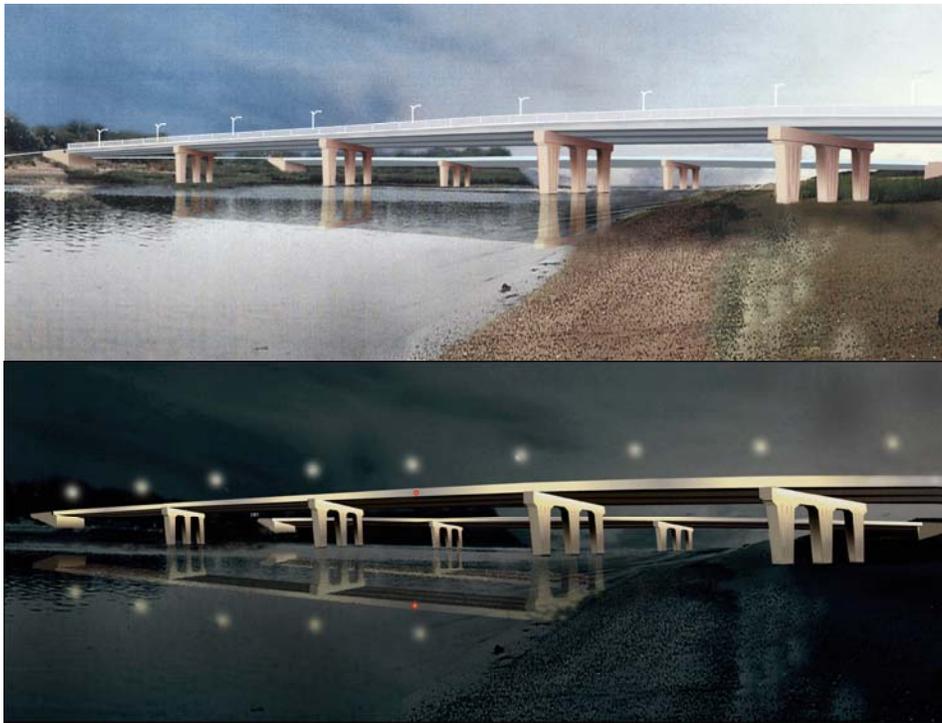
Rendering of New Belt Parkway Bridge Over Paerdegat Basin, In Daylight, and Under Nightly Illumination. (Credit: Alexander Berens)

Projects underway in 2008 included the Belt Parkway Bridge over Paerdegat Basin in Brooklyn. The existing bridge with its nest of thirteen piers will be replaced in its entirety by two split bridges, one each for eastbound and westbound traffic. The bridge for eastbound traffic will have four piers whereas the bridge for westbound traffic will have two piers. This is the first bridge to be designed by NYCDOT with trapezoidal steel box girders utilizing high performance steel and seismic isolation sliding bearings. In addition, the aesthetics of the bridge will be enhanced by its nightly illumination utilizing light emitting diodes on both fascias and piers. This project will also include wetland mitigation and landscaping in the immediate vicinity of the proposed bridges. The design phase of this project is now complete, and it will be constructed together with two other adjacent bridges in the Belt Parkway Corridor as a combined contract.

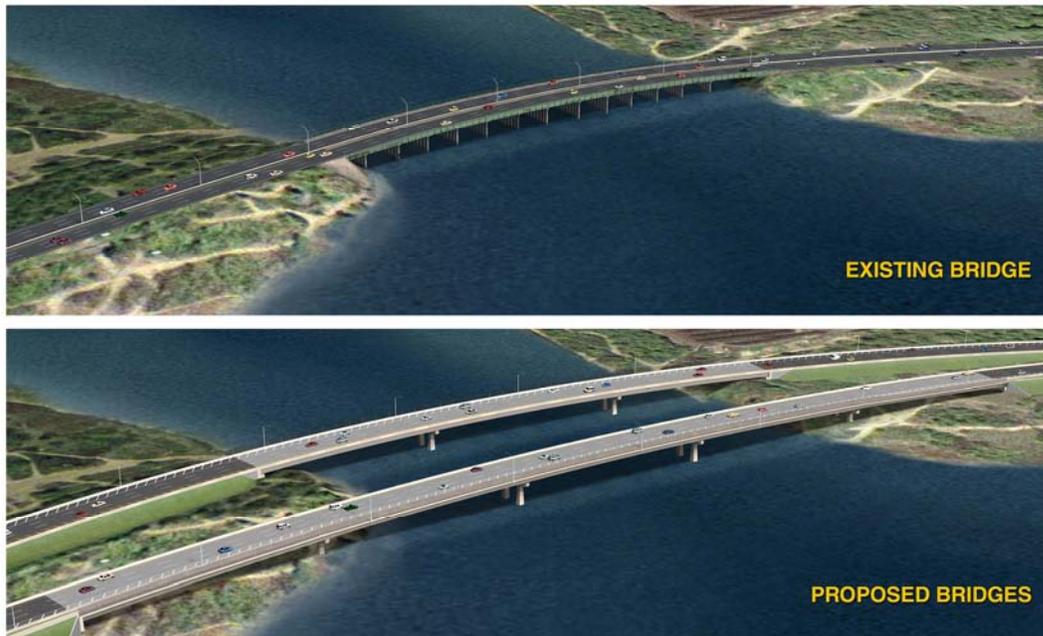
Rendering of Existing and Proposed Belt Parkway Bridges Over Paerdegat Basin. (Credit: Alexander Berens)

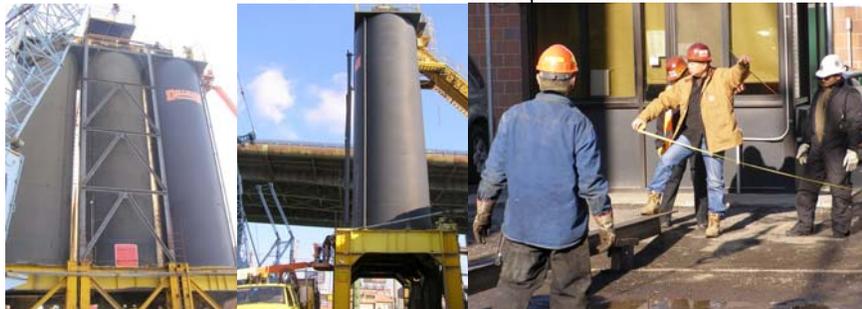
Erecting the New Support System. (Support System Credit: Hany Soliman) Measuring the Steel: Bridge Repairer & Riveters David Collins and Yiu Liu, and Assistant Civil Engineers Clara Medina (Obscured) and Hany Soliman. (Credit: George Klein)

In late 2007, the existing support system for the conveyor platform of the Roadway Repair and Maintenance Division's Hamilton Avenue Asphalt Plant exhibited some settlement. This rendered the plant inoperable. Our staff was requested to perform the urgent total design of a new support system. The Surveying Unit conducted field measurements of the damaged structure on December 7, 11, 20, and 21, 2007. Within two weeks, the In-House Design staff designed the system and prepared fabrication drawings for the Bridge Maintenance, Inspections and Operations Bureau. The Division's In-House Repair personnel then fabricated and installed the side frames, bracings, and I-beams necessary to restore operations at the facility. Additional emergency repairs were also made to the drum, conveyor belt, and hopper. Upon completion, Division bridge painters painted the new steel. The plant is now operational and 400 tons of asphalt were processed on January 21, 2008.

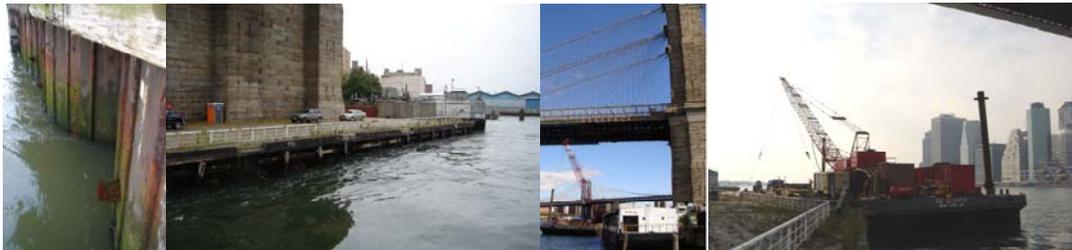
Holes in the Steel Sheet Cofferdam of the Brooklyn Bridge Esplanade in April 2007. View of the Work Area in October 2007. The Barge and Equipment Used on the Steel Cofferdam Repairs. (Credit: Thomas Leung)

The project was subcontracted to a specialized marine contractor to perform underwater weld patching to plug up numerous holes in the existing steel cofferdam sheeting, thus preventing further loss of the existing fill material. Immediately after the steel sheets were patched, the contractor removed the paving blocks and stored them at an Agency maintenance facility. Then new good fill material was placed and compacted in the voided areas. In addition, specialized flowable concrete fill was placed under the existing concrete walkway as a buttressing wall abutting the patched steel cofferdam. The entire area of the promenade was then backfilled, tamped and graded to the level of the existing paving blocks. The site was then turned over to the outside contractor who installed a concrete foundation and the waterfall structure over the area we prepared. The When and Where contractor completed the work on March 10, 2008. The waterfall contractor erected the tower structure, and the attraction opened on June 26, 2008.

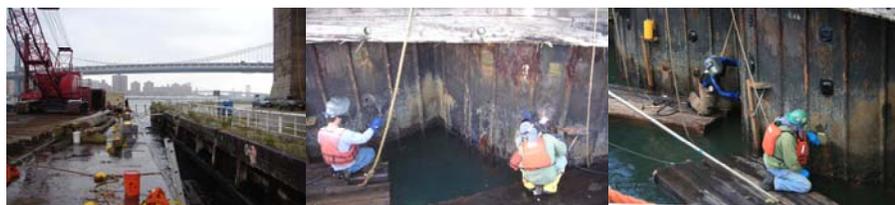
October 2007 - View of the Barge Equipment Blocking the East River Waves and Protecting the Crew Patching the Steel Wall. Dockbuilders Preparing Holes Prior to Welding Steel Patches on the Existing Cofferdam. Dockbuilders Applying Splash Zone Compound Over the Welded Steel Patch Plates. (Credit: Thomas Leung)

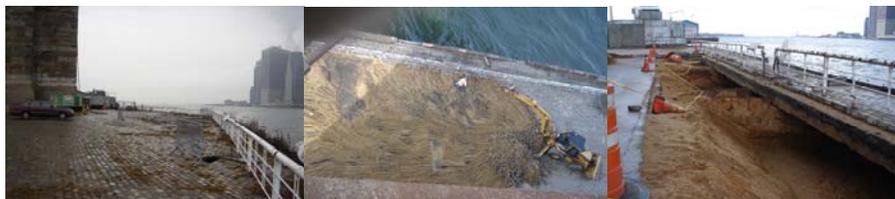
View of the Pavers Before Work Began to Stabilize the Area in December 2007. January 2008 - Top View of Backhoe Removing the Paving Blocks. Excavated Promenade Revealing the Exposed Steel Cofferdam Under the Concrete Walkway. (Credit: Thomas Leung)

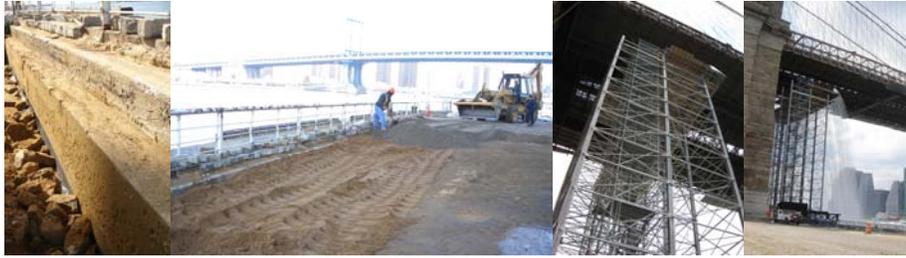
New Concrete Fill Material Under the Sidewalk in February 2008. Excavated Area Backfilled With Sand and Crushed Stone as Top Layer in March 2008. (Credit: Thomas Leung) Waterfall Structure Under Construction in May 2008. (Credit: Russell Holcomb) View of the Structure From the Brooklyn Side in June 2008. (Credit: Thomas Leung)

The man-made waterfalls ranged from 90 to 120-feet tall and were on view from June 26 through October 13, 2008. They were lit each night after sunset. The Waterfalls were made of common building materials, mainly scaffolding, pumps and piping. Water from the East River was collected in "intake filter pools", which were covered in fine mesh and placed underwater. These pools, which filtered the water, protected the fish and aquatic life because they could not penetrate the fabric. Pumps pulled water out of these pools and raised it from the river to the top of the scaffolding through pipes. Water was then pushed over a "trough," and fell back into the river creating a waterfall effect.

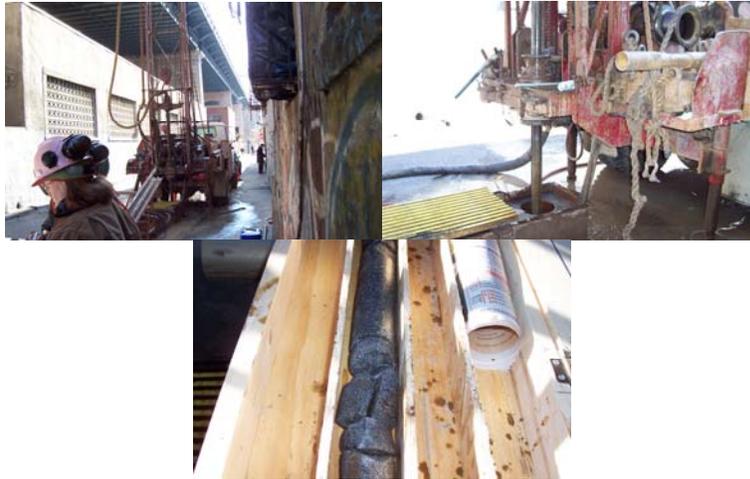
Conducting Soil Borings as Part of the Seismic Retrofit Design of the Manhattan Bridge. Drilling to a Depth of Approximately 210 Feet to Obtain an 8-foot Long Hard Rock Sample. A 2 1/2 -Foot Long Hard Rock Sample Taken From a Depth of Between 202 and 204 1/2 Feet.

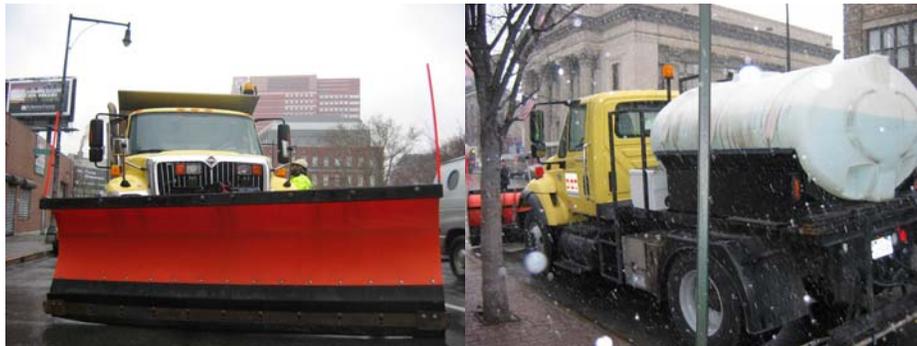
Anti-Icing Trucks. (Credit: Chris Gilbride)

New anti-icing yards storing both chemicals have been established under all four East River bridges. Supervisors monitor the bridge decks during storm events by traversing them and using thermal instrumentation installed in their vehicles to make informed decisions as to when to apply chemicals. GPS capabilities have been installed in key vehicles to assist supervisors with the decision making process.

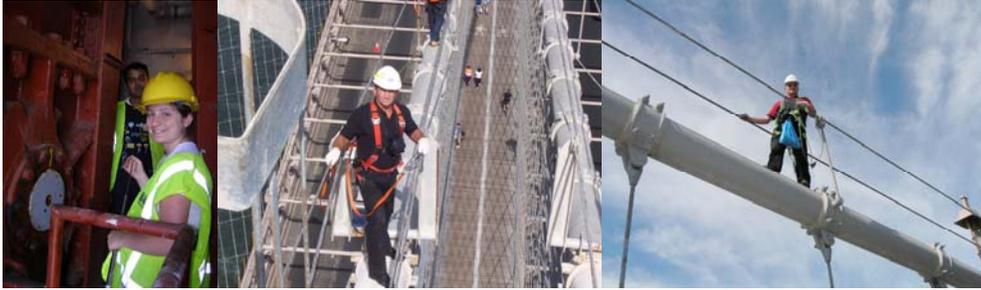
Summer Intern Samantha Shropshire and Mechanical Engineering Intern Shafqat Wasi Measuring the Main Pinion Shaft Displacement on the Pulaski Bridge in July 2008. (Credit: Vera Ovetskaya) Civil Engineer Gennadiy Kaplun Climbing the Brooklyn Bridge Cable in August 2008. (Credit: Anatoly Orlov) Assistant Mechanical Engineer Anatoly Orlov on the Cable. (Credit: Gennadiy Kaplun)

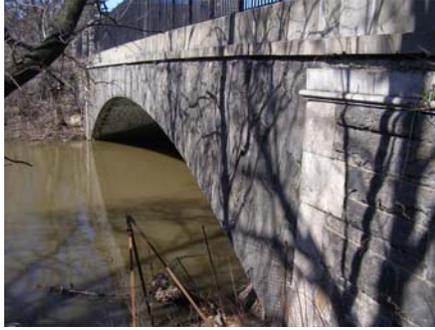
Snuff Mill Road Bridge is One of the Bridges Investigated for Scour Vulnerability and Found to be Structurally Sound, But it Remains Under Surveillance During Heavy Rains and Floods.

In 2008, the Research and Development Unit successfully used a new borescope and the acoustic emission equipment for monitoring inaccessible details at the Williamsburg Bridge, and the Bridge Inspection Unit retained consultants to inspect and evaluate the potential vulnerability to scour of bridges over the Bronx River.

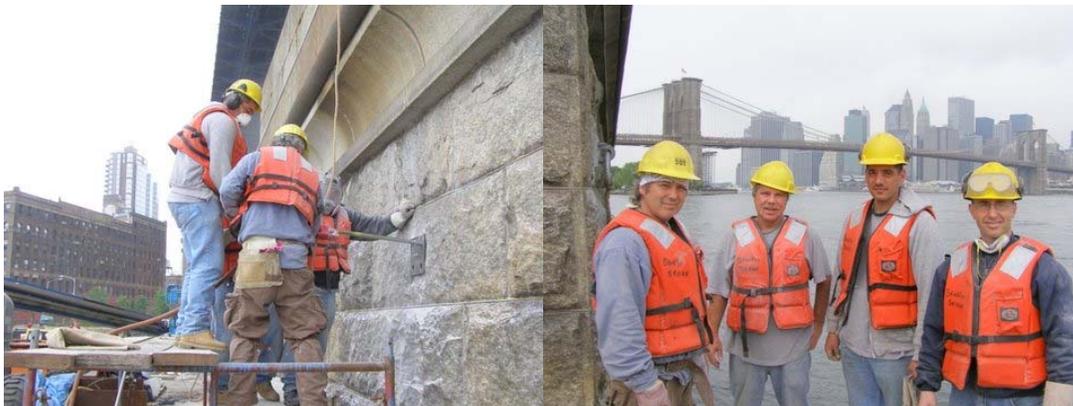
Cement Masons Installing Ladders and Mooring Rings for the FDNY on the Manhattan Bridge Towers. Cement Masons Victor Porowski, Paul Maguire, and Frank Finizio, and Bricklayer Vincent Sciulla. (Credit: Hany Soliman)

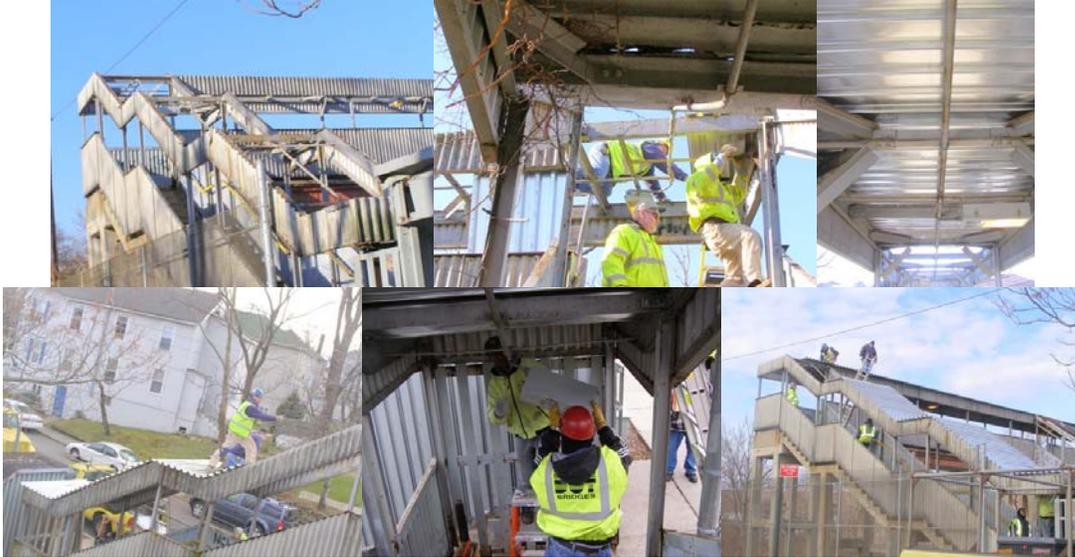
Carpenters and Electricians Replacing the Corrugated Roof and Lighting on the Bethel Avenue Pedestrian Bridge. Bridge View. Carpenter Michael Short III, Supervisor Carpenter John Motylewski, and Carpenter Mark Pavia. Roof Detail. Carpenter Pavia on the Roof. Electrician Gary Emmanuel and Supervisor Electrician Jose Done. Inspecting the Work: Carpenters Pavia and Short III, Supervisor Carpenter Motylewski, Carpenter John Green, and Electricians Emmanuel and Nelson Crooks. (Credit: Samuel Teaw)

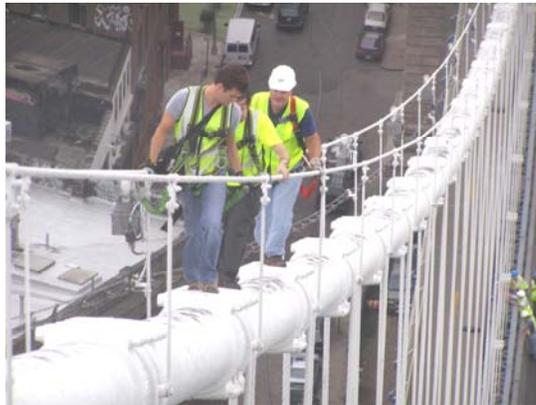
On September 8, 2008, Researchers From Columbia University and Engineer-In-Charge Brian Gill (at Right) Climbed the Manhattan Bridge and Installed Accelerometers and GPS Sensors to Monitor the Overall Dynamic Behavior of the Bridge to Improve Computer Modeling Techniques for a Possible Reduction of Seismic Retrofit Modifications. (Credit: Bojidar Yanev)
